Final Report

Corrosion Prevention of Bridge Tendons Using Flexible Filler Materials
BDV27-977-10

Submitted to
Florida Department of Transportation Research Center
605 Suwannee Street
Tallahassee, Florida 32399

November 2018

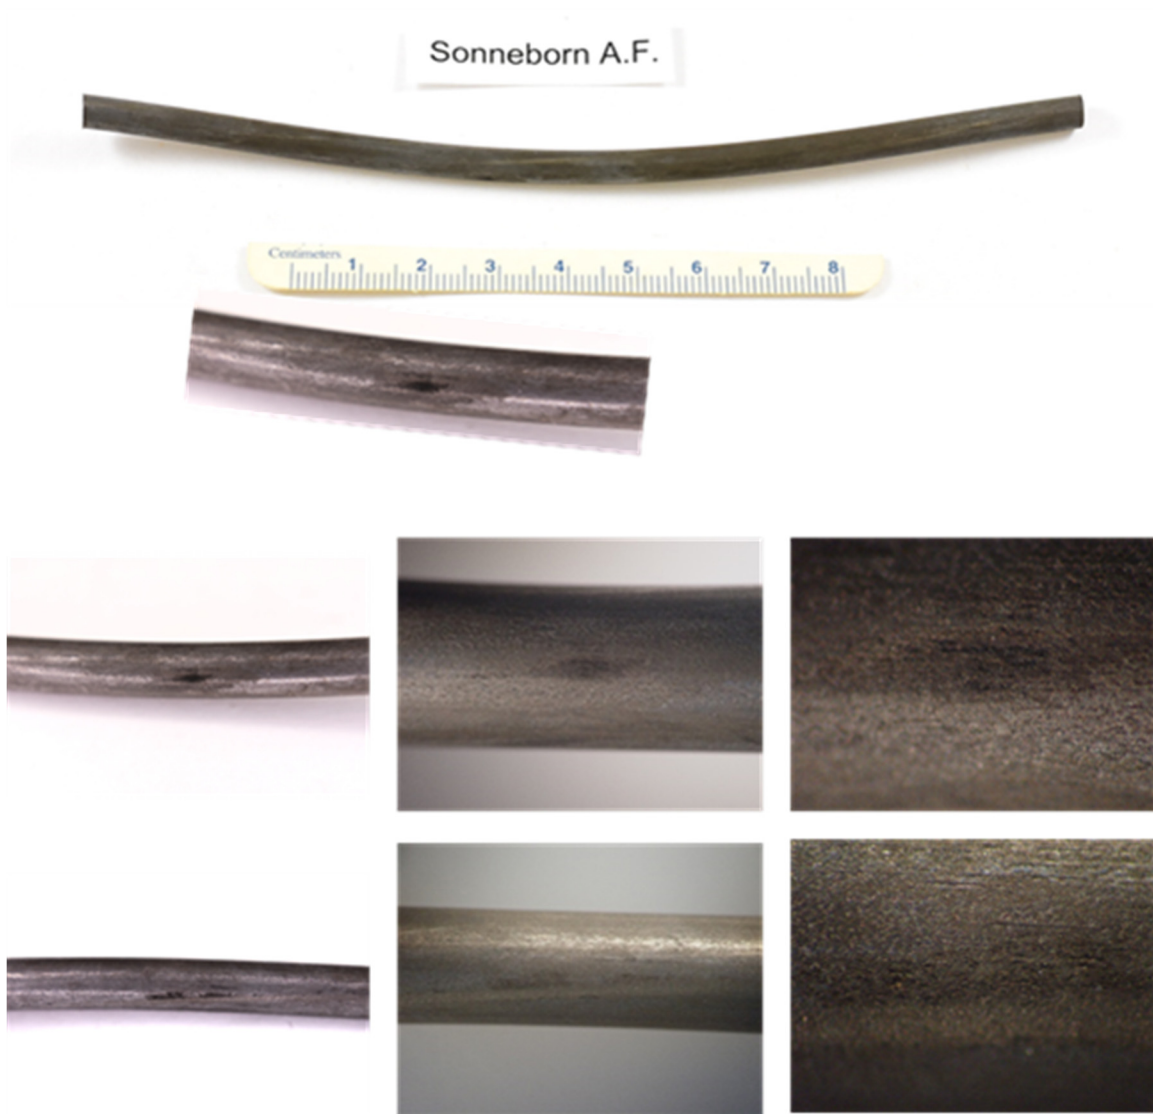
Figure 264. Coated with filler Sonneborn and sprayed with 0.6 milliliter of solution containing fungus AF (close-p view 1).

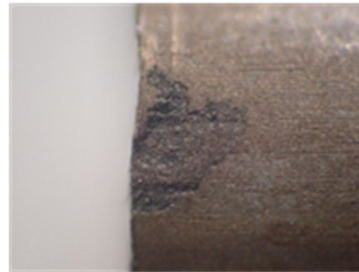
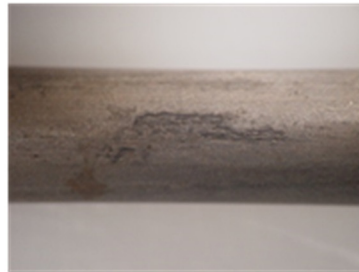
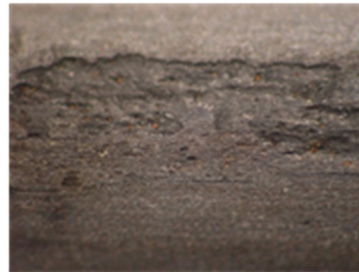
Sanchem A.F.

Figure 268. Coated with filler Sanchem and sprayed with 0.6 milliliter of solution containing fungus AF (close-up).

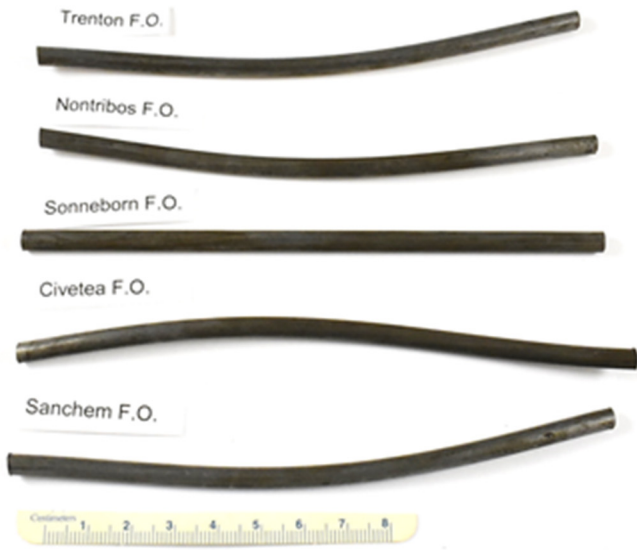
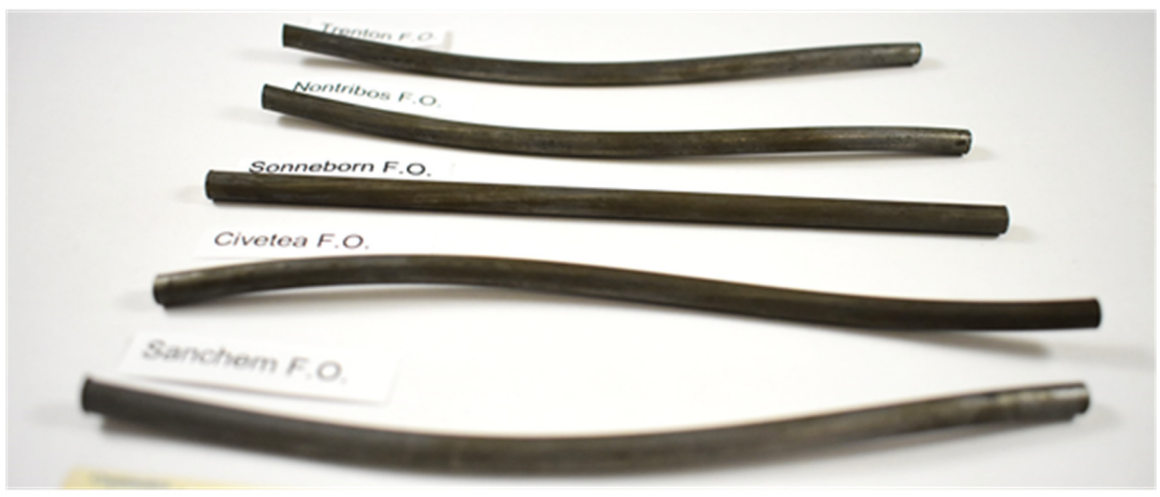
Figure 269. Coated with filler and sprayed with 0.6 milliliter of solution containing fungus FO

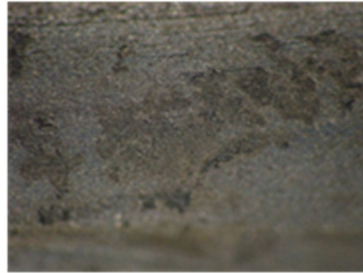
Figure 270. Coated with filler Trenton and sprayed with 0.6 milliliter of solution containing fungus FO (close-up 1).

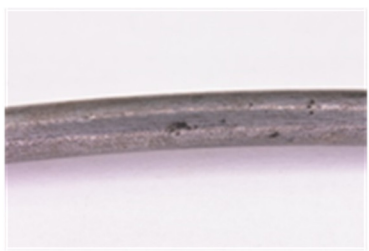
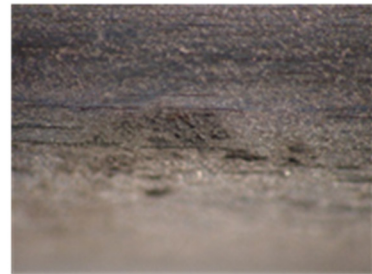
Figure 278. Coated with filler Sanchem and sprayed with 0.6 milliliter of solution containing fungus FO

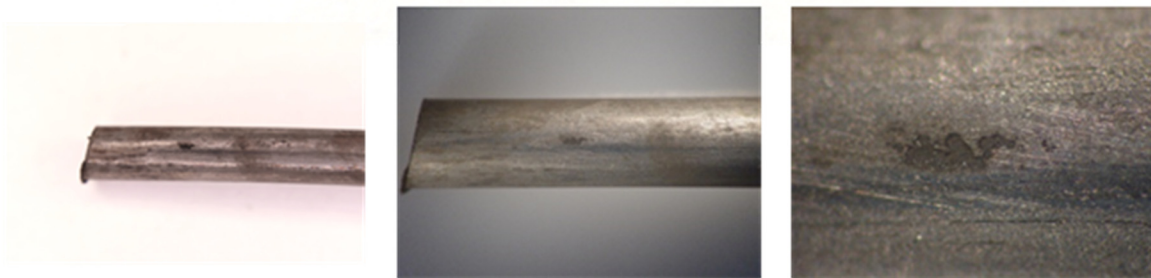
Figure 288. Coated with filler Sanchem and sprayed with 0.6 milliliter of water (close-up 1).

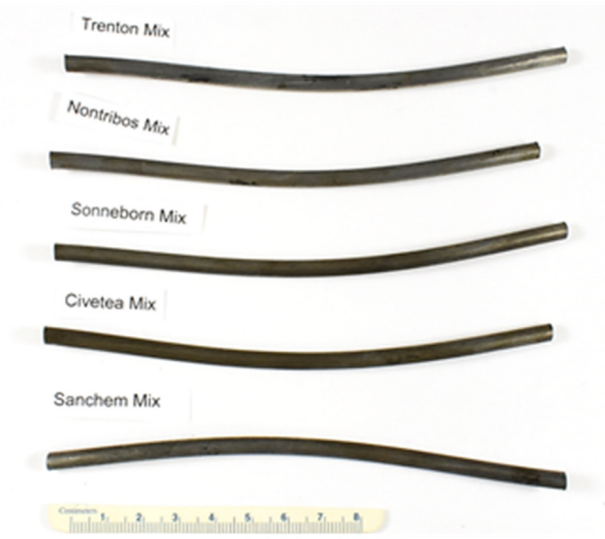
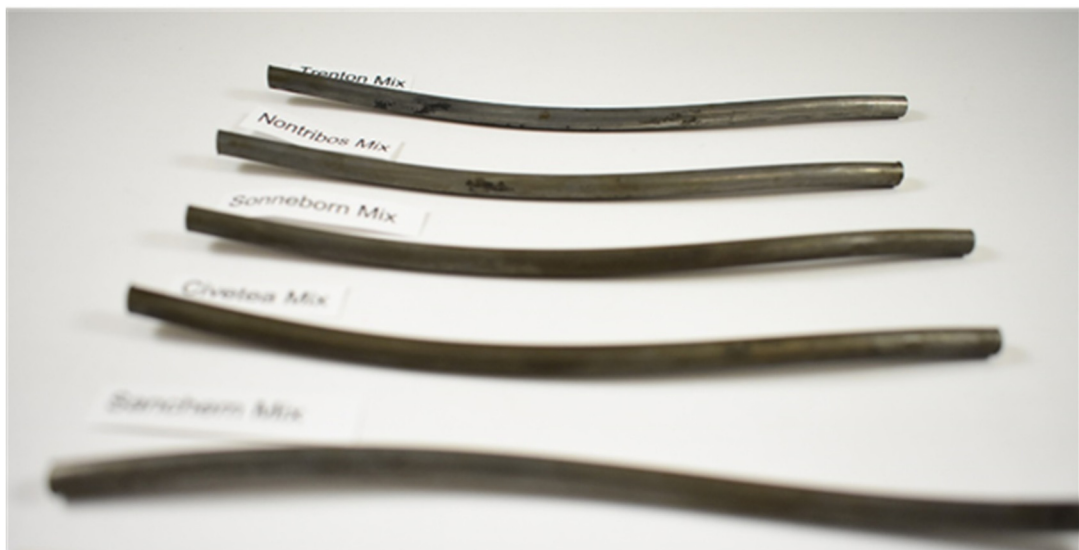
Figure 289. Coated with filler Sanchem and sprayed with 0.6 milliliter of water (close-up 2).

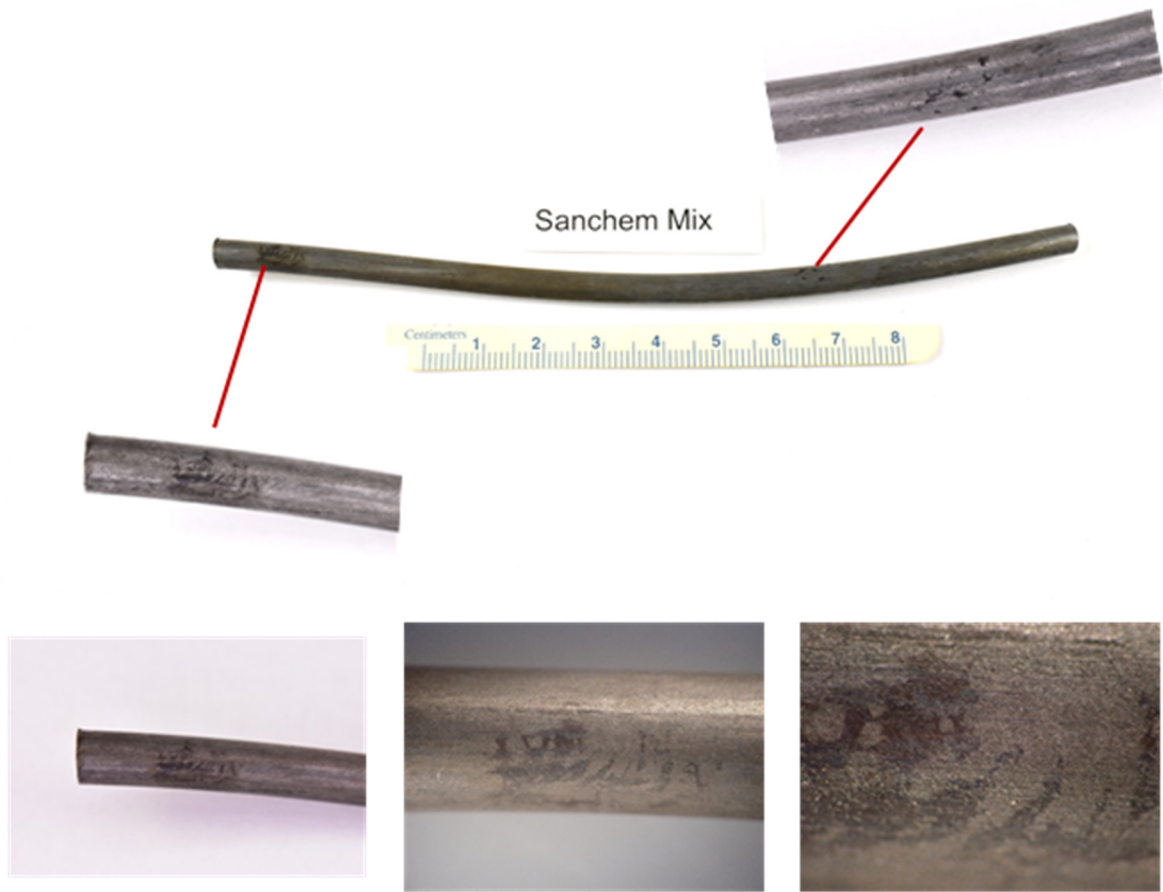
Figure 298. Coated with filler Sanchem and sprayed with 0.6 milliliter of solution containing fungi mix (close-up 1).

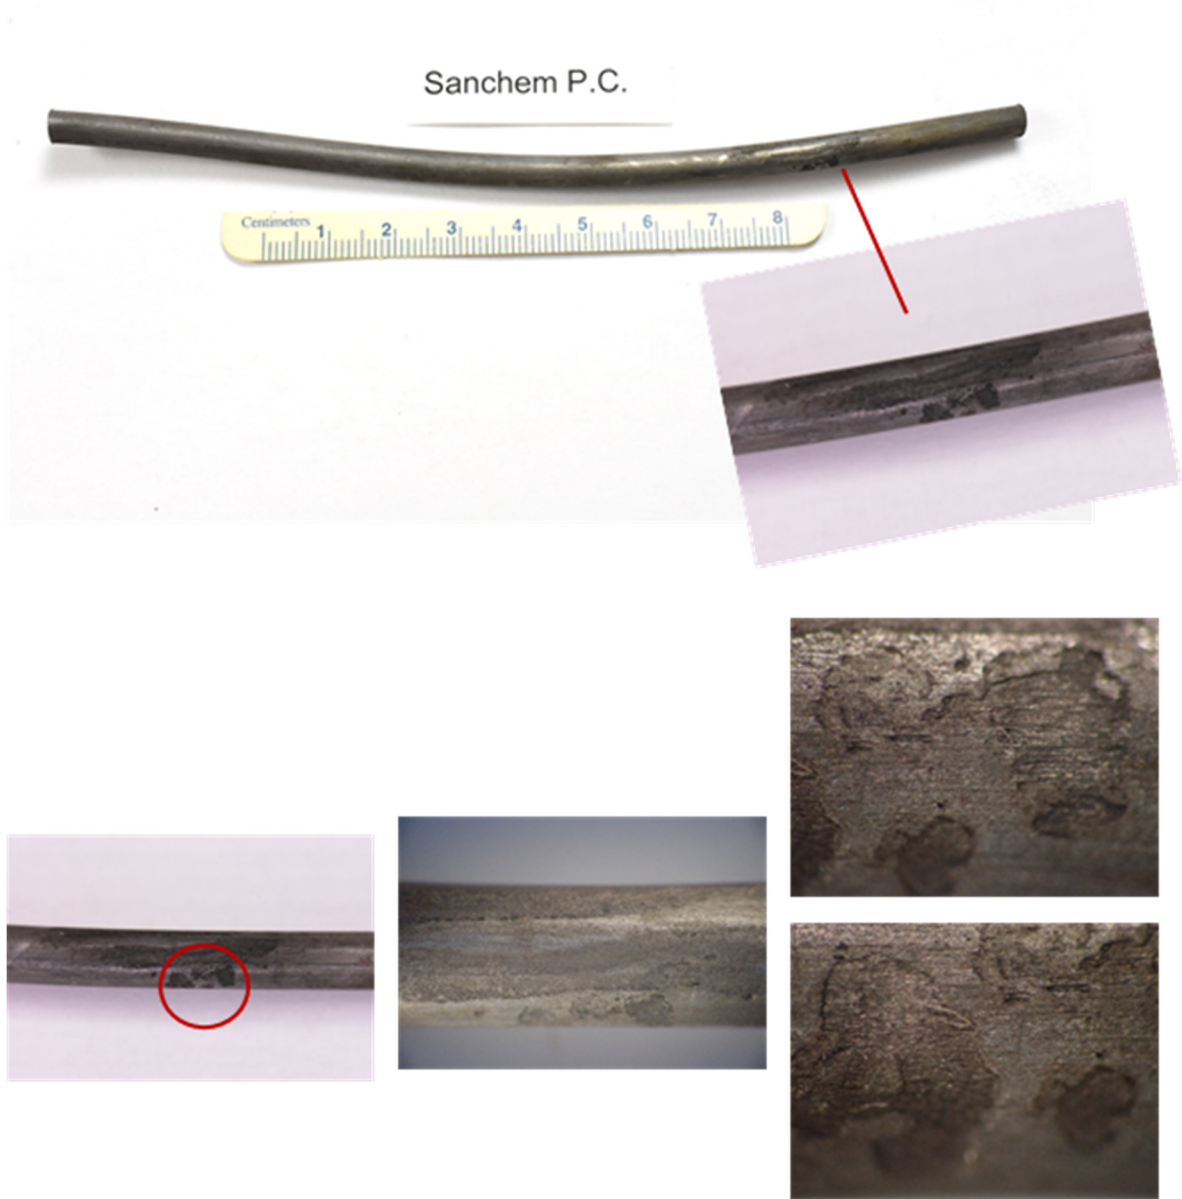
Figure 308. Coated with filler Sanchem and sprayed with 0.6 milliliter of solution containing fungus PC (close-up 1).

Figure 308. Coated with filler Sanchem and sprayed with 0.6 milliliter of solution containing fungus PC (close-up 1)..... 284
