**Development of Quality Assurance and Quality Control
System for Post Tensioned Segmental Bridges in Florida:
Case of Ringling Bridge – Phase II**

**FDOT Contract No. BDV29-977-34
FINAL REPORT**

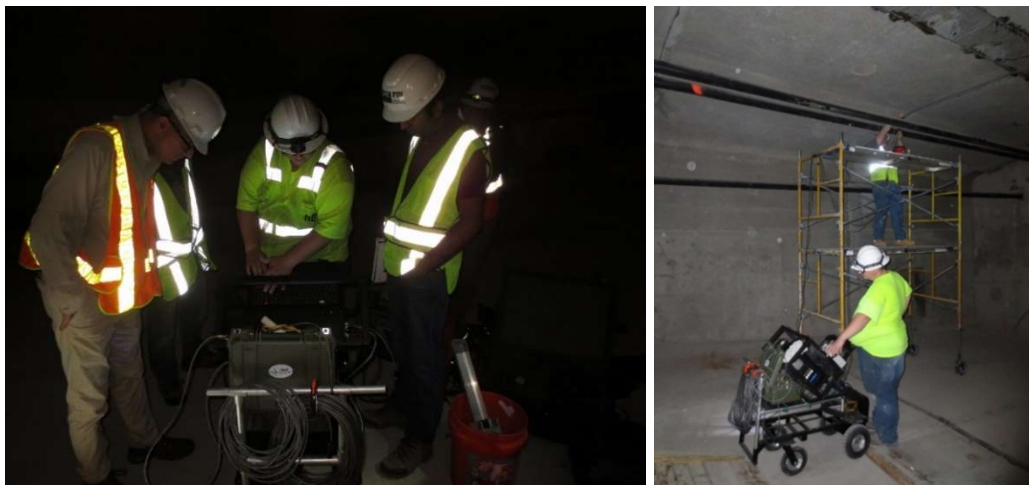
A data acquisition system was used for processing data (Figure 2-2). There were early indications of tendon grout anomalies in tendon 401-7L. Three other locations in spans 1-6 showed results that may be indicative of voids. The testing was completed by Nov. 15, 2017 and it was believed that field testing requirements have been met by USTC.

Figure 2-2: Testing on high elevation tendon and data processing unit.

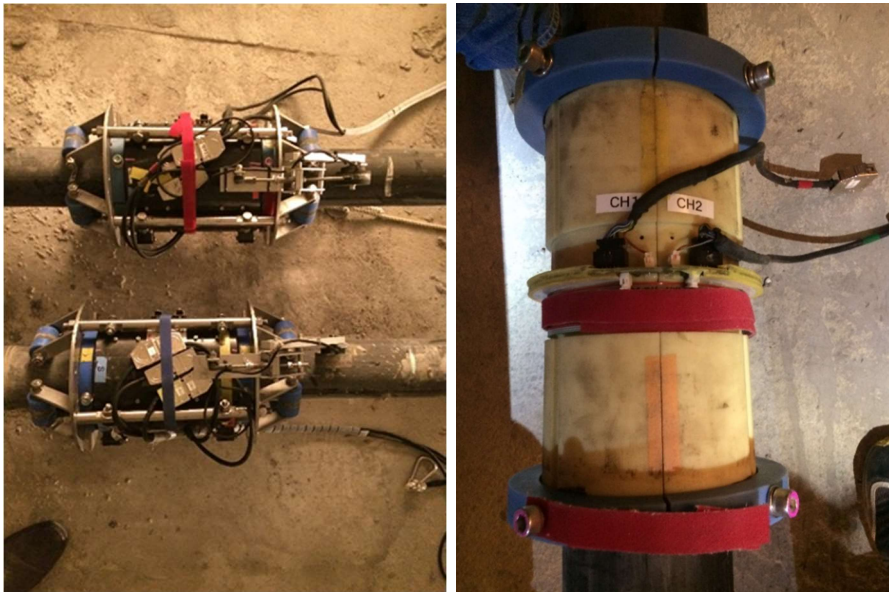
MTC has demonstrated field applicability of permanent magnet type MMFM. The equipment consists of a magnetizer, a controller and data acquisition system. This MMFM technology does not require external power sources making it a feasible choice when testing sites with no power access. The magnetizer assembly consisting of search coil and permanent magnet was wound over the external PT as shown in Figure 3-1. The installation of the magnetizer on the tendon was accomplished in a short period of time.

Figure 3-1: Installation of search coil and magnetizer on PT tendon.

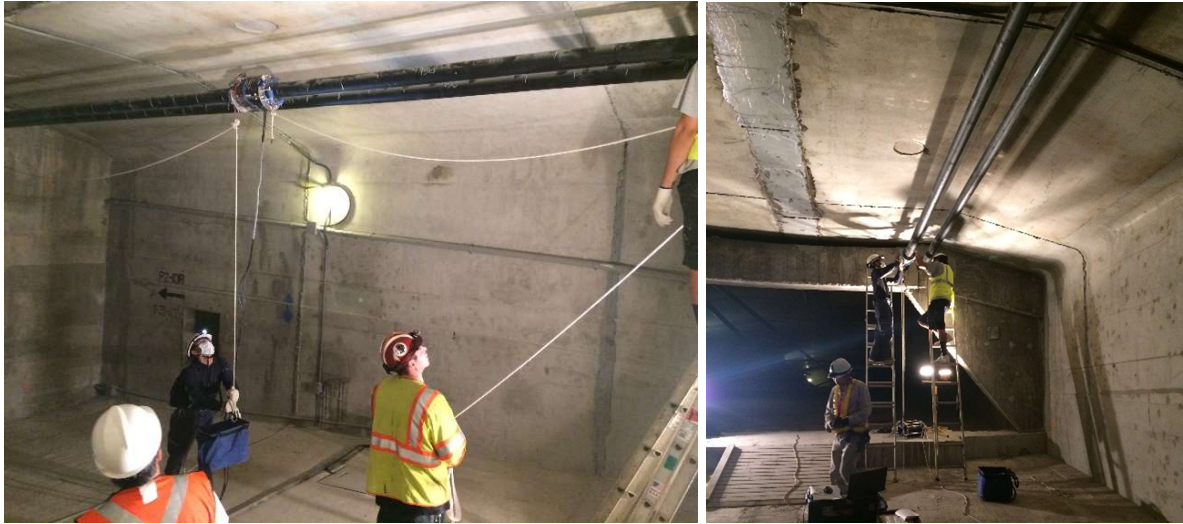
Testing was only carried on high horizontal and inclined tendons. The low horizontal tendons were not tested due to low clearance. After the MMFM assembly was installed on the tendon, the magnetization of the tendon was carried multiple times before a reading was taken. The installation at high elevations required use of ladders, and a pulley assembly was used to move the magnetizer along the length of tendon (Figure 3-2).

Figure 3-2: Installation of magnetizer at high elevations.

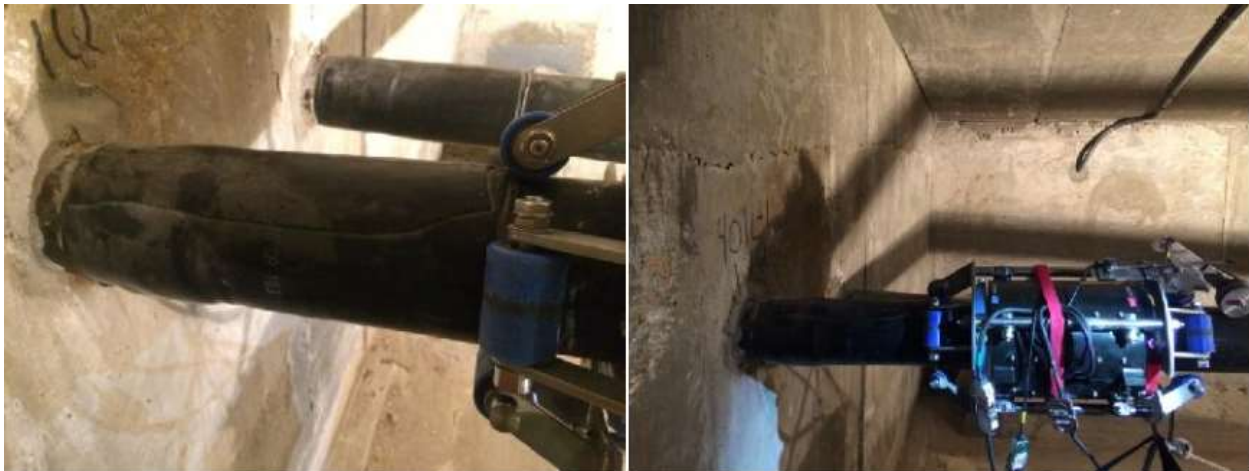
The lengths of the segments were measured between the walls and diaphragm. However, the starting point for magnetizer assembly was away from the face of the walls due to increased thicknesses of the HDPE sheathing at these locations as shown in Figure 3-3. Few locations on the tendon spans had spiral deformation which caused irregular movement and bumping of magnetizer. The joint in the HDPE was typically located between the scanned segments causing an abrupt change in signal. The location of this joint was recorded so that it may not be confused with a defect signal. Typically for each tendon, multiple readings were taken. Based on preliminary data, additional readings were taken or if an anomalous signal was encountered.

Figure 3-3: Offset of magnetizer from face of walls and deviators.

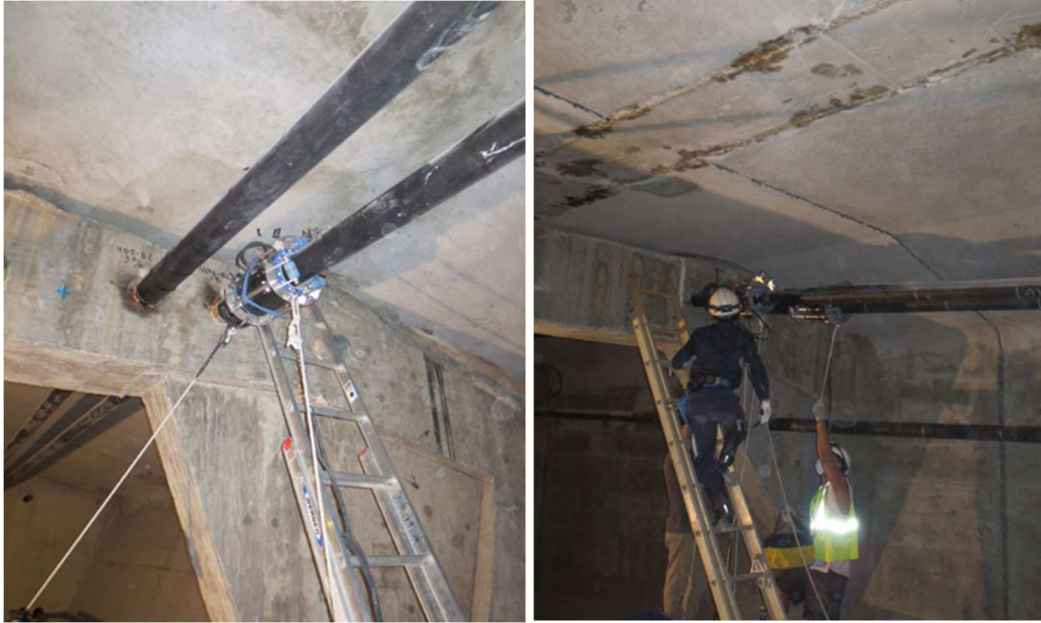
Only the high free span and deviated portions of each tendon were tested. Tendon locations with low clearance inhibited the movement of the sensor and were not tested. Scaffolding was not needed as the sensor head could be placed at lower tendon elevations using extension ladders as shown in Figure 3-4. Measurements were typically made continuously along the length of the tendons in the high free span and deviated portions of the tendons via installment of a temporary pulley system or manual carriage. Some tendon locations directly adjacent to concrete deviators that had excess repair wrap material prohibiting placement of the sensor (up to 2 feet) were not tested. Tendons that had deformation of the HDPE duct were tested without major disruption to test procedures.

Figure 3-4: Scanning of tendons using MMFM.

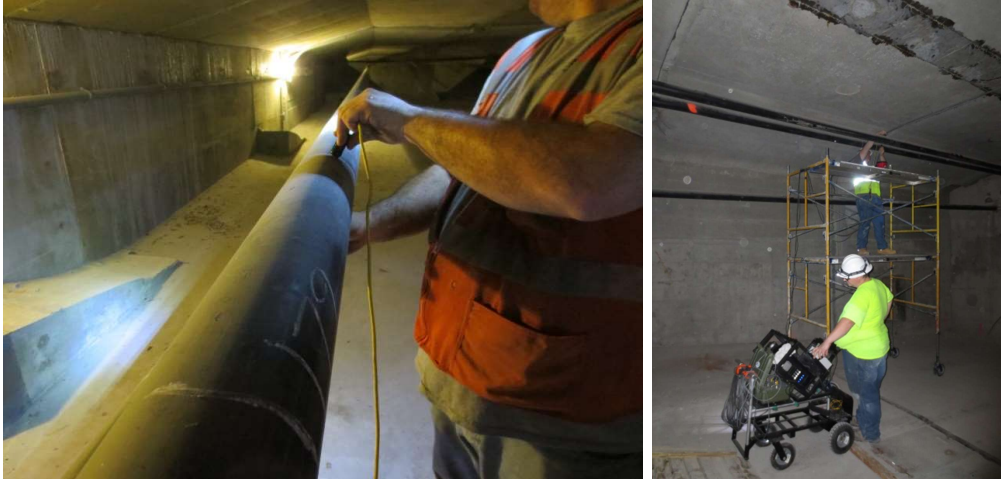
The full length of each tendon (including sections along the floor of the precast segments, along the free span with vertical deviation, and high elevation tendon spans) were tested. Measurements were typically made at 2-ft intervals for tendons along the precast segment floor and along the deviated free span. Shorter intervals were sometimes made especially when measurements indicated some form of tendon anomaly. Measurements were always made at 1-ft intervals for the high elevation tendon spans. Measurements typically were made in alternating sensor positions at 1-7 o'clock and 11-5 o'clock positions at the intervals described above for the deviated and high elevation tendon spans. 3-9 o'clock sensor positions were used for the floor tendon spans.

Figure 4-1: Ultrasonic/sonic testing on external PT tendons.

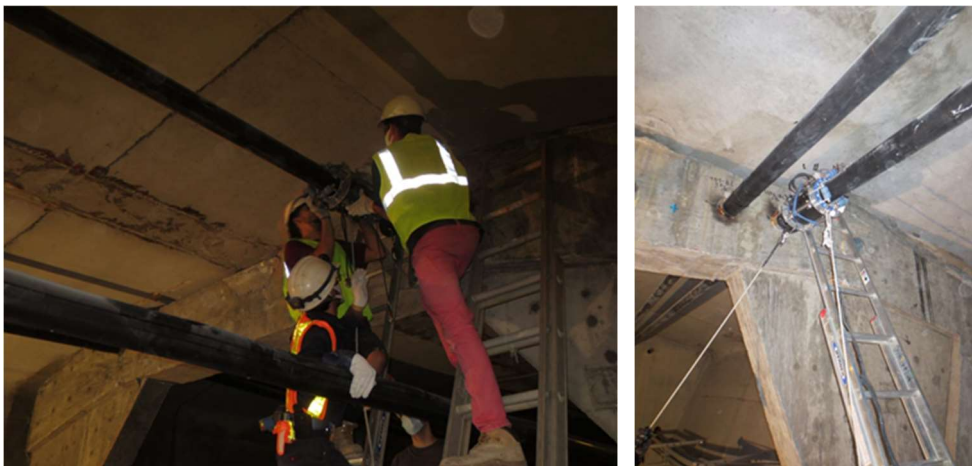
Figure 4-2: MMFM testing on external PT tendons.

MMFM testing on the external tendons on Feb. 5-22, 2018 by MTC was conducted to identify steel strand corrosion. In the time and budget allocated for the testing and demonstration, MTC was able to test additional tendon sites beyond the original agreed-upon scope, demonstrating field practicality. In total, MTC conducted MMFM testing on all tendons (44 tendons) in the center aisle of the precast segments at all high free span and deviated portions of tendons (tendons 402L, 401L, 401R, 402R and additional tendons 303R and 303L in spans 5 and 7) as well as additional tendons in span 8 and 9 on the left and right segment aisles.

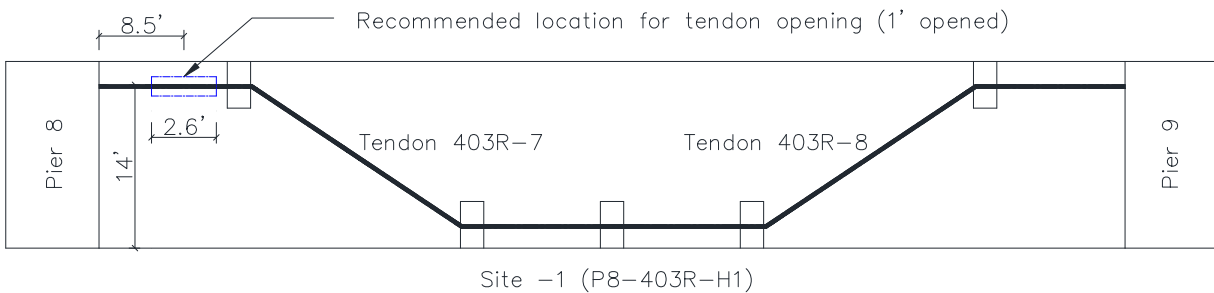
TEST SITE 1 (403R-7)

- Tendon opening recentered to 9'10" off of Pier 8 wall per recommendation by MTC.
- Opening of 1' tendon segment revealed deficient grout and severe steel corrosion. Pits up to 1.77 mm depth.
- Open circuit potentials -150 to -260 mV_{CSE}. Deficient grout pH 9-11. Hardened grout pH 13.

Figure 4-3: Tendon verification at site 1

about 3 $\frac{1}{2}$ " wide by $\frac{1}{2}$ " deep. All of the remaining grout was of normal color, consistency, and hardness. There were three corroded strands in the abnormal grout at 11, 12, and 1 o'clock. The corrosion products consisted mostly of red rust, but there were a few small areas with black corrosion products. The corroded strands exhibited severe corrosion and extensive pitting after being cleaned using a wire brush. The depth of the pitting was measured on individual wires using a gauge provided by Kingsley Lau (representative of FIU) and measurements at two locations that represented worst-case conditions were 1.44 mm and 1.77 mm. There was a $\frac{1}{2}$ " deep void at 12 o'clock, and the void extended along the entire length of the opening. The width of the void could not be estimated due to the location of the corroded strands. Samples of the abnormal and normal grouts were collected (total of two samples). The pH of the normal grout was 13. As a result of extracting a sample of the normal grout, two strands with no corrosion were exposed at 3 and 4 o'clock.

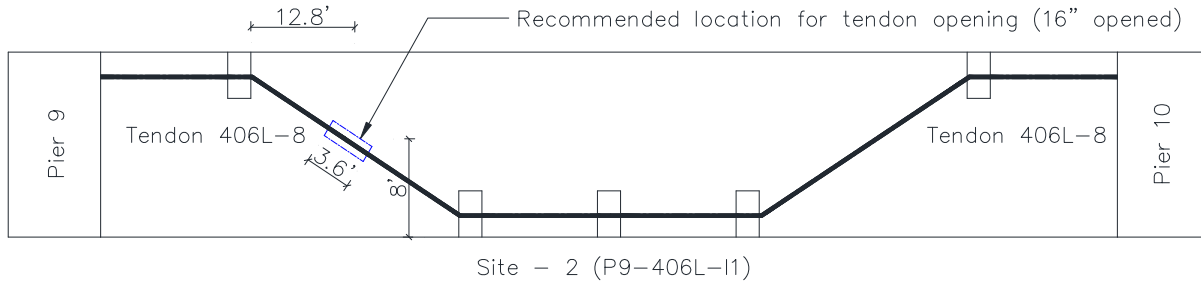
TEST SITE 2 (406L-8)

- Opening of 16" tendon segment revealed grout bleed trail (about 7 mm depth) at 12 o'clock position with accumulated carbon black/silica fume.
- Grout bleed trail pH 9-11. Freshly fractured hardened grout pH 11.
- Open circuit potential -111 to -211 mV_{CSE}.

Figure 4-4: Tendon verification at site 2

- Additional grout removed from test site 2. No indication of strand corrosion. Normal hardened grout observed outside of 12 o'clock bleed trail.
- Observation of strand bundle clustering at approx. 9 o'clock position. Grout cover depth at 9 o'clock (0 mm). Grout cover depth at 3 o'clock position (18 mm).

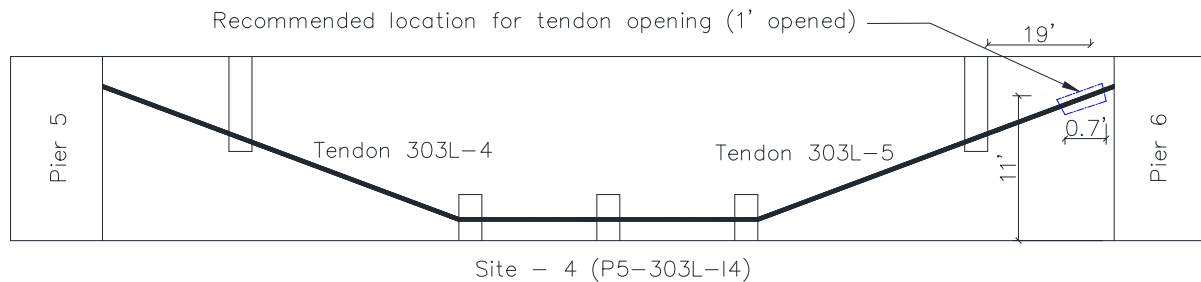
TEST SITE 4 (303L-5)

- Opening of 1' tendon segment revealed grout bleed trail at 12 o'clock position with grout pH 9 but no indication of steel corrosion.
- Steel debris embedded within tendon grout revealed around 7 o'clock position. Ball-headed smooth hollow cylindrical steel pin (about 8.5 cm length) embedded parallel lengthwise to the tendon.

Figure 4-5: Tendon verification at site 4

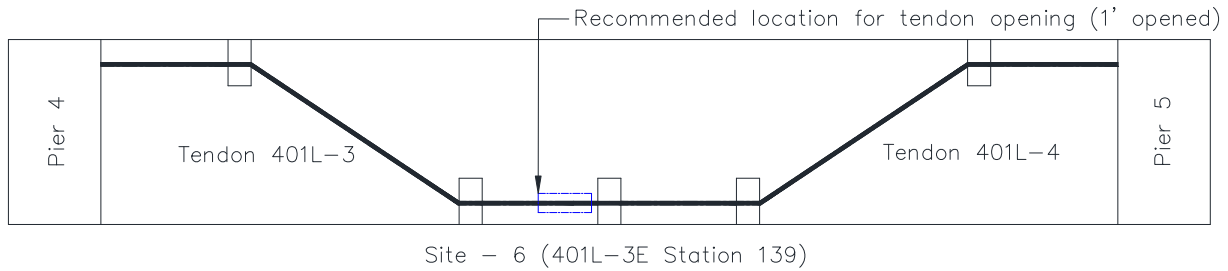
- Opening of 1' tendon segment revealed minor bleed trail at 12 o'clock but normal hardened grout elsewhere throughout.

- Observation of strand bundle clustering towards bottom tendon cross-section. Grout cover depth at 12 o'clock (20 mm).

Figure 4-6: Tendon verification at site 6

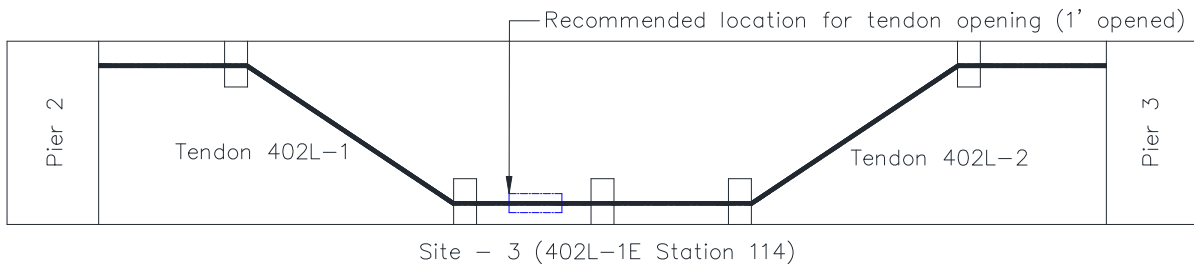
TEST SITE 3 (402L-1)

- Opening of 1' tendon segment revealed minor bleed trail at 12 o'clock position with friable dark grey grout particles. Strand at bleed trail retained bright finish.
- Grout from tendon interior showed no deficiency and no indication of corrosion activity.

Figure 4-7: Tendon verification at site 3

A 12"-long section of duct was removed and the center of the opening was at Station 114. Only the top half of the duct was removed due to the limited space between the bottom of the duct and the concrete floor at this location. There was a mix of dark gray and black soft grout centered at 12 o'clock. The abnormal grout was concentrated in an area about 1" wide by $< \frac{1}{8}$ " deep. No corrosion was observed on portions of wires that were exposed in the abnormal grout. No void was found and all of the remaining grout was of normal color, consistency, and hardness. The grout was removed in about a 2" wide strip located in the center of the opening lengthwise and around the entire circumference of the tendon. A sample of the grout was collected during this process. The sample consisted of normal and abnormal grout, but most of the sample was comprised of normal grout. No corrosion was observed on any of the strands that were exposed after the grout was removed, including portions of the strand that had been encased in abnormal grout, and no other grout deficiencies were found.

Based on subsequent findings at a different tendon, this location was revisited to determine if there was any cracking in the grout. Circumferential cracks with a maximum width of 4 mils were found in the grout on the south side of the opening.

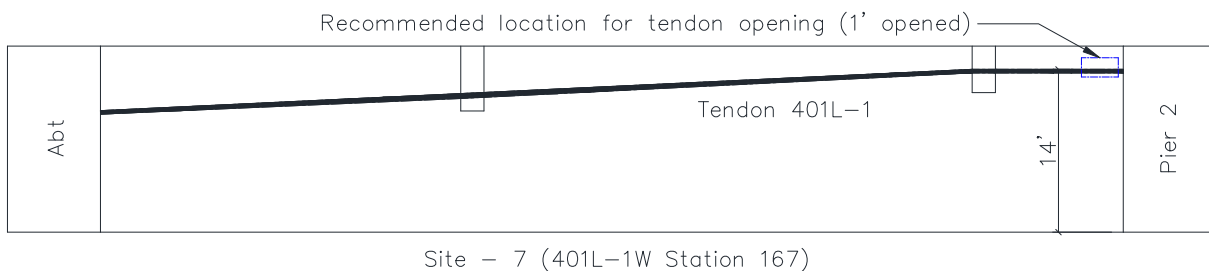
TEST SITE 7 (401L-1)

- Opening of 1' tendon segment revealed small bleed trail at 12 o'clock position with friable grout showing impressions of air bubbles.
- Duct delamination could not be discerned.
- Observation of deep fine transverse cracking up to 4 mils in width.

Figure 4-9: Tendon verification at site 7

A 12"-long section of duct was removed and the center of the opening was at Station 167. There was a mix of dark gray and black abnormal grout centered at 12 o'clock. The abnormal grout was concentrated in an area about $\frac{7}{8}$ " wide by $\frac{1}{16}$ " deep. No portion of any wire was directly exposed anywhere in the duct removal area. No void was found and all of the remaining grout was of normal color, consistency, and hardness. However, there were several circumferential cracks in the grout that were a maximum of 4 mils wide. The grout was removed in about a 1 $\frac{1}{2}$ " wide strip located in the center of the opening lengthwise and around the top half of the circumference of the tendon. A sample of the grout was collected during this process. The sample consisted of normal and abnormal grout, but most of the sample was comprised of normal grout. No corrosion was observed on any of the strands that were exposed after the grout was removed, including a strand at 12 o'clock, and no other grout deficiencies were found.

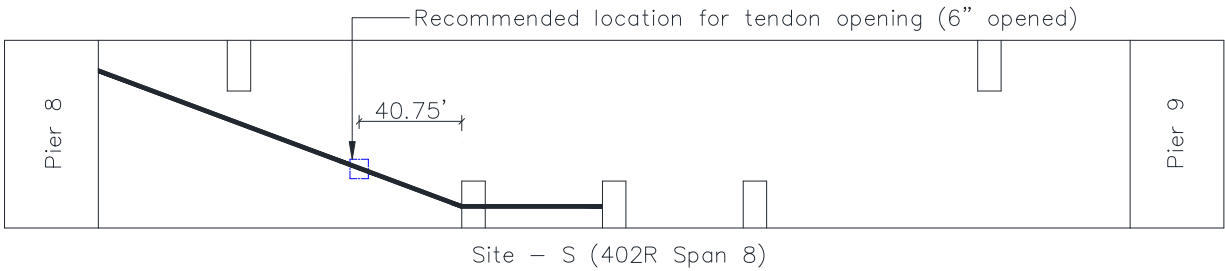
ADDITIONAL TEST SITE “S” (402R span 8)

- Replacement tendon showed periodic spiraling deformation on the HDPE duct.
- 6” opening made at 489” west of the low deviator on a hump portion of the deformed HDPE.
- Opening revealed loose or broken strand following the contour of the spiral deformation. Movement of wires can be made by placement of a screwdriver between wires.
- No steel corrosion observed.
- No deficient grout observed.
- No cracking or physical damage of grout observed.

Figure 4-11: Tendon verification at site s

While work was being performed at the bridge, it was observed that the duct on Tendon 402R in Span 8 was deformed and had a spiraled shape. This tendon is a new tendon that was installed some time ago to replace a defective tendon. At the direction of FDOT personnel, a preliminary investigation was conducted to determine the cause of the misshaped duct. A 6"-long section of the duct was removed, and the center of the opening was located 489" down-station from the low deviator. The opening was positioned at a hump in the duct, and only the top half of the duct was removed. Upon removing the duct, one loose strand was found. The grout was of normal color, consistency, and hardness. Other observations made along the length of the duct led to a preliminary conclusion that the loose strand had failed somewhere along its length as opposed to having pulled out from its wedge at the anchor.

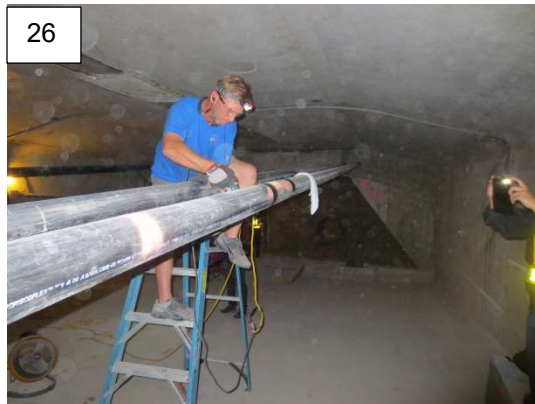
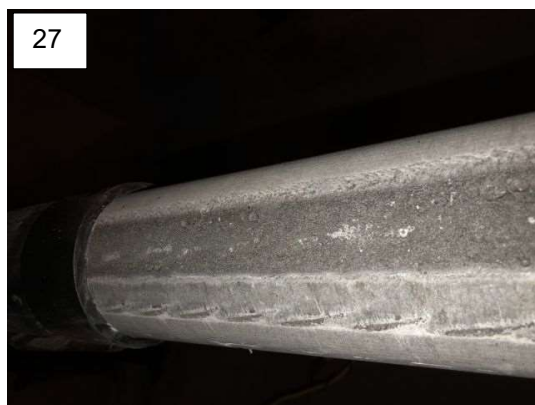
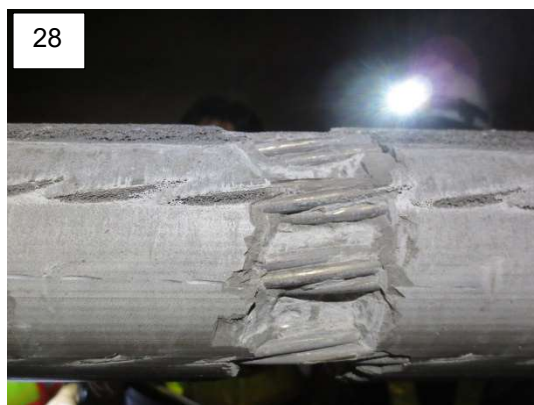
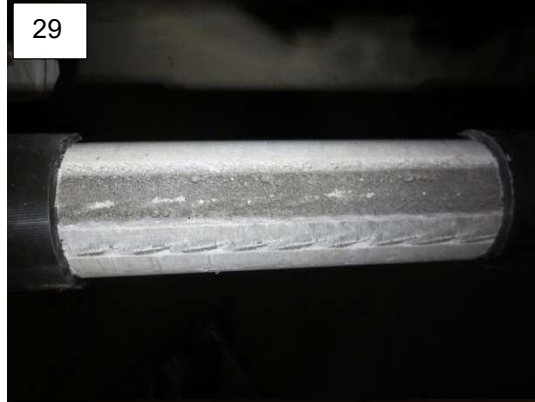
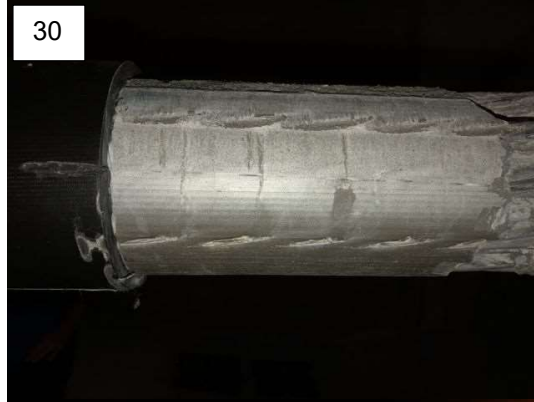
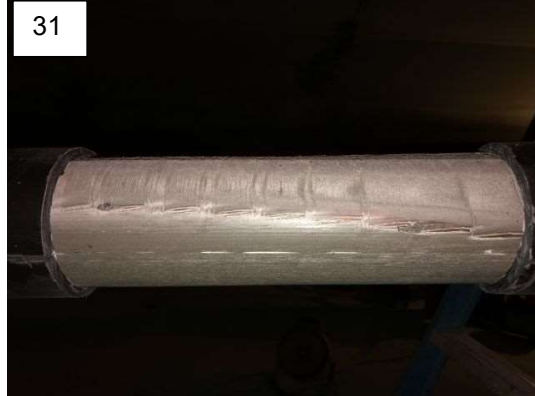
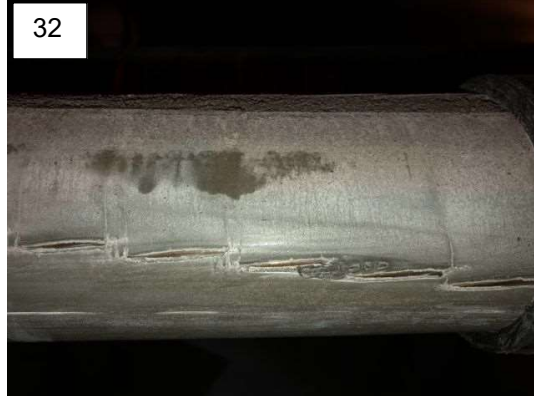
TEST SITE 5a (402L-1)

29. Test Site 5a. 402L-1. Top of tendon. Bleed trail at 12 o'clock position.
30. Test Site 5a. 402L-1. Side of tendon. Hairline circumferential cracking.

31. Test Site 5a. 402L-1. Second opening. Showing bleed trail at 12 o'clock and hardened grout. Angled strand positioning.
32. Test Site 5a. 402L-1. Second opening. Side of tendon. Hairline circumferential cracking.

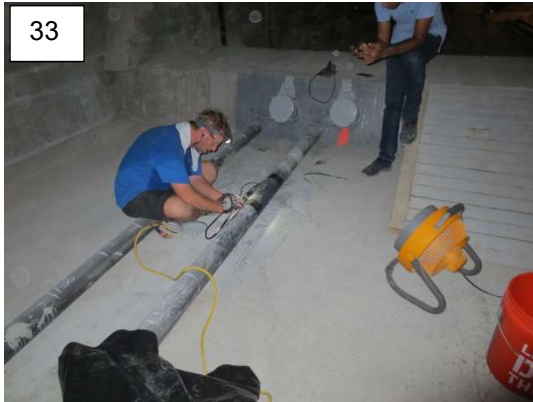
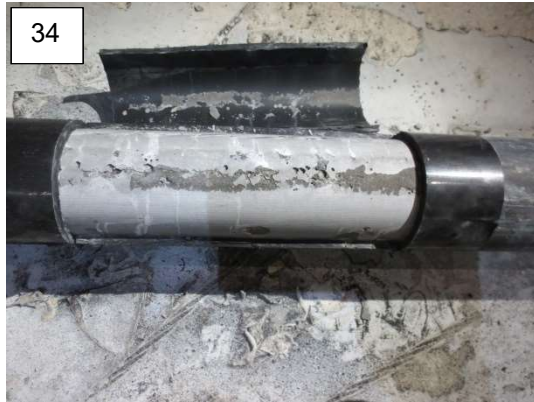
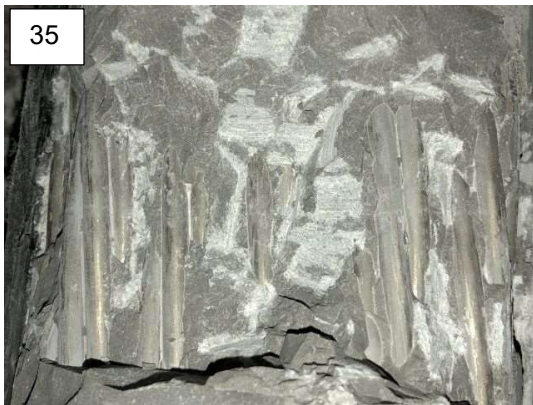
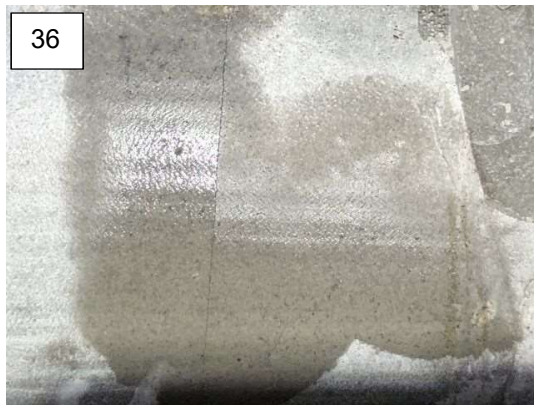
TEST SITE 6 (401L-3)

33. Test Site 6. 401L-3. Tendon wideshot
34. Test Site 6. 401L-3. Top of tendon. Deficient grout at 12 o'clock position.
35. Test Site 6. 401L-3. Top of tendon. Strand with bright luster after removal of grout.

36. Test Site 6. 401L-3. Hairline circumferential cracking.
37. Test Site 7. 401L-1. Tendon wideshot.
38. Test Site 7. 401L-1. Top of tendon. Longitudinal view. Negligible void. Bleed trail at 12 o'clock position.

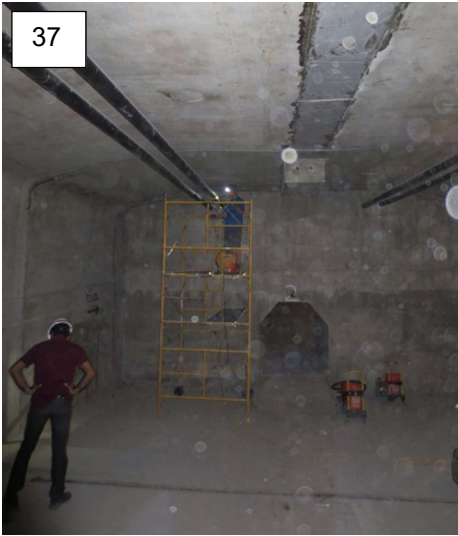
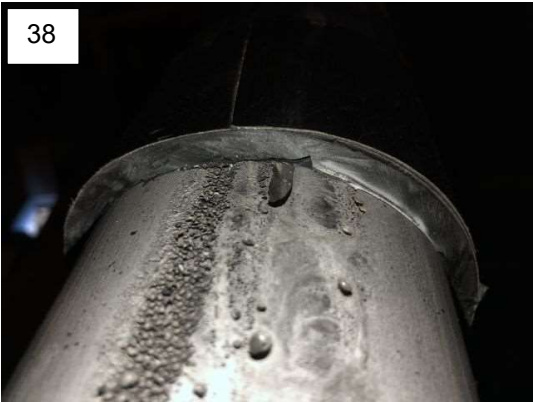
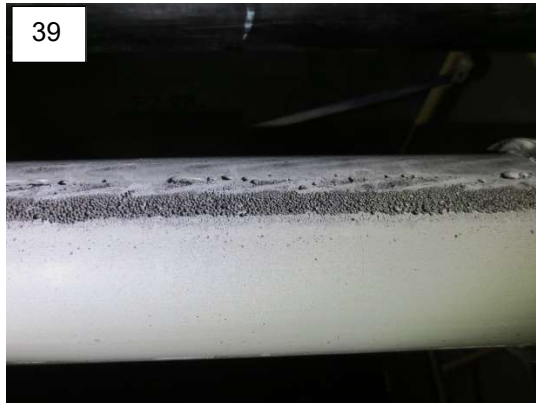
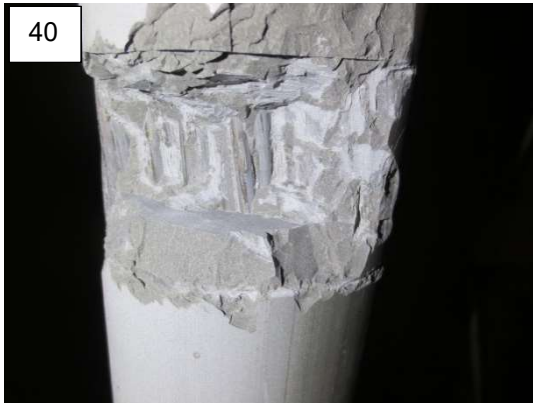
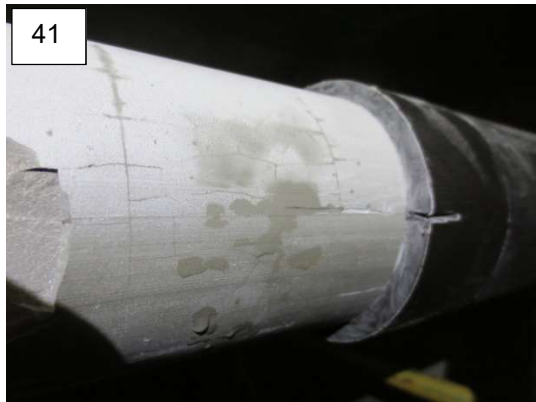
TEST SITE 7 (401L-1)

39. Test Site 7. 401L-1. Top angled view. Bleed trail at 12 o'clock position.
40. Test Site 7. 401L-1. Top of tendon. Clean strand after grout removal. Deep flat faceted grout fracture plane.

41. Test Site 7. 401L-1. Side of tendon. Hairline circumferential cracking. Map cracking.
42. Test Site 8. 401R-1. Hardened grout with bleed trail at 12 o'clock position.

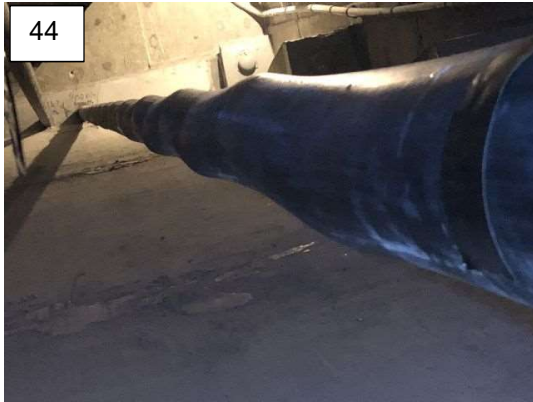
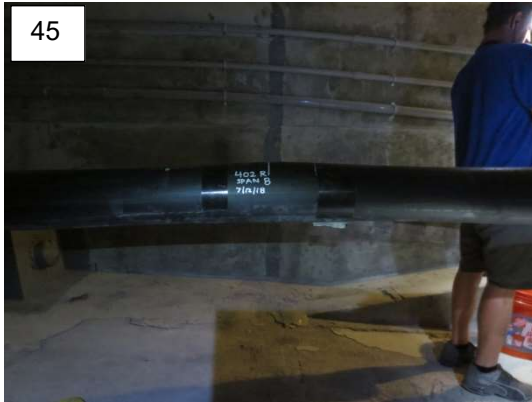
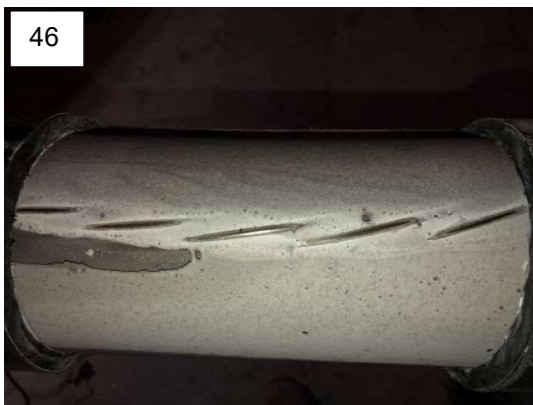
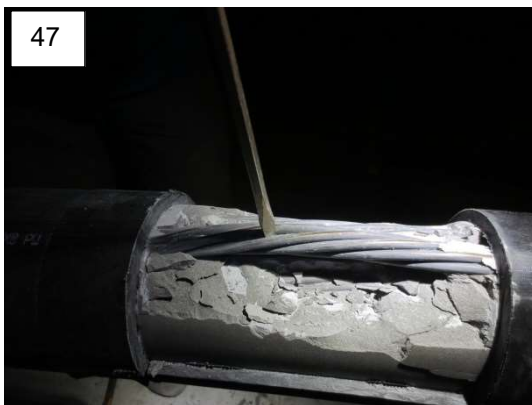
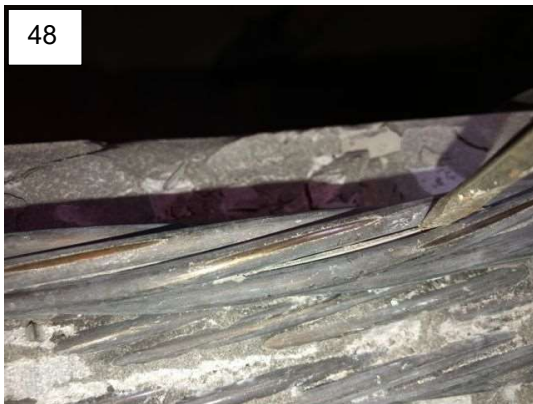
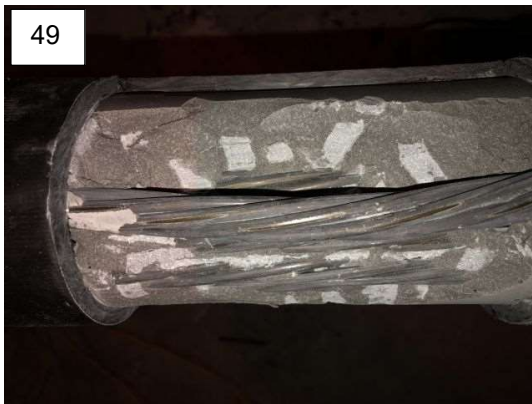
TEST SITE S (402R-7)

46. Test Site S. 402R-7. Top of tendon showing hardened grout and buckled clean strand. No grout distress except for small air bubble void.
47. Test Site S. 402R-7. Loose strand exposed after removal of grout.

48. Test Site S. 402R-7. Loose strand exposed after removal of grout.
49. Test Site S. 402R-7. Loose strand exposed after removal of grout.

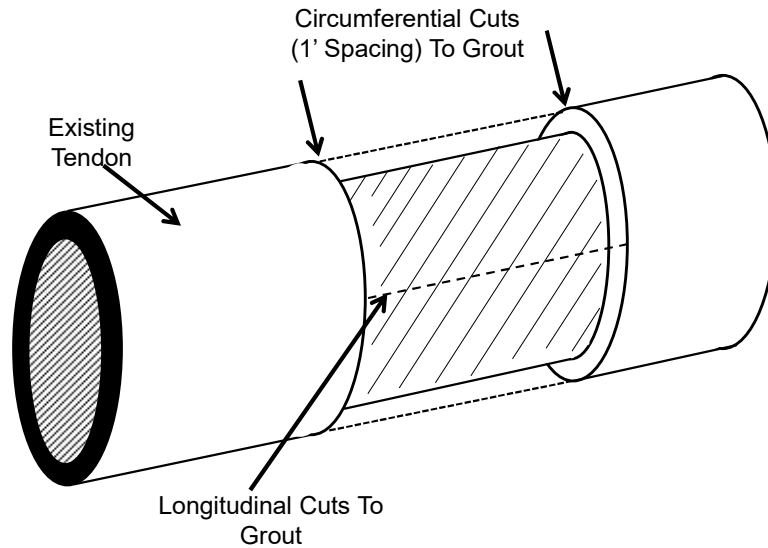
Figure 4-12 Circumferential and longitudinal cuts for tendon opening

- Cuts tentatively made to avoid hitting steel strand (Figure 4-12).
- After two circumferential cuts and two parallel longitudinal cuts at 3 and 9 o'clock, the top half pipe carefully removed to reveal underlying grout.
- Bottom half pipe carefully removed to avoid disturbance, breakage and loss of grout material.
- Only the top half pipe was cut and removed for strand with low ground clearance (Figure 4-13).

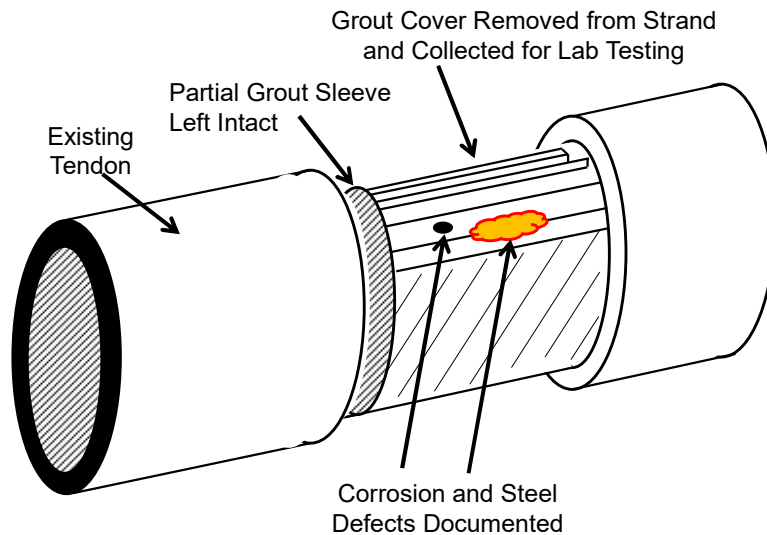
Figure 4-14: Sampling of grout material

- Grout carefully removed by hammer and scoop to reveal underlying steel (Figure 4-14).
- A partial grout sleeve was left intact at one or both cut window edges.
- All grout materials are sealed in labeled plastic bags for later testing.
- Grout was separated into groups if variability in grout deficiencies exist.
- Any visual rust staining and rust accumulation was documented.

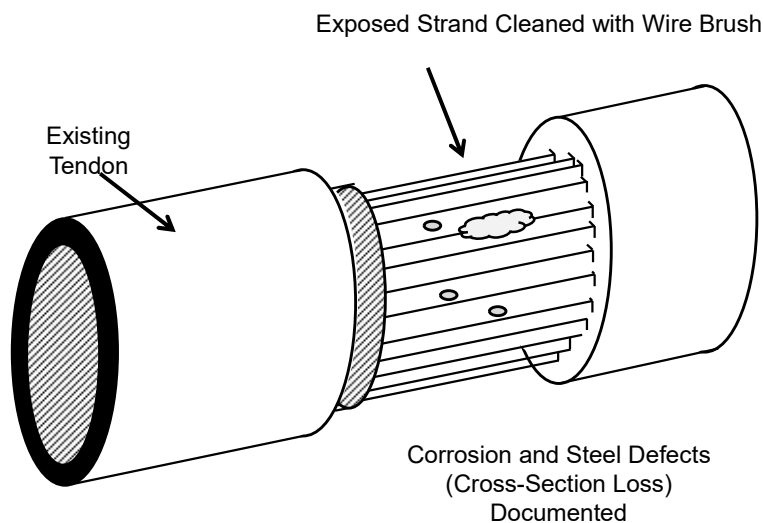
Figure 4-15: Documentation of corrosion activity

- After removal of grout around the circumference of the steel bundle, the exposed steel was hand cleaned with a wire brush to remove (as much as attainable by hand) loose grout and rust particles.
- Steel defects and cross-section loss was documented (Figure 4-15). A pit-depth gage was used if localized corrosion observed.

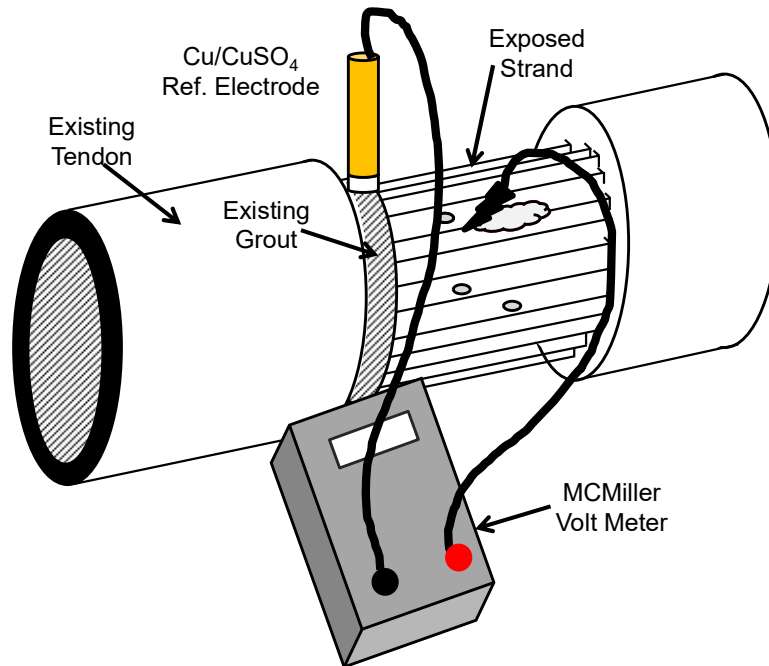
Figure 4-16: Half-cell potentials of steel strands

- Half-cell potentials was made by placing a slender Cu/CuSO₄ electrode on the existing grout sleeve. The tip of the reference electrode may be covered with a wet sponge. The working electrode contact was placed on each exposed steel strand regardless of electrical continuity (Figure 4-16).
- Each measurement was recorded with notes on ref electrode placement, circumferential location of each strand, and observation of rust.

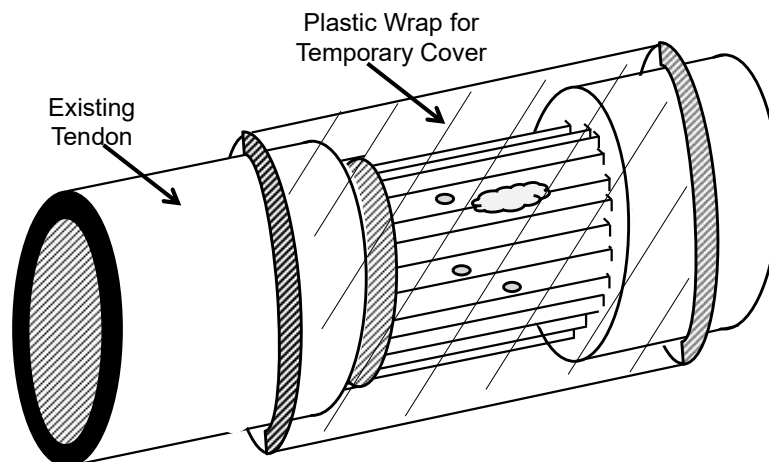
Figure 4-17: Temporary repair work on tendon

- If a permanent repair was delayed, a temporary cover using plastic wrap and duct tape may be used for up to 2 days (Figure 4-17).

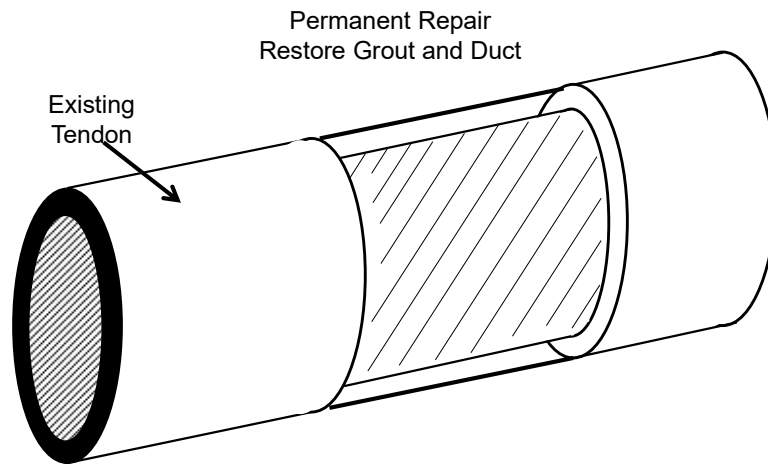
Figure 4-18: Permanent repair work on tendon

- Permanent repairs conforming to FDOT requirements was made (Figure 4-18).
- Quality Control of the permanent repair was made after 1 day.

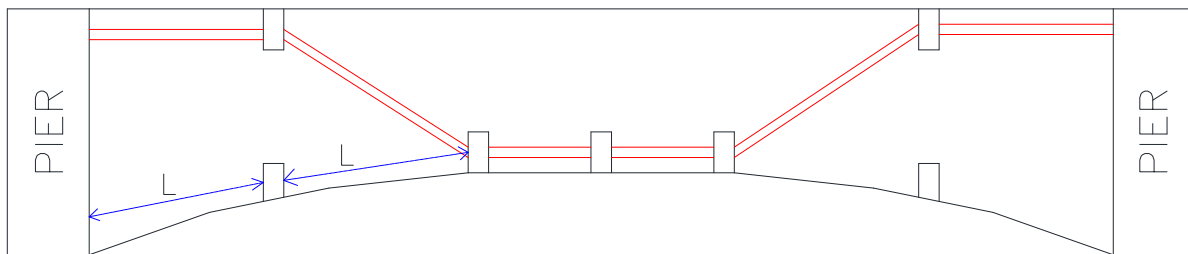
Figure 5-1: MTC tendon measurement procedures.

In the submittals, both vendors used different nomenclature to identify the tendon segments. In order to refer back to the locations, the data of both vendors have been combined for similar tendon segments to provide a uniform report for future reference. There was a difference in measuring spans between the segments. MTC measured tendon segments lengths between deviators and pier walls as shown in Figure 5-1. USTC took linear measurements along the length of the tendon, thus eliminating effect of any slope or variation in deviator thicknesses (Figure 5-2).

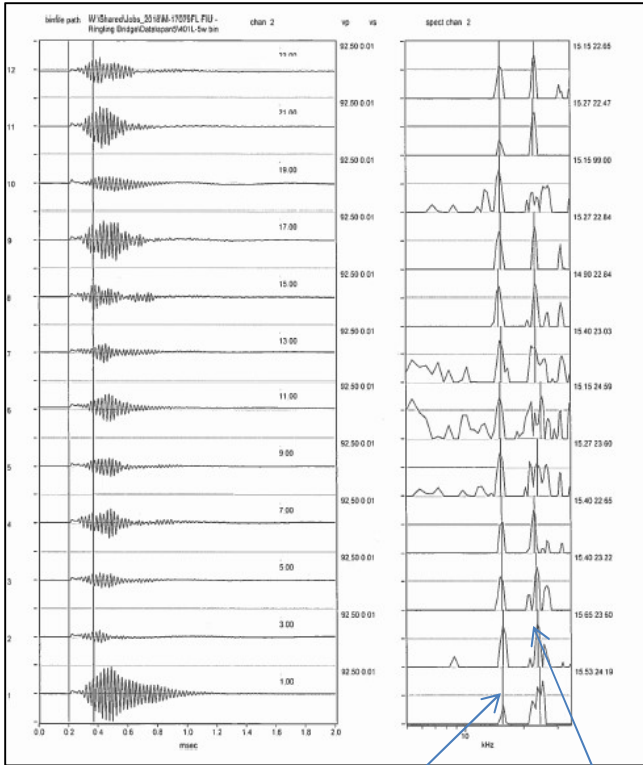
Center Cell Span 5 duct 401L-5W
 "Good" strong 15 and 25 KHZ signal
 Duct filled with hard grout
 Station 1 to 23

15 KHZ 25 KHZ

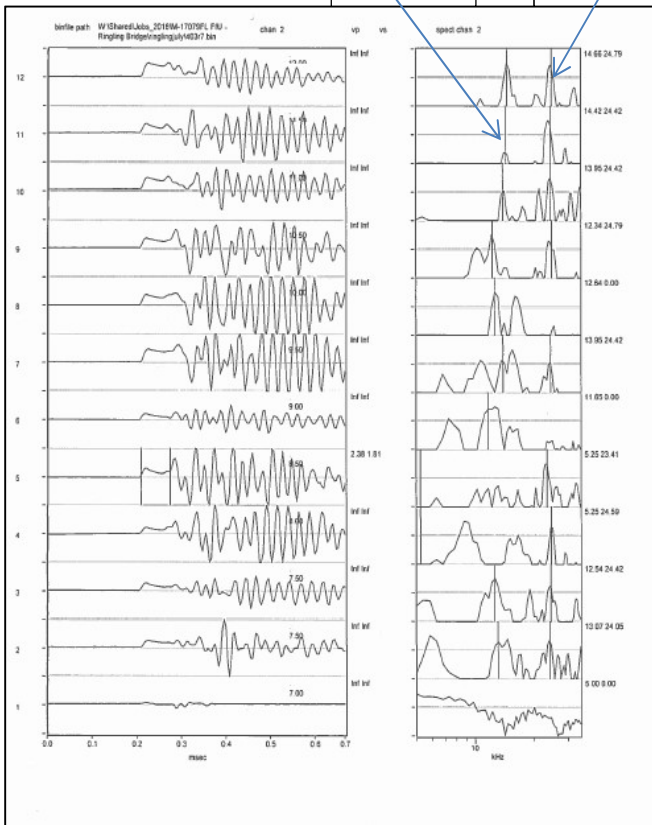
Sonic/ultrasonic data collected
 During Validation after Report submittal
 Right South Cell span 8 duct 403R
 Stations 7 to 12
 Note low amplitude missing 15 and 25 KHZ
 Anomalous sonic/ultrasonic data

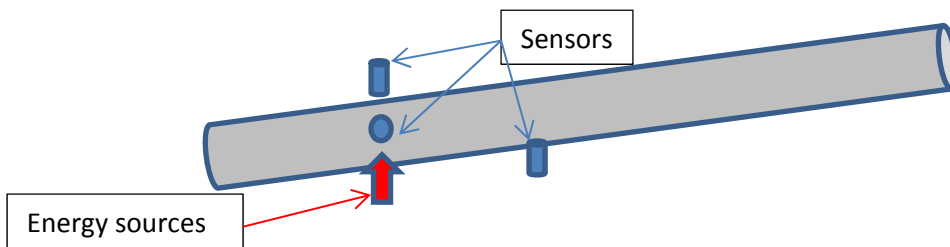
The sonic/ultrasonic testing will use a high frequency, “clicker”, or projectile impact energy source and a four sensor array to acquire multiple data sets simultaneously. The energy source is to be positioned close to the bottom of the duct (or as close as it can be with a 1 inch clearance in some locations) where it is assumed that in most cases there will be grout in the bottom of the duct. Receiver sensors will be positioned 180, 90 and 240 degrees from the energy source on the circumferences of the PT duct. These sensors will measure direct through waves and impact echo data. A fourth sensor will be positioned 1 foot from the energy sources at the same position on the duct. This sensor will be used to measure refracted wave signals from the grout inside the duct. This data acquisition set up is displayed below:

It is anticipated that if the duct is filled with hard grout: all the circumferential sensors will have high amplitude, high velocity wave arrivals and impact echo resonate frequencies and the refracted wave velocities will be high. If the duct is partially voided or soft grout: the signal quality for the sensors the circumferential sensors will be poor and the refracted wave signals low velocity. If the duct is voided or filled with soft grout; there will be no or poor arrivals at all sensors.

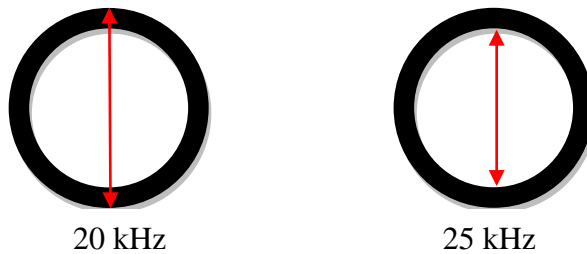
Figure 2: Sonic Wave paths for fully grouted external PT Ducts

For the sonic testing, energy input with a piezo-ceramic “clicker” energy source was at the 11:00 o’clock duct position and a sensor at the 5:00 o’clock duct position. The energy source creates a compressional wave that propagates through the PVC duct and into the grout filling the PVC duct and reflects from the back surface of the PT duct. This energy is trapped between the two surfaces and resonates at a frequency that is a function of the compressional wave velocity and the duct or grout thickness. When the thickness and the compressional wave velocity remain constant, which is the normal condition for duct filled with competent grout, the resonant frequency is expected to be approximately 20 kHz for the 4 inch thick external PT Duct. If the compressional wave is trapped within the 3.75 inch thick grout inside the PVC PT duct the resonant frequency is expected to be approximately 25 kHz. When the 20 and 25 kHz thickness resonant frequencies are missing, then anomalies such as voids, soft grout or grout delaminated from the PVC duct are suspected.

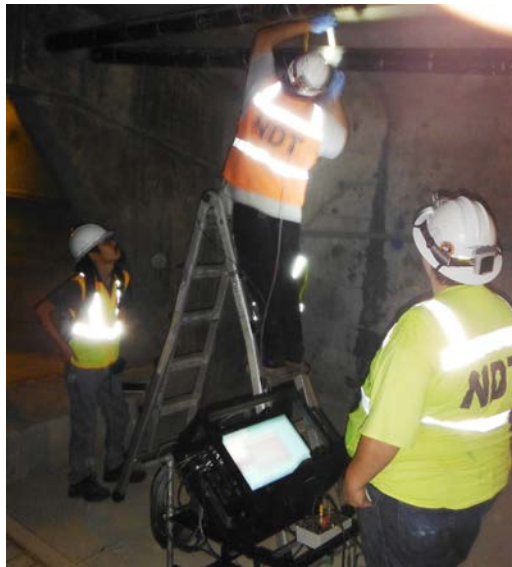
Photograph 1-Data acquisition

Sonic/ultrasonic and impact echo/resonant (multiple reflections) frequency measurements were obtained using a piezo electric "clicker" energy source, a hand-held sensor and a portable computer to archive and provide a quality control field display of data (Photograph 1). Sonic/ultrasonic data were obtained for each tendon by positioning the energy source on one side of the PT duct and a sensor on the opposite side and incrementing the readings at 1 or 2 foot intervals. Sonic/ultrasonic impact echo measurements were made at 1 foot intervals at tendon high points and 2 foot intervals in transition and low areas. Measurements were made by positioning the "clicker" energy source at 11:00 o'clock and the sensor at 5:00 o'clock or 1:00 and 7:00 o'clock positions depending on access, activating the energy sources and recording the resulting signal for 4 milliseconds. A discussion of the sonic/ultrasonic survey method is included in Appendix 1.

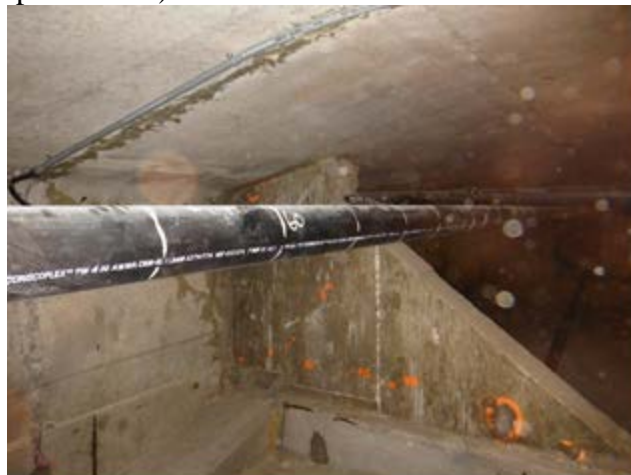
Photograph 3- Location station marks on duct

One foot station marks with station labeling at 5 foot intervals was marked on the ducts with chalk (Photograph 3 below).

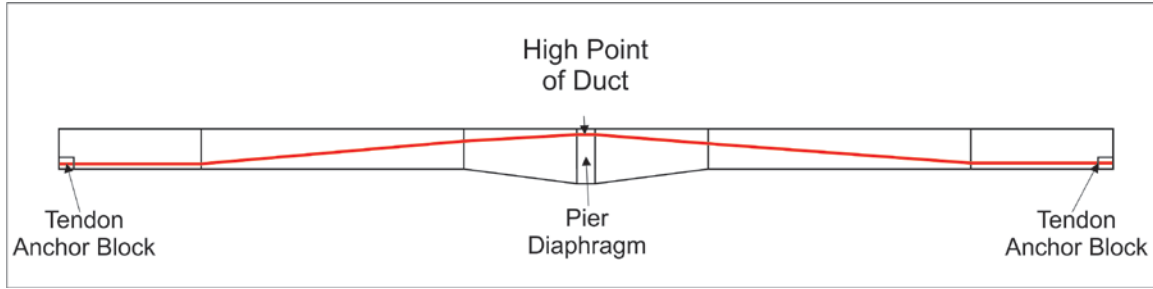
Figure 2- Sketch plan of the typical layout of a tendon duct.

In span 1 and 11 the ducts were anchored to the abutments. See sketch Figure 2 below

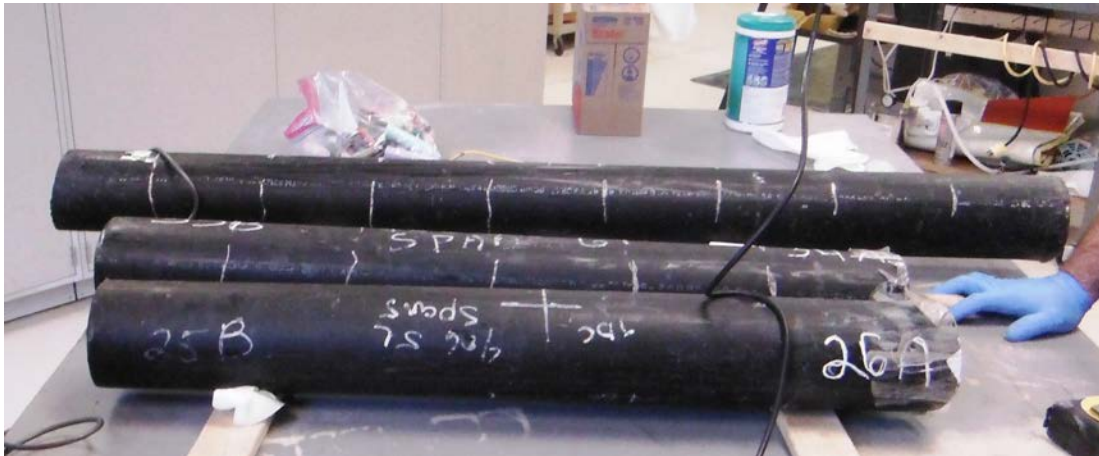
Photograph 4- Duct segments 25b, 33b and 36

Prior to initiating testing at the Ringling Bridge, sonic/ultrasonic testing was conducted at the Florida DOT's materials department in Gainesville on duct segments 25b, 33b and 36 (Photograph 4 below) removed from the Ringling Bridge during repairs.

Calibration sonic/ultrasonic testing was conducted at Florida DOT's Materials Department in Gainesville on duct segments 25b, 33b and 36 (FDOT designations) removed from the Ringling Bridge during repairs. This calibration determined that there is a full grout through thickness impact echo 20 kHz frequency indicative of "good" grout and when the 20 kHz was not present the ducts have weak segregated grout.
