**Development of Quality Assurance and Quality Control
System for Post Tensioned Segmental Bridges in Florida:
Case of Ringling Bridge – Phase II**

**FDOT Contract No. BDV29-977-34
FINAL REPORT**

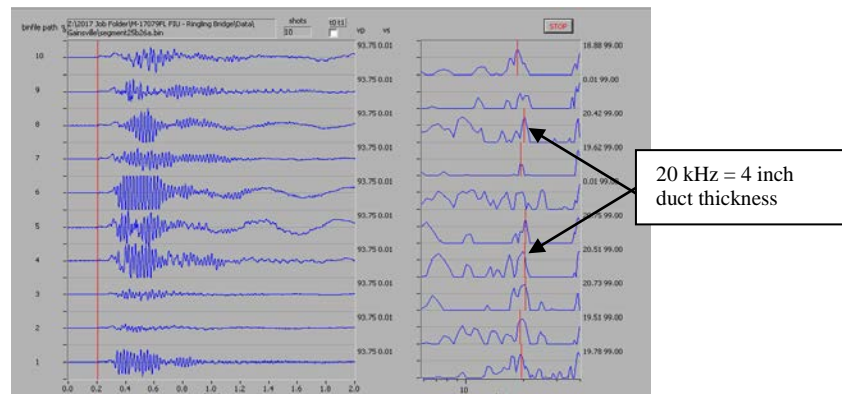
Measurements were repeated at the same location with the “clicker at 6:00 o’clock and sensor at 12:00 o’clock. The results were evaluated as data were acquired and duct segments 25b and 33b have a full through thickness impact echo 20 kHz frequency indicative of “good” grout and duct segment 36 did not have the 20 kHz and was suspect of having anomalous grout conditions. Data recordings of these signal characteristics are shown on Figure 3 and 4.

Figure 3-Duct 25b sonic/ultrasonic data – “good grout (note 20 kHz 4 inch duct thickness resonances)

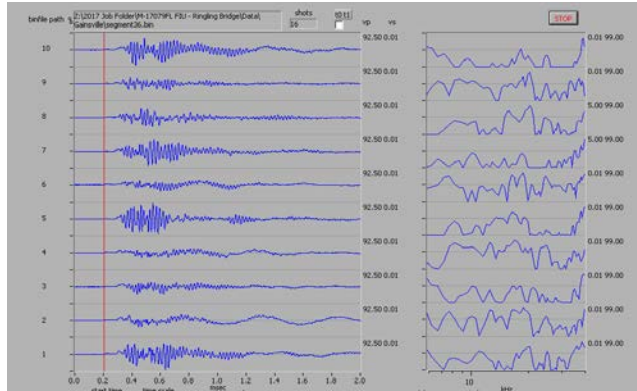
Figure 4 -Duct 36 sonic/ultrasonic data
Anomalous data/no 20 +/- kHz thickness resonance

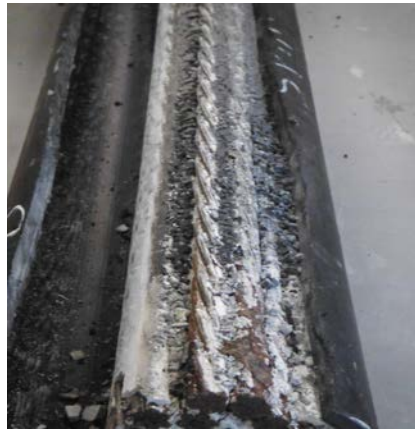
The PVC jackets were cut open and grout conditions evaluated. Duct 36 (Photograph 6 below) has approximately 1 inch of fly ash segregated from grout.

Photograph 6- Duct 36 with PVC Jacket Removed

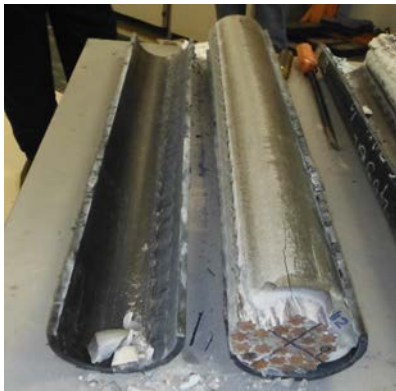
Duct 25b (Photograph 7 below) has hard “good” grout.

Photograph 7- Duct 25b with PVC Jacket Removed

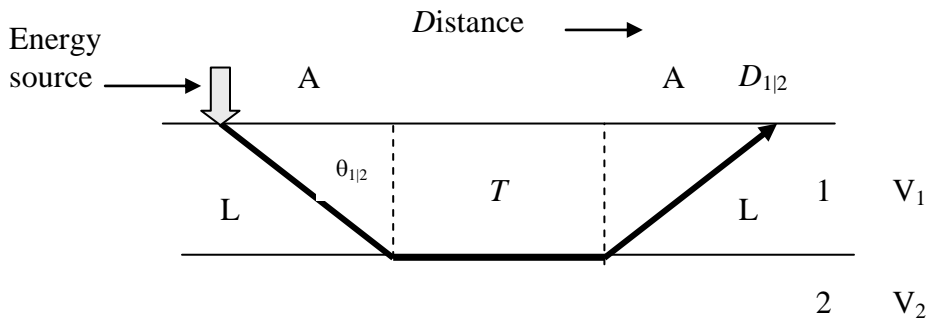
Figure A1

The diagram below shows the wave path for refracted energy generated for a softer (1) lower velocity layer over a harder (2) higher velocity layer. For example asphalt (1) over good concrete (2). The wave is bent (similar to the appearance of a stick in water) and travels along the boundary between the lower velocity layer and the higher velocity layer and radiates back to the surface. The higher velocity of the good concrete allows the refracted wave to overtake the direct wave in layer 1 at some distance designated as $D_{1|2}$. To the left of this point the lower velocity of layer 1 will be measured and beyond it the velocity of the deeper layer 2 is measured.

The time for the direct path is D/V_1 , the refracted path time is $2L/V_1 + (D_{1|2} - 2A)/V_2$. The array of sensors is placed in the distance direction and the time elapsed (travel time) from the time of energy impact to the sensor distance is measured. The velocity is determined from this time-distance measurement(s). The angle θ is the angle between the perpendicular to the layer and the incident wave that is critically refracted. The sine of this angle is the velocity of the first layer divided by that of the second layer (Snell's Law). The distance shown $D_{1|2}$ is the point on the surface where the refracted time arrival equals that of the direct wave (the refracted wave travels at a higher velocity than the direct wave).

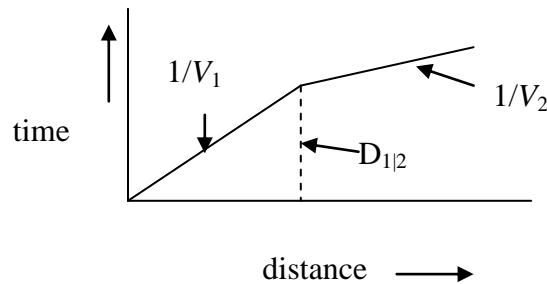
Figure A2

D is the distance and T is the thickness. Since the times as well as the distances are measured, then V_1 and V_2 are determined. If a plot of distance versus time is made then the resulting graph will look like Figure A2.

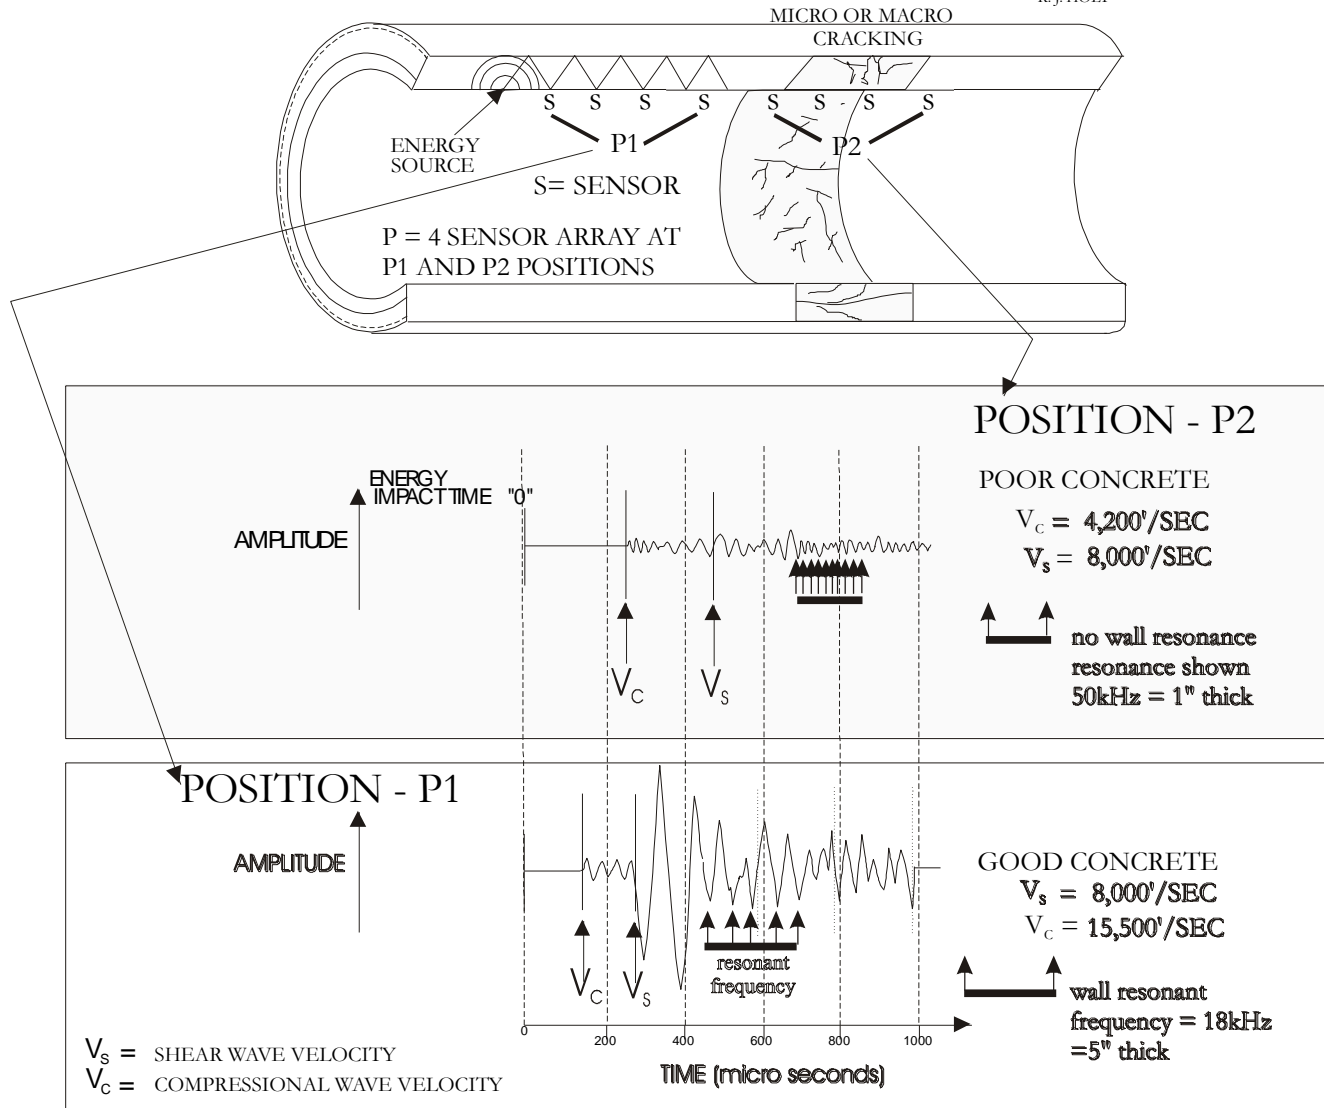
FIGURE A3

SONIC/ULTRASONIC TIME AMPLITUDE RECORDS
FOR FOURTH SENSOR - POOR AND GOOD CONCRETE

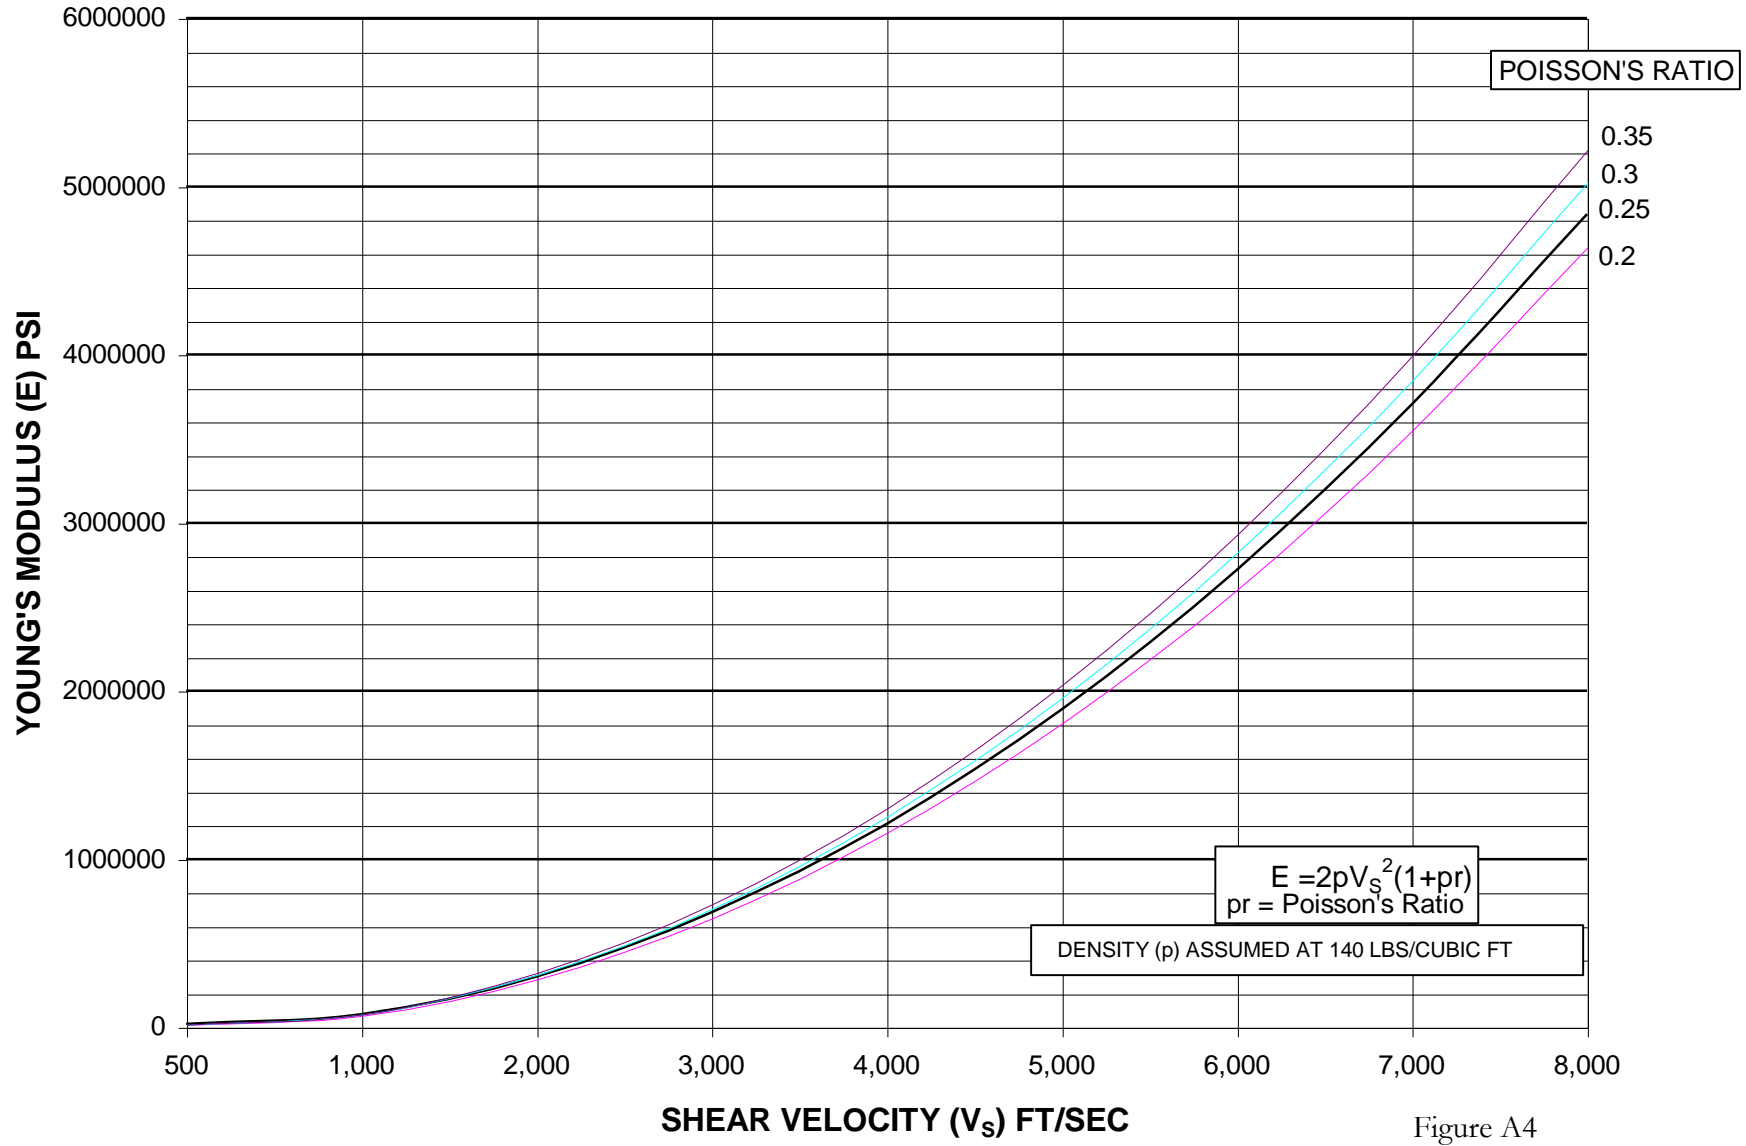
Figure A4

YOUNG'S MODULUS - SHEAR VELOCITY- POISSON'S RATIO

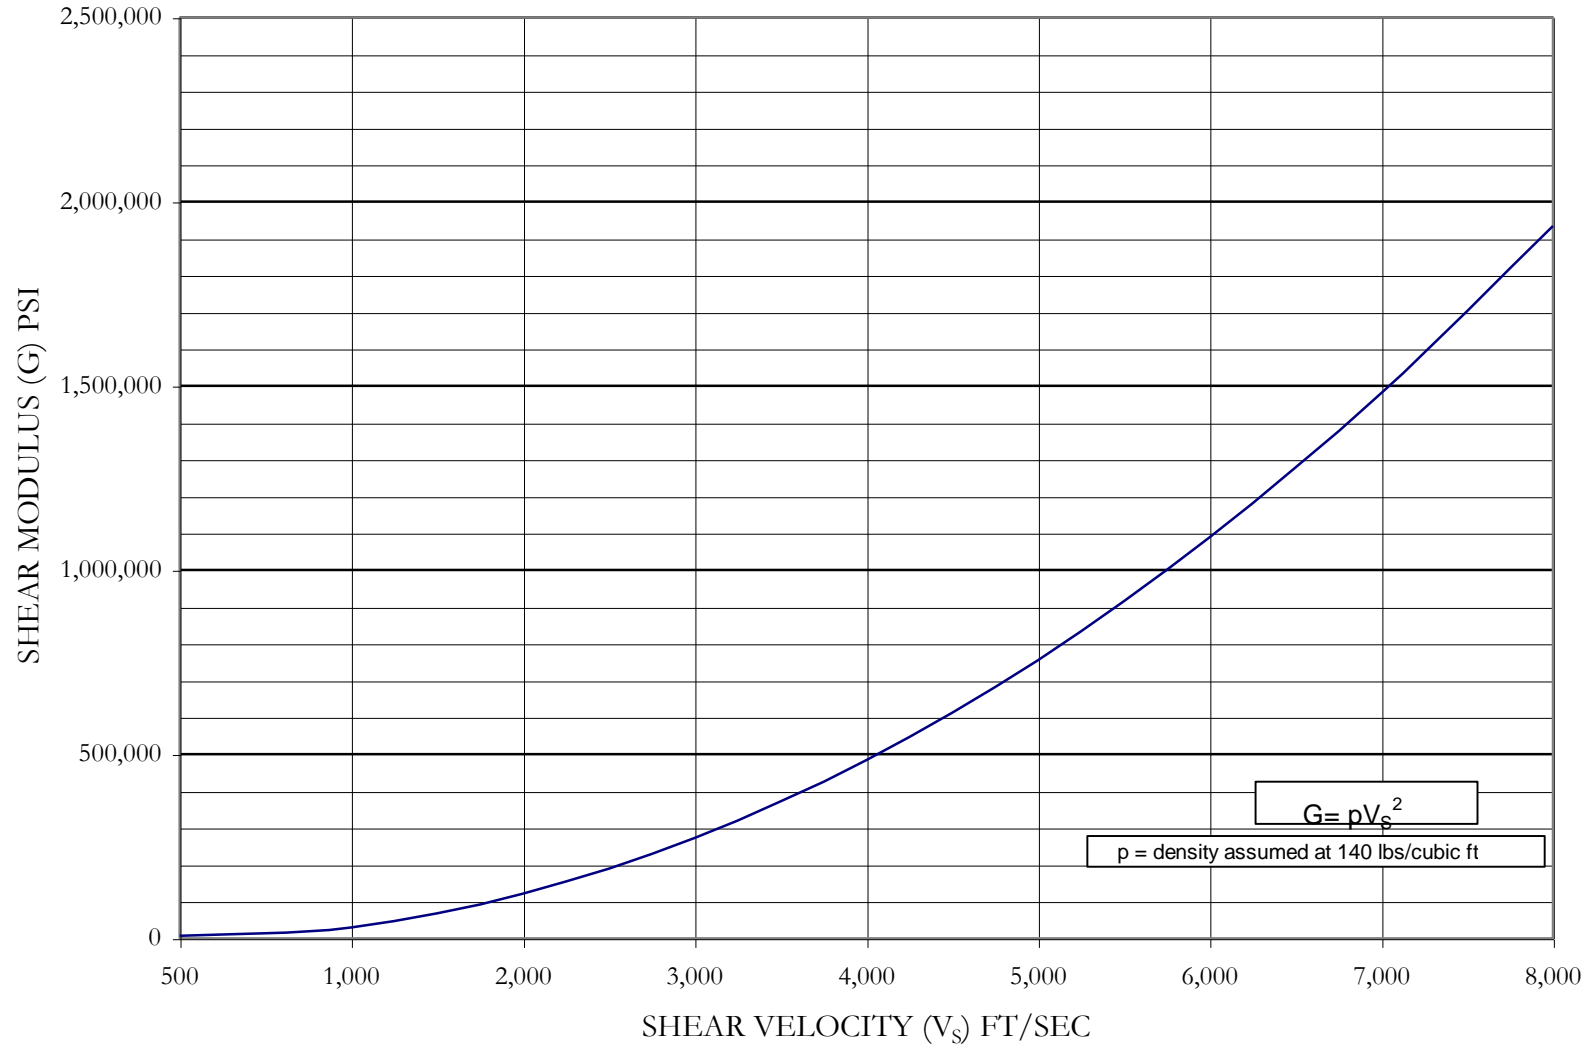
Figure A5

SHEAR MODULUS - SHEAR VELOCITY

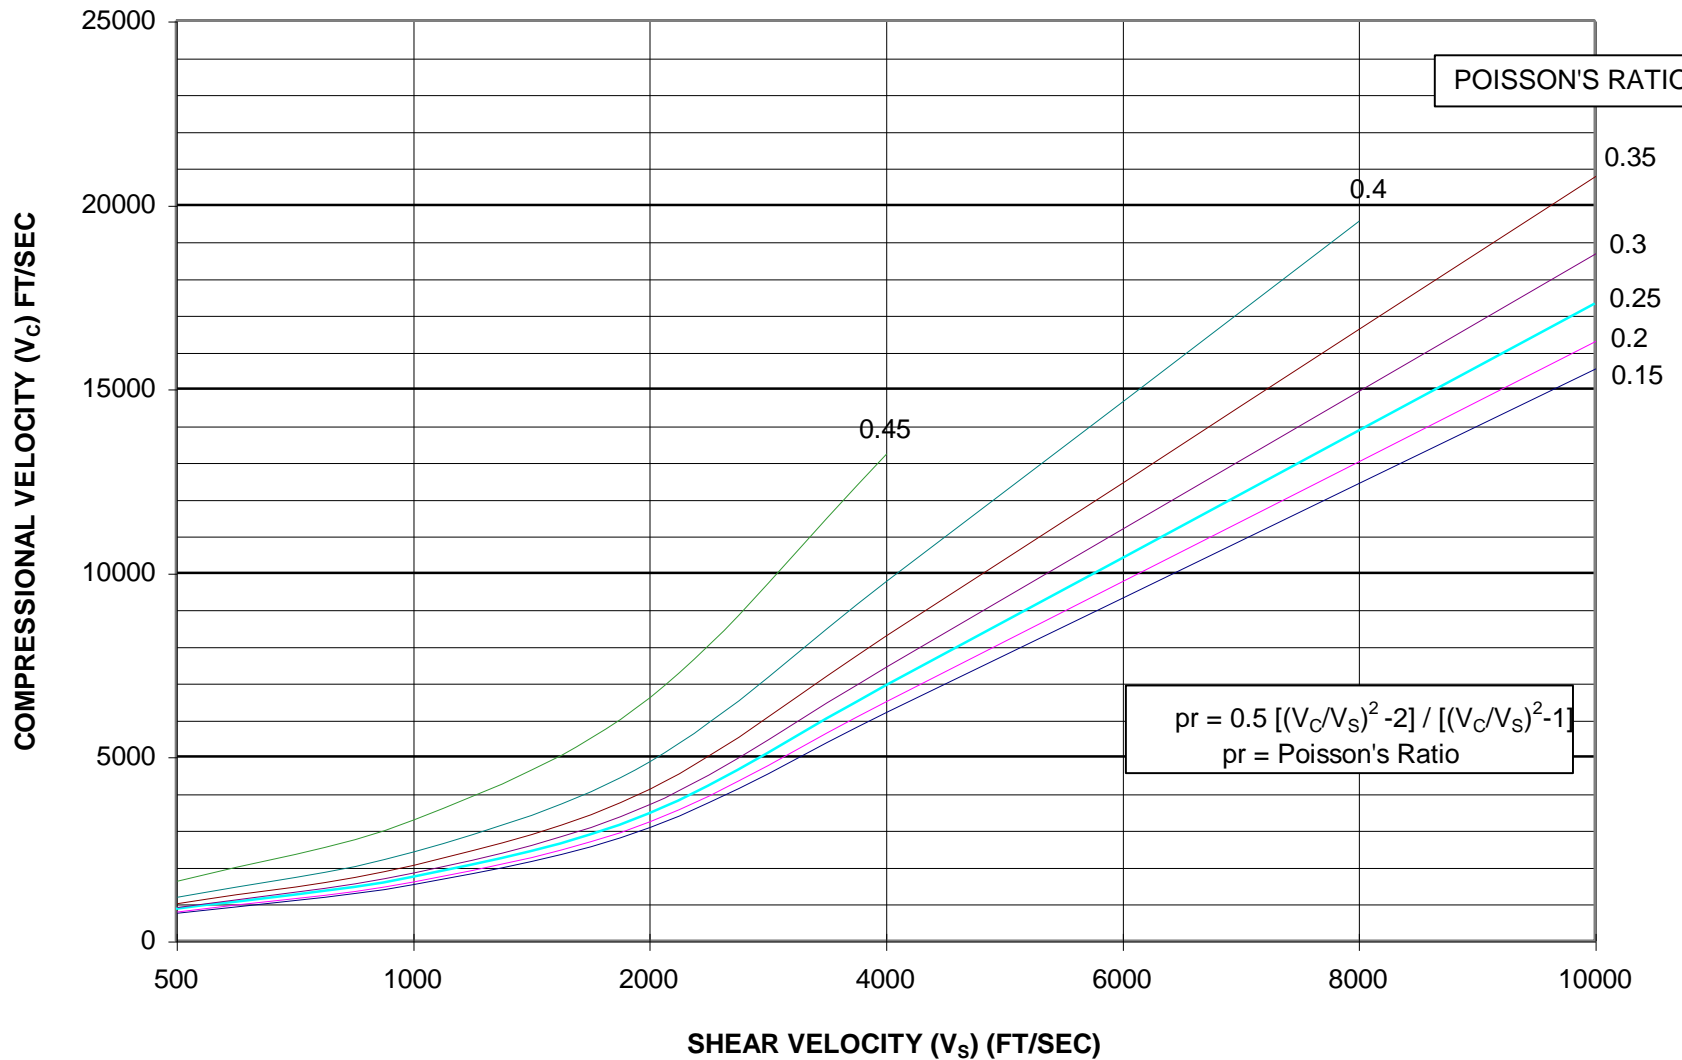
Figure A6

COMPRESSIONAL VELOCITY - SHEAR VELOCITY - POISSON'S RATIO

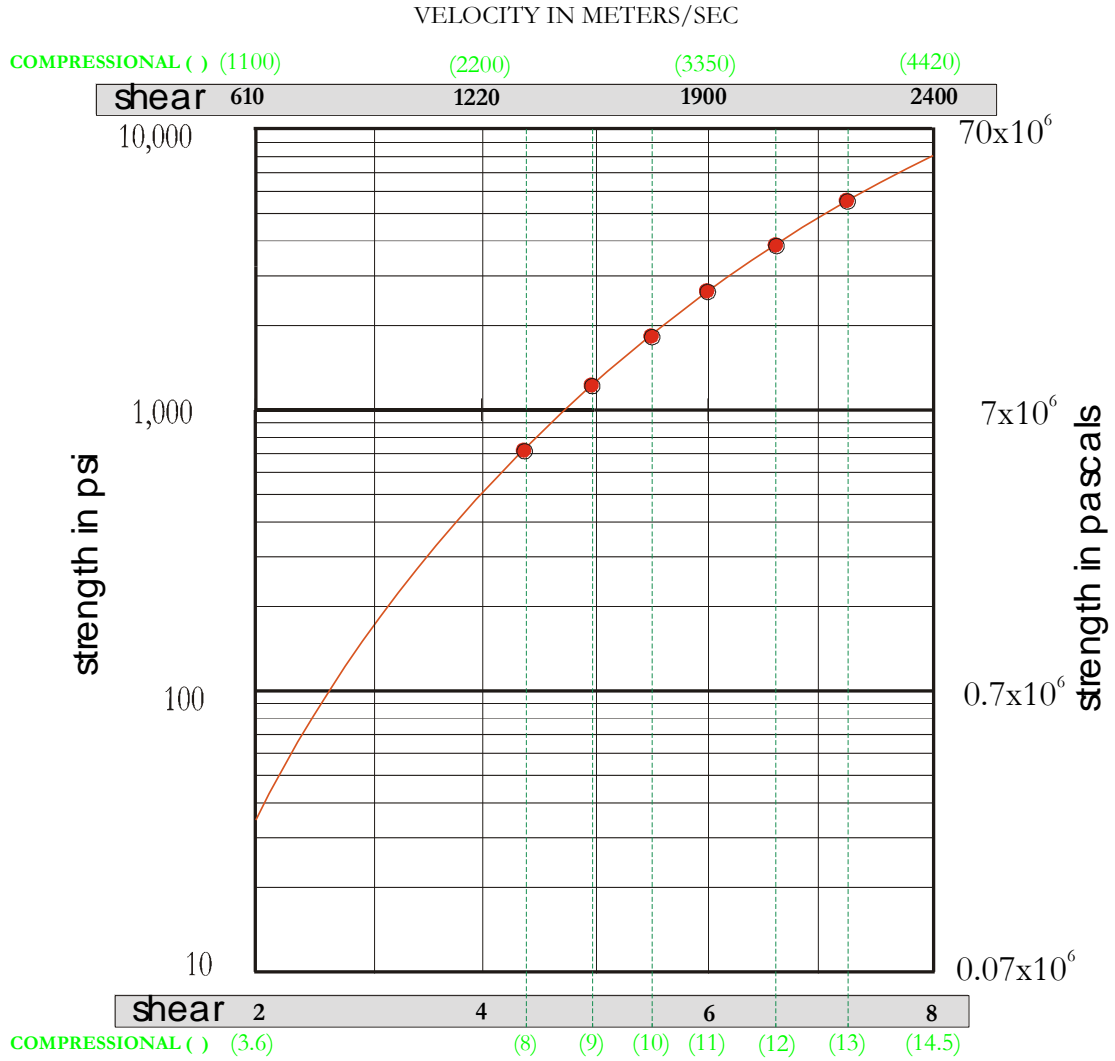
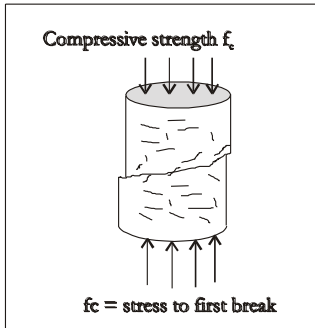
strength of concrete versus velocity

VELOCITY IN FEET/SEC (X 1,000)

CURVE FOR RATIO: $V_{SHEAR} / V_{COMPRESSIVE} = 0.55$
 EQUALS POISSON'S RATIO OF 0.28

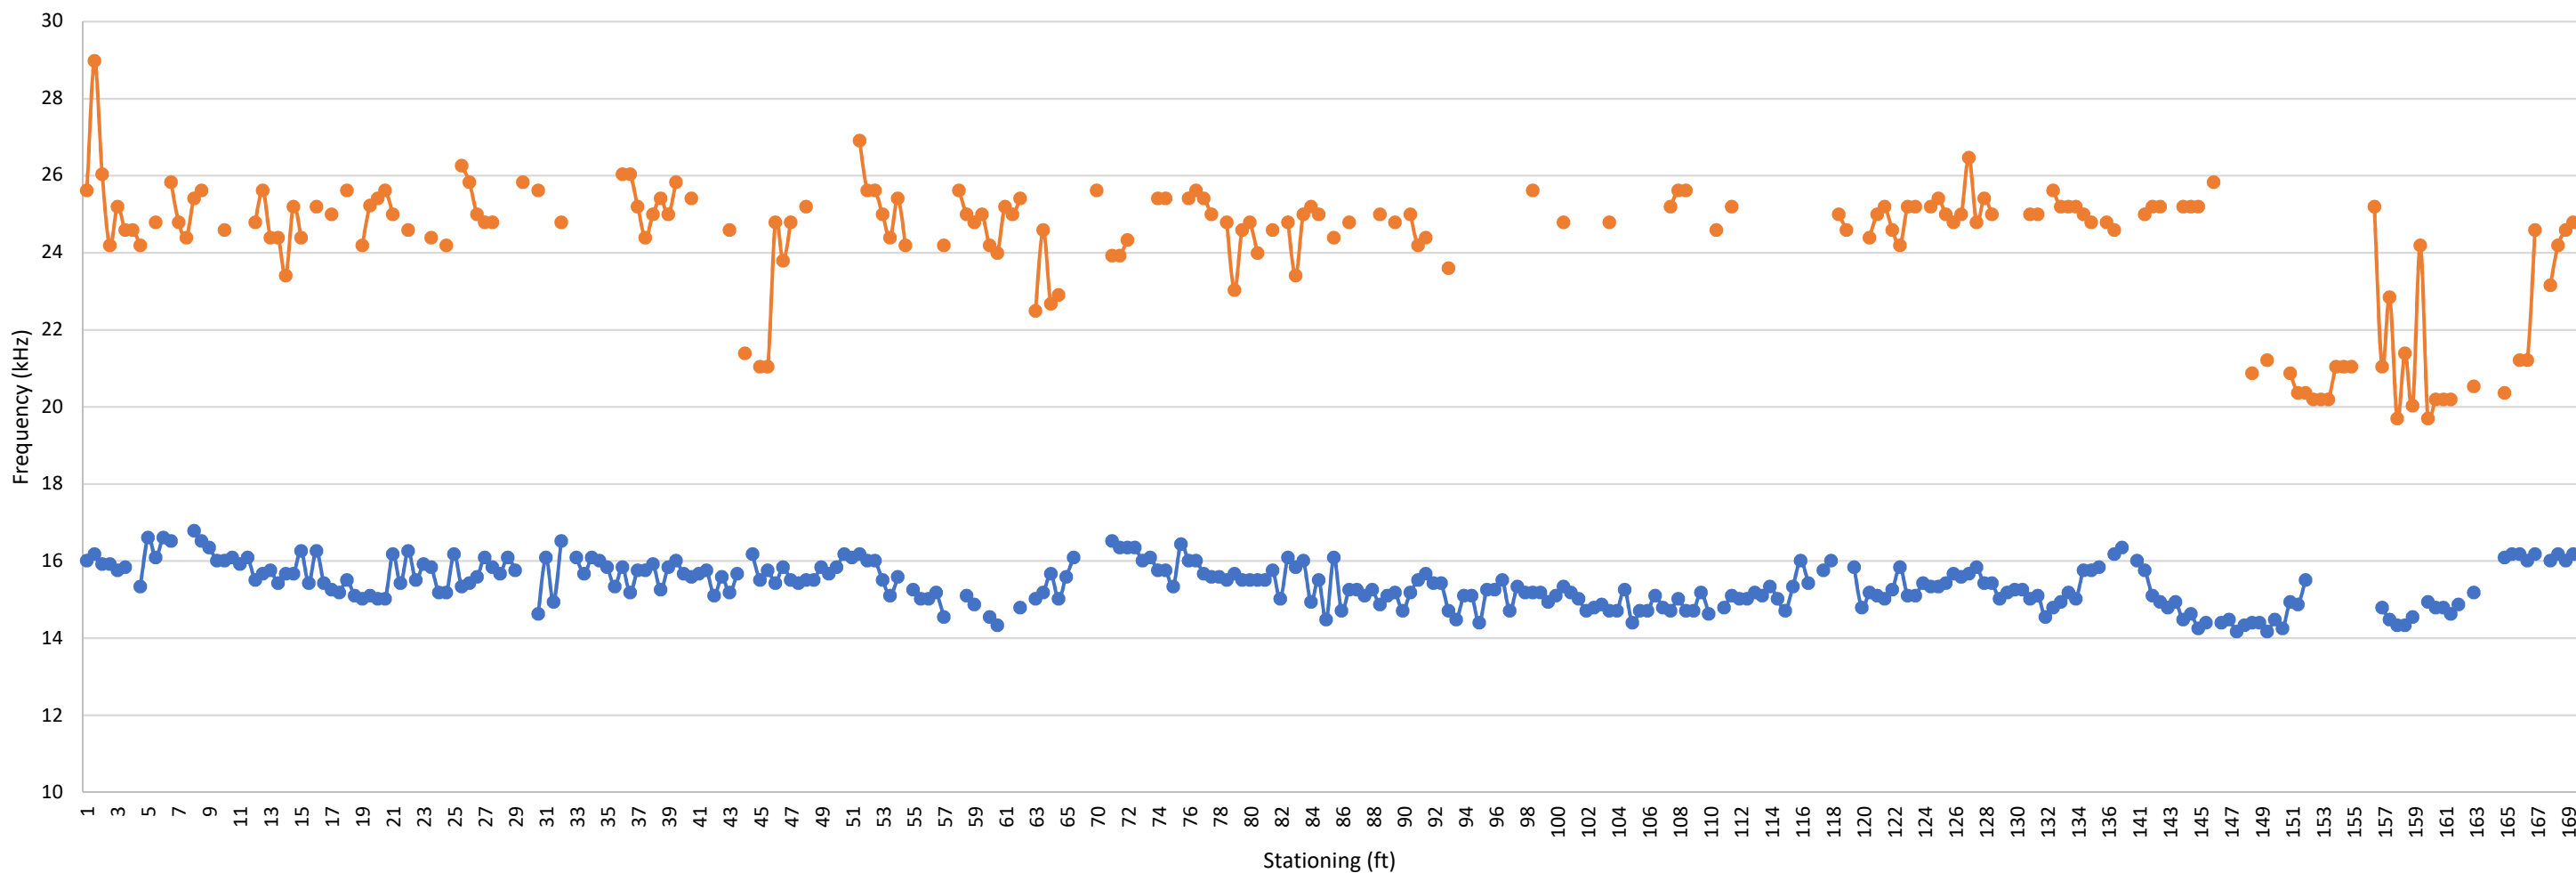
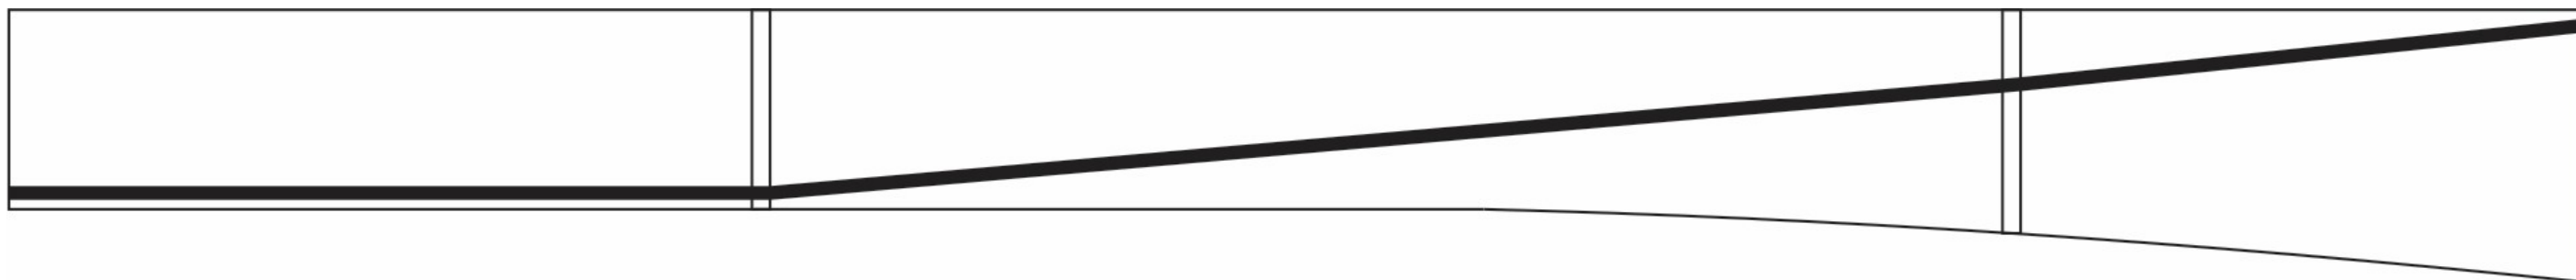
—●— Circumferential Frequency —●— Average Through Frequency ■ Anomalous Grout Condition

<p>Nondestructive Testing External Tendon Ducts John Ringling Causeway Bridge Over Sarasota Bay Sarasota, Florida Prepared for Florida International University by NDT Corporation</p>		<p>Span 1 Tendon 402L-1W Graph Results</p>	
		<p>January. 2018</p>	<p>Figure A1</p>

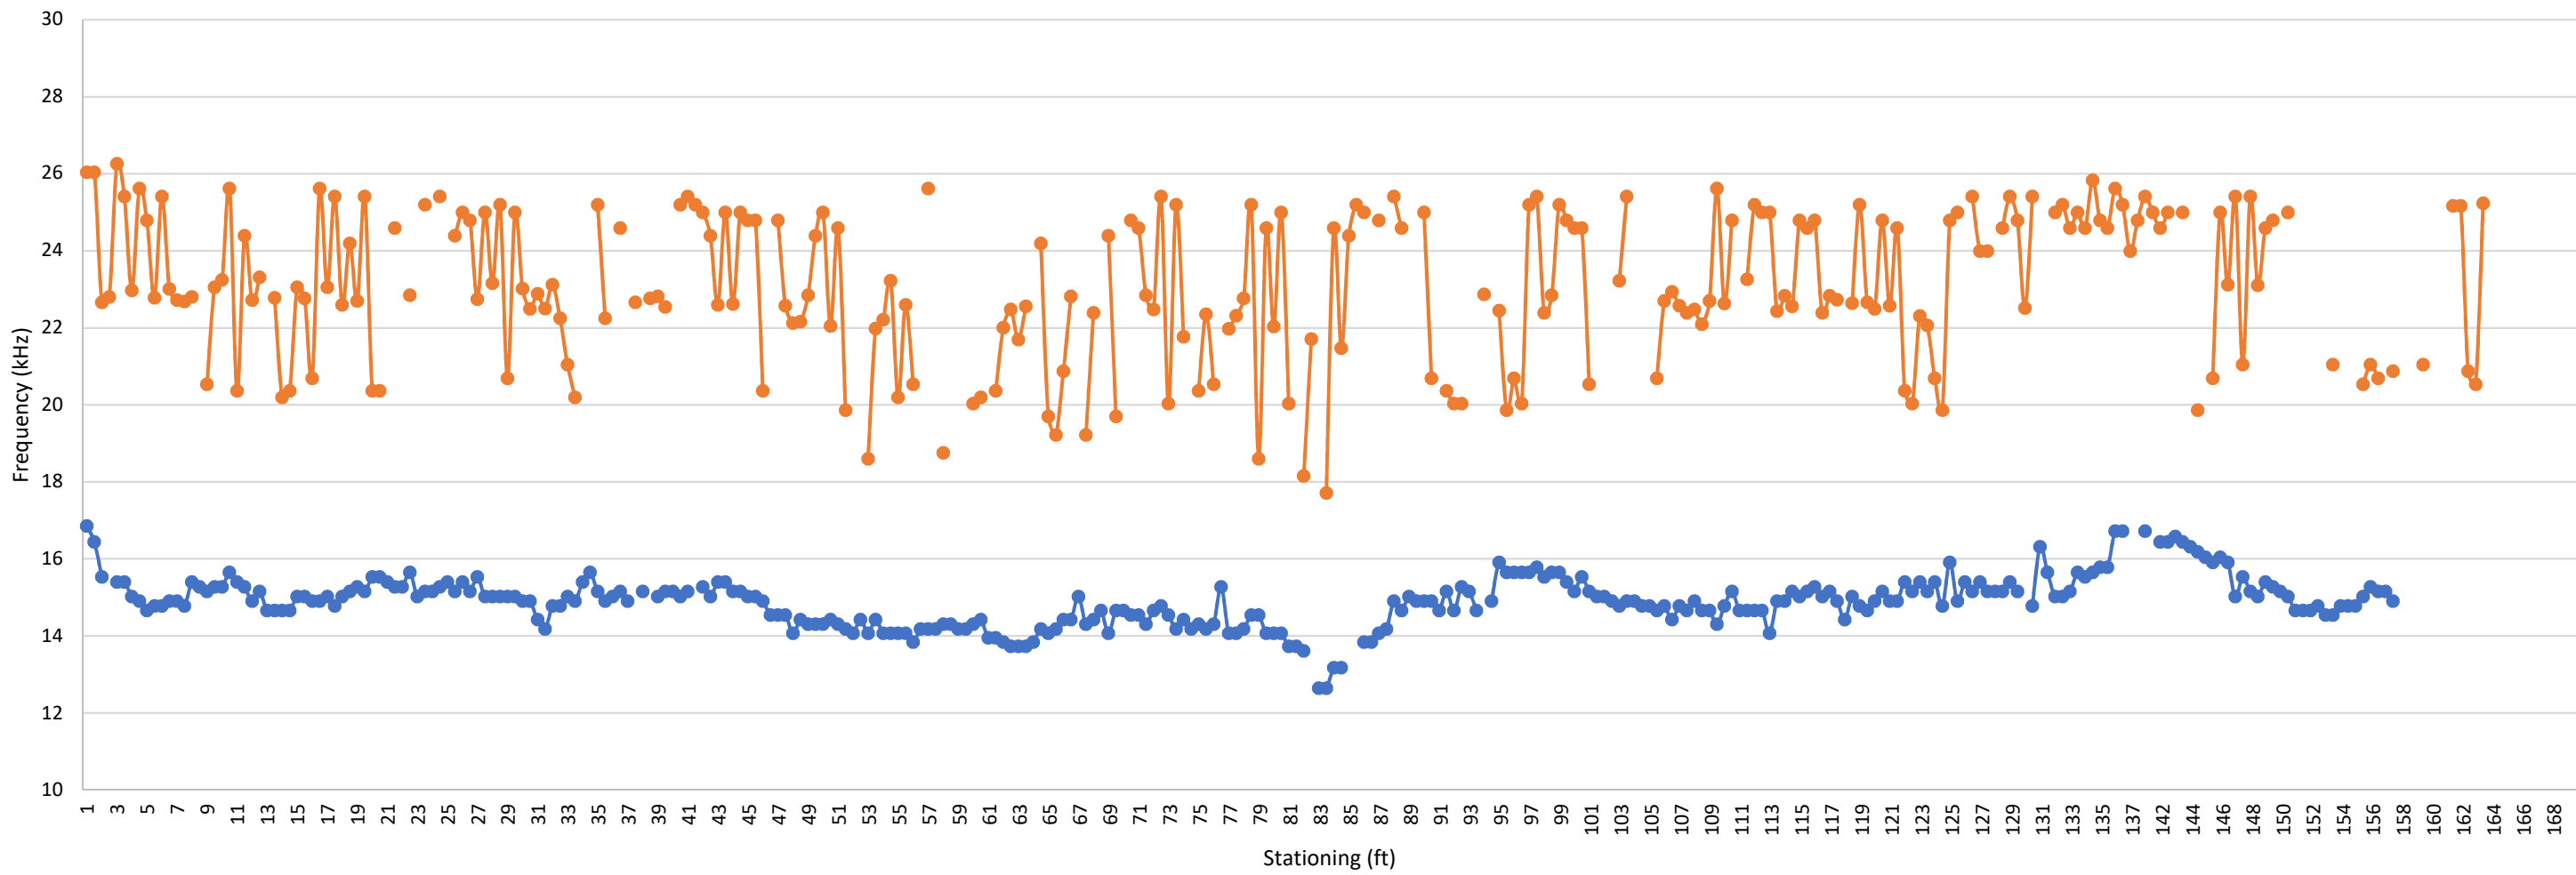
—●— Circumferential Frequency —●— Average Through Frequency ■ Anomalous Grout Condition

Nondestructive Testing External Tendon Ducts John Ringling Causeway Bridge Over Sarasota Bay Sarasota, Florida Prepared for Florida International University by NDT Corporation		Span 1 Tendon 401L-1W Graph Results	
		January. 2018	Figure A2

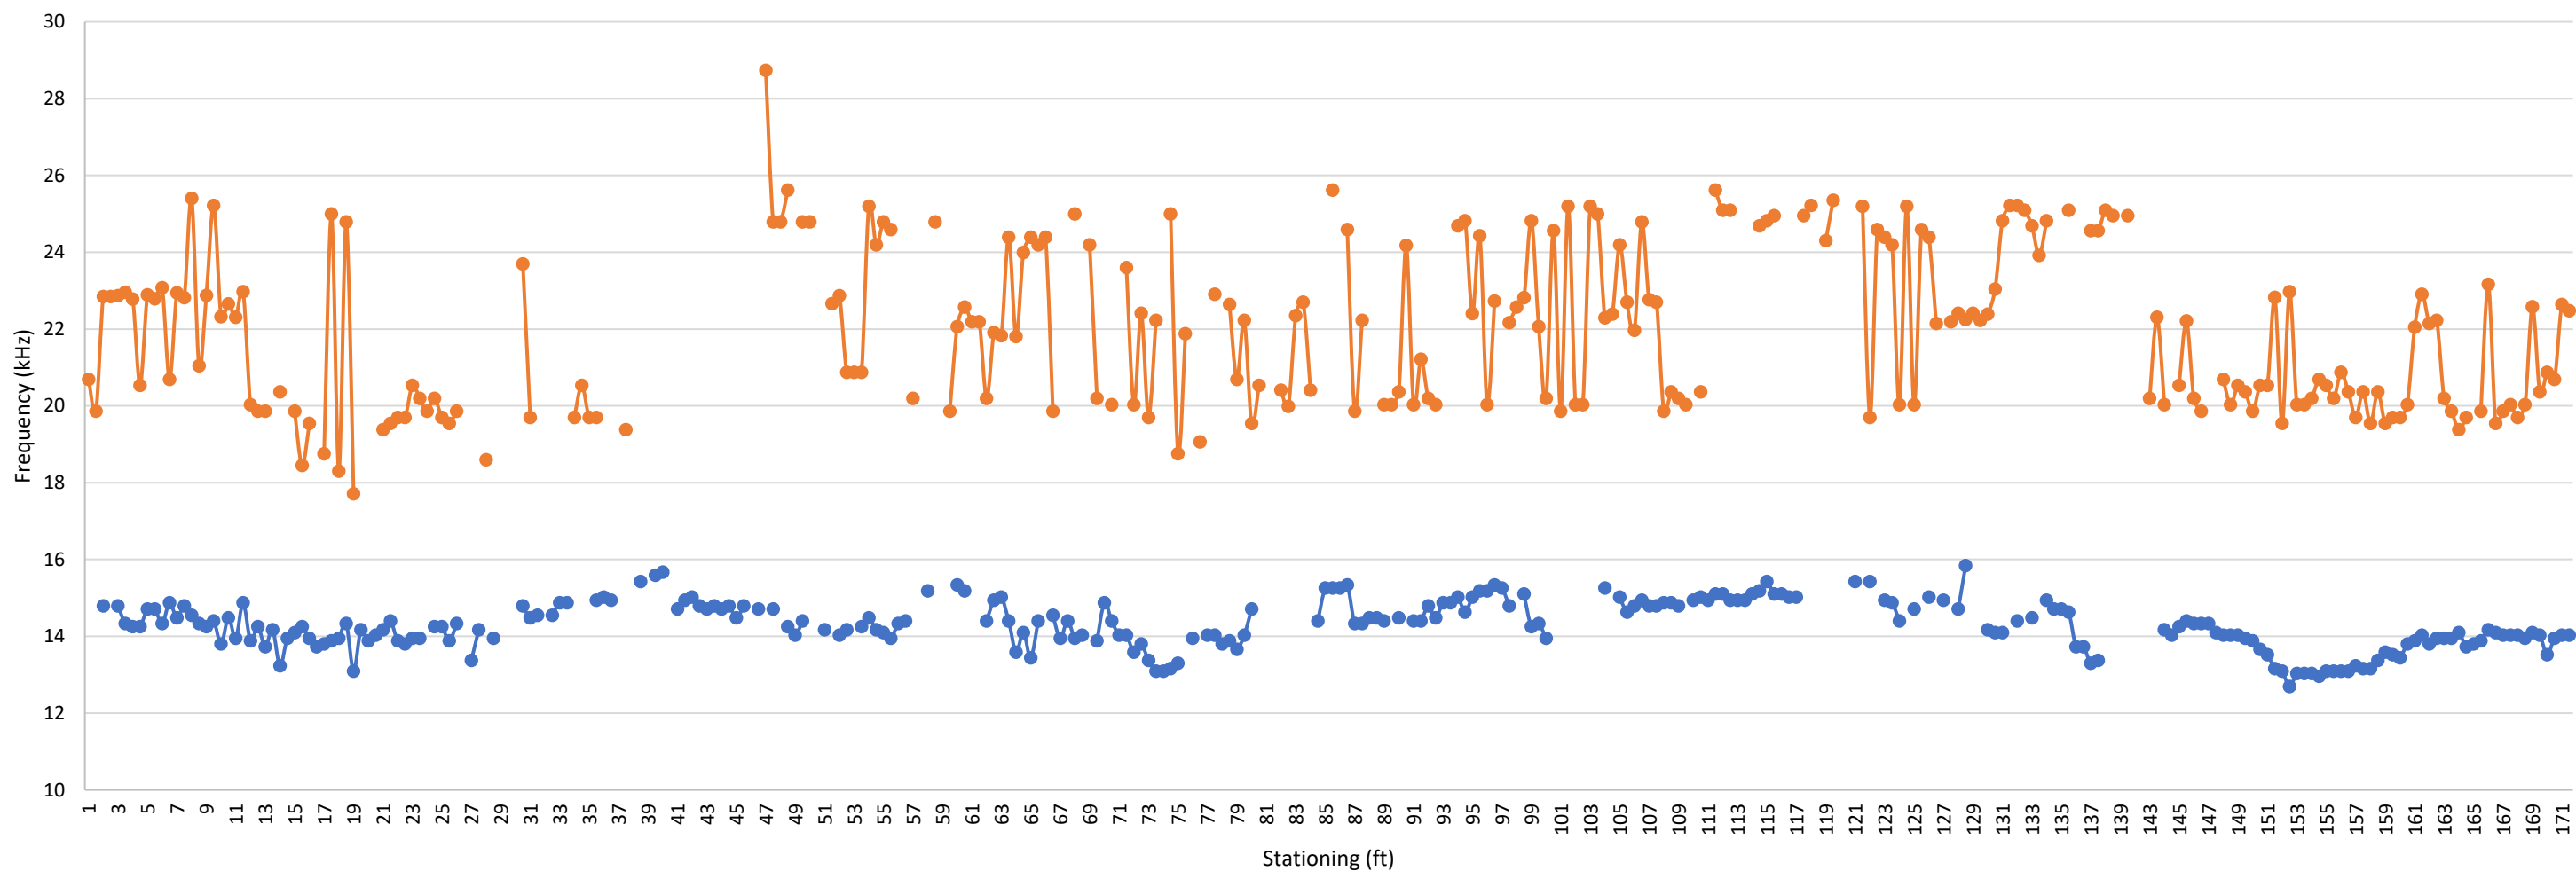
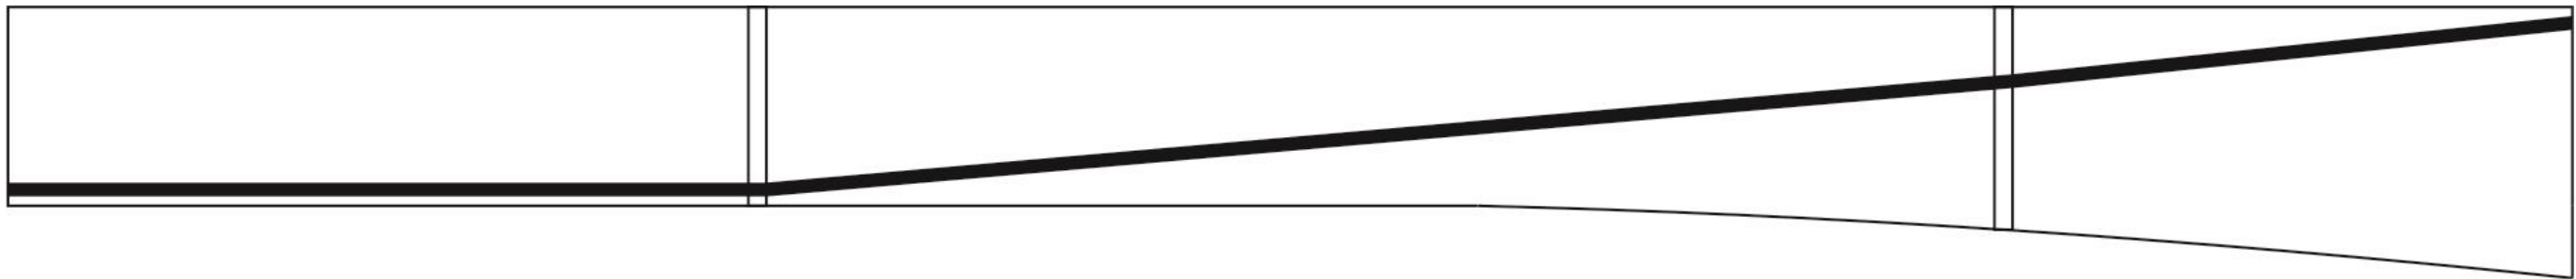
● Circumferential Frequency
 ● Average Through Frequency
 ■ Anomalous Grout Condition

Nondestructive Testing External Tendon Ducts John Ringling Causeway Bridge Over Sarasota Bay Sarasota, Florida Prepared for Florida International University by NDT Corporation		Span 1 Tendon 401R-1W Graph Results	
January. 2018		Figure A3

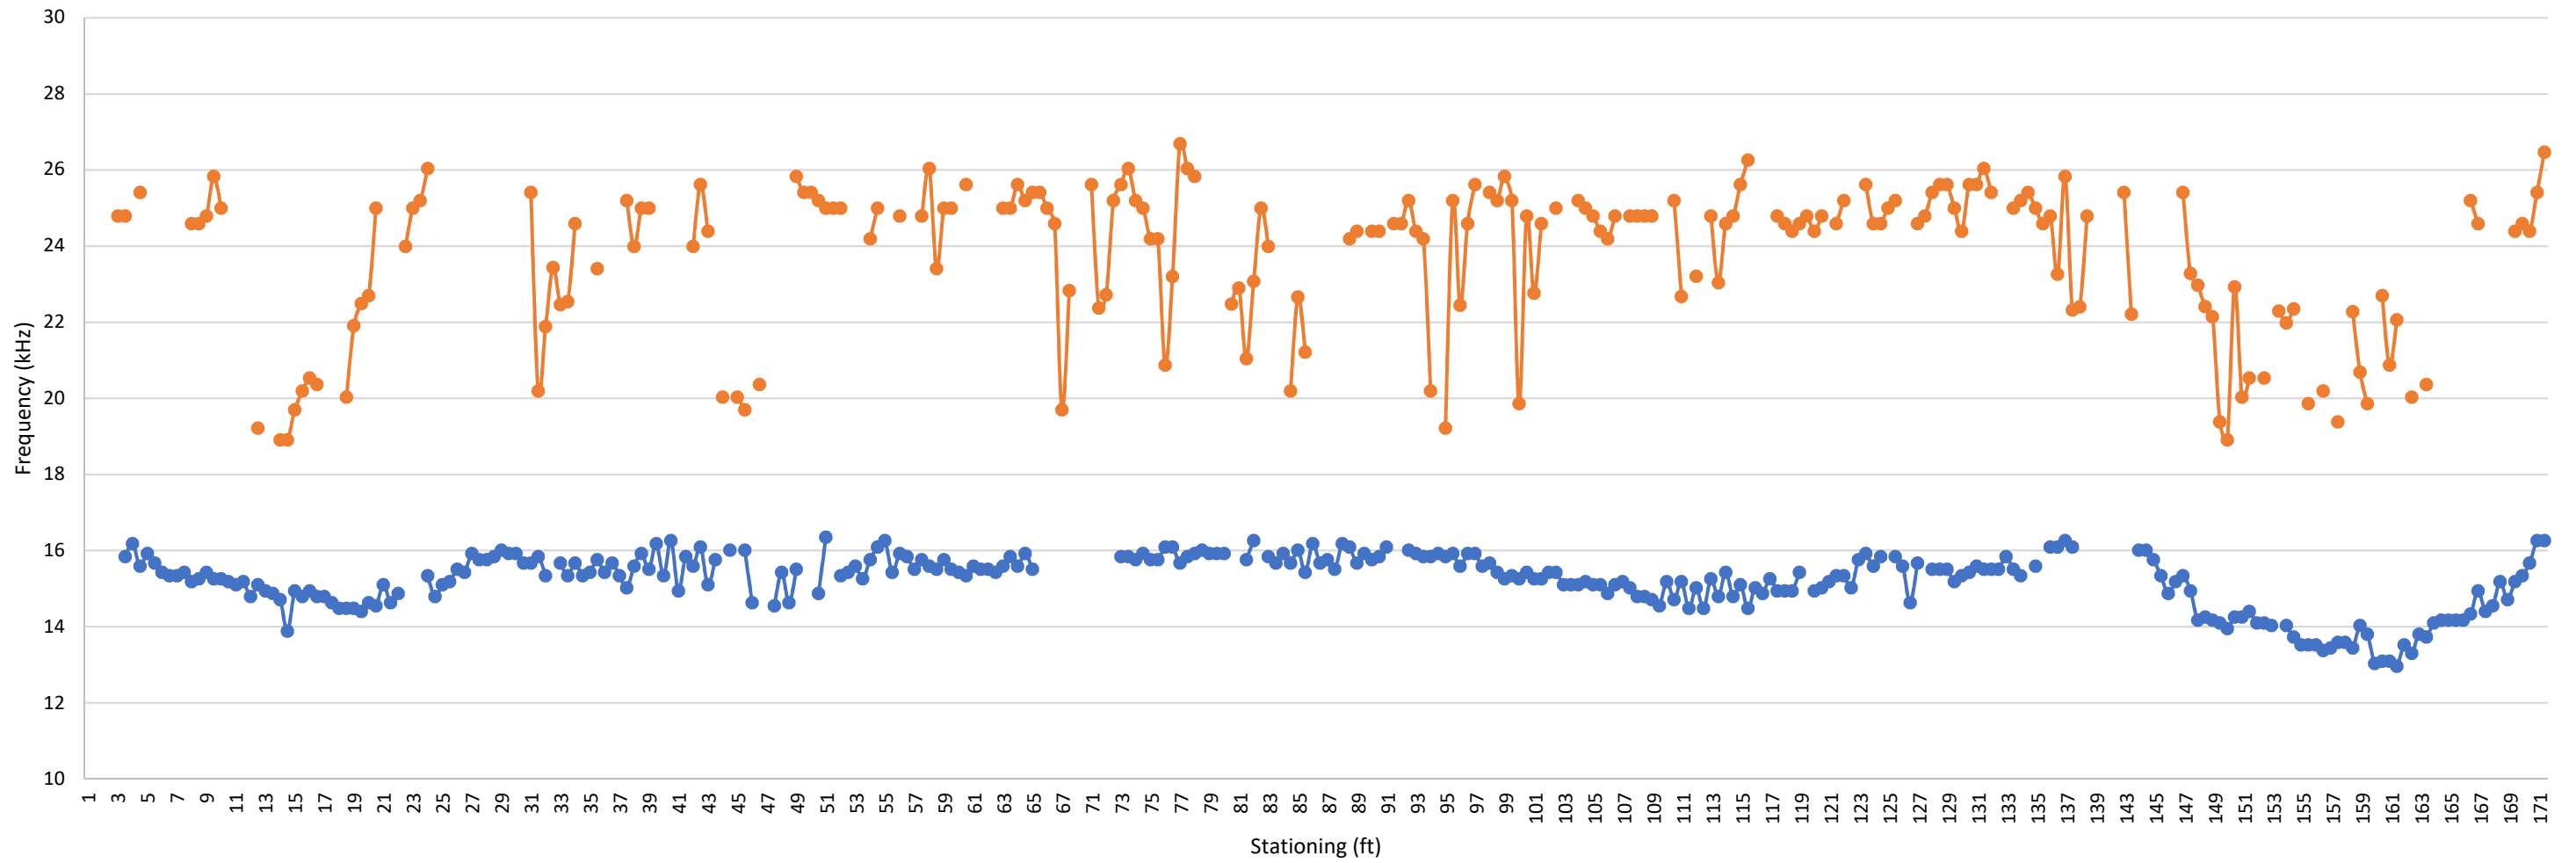
—●— Circumferential Frequency
 —●— Average Through Frequency
 ■ Anomalous Grout Condition

Nondestructive Testing External Tendon Ducts John Ringling Causeway Bridge Over Sarasota Bay Sarasota, Florida Prepared for Florida International University by NDT Corporation		Span 1 Tendon 402R-1W Graph Results	
January. 2018		Figure A4
