**Development of Quality Assurance and Quality Control
System for Post Tensioned Segmental Bridges in Florida:
Case of Ringling Bridge – Phase II**

**FDOT Contract No. BDV29-977-34
FINAL REPORT**

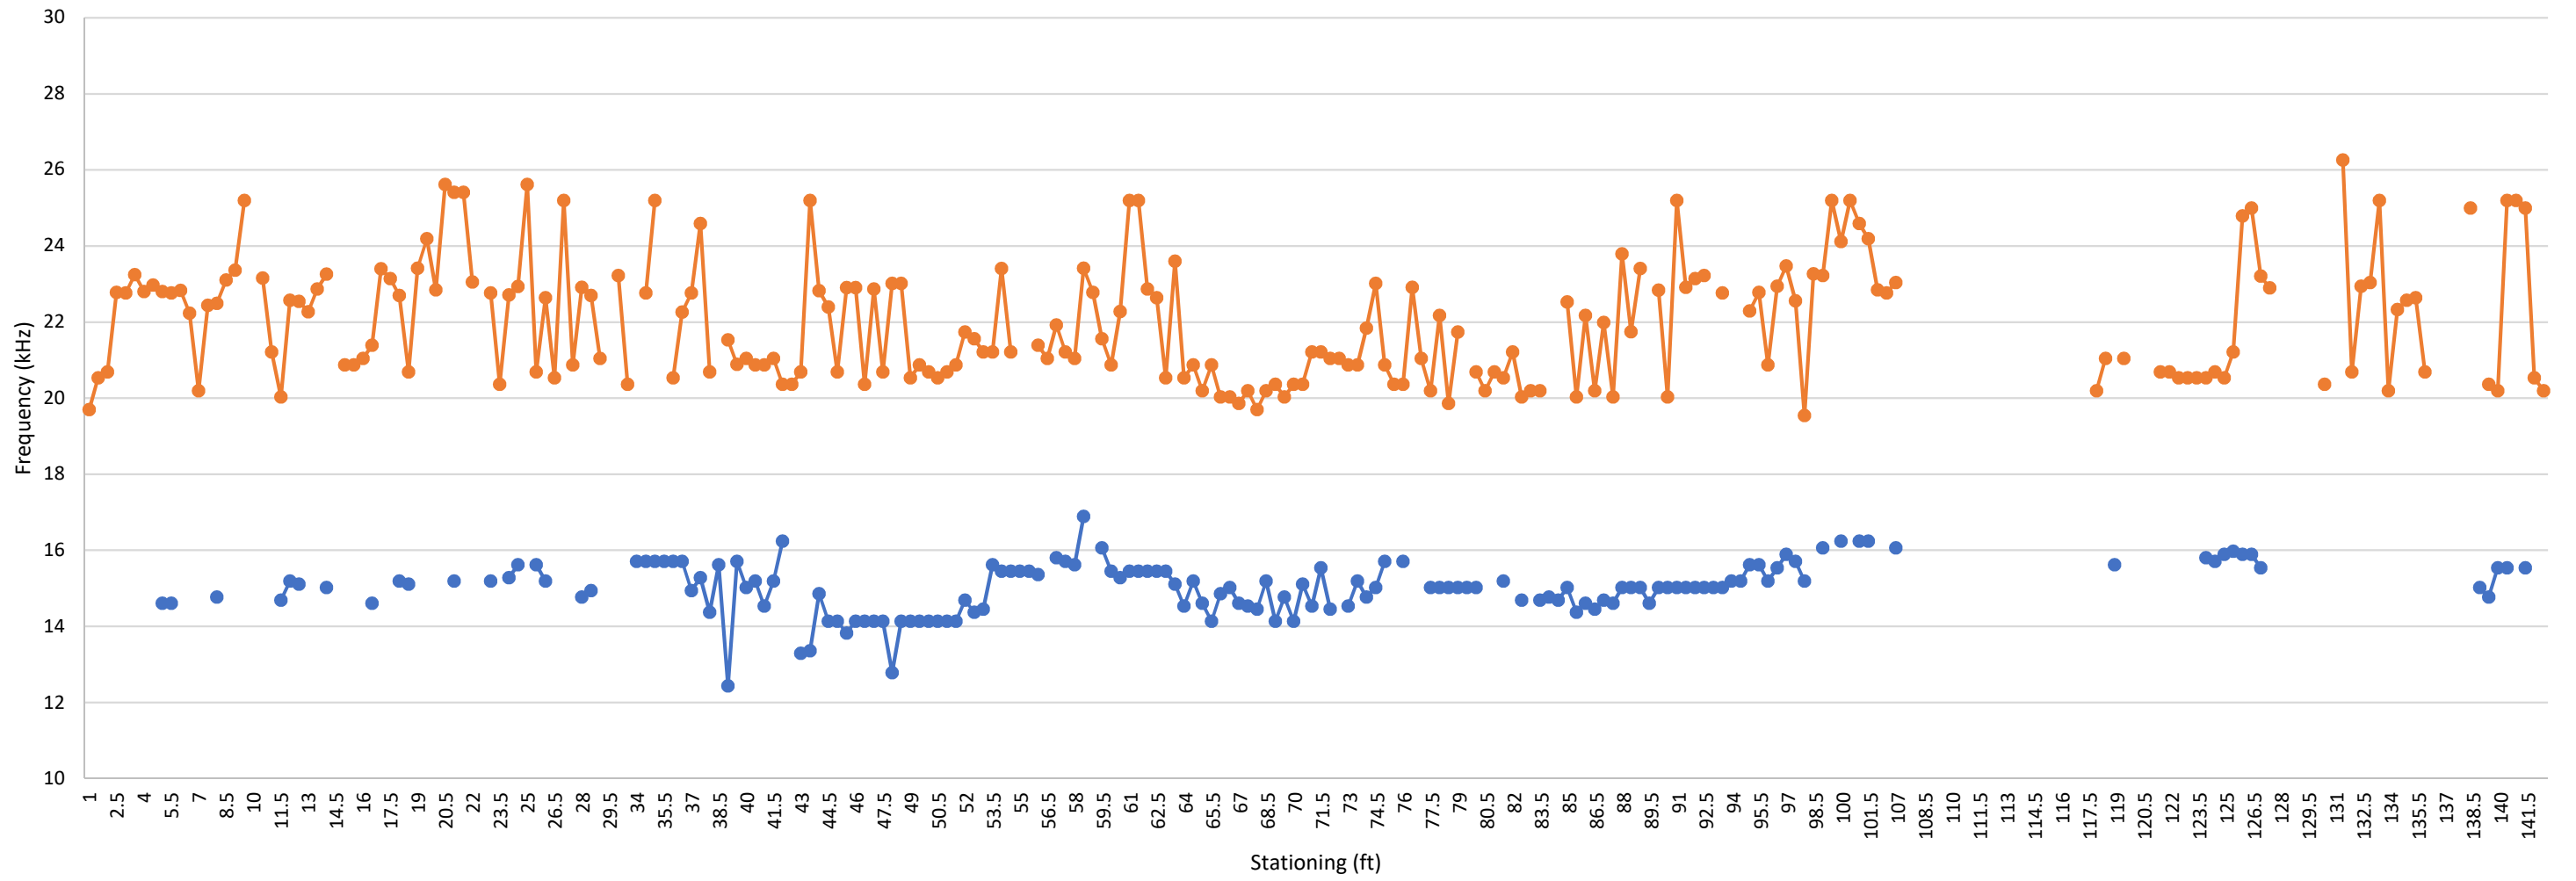
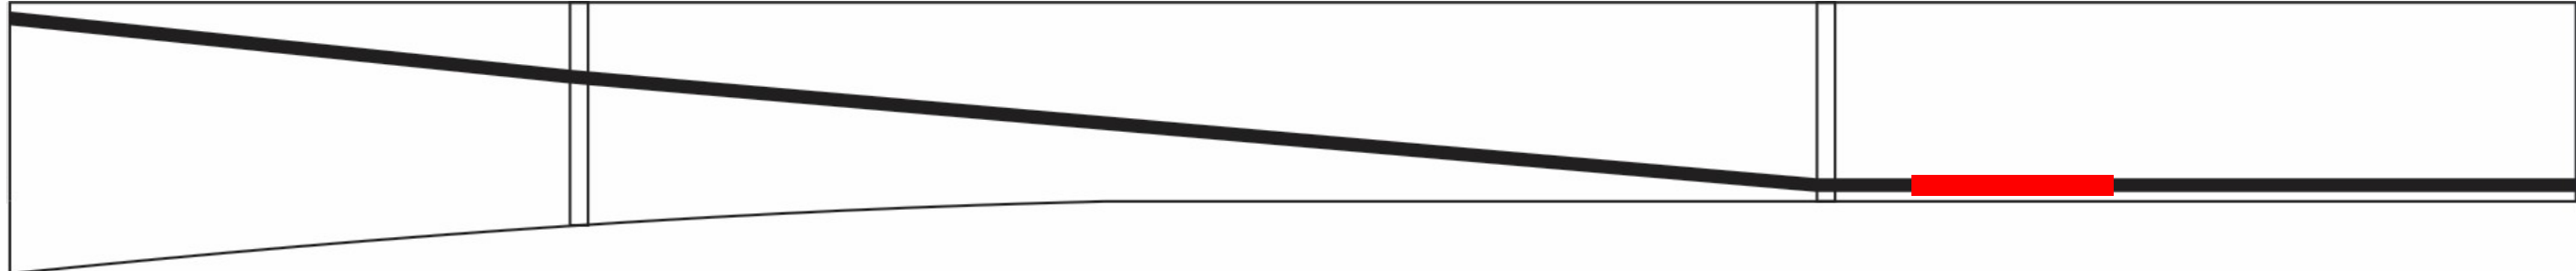
—●— Circumferential Frequency
 —●— Average Through Frequency
 ■ Anomalous Grout Condition

Nondestructive Testing External Tendon Ducts John Ringling Causeway Bridge Over Sarasota Bay Sarasota, Florida Prepared for Florida International University by NDT Corporation		Span 2 Tendon 402L-1E Graph Results	
January. 2018		Figure A5

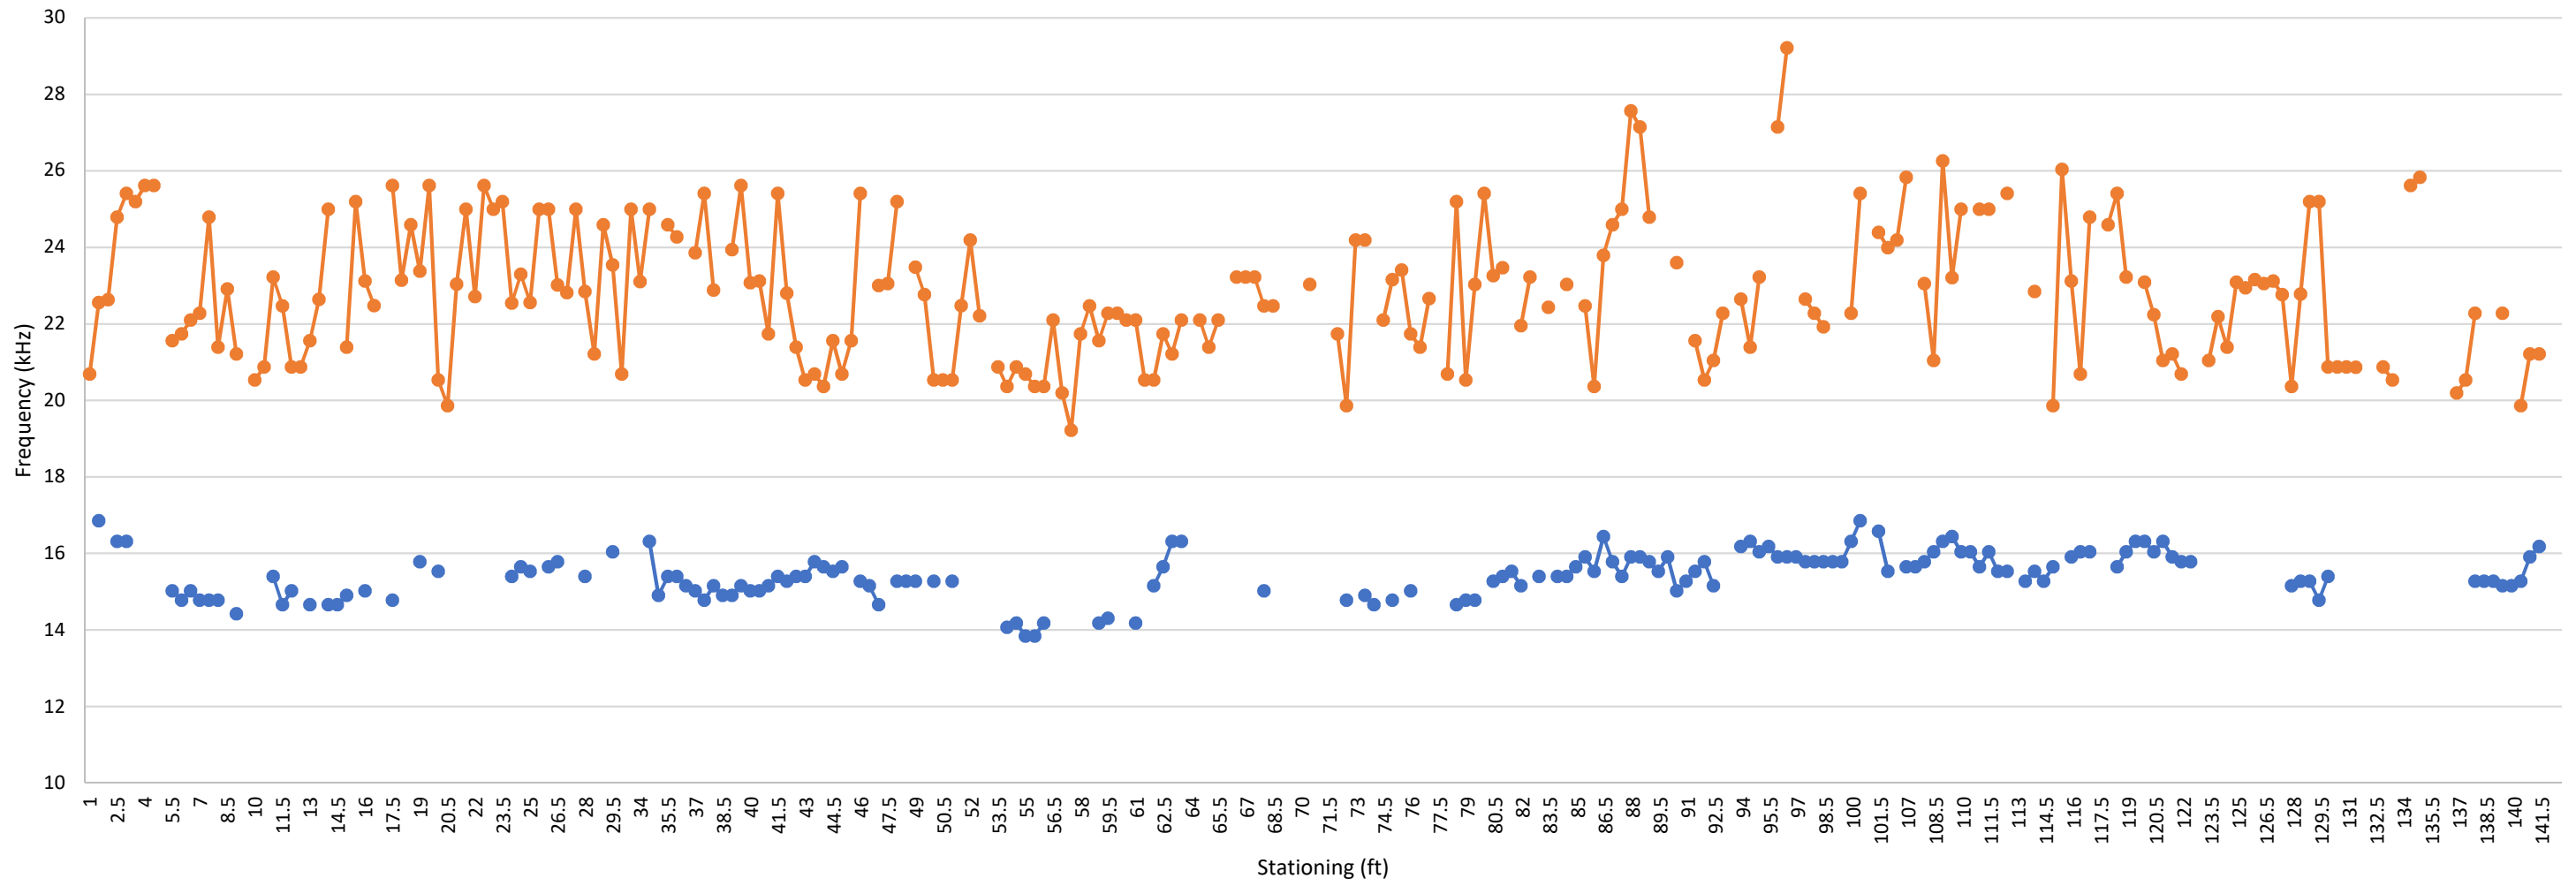
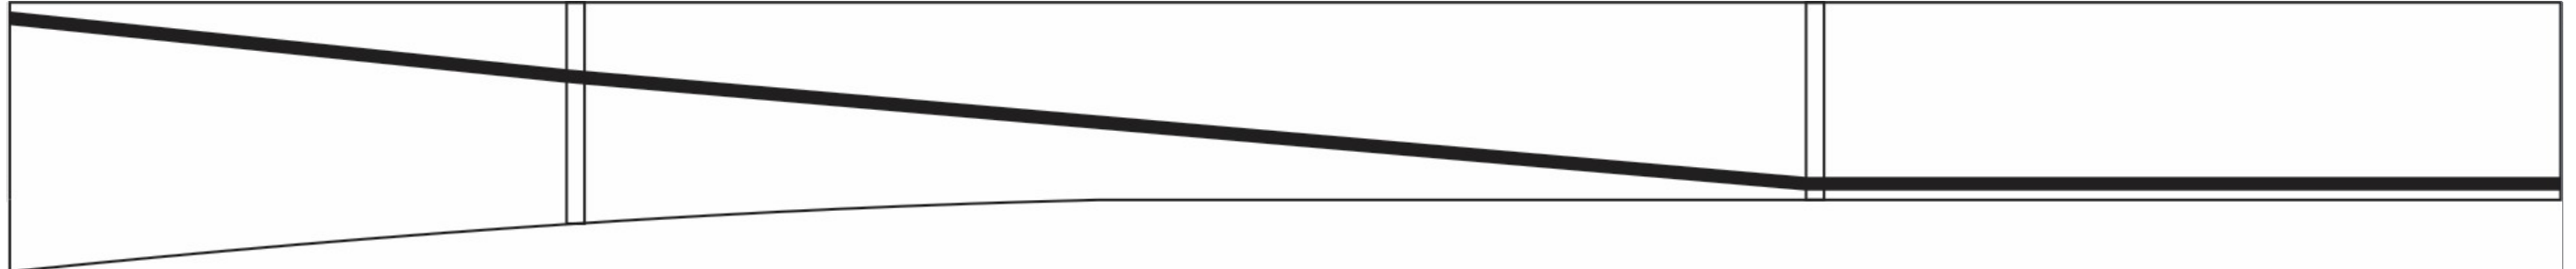
—●— Circumferential Frequency
 —●— Average Through Frequency
 ■ Anomalous Grout Condition

Nondestructive Testing External Tendon Ducts John Ringling Causeway Bridge Over Sarasota Bay Sarasota, Florida Prepared for Florida International University by NDT Corporation		Span 2 Tendon 401L-1E Graph Results	
January. 2018		Figure A6

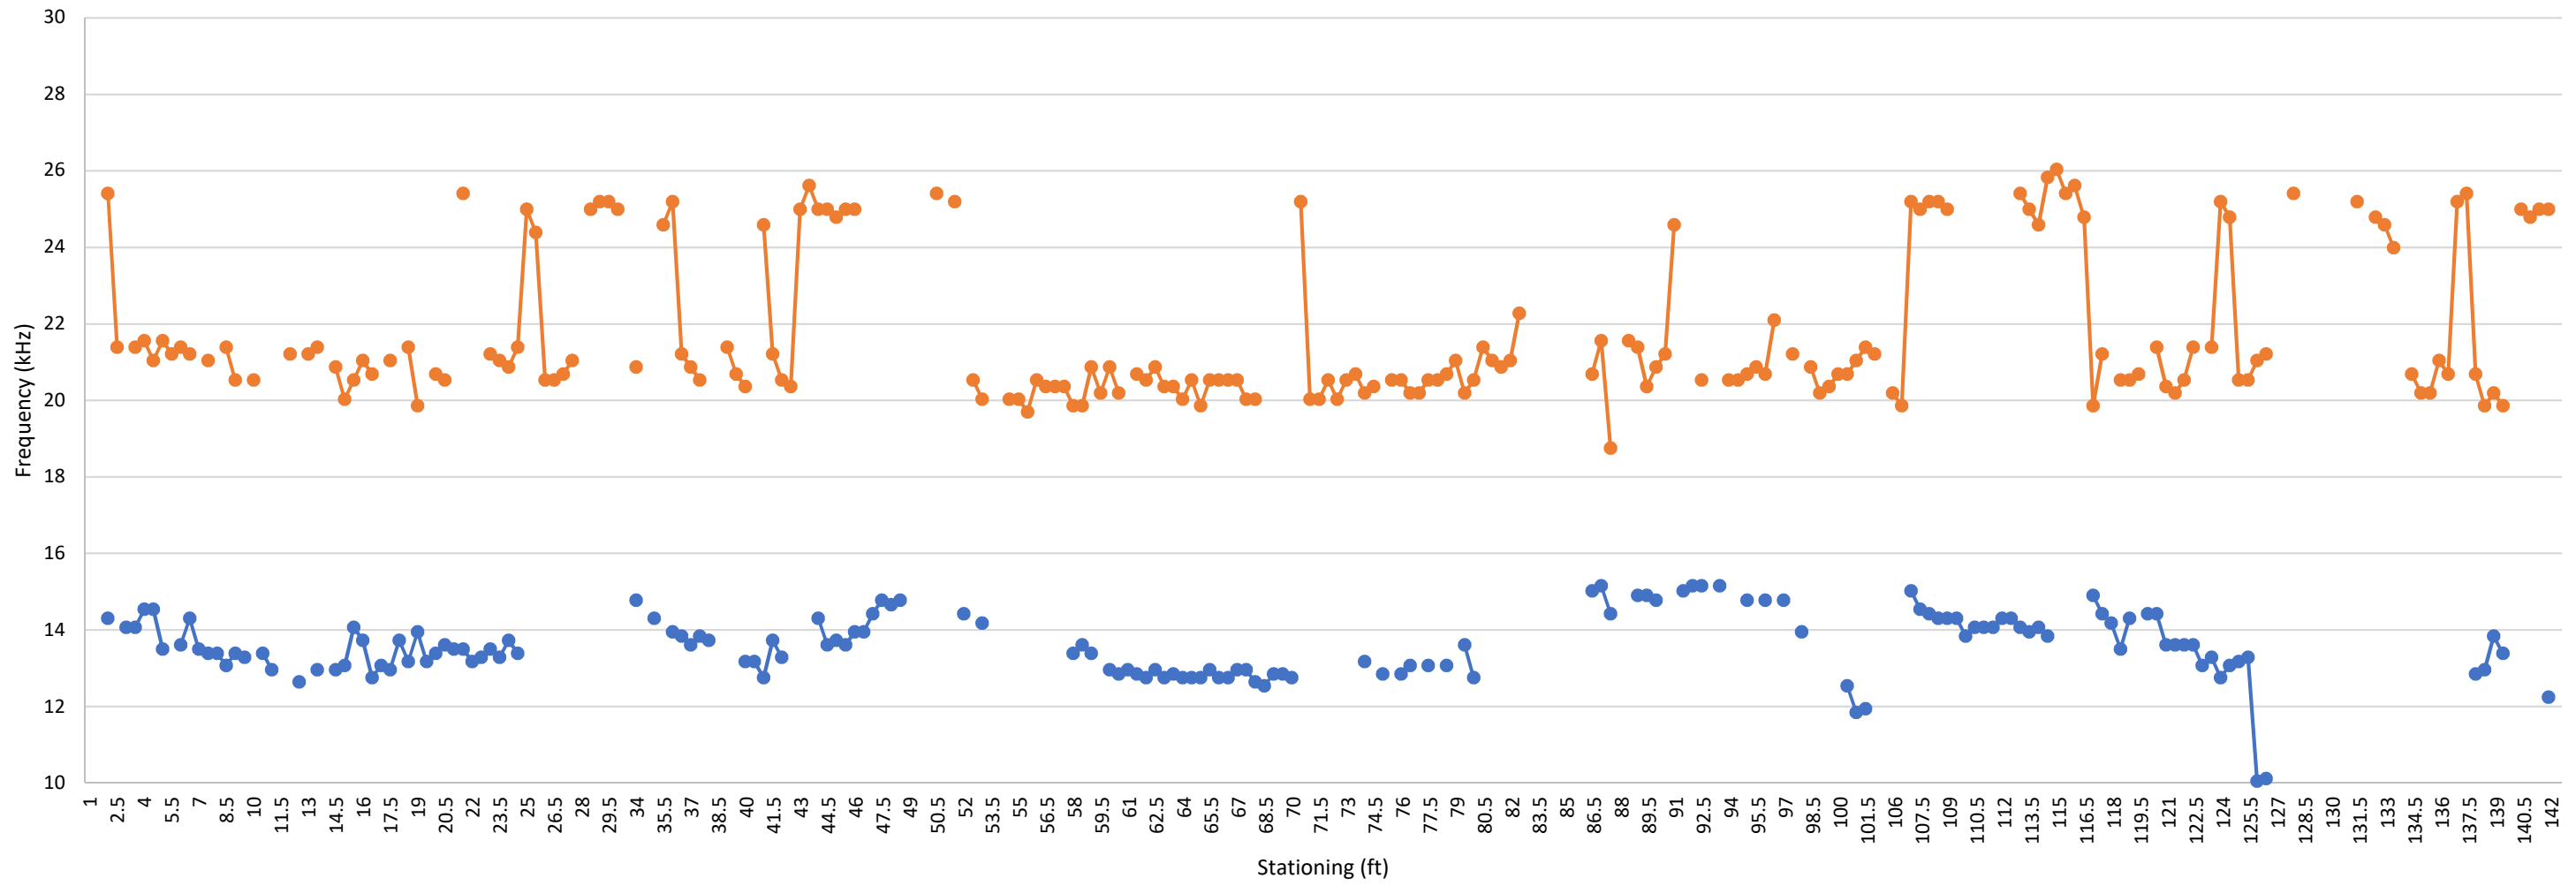
—●— Circumferential Frequency
 —●— Average Through Frequency
 ■ Anomalous Grout Condition

Nondestructive Testing External Tendon Ducts John Ringling Causeway Bridge Over Sarasota Bay Sarasota, Florida Prepared for Florida International University by NDT Corporation		Span 2 Tendon 401R-1E Graph Results	
January. 2018		Figure A7

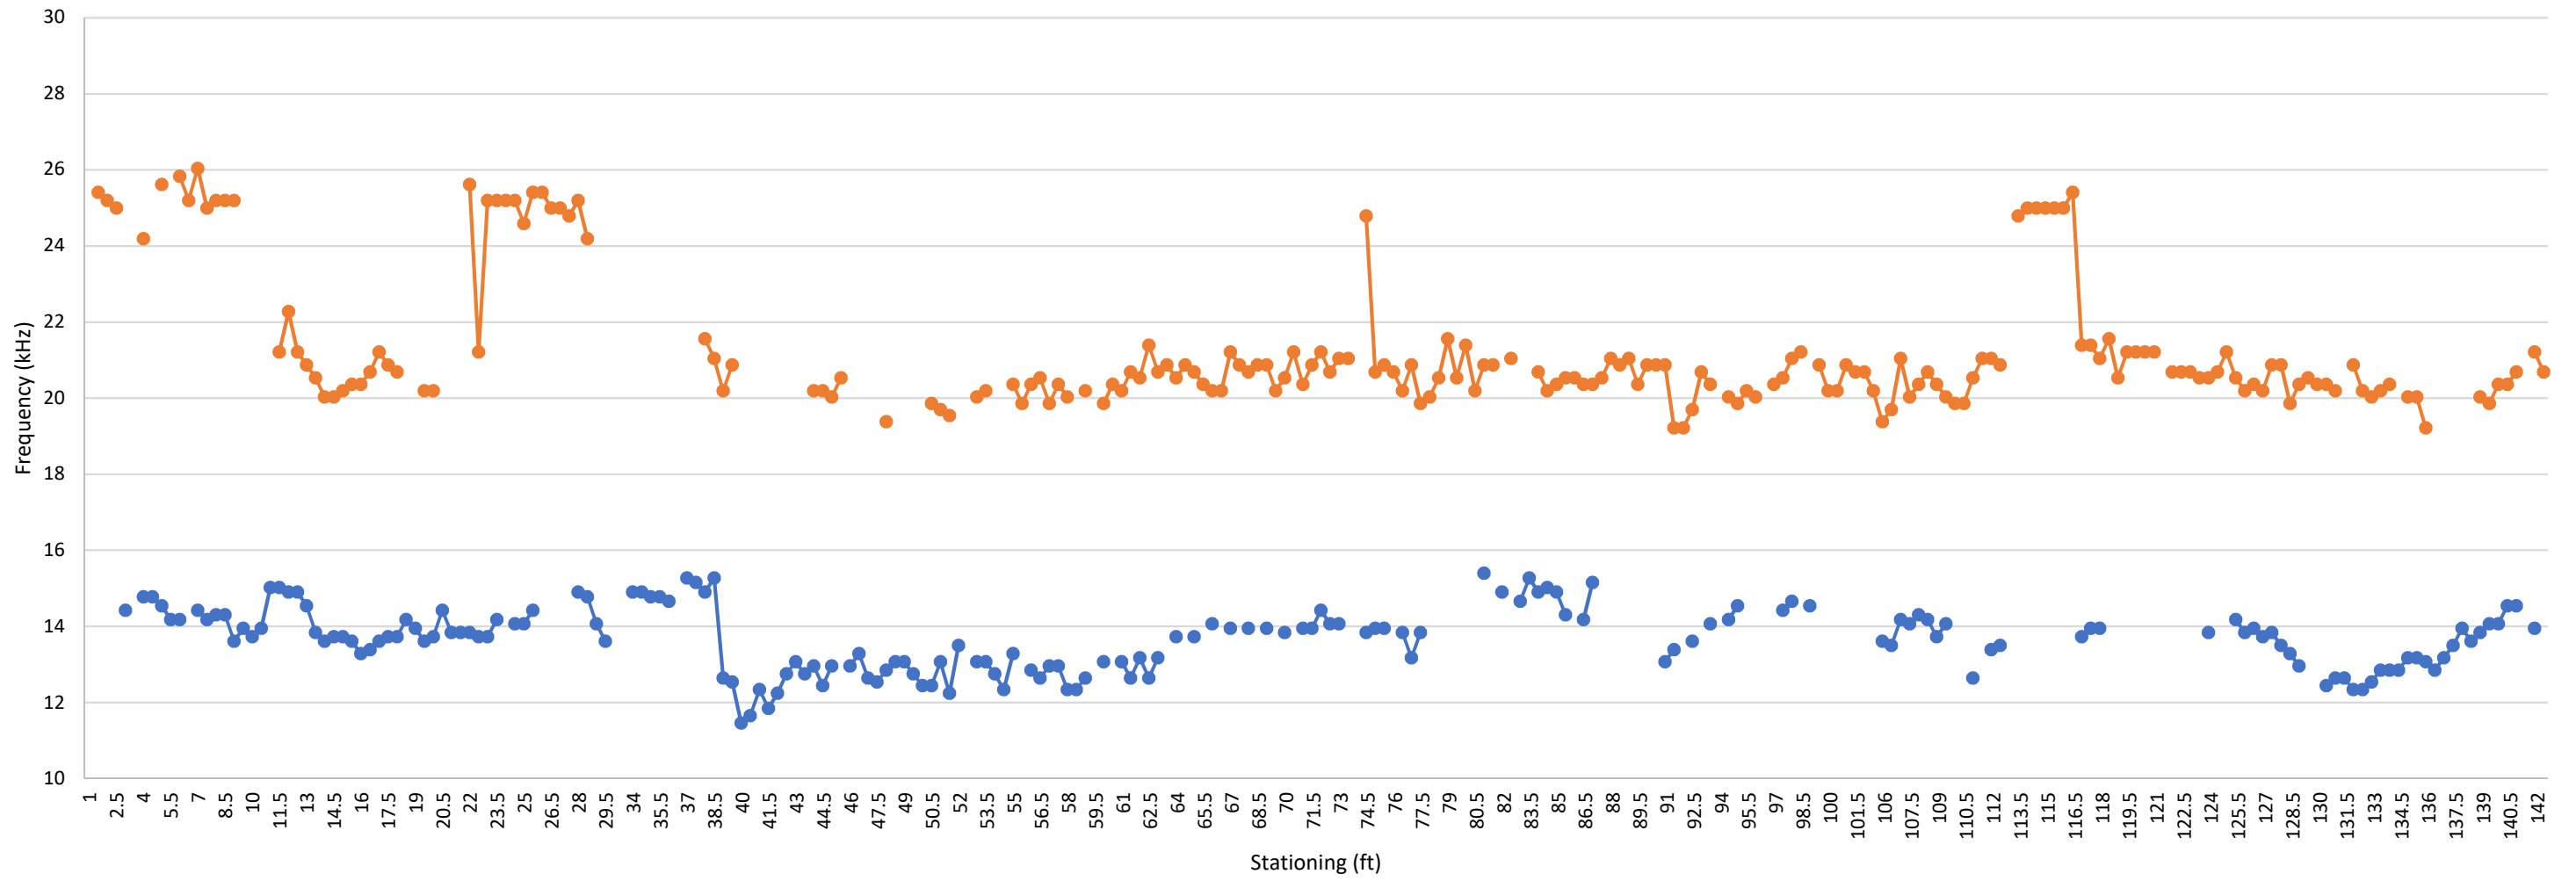
—●— Circumferential Frequency
 —●— Average Through Frequency
 ■ Anomalous Grout Condition

Nondestructive Testing External Tendon Ducts John Ringling Causeway Bridge Over Sarasota Bay Sarasota, Florida Prepared for Florida International University by NDT Corporation		Span 2 Tendon 402R-1E Graph Results	
January. 2018		Figure A8

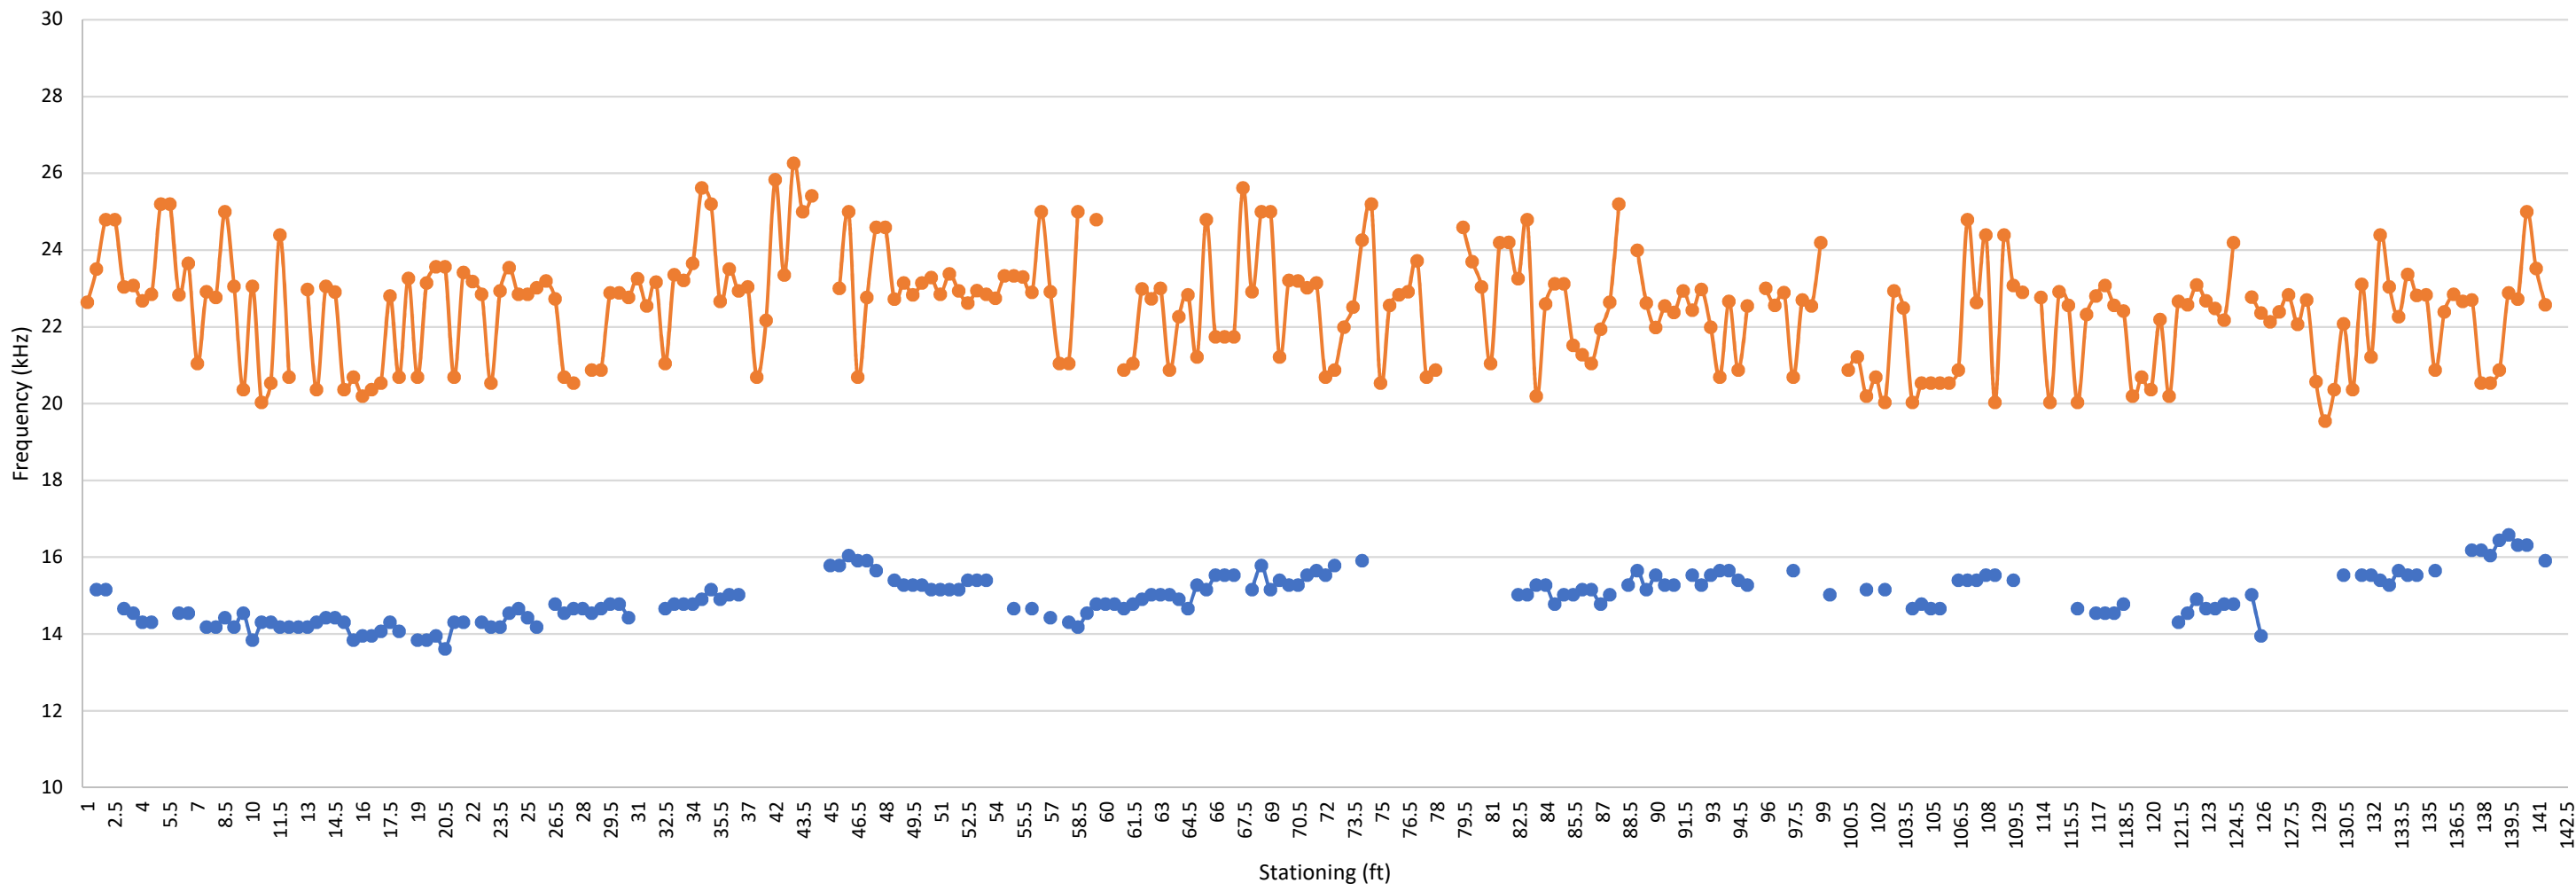
—●— Circumferential Frequency
 —●— Average Through Frequency
 ■ Anomalous Grout Condition

Nondestructive Testing External Tendon Ducts John Ringling Causeway Bridge Over Sarasota Bay Sarasota, Florida Prepared for Florida International University by NDT Corporation		Span 2 Tendon 402L-2W Graph Results	
January. 2018		Figure A9

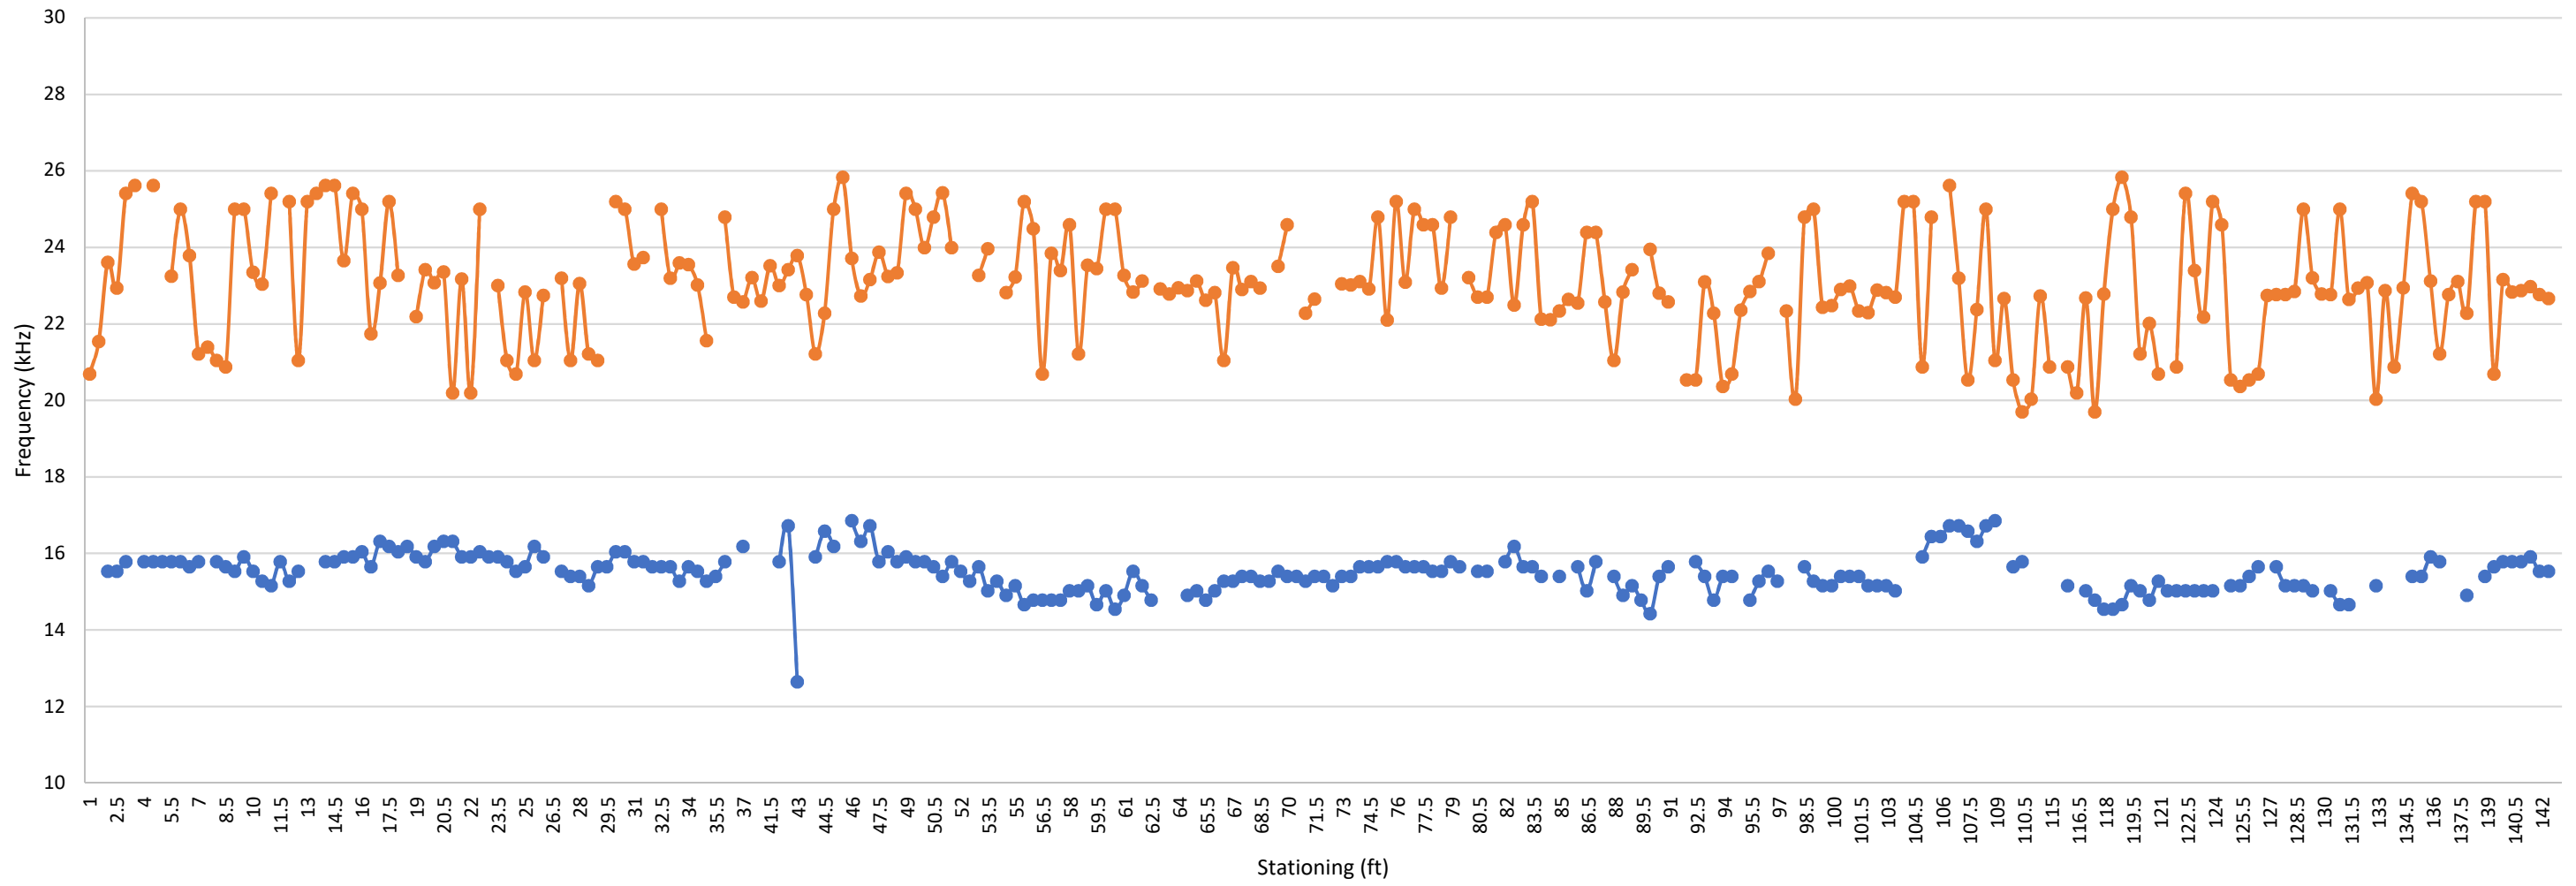
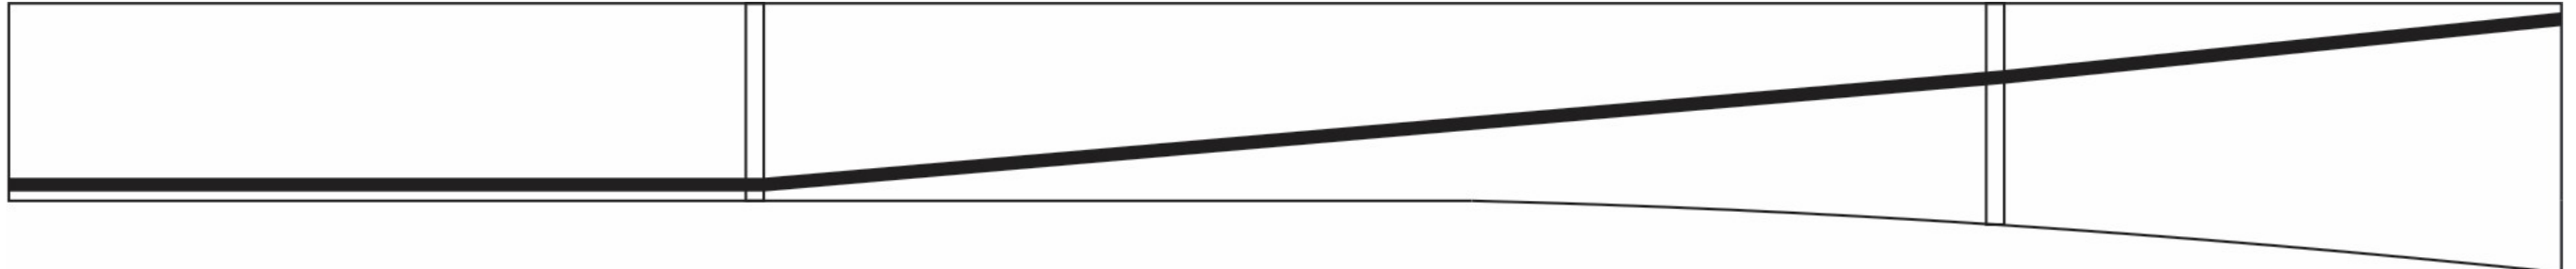
—●— Circumferential Frequency
 —●— Average Through Frequency
 ■ Anomalous Grout Condition

Nondestructive Testing External Tendon Ducts John Ringling Causeway Bridge Over Sarasota Bay Sarasota, Florida Prepared for Florida International University by NDT Corporation		Span 2 Tendon 401L-2W Graph Results	
January. 2018		Figure A10

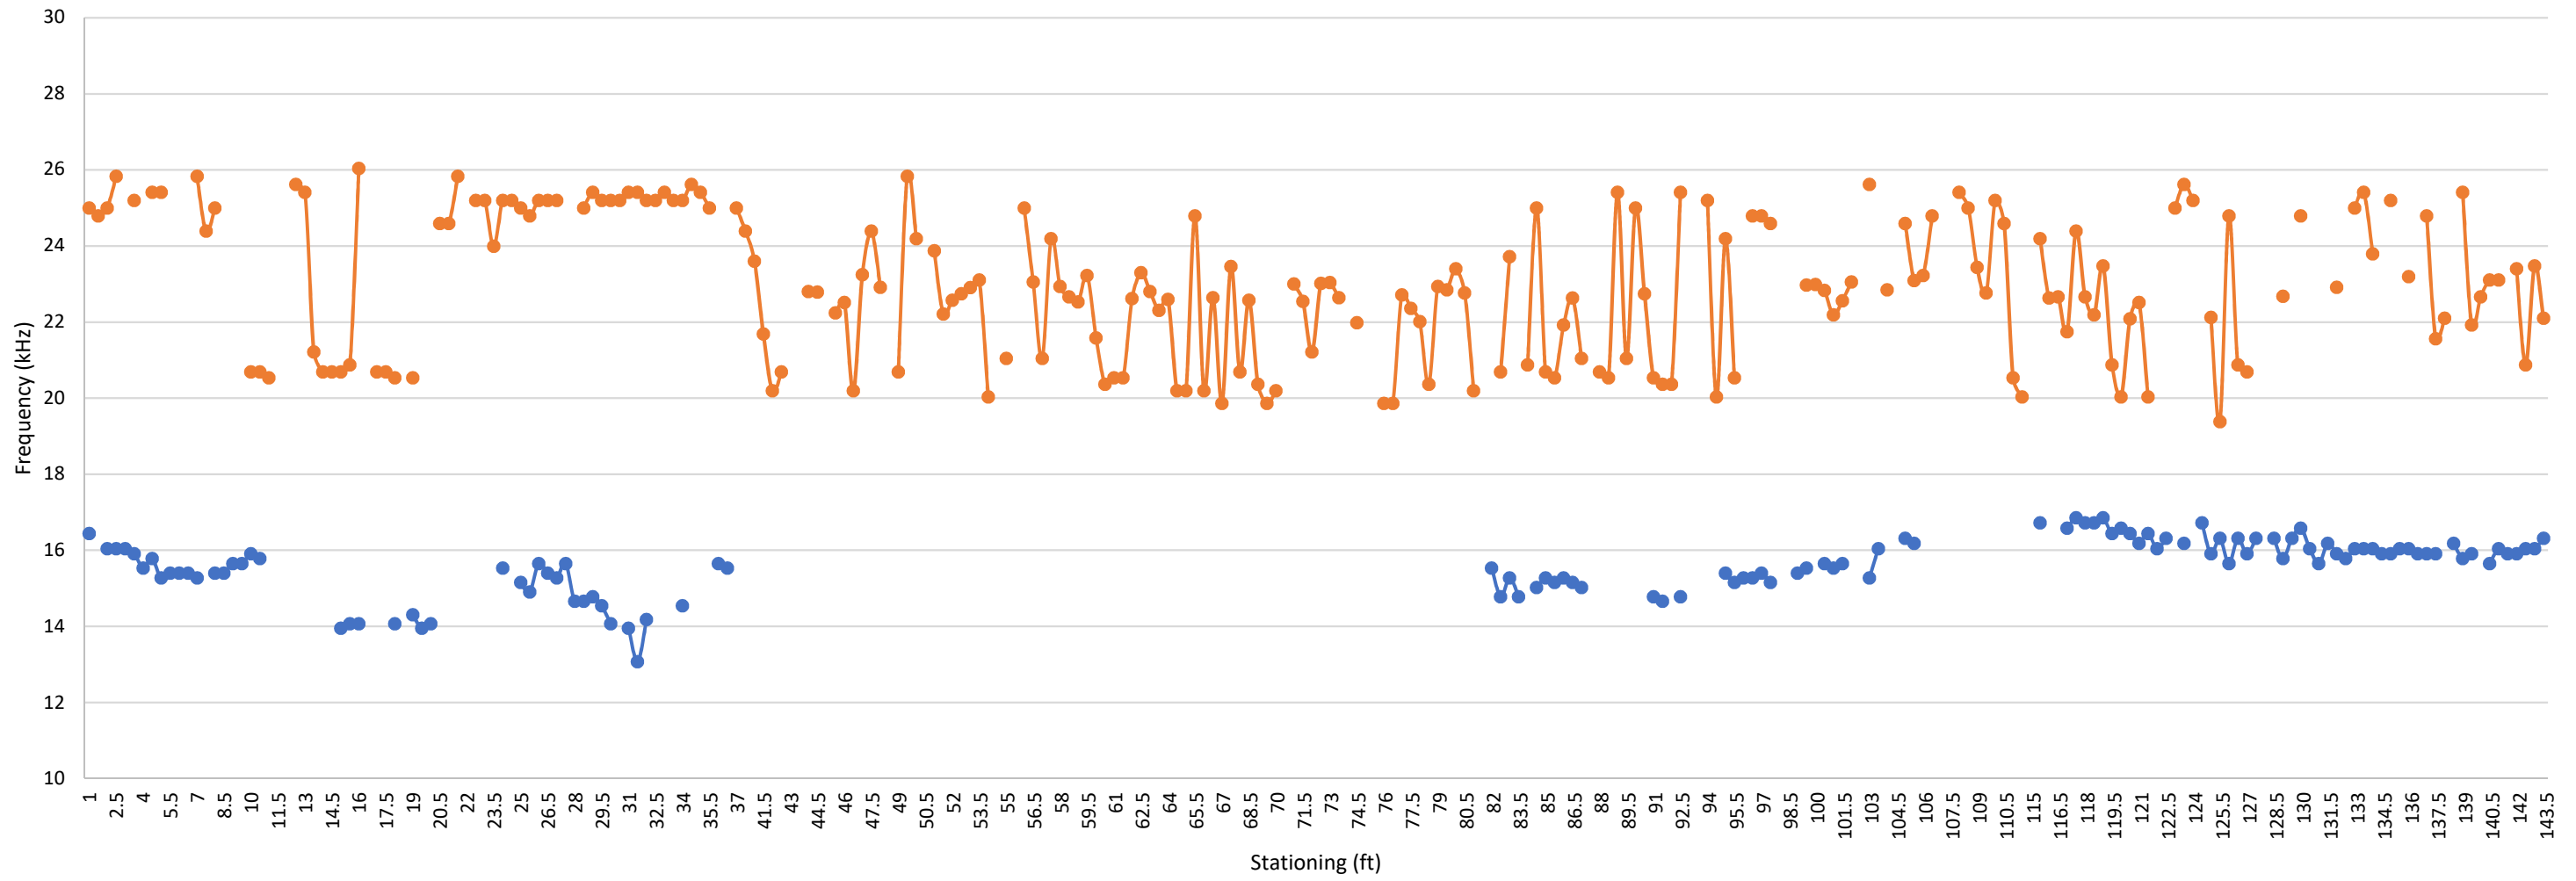
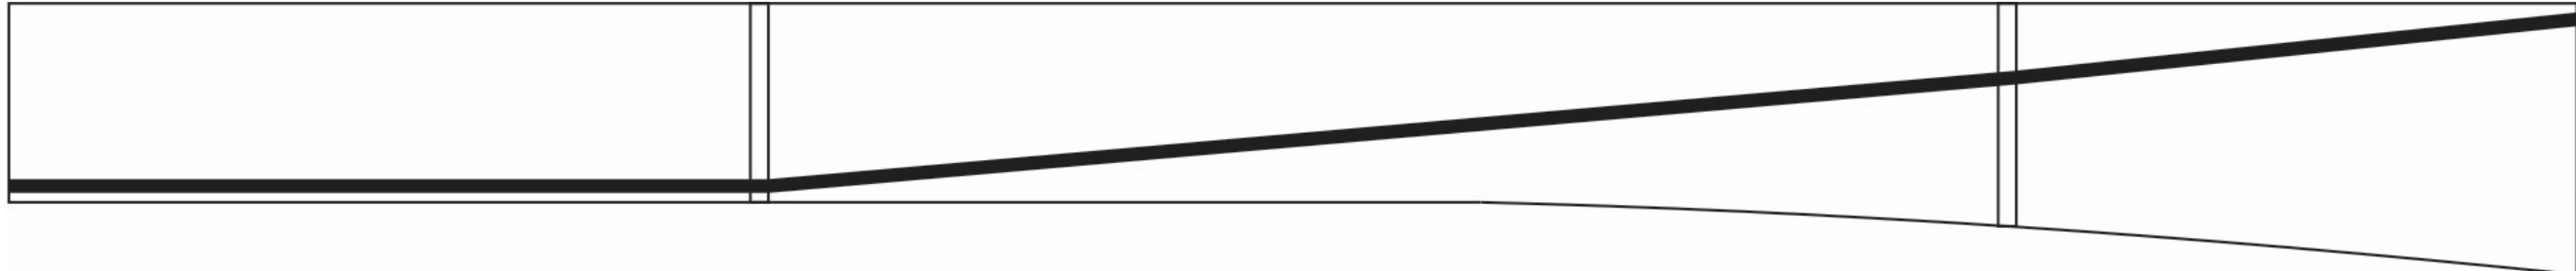
—●— Circumferential Frequency
 —●— Average Through Frequency
 ■ Anomalous Grout Condition

Nondestructive Testing External Tendon Ducts John Ringling Causeway Bridge Over Sarasota Bay Sarasota, Florida Prepared for Florida International University by NDT Corporation		Span 2 Tendon 401R-2W Graph Results	
January. 2018		Figure A11

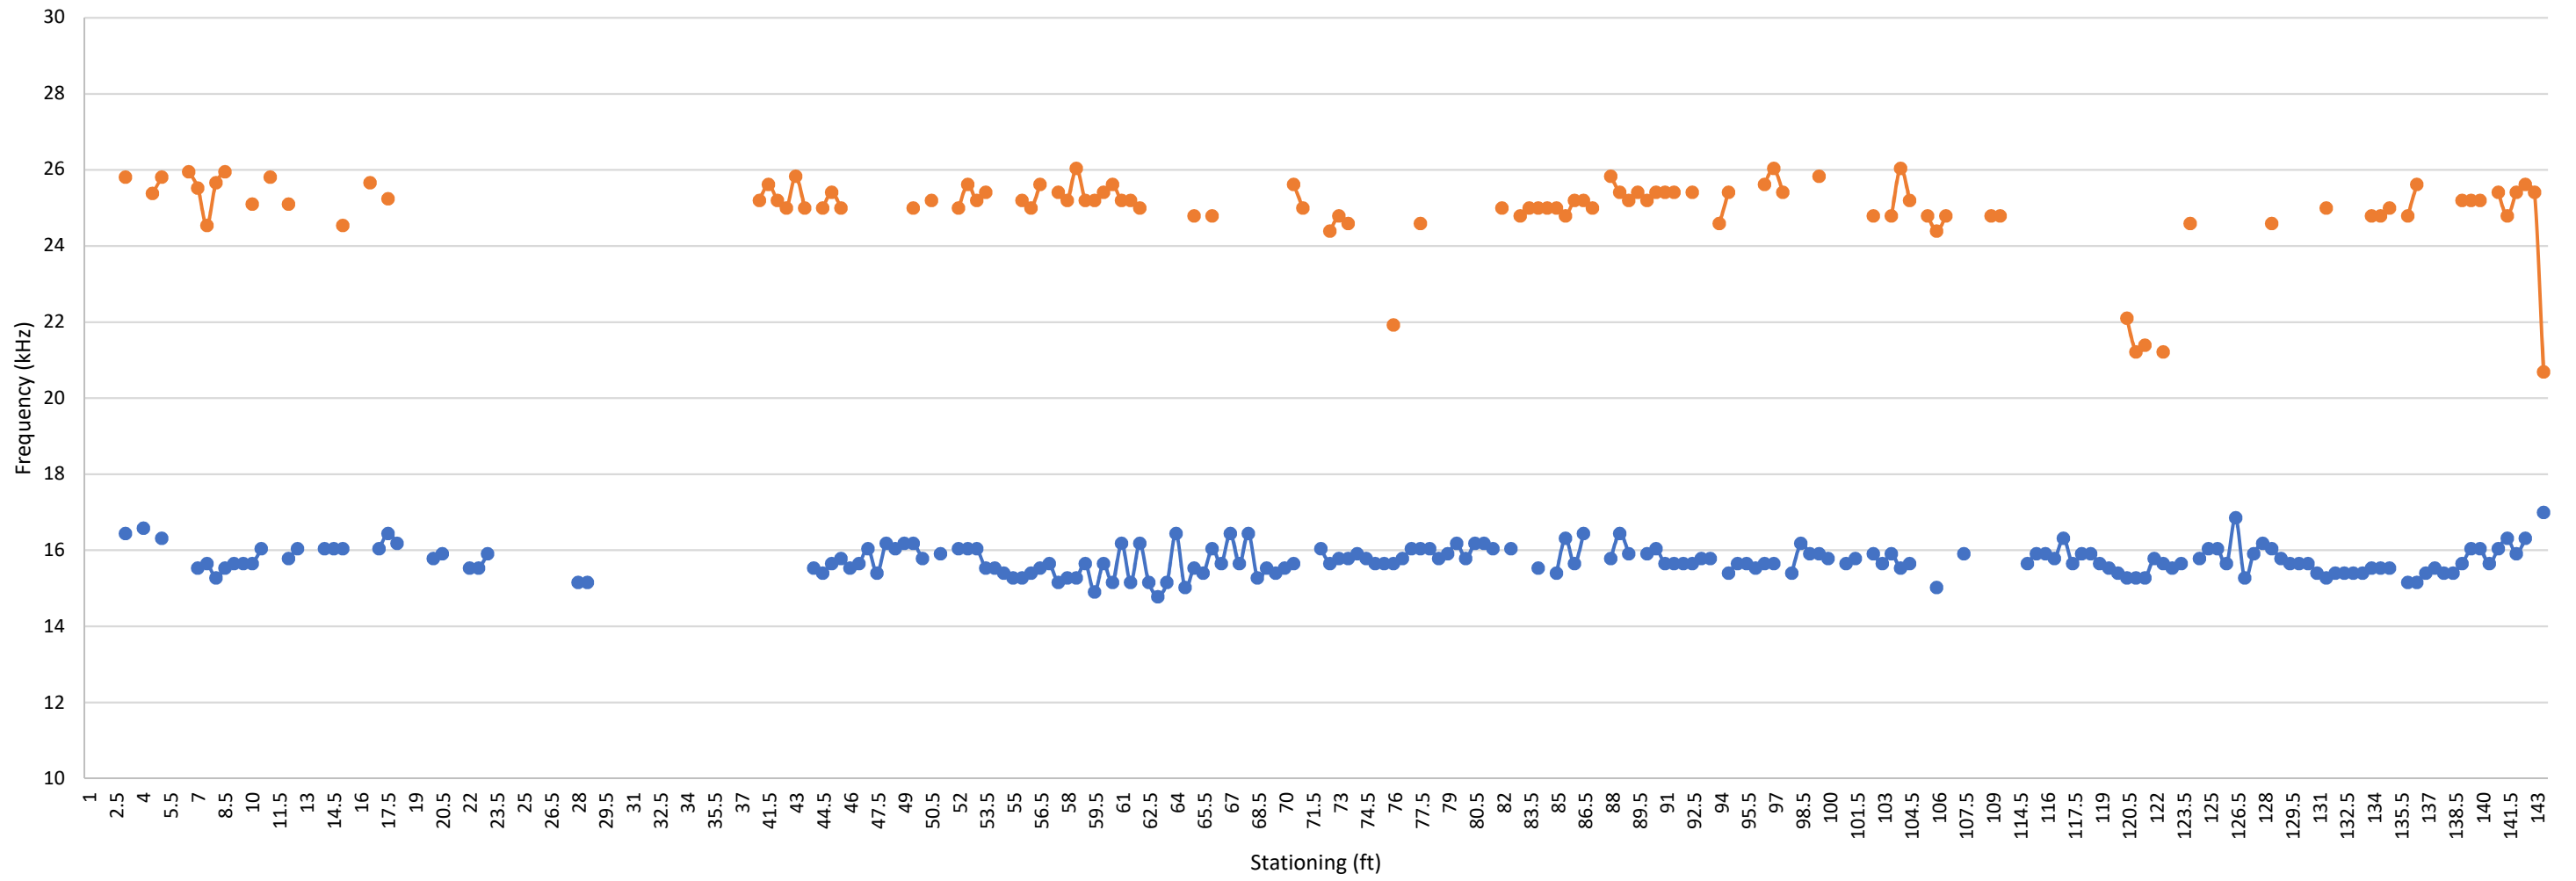
—●— Circumferential Frequency —●— Average Through Frequency ■ Anomalous Grout Condition

Nondestructive Testing External Tendon Ducts John Ringling Causeway Bridge Over Sarasota Bay Sarasota, Florida Prepared for Florida International University by NDT Corporation		Span 2 Tendon 402R-2W Graph Results	
		January. 2018	Figure A12
