**Development of Quality Assurance and Quality Control
System for Post Tensioned Segmental Bridges in Florida:
Case of Ringling Bridge – Phase II**

**FDOT Contract No. BDV29-977-34
FINAL REPORT**

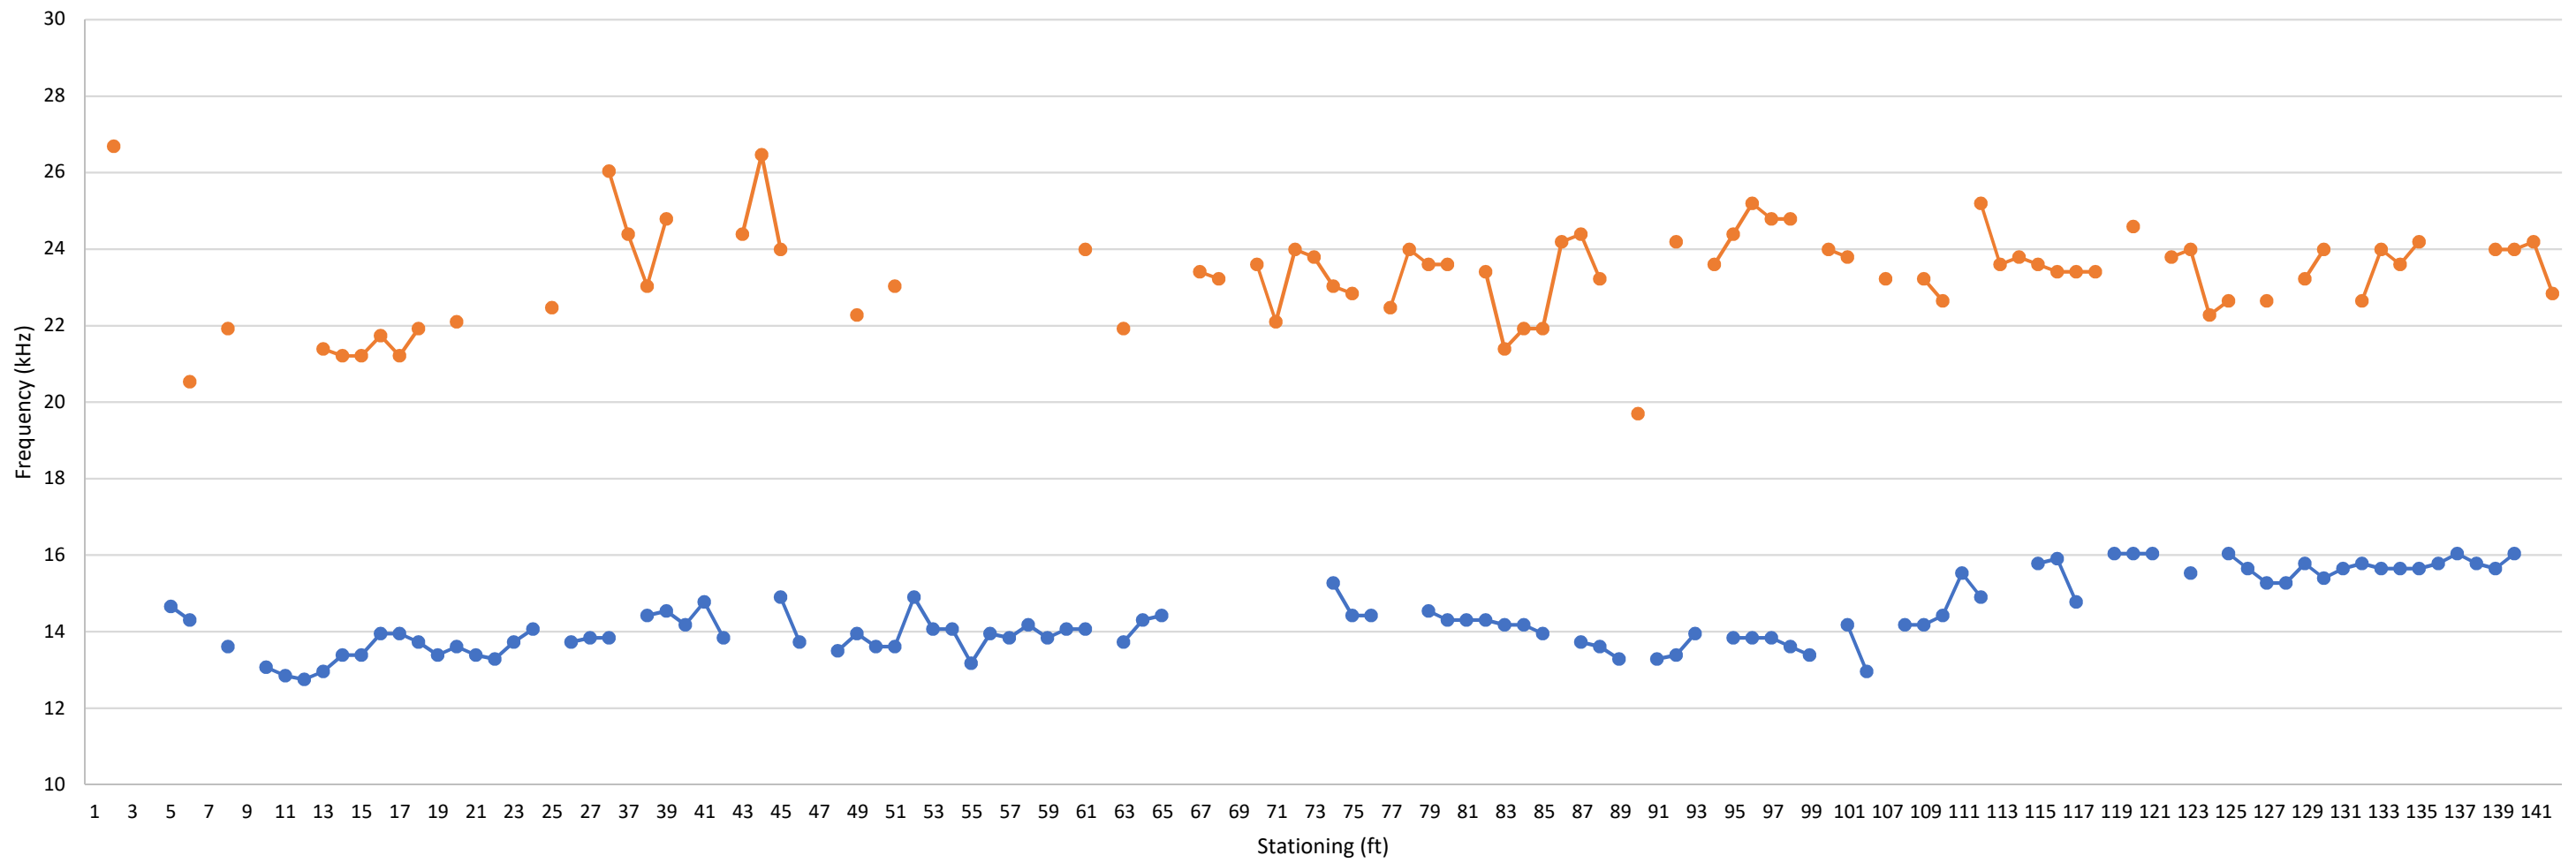
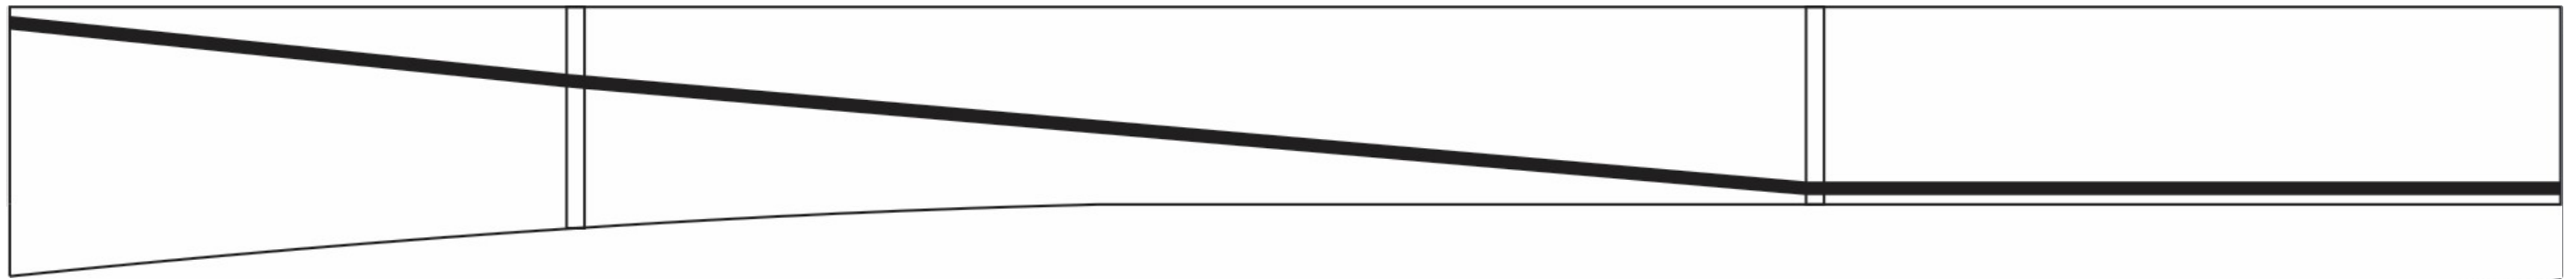
—●— Circumferential Frequency —●— Average Through Frequency ■ Anomalous Grout Condition

Nondestructive Testing External Tendon Ducts John Ringling Causeway Bridge Over Sarasota Bay Sarasota, Florida Prepared for Florida International University by NDT Corporation		Span 3 Tendon 402L-2E Graph Results	
		January. 2018	Figure A13

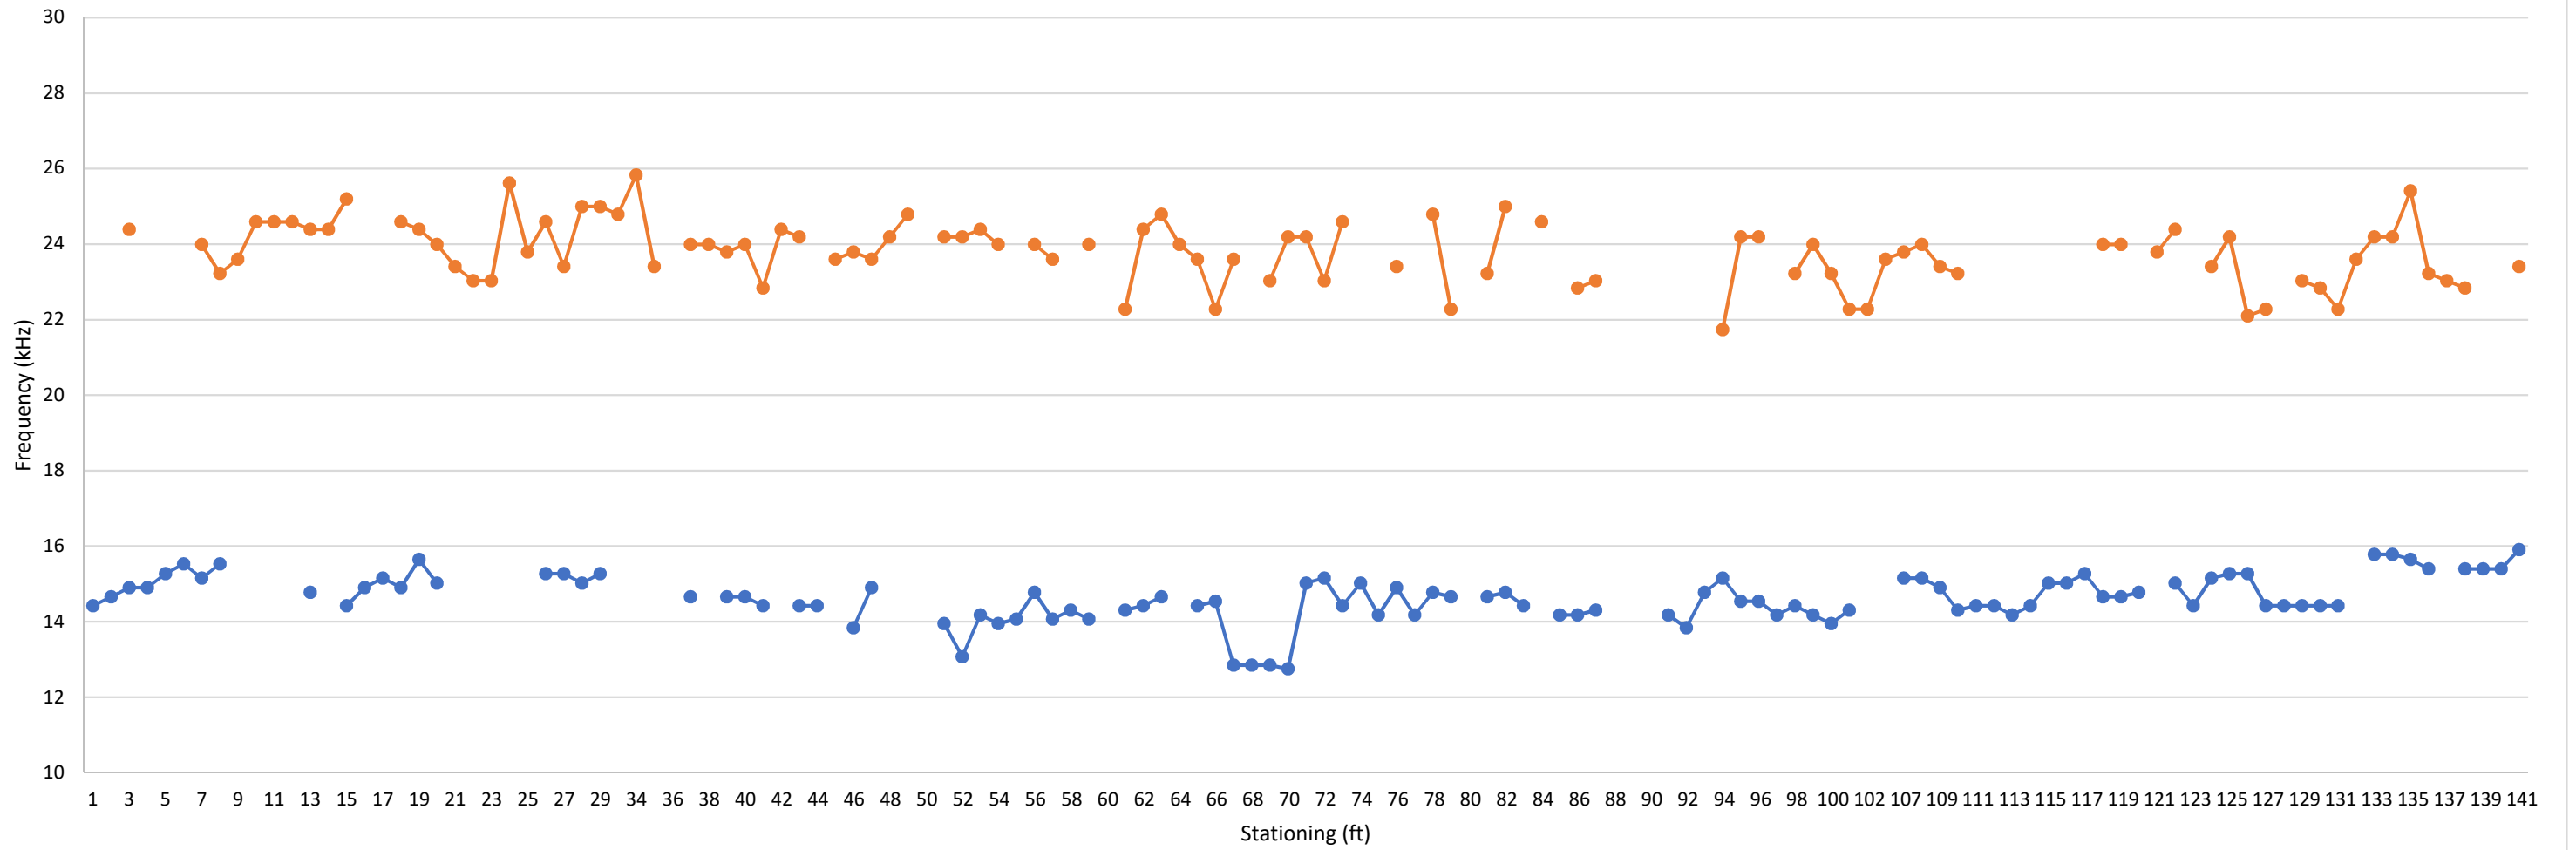
—●— Circumferential Frequency —●— Average Through Frequency ■ Anomalous Grout Condition

Nondestructive Testing External Tendon Ducts John Ringling Causeway Bridge Over Sarasota Bay Sarasota, Florida Prepared for Florida International University by NDT Corporation		Span 3 Tendon 401L-2E Graph Results	
		January. 2018	Figure A14

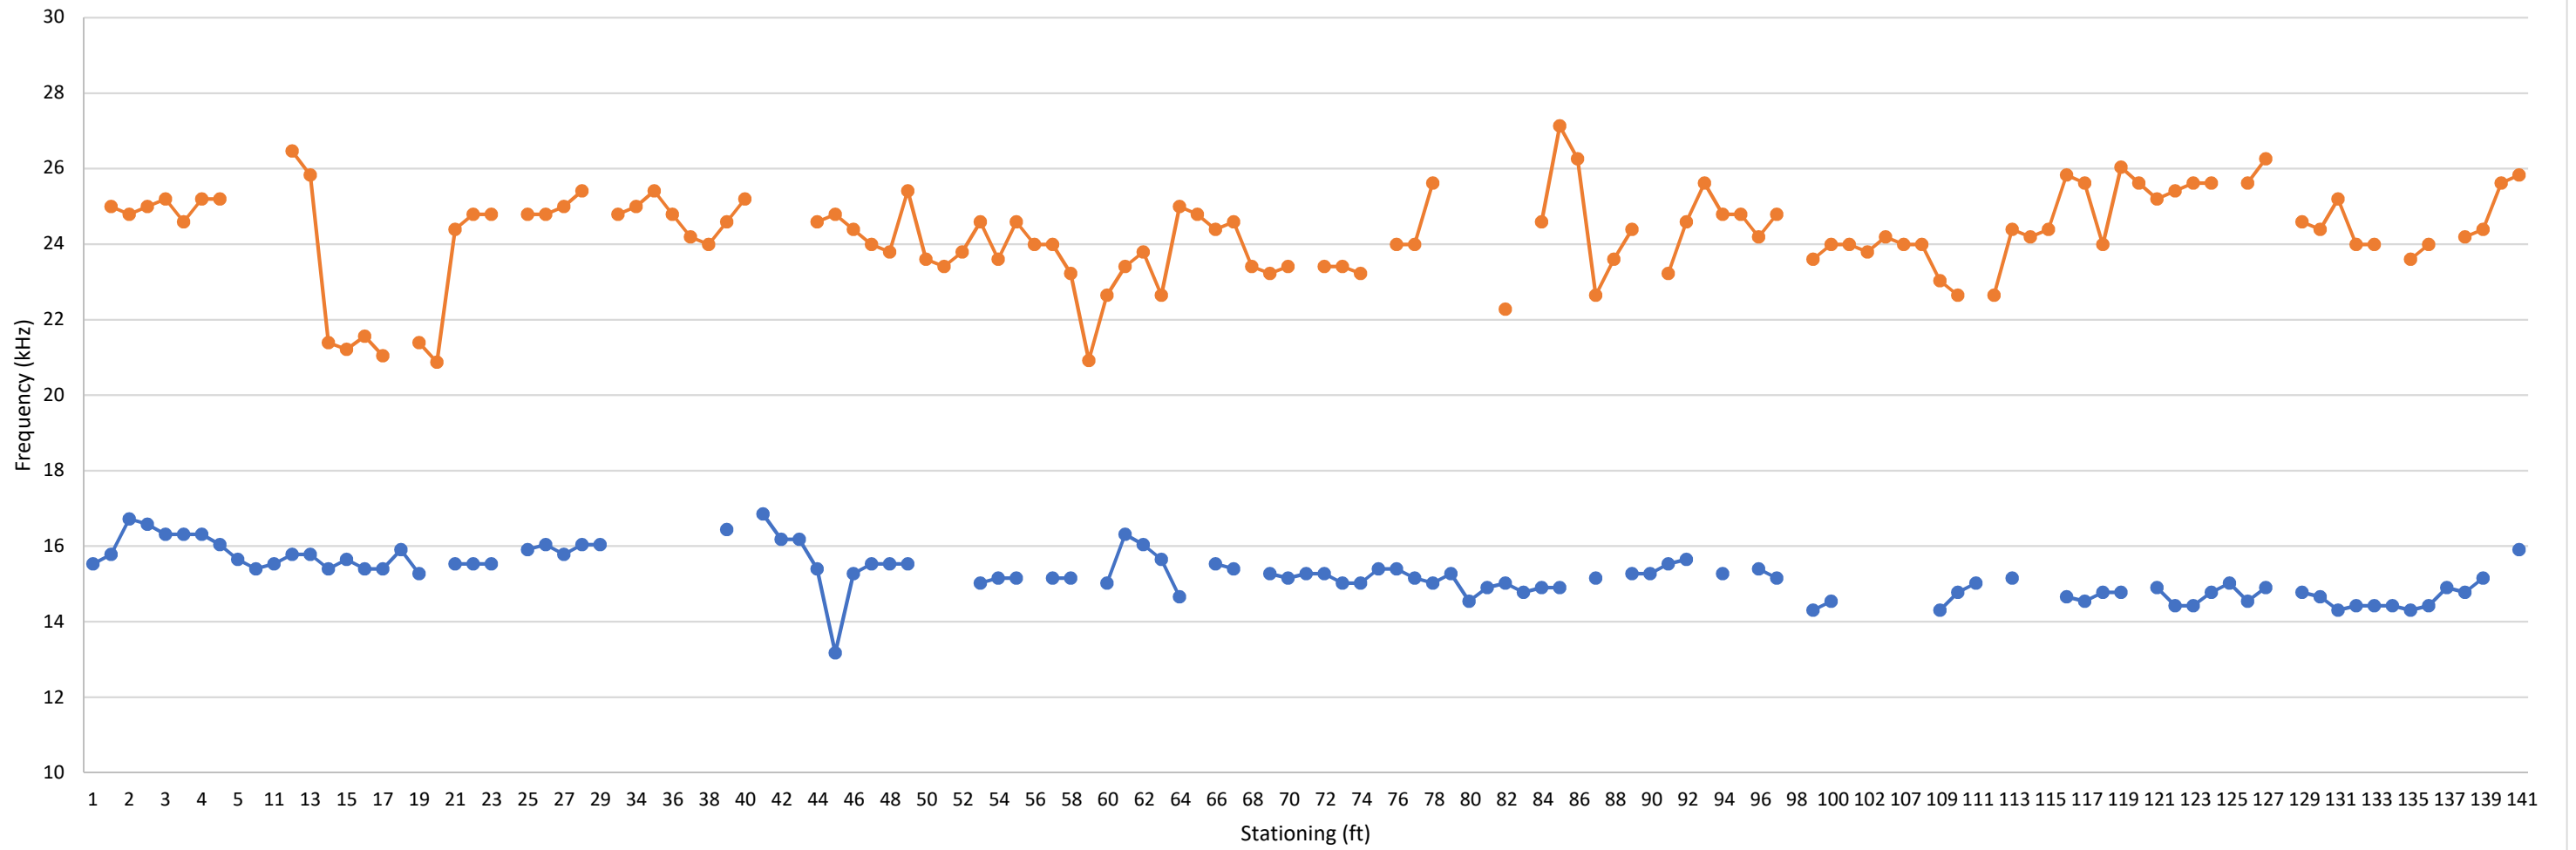
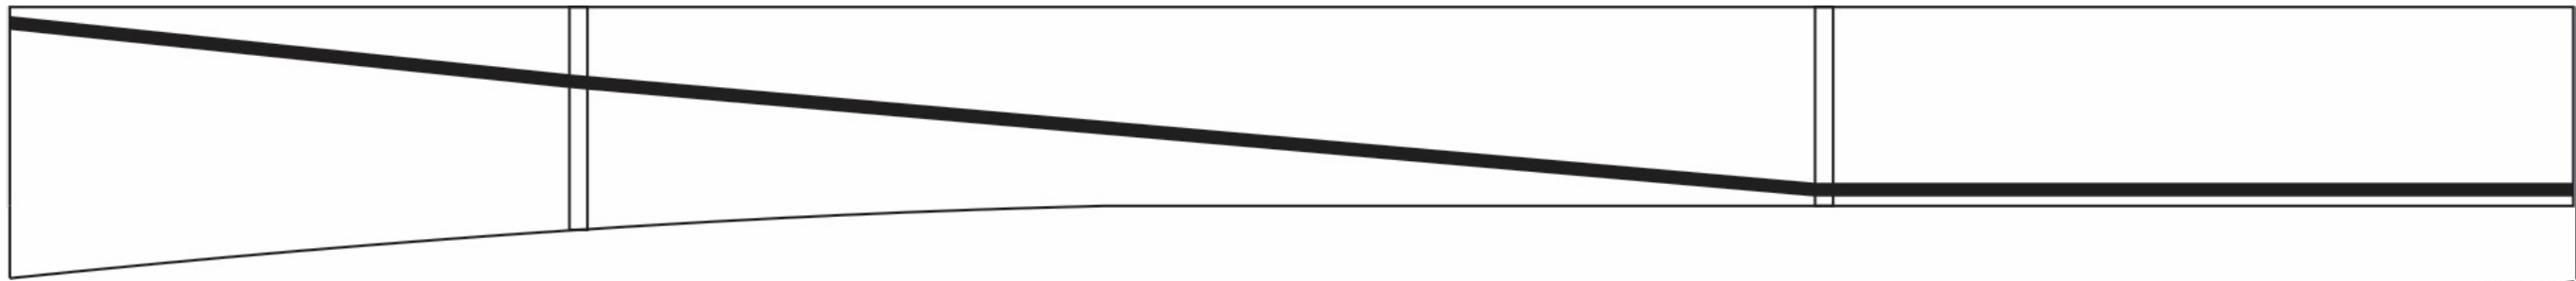
—●— Circumferential Frequency
 —●— Average Through Frequency
 ■ Anomalous Grout Condition

Nondestructive Testing External Tendon Ducts John Ringling Causeway Bridge Over Sarasota Bay Sarasota, Florida Prepared for Florida International University by NDT Corporation		Span 3 Tendon 401R-2E Graph Results	
January. 2018		Figure A15

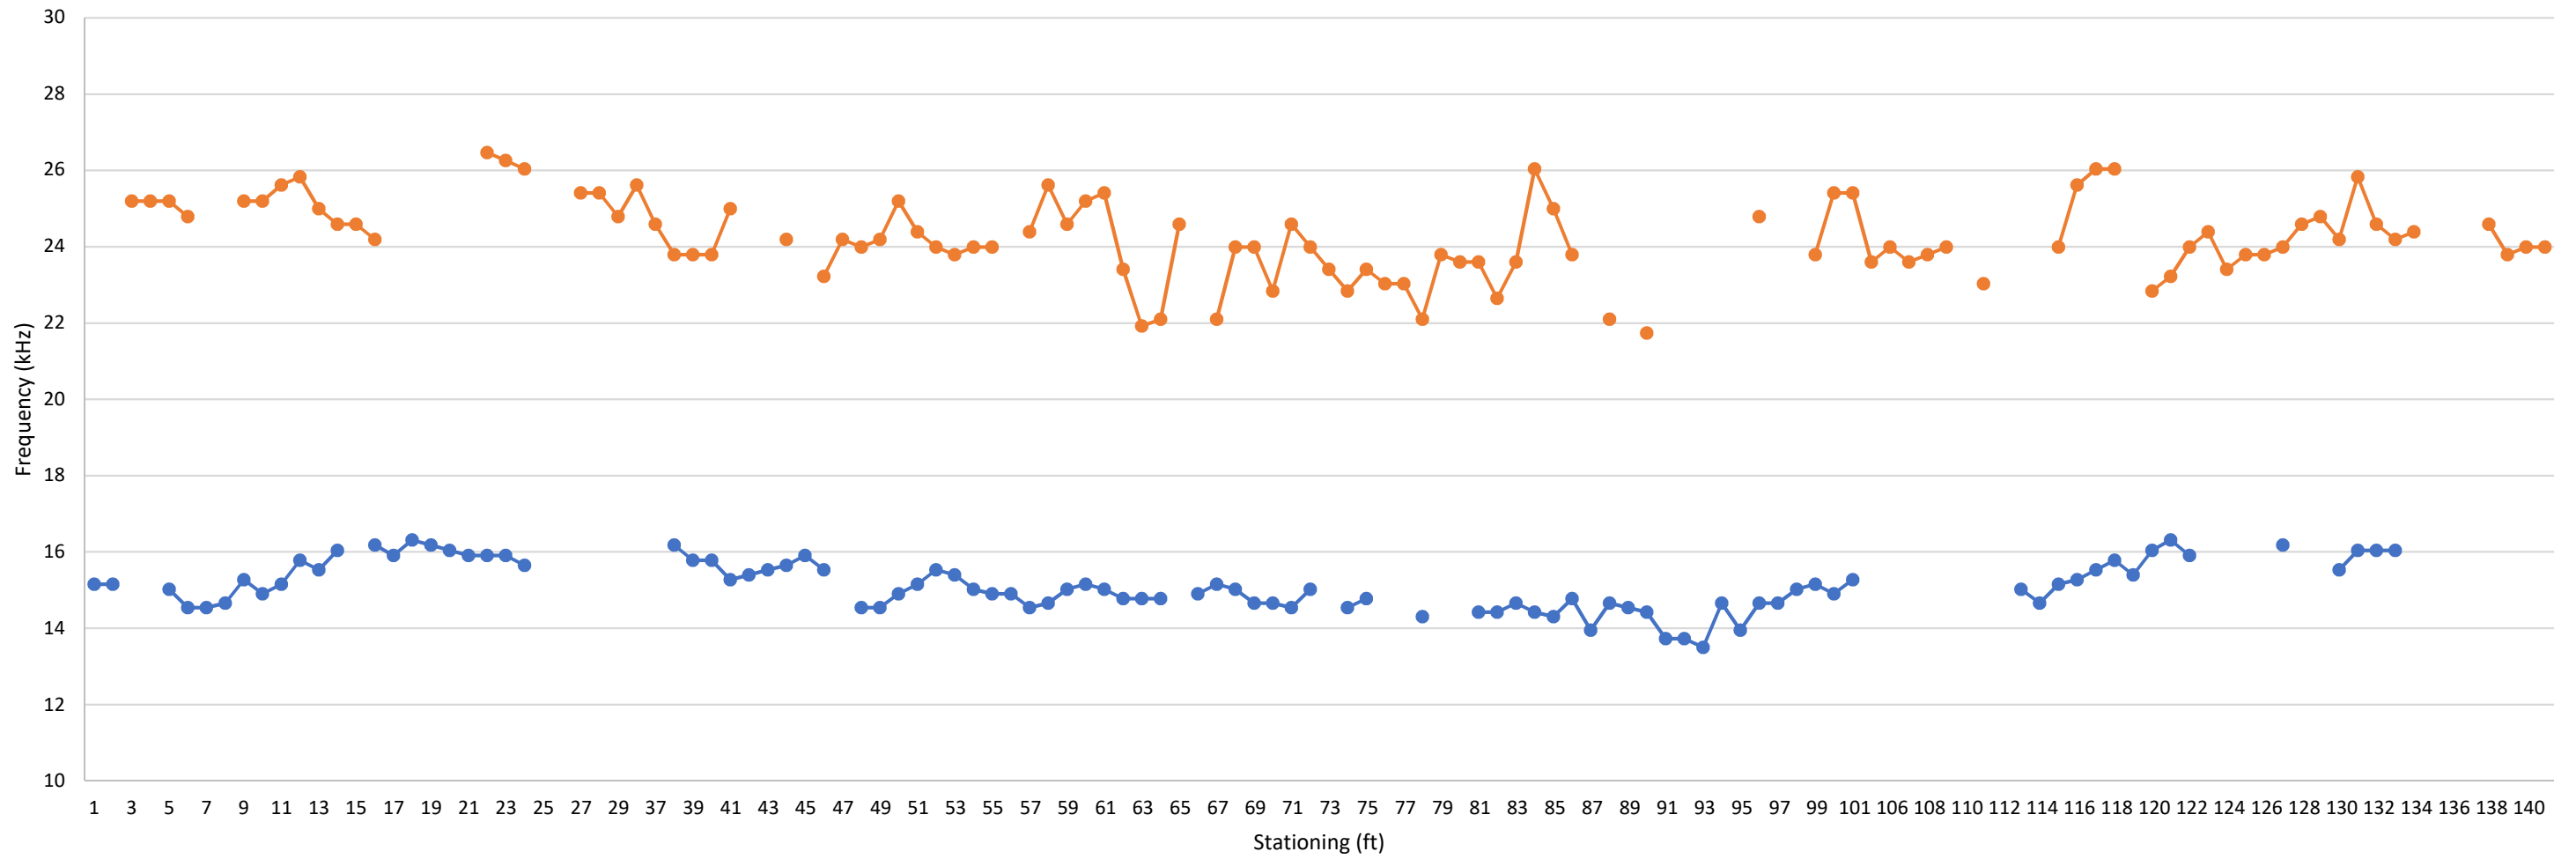
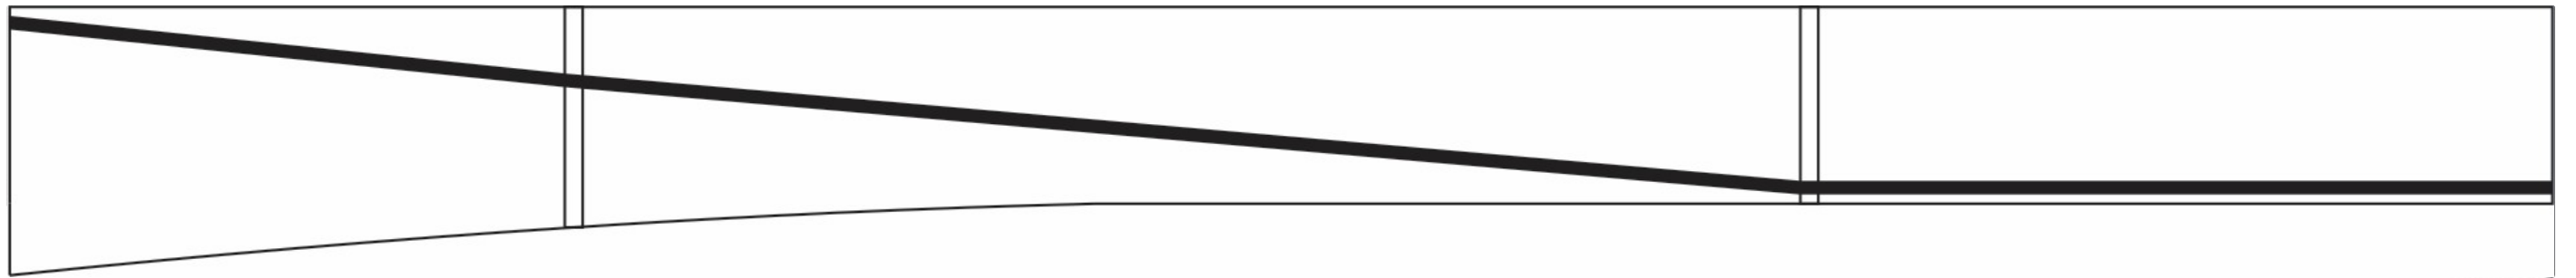
—●— Circumferential Frequency —●— Average Through Frequency ■ Anomalous Grout Condition

Nondestructive Testing External Tendon Ducts John Ringling Causeway Bridge Over Sarasota Bay Sarasota, Florida Prepared for Florida International University by NDT Corporation		Span 3 Tendon 402R-2E Graph Results	
		January. 2018	Figure A16

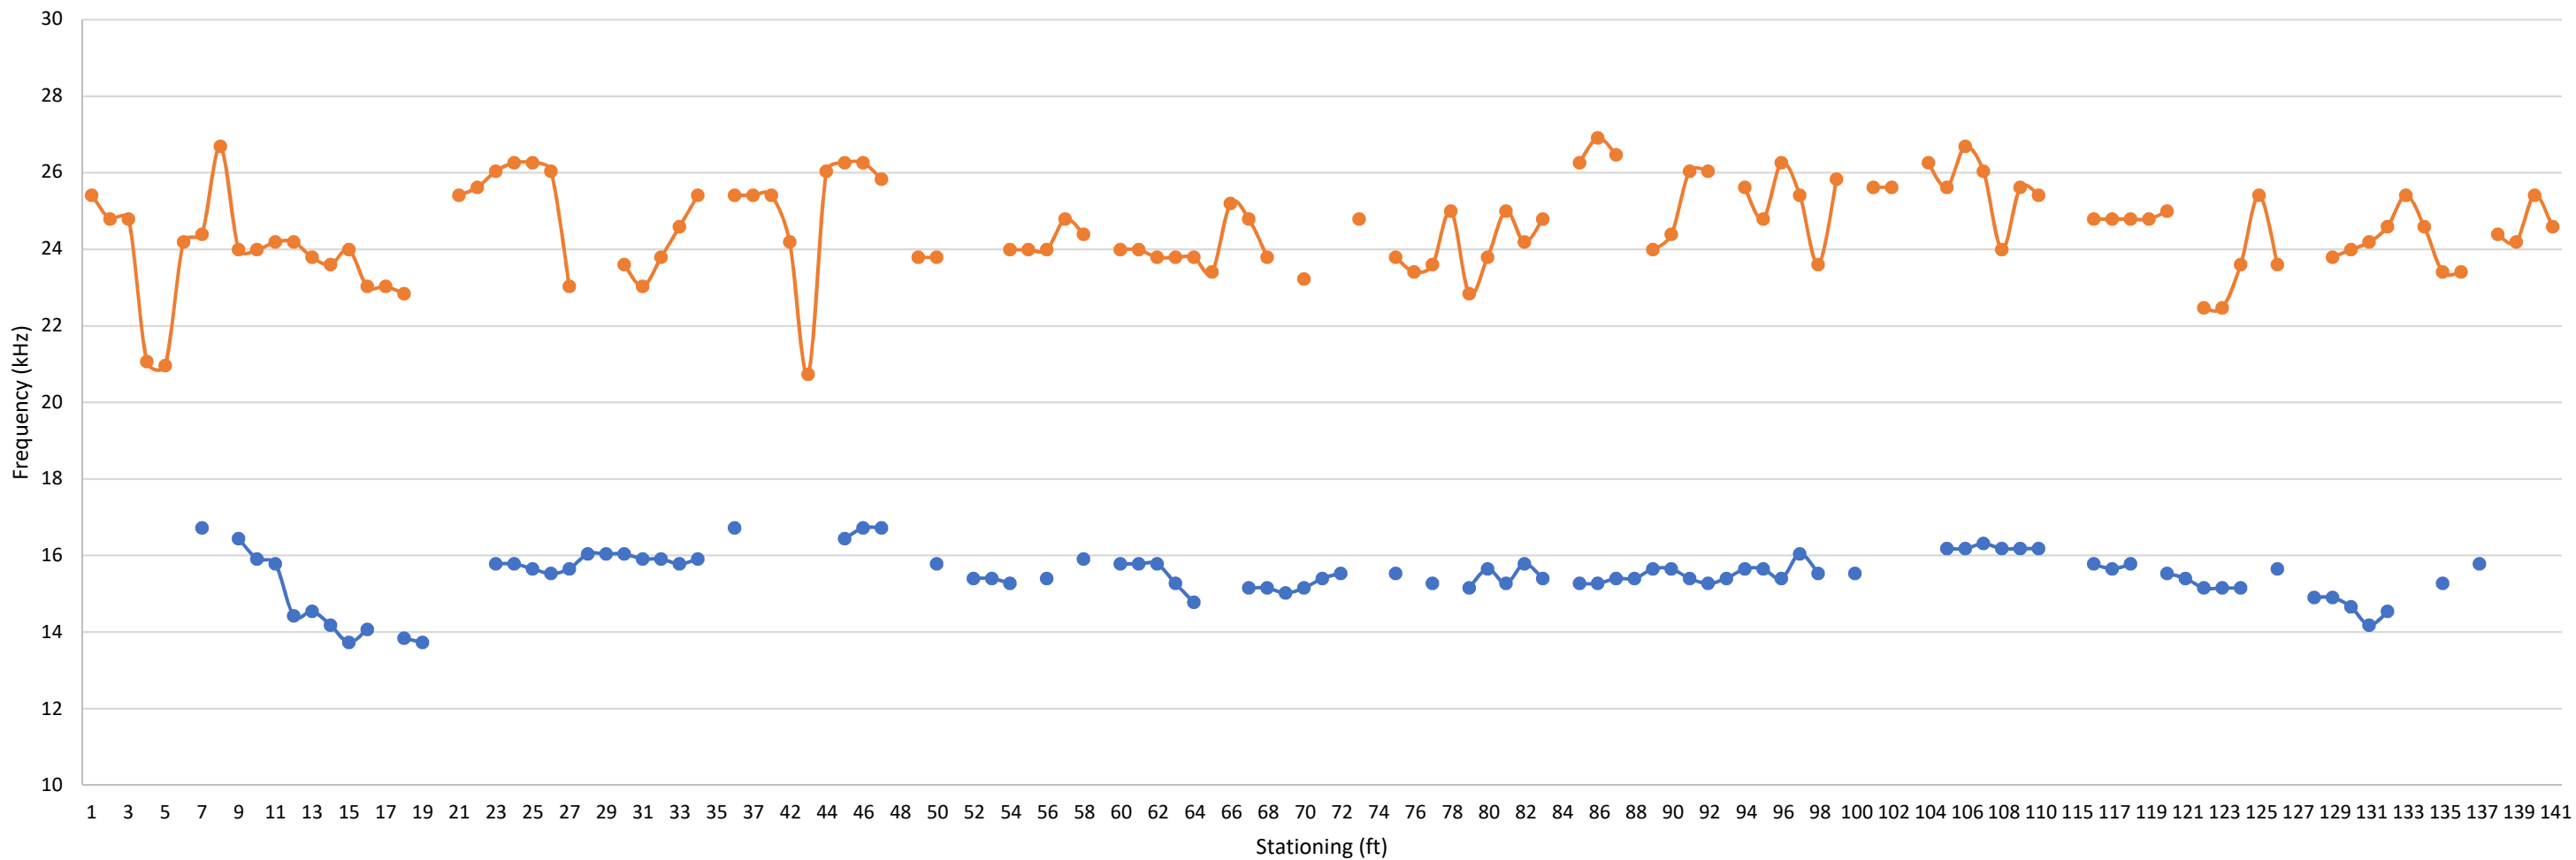
—●— Circumferential Frequency
 —●— Average Through Frequency
 ■ Anomalous Grout Condition

Nondestructive Testing External Tendon Ducts John Ringling Causeway Bridge Over Sarasota Bay Sarasota, Florida Prepared for Florida International University by NDT Corporation		Span 3 Tendon 402L-3W Graph Results	
January. 2018		Figure A17

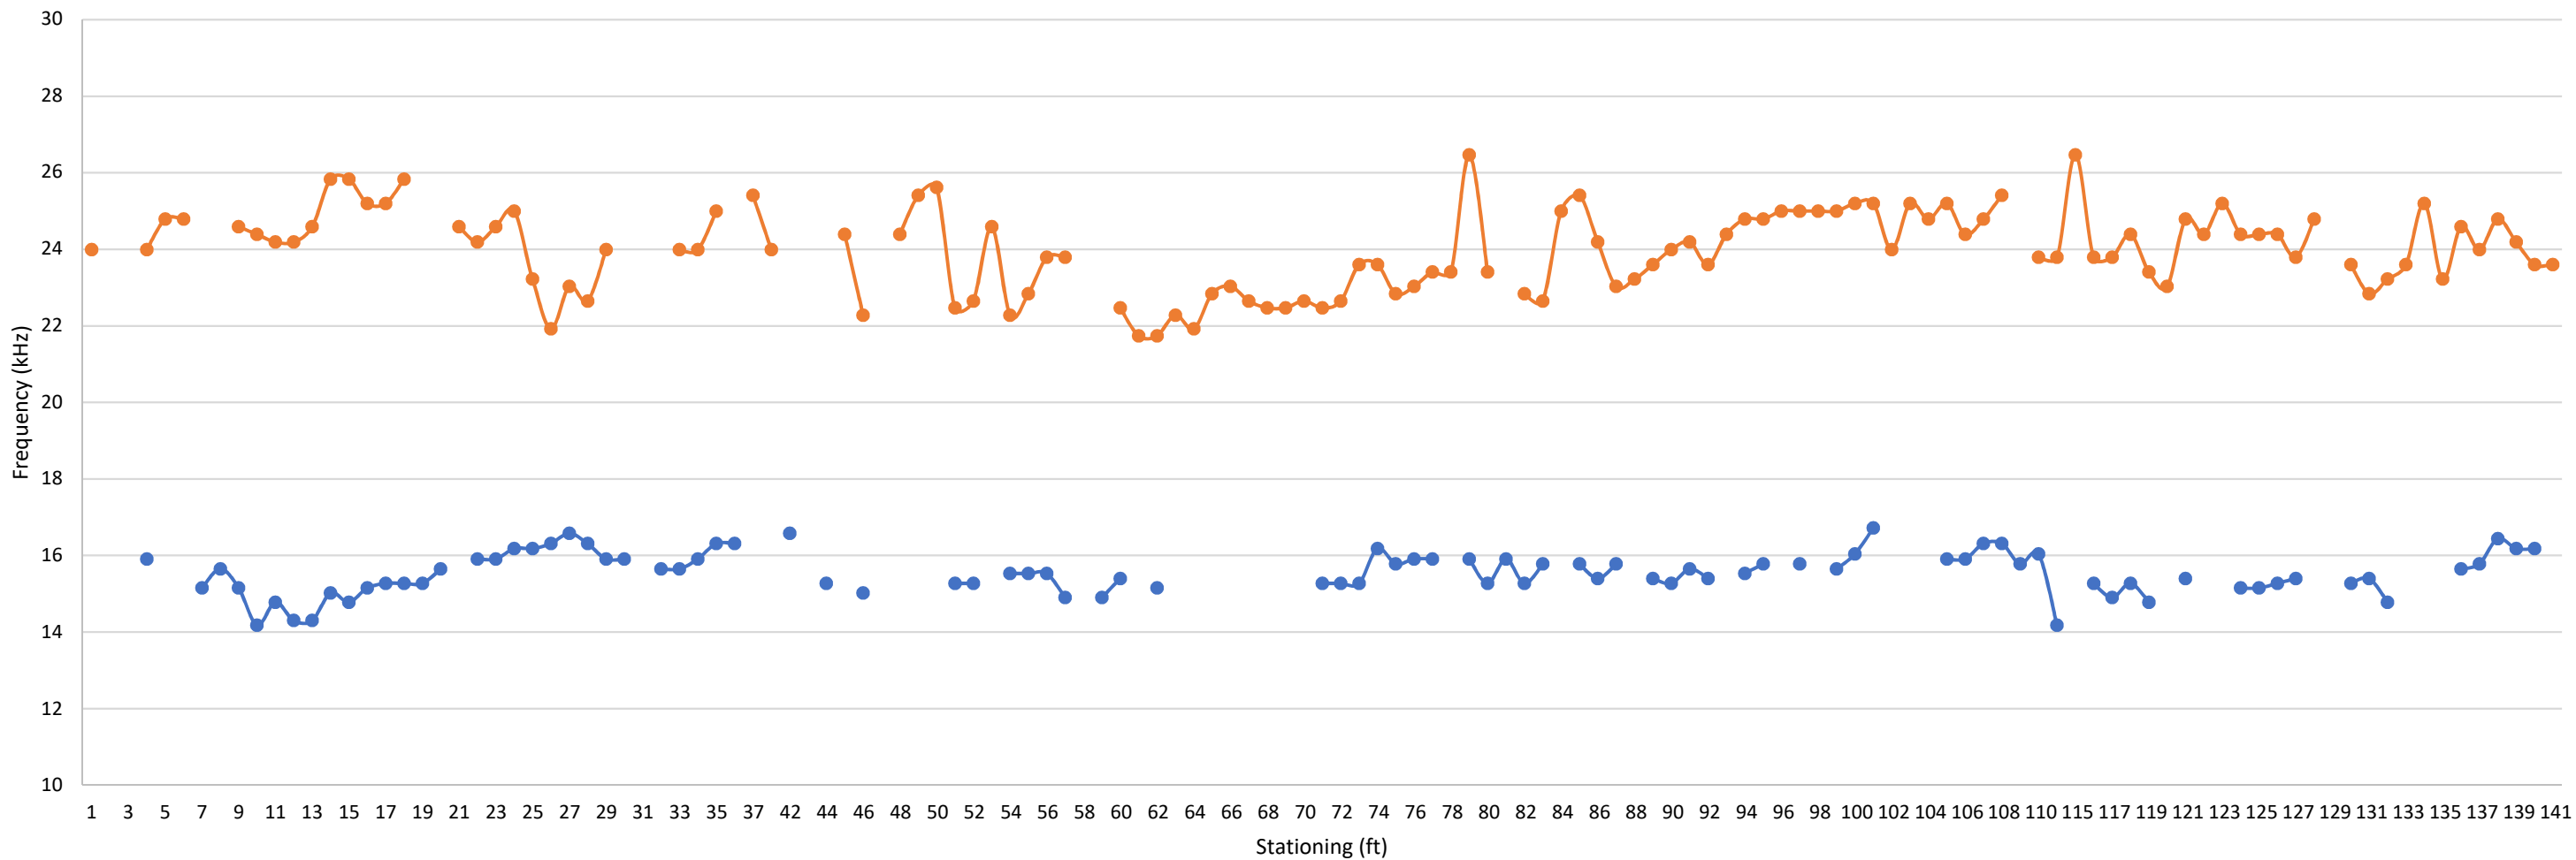
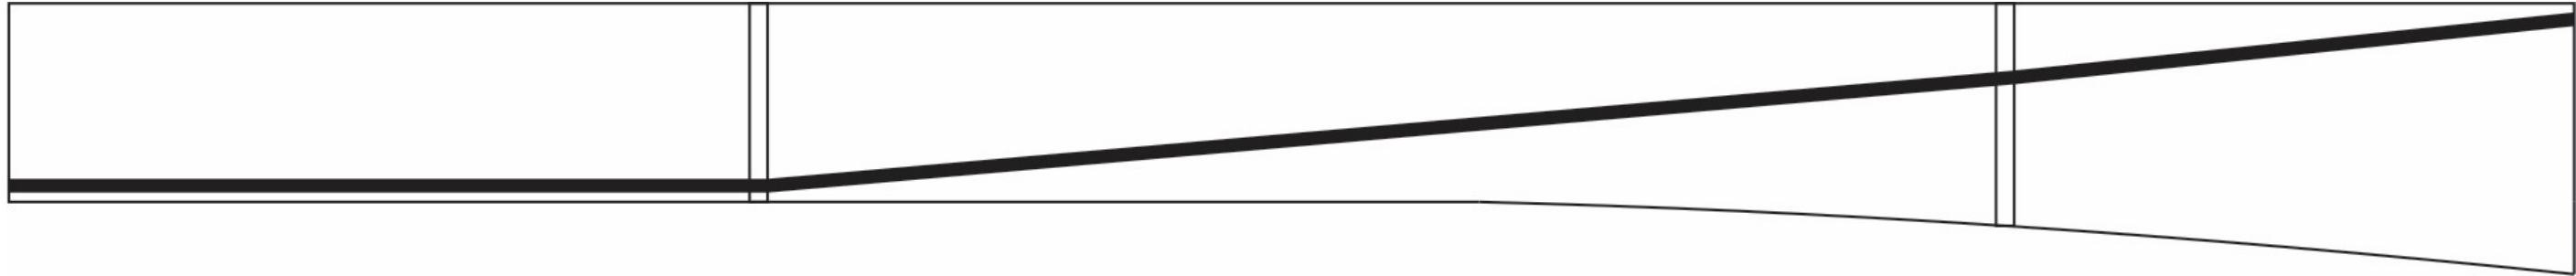
—●— Circumferential Frequency
 —●— Average Through Frequency
 ■ Anomalous Grout Condition

Nondestructive Testing External Tendon Ducts John Ringling Causeway Bridge Over Sarasota Bay Sarasota, Florida Prepared for Florida International University by NDT Corporation		Span 3 Tendon 401L-3W Graph Results	
		January. 2018	Figure A18

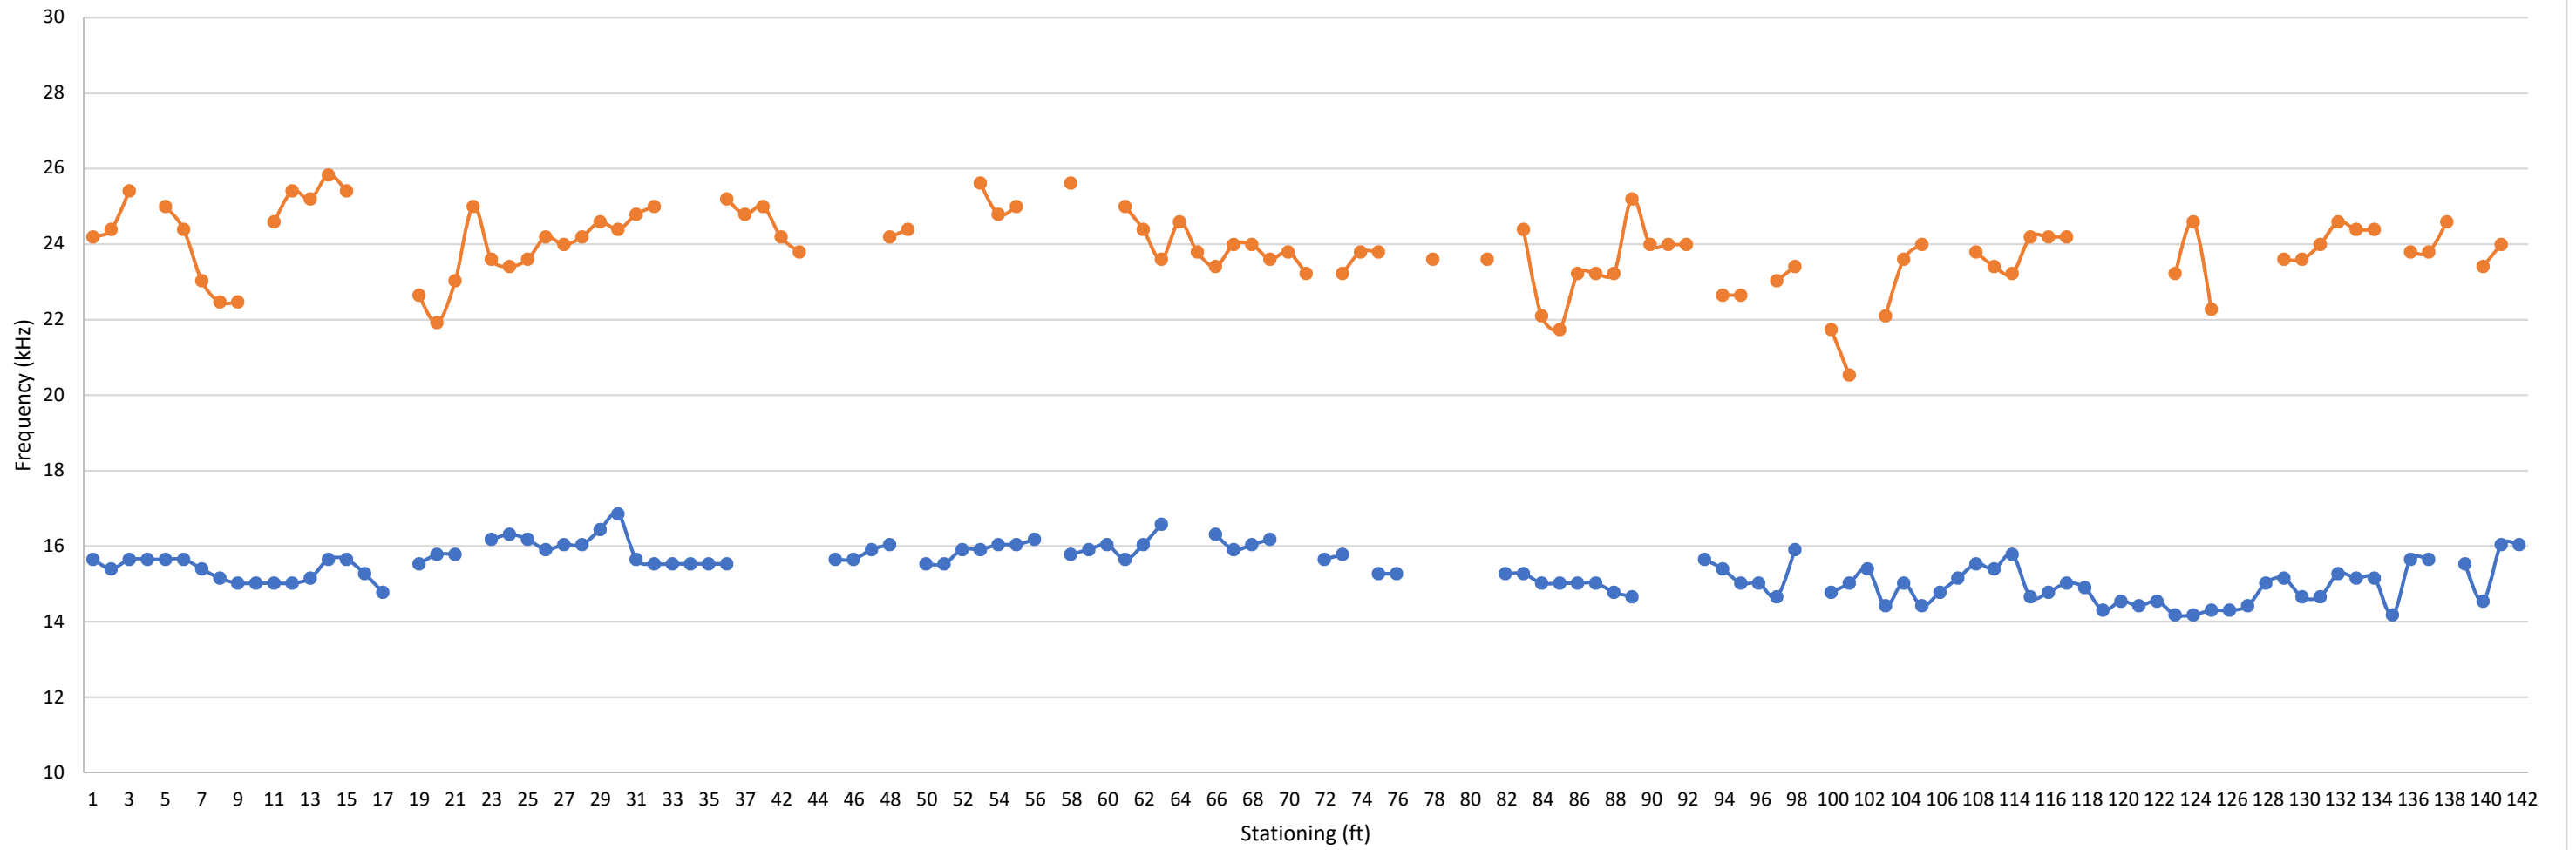
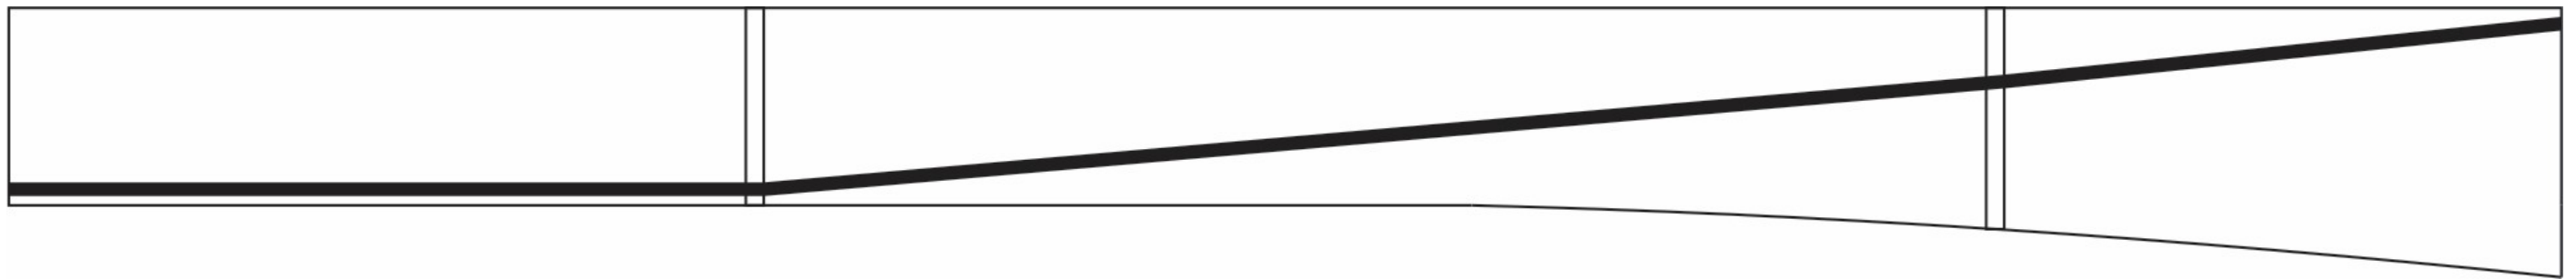
—●— Circumferential Frequency —●— Average Through Frequency ■ Anomalous Grout Condition

Nondestructive Testing External Tendon Ducts John Ringling Causeway Bridge Over Sarasota Bay Sarasota, Florida Prepared for Florida International University by NDT Corporation		Span 3 Tendon 401R-3W Graph Results	
		January. 2018	Figure A19

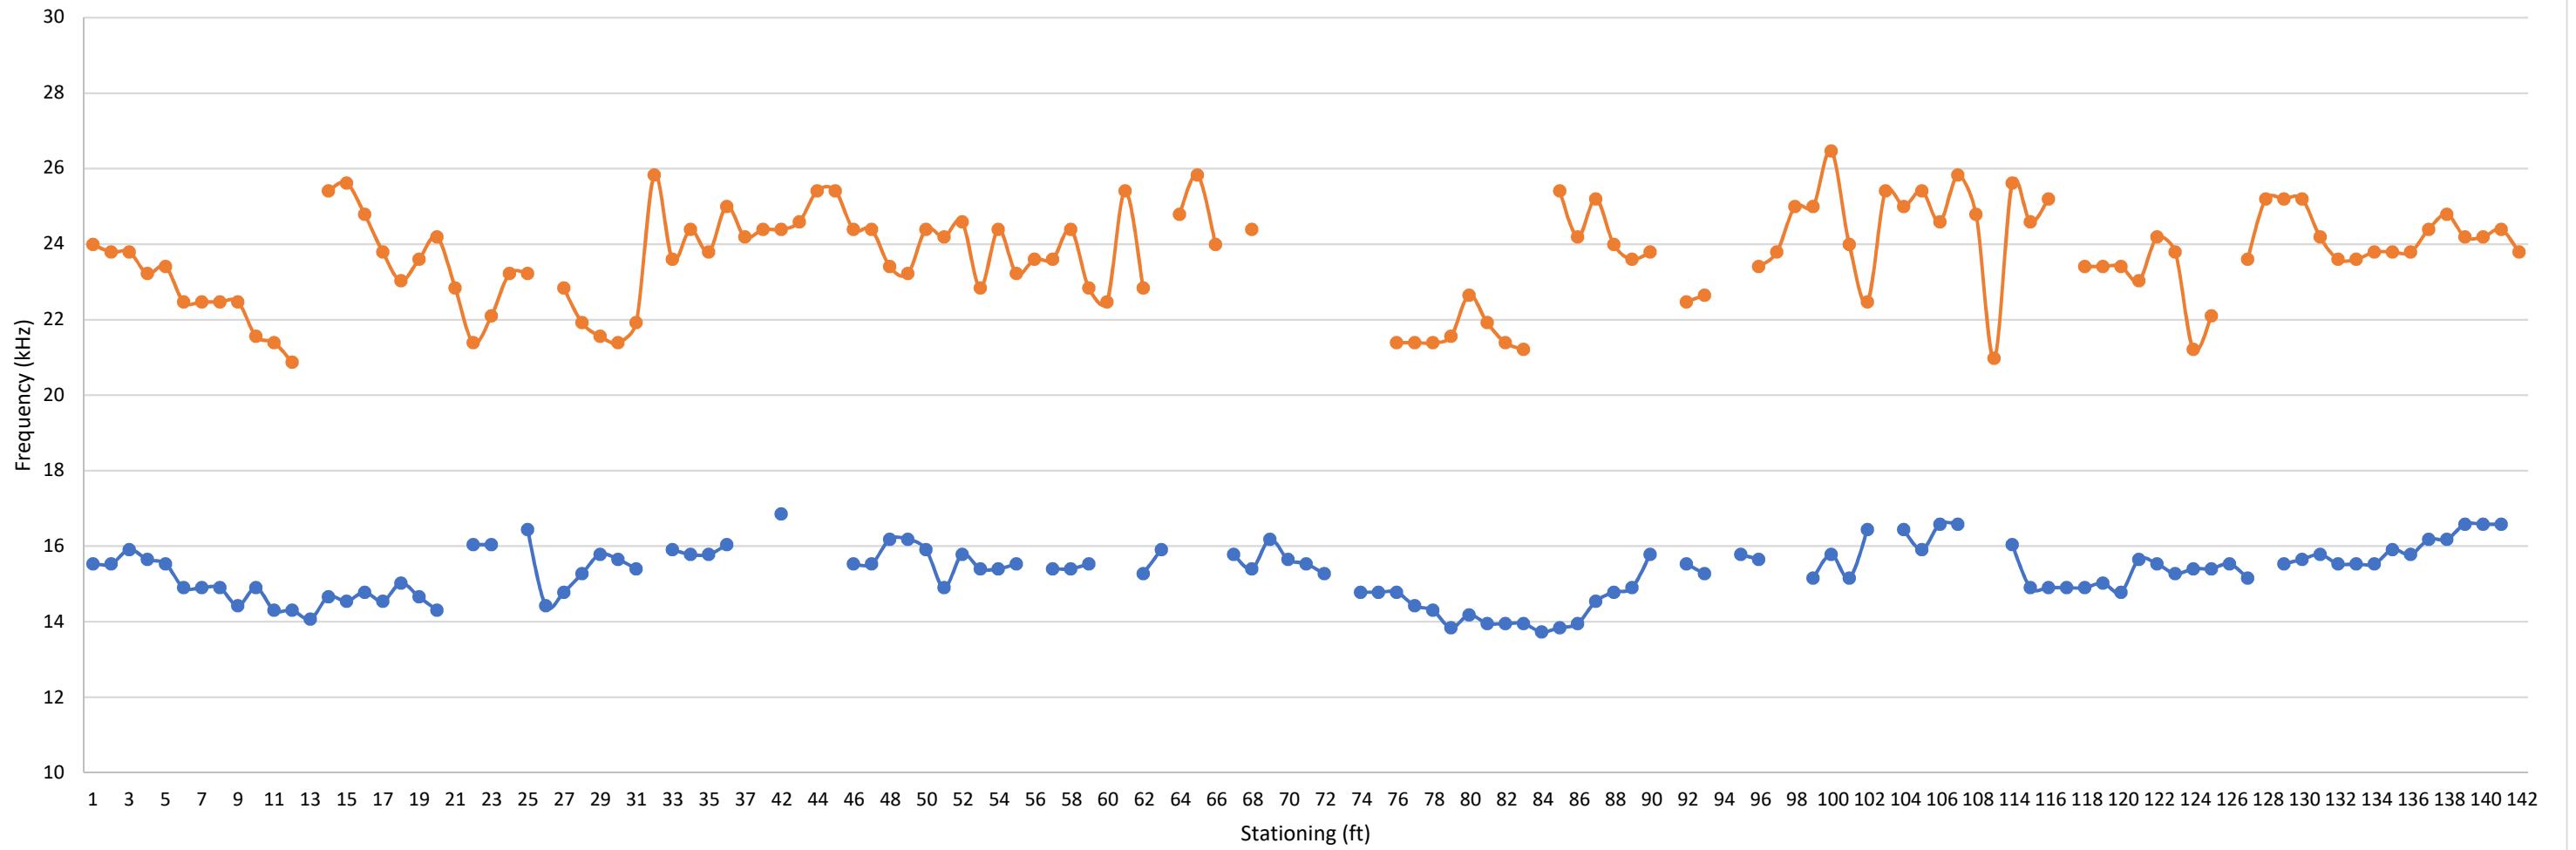
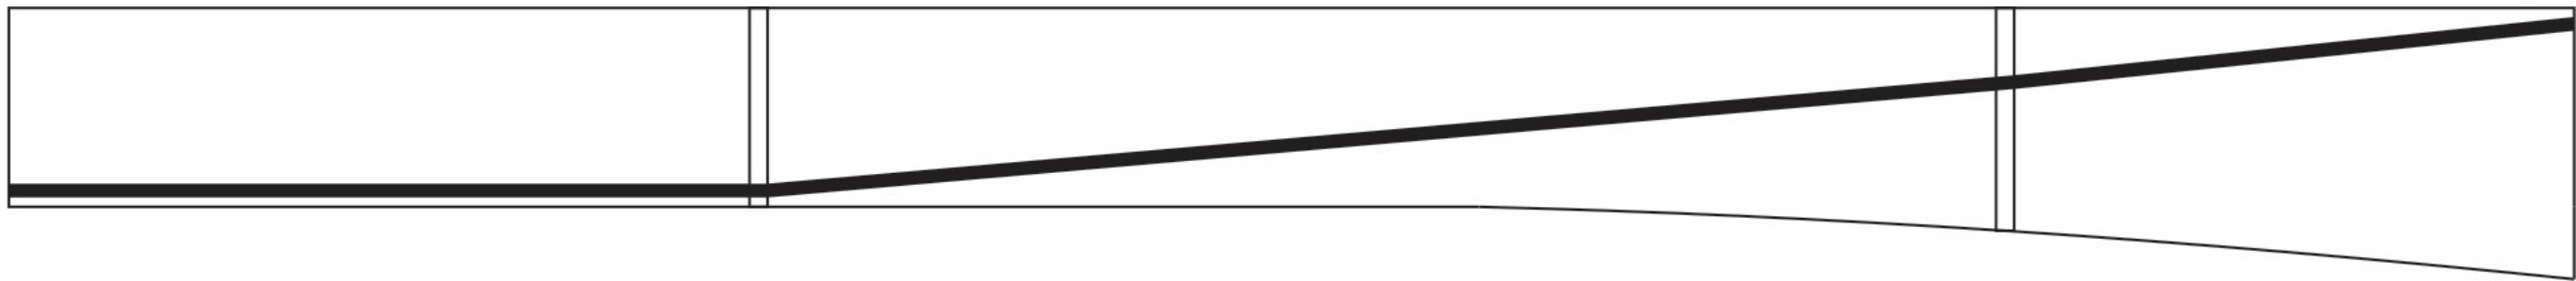
—●— Circumferential Frequency —●— Average Through Frequency ■ Anomalous Grout Condition

Nondestructive Testing External Tendon Ducts John Ringling Causeway Bridge Over Sarasota Bay Sarasota, Florida Prepared for Florida International University by NDT Corporation		Span 3 Tendon 402R-3W Graph Results	
		January. 2018	Figure A20
