**Development of Quality Assurance and Quality Control
System for Post Tensioned Segmental Bridges in Florida:
Case of Ringling Bridge – Phase II**

**FDOT Contract No. BDV29-977-34
FINAL REPORT**

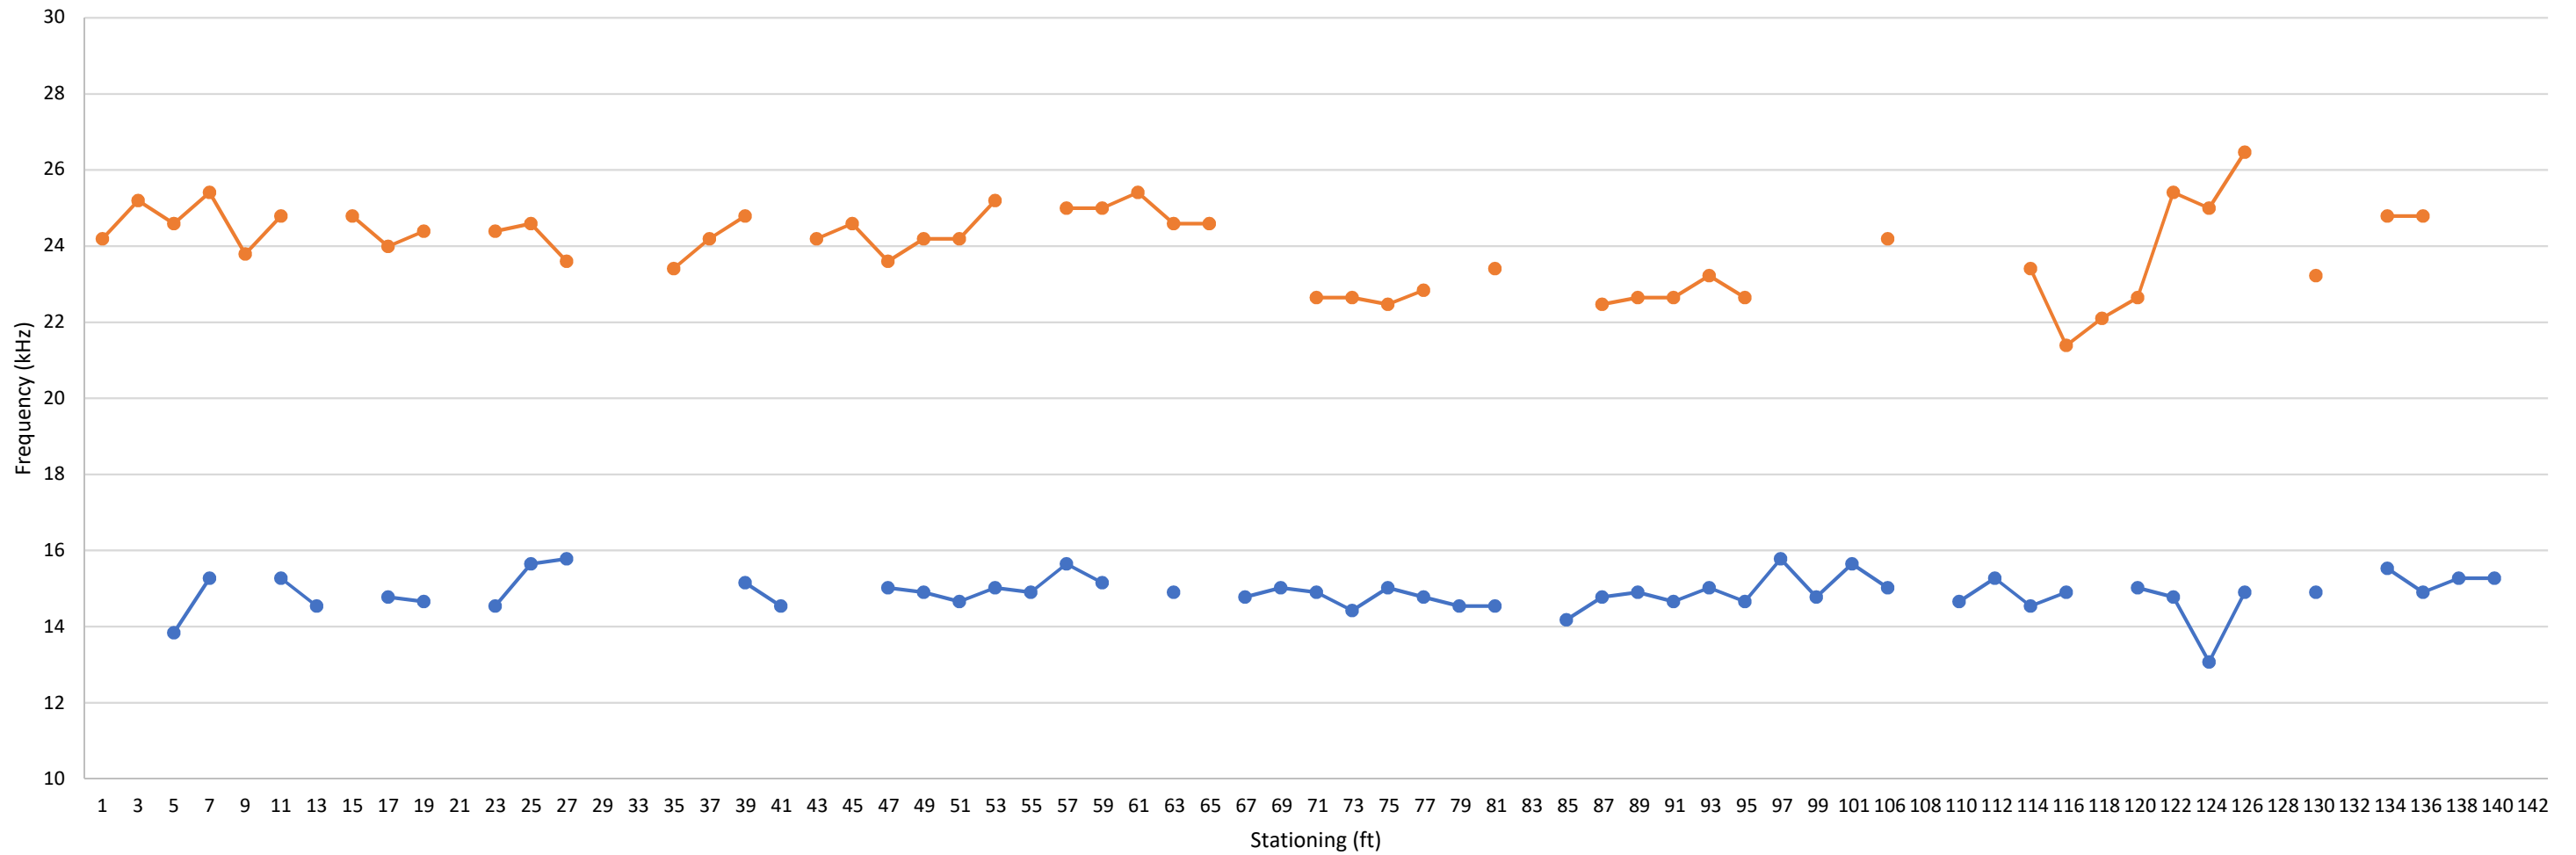
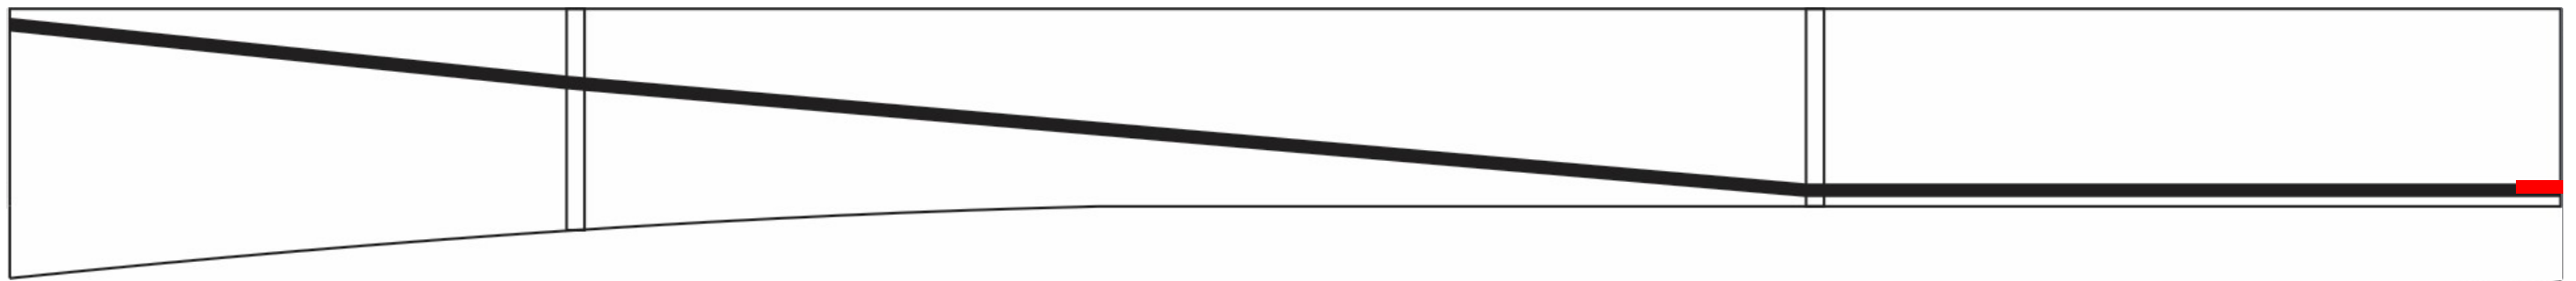
—●— Circumferential Frequency —●— Average Through Frequency ■ Anomalous Grout Condition

Nondestructive Testing External Tendon Ducts John Ringling Causeway Bridge Over Sarasota Bay Sarasota, Florida Prepared for Florida International University by NDT Corporation		Span 4 Tendon 402L-3E Graph Results	
		January. 2018	Figure A21

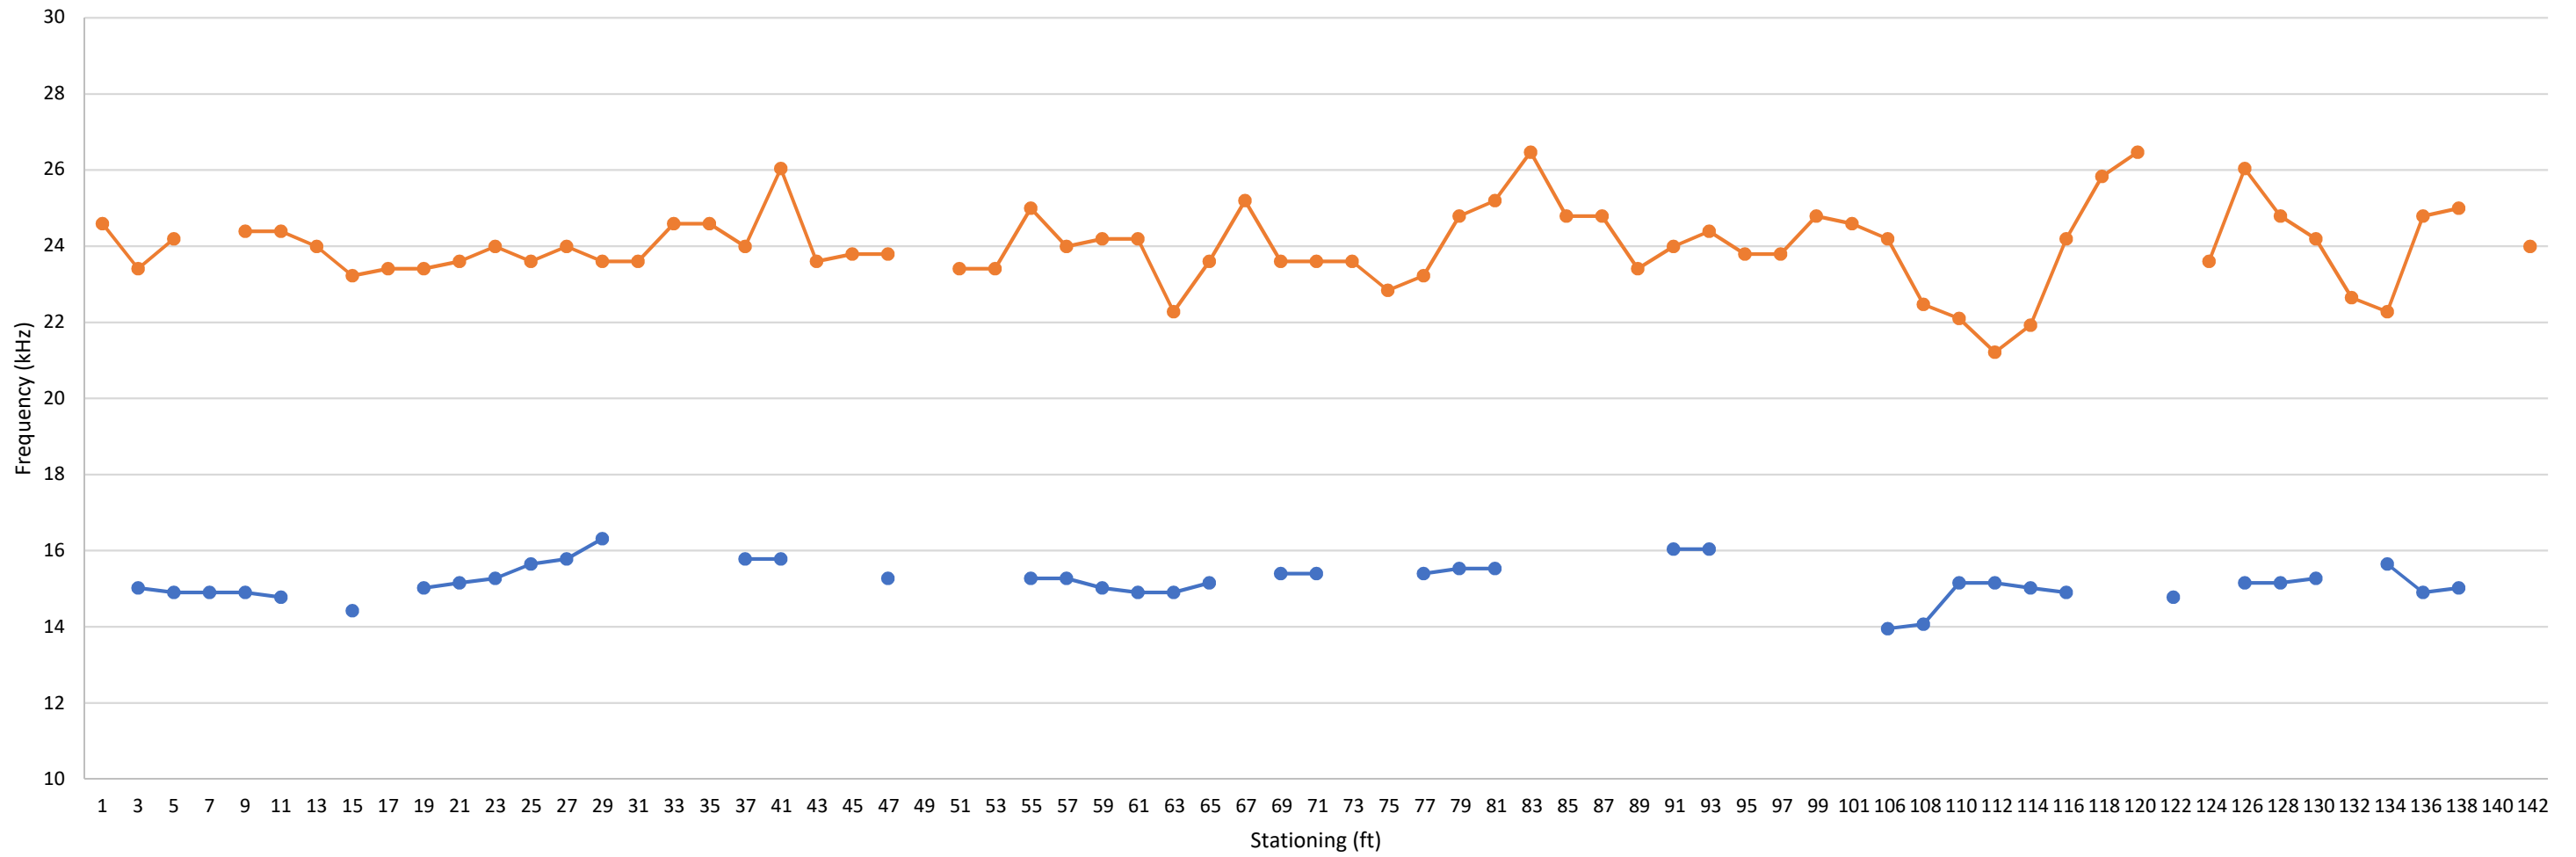
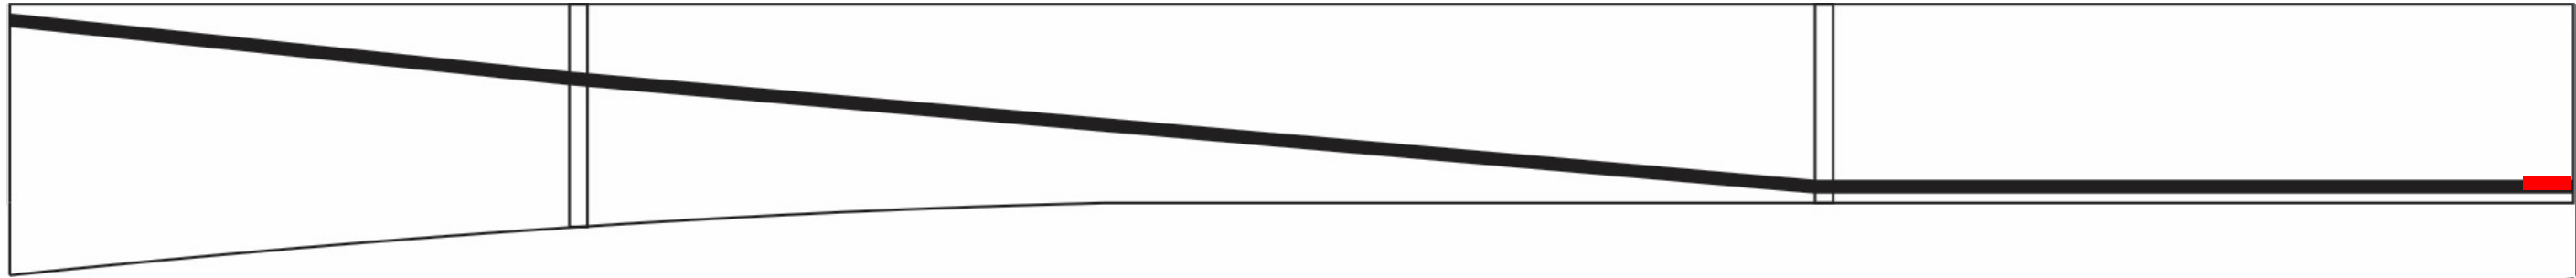
—●— Circumferential Frequency —●— Average Through Frequency ■ Anomalous Grout Condition

Nondestructive Testing External Tendon Ducts John Ringling Causeway Bridge Over Sarasota Bay Sarasota, Florida Prepared for Florida International University by NDT Corporation		Span 4 Tendon 401L-3E Graph Results	
		January. 2018	Figure A22

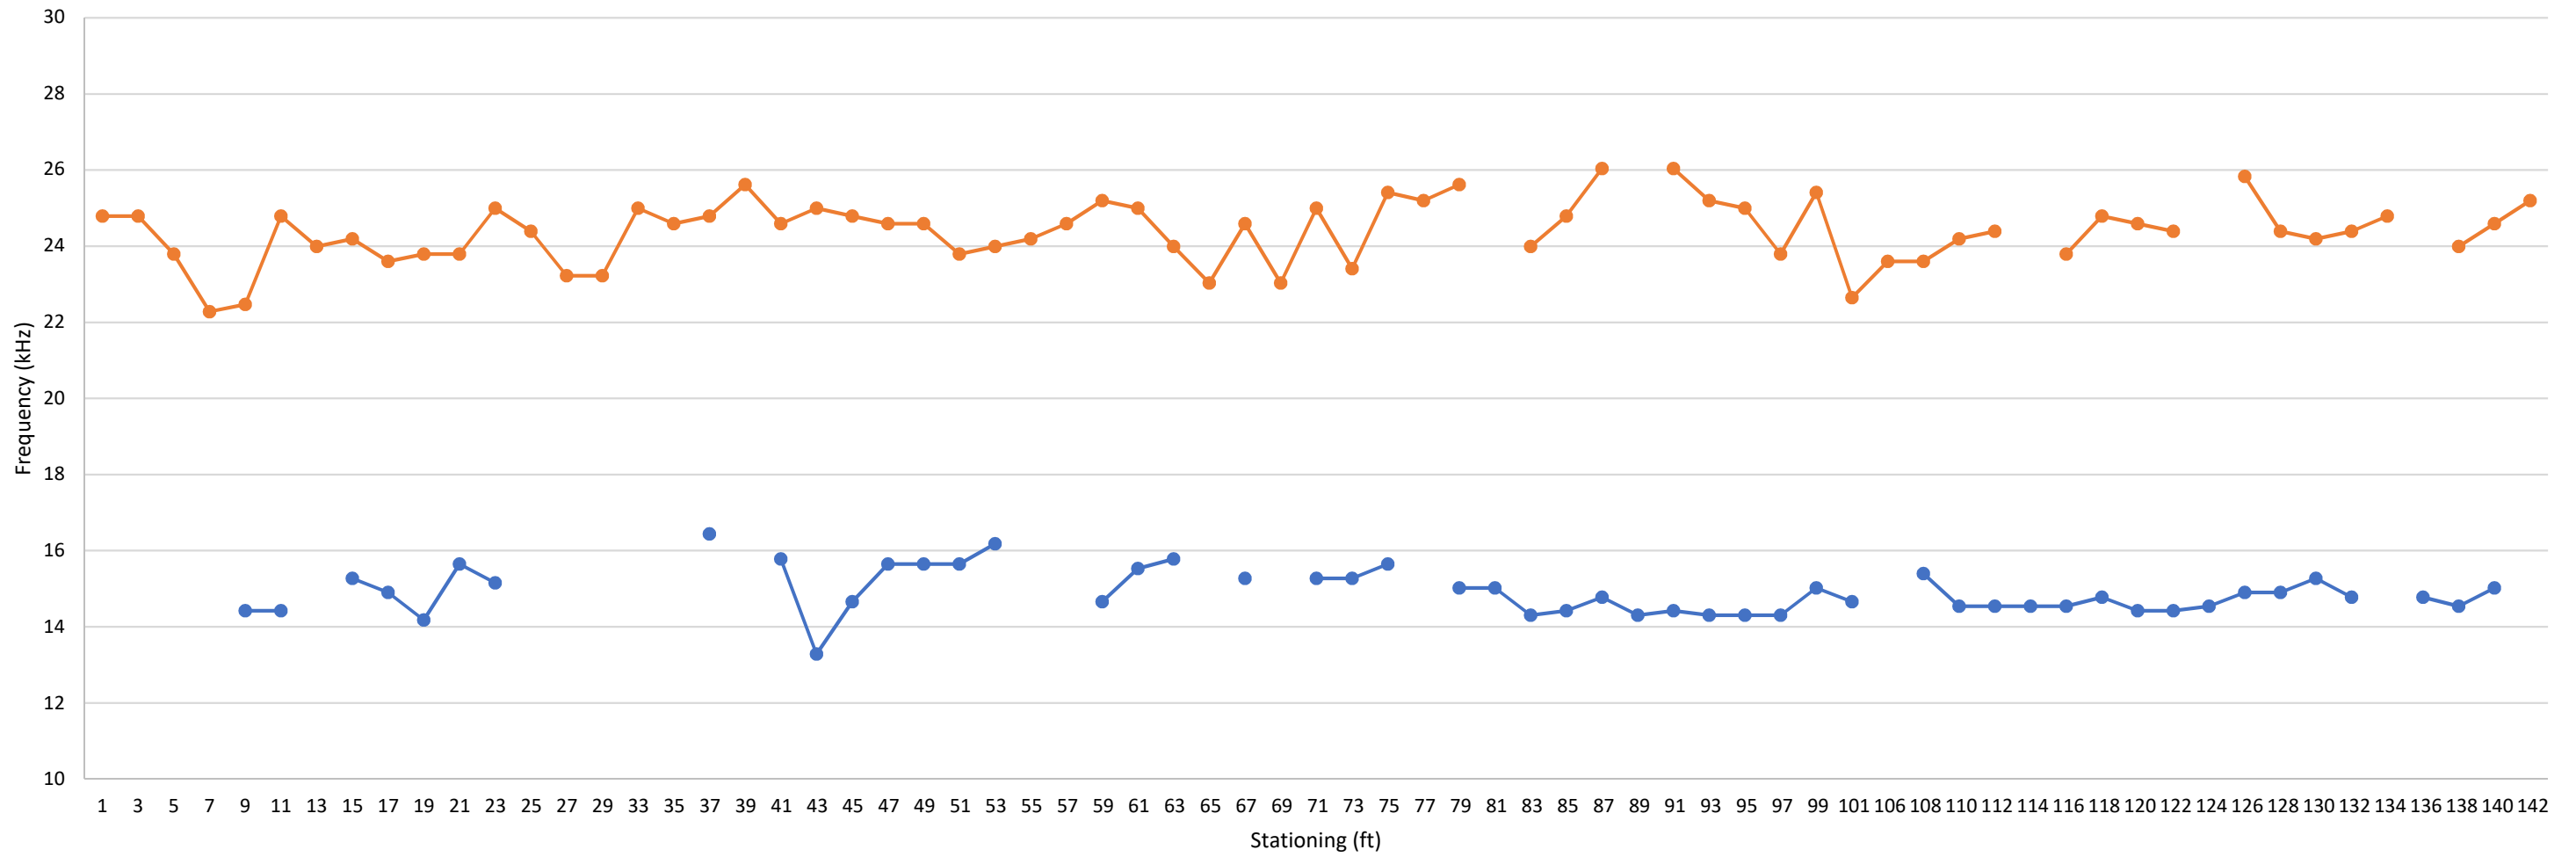
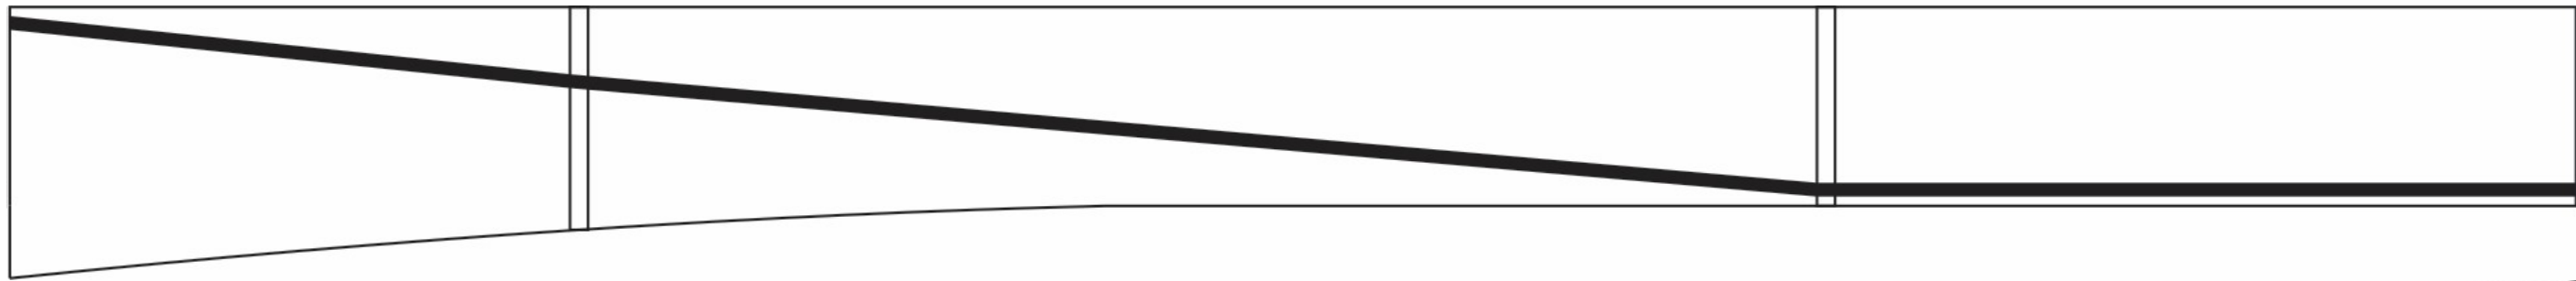
—●— Circumferential Frequency
 —●— Average Through Frequency
 ■ Anomalous Grout Condition

Nondestructive Testing External Tendon Ducts John Ringling Causeway Bridge Over Sarasota Bay Sarasota, Florida Prepared for Florida International University by NDT Corporation		Span 4 Tendon 401R-3E Graph Results	
		January. 2018	Figure A23

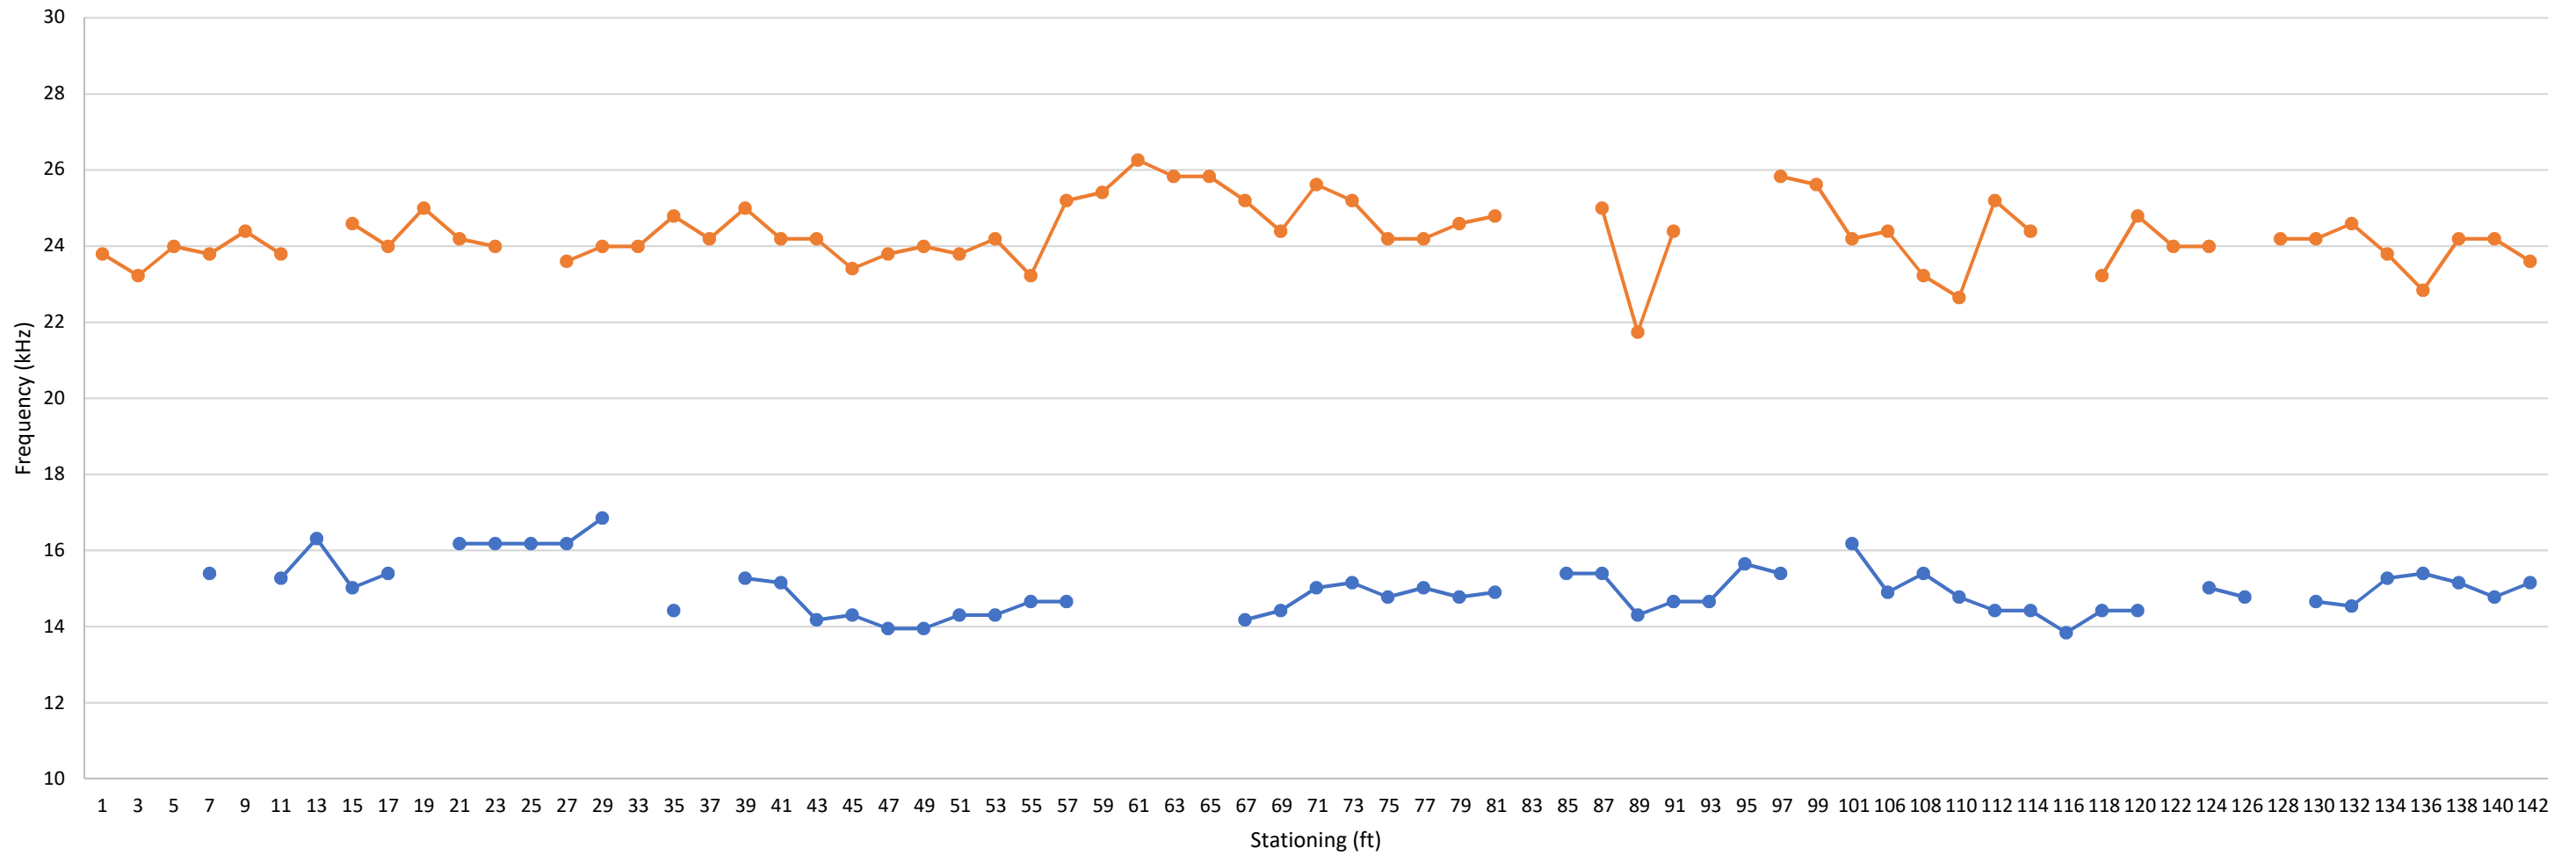
—●— Circumferential Frequency
 —●— Average Through Frequency
 ■ Anomalous Grout Condition

Nondestructive Testing External Tendon Ducts John Ringling Causeway Bridge Over Sarasota Bay Sarasota, Florida Prepared for Florida International University by NDT Corporation		Span 4 Tendon 402R-3E Graph Results	
January. 2018		Figure A24

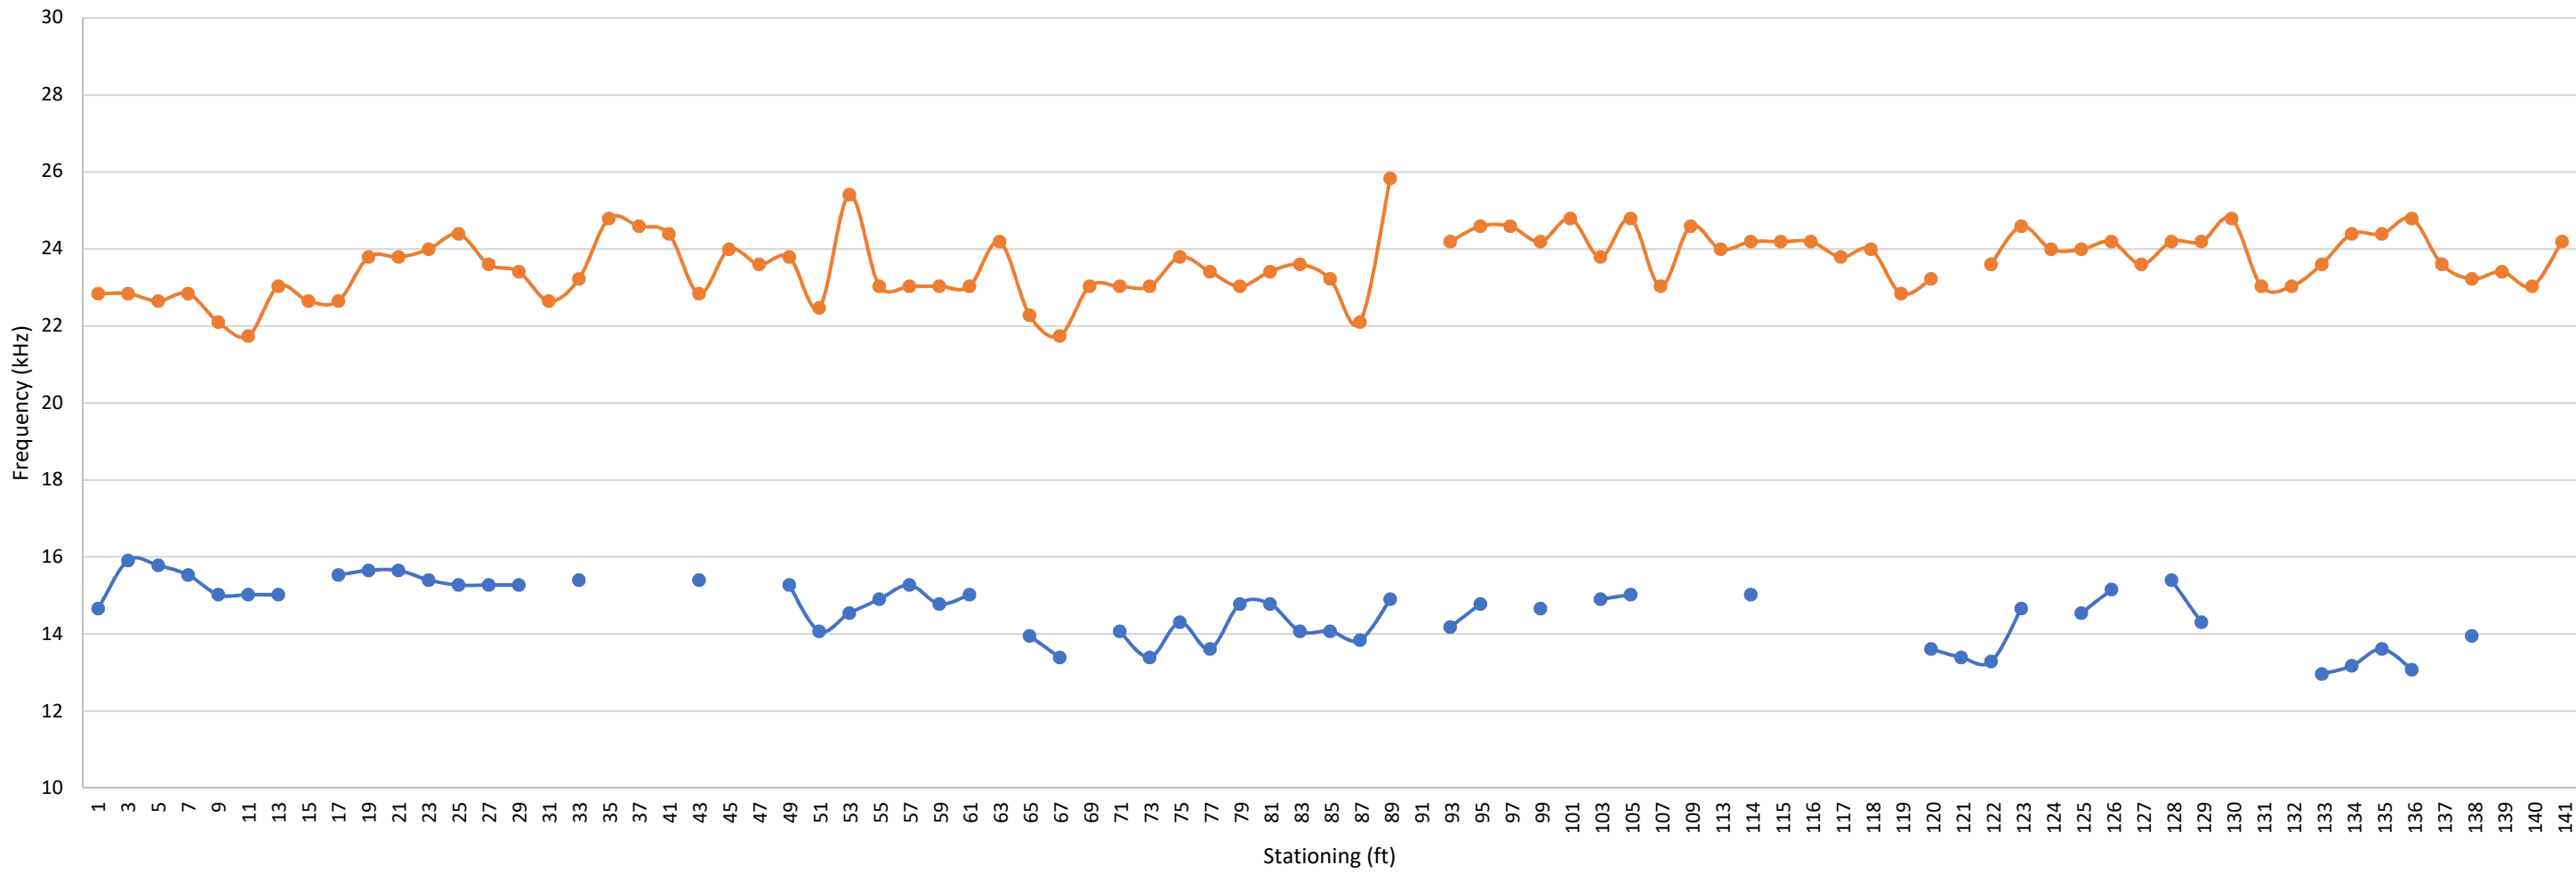
—●— Circumferential Frequency
 —●— Average Through Frequency
 ■ Anomalous Grout Condition

Nondestructive Testing External Tendon Ducts John Ringling Causeway Bridge Over Sarasota Bay Sarasota, Florida Prepared for Florida International University by NDT Corporation		Span 4 Tendon 402L-4W Graph Results	
January. 2018		Figure A25

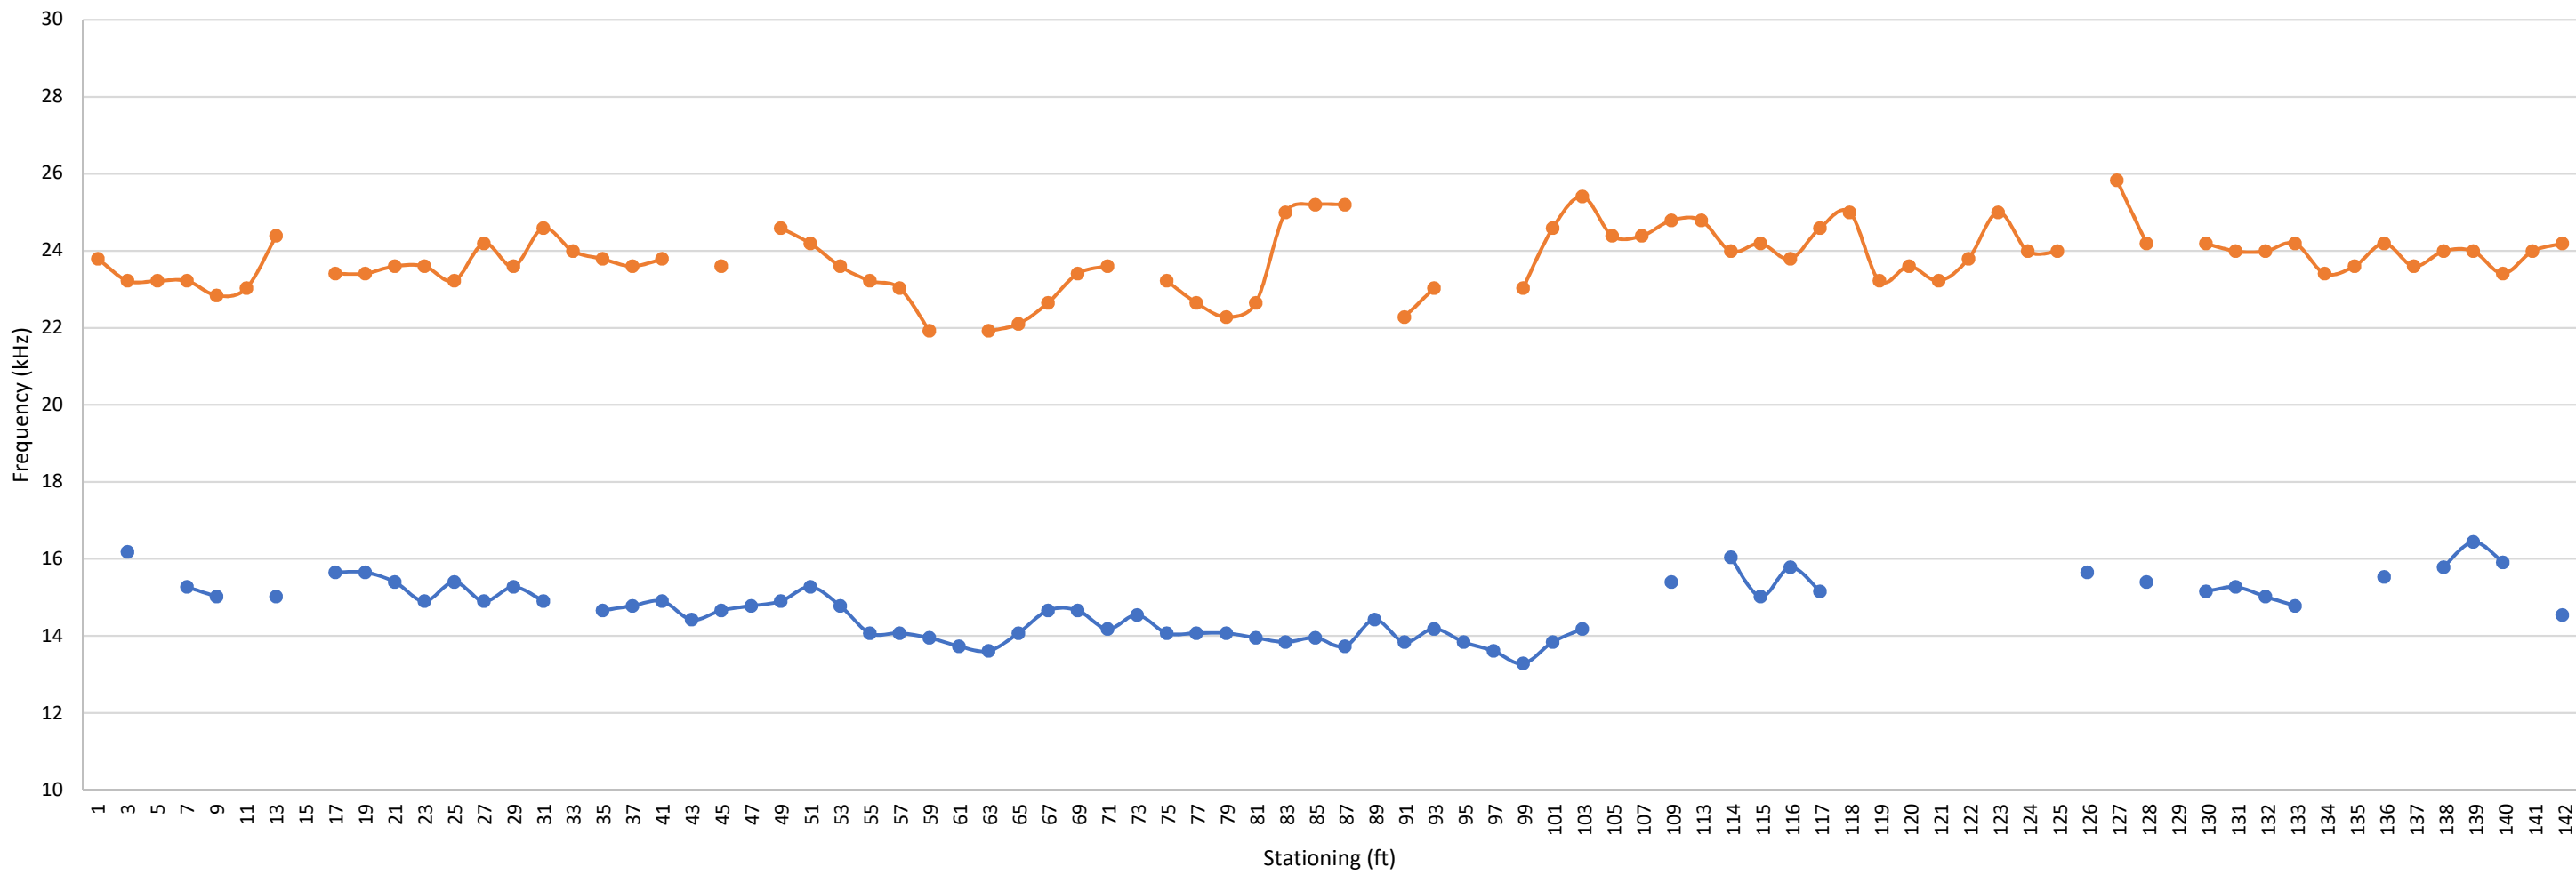
—●— Circumferential Frequency
 —●— Average Through Frequency
 ■ Anomalous Grout Condition

Nondestructive Testing External Tendon Ducts John Ringling Causeway Bridge Over Sarasota Bay Sarasota, Florida Prepared for Florida International University by NDT Corporation		Span 4 Tendon 401L-4W Graph Results	
January. 2018		Figure A26

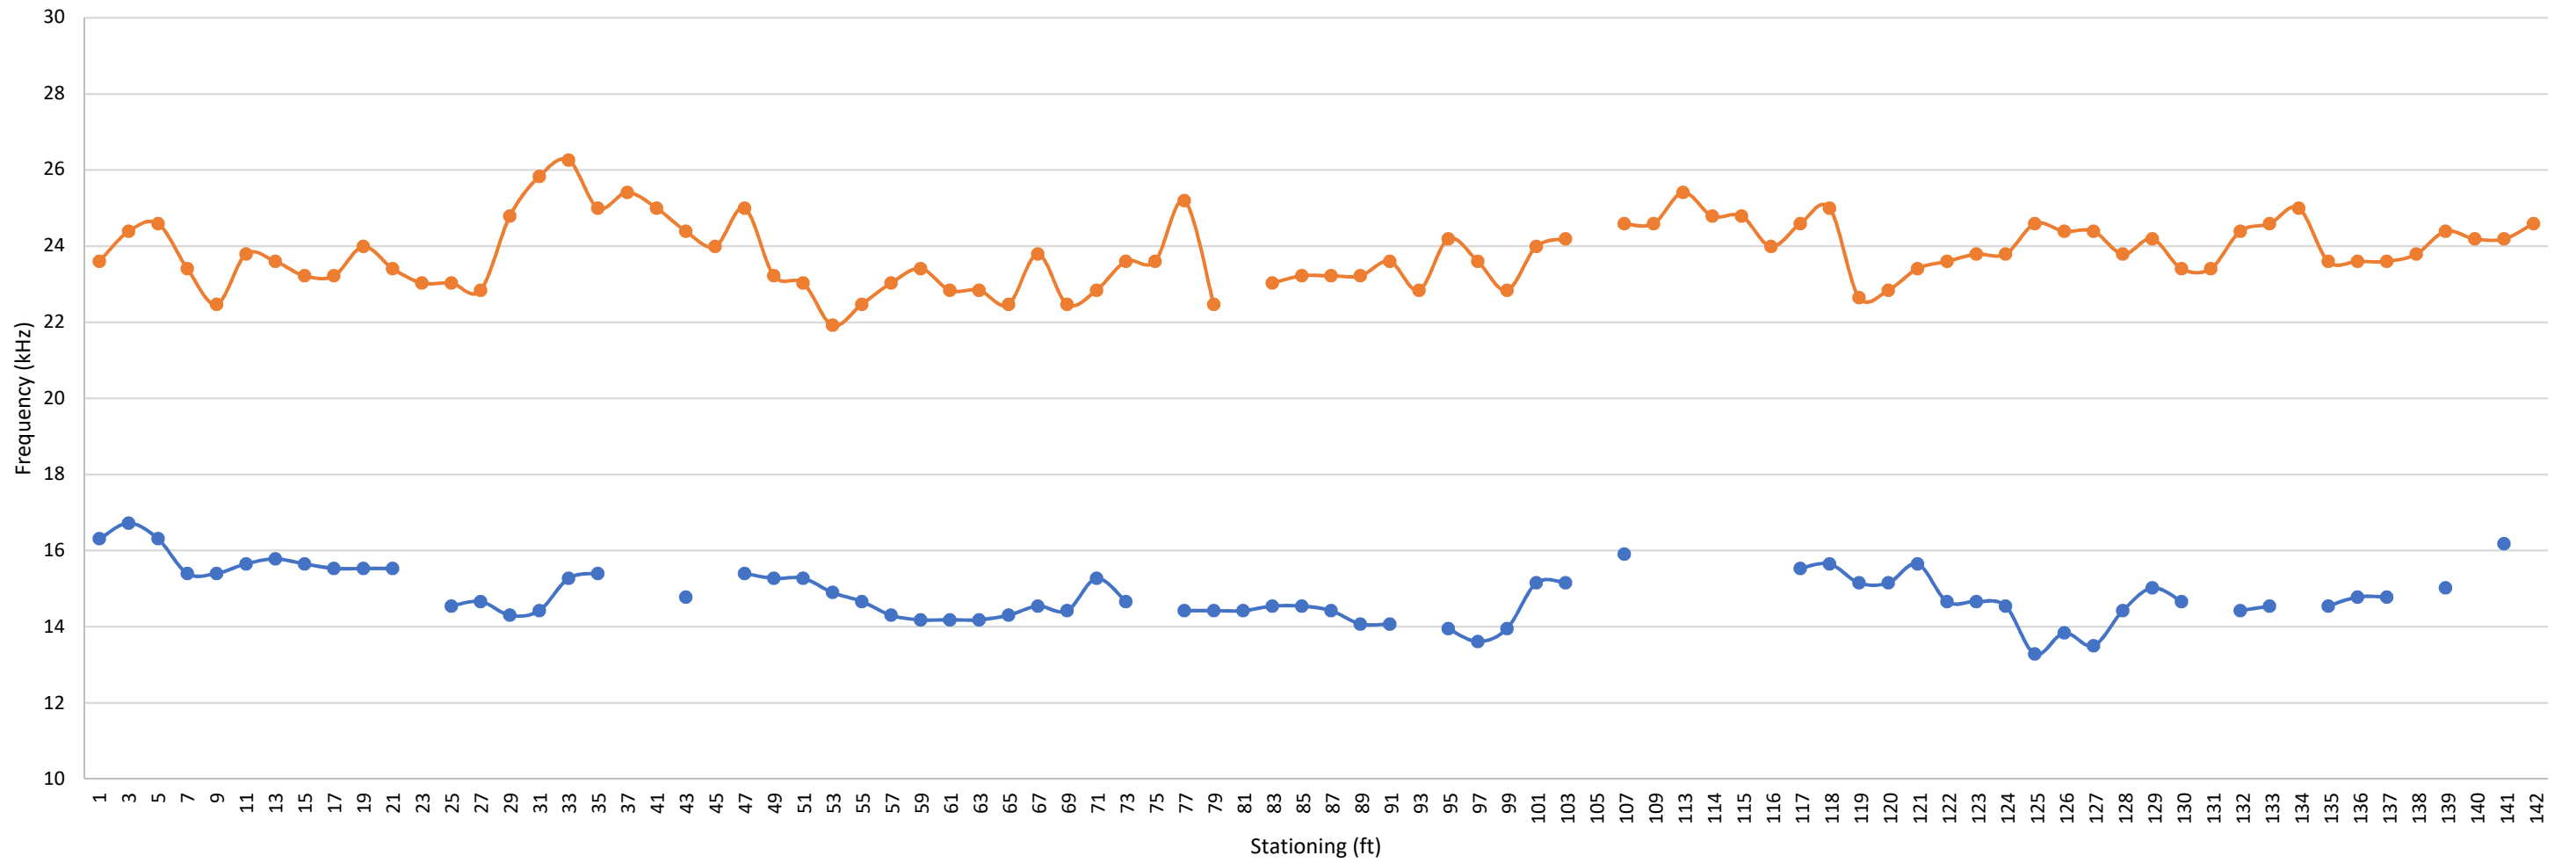
—●— Circumferential Frequency
 —●— Average Through Frequency
 ■ Anomalous Grout Condition

Nondestructive Testing External Tendon Ducts John Ringling Causeway Bridge Over Sarasota Bay Sarasota, Florida Prepared for Florida International University by NDT Corporation		Span 4 Tendon 401R-4W Graph Results	
January. 2018		Figure A27

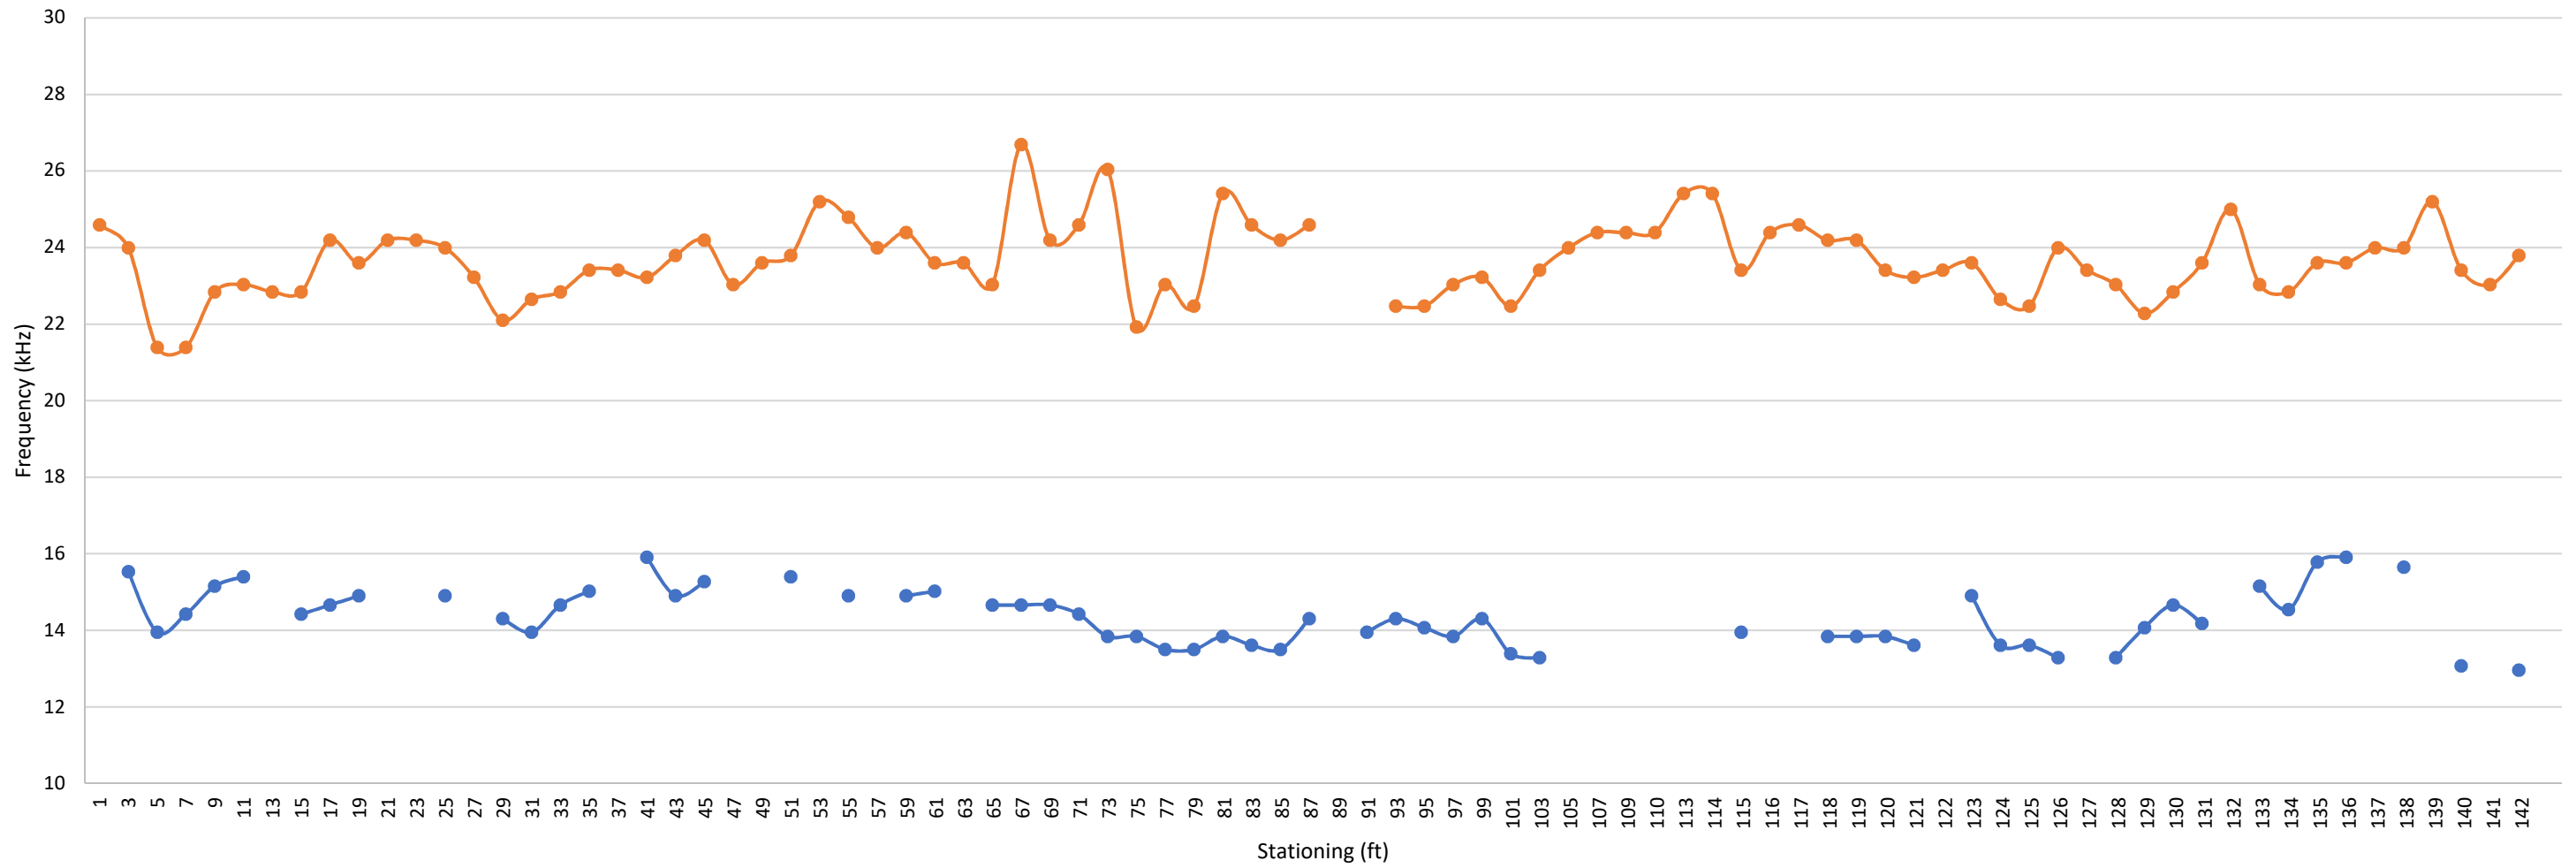
—●— Circumferential Frequency —●— Average Through Frequency ■ Anomalous Grout Condition

Nondestructive Testing External Tendon Ducts John Ringling Causeway Bridge Over Sarasota Bay Sarasota, Florida Prepared for Florida International University by NDT Corporation		Span 4 Tendon 402R-4W Graph Results	
		January. 2018	Figure A28

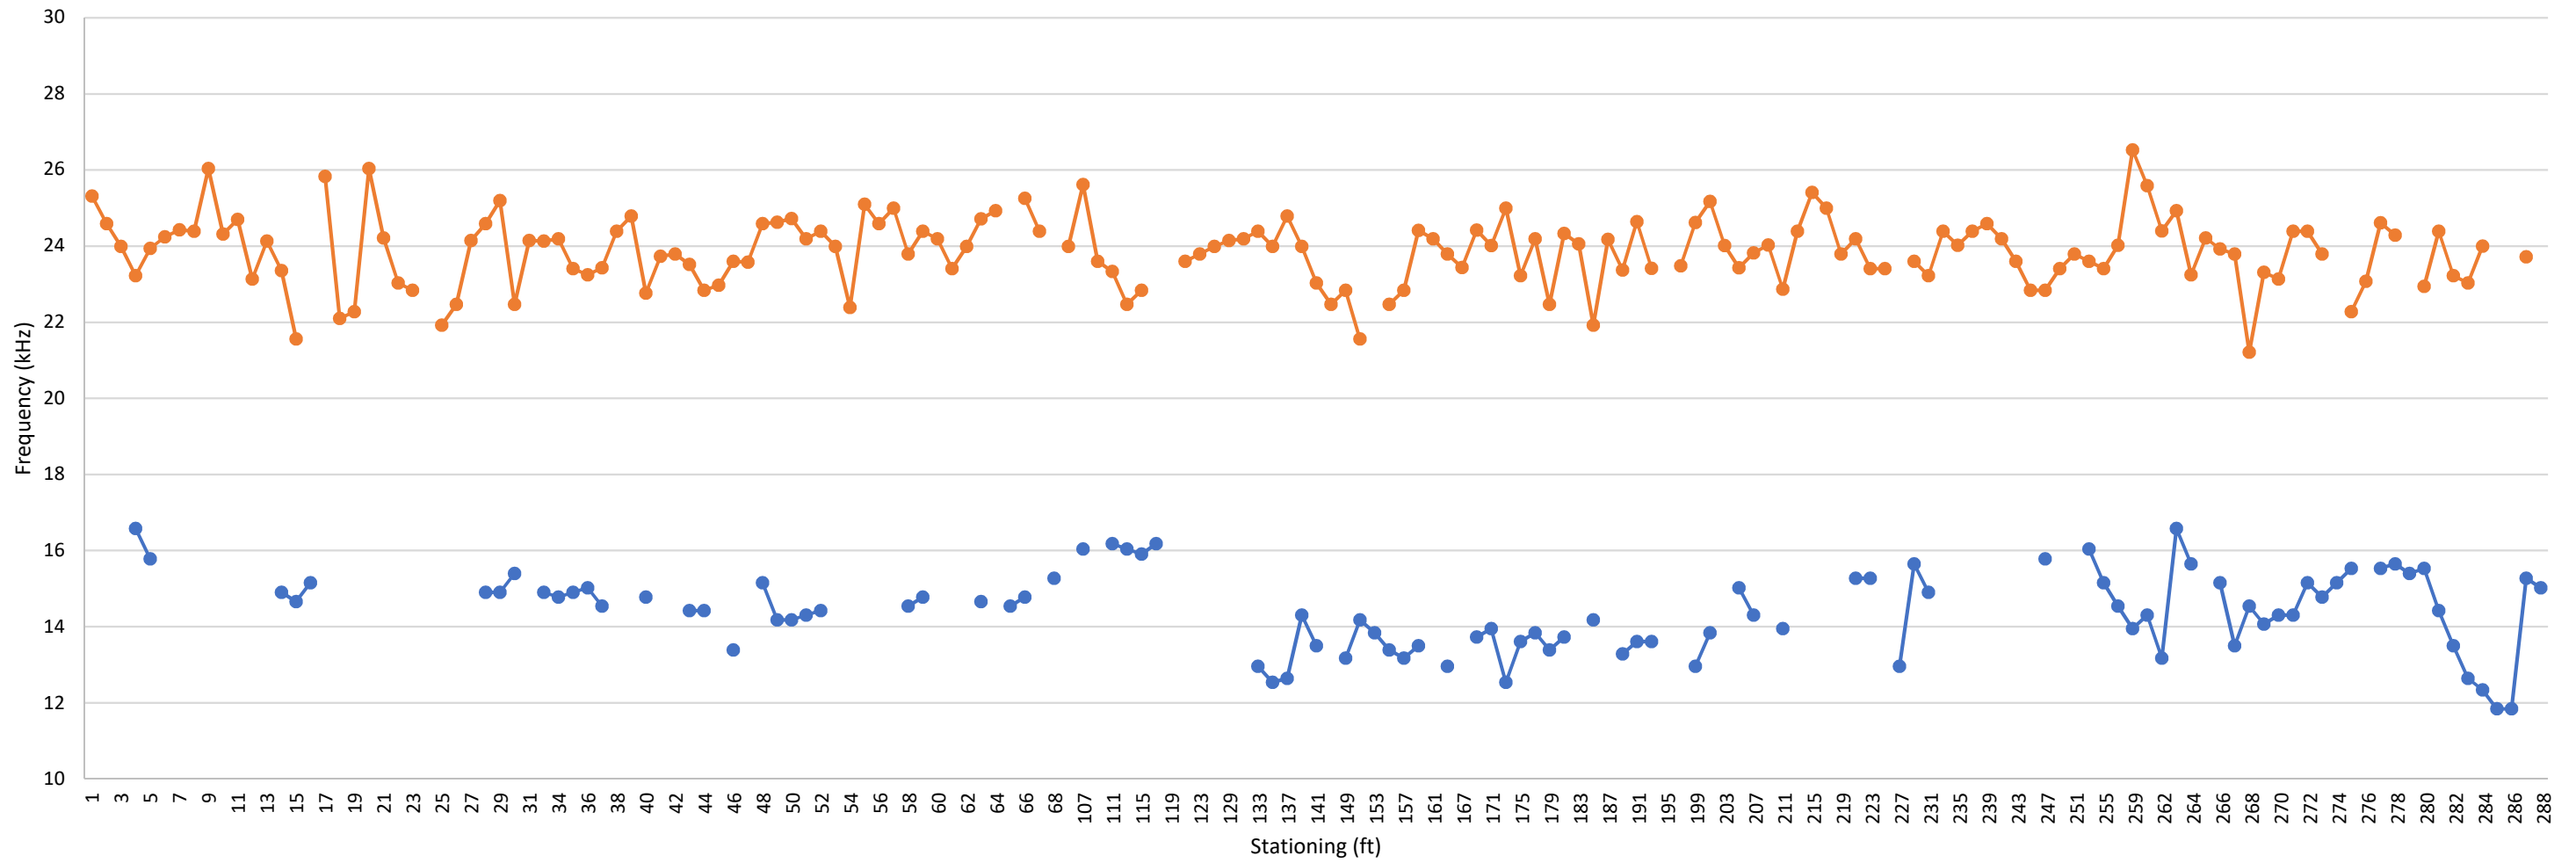
—●— Circumferential Frequency
 —●— Average Through Frequency
 ■ Anomalous Grout Condition

Nondestructive Testing External Tendon Ducts John Ringling Causeway Bridge Over Sarasota Bay Sarasota, Florida Prepared for Florida International University by NDT Corporation		Span 5 Tendon 303L-4E Graph Results	
January. 2018		Figure A29
