**Development of Quality Assurance and Quality Control
System for Post Tensioned Segmental Bridges in Florida:
Case of Ringling Bridge – Phase II**

**FDOT Contract No. BDV29-977-34
FINAL REPORT**

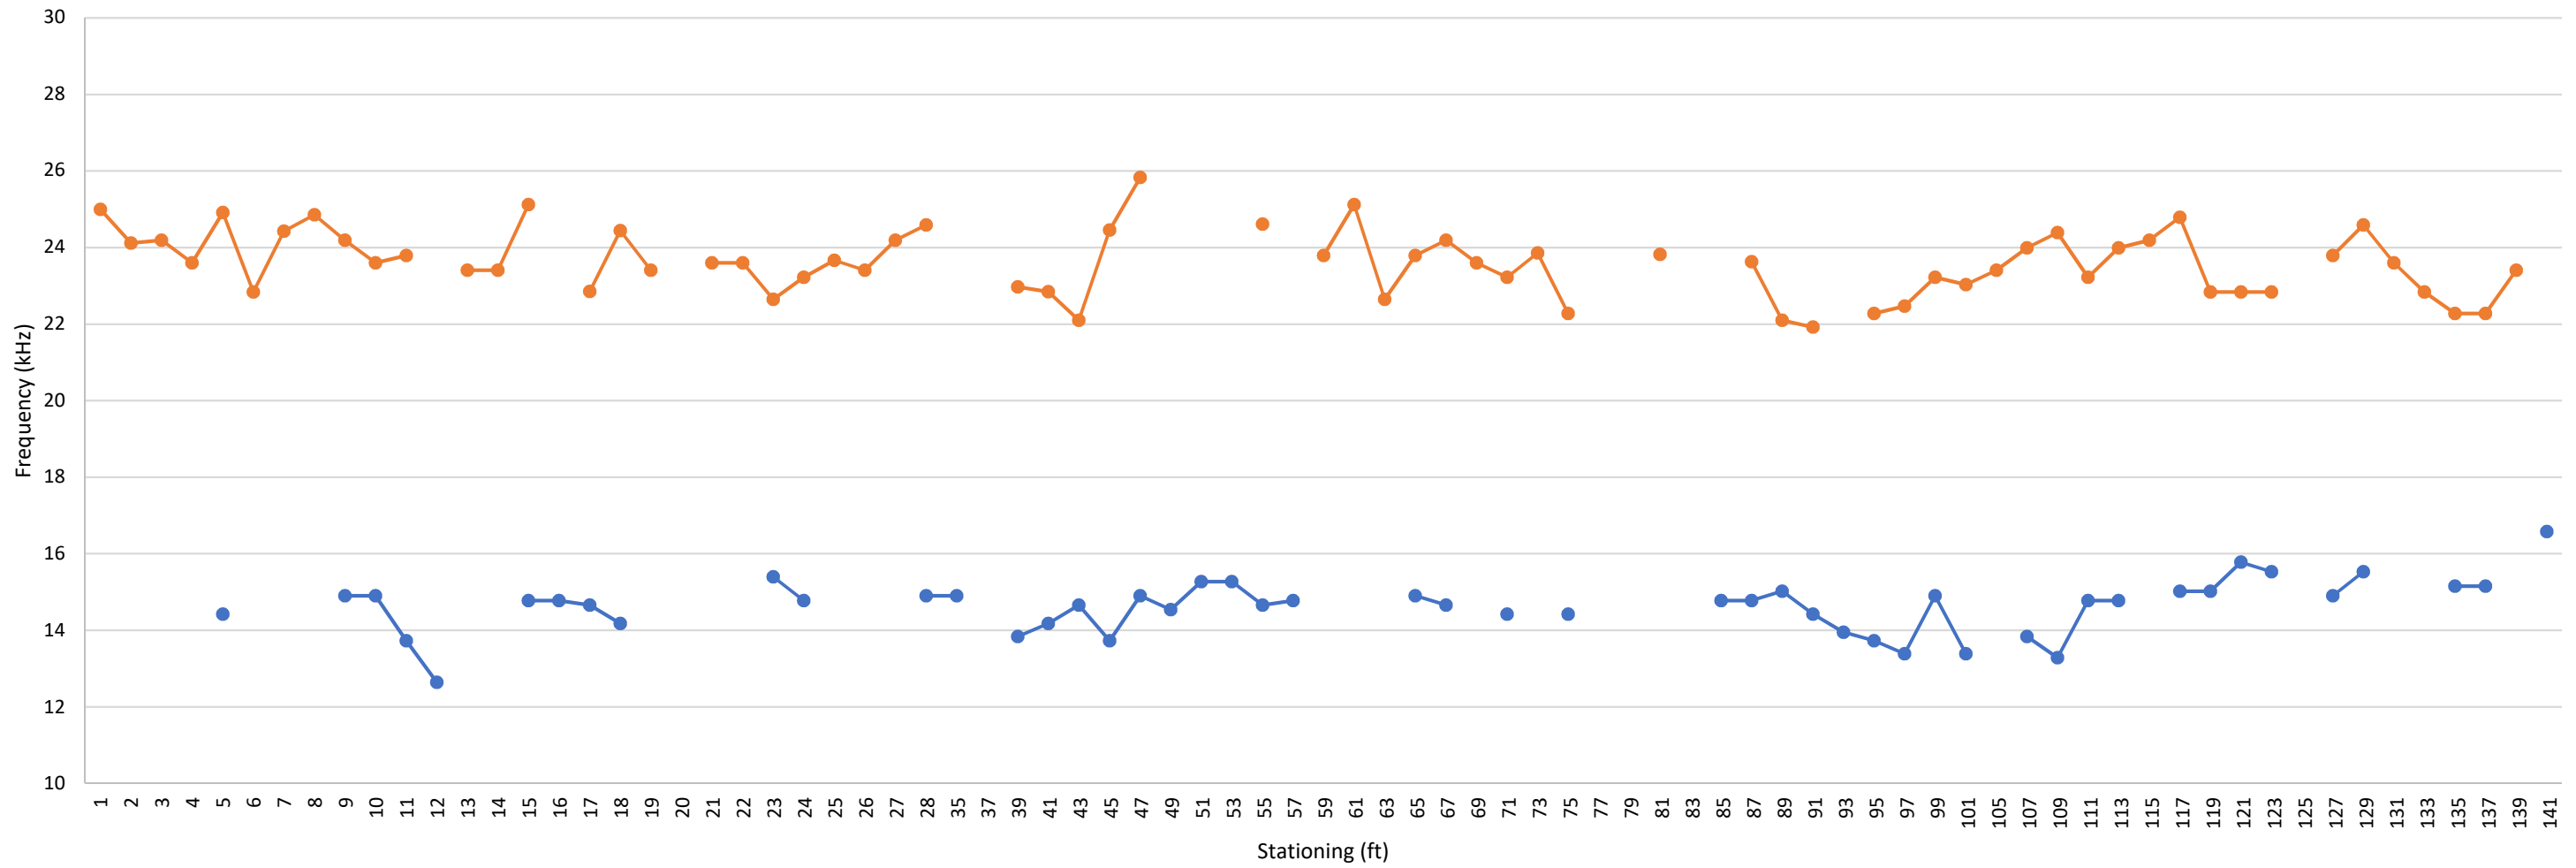
● Circumferential Frequency
 ● Average Through Frequency
 ■ Anomalous Grout Condition

Nondestructive Testing External Tendon Ducts John Ringling Causeway Bridge Over Sarasota Bay Sarasota, Florida Prepared for Florida International University by NDT Corporation		Span 5 Tendon 402L-4E Graph Results	
January. 2018		Figure A30

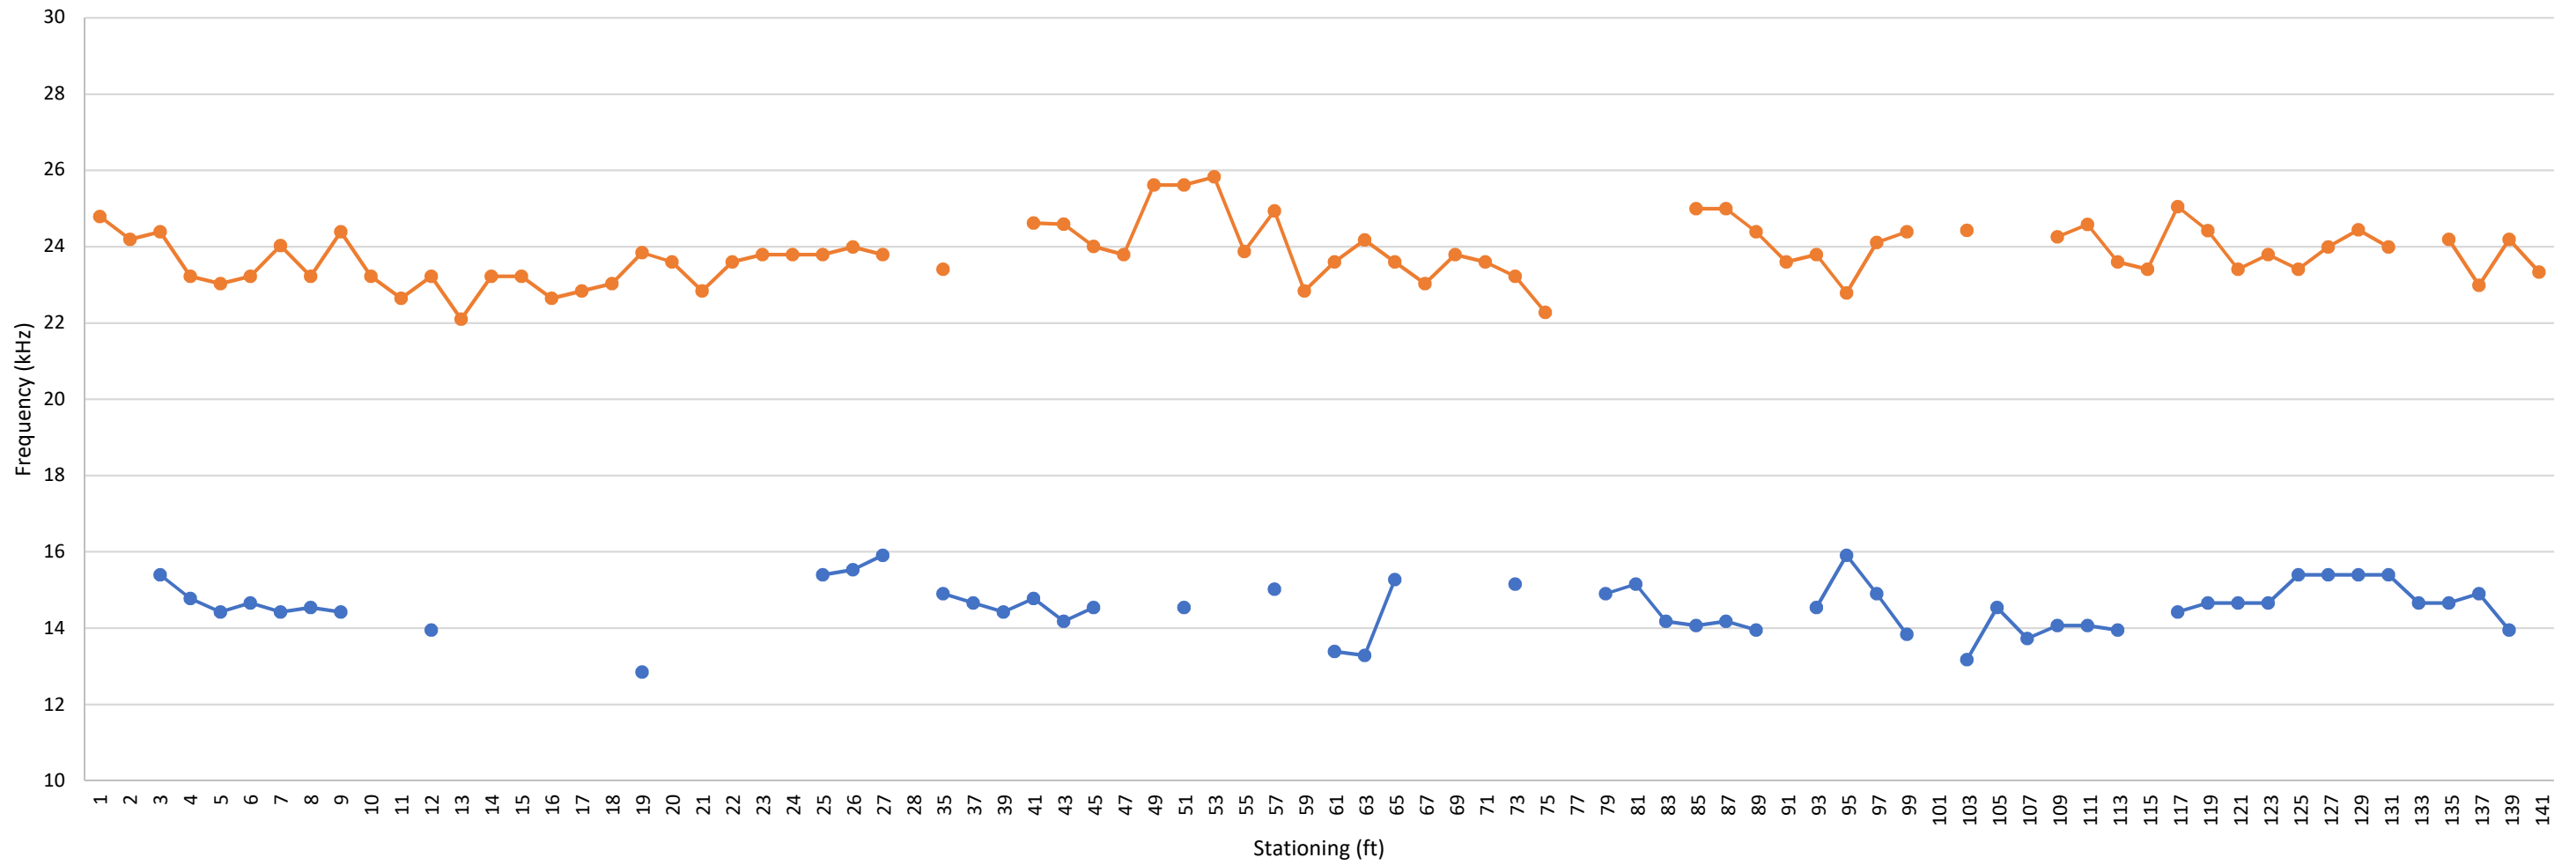
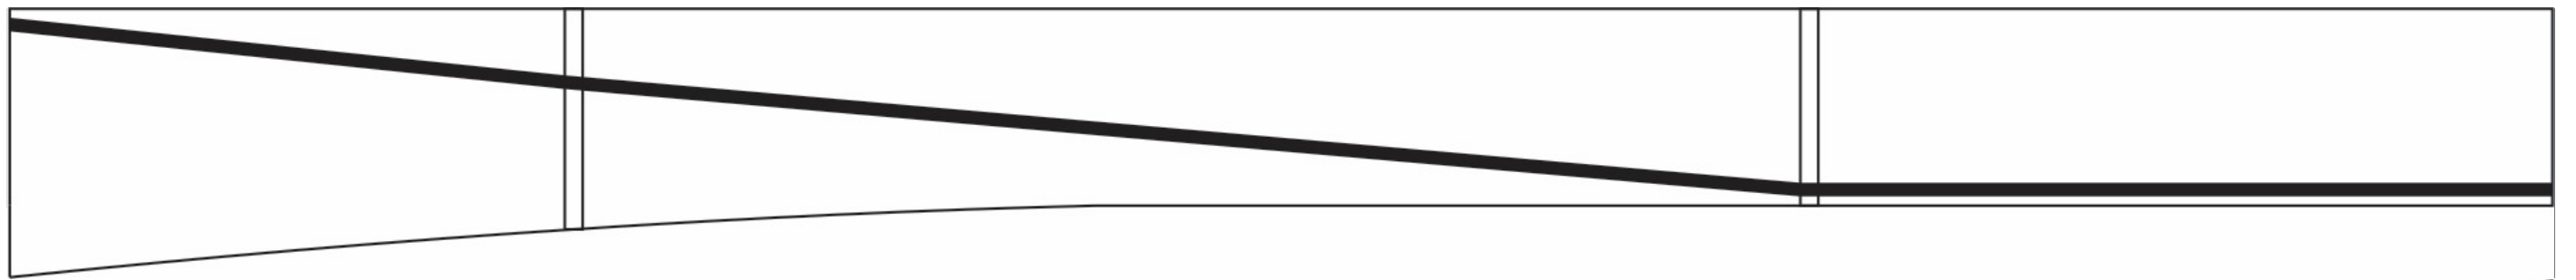
—●— Circumferential Frequency
 —●— Average Through Frequency
 ■ Anomalous Grout Condition

Nondestructive Testing External Tendon Ducts John Ringling Causeway Bridge Over Sarasota Bay Sarasota, Florida Prepared for Florida International University by NDT Corporation		Span 5 Tendon 401L-4E Graph Results	
January. 2018		Figure A31

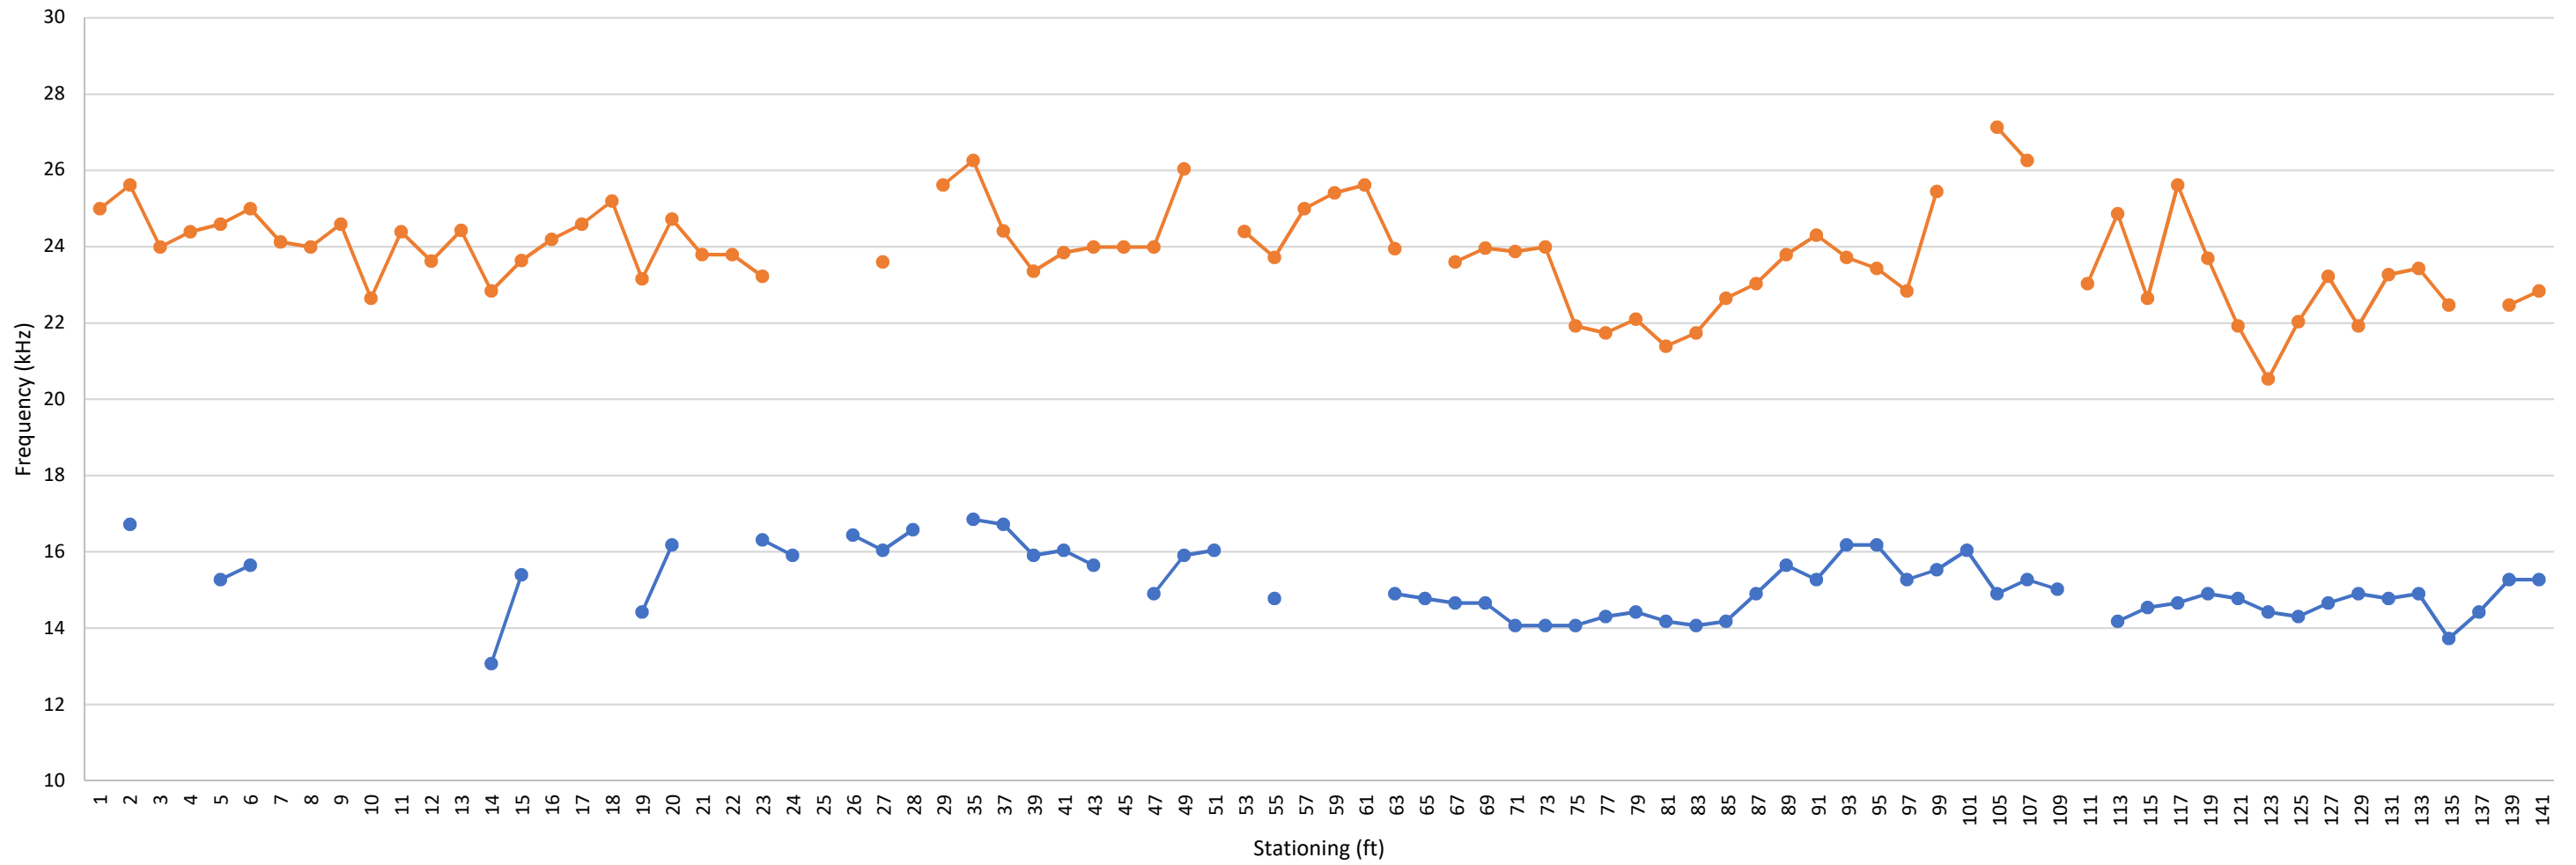
—●— Circumferential Frequency —●— Average Through Frequency ■ Anomalous Grout Condition

Nondestructive Testing External Tendon Ducts John Ringling Causeway Bridge Over Sarasota Bay Sarasota, Florida Prepared for Florida International University by NDT Corporation		Span 5 Tendon 401R-4E Graph Results	
		January. 2018	Figure A32

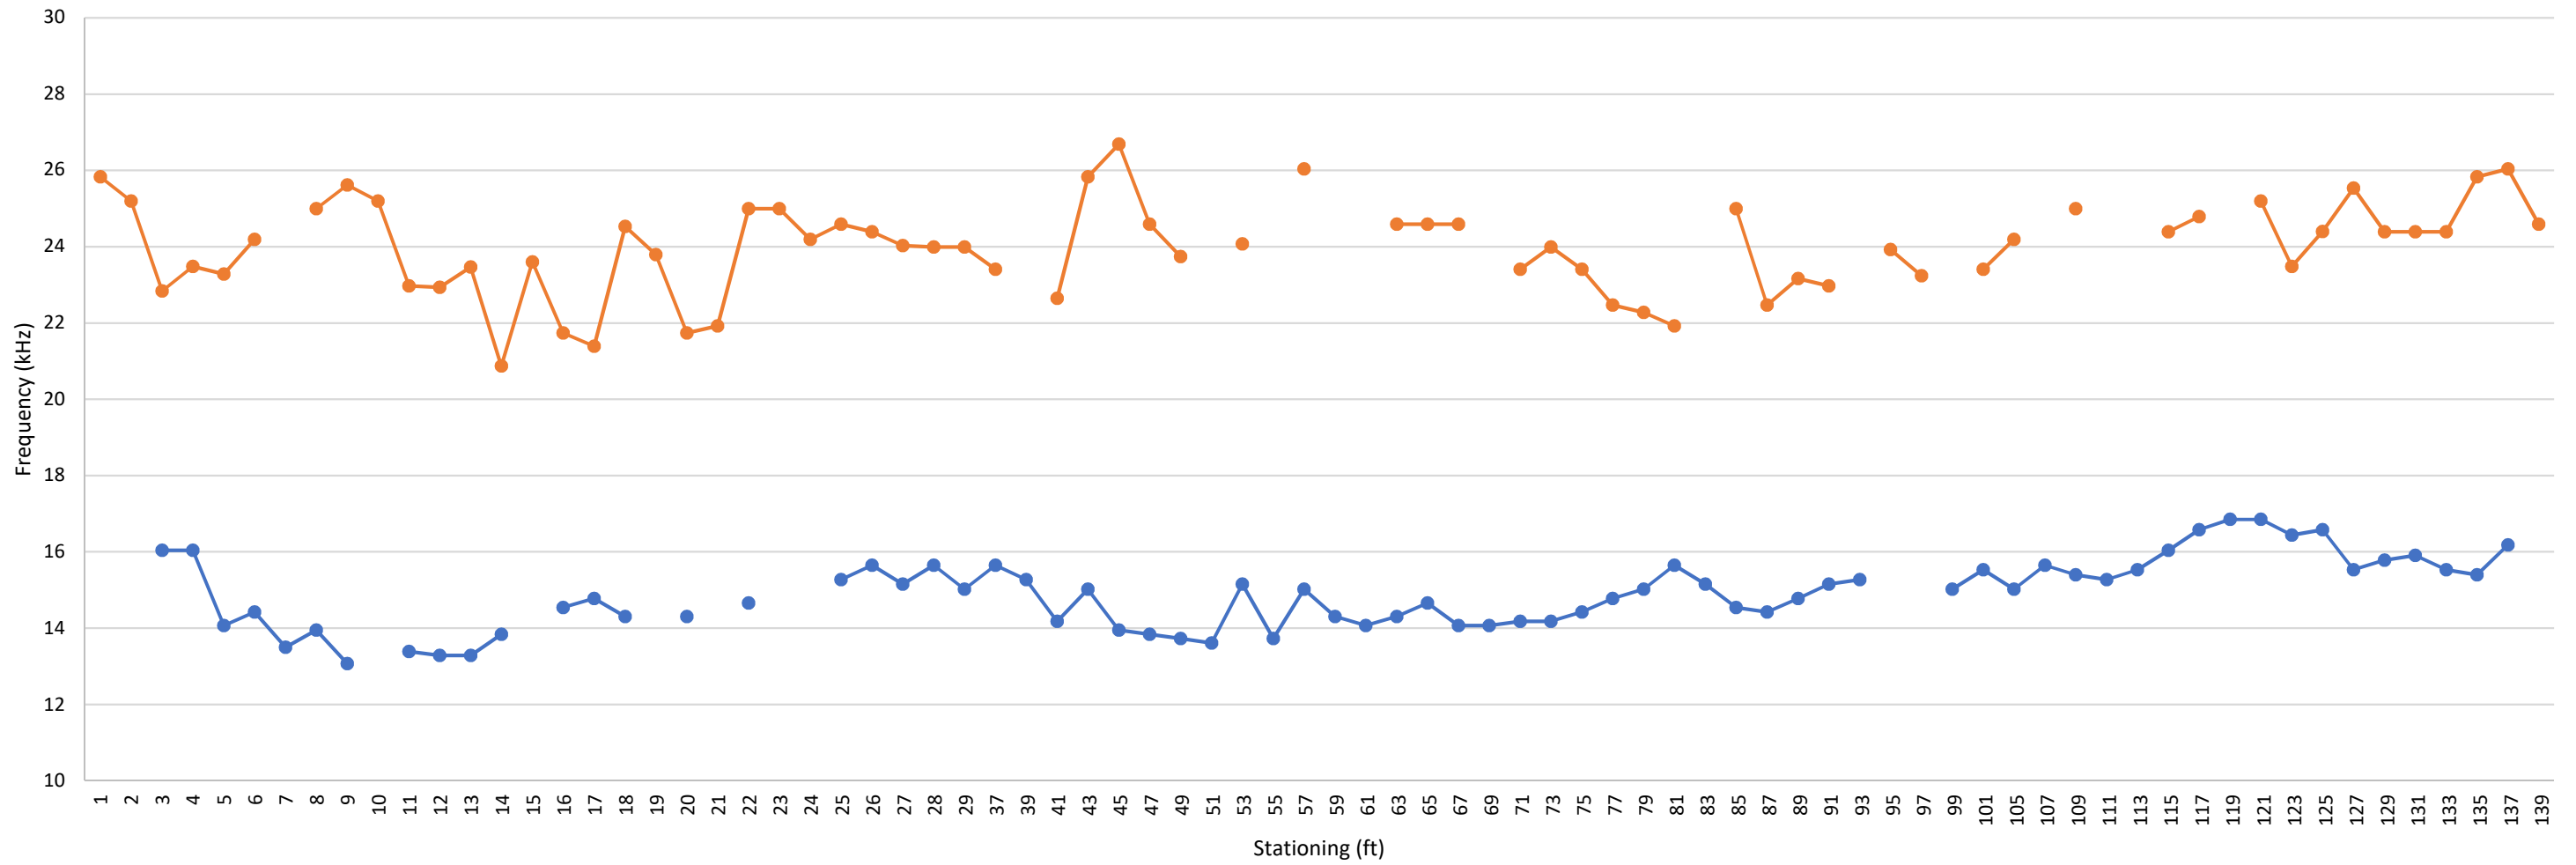
—●— Circumferential Frequency
 —●— Average Through Frequency
 ■ Anomalous Grout Condition

Nondestructive Testing External Tendon Ducts John Ringling Causeway Bridge Over Sarasota Bay Sarasota, Florida Prepared for Florida International University by NDT Corporation		Span 5 Tendon 402R-4E Graph Results	
January. 2018		Figure A33

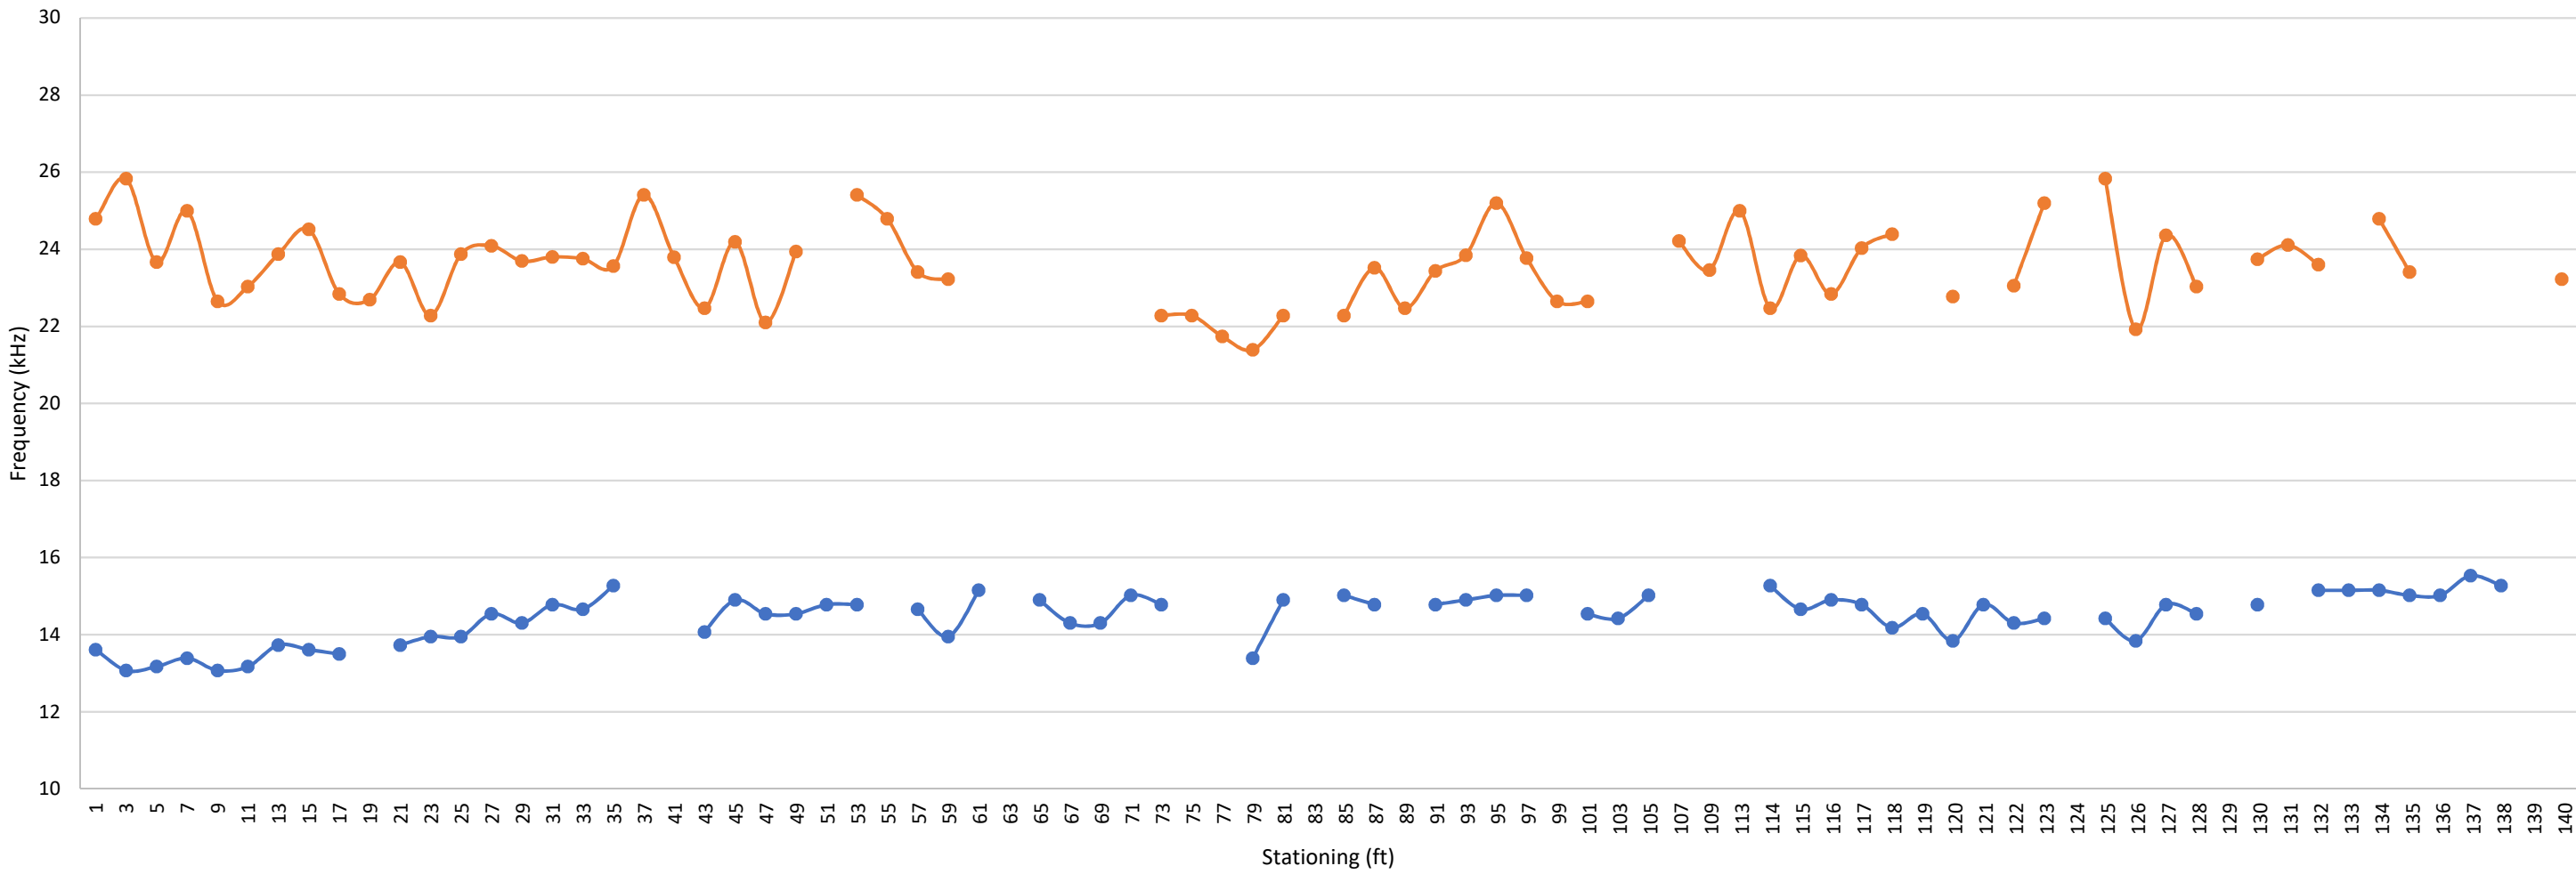
—●— Circumferential Frequency —●— Average Through Frequency ■ Anomalous Grout Condition

Nondestructive Testing External Tendon Ducts John Ringling Causeway Bridge Over Sarasota Bay Sarasota, Florida Prepared for Florida International University by NDT Corporation		Span 5 Tendon 402L-5W Graph Results	
		January. 2018	Figure A34

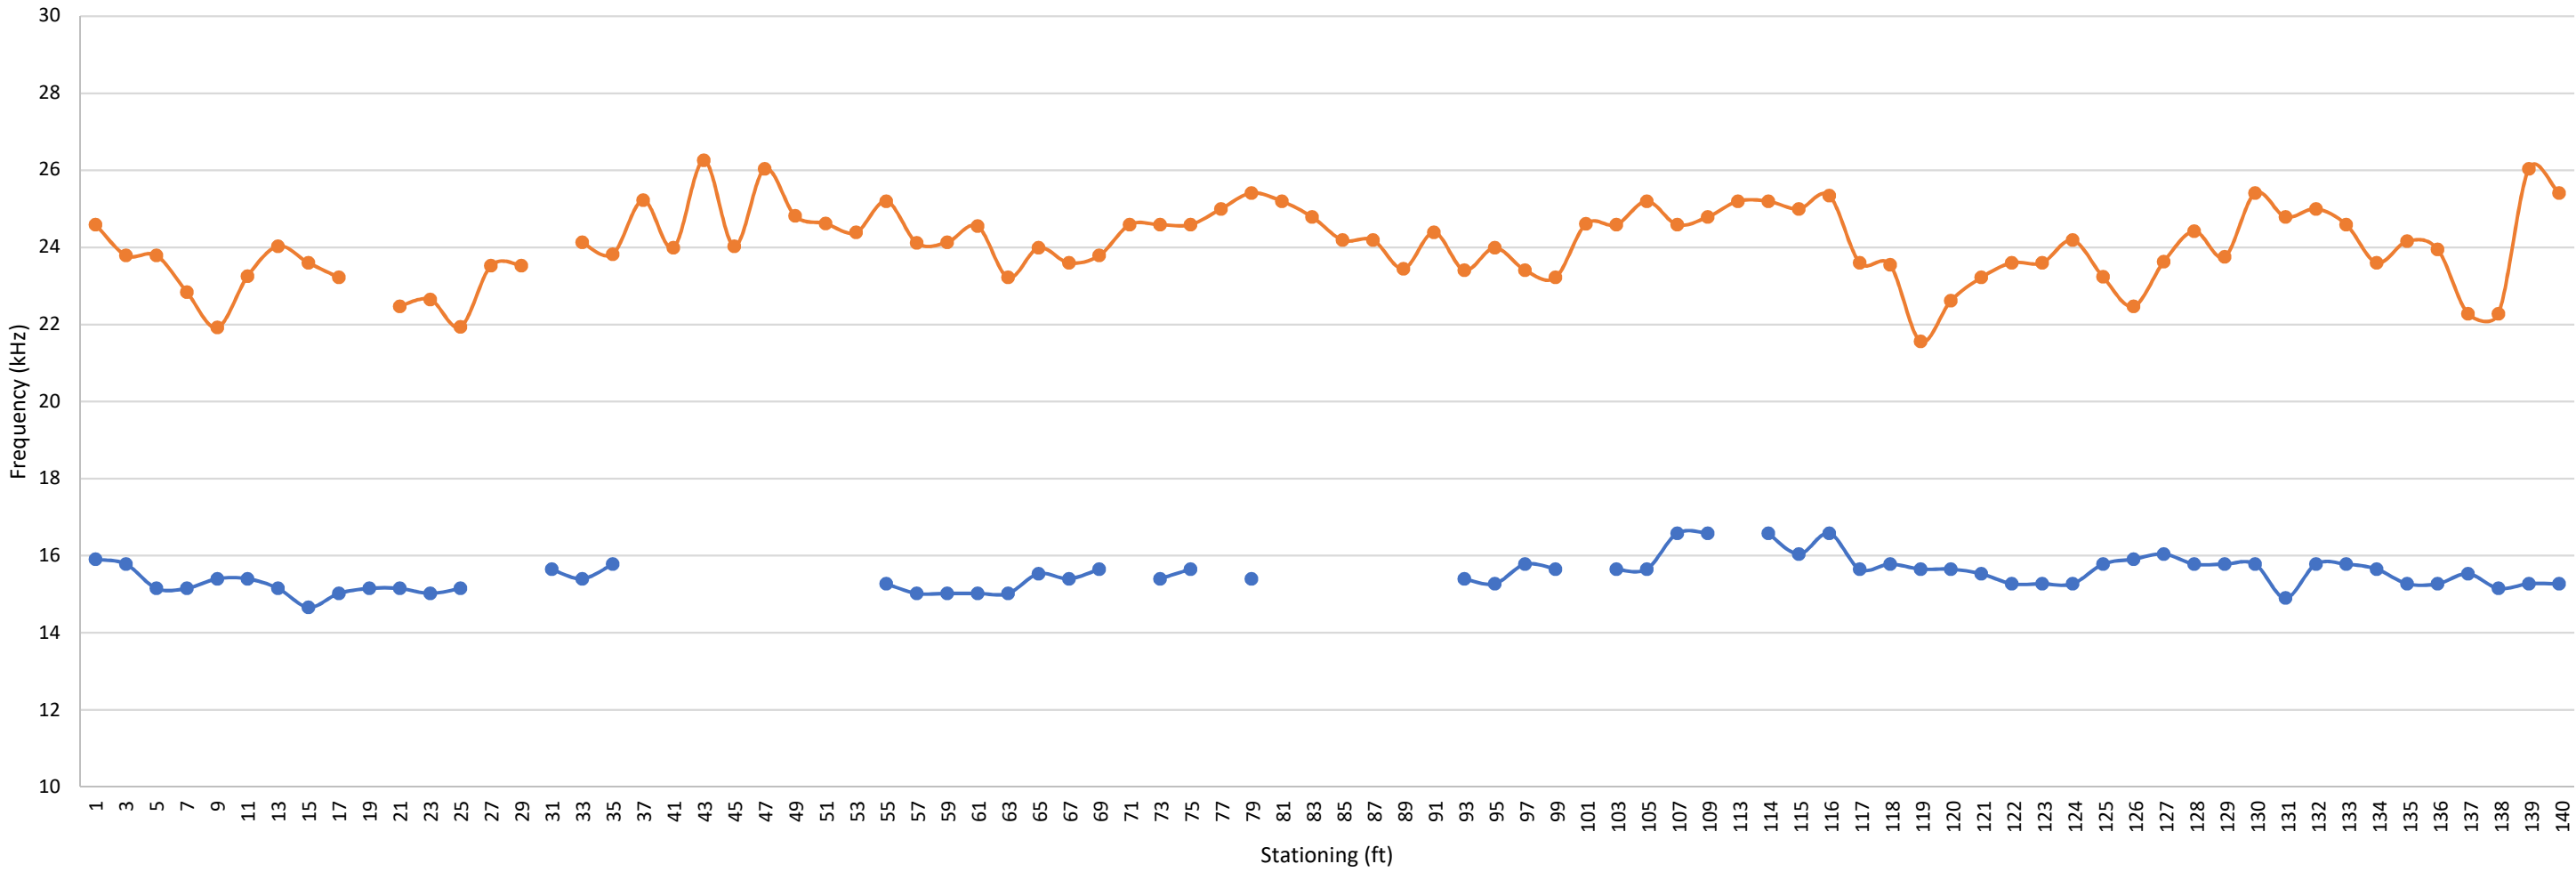
—●— Circumferential Frequency
 —●— Average Through Frequency
 ■ Anomalous Grout Condition

Nondestructive Testing External Tendon Ducts John Ringling Causeway Bridge Over Sarasota Bay Sarasota, Florida Prepared for Florida International University by NDT Corporation		Span 5 Tendon 401L-5W Graph Results	
January. 2018		Figure A35

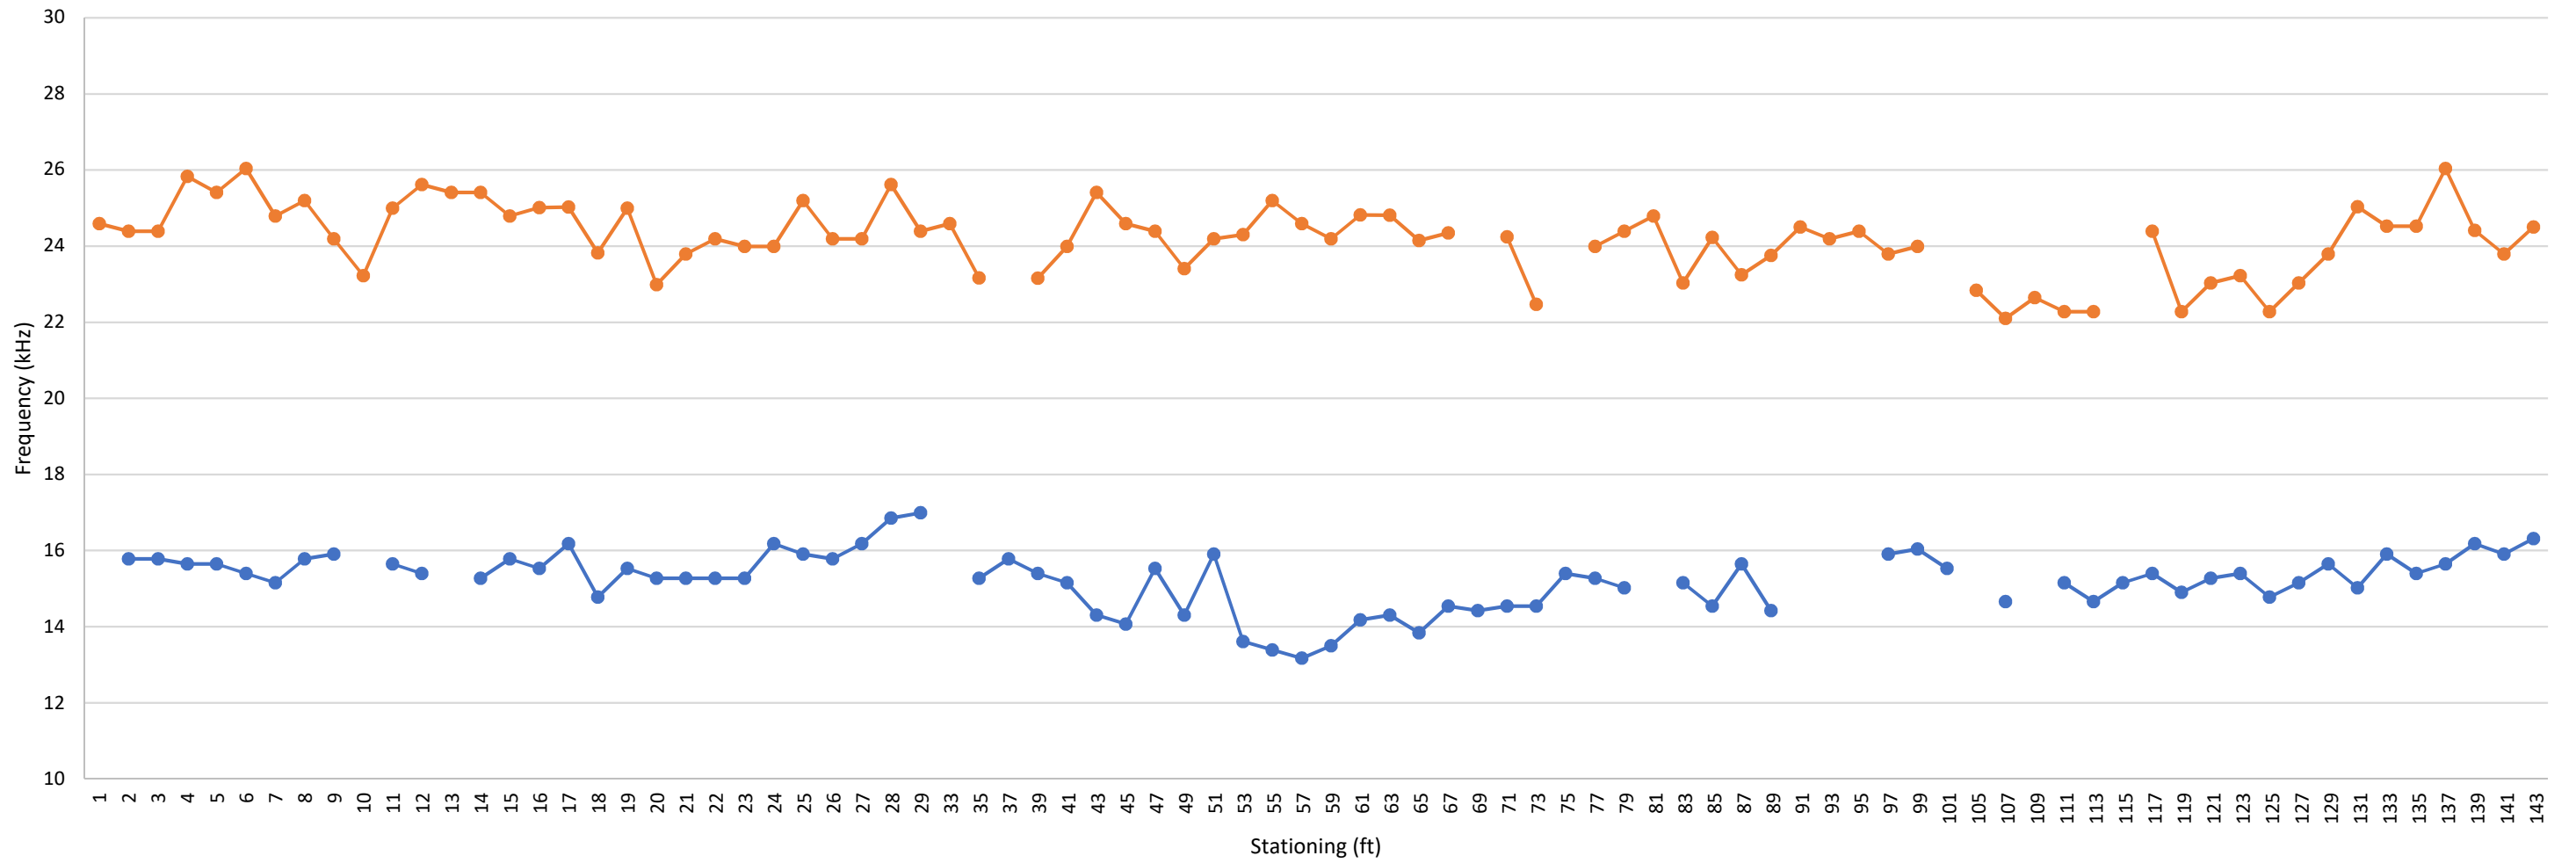
—●— Circumferential Frequency
 —●— Average Through Frequency
 ■ Anomalous Grout Condition

Nondestructive Testing External Tendon Ducts John Ringling Causeway Bridge Over Sarasota Bay Sarasota, Florida Prepared for Florida International University by NDT Corporation		Span 6 Tendon 401L-5E Graph Results	
January. 2018		Figure A40

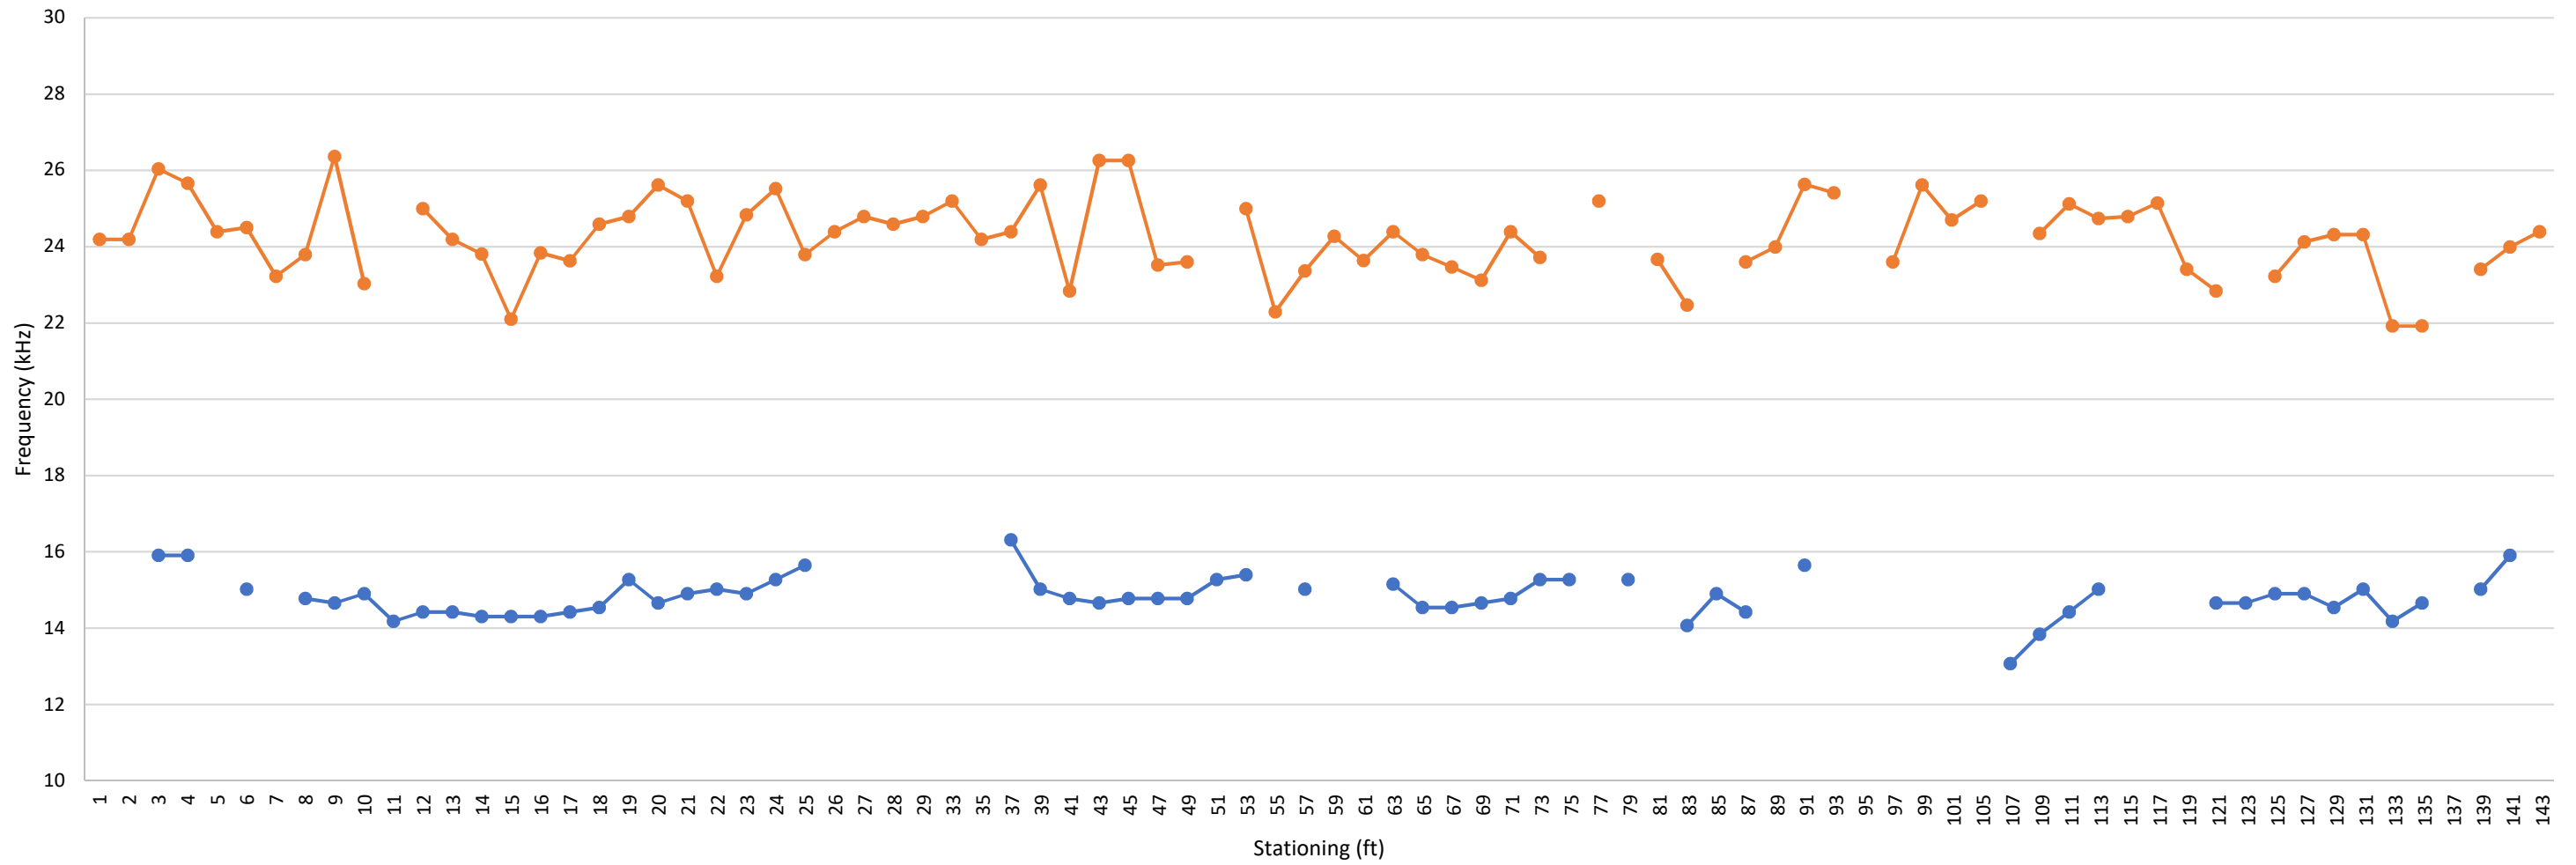
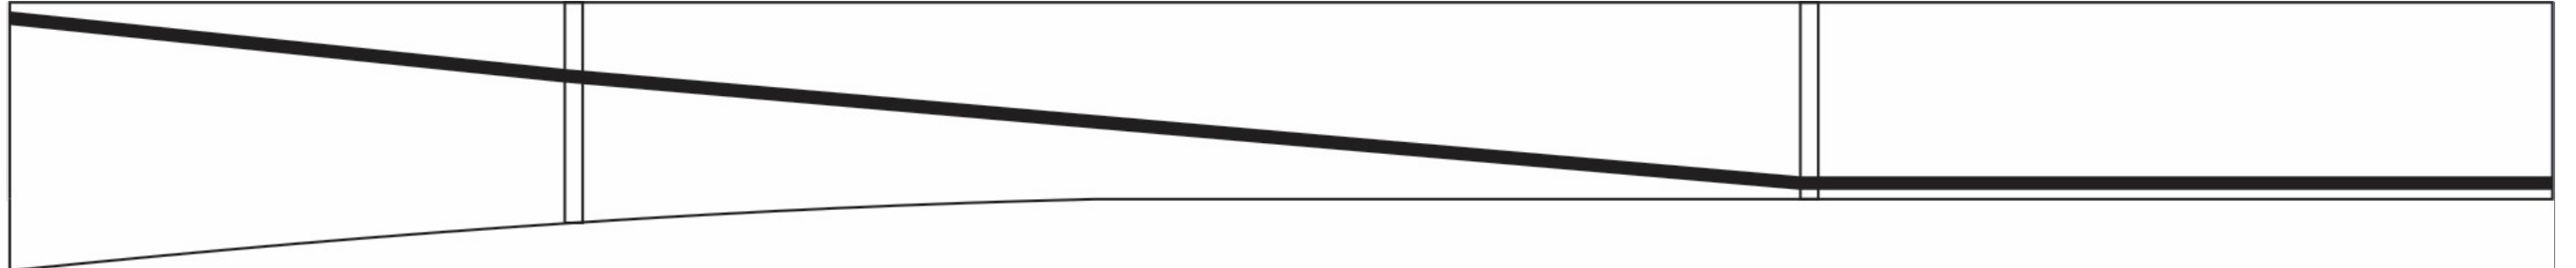
—●— Circumferential Frequency
 —●— Average Through Frequency
 ■ Anomalous Grout Condition

Nondestructive Testing External Tendon Ducts John Ringling Causeway Bridge Over Sarasota Bay Sarasota, Florida Prepared for Florida International University by NDT Corporation		Span 6 Tendon 401R-5E Graph Results	
January. 2018		Figure A41

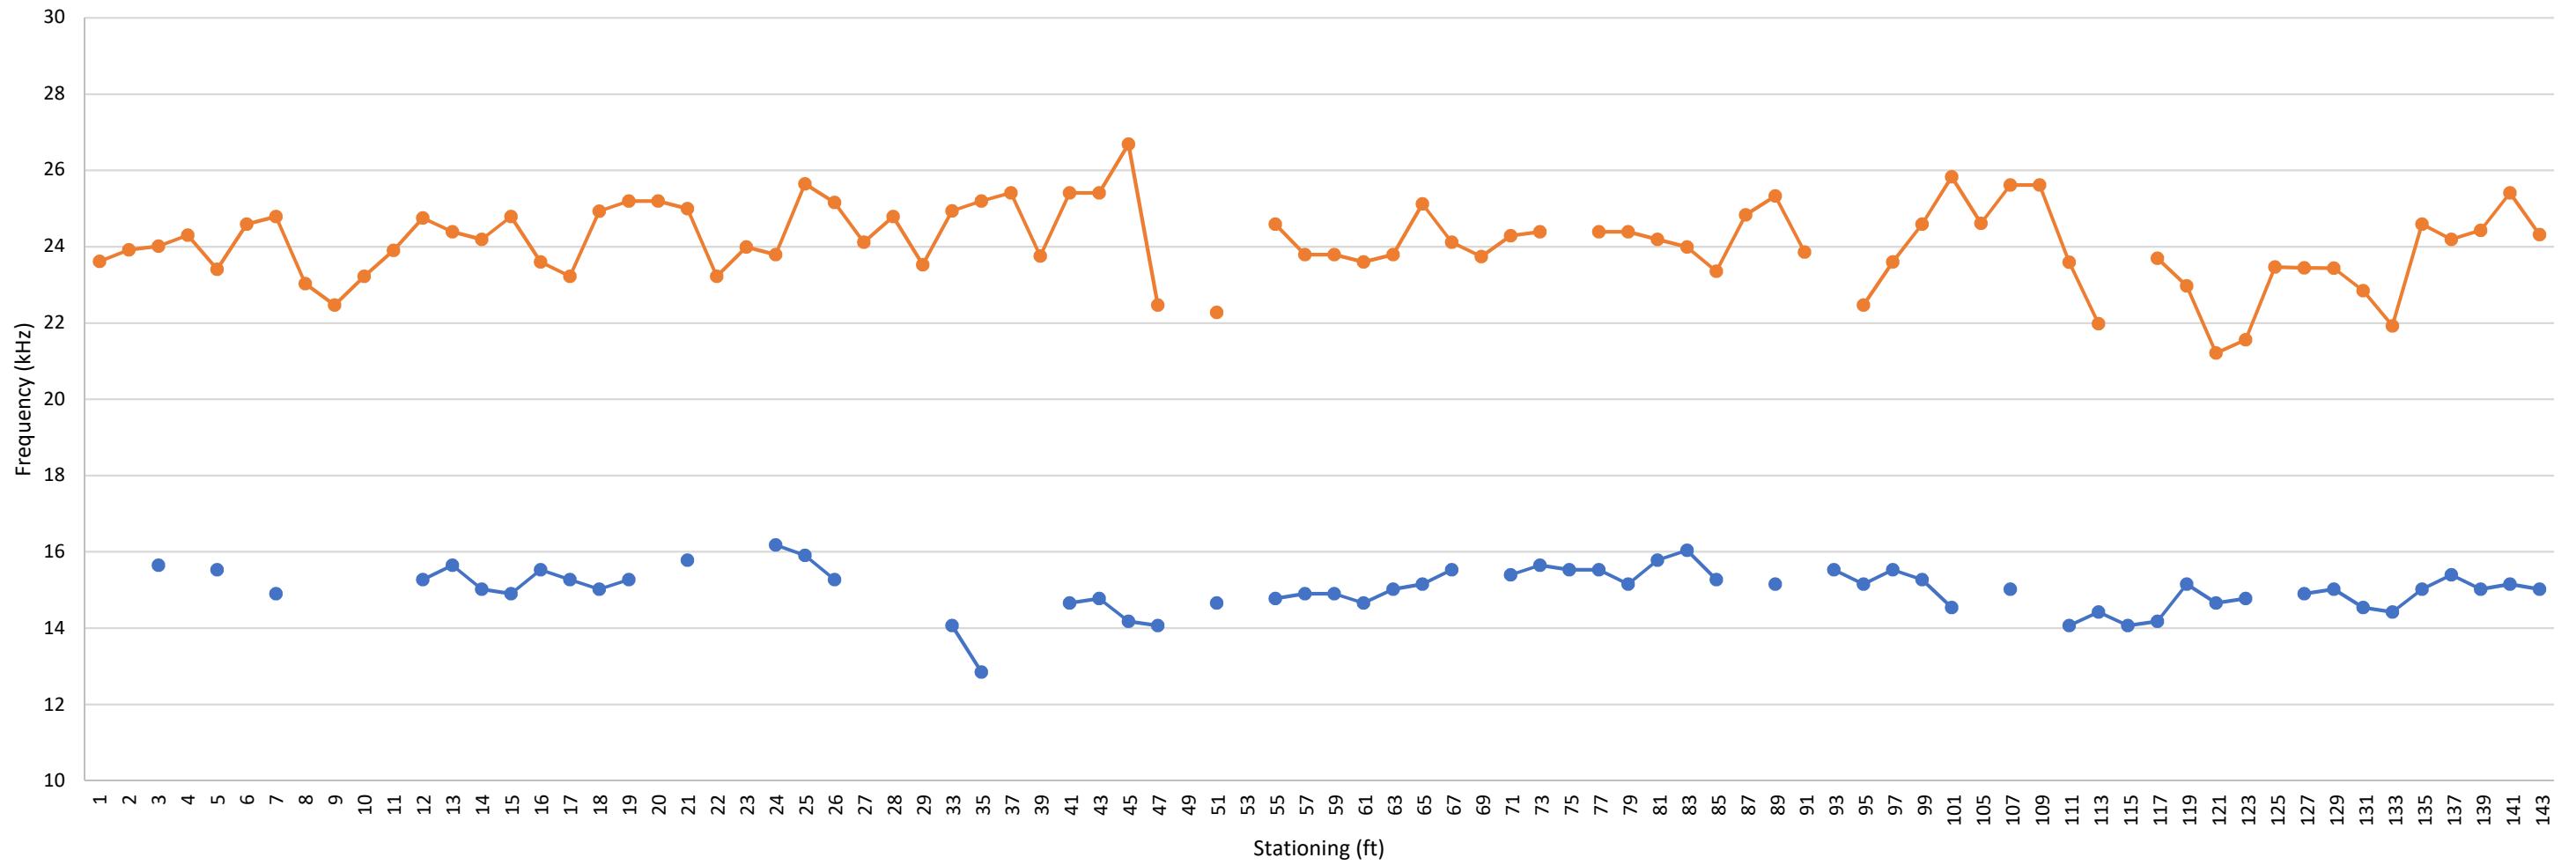
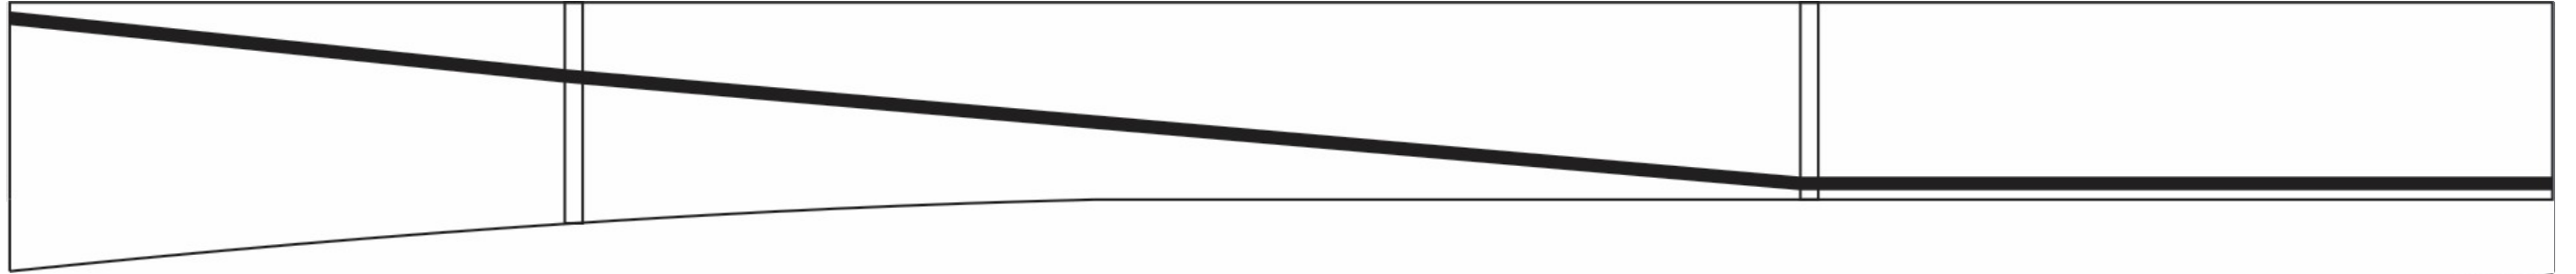
—●— Circumferential Frequency
 —●— Average Through Frequency
 ■ Anomalous Grout Condition

Nondestructive Testing External Tendon Ducts John Ringling Causeway Bridge Over Sarasota Bay Sarasota, Florida Prepared for Florida International University by NDT Corporation		Span 6 Tendon 402R-5E Graph Results	
January. 2018		Figure A42
