**Development of Quality Assurance and Quality Control
System for Post Tensioned Segmental Bridges in Florida:
Case of Ringling Bridge – Phase II**

**FDOT Contract No. BDV29-977-34
FINAL REPORT**

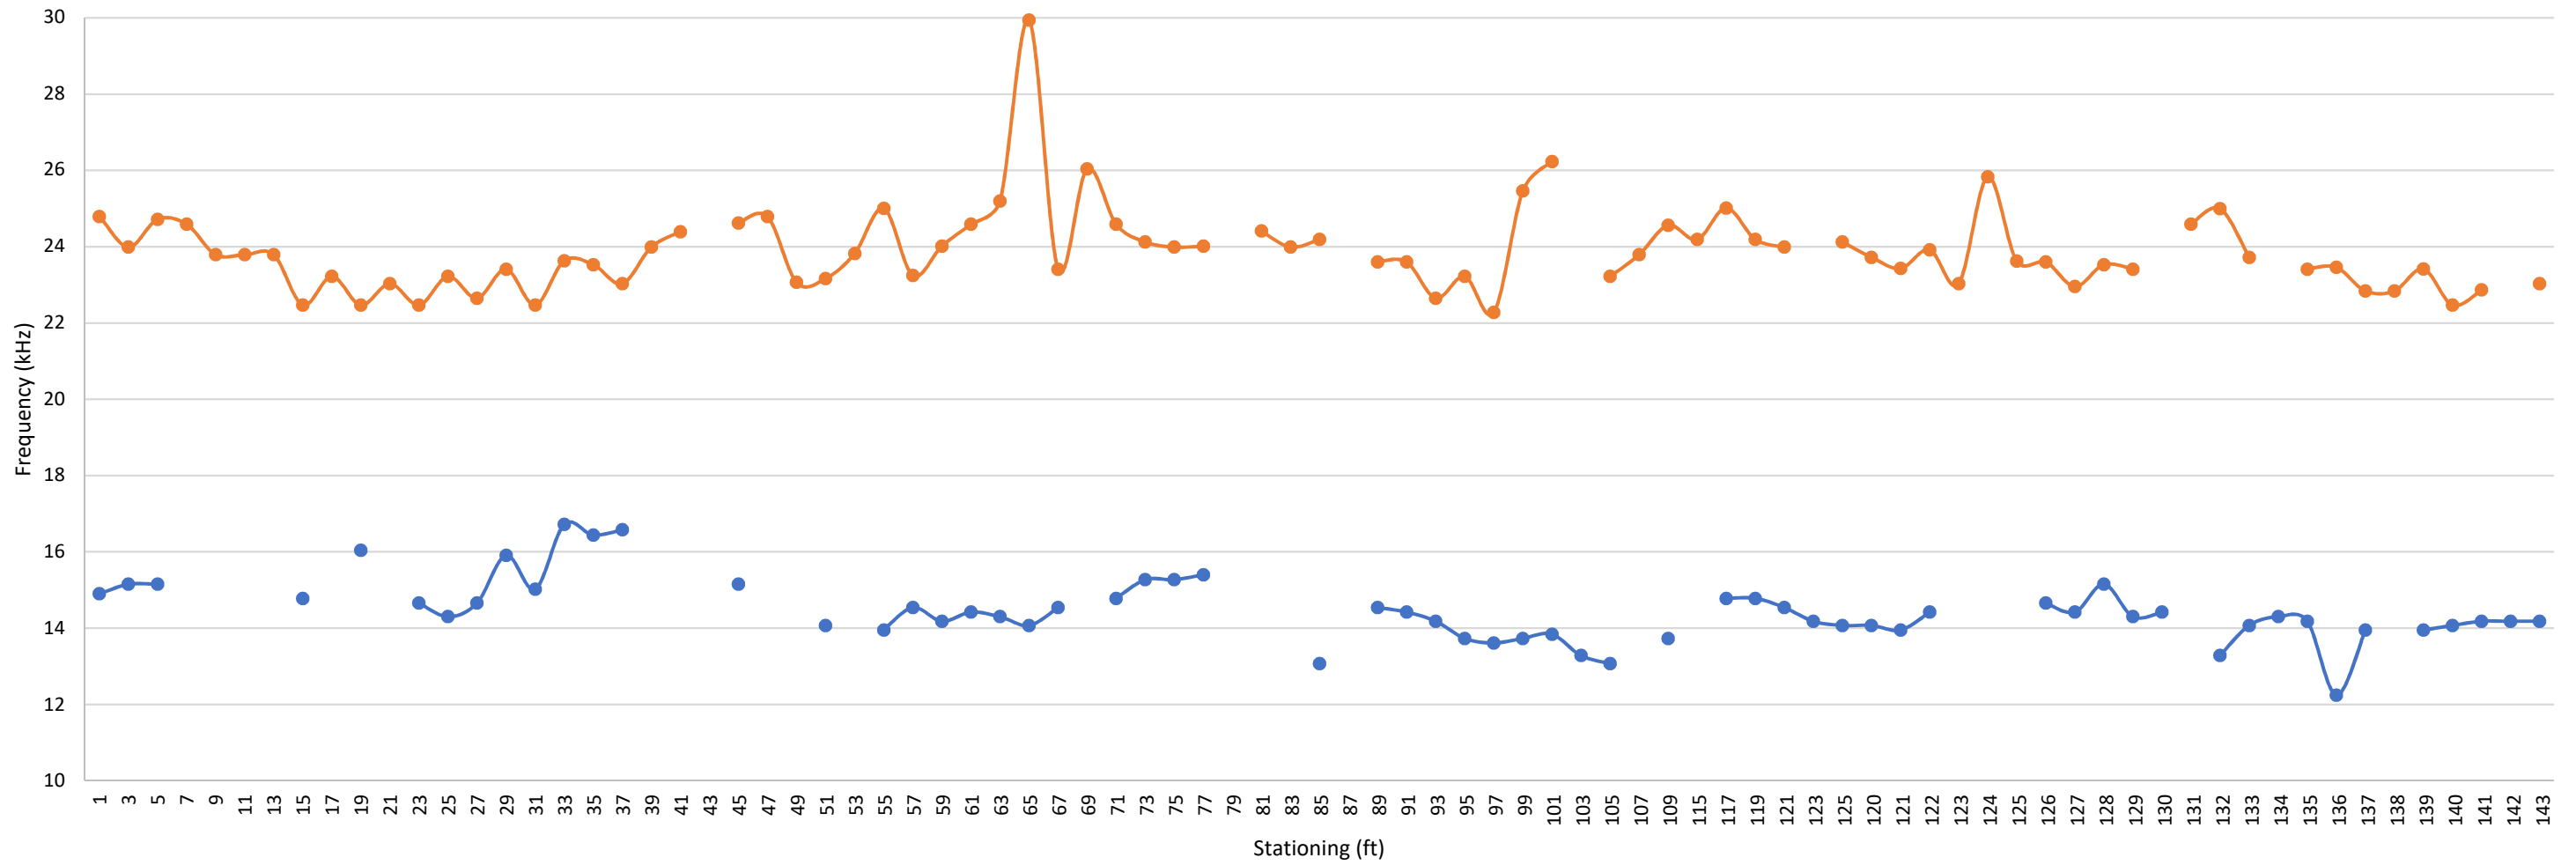
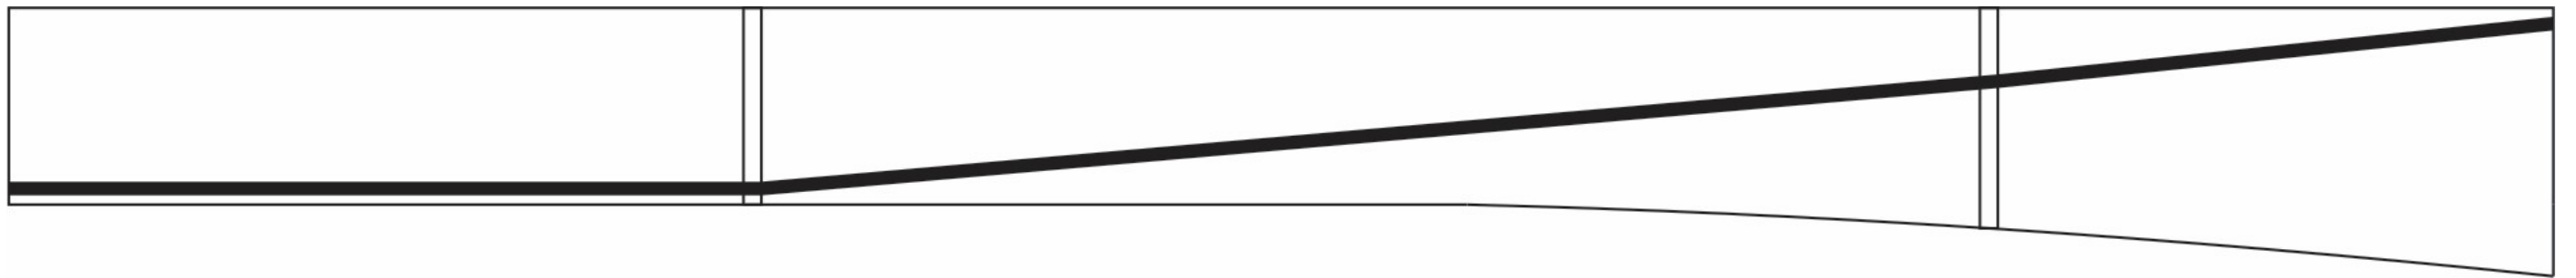
—●— Circumferential Frequency
 —●— Average Through Frequency
 ■ Anomalous Grout Condition

Nondestructive Testing External Tendon Ducts John Ringling Causeway Bridge Over Sarasota Bay Sarasota, Florida Prepared for Florida International University by NDT Corporation		Span 6 Tendon 402R-6W Graph Results	
January. 2018		Figure A46

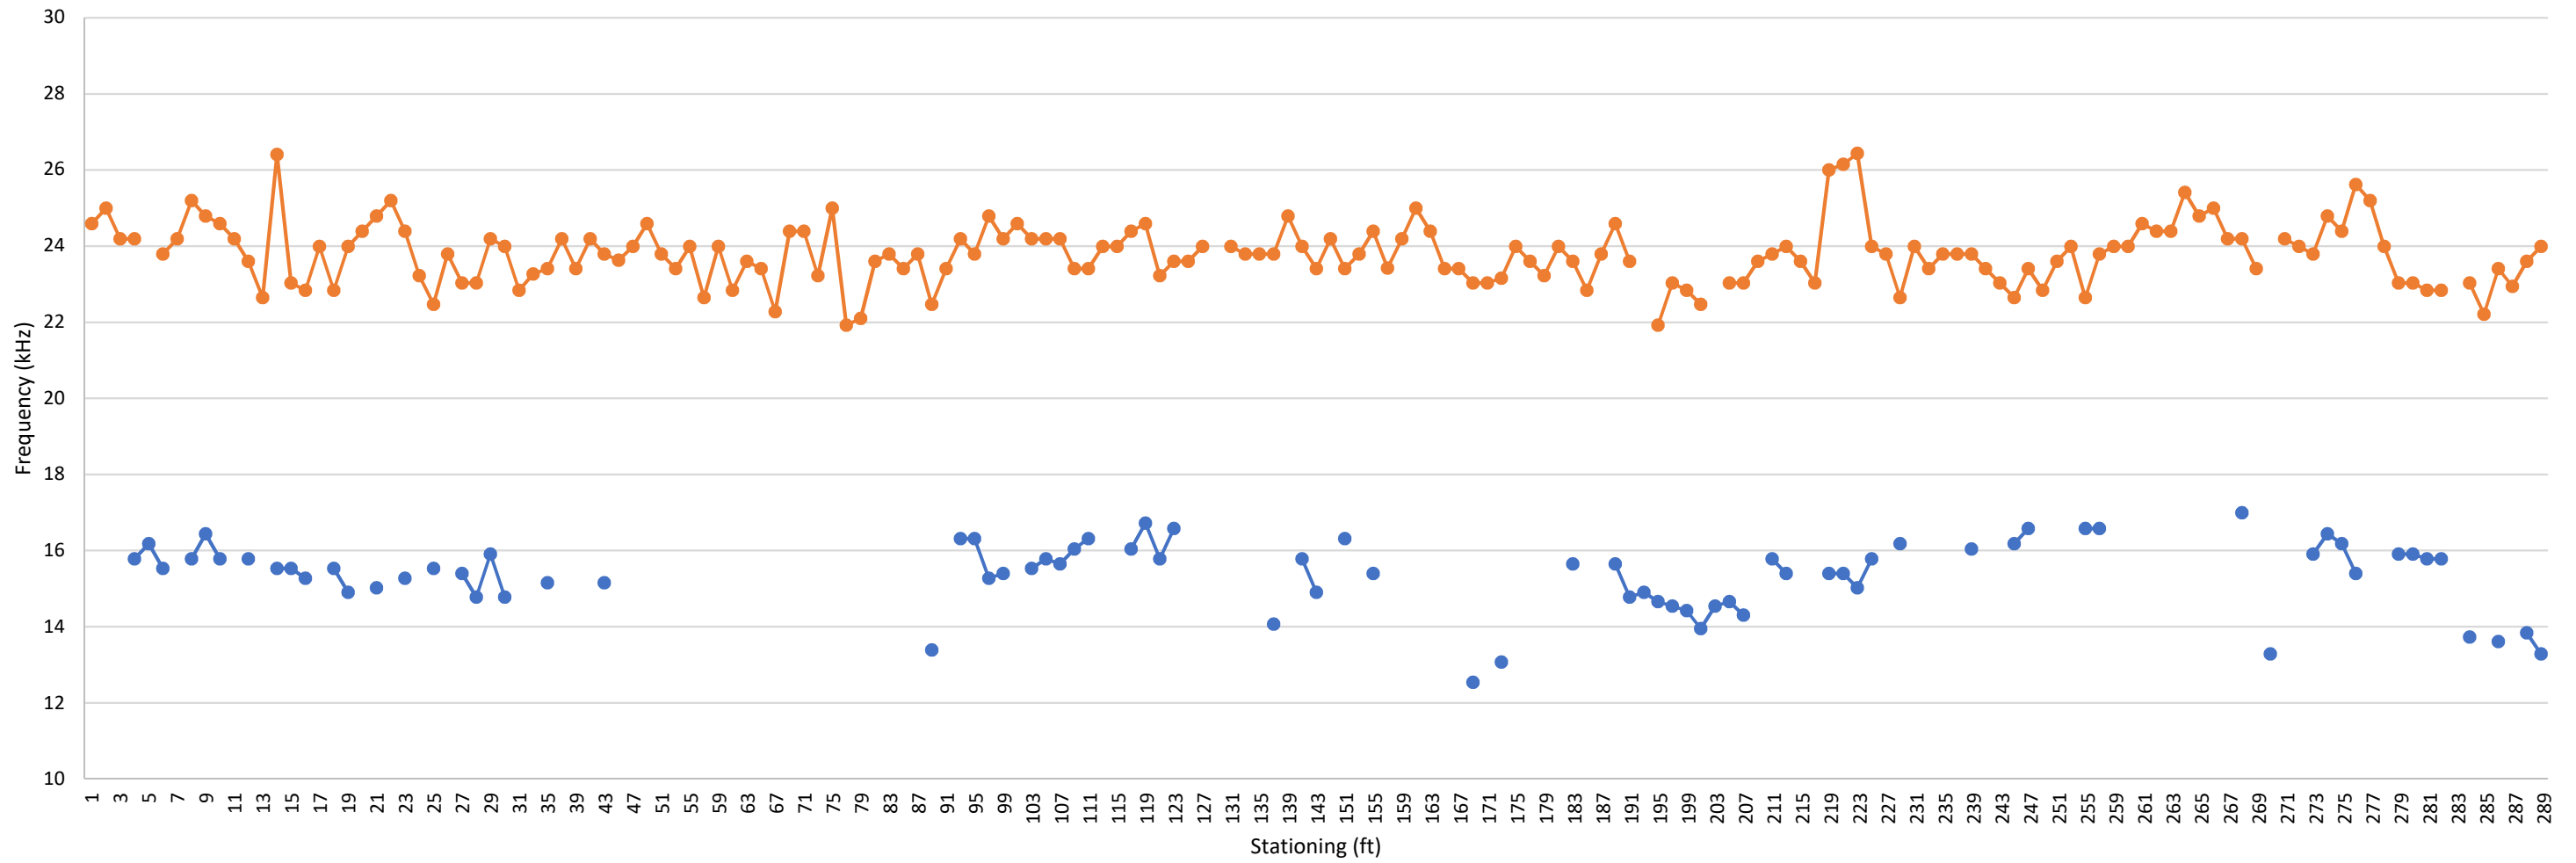
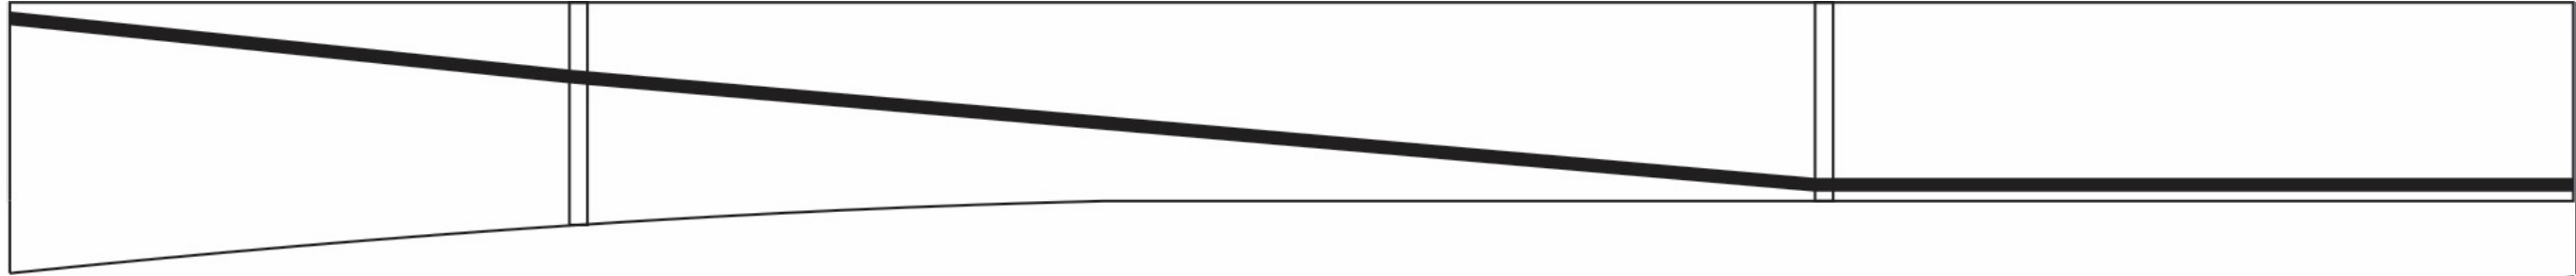
—●— Circumferential Frequency —●— Average Through Frequency ■ Anomalous Grout Condition

Nondestructive Testing External Tendon Ducts John Ringling Causeway Bridge Over Sarasota Bay Sarasota, Florida Prepared for Florida International University by NDT Corporation		Span 7 Tendon 303L-6E Graph Results	
		January. 2018	Figure A47

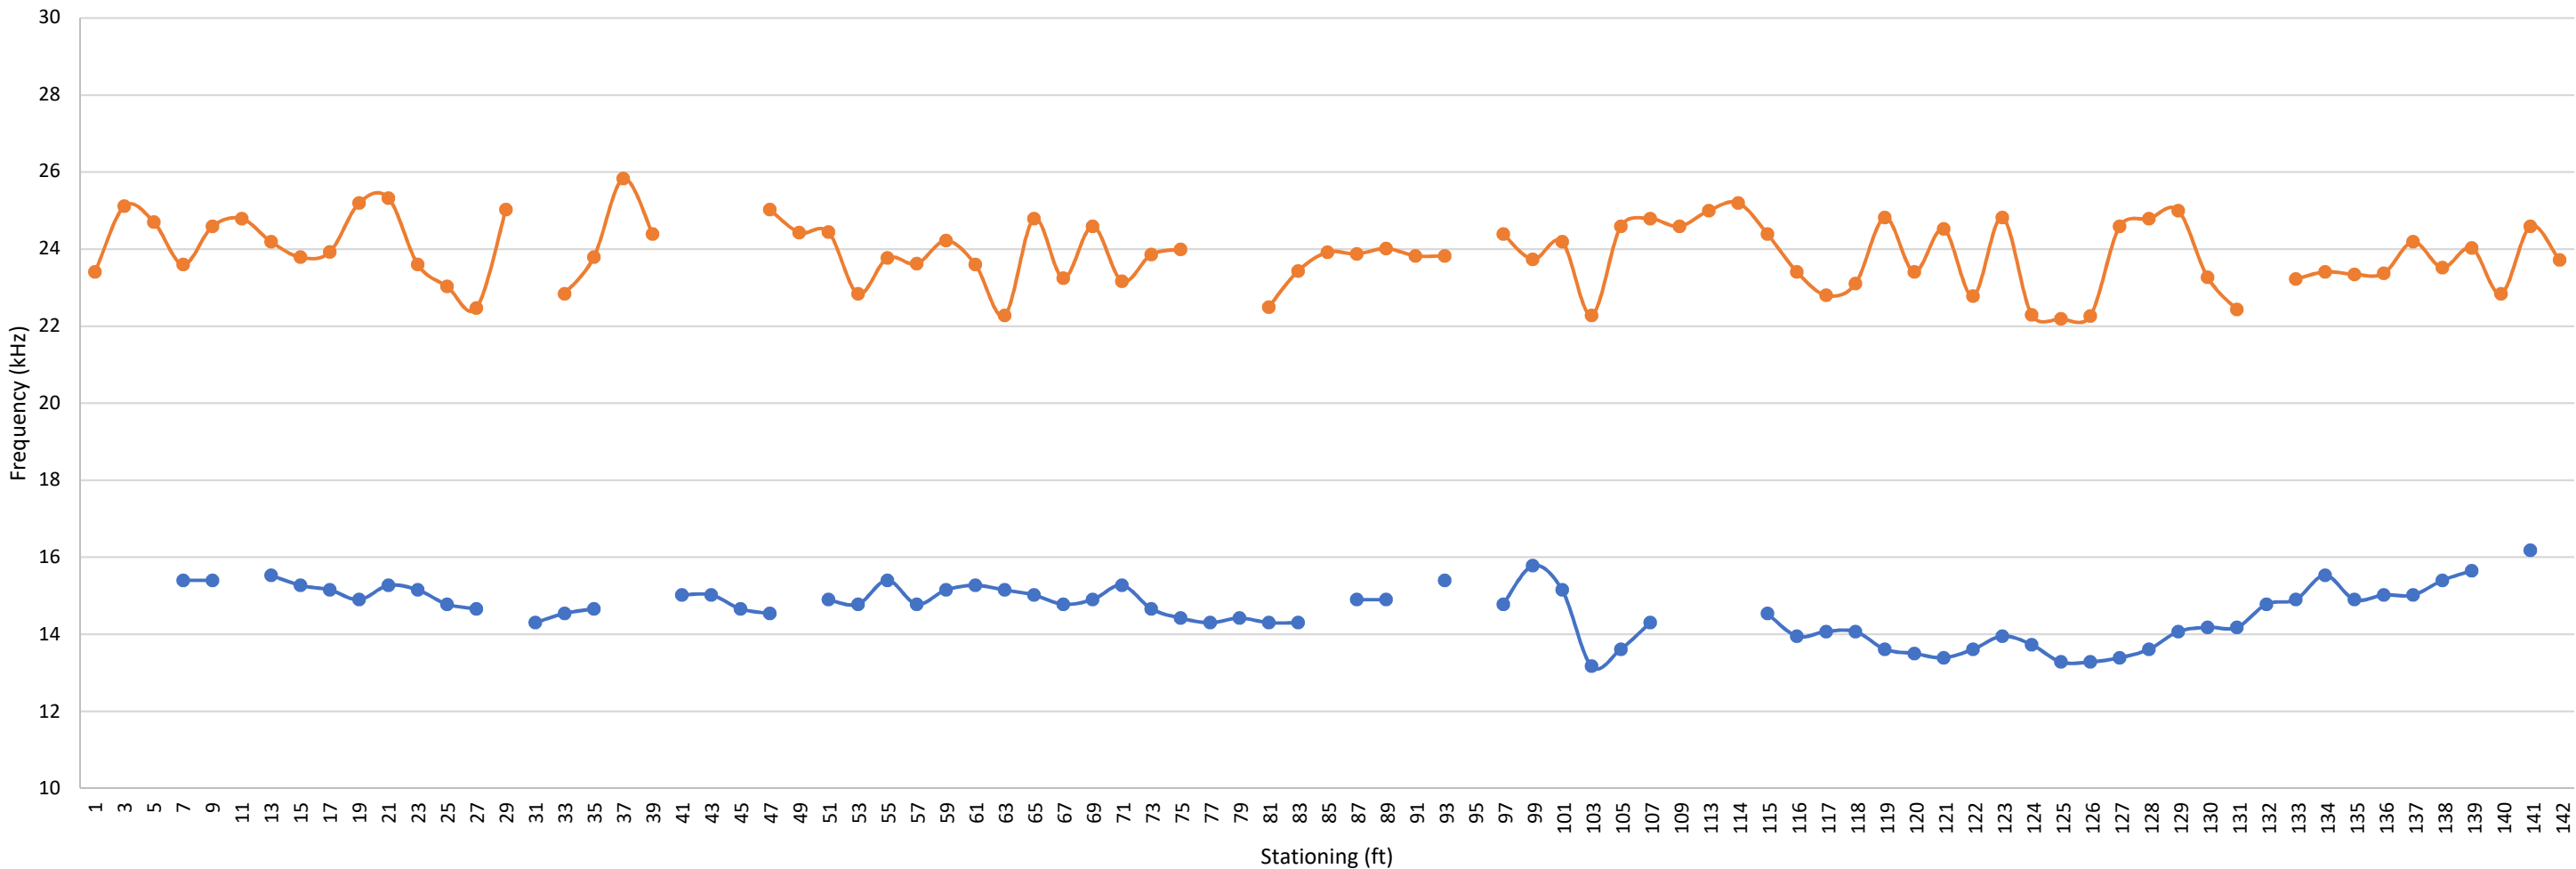
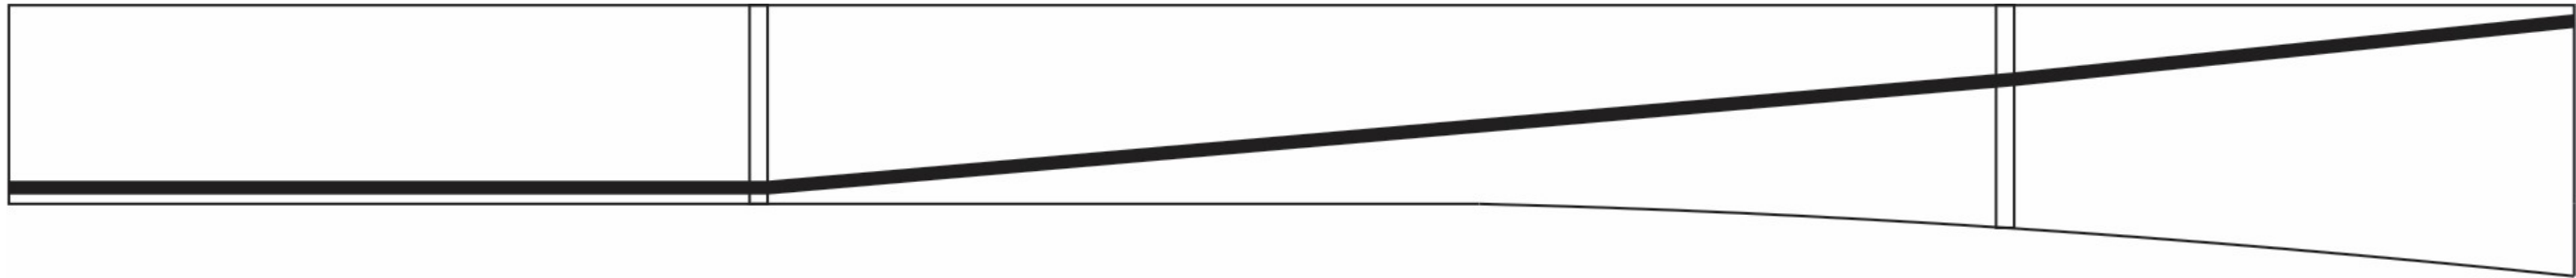
—●— Circumferential Frequency
 —●— Average Through Frequency
 ■ Anomalous Grout Condition

Nondestructive Testing External Tendon Ducts John Ringling Causeway Bridge Over Sarasota Bay Sarasota, Florida Prepared for Florida International University by NDT Corporation		Span 7 Tendon 401L-7W Graph Results	
January. 2018		Figure A53

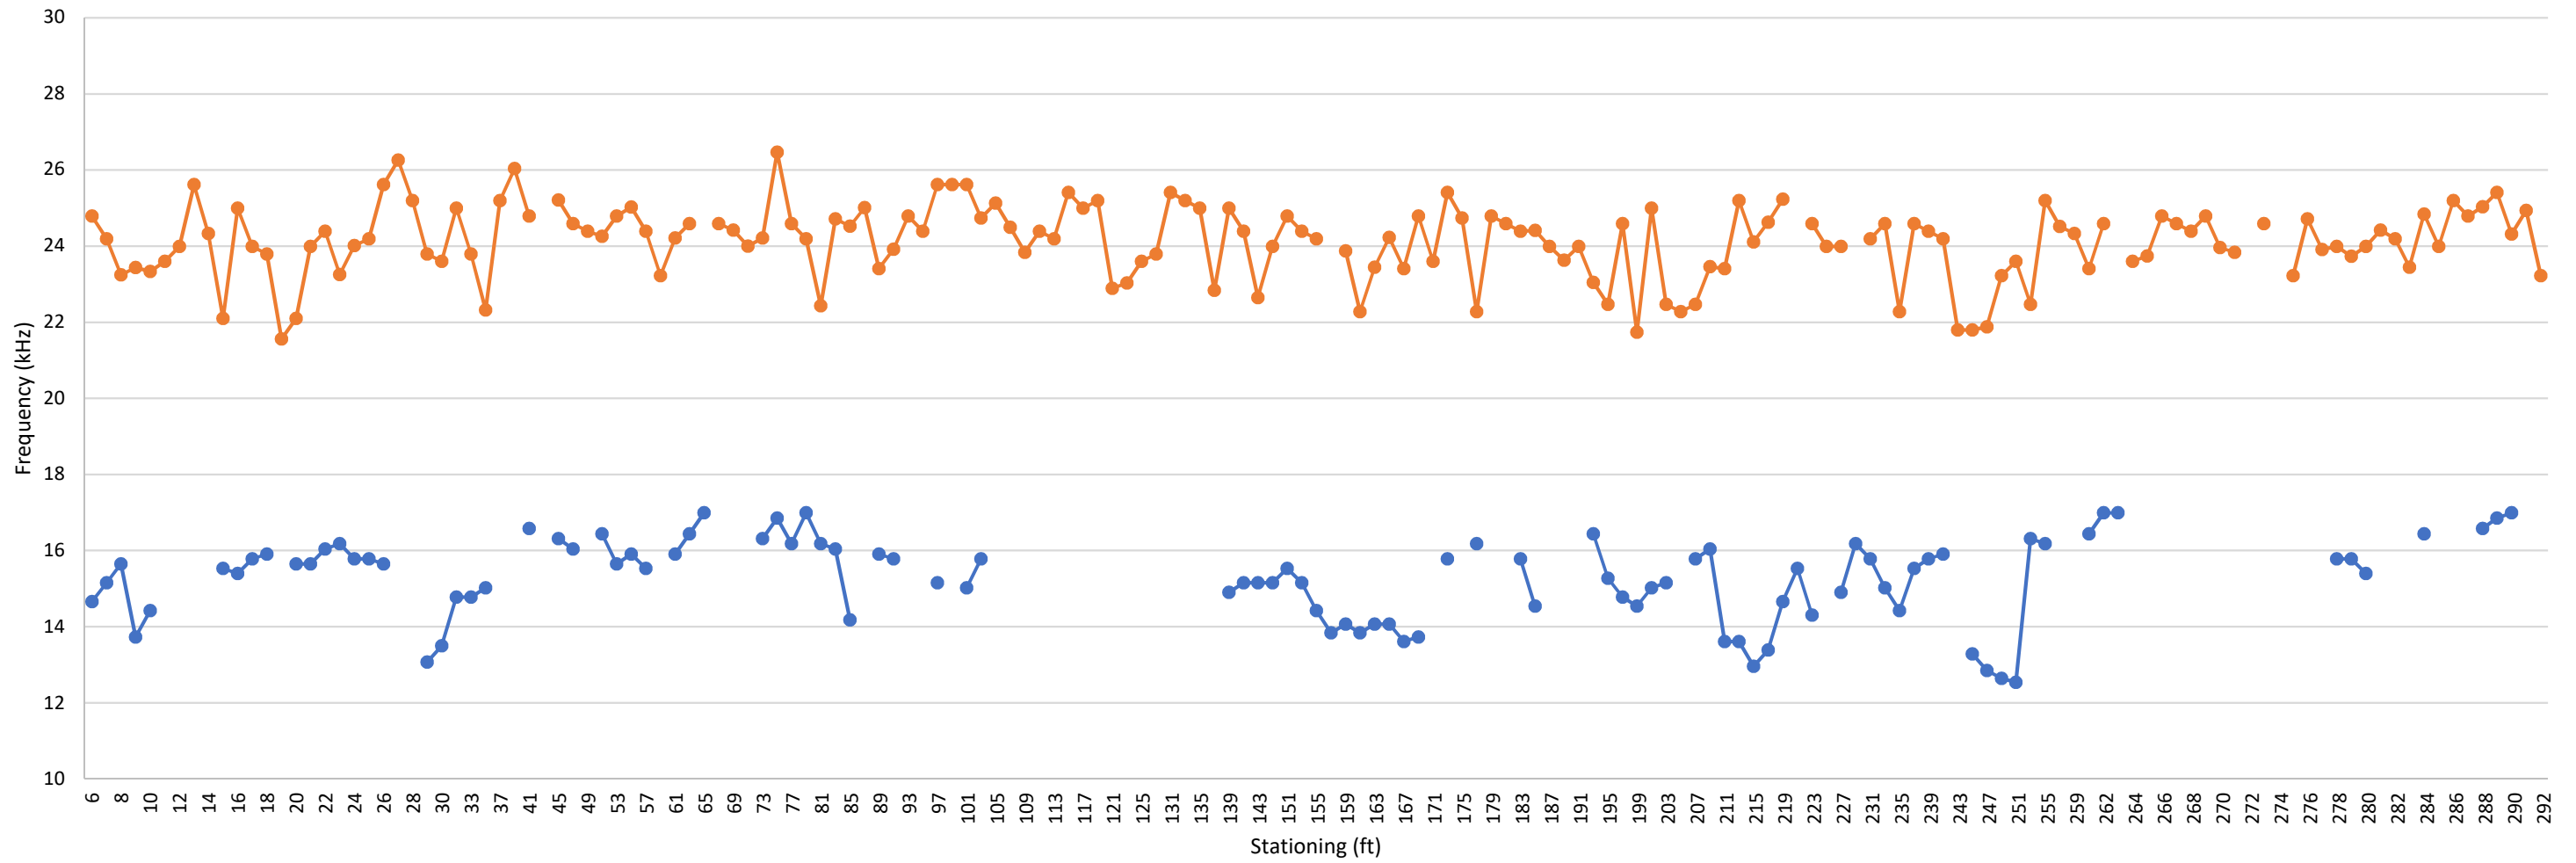
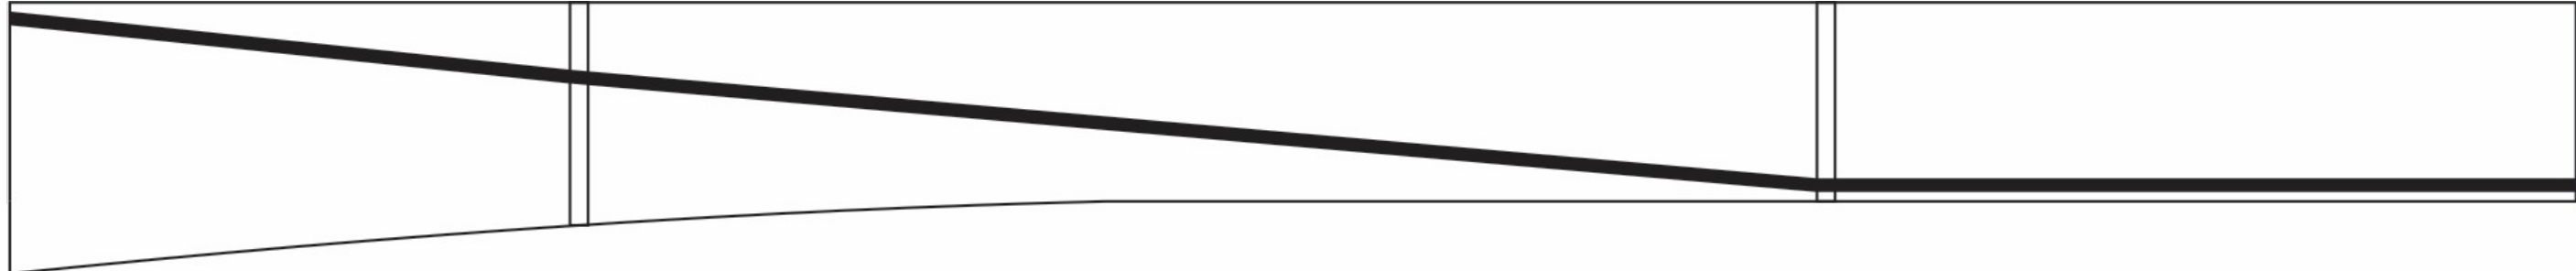
—●— Circumferential Frequency
 —●— Average Through Frequency
 ■ Anomalous Grout Condition

Nondestructive Testing External Tendon Ducts John Ringling Causeway Bridge Over Sarasota Bay Sarasota, Florida Prepared for Florida International University by NDT Corporation		Span 7 Tendon 303R-6E Graph Results	
January. 2018		Figure A56

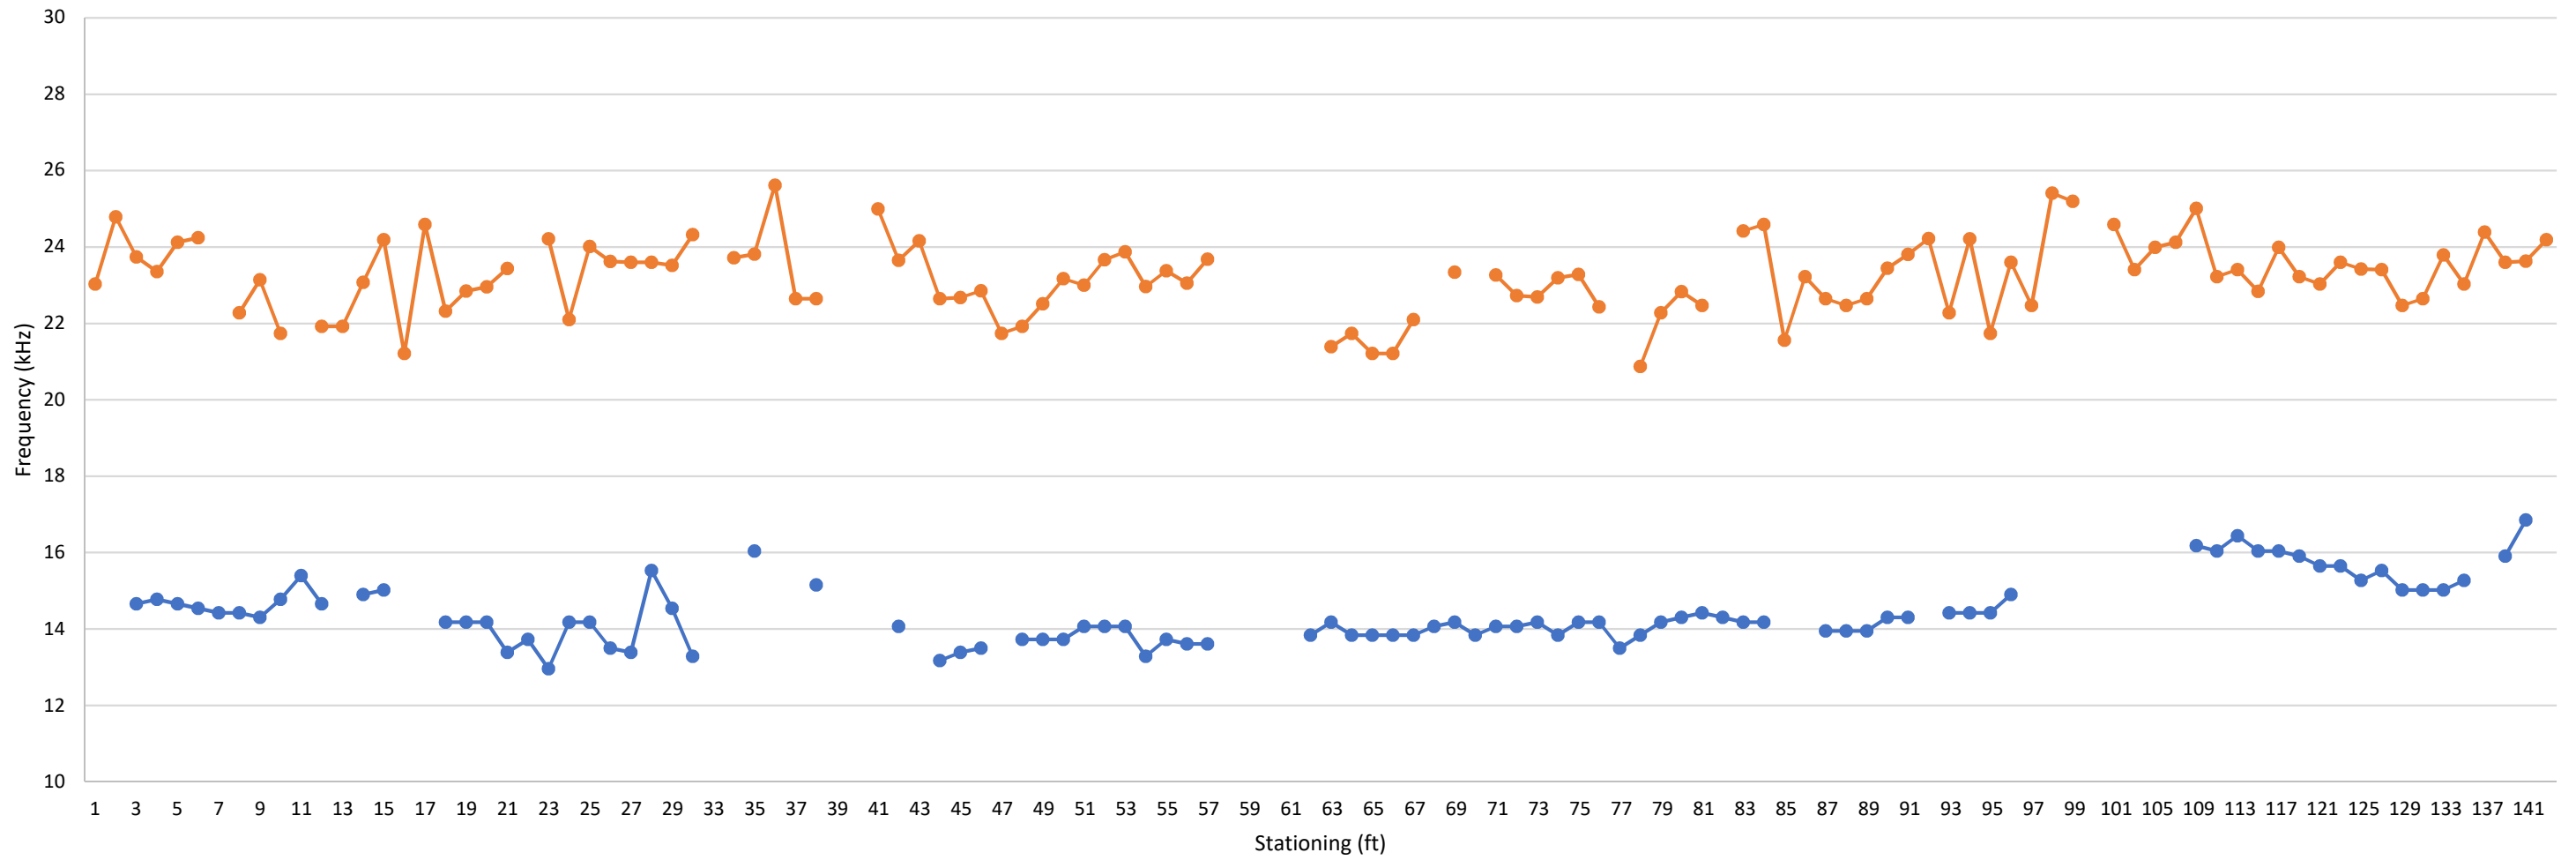
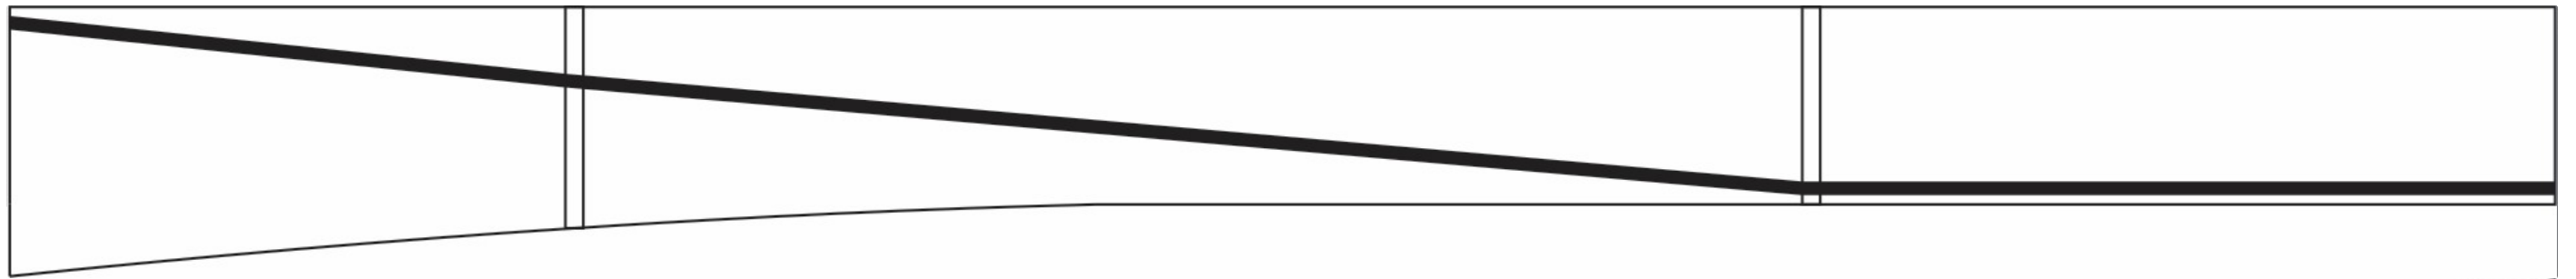
—●— Circumferential Frequency
 —●— Average Through Frequency
 ■ Anomalous Grout Condition

Nondestructive Testing External Tendon Ducts John Ringling Causeway Bridge Over Sarasota Bay Sarasota, Florida Prepared for Florida International University by NDT Corporation		Span 8 Tendon 402L-7E Graph Results	
		January. 2018	Figure A57

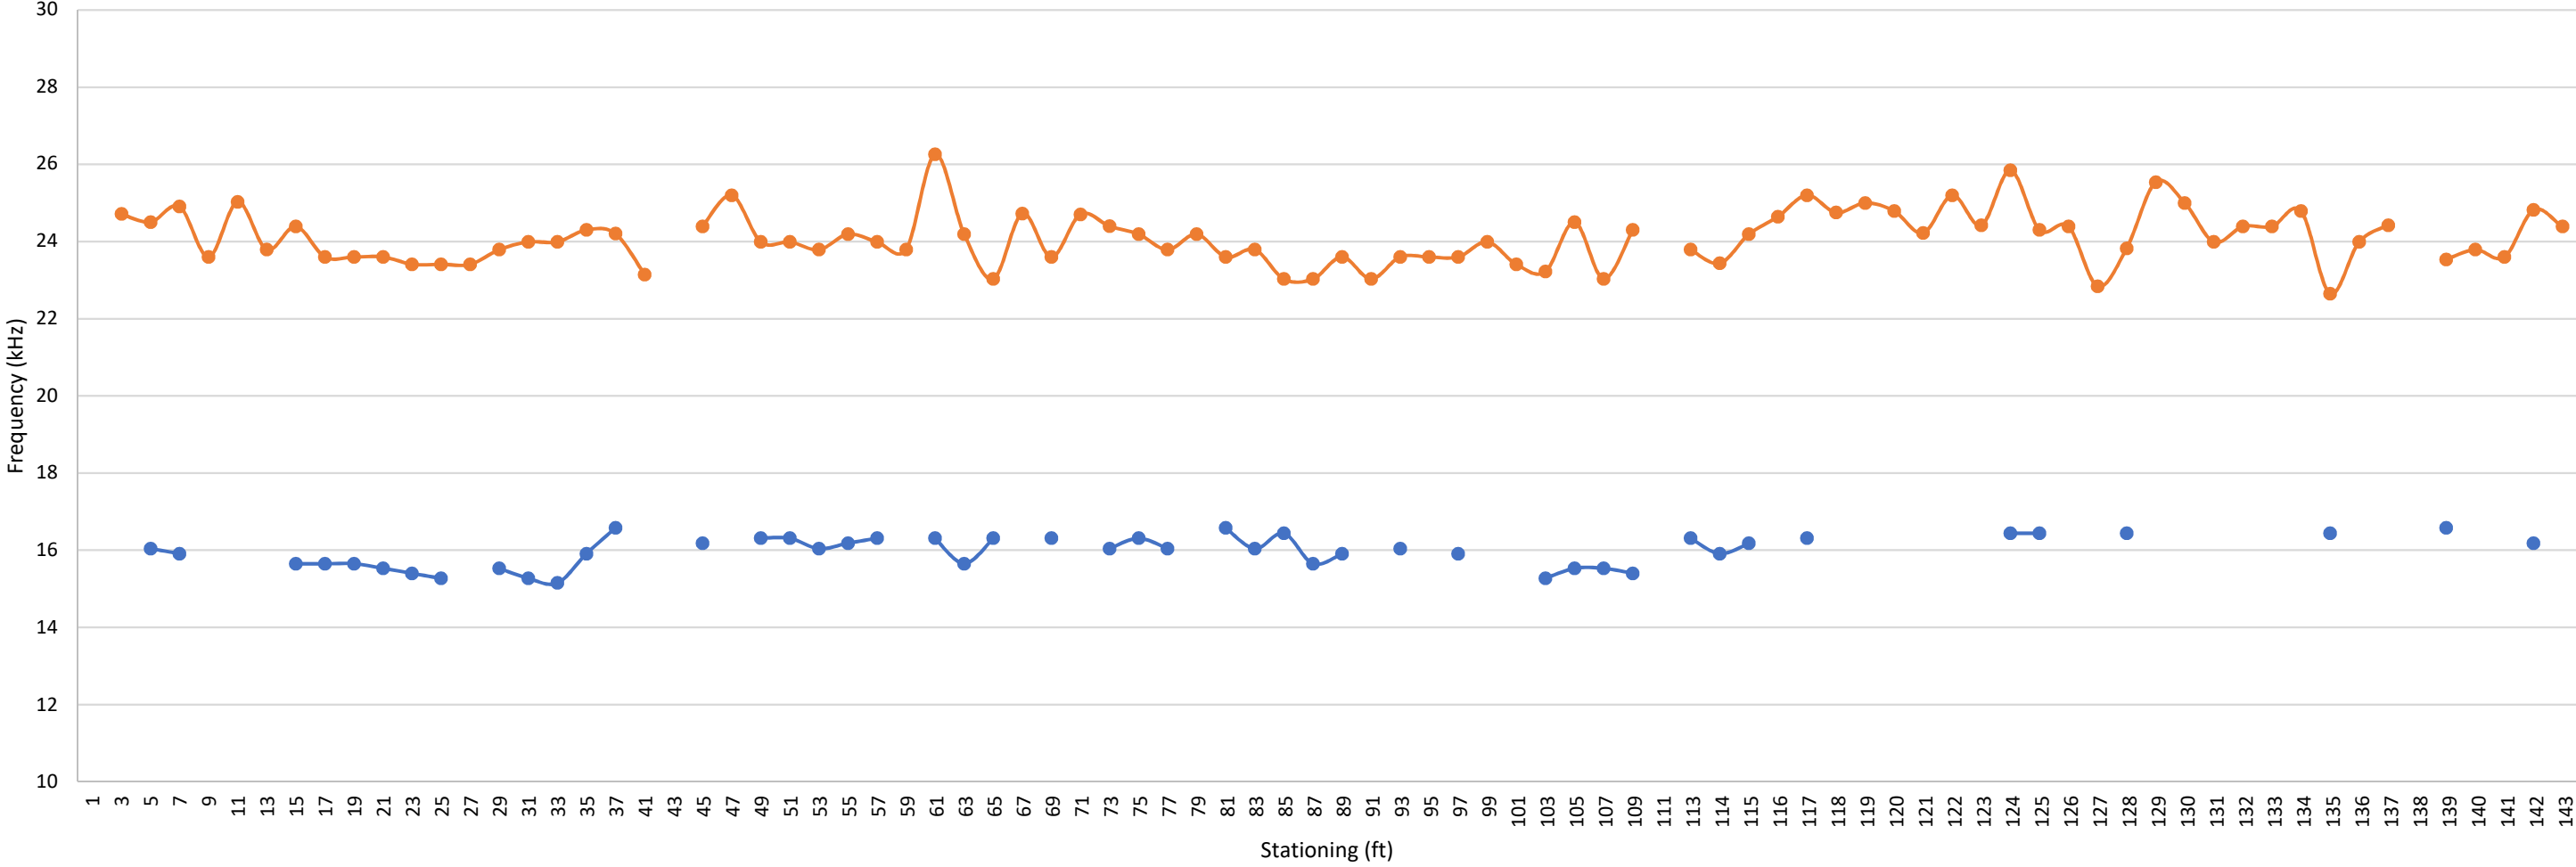
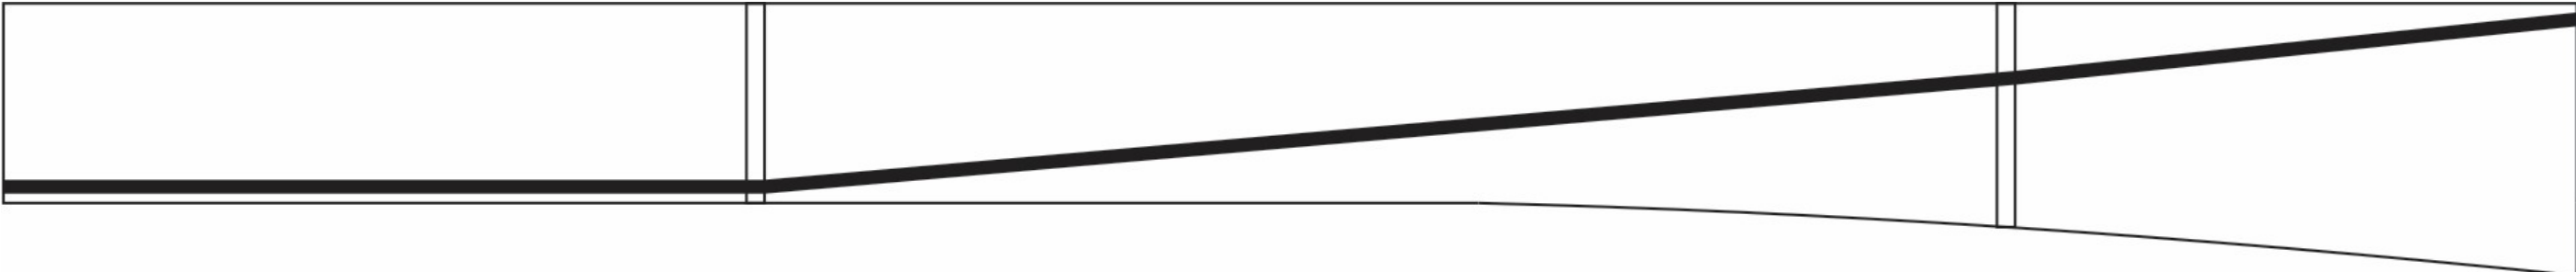
—●— Circumferential Frequency
 —●— Average Through Frequency
 ■ Anomalous Grout Condition

Nondestructive Testing External Tendon Ducts John Ringling Causeway Bridge Over Sarasota Bay Sarasota, Florida Prepared for Florida International University by NDT Corporation		Span 9 Tendon 402L-9W Graph Results	
January. 2018		Figure A69

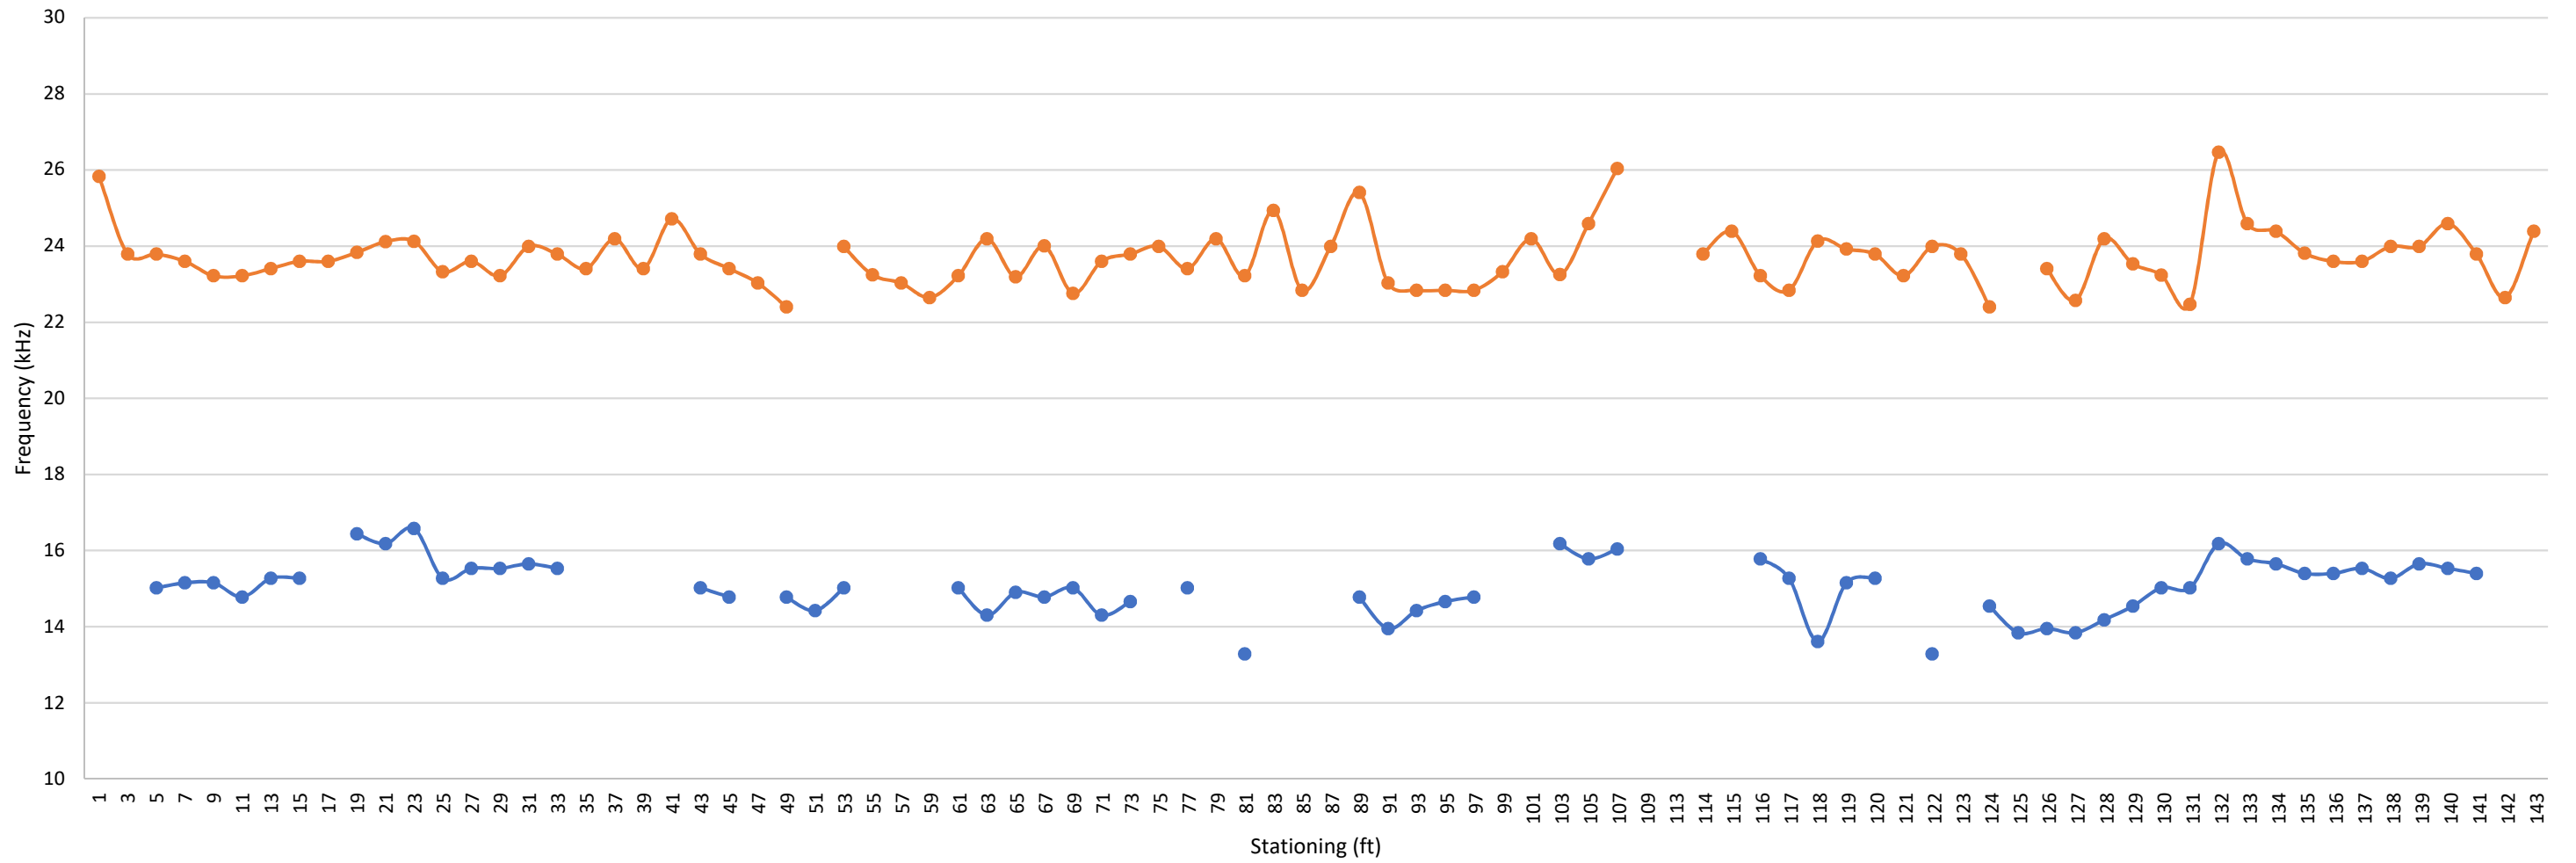
—●— Circumferential Frequency
 —●— Average Through Frequency
 ■ Anomalous Grout Condition

Nondestructive Testing External Tendon Ducts John Ringling Causeway Bridge Over Sarasota Bay Sarasota, Florida Prepared for Florida International University by NDT Corporation		Span 10 Tendon 401R-10W Graph Results	
January. 2018		Figure A79
