**Development of Quality Assurance and Quality Control
System for Post Tensioned Segmental Bridges in Florida:
Case of Ringling Bridge – Phase II**

**FDOT Contract No. BDV29-977-34
FINAL REPORT**

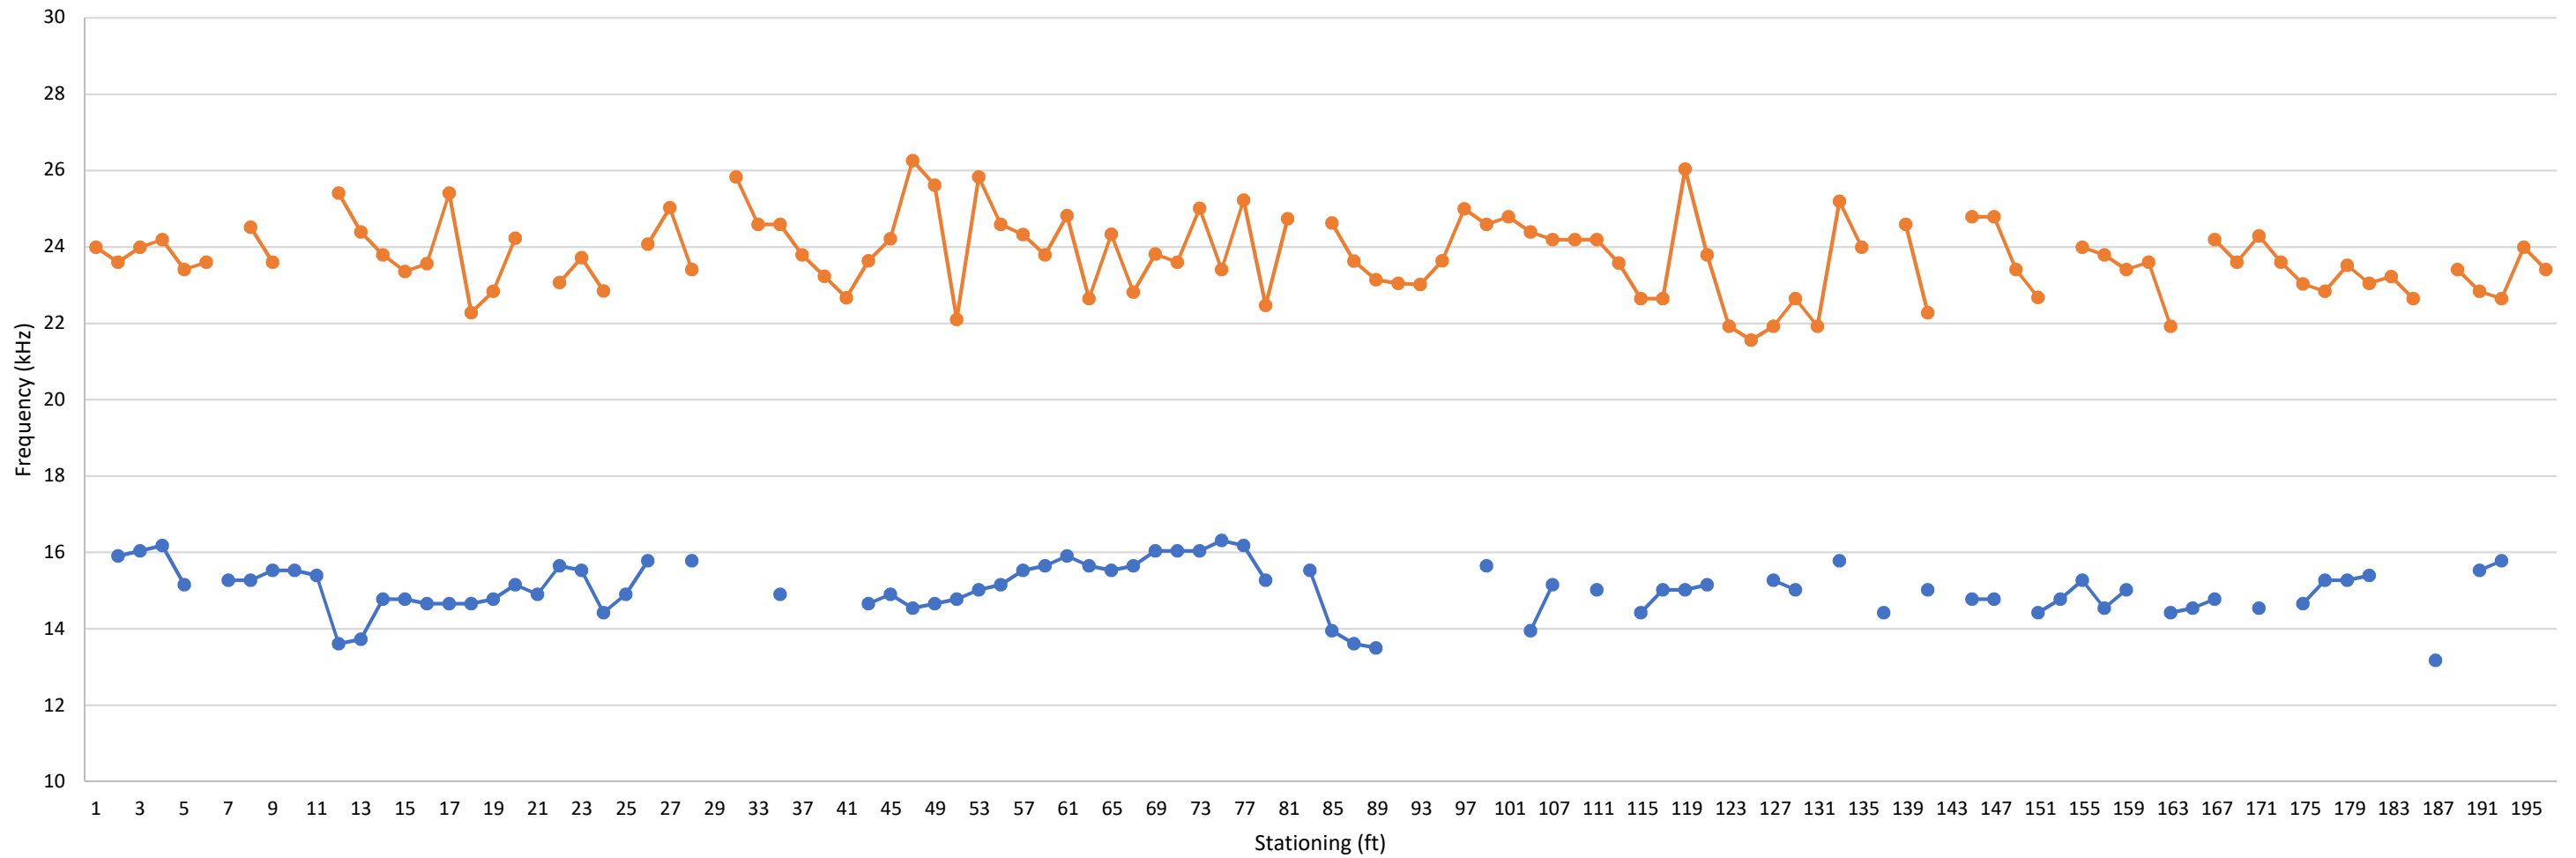
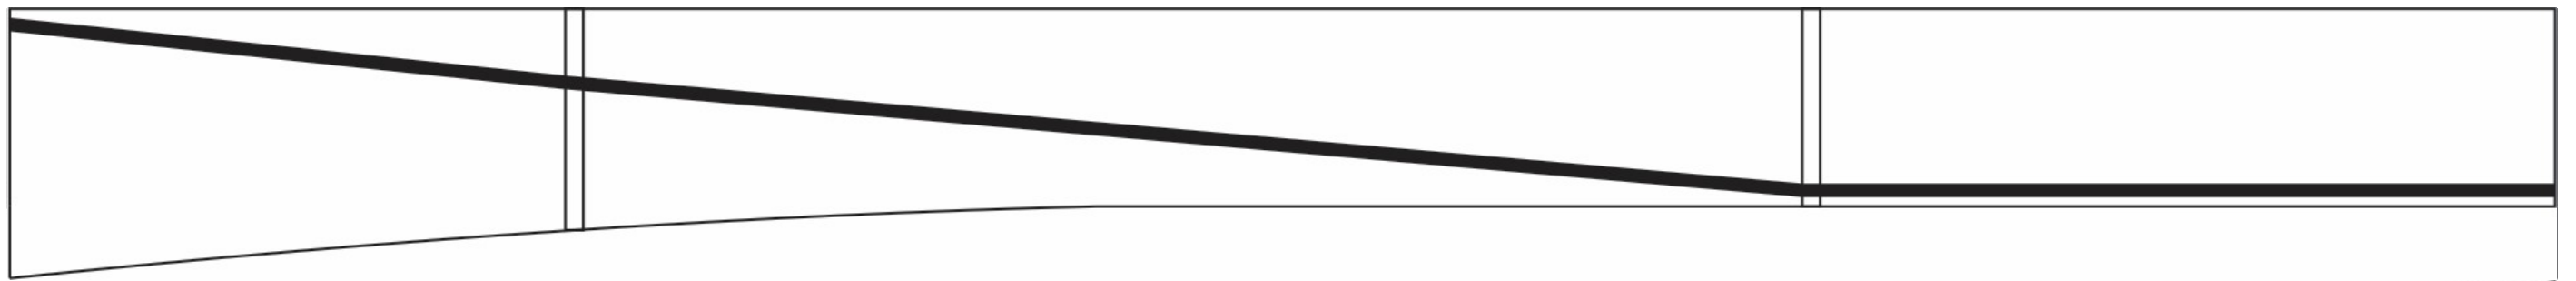
—●— Circumferential Frequency
 —●— Average Through Frequency
 ■ Anomalous Grout Condition

Nondestructive Testing External Tendon Ducts John Ringling Causeway Bridge Over Sarasota Bay Sarasota, Florida Prepared for Florida International University by NDT Corporation		Span 11 Tendon 402L-10E Graph Results	
		January. 2018	Figure A81

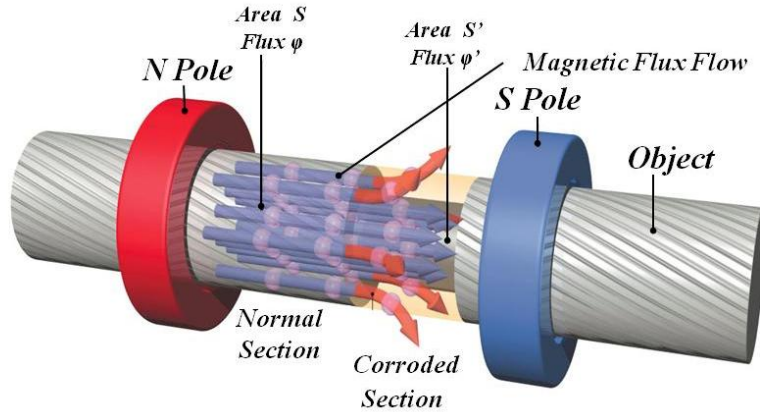
Figure 1. Flow of magnetic flux in a metal object.⁽²⁾

Structural metal members of bridges such as steel tendon and cable are ferromagnetic. The MMFM relies on a fundamental principle that when a metal object is magnetized, magnetic flux flows in the longitudinal direction through the cross-sectional area of the metal. When there is a loss of cross-sectional area due to corrosion or wire breaks in the metal, magnetic flux leaks outside through the reduced cross-sectional area and thus the portion flowing inside of the metal decreases. Figure 1 depicts these conditions.

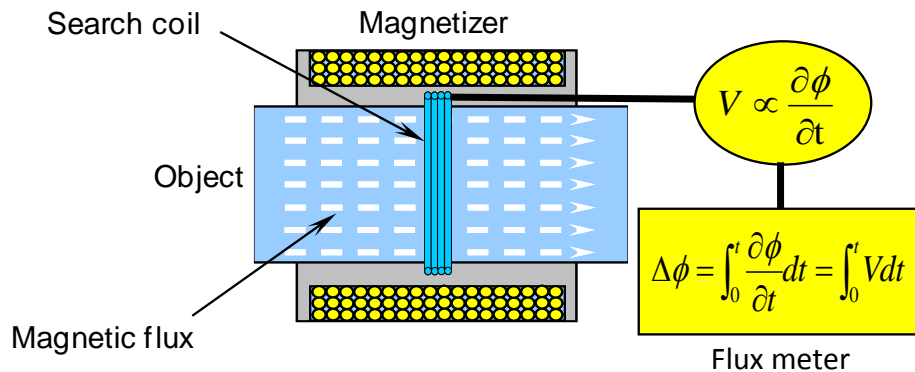
When magnetic flux (ϕ) flows inside the object as illustrated in Figure 2, a search coil reads the induced voltage which is proportional to the rate at which the magnetic flux changes. The total change in magnetic flux ($\Delta\phi$) is calculated by integrating the induced voltage over time, according to the equation embedded in Figure 2.

Figure 2. Schematic of magnetic flux measurement.⁽²⁾

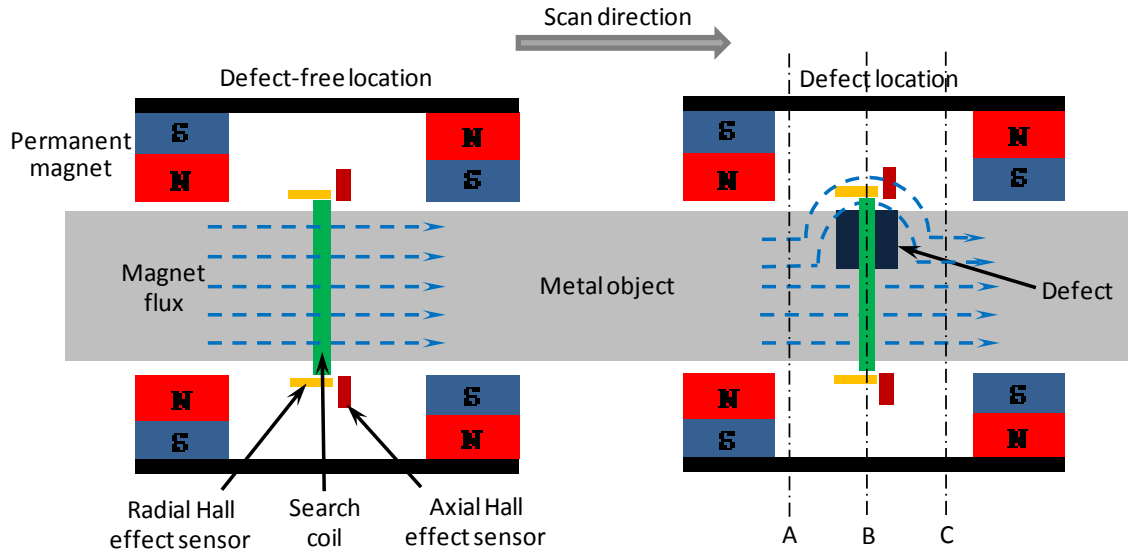
software on a laptop computer. Figure 3 illustrates the magnetic flux flow in the permanent magnet type magnetizer which has four pairs of the permanent magnet, a search coil, radial Hall effect sensors, and axial Hall effect sensors. This particular example also shows how the flow of magnetic flux is affected by the presence of a defect in the metal object.

Figure 3. Schematic of the magnetic flux flow in the permanent magnet type magnetizer.

With help of Figure 3, the following describes how individual sensors respond when a permanent magnet type magnetizer moves through defect-free locations (point A and point C) and defect containing the location (point B) during a scan measurement. As magnetic flux leaks at the

defect (point B), the leaked magnetic flux is divided into vertical component (radial) and a horizontal component (axial). During this transition from defect-free → defect → defect-free conditions, change of magnetic flux influences the sensors as follows:

2. Upper region radial Hall effect sensors: After passing point A, magnet flux starts leaking and the vertical (i.e., perpendicular to the metal object) component of the leaked magnetic flux increases and then decreases until it becomes the normal value at point B. After passing point B, the vertical component of the leaked magnetic flux increases again in the opposite direction and then decreases until it becomes the normal value again at point C and onward.

3. Upper region axial Hall effect sensors: After passing point A, magnet flux starts leaking and the horizontal (i.e., parallel to the metal object) component of the leaked magnetic flux increases until it becomes the highest at point B. After passing point B, the horizontal component of the leaked magnetic flux decreases until it becomes the normal value at point C and onward.

4. Bottom region radial and axial Hall effect sensors: Because these Hall effect sensors are situated far away from the defect located in the upper region, the effect of the magnetic flux fluctuations is minimal.

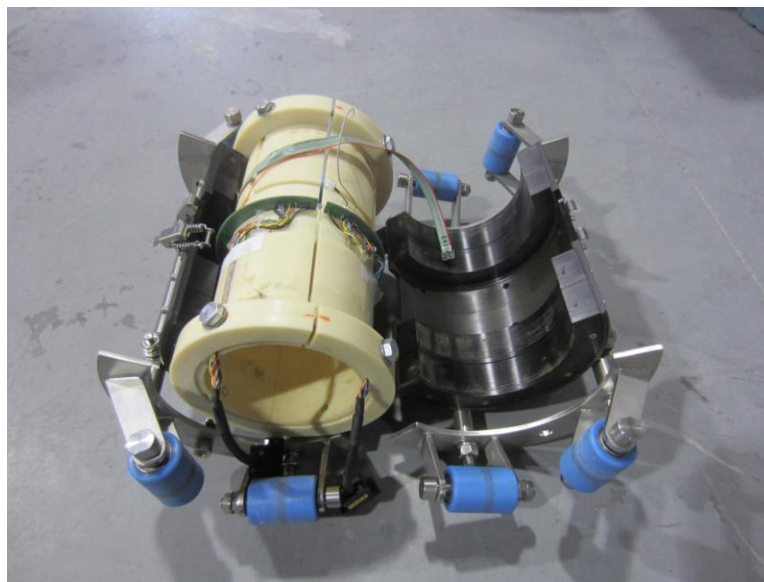
Figure 4 shows an interior view of the magnetizer when the half-split outer steel shell is opened. A cylindrical shape plastic sensor holder and two permanent magnets can be seen. Two more magnets are hidden under the sensor holder. The steel shell has eight rollers attached to the front and rear faces of the magnetizer. The magnetizer is also equipped with a rotary encoder type distance meter as shown in Figure 5. This device allows synchronizing magnetizer scan distance with the magnetic flux data. The weight of the magnetizer is approximately 56 lb.

Figure 4. Interior view of the permanent magnet type MMFM magnetizer.

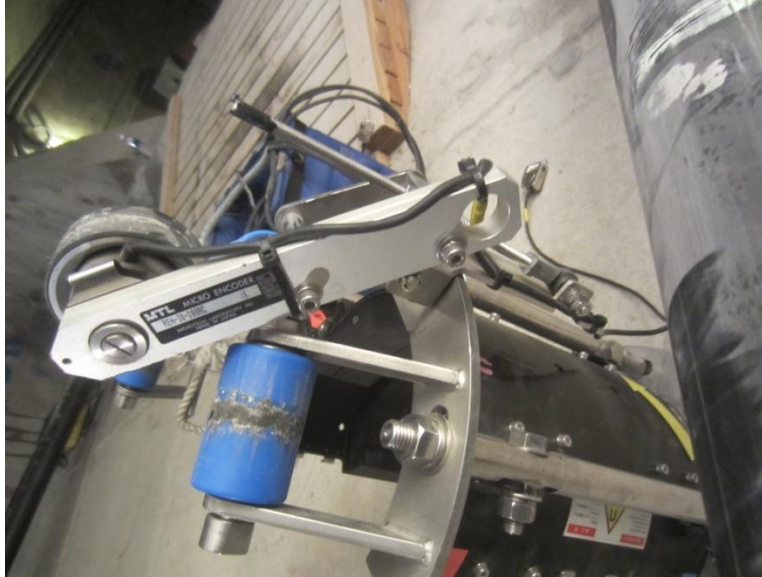
Figure 5. Rotary encoder type distance meter.

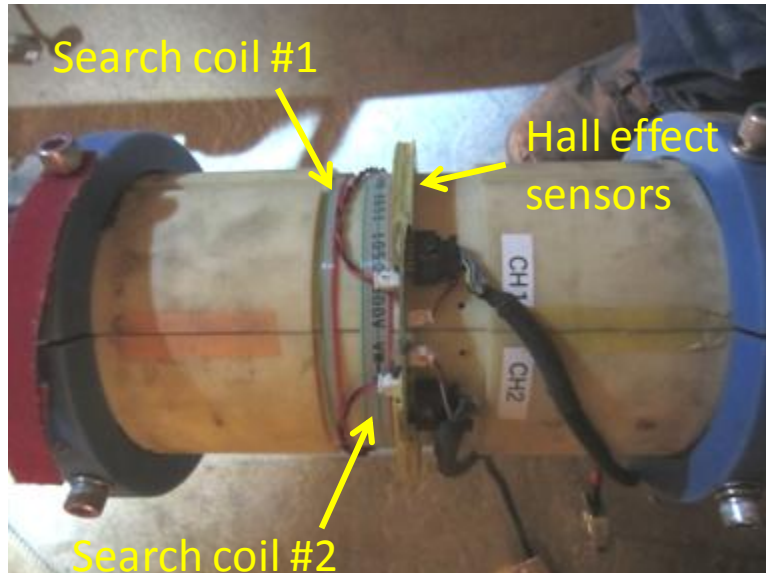
In this study, two search coils were wrapped around the assembled sensor holder (see Figure 7). The search coil #1 (coil 5Turn) can detect up to ten percent section loss and the search coil #2 (coil 10Turn) up to five percent section loss.

Figure 7. Assembled sensor holder.

A Hall effect sensor produces the voltage proportional to the intensity of magnetic field (H, or magnetic flux density) which passes through the sensor. A gauss meter measures the changes in the magnetic field via the Hall effect sensor. In order to collect the induced voltages at various positions, a total of 16 Hall effect sensors are set around the metal object: eight radial sensors face the center of the object and eight axial sensors face in the longitudinal direction. Figure 8 shows the Hall effect sensor arrangement schematically. Actual Hall effect sensors are installed on the half split rings that are shown in Figure 7.

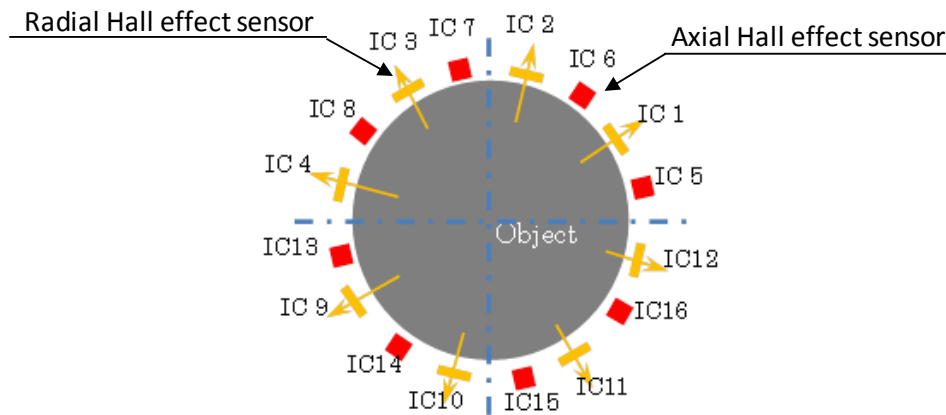
Figure 8. Arrangement of Hall effect sensors.

With such a sensor arrangement, no matter where a defect exists in the metal object, detecting a change of the magnetic flux can be ensured.

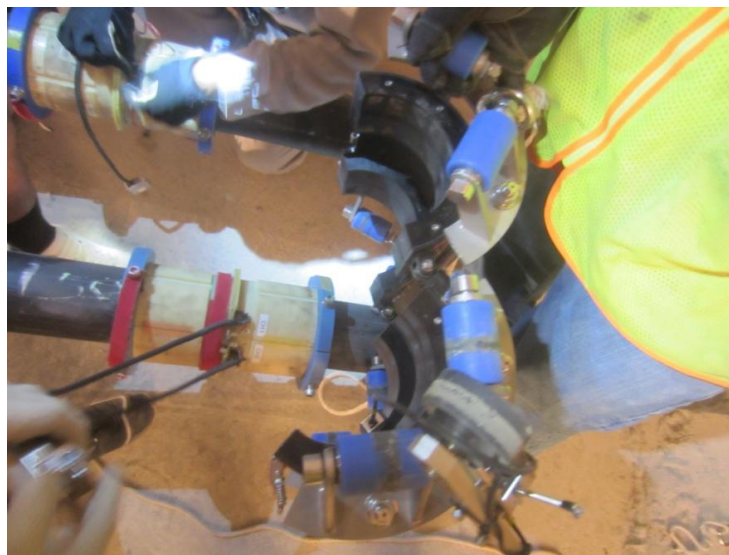
Once the sensor holder is installed, the steel outer shell is wrapped around the sensor holder and is closed using two spring-loaded clamps. Figure 9 shows the steel shell being wrapped around the sensor holder. Two black cables coming from the sensor holder go through a rectangular slot in the steel shell.

Figure 9. A steel outer shell being installed.

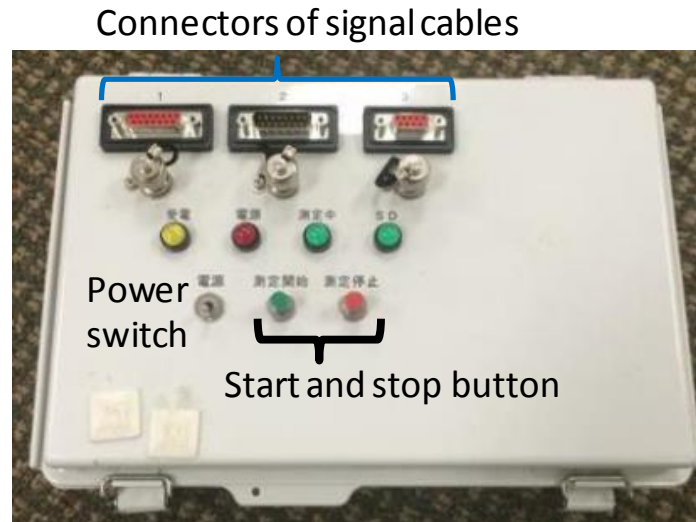
A key component of the permanent magnet type MMFM system is the controller. It operates with a 9-volt battery and the collecting data are transmitted wirelessly to the laptop computer. Figure 10 shows one type of the MMFM controller.

Figure 10. Controller.

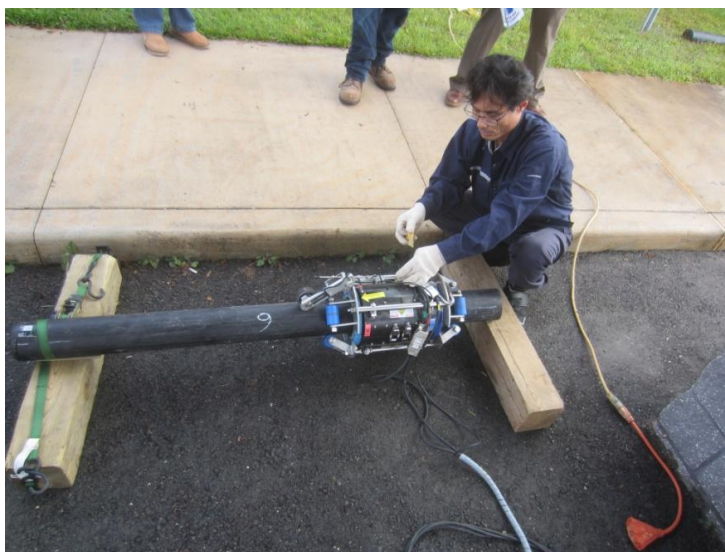
In order to ensure the accuracy and error-free condition of the MMFM systems, a half-day testing was performed for calibration and system check at the FDOT Manatee Operations Center in Bradenton, FL on February 5, 2018. For this testing, two 5-ft PT tendon samples retrieved from the Ringling Bridge were provided by FDOT. Since these tendon samples are identical to in-service tendons, they were considered the ideal specimens for calibration. Figure 11 shows the testing setup for tendon sample #1.

Figure 11. Calibration setup for tendon sample #1.

The calibration work was performed by introducing four levels of damage into 22 of 0.6-inch 7-wire strands (total 154 wires) in the tendon. The artificial damage simulating corrosion-induced section loss was created by removing 1, 7, 14, and 21 wire segments sequentially using an angle grinder. The average length of the removed wires was 6 inches. Although the center wire is slightly larger than the outer ones, a rough estimation was made by treating two wire types the same. From this, the removed wires were equivalent to 0.6, 4.5, 9.1, and 13.6 percent section loss, respectively.

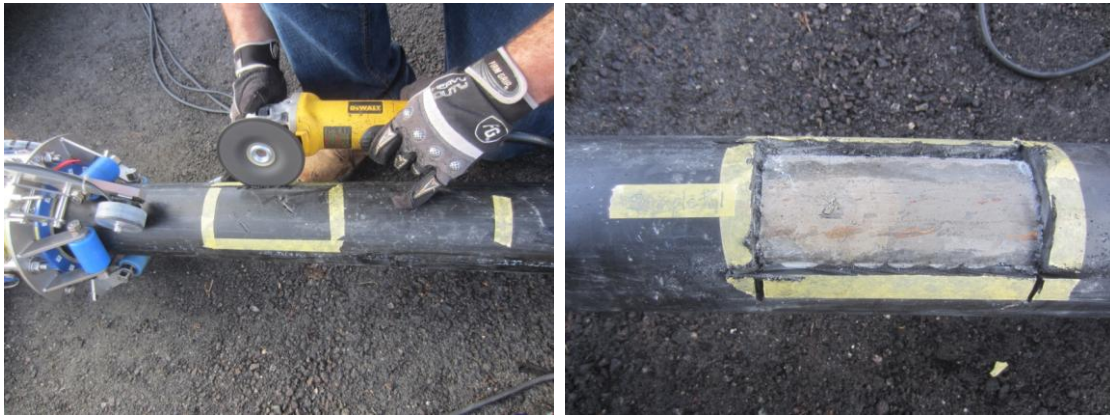
Figure 12 shows a 6 x 3 inches cut-out area in preparation of the artificial damage. Center of the cut-out area was 27 inches away from one end of the sample.

Figure 12. Making a 6 x 3 inches duct opening (left) and as-exposed grout condition (right).

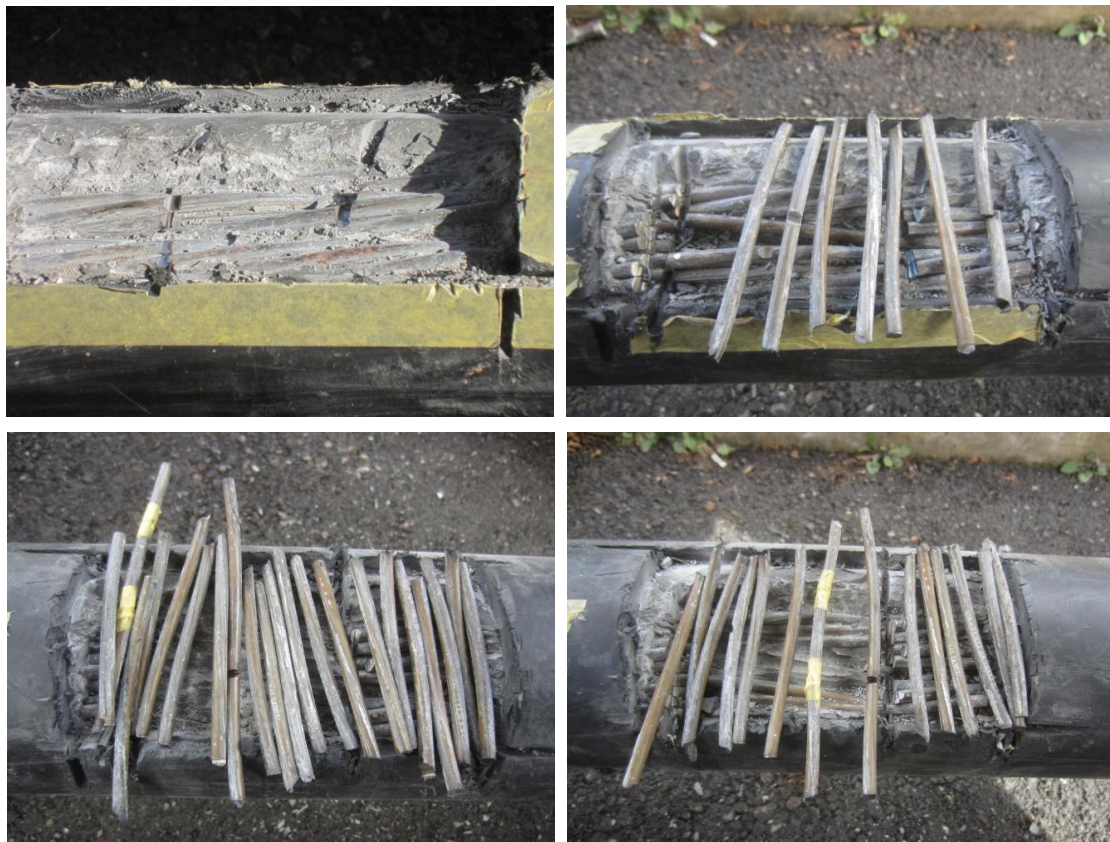
Figure 13 shows removed wires during the calibration work.

Figure 13. Removed wires for 0.6, 4.5, 9.1, and 13.6 percent section losses (clockwise from top left).

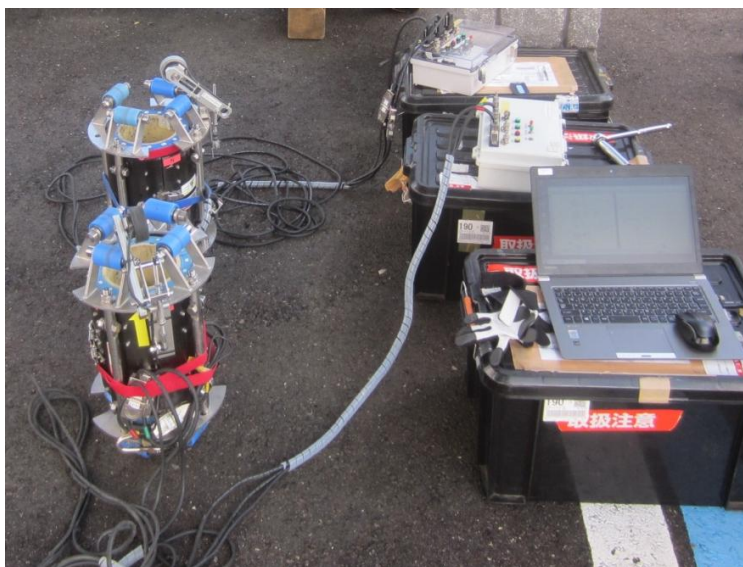
TRM prepared two MMFM systems to expedite the field testing. Figure 14 and Figure 15 show two complete MMFM systems and two magnetizers installed side by side on adjacent 4-inch external PT tendons on the bridge, respectively.

Figure 14. Two complete permanent magnet type MMFM systems.

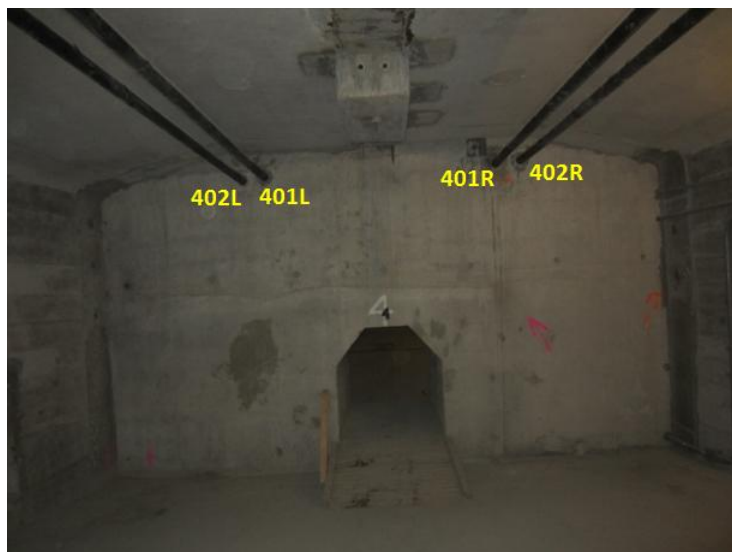
Figure 16. Typical tendon arrangement in the center cell (west face of pier 4 diaphragm).

Figure 16 and Figure 17 show examples of four tendons (401L, 402L, 402R, and 401R) coming out of pier 4 center cell diaphragm and six tendons (401L, 402L, 402R, 401R, 301L, and 301R) coming out of pier 5 center cell diaphragm, respectively.

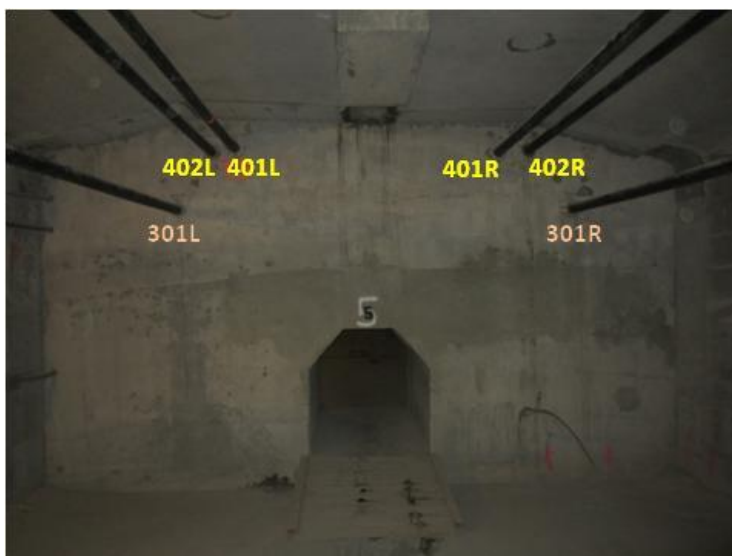
Figure 17. Tendon arrangement having two extra tendons in the center cell (east face of pier 5 diaphragm).

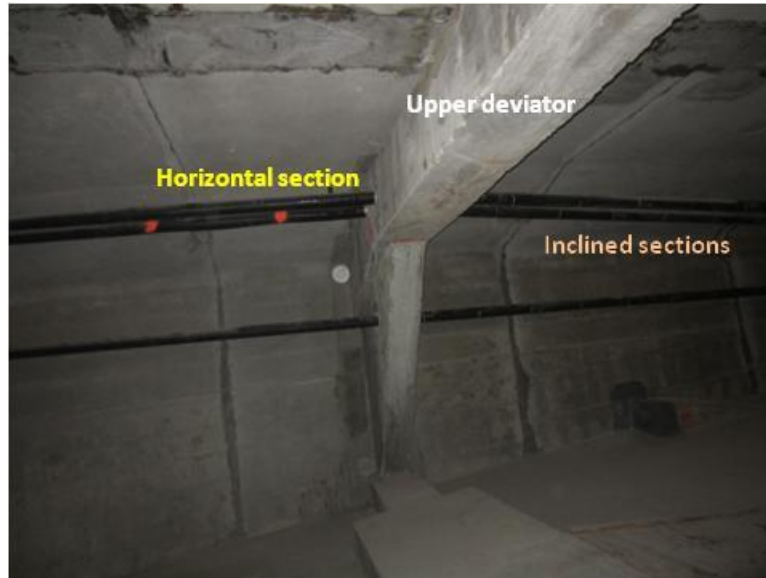
Figure 18 shows an example of tendon deflection at an upper deviator that re-directs two horizontal sections to two inclined sections.

Figure 18. Tendons going through an upper deviator.

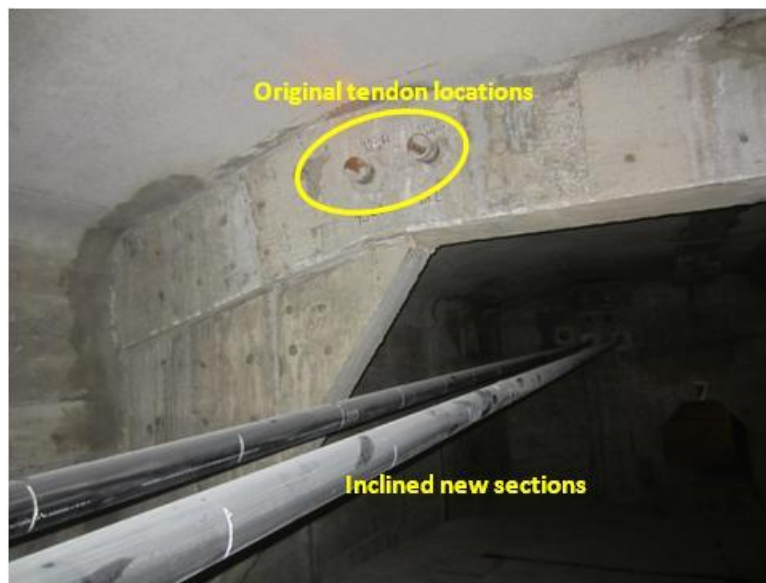
In some spans, severely corroded tendons were replaced with new ones which were installed in different locations. Figure 19 shows one example where two new tendons avoided the original tendon penetration points. In such a case, horizontal sections disappeared and only long inclined sections existed.

Figure 19. Two replaced tendons that bypassed an upper deviator.

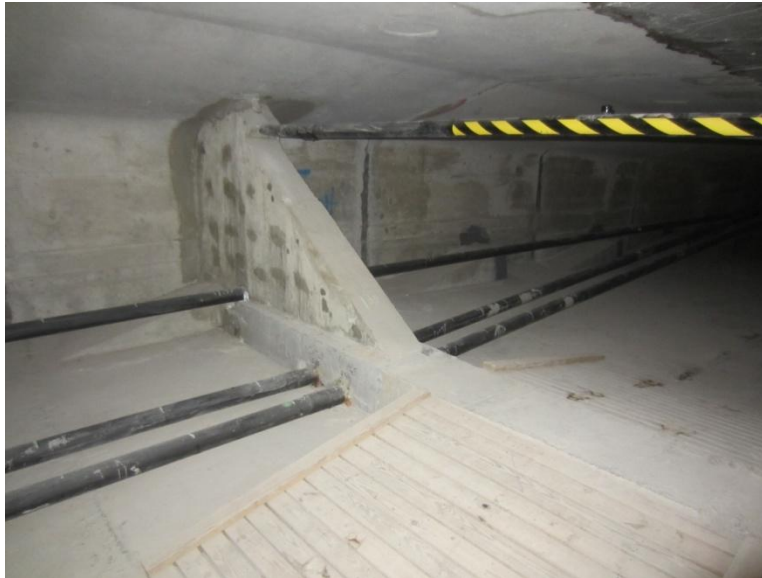
Figure 20. Horizontal tendon sections going through a lower deviator.

Figure 20 and Figure 21 show bottom horizontal tendon sections going through a lower deviator and the same tendons at a mid-span anchor block, respectively. As mentioned earlier, these bottom horizontal sections were not scanned.

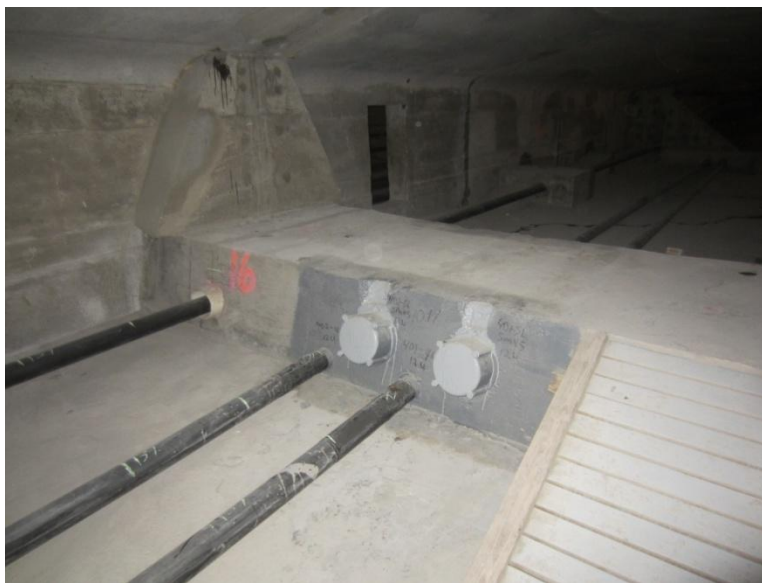
Figure 21. Horizontal tendon sections at an anchor block in the mid-span.

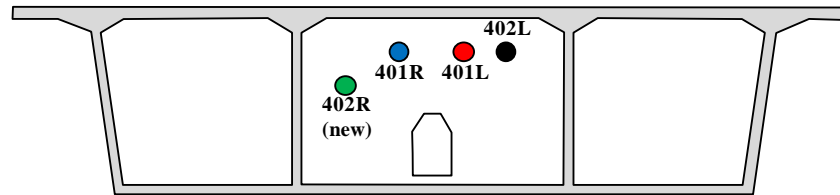
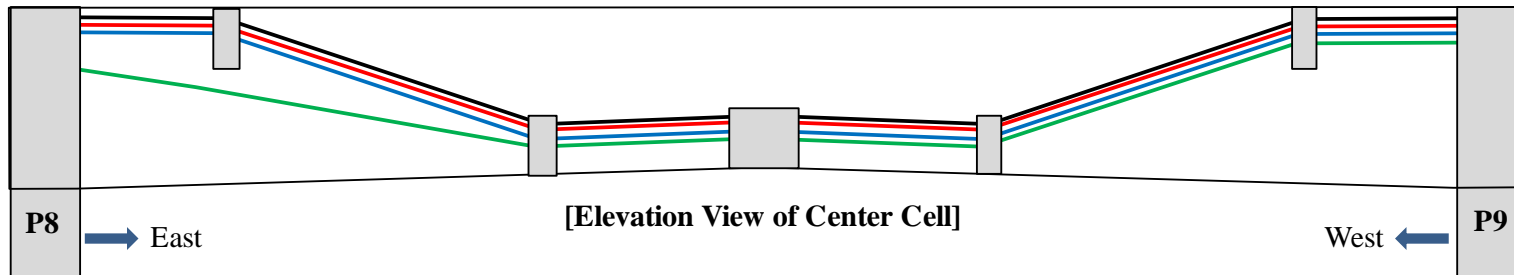
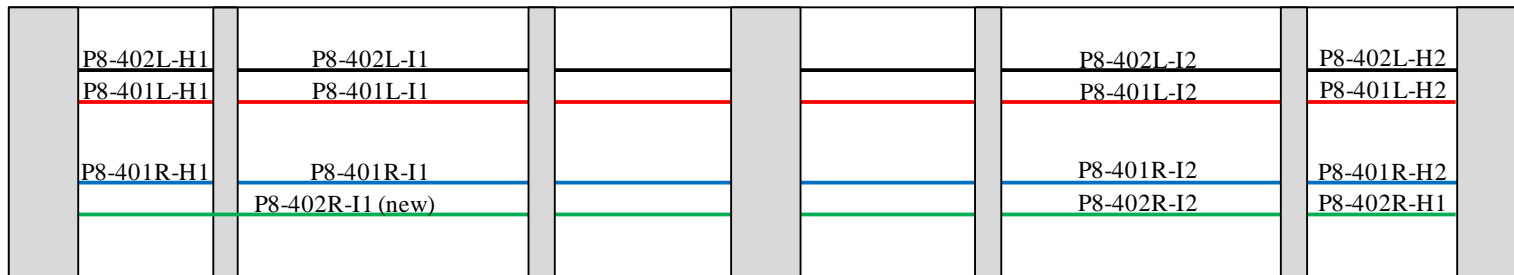
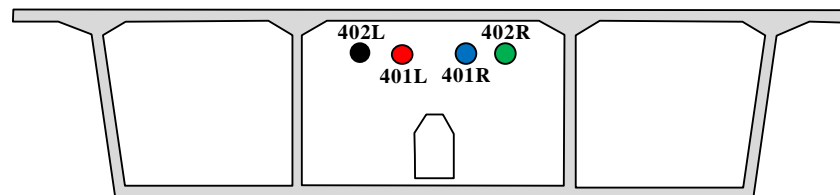
Figure 22. Scanned tendon sections in P8 – P9 (center cell).

Figure 22 through Figure 24 present examples of schematic tendon arrangement and scanned sections of center cell, left cell, and right cell in P8 – P9 span, respectively. Schematic diagrams for all the spans are included in Appendix 1. Each figure consists of two opposite diaphragm faces and a tendon arrangement in elevation and plan views. Intermediate deviators dividing horizontal sections and inclined sections are also included in both views. Four tendon IDs are included in the diaphragm faces. When there is a replaced tendon, it is indicated by the original tendon ID (new). The scanned section IDs are included in the plan view. Since the bottom horizontal sections were not scanned, their IDs are not included. There was one tendon with no ID in the right cell and it is indicated with P8-40?R-I1 (new) in Figure 24.

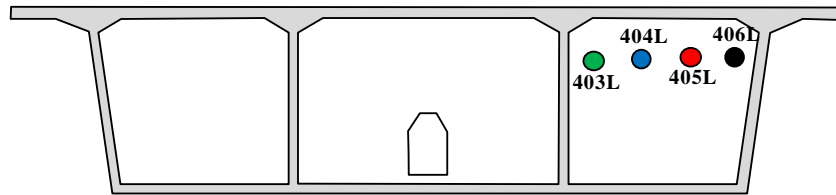
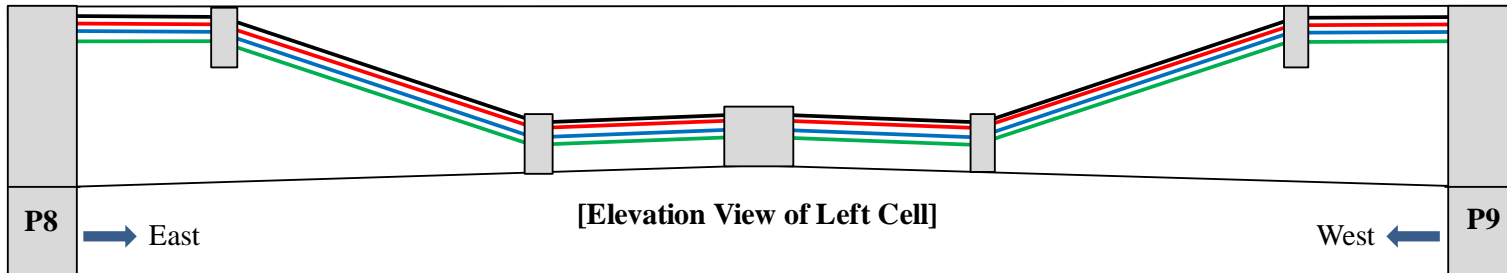
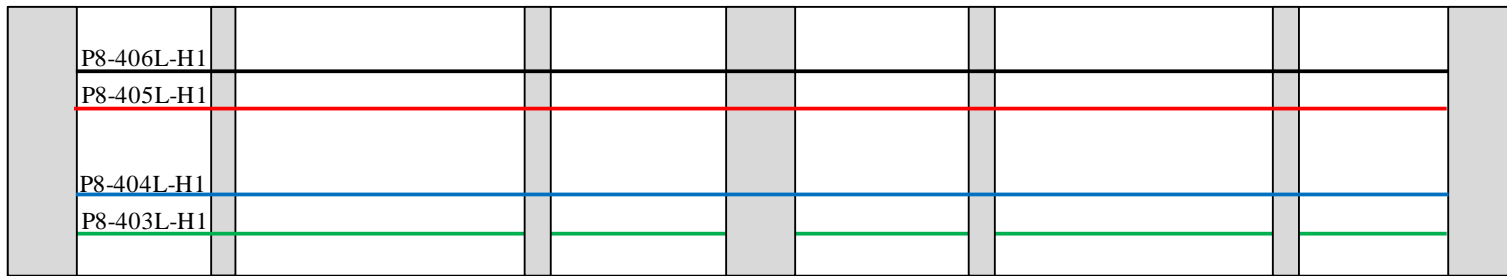
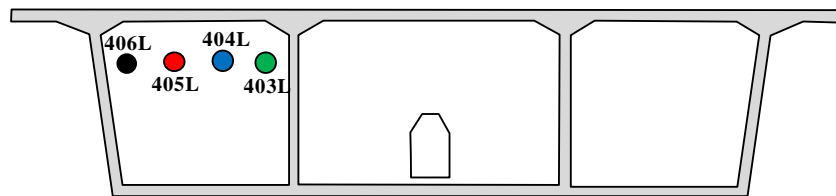
Figure 23. Scanned tendon sections in P8 – P9 (left cell).

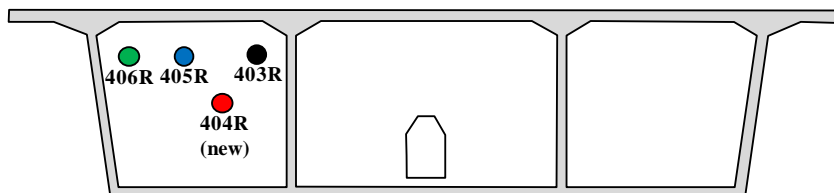
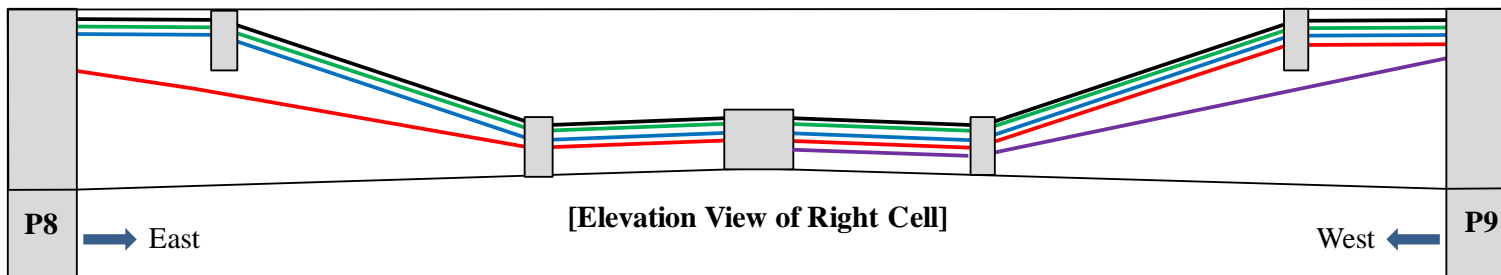
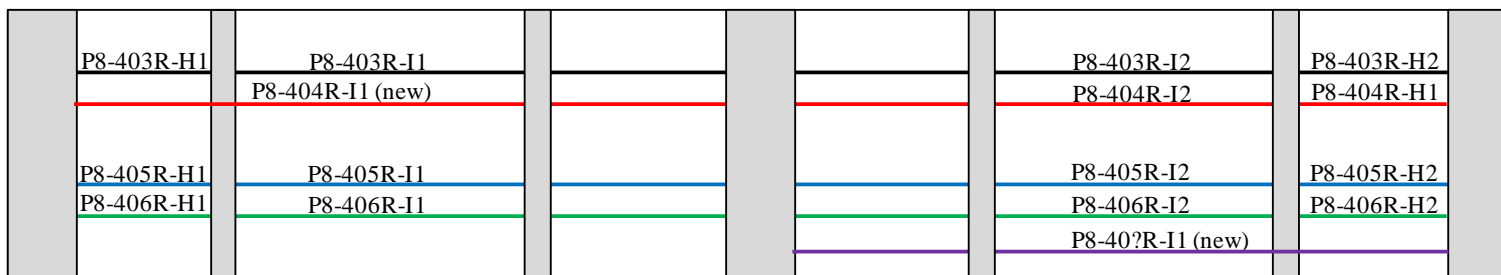
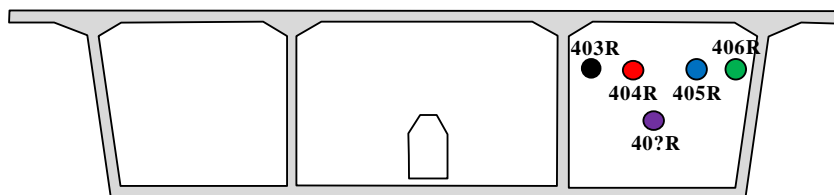
Figure 24. Scanned tendon sections in P8 – P9 (right cell).

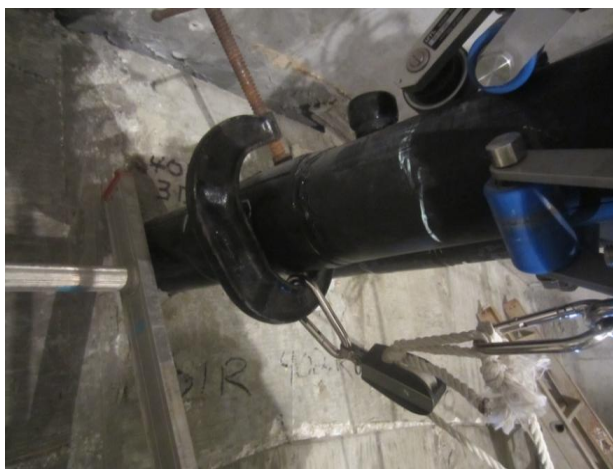
As shown in Figure 25, a steel clamp was attached to the highest point of an inclined section and a pulley was attached to the clamp. For every high elevation horizontal section, one more set of a clamp and a pulley was installed at the other end of the section.

Figure 25. Installing a steel clamp and a pulley.

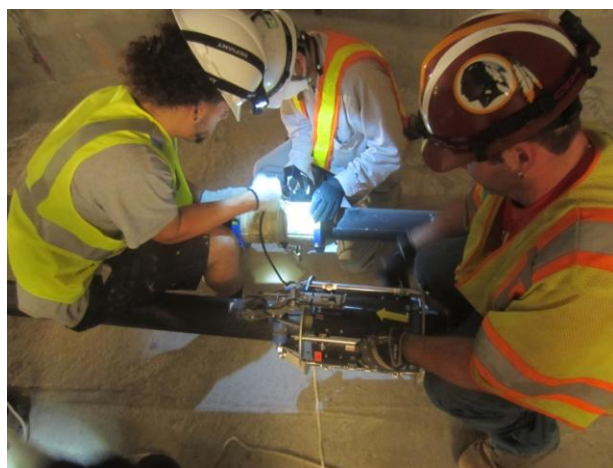
The sensor holder and the steel outer shell were installed on the tendon section. For the inclined section, this work was done at a low elevation for a better work environment. Figure 26 shows a sensor holder installation for the first magnetizer and a steel outer shell for the second magnetizer.

Figure 26. Installation of two magnetizers on the inclined sections at low elevation.

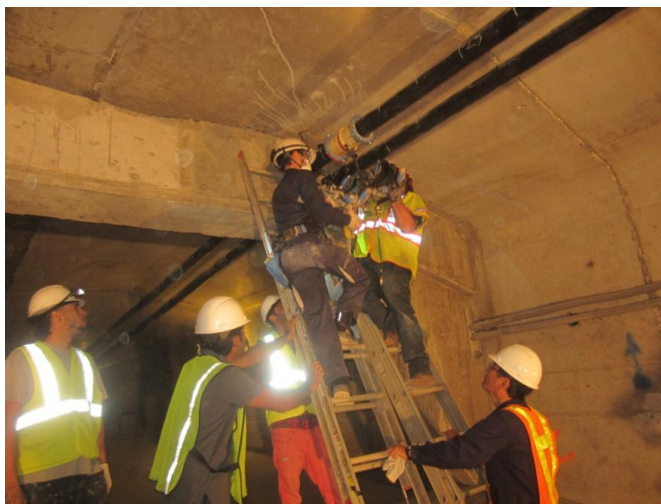
Figure 27. Installation of a magnetizer on a horizontal section at high elevation.

For the horizontal sections at high elevation, installation of the magnetizer was somewhat difficult due to lifting the magnetizer components and installing them on the ladders. Figure 27 and Figure 28 show the high elevation installation work in progress and the installed magnetizer, respectively. The latter shows the magnetizer installed at high elevation above a worker who is pulling the rope from the floor.

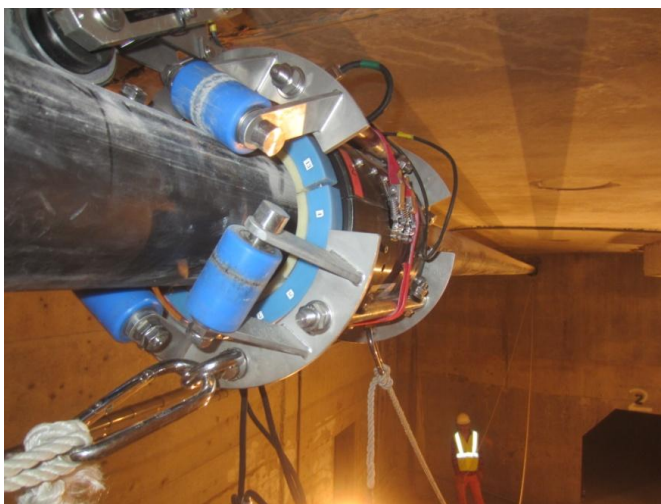
Figure 28. Installed magnetizer on a high elevation horizontal section.

For the horizontal sections at high elevation, the magnetizer was pulled in both directions with two separate ropes and pulleys as shown in Figure 30. A close-up view of the rope attachment to the magnetizer is also shown in Figure 28.

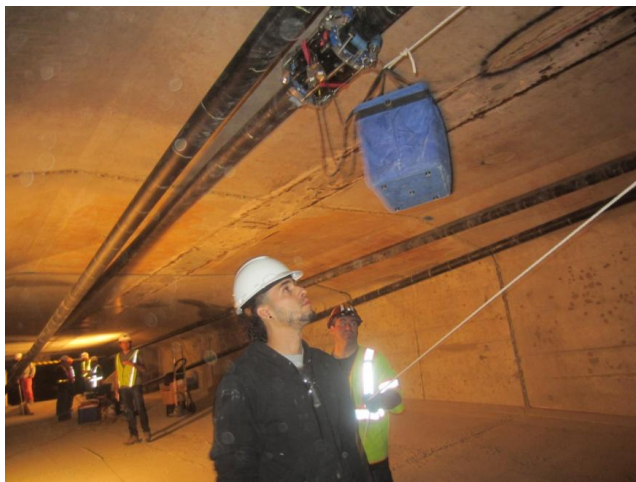
Figure 29. Scan measurement on an inclined tendon section.

One end of the rope was tied to the magnetizer through the pulley and the signal cables from the sensors and the rotary encoder type distance meter were connected to the controller placed in the blue cloth basket. A scan measurement was performed by moving the magnetizer along the tendon section. For the inclined sections, the upward scan was made by pulling the other end of the rope and the downward scan was done by gravity while releasing the rope. Figure 29 shows this work.

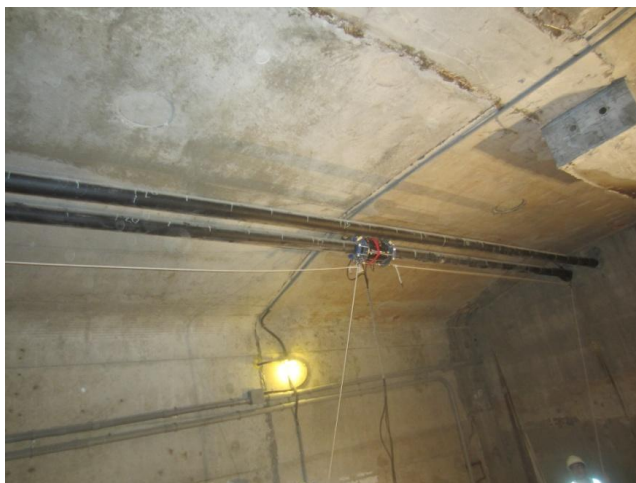
Figure 30. Magnetizer on a high elevation horizontal section.

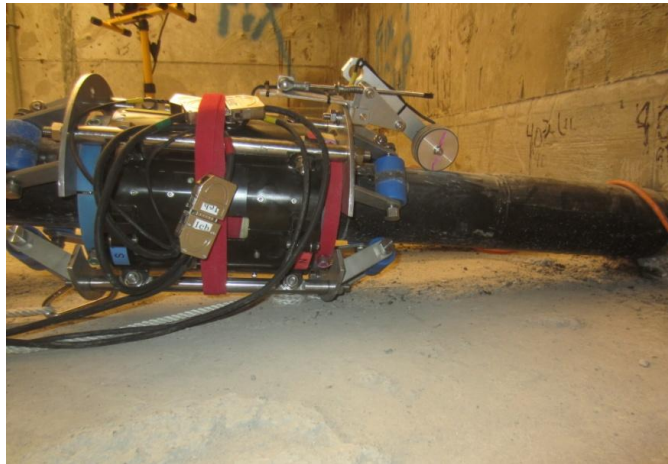
Figure 31. A dead zone near the end of an inclined test section.

Two problems were encountered during the field testing. The first problem was related to the extended dead zone (untestable area) created by lack of clearance between the magnetizer and the inclined test section end. Figure 31 shows one of these situations.

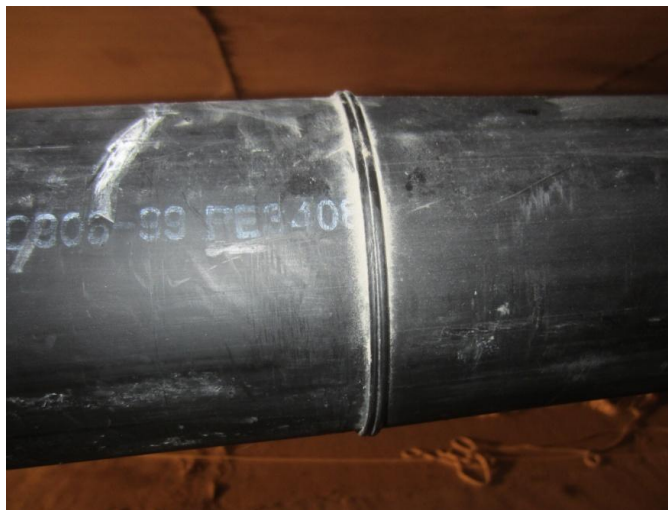
Figure 32. Extruded HDPE welding joint.

The second problem was extruded welding butt joints over the HDPE duct. One example is shown in Figure 32. Such a surface irregularity caused the magnetizer to jump and resulted in data disturbance in the waveforms.

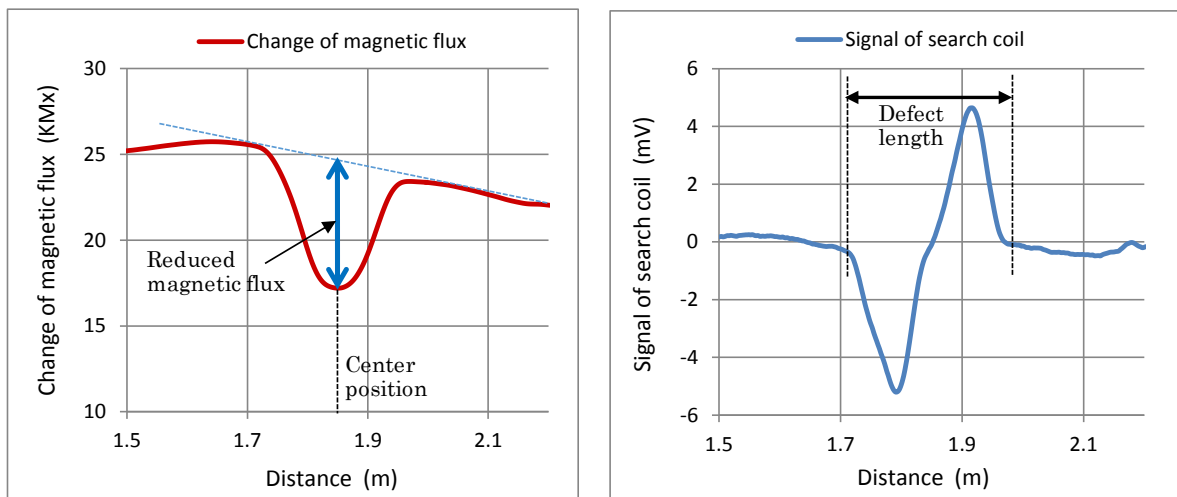
The following explains the MMFM data with an example of a 3-wire cut case where the defect was located approximately 1.85 m (6.07 ft.) from the starting point. The first and second waveforms, i.e., change of magnetic flux versus distance and signal of search coil versus distance, are usually presented together in a single plot. Figure 33 shows magnified views of the change of magnetic flux (left) and the voltage signal of the search coil (right) at the defect location. The change of magnetic flux (left) is integration of the voltage signal of search coil (right). As illustrated in the figure, reduced magnetic flux corresponding to a section loss at the defect is measured from the bottom of the recessed curve to a straight line spanning over two adjacent highest points. The defect length can be estimated by measuring a peak-and-valley distance of the search coil signal associated with the reduced magnetic flux.

Figure 33. Examples of change of magnetic flux (left) and signal of search coil (right) plots.

It can be seen that these MMFM data reflect progressively increasing defect size by showing augmented signal changes. Based on changes of the magnetic flux (determined by the method illustrated in Figure 33) corresponding to the known section loss values, two calibration charts can be constructed as shown in Figure 41 and Figure 42. They show one-to-one relationships between section loss and change of magnetic flux sensed with 10-turn and 5-turn search coils, respectively. Both charts also include additional calibration data produced in the laboratory.

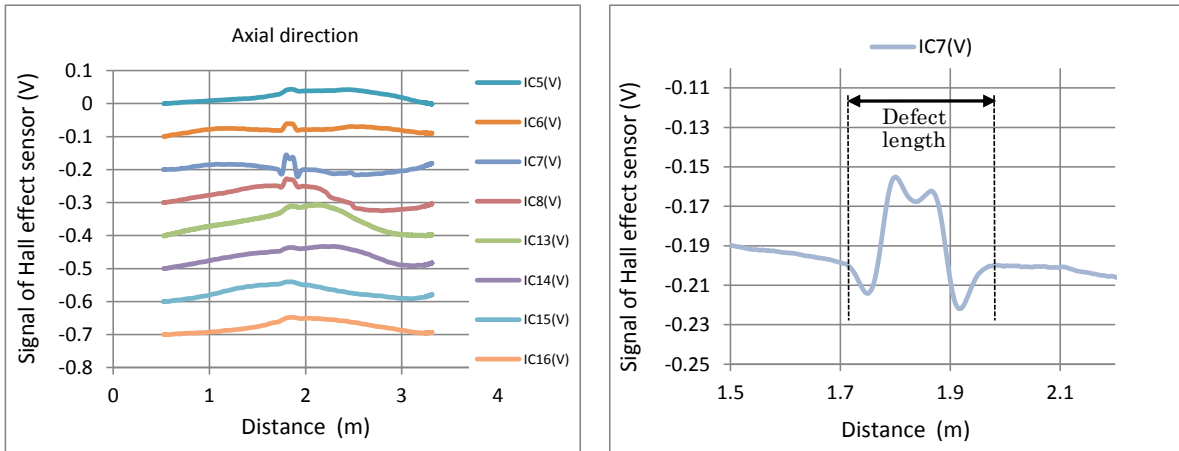
The third waveform is related to axial Hall effect sensors. Figure 34 shows voltage signals coming from eight axial Hall effect sensors (left) and a magnified view of the IC7 sensor signal at the defect location (right) along the scan length. It can be seen in Figure 34 that some of the Hall effect sensors clearly responded to the defect location and the disturbed IC7 signal can be used to estimate the defect length.

Figure 34. Example of axial Hall effect sensor signals (left) and a magnified view of IC7 sensor signal at the defect location (right).
