**Development of Quality Assurance and Quality Control
System for Post Tensioned Segmental Bridges in Florida:
Case of Ringling Bridge – Phase II**

**FDOT Contract No. BDV29-977-34
FINAL REPORT**

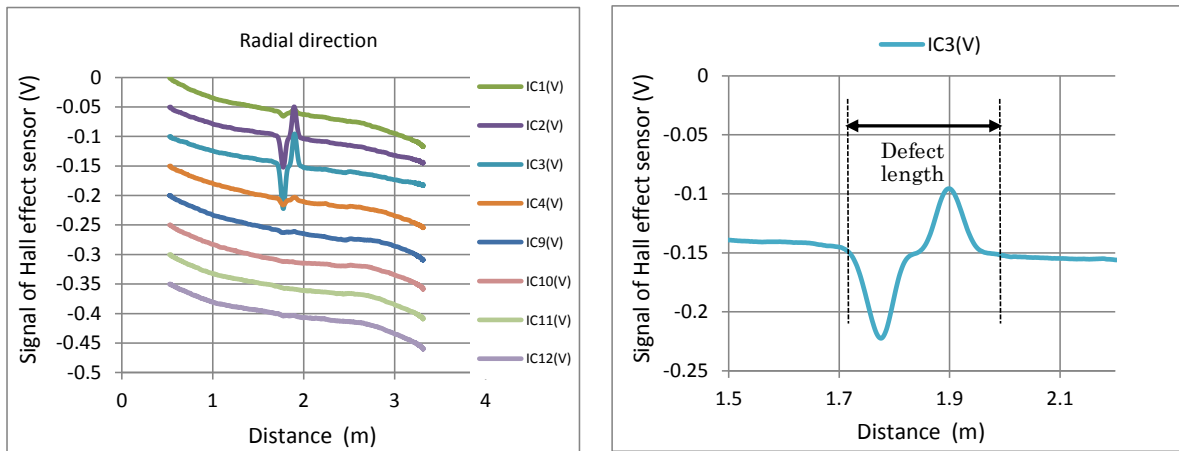
The last waveform is related to radial Hall effect sensors. Figure 35 shows voltage signals coming from eight radial Hall effect sensors (left) and a magnified view of the IC3 sensor signal at the defect location (right) along the scan length. Similar to the axial Hall effect sensors, three radial Hall effect sensors clearly picked up the defect location and the disturbed IC3 signal can also provide estimated defect length.

Figure 35. Example of radial Hall effect sensor signals (left) and a magnified view of IC3 sensor signal at the defect location (right).

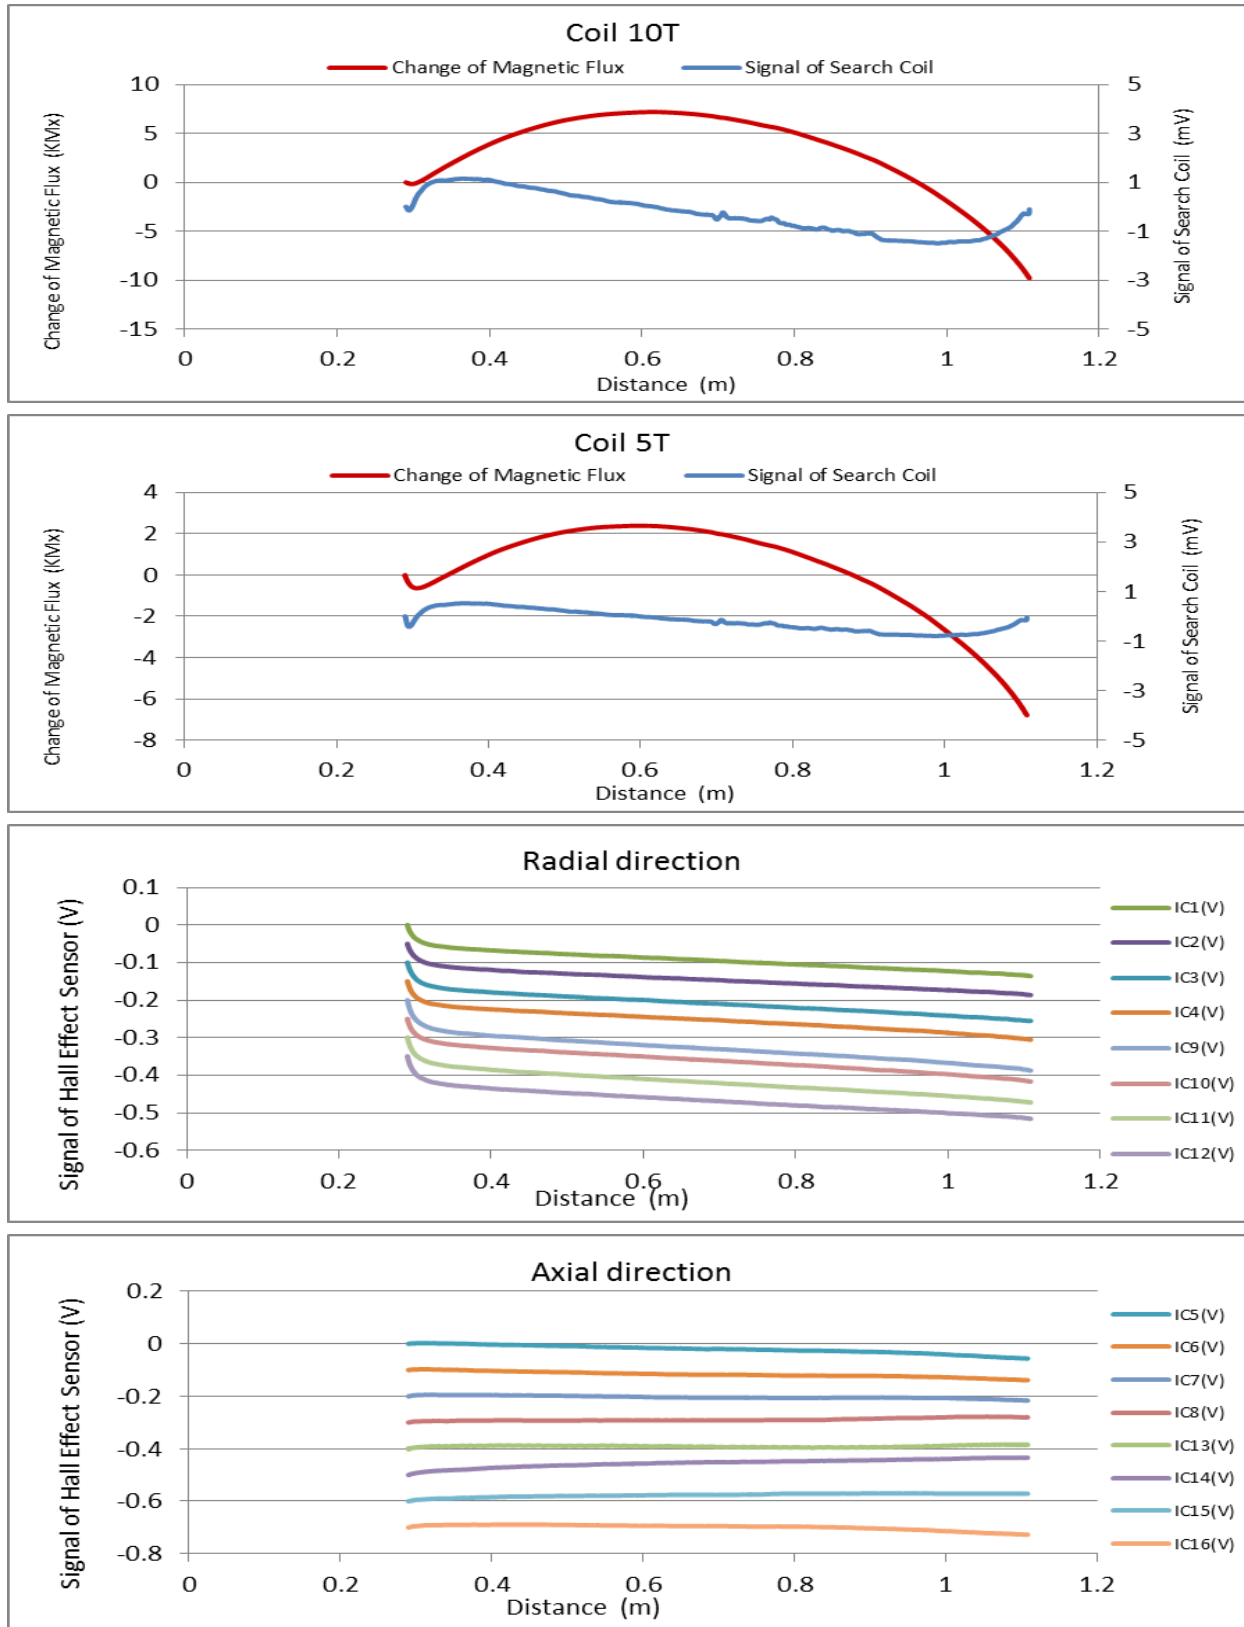
Figure 36. MMFM data for the intact condition of tendon sample #1.

Figure 36 through Figure 40 show the MMFM data of tendon sample #1 having intact and four different artificial damage conditions. Each figure consists of four plots including two search coil data, one for 10 turns (labeled as Coil 10T) and the other for 5 turns (labeled as Coil 5T).

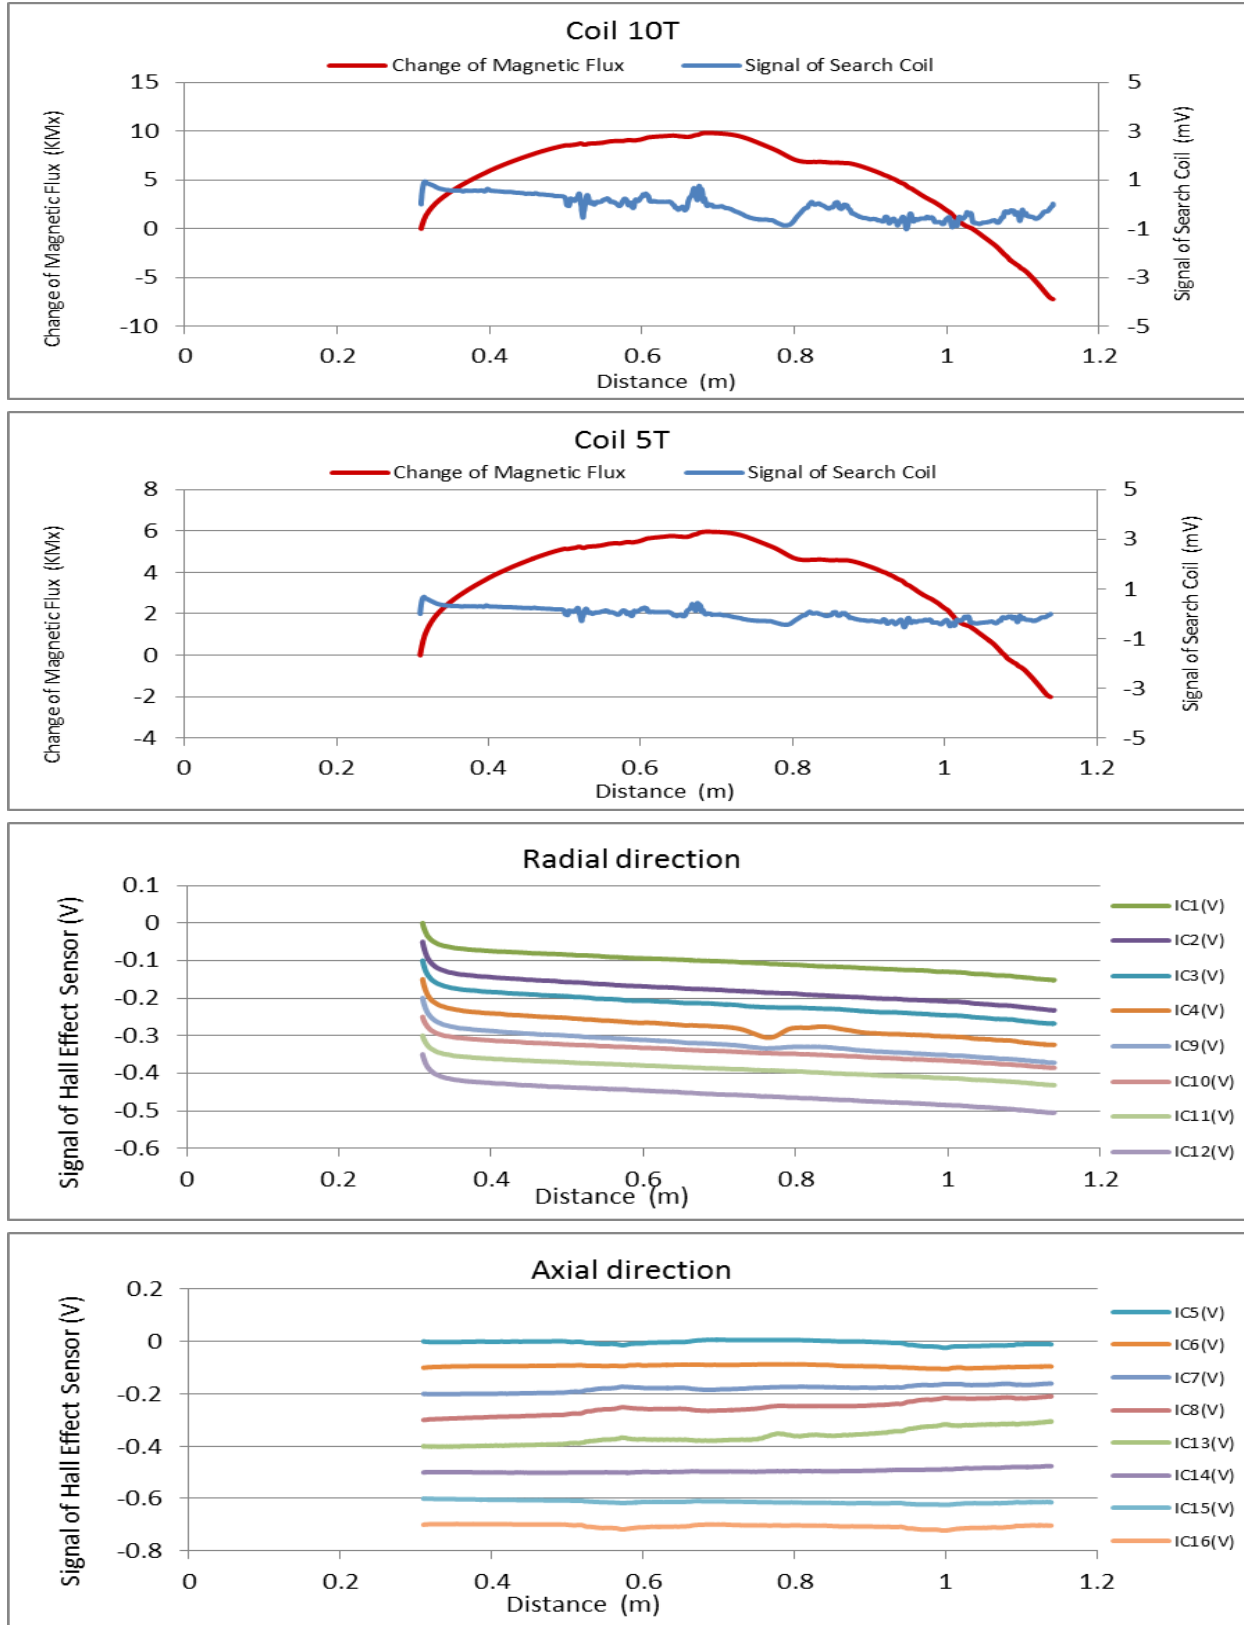
Figure 37. MMFM data for 0.6 percent damage (1 wire cut) of tendon sample #1.

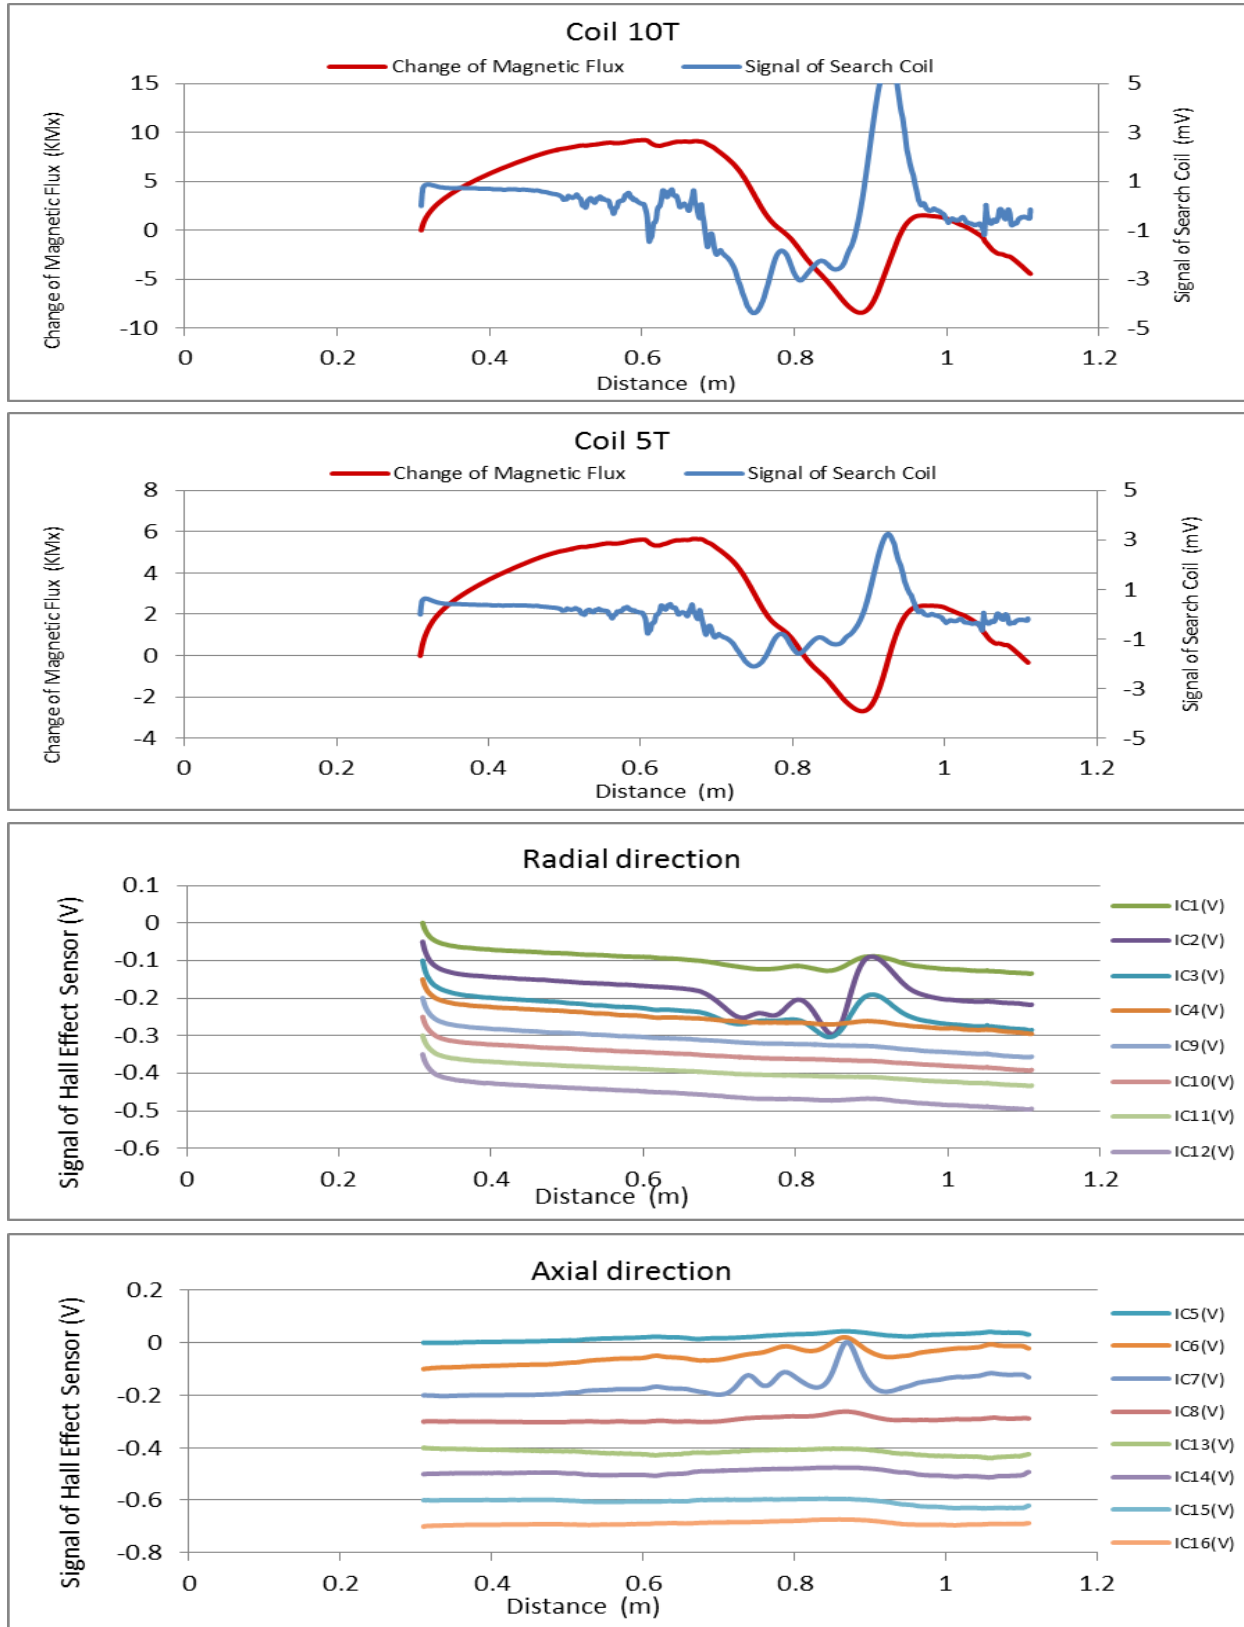
Figure 38. MMFM data for 4.5 percent damage (7 wires cut) of tendon sample #1.

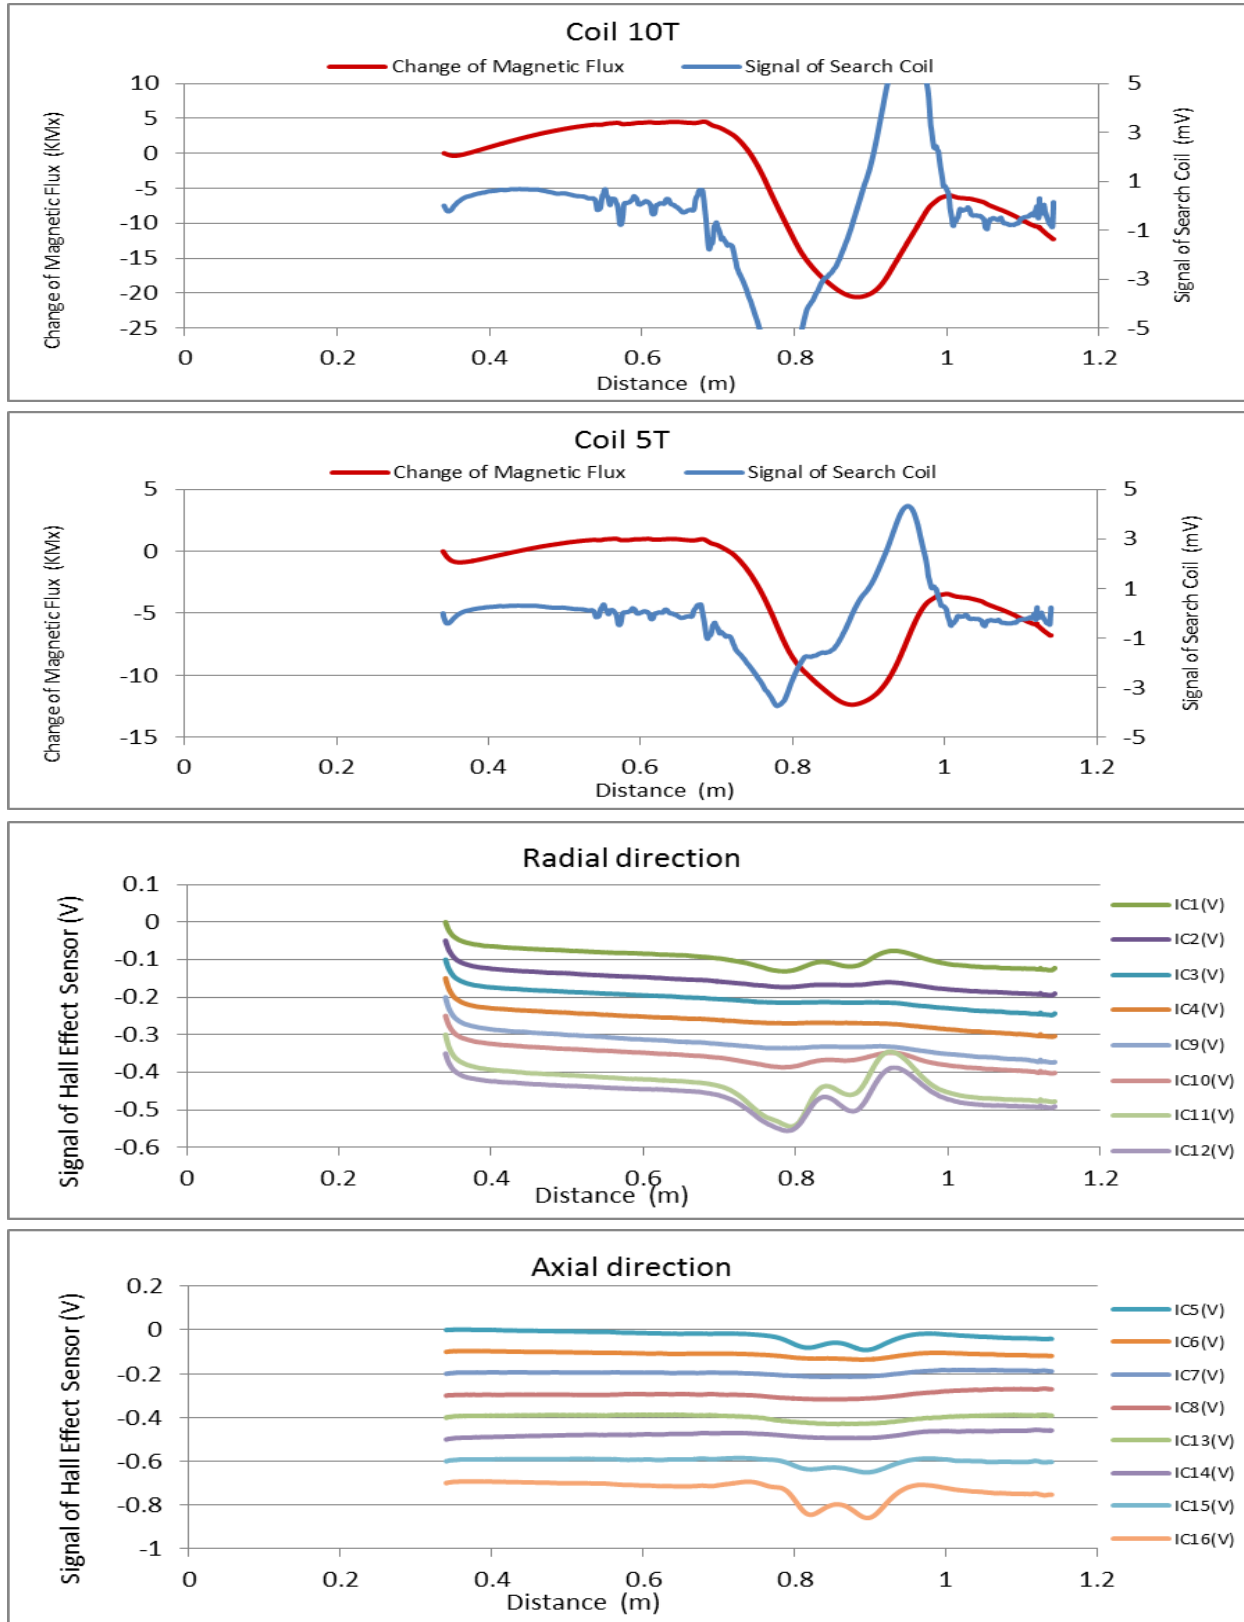
Figure 39. MMFM data for 9.1 percent damage (14 wires cut) of tendon sample #1.

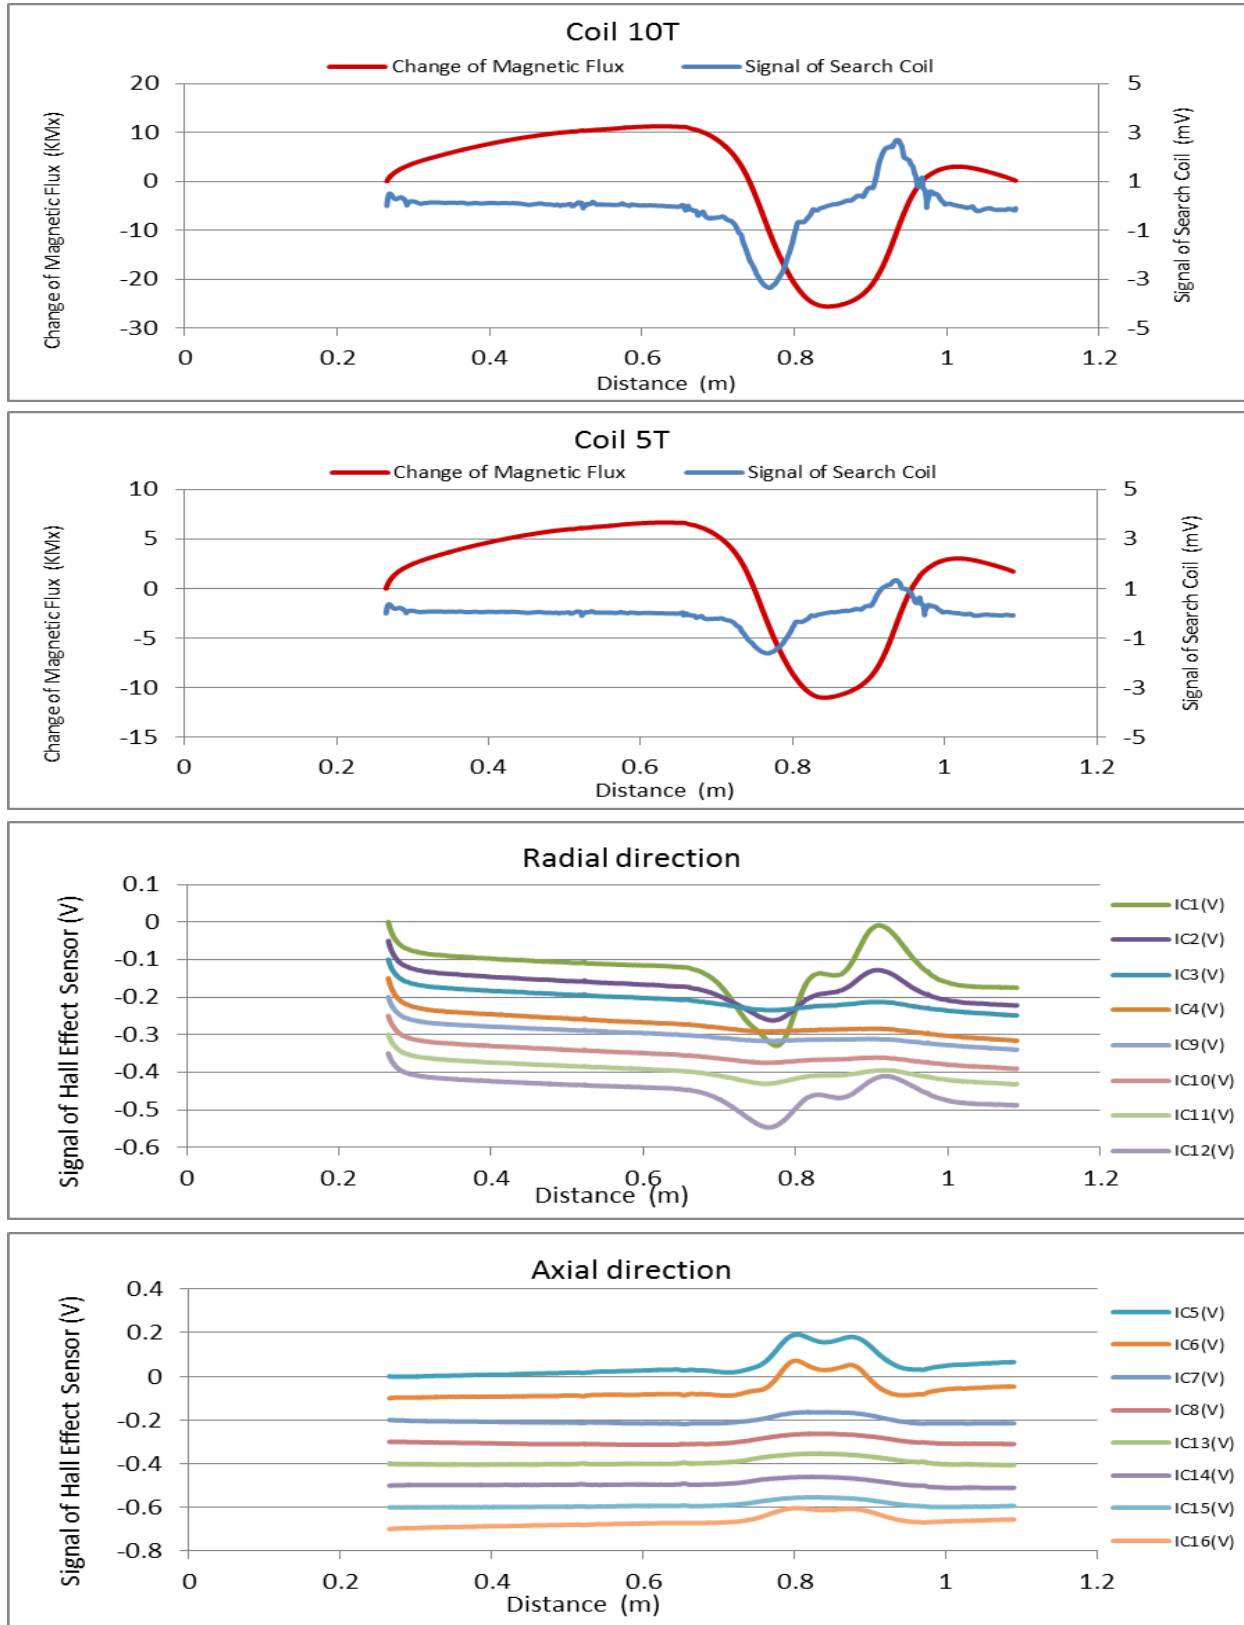
Figure 40. MMFM data for 13.6 percent damage (21 wires cut) of tendon sample #1.

It can be seen that these MMFM data reflect progressively increasing defect size by showing augmented signal changes. Based on changes of the magnetic flux (determined by the method illustrated in Figure 33) corresponding to the known section loss values, two calibration charts can be constructed as shown in Figure 41 and Figure 42. They show one-to-one relationships between section loss and change of magnetic flux sensed with 10-turn and 5-turn search coils, respectively. Both charts also include additional calibration data produced in the laboratory.

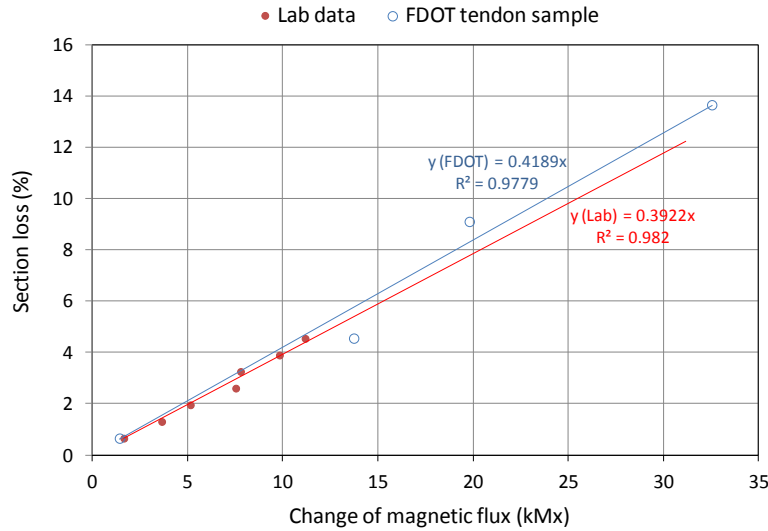
Figure 41. A calibration chart for 10T search coil.

Linear regression analysis results indicate that the calibration charts are accurate evidenced by high coefficient of determination (R^2) values and there is a reasonable agreement between the FDOT tendon sample data and the laboratory data in each chart. As shown in Figure 42, 5-turn search coil can handle larger flux changes and thus detect up to twice larger defect size compared to the 10-turn one.

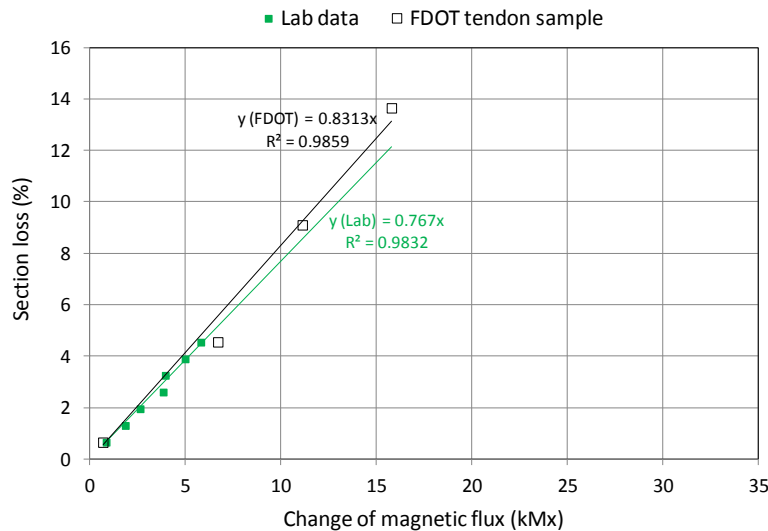
Figure 42. A calibration chart for 5T search coil.

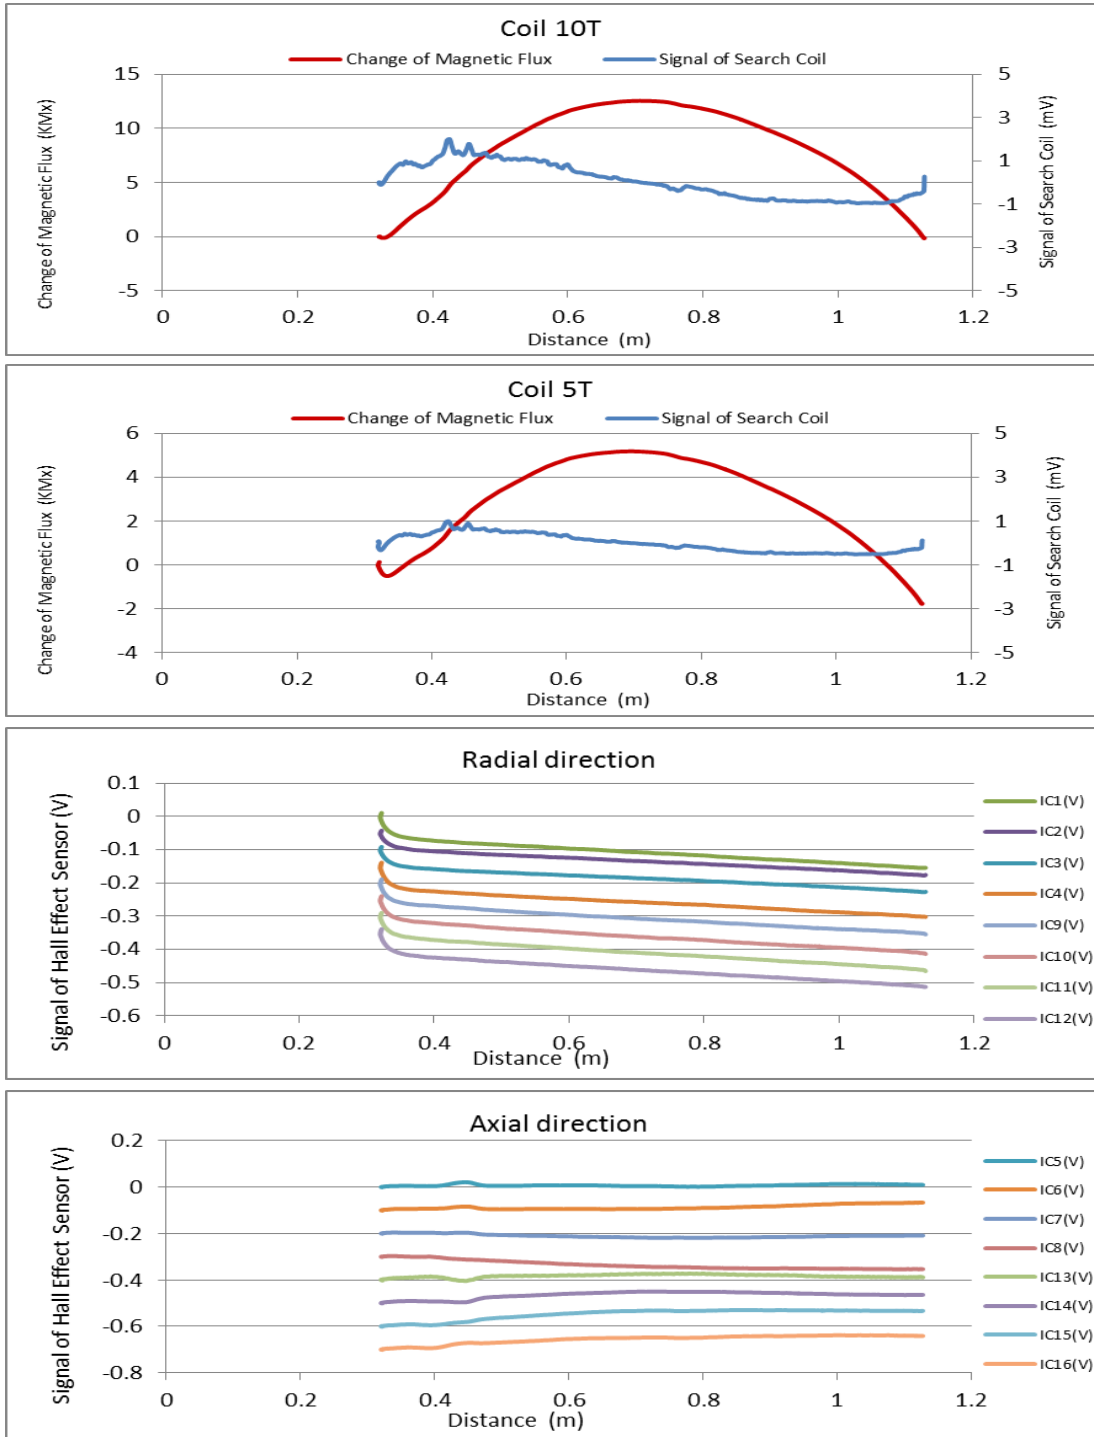
Figure 43. MMFM Data of tendon sample #2.

A very small section loss (estimated to be 0.3percent) was detected in an area between 16 and 22 inches (0.41 - 0.56 m) in the sample #2. Figure 43 shows the MMFM data of the sample #2.

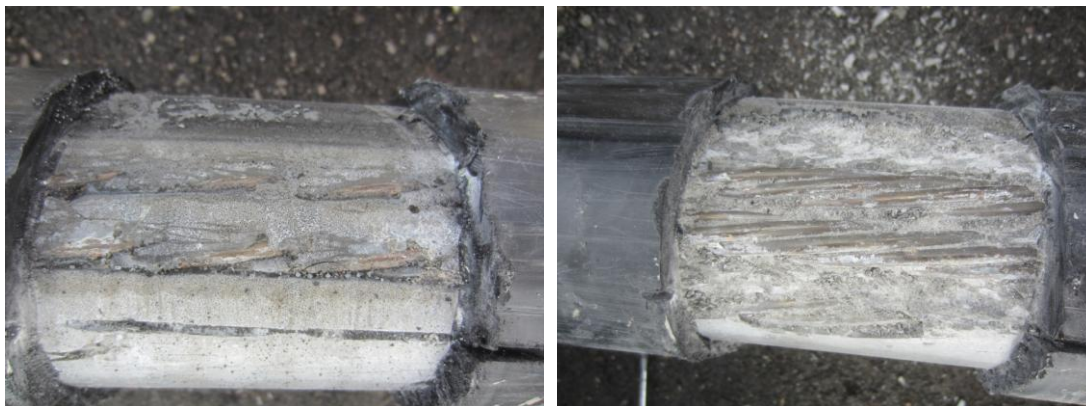
Figure 44. Front face of the suspected damage area as exposed (left) and after grout layer was partially removed (right).

Upon reviewing the data, a 6-inch duct section was removed at the Manatee Operation Center to reveal the suspected area of damage. Figure 44 and Figure 45 show the exposed conditions soon after the duct was removed. When grout was partially removed, corrosion was apparent on the bottom side (Figure 45) compared to minor corrosion appeared on the top side (Figure 44). Even though 0.3 percent section loss is insignificant for naked eyes, none of the exposed strands appeared to contain the recognizable damage.

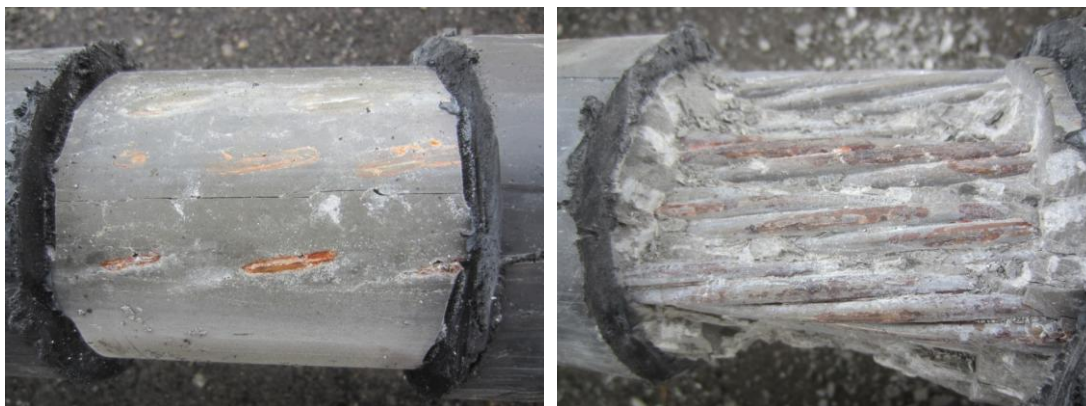
Figure 45. Back face of the suspected damage area as exposed (left) and after grout layer was partially removed (right).

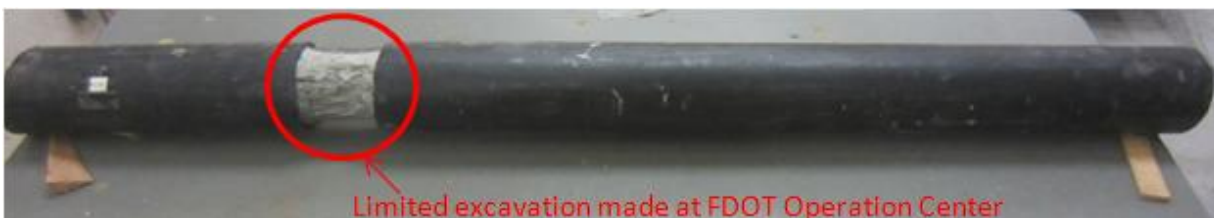
Figure 46. Tendon sample #2 before full autopsy.

A further autopsy was performed in the laboratory to document strand condition after the entire sample #2 was dismantled. Figure 46 and Figure 47 show the sample condition before and after a full autopsy was performed, respectively.

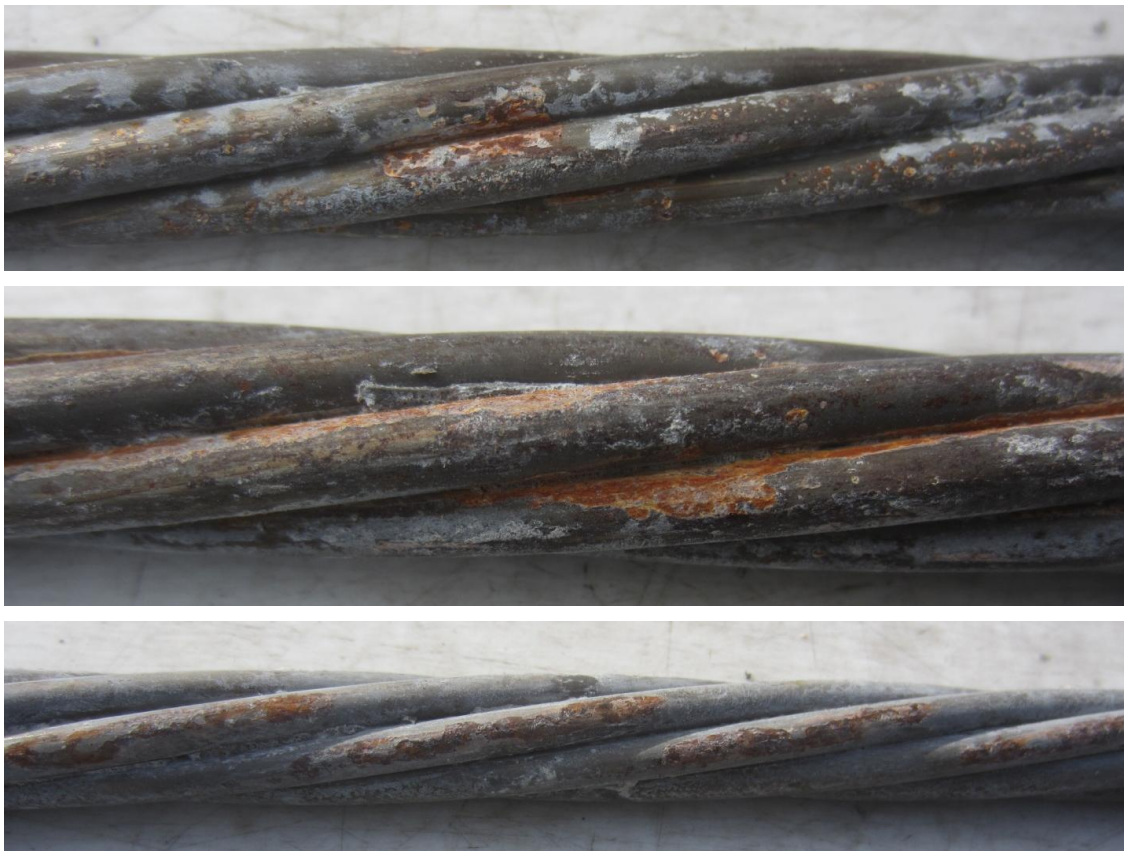
Figure 48. Representative conditions of rusted strands.

Figure 48 shows three strands that appeared to be in the worst condition. When they were cleaned with a scrubbing pad, superficial corrosion was revealed.

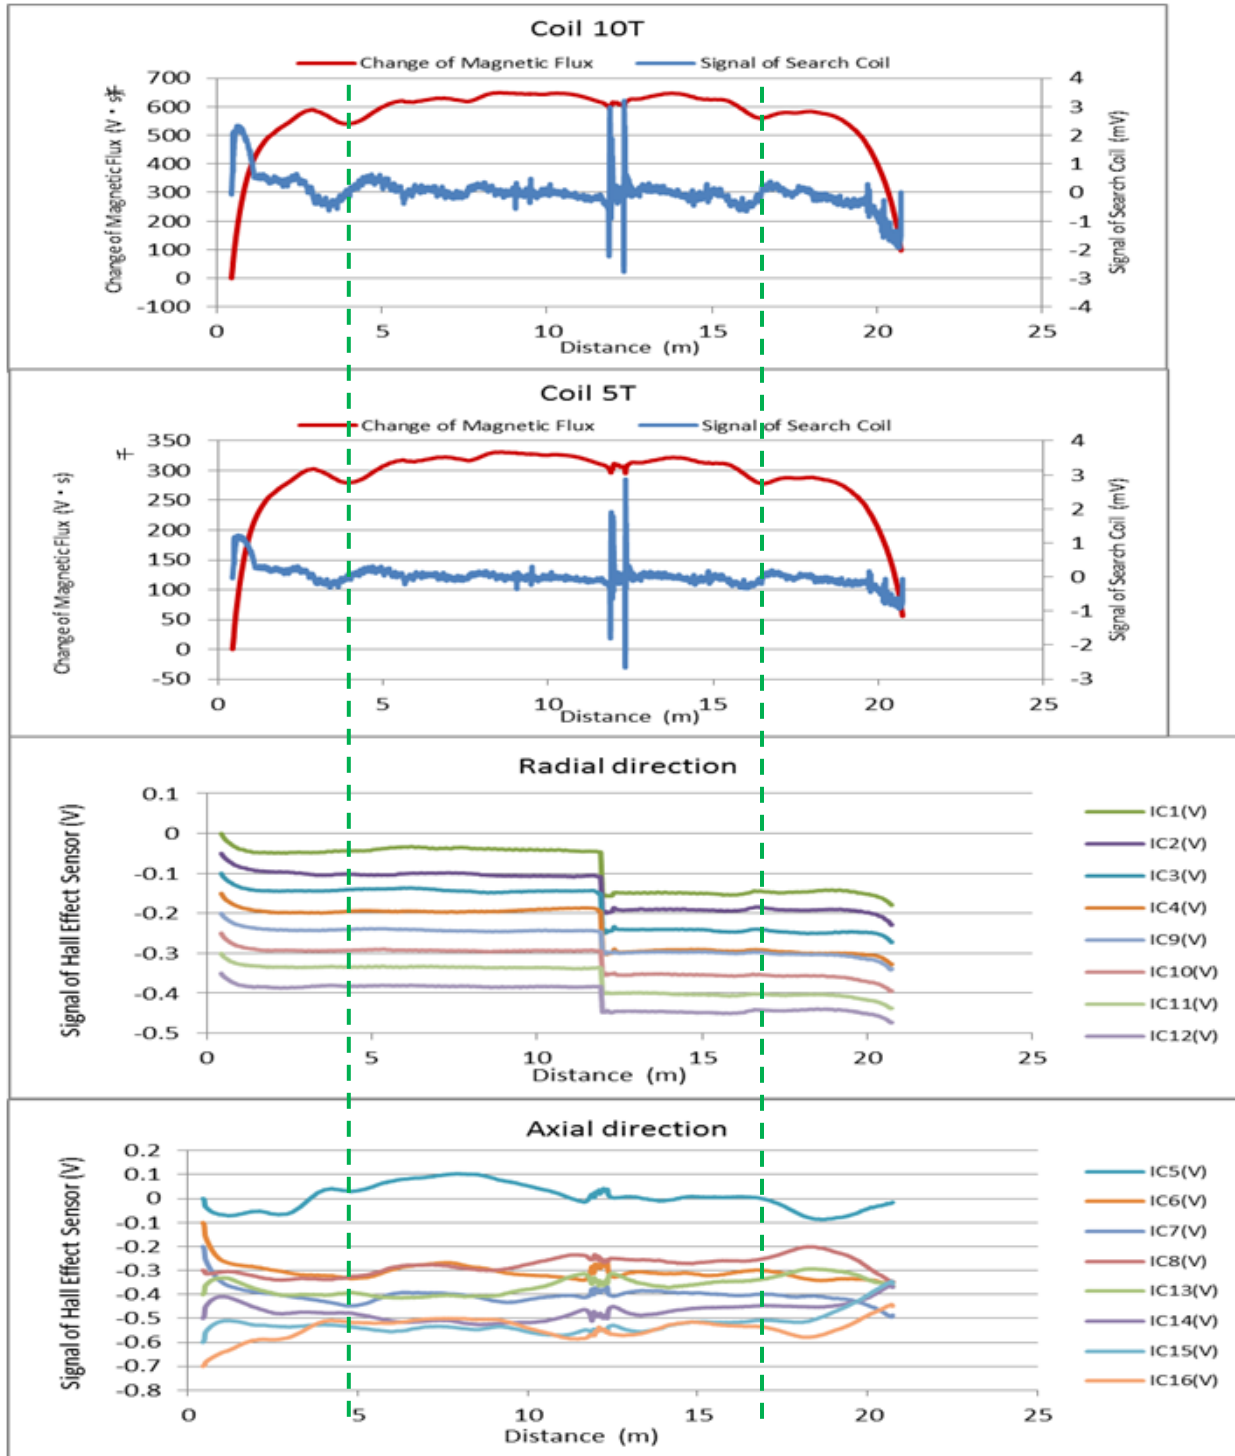
Figure 49. MMFM data for P9-406L-I1 (estimated section loss = 1.4 and 1.2 percent).

* Coil 10T = search coil 10 Turns; Coil 5T = search coil 5 Turns.

Scan ID	Pier ID-Tendon ID- Section ID	Section Length (m)	Scanned Length		Identified Damage			
			Starting Point (m)	Ending Point (m)	Center of Damage (m)	Length of Damage (m)	Estimated Section Loss (%)	Damage Orientation (Clock Position)
176	P9-404L-H1	9.5	0.5	8.7	—	—	—	—
177	P9-403L-H1	9.5	0.4	8.6	—	—	—	—
178	P9-405L-H1	9.4	0.6	8.8	—	—	—	—
179	P9-406L-H1	9.4	0.5	8.7	3.7	1.0	0.8	10 to 4
180	P9-403L-I1	21.5	0.5	20.7	—	—	—	—
181	P9-404L-I1	21.5	0.5	20.8	—	—	—	—
182	P9-405L-I1	21.5	0.4	20.8	—	—	—	—
183	P9-406L-I1	21.5	0.5	20.8	3.9	1.1	1.4	2 to 4

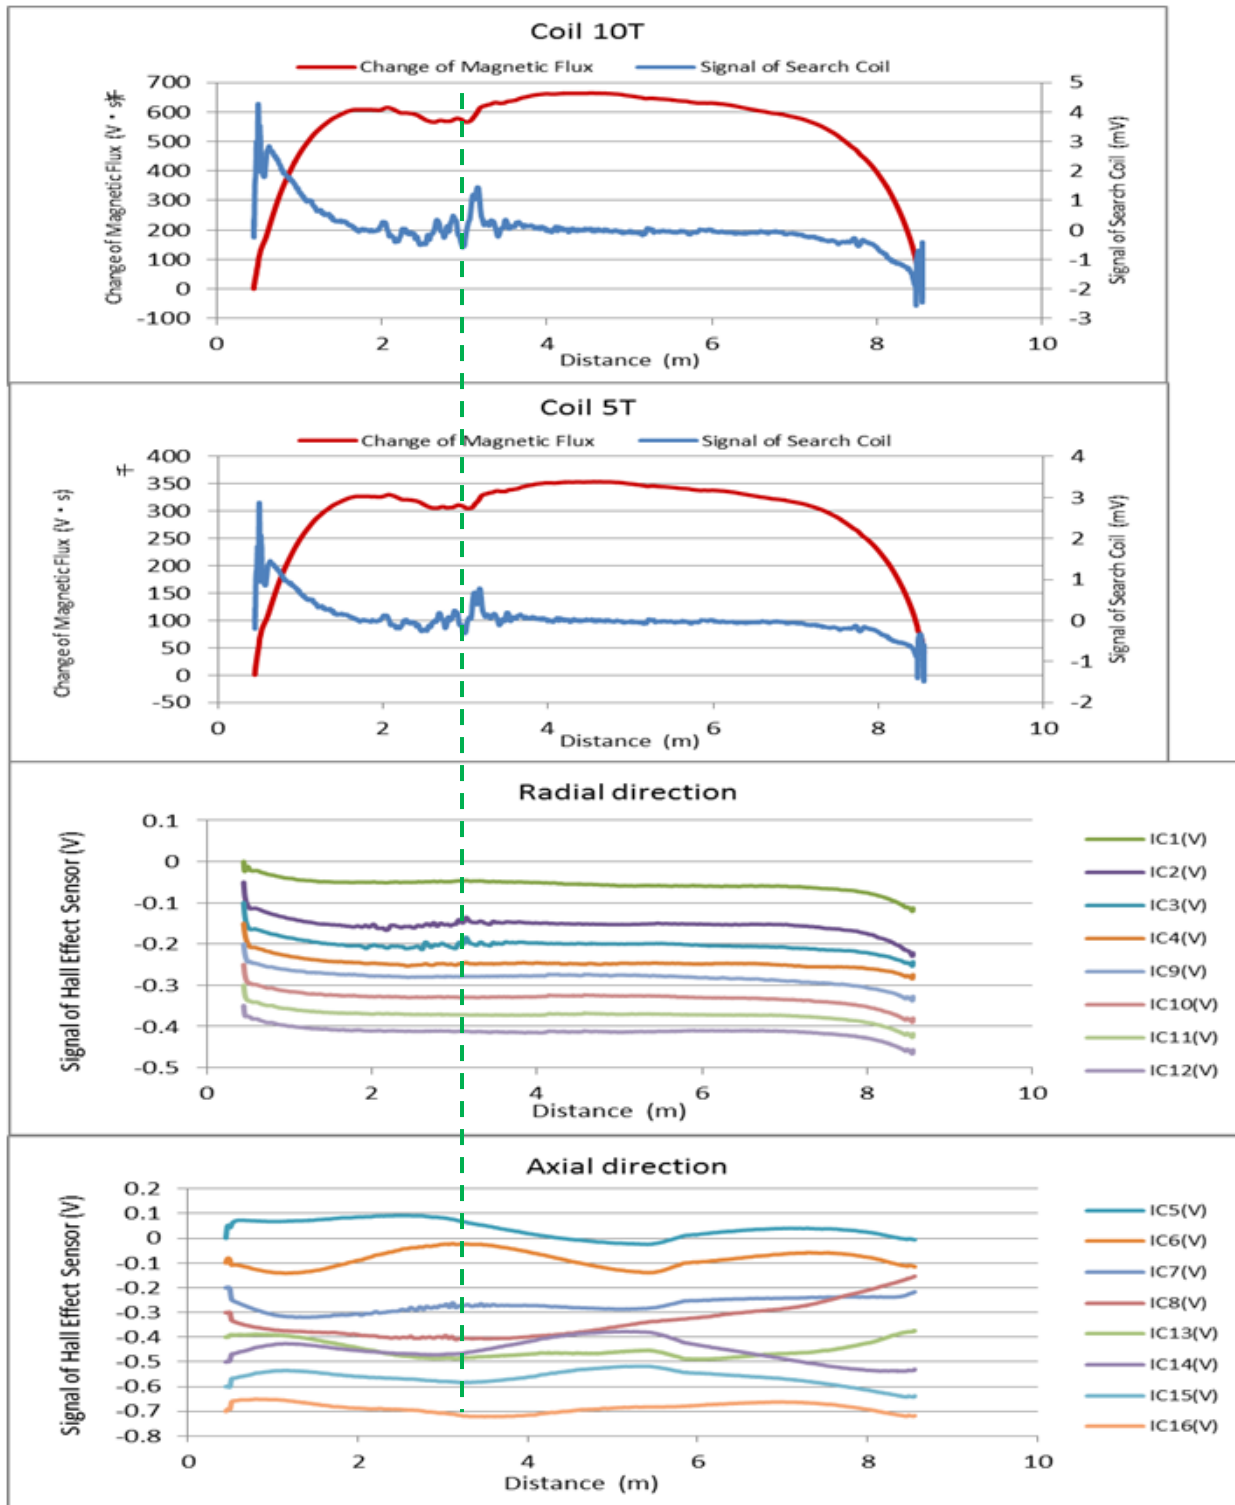
Figure 50. MMFM data for P8-403R-H1 (estimated section loss = 1.5 percent).

* Coil 10T = search coil 10 Turns; Coil 5T = search coil 5 Turns.

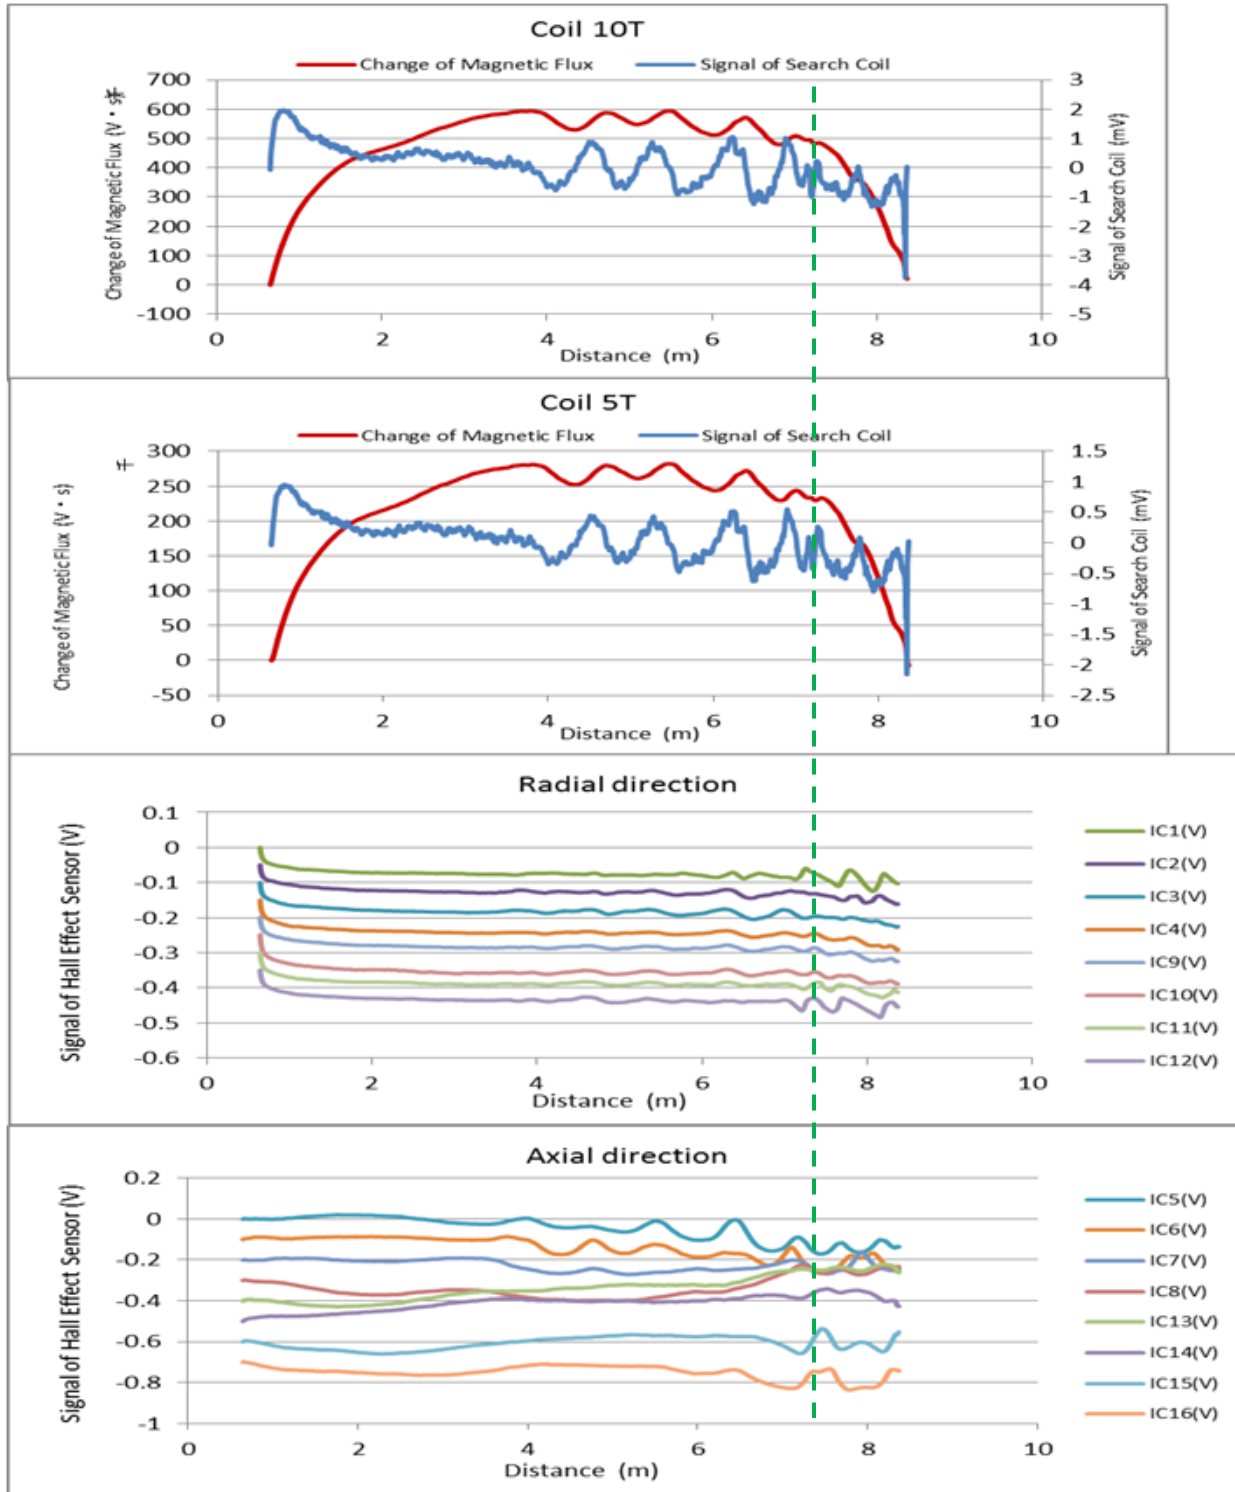
Figure 51. MMFM data for P5-402L-H1 (estimated section loss = 1.3 percent).

* Coil 10T = search coil 10 Turns; Coil 5T = search coil 5 Turns.

Scan ID	Pier ID-Tendon ID-Section ID	Section Length (m)	Scanned Length		Identified Damage			
			Starting Point (m)	Ending Point (m)	Center of Damage (m)	Length of Damage (m)	Estimated Section Loss (%)	Damage Orientation (Clock Position)
51	P4-401L-I1	21.5	0.5	20.6	—	—	—	—
49	P4-401R-I1	21.6	0.5	20.7	17.6	0.7	1.2	8 to 11
50	P4-402R-I1	21.6	0.6	20.8	—	—	—	—
51	P4-401L-I1	21.5	0.5	20.6	—	—	—	—
52	P4-402L-I1	21.5	0.5	20.8	—	—	—	—
53	P4-401R-I2	21.5	0.7	20.9	19.8	0.1	-1.8	2 to 4
54	P4-402R-I2	21.5	0.7	20.9	—	—	—	—
55	P4-401L-I2	21.5	0.8	20.9	9.1	0.2	-2.2	12 to 2
56	P4-402L-I2	21.5	0.7	20.9	—	—	—	—
57	P4-401R-H2	9.4	0.7	8.8	—	—	—	—
58	P4-402R-H2	9.4	0.8	8.8	—	—	—	—
59	P4-401L-H2	9.4	0.8	8.9	—	—	—	—
60	P4-401L-H2	9.4	0.8	8.8	3.3	0.8	1.0	1 to 4
61	P5-401R-H1	9.4	0.6	8.8	—	—	—	—
62	P5-402R-H1	9.4	0.6	8.5	—	—	—	—
63	P5-303R-I1	9.6	0.6	9.2	—	—	—	—
64	P5-401L-H1	9.3	0.7	8.5	—	—	—	—
65	P5-402L-H1	9.3	0.7	8.4	7.5	1.4	1.3	8 to 11
