**Development of Quality Assurance and Quality Control
System for Post Tensioned Segmental Bridges in Florida:
Case of Ringling Bridge – Phase II**

**FDOT Contract No. BDV29-977-34
FINAL REPORT**

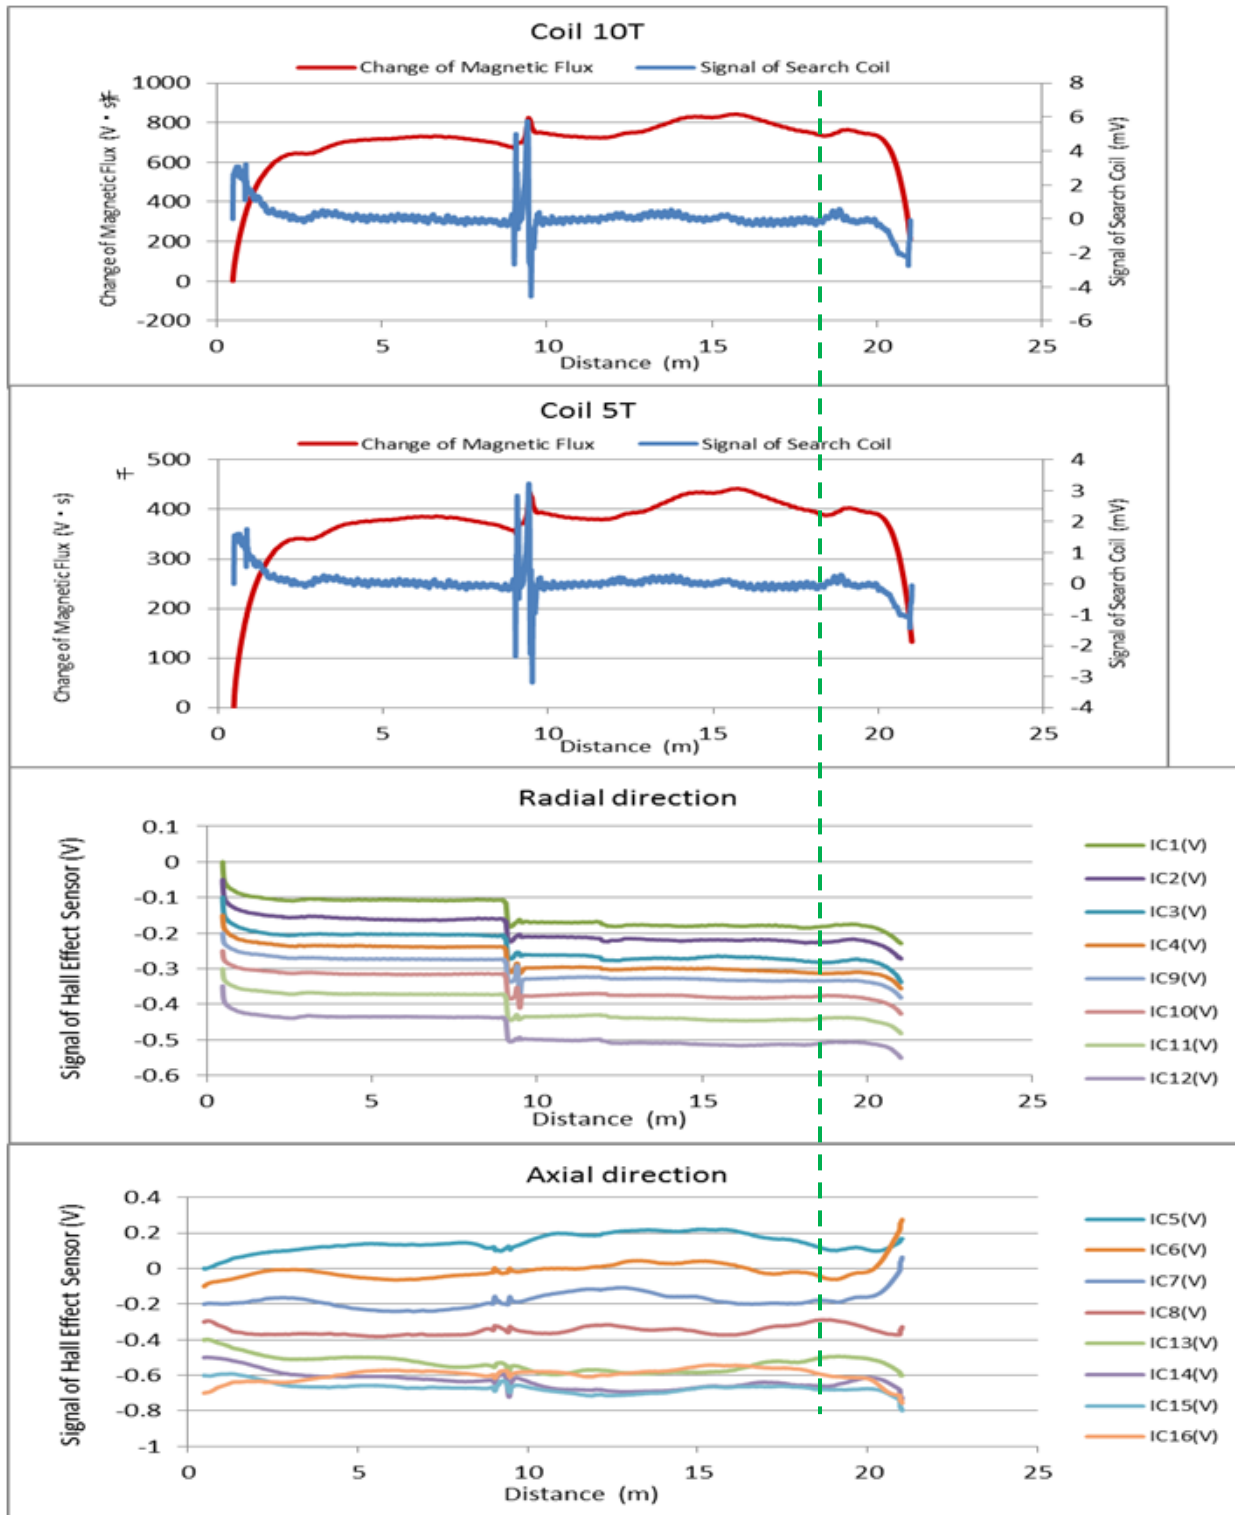
Figure 52. MMFM data for P9-405L-I2 (estimated section loss = 1.5 percent).

* Coil 10T = search coil 10 Turns; Coil 5T = search coil 5 Turns.

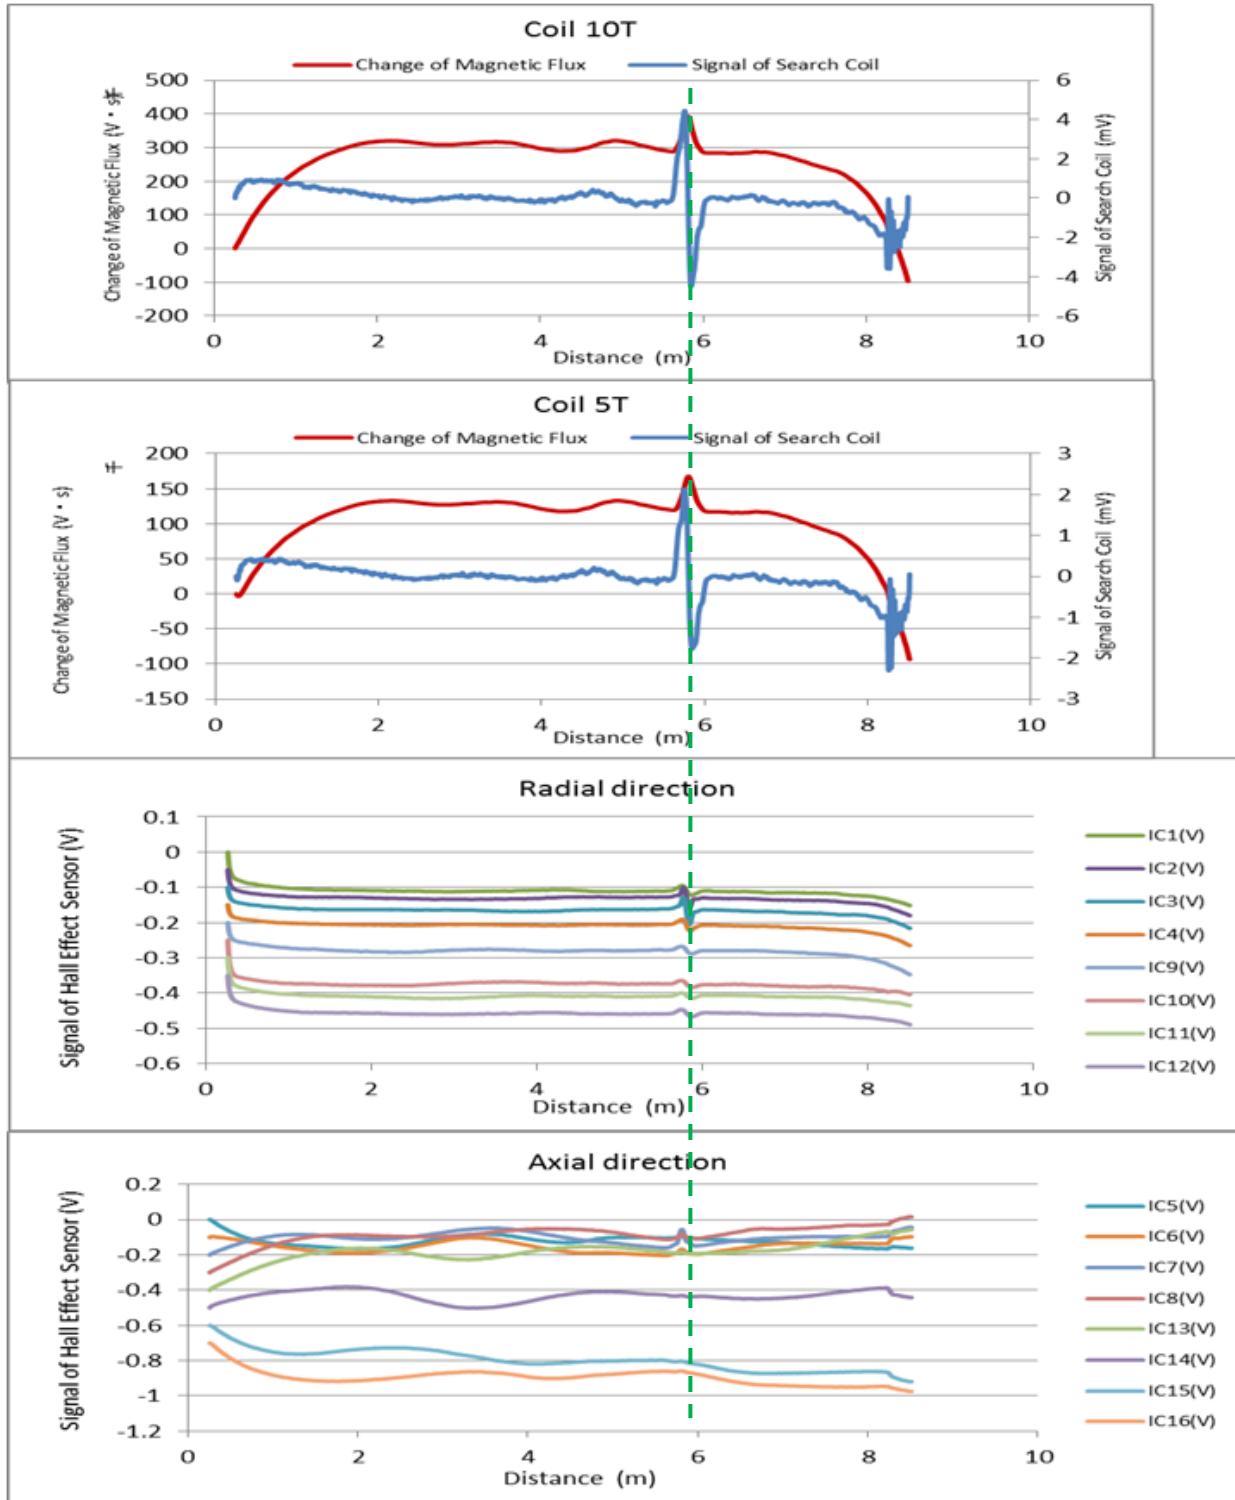
Figure 53. MMFM data for P5-303L-I4 (estimated section increase = 2.2 percent).

* Coil 10T = search coil 10 Turns; Coil 5T = search coil 5 Turns.

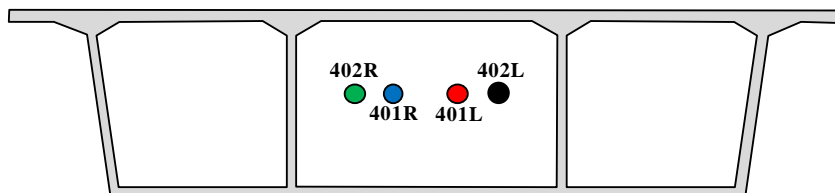
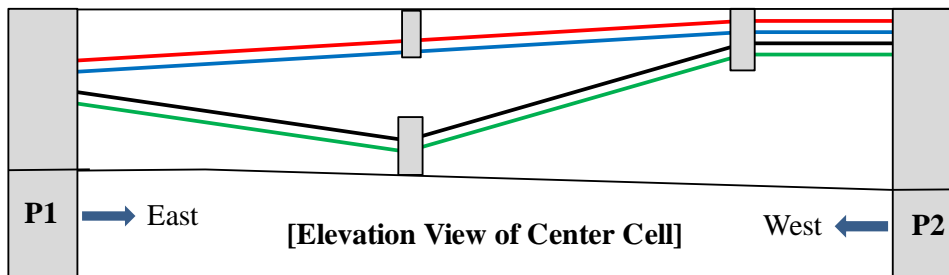
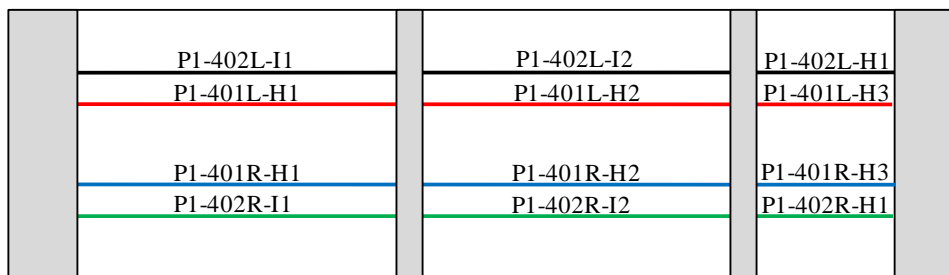
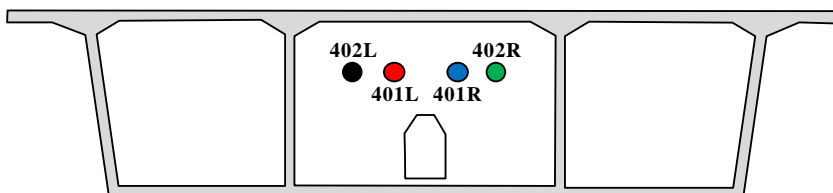
Figure A1. Scanned tendon sections in P1 – P2 (center cell).

[Diaphragm: East Face at Pier 1 (Abutment)]

[Elevation View of Center Cell]

[Plan View of Center Cell]

[Diaphragm: West Face at Pier 2]

A total of 175 tendon sections were scanned in the entire center cells on the bridge. Table 1 summarizes the scan results in terms of scan ID, tendon section ID, starting/ending points, center position/length of the identified damage, estimated section loss, and damage orientation. In addition, 46 tendon sections were also scanned in the left and right cells in P8 – P9 and P9 – P10 spans. Their scan results are summarized similarly in Table 2. The information in the tables is organized by the scan sequence. The replaced tendon sections (marked as ‘new’) were not tested due to their young age. The exact location of each scanned tendon section can be found in the schematic tendon arrangement diagrams provided in Appendix 1.

None of the MMFM data indicated 3.0 percent and larger section loss. Considering previous corrosion problems associated with this bridge, the absence of noticeable corrosion damage suggested by the present NDE technology is a very encouraging finding. For the purpose of validating the NDE data, four tendon sections containing 1.2 to 1.5 percent section losses are recommended for excavation and they are highlighted in green in Table 1 and Table 2. Interestingly, 21 tendon sections were estimated to have increased cross-sectional areas, instead of section loss. It might be caused by some foreign metal pieces installed in the duct prior to grouting. One of these sections showing 2.2 percent section increase is also recommended for excavation to investigate the cause. Figure 49 through Figure 53 show the MMFM data of five tendon sections recommended for destructive verification. Their opening locations are indicated by green dash lines in the figures.

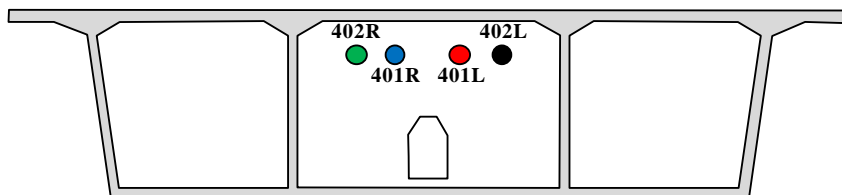
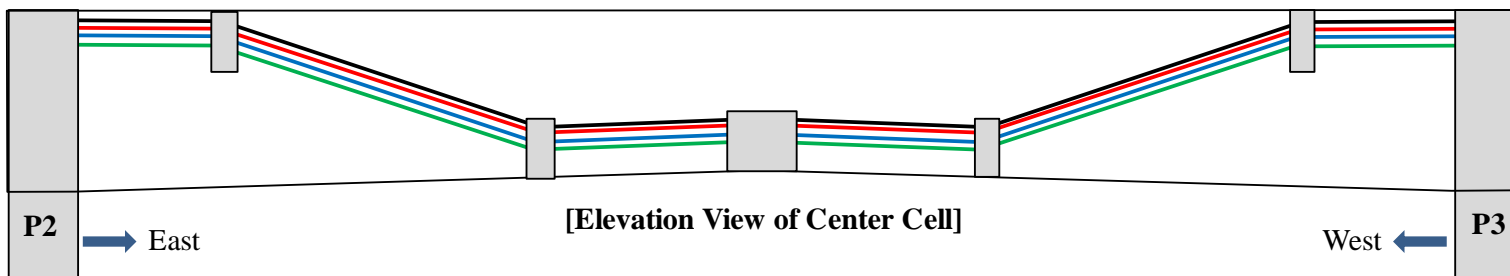
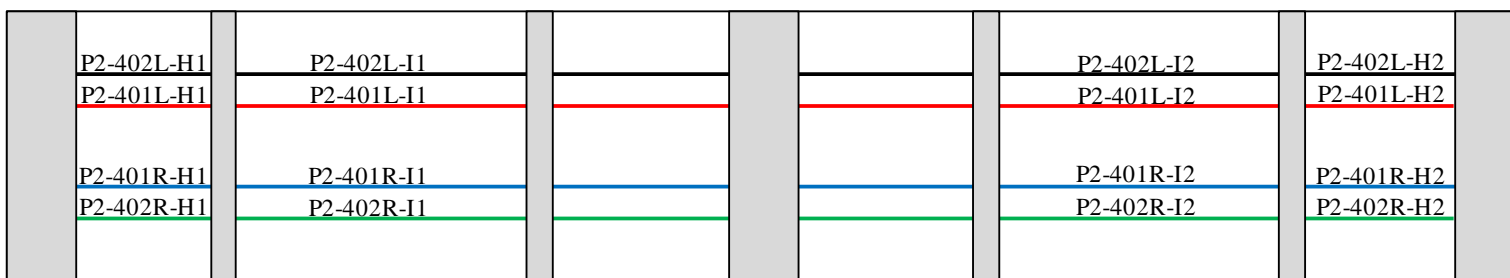
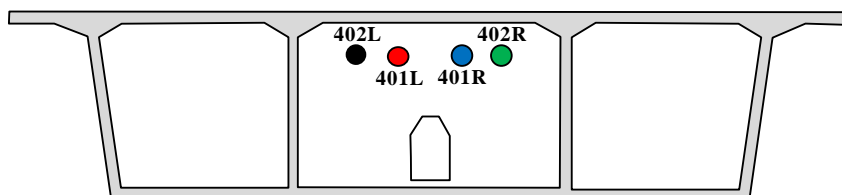
Figure A2. Scanned tendon sections in P2 – P3 (center cell).

[Diaphragm: East Face at Pier 2]

[Elevation View of Center Cell]

[Plan View of Center Cell]

[Diaphragm: West Face at Pier 3]

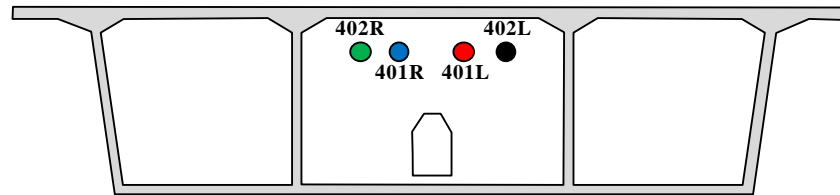
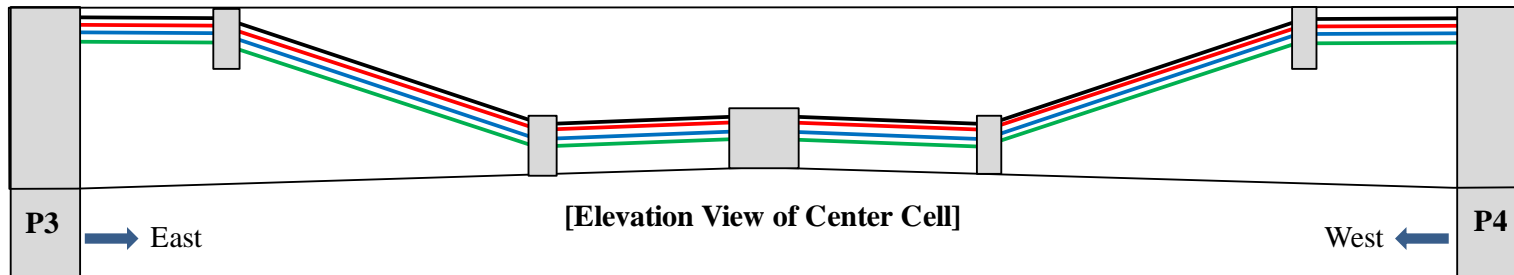
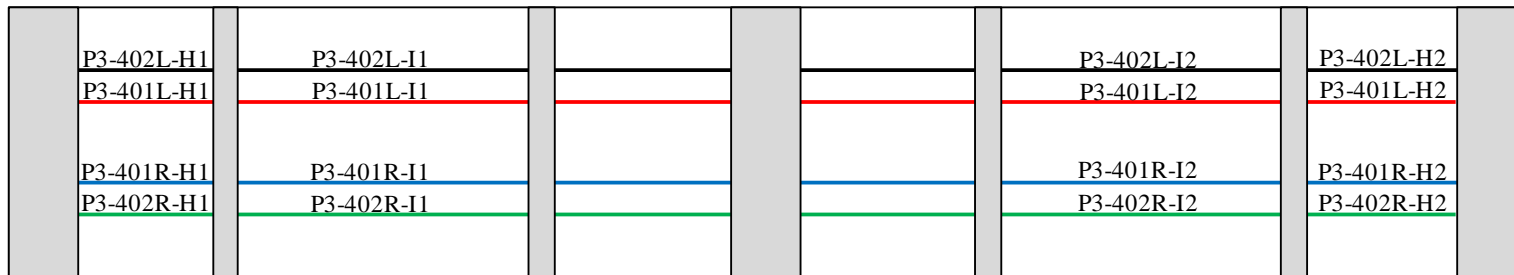
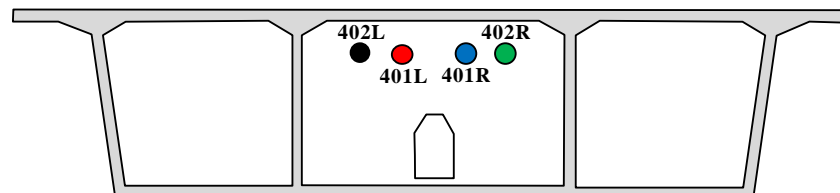
Figure A3. Scanned tendon sections in P3 – P4 (center cell).

[Diaphragm: East Face at Pier 3]

[Elevation View of Center Cell]

[Plan View of Center Cell]

[Diaphragm: West Face at Pier 4]

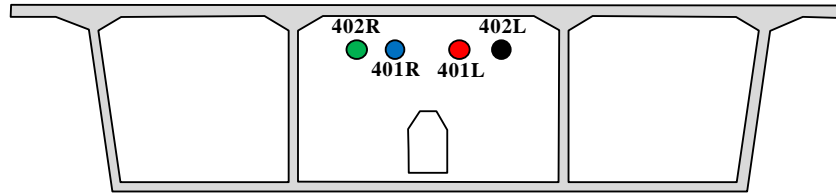
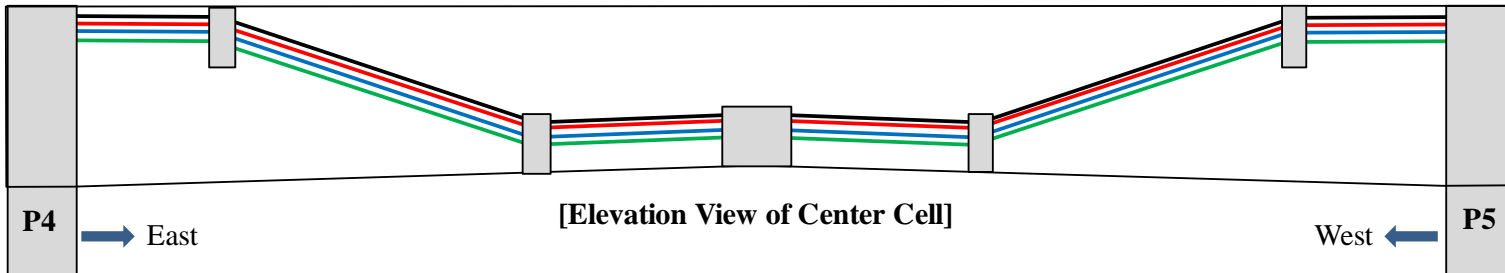
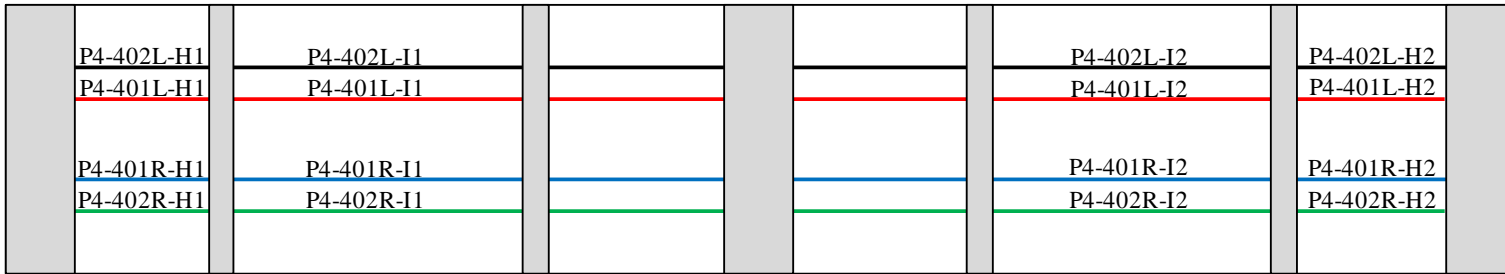
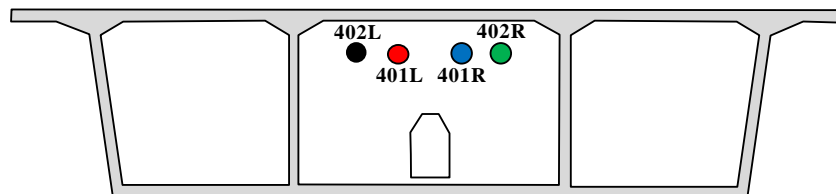
Figure A4. Scanned tendon sections in P4 – P5 (center cell).

[Diaphragm: East Face at Pier 4]

[Elevation View of Center Cell]

[Plan View of Center Cell]

[Diaphragm: West Face at Pier 5]

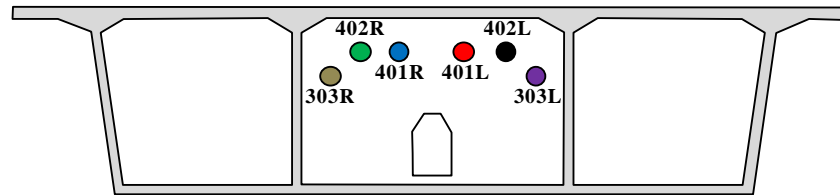
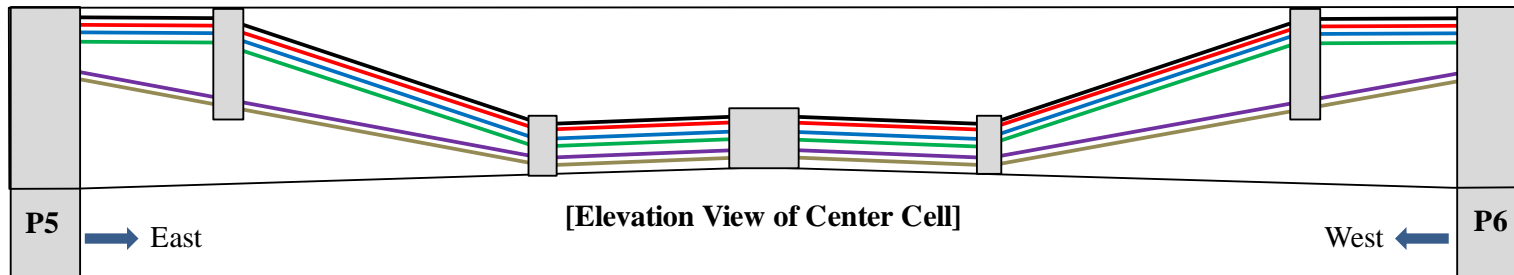
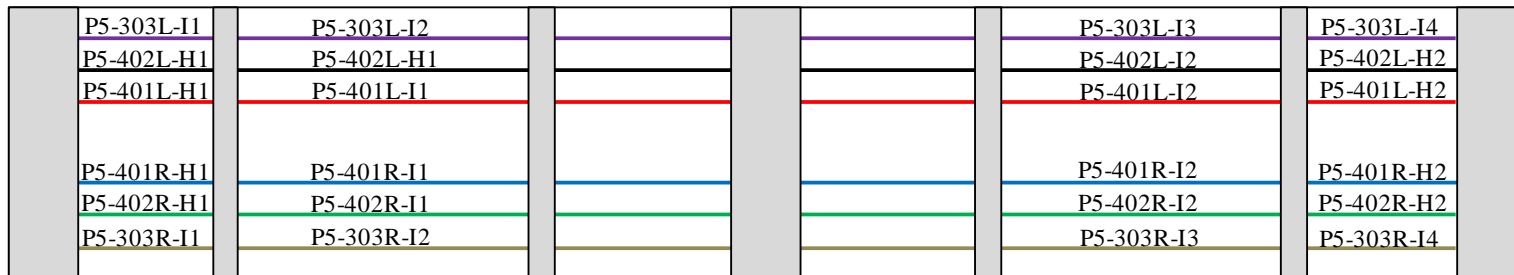
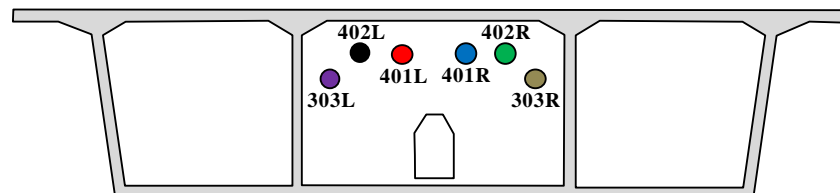
Figure A5. Scanned tendon sections in P5 – P6 (center cell).

[Diaphragm: East Face at Pier 5]

[Elevation View of Center Cell]

[Plan View of Center Cell]

[Diaphragm: West Face at Pier 6]

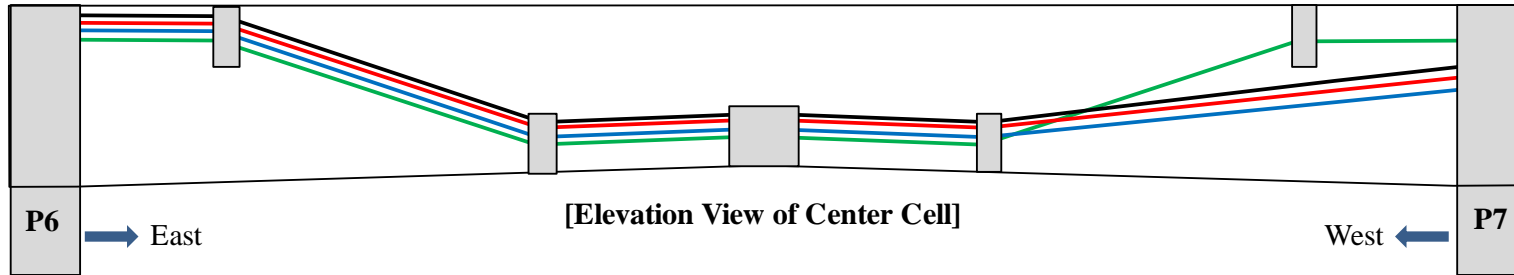
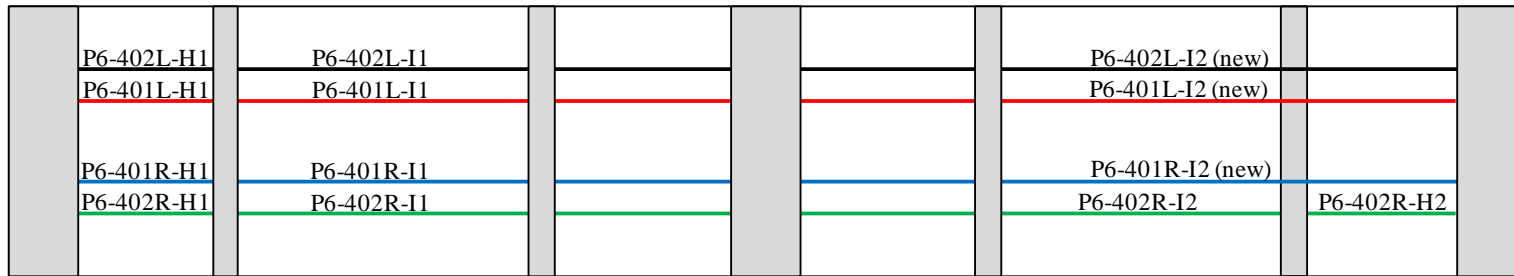
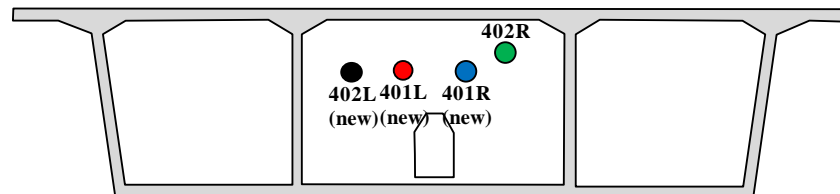
Figure A6. Scanned tendon sections in P6 – P7 (center cell).

[Diaphragm: East Face at Pier 6]

[Plan View of Center Cell]

[Diaphragm: West Face at Pier 7]

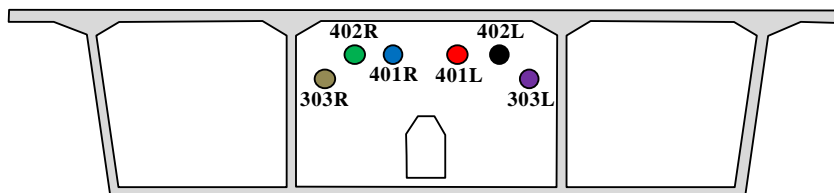
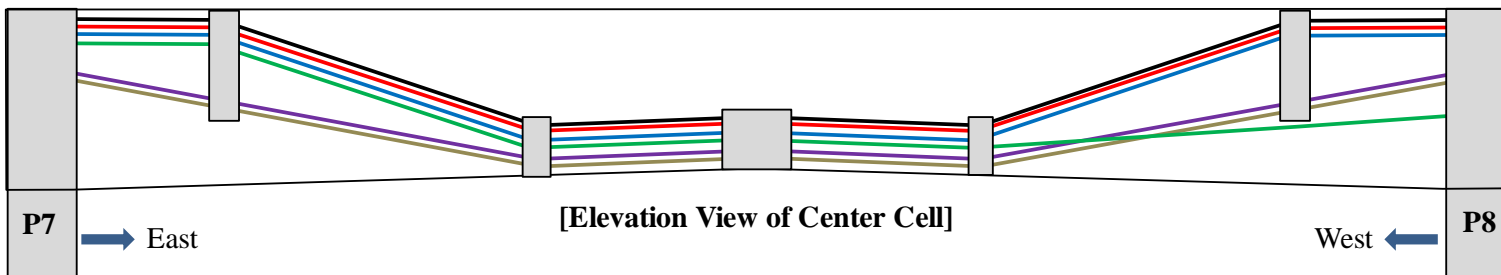
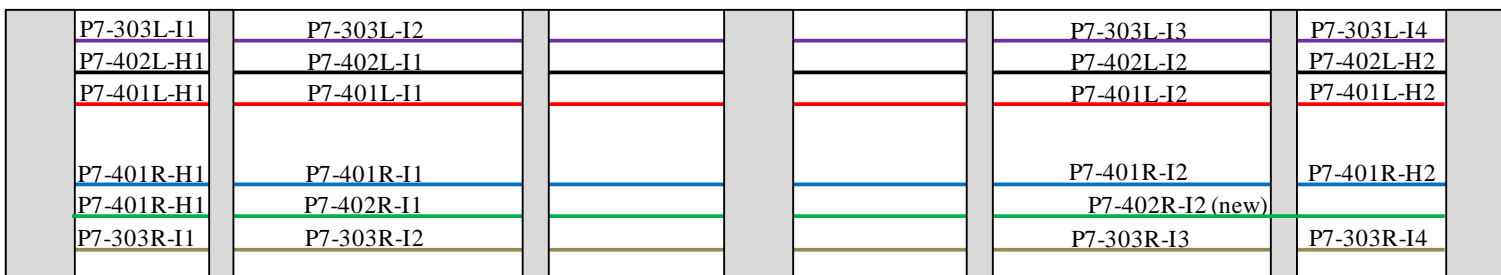
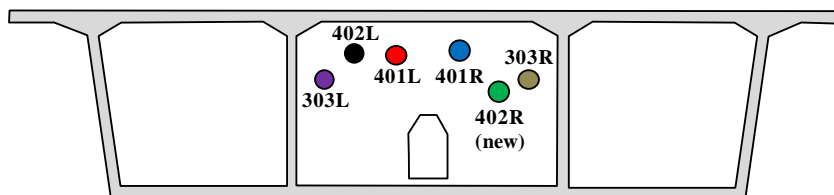
Figure A7. Scanned tendon sections in P7 – P8 (center cell).

[Diaphragm: East Face at Pier 7]

[Elevation View of Center Cell]

[Plan View of Center Cell]

[Diaphragm: West Face at Pier 8]

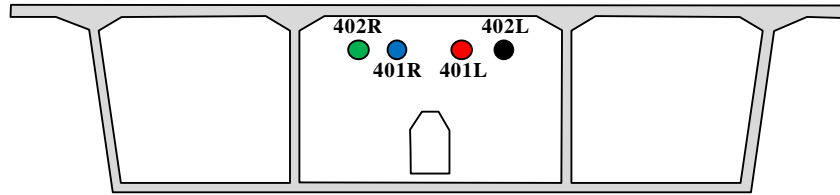
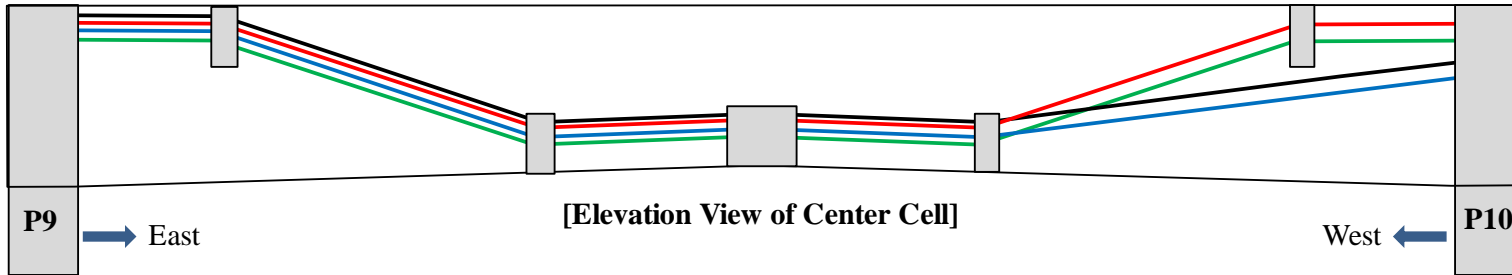
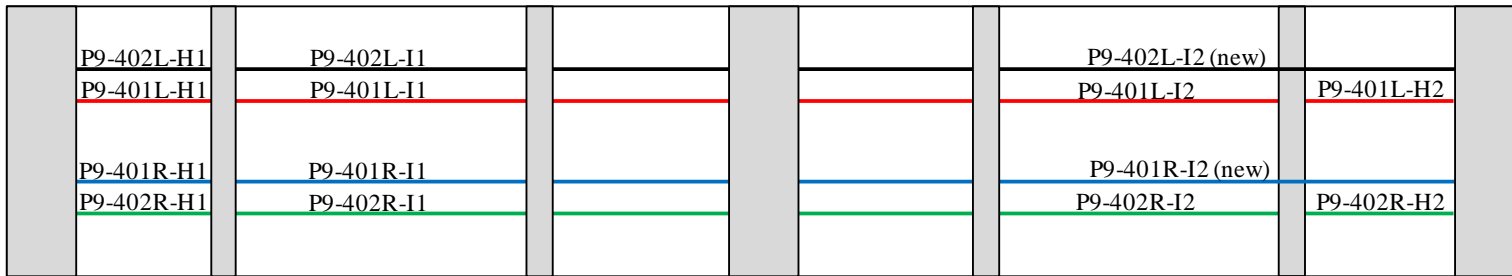
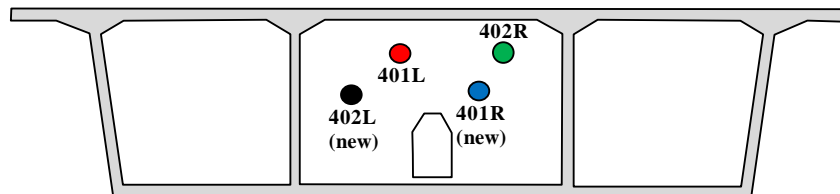
Figure A11. Scanned tendon sections in P9 – P10 (center cell).

[Diaphragm: East Face at Pier 9]

[Elevation View of Center Cell]

[Plan View of Center Cell]

[Diaphragm: West Face at Pier 10]

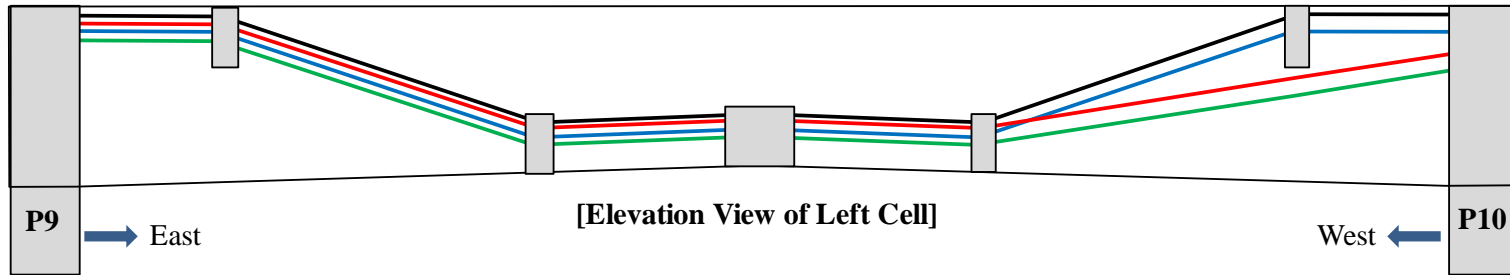
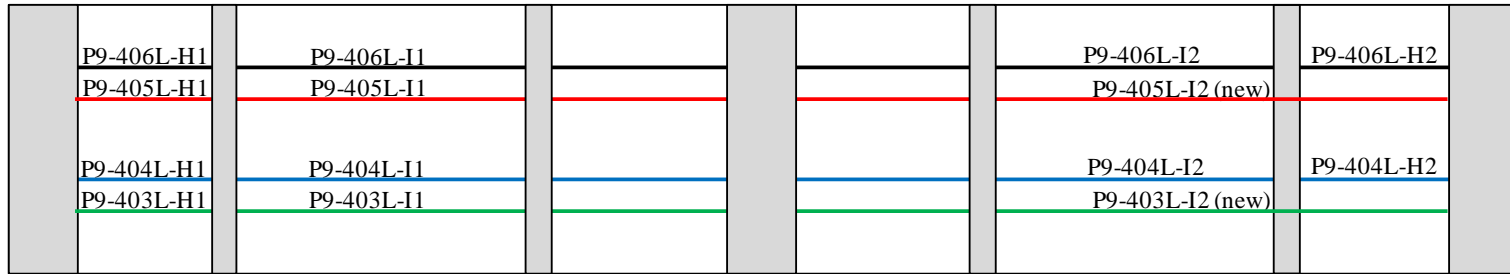
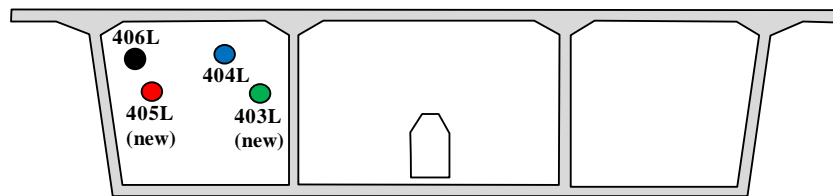
Figure A12. Scanned tendon sections in P9 – P10 (left cell).

[Diaphragm: East Face at Pier 9]

[Elevation View of Left Cell]

[Plan View of Left Cell]

[Diaphragm: West Face at Pier 10]

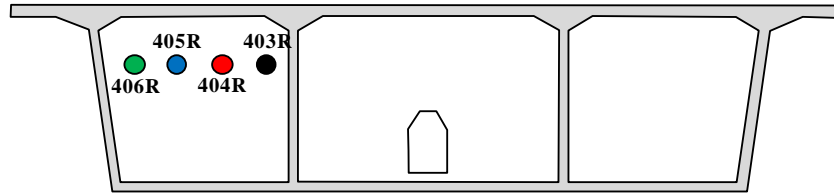
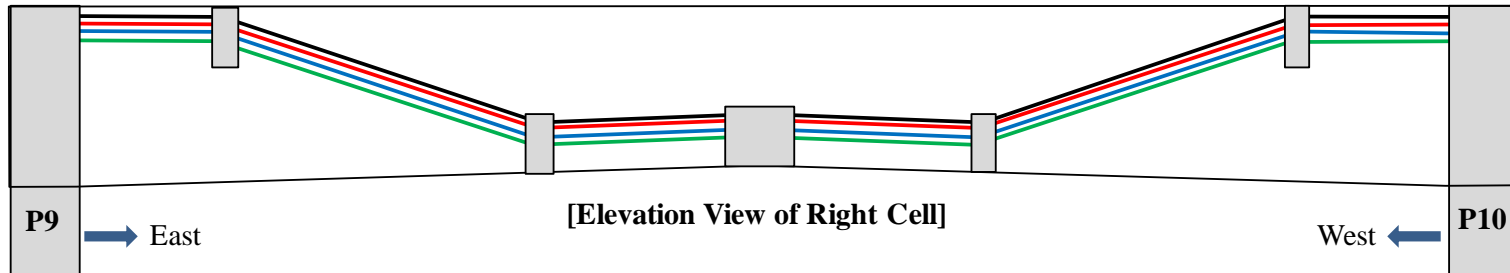
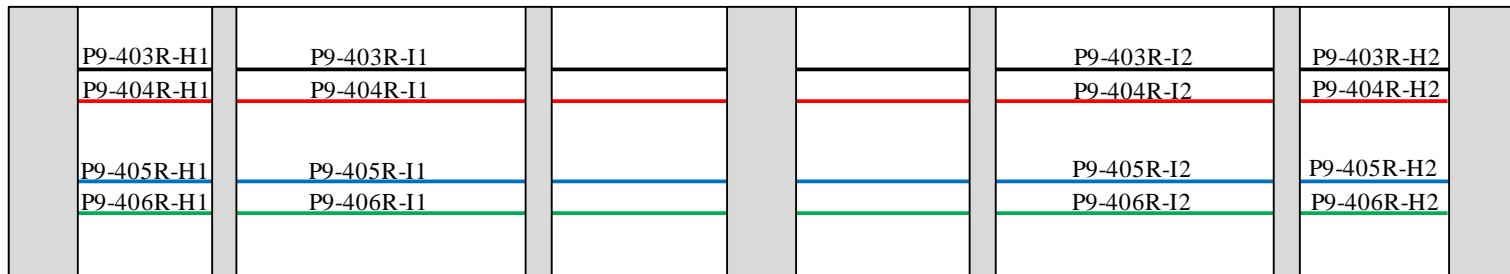
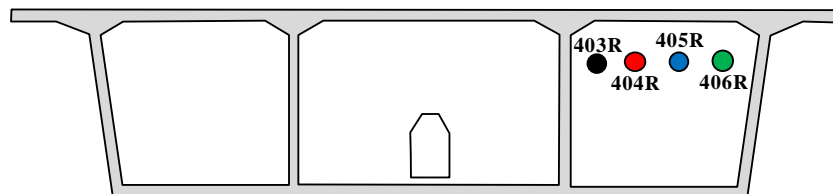
Figure A13. Scanned tendon sections in P9 – P10 (right cell).

[Diaphragm: East Face at Pier 9]

[Elevation View of Right Cell]

[Plan View of Right Cell]

[Diaphragm: West Face at Pier 10]

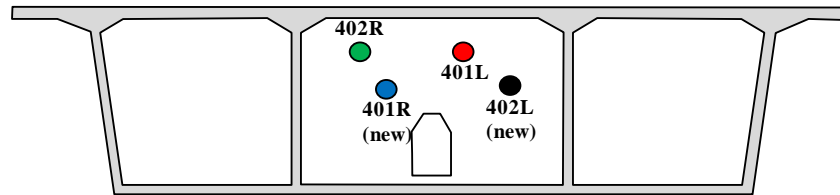
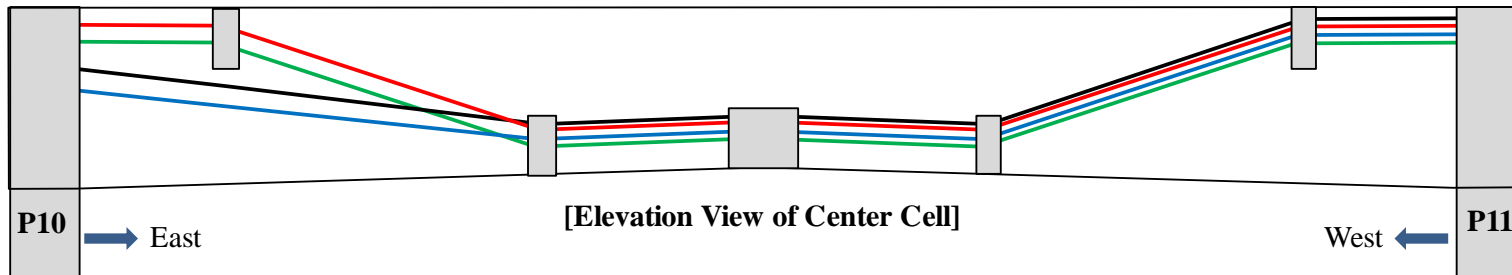
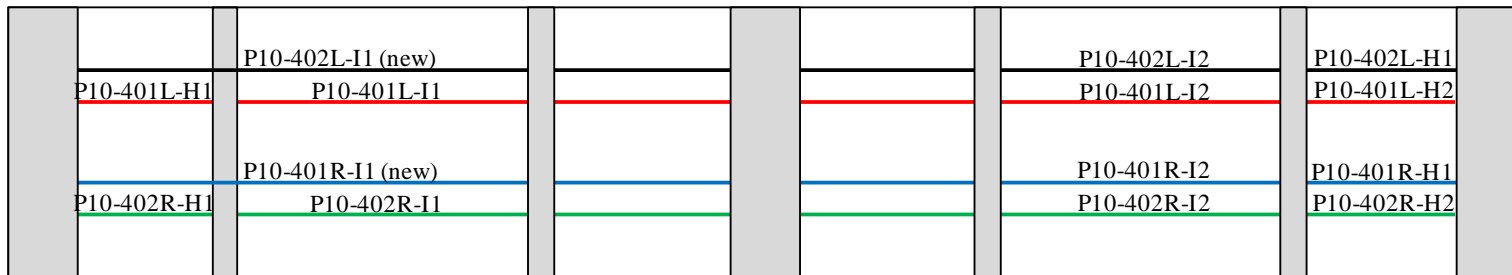
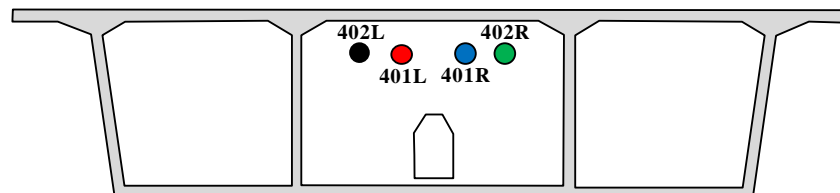
Figure A14. Scanned tendon sections in P10 – P11 (center cell).

[Diaphragm: East Face at Pier 10]

[Elevation View of Center Cell]

[Plan View of Center Cell]

[Diaphragm: West Face at Pier 11]

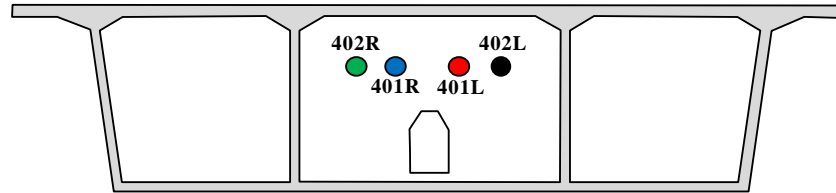
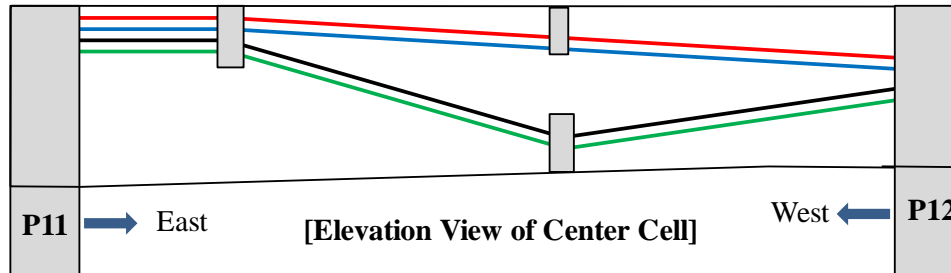
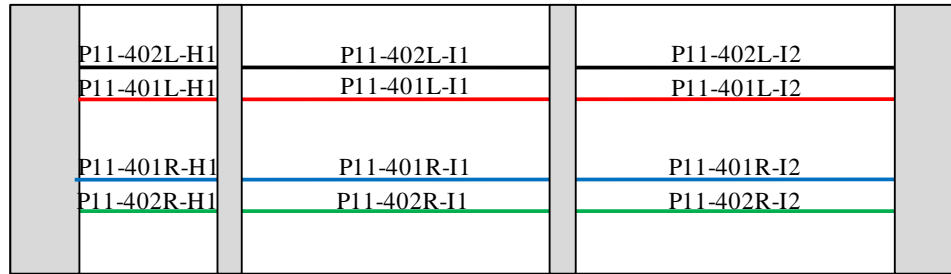
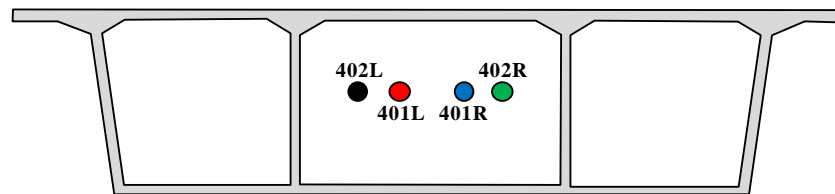
Figure A15. Scanned tendon sections in P11 – P12 (center cell)

[Diaphragm: East Face at Pier 11]

[Elevation View of Center Cell]

[Plan View of Center Cell]

[Diaphragm: West Face at Pier 12 (Abutment)]

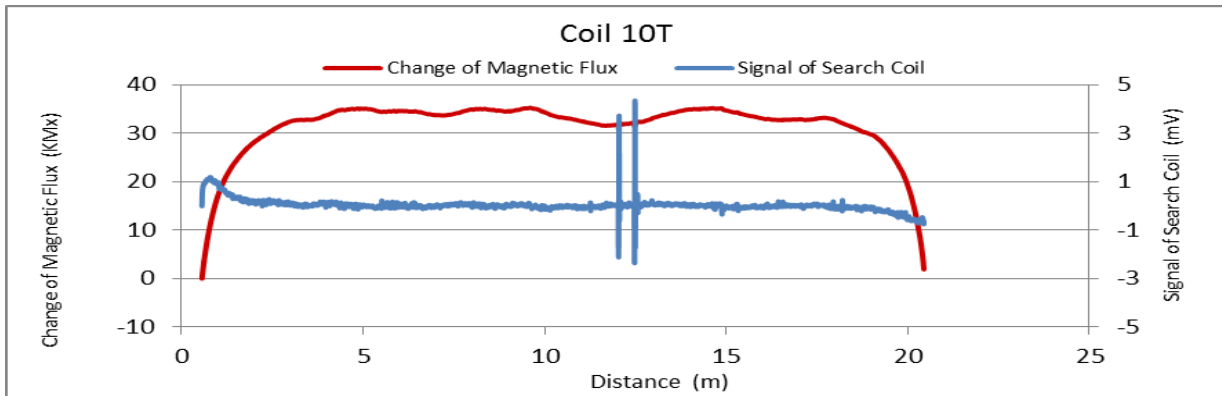
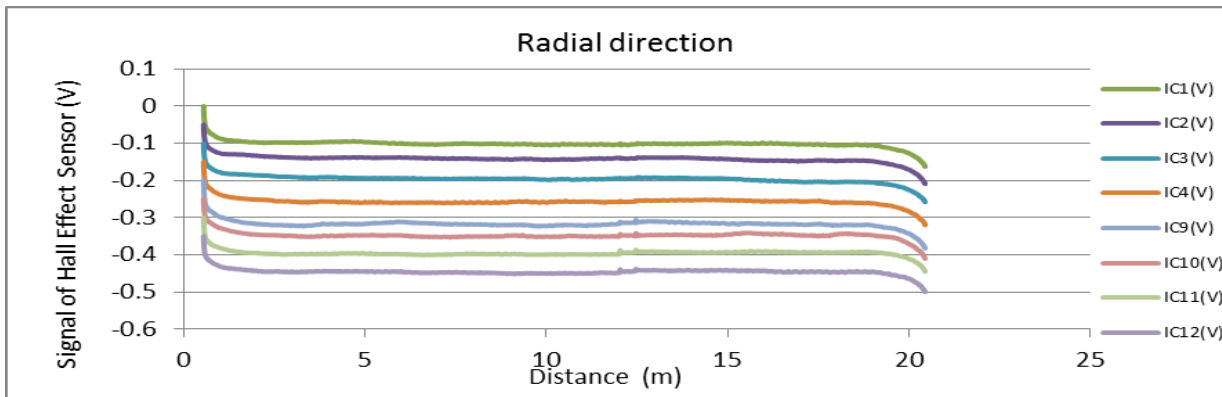
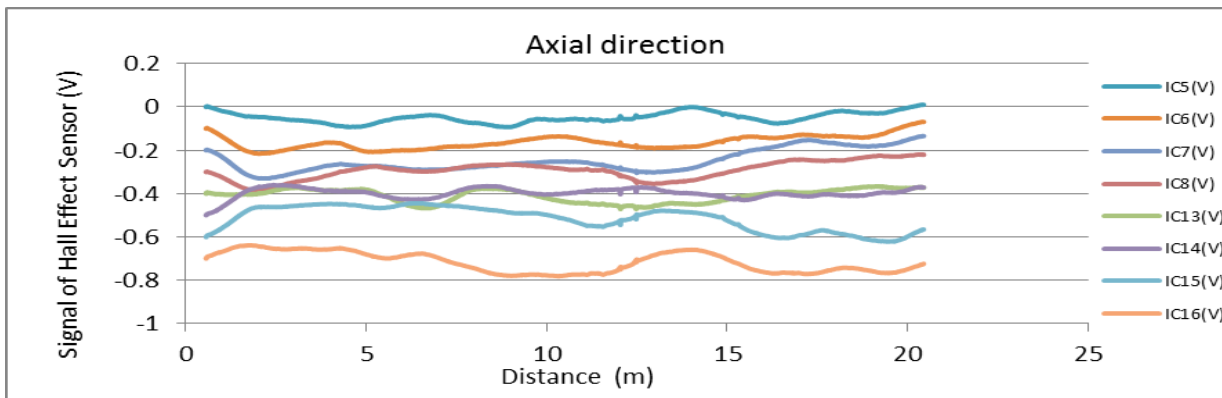
Figure A16. MMFM data of P1-401R-H1 tendon section.

File Name 【Pier-Tendon-Section】	Section Total Length (m)	Scanned Length		Note			
		Starting Point (m)	Ending Point (m)				
P1-401R-H1	20.8	0.56	20.46	Joint position : 12.7 mm Repair tape position : 7.64 m			
Identified Damage 1				Identified Damage 2			
Max Loss Point (m)	Section Loss (%)	Damage Length (m)	Damage Orientation	Max Loss Point (m)	Section Loss (%)	Damage Length (m)	Damage Orientation
11.7	1.5	1.7	—	—	—	—	—

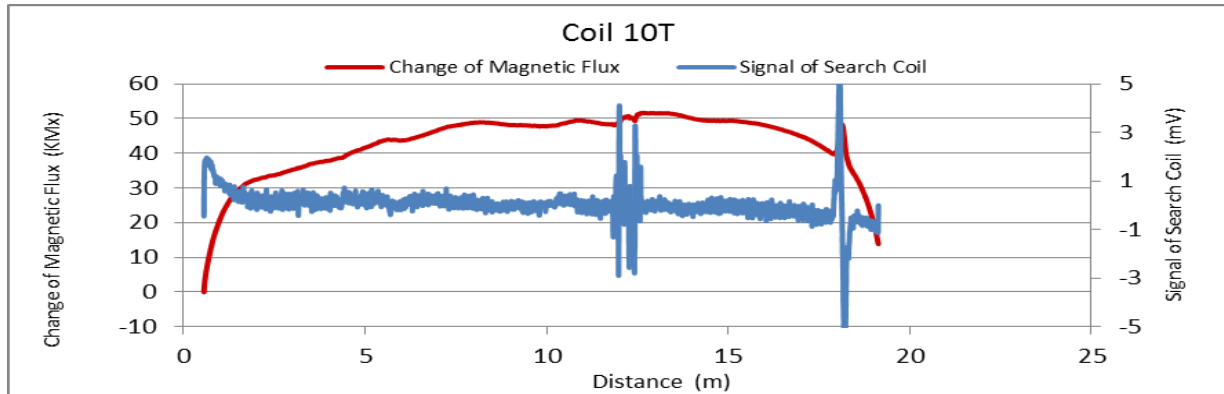
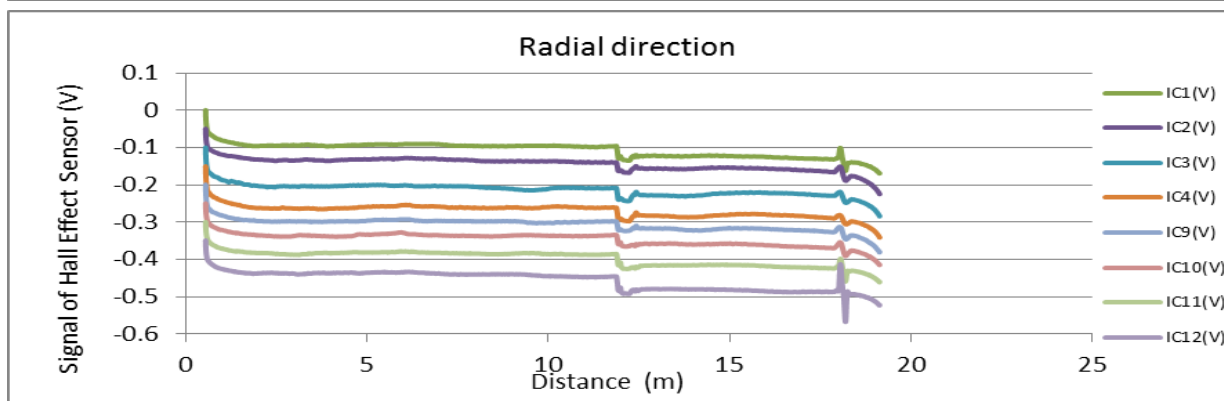
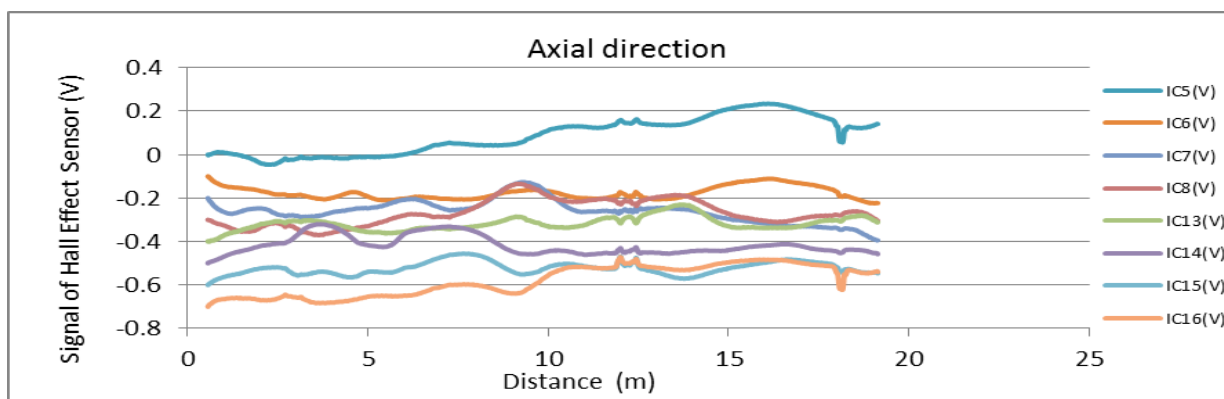
Figure A17. MMFM data of P1-402R-I1 tendon section.

File Name 【Pier-Tendon-Section】	Section Total Length (m)	Scanned Length		Note			
		Starting Point (m)	Ending Point (m)				
P1-402R-I1	20.5	0.56	19.14	Joint position : 12.3 m Identified damage 1 : Increase of magnetic flux Repair tape position : 18.05 m			
Identified Damage 1				Identified Damage 2			
Max Loss Point (m)	Loss (%)	Length (m)	Damage Orientation	Max Loss Point (m)	Loss (%)	Length (m)	Damage Orientation
18.1	-4.1	0.2	—	—	—	—	—

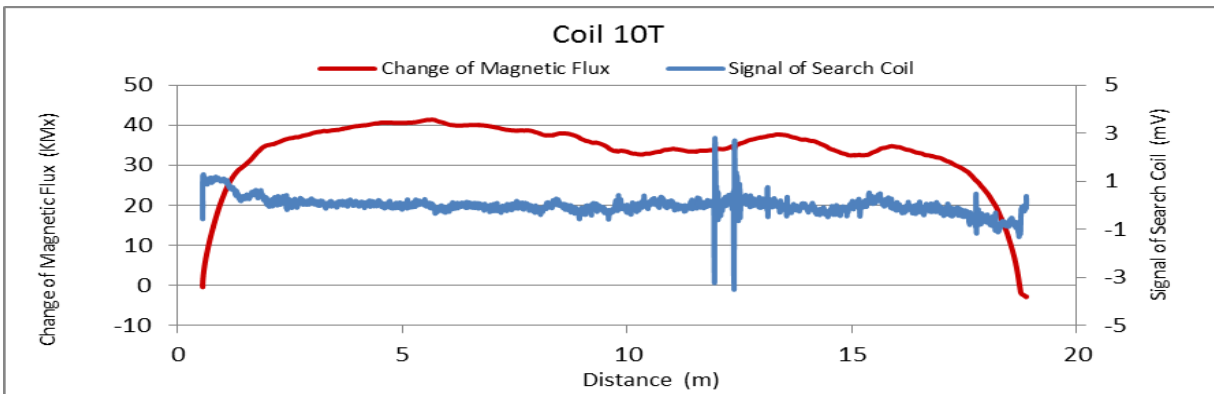
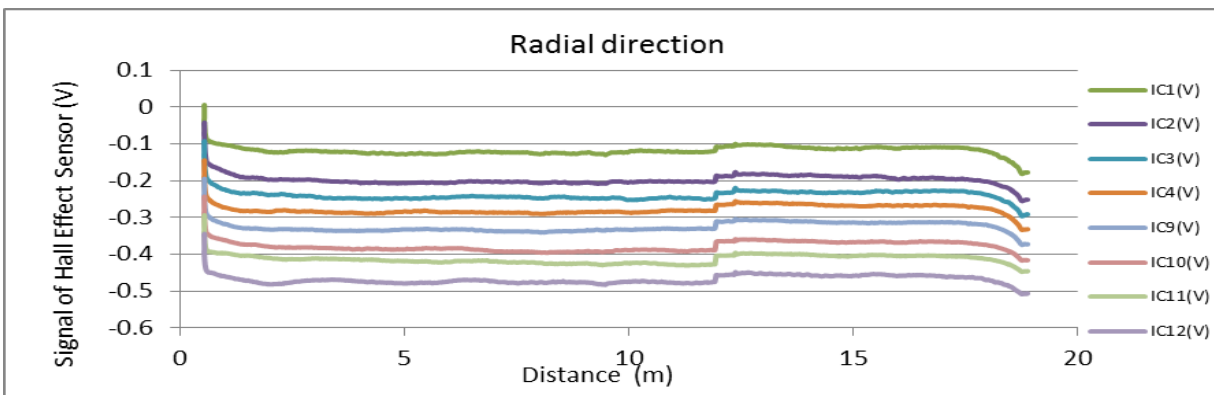
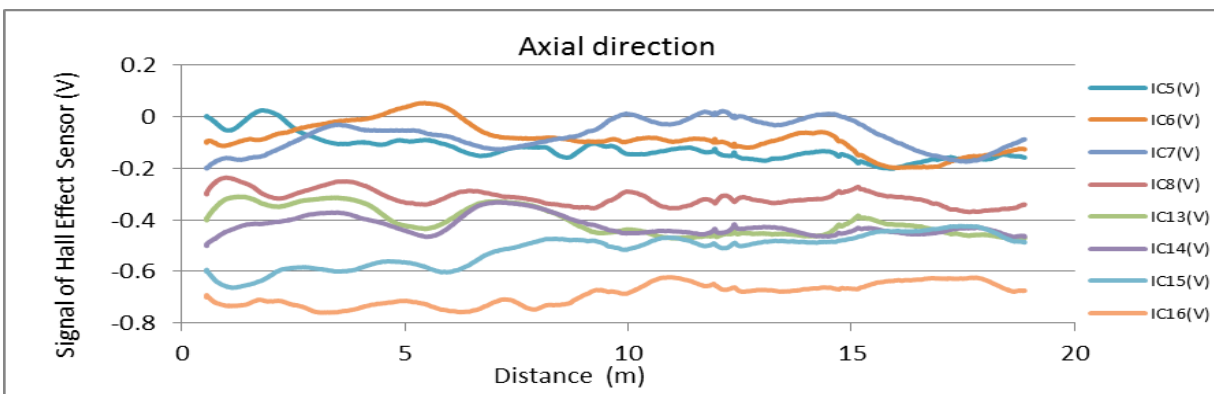
Figure A18. MMFM data of P1-402L-I1 tendon section.

File Name 【Pier-Tendon-Section】	Section Total Length (m)	Scanned Length		Note			
		Starting Point (m)	Ending Point (m)				
P1-402L-I1	20.4	0.55	18.88	Joint position : 12.3 m Starting point of damage 1 : 8.61 m Starting point of damage 2 : 14.4 m			
Identified Damage 1				Identified Damage 2			
Max Loss Point (m)	Loss (%)	Length (m)	Damage Orientation	Max Loss Point (m)	Loss (%)	Length (m)	Damage Orientation
10.3	2.7	2.8	—	15.0	1.5	0.9	—
