**Development of Quality Assurance and Quality Control
System for Post Tensioned Segmental Bridges in Florida:
Case of Ringling Bridge – Phase II**

**FDOT Contract No. BDV29-977-34
FINAL REPORT**

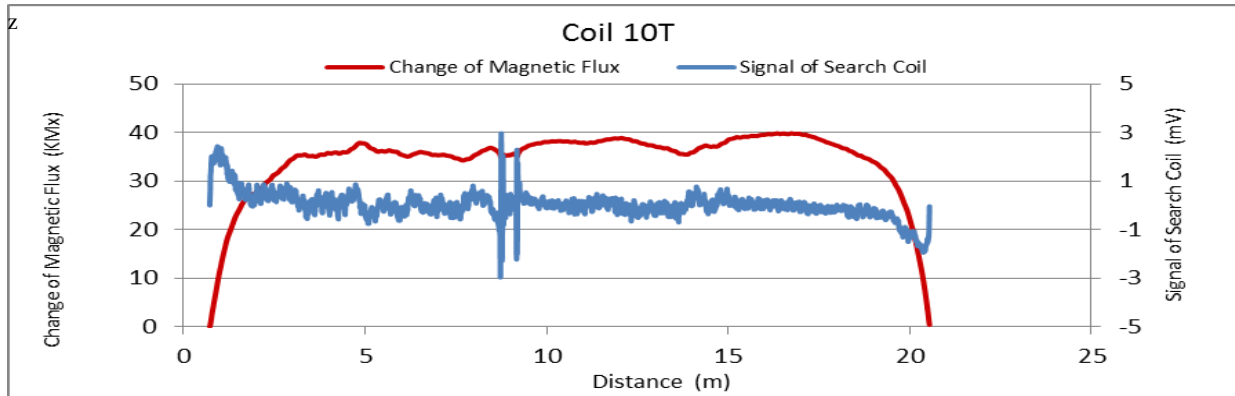
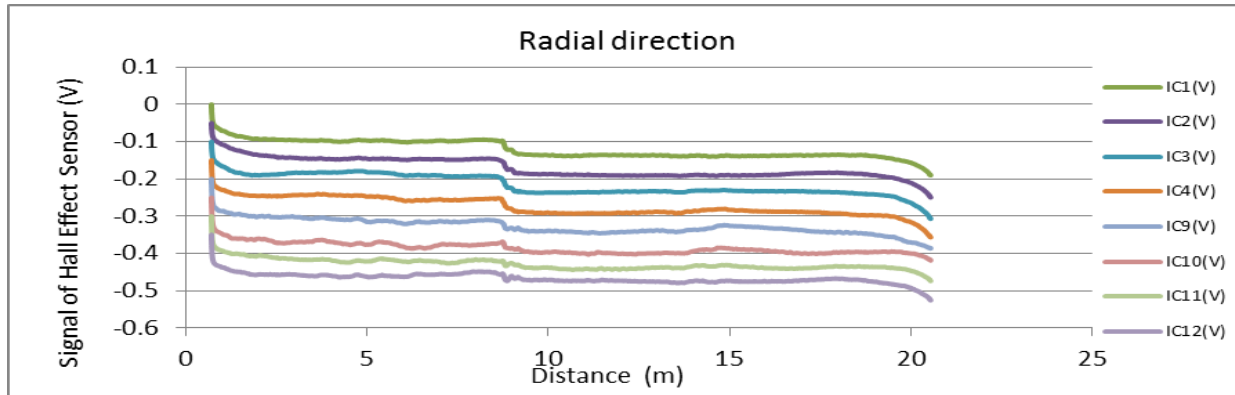
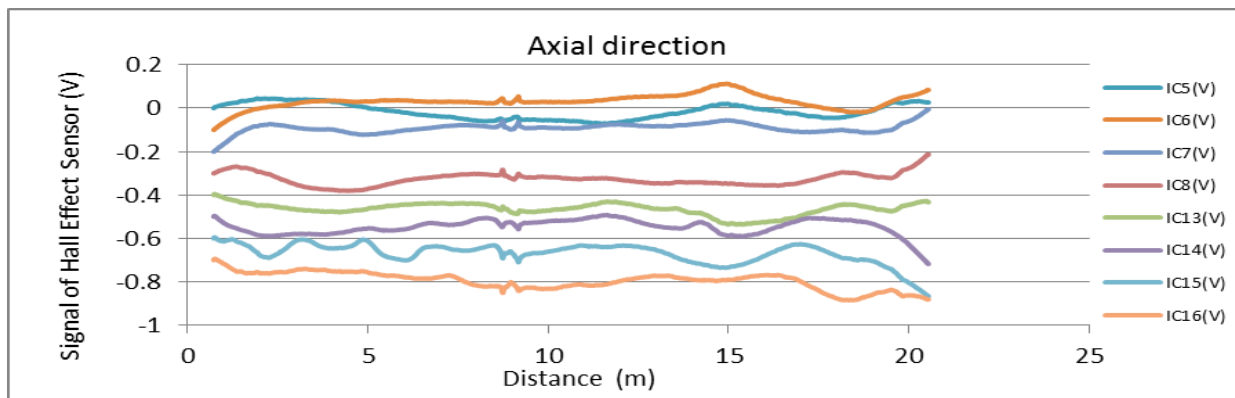
Figure A19. MMFM data of P1-402L-I2 tendon section.

File Name 【Pier-Tendon-Section】	Section Total Length (m)	Scanned Length		Note Joint position : 9.1 m Starting point of damage 1 : 13.15 m			
		Starting Point (m)	Ending Point (m)				
P1-402L-I2	21.19	0.72	20.54				
Identified Damage 1				Identified Damage 2			
Max Loss Point (m)	Loss (%)	Length (m)	Damage Orientation	Max Loss Point (m)	Loss (%)	Length (m)	Damage Orientation
13.8	1.5	1.2	—	—	—	—	—

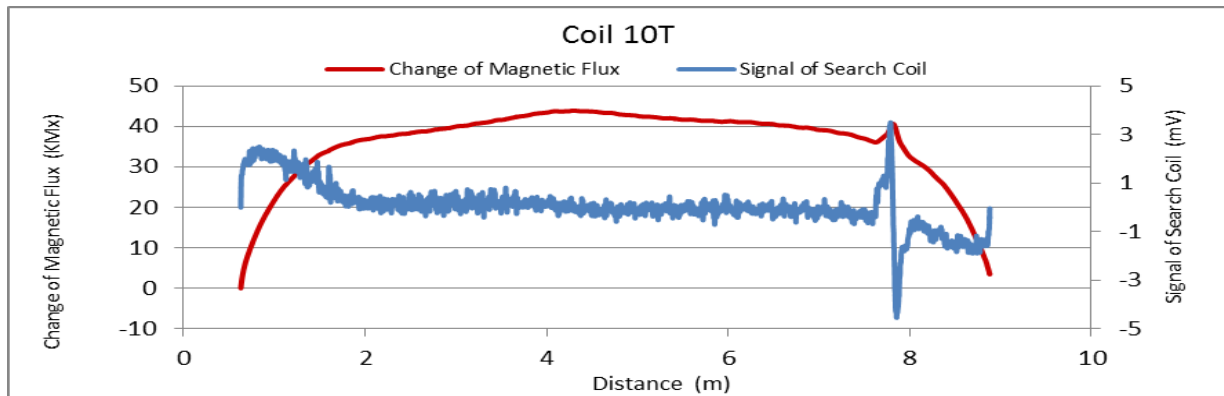
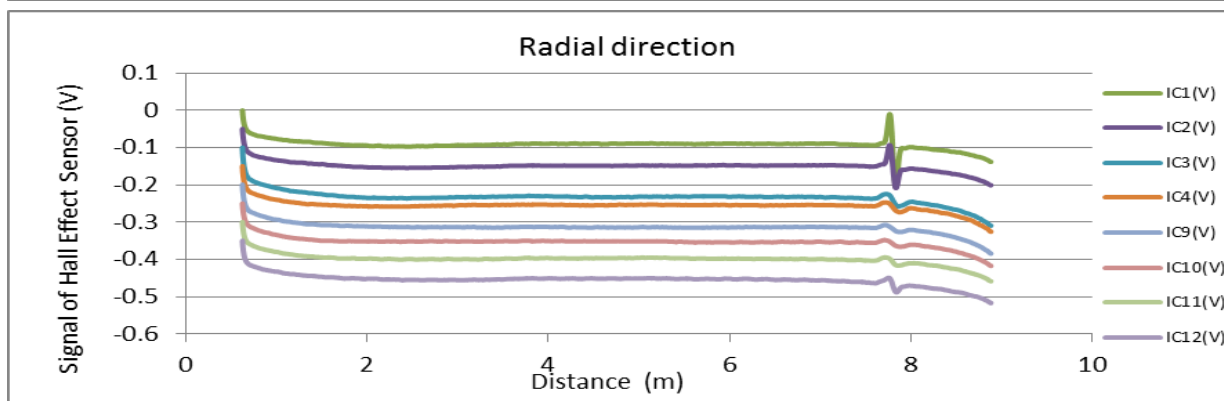
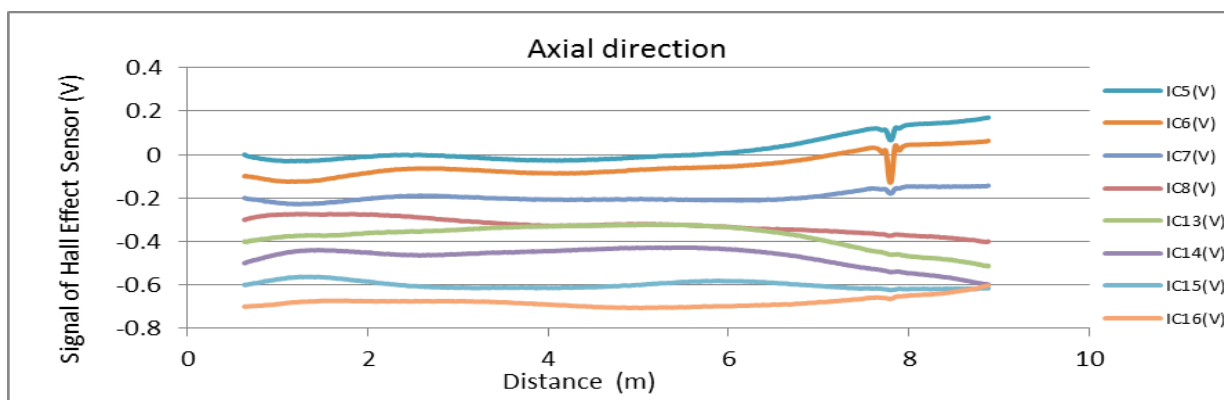
Figure A20. MMFM data of P1-401L-H3 tendon section.

File Name 【Pier-Tendon-Section】	Section Total Length (m)	Scanned Length		Note			
		Starting Point (m)	Ending Point (m)				
P1-401L-H3	9.45	0.63	8.88	Identified damage 1 : Increase of magnetic flux Starting point of damage 1 : 7.74 m			
Identified Damage 1				Identified Damage 2			
Max Loss Point (m)	Loss (%)	Length (m)	Damage Orientation	Max Loss Point (m)	Loss (%)	Length (m)	Damage Orientation
7.8	-2.4	0.13	12~2 o'clock	—	—	—	—

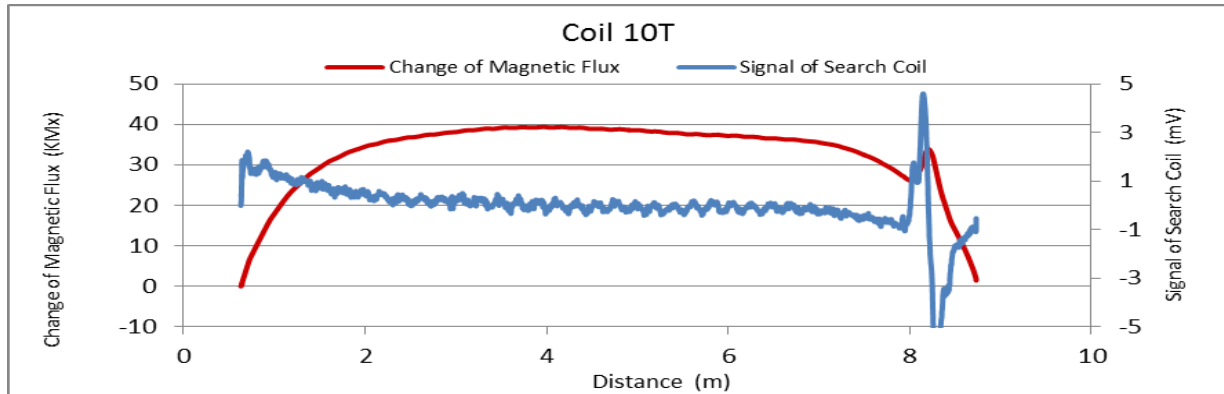
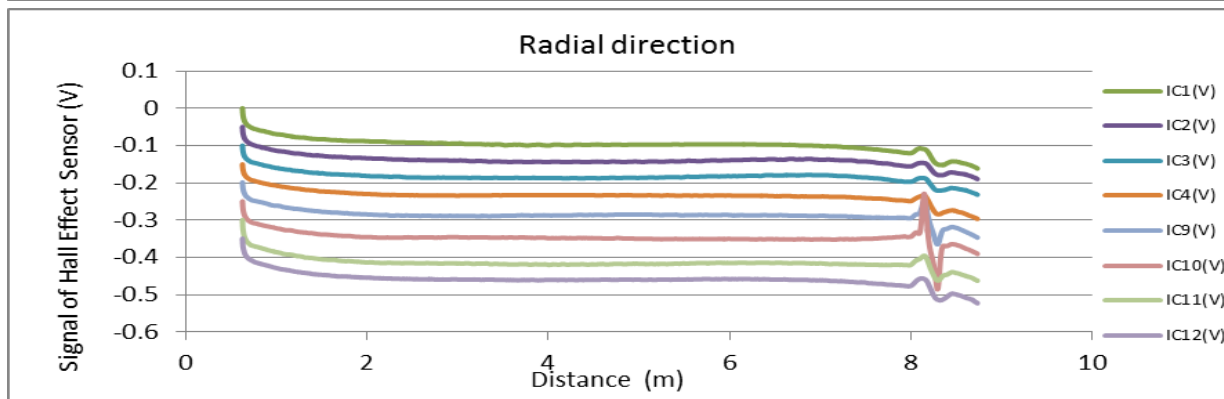
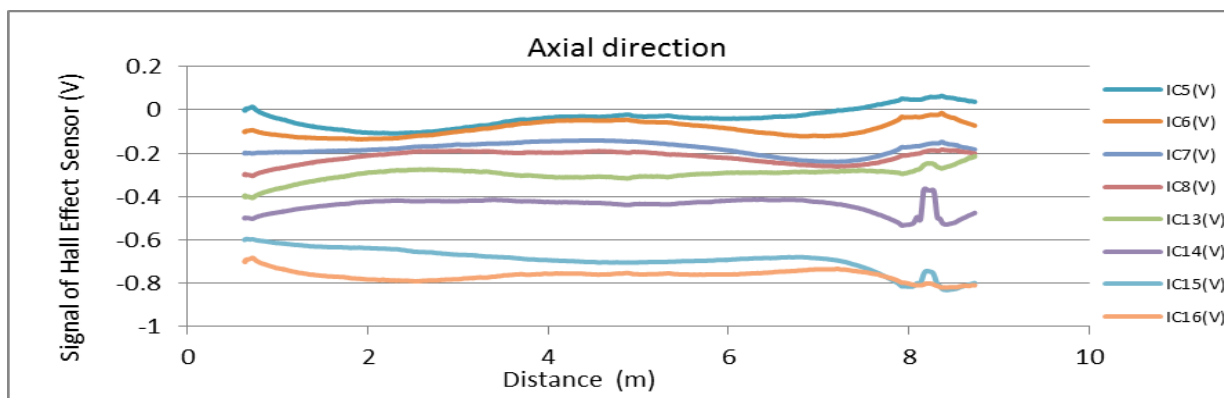
Figure A21. MMFM data of P2-401L-H1 tendon section.

File Name 【Pier-Tendon-Section】	Section Total Length (m)	Scanned Length		Note			
		Starting Point (m)	Ending Point (m)				
P2-401L-H1	9.38	0.63	8.73	Identified damage 1 : Increase of magnetic flux Starting point of damage 1 : 8.13 m			
Identified Damage 1				Identified Damage 2			
Max Loss Point (m)	Loss (%)	Length (m)	Damage Orientation	Max Loss Point (m)	Loss (%)	Length (m)	Damage Orientation
8.2	-5.0	0.18	12~1 o'clock	—	—	—	—

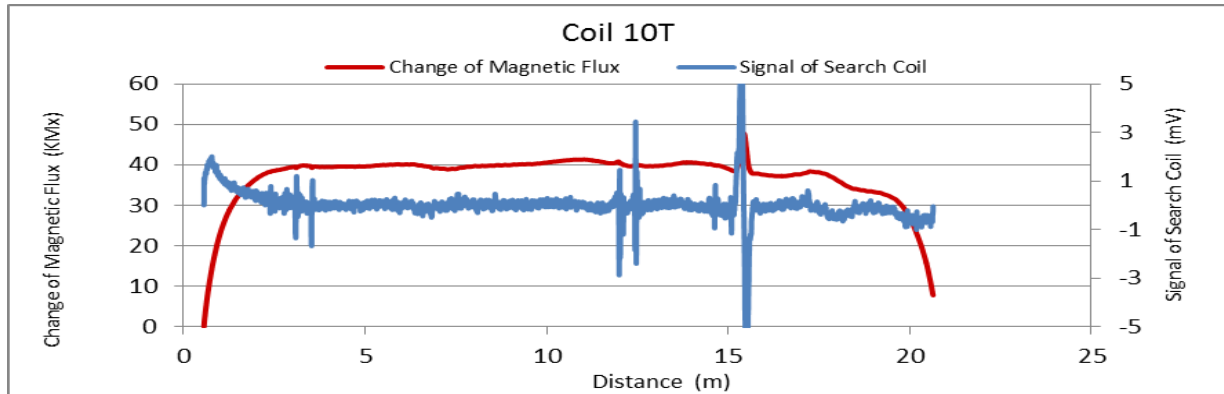
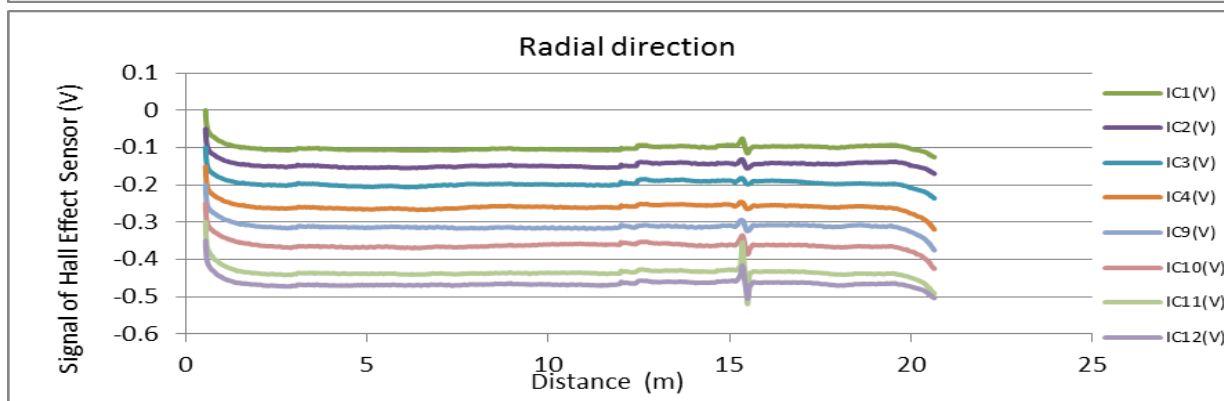
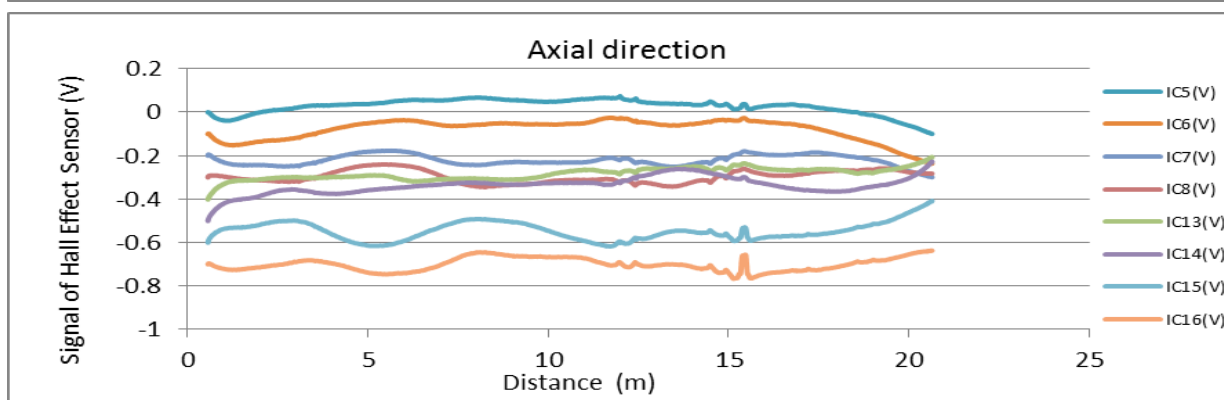
Figure A22. MMFM data of P2-401R-I1 tendon section.

File Name 【Pier-Tendon-Section】	Section Total Length (m)	Scanned Length		Note			
		Starting Point (m)	Ending Point (m)				
P2-401R-I1	21.43	0.56	20.64	Joint position : 12.2 m Identified damage 1 : Increase of magnetic flux Starting point of damage 1 : 15.33 m			
Identified Damage 1				Identified Damage 2			
Max Loss Point (m)	Loss (%)	Length (m)	Damage Orientation	Max Loss Point (m)	Loss (%)	Length (m)	Damage Orientation
15.4	-3.8	0.17	8~12 o'clock	—	—	—	—

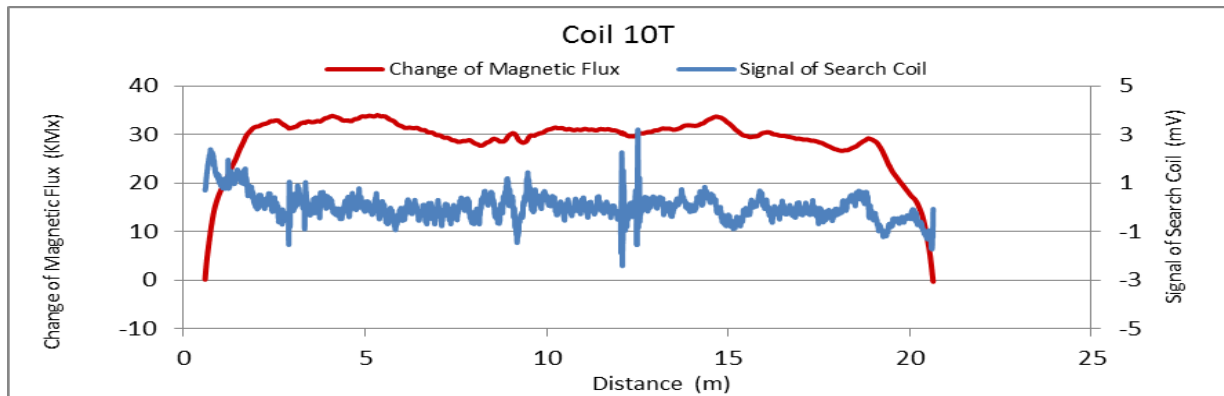
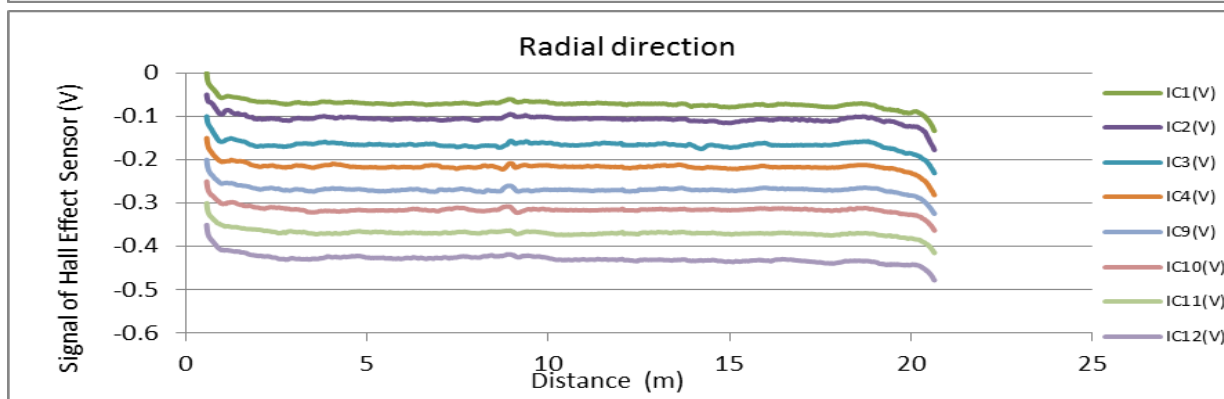
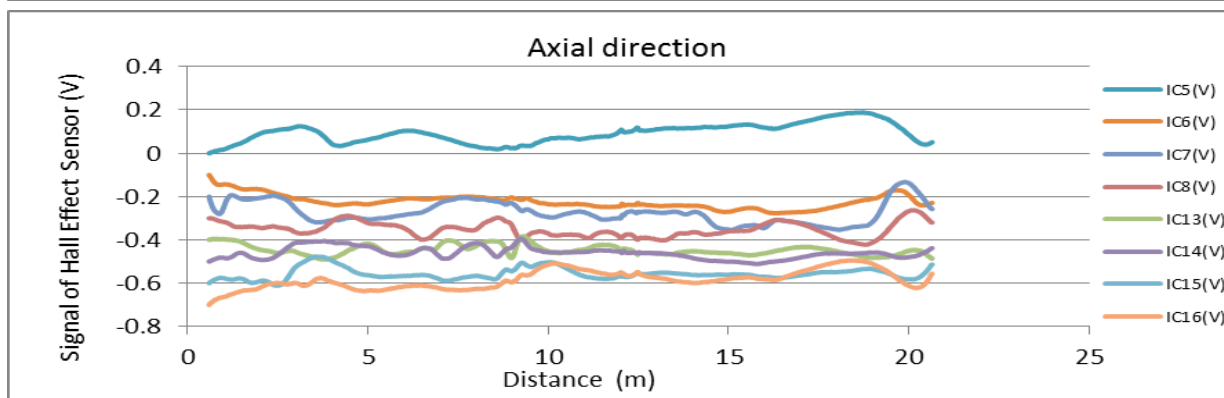
Figure A23. MMFM data of P2-402L-I1 tendon section.

File Name 【Pier-Tendon-Section】	Section Total Length (m)	Scanned Length		Note Joint position : 12.3 m Starting point of damage 1 : 7.15 m			
		Starting Point (m)	Ending Point (m)				
P2-402L-I1	21.37	0.59	20.68				
Identified Damage 1				Identified Damage 2			
Max Loss Point (m)	Loss (%)	Length (m)	Damage Orientation	Max Loss Point (m)	Loss (%)	Length (m)	Damage Orientation
8.2	2.4	1.78	6~8 o'clock	—	—	—	—

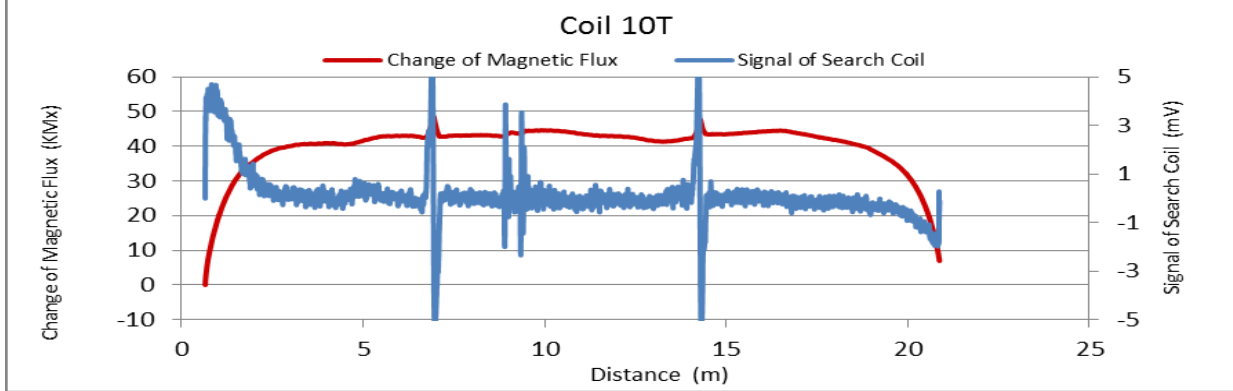
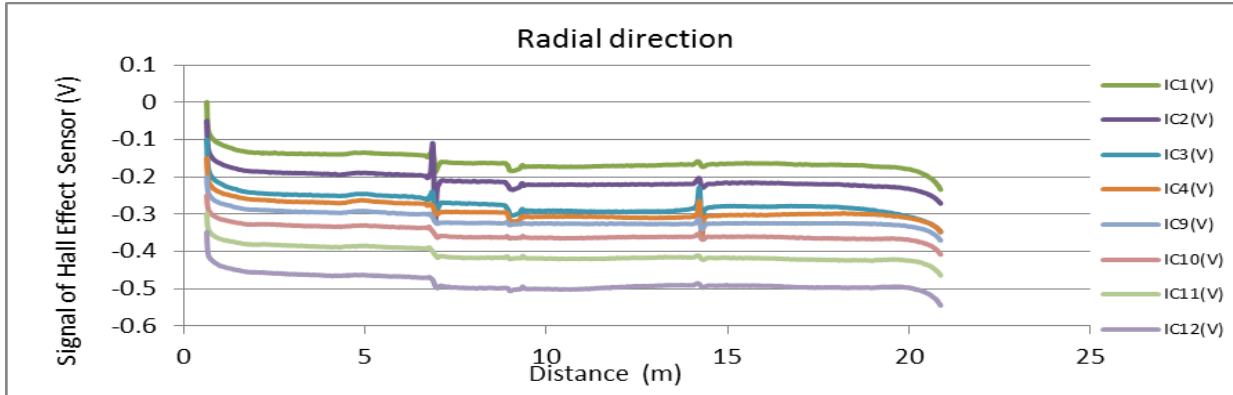
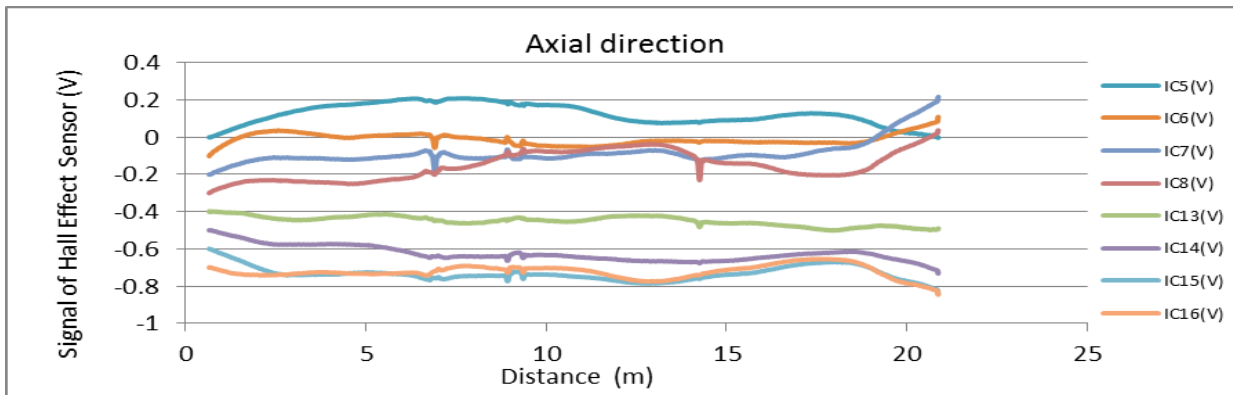
Figure A24. MMFM data of P2-402R-I2 tendon section.

File Name 【Pier-Tendon-Section】	Section Total Length (m)	Scanned Length		Note			
		Starting Point (m)	Ending Point (m)				
P2-402R-I2	21.47	0.65	20.87	Joint position : 12.3 m Identified damage 1&2 : Increase of magnetic flux Starting point of damage 1 : 6.85 m Starting point of damage 2 : 14.2 m			
Identified Damage 1				Identified Damage 2			
Max Loss Point (m)	Loss (%)	Length (m)	Damage Orientation	Max Loss Point (m)	Loss (%)	Length (m)	Damage Orientation
6.9	-2.3	0.15	11~1 o'clock	14.3	-1.9	0.16	9~11 o'clock

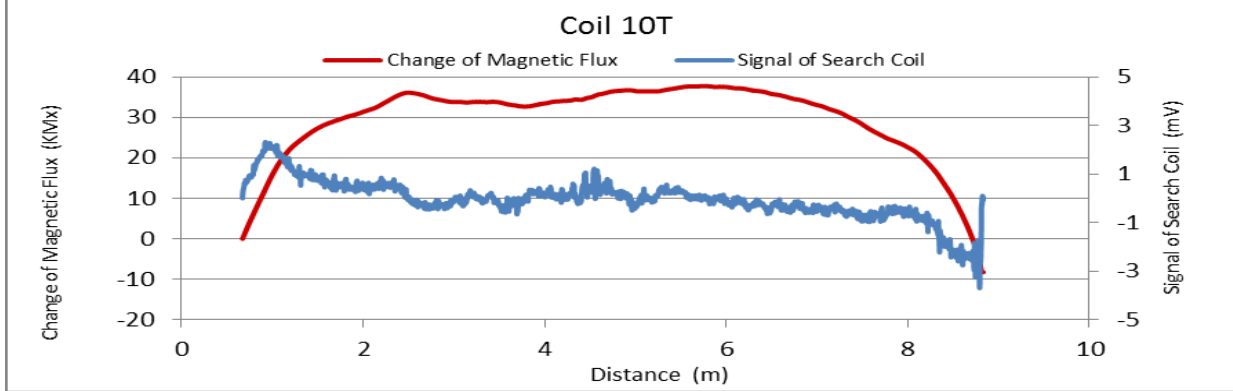
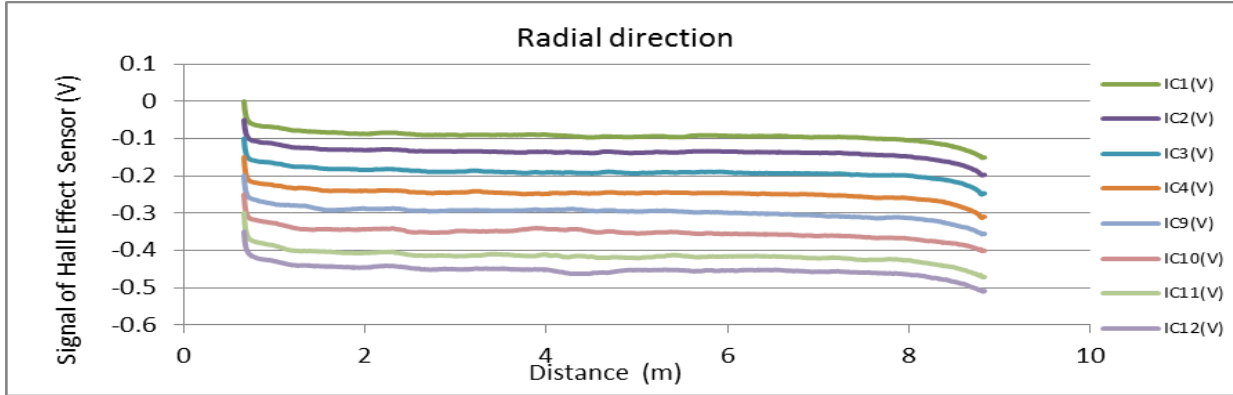
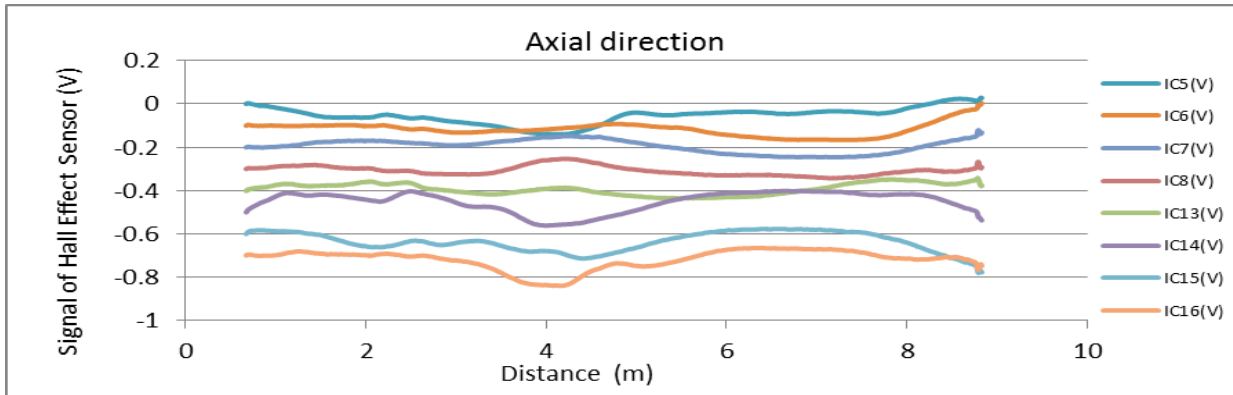
Figure A25. MMFM data of P2-402R-H2 tendon section.

File Name 【Pier-Tendon-Section】	Section Total Length (m)	Scanned Length		Note Starting point of damage 1 : 3.31 m			
		Starting Point (m)	Ending Point (m)				
P2-402R-H2	9.43	0.67	8.83				
Identified Damage 1				Identified Damage 2			
Max Loss Point (m)	Loss (%)	Length (m)	Damage Orientation	Max Loss Point (m)	Loss (%)	Length (m)	Damage Orientation
3.8	1.7	1.14	8~11 o'clock	—	—	—	—

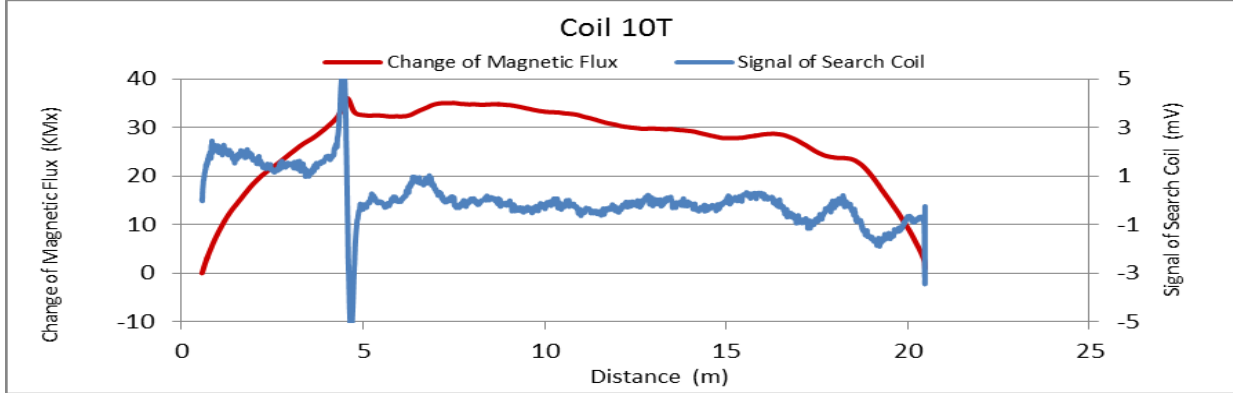
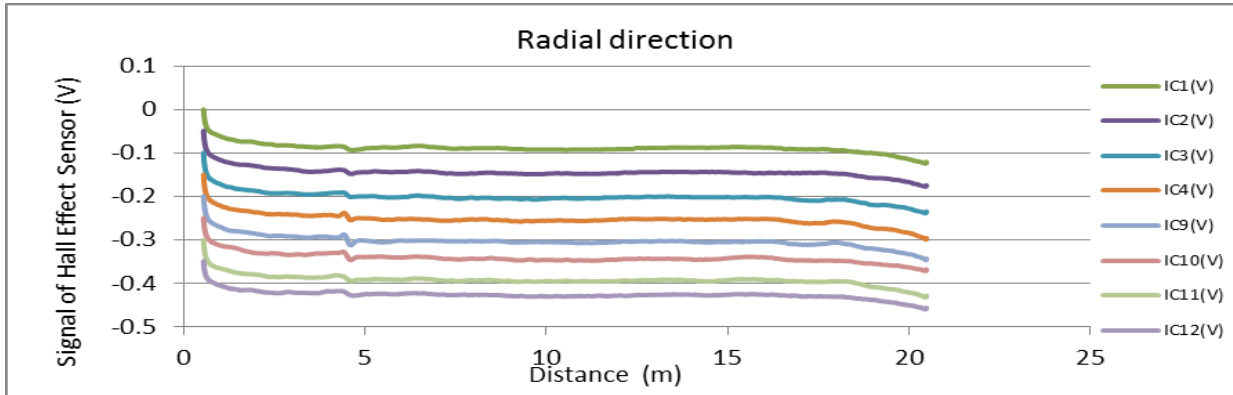
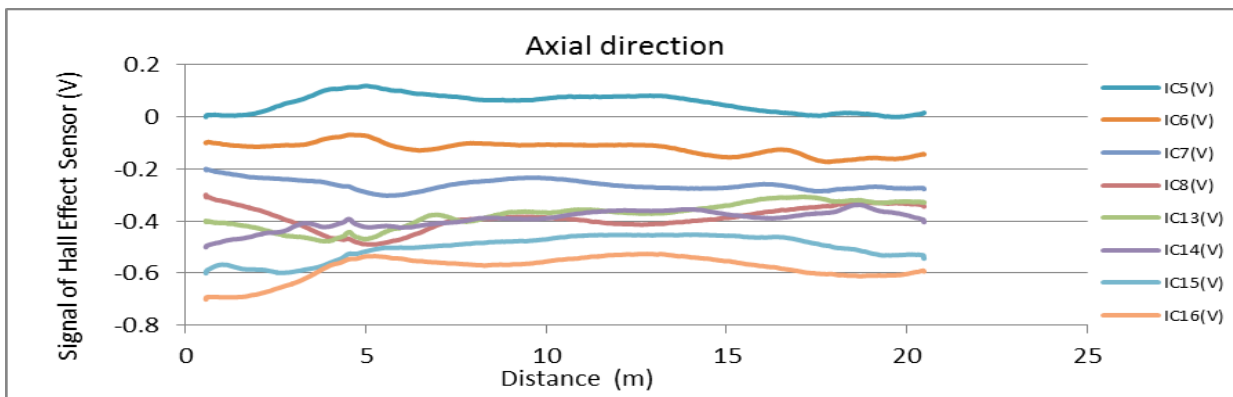
Figure A26. MMFM data of P3-402L-H1 tendon section.

File Name 【Pier-Tendon-Section】	Section Total Length (m)	Scanned Length		Note Identified damage 1 : Increase of magnetic flux Starting point of damage 1 : 4.43 m			
		Starting Point (m)	Ending Point (m)				
P3-402L-H1	21.43	0.56	20.64				
Identified Damage 1				Identified Damage 2			
Max Loss Point (m)	Loss (%)	Length (m)	Damage Orientation	Max Loss Point (m)	Loss (%)	Length (m)	Damage Orientation
4.5	-1.5	0.27	1~4 o'clock	—	—	—	—

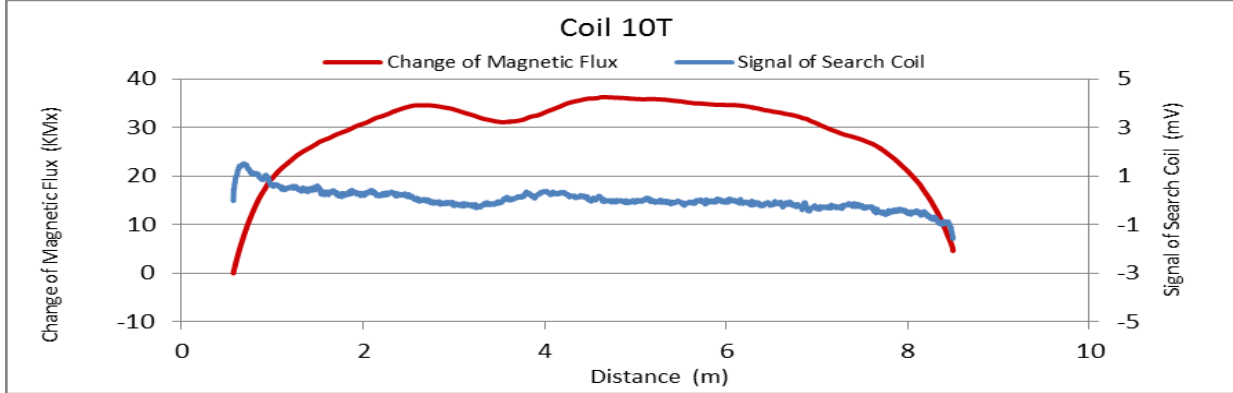
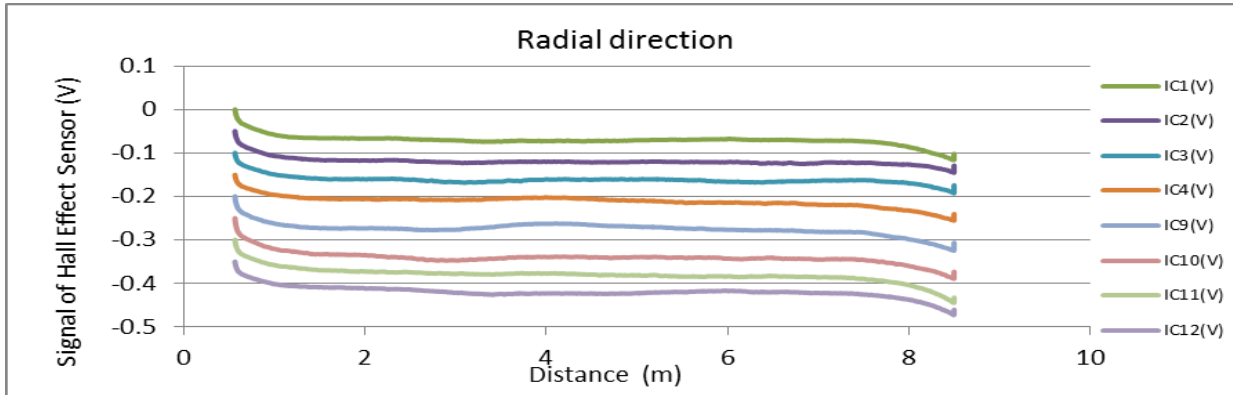
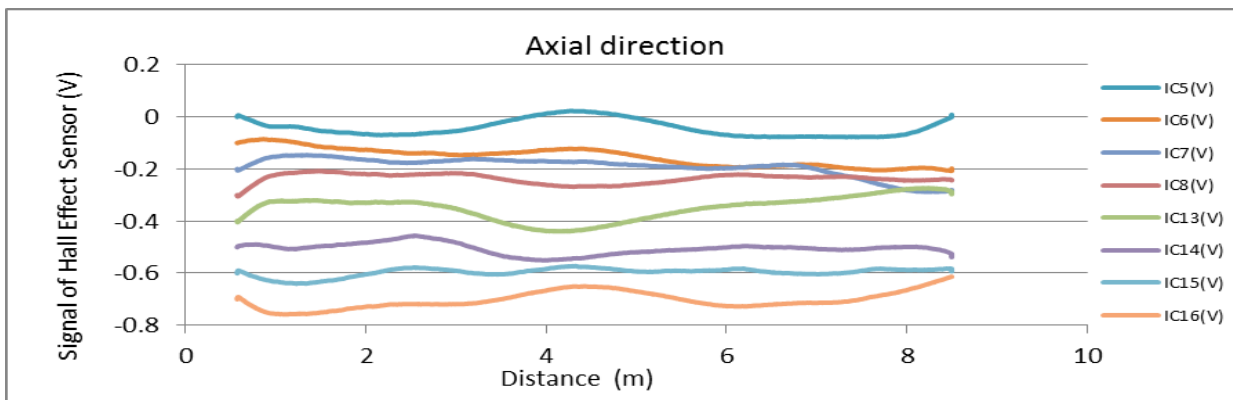
Figure A27. MMFM data of P4-402R-H1 tendon section.

File Name 【Pier-Tendon-Section】	Section Total Length (m)	Scanned Length		Note Starting point of damage 1 : 3.24 m			
		Starting Point (m)	Ending Point (m)				
P4-402R-H1	9.35	0.57	8.56				
Identified Damage 1				Identified Damage 2			
Max Loss Point (m)	Loss (%)	Length (m)	Damage Orientation	Max Loss Point (m)	Loss (%)	Length (m)	Damage Orientation
3.5	1.7	0.71	12~3 o'clock	—	—	—	—

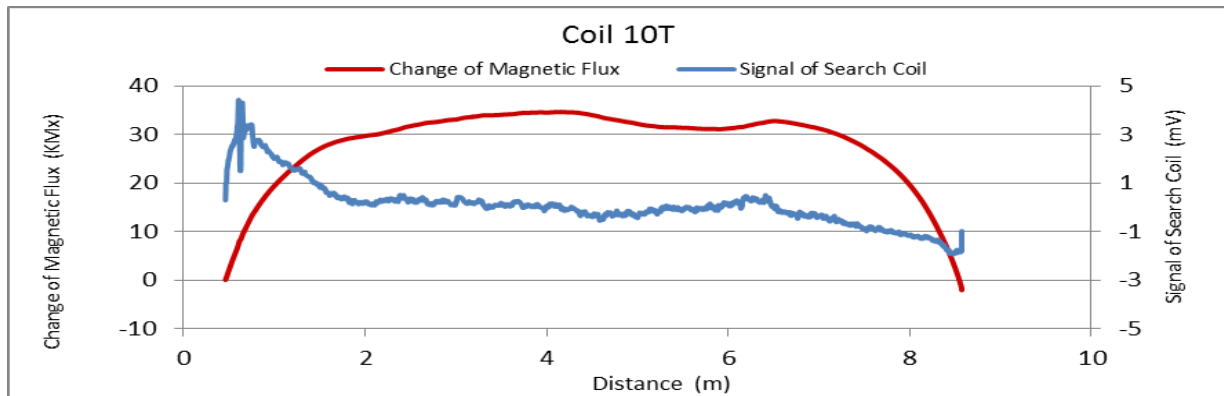
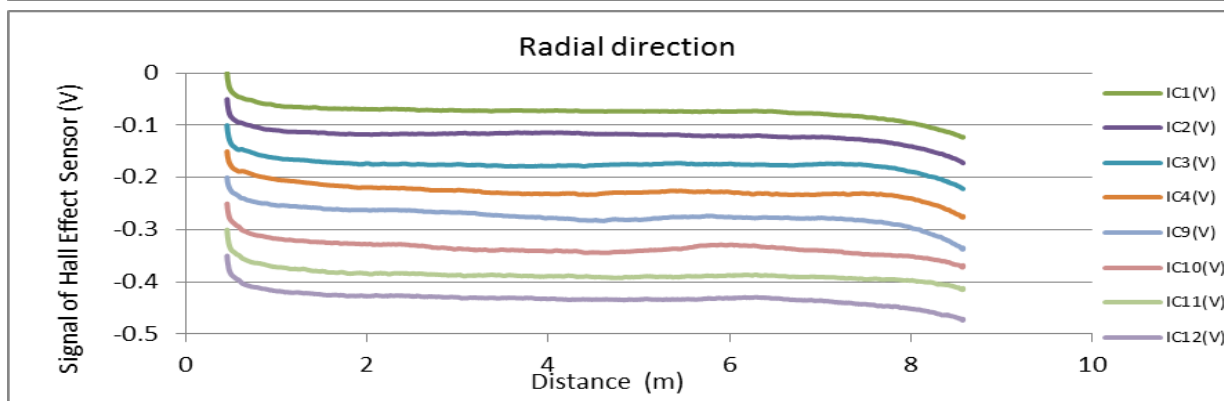
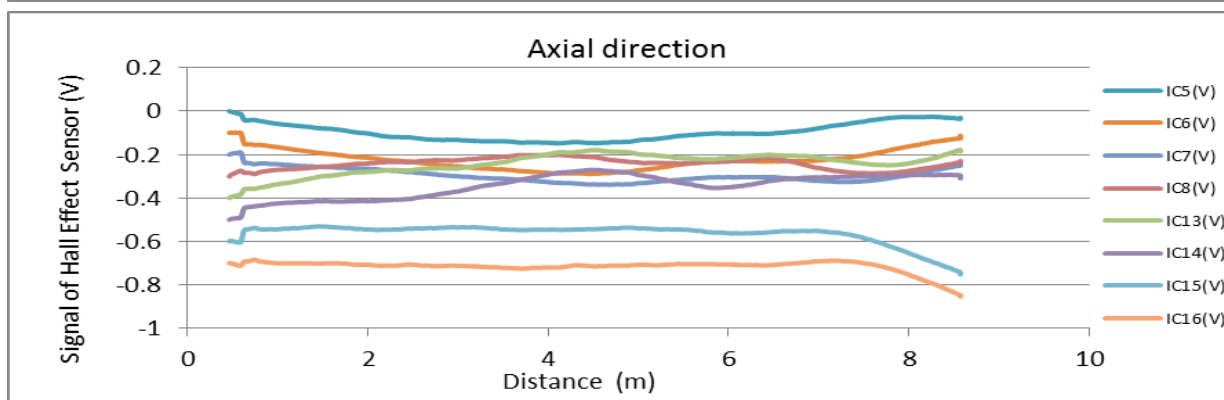
Figure A28. MMFM data of P4-402L-H1 tendon section.

File Name 【Pier-Tendon-Section】	Section Total Length (m)	Scanned Length		Note Starting point of damage 1 : 5.26 m			
		Starting Point (m)	Ending Point (m)				
P4-402L-H1	9.36	0.46	8.64				
Identified Damage 1				Identified Damage 2			
Max Loss Point (m)	Loss (%)	Length (m)	Damage Orientation	Max Loss Point (m)	Loss (%)	Length (m)	Damage Orientation
5.9	1.0	0.86	12~2 o'clock	—	—	—	—

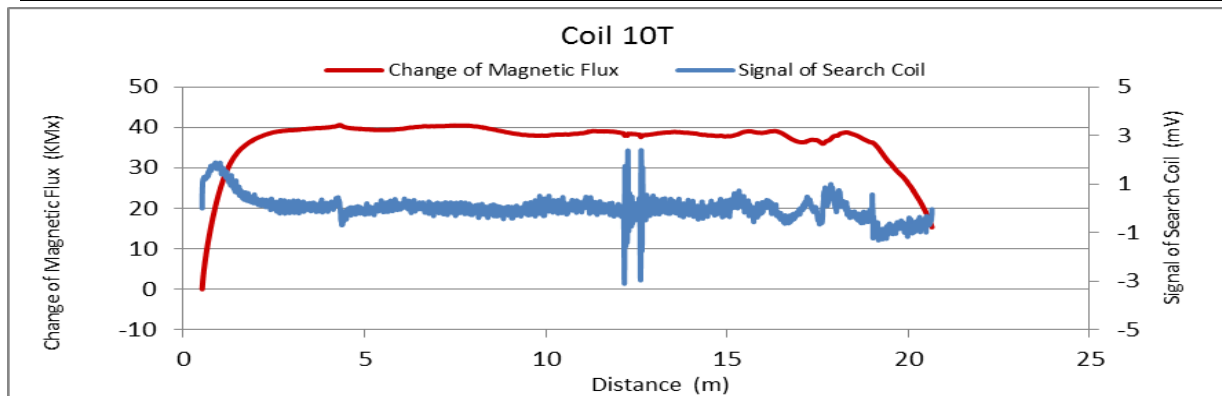
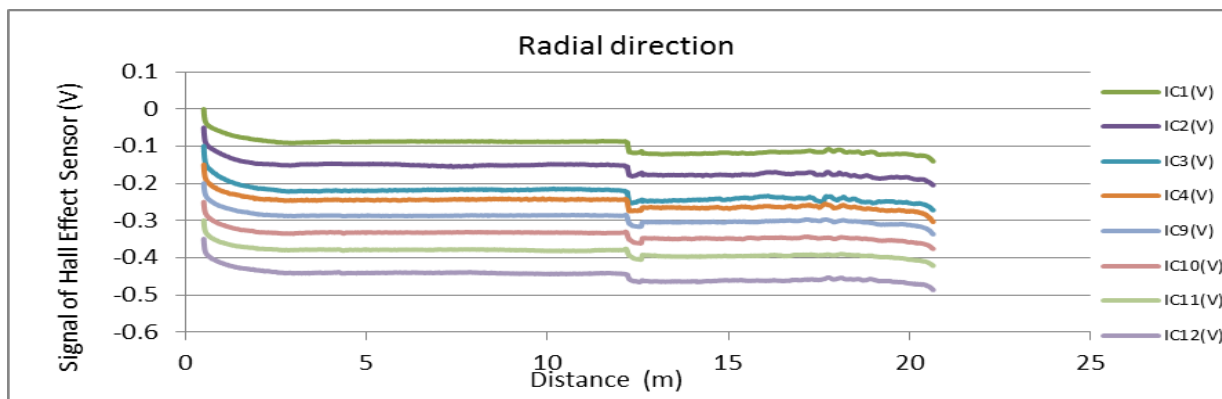
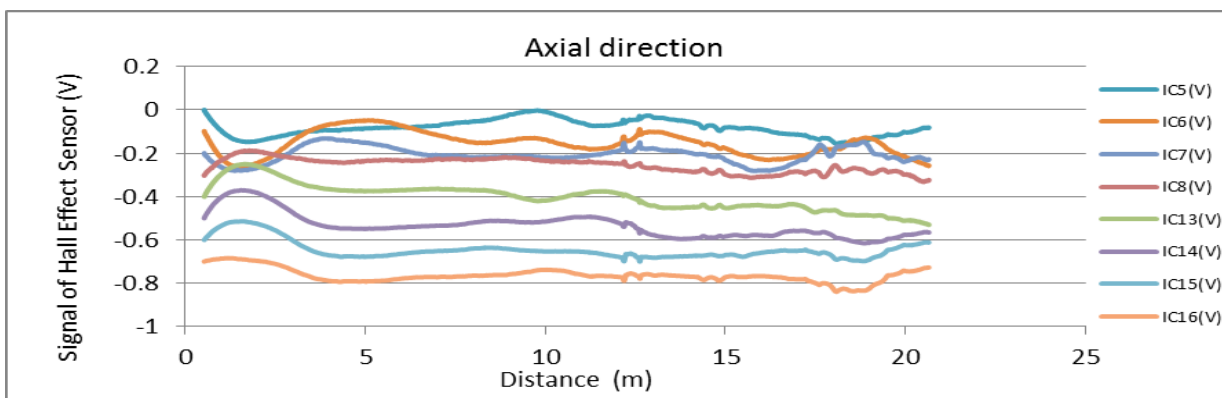
Figure A29. MMFM data of P4-401R-II tendon section.

File Name		Section	Scanned Length		Note		
【Pier-Tendon-Section】		Total Length (m)	Starting Point (m)	Ending Point (m)	Joint position: 12.37 m Starting point of damage 1: 17.15 m		
P4-401R-II		21.57	0.52	20.65			
Identified Damage 1				Identified Damage 2			
Max Loss Point (m)	Loss (%)	Length (m)	Damage Orientation	Max Loss Point (m)	Loss (%)	Length (m)	Damage Orientation
17.6	1.2	0.74	8~11 o'clock	—	—	—	—

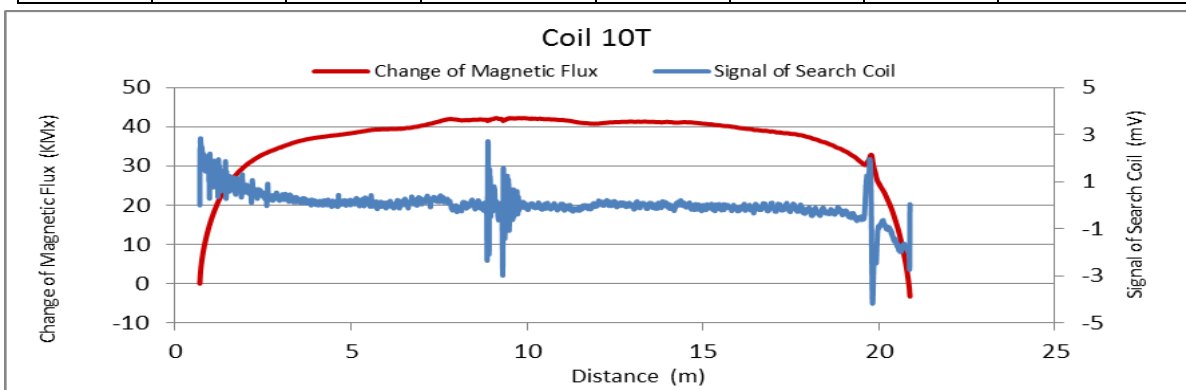
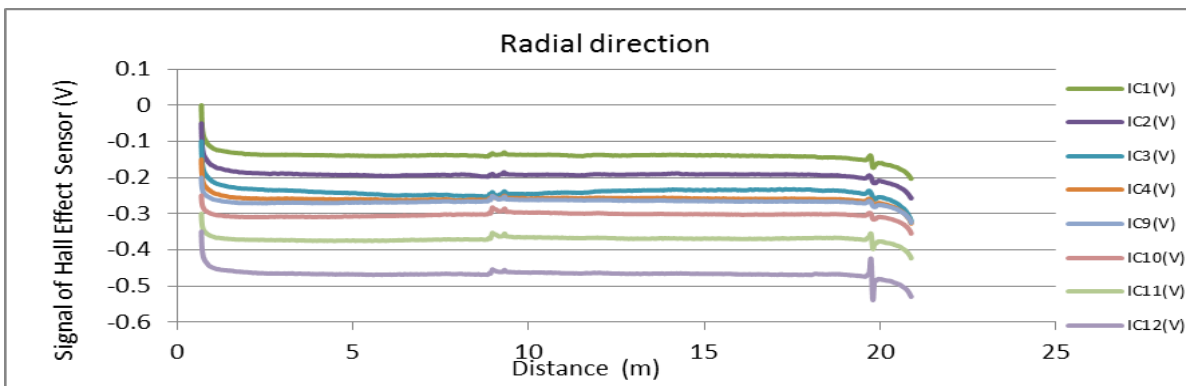
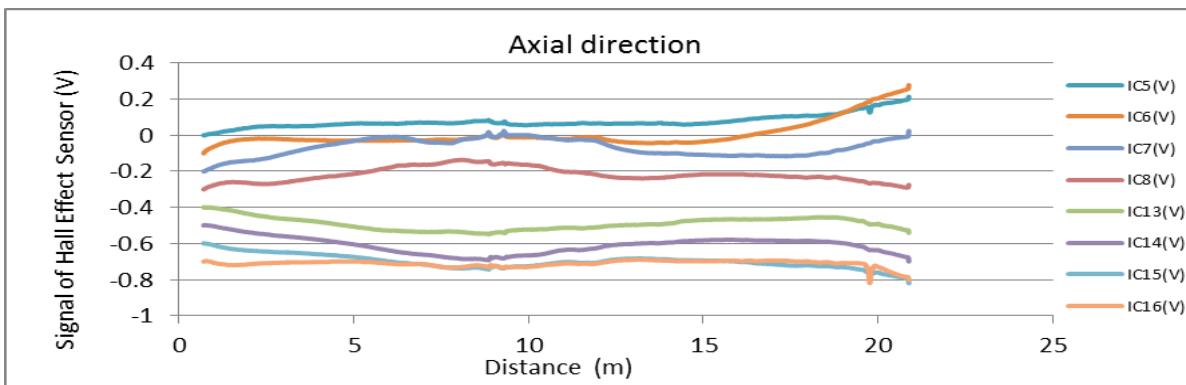
Figure A30. MMFM data of P4-401R-I2 tendon section.

File Name 【Pier-Tendon-Section】	Section Total Length (m)	Scanned Length		Note			
		Starting Point (m)	Ending Point (m)				
P4-401R-I2	21.46	0.7	20.88	Joint position : 9.14 m Identified damage 1 : Increase of magnetic flux Starting point of damage 1 : 19.71 m			
Identified Damage 1				Identified Damage 2			
Max Loss Point (m)	Section Loss (%)	Damage Length (m)	Damage Orientation	Max Loss Point (m)	Section Loss (%)	Damage Length (m)	Damage Orientation
19.8	-1.8	0.13	2~4 o'clock	—	—	—	—

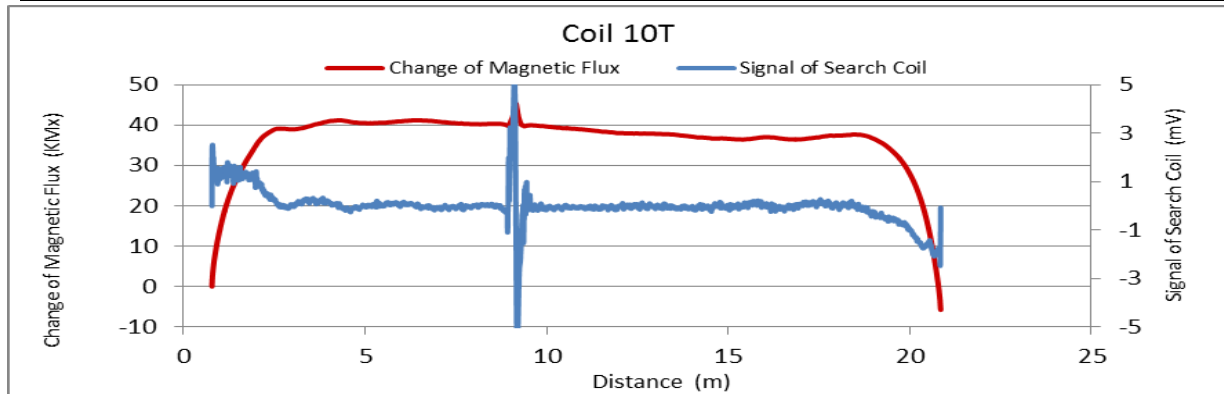
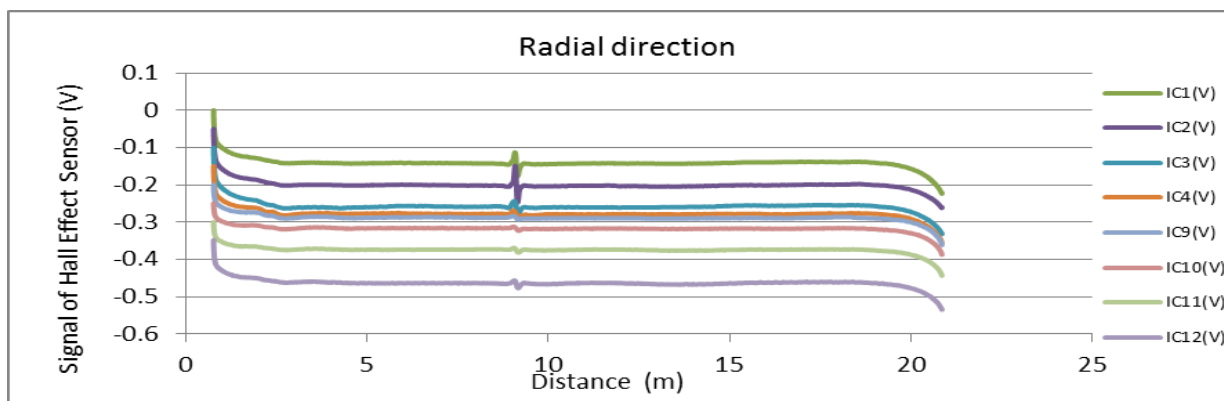
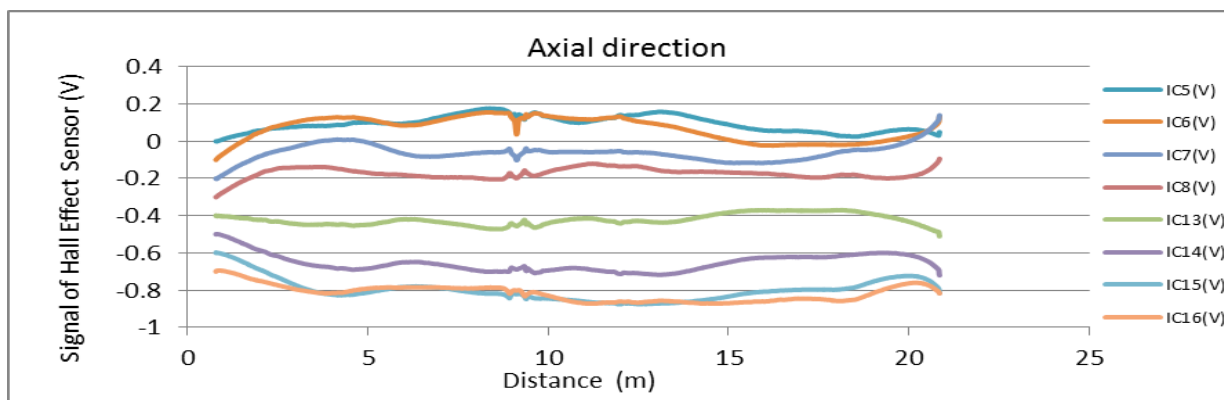
Figure A31. MMFM data of P4-401L-I2 tendon section.

File Name 【Pier-Tendon-Section】	Section Total Length (m)	Scanned Length		Note Joint position: 9.18 m Identified damage 1 : Increase of magnetic flux Starting point of damage 1 : 9.07 m			
		Starting Point (m)	Ending Point (m)				
P4-401L-I2	21.5	0.78	20.85				
Identified Damage 1				Identified Damage 2			
Max Loss Point (m)	Loss (%)	Length (m)	Damage Orientation	Max Loss Point (m)	Loss (%)	Length (m)	Damage Orientation
9.1	-2.2	0.17	12~2 o'clock	—	—	—	—

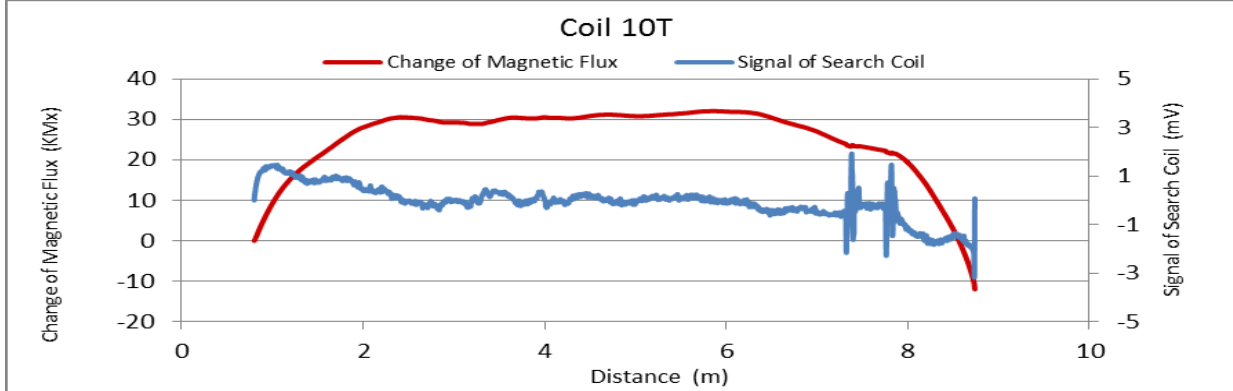
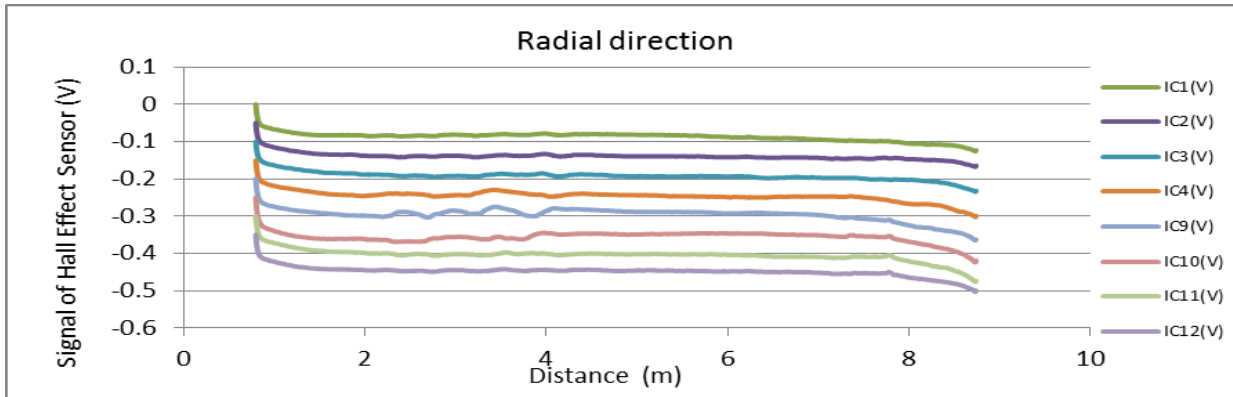
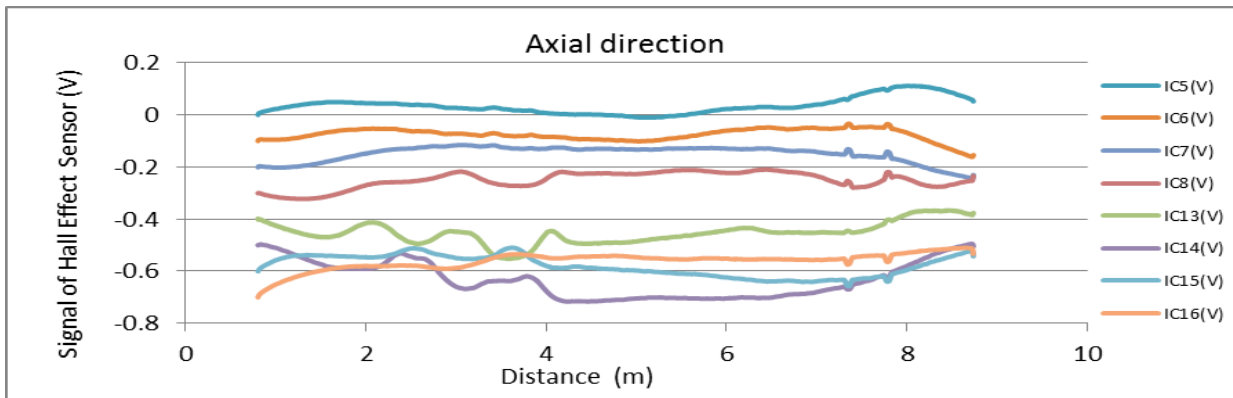
Figure A32. MMFM data of P4-402L-H2 tendon section.

File Name 【Pier-Tendon-Section】	Section Total Length (m)	Scanned Length		Note Repair tape position : 7.64 m Starting point of damage 1 : 2.97 m			
		Starting Point (m)	Ending Point (m)				
P4-402L-H2	9.39	0.8	8.81				
Identified Damage 1				Identified Damage 2			
Max Loss Point (m)	Loss (%)	Length (m)	Damage Orientation	Max Loss Point (m)	Loss (%)	Length (m)	Damage Orientation
3.3	1.0	0.83	1~4 o'clock	—	—	—	—
