**Development of Quality Assurance and Quality Control
System for Post Tensioned Segmental Bridges in Florida:
Case of Ringling Bridge – Phase II**

**FDOT Contract No. BDV29-977-34
FINAL REPORT**

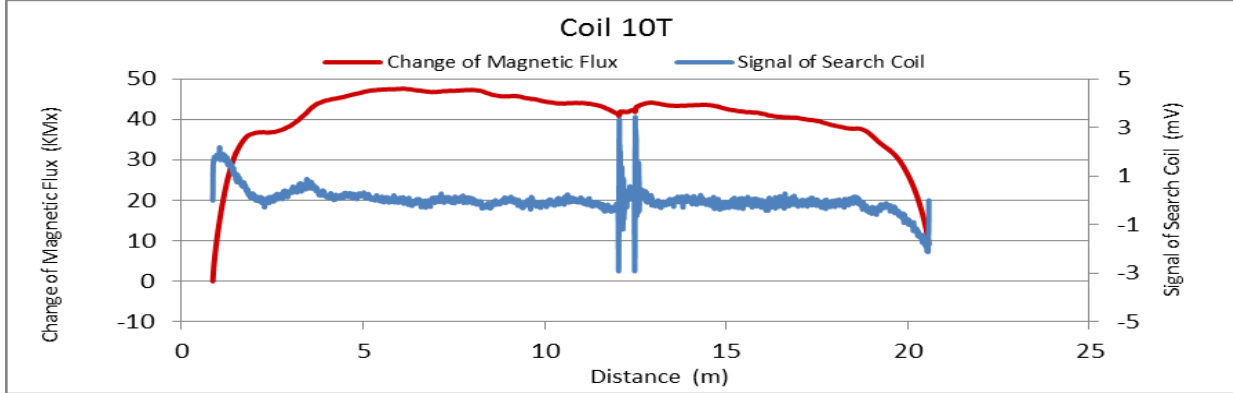
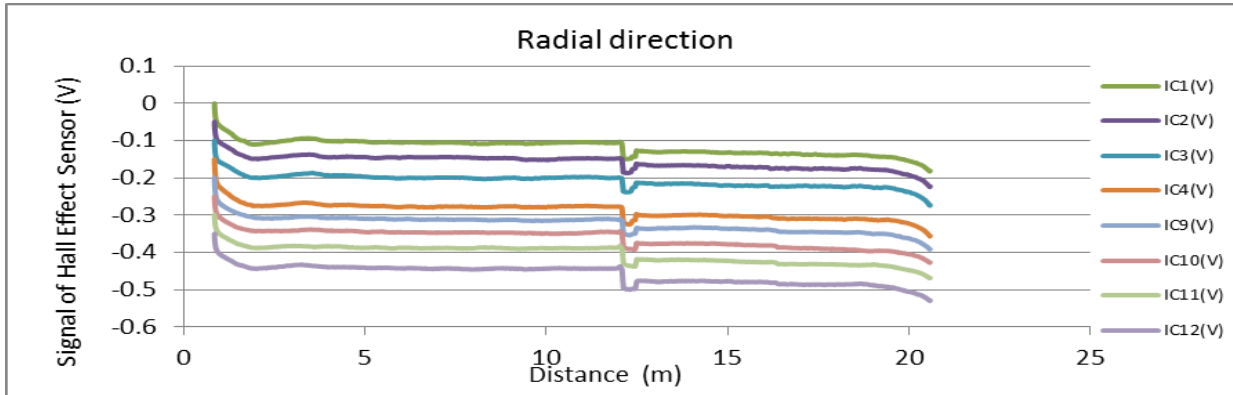
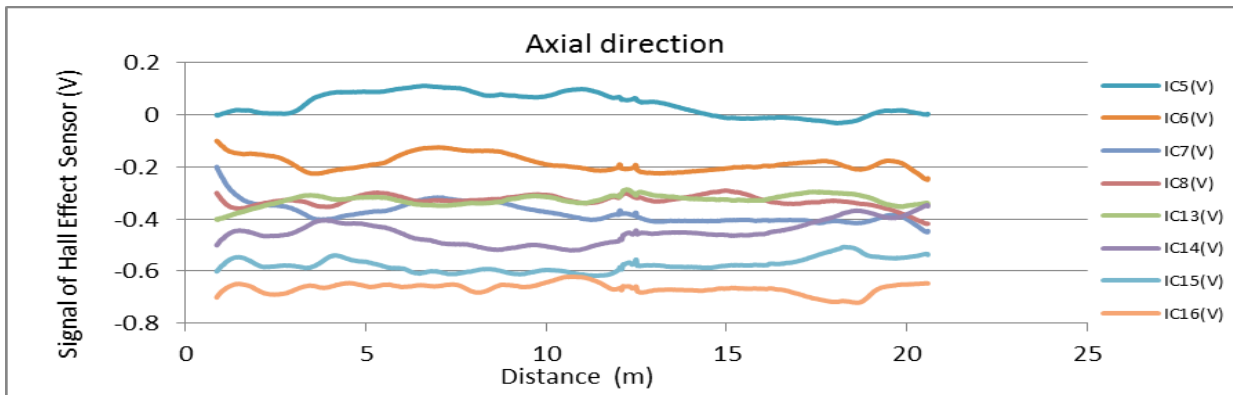
Figure A33. MMFM data of P5-401R-II tendon section.

File Name 【Pier-Tendon-Section】	Section Total Length (m)	Scanned Length		Note Joint position : 12.24 m Starting point of damage 1 : 2.29 m			
		Starting Point (m)	Ending Point (m)				
P5-401R-II	21.45	0.86	20.58				
Identified Damage 1				Identified Damage 2			
Max Loss Point (m)	Loss (%)	Length (m)	Damage Orientation	Max Loss Point (m)	Loss (%)	Length (m)	Damage Orientation
2.3	1.5	0.61	3~9 o'clock	—	—	—	—

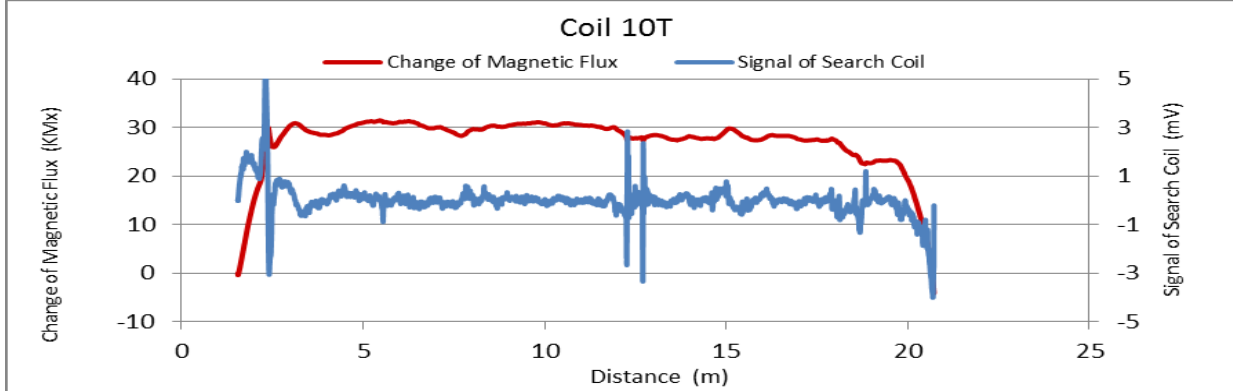
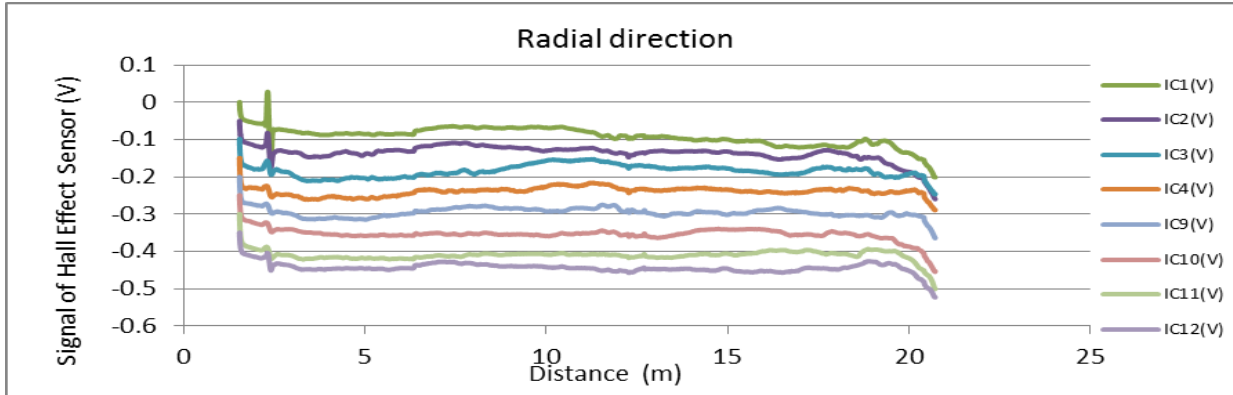
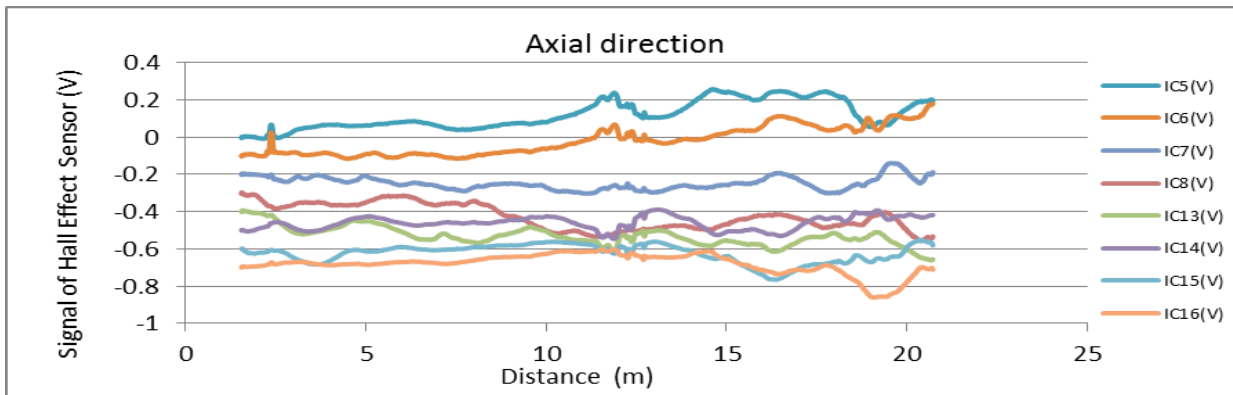
Figure A34. MMFM data of P5-402R-I1 tendon section.

File Name 【Pier-Tendon-Section】	Section Total Length (m)	Scanned Length		Note			
		Starting Point (m)	Ending Point (m)				
P5-402R-I1	21.45	1.55	20.83	Joint position : 12.56 m Identified damage 1 : Increase of magnetic flux Identified damage 2 : Elliptical deformed duct Starting point of damage 1 : 2.34 m Starting point of damage 2 : 18.5 m			
Identified Damage 1				Identified Damage 2			
Max Loss Point (m)	Loss (%)	Length (m)	Damage Orientation	Max Loss Point (m)	Loss (%)	Length (m)	Damage Orientation
2.4	-2.3	0.08	6~10 o'clock	18.8	1.2	0.6	7~11 o'clock

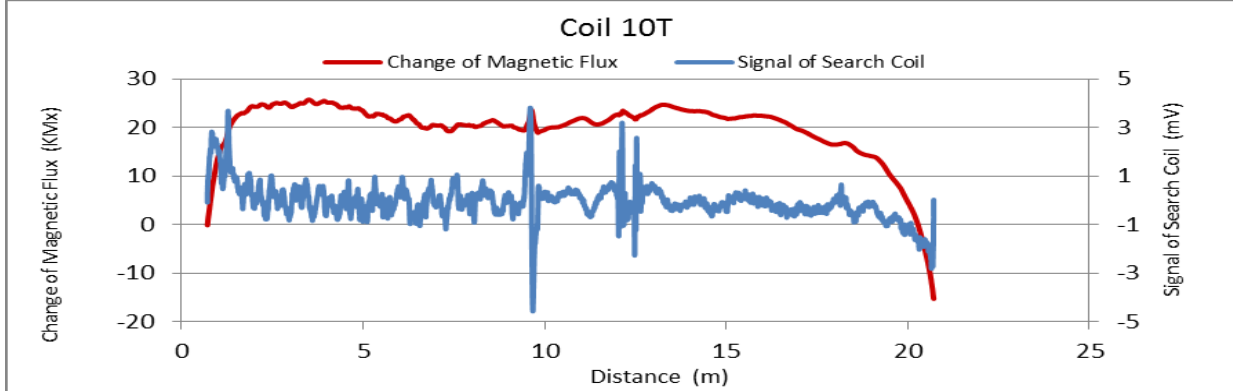
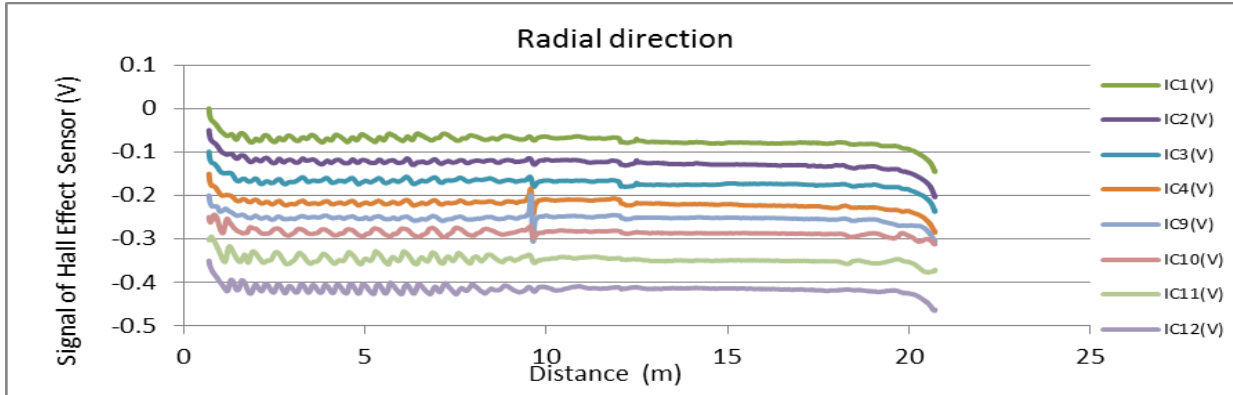
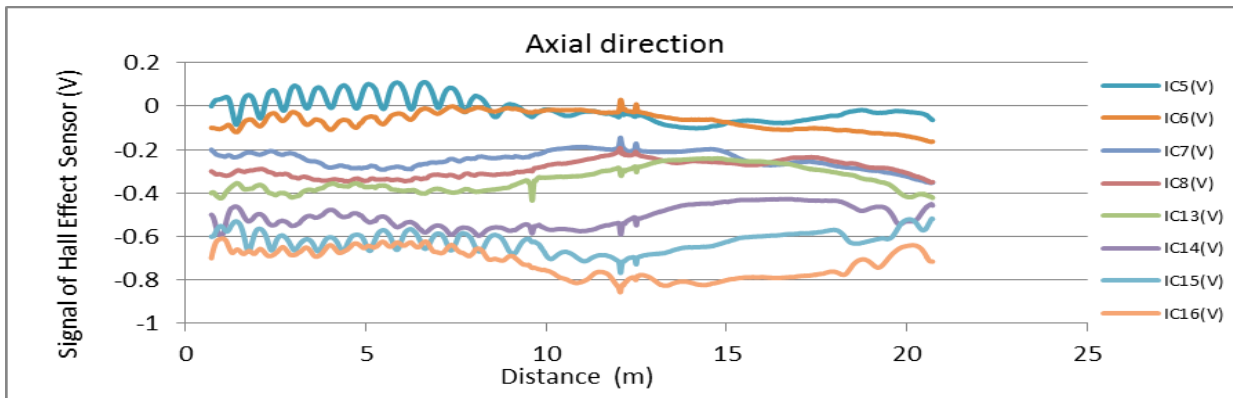
Figure A35. MMFM data of P5-401L-I1 tendon section.

File Name 【Pier-Tendon-Section】	Section Total Length (m)	Scanned Length		Note Joint or repair position : 12.28 m Identified damage 1 : Increase of magnetic flux Starting point of damage 1 : 9.56 m			
		Starting Point (m)	Ending Point (m)				
P5-401L-I1	21.51	0.71	20.73				
Identified Damage 1				Identified Damage 2			
Max Loss Point (m)	Loss (%)	Length (m)	Damage Orientation	Max Loss Point (m)	Loss (%)	Length (m)	Damage Orientation
9.6	-1.7	0.14	6~9 o'clock	—	—	—	—

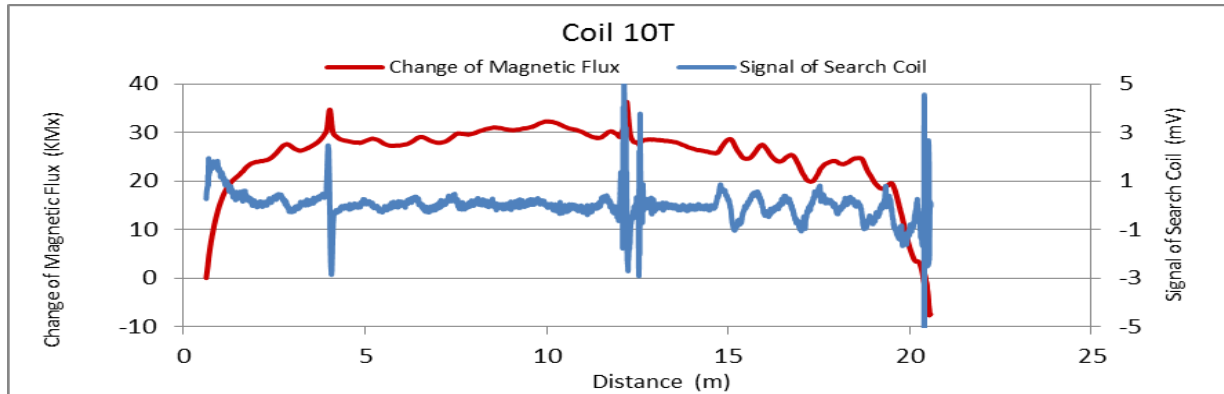
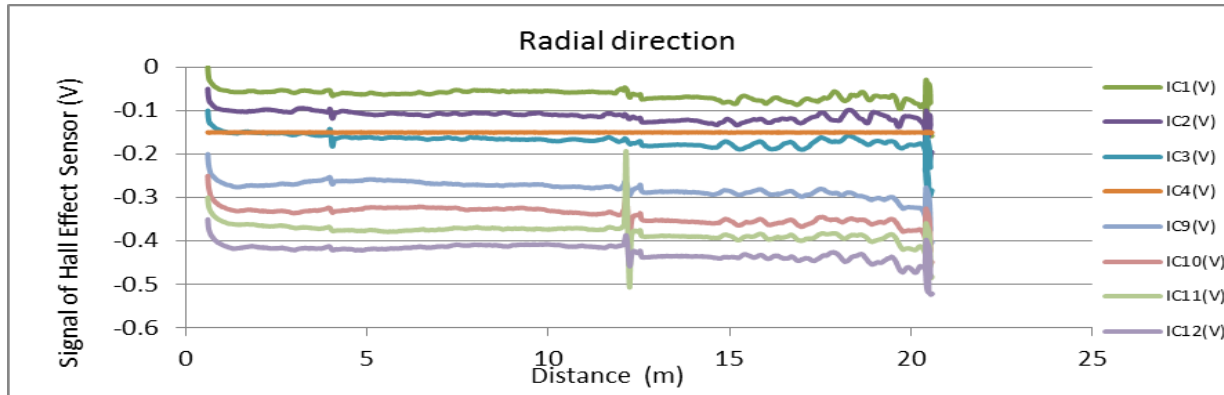
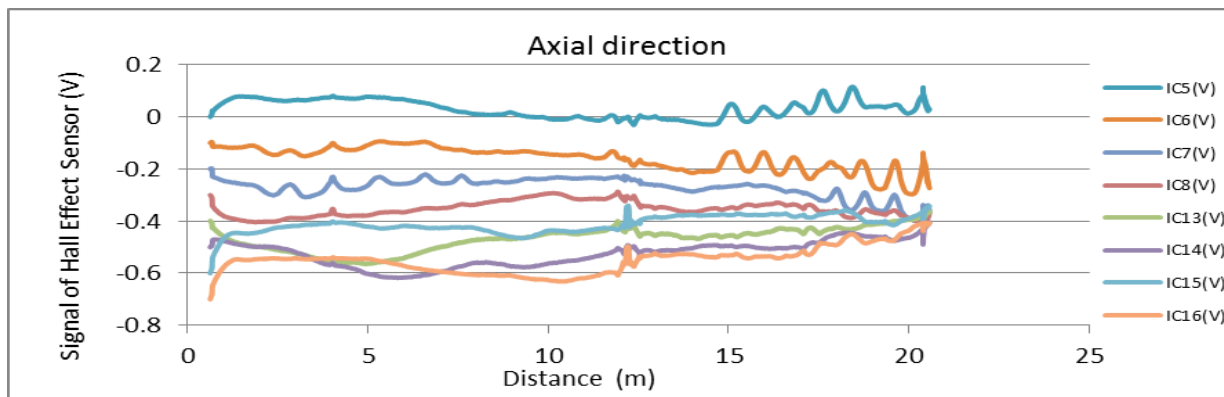
Figure A36. MMFM data of P5-402L-I1 tendon section.

File Name 【Pier-Tendon-Section】	Section Total Length (m)	Scanned Length		Note			
		Starting Point (m)	Ending Point (m)				
P5-402L-I1	21.51	0.62	20.62	Joint or repair position : 12.28 m Identified damage 1&2 : Increase of magnetic flux Starting point of damage 1 : 3.94 m Starting point of damage 2 : 12.13 m			
Identified Damage 1				Identified Damage 2			
Max Loss Point (m)	Loss (%)	Length (m)	Damage Orientation	Max Loss Point (m)	Loss (%)	Length (m)	Damage Orientation
4.0	-2.3	0.15	5~7 o'clock	12.2	-3.1	0.2	10~12 o'clock

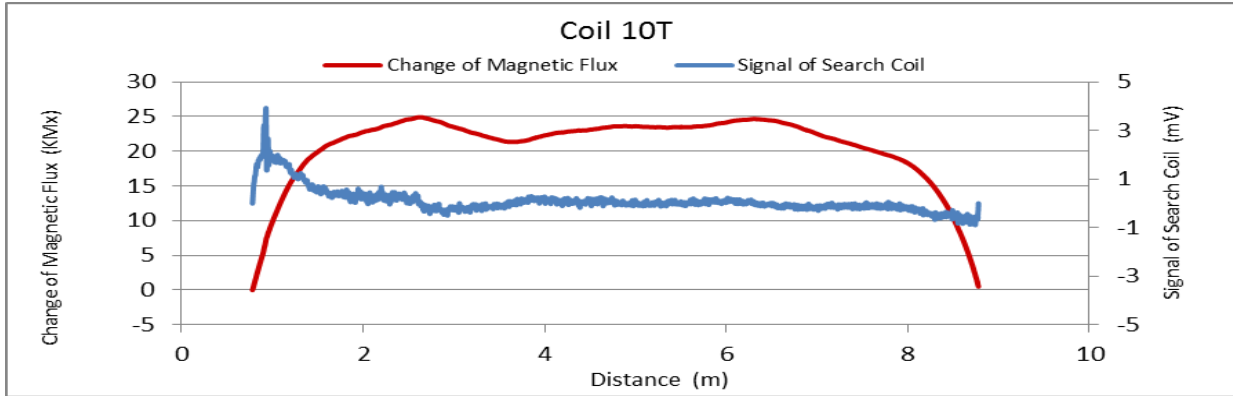
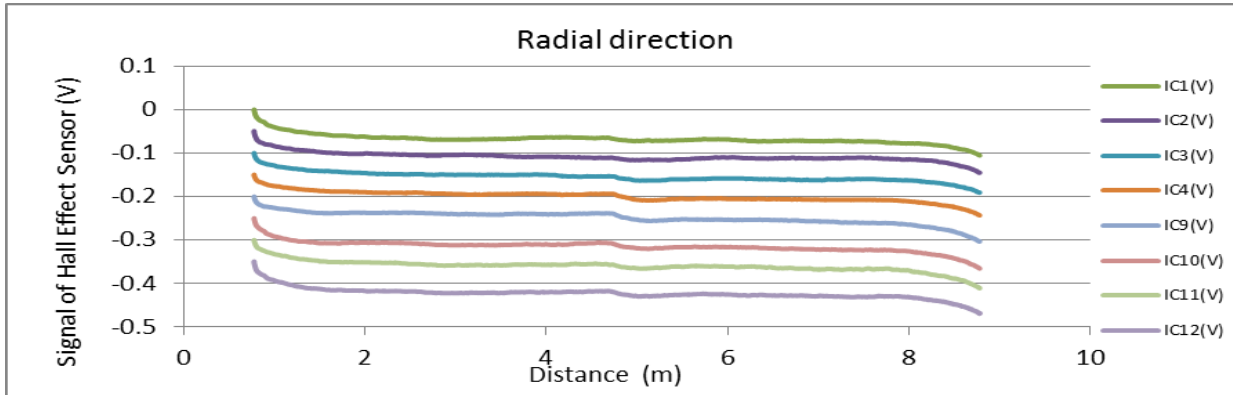
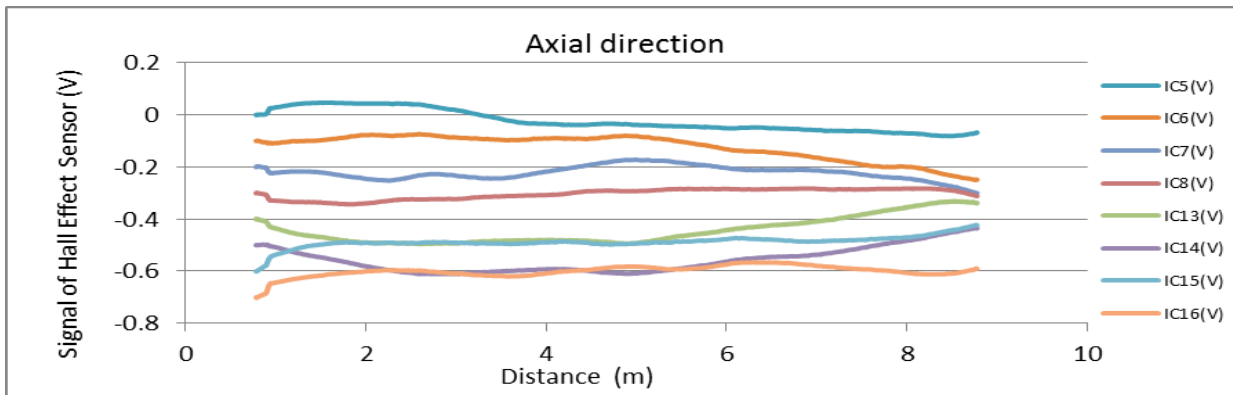
Figure A37. MMFM data of P6-402R-H2 tendon section.

File Name 【Pier-Tendon-Section】	Section Total Length (m)	Scanned Length		Note Starting point of damage 1 : 3.28 m			
		Starting Point (m)	Ending Point (m)				
P6-402R-H2	9.36	0.78	8.83				
Identified Damage 1				Identified Damage 2			
Max Loss Point (m)	Loss (%)	Length (m)	Damage Orientation	Max Loss Point (m)	Loss (%)	Length (m)	Damage Orientation
3.7	1.3	1.34	5~9 o'clock	—	—	—	—

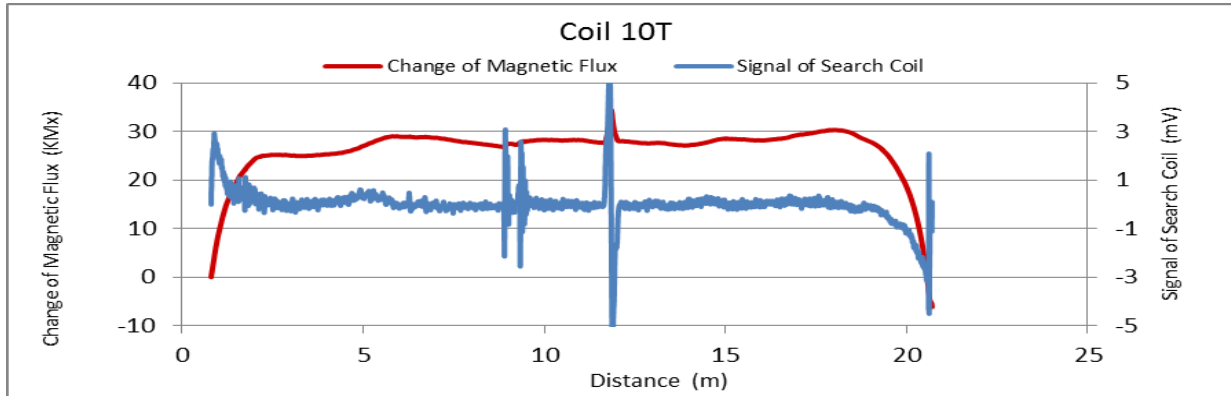
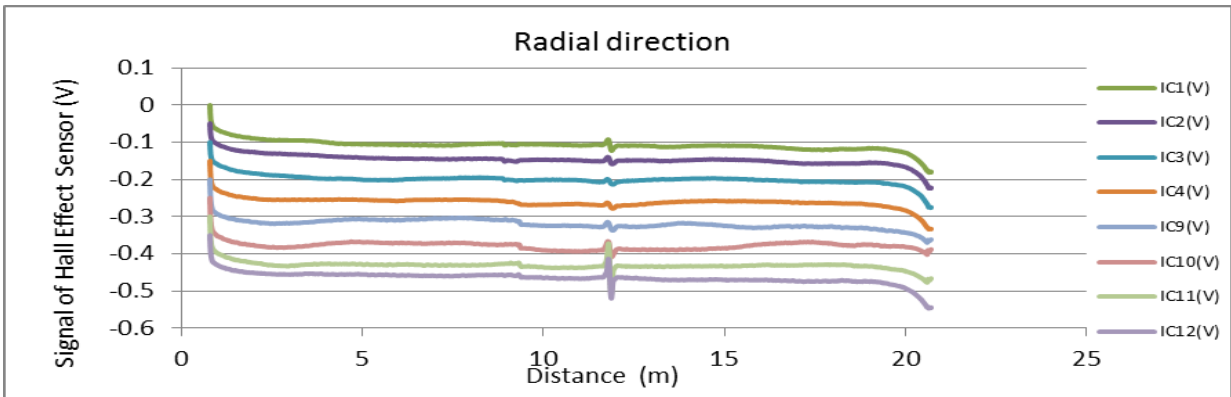
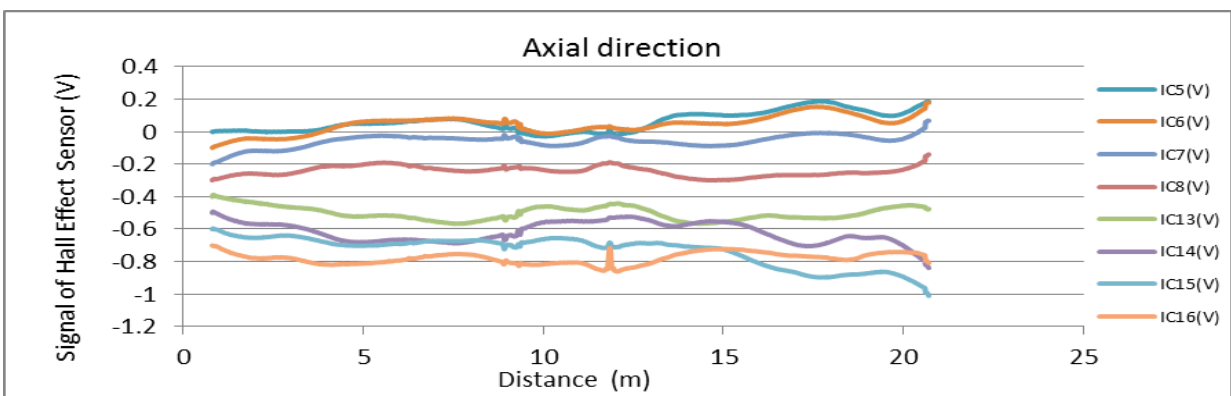
Figure A38. MMFM data of P7-401L-I2 tendon section.

File Name		Section	Scanned Length		Note		
【Pier-Tendon-Section】		Total Length (m)	Starting Point (m)	Ending Point (m)	Joint position: 9.23m Identified damage 1 : Increase of magnetic flux Starting point of damage 1 : 11.77 m		
P7-401L-I2		21.51	0.8	20.95			
Identified Damage 1				Identified Damage 2			
Max Loss Point (m)	Loss (%)	Length (m)	Damage Orientation	Max Loss Point (m)	Loss (%)	Length (m)	Damage Orientation
11.8	-2.6	0.17	9~12 o'clock	—	—	—	—

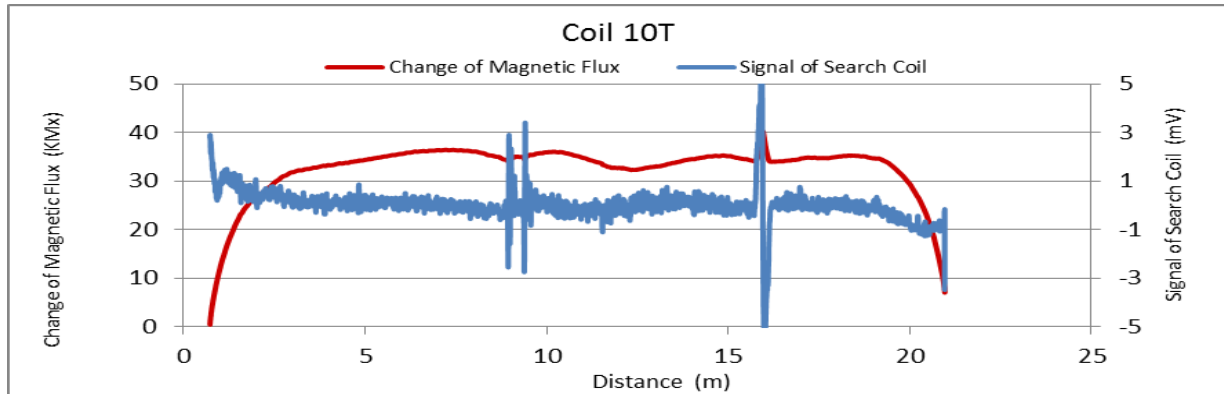
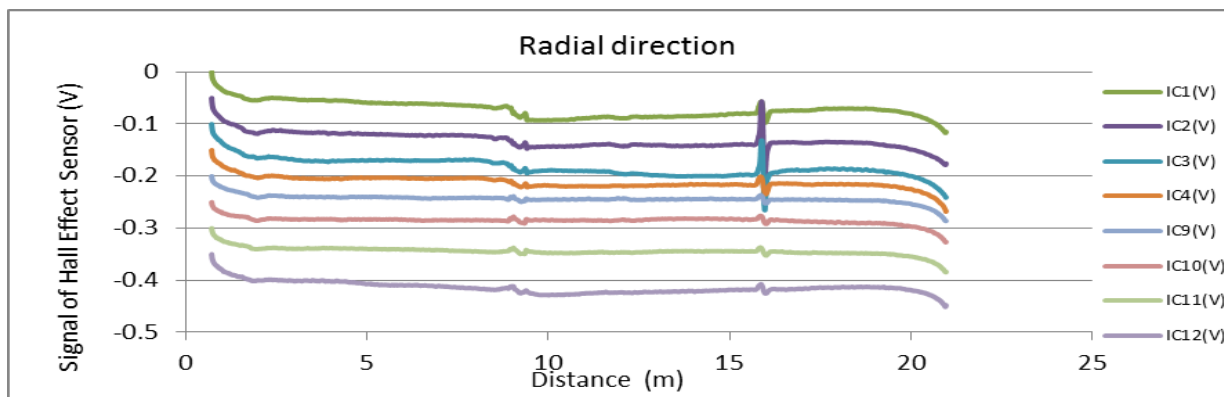
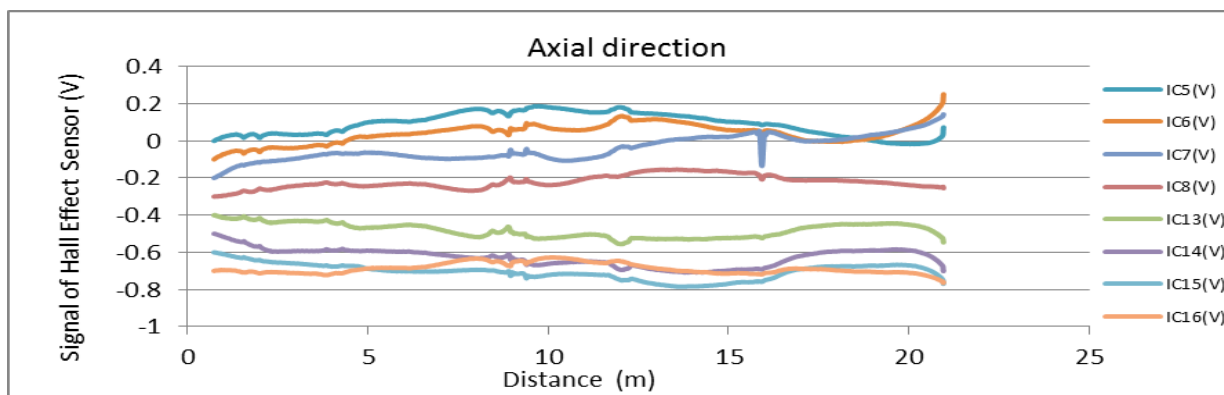
Figure A39. MMFM data of P7-402L-I2 tendon section.

File Name 【Pier-Tendon-Section】	Section Total Length (m)	Scanned Length		Note Joint position: 9.2 m Identified damage 1 : Increase of magnetic flux Starting point of damage 1 : 15.87 m			
		Starting Point (m)	Ending Point (m)				
P7-402L-I2	21.51	0.72	20.97				
Identified Damage 1				Identified Damage 2			
Max Loss Point (m)	Loss (%)	Length (m)	Damage Orientation	Max Loss Point (m)	Loss (%)	Length (m)	Damage Orientation
15.9	-2.5	0.17	11~1 o'clock	—	—	—	—

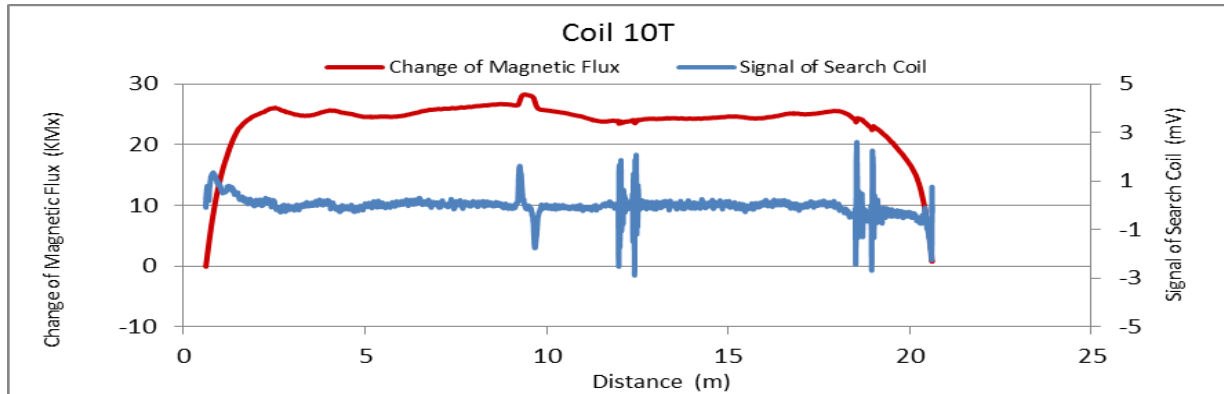
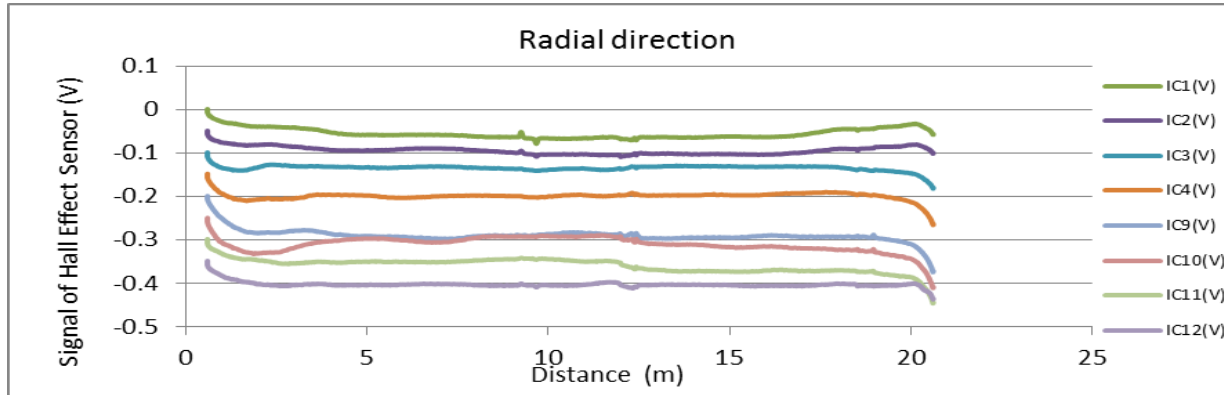
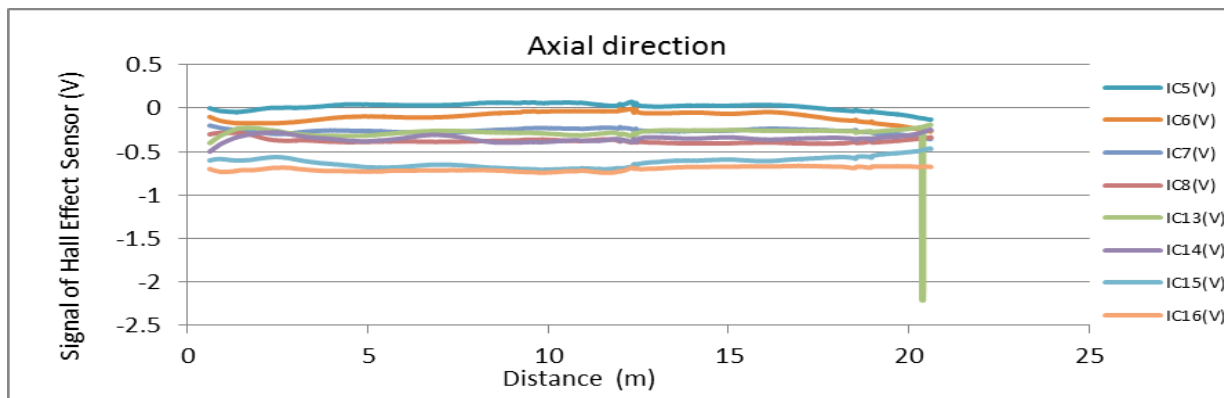
Figure A40. MMFM data of P9-401R-I1 tendon section.

File Name 【Pier-Tendon-Section】	Section Total Length (m)	Scanned Length		Note Joint position: 12.29 m, 18.9 m Identified damage 1: Increase of magnetic flux Starting point of damage 1: 9.31 m			
		Starting Point (m)	Ending Point (m)				
P9-401R-I1	21.57	0.61	20.82				
Identified Damage 1				Identified Damage 2			
Max Loss Point (m)	Loss (%)	Length (m)	Damage Orientation	Max Loss Point (m)	Loss (%)	Length (m)	Damage Orientation
9.4	-0.9	0.28	6~9 o'clock	—	—	—	—

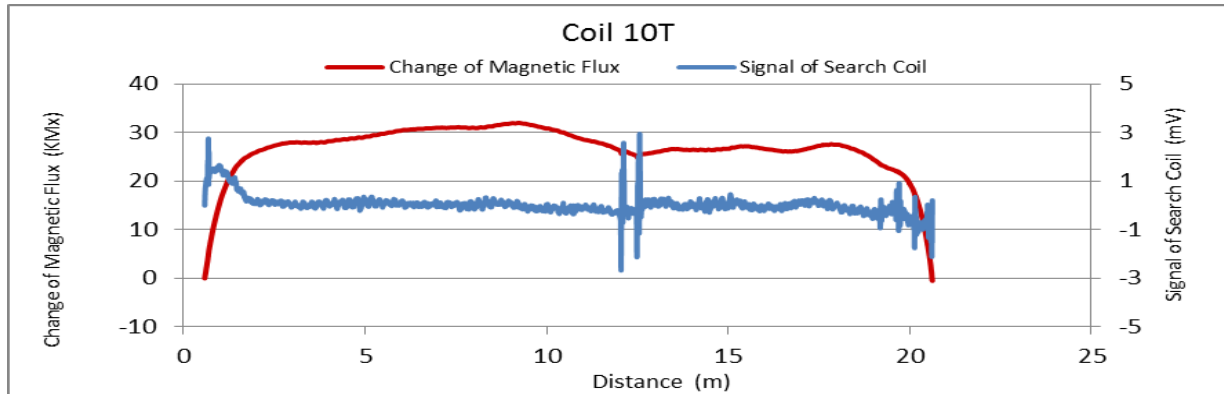
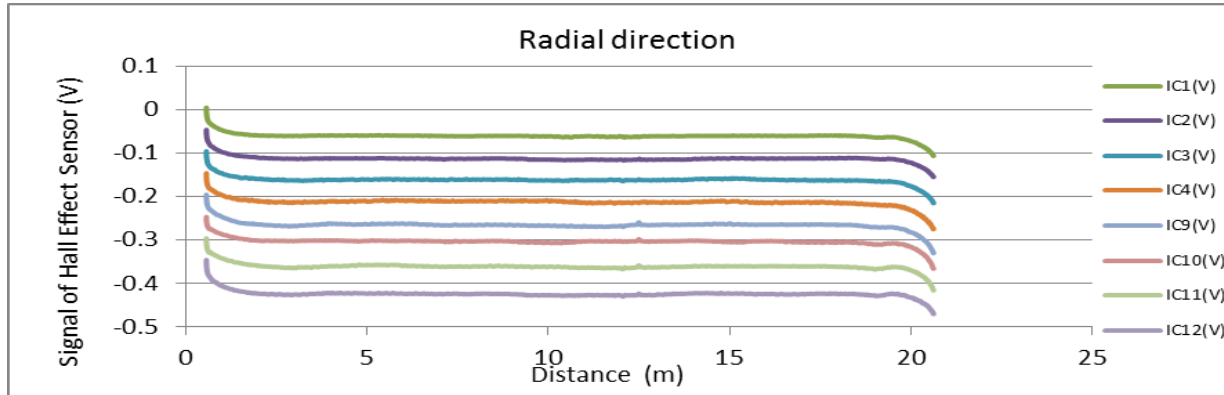
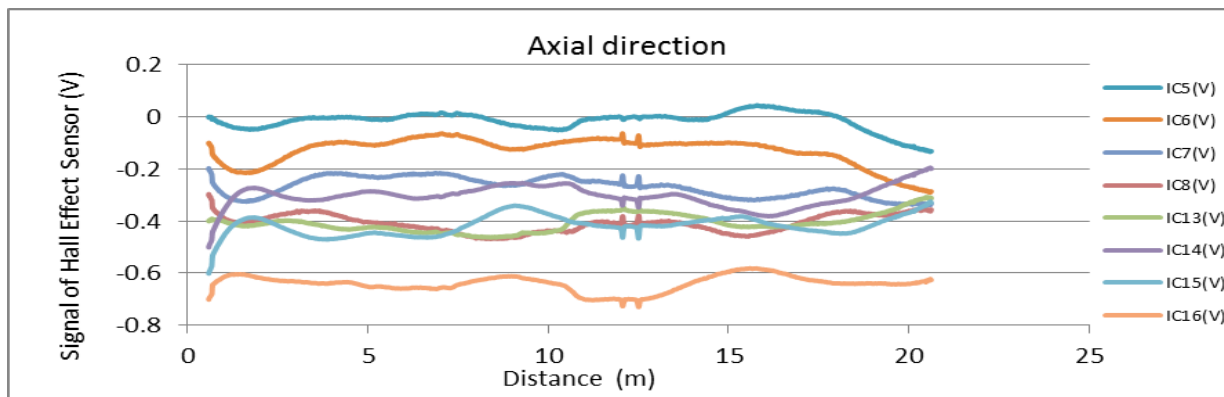
Figure A41. MMFM data of P9-402L-I1 tendon section.

File Name 【Pier-Tendon-Section】	Section Total Length (m)	Scanned Length		Note Joint position : 12.3 m Starting point of damage 1 : 11.2 m			
		Starting Point (m)	Ending Point (m)				
P9-402L-I1	21.48	0.58	20.78				
Identified Damage 1				Identified Damage 2			
Max Loss Point (m)	Loss (%)	Length (m)	Damage Orientation	Max Loss Point (m)	Loss (%)	Length (m)	Damage Orientation
12.3	1.6	3.13	3~9 o'clock	—	—	—	—

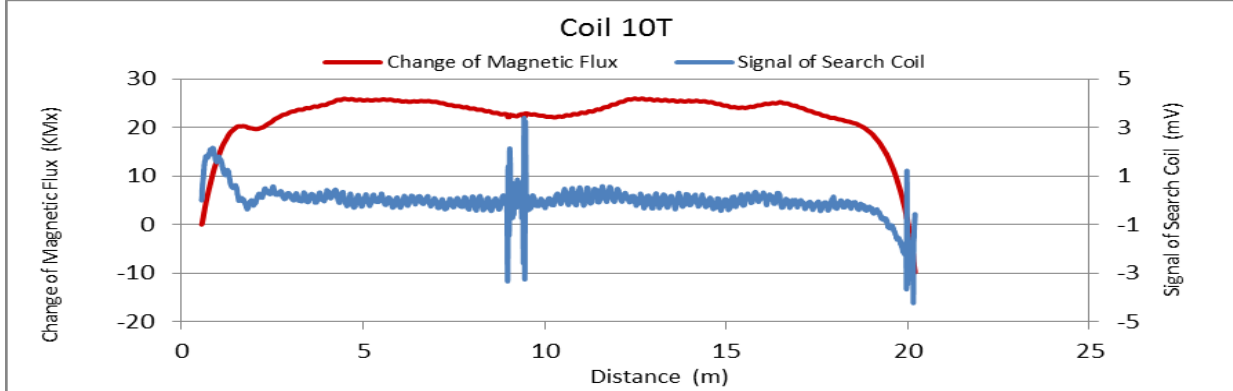
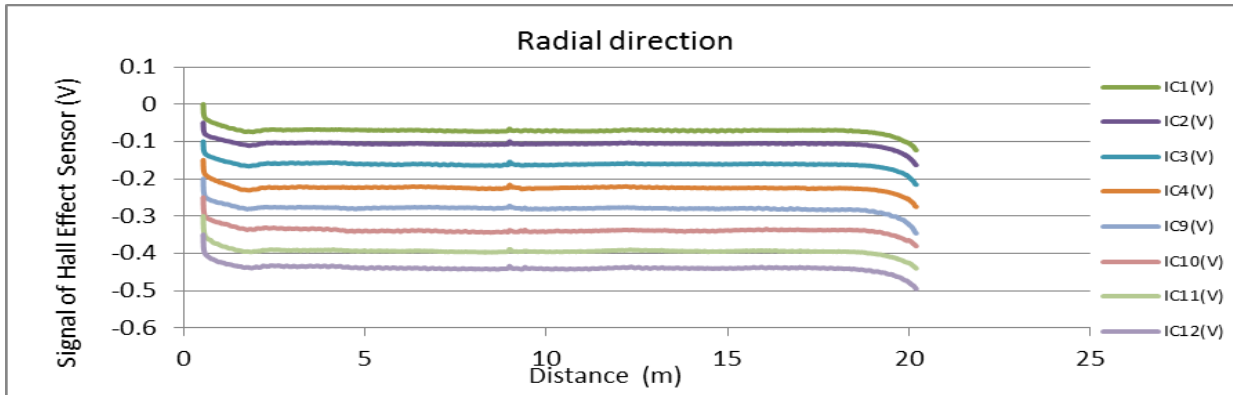
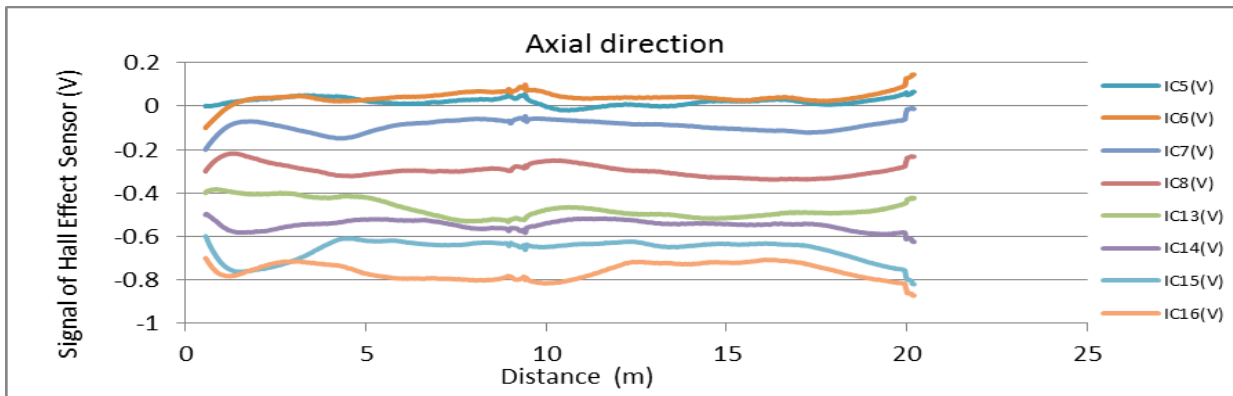
Figure A42. MMFM data of P9-402R-I2 tendon section.

File Name 【Pier-Tendon-Section】	Section Total Length (m)	Scanned Length		Note Joint position : 9.24 m Starting point of damage 1 : 8.55 m			
		Starting Point (m)	Ending Point (m)				
P9-402R-I2	21.47	0.55	20.42				
Identified Damage 1				Identified Damage 2			
Max Loss Point (m)	Loss (%)	Length (m)	Damage Orientation	Max Loss Point (m)	Loss (%)	Length (m)	Damage Orientation
10.3	1.5	2.52	5~10 o'clock	—	—	—	—

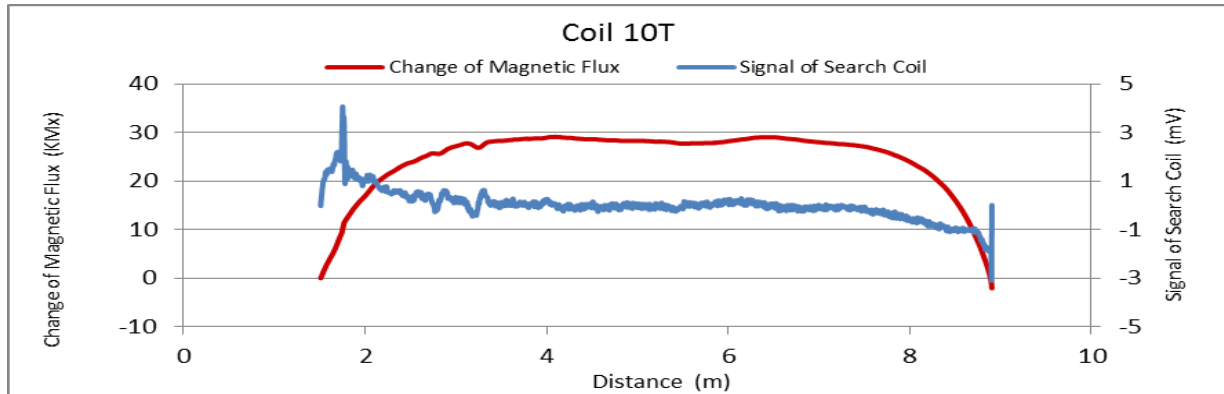
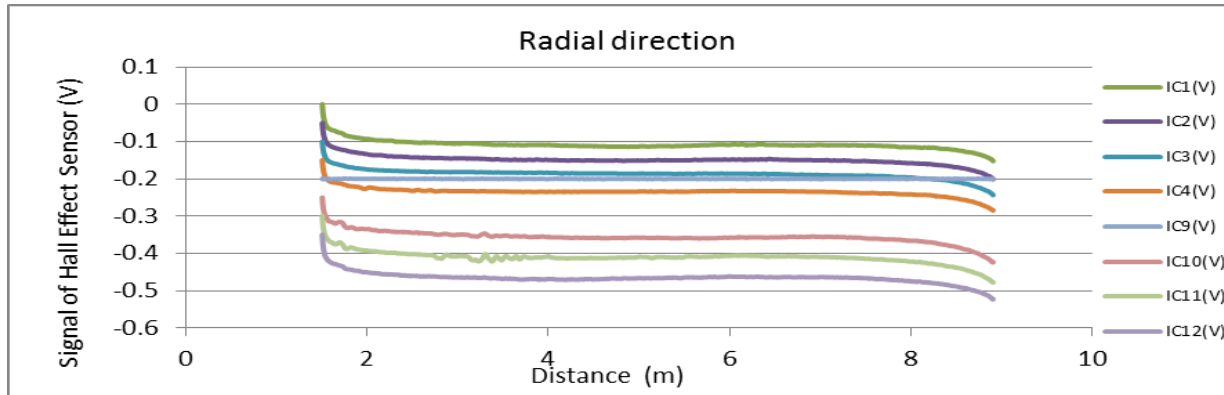
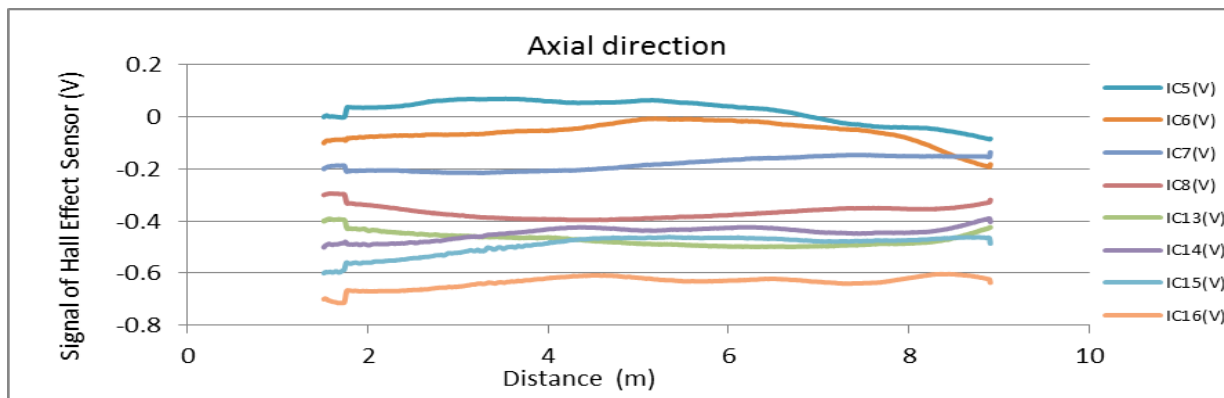
Figure A43. MMFM data of P9-401L-H2 tendon section.

File Name 【Pier-Tendon-Section】	Section Total Length (m)	Scanned Length		Note Starting point of damage 1 : 3.2 m			
		Starting Point (m)	Ending Point (m)				
P9-401L-H2	9.37	1.51	8.91				
Identified Damage 1				Identified Damage 2			
Max Loss Point (m)	Loss (%)	Length (m)	Damage Orientation	Max Loss Point (m)	Loss (%)	Length (m)	Damage Orientation
3.2	0.5	0.11	11~3 o'clock	—	—	—	—

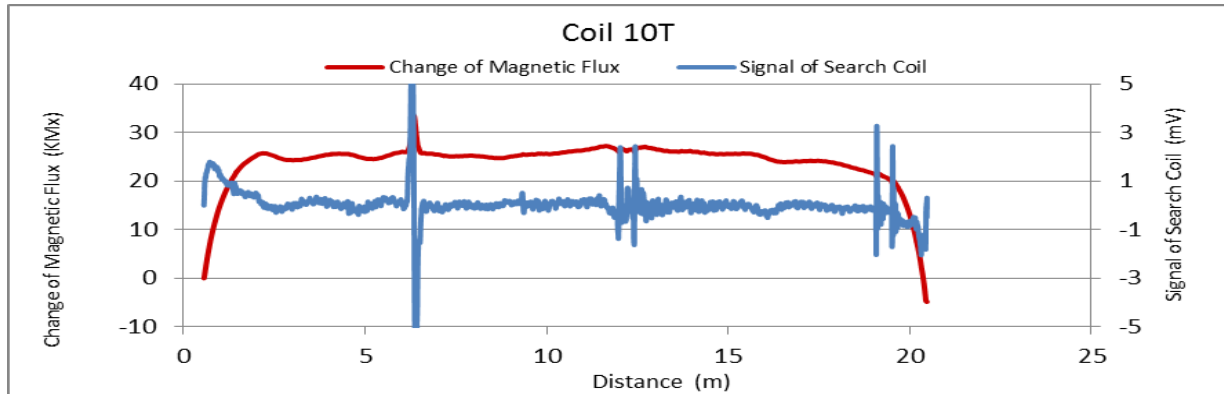
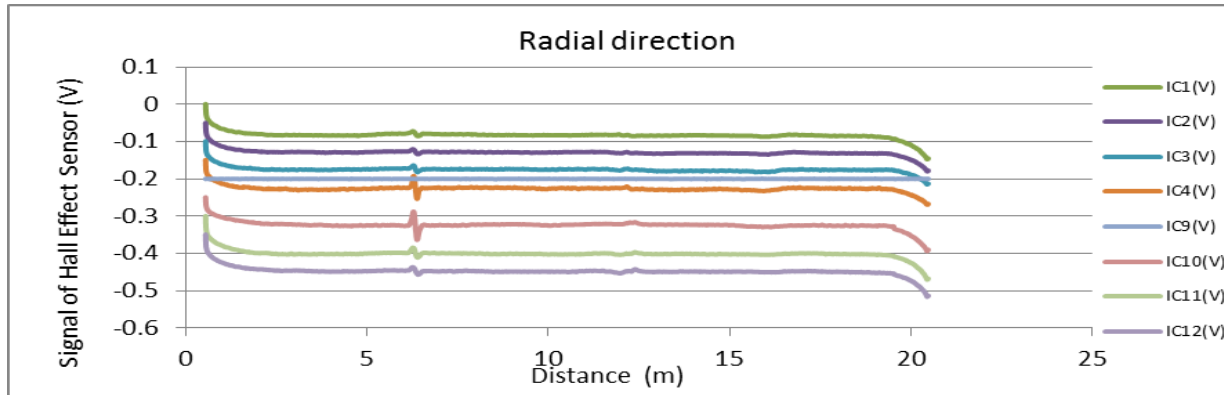
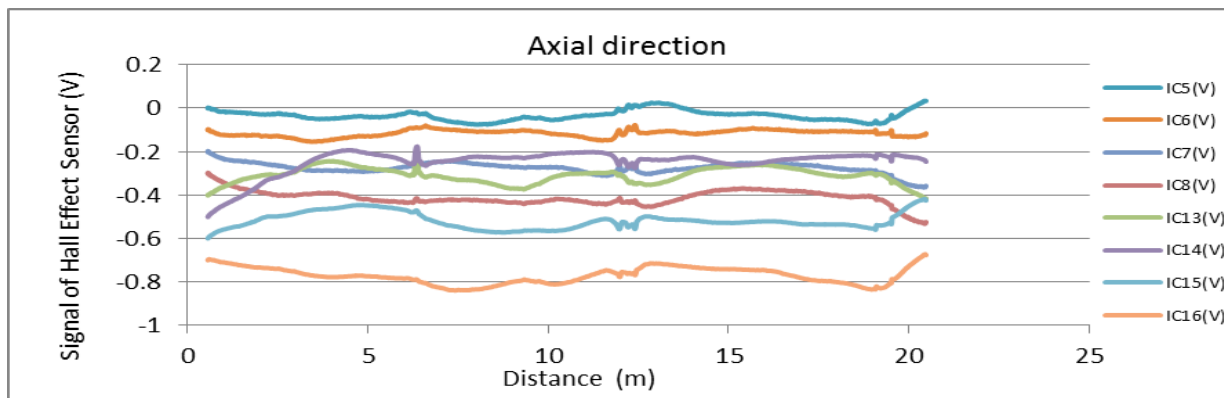
Figure A44. MMFM data of P10-401L-I1 tendon section.

File Name 【Pier-Tendon-Section】	Section Total Length (m)	Scanned Length		Note Joint position: 12.23 m, 19.6 m Identified damage 1: Increase of magnetic flux Starting point of damage 1: 6.25 m			
		Starting Point (m)	Ending Point (m)				
P10-401L-I1	21.47	0.56	20.63				
Identified Damage 1				Identified Damage 2			
Max Loss Point (m)	Loss (%)	Length (m)	Damage Orientation	Max Loss Point (m)	Loss (%)	Length (m)	Damage Orientation
6.3	-3.0	0.23	11~3 o'clock	—	—	—	—

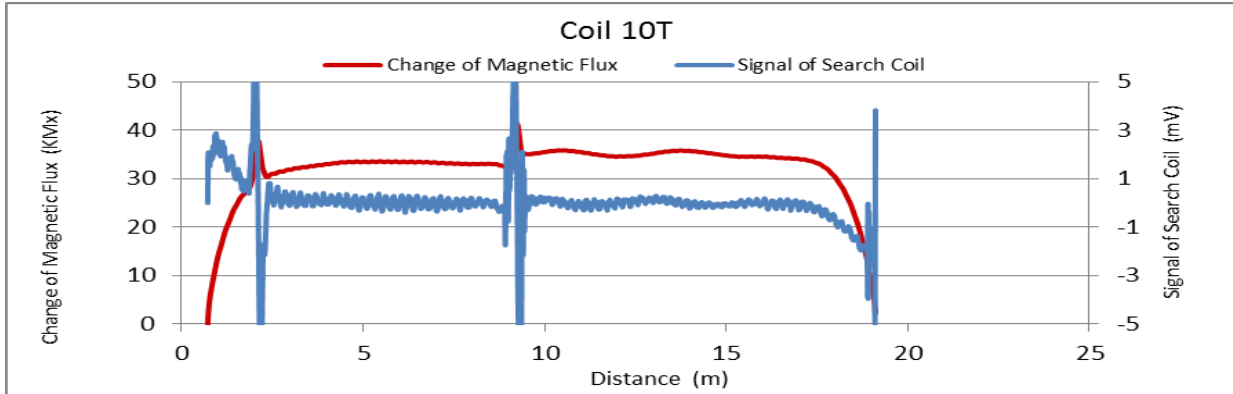
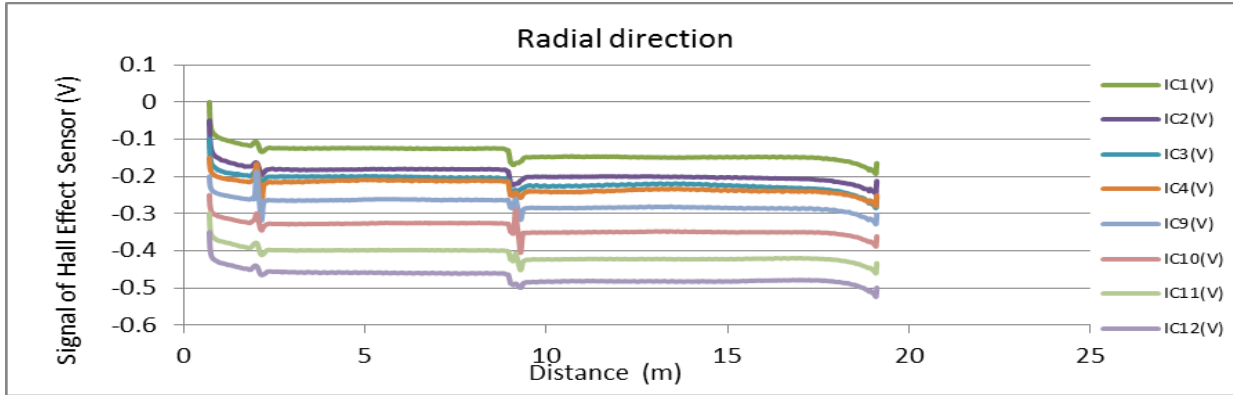
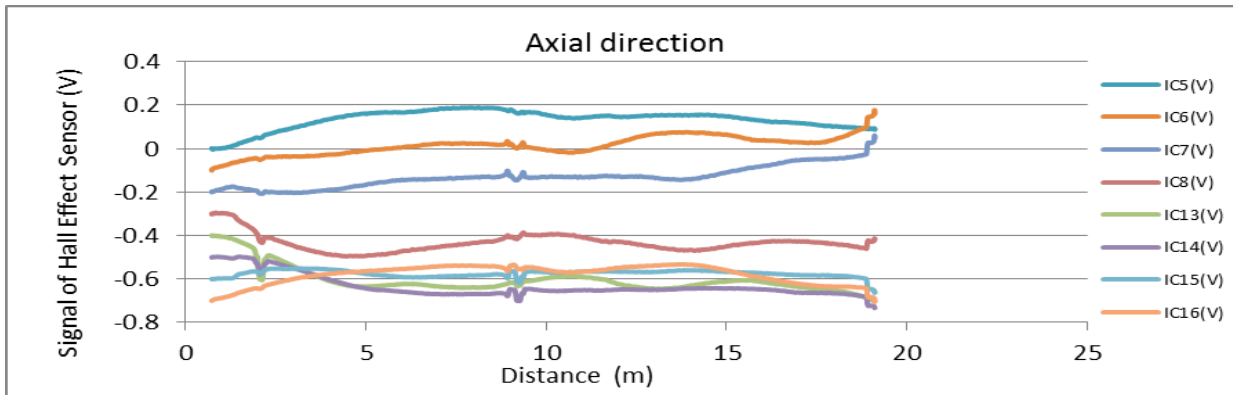
Figure A45. MMFM data of P10-402L-I2 tendon section.

File Name 【Pier-Tendon-Section】	Section Total Length (m)	Scanned Length		Note			
		Starting Point (m)	Ending Point (m)				
P10-402L-I2	21.54	0.72	19.11	Joint position: 9.15 m Identified damage 1&2: Increase of magnetic flux Starting point of damage 1: 2.0 m Starting point of damage 2: 9.12 m			
Identified Damage 1				Identified Damage 2			
Max Loss Point (m)	Loss (%)	Length (m)	Damage Orientation	Max Loss Point (m)	Loss (%)	Length (m)	Damage Orientation
2.1	-3.4	0.19	7~10 o'clock	9.2	-3.0	0.23	4~8 o'clock

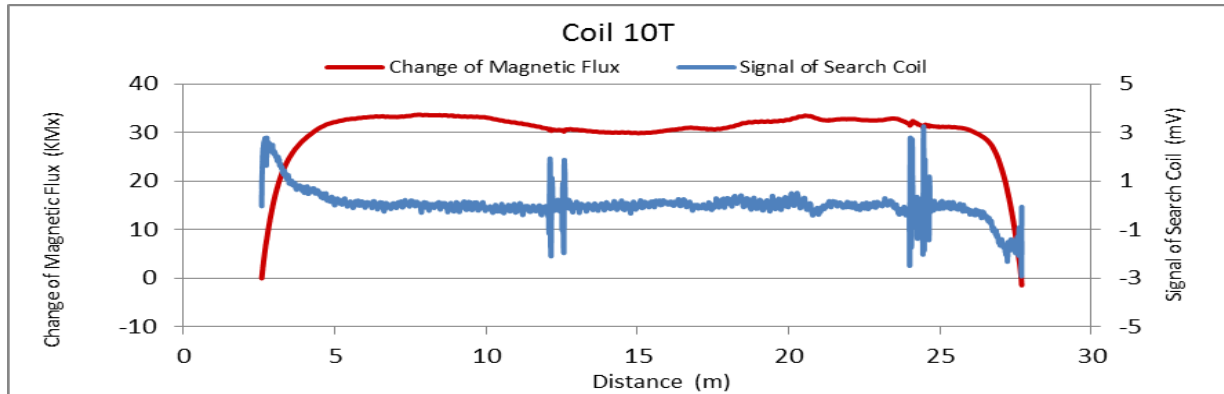
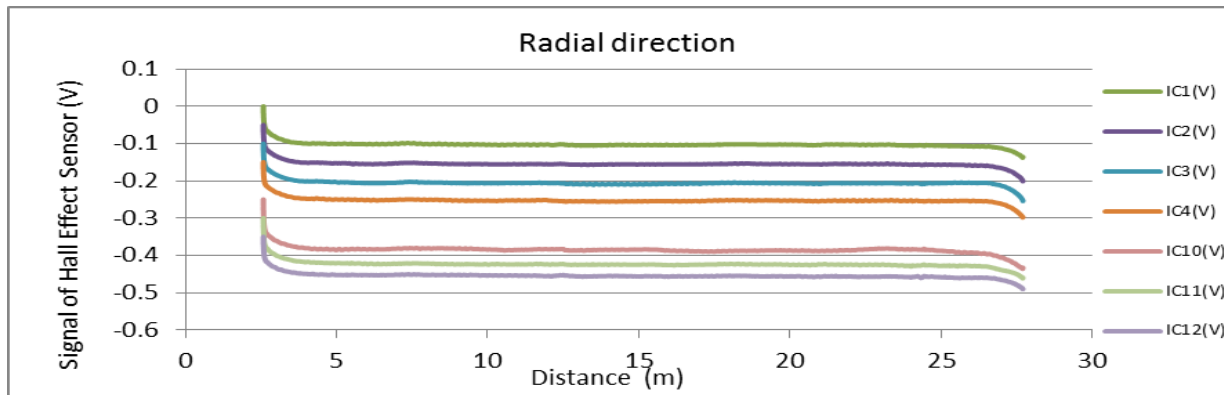
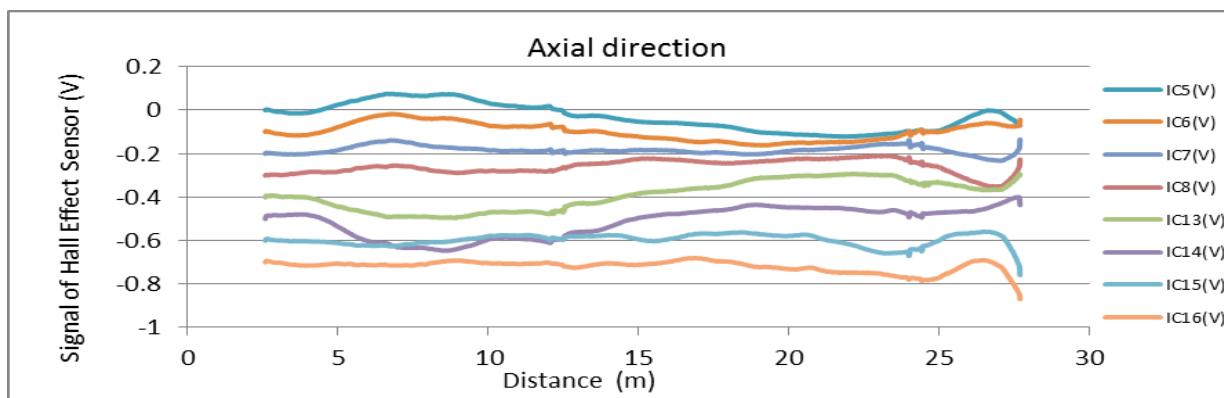
Figure A46. MMFM data of P11-402R-I2 tendon section.

File Name 【Pier-Tendon-Section】	Section Total Length (m)	Scanned Length		Note Joint position : 12.3 m, 24.47 m Starting point of damage 1 : 13.2 m			
		Starting Point (m)	Ending Point (m)				
P11-402R-I2	28.49	2.58	28.02				
Identified Damage 1				Identified Damage 2			
Max Loss Point (m)	Loss (%)	Length (m)	Damage Orientation	Max Loss Point (m)	Loss (%)	Length (m)	Damage Orientation
15.0	1.5	3.85	10~2 o'clock	—	—	—	—
