**Development of Quality Assurance and Quality Control
System for Post Tensioned Segmental Bridges in Florida:
Case of Ringling Bridge – Phase II**

**FDOT Contract No. BDV29-977-34
FINAL REPORT**

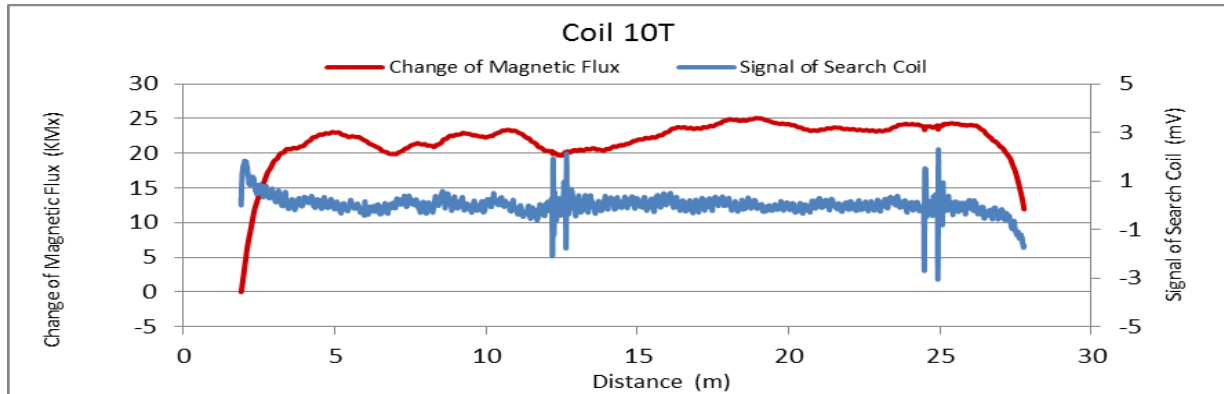
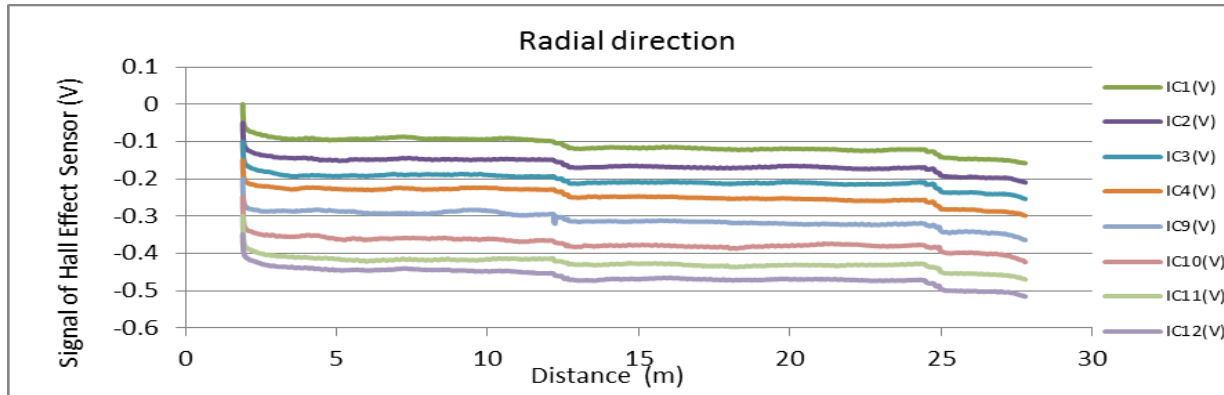
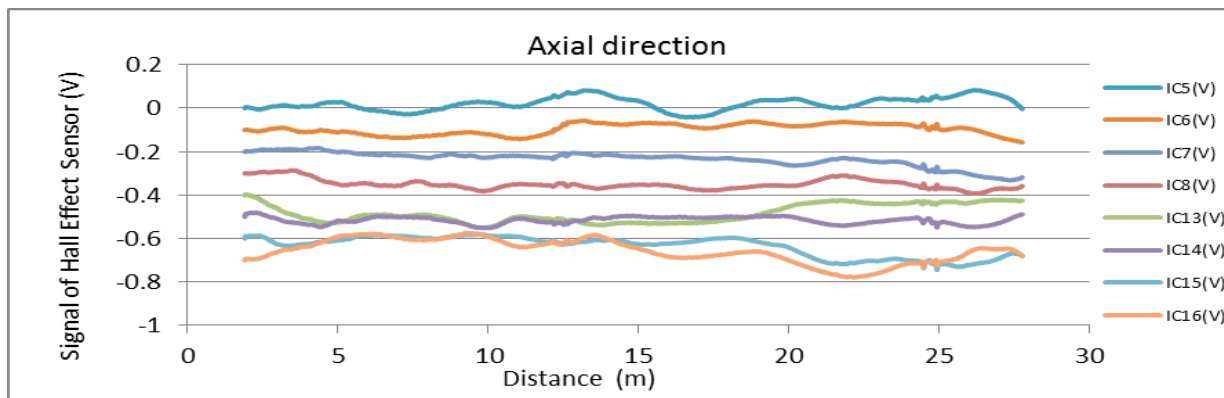
Figure A47. MMFM data of P11-402L-I2 tendon section.

File Name 【Pier-Tendon-Section】	Section Total Length (m)	Scanned Length		Note Joint position : 12.26 m, 24.42 m Starting point of damage 1 : 6.25 m Starting point of damage 2 : 11.73 m			
		Starting Point (m)	Ending Point (m)				
P11-402L-I2	28.46	1.9	27.97				
Identified Damage 1				Identified Damage 2			
Max Loss Point (m)	Loss (%)	Length (m)	Damage Orientation	Max Loss Point (m)	Loss (%)	Length (m)	Damage Orientation
7.0	1.3	2.06	3~9 o'clock	12.4	1.8	3.04	3~9 o'clock

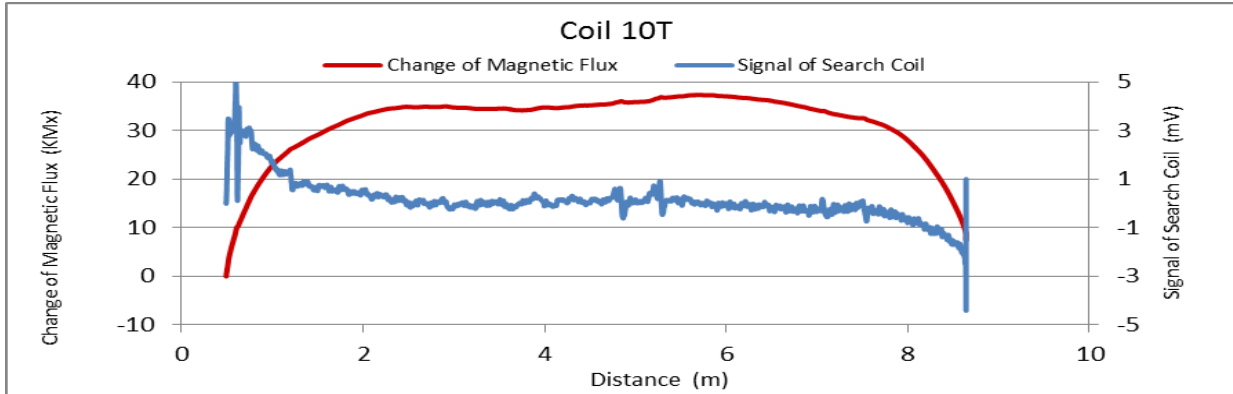
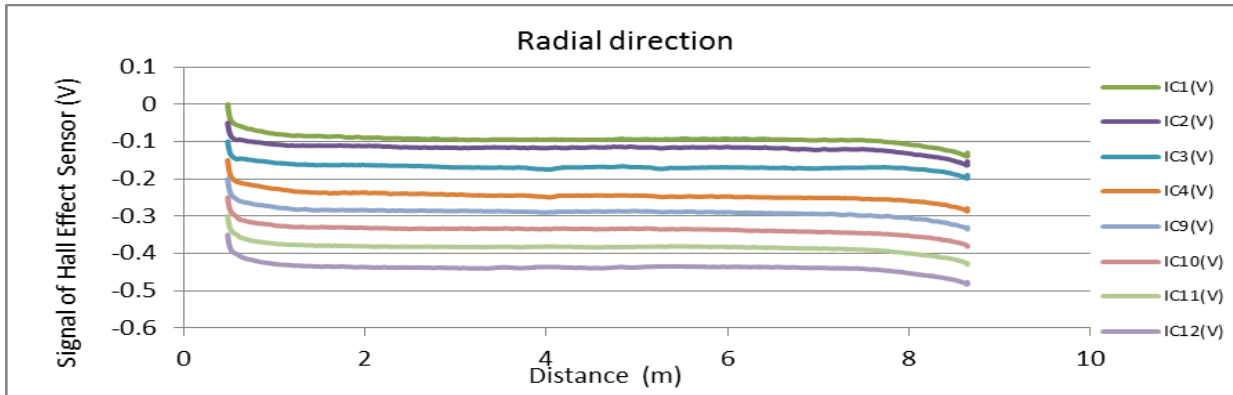
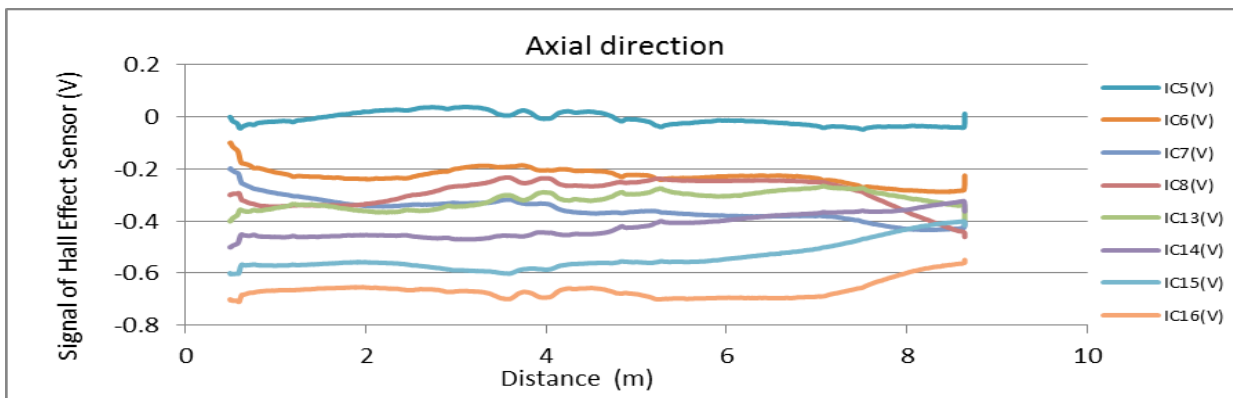
Figure A48. MMFM data of P9-406L-H1 tendon section.

File Name 【Pier-Tendon-Section】	Section Total Length (m)	Scanned Length		Note Starting point of damage 1 : 3.43 m			
		Starting Point (m)	Ending Point (m)				
P9-406L-H1	9.43	0.49	8.65				
Identified Damage 1				Identified Damage 2			
Max Loss Point (m)	Loss (%)	Length (m)	Damage Orientation	Max Loss Point (m)	Loss (%)	Length (m)	Damage Orientation
3.7	0.8	1.01	10~4 o'clock	—	—	—	—

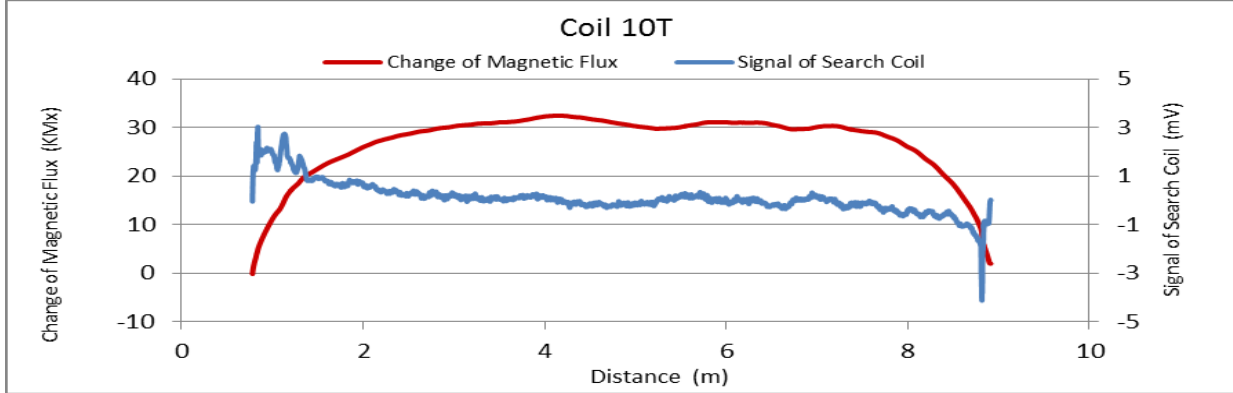
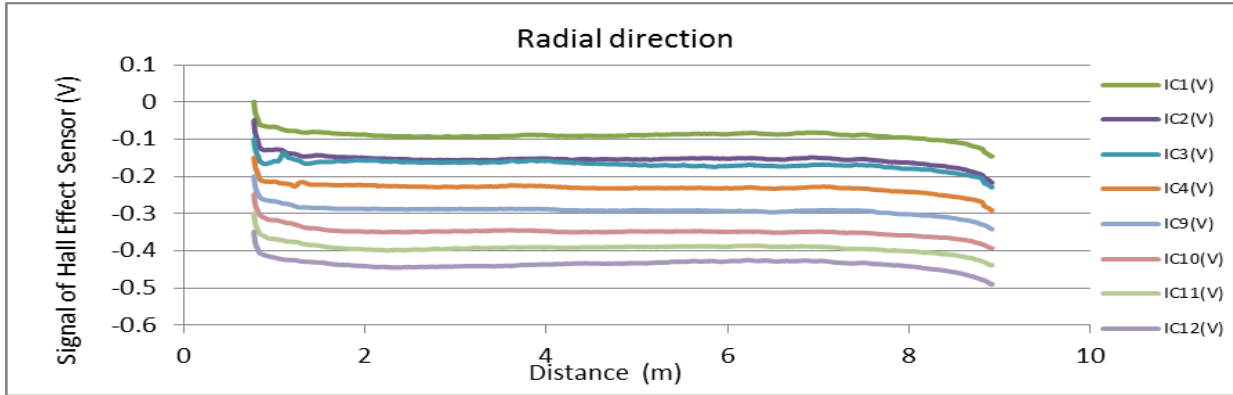
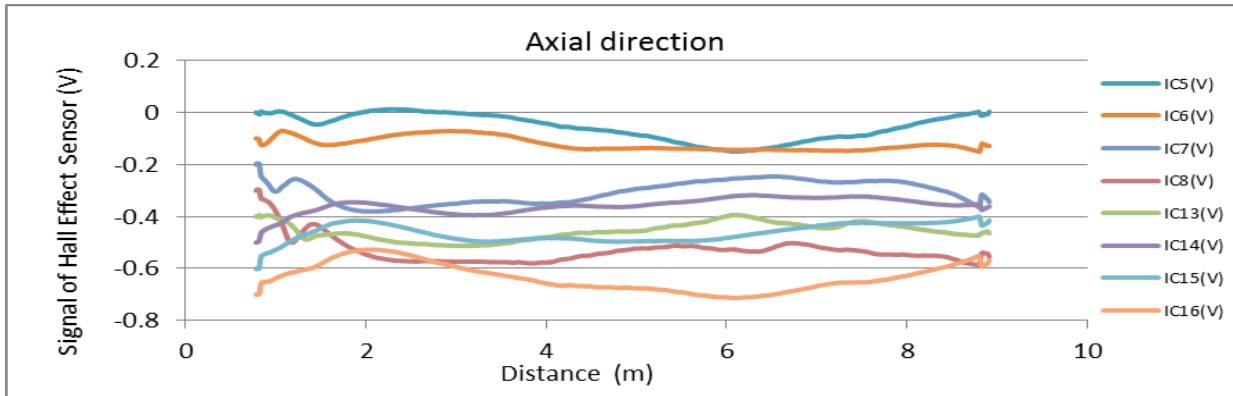
Figure A49. MMFM data of P9-403R-H2 tendon section.

File Name 【Pier-Tendon-Section】	Section Total Length (m)	Scanned Length		Note Starting point of damage 1 : 4.83 m			
		Starting Point (m)	Ending Point (m)				
P9-403R-H2	9.4	0.78	8.92				
Identified Damage 1				Identified Damage 2			
Max Loss Point (m)	Loss (%)	Length (m)	Damage Orientation	Max Loss Point (m)	Loss (%)	Length (m)	Damage Orientation
5.2	0.8	0.63	7~1 o'clock	—	—	—	—

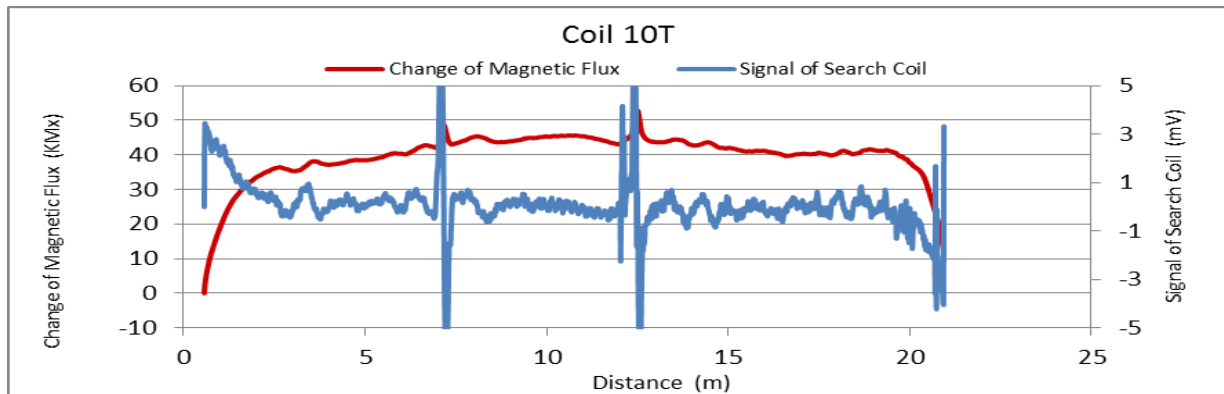
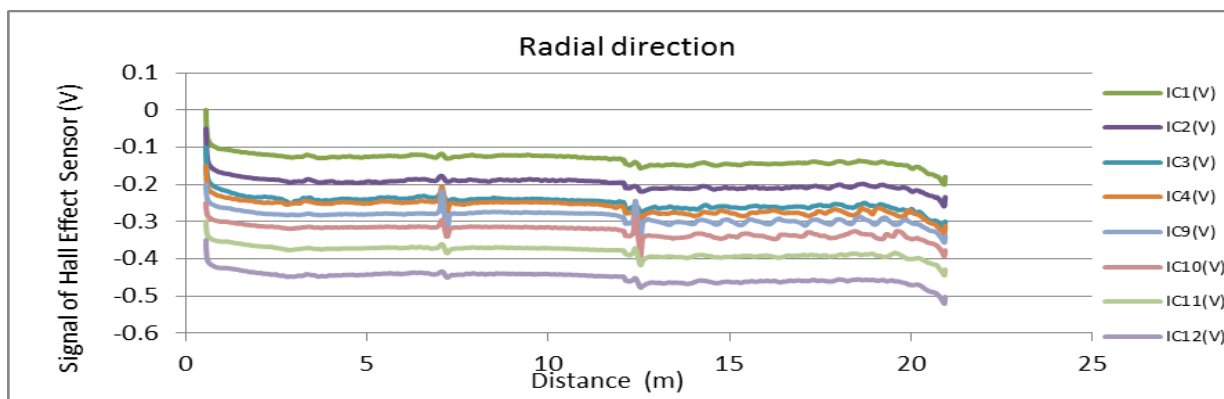
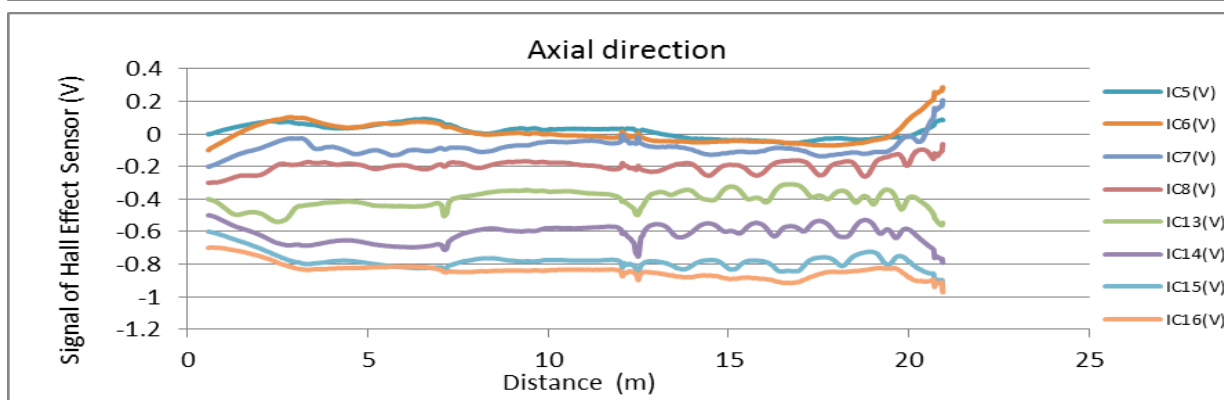
File Name 【Pier-Tendon-Section】	Section Total Length (m)	Scanned Length		Note			
		Starting Point (m)	Ending Point (m)				
P9-403R-I2	21.49	0.57	20.94	Joint position: 12.3 m Identified damage 1&2: Increase of magnetic flux Starting point of damage 1: 7.1 m Starting point of damage 2: 12.32 m			
Identified Damage 1				Identified Damage 2			
Max Loss Point (m)	Loss (%)	Length (m)	Damage Orientation	Max Loss Point (m)	Loss (%)	Length (m)	Damage Orientation
7.2	-2.4	0.17	6~9 o'clock	12.5	-3.9	0.39	6~9 o'clock

Figure A50. MMFM data of P9-403R-I2 tendon section.

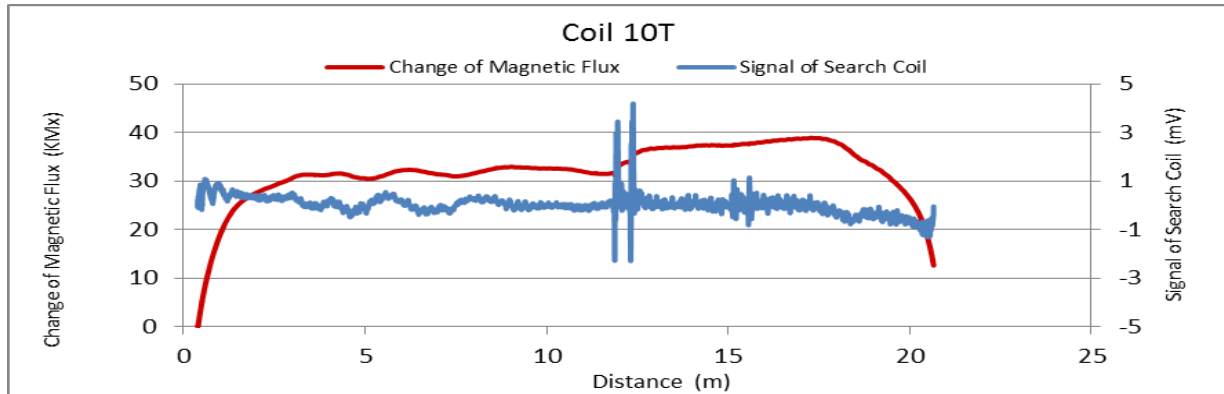
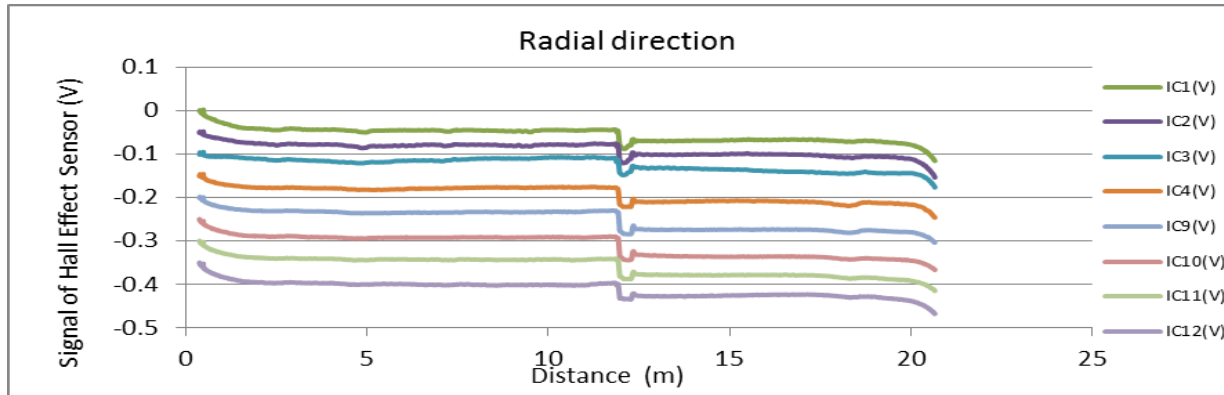
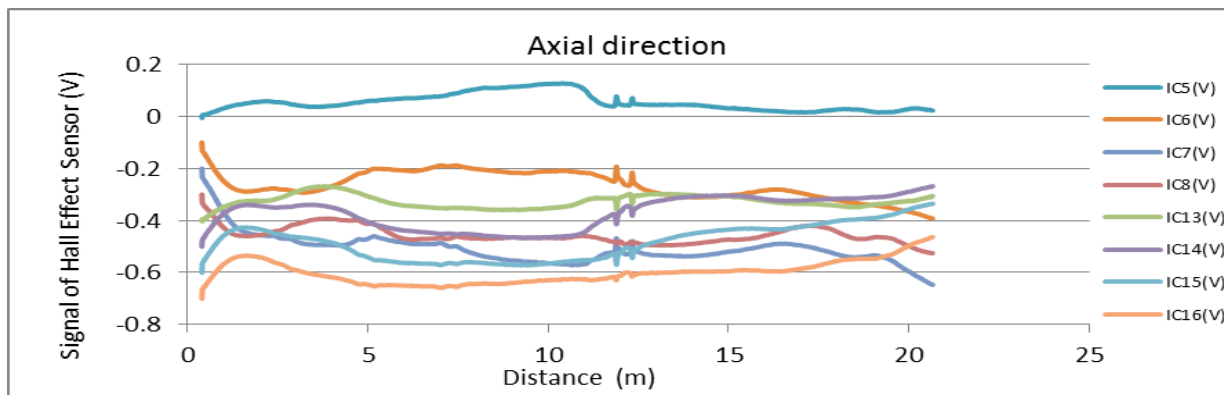
File Name 【Pier-Tendon-Section】	Section Total Length (m)	Scanned Length		Note Joint position : 12.26 m Starting point of damage 1 : 10.66 m			
		Starting Point (m)	Ending Point (m)				
P9-406R-I1	21.47	0.39	20.74				
Identified Damage 1				Identified Damage 2			
Max Loss Point (m)	Loss (%)	Length (m)	Damage Orientation	Max Loss Point (m)	Loss (%)	Length (m)	Damage Orientation
11.6	1.4	1.54	11~4 o'clock	—	—	—	—

Figure A51. MMFM data of P9-406R-I1 tendon section.

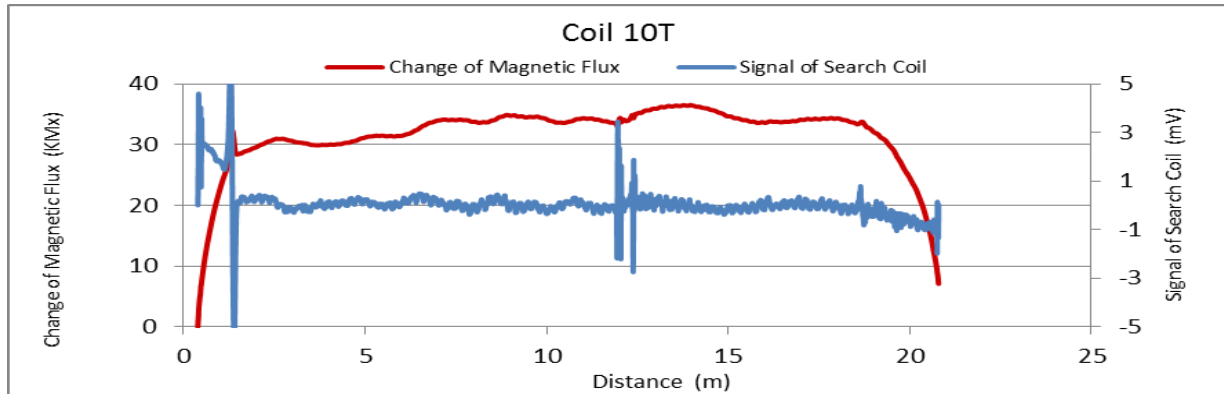
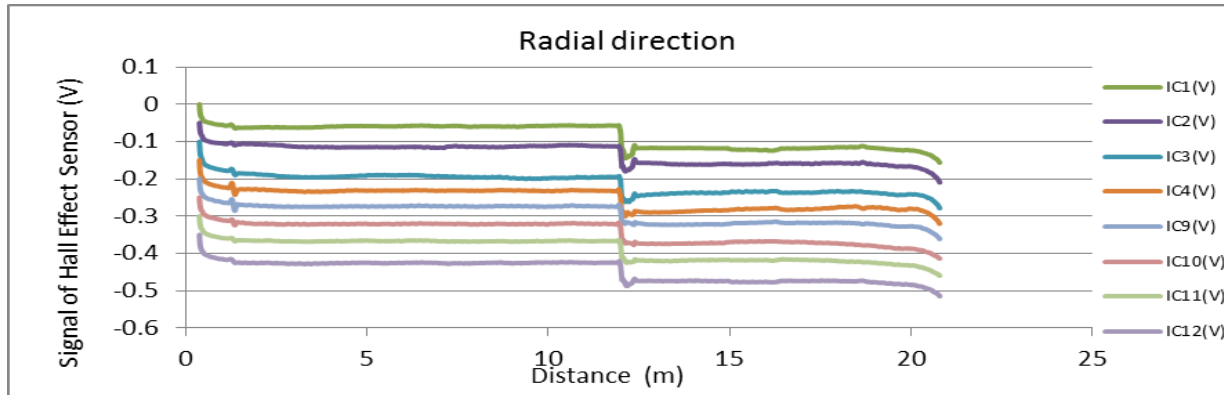
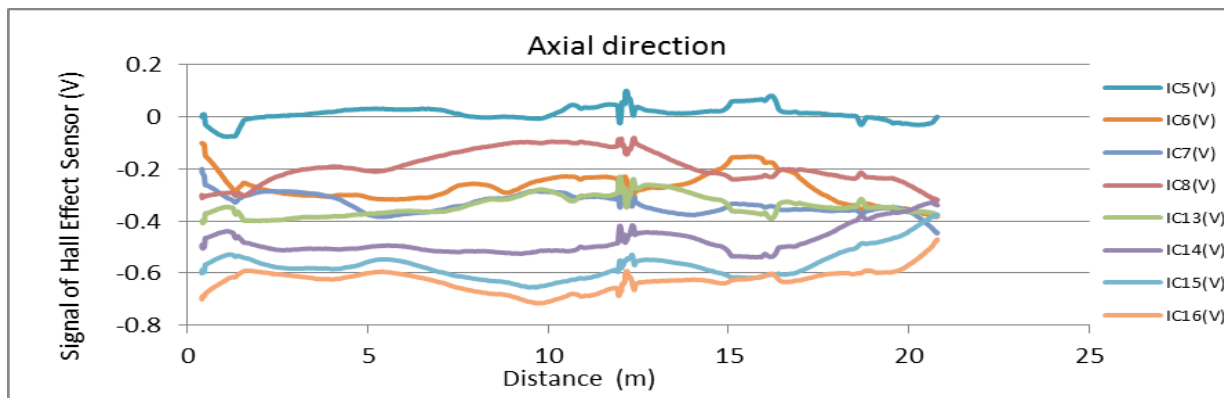
File Name 【Pier-Tendon-Section】	Section Total Length (m)	Scanned Length		Note Joint position : 12.28 m Identified damage 1 : Increase of magnetic flux Starting point of damage 1 : 1.26 m			
		Starting Point (m)	Ending Point (m)				
P9-404R-I1	21.44	0.39	20.79				
Identified Damage 1				Identified Damage 2			
Max Loss Point (m)	Loss (%)	Length (m)	Damage Orientation	Max Loss Point (m)	Loss (%)	Length (m)	Damage Orientation
1.3	-2.2	0.12	6~12 o'clock	—	—	—	—

Figure A52. MMFM data of P9-404R-I1 tendon section.

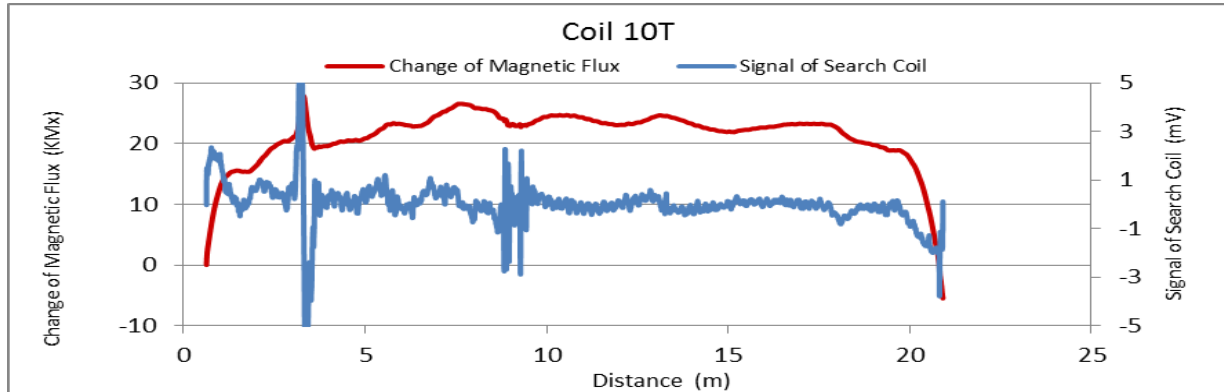
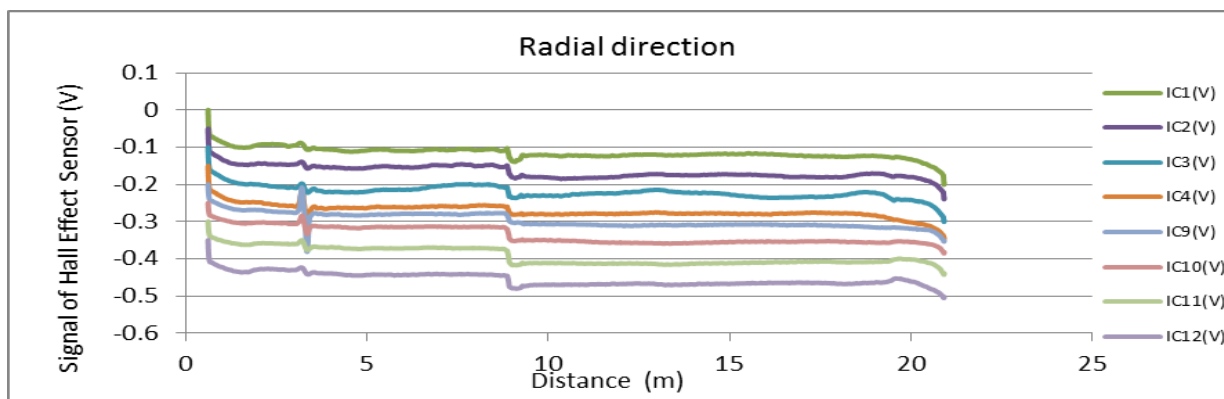
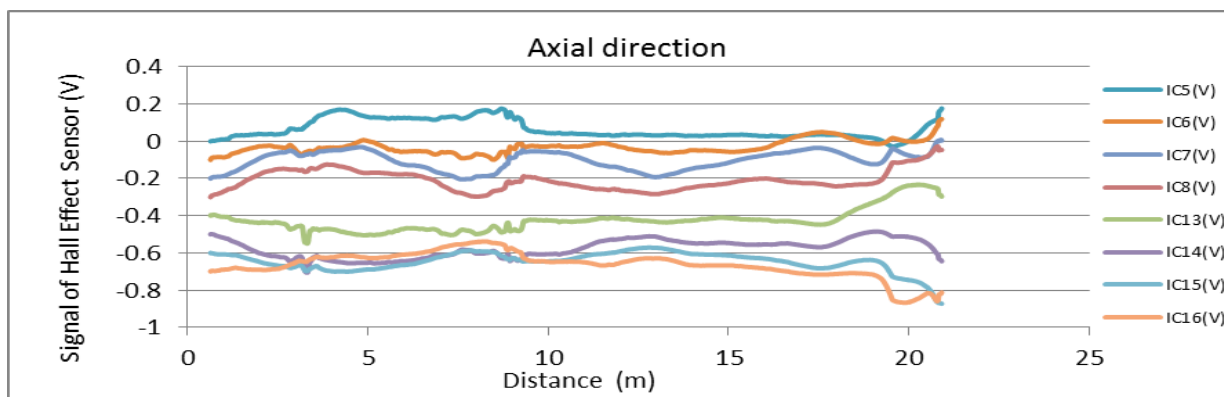
File Name 【Pier-Tendon-Section】	Section Total Length (m)	Scanned Length		Note			
		Starting Point (m)	Ending Point (m)				
P8-405R-I2	21.43	0.63	20.95	Joint position: 9.1 m Identified damage 1 : Increase of magnetic flux Starting point of damage 1 : 3.14 m			
Identified Damage 1				Identified Damage 2			
Max Loss Point (m)	Loss (%)	Length (m)	Damage Orientation	Max Loss Point (m)	Loss (%)	Length (m)	Damage Orientation
3.3	-3.1	0.33	6~10 o'clock	—	—	—	—

Figure A53. MMFM data of P8-405R-I2 tendon section.

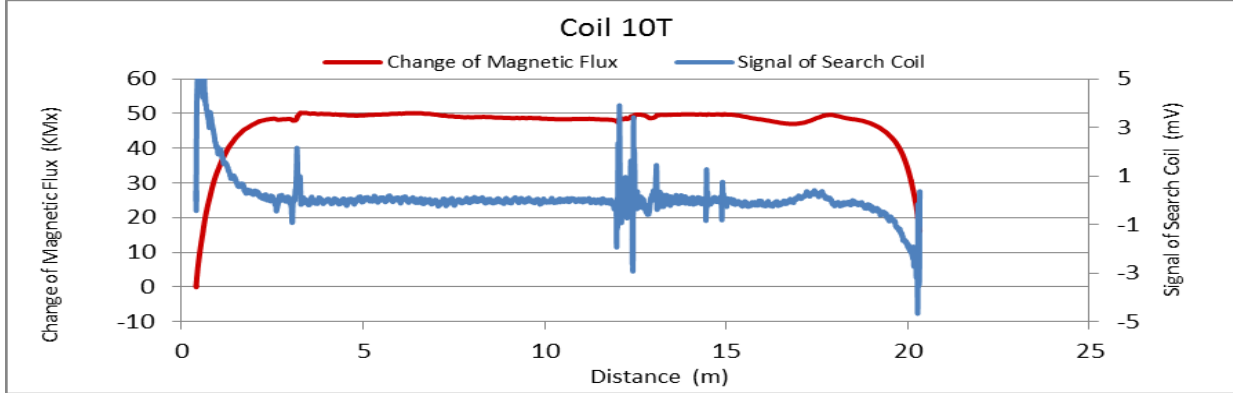
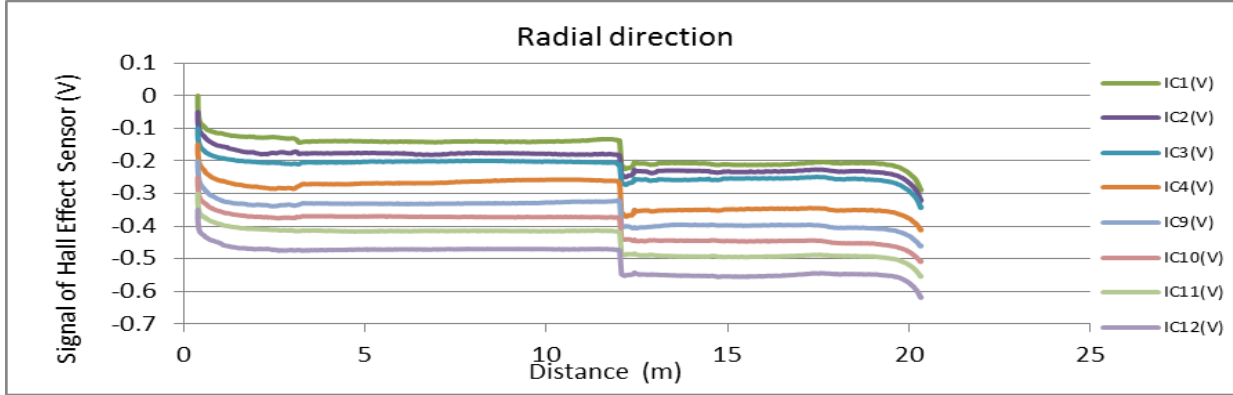
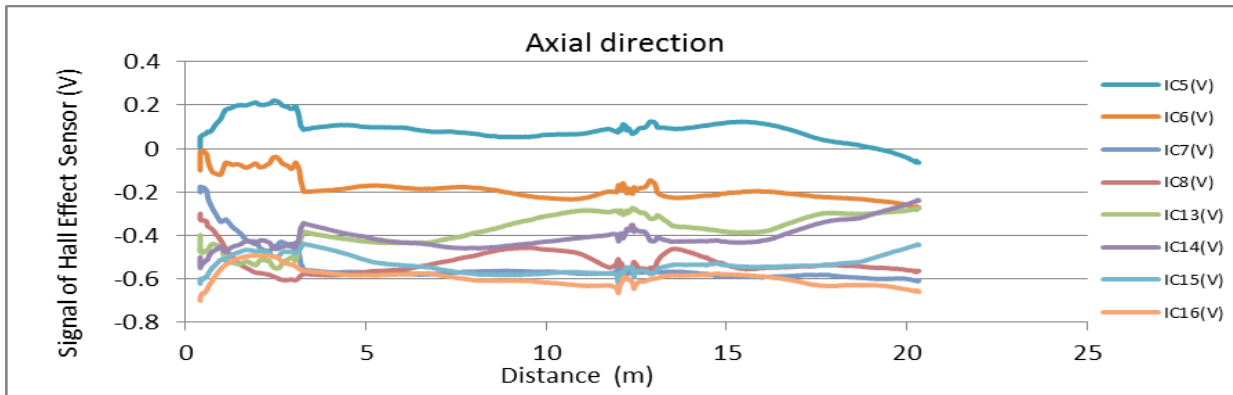
File Name 【Pier-Tendon-Section】	Section Total Length (m)	Scanned Length		Note Joint position : 12.24 m Starting point of damage 1 : 16.21 m			
		Starting Point (m)	Ending Point (m)				
P8-406R-I1	21.4	0.4	20.39				
Identified Damage 1				Identified Damage 2			
Max Loss Point (m)	Loss (%)	Length (m)	Damage Orientation	Max Loss Point (m)	Loss (%)	Length (m)	Damage Orientation
16.8	1.0	1.01	4~10 o'clock	—	—	—	—

Figure A54. MMFM data of P8-406R-I1 tendon section.

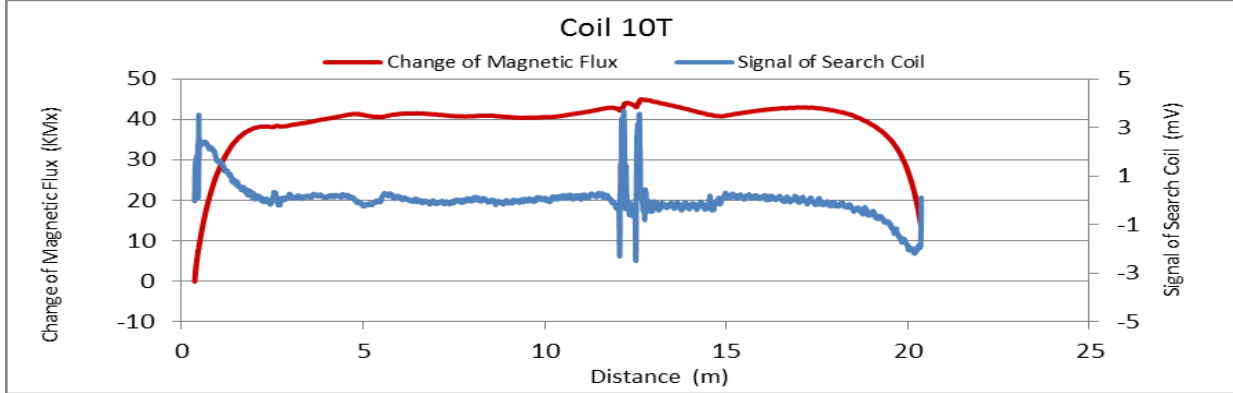
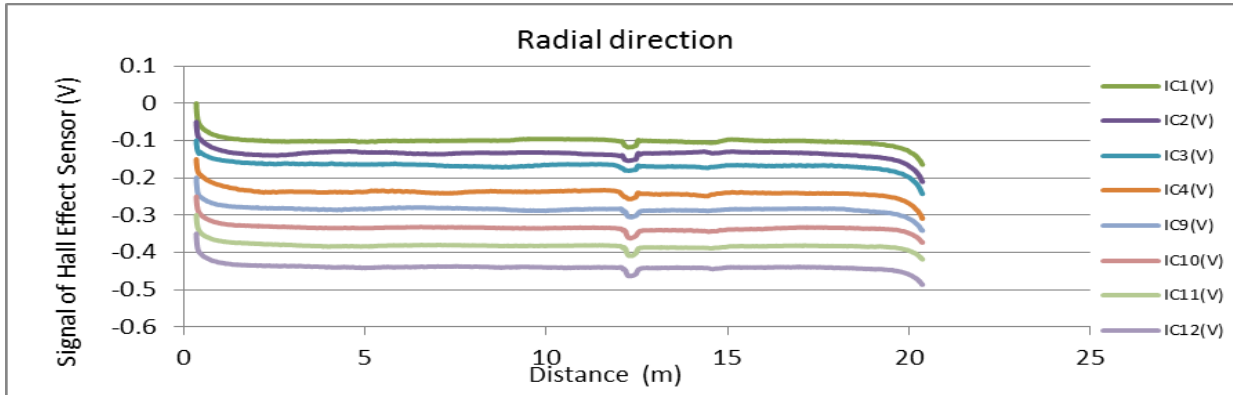
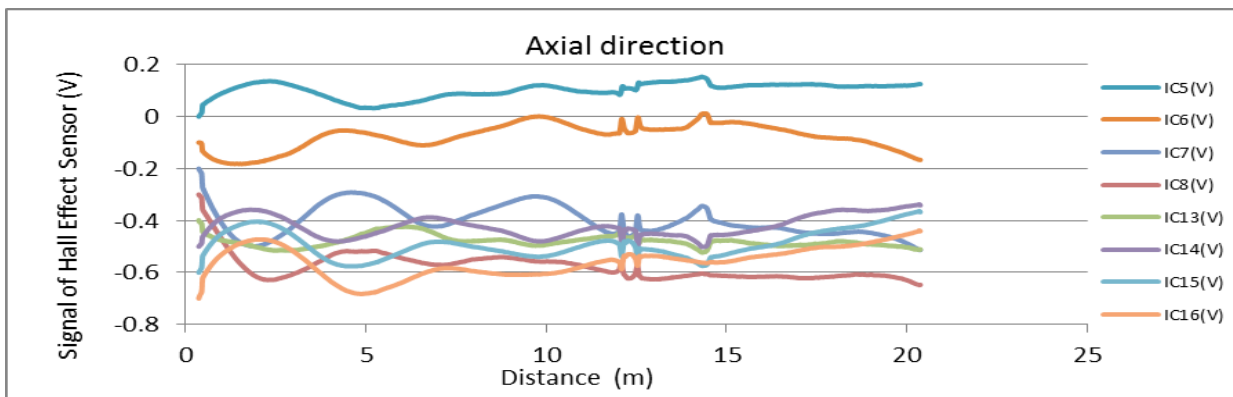
File Name 【Pier-Tendon-Section】	Section Total Length (m)	Scanned Length		Note Joint position : 12.3 m Starting point of damage 1 : 14.07 m			
		Starting Point (m)	Ending Point (m)				
P8-405R-I1	21.4	0.36	20.37				
Identified Damage 1				Identified Damage 2			
Max Loss Point (m)	Loss (%)	Length (m)	Damage Orientation	Max Loss Point (m)	Loss (%)	Length (m)	Damage Orientation
14.9	1.3	1.64	10~4 o'clock	—	—	—	—

Figure A55. MMFM data of P8-405R-I1 tendon section.

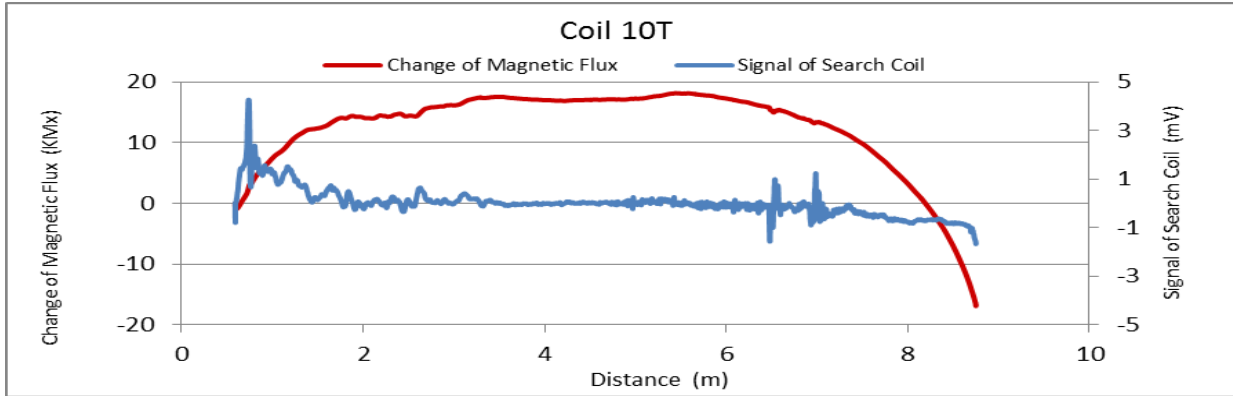
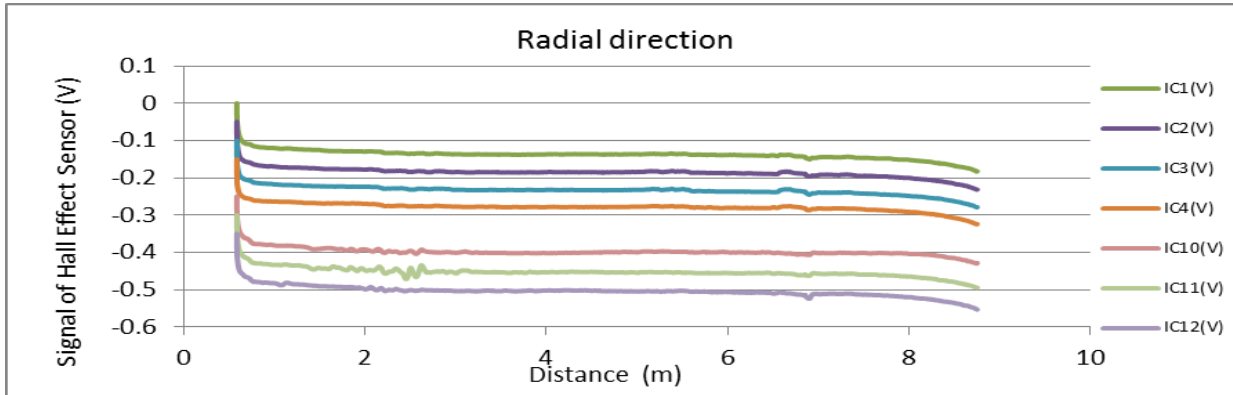
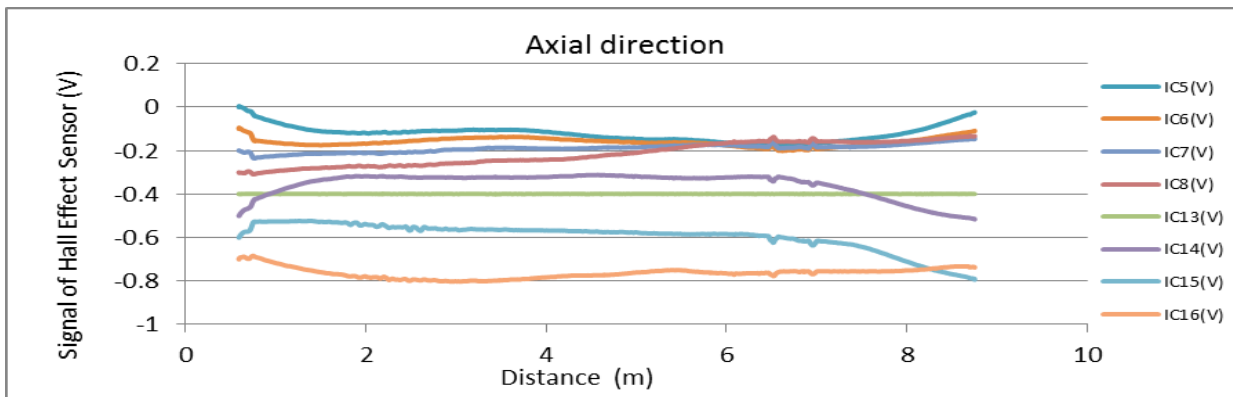
File Name 【Pier-Tendon-Section】	Section Total Length (m)	Scanned Length		Note Starting point of damage 1 : 2.32 m			
		Starting Point (m)	Ending Point (m)				
P8-404L-H1	9.44	0.59	8.75				
Identified Damage 1				Identified Damage 2			
Max Loss Point (m)	Loss (%)	Length (m)	Damage Orientation	Max Loss Point (m)	Loss (%)	Length (m)	Damage Orientation
2.6	0.7	0.59	10~1 o'clock	—	—	—	—

Figure A56. MMFM data of P8-404L-H1 tendon section.

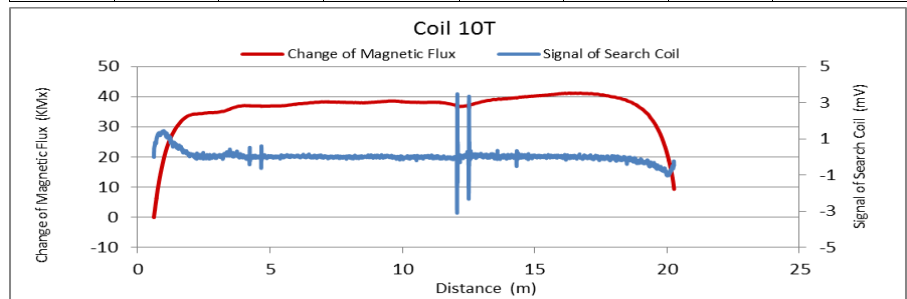
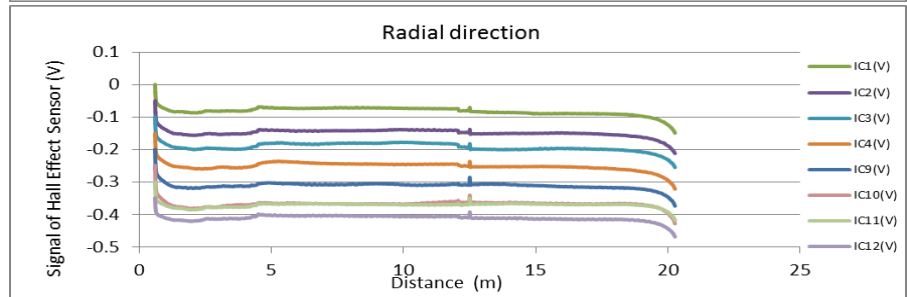
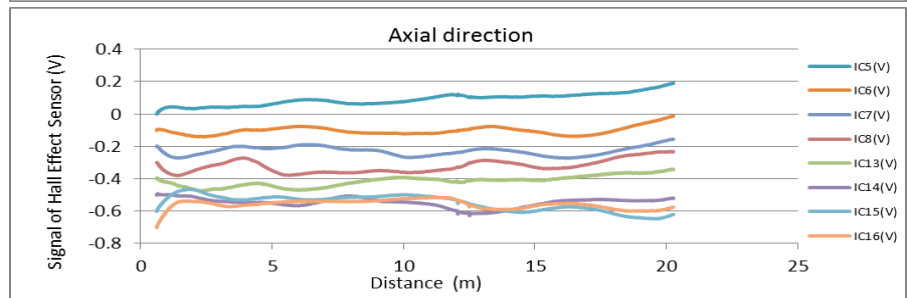
File Name 【Pier-Tendon-Section】	Section Total Length (m)	Scanned Length		Note			
		Starting Point (m)	Ending Point (m)				
P1-401L-H1	20.5	0.61	20.28	Joint position: 12.3 m			
Identified Damage 1				Identified Damage 2			
Max Loss Point (m)	Section Loss (%)	Damage Length (m)	Damage Orientation	Max Loss Point (m)	Section Loss (%)	Damage Length (m)	Damage Orientation
—	—	—	—	—	—	—	—

Figure A57. MMFM data of P1-401L-H1 tendon section.

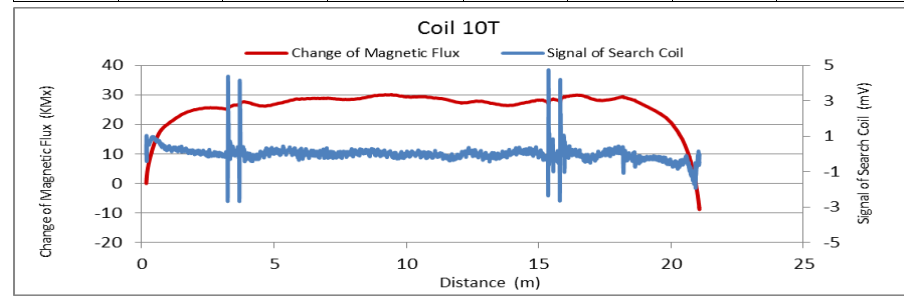
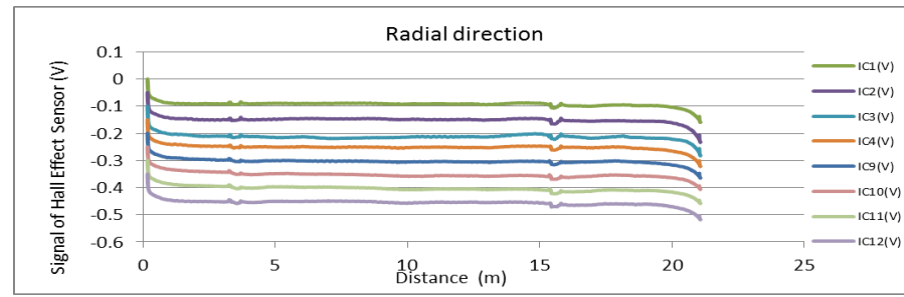
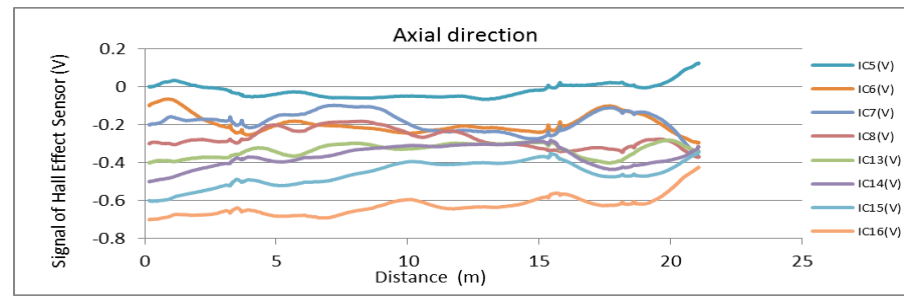
File Name 【Pier-Tendon-Section】	Section Total Length (m)	Scanned Length		Note			
		Starting Point (m)	Ending Point (m)				
P1-401R-H2	21.65	0.17	21.07	Joint position: 3.5 m, 15.6 m			
Identified Damage 1				Identified Damage 2			
Max Loss Point (m)	Section Loss (%)	Damage Length (m)	Damage Orientation	Max Loss Point (m)	Section Loss (%)	Damage Length (m)	Damage Orientation
—	—	—	—	—	—	—	—

Figure A58. MMFM data of P1-401R-H2 tendon section.

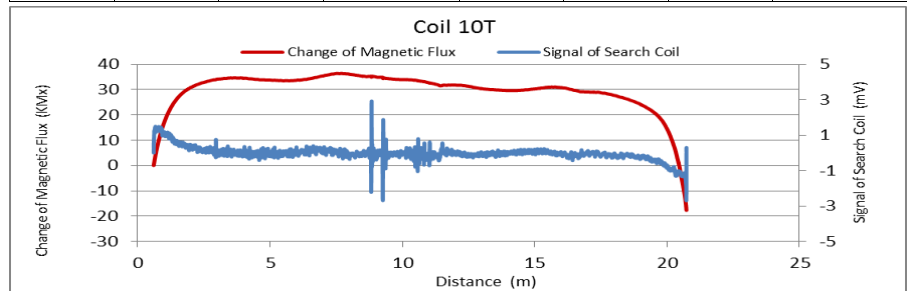
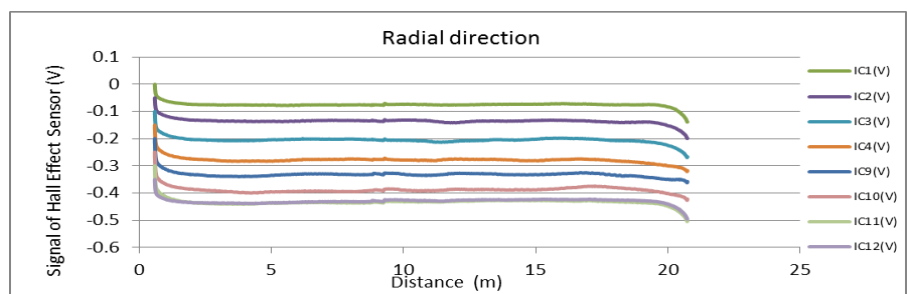
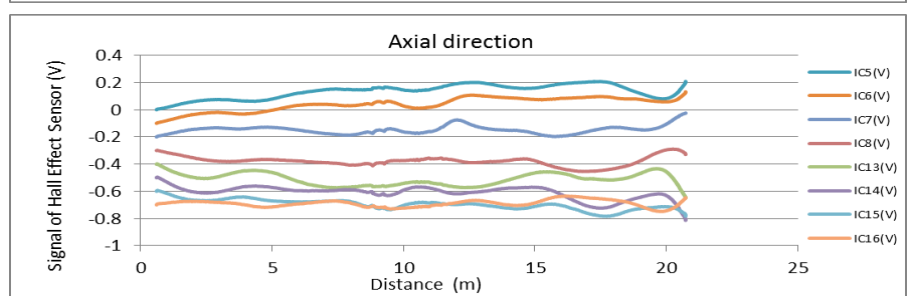
File Name 【Pier-Tendon-Section】	Section Total Length (m)	Scanned Length		Note			
		Starting Point (m)	Ending Point (m)				
P1-402R-I2	21.5	0.6	20.73	Joint position: 9.1 m			
Identified Damage 1				Identified Damage 2			
Max Loss Point (m)	Section Loss (%)	Damage Length (m)	Damage Orientation	Max Loss Point (m)	Section Loss (%)	Damage Length (m)	Damage Orientation
—	—	—	—	—	—	—	—

Figure A59. MMFM data of P1-402R-I2 tendon section.

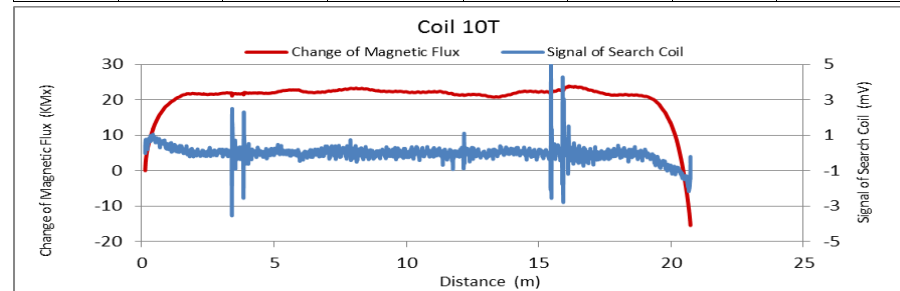
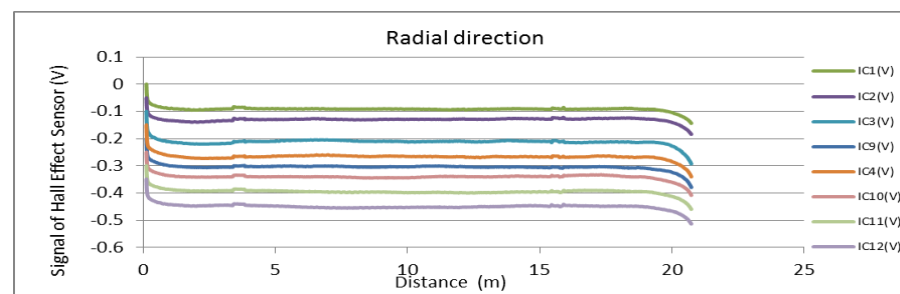
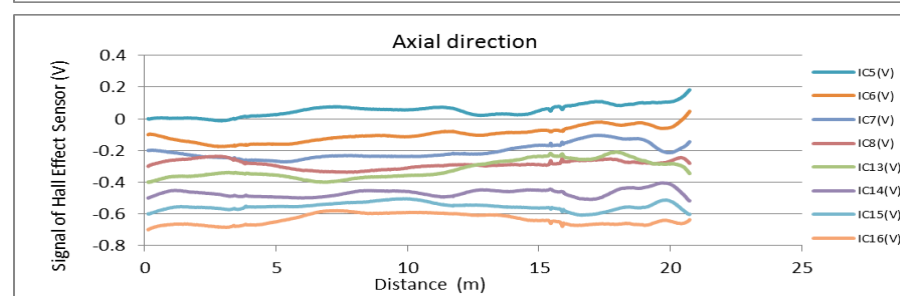
File Name 【Pier-Tendon-Section】	Section Total Length (m)	Scanned Length		Note			
		Starting Point (m)	Ending Point (m)				
P1-401L-H2	21.34	0.13	20.73	Joint position: 3.6 m, 15.7 m			
Identified Damage 1				Identified Damage 2			
Max Loss Point (m)	Section Loss (%)	Damage Length (m)	Damage Orientation	Max Loss Point (m)	Section Loss (%)	Damage Length (m)	Damage Orientation
—	—	—	—	—	—	—	—

Figure A60. MMFM data of P1-401L-H2 tendon section.

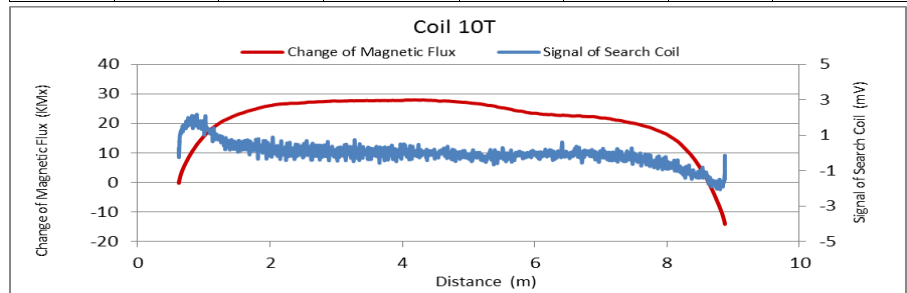
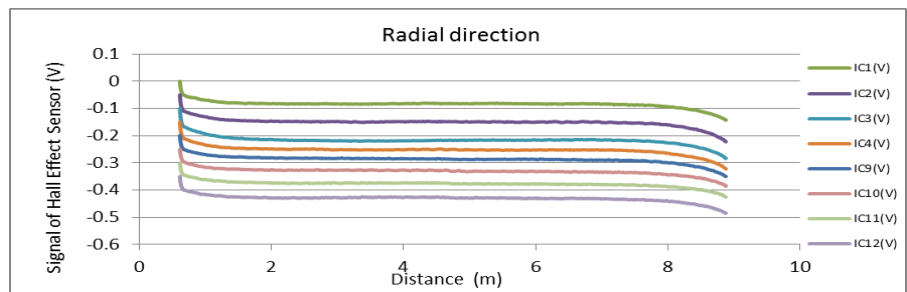
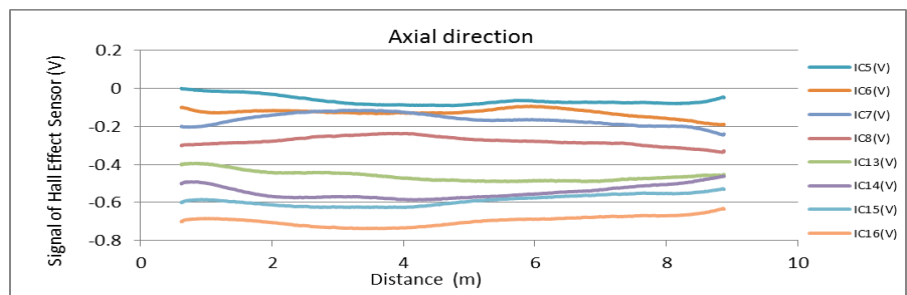
File Name 【Pier-Tendon-Section】	Section Total Length (m)	Scanned Length		Note			
		Starting Point (m)	Ending Point (m)				
P1-401R-H3	9.45	0.62	8.88				
Identified Damage 1				Identified Damage 2			
Max Loss Point (m)	Section Loss (%)	Damage Length (m)	Damage Orientation	Max Loss Point (m)	Section Loss (%)	Damage Length (m)	Damage Orientation
—	—	—	—	—	—	—	—

Figure A61. MMFM data of P1-401R-H3 tendon section.

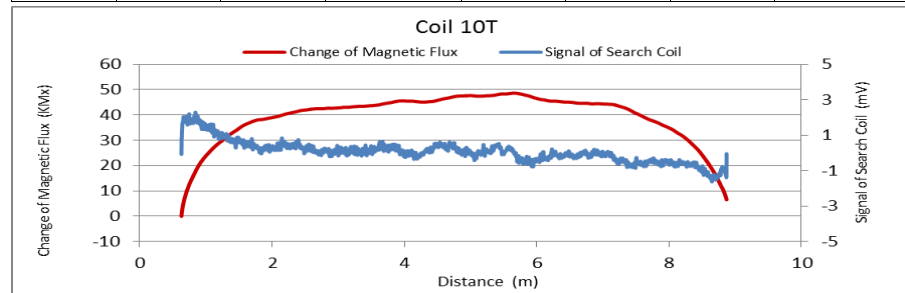
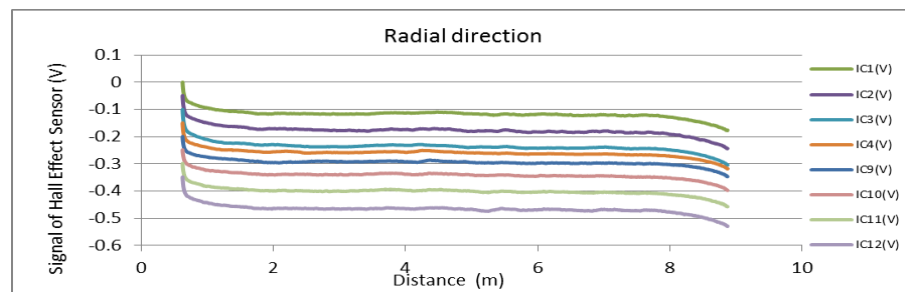
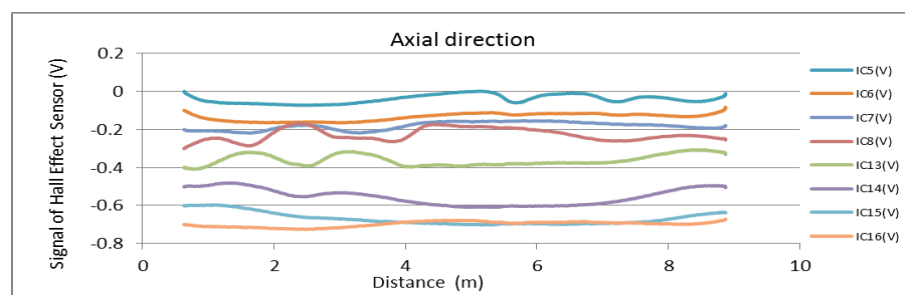
File Name 【Pier-Tendon-Section】	Section Total Length (m)	Scanned Length		Note			
		Starting Point (m)	Ending Point (m)				
P1-402R-H1	9.45	0.63	8.88				
Identified Damage 1				Identified Damage 2			
Max Loss Point (m)	Section Loss (%)	Damage Length (m)	Damage Orientation	Max Loss Point (m)	Section Loss (%)	Damage Length (m)	Damage Orientation
—	—	—	—	—	—	—	—

Figure A62. MMFM data of P1-402R-H1 tendon section.

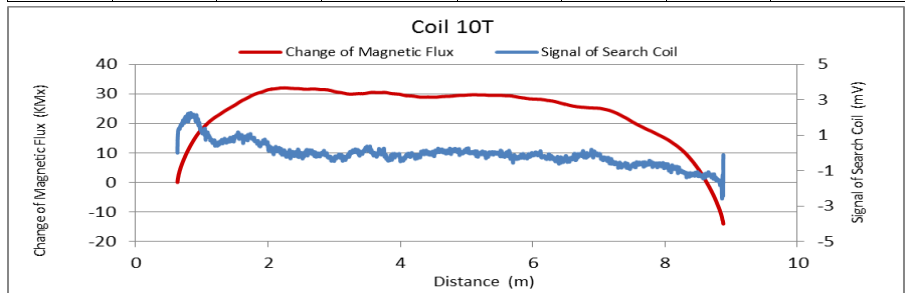
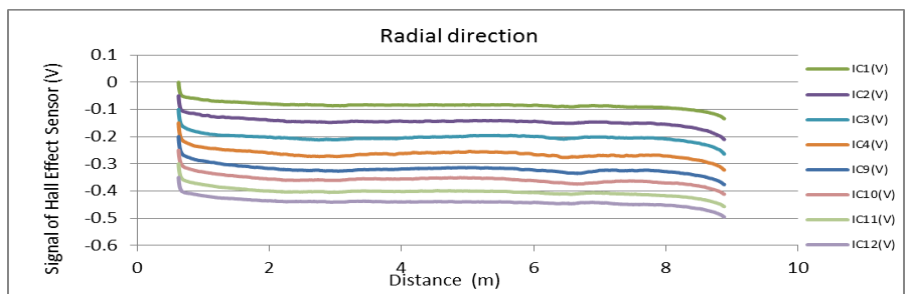
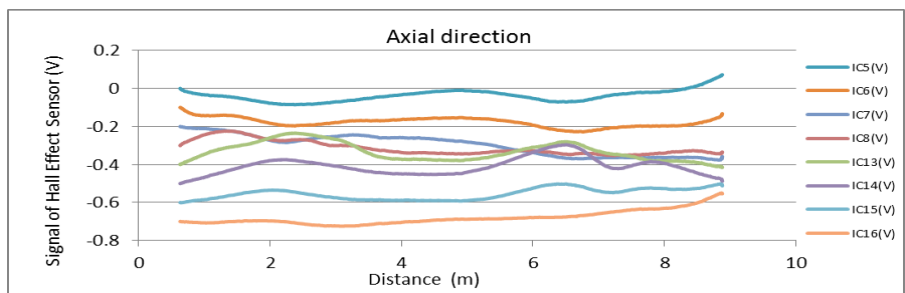
File Name 【Pier-Tendon-Section】	Section Total Length (m)	Scanned Length		Note			
		Starting Point (m)	Ending Point (m)				
P1-402L-H1	9.45	0.63	8.88				
Identified Damage 1				Identified Damage 2			
Max Loss Point (m)	Section Loss (%)	Damage Length (m)	Damage Orientation	Max Loss Point (m)	Section Loss (%)	Damage Length (m)	Damage Orientation
—	—	—	—	—	—	—	—

Figure A63. MMFM data of P1-402L-H1 tendon section.
