**Development of Quality Assurance and Quality Control
System for Post Tensioned Segmental Bridges in Florida:
Case of Ringling Bridge – Phase II**

**FDOT Contract No. BDV29-977-34
FINAL REPORT**

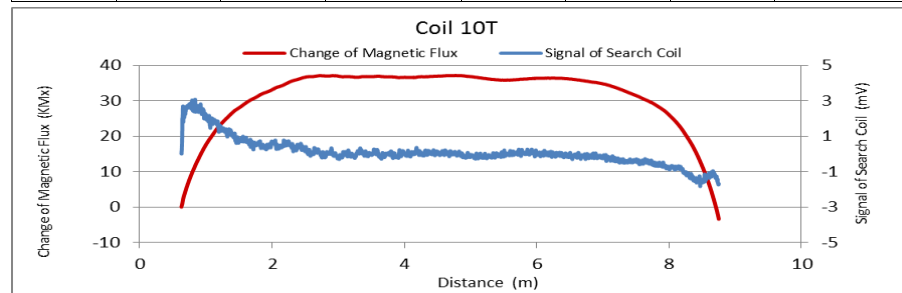
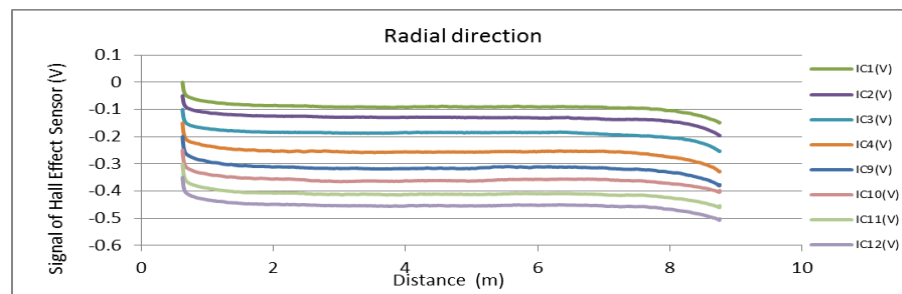
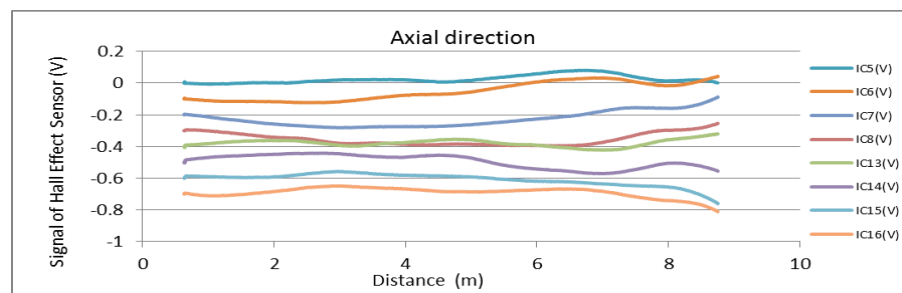
File Name 【Pier-Tendon-Section】	Section Total Length (m)	Scanned Length		Note			
		Starting Point (m)	Ending Point (m)				
P2-401R-H1	9.45	0.63	8.75				
Identified Damage 1				Identified Damage 2			
Max Loss Point (m)	Section Loss (%)	Damage Length (m)	Damage Orientation	Max Loss Point (m)	Section Loss (%)	Damage Length (m)	Damage Orientation
—	—	—	—	—	—	—	—

Figure A64. MMFM data of P2-401R-H1 tendon section.

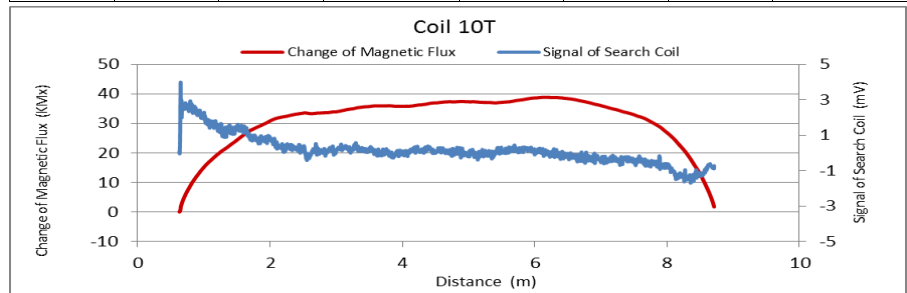
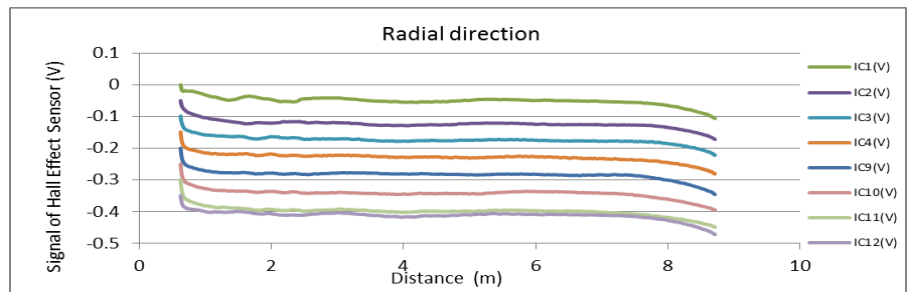
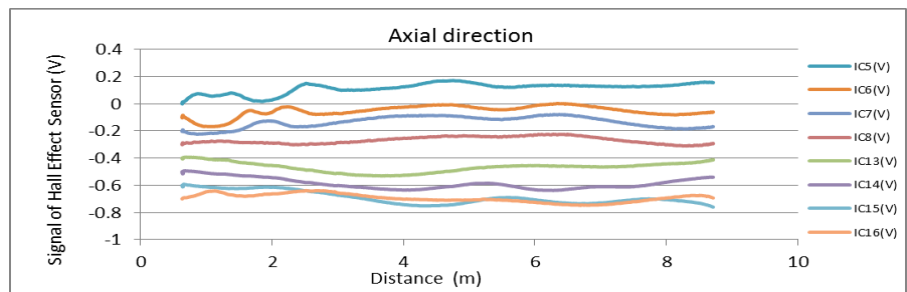
File Name 【Pier-Tendon-Section】	Section Total Length (m)	Scanned Length		Note			
		Starting Point (m)	Ending Point (m)				
P2-402R-H1	9.45	0.63	8.71				
Identified Damage 1				Identified Damage 2			
Max Loss Point (m)	Section Loss (%)	Damage Length (m)	Damage Orientation	Max Loss Point (m)	Section Loss (%)	Damage Length (m)	Damage Orientation
—	—	—	—	—	—	—	—

Figure A65. MMFM data of P2-402R-H1 tendon section.

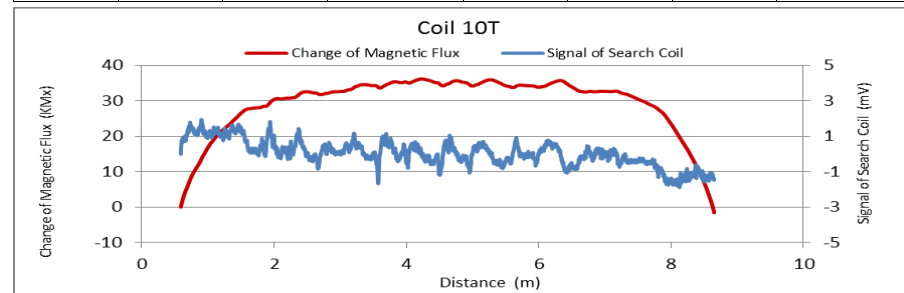
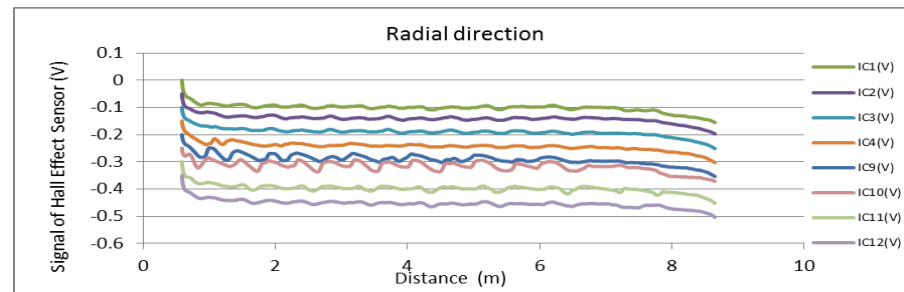
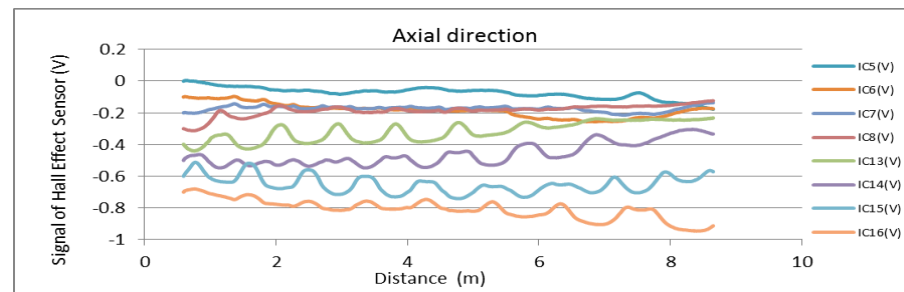
File Name 【Pier-Tendon-Section】	Section Total Length (m)	Scanned Length		Note			
		Starting Point (m)	Ending Point (m)				
P2-402L-H1	9.38	0.59	8.66	The grout sticks to the duct and has irregularities.			
Identified Damage 1				Identified Damage 2			
Max Loss Point (m)	Section Loss (%)	Damage Length (m)	Damage Orientation	Max Loss Point (m)	Section Loss (%)	Damage Length (m)	Damage Orientation
—	—	—	—	—	—	—	—

Figure A66. MMFM data of P2-402L-H1 tendon section.

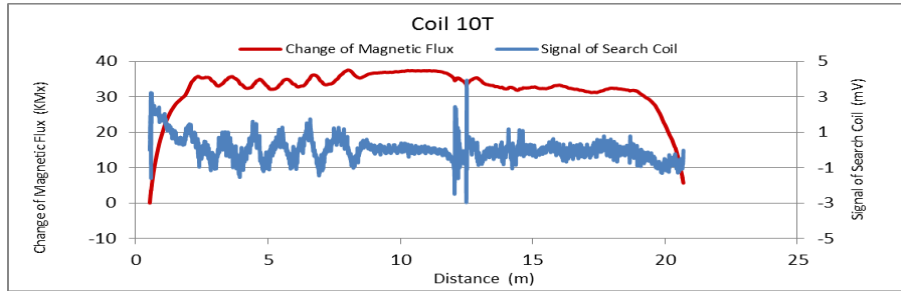
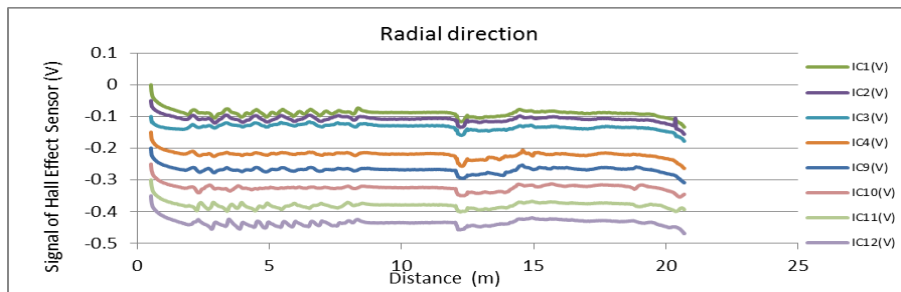
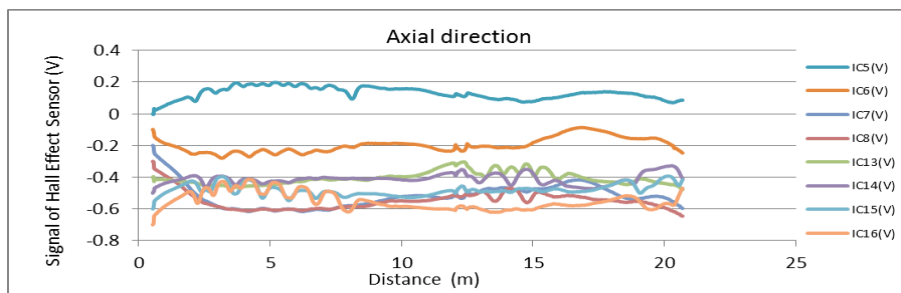
File Name 【Pier-Tendon-Section】	Section Total Length (m)	Scanned Length		Note			
		Starting Point (m)	Ending Point (m)				
P2-402R-I1	21.43	0.53	20.69	Joint position: 12.2 m			
Identified Damage 1				Identified Damage 2			
Max Loss Point (m)	Section Loss (%)	Damage Length (m)	Damage Orientation	Max Loss Point (m)	Section Loss (%)	Damage Length (m)	Damage Orientation
—	—	—	—	—	—	—	—

Figure A67. MMFM data of P2-402R-I1 tendon section.

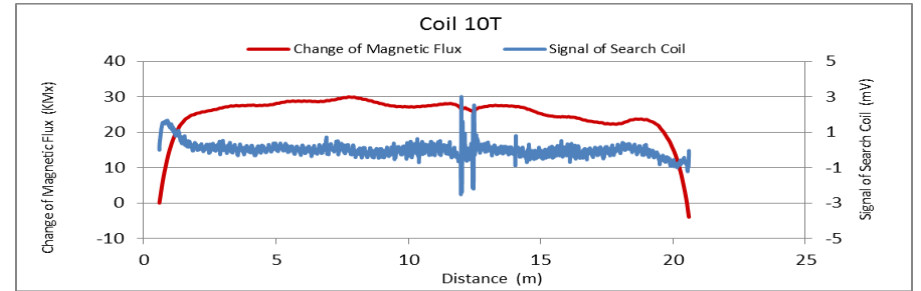
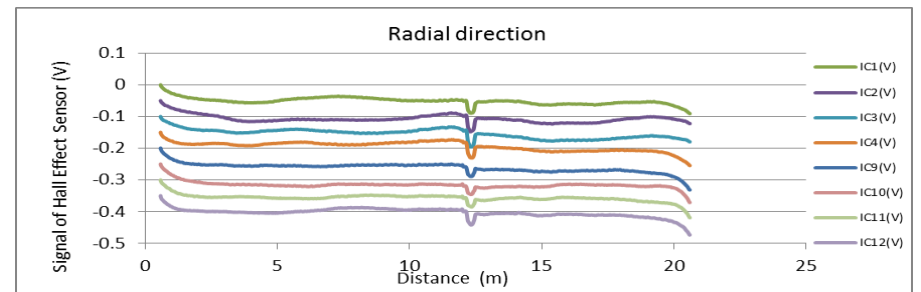
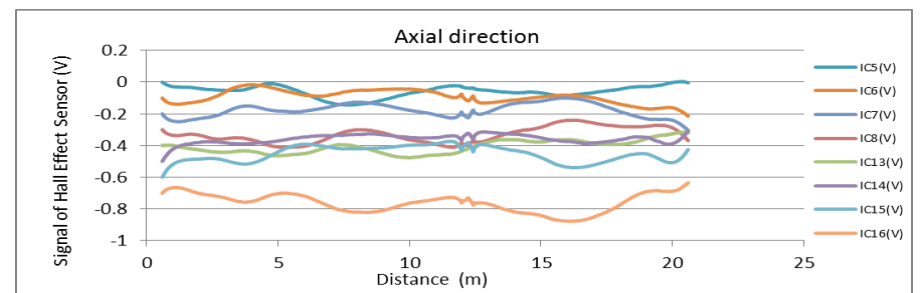
File Name 【Pier-Tendon-Section】	Section Total Length (m)	Scanned Length		Note			
		Starting Point (m)	Ending Point (m)				
P2-401L-I1	21.37	0.59	20.68	Joint position: 12.3 m			
Identified Damage 1				Identified Damage 2			
Max Loss Point (m)	Section Loss (%)	Damage Length (m)	Damage Orientation	Max Loss Point (m)	Section Loss (%)	Damage Length (m)	Damage Orientation
—	—	—	—	—	—	—	—

Figure A68. MMFM data of P2-401L-I1 tendon section.

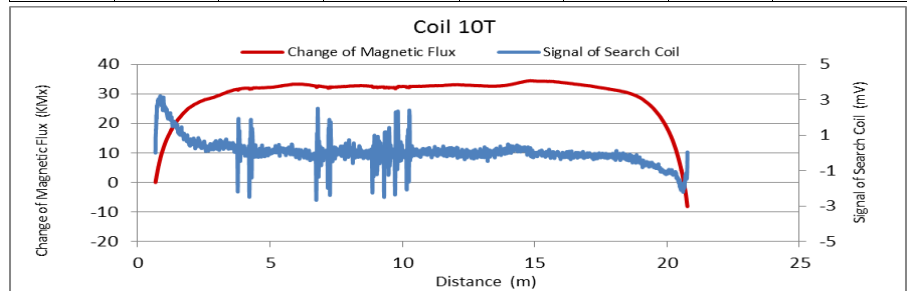
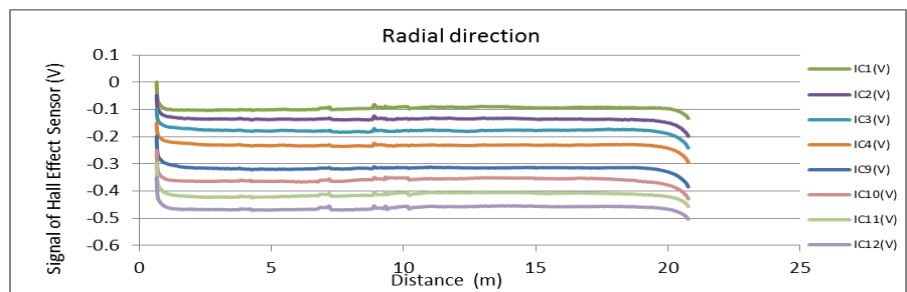
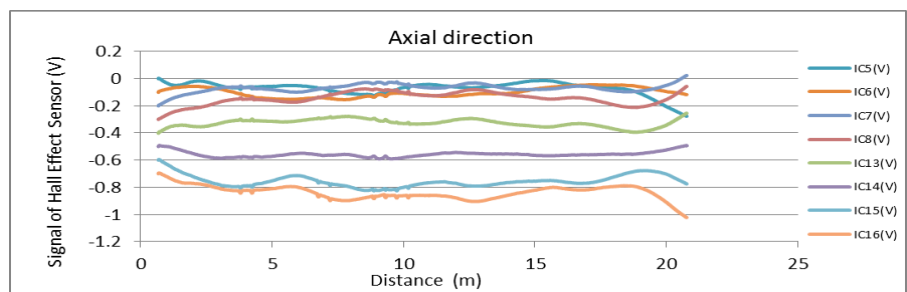
File Name 【Pier-Tendon-Section】	Section Total Length (m)	Scanned Length		Note			
		Starting Point (m)	Ending Point (m)				
P2-401R-I2	21.47	0.67	20.87	Joint position: 4 m, 7 m, 9.1 m, 10 m			
Identified Damage 1				Identified Damage 2			
Max Loss Point (m)	Section Loss (%)	Damage Length (m)	Damage Orientation	Max Loss Point (m)	Section Loss (%)	Damage Length (m)	Damage Orientation
—	—	—	—	—	—	—	—

Figure A69. MMFM data of P2-402R-I2 tendon section.

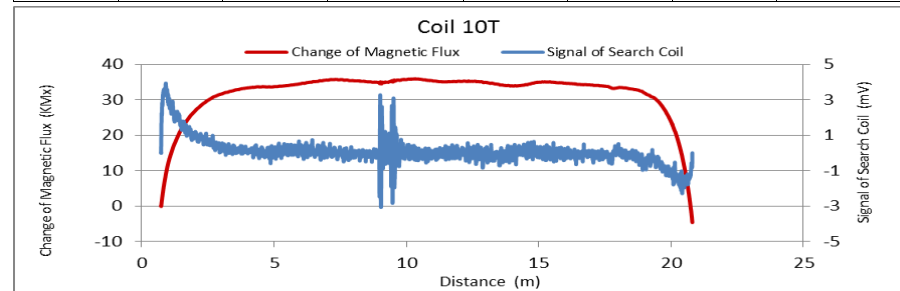
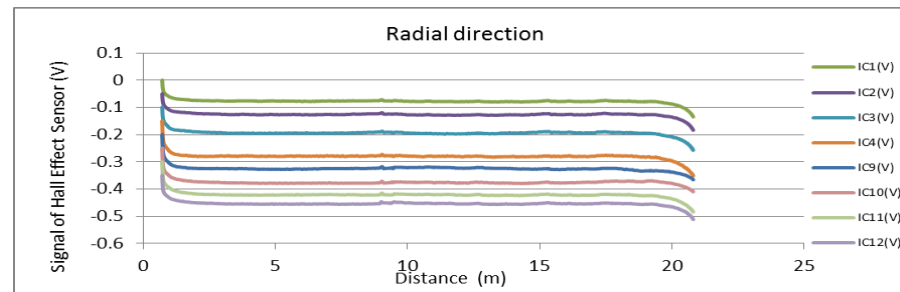
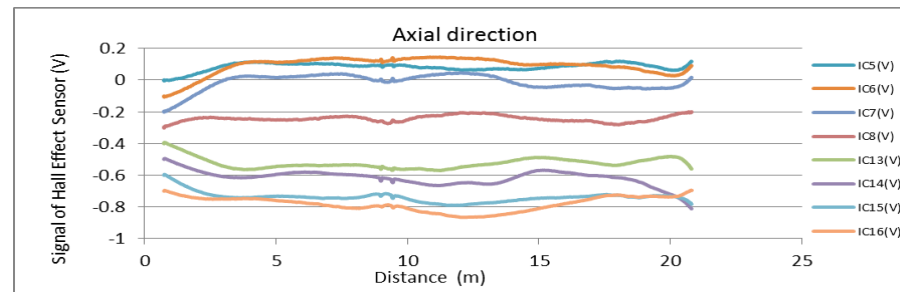
File Name 【Pier-Tendon-Section】	Section Total Length (m)	Scanned Length		Note			
		Starting Point (m)	Ending Point (m)				
P2-401L-I2	21.5	0.73	20.93	Joint position: 9.3 m			
Identified Damage 1				Identified Damage 2			
Max Loss Point (m)	Section Loss (%)	Damage Length (m)	Damage Orientation	Max Loss Point (m)	Section Loss (%)	Damage Length (m)	Damage Orientation
—	—	—	—	—	—	—	—

Figure A70. MMFM data of P2-401L-I2 tendon section.

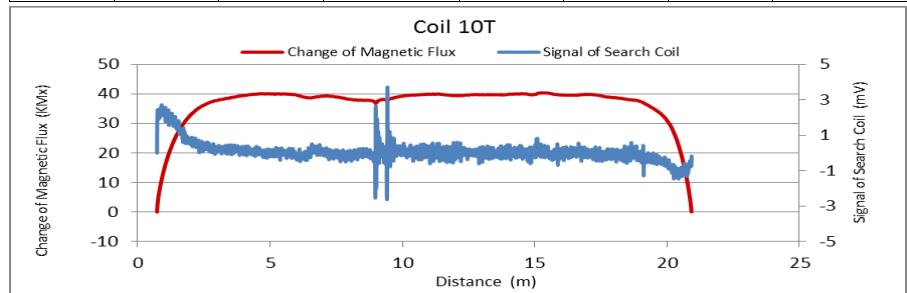
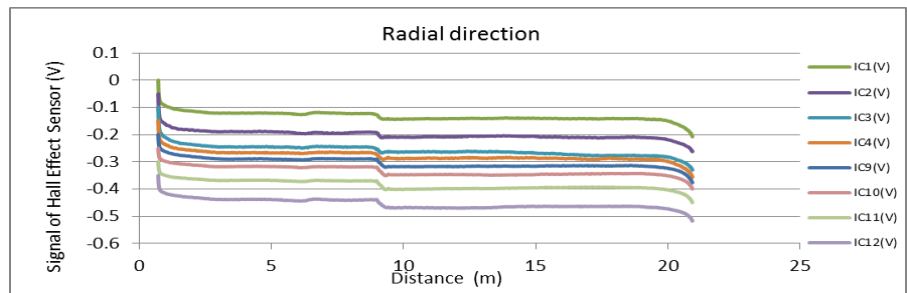
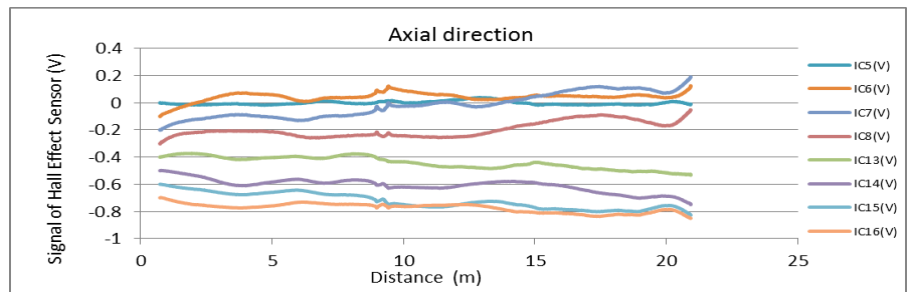
File Name 【Pier-Tendon-Section】	Section Total Length (m)	Scanned Length		Note			
		Starting Point (m)	Ending Point (m)				
P2-402L-I2	21.5	0.73	20.93	Joint position: 9.3 m			
Identified Damage 1				Identified Damage 2			
Max Loss Point (m)	Section Loss (%)	Damage Length (m)	Damage Orientation	Max Loss Point (m)	Section Loss (%)	Damage Length (m)	Damage Orientation
—	—	—	—	—	—	—	—

Figure A71. MMFM data of P2-402L-I2 tendon section.

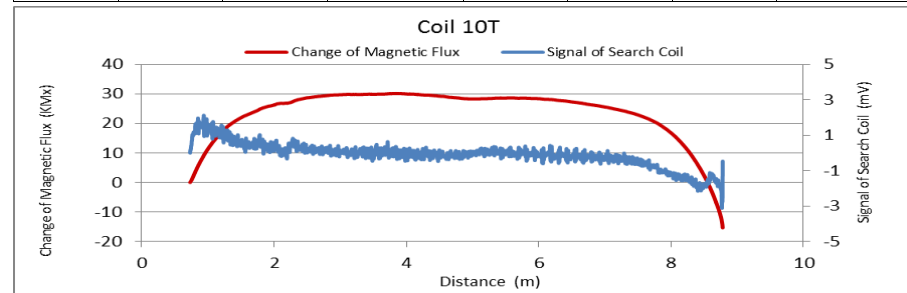
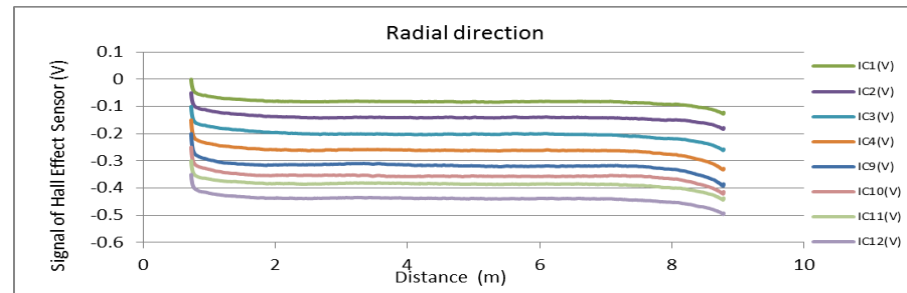
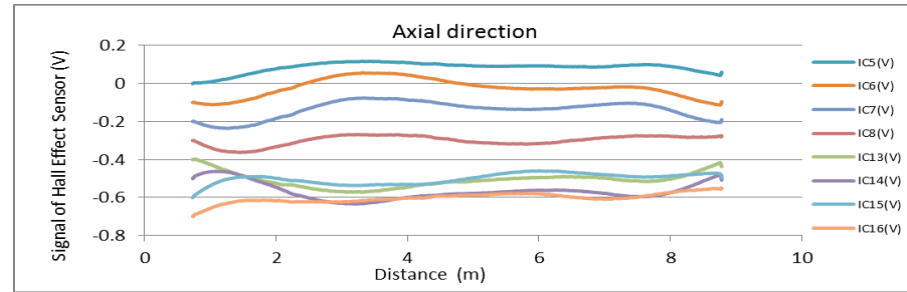
File Name 【Pier-Tendon-Section】	Section Total Length (m)	Scanned Length		Note			
		Starting Point (m)	Ending Point (m)				
P2-401R-H2	9.43	0.73	8.83				
Identified Damage 1				Identified Damage 2			
Max Loss Point (m)	Section Loss (%)	Damage Length (m)	Damage Orientation	Max Loss Point (m)	Section Loss (%)	Damage Length (m)	Damage Orientation
—	—	—	—	—	—	—	—

Figure A72. MMFM data of P2-401R-H2 tendon section.

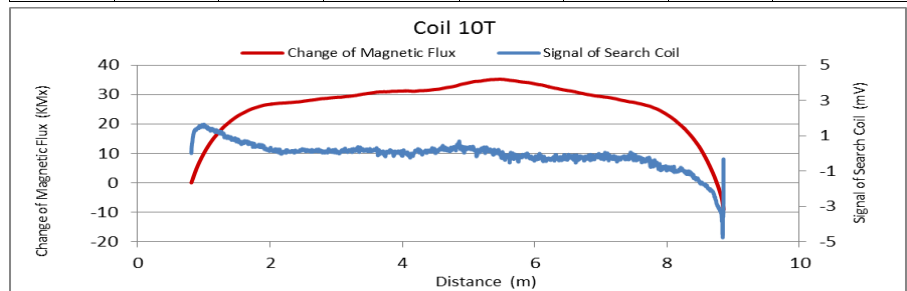
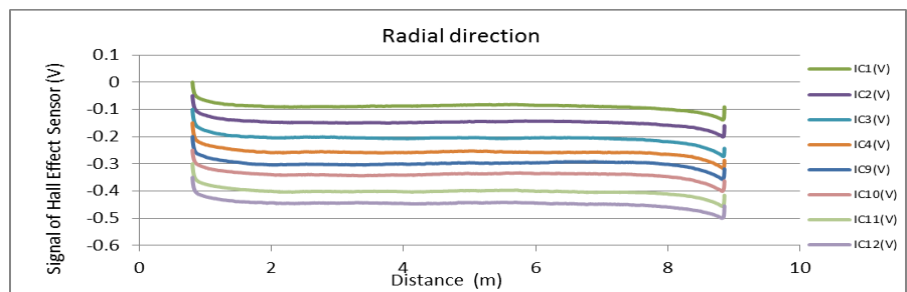
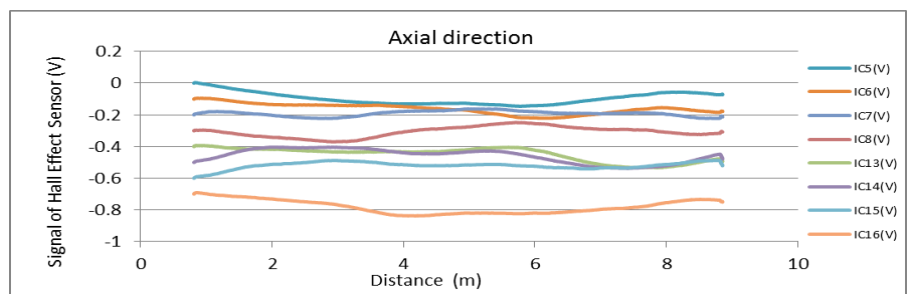
File Name 【Pier-Tendon-Section】	Section Total Length (m)	Scanned Length		Note			
		Starting Point (m)	Ending Point (m)				
P2-401L-H2	9.4	0.81	8.9				
Identified Damage 1				Identified Damage 2			
Max Loss Point (m)	Section Loss (%)	Damage Length (m)	Damage Orientation	Max Loss Point (m)	Section Loss (%)	Damage Length (m)	Damage Orientation
—	—	—	—	—	—	—	—

Figure A73. MMFM data of P2-401L-H2 tendon section.

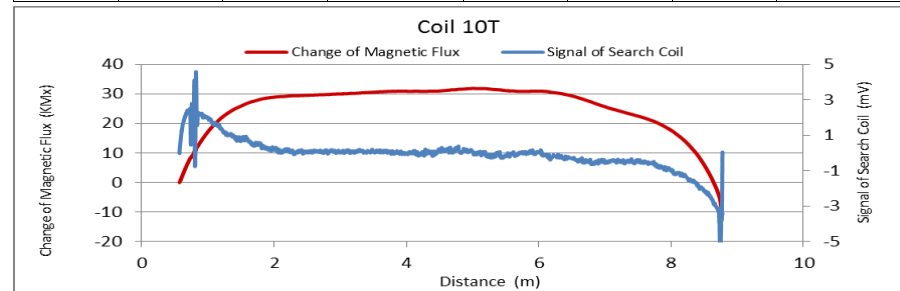
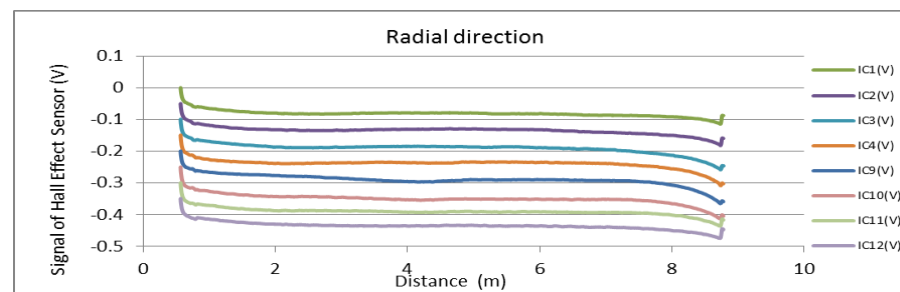
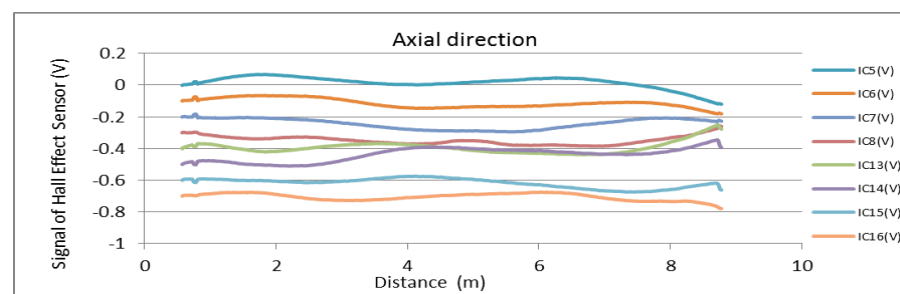
File Name 【Pier-Tendon-Section】	Section Total Length (m)	Scanned Length		Note			
		Starting Point (m)	Ending Point (m)				
P2-402L-H2	9.4	0.57	8.84				
Identified Damage 1				Identified Damage 2			
Max Loss Point (m)	Section Loss (%)	Damage Length (m)	Damage Orientation	Max Loss Point (m)	Section Loss (%)	Damage Length (m)	Damage Orientation
—	—	—	—	—	—	—	—

Figure A74. MMFM data of P2-402L-H2 tendon section.

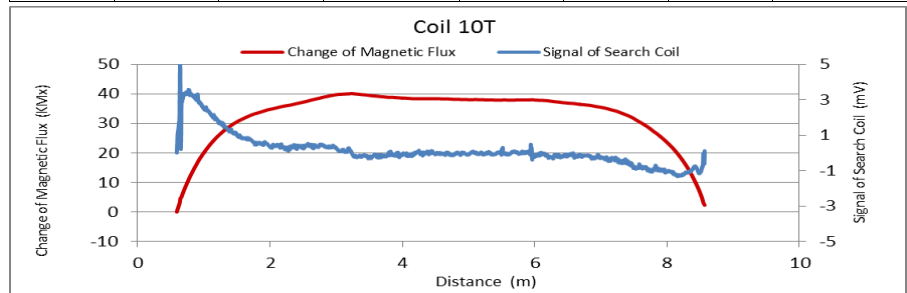
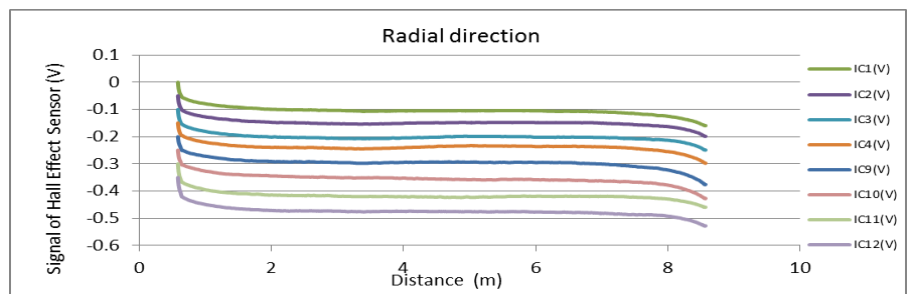
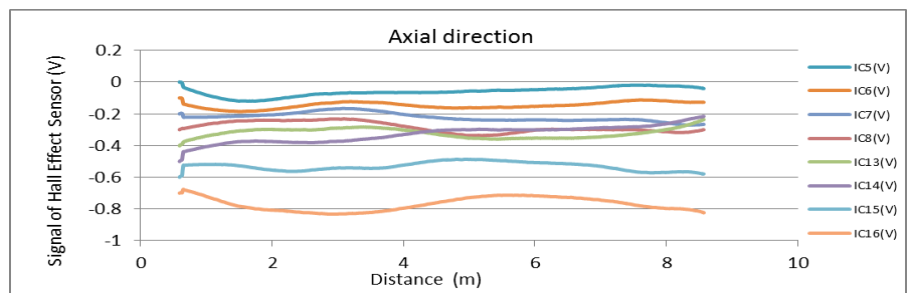
File Name 【Pier-Tendon-Section】	Section Total Length (m)	Scanned Length		Note			
		Starting Point (m)	Ending Point (m)				
P3-401R-H1	9.43	0.59	8.63				
Identified Damage 1				Identified Damage 2			
Max Loss Point (m)	Section Loss (%)	Damage Length (m)	Damage Orientation	Max Loss Point (m)	Section Loss (%)	Damage Length (m)	Damage Orientation
—	—	—	—	—	—	—	—

Figure A75. MMFM data of P3-401R-H1 tendon section.

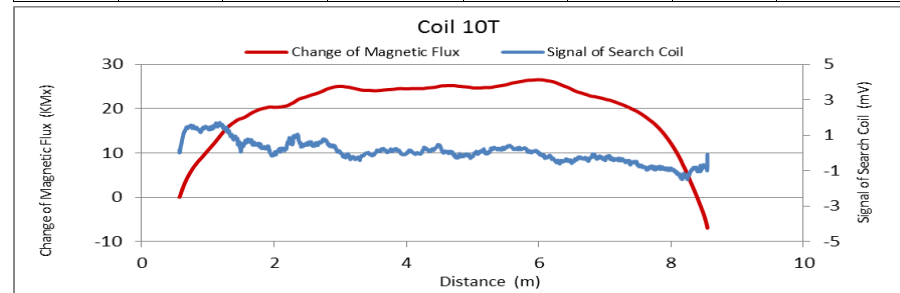
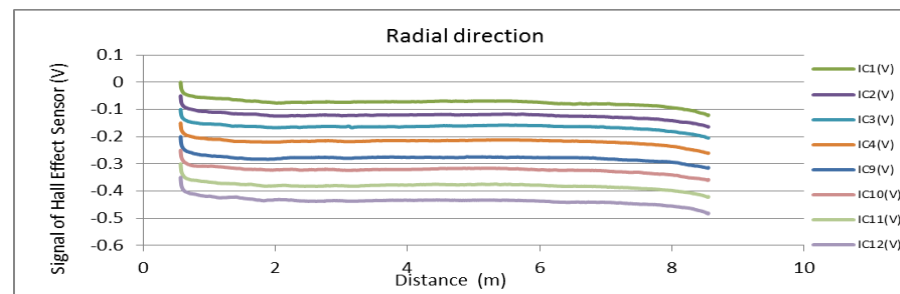
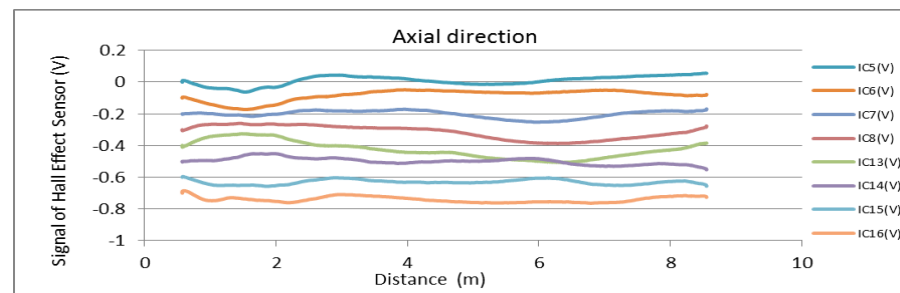
Figure A76. MMFM data of P3-402R-H1 tendon section.

File Name 【Pier-Tendon-Section】	Section Total Length (m)	Scanned Length		Note			
		Starting Point (m)	Ending Point (m)				
P3-402R-H1	9.43	0.57	8.62				
Identified Damage 1				Identified Damage 2			
Max Loss Point (m)	Section Loss (%)	Damage Length (m)	Damage Orientation	Max Loss Point (m)	Section Loss (%)	Damage Length (m)	Damage Orientation
—	—	—	—	—	—	—	—

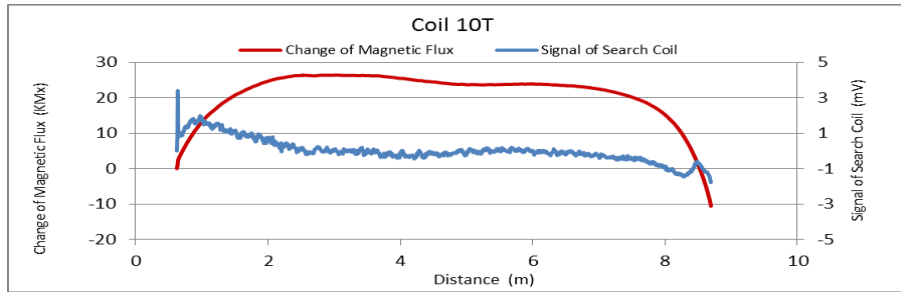
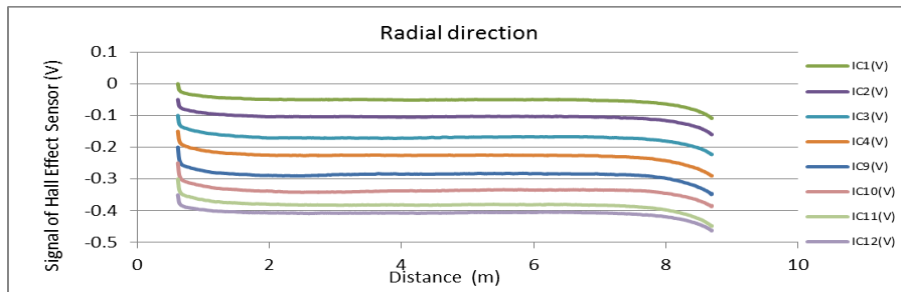
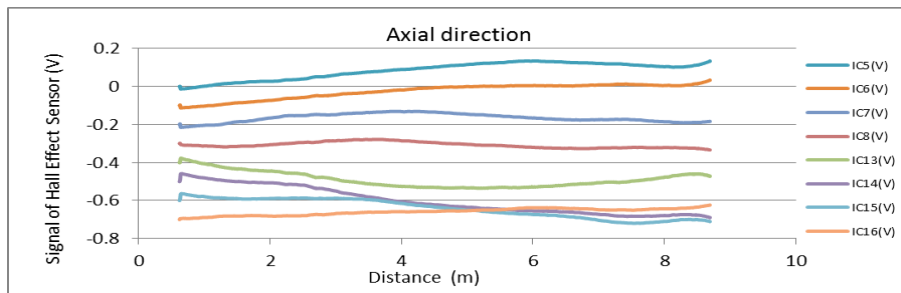
Figure A77. MMFM data of P3-401L-H1 tendon section.

File Name 【Pier-Tendon-Section】	Section Total Length (m)	Scanned Length		Note			
		Starting Point (m)	Ending Point (m)				
P3-401L-H1	9.49	0.62	8.74				
Identified Damage 1				Identified Damage 2			
Max Loss Point (m)	Section Loss (%)	Damage Length (m)	Damage Orientation	Max Loss Point (m)	Section Loss (%)	Damage Length (m)	Damage Orientation
—	—	—	—	—	—	—	—

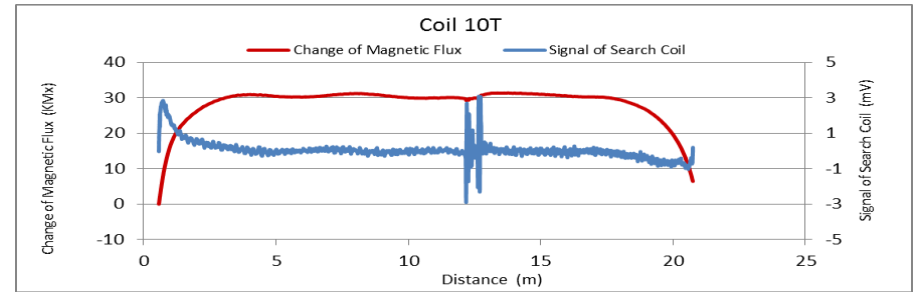
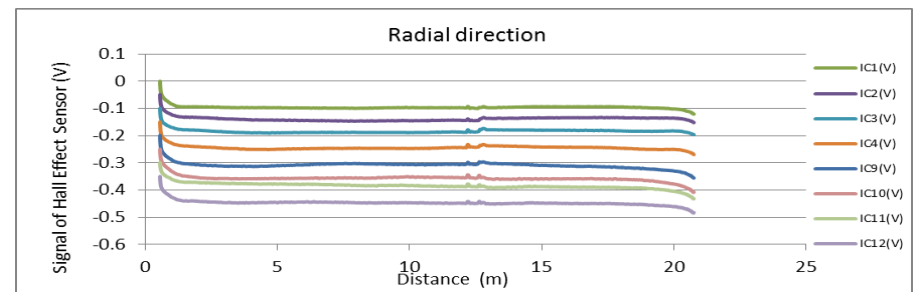
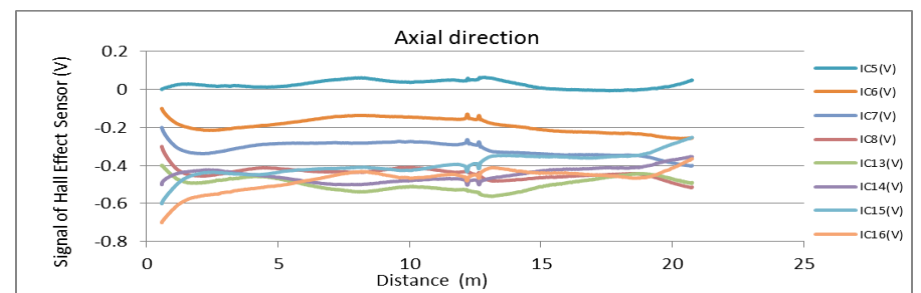
Figure A78. MMFM data of P3-401R-I1 tendon section.

File Name 【Pier-Tendon-Section】	Section Total Length (m)	Scanned Length		Note			
		Starting Point (m)	Ending Point (m)				
P3-401R-I1	21.53	0.57	20.92				
Identified Damage 1				Identified Damage 2			
Max Loss Point (m)	Section Loss (%)	Damage Length (m)	Damage Orientation	Max Loss Point (m)	Section Loss (%)	Damage Length (m)	Damage Orientation
—	—	—	—	—	—	—	—

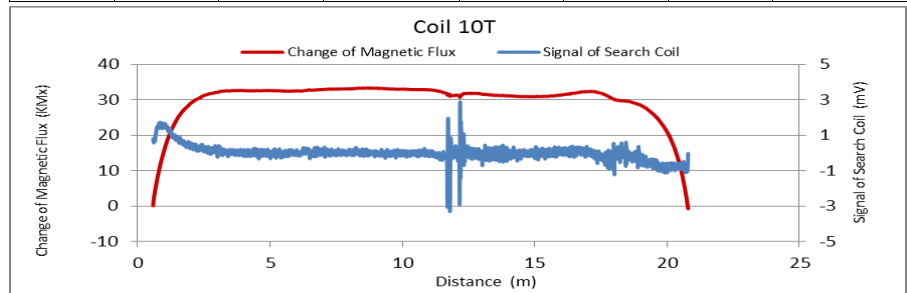
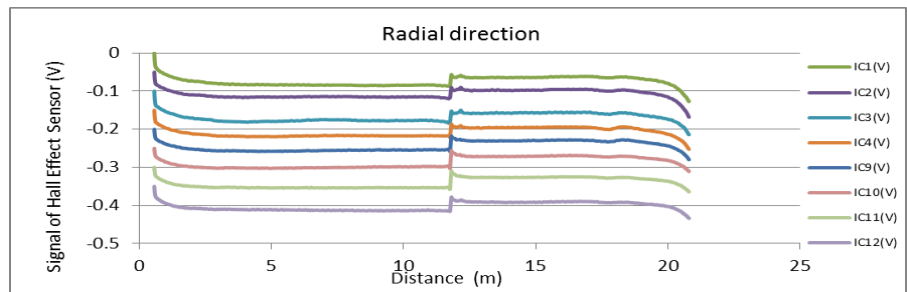
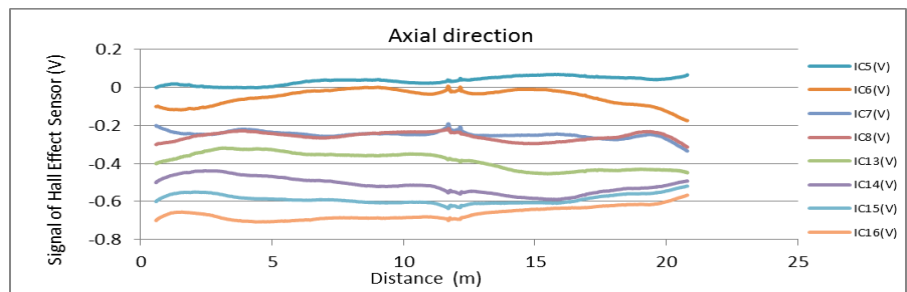
Figure A79. MMFM data of P3-402R-I1 tendon section.

File Name 【Pier-Tendon-Section】	Section Total Length (m)	Scanned Length		Note			
		Starting Point (m)	Ending Point (m)				
P3-402R-I1	21.53	0.58	20.81	Joint position: 13.3 m			
Identified Damage 1				Identified Damage 2			
Max Loss Point (m)	Section Loss (%)	Damage Length (m)	Damage Orientation	Max Loss Point (m)	Section Loss (%)	Damage Length (m)	Damage Orientation
—	—	—	—	—	—	—	—

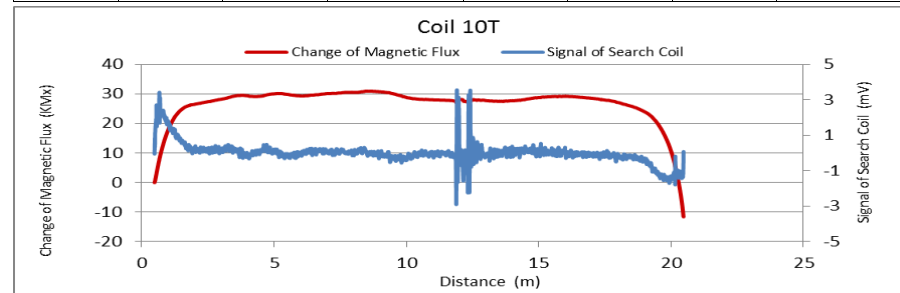
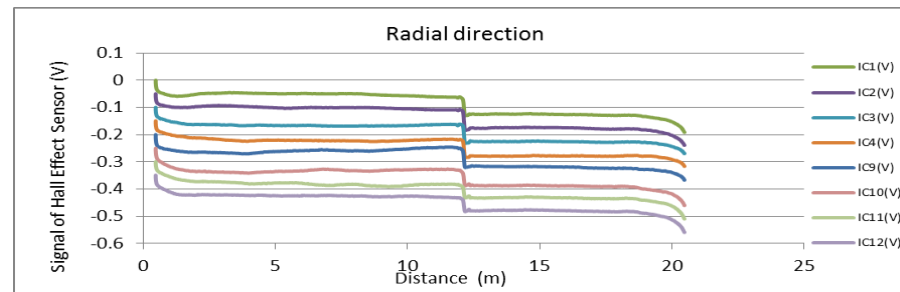
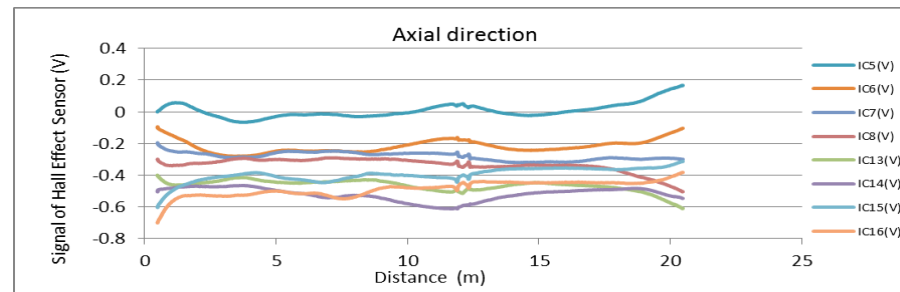
Figure A80. MMFM data of P3-401L-I1 tendon section.

File Name 【Pier-Tendon-Section】	Section Total Length (m)	Scanned Length		Note			
		Starting Point (m)	Ending Point (m)				
P3-401L-I1	21.53	0.48	20.68	Joint position: 12.2 m			
Identified Damage 1				Identified Damage 2			
Max Loss Point (m)	Section Loss (%)	Damage Length (m)	Damage Orientation	Max Loss Point (m)	Section Loss (%)	Damage Length (m)	Damage Orientation
—	—	—	—	—	—	—	—

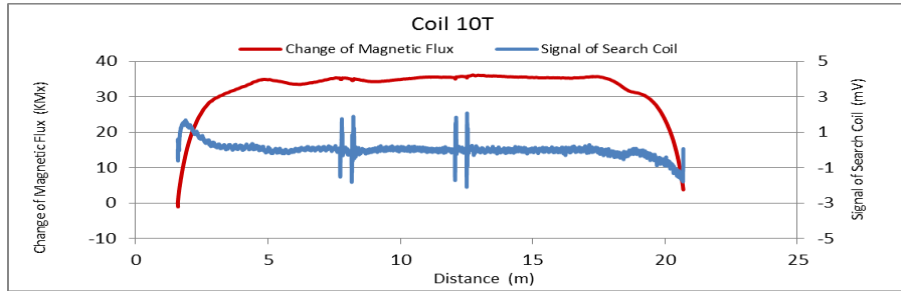
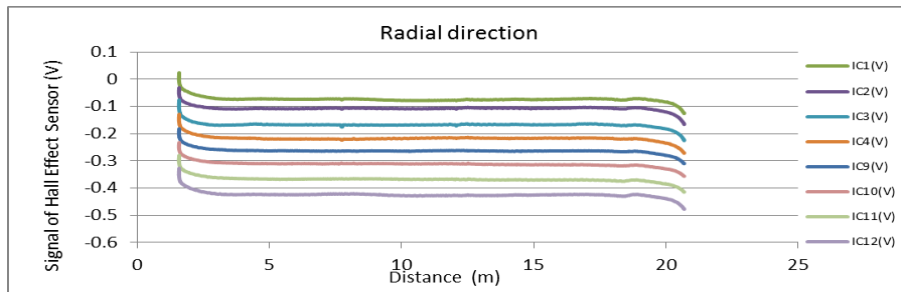
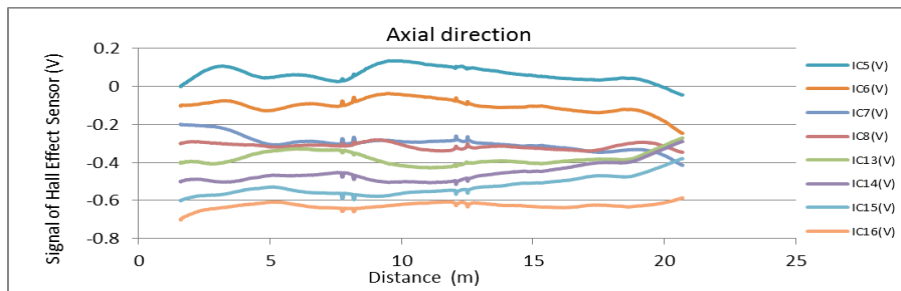
Figure A81. MMFM data of P3-402L-I1 tendon section.

File Name 【Pier-Tendon-Section】	Section Total Length (m)	Scanned Length		Note			
		Starting Point (m)	Ending Point (m)				
P3-402L-I1	21.53	1.59	20.75	Joint position: 8.02 m, 12.35 m			
Identified Damage 1				Identified Damage 2			
Max Loss Point (m)	Section Loss (%)	Damage Length (m)	Damage Orientation	Max Loss Point (m)	Section Loss (%)	Damage Length (m)	Damage Orientation
—	—	—	—	—	—	—	—

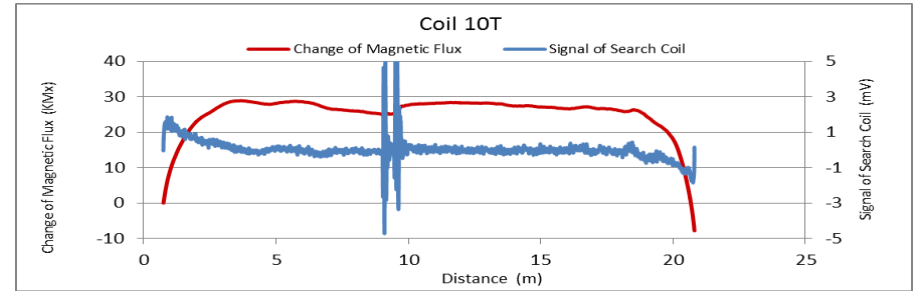
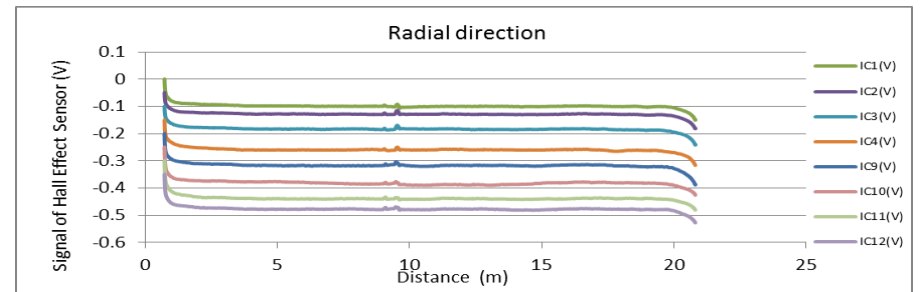
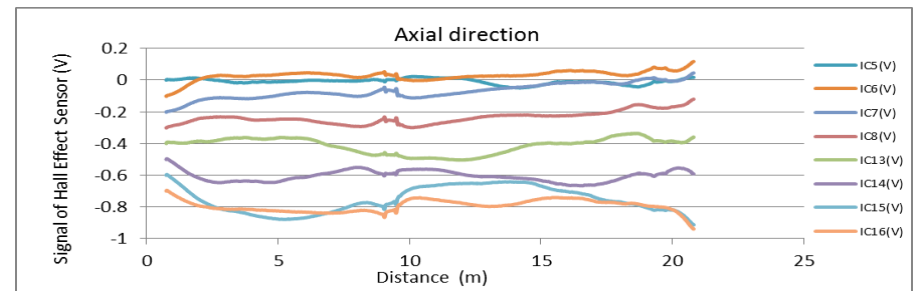
Figure A82. MMFM data of P3-401R-I2 tendon section.

File Name 【Pier-Tendon-Section】	Section Total Length (m)	Scanned Length		Note			
		Starting Point (m)	Ending Point (m)				
P3-401R-I2	21.5	0.74	20.95	Joint position: 9.3 m			
Identified Damage 1				Identified Damage 2			
Max Loss Point (m)	Section Loss (%)	Damage Length (m)	Damage Orientation	Max Loss Point (m)	Section Loss (%)	Damage Length (m)	Damage Orientation
—	—	—	—	—	—	—	—

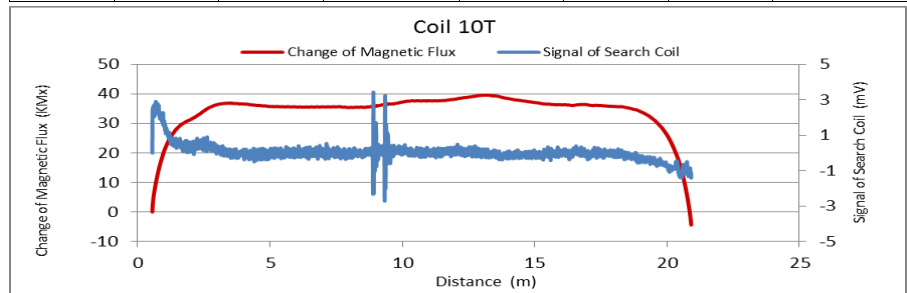
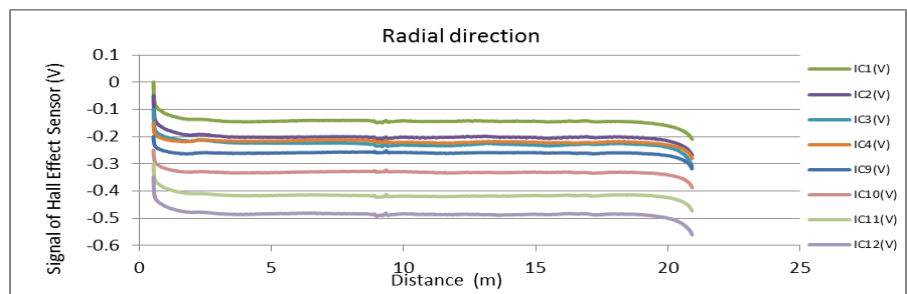
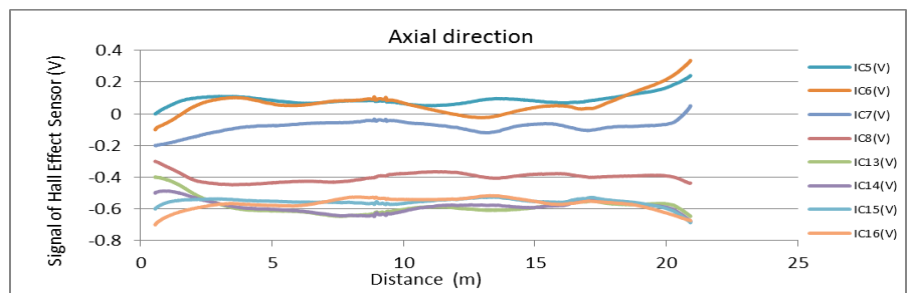
Figure A83. MMFM data of P3-402R-I2 tendon section.

File Name 【Pier-Tendon-Section】	Section Total Length (m)	Scanned Length		Note			
		Starting Point (m)	Ending Point (m)				
P3-402R-I2	21.5	0.55	20.91	Joint position: 9.2 m			
Identified Damage 1				Identified Damage 2			
Max Loss Point (m)	Section Loss (%)	Damage Length (m)	Damage Orientation	Max Loss Point (m)	Section Loss (%)	Damage Length (m)	Damage Orientation
—	—	—	—	—	—	—	—

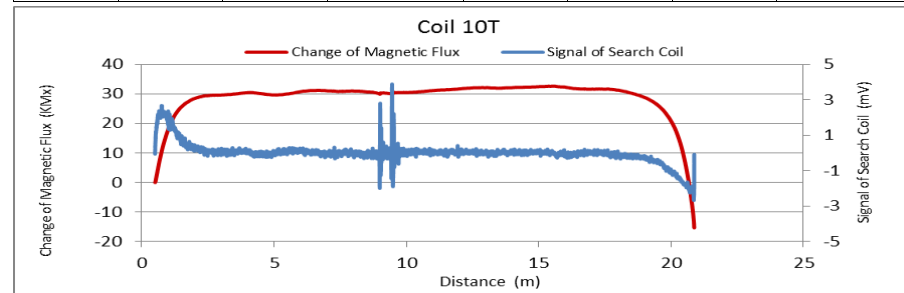
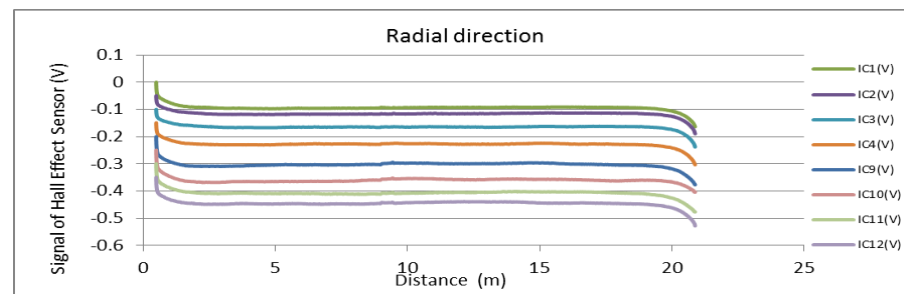
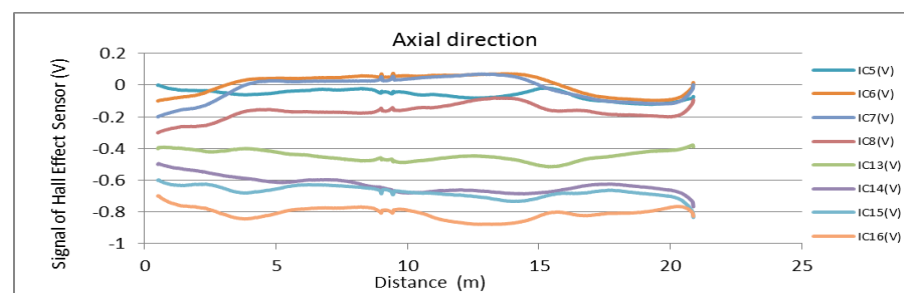
Figure A84. MMFM data of P3-401L-I2 tendon section.

File Name 【Pier-Tendon-Section】	Section Total Length (m)	Scanned Length		Note			
		Starting Point (m)	Ending Point (m)				
P3-401L-I2	21.6	0.5	21.05	Joint position: 9.34 m			
Identified Damage 1				Identified Damage 2			
Max Loss Point (m)	Section Loss (%)	Damage Length (m)	Damage Orientation	Max Loss Point (m)	Section Loss (%)	Damage Length (m)	Damage Orientation
—	—	—	—	—	—	—	—

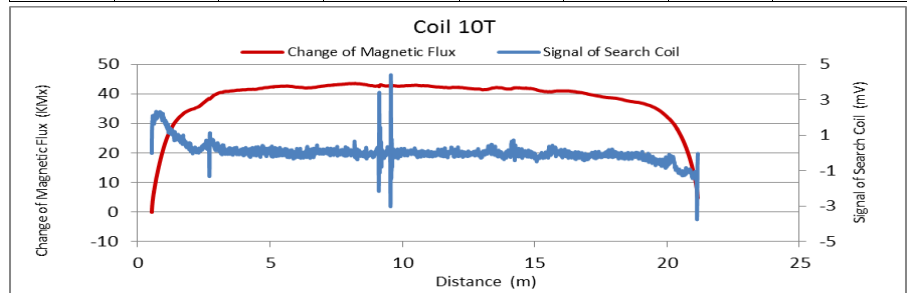
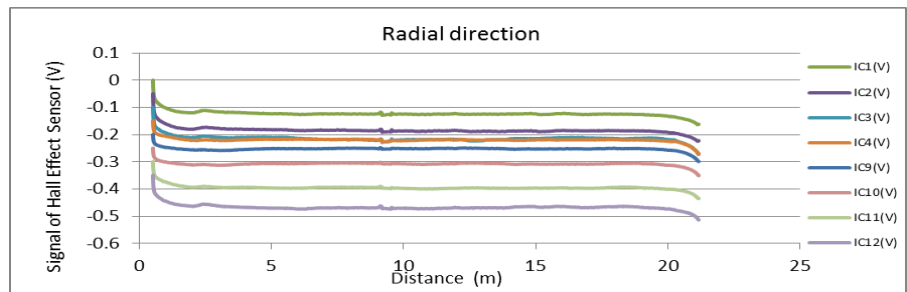
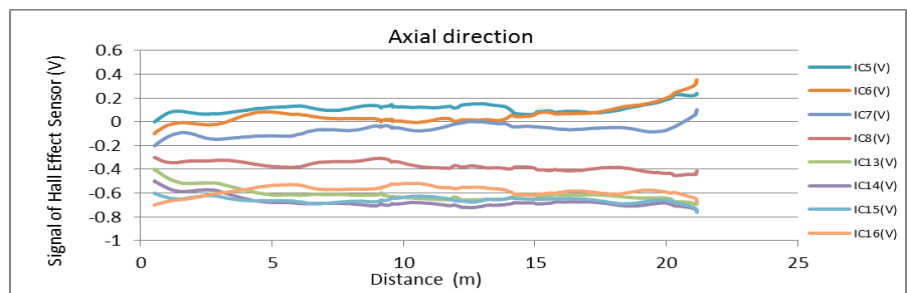
Figure A85. MMFM data of P3-402L-I2 tendon section.

File Name 【Pier-Tendon-Section】	Section Total Length (m)	Scanned Length		Note			
		Starting Point (m)	Ending Point (m)				
P3-402L-I2	21.6	0.53	21.16	Joint position:9.34 m			
Identified Damage 1				Identified Damage 2			
Max Loss Point (m)	Section Loss (%)	Damage Length (m)	Damage Orientation	Max Loss Point (m)	Section Loss (%)	Damage Length (m)	Damage Orientation
—	—	—	—	—	—	—	—

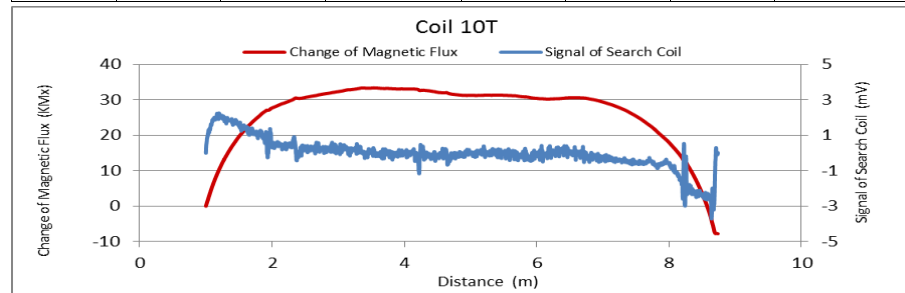
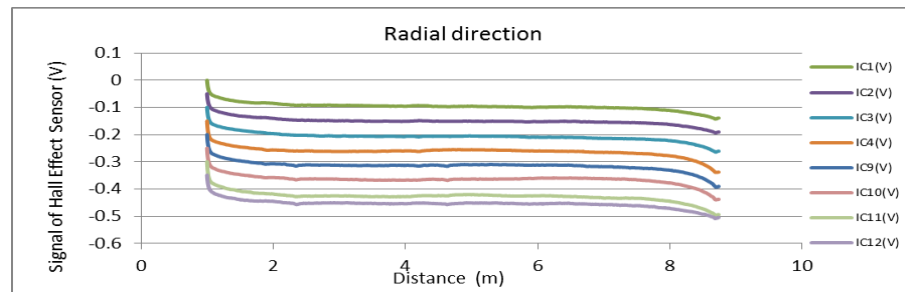
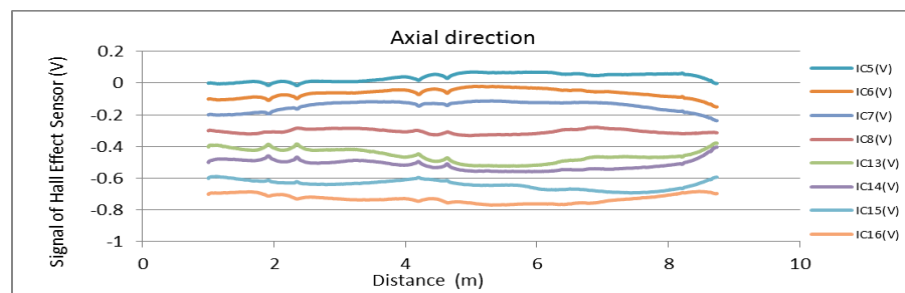
Figure A86. MMFM data of P3-401R-H2 tendon section.

File Name 【Pier-Tendon-Section】	Section Total Length (m)	Scanned Length		Note			
		Starting Point (m)	Ending Point (m)				
P3-401R-H2	9.45	1	8.79				
Identified Damage 1				Identified Damage 2			
Max Loss Point (m)	Section Loss (%)	Damage Length (m)	Damage Orientation	Max Loss Point (m)	Section Loss (%)	Damage Length (m)	Damage Orientation
—	—	—	—	—	—	—	—

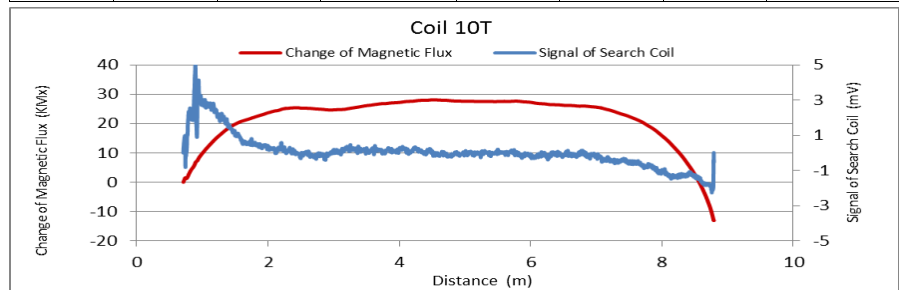
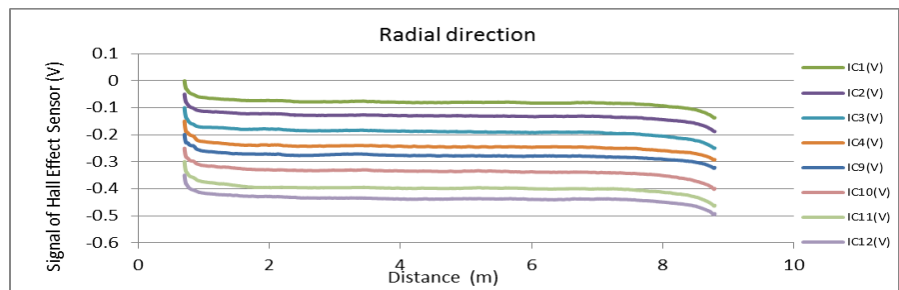
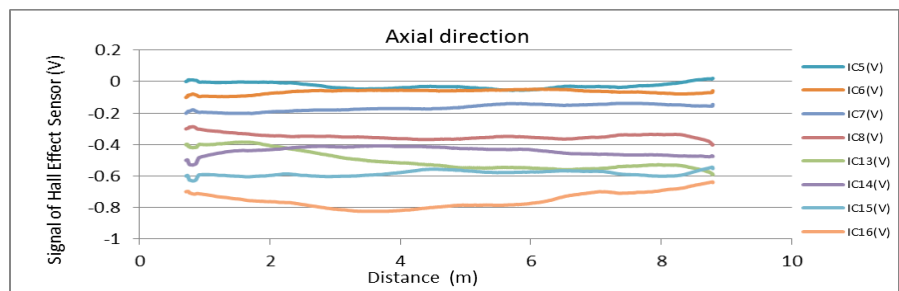
Figure A87. MMFM data of P3-402R-H2 tendon section.

File Name 【Pier-Tendon-Section】	Section Total Length (m)	Scanned Length		Note			
		Starting Point (m)	Ending Point (m)				
P3-402R-H2	9.45	0.71	8.85				
Identified Damage 1				Identified Damage 2			
Max Loss Point (m)	Section Loss (%)	Damage Length (m)	Damage Orientation	Max Loss Point (m)	Section Loss (%)	Damage Length (m)	Damage Orientation
—	—	—	—	—	—	—	—

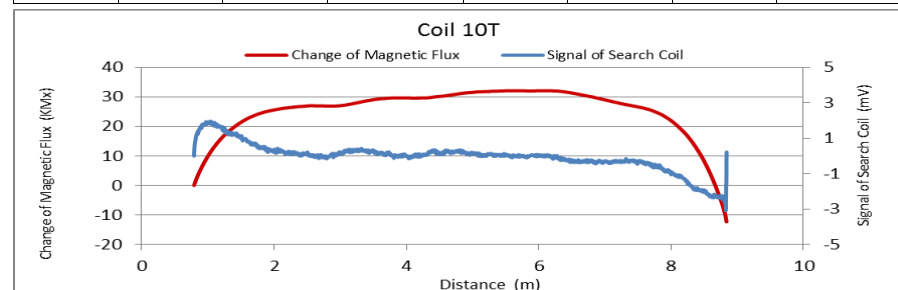
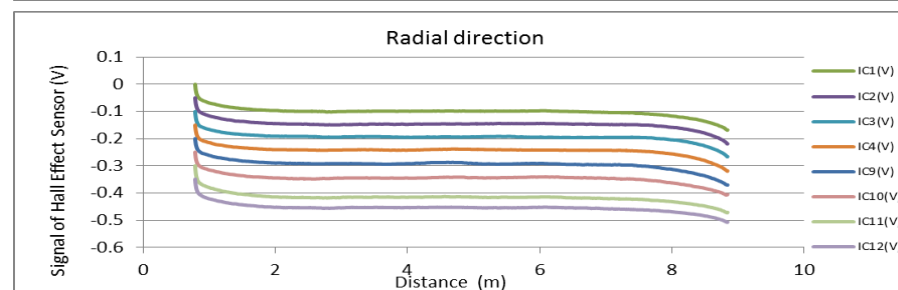
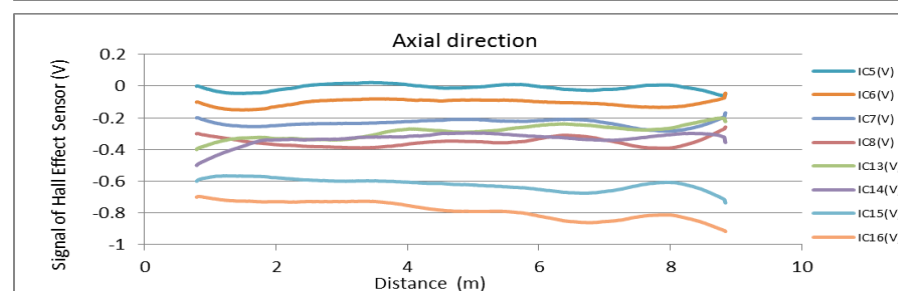
Figure A88. MMFM data of P3-401L-H2 tendon section.

File Name 【Pier-Tendon-Section】	Section Total Length (m)	Scanned Length		Note			
		Starting Point (m)	Ending Point (m)				
P3-401L-H2	9.49	0.79	8.91				
Identified Damage 1				Identified Damage 2			
Max Loss Point (m)	Section Loss (%)	Damage Length (m)	Damage Orientation	Max Loss Point (m)	Section Loss (%)	Damage Length (m)	Damage Orientation
—	—	—	—	—	—	—	—
