**Development of Quality Assurance and Quality Control
System for Post Tensioned Segmental Bridges in Florida:
Case of Ringling Bridge – Phase II**

**FDOT Contract No. BDV29-977-34
FINAL REPORT**

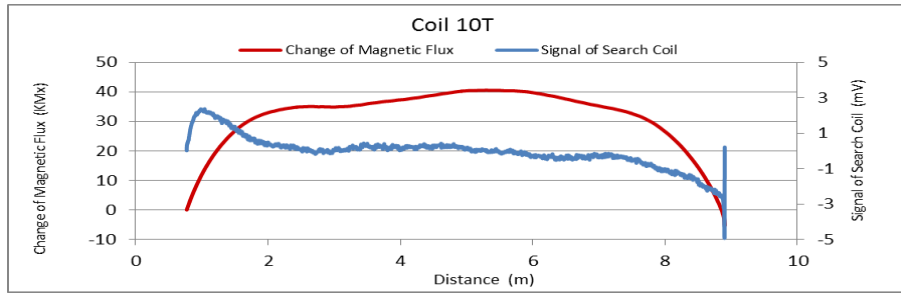
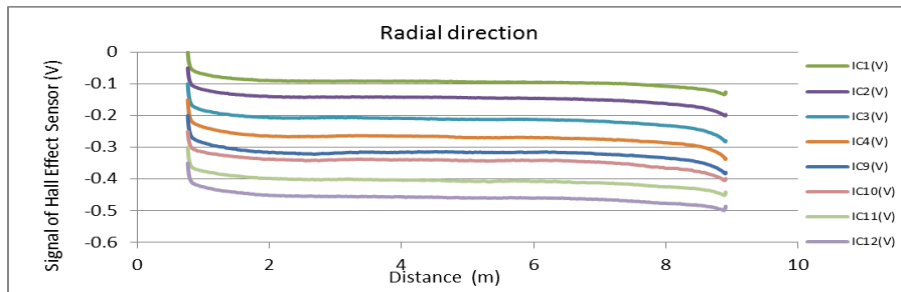
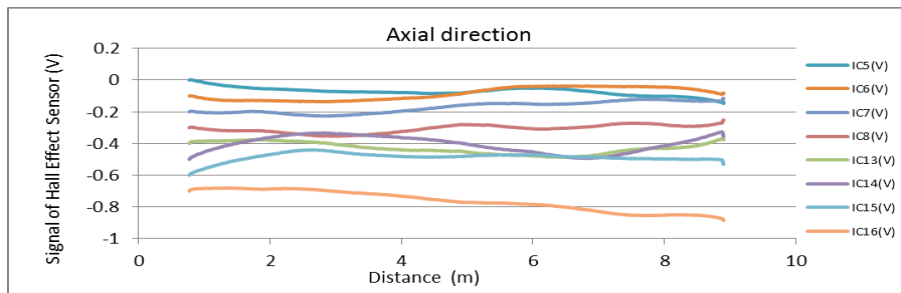
File Name 【Pier-Tendon-Section】	Section Total Length (m)	Scanned Length		Note			
		Starting Point (m)	Ending Point (m)				
P3-402L-H2	9.49	0.77	8.96				
Identified Damage 1				Identified Damage 2			
Max Loss Point (m)	Section Loss (%)	Damage Length (m)	Damage Orientation	Max Loss Point (m)	Section Loss (%)	Damage Length (m)	Damage Orientation
—	—	—	—	—	—	—	—

Figure A89. MMFM data of P3-402L-H2 tendon section.

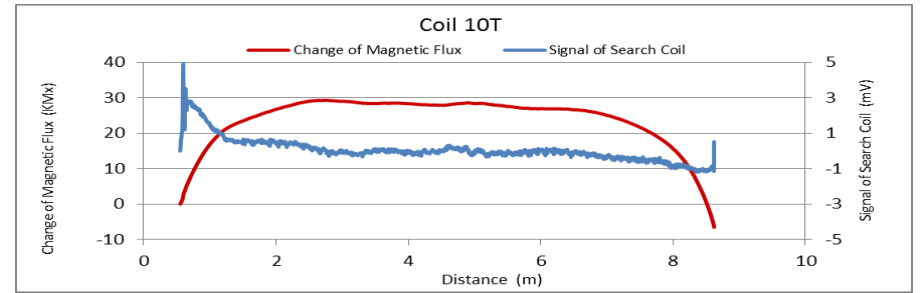
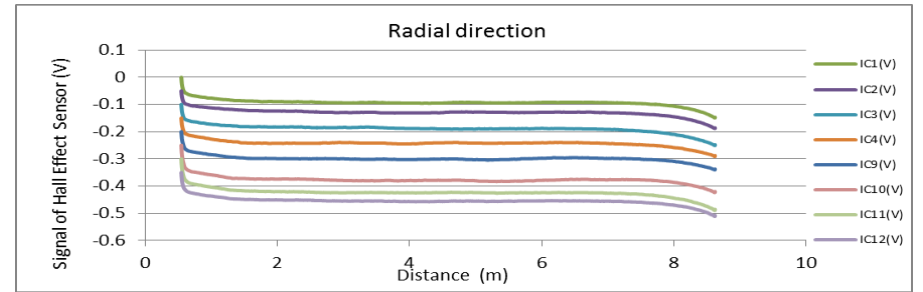
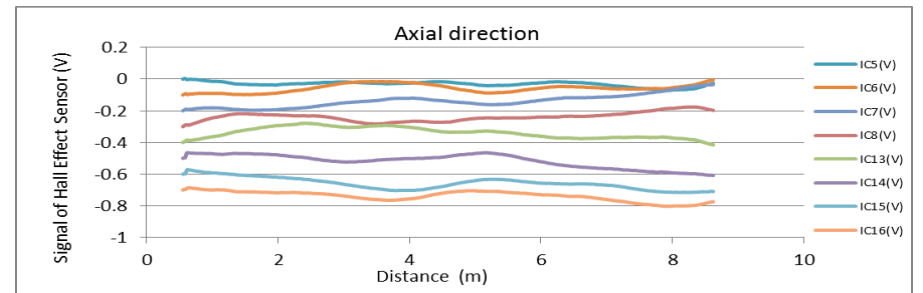
File Name 【Pier-Tendon-Section】	Section Total Length (m)	Scanned Length		Note			
		Starting Point (m)	Ending Point (m)				
P4-401R-H1	9.35	0.55	8.66				
Identified Damage 1				Identified Damage 2			
Max Loss Point (m)	Section Loss (%)	Damage Length (m)	Damage Orientation	Max Loss Point (m)	Section Loss (%)	Damage Length (m)	Damage Orientation
—	—	—	—	—	—	—	—

Figure A90. MMFM data of P4-401R-H1 tendon section.

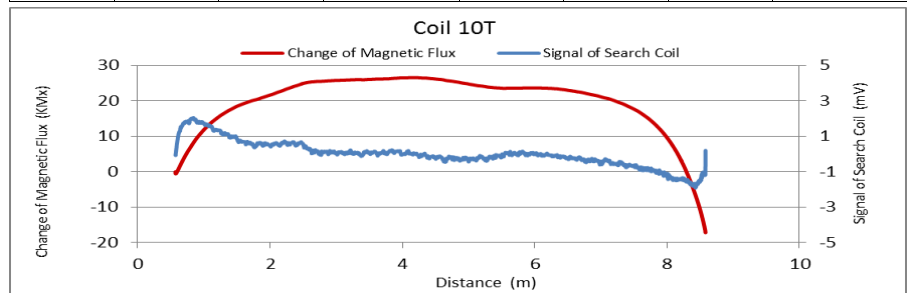
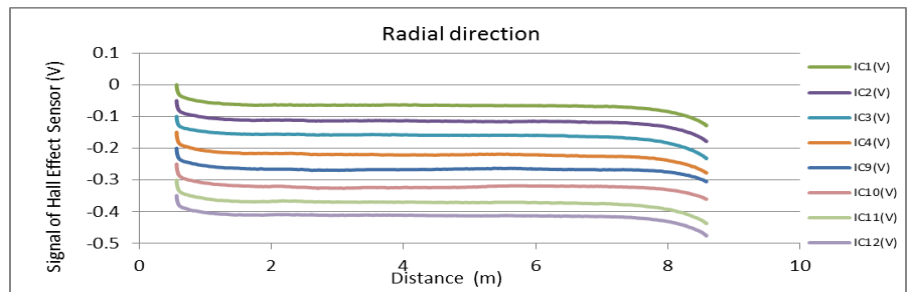
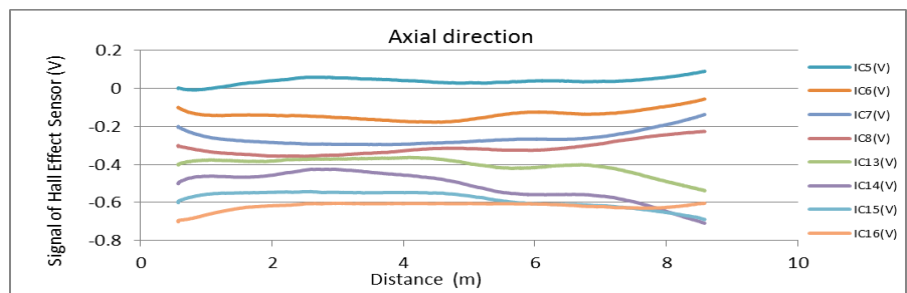
File Name 【Pier-Tendon-Section】	Section Total Length (m)	Scanned Length		Note			
		Starting Point (m)	Ending Point (m)				
P4-401L-H1	9.36	0.57	8.66				
Identified Damage 1				Identified Damage 2			
Max Loss Point (m)	Section Loss (%)	Damage Length (m)	Damage Orientation	Max Loss Point (m)	Section Loss (%)	Damage Length (m)	Damage Orientation
—	—	—	—	—	—	—	—

Figure A91. MMFM data of P4-401L-H1 tendon section.

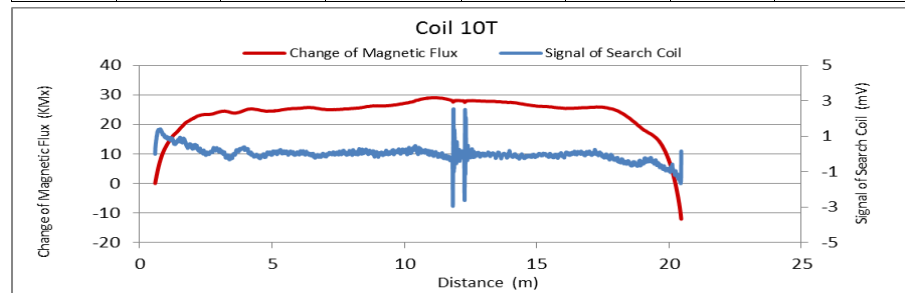
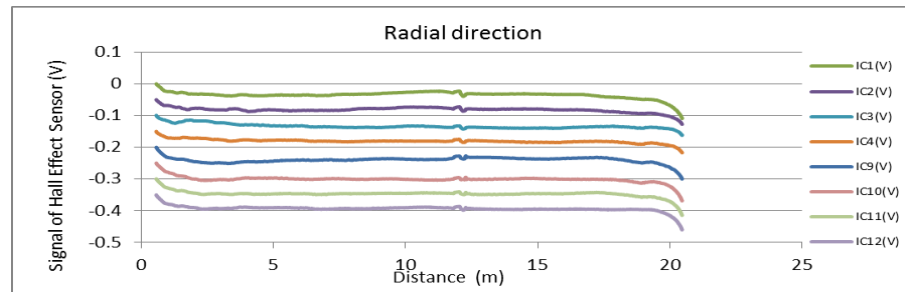
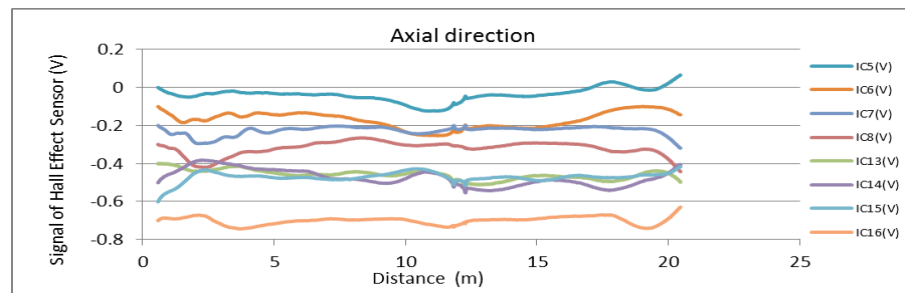
File Name 【Pier-Tendon-Section】	Section Total Length (m)	Scanned Length		Note			
		Starting Point (m)	Ending Point (m)				
P4-402R-I1	21.57	0.58	20.78	Joint position: 12.27 m			
Identified Damage 1				Identified Damage 2			
Max Loss Point (m)	Section Loss (%)	Damage Length (m)	Damage Orientation	Max Loss Point (m)	Section Loss (%)	Damage Length (m)	Damage Orientation
—	—	—	—	—	—	—	—

Figure A92. MMFM data of P4-402R-I1 tendon section.

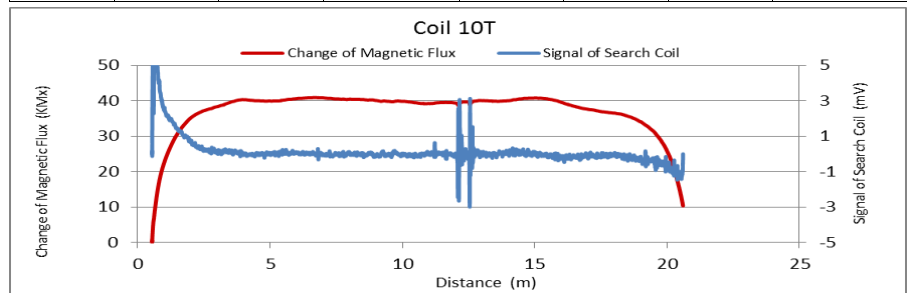
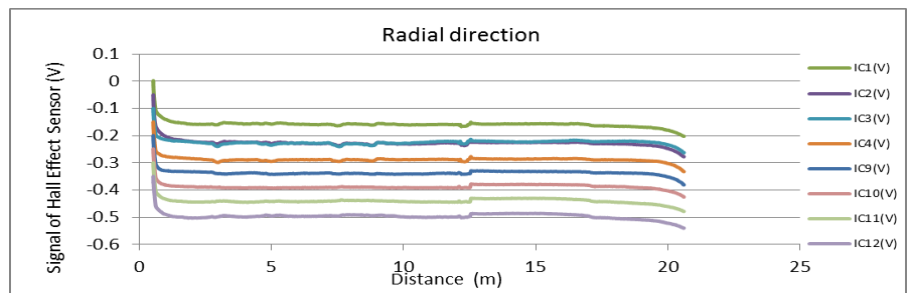
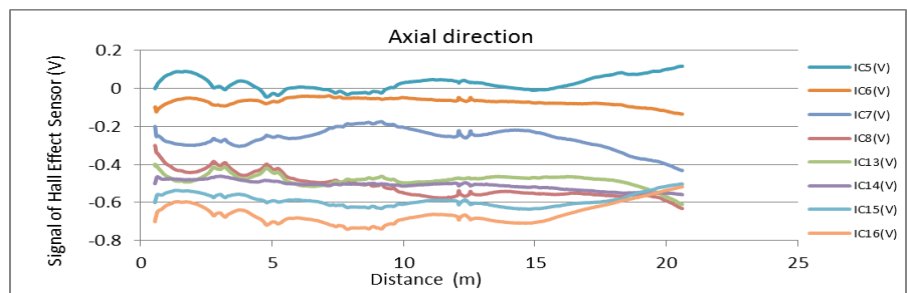
File Name 【Pier-Tendon-Section】	Section Total Length (m)	Scanned Length		Note			
		Starting Point (m)	Ending Point (m)				
P4-401L-I1	21.5	0.54	20.61	Joint position: 12.27 m			
Identified Damage 1				Identified Damage 2			
Max Loss Point (m)	Section Loss (%)	Damage Length (m)	Damage Orientation	Max Loss Point (m)	Section Loss (%)	Damage Length (m)	Damage Orientation
—	—	—	—	—	—	—	—

Figure A93. MMFM data of P4-401L-I1 tendon section.

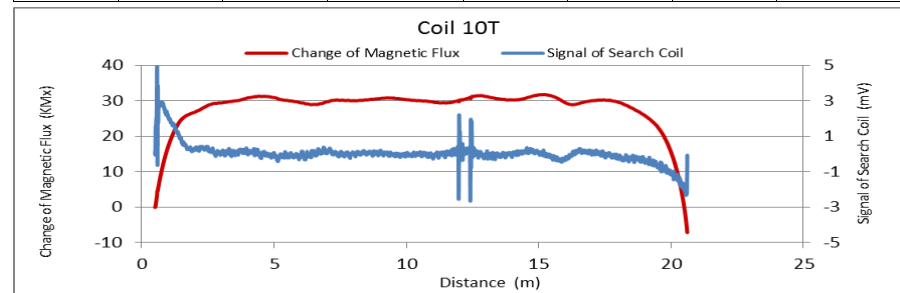
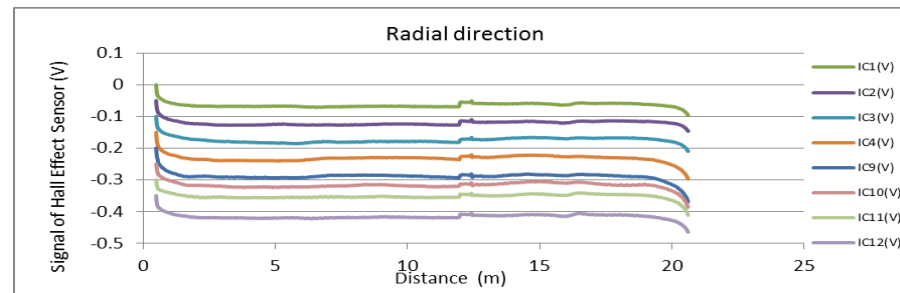
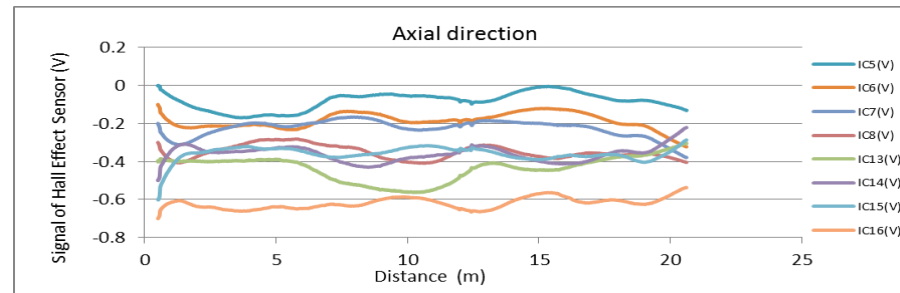
File Name 【Pier-Tendon-Section】	Section Total Length (m)	Scanned Length		Note			
		Starting Point (m)	Ending Point (m)				
P4-402L-I1	21.5	0.5	20.75	Joint position: 12.27 m			
Identified Damage 1				Identified Damage 2			
Max Loss Point (m)	Section Loss (%)	Damage Length (m)	Damage Orientation	Max Loss Point (m)	Section Loss (%)	Damage Length (m)	Damage Orientation
—	—	—	—	—	—	—	—

Figure A94. MMFM data of P4-402L-I1 tendon section.

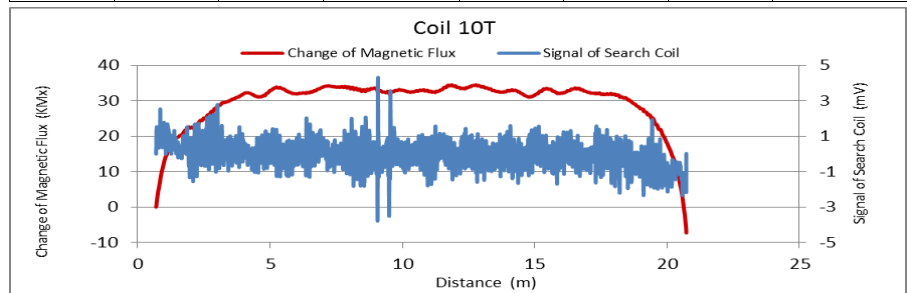
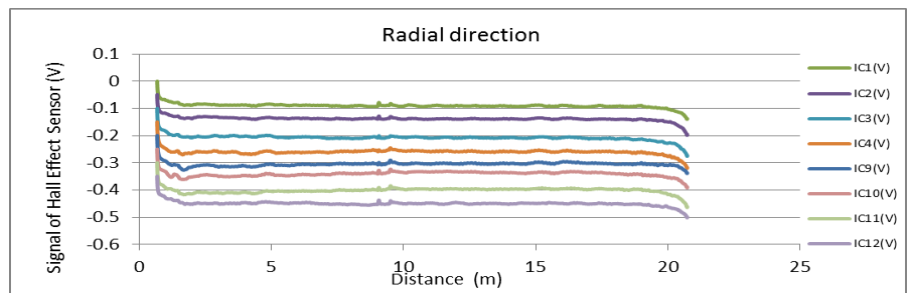
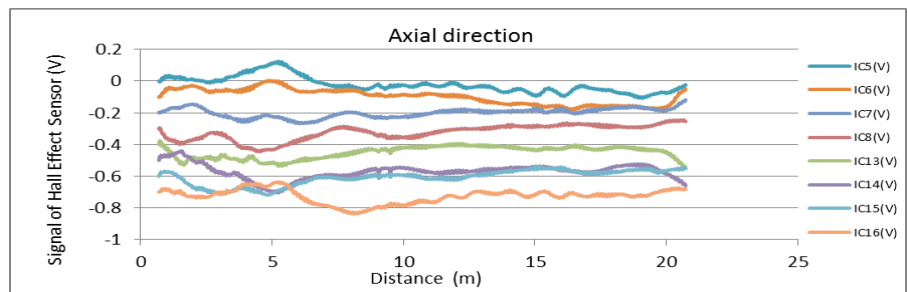
File Name 【Pier-Tendon-Section】	Section Total Length (m)	Scanned Length		Note			
		Starting Point (m)	Ending Point (m)				
P4-402R-I2	21.46	0.69	20.92	Joint position: 9.38 m			
Identified Damage 1				Identified Damage 2			
Max Loss Point (m)	Section Loss (%)	Damage Length (m)	Damage Orientation	Max Loss Point (m)	Section Loss (%)	Damage Length (m)	Damage Orientation
—	—	—	—	—	—	—	—

Figure A95. MMFM data of P4-402R-I2 tendon section.

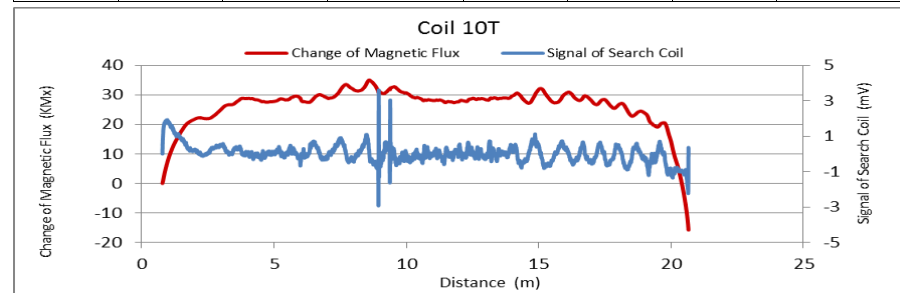
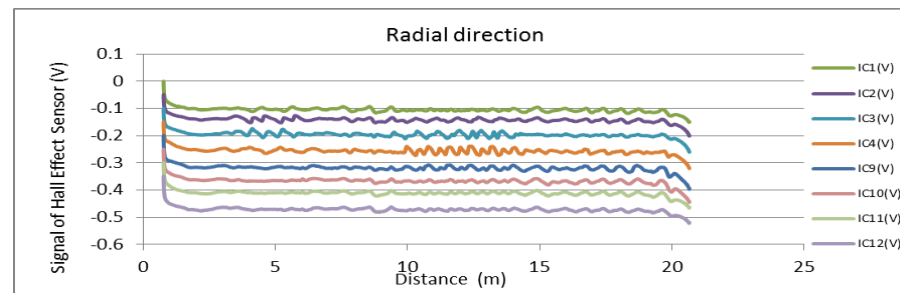
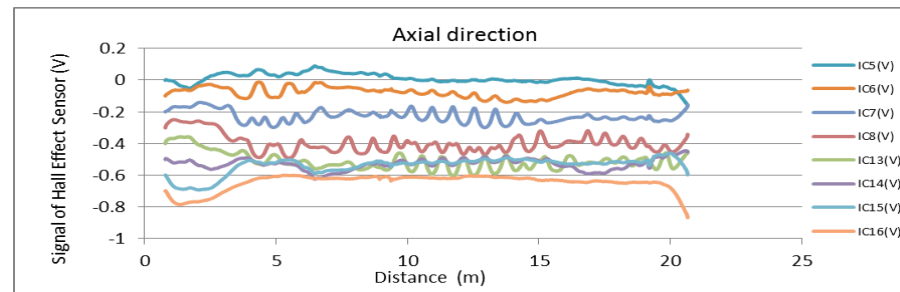
File Name 【Pier-Tendon-Section】	Section Total Length (m)	Scanned Length		Note			
		Starting Point (m)	Ending Point (m)				
P4-402L-I2	21.5	0.78	20.85	Joint position: 9.18 m			
Identified Damage 1				Identified Damage 2			
Max Loss Point (m)	Section Loss (%)	Damage Length (m)	Damage Orientation	Max Loss Point (m)	Section Loss (%)	Damage Length (m)	Damage Orientation
—	—	—	—	—	—	—	—

Figure A96. MMFM data of P4-402L-I2 tendon section.

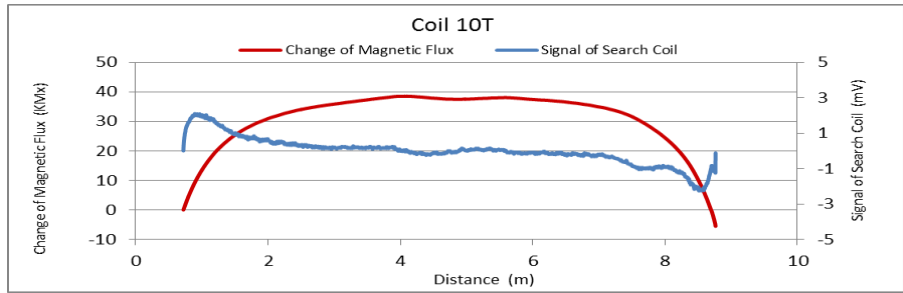
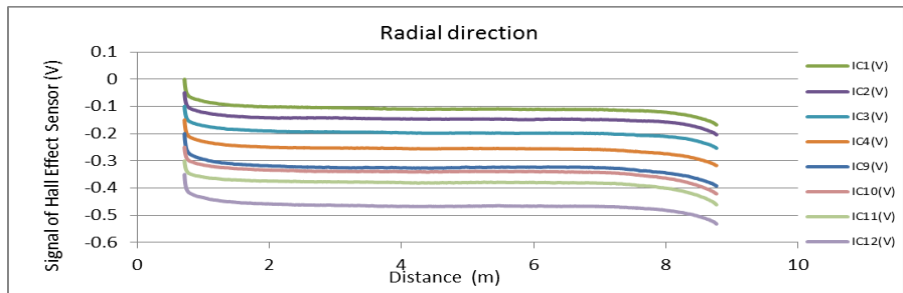
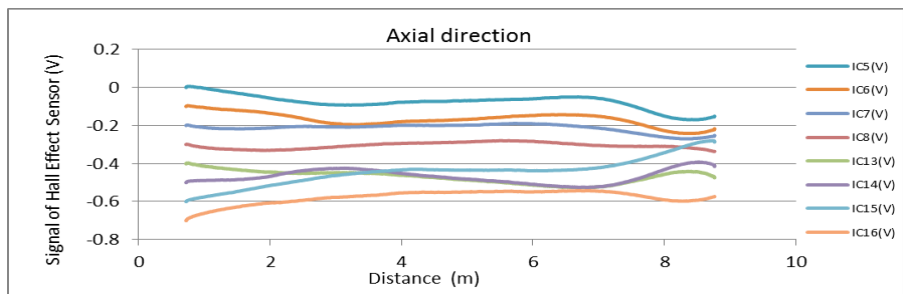
File Name 【Pier-Tendon-Section】	Section Total Length (m)	Scanned Length		Note			
		Starting Point (m)	Ending Point (m)				
P4-401R-H2	9.38	0.72	8.84				
Identified Damage 1				Identified Damage 2			
Max Loss Point (m)	Section Loss (%)	Damage Length (m)	Damage Orientation	Max Loss Point (m)	Section Loss (%)	Damage Length (m)	Damage Orientation
—	—	—	—	—	—	—	—

Figure A97. MMFM data of P4-401R-H2 tendon section.

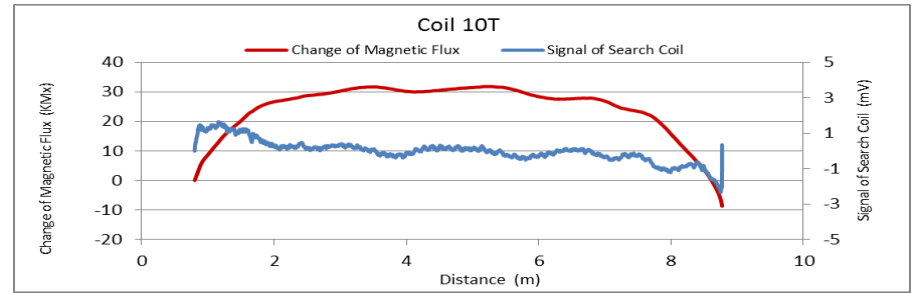
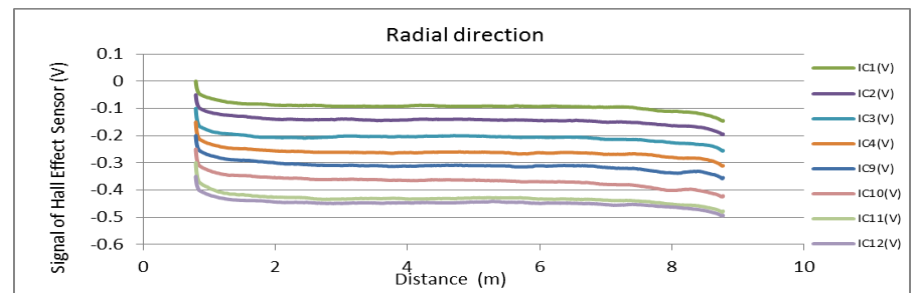
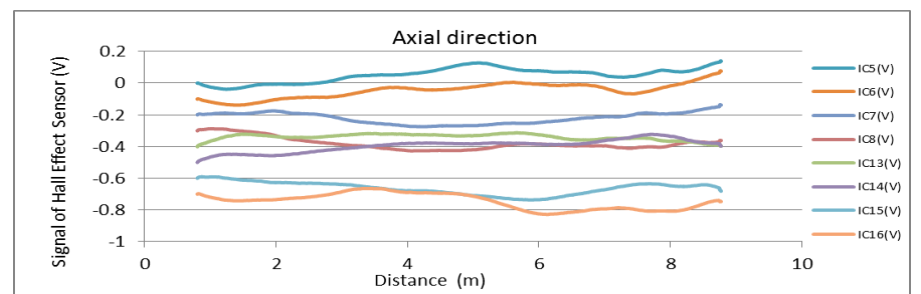
File Name 【Pier-Tendon-Section】	Section Total Length (m)	Scanned Length		Note			
		Starting Point (m)	Ending Point (m)				
P4-402R-H2	9.38	0.8	8.77				
Identified Damage 1				Identified Damage 2			
Max Loss Point (m)	Section Loss (%)	Damage Length (m)	Damage Orientation	Max Loss Point (m)	Section Loss (%)	Damage Length (m)	Damage Orientation
—	—	—	—	—	—	—	—

Figure A98. MMFM data of P4-402R-H2 tendon section.

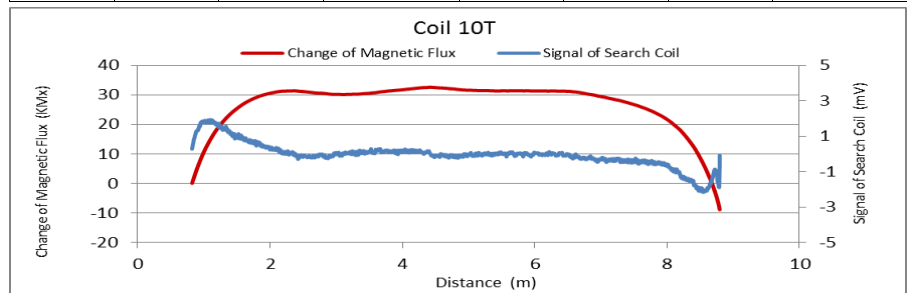
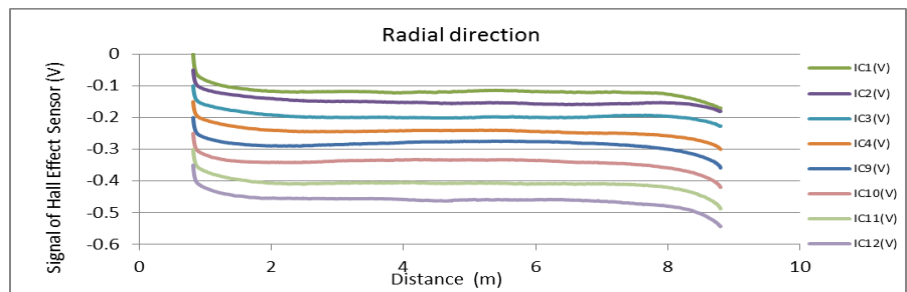
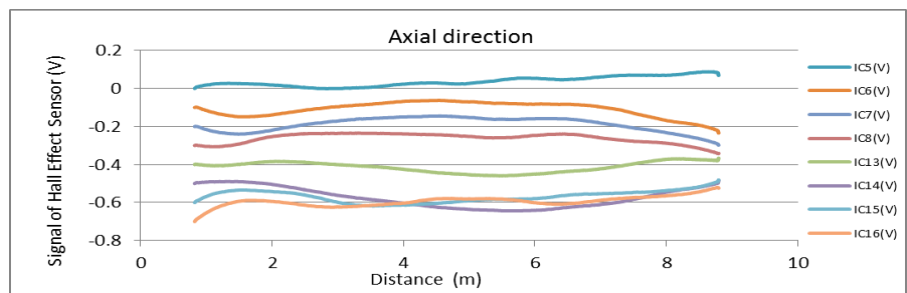
File Name 【Pier-Tendon-Section】	Section Total Length (m)	Scanned Length		Note			
		Starting Point (m)	Ending Point (m)				
P4-401L-H2	9.39	0.82	8.86				
Identified Damage 1				Identified Damage 2			
Max Loss Point (m)	Section Loss (%)	Damage Length (m)	Damage Orientation	Max Loss Point (m)	Section Loss (%)	Damage Length (m)	Damage Orientation
—	—	—	—	—	—	—	—

Figure A99. MMFM data of P4-401L-H2 tendon section.

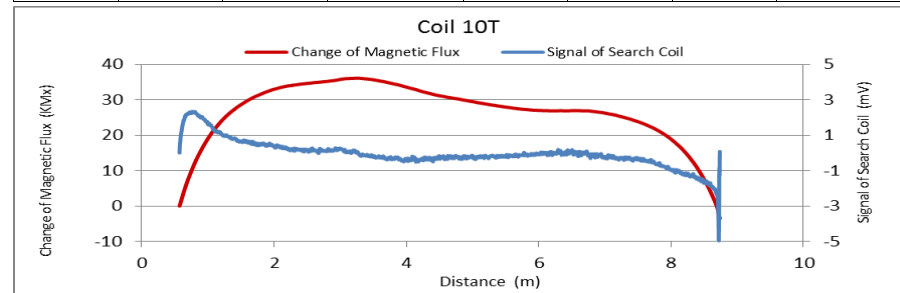
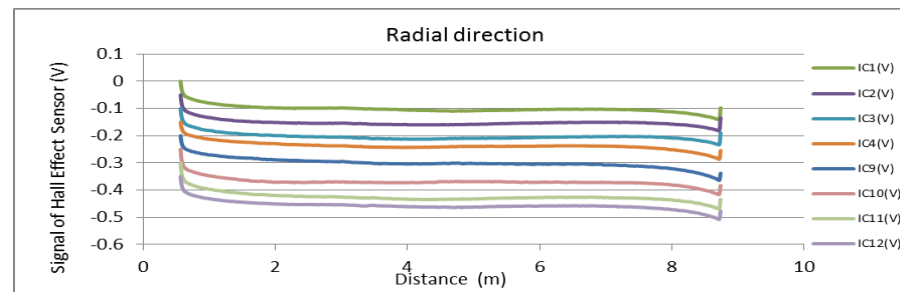
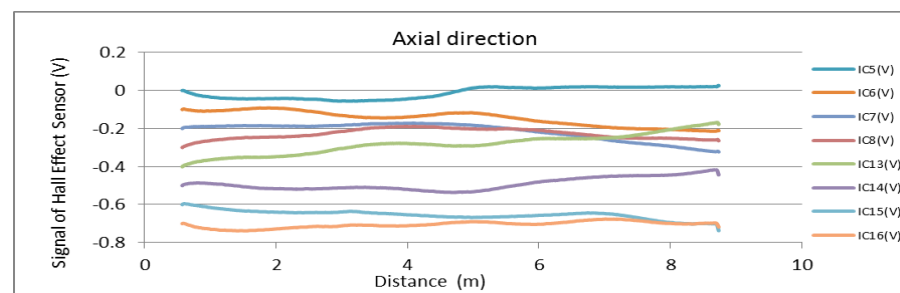
File Name 【Pier-Tendon-Section】	Section Total Length (m)	Scanned Length		Note			
		Starting Point (m)	Ending Point (m)				
P5-401R-H1	9.35	0.57	8.76				
Identified Damage 1				Identified Damage 2			
Max Loss Point (m)	Section Loss (%)	Damage Length (m)	Damage Orientation	Max Loss Point (m)	Section Loss (%)	Damage Length (m)	Damage Orientation
—	—	—	—	—	—	—	—

Figure A100. MMFM data of P5-401R-H1 tendon section.

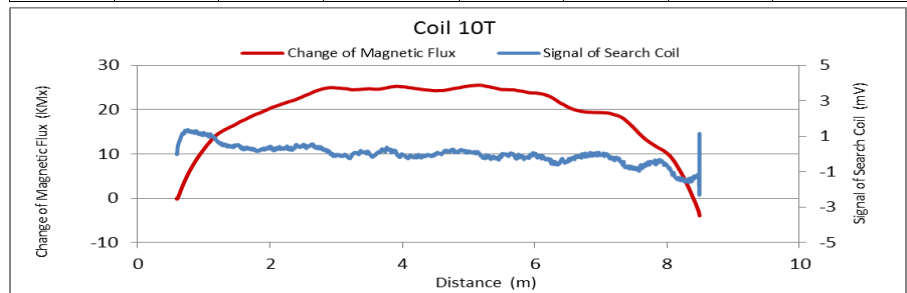
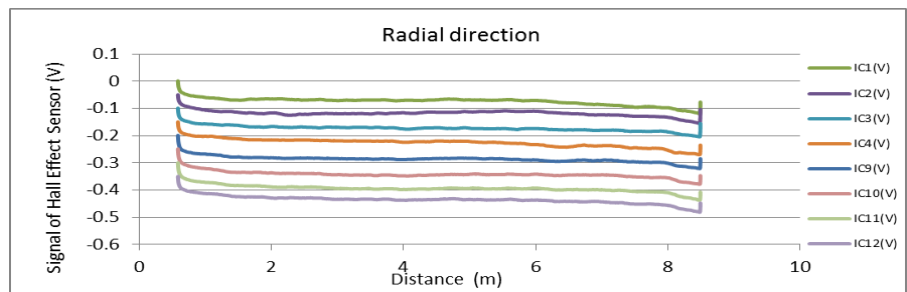
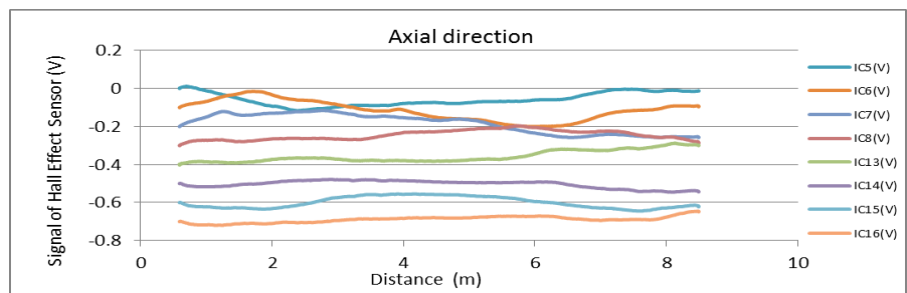
File Name 【Pier-Tendon-Section】	Section Total Length (m)	Scanned Length		Note			
		Starting Point (m)	Ending Point (m)				
P5-402R-H1	9.35	0.59	8.49				
Identified Damage 1				Identified Damage 2			
Max Loss Point (m)	Section Loss (%)	Damage Length (m)	Damage Orientation	Max Loss Point (m)	Section Loss (%)	Damage Length (m)	Damage Orientation
—	—	—	—	—	—	—	—

Figure A101. MMFM data of P5-402R-H1 tendon section.

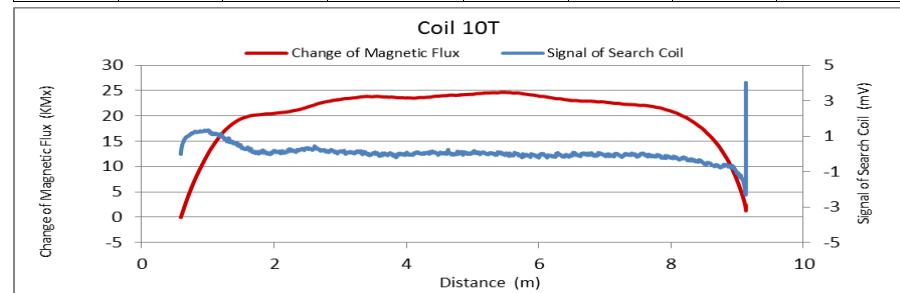
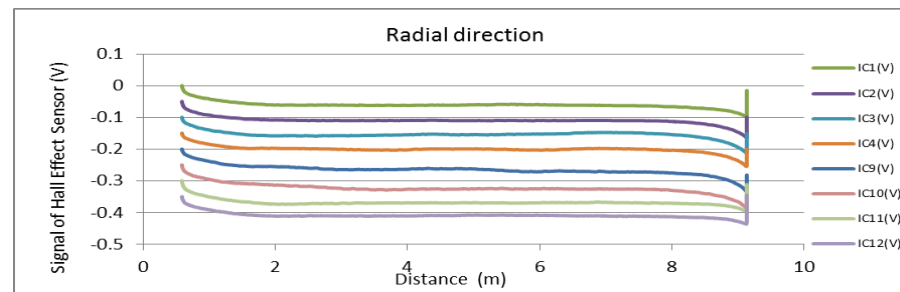
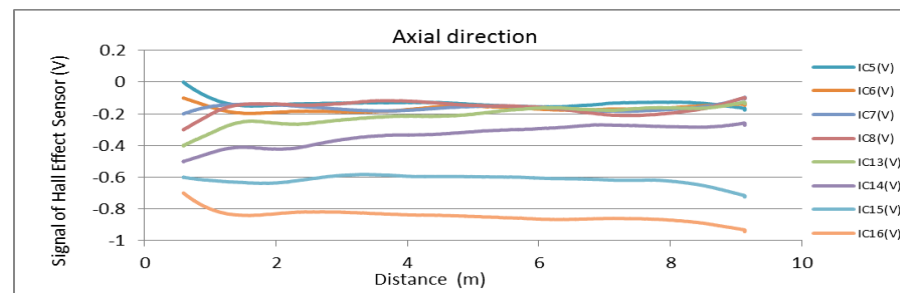
Figure A102. MMFM data of P5-303R-I1 tendon section.

File Name 【Pier-Tendon-Section】	Section Total Length (m)	Scanned Length		Note			
		Starting Point (m)	Ending Point (m)				
P5-303R-I1	9.6	0.59	9.19				
Identified Damage 1				Identified Damage 2			
Max Loss Point (m)	Section Loss (%)	Damage Length (m)	Damage Orientation	Max Loss Point (m)	Section Loss (%)	Damage Length (m)	Damage Orientation
—	—	—	—	—	—	—	—

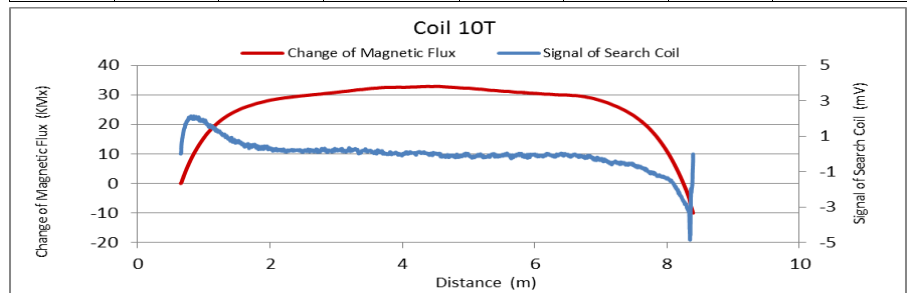
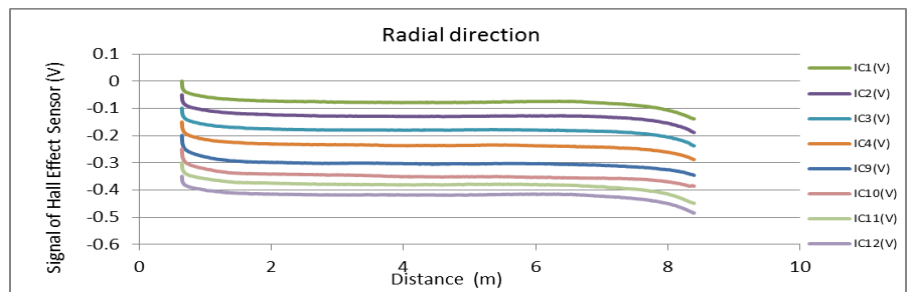
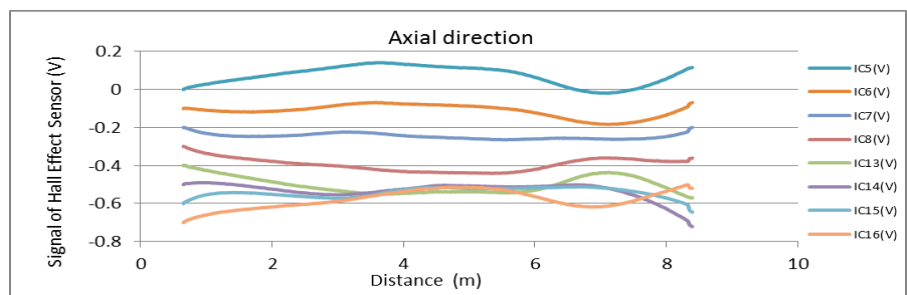
Figure A103. MMFM data of P5-401L-H1 tendon section.

File Name 【Pier-Tendon-Section】	Section Total Length (m)	Scanned Length		Note			
		Starting Point (m)	Ending Point (m)				
P5-401L-H1	9.28	0.65	8.45				
Identified Damage 1				Identified Damage 2			
Max Loss Point (m)	Section Loss (%)	Damage Length (m)	Damage Orientation	Max Loss Point (m)	Section Loss (%)	Damage Length (m)	Damage Orientation
—	—	—	—	—	—	—	—

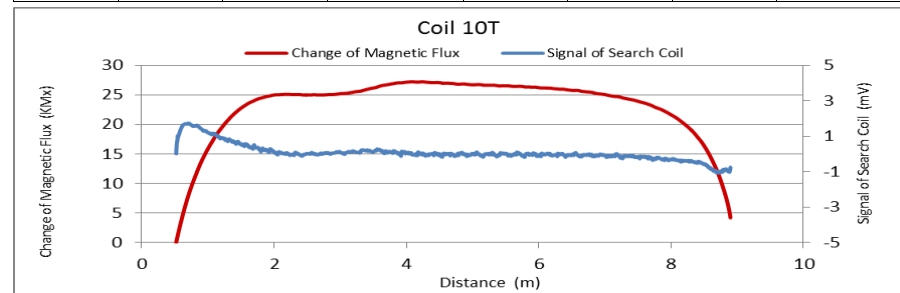
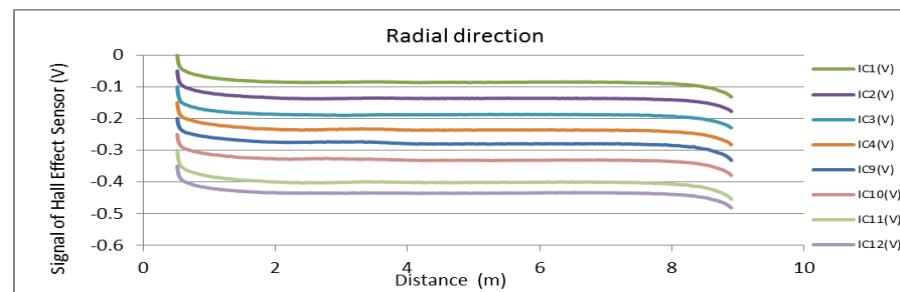
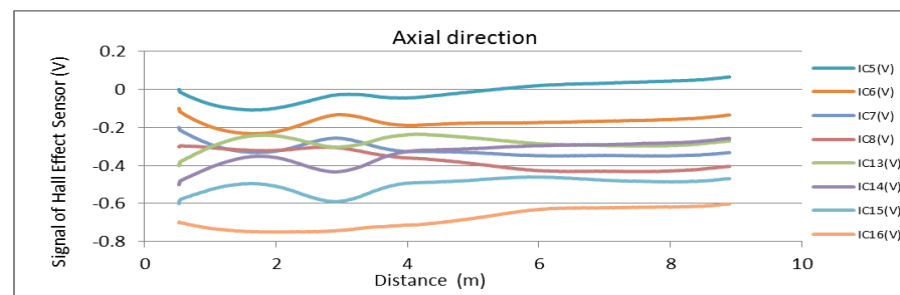
Figure A104. MMFM data of P5-303L-I1 tendon section.

File Name 【Pier-Tendon-Section】	Section Total Length (m)	Scanned Length		Note			
		Starting Point (m)	Ending Point (m)				
P5-303L-I1	9.39	0.52	9.01				
Identified Damage 1				Identified Damage 2			
Max Loss Point (m)	Section Loss (%)	Damage Length (m)	Damage Orientation	Max Loss Point (m)	Section Loss (%)	Damage Length (m)	Damage Orientation
—	—	—	—	—	—	—	—

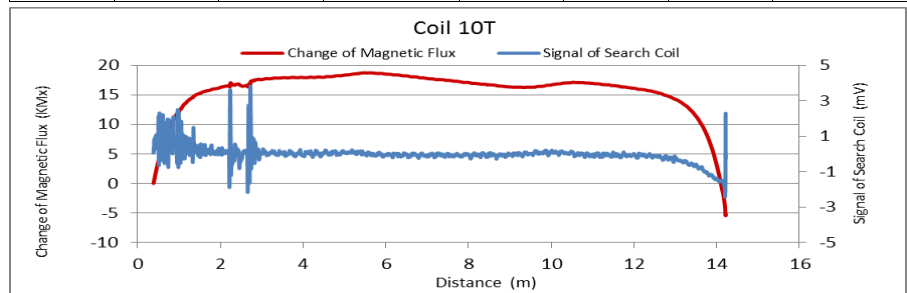
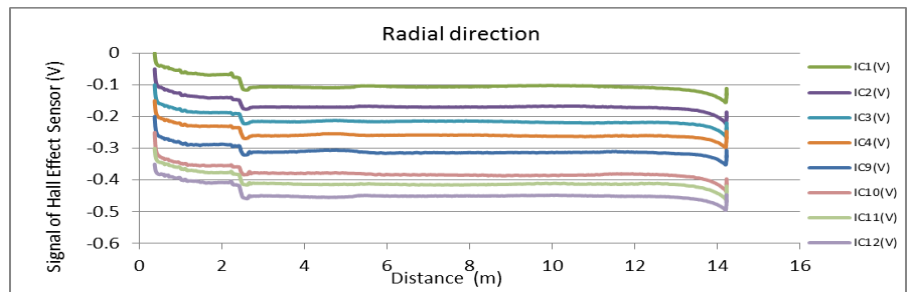
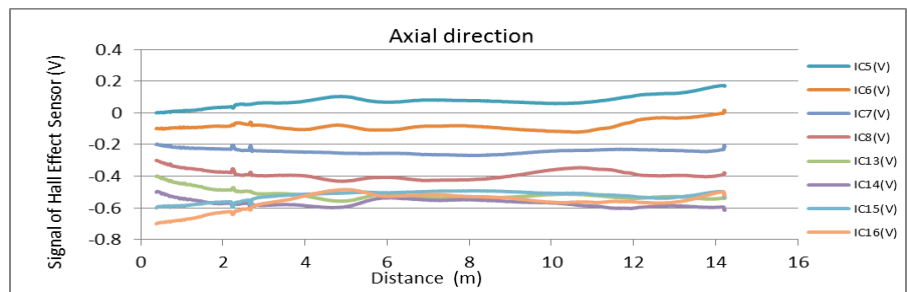
Figure A105. MMFM data of P5-303R-I2-1 tendon section.

File Name 【Pier-Tendon-Section】	Section Total Length (m)	Scanned Length		Note			
		Starting Point (m)	Ending Point (m)				
P5-303R-I2-1	21.62	0.38	14.3	Joint position : 8 m Has a large repair at 14.6 m position. Measured in two separate times			
Identified Damage 1				Identified Damage 2			
Max Loss Point (m)	Section Loss (%)	Damage Length (m)	Damage Orientation	Max Loss Point (m)	Section Loss (%)	Damage Length (m)	Damage Orientation
—	—	—	—	—	—	—	—

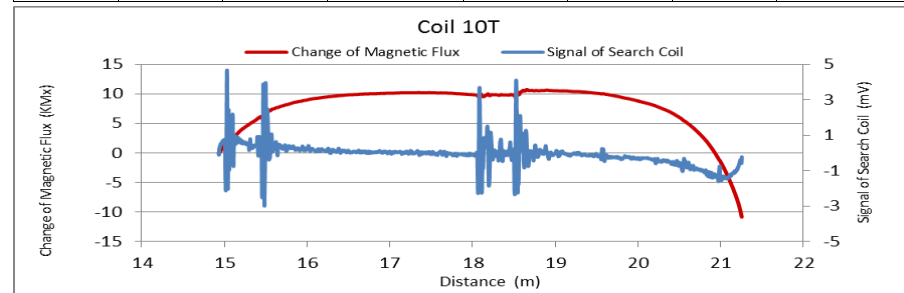
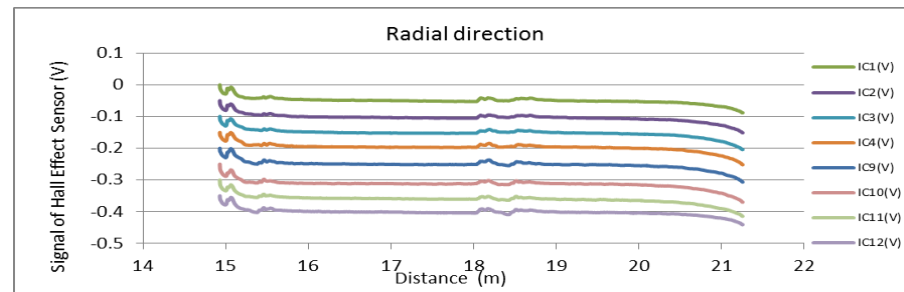
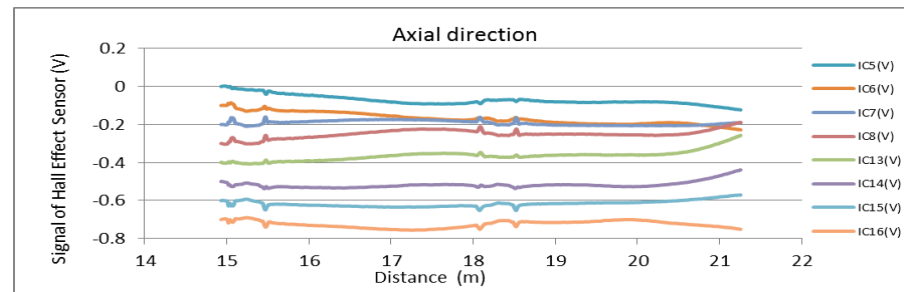
Figure A106. MMFM data of P5-303R-I2-2 tendon section.

File Name 【Pier-Tendon-Section】	Section Total Length (m)	Scanned Length		Note			
		Starting Point (m)	Ending Point (m)				
P5-303R-I2-2	21.62	14.93	21.31	Joint or repair position : 14.87 m, 15.26 m, 18.31 m Has a large repair 14.6 m position. Measured in two separate times			
Identified Damage 1				Identified Damage 2			
Max Loss Point (m)	Section Loss (%)	Damage Length (m)	Damage Orientation	Max Loss Point (m)	Section Loss (%)	Damage Length (m)	Damage Orientation
—	—	—	—	—	—	—	—

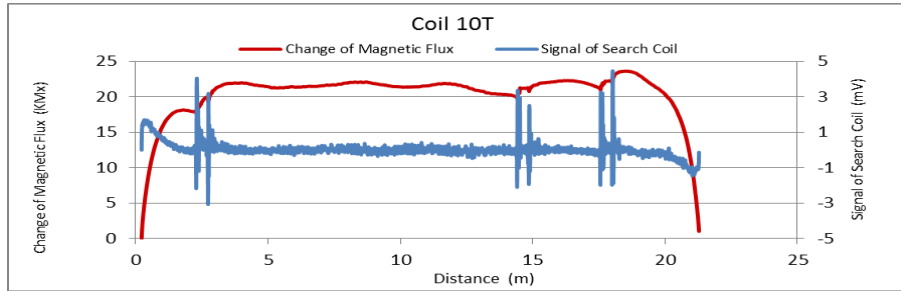
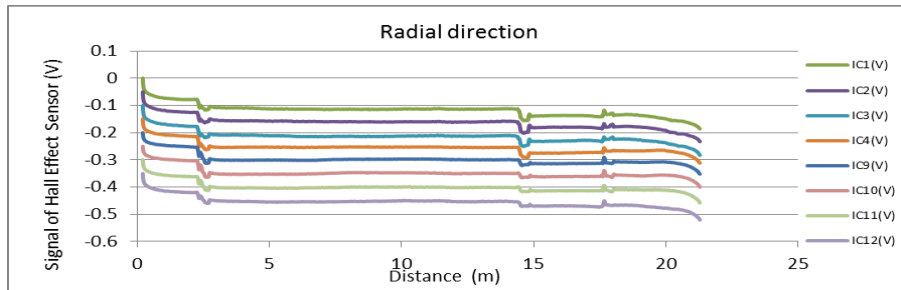
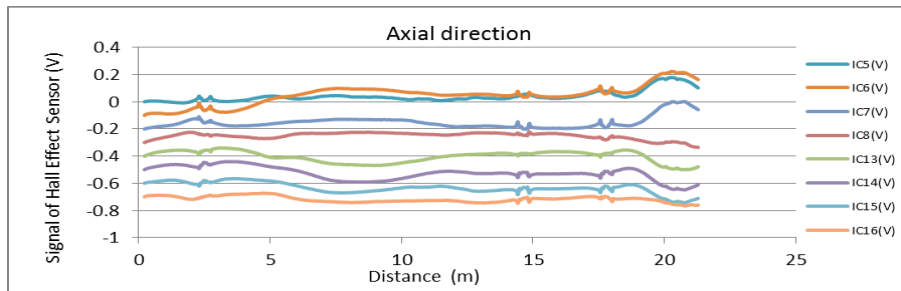
Figure A107. MMFM data of P5-303L-I2 tendon section.

File Name 【Pier-Tendon-Section】	Section Total Length (m)	Scanned Length		Note			
		Starting Point (m)	Ending Point (m)				
P5-303L-I2	21.65	0.22	21.28	Joint and repair position : 2.55 m, 14.68 m, 17.82 m			
Identified Damage 1				Identified Damage 2			
Max Loss Point (m)	Section Loss (%)	Damage Length (m)	Damage Orientation	Max Loss Point (m)	Section Loss (%)	Damage Length (m)	Damage Orientation
—	—	—	—	—	—	—	—

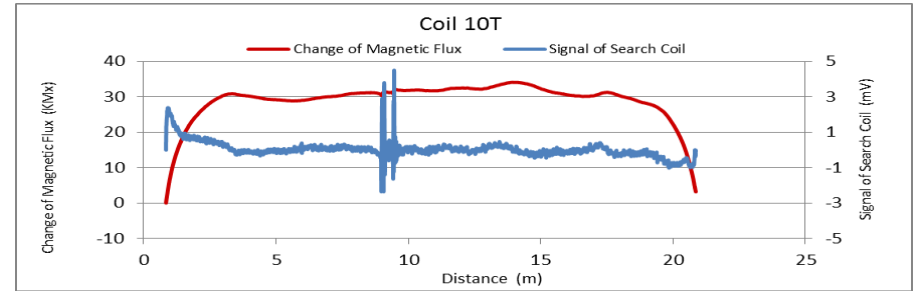
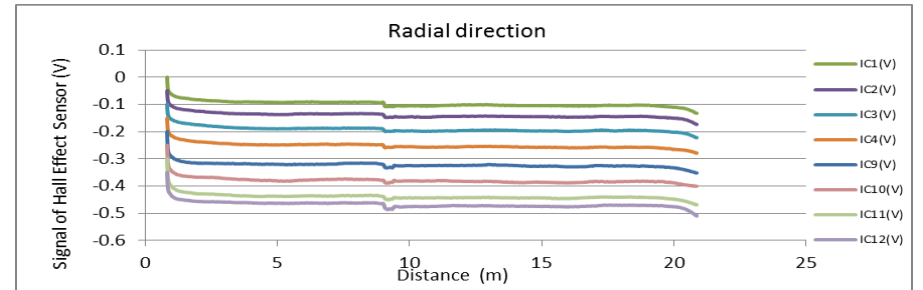
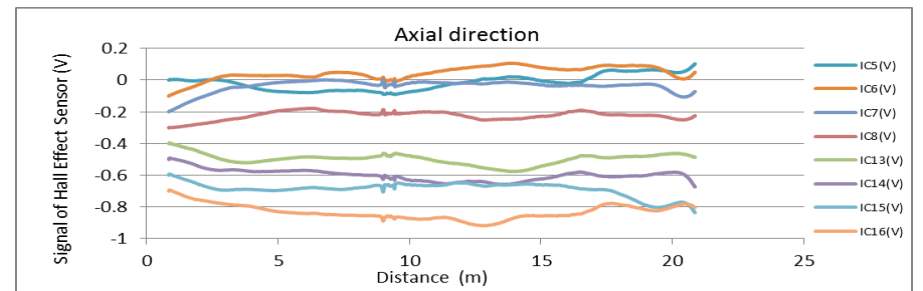
Figure A108. MMFM data of P5-401R-I2 tendon section.

File Name 【Pier-Tendon-Section】	Section Total Length (m)	Scanned Length		Note			
		Starting Point (m)	Ending Point (m)				
P5-401R-I2	21.47	0.84	20.87	Joint or Repair position : 9.2m			
Identified Damage 1				Identified Damage 2			
Max Loss Point (m)	Section Loss (%)	Damage Length (m)	Damage Orientation	Max Loss Point (m)	Section Loss (%)	Damage Length (m)	Damage Orientation
—	—	—	—	—	—	—	—

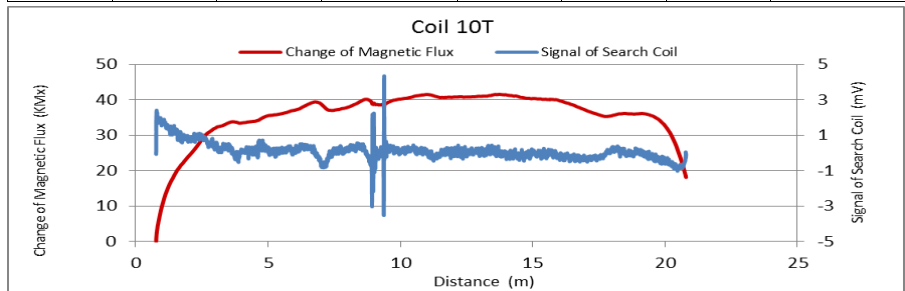
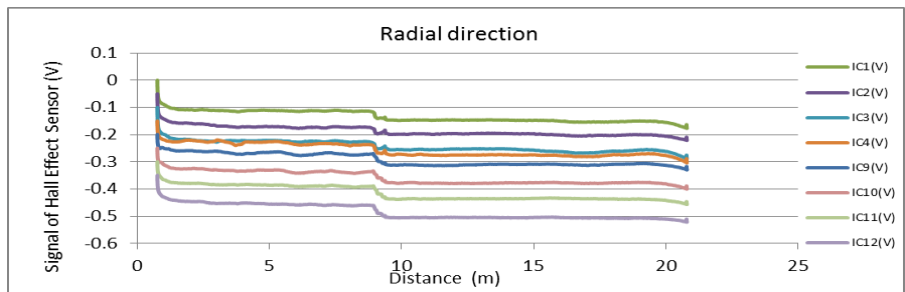
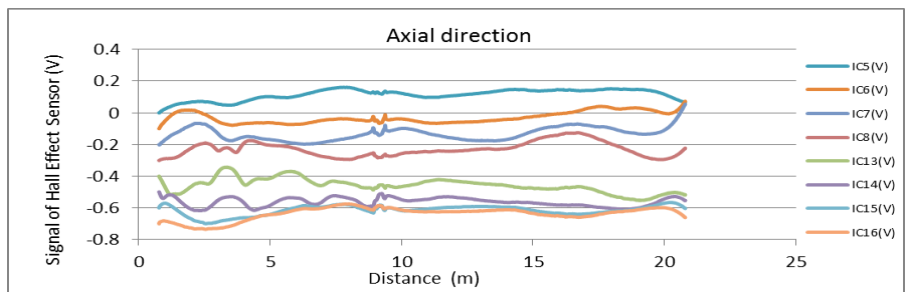
Figure A109. MMFM data of P5-402R-I2 tendon section.

File Name 【Pier-Tendon-Section】	Section Total Length (m)	Scanned Length		Note			
		Starting Point (m)	Ending Point (m)				
P5-402R-I2	21.47	0.77	20.79	Joint or repair position: 9.15 m			
Identified Damage 1				Identified Damage 2			
Max Loss Point (m)	Section Loss (%)	Damage Length (m)	Damage Orientation	Max Loss Point (m)	Section Loss (%)	Damage Length (m)	Damage Orientation
—	—	—	—	—	—	—	—

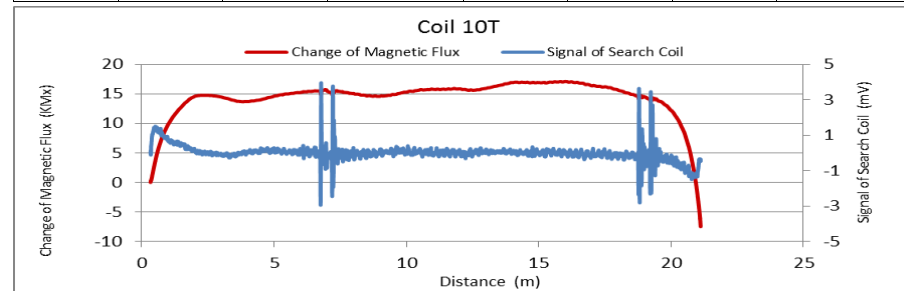
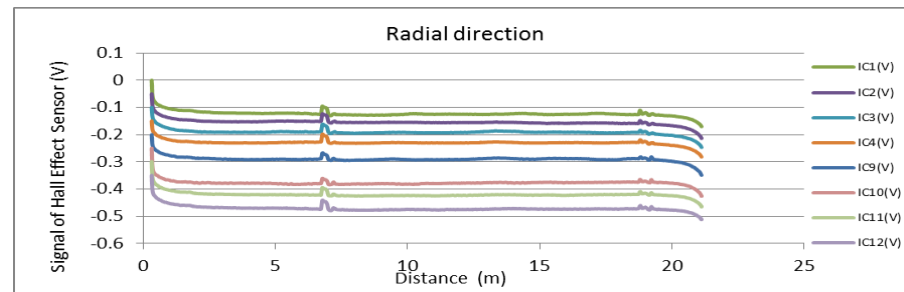
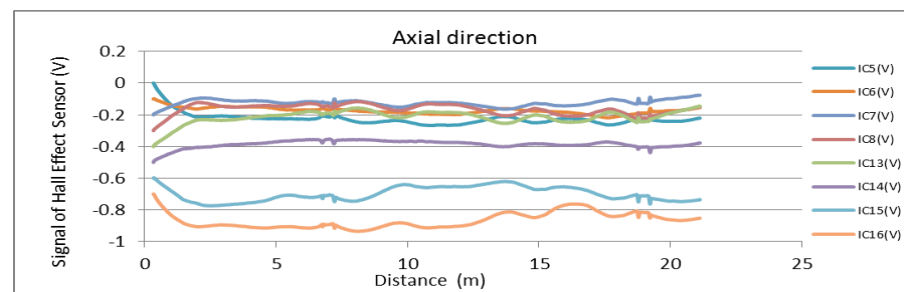
Figure A110. MMFM data of P5-303R-I3 tendon section.

File Name 【Pier-Tendon-Section】	Section Total Length (m)	Scanned Length		Note			
		Starting Point (m)	Ending Point (m)				
P5-303R-I3	21.6	0.33	21.27	Joint or repair position: 7.04 m, 19.18 m			
Identified Damage 1				Identified Damage 2			
Max Loss Point (m)	Section Loss (%)	Damage Length (m)	Damage Orientation	Max Loss Point (m)	Section Loss (%)	Damage Length (m)	Damage Orientation
—	—	—	—	—	—	—	—

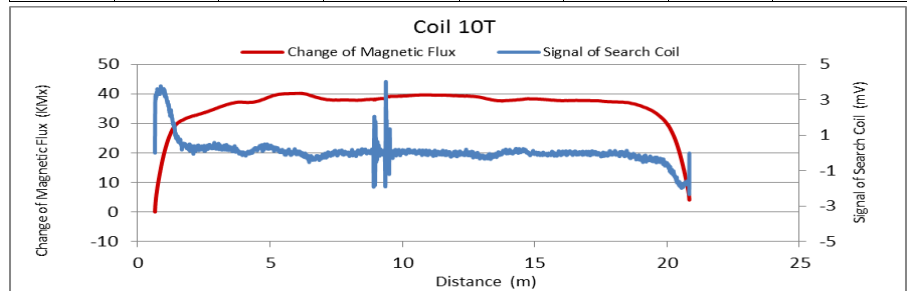
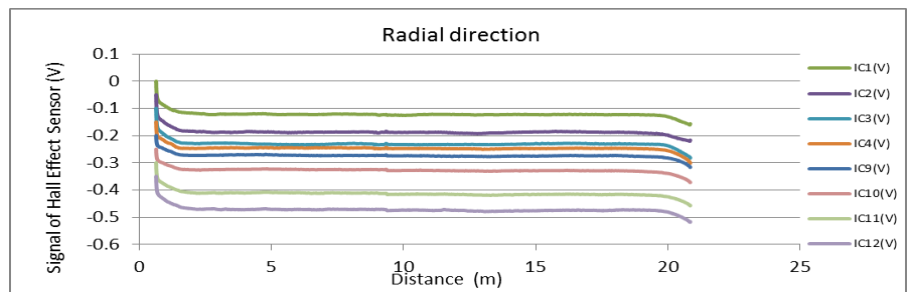
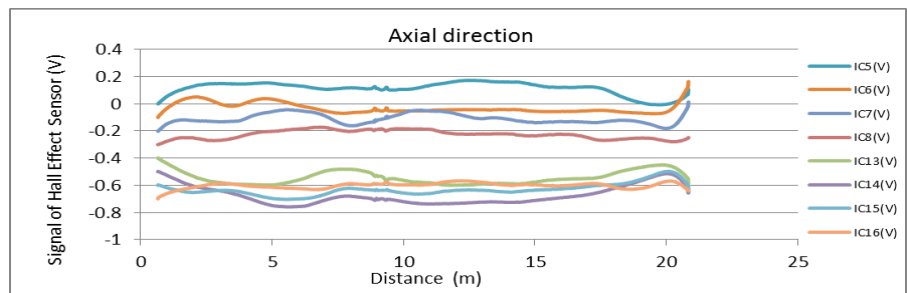
Figure A111. MMFM data of P5-401L-I2 tendon section.

File Name 【Pier-Tendon-Section】	Section Total Length (m)	Scanned Length		Note			
		Starting Point (m)	Ending Point (m)				
P5-401L-I2	21.43	0.65	20.84	Joint or repair position: 9.18 m			
Identified Damage 1				Identified Damage 2			
Max Loss Point (m)	Section Loss (%)	Damage Length (m)	Damage Orientation	Max Loss Point (m)	Section Loss (%)	Damage Length (m)	Damage Orientation
—	—	—	—	—	—	—	—

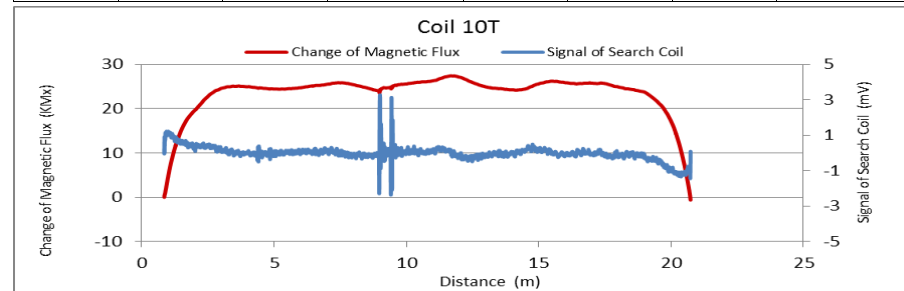
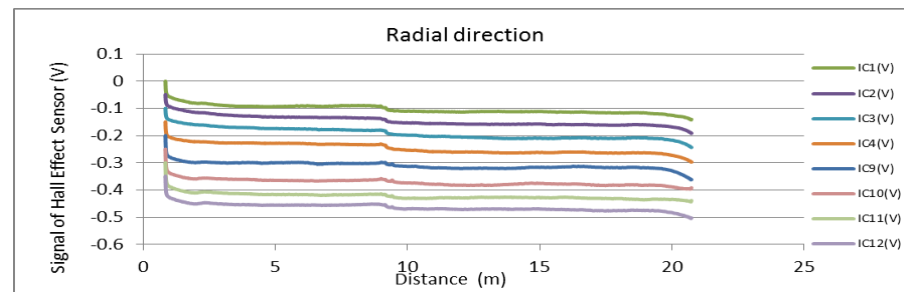
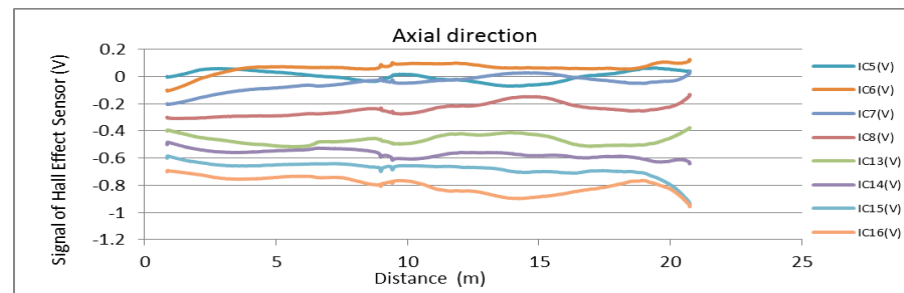
Figure A112. MMFM data of P5-402L-I2 tendon section.

File Name 【Pier-Tendon-Section】	Section Total Length (m)	Scanned Length		Note			
		Starting Point (m)	Ending Point (m)				
P5-402L-I2	21.43	0.85	20.85	Joint or repair position: 9.21 m			
Identified Damage 1				Identified Damage 2			
Max Loss Point (m)	Section Loss (%)	Damage Length (m)	Damage Orientation	Max Loss Point (m)	Section Loss (%)	Damage Length (m)	Damage Orientation
—	—	—	—	—	—	—	—

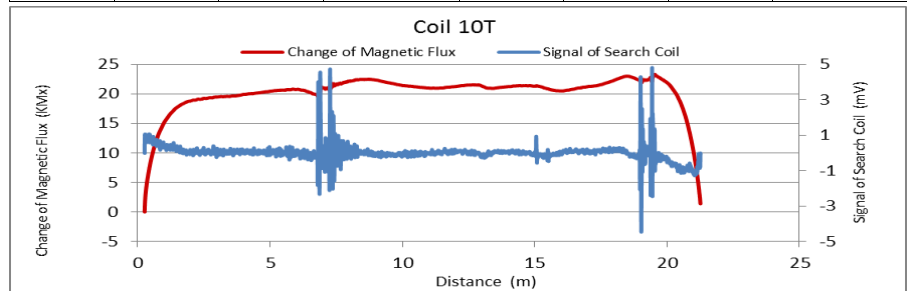
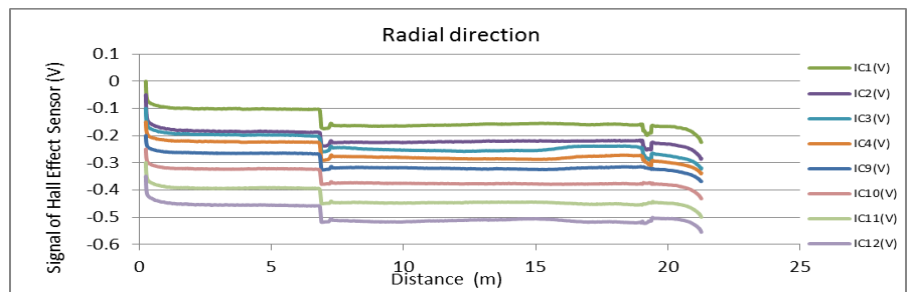
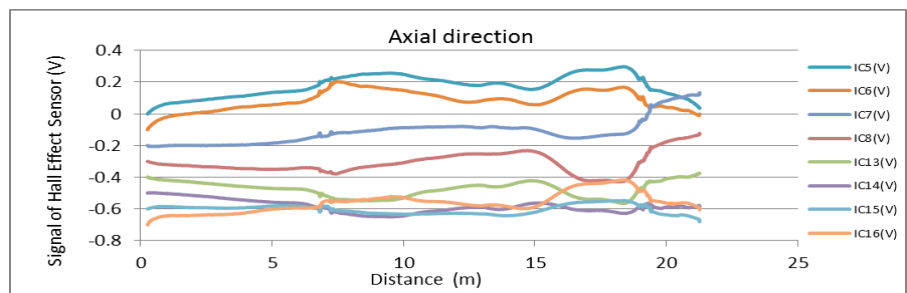
Figure A113. MMFM data of P5-303L-I3 tendon section.

File Name 【Pier-Tendon-Section】	Section Total Length (m)	Scanned Length		Note			
		Starting Point (m)	Ending Point (m)				
P5-303L-I3	21.6	0.26	21.26	Joint or repair position: 7.05 m, 19.18 m			
Identified Damage 1				Identified Damage 2			
Max Loss Point (m)	Section Loss (%)	Damage Length (m)	Damage Orientation	Max Loss Point (m)	Section Loss (%)	Damage Length (m)	Damage Orientation
—	—	—	—	—	—	—	—
