**Development of Quality Assurance and Quality Control
System for Post Tensioned Segmental Bridges in Florida:
Case of Ringling Bridge – Phase II**

**FDOT Contract No. BDV29-977-34
FINAL REPORT**

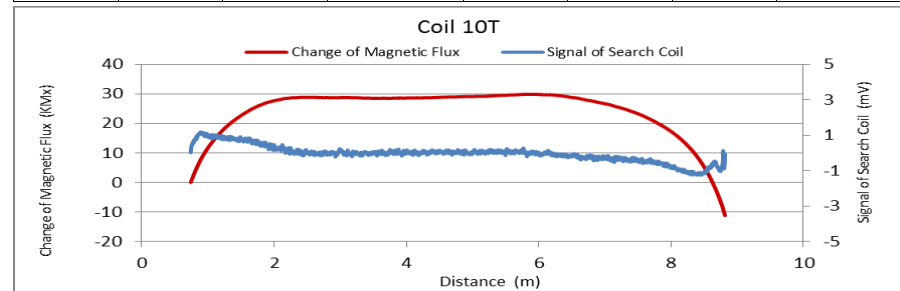
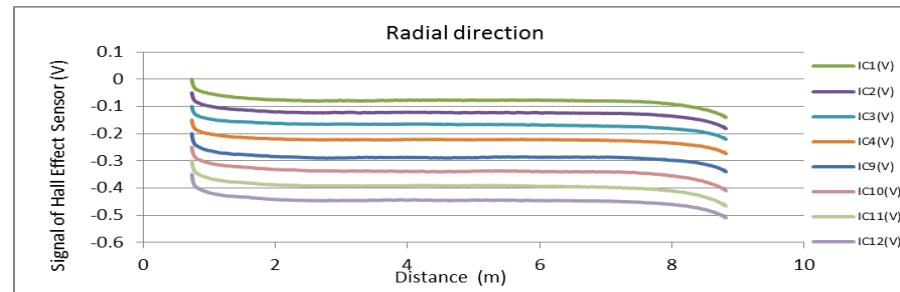
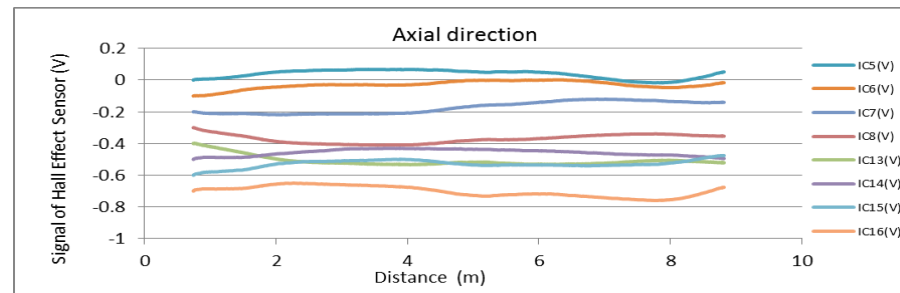
Figure A114. MMFM data of P5-401R-H2 tendon section.

File Name 【Pier-Tendon-Section】	Section Total Length (m)	Scanned Length		Note			
		Starting Point (m)	Ending Point (m)				
P5-401R-H2	9.37	0.74	8.86				
Identified Damage 1				Identified Damage 2			
Max Loss Point (m)	Section Loss (%)	Damage Length (m)	Damage Orientation	Max Loss Point (m)	Section Loss (%)	Damage Length (m)	Damage Orientation
—	—	—	—	—	—	—	—

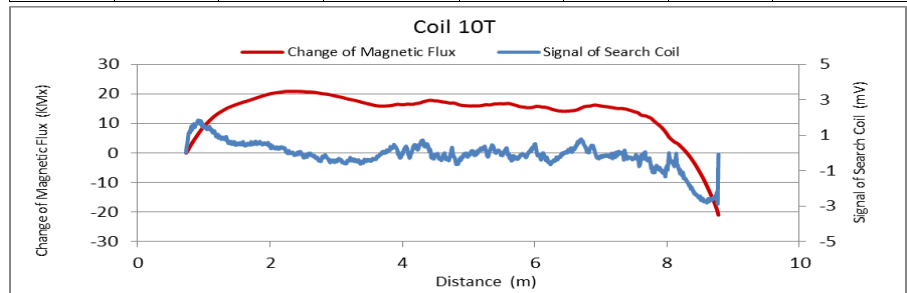
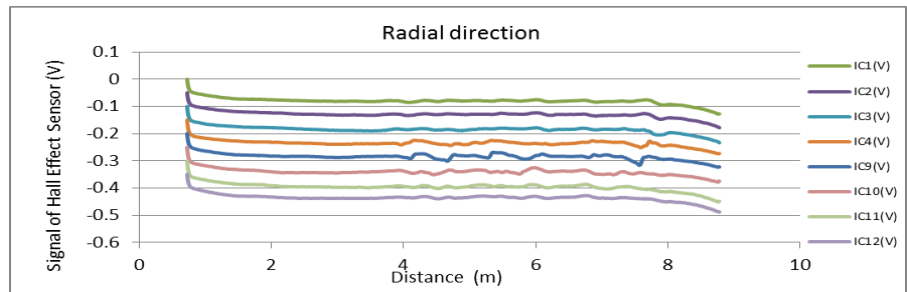
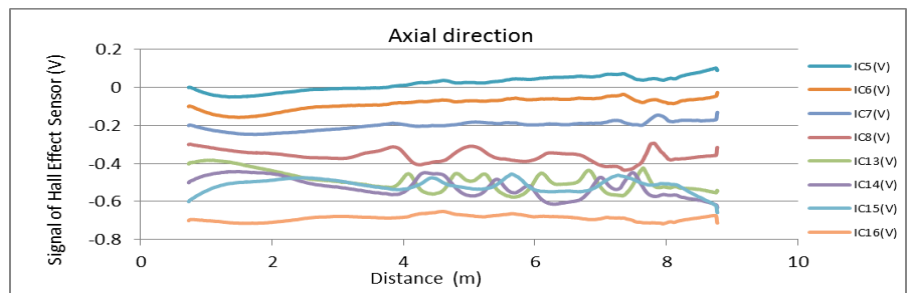
File Name 【Pier-Tendon-Section】	Section Total Length (m)	Scanned Length		Note			
		Starting Point (m)	Ending Point (m)				
P5-402R-H2	9.37	0.73	8.81	There is a distortion at 8 m position.			
Identified Damage 1							
Max Loss Point (m)	Section Loss (%)	Damage Length (m)	Damage Orientation	Identified Damage 2			
Max Loss Point (m)	Section Loss (%)	Damage Length (m)	Damage Orientation	Max Loss Point (m)	Section Loss (%)	Damage Length (m)	Damage Orientation
—	—	—	—	—	—	—	—

Figure A115. MMFM data of P5-402R-H2 tendon section.

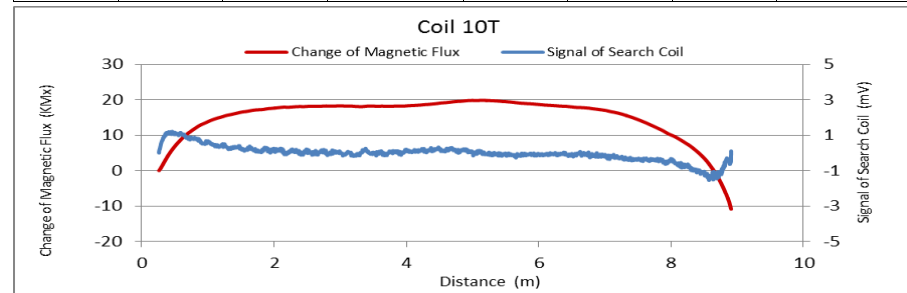
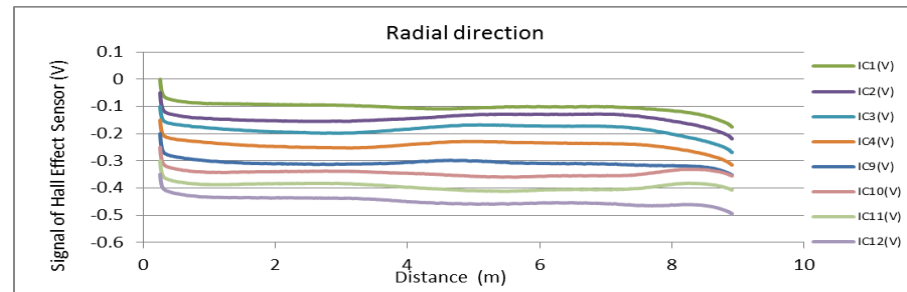
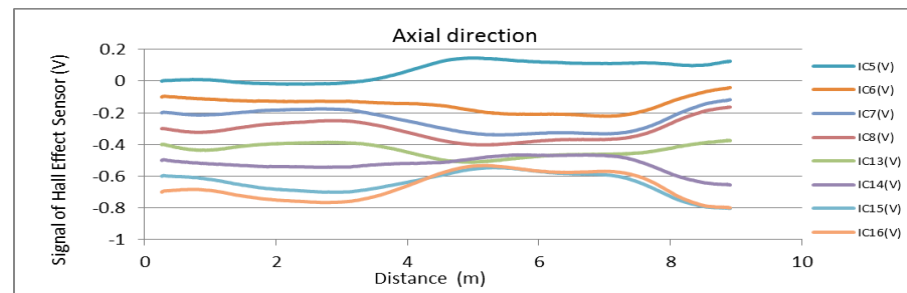
File Name 【Pier-Tendon-Section】	Section Total Length (m)	Scanned Length		Note			
		Starting Point (m)	Ending Point (m)				
P5-303R-I4	9.47	0.26	8.95				
Identified Damage 1							
Max Loss Point (m)	Section Loss (%)	Damage Length (m)	Damage Orientation	Identified Damage 2			
Max Loss Point (m)	Section Loss (%)	Damage Length (m)	Damage Orientation	Max Loss Point (m)	Section Loss (%)	Damage Length (m)	Damage Orientation
—	—	—	—	—	—	—	—

Figure A116. MMFM data of P5-303R-I4 tendon section.

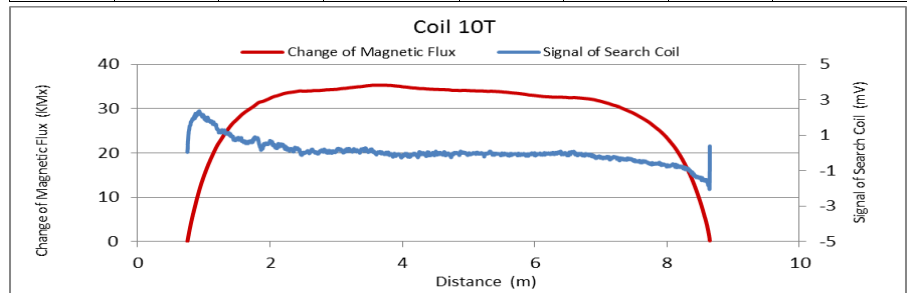
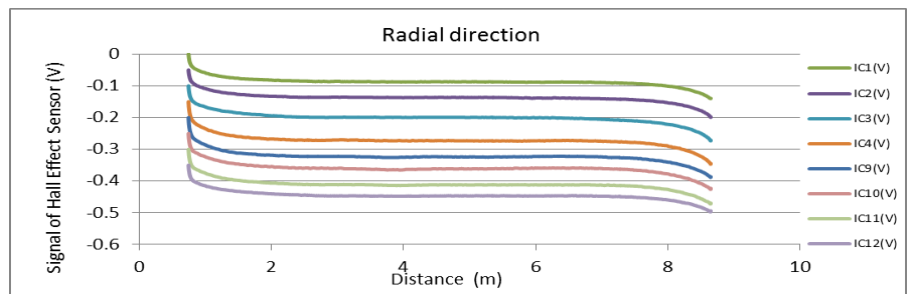
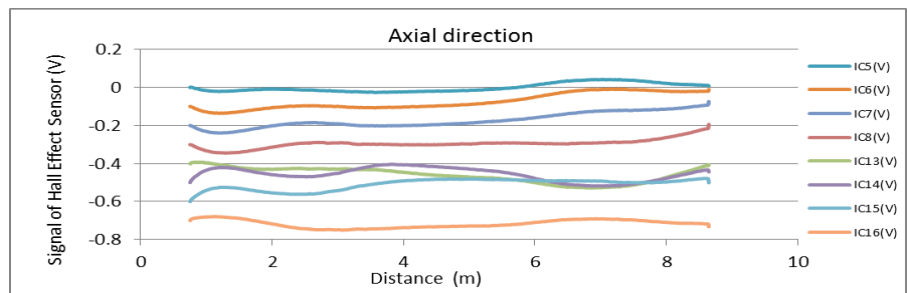
File Name 【Pier-Tendon-Section】	Section Total Length (m)	Scanned Length		Note			
		Starting Point (m)	Ending Point (m)				
P5-401L-H2	9.37	0.75	8.68				
Identified Damage 1				Identified Damage 2			
Max Loss Point (m)	Section Loss (%)	Damage Length (m)	Damage Orientation	Max Loss Point (m)	Section Loss (%)	Damage Length (m)	Damage Orientation
—	—	—	—	—	—	—	—

Figure A117. MMFM data of P5-401L-H2 tendon section.

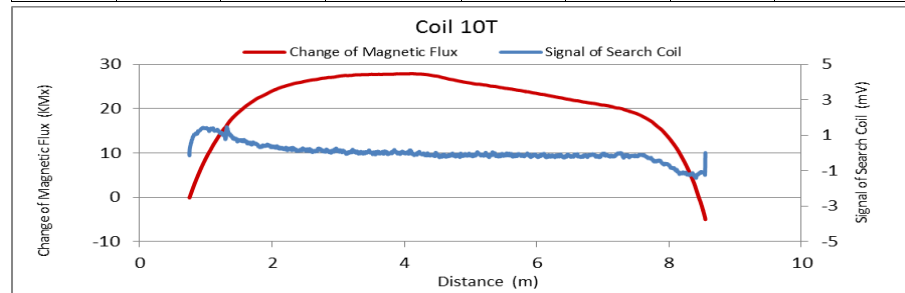
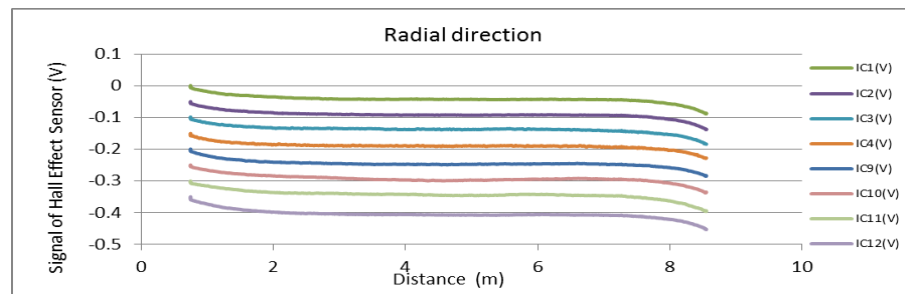
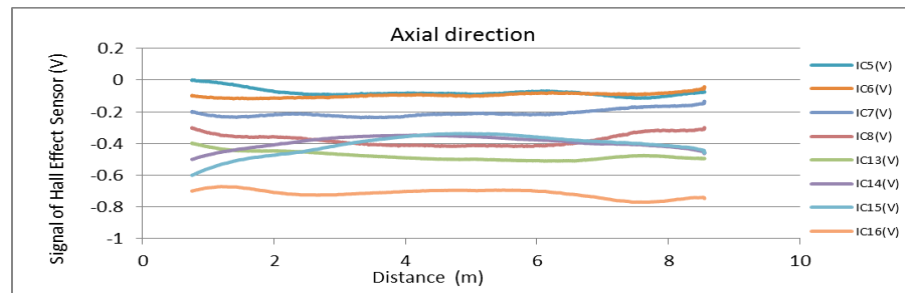
File Name 【Pier-Tendon-Section】	Section Total Length (m)	Scanned Length		Note			
		Starting Point (m)	Ending Point (m)				
P5-402L-H2	9.37	0.75	8.7				
Identified Damage 1				Identified Damage 2			
Max Loss Point (m)	Section Loss (%)	Damage Length (m)	Damage Orientation	Max Loss Point (m)	Section Loss (%)	Damage Length (m)	Damage Orientation
—	—	—	—	—	—	—	—

Figure A118. MMFM data of P5-402L-H2 tendon section.

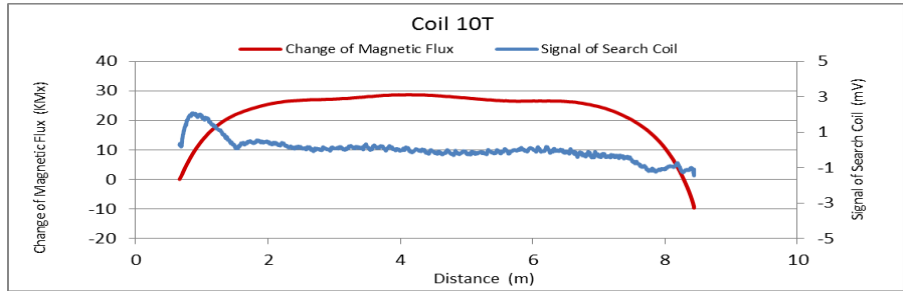
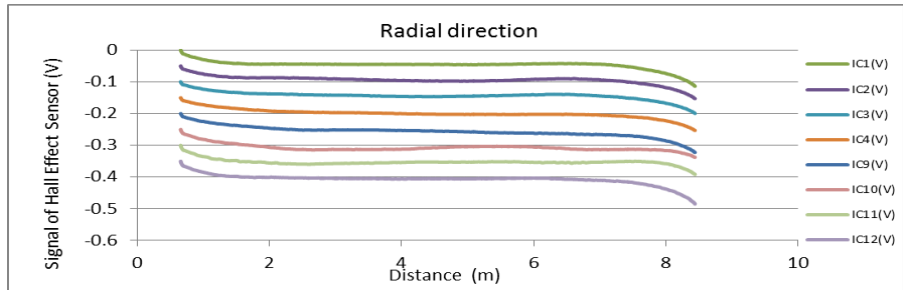
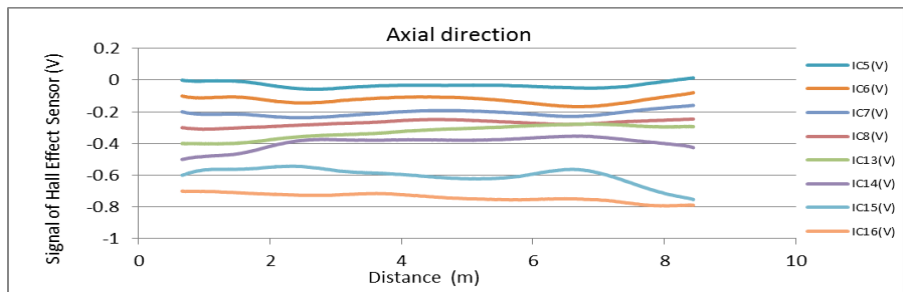
File Name 【Pier-Tendon-Section】	Section Total Length (m)	Scanned Length		Note			
		Starting Point (m)	Ending Point (m)				
P6-401R-H1	9.43	0.66	8.67				
Identified Damage 1				Identified Damage 2			
Max Loss Point (m)	Section Loss (%)	Damage Length (m)	Damage Orientation	Max Loss Point (m)	Section Loss (%)	Damage Length (m)	Damage Orientation
—	—	—	—	—	—	—	—

Figure A119. MMFM data of P6-401R-H1 tendon section.

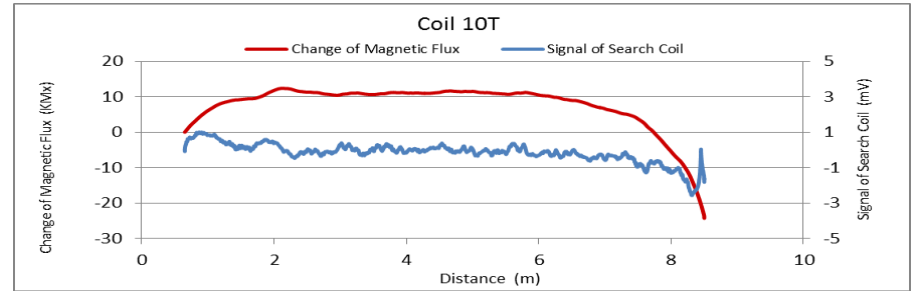
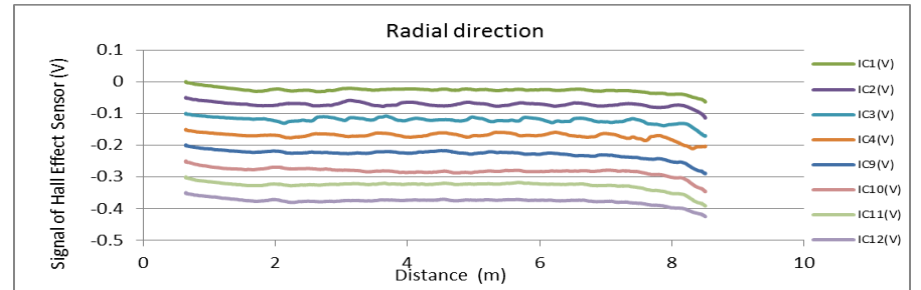
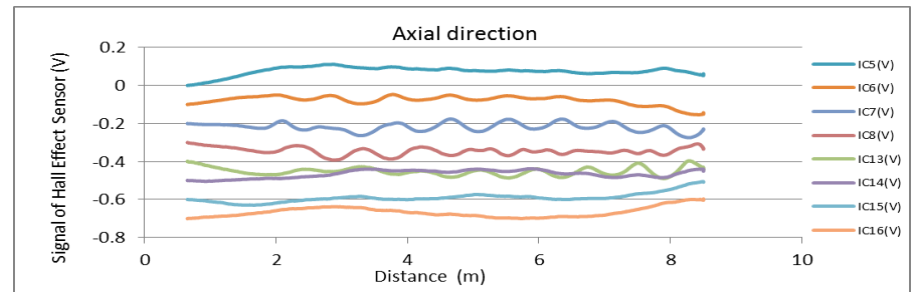
File Name 【Pier-Tendon-Section】	Section Total Length (m)	Scanned Length		Note			
		Starting Point (m)	Ending Point (m)				
P6-402R-H1	9.43	0.65	8.65				
Identified Damage 1				Identified Damage 2			
Max Loss Point (m)	Section Loss (%)	Damage Length (m)	Damage Orientation	Max Loss Point (m)	Section Loss (%)	Damage Length (m)	Damage Orientation
—	—	—	—	—	—	—	—

Figure A120. MMFM data of P6-402R-H1 tendon section.

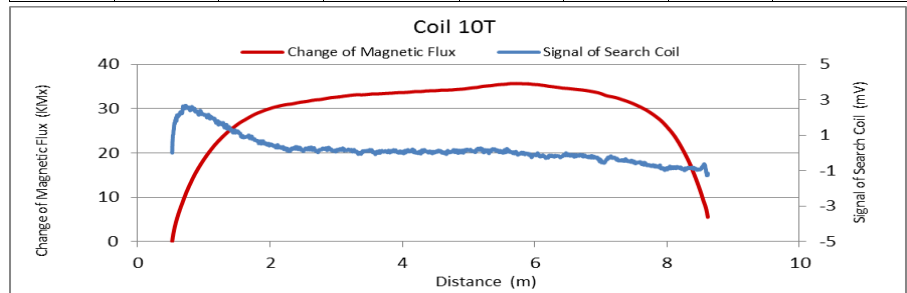
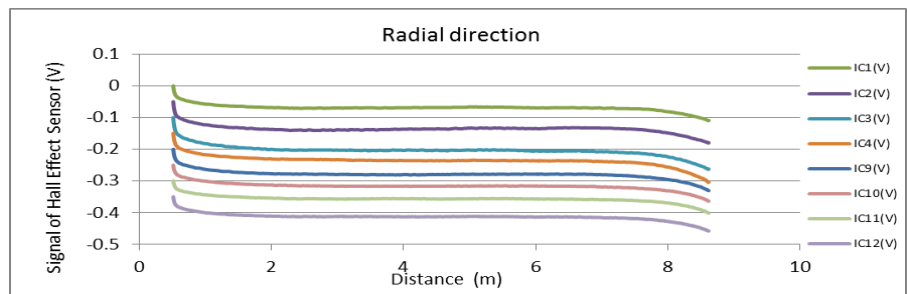
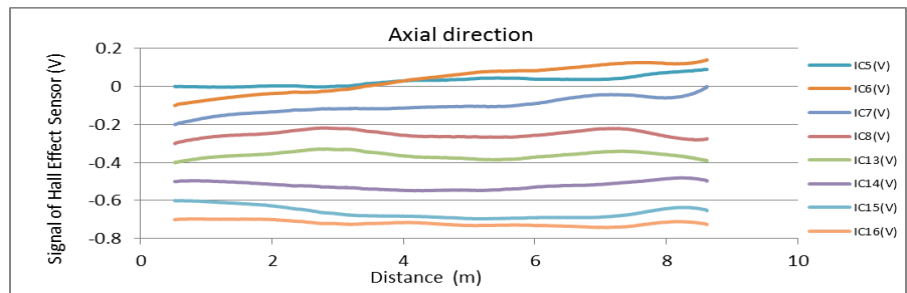
File Name 【Pier-Tendon-Section】	Section Total Length (m)	Scanned Length		Note			
		Starting Point (m)	Ending Point (m)				
P6-401L-H1	9.41	0.52	8.62				
Identified Damage 1				Identified Damage 2			
Max Loss Point (m)	Section Loss (%)	Damage Length (m)	Damage Orientation	Max Loss Point (m)	Section Loss (%)	Damage Length (m)	Damage Orientation
—	—	—	—	—	—	—	—

Figure A121. MMFM data of P6-401L-H1 tendon section.

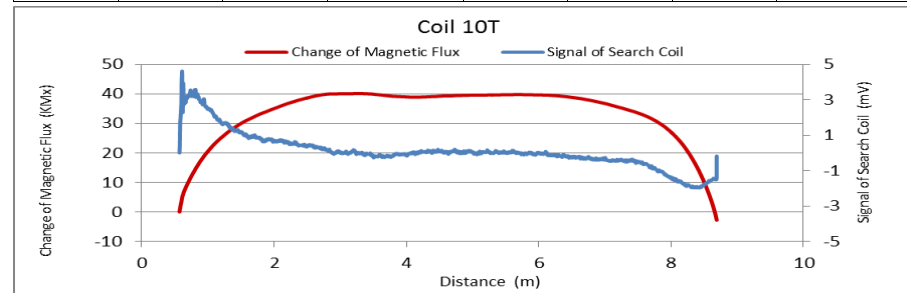
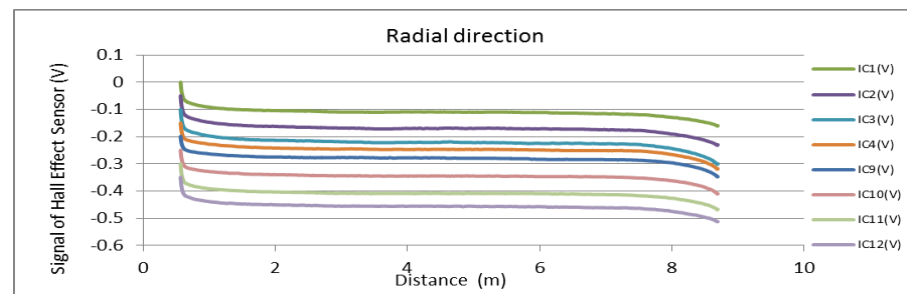
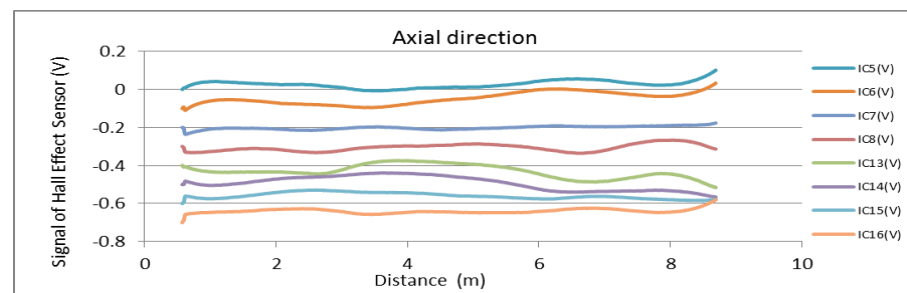
File Name 【Pier-Tendon-Section】	Section Total Length (m)	Scanned Length		Note			
		Starting Point (m)	Ending Point (m)				
P6-402L-H1	9.41	0.57	8.69				
Identified Damage 1				Identified Damage 2			
Max Loss Point (m)	Section Loss (%)	Damage Length (m)	Damage Orientation	Max Loss Point (m)	Section Loss (%)	Damage Length (m)	Damage Orientation
—	—	—	—	—	—	—	—

Figure A122. MMFM data of P6-402L-H1 tendon section.

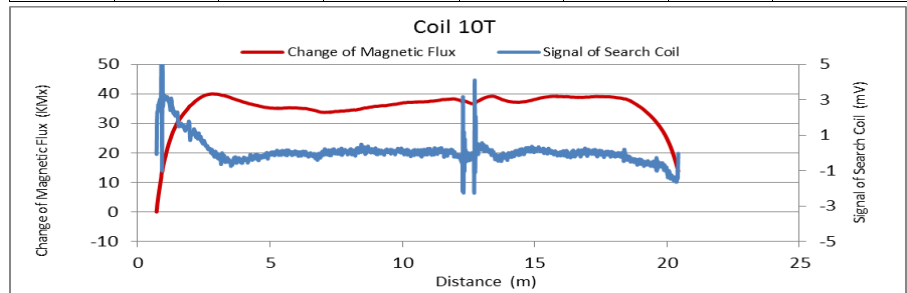
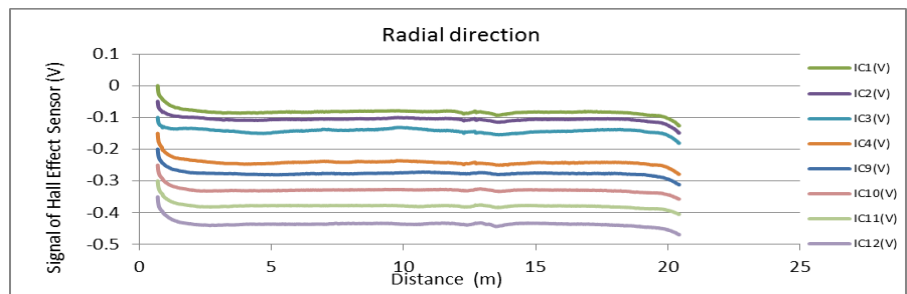
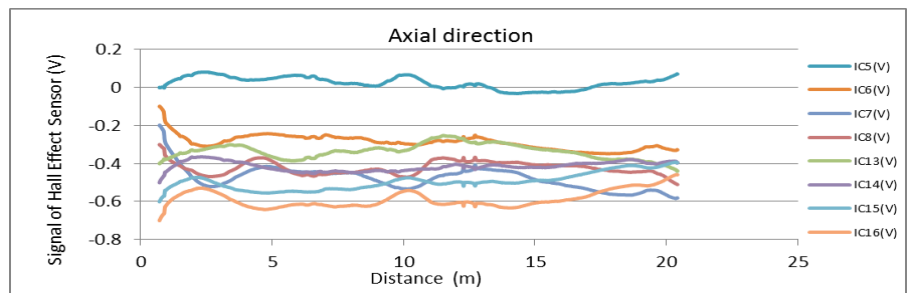
File Name 【Pier-Tendon-Section】	Section Total Length (m)	Scanned Length		Note			
		Starting Point (m)	Ending Point (m)				
P6-401R-I1	21.5	0.71	20.42	Joint position: 12.4 m			
Identified Damage 1				Identified Damage 2			
Max Loss Point (m)	Section Loss (%)	Damage Length (m)	Damage Orientation	Max Loss Point (m)	Section Loss (%)	Damage Length (m)	Damage Orientation
—	—	—	—	—	—	—	—

Figure A123. MMFM data of P6-401R-I1 tendon section.

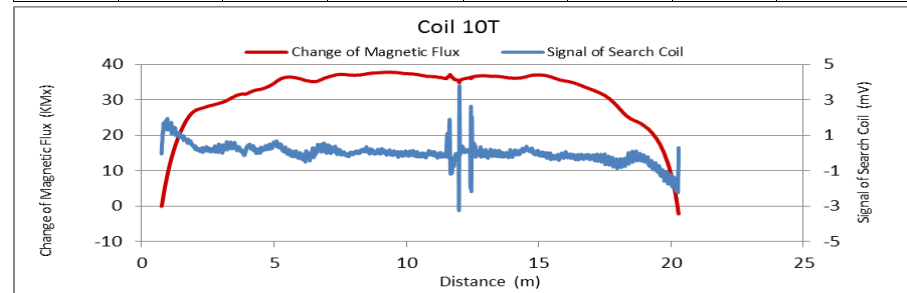
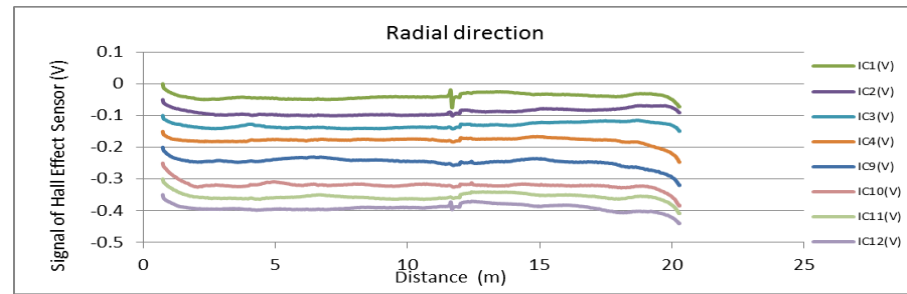
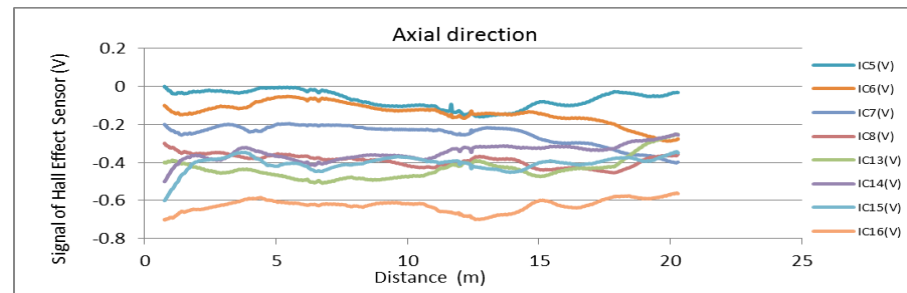
File Name 【Pier-Tendon-Section】	Section Total Length (m)	Scanned Length		Note			
		Starting Point (m)	Ending Point (m)				
P6-402R-I1	21.5	0.75	20.52	Joint position: 12.35 m			
Identified Damage 1				Identified Damage 2			
Max Loss Point (m)	Section Loss (%)	Damage Length (m)	Damage Orientation	Max Loss Point (m)	Section Loss (%)	Damage Length (m)	Damage Orientation
—	—	—	—	—	—	—	—

Figure A124. MMFM data of P6-402R-I1 tendon section.

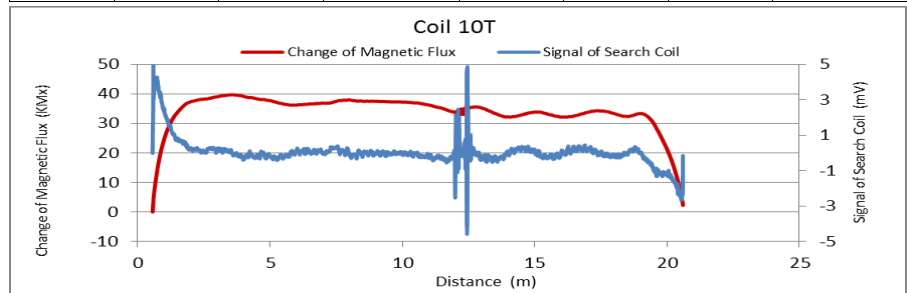
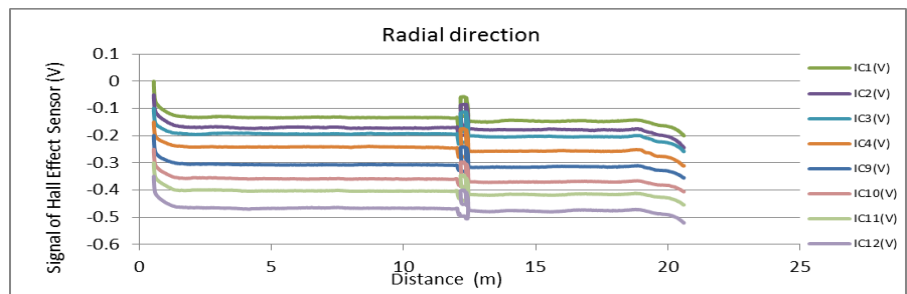
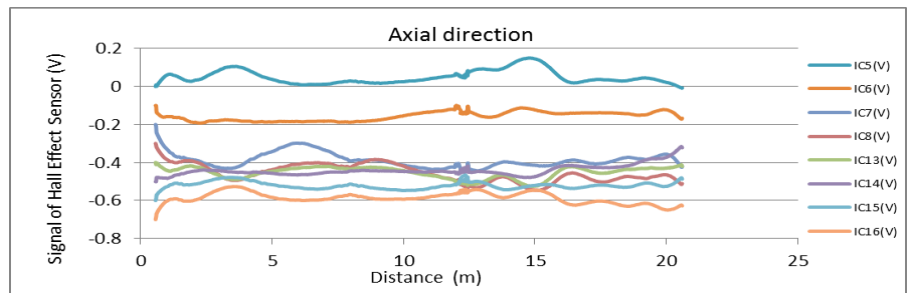
File Name 【Pier-Tendon-Section】	Section Total Length (m)	Scanned Length		Note			
		Starting Point (m)	Ending Point (m)				
P6-401L-I1	21.44	0.56	20.67	Joint position: 12.23 m			
Identified Damage 1				Identified Damage 2			
Max Loss Point (m)	Section Loss (%)	Damage Length (m)	Damage Orientation	Max Loss Point (m)	Section Loss (%)	Damage Length (m)	Damage Orientation
—	—	—	—	—	—	—	—

Figure A125. MMFM data of P6-401L-H1 tendon section.

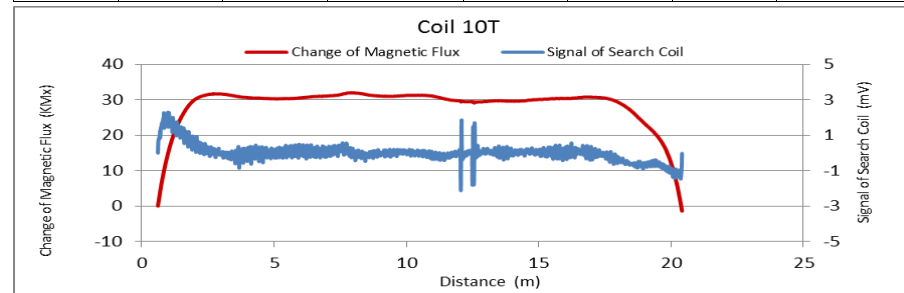
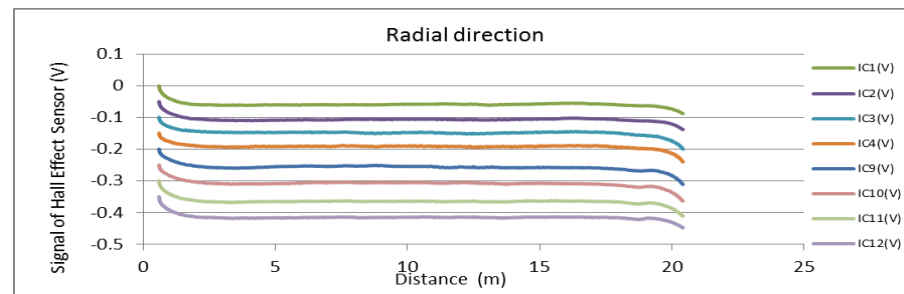
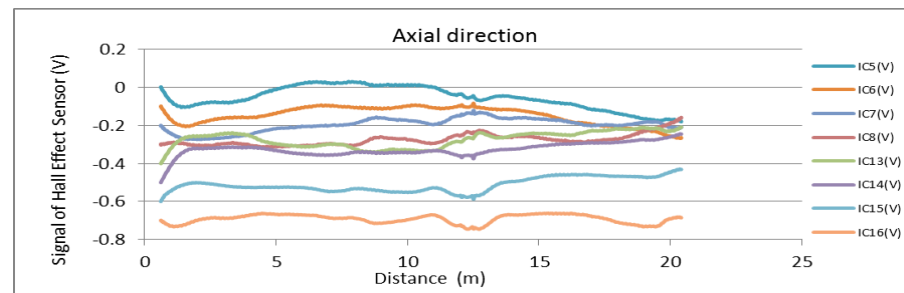
File Name 【Pier-Tendon-Section】	Section Total Length (m)	Scanned Length		Note			
		Starting Point (m)	Ending Point (m)				
P6-402L-I1	21.44	0.61	20.6	Joint position: 12.32 m			
Identified Damage 1				Identified Damage 2			
Max Loss Point (m)	Section Loss (%)	Damage Length (m)	Damage Orientation	Max Loss Point (m)	Section Loss (%)	Damage Length (m)	Damage Orientation
—	—	—	—	—	—	—	—

Figure A126. MMFM data of P6-402L-I1 tendon section.

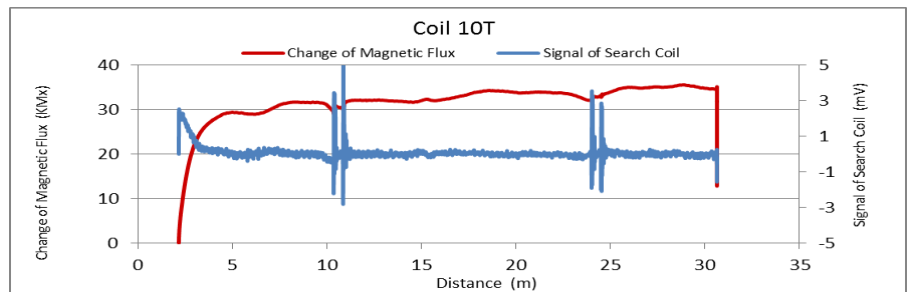
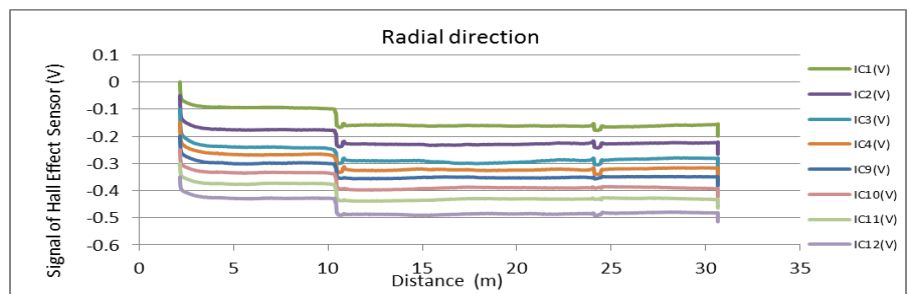
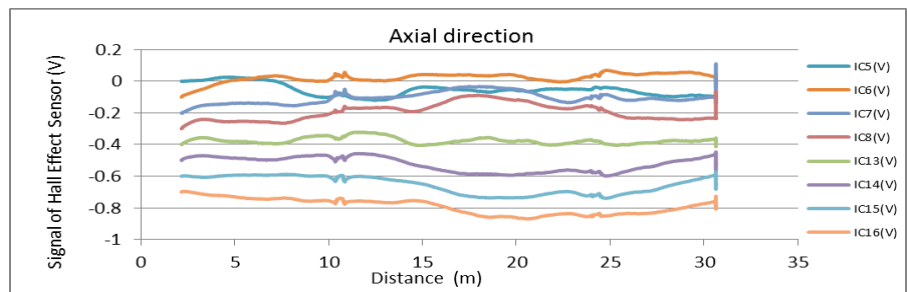
File Name 【Pier-Tendon-Section】	Section Total Length (m)	Scanned Length		Note			
		Starting Point (m)	Ending Point (m)				
P6-401R-I2	31.31	2.17	30.66	Joint position: 9.67 m, 21.76 m			
Identified Damage 1				Identified Damage 2			
Max Loss Point (m)	Section Loss (%)	Damage Length (m)	Damage Orientation	Max Loss Point (m)	Section Loss (%)	Damage Length (m)	Damage Orientation
—	—	—	—	—	—	—	—

Figure A127. MMFM data of P6-401R-I2 tendon section.

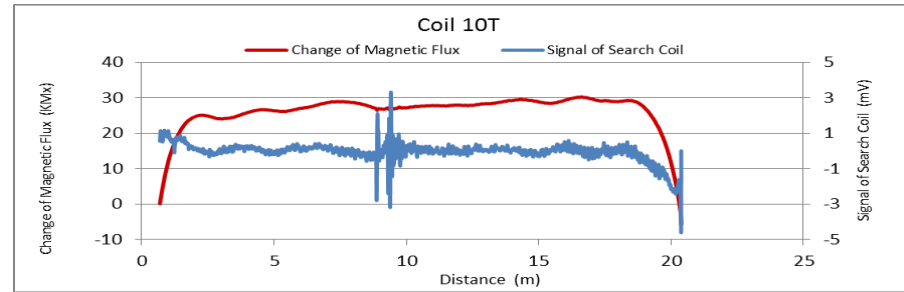
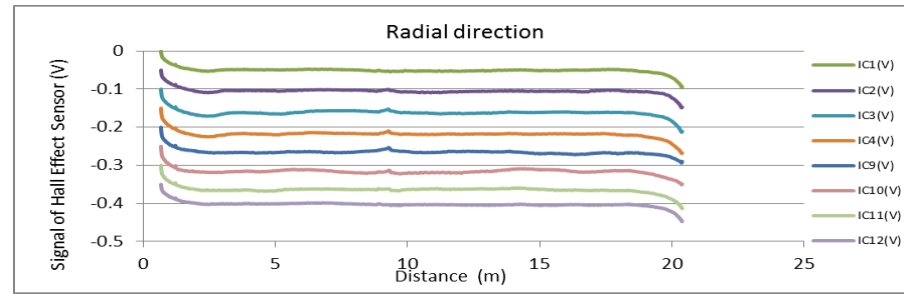
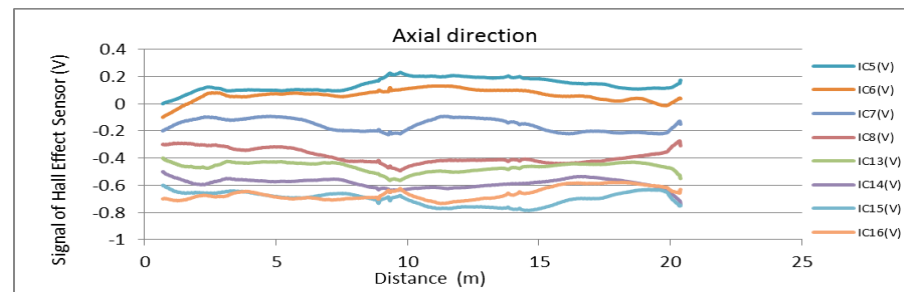
File Name 【Pier-Tendon-Section】	Section Total Length (m)	Scanned Length		Note			
		Starting Point (m)	Ending Point (m)				
P6-402R-I2	21.46	0.68	20.6	Joint position: 9.18 m			
Identified Damage 1				Identified Damage 2			
Max Loss Point (m)	Section Loss (%)	Damage Length (m)	Damage Orientation	Max Loss Point (m)	Section Loss (%)	Damage Length (m)	Damage Orientation
—	—	—	—	—	—	—	—

Figure A128. MMFM data of P6-402R-I2 tendon section.

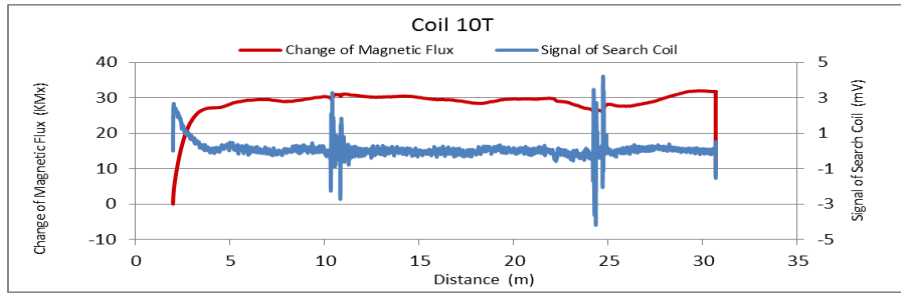
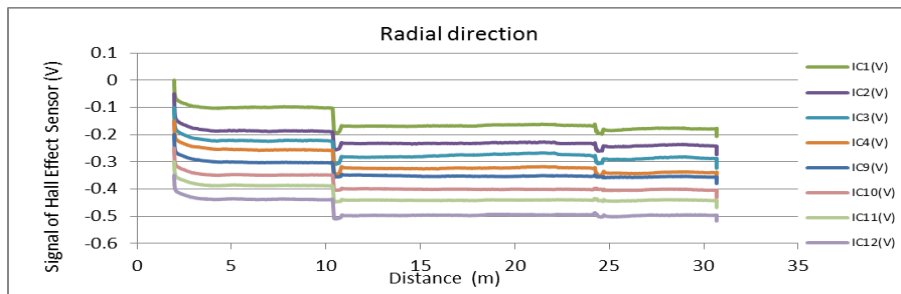
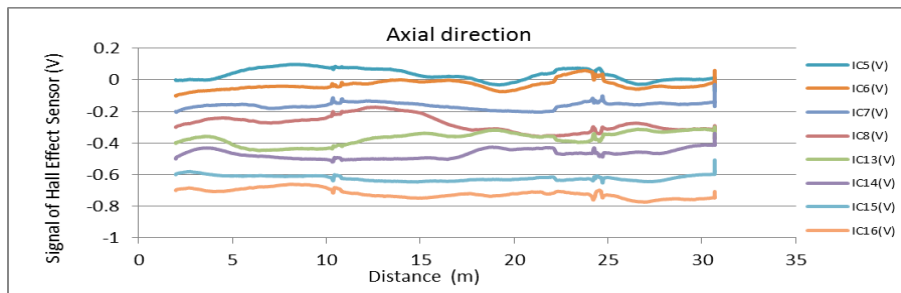
File Name 【Pier-Tendon-Section】	Section Total Length (m)	Scanned Length		Note			
		Starting Point (m)	Ending Point (m)				
P6-401L-I2	31.3	1.97	30.68	Joint position: 9.51 m, 24.65 m			
Identified Damage 1				Identified Damage 2			
Max Loss Point (m)	Section Loss (%)	Damage Length (m)	Damage Orientation	Max Loss Point (m)	Section Loss (%)	Damage Length (m)	Damage Orientation
—	—	—	—	—	—	—	—

Figure A129. MMFM data of P6-401L-I2 tendon section.

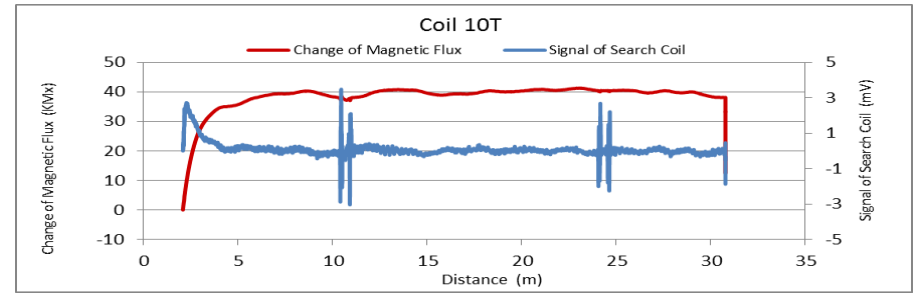
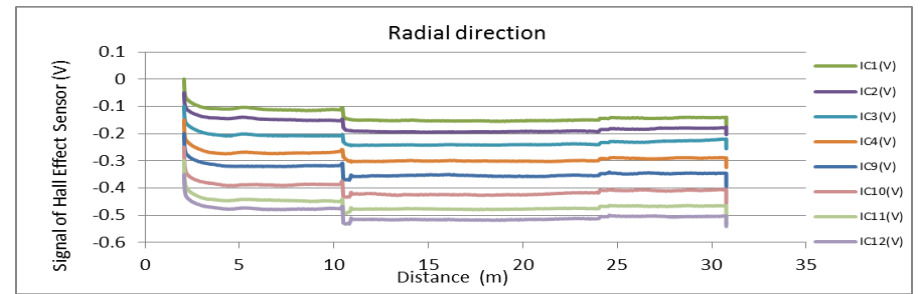
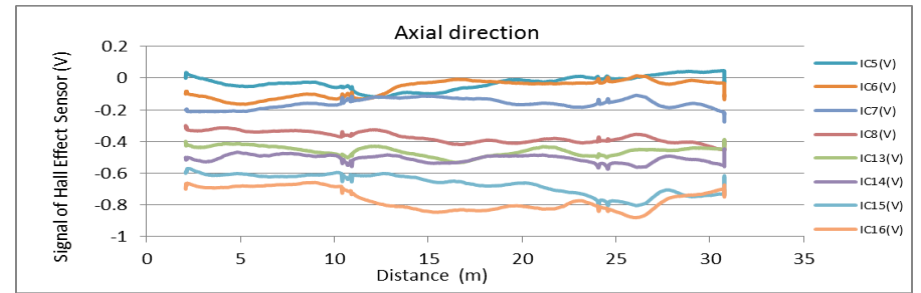
File Name 【Pier-Tendon-Section】	Section Total Length (m)	Scanned Length		Note			
		Starting Point (m)	Ending Point (m)				
P6-402L-I2	31.3	2.07	30.82	Joint position: 9.58 m, 24.65 m			
Identified Damage 1				Identified Damage 2			
Max Loss Point (m)	Section Loss (%)	Damage Length (m)	Damage Orientation	Max Loss Point (m)	Section Loss (%)	Damage Length (m)	Damage Orientation
—	—	—	—	—	—	—	—

Figure A130. MMFM data of P6-402L-I2 tendon section.

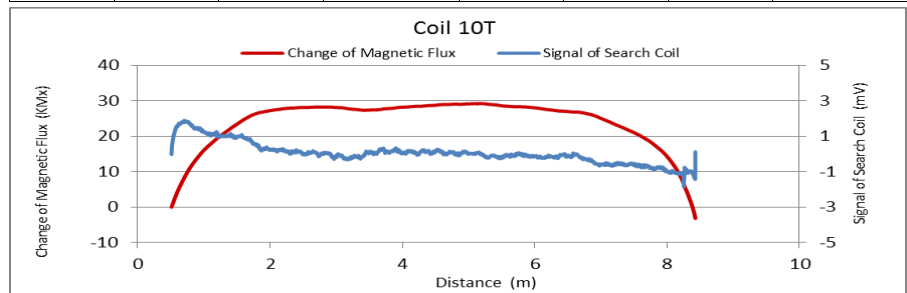
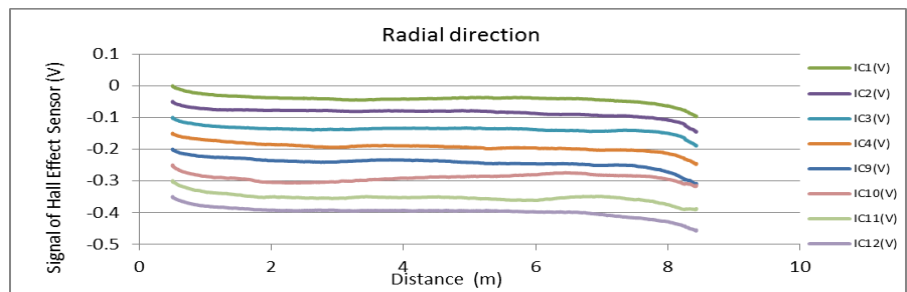
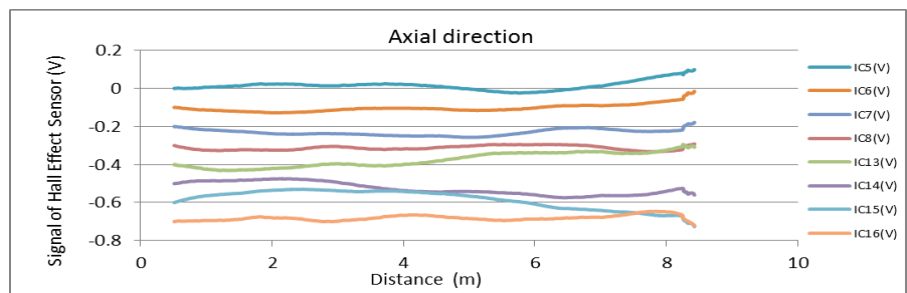
File Name 【Pier-Tendon-Section】	Section Total Length (m)	Scanned Length		Note			
		Starting Point (m)	Ending Point (m)				
P7-401R-H1	9.35	0.51	8.54				
Identified Damage 1				Identified Damage 2			
Max Loss Point (m)	Section Loss (%)	Damage Length (m)	Damage Orientation	Max Loss Point (m)	Section Loss (%)	Damage Length (m)	Damage Orientation
—	—	—	—	—	—	—	—

Figure A131. MMFM data of P7-401R-H1 tendon section.

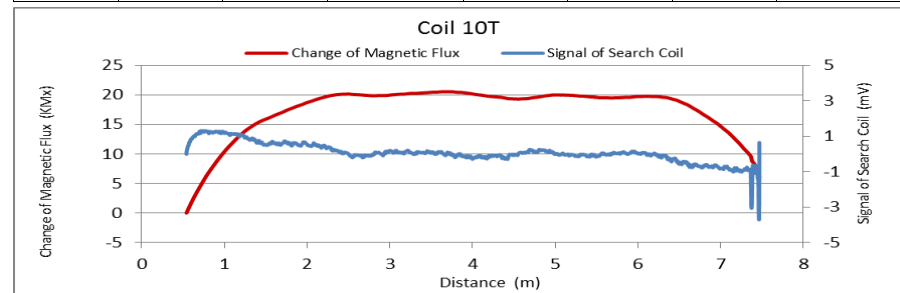
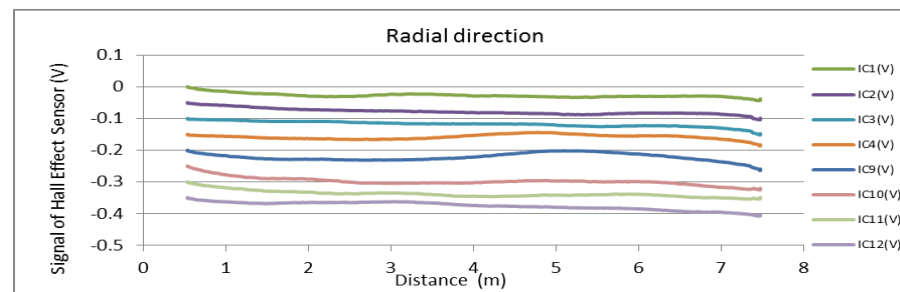
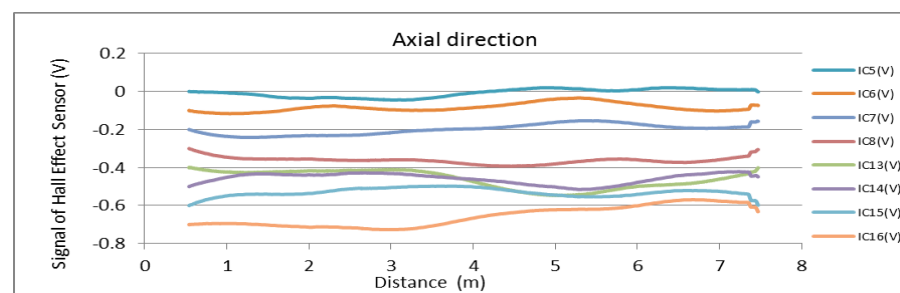
File Name 【Pier-Tendon-Section】	Section Total Length (m)	Scanned Length		Note			
		Starting Point (m)	Ending Point (m)				
P7-402R-H1	9.35	0.54	7.78				
Identified Damage 1				Identified Damage 2			
Max Loss Point (m)	Section Loss (%)	Damage Length (m)	Damage Orientation	Max Loss Point (m)	Section Loss (%)	Damage Length (m)	Damage Orientation
—	—	—	—	—	—	—	—

Figure A132. MMFM data of P7-402R-H1 tendon section.

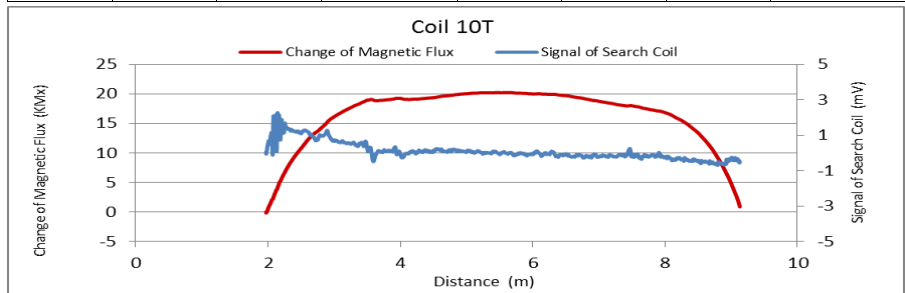
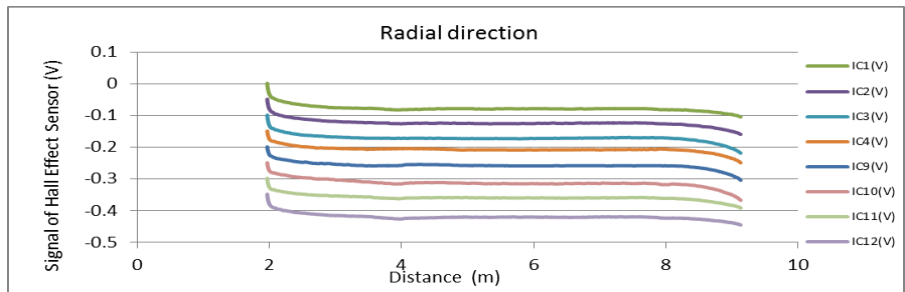
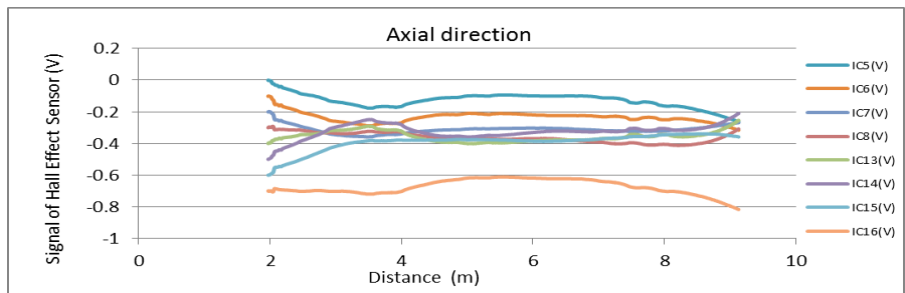
File Name 【Pier-Tendon-Section】	Section Total Length (m)	Scanned Length		Note			
		Starting Point (m)	Ending Point (m)				
P7-303R-I1	9.48	1.97	9.17				
Identified Damage 1				Identified Damage 2			
Max Loss Point (m)	Section Loss (%)	Damage Length (m)	Damage Orientation	Max Loss Point (m)	Section Loss (%)	Damage Length (m)	Damage Orientation
—	—	—	—	—	—	—	—

Figure A133. MMFM data of P7-303R-I1 tendon section.

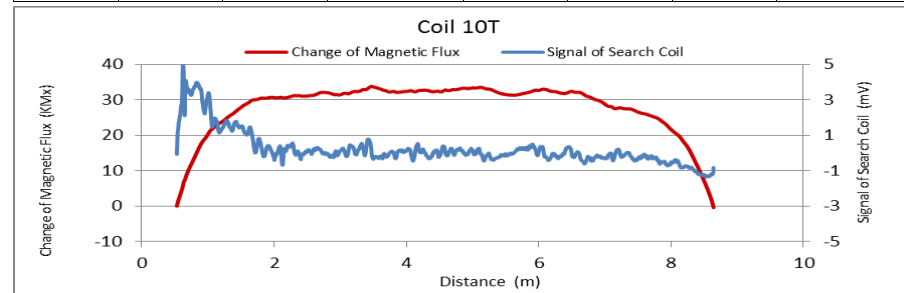
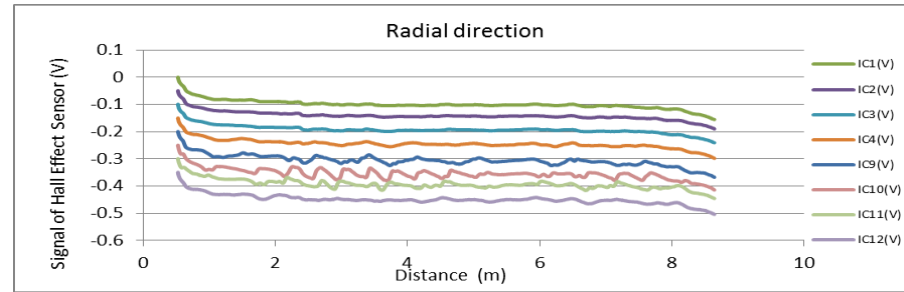
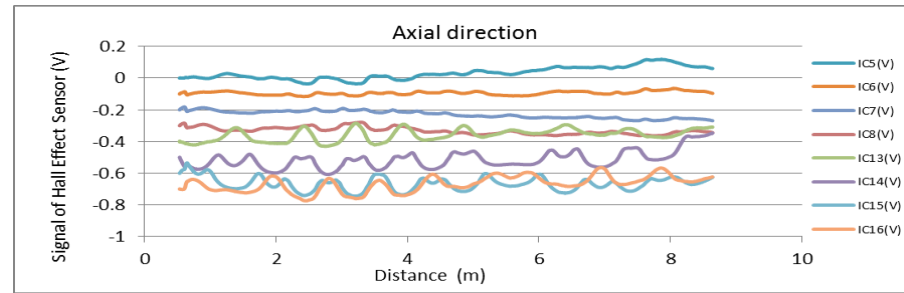
File Name 【Pier-Tendon-Section】	Section Total Length (m)	Scanned Length		Note			
		Starting Point (m)	Ending Point (m)				
P7-401L-H1	9.37	0.53	8.64	Approximately 4 m from the beginning is distorted.			
Identified Damage 1				Identified Damage 2			
Max Loss Point (m)	Section Loss (%)	Damage Length (m)	Damage Orientation	Max Loss Point (m)	Section Loss (%)	Damage Length (m)	Damage Orientation
—	—	—	—	—	—	—	—

Figure A134. MMFM data of P7-401L-H1 tendon section.

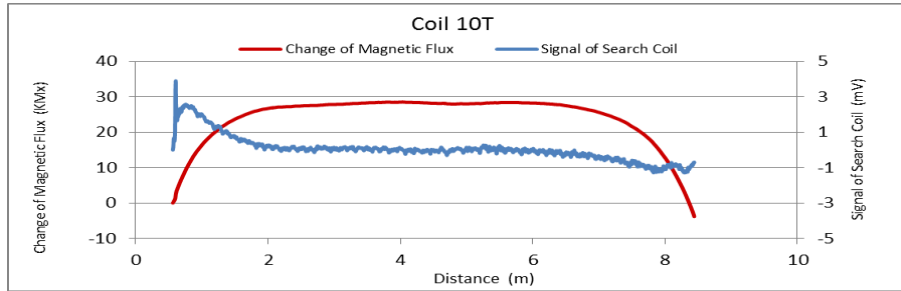
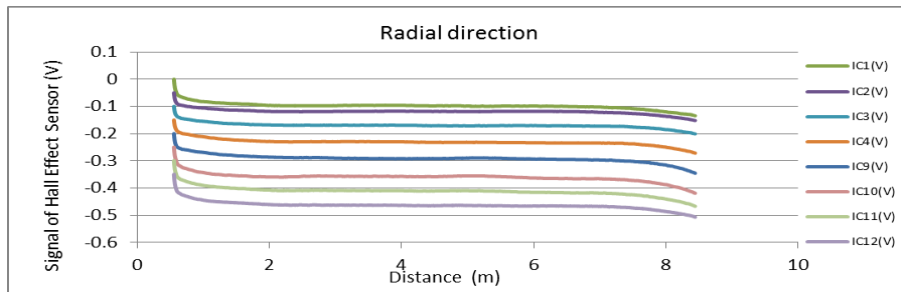
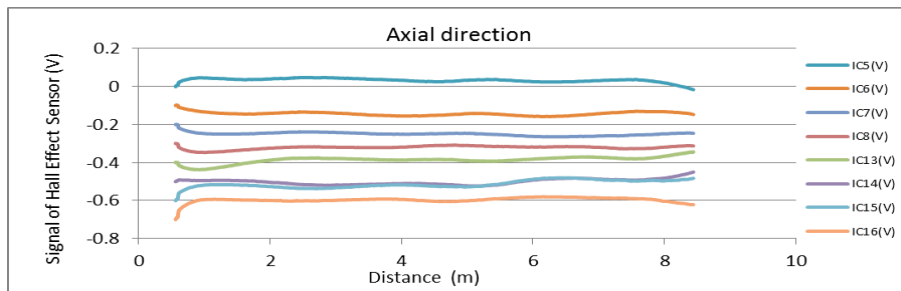
File Name 【Pier-Tendon-Section】	Section Total Length (m)	Scanned Length		Note			
		Starting Point (m)	Ending Point (m)				
P7-402L-H1	9.37	0.56	8.58				
Identified Damage 1				Identified Damage 2			
Max Loss Point (m)	Section Loss (%)	Damage Length (m)	Damage Orientation	Max Loss Point (m)	Section Loss (%)	Damage Length (m)	Damage Orientation
—	—	—	—	—	—	—	—

Figure A135. MMFM data of P7-402L-H1 tendon section.

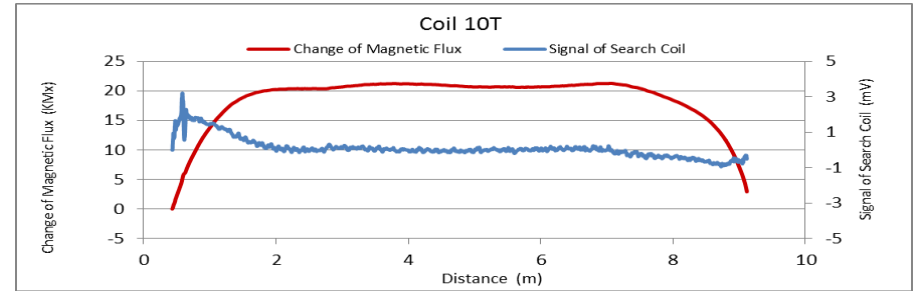
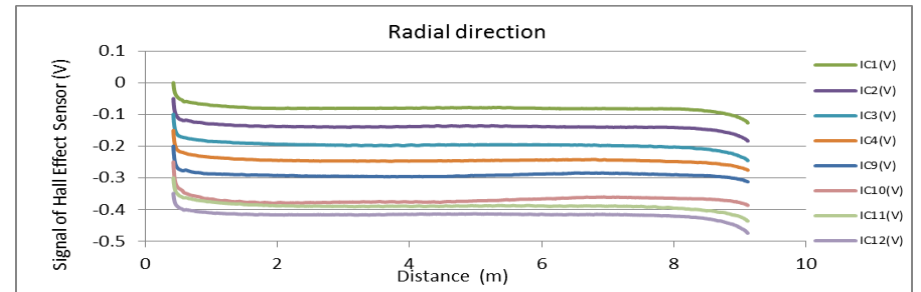
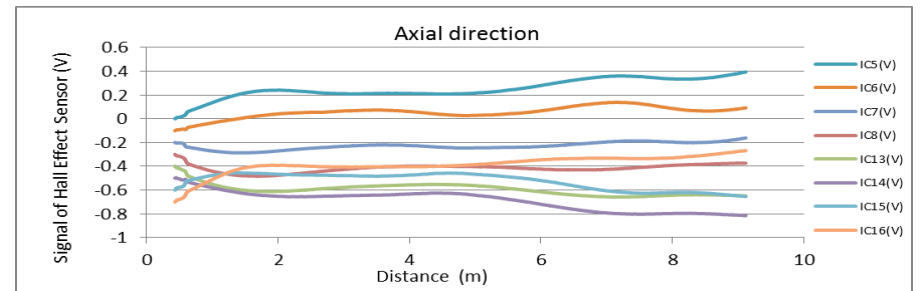
File Name 【Pier-Tendon-Section】	Section Total Length (m)	Scanned Length		Note			
		Starting Point (m)	Ending Point (m)				
P7-303L-I1	9.52	0.43	9.19				
Identified Damage 1				Identified Damage 2			
Max Loss Point (m)	Section Loss (%)	Damage Length (m)	Damage Orientation	Max Loss Point (m)	Section Loss (%)	Damage Length (m)	Damage Orientation
—	—	—	—	—	—	—	—

Figure A136. MMFM data of P7-303L-I1 tendon section.

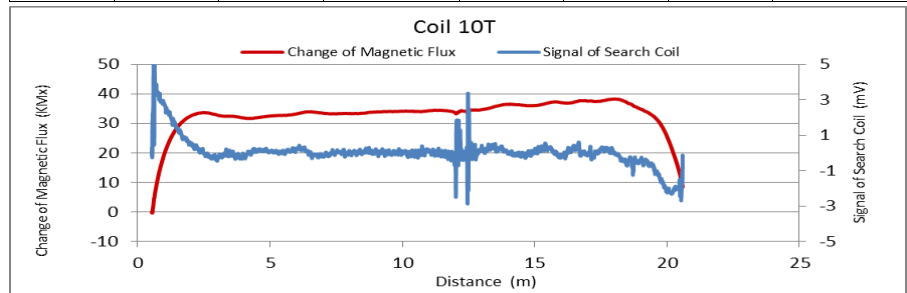
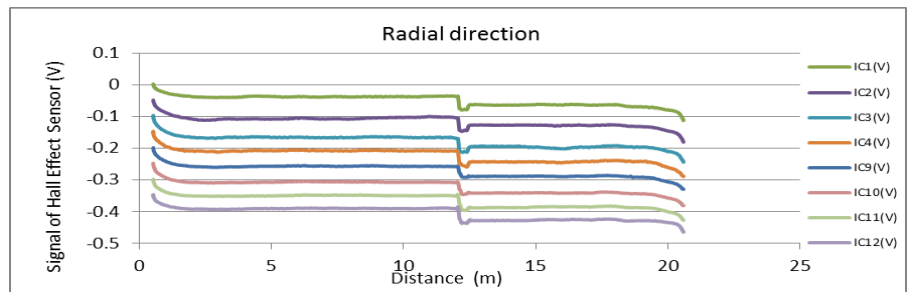
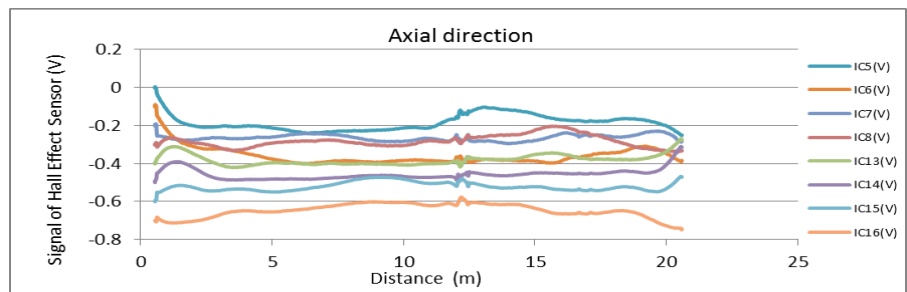
File Name 【Pier-Tendon-Section】	Section Total Length (m)	Scanned Length		Note			
		Starting Point (m)	Ending Point (m)				
P7-401R-I1	21.44	0.54	20.62				
Identified Damage 1				Identified Damage 2			
Max Loss Point (m)	Section Loss (%)	Damage Length (m)	Damage Orientation	Max Loss Point (m)	Section Loss (%)	Damage Length (m)	Damage Orientation
—	—	—	—	—	—	—	—

Figure A137. MMFM data of P7-401R-I1 tendon section.

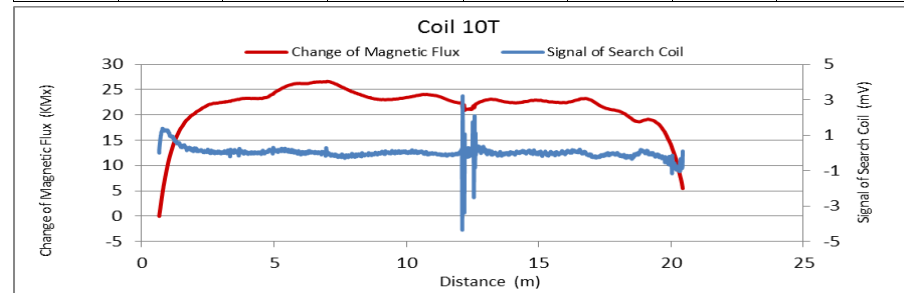
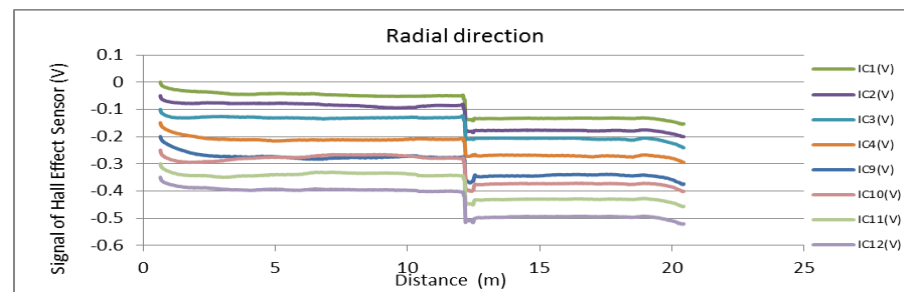
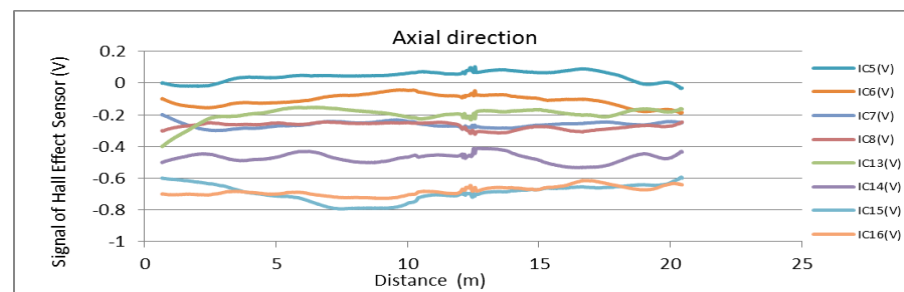
File Name 【Pier-Tendon-Section】	Section Total Length (m)	Scanned Length		Note			
		Starting Point (m)	Ending Point (m)				
P7-402R-I1	21.44	0.66	20.66	Joint position: 12.35 m			
Identified Damage 1				Identified Damage 2			
Max Loss Point (m)	Section Loss (%)	Damage Length (m)	Damage Orientation	Max Loss Point (m)	Section Loss (%)	Damage Length (m)	Damage Orientation
—	—	—	—	—	—	—	—

Figure A138. MMFM data of P7-402R-I1 tendon section.
