**Development of Quality Assurance and Quality Control
System for Post Tensioned Segmental Bridges in Florida:
Case of Ringling Bridge – Phase II**

**FDOT Contract No. BDV29-977-34
FINAL REPORT**

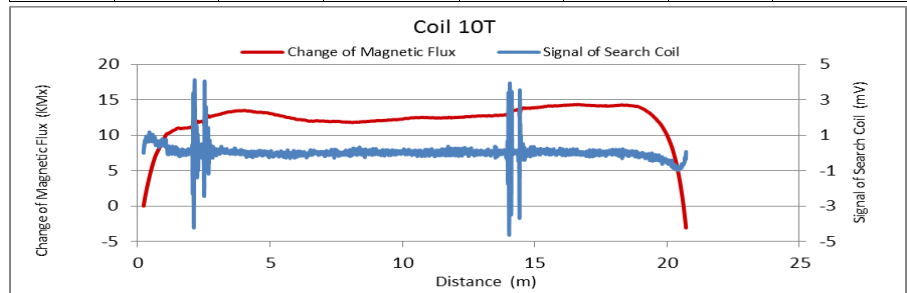
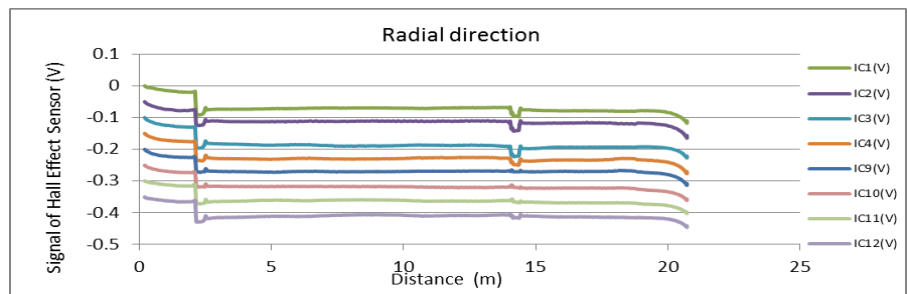
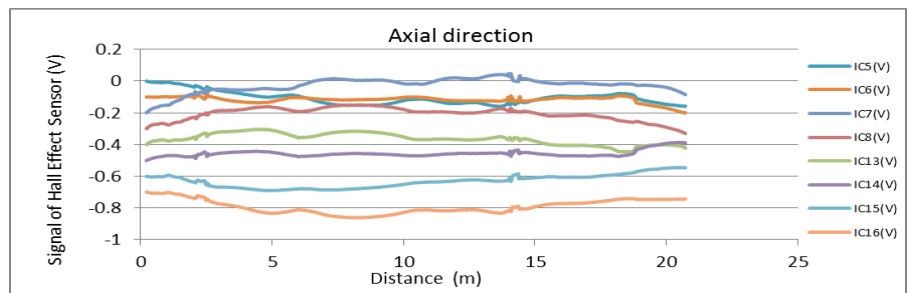
File Name 【Pier-Tendon-Section】	Section Total Length (m)	Scanned Length		Note			
		Starting Point (m)	Ending Point (m)				
P7-303R-I2	21.65	0.22	20.83	Joint position : 2.5 m, 12.63 m			
Identified Damage 1				Identified Damage 2			
Max Loss Point (m)	Section Loss (%)	Damage Length (m)	Damage Orientation	Max Loss Point (m)	Section Loss (%)	Damage Length (m)	Damage Orientation
—	—	—	—	—	—	—	—

Figure A139. MMFM data of P7-303R-I2 tendon section.

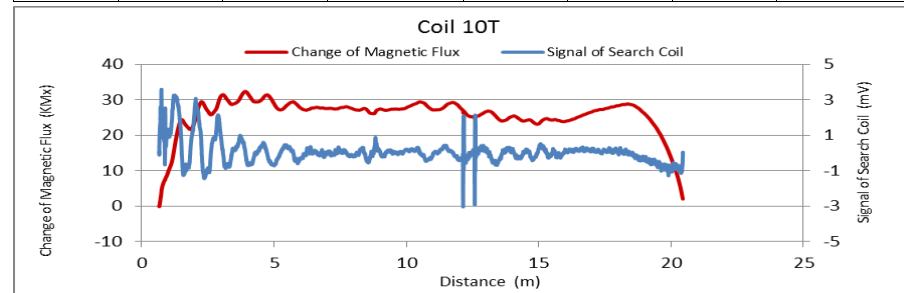
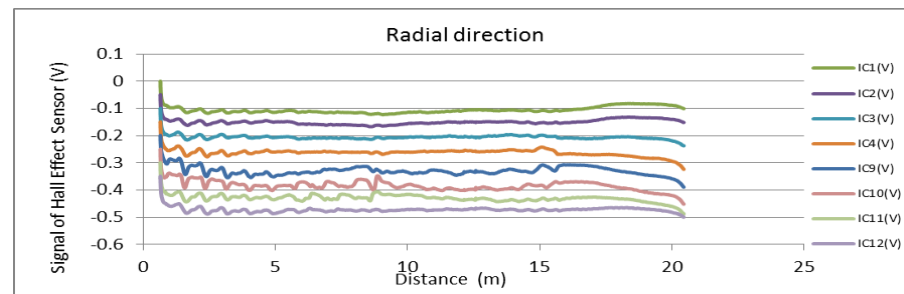
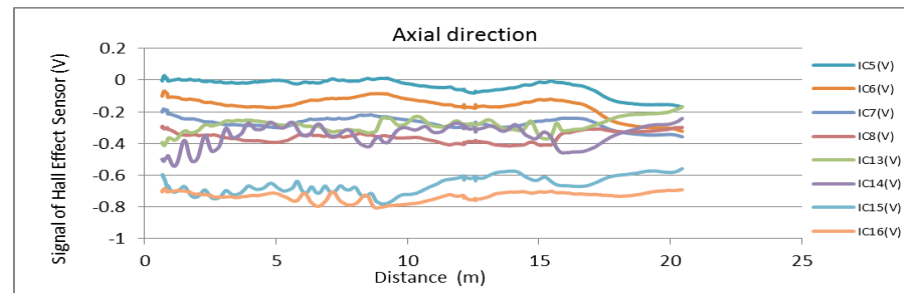
File Name 【Pier-Tendon-Section】	Section Total Length (m)	Scanned Length		Note			
		Starting Point (m)	Ending Point (m)				
P7-401L-I1	21.37	0.66	20.6	Joint position : 12.3 m			
Identified Damage 1				Identified Damage 2			
Max Loss Point (m)	Section Loss (%)	Damage Length (m)	Damage Orientation	Max Loss Point (m)	Section Loss (%)	Damage Length (m)	Damage Orientation
—	—	—	—	—	—	—	—

Figure A140. MMFM data of P7-401L-I1 tendon section.

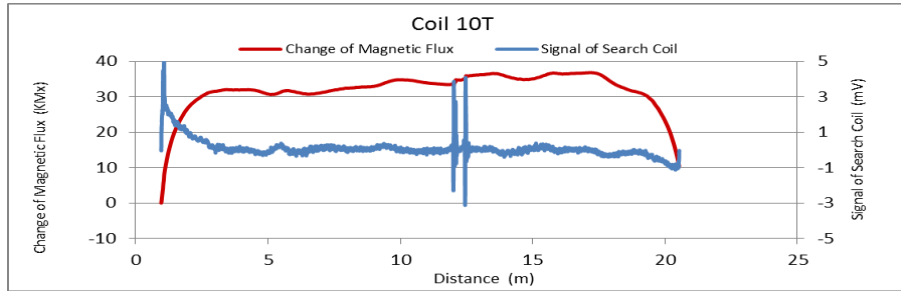
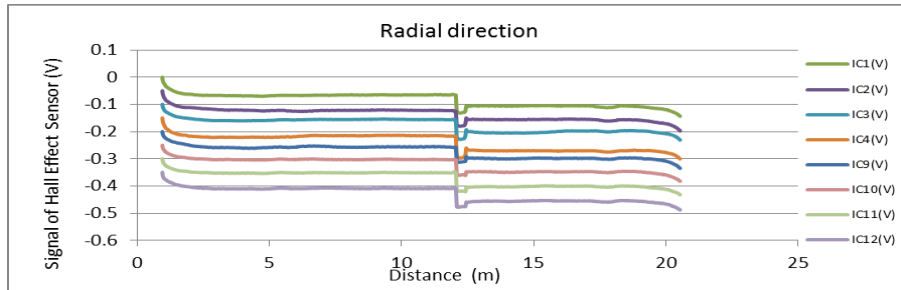
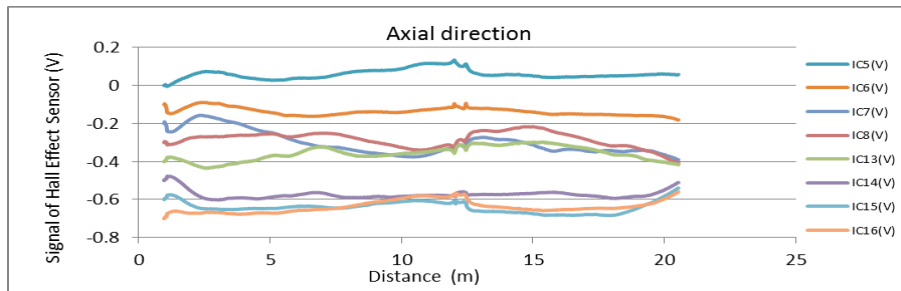
File Name 【Pier-Tendon-Section】	Section Total Length (m)	Scanned Length		Note			
		Starting Point (m)	Ending Point (m)				
P7-402L-I1	21.37	0.96	20.55	Joint position : 12.23 m			
Identified Damage 1				Identified Damage 2			
Max Loss Point (m)	Section Loss (%)	Damage Length (m)	Damage Orientation	Max Loss Point (m)	Section Loss (%)	Damage Length (m)	Damage Orientation
—	—	—	—	—	—	—	—

Figure A141. MMFM data of P7-402L-I1 tendon section.

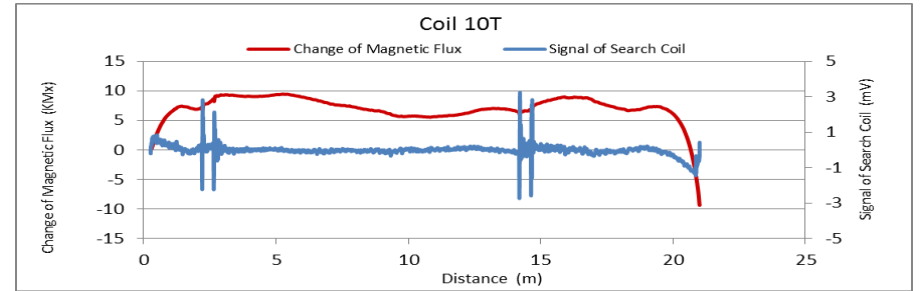
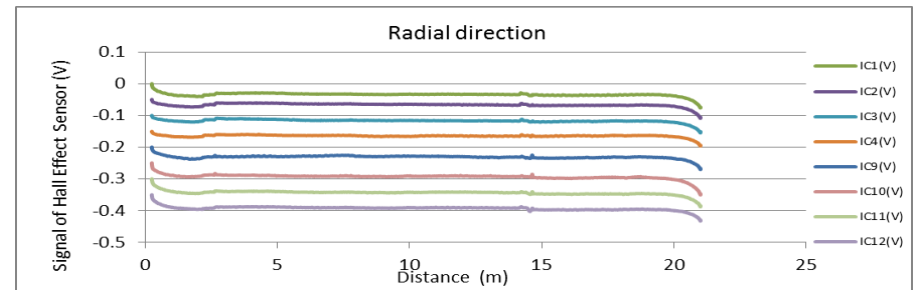
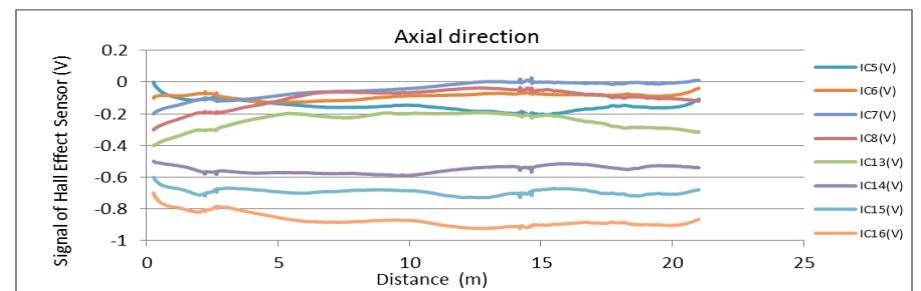
File Name 【Pier-Tendon-Section】	Section Total Length (m)	Scanned Length		Note			
		Starting Point (m)	Ending Point (m)				
P7-303L-I2	21.56	0.26	21.25	Joint position : 2.47 m, 14.56 m			
Identified Damage 1				Identified Damage 2			
Max Loss Point (m)	Section Loss (%)	Damage Length (m)	Damage Orientation	Max Loss Point (m)	Section Loss (%)	Damage Length (m)	Damage Orientation
—	—	—	—	—	—	—	—

Figure A142. MMFM data of P7-303L-I2 tendon section.

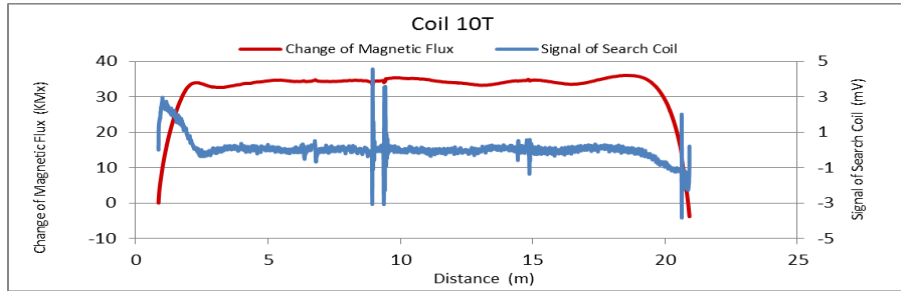
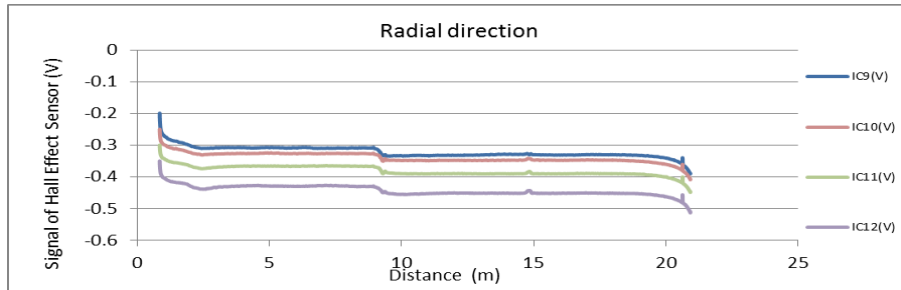
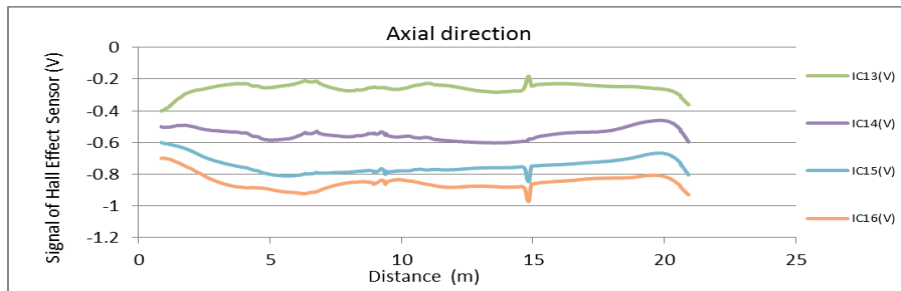
File Name 【Pier-Tendon-Section】	Section Total Length (m)	Scanned Length		Note			
		Starting Point (m)	Ending Point (m)				
P7-401R-I2	21.52	0.86	20.92	Joint position: 9.18 m IC (1)-IC (8)-detection by poor contact			
Identified Damage 1				Identified Damage 2			
Max Loss Point (m)	Section Loss (%)	Damage Length (m)	Damage Orientation	Max Loss Point (m)	Section Loss (%)	Damage Length (m)	Damage Orientation
—	—	—	—	—	—	—	—

Figure A143. MMFM data of P7-401R-I2 tendon section.

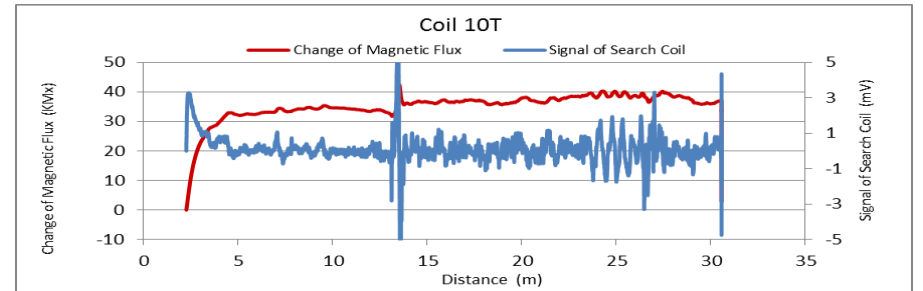
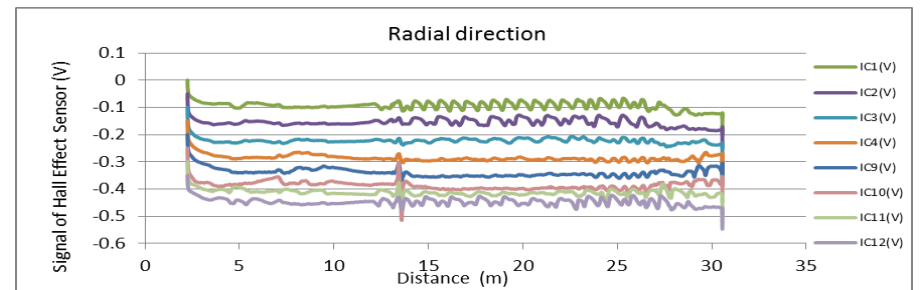
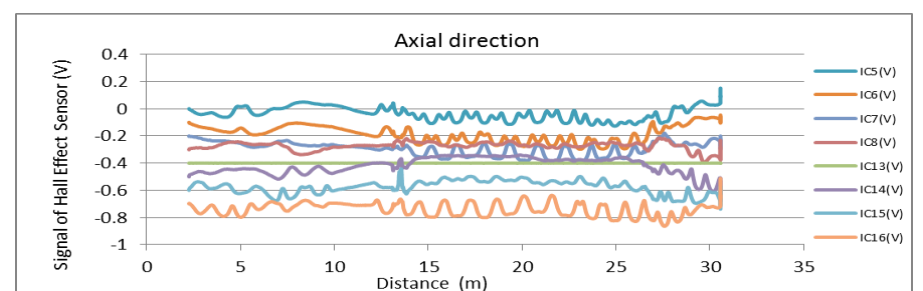
File Name 【Pier-Tendon-Section】	Section Total Length (m)	Scanned Length		Note			
		Starting Point (m)	Ending Point (m)				
P7-402R-I2	31.35	2.25	30.95	Joint position: 12.25 m, 24.36 m Many distortions: 12m~			
Identified Damage 1				Identified Damage 2			
Max Loss Point (m)	Section Loss (%)	Damage Length (m)	Damage Orientation	Max Loss Point (m)	Section Loss (%)	Damage Length (m)	Damage Orientation
—	—	—	—	—	—	—	—

Figure A144. MMFM data of P7-402R-I2 tendon section.

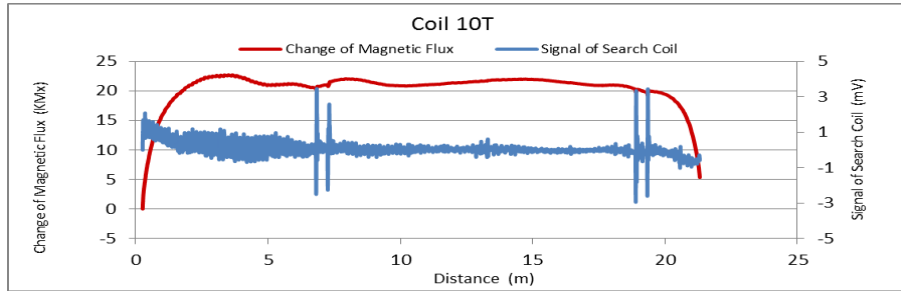
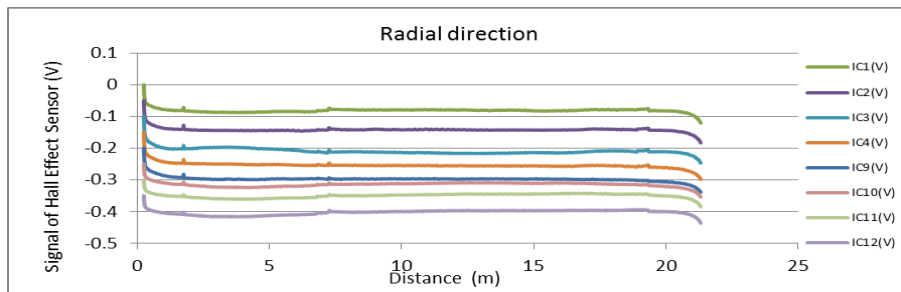
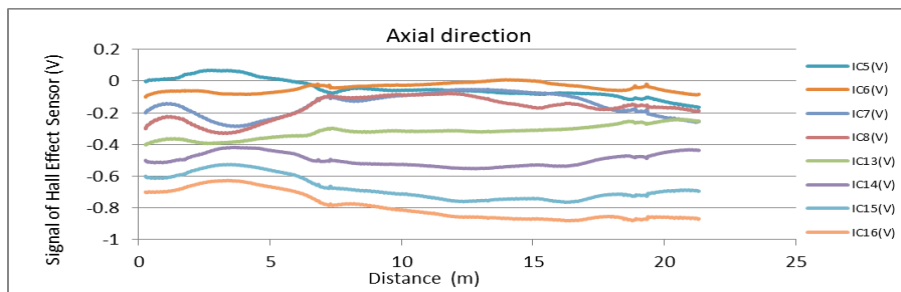
File Name 【Pier-Tendon-Section】	Section Total Length (m)	Scanned Length		Note			
		Starting Point (m)	Ending Point (m)				
P7-303R-I3	21.64	0.26	21.31	Joint position: 7.04 m, 19.14 m			
Identified Damage 1				Identified Damage 2			
Max Loss Point (m)	Section Loss (%)	Damage Length (m)	Damage Orientation	Max Loss Point (m)	Section Loss (%)	Damage Length (m)	Damage Orientation
—	—	—	—	—	—	—	—

Figure A145. MMFM data of P7-303R-I3 tendon section.

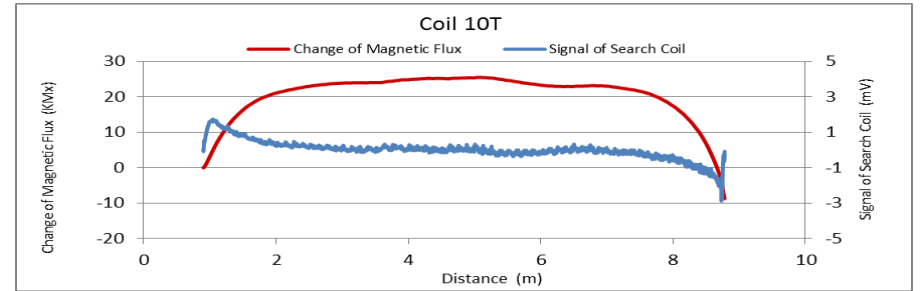
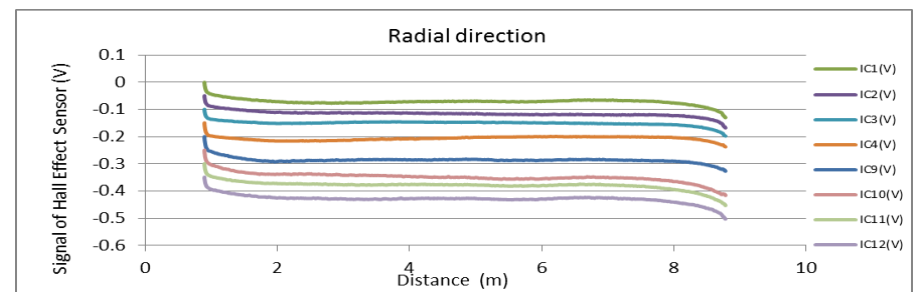
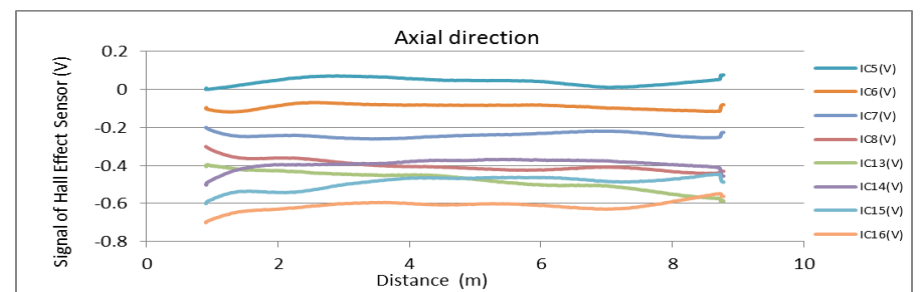
File Name 【Pier-Tendon-Section】	Section Total Length (m)	Scanned Length		Note			
		Starting Point (m)	Ending Point (m)				
P7-401R-H2	9.38	0.9	8.84				
Identified Damage 1				Identified Damage 2			
Max Loss Point (m)	Section Loss (%)	Damage Length (m)	Damage Orientation	Max Loss Point (m)	Section Loss (%)	Damage Length (m)	Damage Orientation
—	—	—	—	—	—	—	—

Figure A146. MMFM data of P7-401R-H2 tendon section.

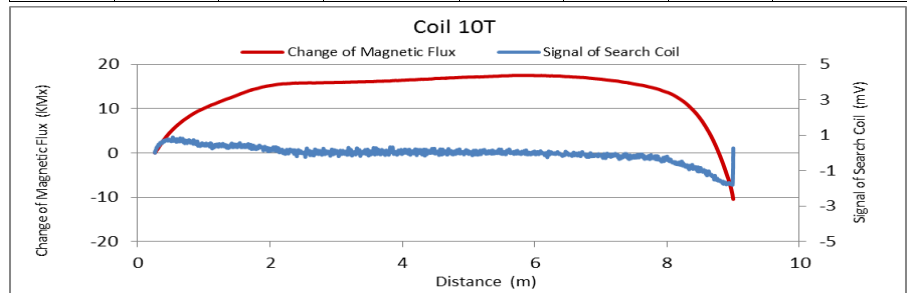
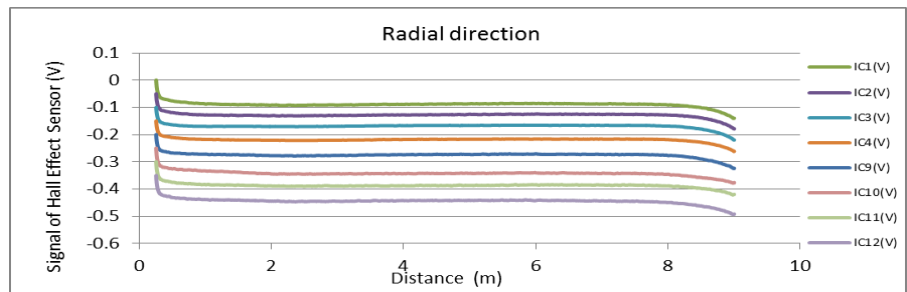
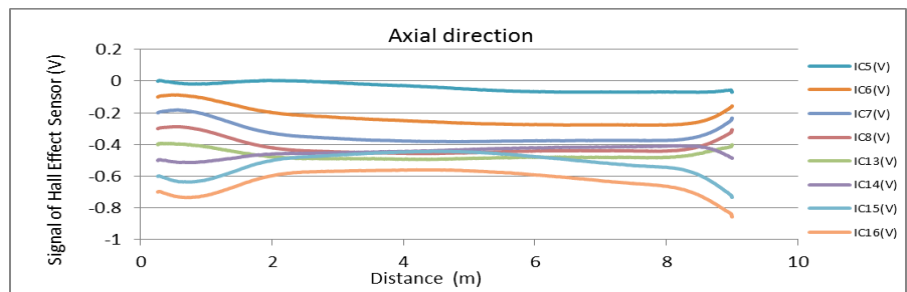
File Name 【Pier-Tendon-Section】	Section Total Length (m)	Scanned Length		Note			
		Starting Point (m)	Ending Point (m)				
P7-303R-I4	9.47	0.26	9.06				
Identified Damage 1				Identified Damage 2			
Max Loss Point (m)	Section Loss (%)	Damage Length (m)	Damage Orientation	Max Loss Point (m)	Section Loss (%)	Damage Length (m)	Damage Orientation
—	—	—	—	—	—	—	—

Figure A147. MMFM data of P7-303R-I4 tendon section.

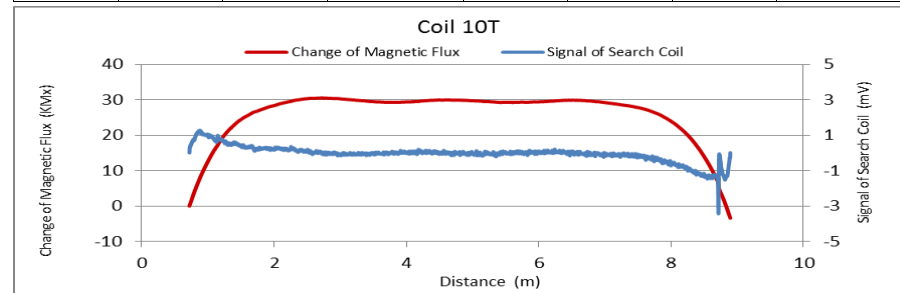
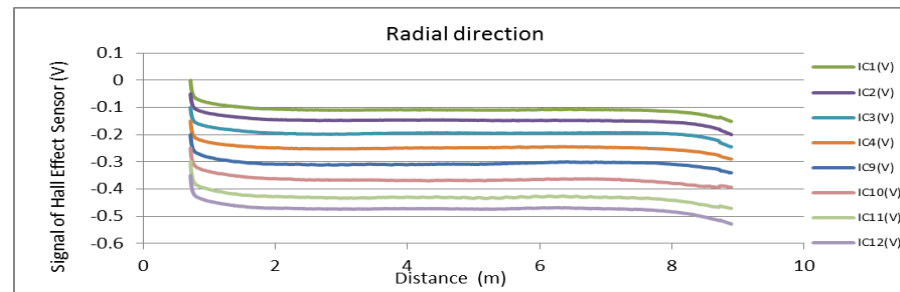
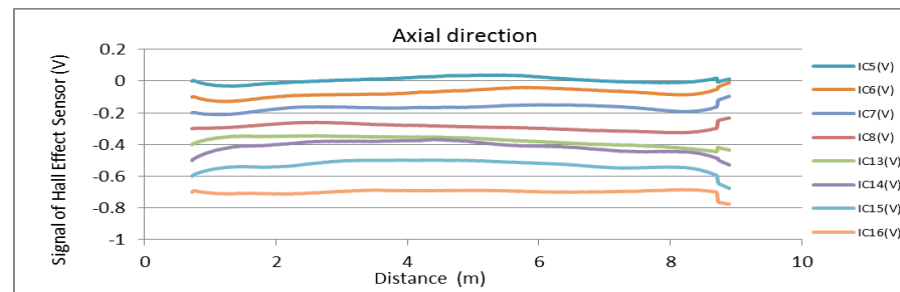
File Name 【Pier-Tendon-Section】	Section Total Length (m)	Scanned Length		Note			
		Starting Point (m)	Ending Point (m)				
P7-401L-H2	9.41	0.72	8.95				
Identified Damage 1				Identified Damage 2			
Max Loss Point (m)	Section Loss (%)	Damage Length (m)	Damage Orientation	Max Loss Point (m)	Section Loss (%)	Damage Length (m)	Damage Orientation
—	—	—	—	—	—	—	—

Figure A148. MMFM data of P7-401L-H2 tendon section.

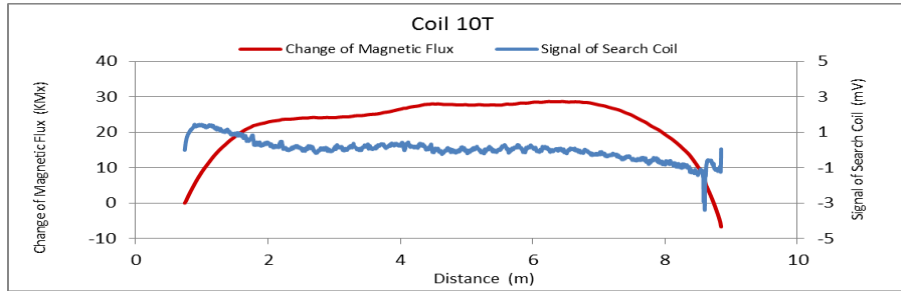
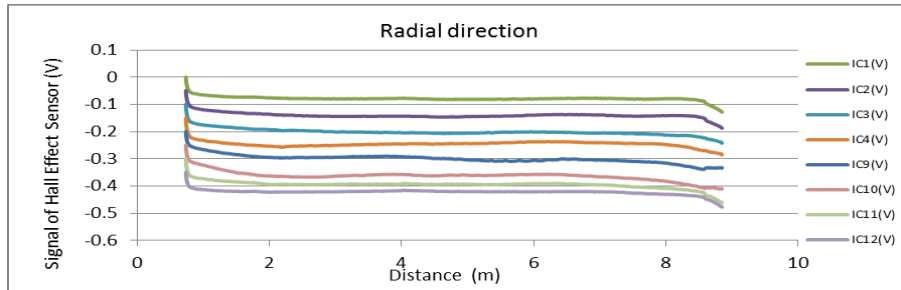
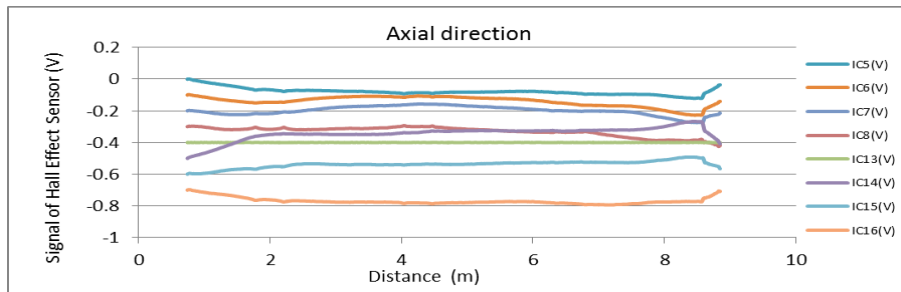
File Name 【Pier-Tendon-Section】	Section Total Length (m)	Scanned Length		Note			
		Starting Point (m)	Ending Point (m)				
P7-402L-H2	9.41	0.74	8.92				
Identified Damage 1				Identified Damage 2			
Max Loss Point (m)	Section Loss (%)	Damage Length (m)	Damage Orientation	Max Loss Point (m)	Section Loss (%)	Damage Length (m)	Damage Orientation
—	—	—	—	—	—	—	—

Figure A149. MMFM data of P7-402L-H2 tendon section.

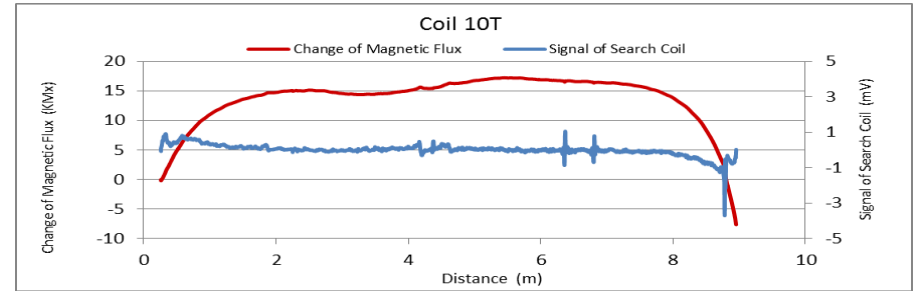
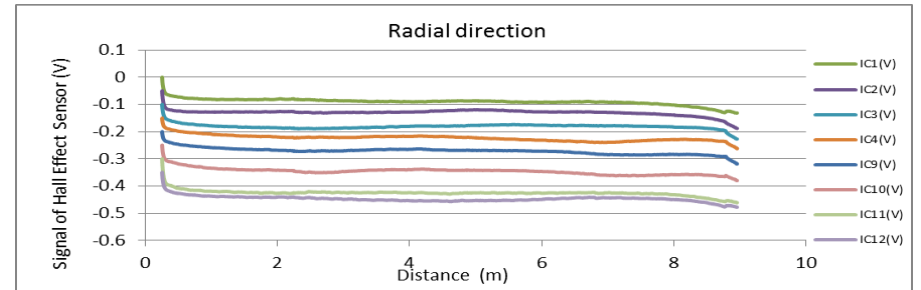
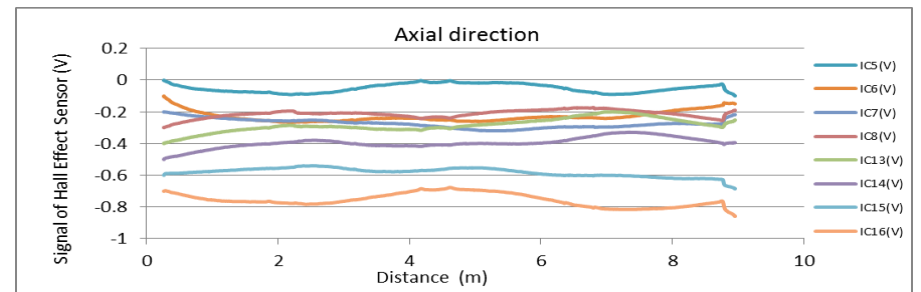
File Name 【Pier-Tendon-Section】	Section Total Length (m)	Scanned Length		Note			
		Starting Point (m)	Ending Point (m)				
P7-303L-I4	9.46	0.26	9.01				
Identified Damage 1				Identified Damage 2			
Max Loss Point (m)	Section Loss (%)	Damage Length (m)	Damage Orientation	Max Loss Point (m)	Section Loss (%)	Damage Length (m)	Damage Orientation
—	—	—	—	—	—	—	—

Figure A150. MMFM data of P7-303L-I4 tendon section.

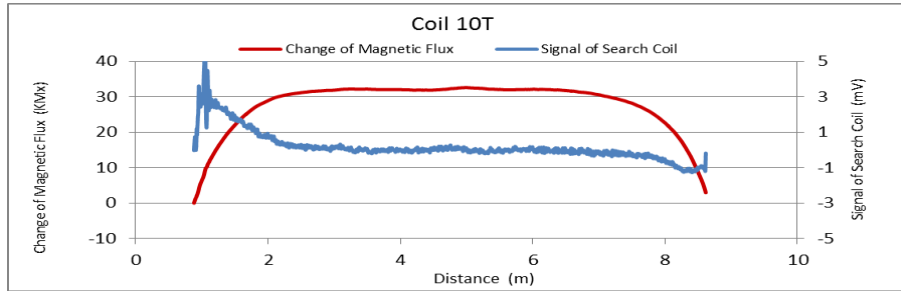
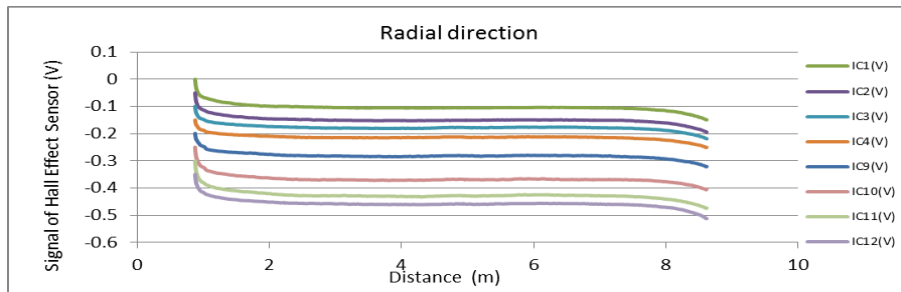
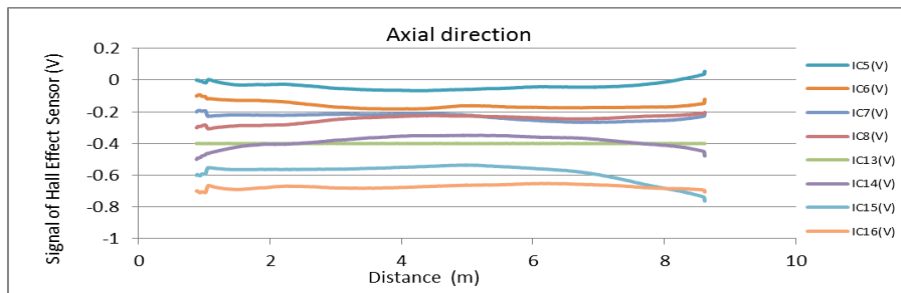
File Name 【Pier-Tendon-Section】	Section Total Length (m)	Scanned Length		Note			
		Starting Point (m)	Ending Point (m)				
P8-401R-H1	9.49	0.88	8.67				
Identified Damage 1				Identified Damage 2			
Max Loss Point (m)	Section Loss (%)	Damage Length (m)	Damage Orientation	Max Loss Point (m)	Section Loss (%)	Damage Length (m)	Damage Orientation
—	—	—	—	—	—	—	—

Figure A151. MMFM data of P8-401R-H1 tendon section.

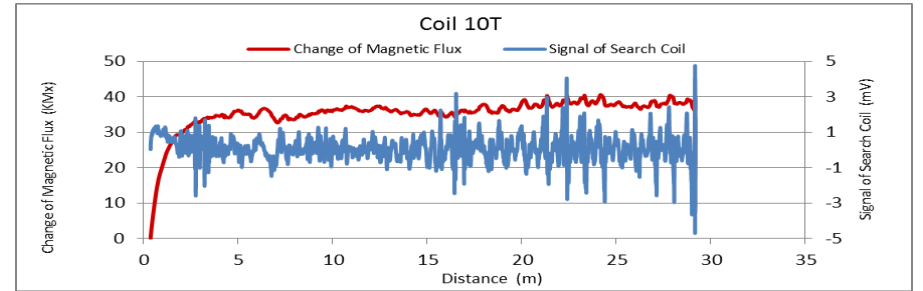
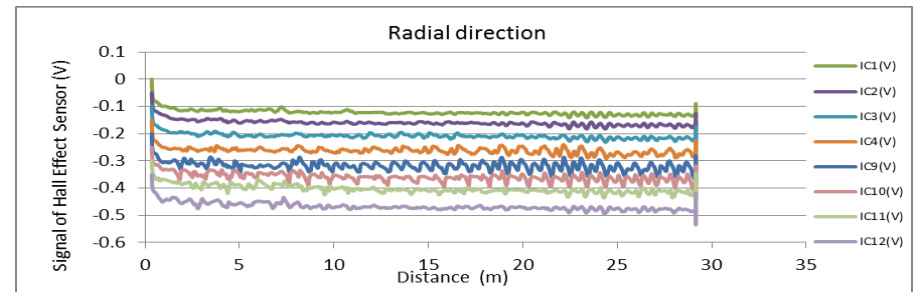
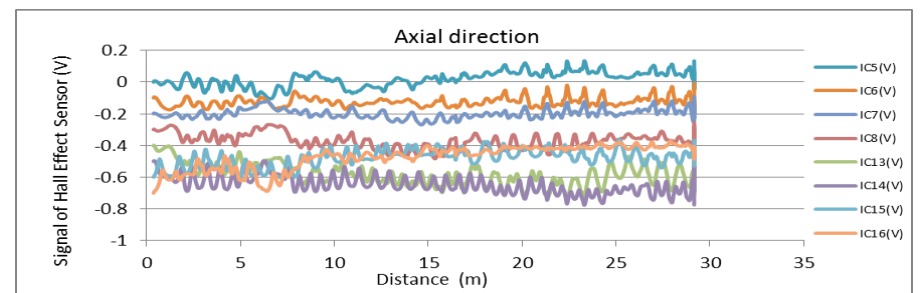
File Name 【Pier-Tendon-Section】	Section Total Length (m)	Scanned Length		Note			
		Starting Point (m)	Ending Point (m)				
P8-402R-I1	31.34	0.36	29.36	Joint position : 2.67 m, 14.8 m, 26.93 m Have a lot of distortion			
Identified Damage 1				Identified Damage 2			
Max Loss Point (m)	Section Loss (%)	Damage Length (m)	Damage Orientation	Max Loss Point (m)	Section Loss (%)	Damage Length (m)	Damage Orientation
—	—	—	—	—	—	—	—

Figure A152. MMFM data of P8-402R-I1 tendon section.

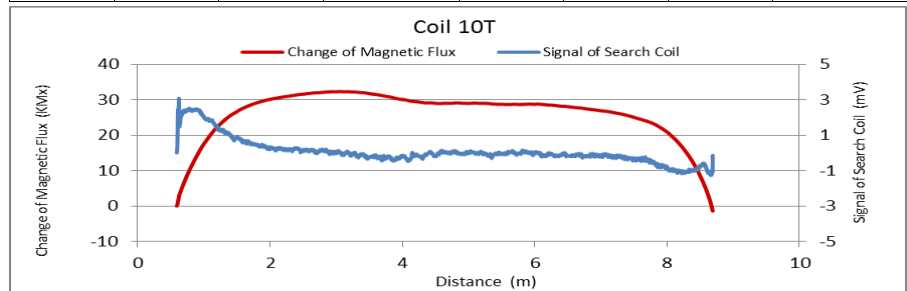
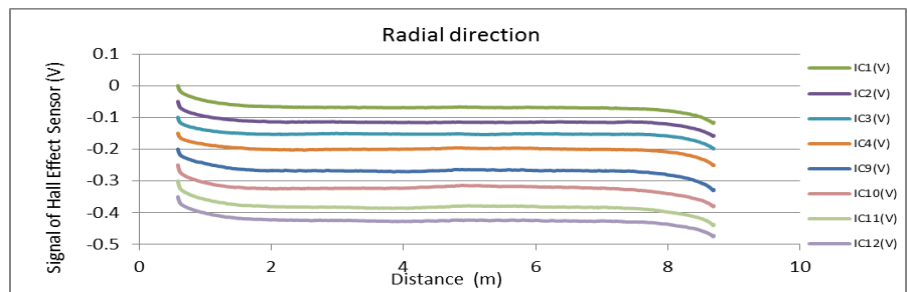
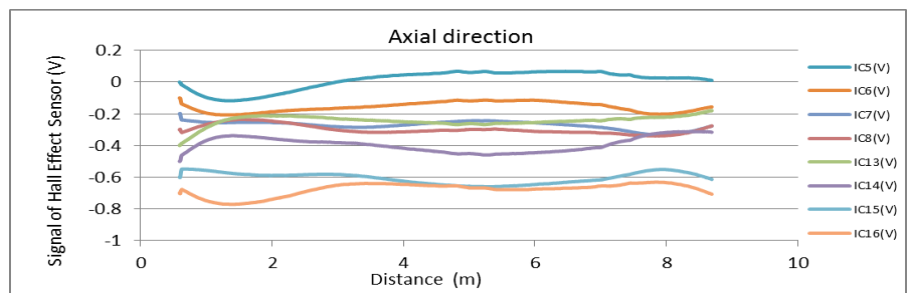
File Name 【Pier-Tendon-Section】	Section Total Length (m)	Scanned Length		Note			
		Starting Point (m)	Ending Point (m)				
P8-401L-H1	9.45	0.59	8.78				
Identified Damage 1				Identified Damage 2			
Max Loss Point (m)	Section Loss (%)	Damage Length (m)	Damage Orientation	Max Loss Point (m)	Section Loss (%)	Damage Length (m)	Damage Orientation
—	—	—	—	—	—	—	—

Figure A153. MMFM data of P8-401L-H1 tendon section.

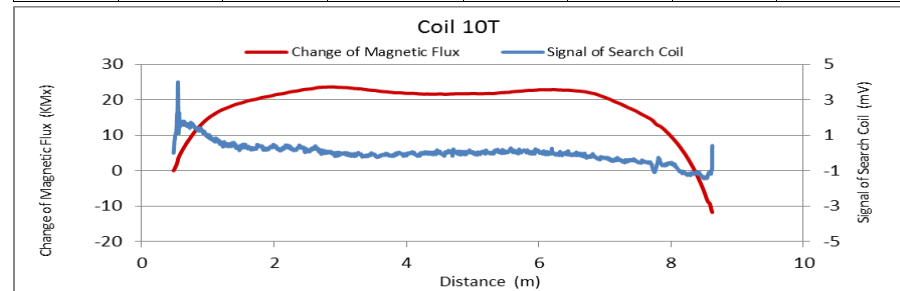
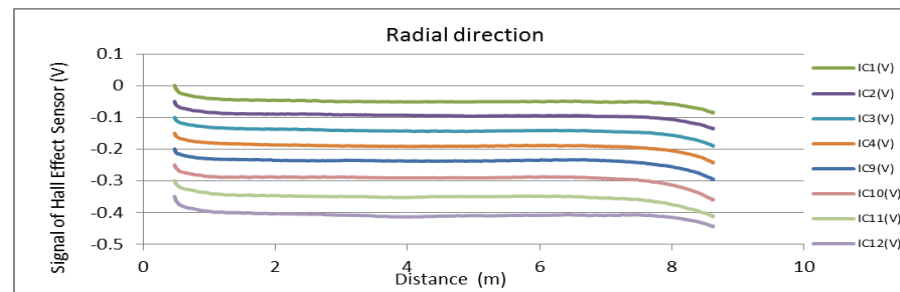
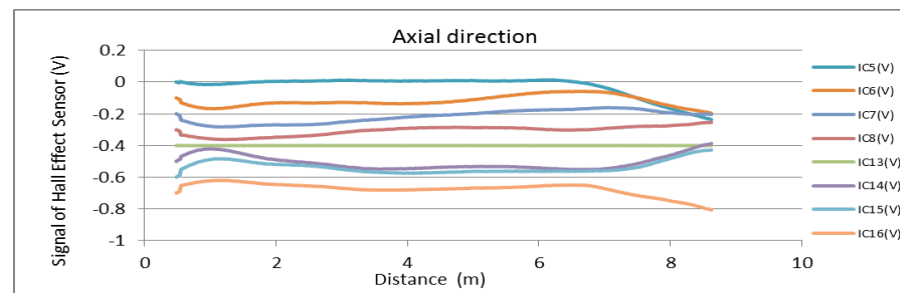
Figure A154. MMFM data of P8-402L-H1 tendon section.

File Name 【Pier-Tendon-Section】	Section Total Length (m)	Scanned Length		Note			
		Starting Point (m)	Ending Point (m)				
P8-402L-H1	9.45	0.48	8.69				
Identified Damage 1				Identified Damage 2			
Max Loss Point (m)	Section Loss (%)	Damage Length (m)	Damage Orientation	Max Loss Point (m)	Section Loss (%)	Damage Length (m)	Damage Orientation
—	—	—	—	—	—	—	—

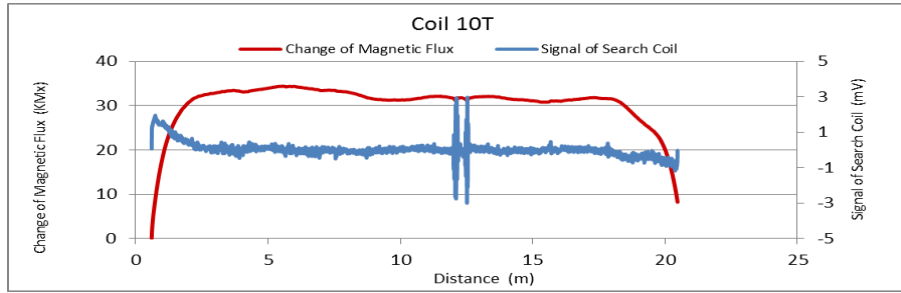
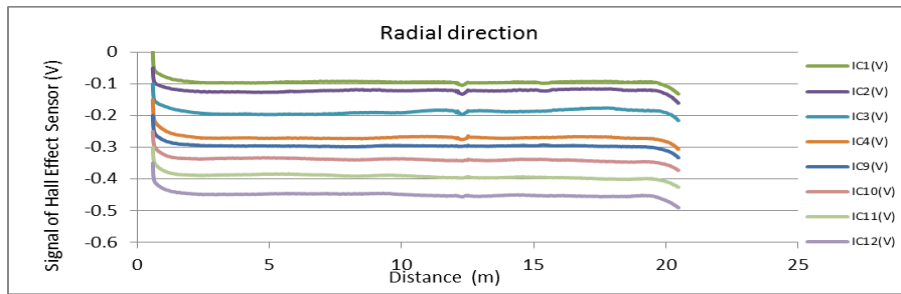
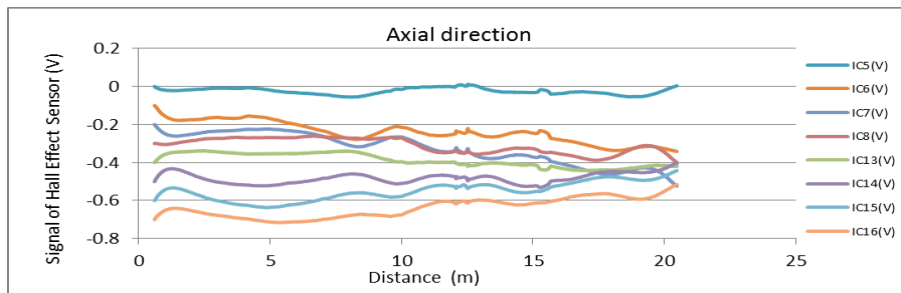
Figure A155. MMFM data of P8-401R-I1 tendon section.

File Name 【Pier-Tendon-Section】	Section Total Length (m)	Scanned Length		Note			
		Starting Point (m)	Ending Point (m)				
P8-401R-I1	21.49	0.6	20.49	Joint position: 12.31 m			
Identified Damage 1				Identified Damage 2			
Max Loss Point(m)	Section Loss (%)	Damage Length(m)	Damage Orientation	Max Loss Point(m)	Section Loss (%)	Damage Length(m)	Damage Orientation
—	—	—	—	—	—	—	—

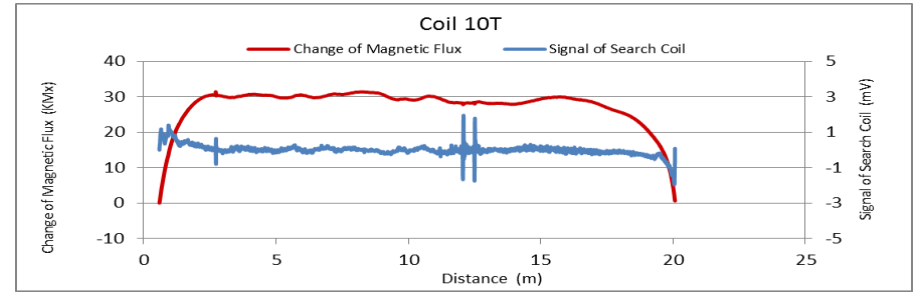
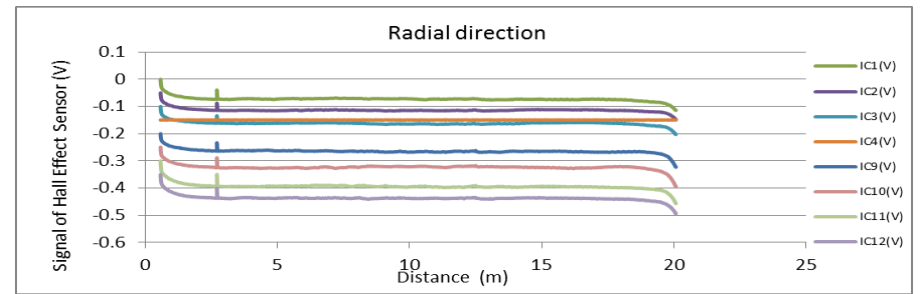
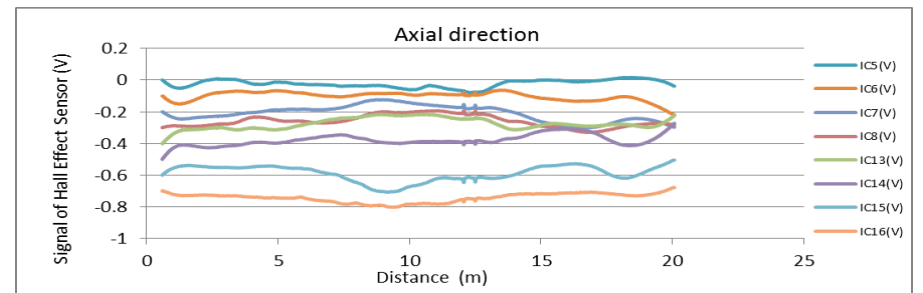
Figure A156. MMFM data of P8-401L-I1 tendon section.

File Name 【Pier-Tendon-Section】	Section Total Length (m)	Scanned Length		Note			
		Starting Point (m)	Ending Point (m)				
P8-401L-I1	21.48	0.59	20.24	Joint position: 12.37 m			
Identified Damage 1				Identified Damage 2			
Max Loss Point (m)	Section Loss (%)	Damage Length (m)	Damage Orientation	Max Loss Point (m)	Section Loss (%)	Damage Length (m)	Damage Orientation
—	—	—	—	—	—	—	—

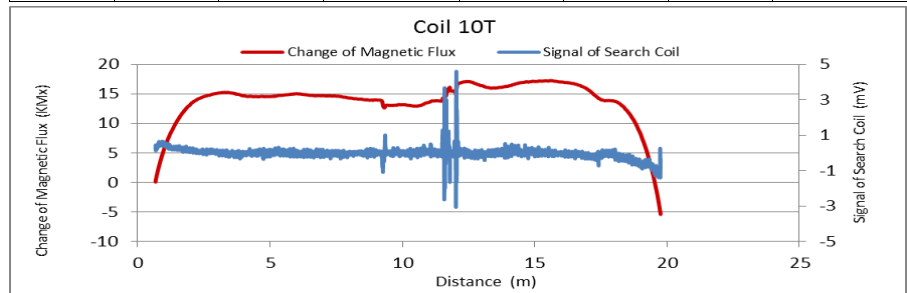
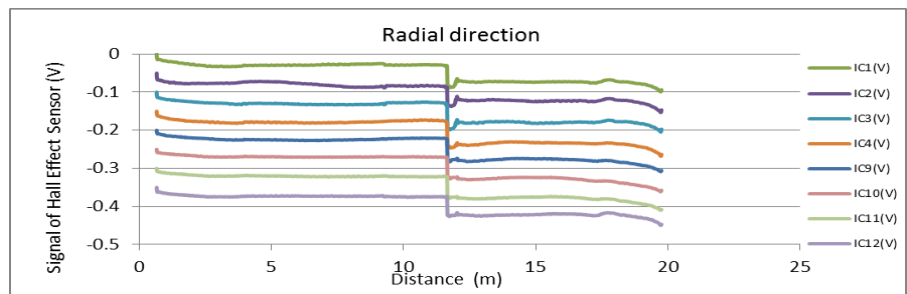
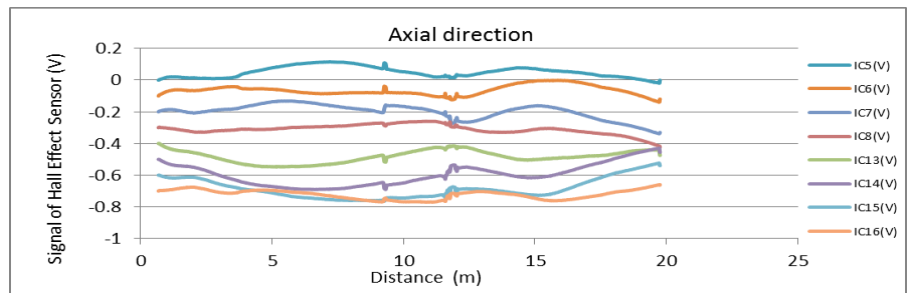
Figure A157. MMFM data of P8-402L-I1 tendon section.

File Name 【Pier-Tendon-Section】	Section Total Length (m)	Scanned Length		Note			
		Starting Point (m)	Ending Point (m)				
P8-402L-I1	21.48	0.67	20.22	Joint position: 12.3 m			
Identified Damage 1				Identified Damage 2			
Max Loss Point (m)	Section Loss (%)	Damage Length (m)	Damage Orientation	Max Loss Point (m)	Section Loss (%)	Damage Length (m)	Damage Orientation
—	—	—	—	—	—	—	—

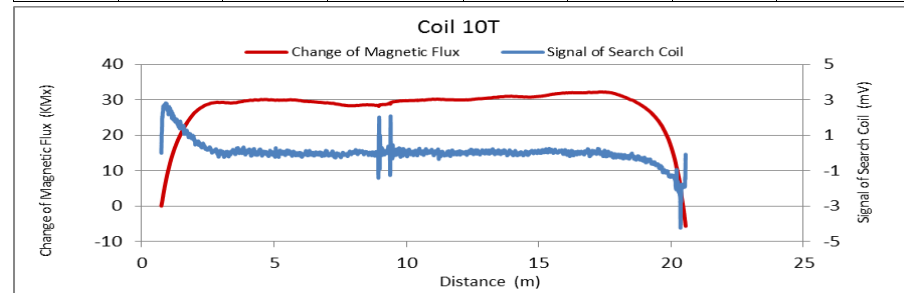
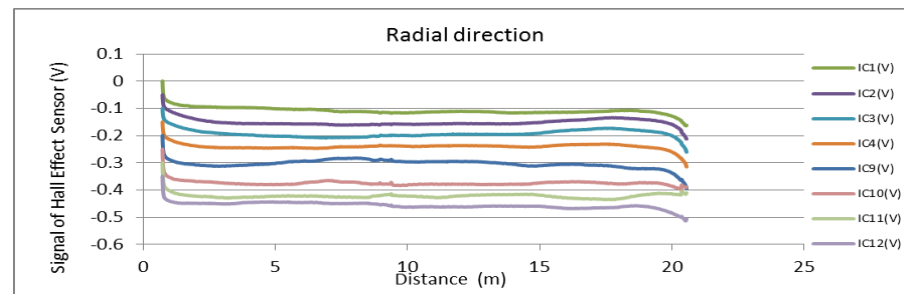
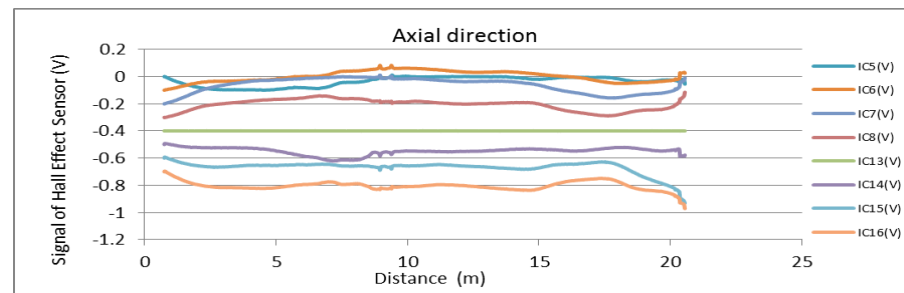
Figure A158. MMFM data of P8-401R-I2 tendon section.

File Name 【Pier-Tendon-Section】	Section Total Length (m)	Scanned Length		Note			
		Starting Point (m)	Ending Point (m)				
P8-401R-I2	21.48	0.74	20.72	Joint position: 9.2 m			
Identified Damage 1				Identified Damage 2			
Max Loss Point (m)	Section Loss (%)	Damage Length (m)	Damage Orientation	Max Loss Point (m)	Section Loss (%)	Damage Length (m)	Damage Orientation
—	—	—	—	—	—	—	—

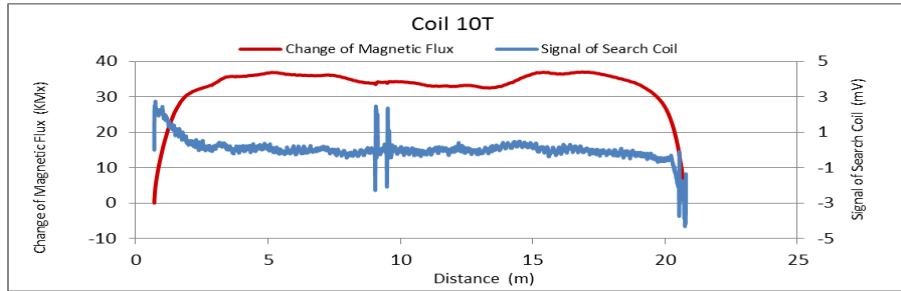
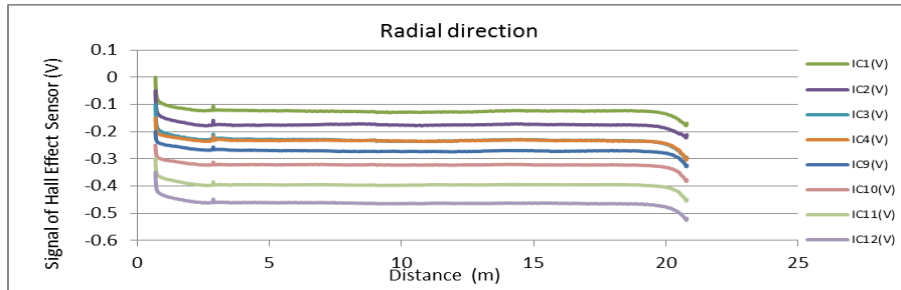
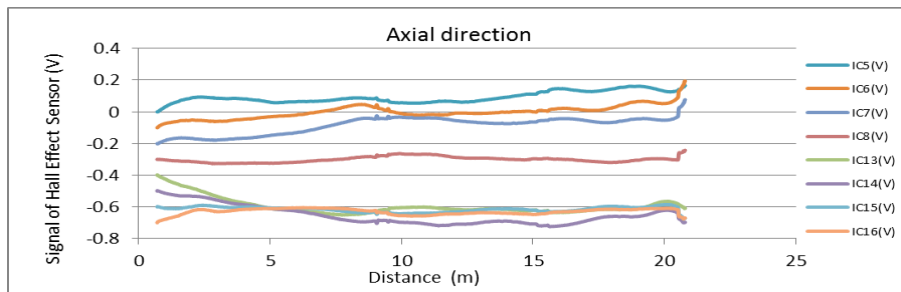
Figure A159. MMFM data of P8-402R-I2 tendon section.

File Name 【Pier-Tendon-Section】	Section Total Length (m)	Scanned Length		Note			
		Starting Point (m)	Ending Point (m)				
P8-402R-I2	21.48	0.7	20.8	Joint position: 9.2 m			
Identified Damage 1				Identified Damage 2			
Max Loss Point (m)	Section Loss (%)	Damage Length (m)	Damage Orientation	Max Loss Point (m)	Section Loss (%)	Damage Length (m)	Damage Orientation
—	—	—	—	—	—	—	—

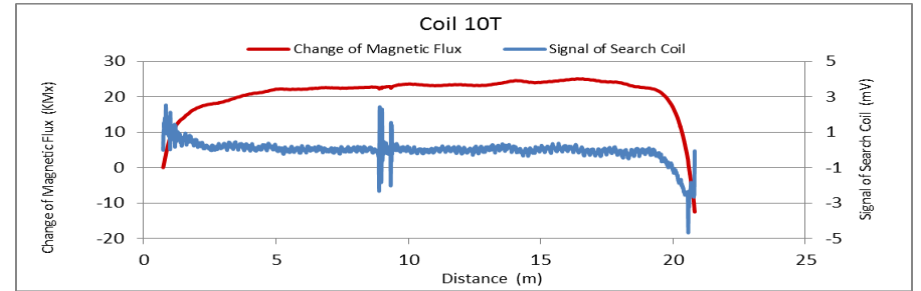
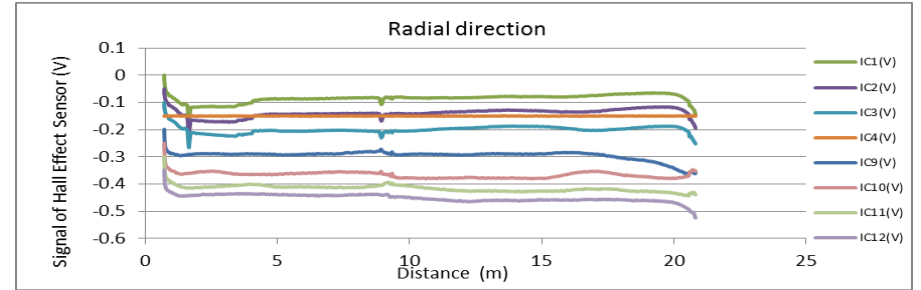
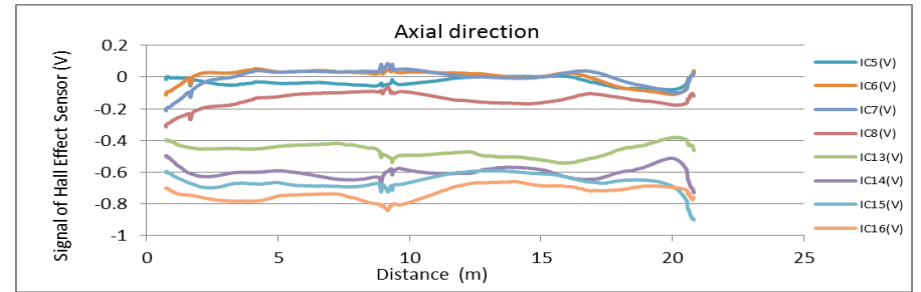
Figure A160. MMFM data of P8-401L-I2 tendon section.

File Name 【Pier-Tendon-Section】	Section Total Length (m)	Scanned Length		Note			
		Starting Point (m)	Ending Point (m)				
P8-401L-I2	21.47	0.73	21.01	Joint position: 9.17 m			
Identified Damage 1				Identified Damage 2			
Max Loss Point (m)	Section Loss (%)	Damage Length (m)	Damage Orientation	Max Loss Point (m)	Section Loss (%)	Damage Length (m)	Damage Orientation
—	—	—	—	—	—	—	—

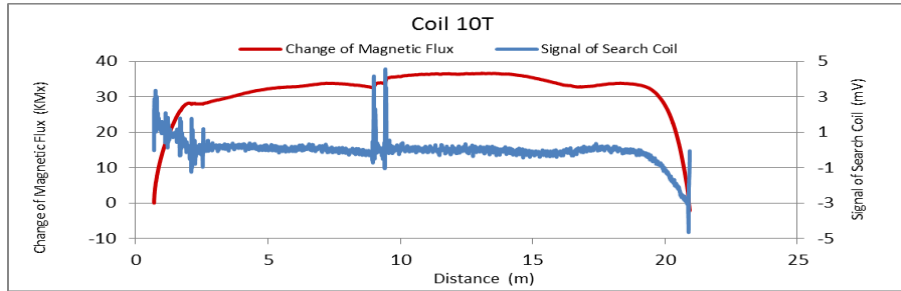
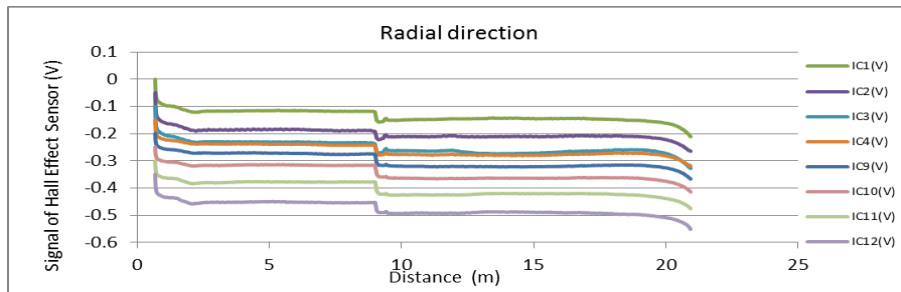
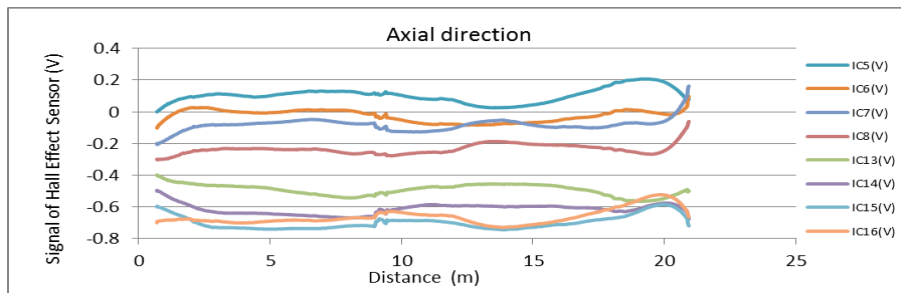
Figure A161. MMFM data of P8-402L-I2 tendon section.

File Name 【Pier-Tendon-Section】	Section Total Length (m)	Scanned Length		Note			
		Starting Point (m)	Ending Point (m)				
P8-402L-I2	21.47	0.69	20.93	Joint position: 9.2 m			
Identified Damage 1				Identified Damage 2			
Max Loss Point (m)	Section Loss (%)	Damage Length (m)	Damage Orientation	Max Loss Point (m)	Section Loss (%)	Damage Length (m)	Damage Orientation
—	—	—	—	—	—	—	—

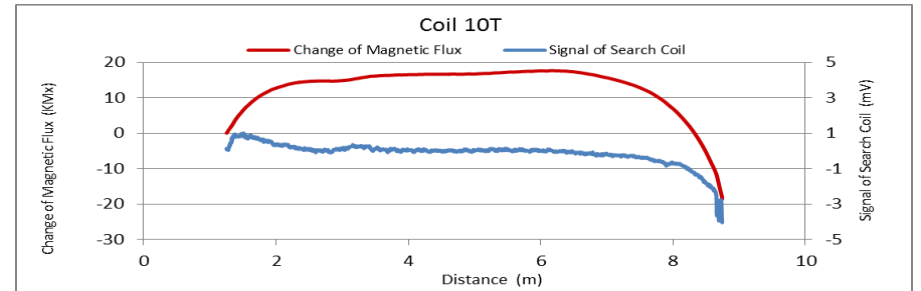
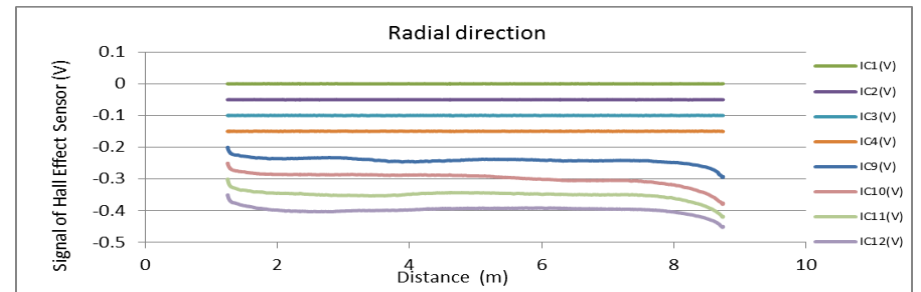
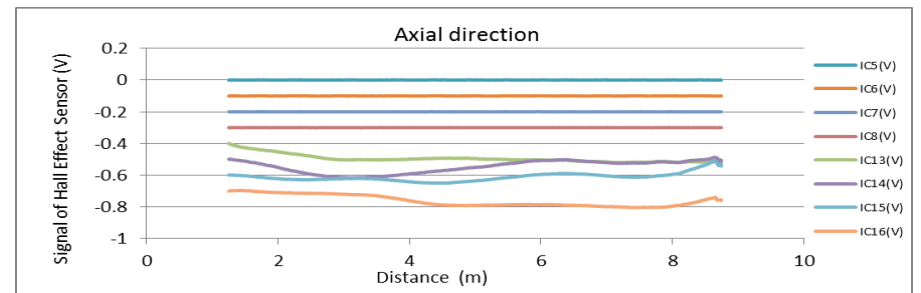
Figure A162. MMFM data of P8-401R-H2 tendon section.

File Name 【Pier-Tendon-Section】	Section Total Length (m)	Scanned Length		Note			
		Starting Point (m)	Ending Point (m)				
P8-401R-H2	9.34	1.25	8.82				
Identified Damage 1				Identified Damage 2			
Max Loss Point (m)	Section Loss (%)	Damage Length (m)	Damage Orientation	Max Loss Point (m)	Section Loss (%)	Damage Length (m)	Damage Orientation
—	—	—	—	—	—	—	—

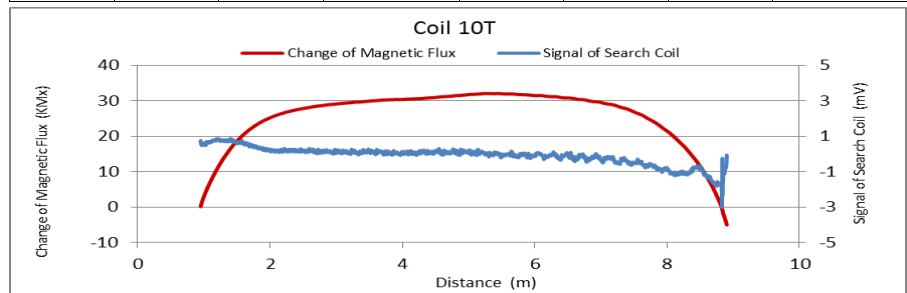
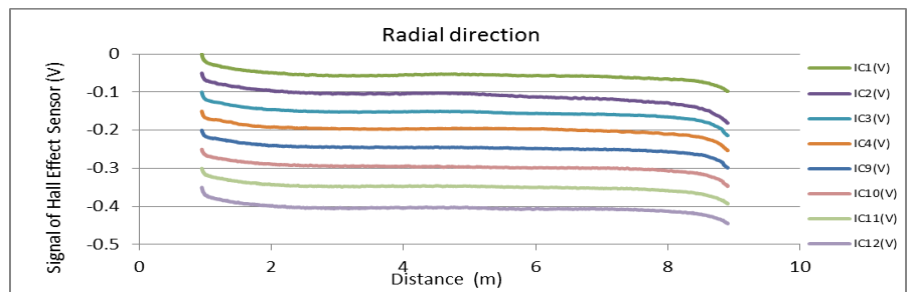
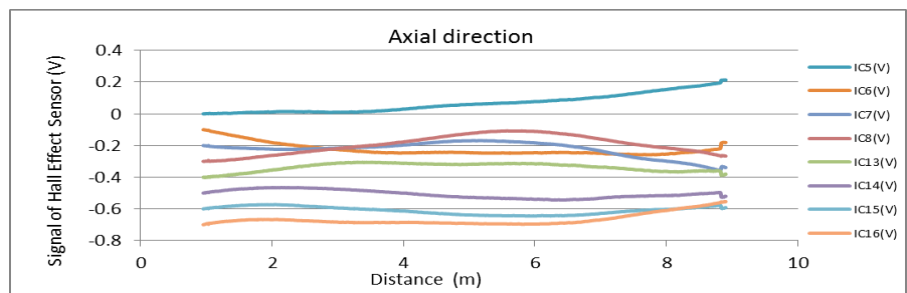
Figure A163. MMFM data of P8-402R-H1 tendon section.

File Name 【Pier-Tendon-Section】	Section Total Length (m)	Scanned Length		Note			
		Starting Point (m)	Ending Point (m)				
P8-402R-H1	9.34	0.95	8.92				
Identified Damage 1				Identified Damage 2			
Max Loss Point (m)	Section Loss (%)	Damage Length (m)	Damage Orientation	Max Loss Point (m)	Section Loss (%)	Damage Length (m)	Damage Orientation
—	—	—	—	—	—	—	—
