**Development of Quality Assurance and Quality Control
System for Post Tensioned Segmental Bridges in Florida:
Case of Ringling Bridge – Phase II**

**FDOT Contract No. BDV29-977-34
FINAL REPORT**

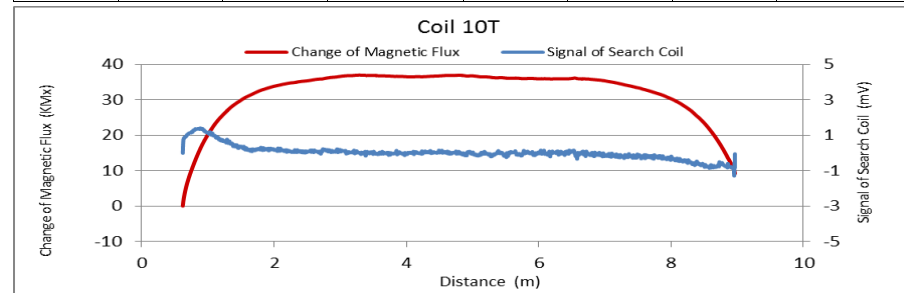
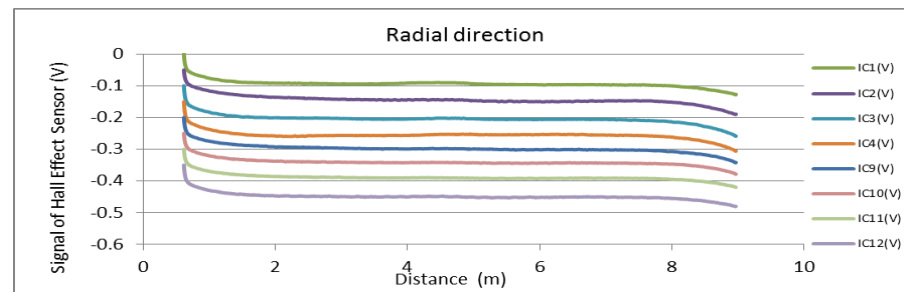
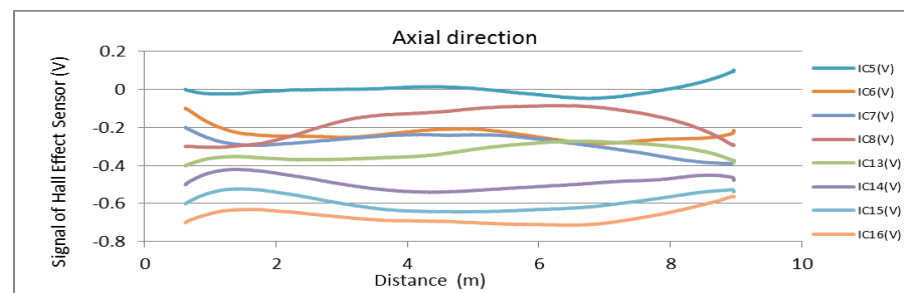
Figure A164. MMFM data of P8-401L-H2 tendon section.

File Name 【Pier-Tendon-Section】	Section Total Length (m)	Scanned Length		Note			
		Starting Point (m)	Ending Point (m)				
P8-401L-H2	9.36	0.62	8.97				
Identified Damage 1				Identified Damage 2			
Max Loss Point (m)	Section Loss (%)	Damage Length (m)	Damage Orientation	Max Loss Point (m)	Section Loss (%)	Damage Length (m)	Damage Orientation
—	—	—	—	—	—	—	—

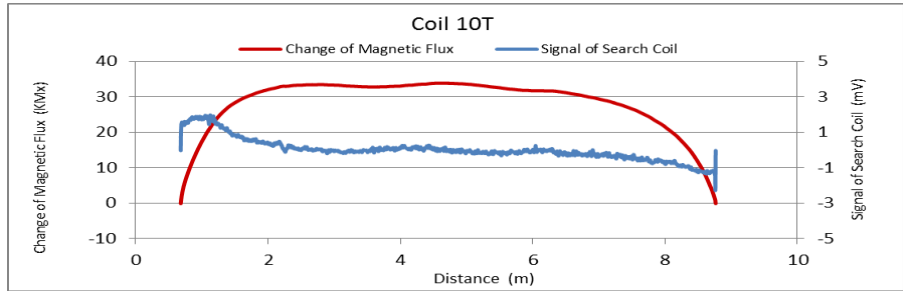
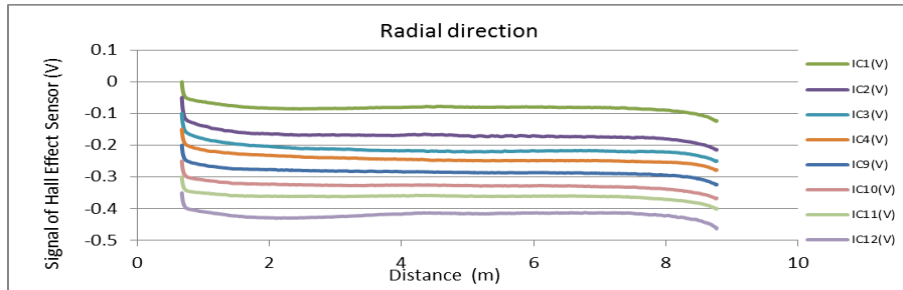
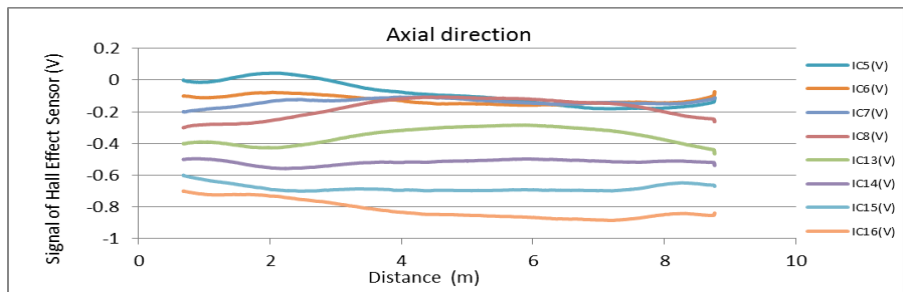
Figure A165. MMFM data of P8-402L-H2 tendon section.

File Name 【Pier-Tendon-Section】	Section Total Length (m)	Scanned Length		Note			
		Starting Point (m)	Ending Point (m)				
P8-402L-H2	9.36	0.68	8.77				
Identified Damage 1				Identified Damage 2			
Max Loss Point (m)	Section Loss (%)	Damage Length (m)	Damage Orientation	Max Loss Point (m)	Section Loss (%)	Damage Length (m)	Damage Orientation
—	—	—	—	—	—	—	—

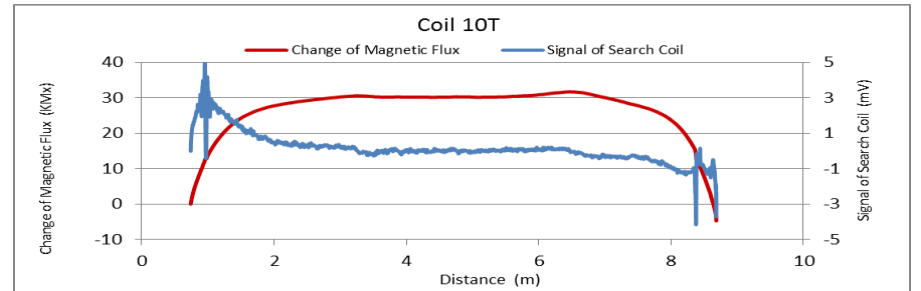
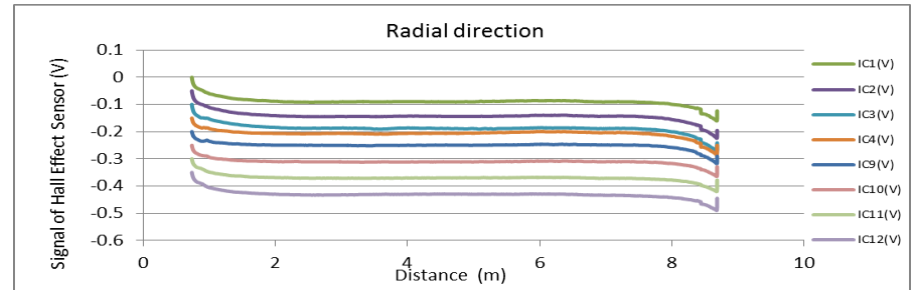
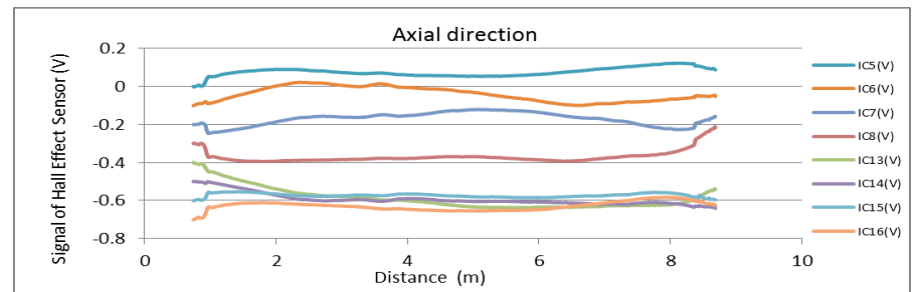
Figure A166. MMFM data of P9-401R-H1 tendon section.

File Name 【Pier-Tendon-Section】	Section Total Length (m)	Scanned Length		Note			
		Starting Point (m)	Ending Point (m)				
P9-401R-H1	9.33	0.74	8.7				
Identified Damage 1				Identified Damage 2			
Max Loss Point (m)	Section Loss (%)	Damage Length (m)	Damage Orientation	Max Loss Point (m)	Section Loss (%)	Damage Length (m)	Damage Orientation
—	—	—	—	—	—	—	—

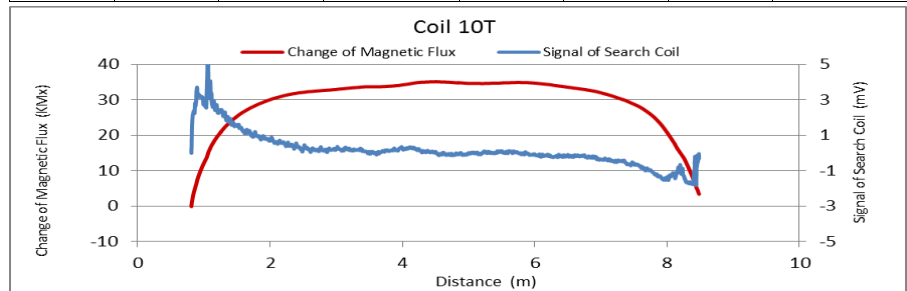
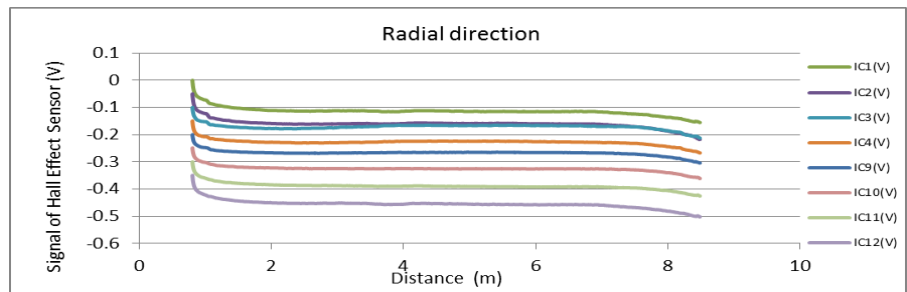
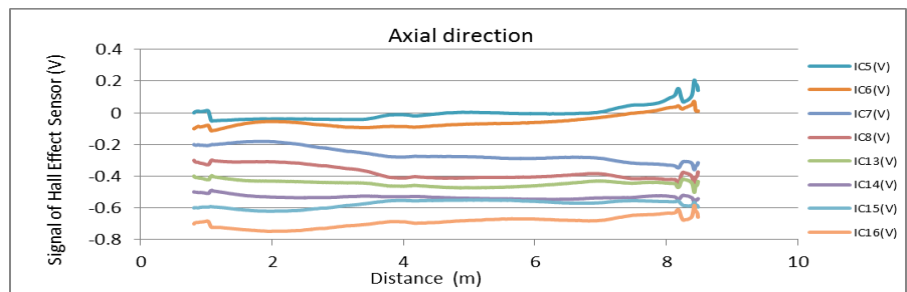
File Name 【Pier-Tendon-Section】	Section Total Length (m)	Scanned Length		Note			
		Starting Point (m)	Ending Point (m)				
P9-402R-H1	9.33	0.81	8.49				
Identified Damage 1				Identified Damage 2			
Max Loss Point (m)	Section Loss (%)	Damage Length (m)	Damage Orientation	Max Loss Point (m)	Section Loss (%)	Damage Length (m)	Damage Orientation
—	—	—	—	—	—	—	—

Figure A167. MMFM data of P9-402R-H1 tendon section.

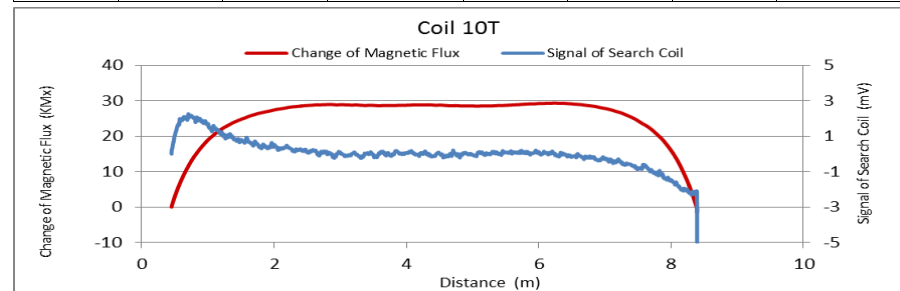
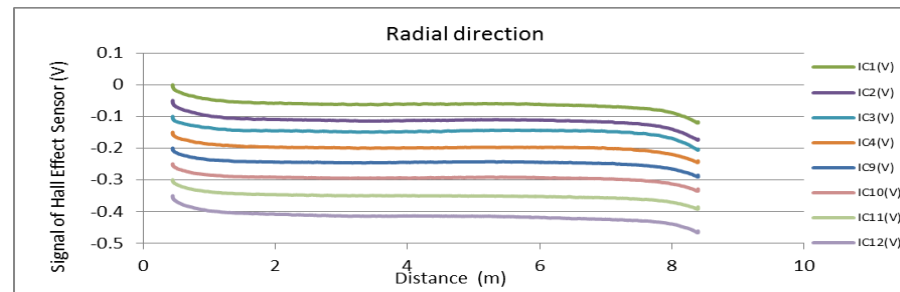
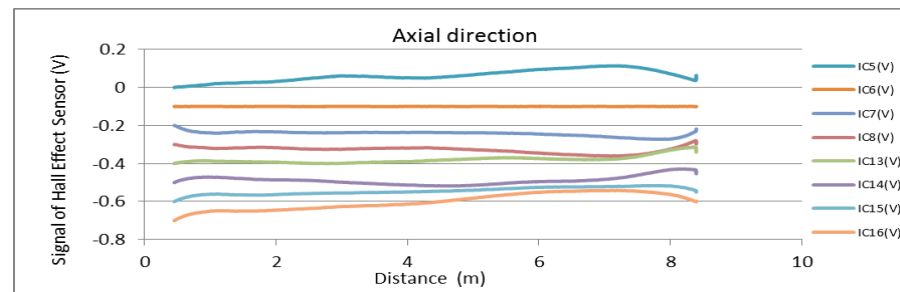
File Name 【Pier-Tendon-Section】	Section Total Length (m)	Scanned Length		Note			
		Starting Point (m)	Ending Point (m)				
P9-401L-H1	9.28	0.45	8.43				
Identified Damage 1				Identified Damage 2			
Max Loss Point (m)	Section Loss (%)	Damage Length (m)	Damage Orientation	Max Loss Point (m)	Section Loss (%)	Damage Length (m)	Damage Orientation
—	—	—	—	—	—	—	—

Figure A168. MMFM data of P9-401L-H1 tendon section.

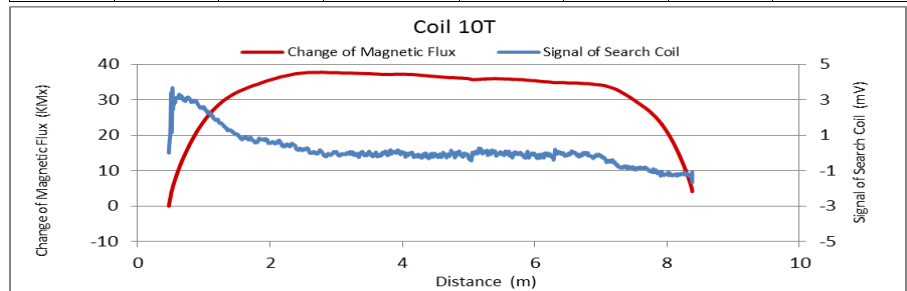
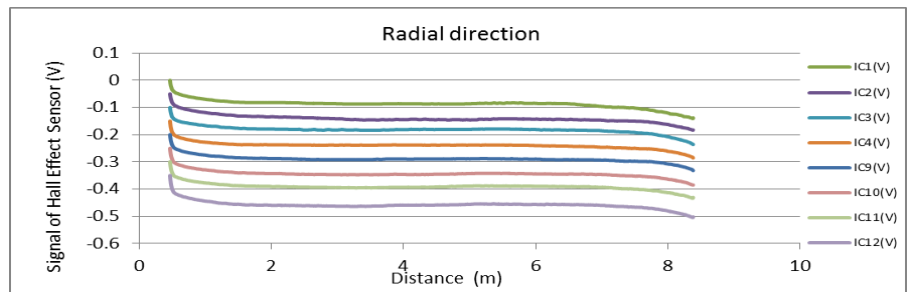
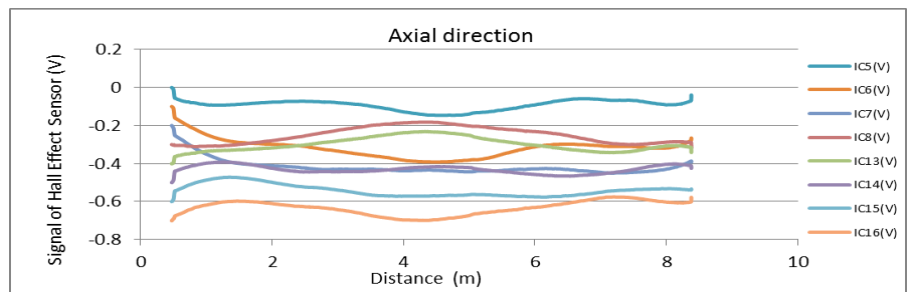
File Name 【Pier-Tendon-Section】	Section Total Length (m)	Scanned Length		Note			
		Starting Point (m)	Ending Point (m)				
P9-402L-H1	9.28	0.47	8.43				
Identified Damage 1				Identified Damage 2			
Max Loss Point (m)	Section Loss (%)	Damage Length (m)	Damage Orientation	Max Loss Point (m)	Section Loss (%)	Damage Length (m)	Damage Orientation
—	—	—	—	—	—	—	—

Figure A169. MMFM data of P9-402L-H1 tendon section.

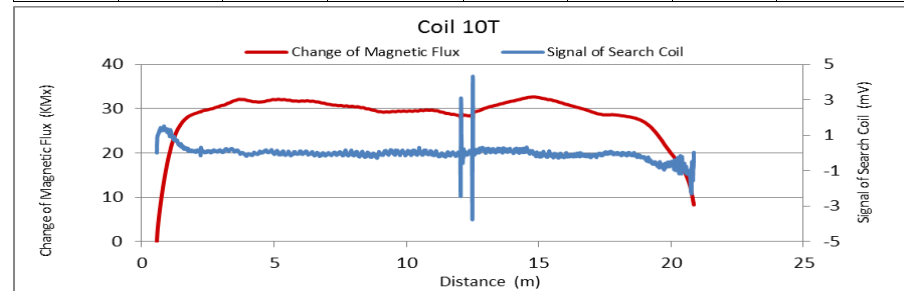
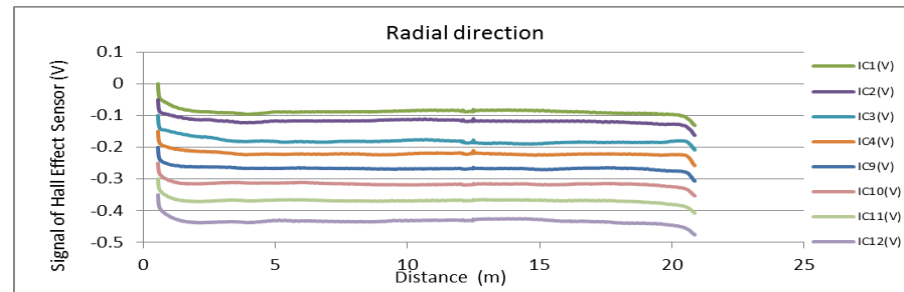
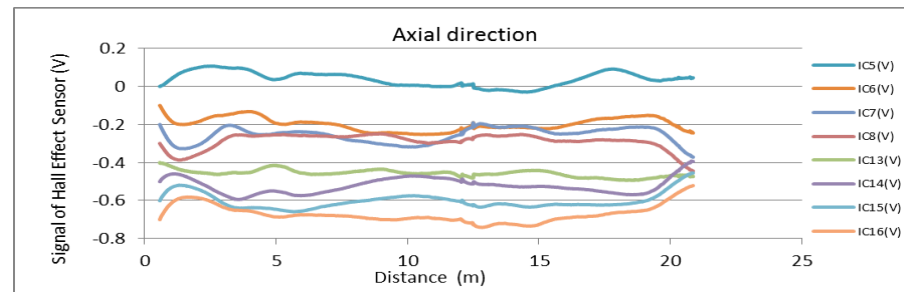
File Name 【Pier-Tendon-Section】	Section Total Length (m)	Scanned Length		Note			
		Starting Point (m)	Ending Point (m)				
P9-402R-I1	21.57	0.57	20.86	Joint position: 12.26 m			
Identified Damage 1				Identified Damage 2			
Max Loss Point (m)	Section Loss (%)	Damage Length (m)	Damage Orientation	Max Loss Point (m)	Section Loss (%)	Damage Length (m)	Damage Orientation
—	—	—	—	—	—	—	—

Figure A170. MMFM data of P9-402R-I1 tendon section.

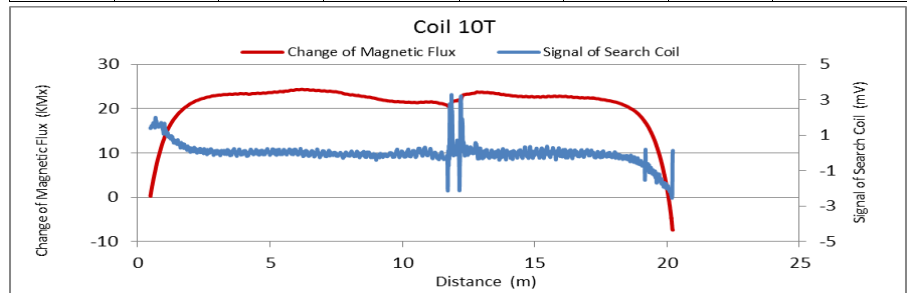
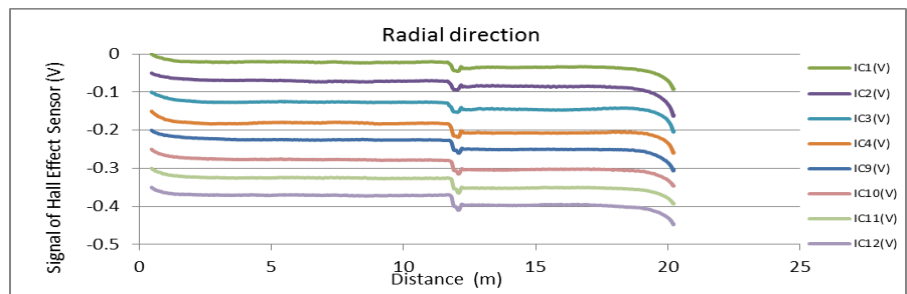
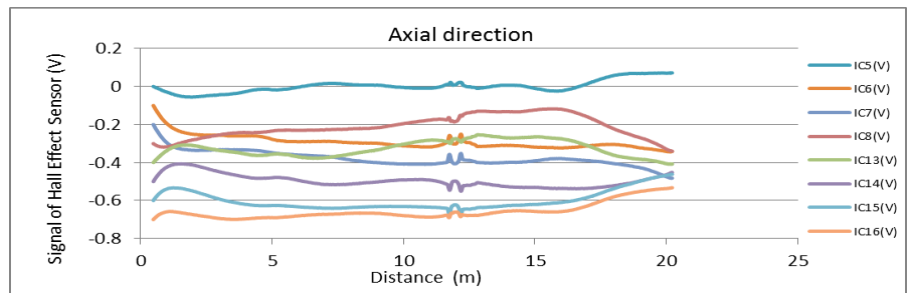
File Name 【Pier-Tendon-Section】	Section Total Length (m)	Scanned Length		Note			
		Starting Point (m)	Ending Point (m)				
P9-401L-I1	21.53	0.47	20.48	Joint position: 12.28 m			
Identified Damage 1				Identified Damage 2			
Max Loss Point (m)	Section Loss (%)	Damage Length (m)	Damage Orientation	Max Loss Point (m)	Section Loss (%)	Damage Length (m)	Damage Orientation
—	—	—	—	—	—	—	—

Figure A171. MMFM data of P9-401L-I1 tendon section.

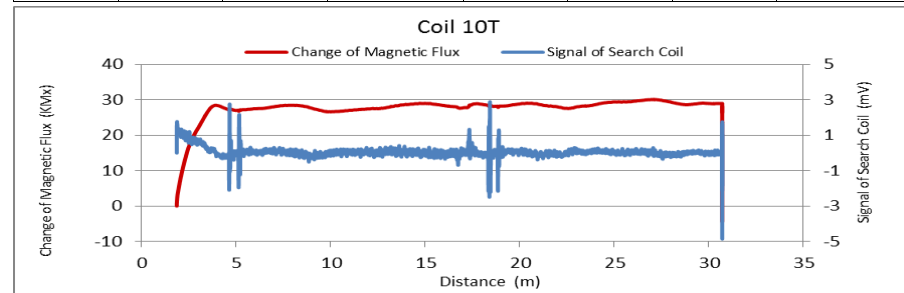
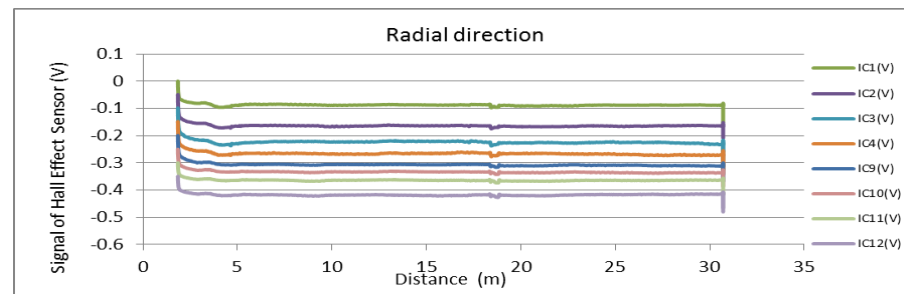
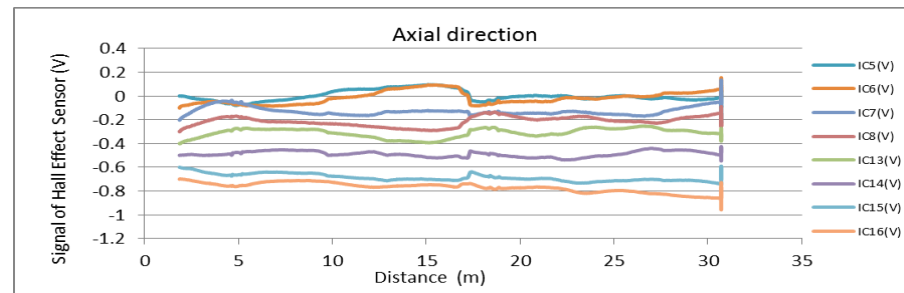
File Name 【Pier-Tendon-Section】	Section Total Length (m)	Scanned Length		Note			
		Starting Point (m)	Ending Point (m)				
P9-401R-I2	31.33	1.85	30.72	Joint position: 4.51 m, 16.61 m			
Identified damage 1				Identified damage 2			
Max Loss Point (m)	Section Loss (%)	Damage Length (m)	Damage Orientation	Max Loss Point (m)	Section Loss (%)	Damage Length (m)	Damage Orientation
—	—	—	—	—	—	—	—

Figure A172. MMFM data of P9-401R-I2 tendon section.

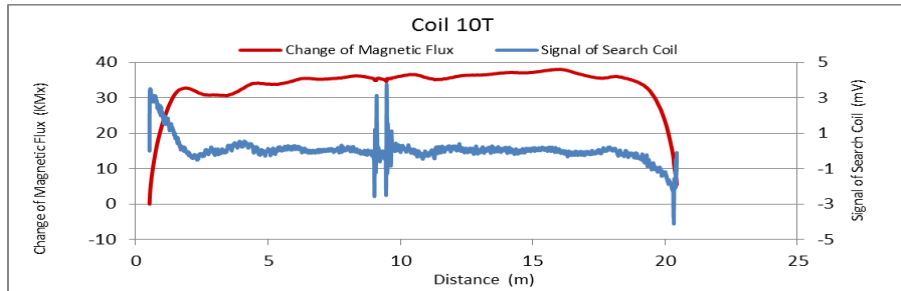
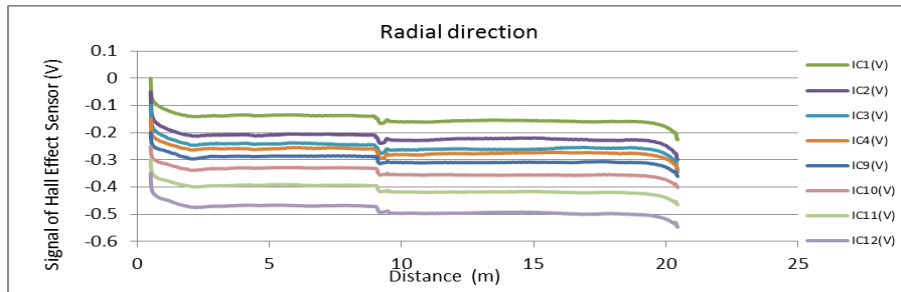
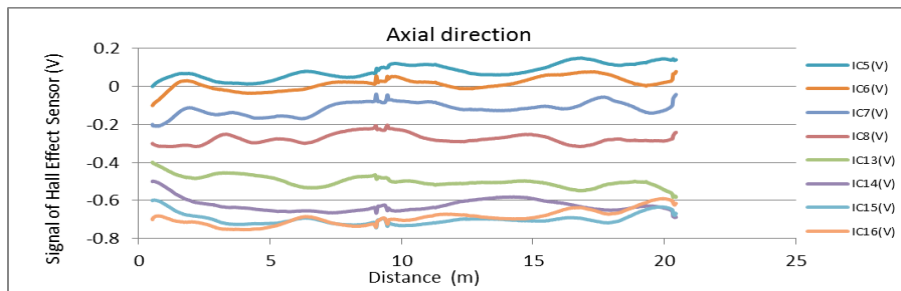
File Name 【Pier-Tendon-Section】	Section Total Length (m)	Scanned Length		Note			
		Starting Point (m)	Ending Point (m)				
P9-401L-I2	21.51	0.52	20.44	Joint position: 9.27 m			
Identified Damage 1				Identified Damage 2			
Max Loss Point (m)	Section Loss (%)	Damage Length (m)	Damage Orientation	Max Loss Point (m)	Section Loss (%)	Damage Length (m)	Damage Orientation
—	—	—	—	—	—	—	—

Figure A173. MMFM data of P9-401L-I2 tendon section.

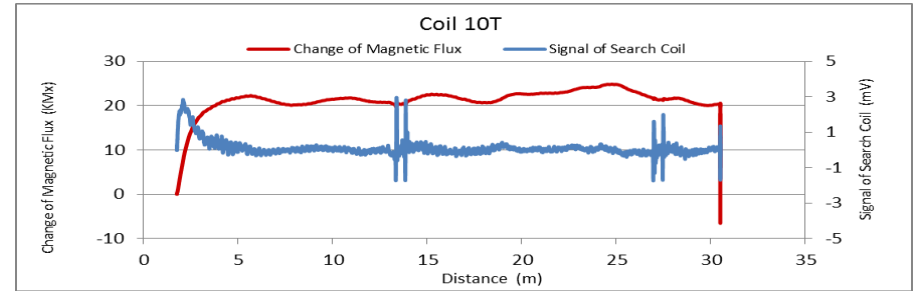
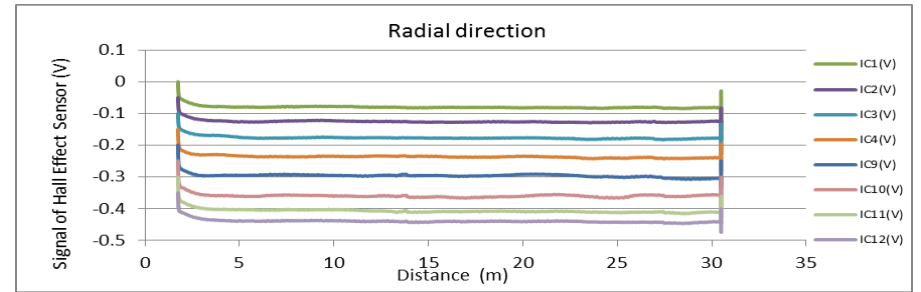
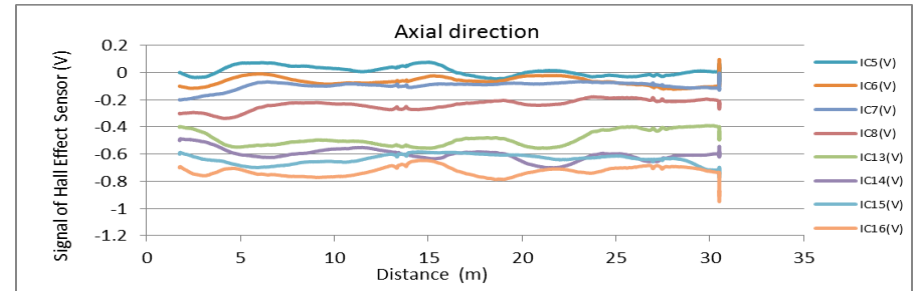
File Name 【Pier-Tendon-Section】	Section Total Length (m)	Scanned Length		Note			
		Starting Point (m)	Ending Point (m)				
P9-402L-I2	31.34	1.75	30.8	Joint position: 13.65 m, 27.25 m			
Identified Damage 1				Identified Damage 2			
Max Loss Point (m)	Section Loss (%)	Damage Length (m)	Damage Orientation	Max Loss Point (m)	Section Loss (%)	Damage Length (m)	Damage Orientation
—	—	—	—	—	—	—	—

Figure A174. MMFM data of P9-402L-I2 tendon section.

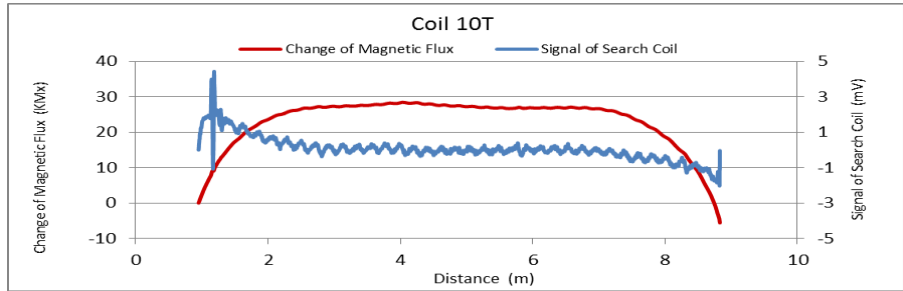
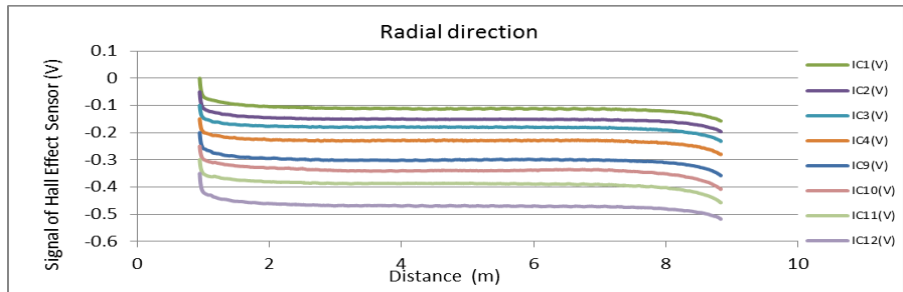
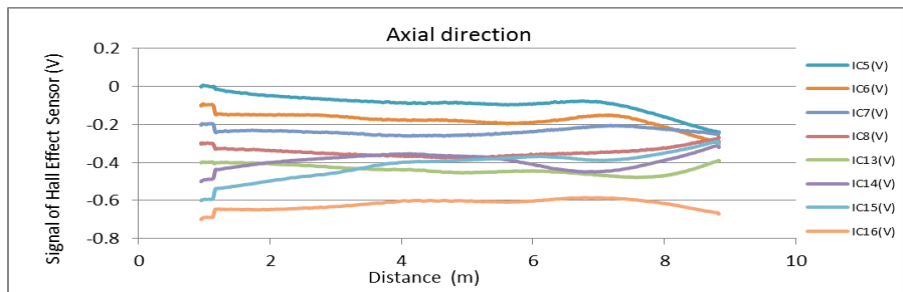
File Name 【Pier-Tendon-Section】	Section Total Length (m)	Scanned Length		Note			
		Starting Point (m)	Ending Point (m)				
P9-402R-H2	9.38	0.95	8.88				
Identified Damage 1				Identified Damage 2			
Max Loss Point (m)	Section Loss (%)	Damage Length (m)	Damage Orientation	Max Loss Point (m)	Section Loss (%)	Damage Length (m)	Damage Orientation
—	—	—	—	—	—	—	—

Figure A175. MMFM data of P9-402R-H2 tendon section.

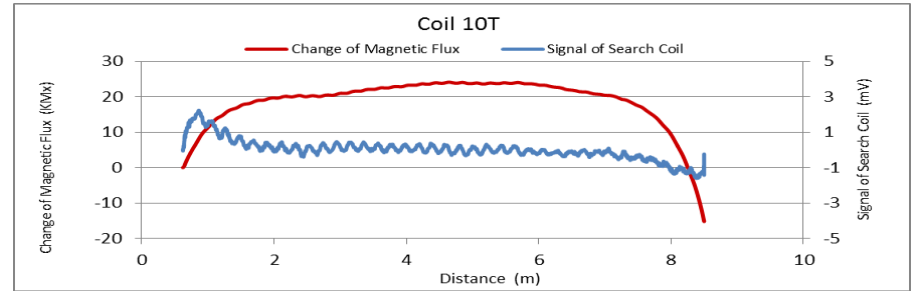
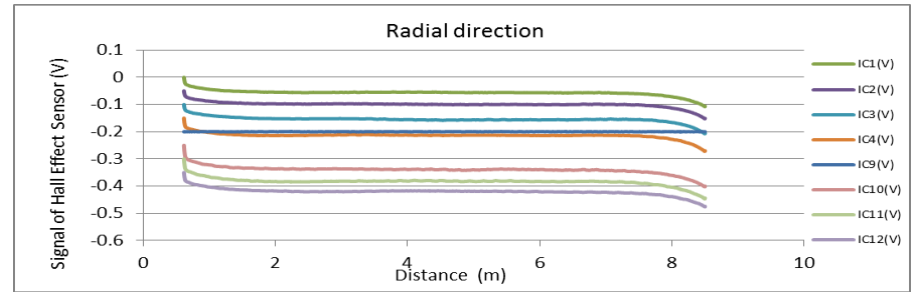
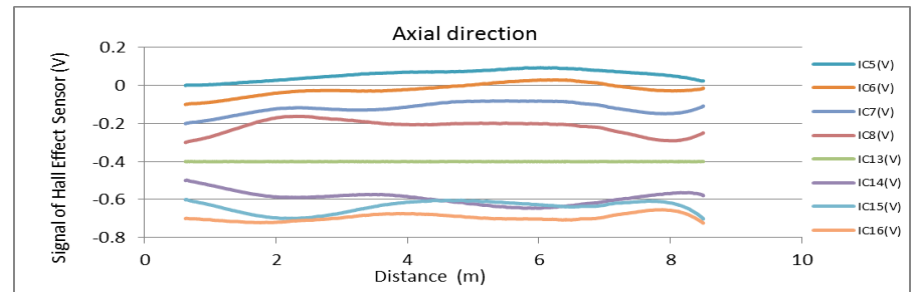
File Name 【Pier-Tendon-Section】	Section Total Length (m)	Scanned Length		Note			
		Starting Point (m)	Ending Point (m)				
P10-402R-H1	9.4	0.62	8.59				
Identified Damage 1				Identified Damage 2			
Max Loss Point (m)	Section Loss (%)	Damage Length (m)	Damage Orientation	Max Loss Point (m)	Section Loss (%)	Damage Length (m)	Damage Orientation
—	—	—	—	—	—	—	—

Figure A176. MMFM data of P10-402R-H1 tendon section.

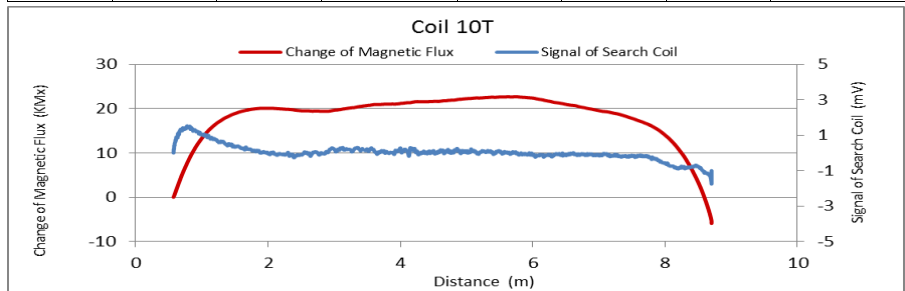
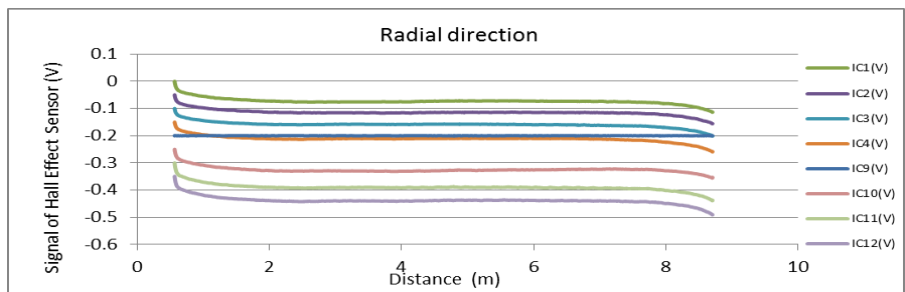
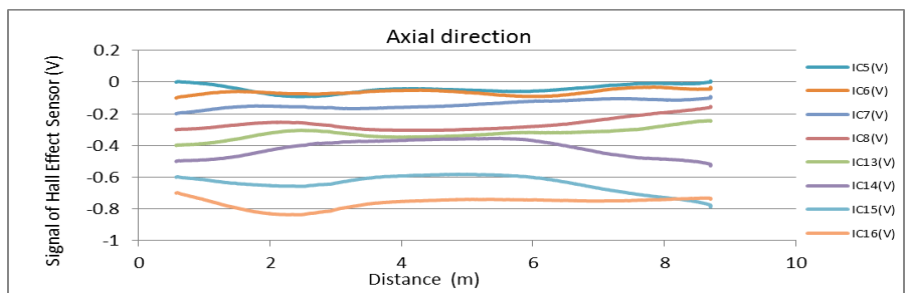
File Name 【Pier-Tendon-Section】	Section Total Length (m)	Scanned Length		Note			
		Starting Point (m)	Ending Point (m)				
P10-401L-H1	9.5	0.57	8.77				
Identified Damage 1				Identified Damage 2			
Max Loss Point (m)	Section Loss (%)	Damage Length (m)	Damage Orientation	Max Loss Point (m)	Section Loss (%)	Damage Length (m)	Damage Orientation
—	—	—	—	—	—	—	—

Figure A177. MMFM data of P10-401L-H1 tendon section.

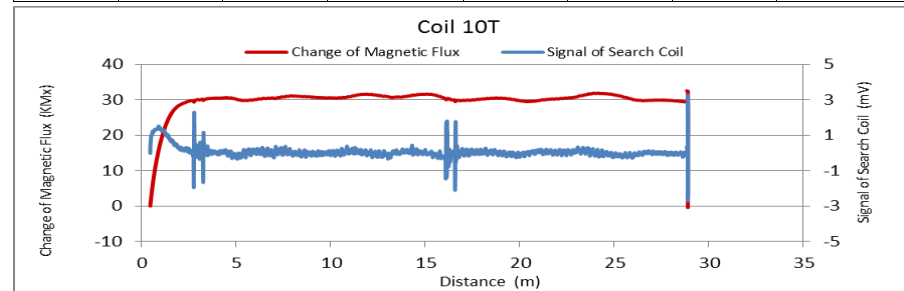
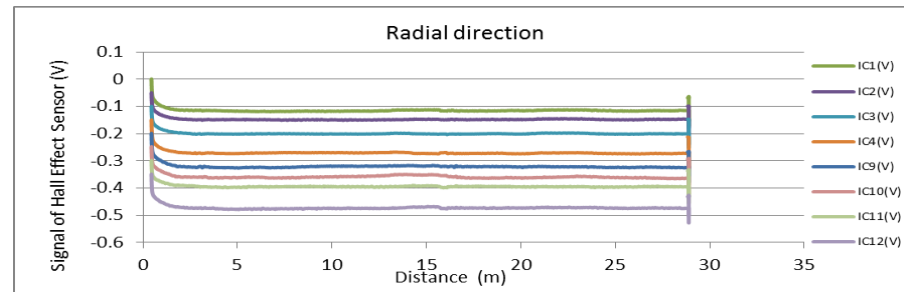
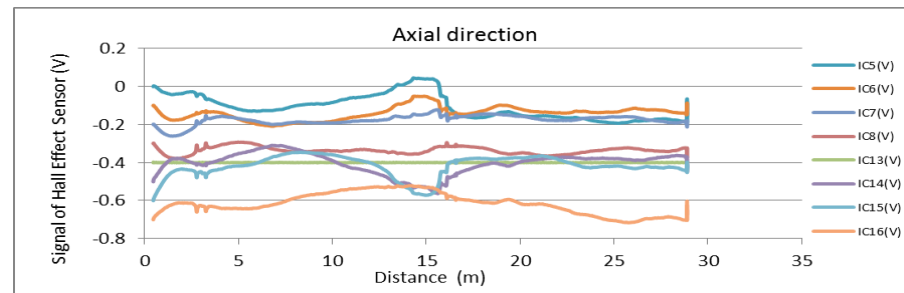
File Name 【Pier-Tendon-Section】	Section Total Length (m)	Scanned Length		Note			
		Starting Point (m)	Ending Point (m)				
P10-402L-I1	31.37	0.45	29.32	Joint position: 3.07 m, 16.3 m			
Identified Damage 1				Identified Damage 2			
Max Loss Point (m)	Section Loss (%)	Damage Length (m)	Damage Orientation	Max Loss Point (m)	Section Loss (%)	Damage Length (m)	Damage Orientation
—	—	—	—	—	—	—	—

Figure A178. MMFM data of P10-402L-I1 tendon section.

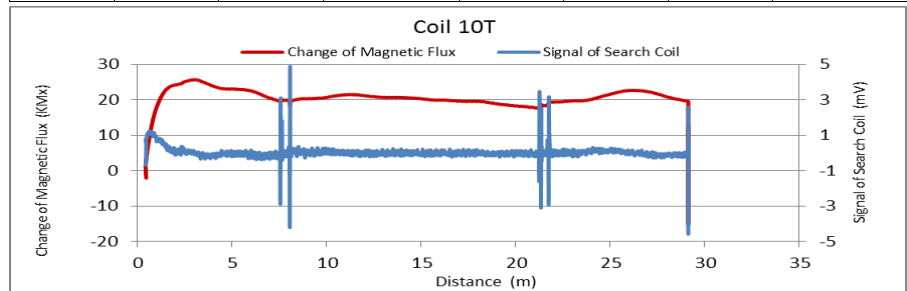
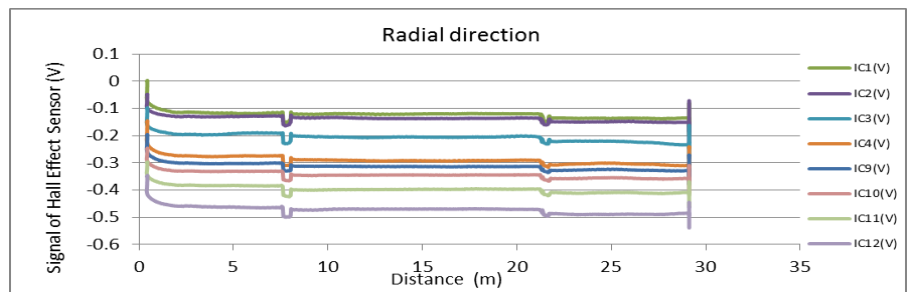
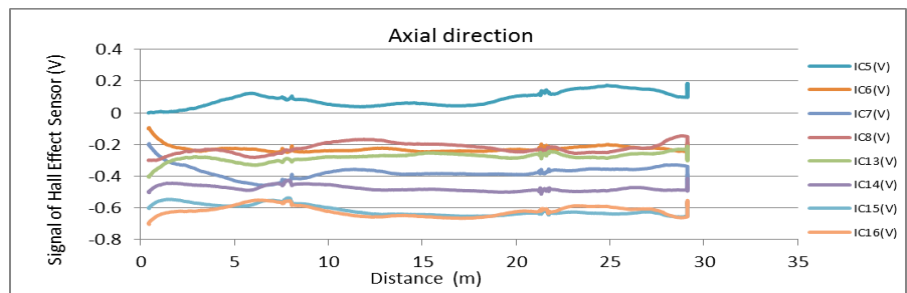
File Name 【Pier-Tendon-Section】	Section Total Length (m)	Scanned Length		Note			
		Starting Point (m)	Ending Point (m)				
P10-401R-I1	31.33	0.41	29.16	Joint position: 7.8 m, 21.4 m			
Identified Damage 1				Identified Damage 2			
Max Loss Point (m)	Section Loss (%)	Damage Length (m)	Damage Orientation	Max Loss Point (m)	Section Loss (%)	Damage Length (m)	Damage Orientation
—	—	—	—	—	—	—	—

Figure A179. MMFM data of P10-401R-I1 tendon section.

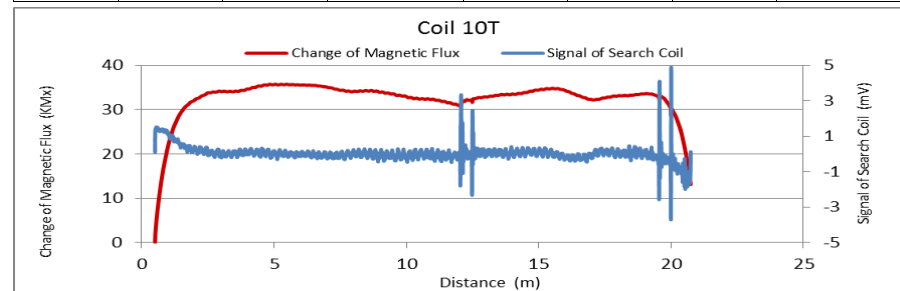
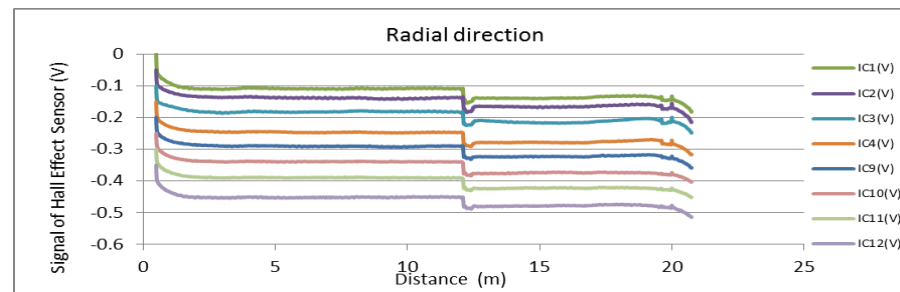
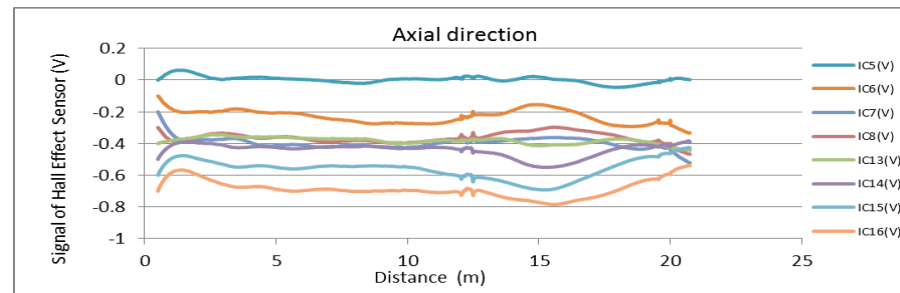
Figure A180. MMFM data of P10-402R-I1 tendon section.

File Name 【Pier-Tendon-Section】	Section Total Length (m)	Scanned Length		Note			
		Starting Point (m)	Ending Point (m)				
P10-402R-I1	21.47	0.5	20.76	Joint position: 12.31 m, 19.84 m			
Identified Damage 1				Identified Damage 2			
Max Loss Point (m)	Section Loss (%)	Damage Length (m)	Damage Orientation	Max Loss Point (m)	Section Loss (%)	Damage Length (m)	Damage Orientation
—	—	—	—	—	—	—	—

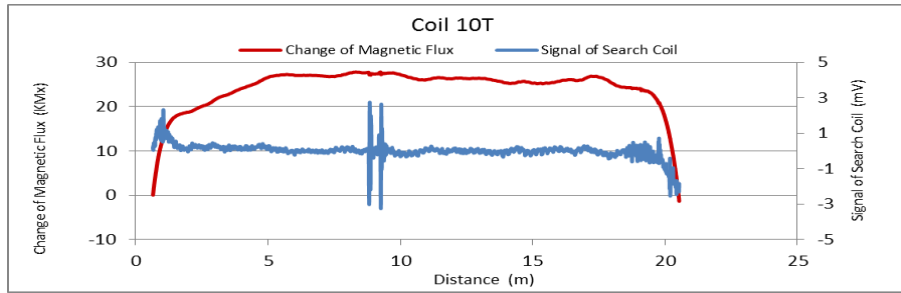
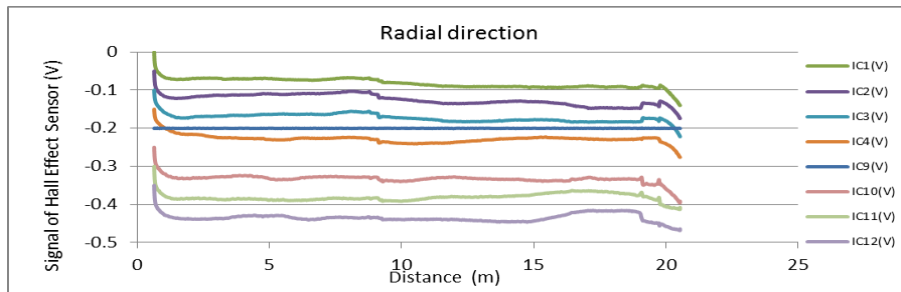
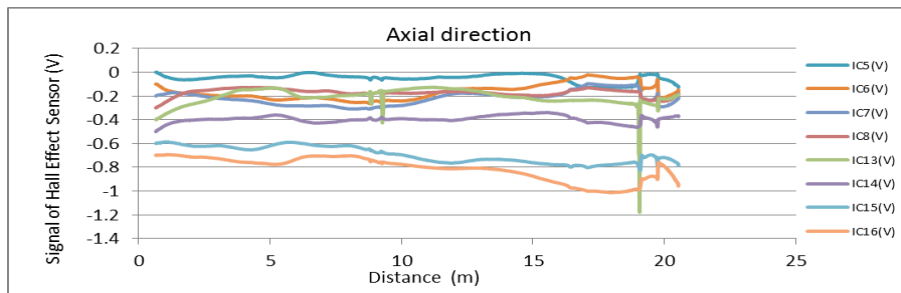
Figure A181. MMFM data of P10-401R-I2 tendon section.

File Name 【Pier-Tendon-Section】	Section Total Length (m)	Scanned Length		Note			
		Starting Point (m)	Ending Point (m)				
P10-401R-I2	21.42	0.65	20.7	Joint position: 9.06 m			
Identified Damage 1				Identified Damage 2			
Max Loss Point (m)	Section Loss (%)	Damage Length (m)	Damage Orientation	Max Loss Point (m)	Section Loss (%)	Damage Length (m)	Damage Orientation
—	—	—	—	—	—	—	—

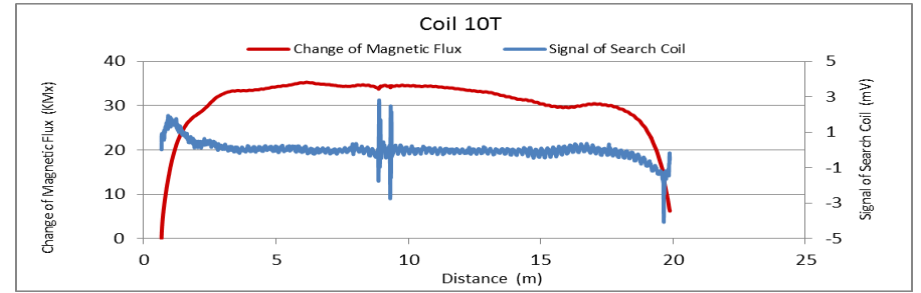
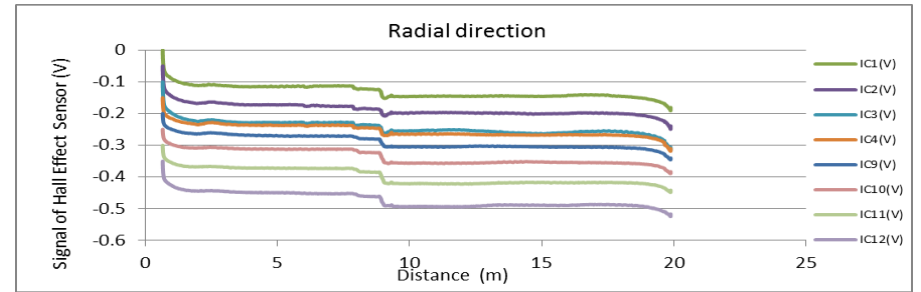
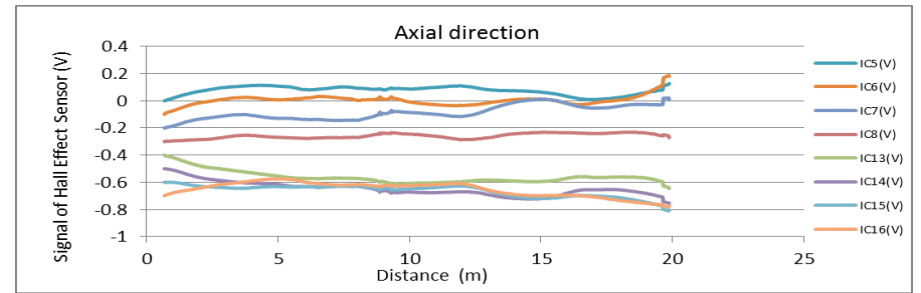
Figure A182. MMFM data of P10-402R-I2 tendon section.

File Name 【Pier-Tendon-Section】	Section Total Length (m)	Scanned Length		Note			
		Starting Point (m)	Ending Point (m)				
P10-402R-I2	21.38	0.67	19.88	Joint position: 9.1 m			
Identified Damage 1				Identified Damage 2			
Max Loss Point (m)	Section Loss (%)	Damage Length (m)	Damage Orientation	Max Loss Point (m)	Section Loss (%)	Damage Length (m)	Damage Orientation
—	—	—	—	—	—	—	—

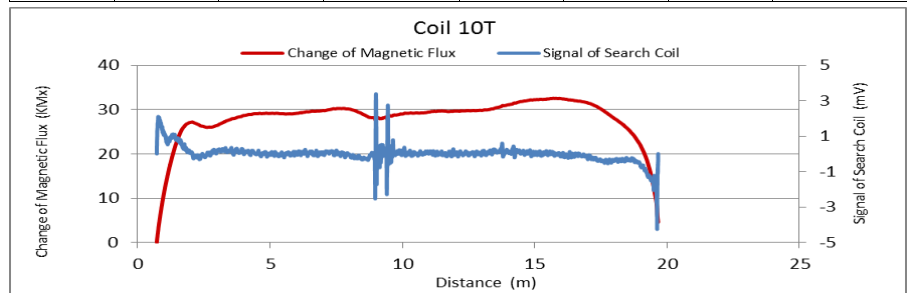
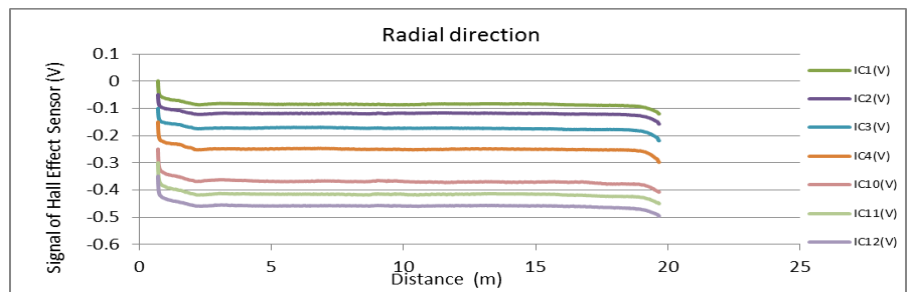
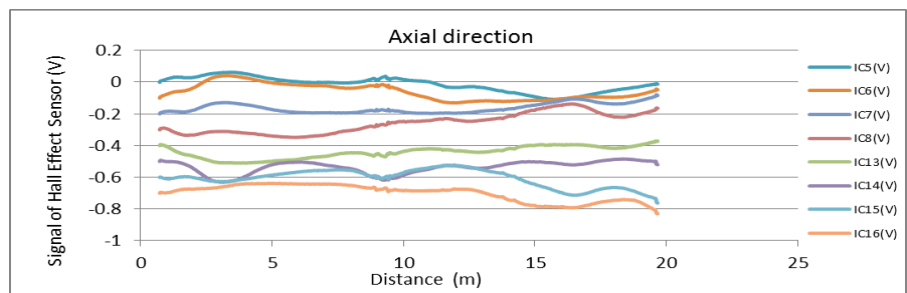
Figure A183. MMFM data of P10-401L-I2 tendon section.

File Name 【Pier-Tendon-Section】	Section Total Length (m)	Scanned Length		Note			
		Starting Point (m)	Ending Point (m)				
P10-401L-I2	21.5	0.72	19.87	Joint position: 9.15 m			
Identified Damage 1				Identified Damage 2			
Max Loss Point (m)	Section Loss (%)	Damage Length (m)	Damage Orientation	Max Loss Point (m)	Section Loss (%)	Damage Length (m)	Damage Orientation
—	—	—	—	—	—	—	—

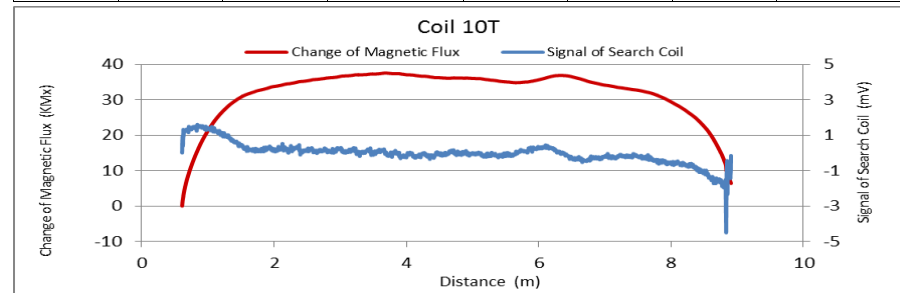
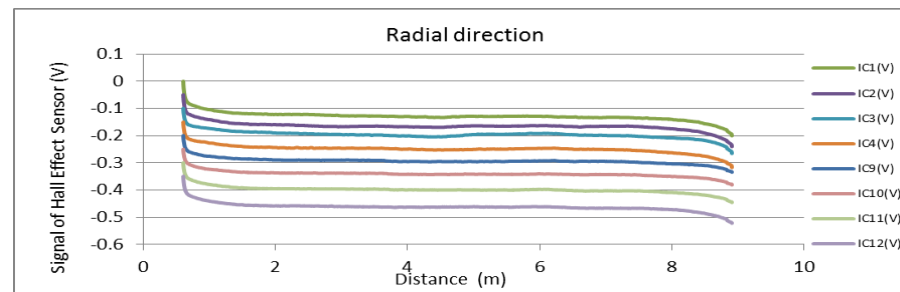
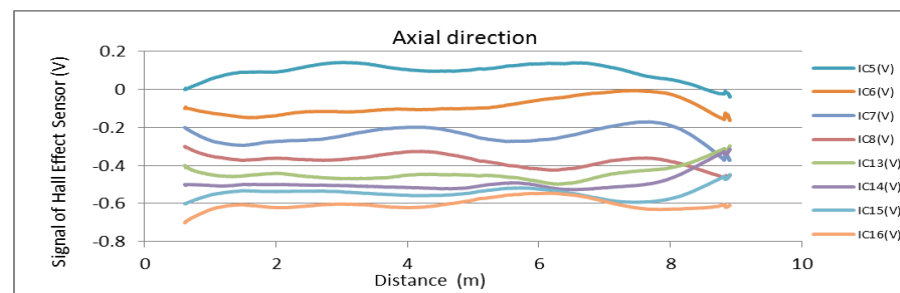
Figure A184. MMFM data of P10-401R-H1 tendon section.

File Name 【Pier-Tendon-Section】	Section Total Length (m)	Scanned Length		Note			
		Starting Point (m)	Ending Point (m)				
P10-401R-H1	9.33	0.61	8.91				
Identified Damage 1				Identified Damage 2			
Max Loss Point (m)	Section Loss (%)	Damage Length (m)	Damage Orientation	Max Loss Point (m)	Section Loss (%)	Damage Length (m)	Damage Orientation
—	—	—	—	—	—	—	—

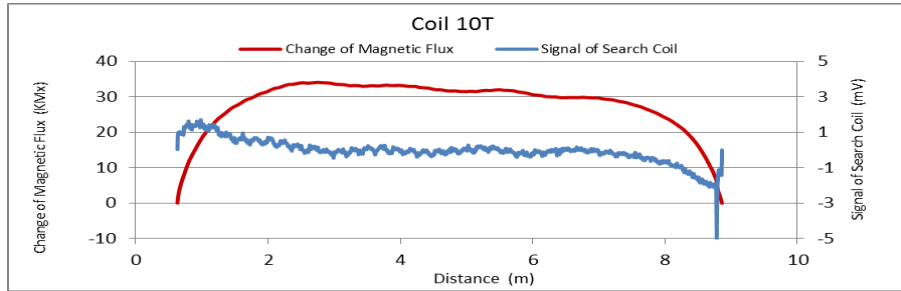
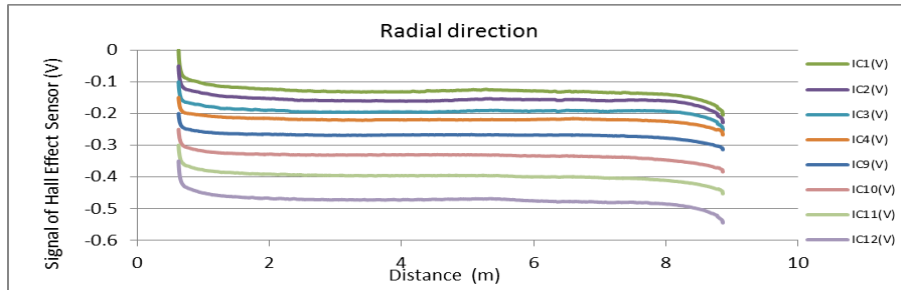
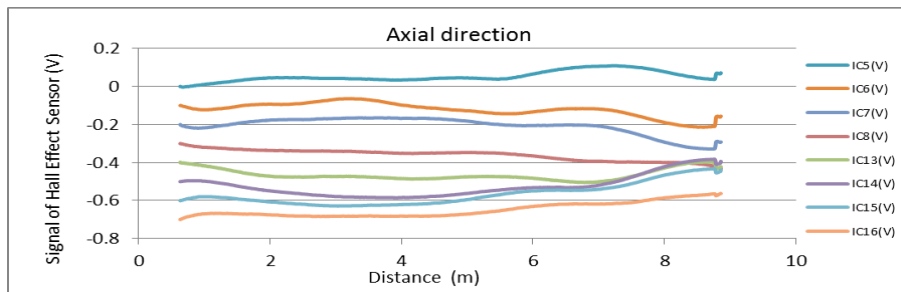
Figure A185. MMFM data of P10-402R-H2 tendon section.

File Name 【Pier-Tendon-Section】	Section Total Length (m)	Scanned Length		Note			
		Starting Point (m)	Ending Point (m)				
P10-402R-H2	9.33	0.63	8.86				
Identified Damage 1				Identified Damage 2			
Max Loss Point (m)	Section Loss (%)	Damage Length (m)	Damage Orientation	Max Loss Point (m)	Section Loss (%)	Damage Length (m)	Damage Orientation
—	—	—	—	—	—	—	—

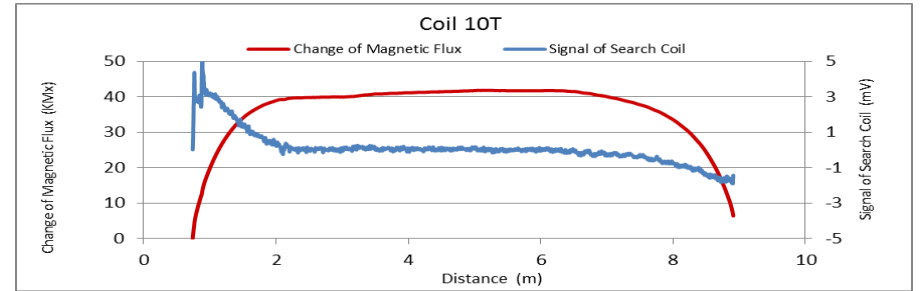
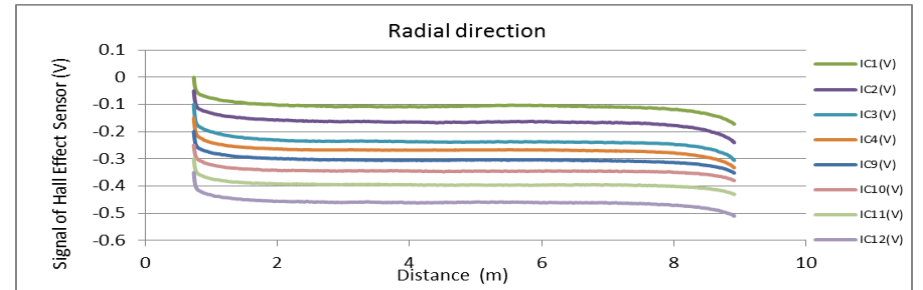
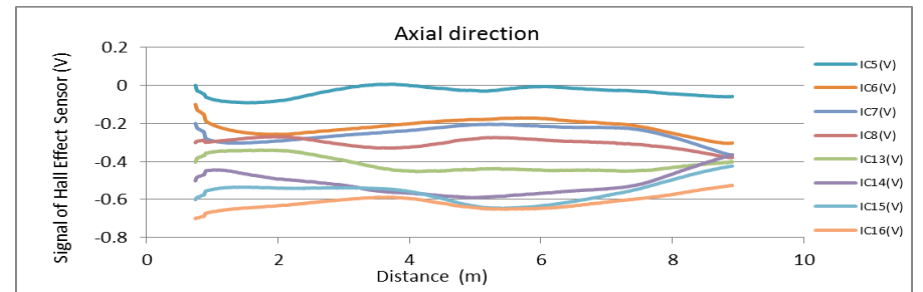
Figure A186. MMFM data of P10-401L-H2 tendon section.

File Name 【Pier-Tendon-Section】	Section Total Length (m)	Scanned Length		Note			
		Starting Point (m)	Ending Point (m)				
P10-401L-H2	9.41	0.74	8.91				
Identified Damage 1				Identified Damage 2			
Max Loss Point (m)	Section Loss (%)	Damage Length (m)	Damage Orientation	Max Loss Point (m)	Section Loss (%)	Damage Length (m)	Damage Orientation
—	—	—	—	—	—	—	—

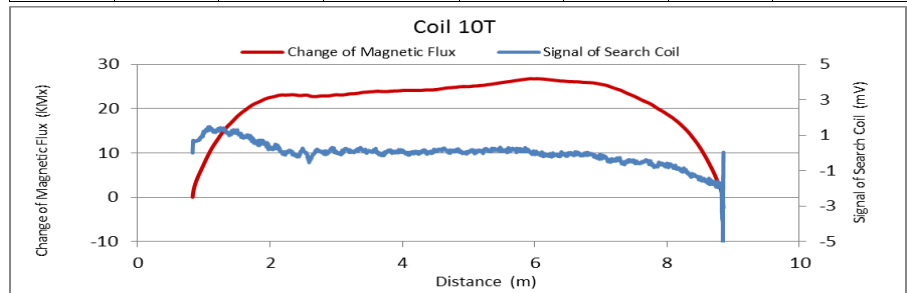
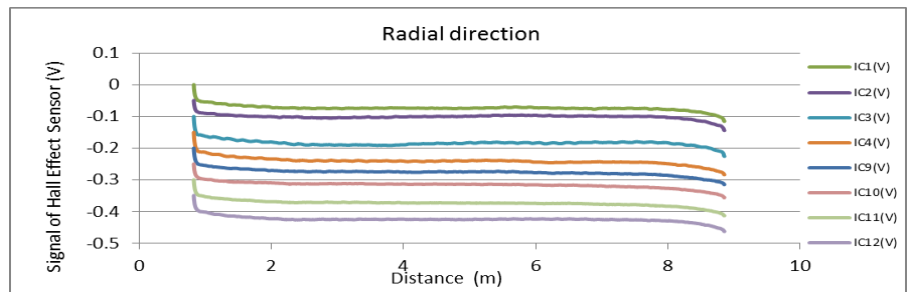
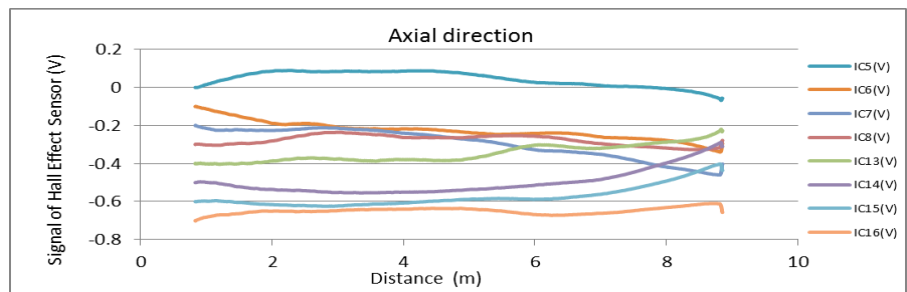
Figure A187. MMFM data of P10-402L-H1 tendon section.

File Name 【Pier-Tendon-Section】	Section Total Length (m)	Scanned Length		Note			
		Starting Point (m)	Ending Point (m)				
P10-402L-H1	9.41	0.83	8.86				
Identified Damage 1				Identified Damage 2			
Max Loss Point (m)	Section Loss (%)	Damage Length (m)	Damage Orientation	Max Loss Point (m)	Section Loss (%)	Damage Length (m)	Damage Orientation
—	—	—	—	—	—	—	—

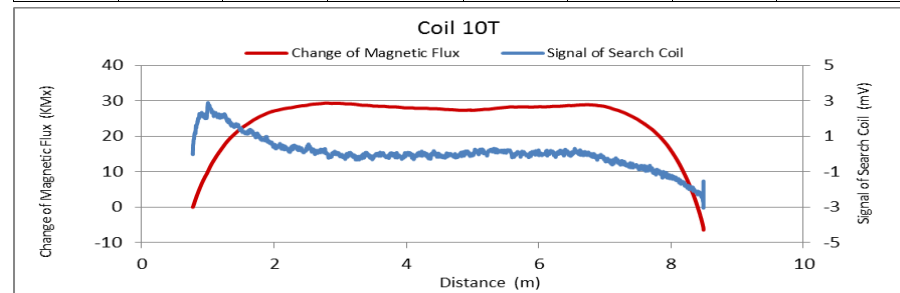
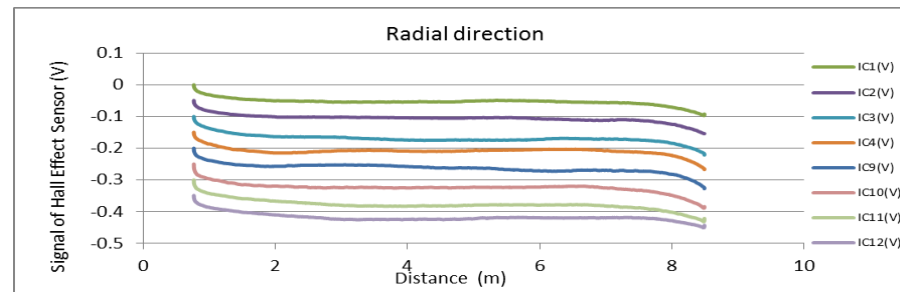
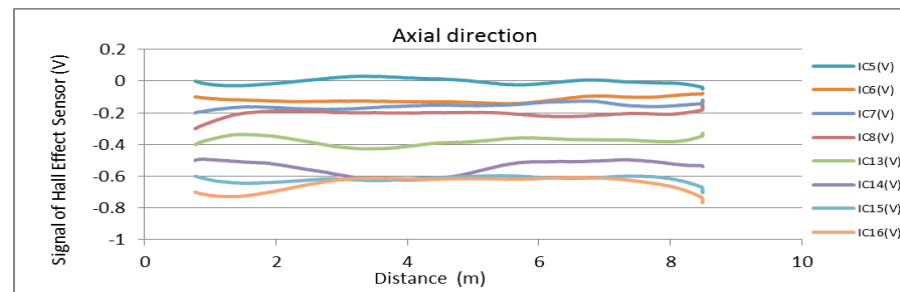
Figure A188. MMFM data of P11-401R-H1 tendon section.

File Name 【Pier-Tendon-Section】	Section Total Length (m)	Scanned Length		Note			
		Starting Point (m)	Ending Point (m)				
P11-401R-H1	9.4	0.77	8.52				
Identified Damage 1				Identified Damage 2			
Max Loss Point (m)	Section Loss (%)	Damage Length (m)	Damage Orientation	Max Loss Point (m)	Section Loss (%)	Damage Length (m)	Damage Orientation
—	—	—	—	—	—	—	—
