**Development of Quality Assurance and Quality Control
System for Post Tensioned Segmental Bridges in Florida:
Case of Ringling Bridge – Phase II**

**FDOT Contract No. BDV29-977-34
FINAL REPORT**

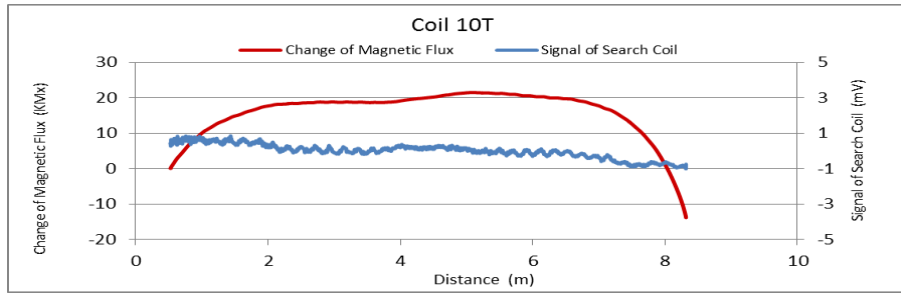
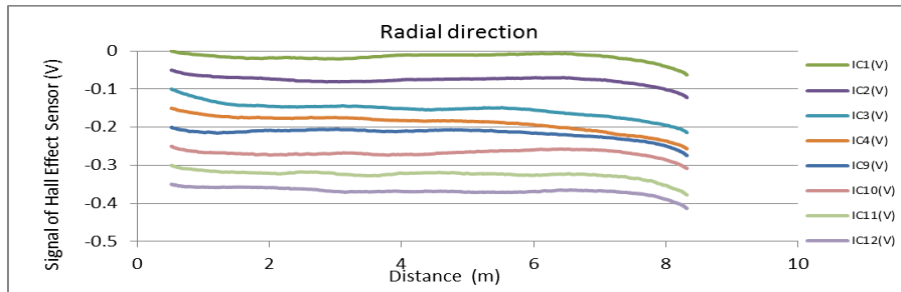
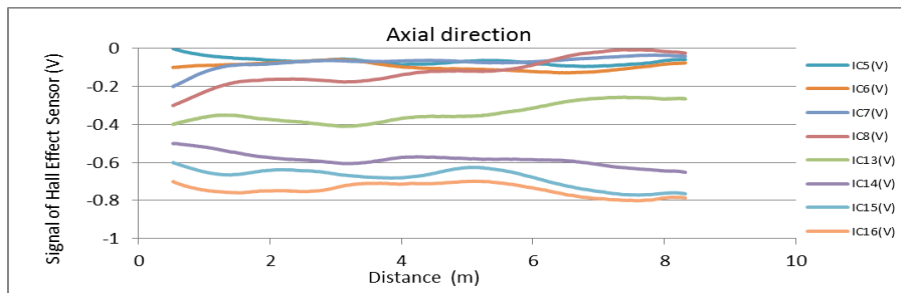
Figure A189. MMFM data of P11-402R-H1 tendon section.

File Name 【Pier-Tendon-Section】	Section Total Length (m)	Scanned Length		Note			
		Starting Point (m)	Ending Point (m)				
P11-402R-H1	9.4	0.52	8.5				
Identified Damage 1				Identified Damage 2			
Max Loss Point (m)	Section Loss (%)	Damage Length (m)	Damage Orientation	Max Loss Point (m)	Section Loss (%)	Damage Length (m)	Damage Orientation
—	—	—	—	—	—	—	—

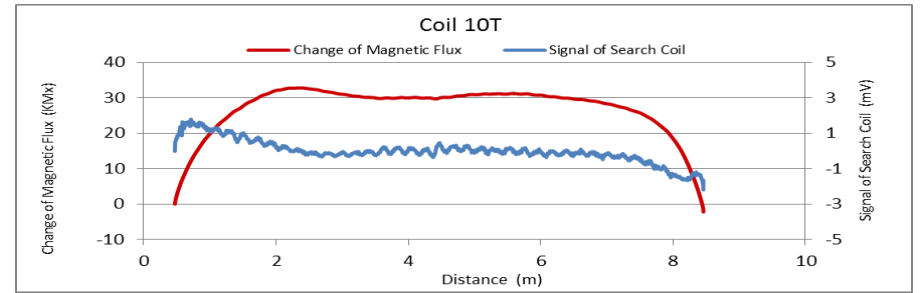
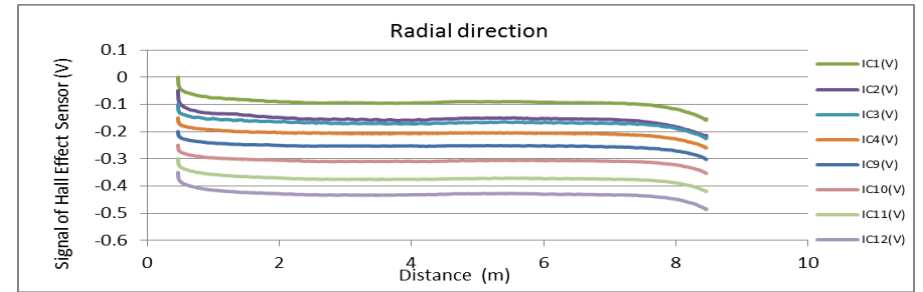
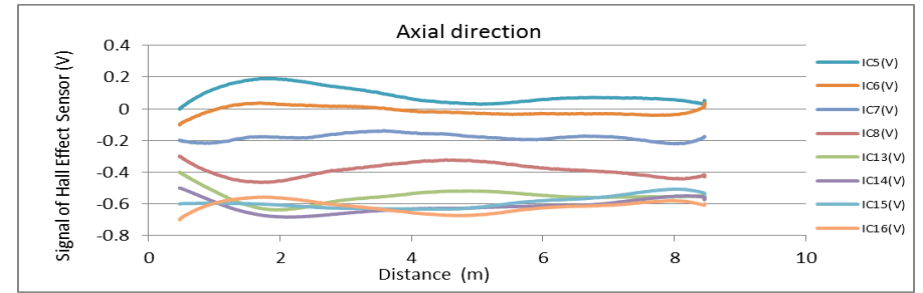
Figure A190. MMFM data of P11-402L-H1 tendon section.

File Name 【Pier-Tendon-Section】	Section Total Length (m)	Scanned Length		Note			
		Starting Point (m)	Ending Point (m)				
P11-402L-H1	9.35	0.47	8.49				
Identified Damage 1				Identified Damage 2			
Max Loss Point (m)	Section Loss (%)	Damage Length (m)	Damage Orientation	Max Loss Point (m)	Section Loss (%)	Damage Length (m)	Damage Orientation
—	—	—	—	—	—	—	—

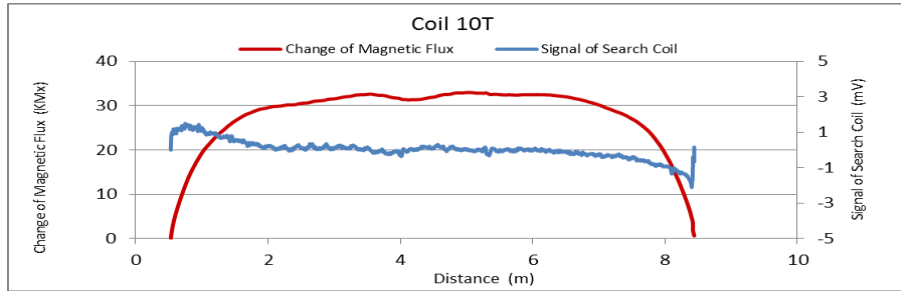
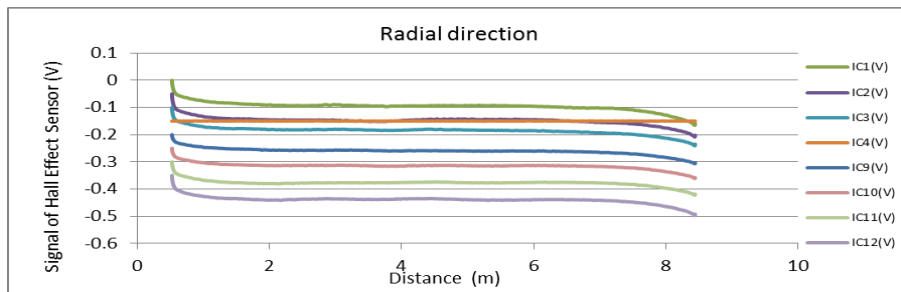
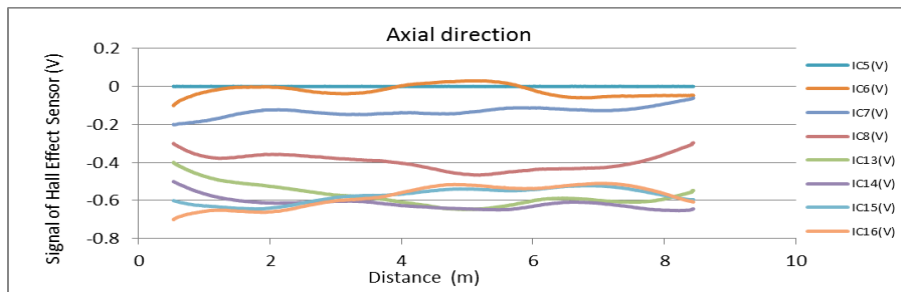
Figure A191. MMFM data of P11-401L-H1 tendon section.

File Name 【Pier-Tendon-Section】	Section Total Length (m)	Scanned Length		Note			
		Starting Point (m)	Ending Point (m)				
P11-401L-H1	9.35	0.53	8.44				
Identified Damage 1				Identified Damage 2			
Max Loss Point (m)	Section Loss (%)	Damage Length (m)	Damage Orientation	Max Loss Point (m)	Section Loss (%)	Damage Length (m)	Damage Orientation
—	—	—	—	—	—	—	—

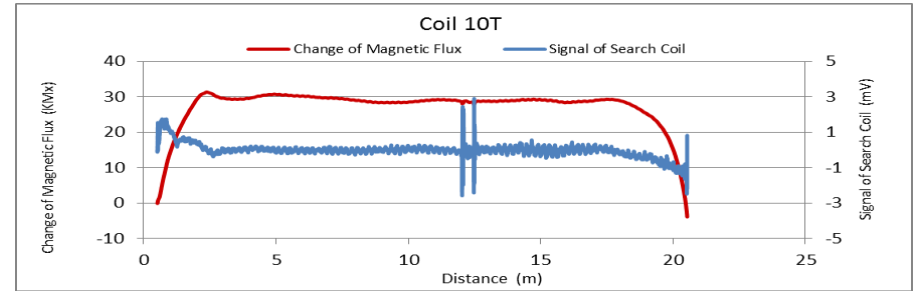
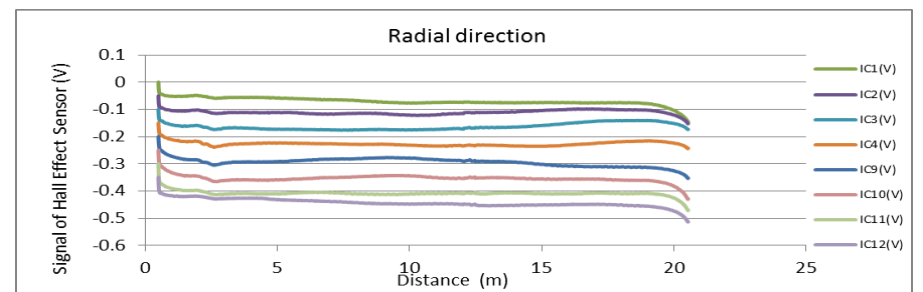
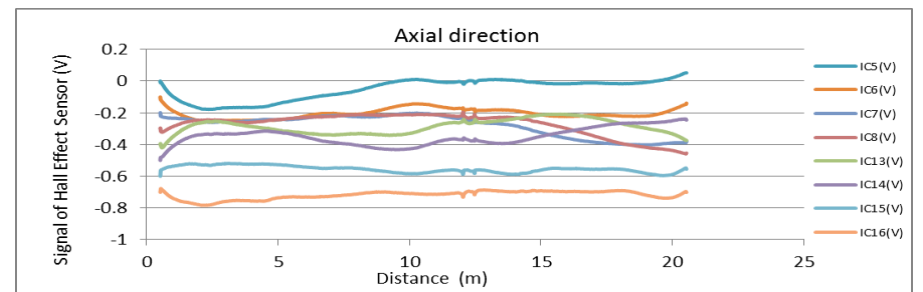
Figure A192. MMFM data of P11-402R-I1 tendon section.

File Name 【Pier-Tendon-Section】	Section Total Length (m)	Scanned Length		Note			
		Starting Point (m)	Ending Point (m)				
P11-402R-I1	21.35	0.51	20.54	Joint position: 12.26 m			
Identified Damage 1				Identified Damage 2			
Max Loss Point (m)	Section Loss (%)	Damage Length (m)	Damage Orientation	Max Loss Point (m)	Section Loss (%)	Damage Length (m)	Damage Orientation
—	—	—	—	—	—	—	—

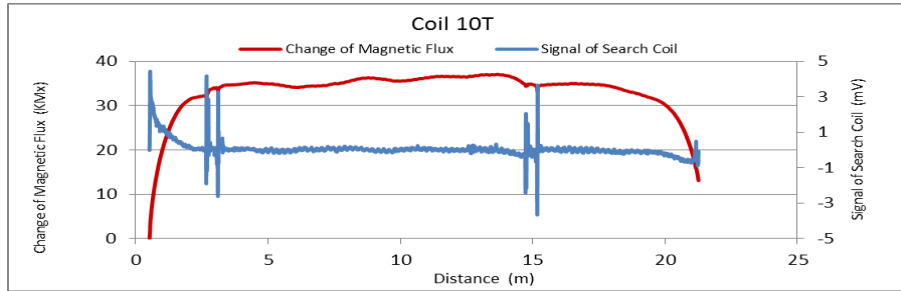
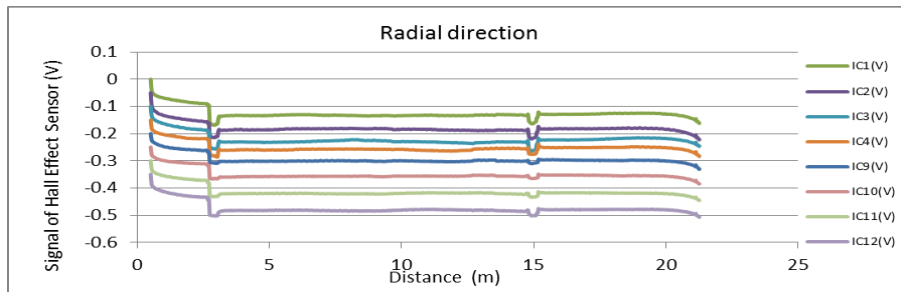
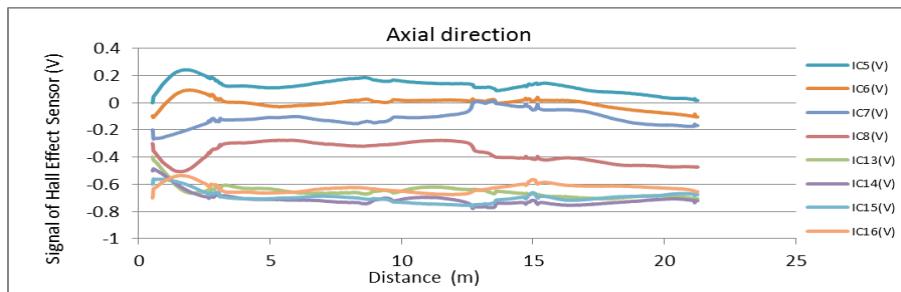
File Name 【Pier-Tendon-Section】	Section Total Length (m)	Scanned Length		Note			
		Starting Point (m)	Ending Point (m)				
P11-401R-I1	21.47	0.52	21.26	Joint position : 2.86 m, 15 m			
Identified Damage 1				Identified Damage 2			
Max Loss Point (m)	Section Loss (%)	Damage Length (m)	Damage Orientation	Max Loss Point (m)	Section Loss (%)	Damage Length (m)	Damage Orientation
—	—	—	—	—	—	—	—

Figure A193. MMFM data of P11-401R-I1 tendon section.

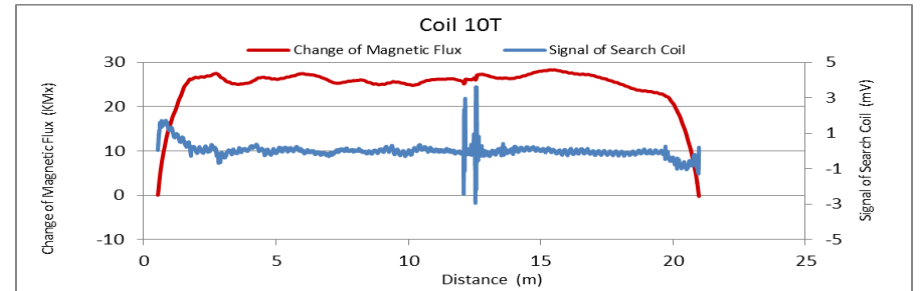
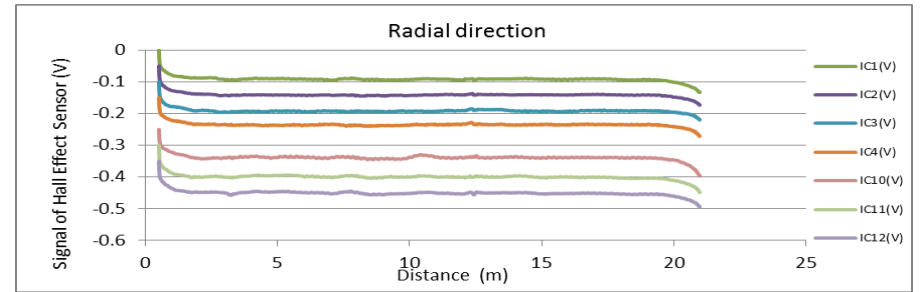
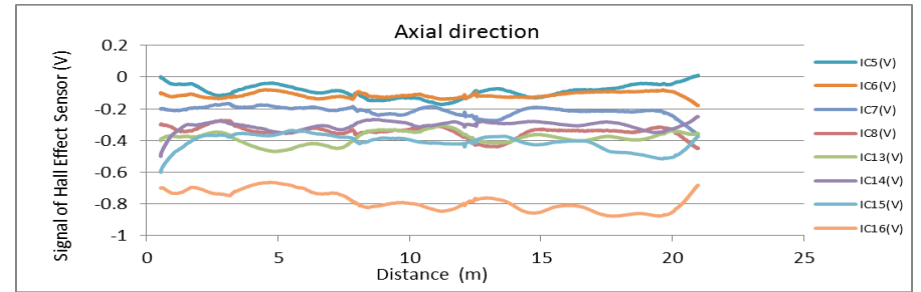
File Name 【Pier-Tendon-Section】	Section Total Length (m)	Scanned Length		Note			
		Starting Point (m)	Ending Point (m)				
P11-402L-I1	21.58	0.53	20.99	Joint position : 12.38 m			
Identified Damage 1				Identified Damage 2			
Max Loss Point (m)	Section Loss (%)	Damage Length (m)	Damage Orientation	Max Loss Point (m)	Section Loss (%)	Damage Length (m)	Damage Orientation
—	—	—	—	—	—	—	—

Figure A194. MMFM data of P11-402L-I1 tendon section.

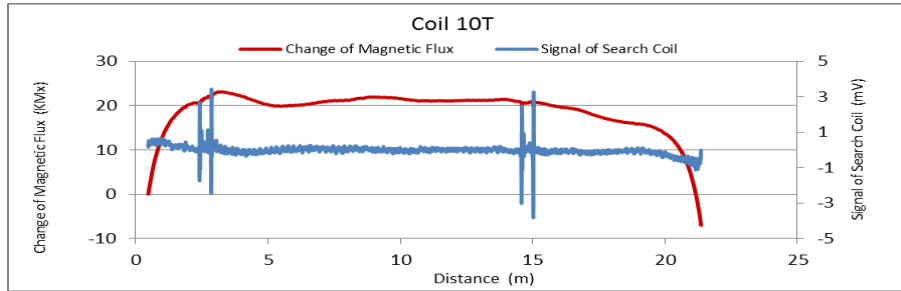
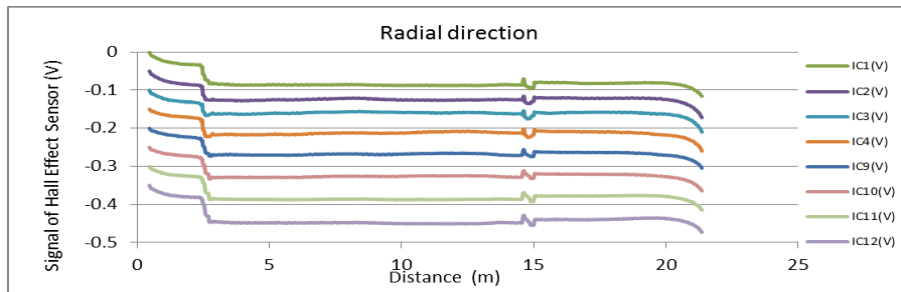
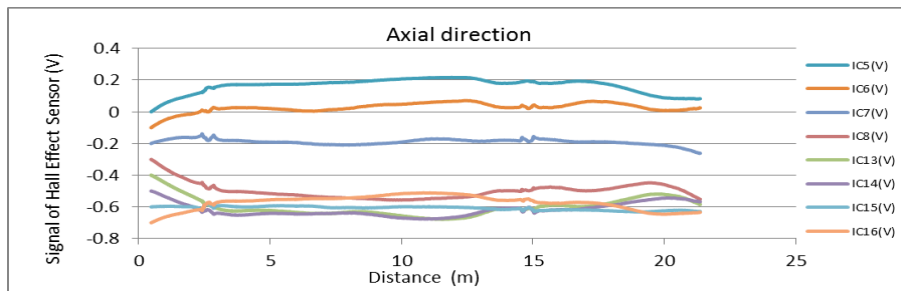
File Name 【Pier-Tendon-Section】	Section Total Length (m)	Scanned Length		Note			
		Starting Point (m)	Ending Point (m)				
P11-401L-I1	21.59	0.47	21.44	Joint position : 2.85 m, 15 m			
Identified Damage 1				Identified Damage 2			
Max Loss Point (m)	Section Loss (%)	Damage Length (m)	Damage Orientation	Max Loss Point (m)	Section Loss (%)	Damage Length (m)	Damage Orientation
—	—	—	—	—	—	—	—

Figure A195. MMFM data of P11-401L-I1 tendon section.

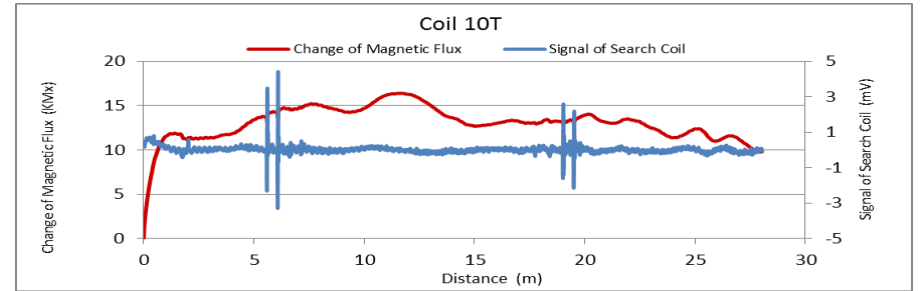
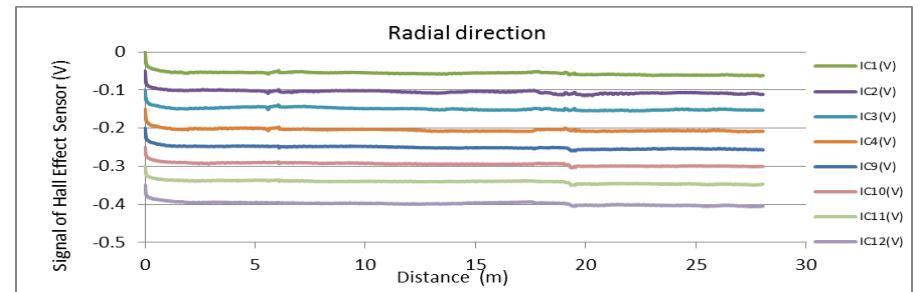
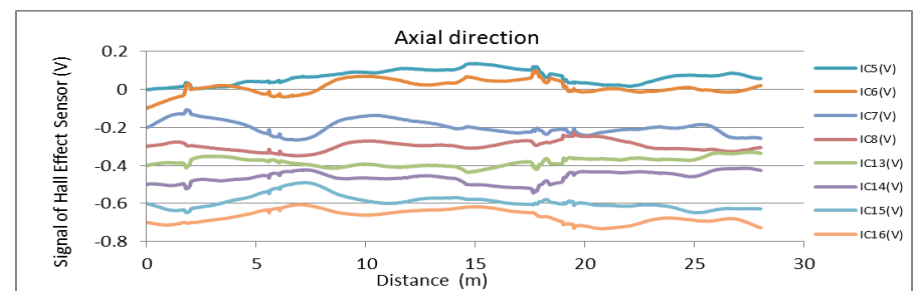
File Name 【Pier-Tendon-Section】	Section Total Length (m)	Scanned Length		Note			
		Starting Point (m)	Ending Point (m)				
P11-401R-I2	28.58	0	28.05	Joint position : 5.6 m, 19.2 m			
Identified Damage 1				Identified Damage 2			
Max Loss Point (m)	Section Loss (%)	Damage Length (m)	Damage Orientation	Max Loss Point (m)	Section Loss (%)	Damage Length (m)	Damage Orientation
—	—	—	—	—	—	—	—

Figure A196. MMFM data of P11-401R-I2 tendon section.

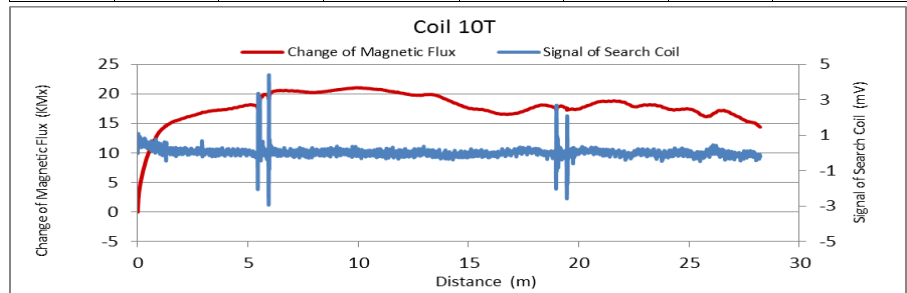
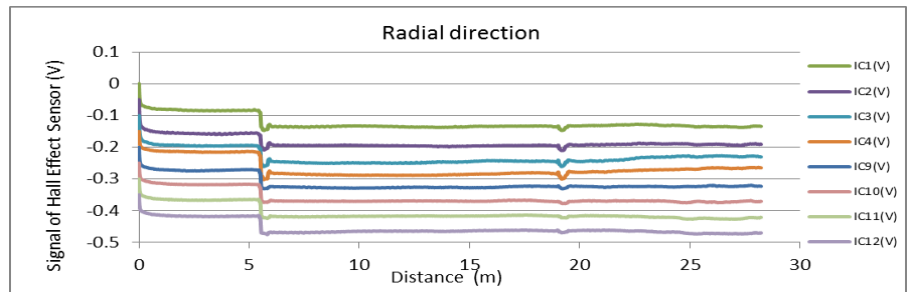
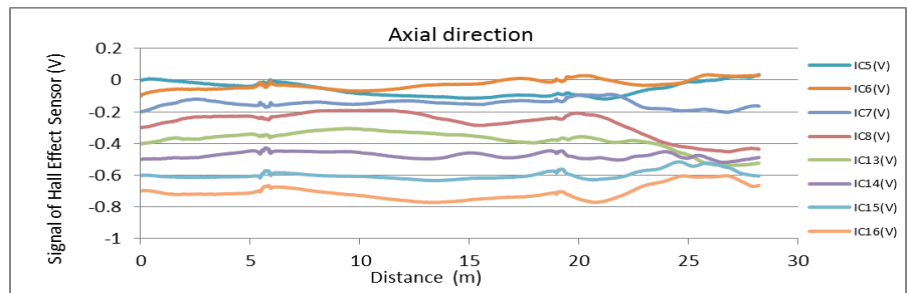
File Name 【Pier-Tendon-Section】	Section Total Length (m)	Scanned Length		Note			
		Starting Point (m)	Ending Point (m)				
P11-401L-I2	28.63	0	28.22	Joint position: 5.7 m, 19.2 m			
Identified Damage 1				Identified Damage 2			
Max Loss Point (m)	Section Loss (%)	Damage Length (m)	Damage Orientation	Max Loss Point (m)	Section Loss (%)	Damage Length (m)	Damage Orientation
—	—	—	—	—	—	—	—

Figure A197. MMFM data of P11-401L-I2 tendon section.

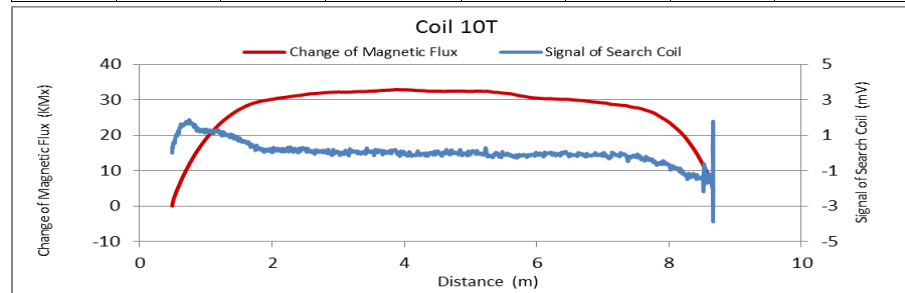
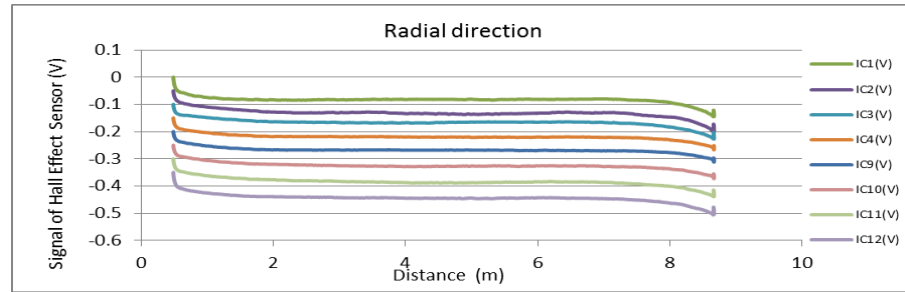
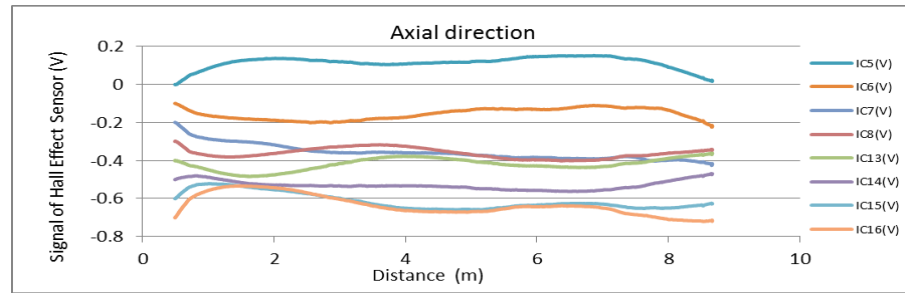
File Name 【Pier-Tendon-Section】	Section Total Length (m)	Scanned Length		Note			
		Starting Point (m)	Ending Point (m)				
P9-404L-H1	9.5	0.49	8.7				
Identified Damage 1				Identified Damage 2			
Max Loss Point (m)	Section Loss (%)	Damage Length (m)	Damage Orientation	Max Loss Point (m)	Section Loss (%)	Damage Length (m)	Damage Orientation
—	—	—	—	—	—	—	—

Figure A198. MMFM data of P9-404L-H1 tendon section.

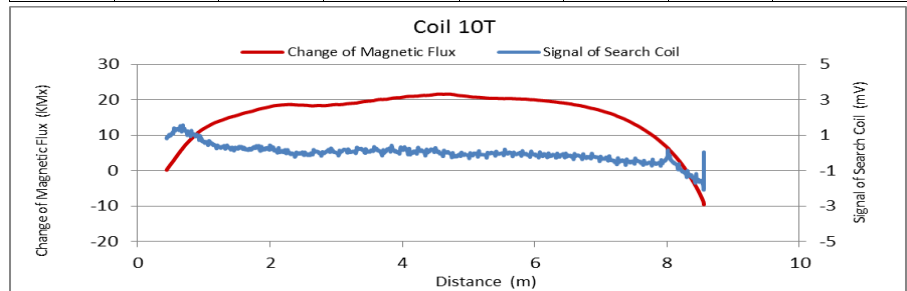
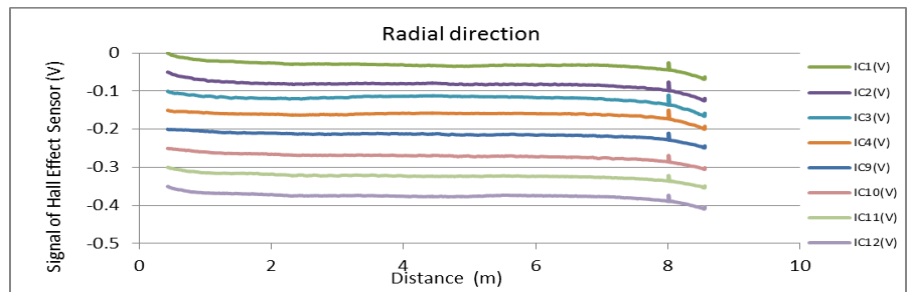
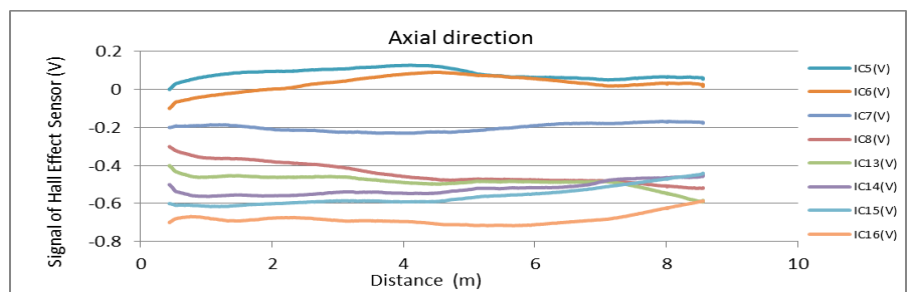
File Name 【Pier-Tendon-Section】	Section Total Length (m)	Scanned Length		Note			
		Starting Point (m)	Ending Point (m)				
P9-403L-H1	9.5	0.43	8.59				
Identified Damage 1				Identified Damage 2			
Max Loss Point (m)	Section Loss (%)	Damage Length (m)	Damage Orientation	Max Loss Point (m)	Section Loss (%)	Damage Length (m)	Damage Orientation
—	—	—	—	—	—	—	—

Figure A199. MMFM data of P9-403L-H1 tendon section.

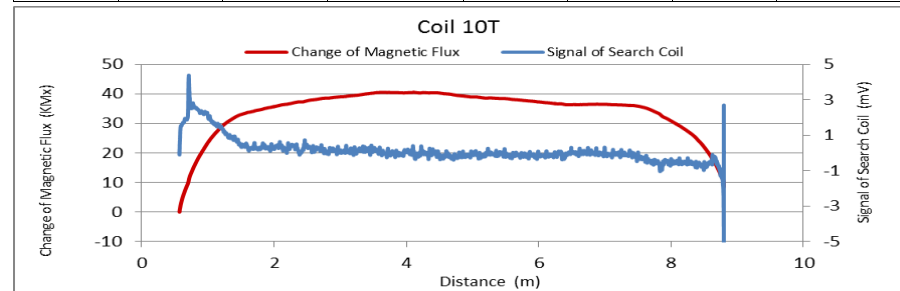
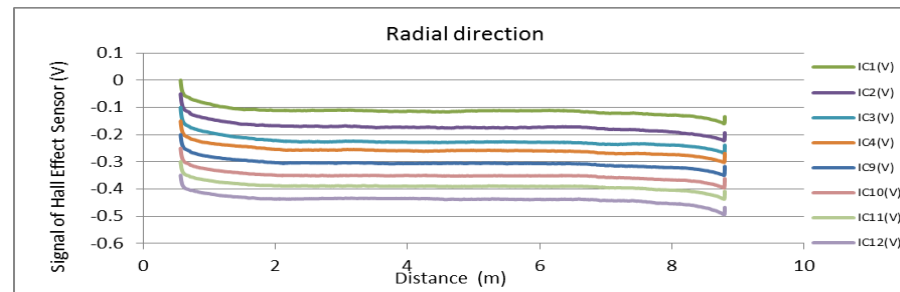
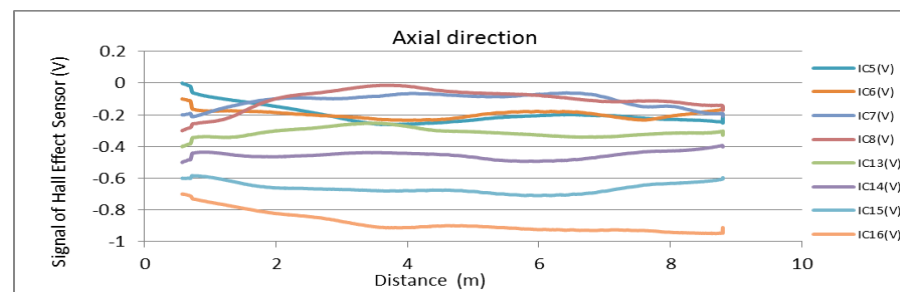
File Name 【Pier-Tendon-Section】	Section Total Length (m)	Scanned Length		Note			
		Starting Point (m)	Ending Point (m)				
P9-405L-H1	9.43	0.57	8.81				
Identified Damage 1				Identified Damage 2			
Max Loss Point (m)	Section Loss (%)	Damage Length (m)	Damage Orientation	Max Loss Point (m)	Section Loss (%)	Damage Length (m)	Damage Orientation
—	—	—	—	—	—	—	—

Figure A200. MMFM data of P9-405L-H1 tendon section.

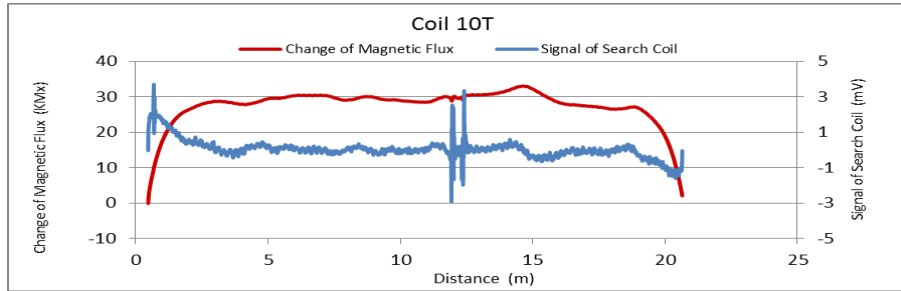
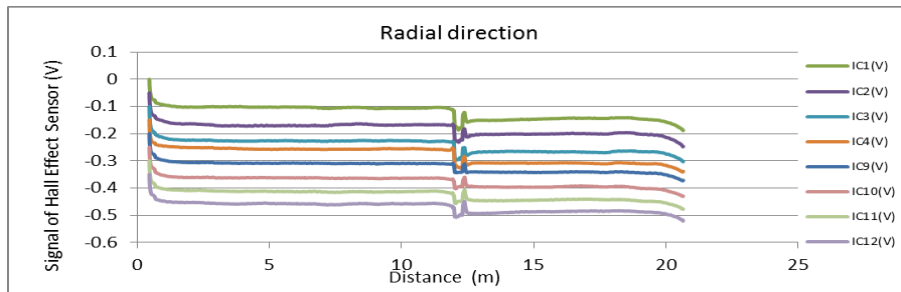
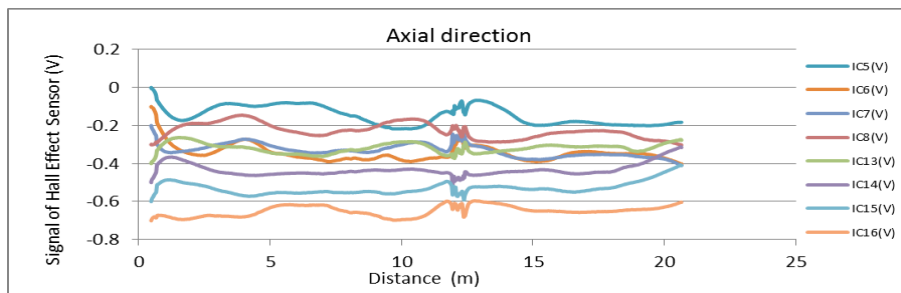
File Name 【Pier-Tendon-Section】	Section Total Length (m)	Scanned Length		Note			
		Starting Point (m)	Ending Point (m)				
P9-403L-I1	21.49	0.47	20.67	Joint position: 12.15 m			
Identified Damage 1				Identified Damage 2			
Max Loss Point (m)	Section Loss (%)	Damage Length (m)	Damage Orientation	Max Loss Point (m)	Section Loss (%)	Damage Length (m)	Damage Orientation
—	—	—	—	—	—	—	—

Figure A201. MMFM data of P9-403L-I1 tendon section.

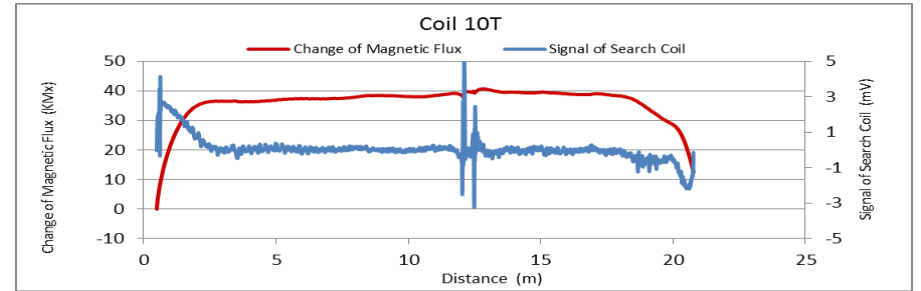
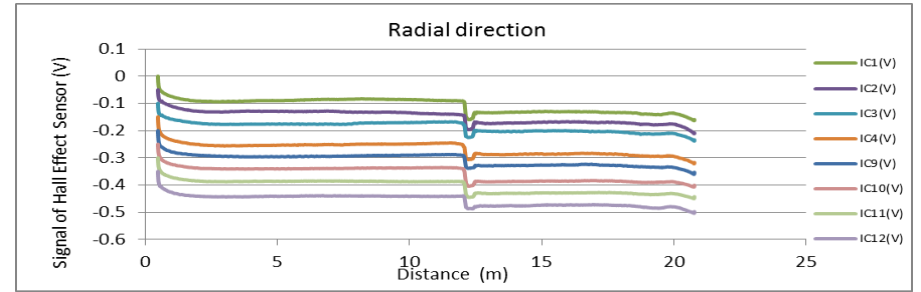
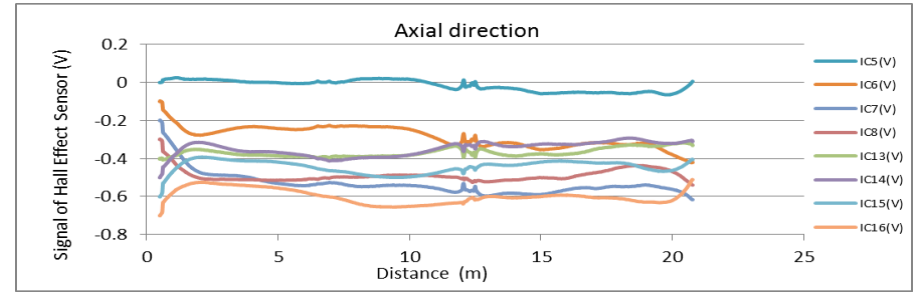
File Name 【Pier-Tendon-Section】	Section Total Length (m)	Scanned Length		Note			
		Starting Point (m)	Ending Point (m)				
P9-404L-I1	21.49	0.49	20.77	Joint position: 12.24 m			
Identified Damage 1				Identified Damage 2			
Max Loss Point (m)	Section Loss (%)	Damage Length (m)	Damage Orientation	Max Loss Point (m)	Section Loss (%)	Damage Length (m)	Damage Orientation
—	—	—	—	—	—	—	—

Figure A202. MMFM data of P9-404L-I1 tendon section.

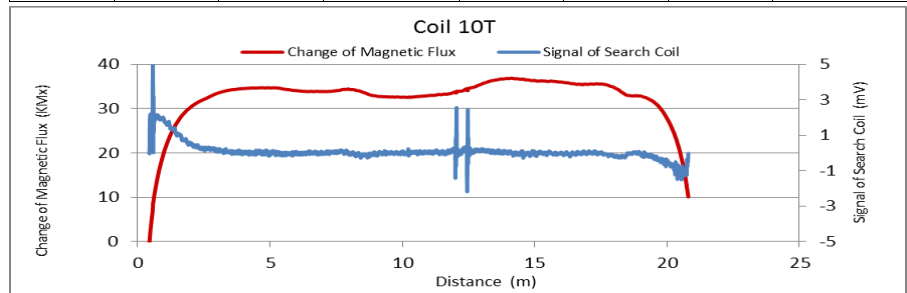
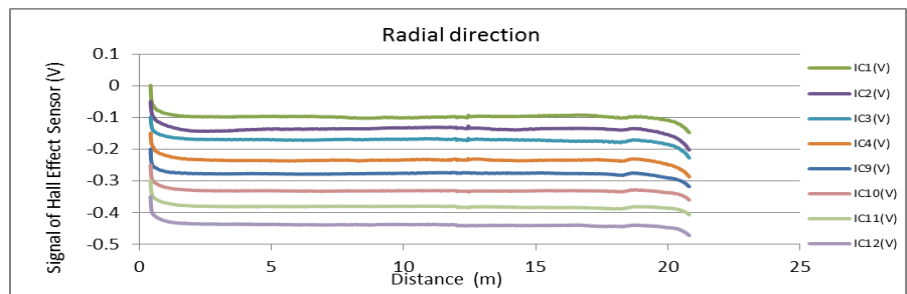
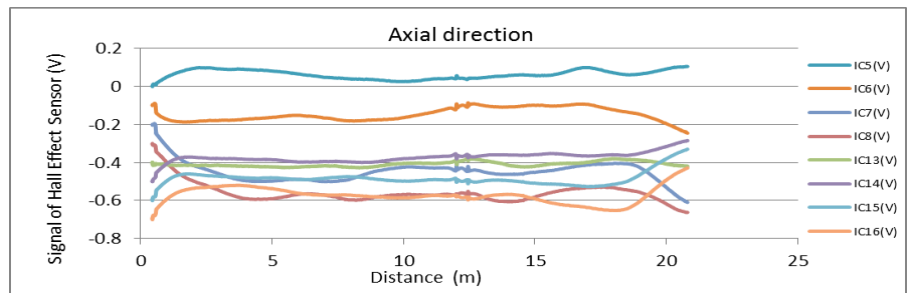
File Name 【Pier-Tendon-Section】	Section Total Length (m)	Scanned Length		Note			
		Starting Point (m)	Ending Point (m)				
P9-405L-I1	21.5	0.44	20.8	Joint position: 12.21 m			
Identified Damage 1				Identified Damage 2			
Max Loss Point (m)	Section Loss (%)	Damage Length (m)	Damage Orientation	Max Loss Point (m)	Section Loss (%)	Damage Length (m)	Damage Orientation
—	—	—	—	—	—	—	—

Figure A203. MMFM data of P9-405L-I1 tendon section.

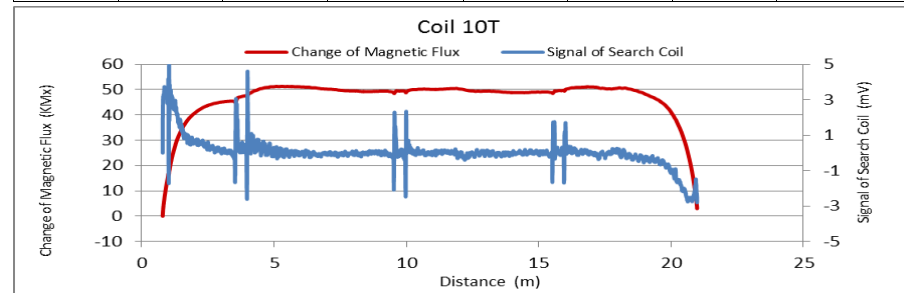
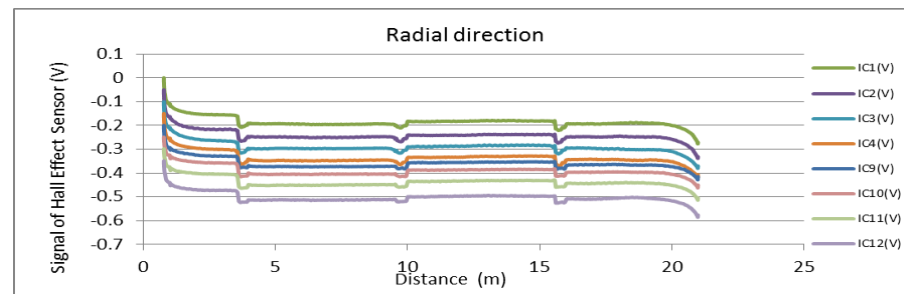
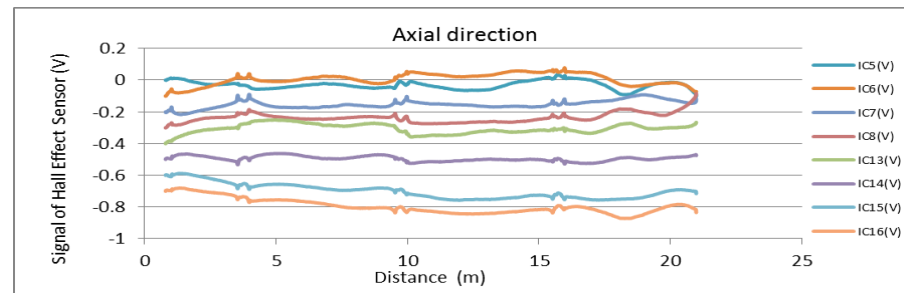
File Name 【Pier-Tendon-Section】	Section Total Length (m)	Scanned Length		Note			
		Starting Point (m)	Ending Point (m)				
P9-404L-I2	21.52	0.79	20.98	Joint position: 0.82 m, 3.74 m, 9.74 m, 15.74 m			
Identified Damage 1				Identified Damage 2			
Max Loss Point (m)	Section Loss (%)	Damage Length (m)	Damage Orientation	Max Loss Point (m)	Section Loss (%)	Damage Length (m)	Damage Orientation
—	—	—	—	—	—	—	—

Figure A204. MMFM data of P9-404L-I2 tendon section.

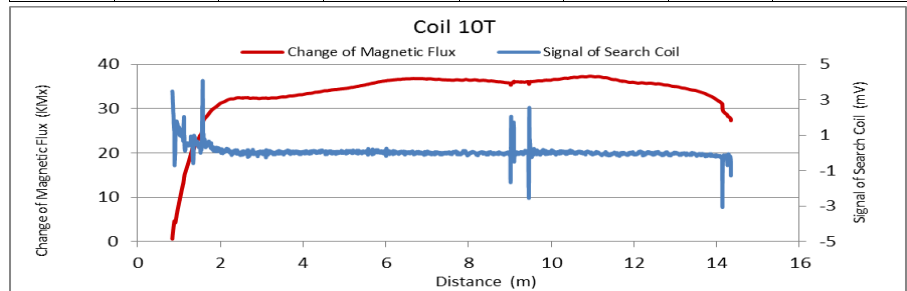
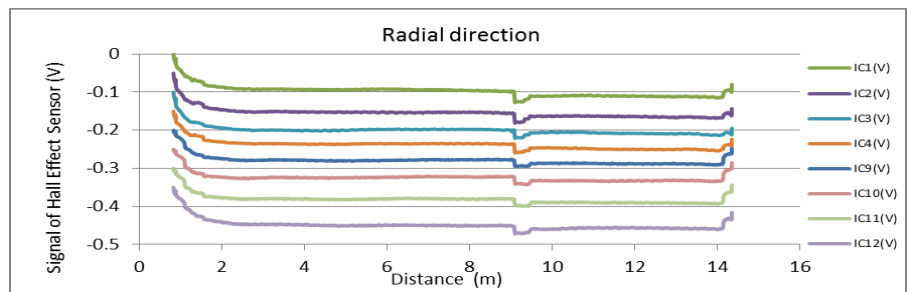
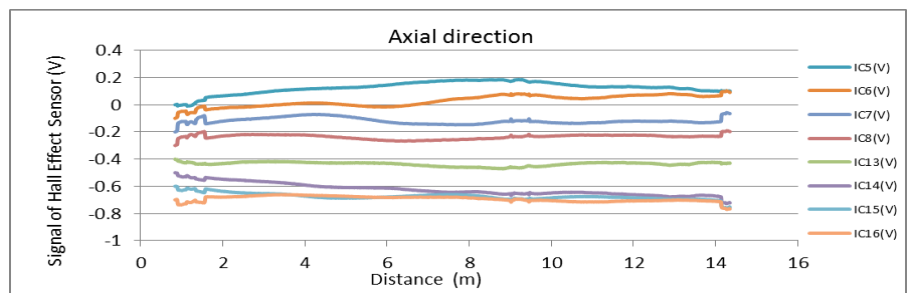
File Name 【Pier-Tendon-Section】	Section Total Length (m)	Scanned Length		Note			
		Starting Point (m)	Ending Point (m)				
P9-406L-I2	21.48	0.83	14.36	Repair tape position : 1.26 m (center) Joint position : 9.23 m After 14.36 m, the repair is large and cannot be measured.			
Identified Damage 1				Identified Damage 2			
Max Loss Point (m)	Section Loss (%)	Damage Length (m)	Damage Orientation	Max Loss Point (m)	Section Loss (%)	Damage Length (m)	Damage Orientation
—	—	—	—	—	—	—	—

Figure A205. MMFM data of P9-406L-I2 tendon section.

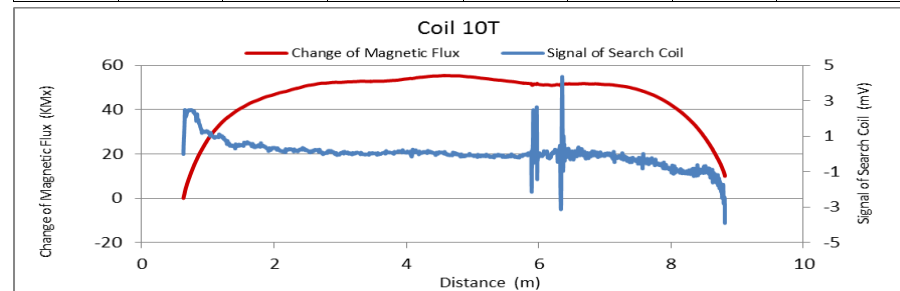
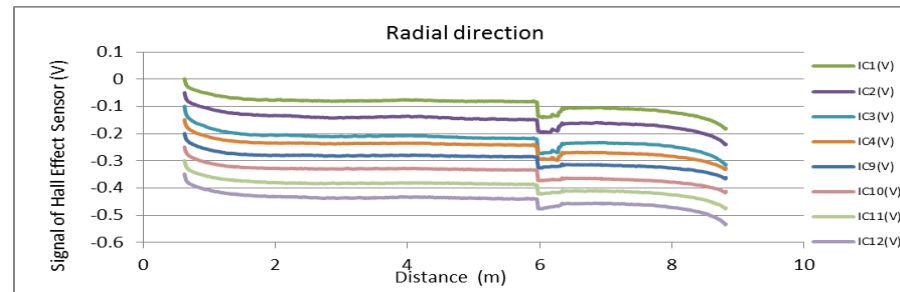
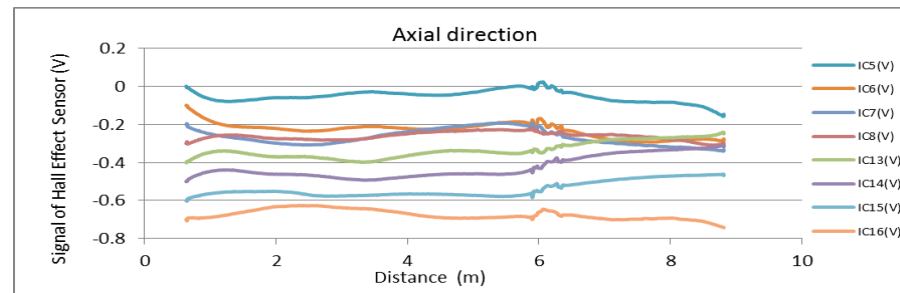
File Name 【Pier-Tendon-Section】	Section Total Length (m)	Scanned Length		Note			
		Starting Point (m)	Ending Point (m)				
P9-404L-H2	9.38	0.63	8.82	Joint position : 6.15 m			
Identified Damage 1				Identified Damage 2			
Max Loss Point (m)	Section Loss (%)	Damage Length (m)	Damage Orientation	Max Loss Point (m)	Section Loss (%)	Damage Length (m)	Damage Orientation
—	—	—	—	—	—	—	—

Figure A206. MMFM data of P9-404L-H2 tendon section.

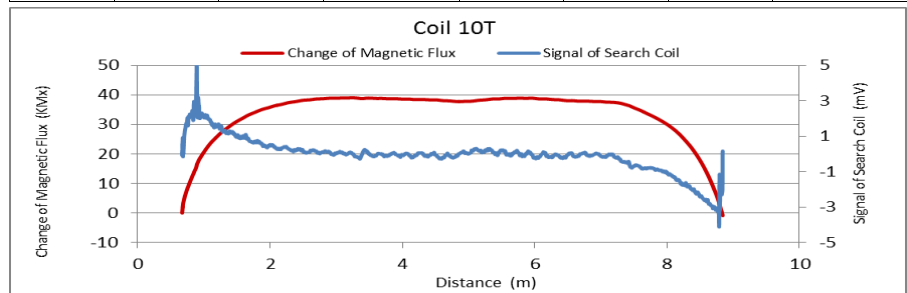
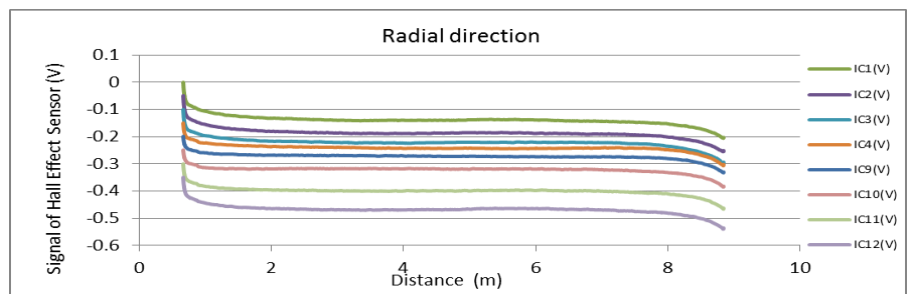
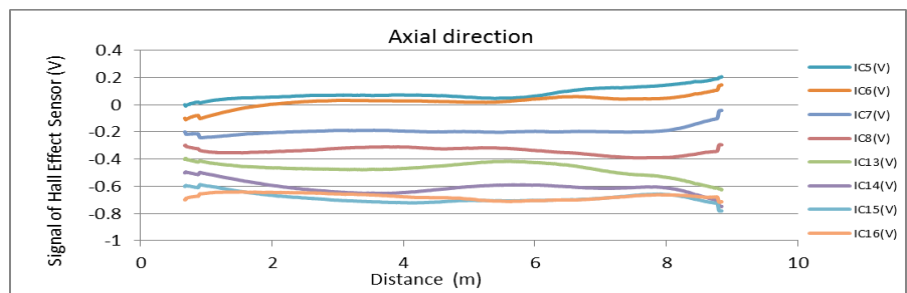
File Name 【Pier-Tendon-Section】	Section Total Length (m)	Scanned Length		Note			
		Starting Point (m)	Ending Point (m)				
P9-406L-H2	9.37	0.67	8.84				
Identified Damage 1				Identified Damage 2			
Max Loss Point (m)	Section Loss (%)	Damage Length (m)	Damage Orientation	Max Loss Point (m)	Section Loss (%)	Damage Length (m)	Damage Orientation
—	—	—	—	—	—	—	—

Figure A207. MMFM data of P9-406L-H2 tendon section.

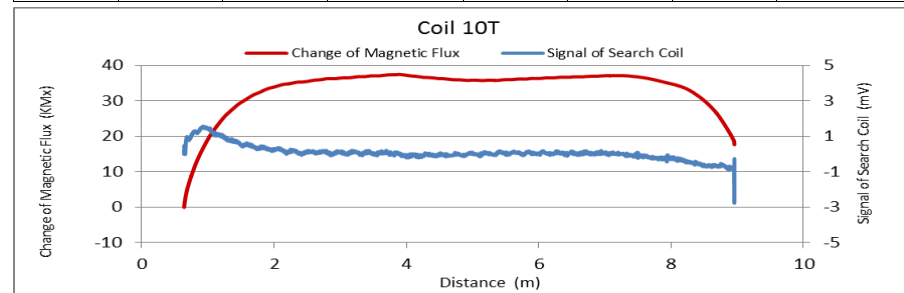
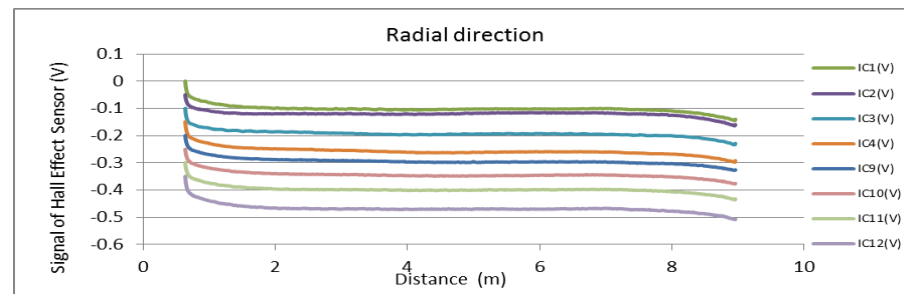
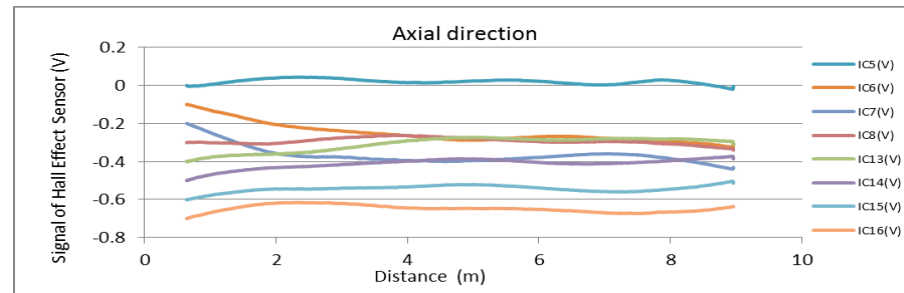
File Name 【Pier-Tendon-Section】	Section Total Length (m)	Scanned Length		Note			
		Starting Point (m)	Ending Point (m)				
P9-406R-H2	9.39	0.64	8.96				
Identified Damage 1				Identified Damage 2			
Max Loss Point (m)	Section Loss (%)	Damage Length (m)	Damage Orientation	Max Loss Point (m)	Section Loss (%)	Damage Length (m)	Damage Orientation
—	—	—	—	—	—	—	—

Figure A208. MMFM data of P9-406R-H2 tendon section.

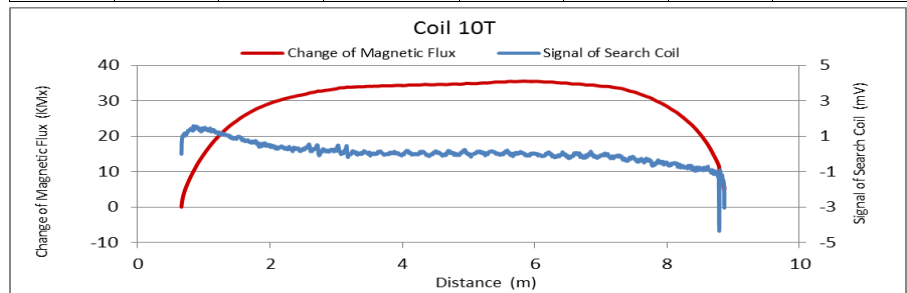
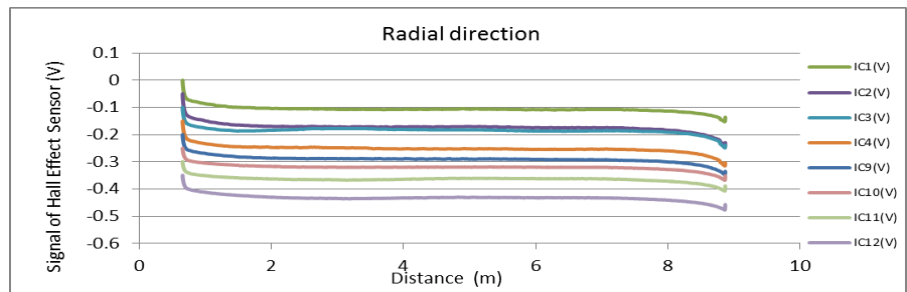
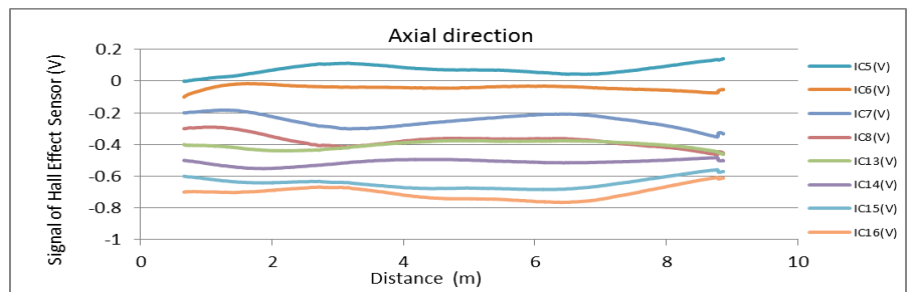
File Name 【Pier-Tendon-Section】	Section Total Length (m)	Scanned Length		Note			
		Starting Point (m)	Ending Point (m)				
P9-405R-H2	9.39	0.66	8.87				
Identified Damage 1				Identified Damage 2			
Max Loss Point (m)	Section Loss (%)	Damage Length (m)	Damage Orientation	Max Loss Point (m)	Section Loss (%)	Damage Length (m)	Damage Orientation
—	—	—	—	—	—	—	—

Figure A209. MMFM data of P9-405R-H2 tendon section.

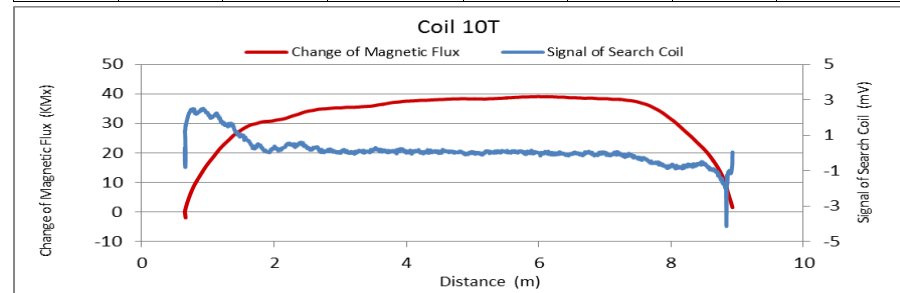
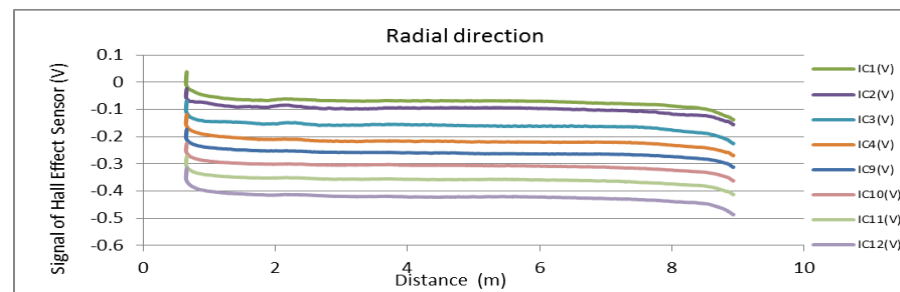
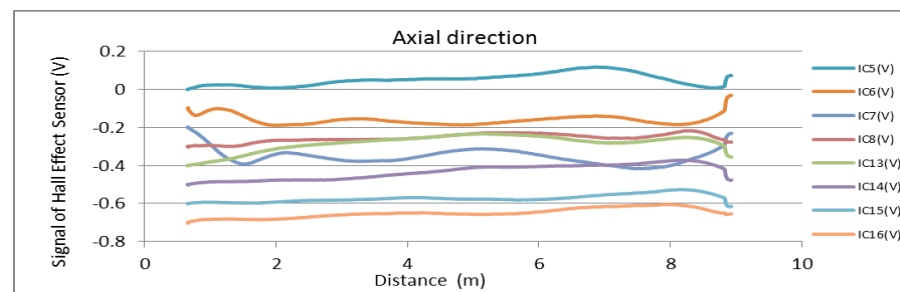
File Name 【Pier-Tendon-Section】	Section Total Length (m)	Scanned Length		Note			
		Starting Point (m)	Ending Point (m)				
P9-404R-H2	9.4	0.65	8.95				
Identified Damage 1				Identified Damage 2			
Max Loss Point (m)	Section Loss (%)	Damage Length (m)	Damage Orientation	Max Loss Point (m)	Section Loss (%)	Damage Length (m)	Damage Orientation
—	—	—	—	—	—	—	—

Figure A210. MMFM data of P9-404R-H2 tendon section.

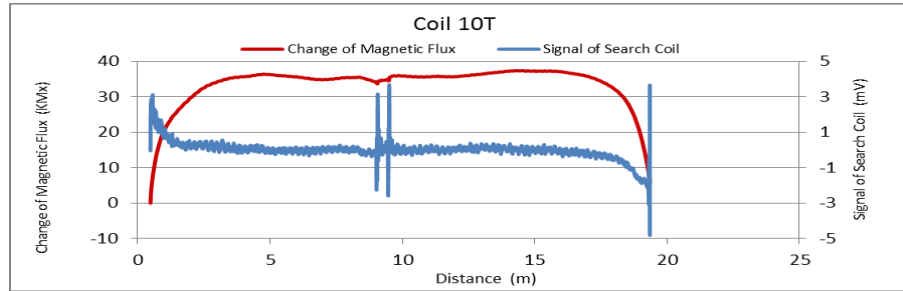
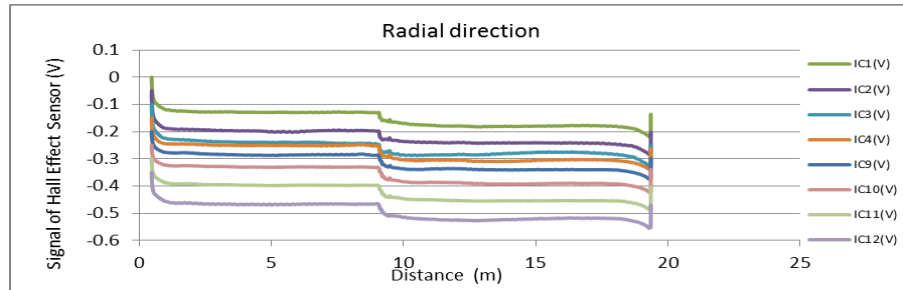
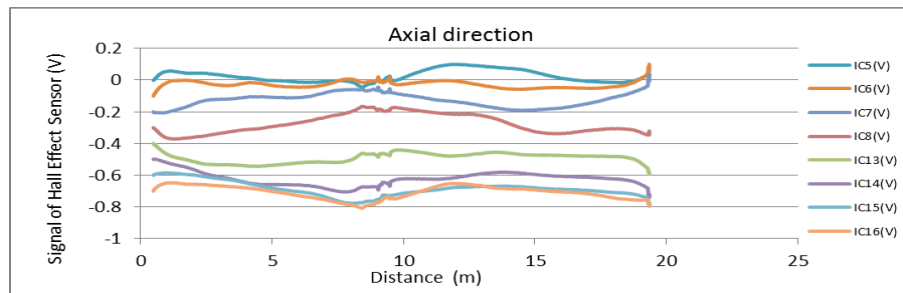
File Name 【Pier-Tendon-Section】	Section Total Length (m)	Scanned Length		Note			
		Starting Point (m)	Ending Point (m)				
P9-406R-I2	21.5	0.48	19.35	Joint position: 9.25 m			
Identified Damage 1				Identified Damage 2			
Max Loss Point (m)	Section Loss (%)	Damage Length (m)	Damage Orientation	Max Loss Point (m)	Section Loss (%)	Damage Length (m)	Damage Orientation
—	—	—	—	—	—	—	—

Figure A211. MMFM data of P9-406R-I2 tendon section.

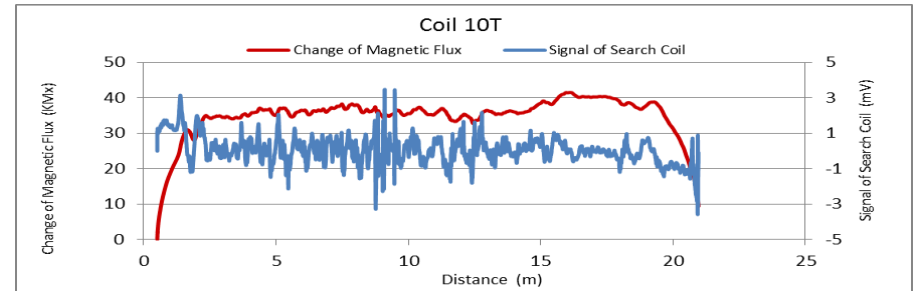
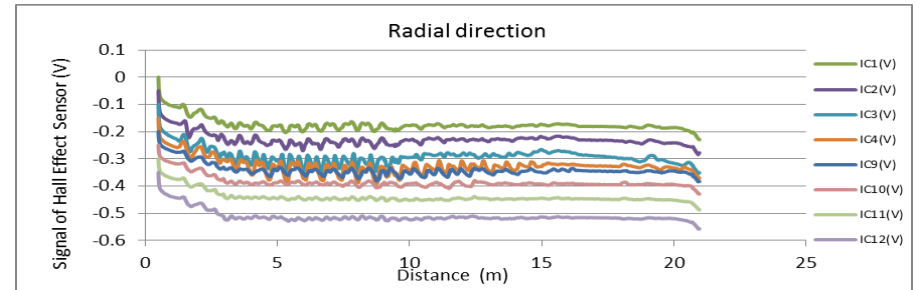
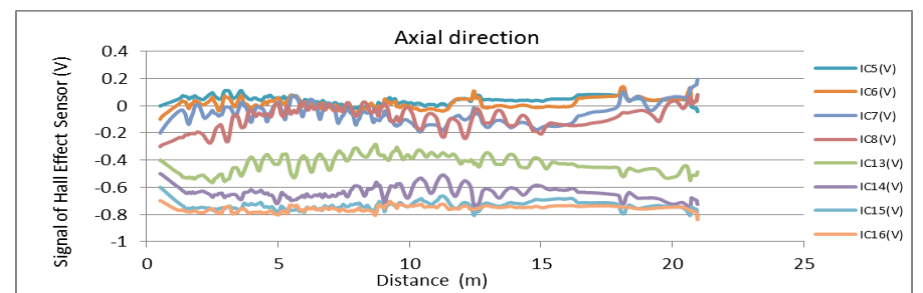
File Name 【Pier-Tendon-Section】	Section Total Length (m)	Scanned Length		Note			
		Starting Point (m)	Ending Point (m)				
P9-404R-I2	21.49	0.51	20.96	Joint position: 9.27 m Noise is greater: distortion or unevenness			
Identified Damage 1				Identified Damage 2			
Max Loss Point (m)	Section Loss (%)	Damage Length (m)	Damage Orientation	Max Loss Point (m)	Section Loss (%)	Damage Length (m)	Damage Orientation
—	—	—	—	—	—	—	—

Figure A212. MMFM data of P9-404R-I2 tendon section.

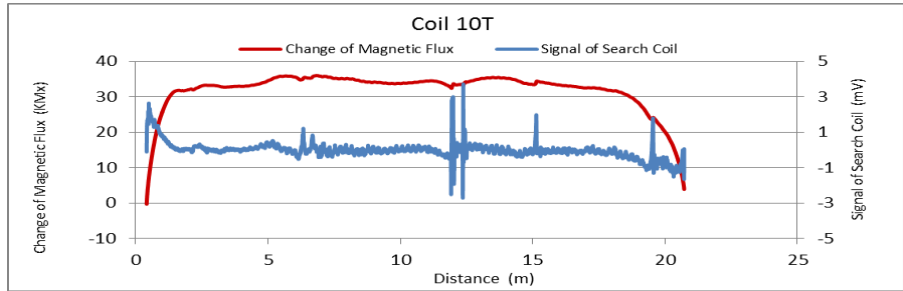
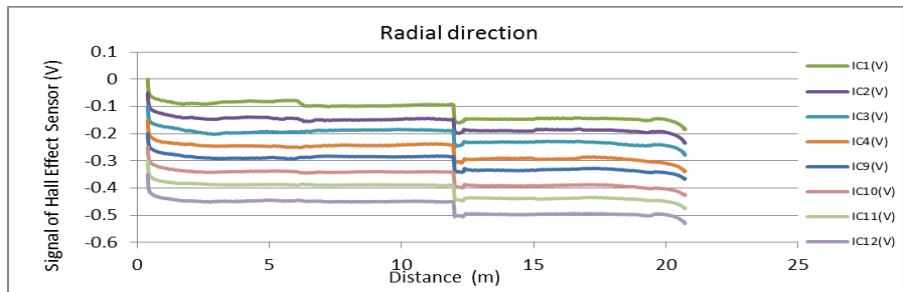
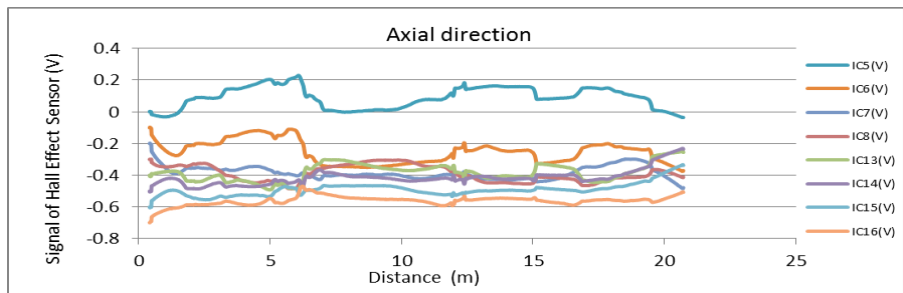
File Name 【Pier-Tendon-Section】	Section Total Length (m)	Scanned Length		Note			
		Starting Point (m)	Ending Point (m)				
P9-405R-I1	21.47	0.41	20.72	Joint position : 21.23 m			
Identified Damage 1				Identified Damage 2			
Max Loss Point (m)	Section Loss (%)	Damage Length (m)	Damage Orientation	Max Loss Point (m)	Section Loss (%)	Damage Length (m)	Damage Orientation
—	—	—	—	—	—	—	—

Figure A213. MMFM data of P9-405R-I1 tendon section.
