**Development of Quality Assurance and Quality Control
System for Post Tensioned Segmental Bridges in Florida:
Case of Ringling Bridge – Phase II**

**FDOT Contract No. BDV29-977-34
FINAL REPORT**

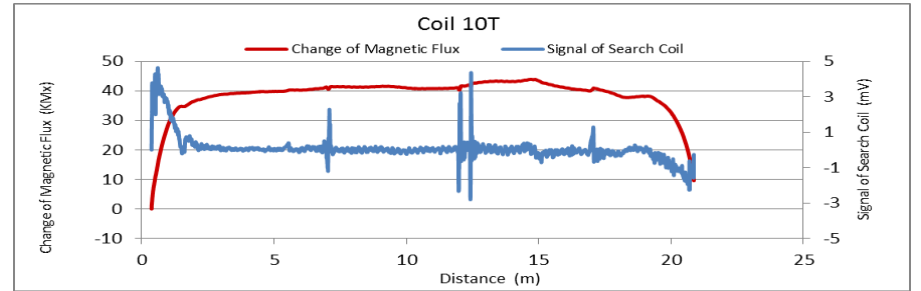
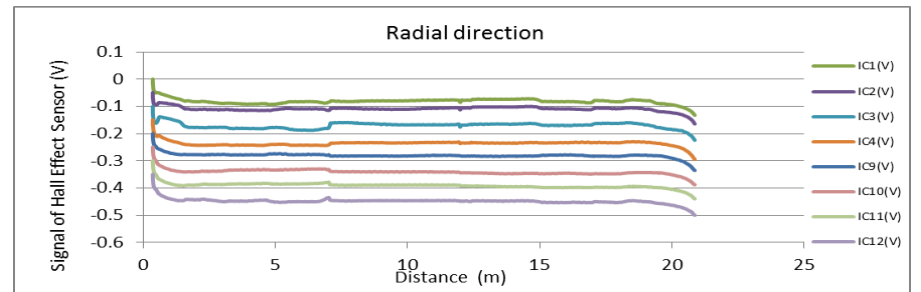
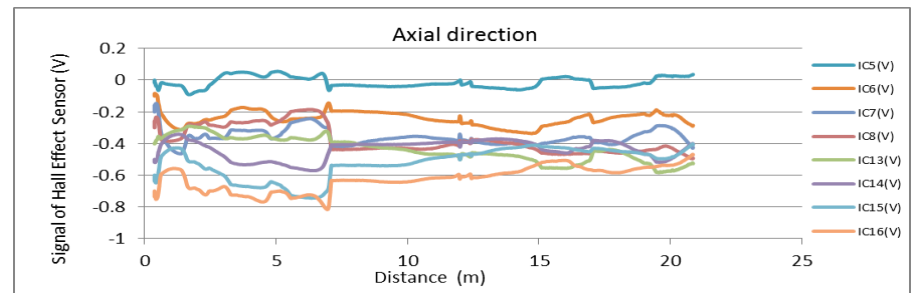
File Name 【Pier-Tendon-Section】	Section Total Length (m)	Scanned Length		Note			
		Starting Point (m)	Ending Point (m)				
P9-403R-I1	21.47	0.37	20.86	Joint position : 12.28 m			
Identified Damage 1				Identified Damage 2			
Max Loss Point (m)	Section Loss (%)	Damage Length (m)	Damage Orientation	Max Loss Point (m)	Section Loss (%)	Damage Length (m)	Damage Orientation
—	—	—	—	—	—	—	—

Figure A214. MMFM data of P9-403R-I1 tendon section.

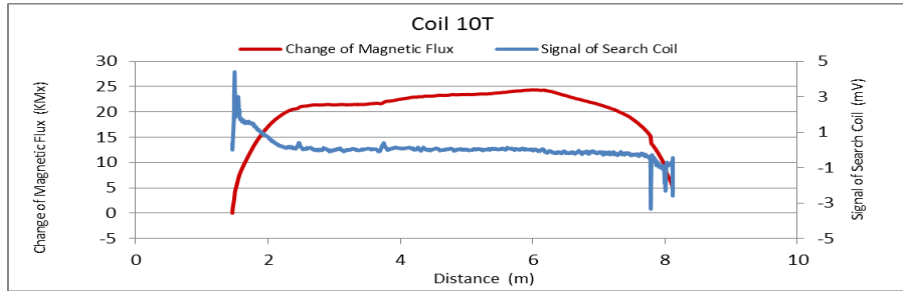
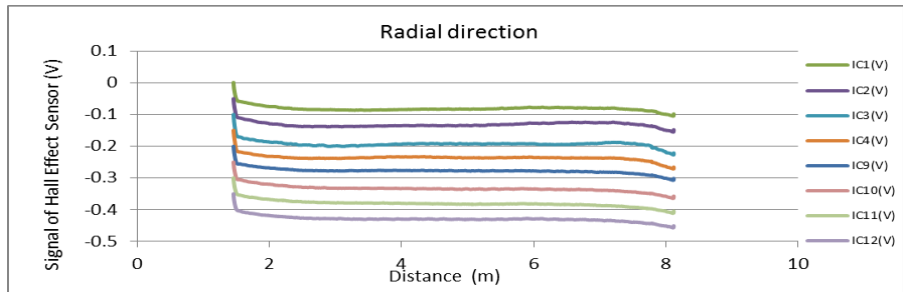
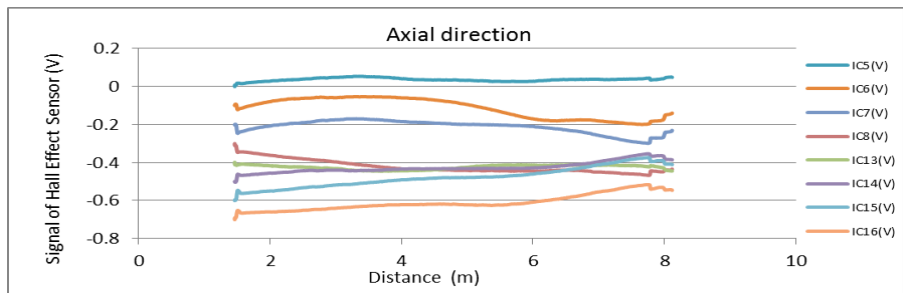
File Name 【Pier-Tendon-Section】	Section Total Length (m)	Scanned Length		Note			
		Starting Point (m)	Ending Point (m)				
P9-403R-H1	9.3	1.46	8.12				
Identified Damage 1				Identified Damage 2			
Max Loss Point (m)	Section Loss (%)	Damage Length (m)	Damage Orientation	Max Loss Point (m)	Section Loss (%)	Damage Length (m)	Damage Orientation
—	—	—	—	—	—	—	—

Figure A215. MMFM data of P9-403R-H1 tendon section.

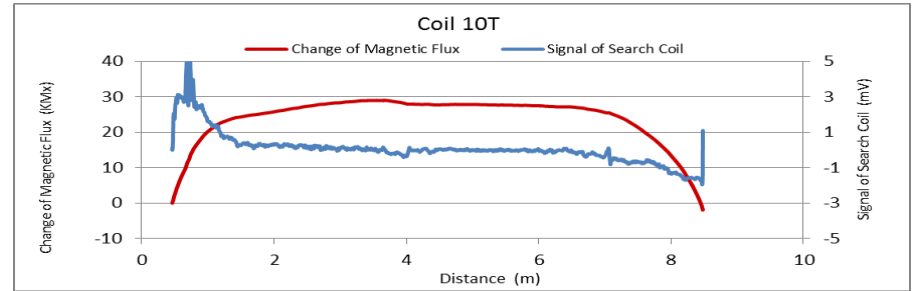
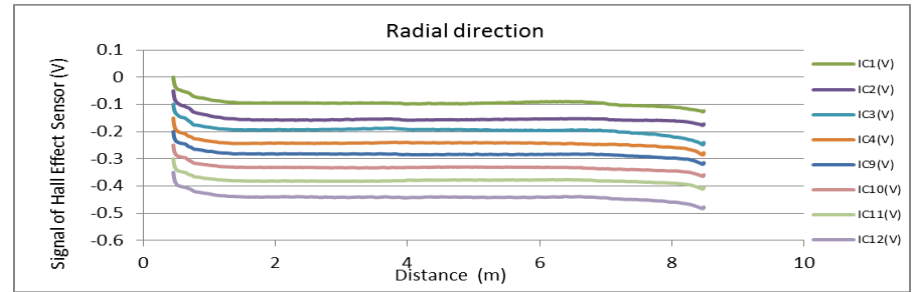
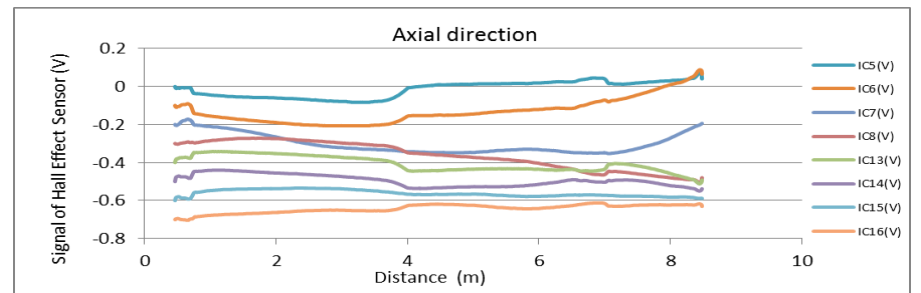
File Name 【Pier-Tendon-Section】	Section Total Length (m)	Scanned Length		Note			
		Starting Point (m)	Ending Point (m)				
P9-404R-H1	9.3	0.46	8.48				
Identified Damage 1				Identified Damage 2			
Max Loss Point (m)	Section Loss (%)	Damage Length (m)	Damage Orientation	Max Loss Point (m)	Section Loss (%)	Damage Length (m)	Damage Orientation
—	—	—	—	—	—	—	—

Figure A216. MMFM data of P9-404R-H1 tendon section.

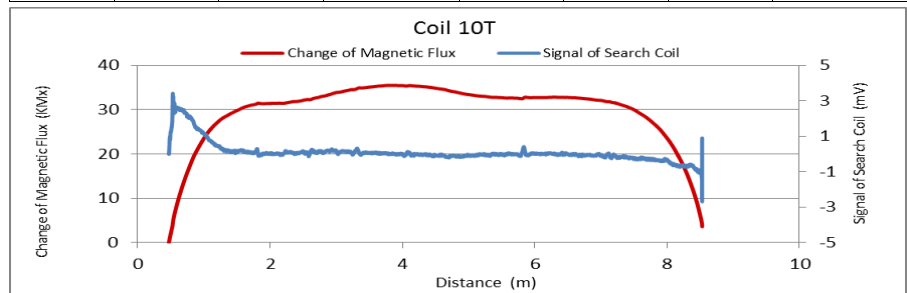
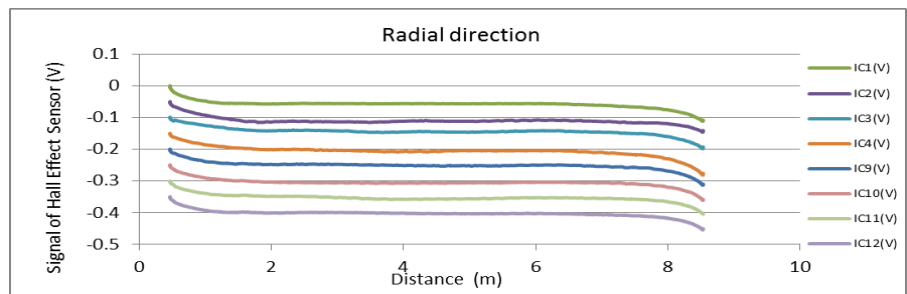
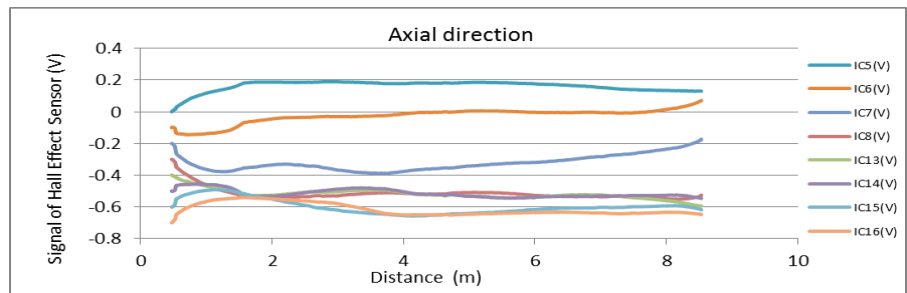
File Name 【Pier-Tendon-Section】	Section Total Length (m)	Scanned Length		Note			
		Starting Point (m)	Ending Point (m)				
P9-405R-H1	9.3	0.47	8.53				
Identified Damage 1				Identified Damage 2			
Max Loss Point (m)	Section Loss (%)	Damage Length (m)	Damage Orientation	Max Loss Point (m)	Section Loss (%)	Damage Length (m)	Damage Orientation
—	—	—	—	—	—	—	—

Figure A217. MMFM data of P9-405R-H1 tendon section.

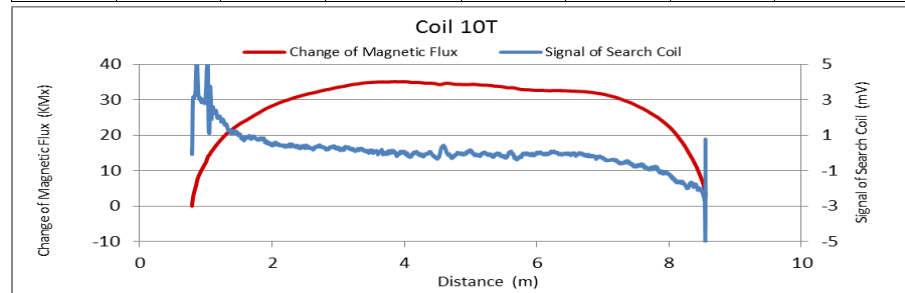
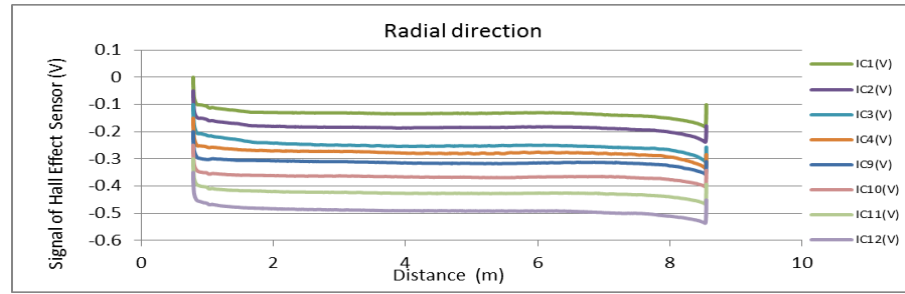
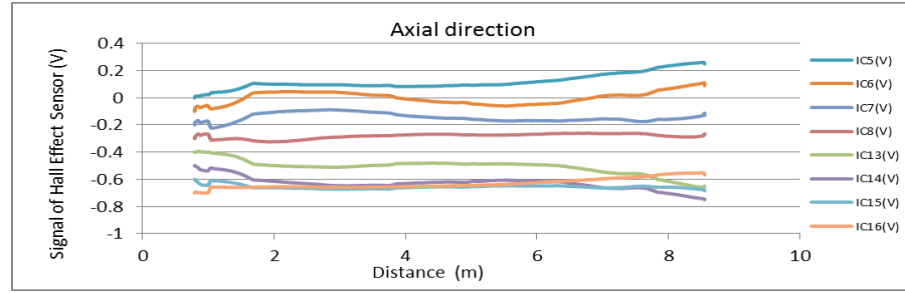
File Name 【Pier-Tendon-Section】	Section Total Length (m)	Scanned Length		Note			
		Starting Point (m)	Ending Point (m)				
P9-406R-H1	9.3	0.79	8.55				
Identified Damage 1				Identified Damage 2			
Max Loss Point (m)	Section Loss (%)	Damage Length (m)	Damage Orientation	Max Loss Point (m)	Section Loss (%)	Damage Length (m)	Damage Orientation
—	—	—	—	—	—	—	—

Figure A218. MMFM data of P9-406R-H1 tendon section.

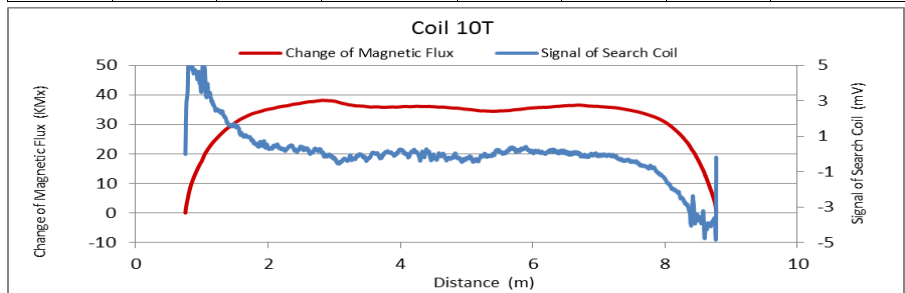
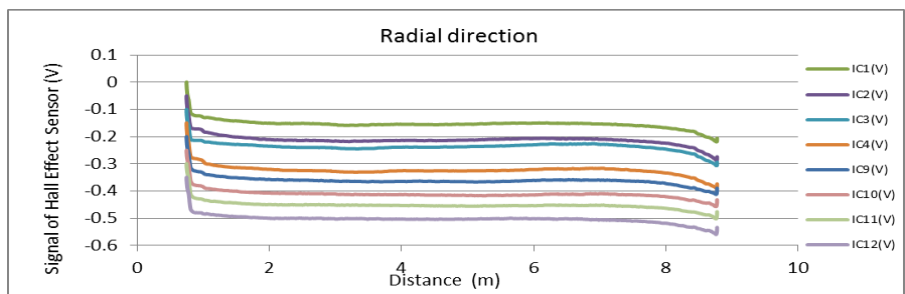
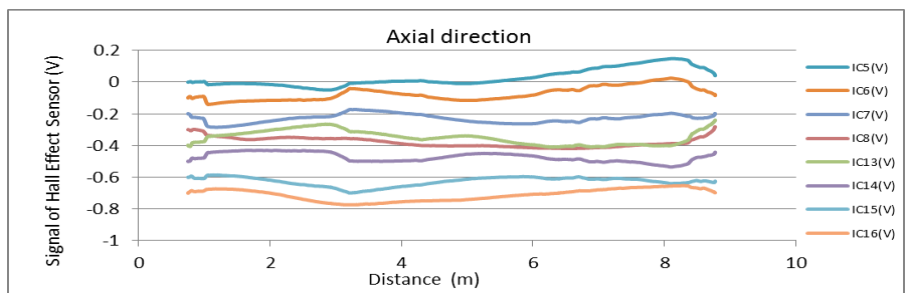
File Name 【Pier-Tendon-Section】	Section Total Length (m)	Scanned Length		Note			
		Starting Point (m)	Ending Point (m)				
P8-406R-H2	9.37	0.75	8.79				
Identified Damage 1				Identified Damage 2			
Max Loss Point (m)	Section Loss (%)	Damage Length (m)	Damage Orientation	Max Loss Point (m)	Section Loss (%)	Damage Length (m)	Damage Orientation
—	—	—	—	—	—	—	—

Figure A219. MMFM data of P8-406R-H2 tendon section.

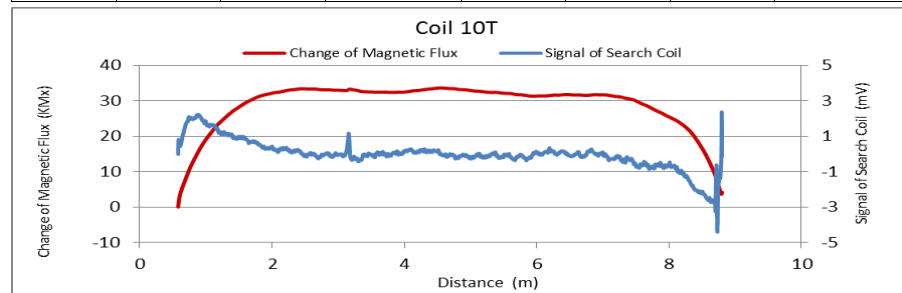
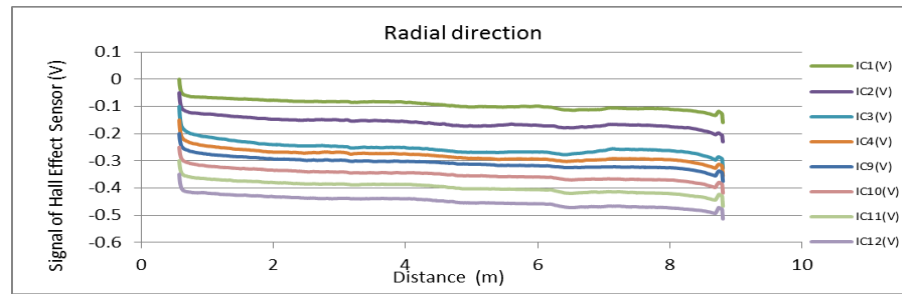
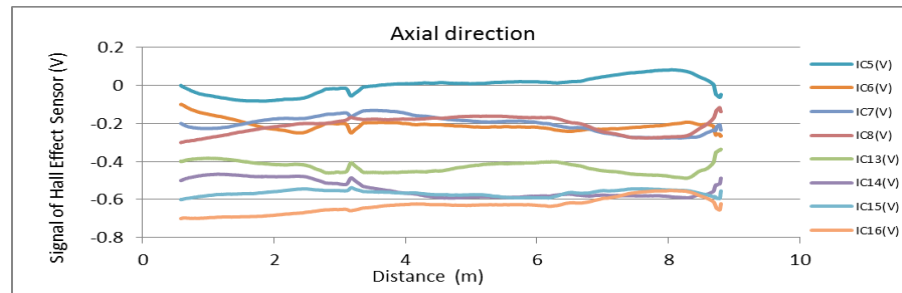
File Name 【Pier-Tendon-Section】	Section Total Length (m)	Scanned Length		Note			
		Starting Point (m)	Ending Point (m)				
P8-405R-H2	9.37	0.58	8.82				
Identified Damage 1				Identified Damage 2			
Max Loss Point (m)	Section Loss (%)	Damage Length (m)	Damage Orientation	Max Loss Point (m)	Section Loss (%)	Damage Length (m)	Damage Orientation
—	—	—	—	—	—	—	—

Figure A220. MMFM data of P8-405R-H2 tendon section.

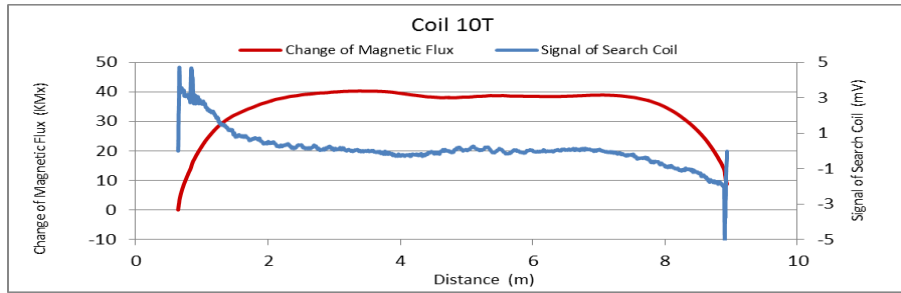
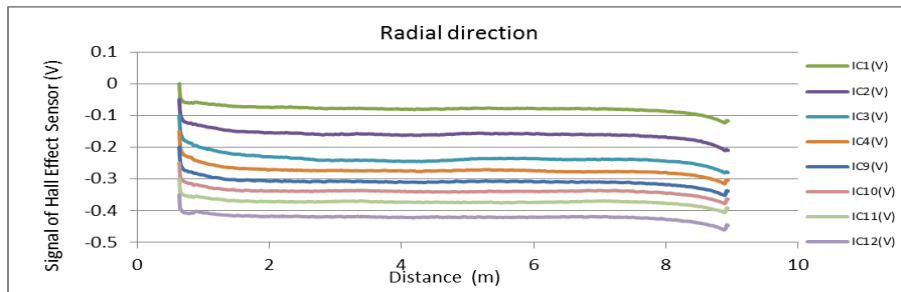
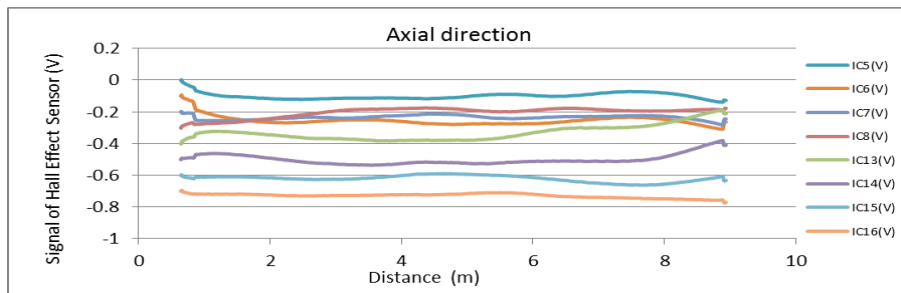
File Name 【Pier-Tendon-Section】	Section Total Length (m)	Scanned Length		Note			
		Starting Point (m)	Ending Point (m)				
P8-404R-H1	9.36	0.64	8.94				
Identified Damage 1				Identified Damage 2			
Max Loss Point (m)	Section Loss (%)	Damage Length (m)	Damage Orientation	Max Loss Point (m)	Section Loss (%)	Damage Length (m)	Damage Orientation
—	—	—	—	—	—	—	—

Figure A221. MMFM data of P8-404R-H1 tendon section.

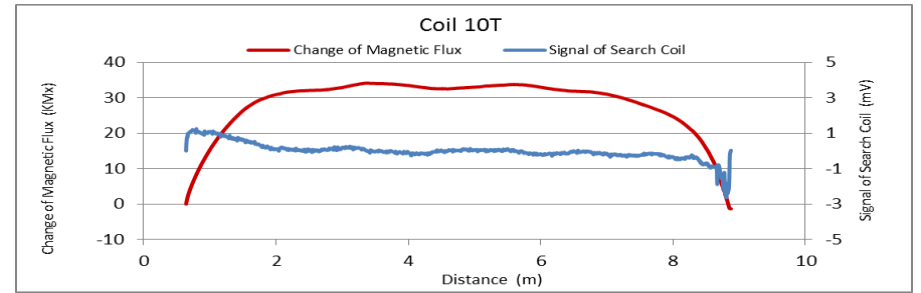
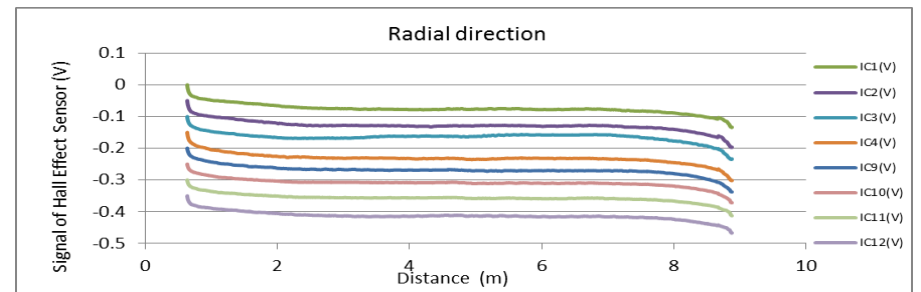
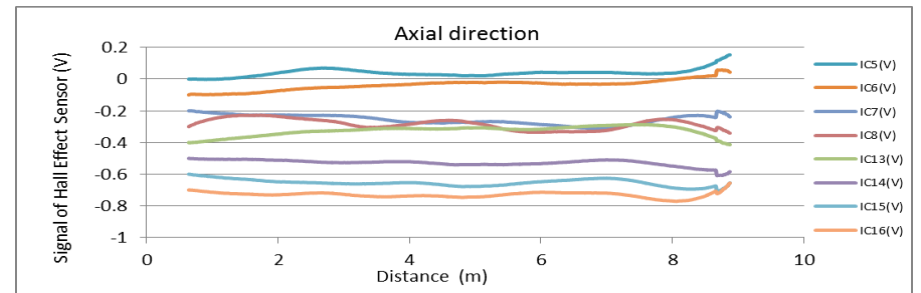
File Name 【Pier-Tendon-Section】	Section Total Length (m)	Scanned Length		Note			
		Starting Point (m)	Ending Point (m)				
P8-403R-H2	9.36	0.64	8.89				
Identified Damage 1				Identified Damage 2			
Max Loss Point (m)	Section Loss (%)	Damage Length (m)	Damage Orientation	Max Loss Point (m)	Section Loss (%)	Damage Length (m)	Damage Orientation
—	—	—	—	—	—	—	—

Figure A222. MMFM data of P8-403R-H2 tendon section.

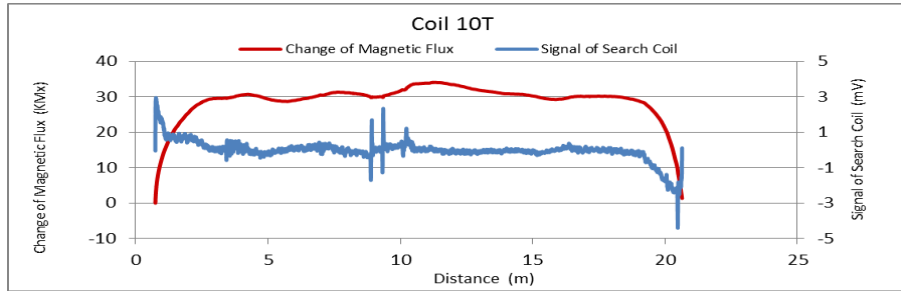
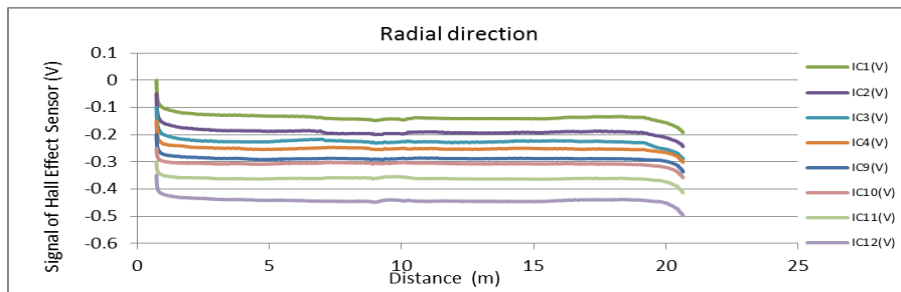
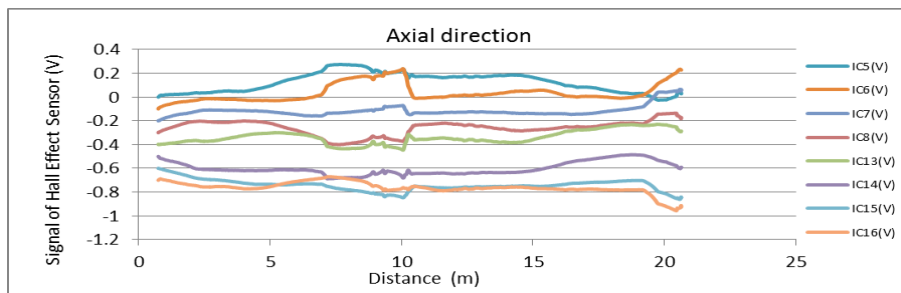
File Name 【Pier-Tendon-Section】	Section Total Length (m)	Scanned Length		Note			
		Starting Point (m)	Ending Point (m)				
P8-406R-I2	21.43	0.74	20.64	Joint position: 9.13 m			
Identified Damage 1				Identified Damage 2			
Max Loss Point (m)	Section Loss (%)	Damage Length (m)	Damage Orientation	Max Loss Point (m)	Section Loss (%)	Damage Length (m)	Damage Orientation
—	—	—	—	—	—	—	—

Figure A223. MMFM data of P8-406R-I2 tendon section.

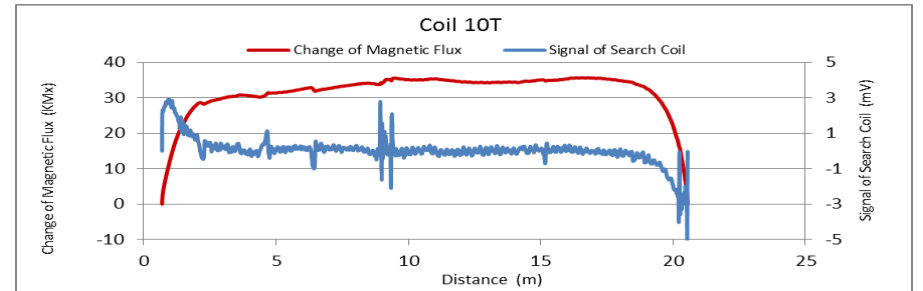
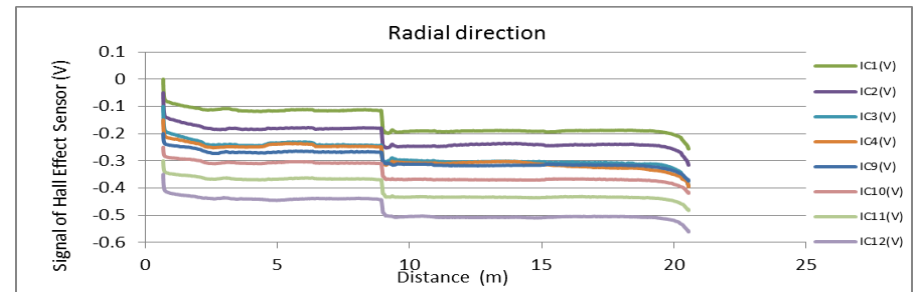
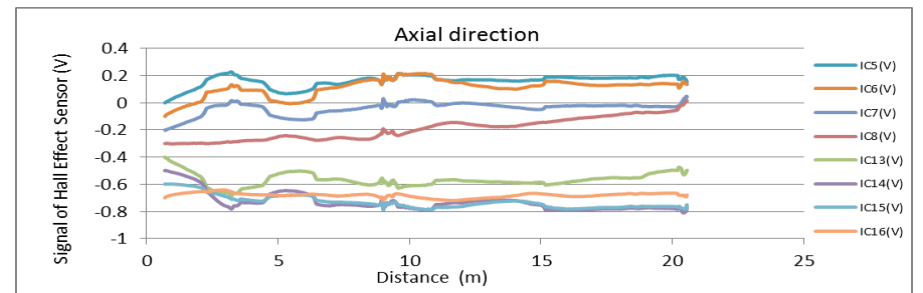
File Name 【Pier-Tendon-Section】	Section Total Length (m)	Scanned Length		Note			
		Starting Point (m)	Ending Point (m)				
P8-404R-I1	21.43	0.69	20.55	Joint position: 9.13 m			
Identified Damage 1				Identified Damage 2			
Max Loss Point (m)	Section Loss (%)	Damage Length (m)	Damage Orientation	Max Loss Point (m)	Section Loss (%)	Damage Length (m)	Damage Orientation
—	—	—	—	—	—	—	—

Figure A224. MMFM data of P8-404R-I1 tendon section.

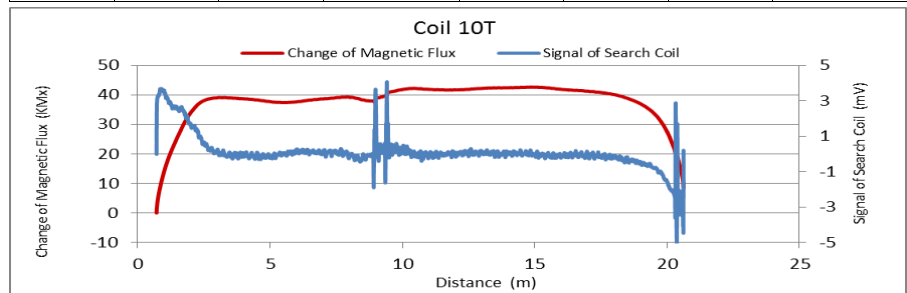
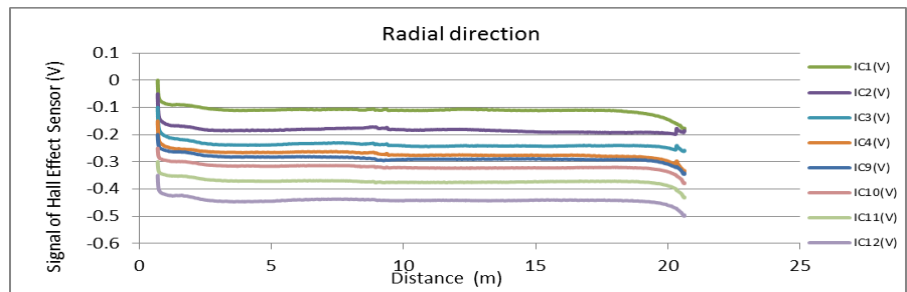
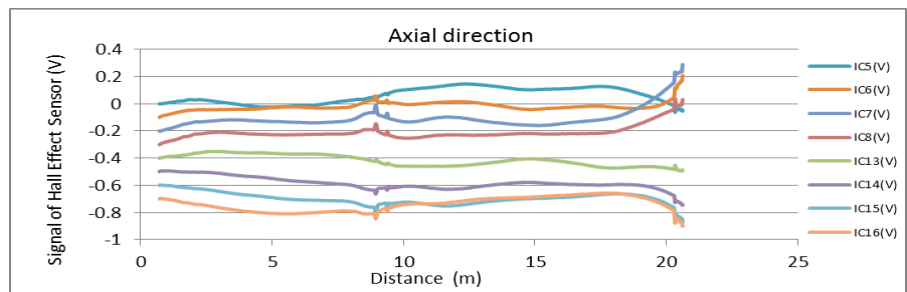
File Name 【Pier-Tendon-Section】	Section Total Length (m)	Scanned Length		Note			
		Starting Point (m)	Ending Point (m)				
P8-403R-I2	21.43	0.71	20.62	Joint position: 9.15 m			
Identified Damage 1				Identified Damage 2			
Max Loss Point (m)	Section Loss (%)	Damage Length (m)	Damage Orientation	Max Loss Point (m)	Section Loss (%)	Damage Length (m)	Damage Orientation
—	—	—	—	—	—	—	—

Figure A225. MMFM data of P8-403R-I2 tendon section.

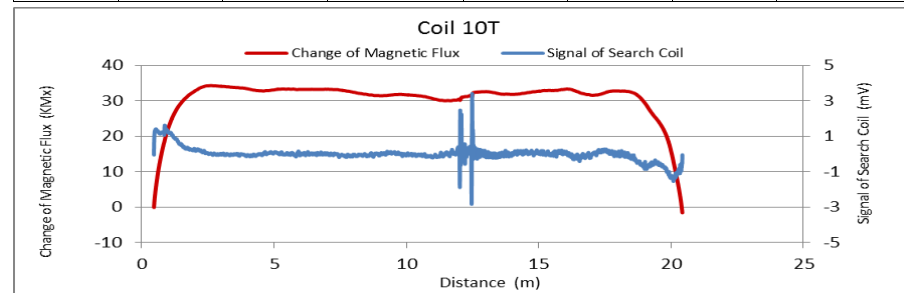
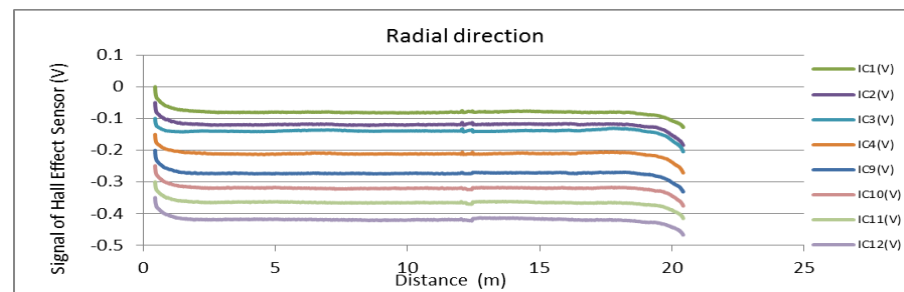
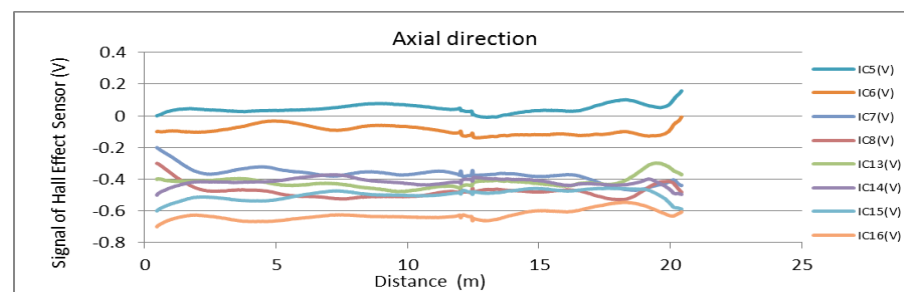
File Name 【Pier-Tendon-Section】	Section Total Length (m)	Scanned Length		Note			
		Starting Point (m)	Ending Point (m)				
P8-403R-I1	21.38	0.46	20.44	Joint position: 12.3 m			
Identified Damage 1				Identified Damage 2			
Max Loss Point (m)	Section Loss (%)	Damage Length (m)	Damage Orientation	Max Loss Point (m)	Section Loss (%)	Damage Length (m)	Damage Orientation
—	—	—	—	—	—	—	—

Figure A226. MMFM data of P8-403R-I1 tendon section.

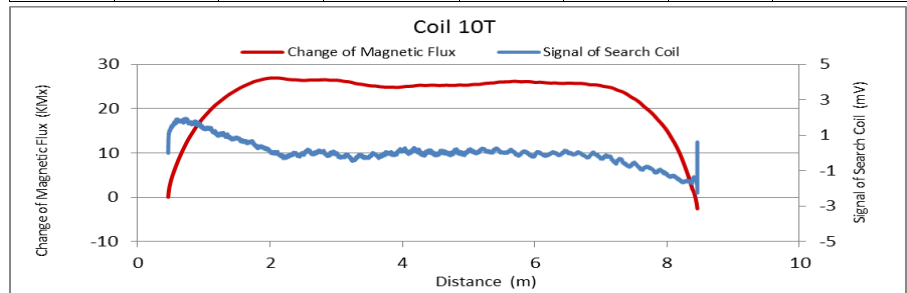
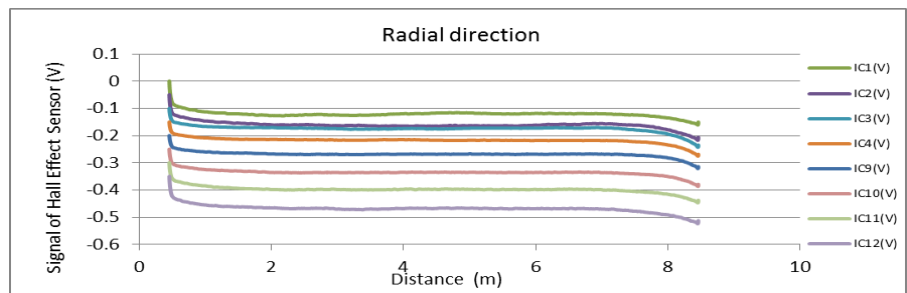
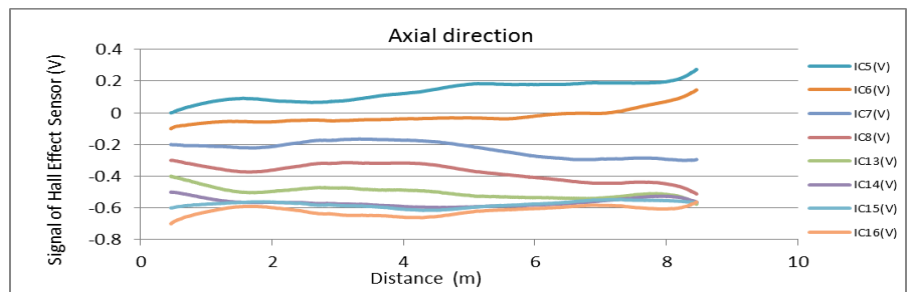
File Name 【Pier-Tendon-Section】	Section Total Length (m)	Scanned Length		Note			
		Starting Point (m)	Ending Point (m)				
P8-406R-H1	9.3	0.46	8.48				
Identified Damage 1				Identified Damage 2			
Max Loss Point (m)	Section Loss (%)	Damage Length (m)	Damage Orientation	Max Loss Point (m)	Section Loss (%)	Damage Length (m)	Damage Orientation
—	—	—	—	—	—	—	—

Figure A227. MMFM data of P8-406R-H1 tendon section.

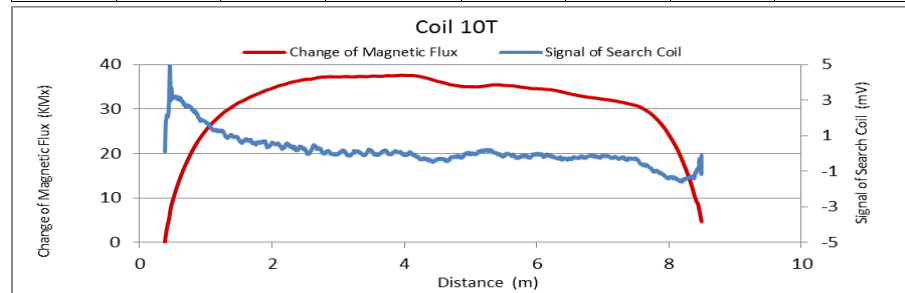
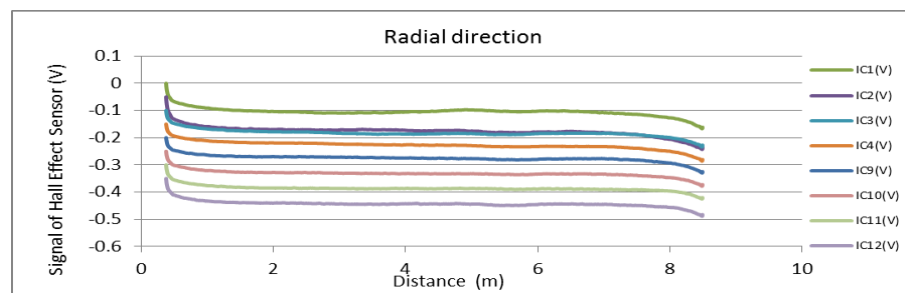
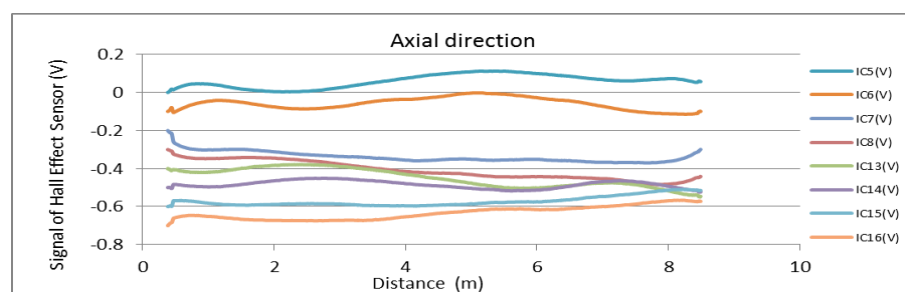
File Name 【Pier-Tendon-Section】	Section Total Length (m)	Scanned Length		Note			
		Starting Point (m)	Ending Point (m)				
P8-405R-H1	9.3	0.38	8.49				
Identified Damage 1				Identified Damage 2			
Max Loss Point (m)	Section Loss (%)	Damage Length (m)	Damage Orientation	Max Loss Point (m)	Section Loss (%)	Damage Length (m)	Damage Orientation
—	—	—	—	—	—	—	—

Figure A228. MMFM data of P8-405R-H1 tendon section.

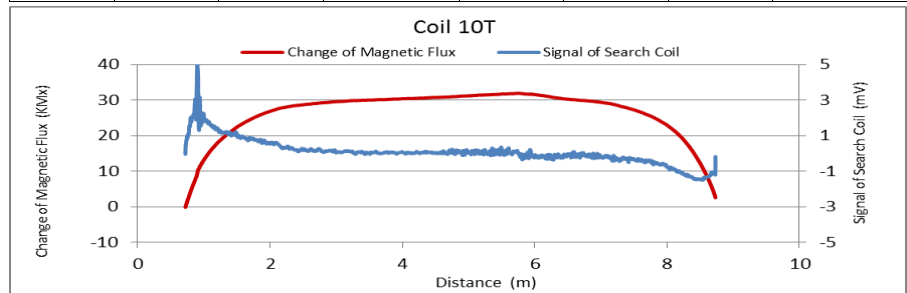
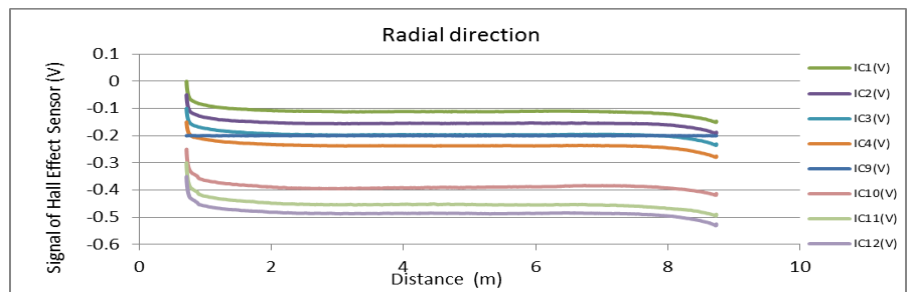
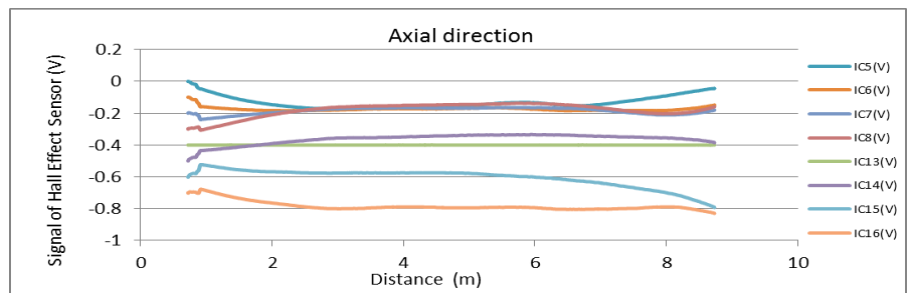
File Name 【Pier-Tendon-Section】	Section Total Length (m)	Scanned Length		Note			
		Starting Point (m)	Ending Point (m)				
P8-403L-H1	9.44	0.72	8.73				
Identified Damage 1				Identified Damage 2			
Max Loss Point (m)	Section Loss (%)	Damage Length (m)	Damage Orientation	Max Loss Point (m)	Section Loss (%)	Damage Length (m)	Damage Orientation
—	—	—	—	—	—	—	—

Figure A229. MMFM data of P8-403L-H1 tendon section.

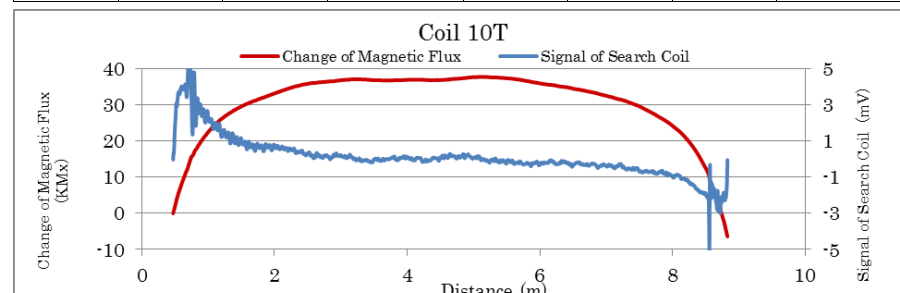
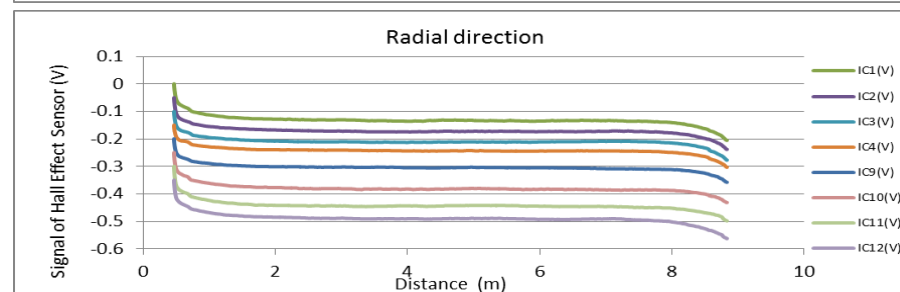
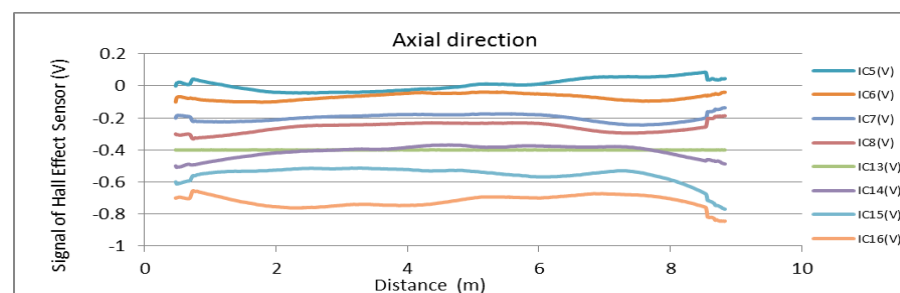
File Name 【Pier-Tendon-Section】	Section Total Length (m)	Scanned Length		Note			
		Starting Point (m)	Ending Point (m)				
P8-405L-H1	9.45	0.47	8.83				
Identified Damage 1				Identified Damage 2			
Max Loss Point (m)	Section Loss (%)	Damage Length (m)	Damage Orientation	Max Loss Point (m)	Section Loss (%)	Damage Length (m)	Damage Orientation
—	—	—	—	—	—	—	—

Figure A230. MMFM data of P8-405L-H1 tendon section.

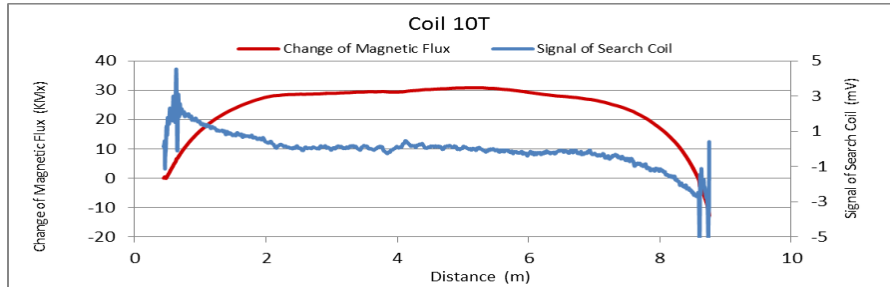
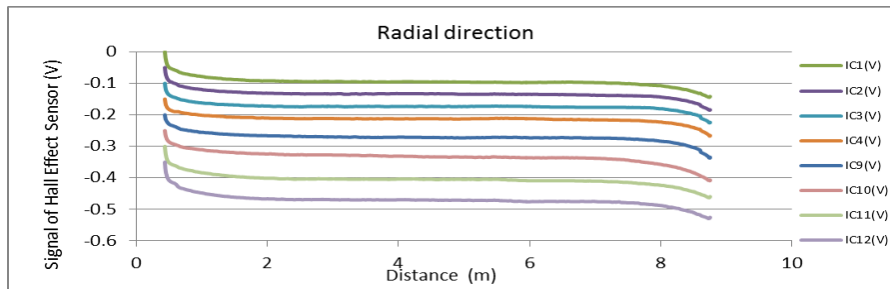
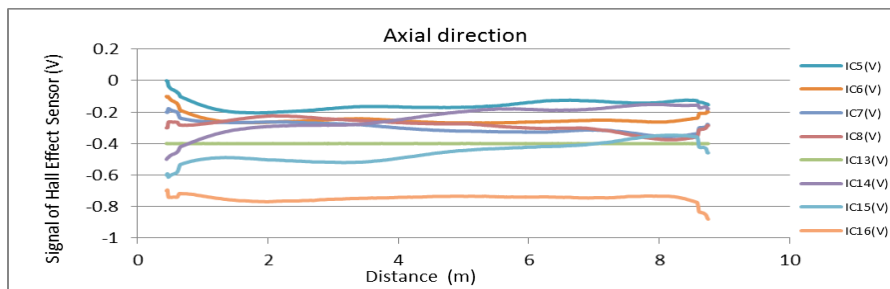
File Name 【Pier-Tendon-Section】	Section Total Length (m)	Scanned Length		Note			
		Starting Point (m)	Ending Point (m)				
P8-406L-H1	9.45	0.44	8.75				
Identified Damage 1				Identified Damage 2			
Max Loss Point (m)	Section Loss (%)	Damage Length (m)	Damage Orientation	Max Loss Point (m)	Section Loss (%)	Damage Length (m)	Damage Orientation
—	—	—	—	—	—	—	—

Figure A231. MMFM data of P8-406L-H1 tendon section.

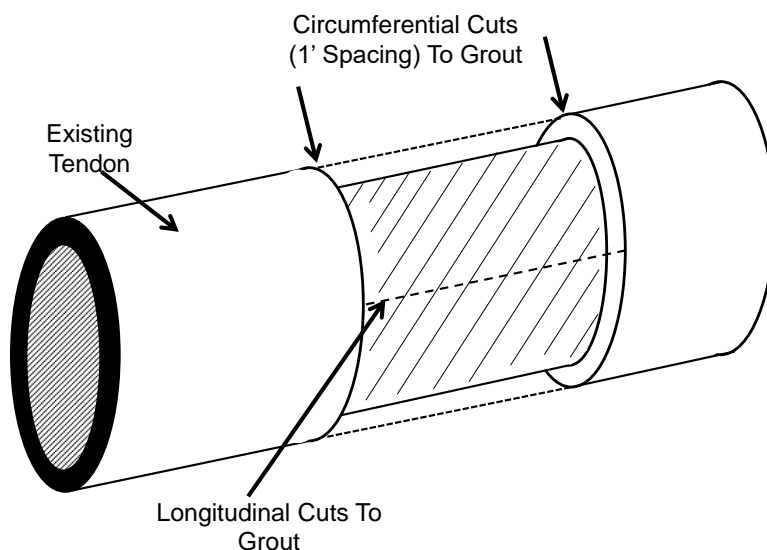
- Photo-documentation with a picture at 12, 3, 6, and 9 o'clock (when possible) should be taken before and after each step

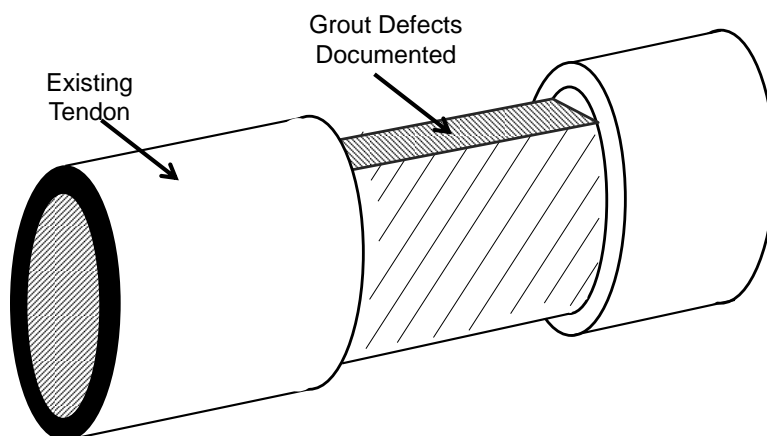
- Cuts tentatively made to avoid hitting steel strand.
- After two circumferential cuts and two parallel longitudinal cuts at 3 and 9 o'clock, the top half pipe carefully removed to reveal underlying grout.
- Bottom half pipe carefully removed to avoid disturbance, breakage and loss of grout material.
- Only the top half pipe should be cut and removed for strand with low ground clearance.

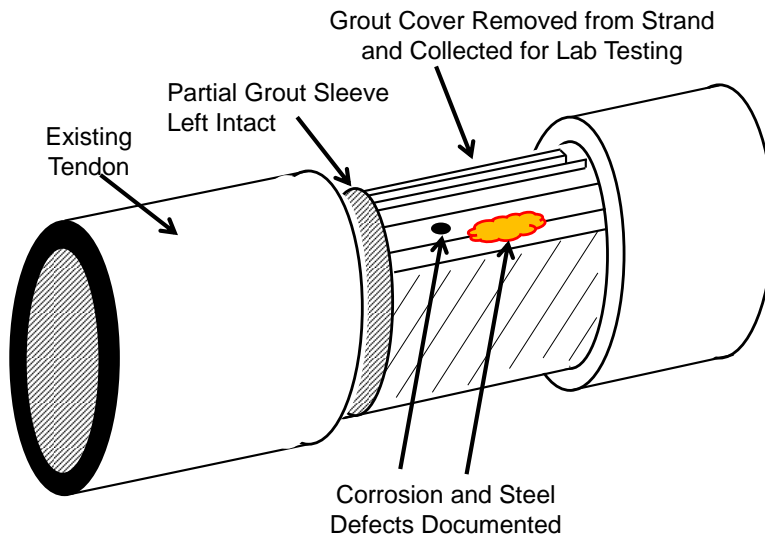
- Grout carefully removed by hammer and scoop to reveal underlying steel.
- A partial grout sleeve should be left intact at one or both cut window edges.
- All grout materials should be sealed in labeled plastic bags for later testing.
- Grout materials may be separated into groups if variability in grout deficiencies exist.
- Any visual rust staining and rust accumulation should be documented.

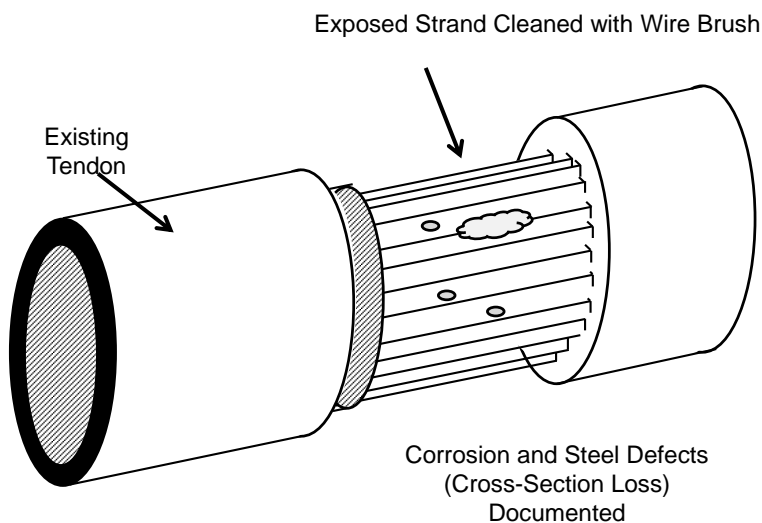
- After removal of grout around the circumference of the steel bundle, the exposed steel should be hand cleaned with a wire brush to remove (as much as attainable by hand) loose grout and rust particles.
- Steel defects and cross-section loss should be documented. A pit-depth gage may be used if localized corrosion observed.

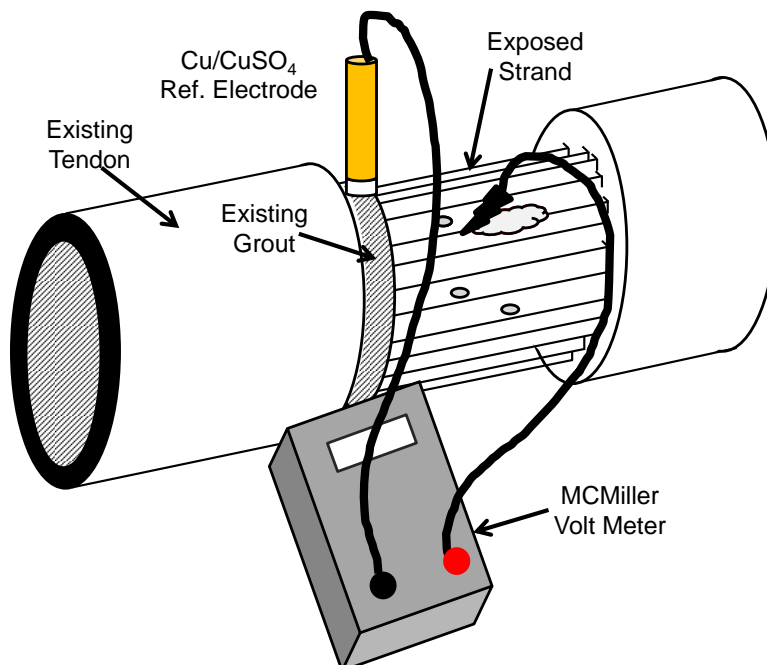
- Half-cell potentials should be made by placing a slender Cu/CuSO_4 electrode on the existing grout sleeve. The tip of the reference electrode may be covered with a wet sponge. The working electrode contact should be placed on each exposed steel strand regardless of electrical continuity .
- Each measurement should be recorded with notes on ref electrode placement, circumferential location of each strand, and observation of rust.

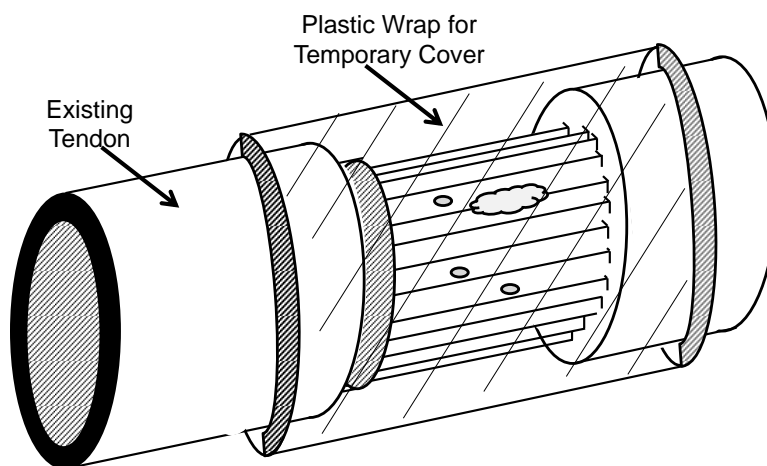
- If a permanent repair is delayed, a temporary cover using plastic wrap and duct tape may be used for up to 2 days.

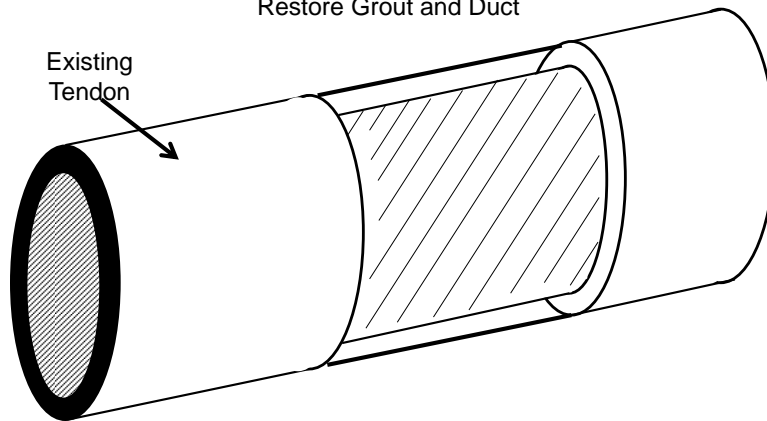
Permanent Repair
Restore Grout and Duct

- Permanent repairs conforming to FDOT requirements should be made.
- QC of the permanent repair should be made after 1 day.

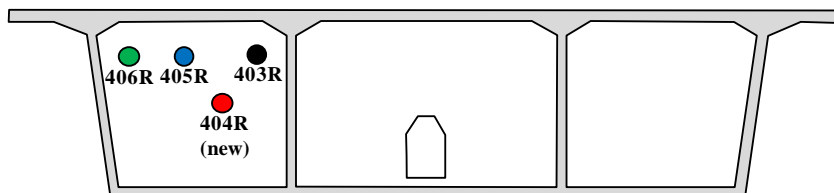
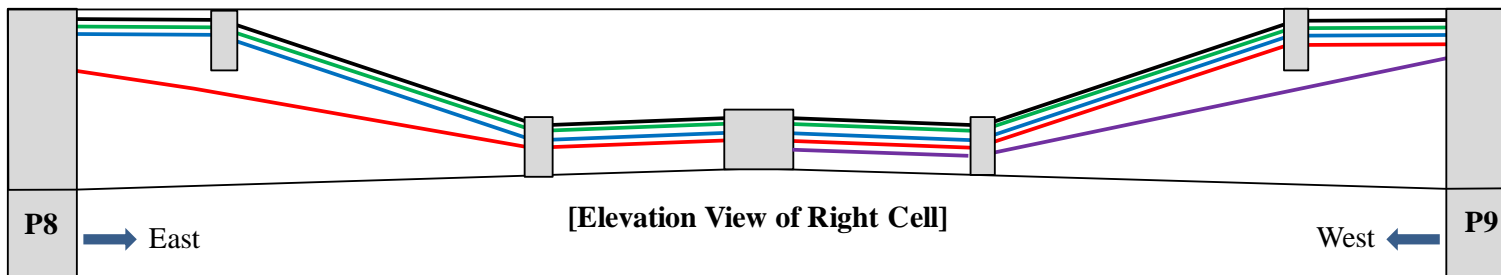
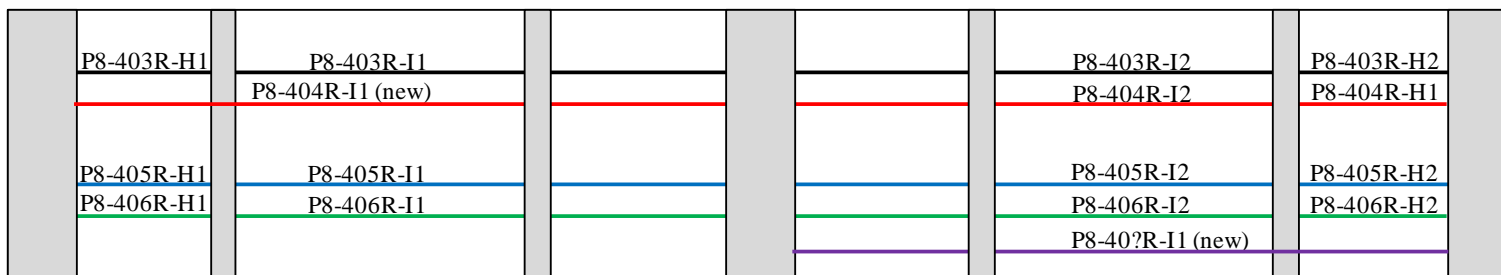
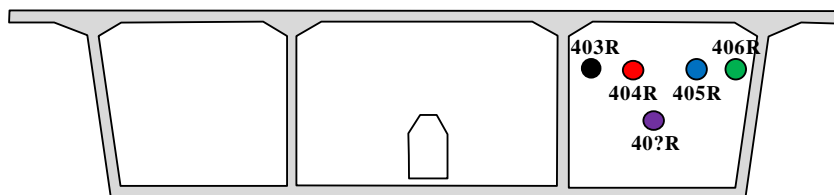
Figure . Scanned tendon sections in P8 – P9 (right cell).

[Diaphragm: East Face at Pier 8]

[Elevation View of Right Cell]

[Plan View of Right Cell]

[Diaphragm: West Face at Pier 9]

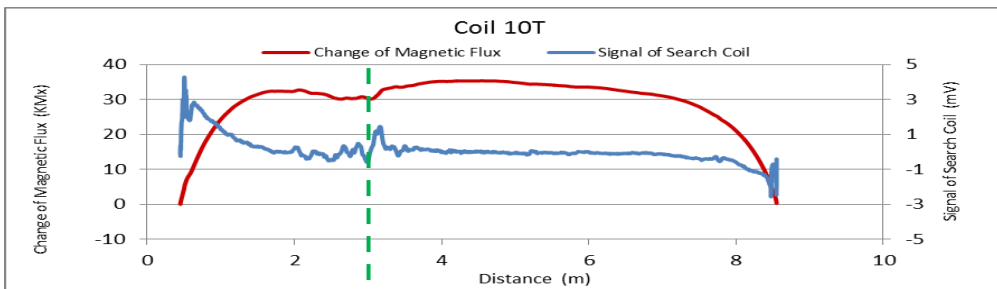
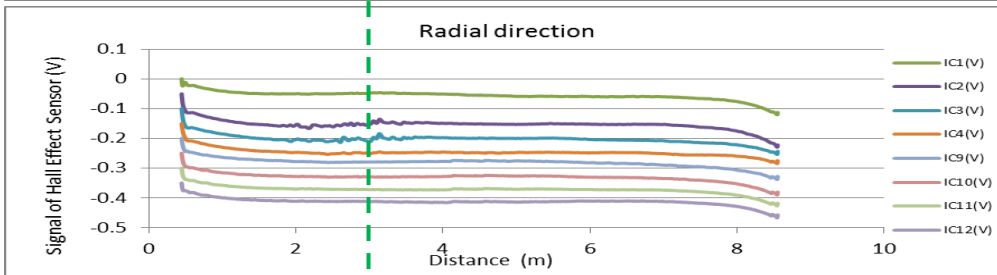
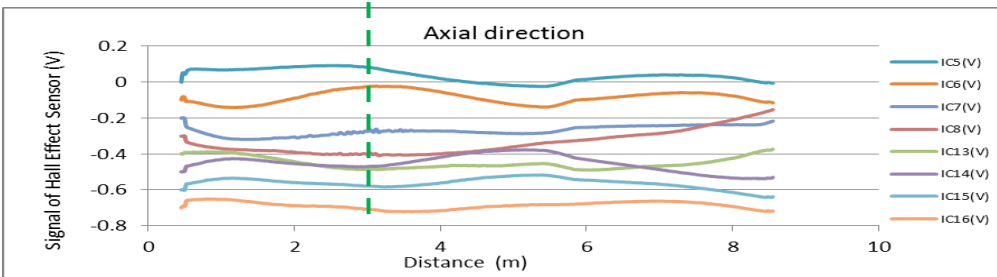
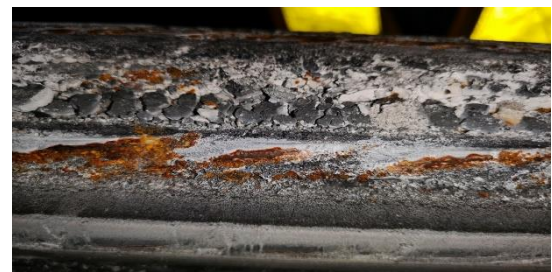
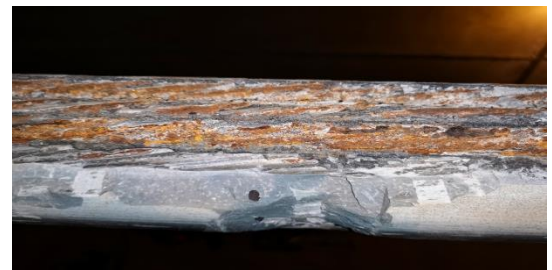
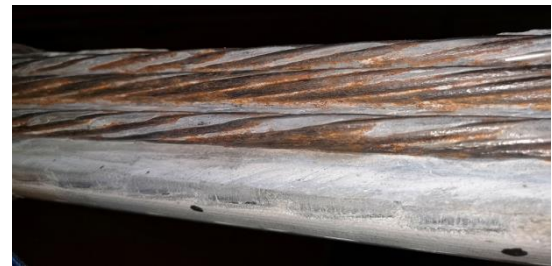
File Name 【Pier-Tendon-Section】	Section Total Length(m)	Scanned Length		Note			
		Starting Point(m)	Ending Point(m)				
P8-403R-H1	9.3	0.45	8.55	Starting point of damage1 : 2.68m			
Identified damage 1				Identified damage 2			
Max Loss Point(m)	Section Loss (%)	Damage Length(m)	Damage Orientation	Max Loss Point(m)	Section Loss (%)	Damage Length(m)	Damage Orientation
3.0	1.5	0.80	10~12 o'clock

- TR Test Result: Approx. 1.5% section loss signal
- Verification Result: Corrosion found
