**Development of Quality Assurance and Quality Control
System for Post Tensioned Segmental Bridges in Florida:
Case of Ringling Bridge – Phase II**

**FDOT Contract No. BDV29-977-34
FINAL REPORT**

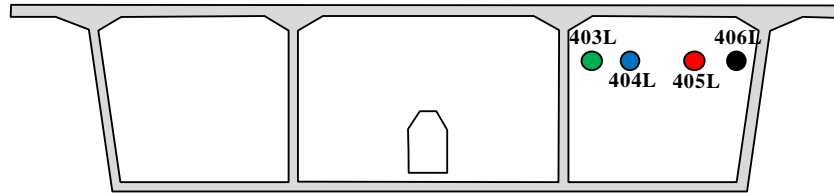
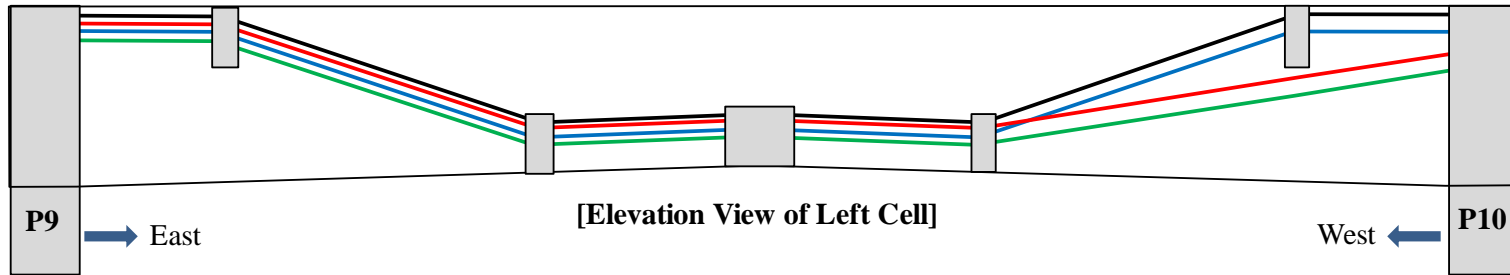
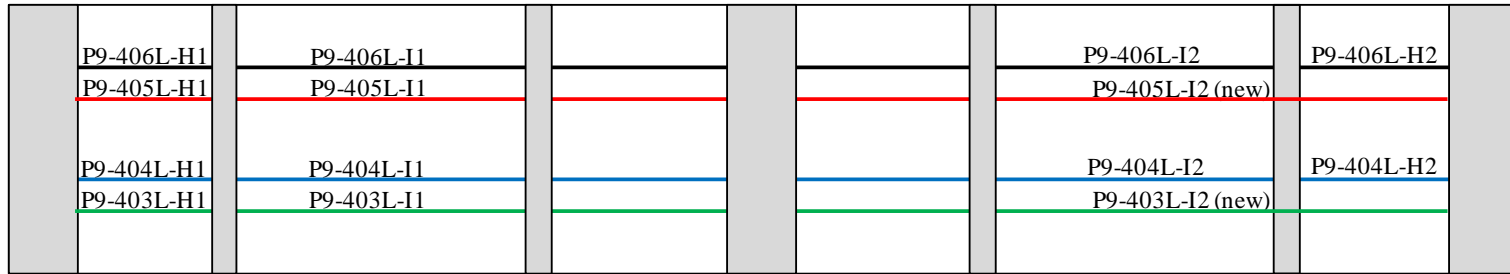
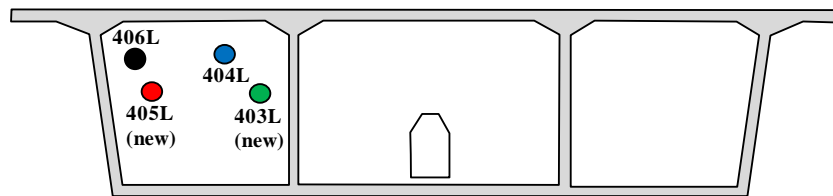
Figure . Scanned tendon sections in P9 – P10 (left cell).

[Diaphragm: East Face at Pier 9]

[Elevation View of Left Cell]

[Plan View of Left Cell]

[Diaphragm: West Face at Pier 10]

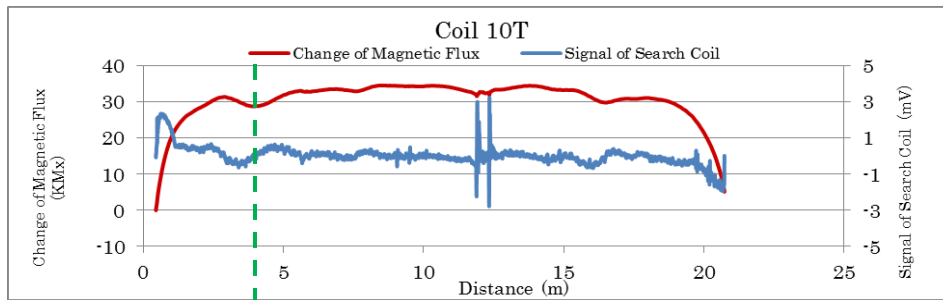
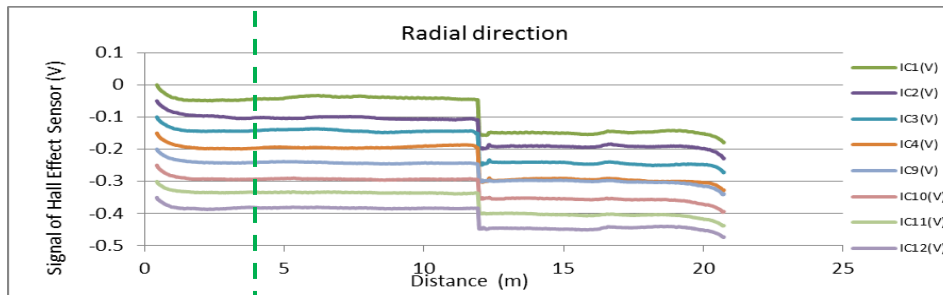
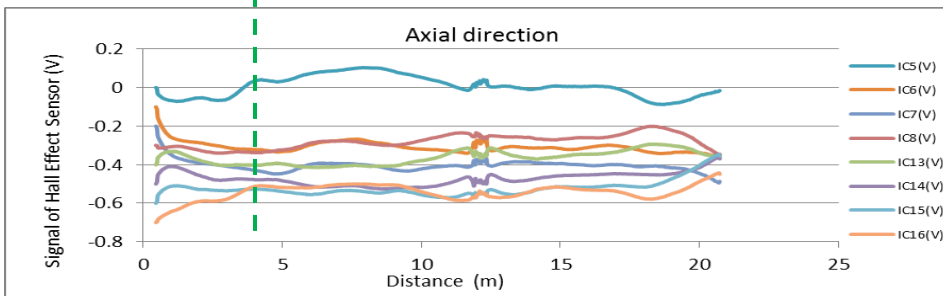
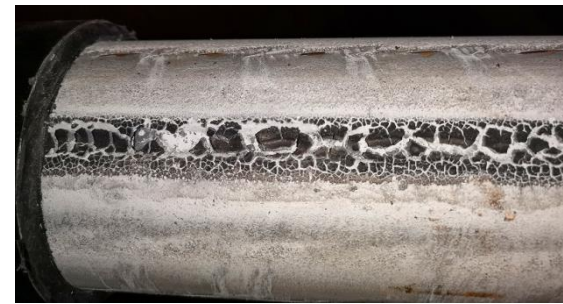
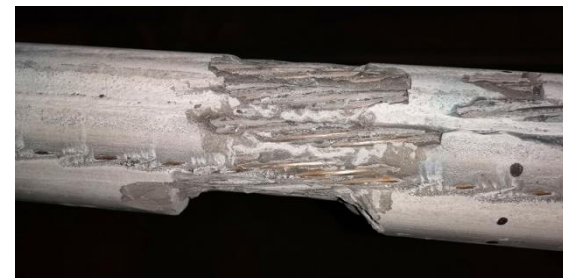
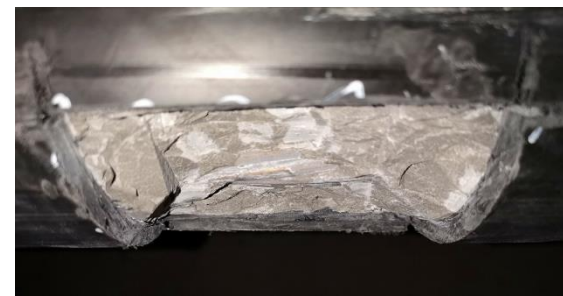
File Name 【Pier-Tendon-Section】	Section Total Length(m)	Scanned Length		Note			
		Starting Point(m)	Ending Point(m)				
P9-406L-II	21.5	0.45	20.77	Joint position : 12.2m Starting point of damage1 : 3.2m Starting point of damage2 : 15.9m			
Identified damage 1				Identified damage 2			
Max Loss Point(m)	Section Loss (%)	Damage Length(m)	Damage Orientation	Max Loss Point(m)	Section Loss (%)	Damage Length(m)	Damage Orientation
3.9	1.4	1.08	2~4 o'clock	16.5	1.2	0.71	12~3 o'clock

- TR Test Result: Approx. 1.4% section loss signal
- Verification Result: Irregular strand position observed but no corrosion found

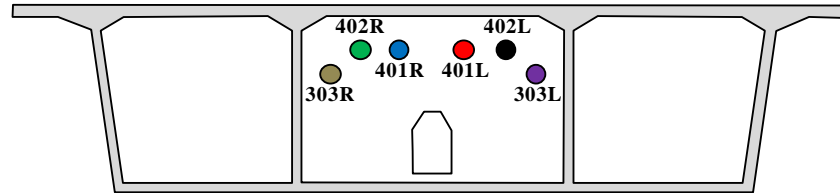
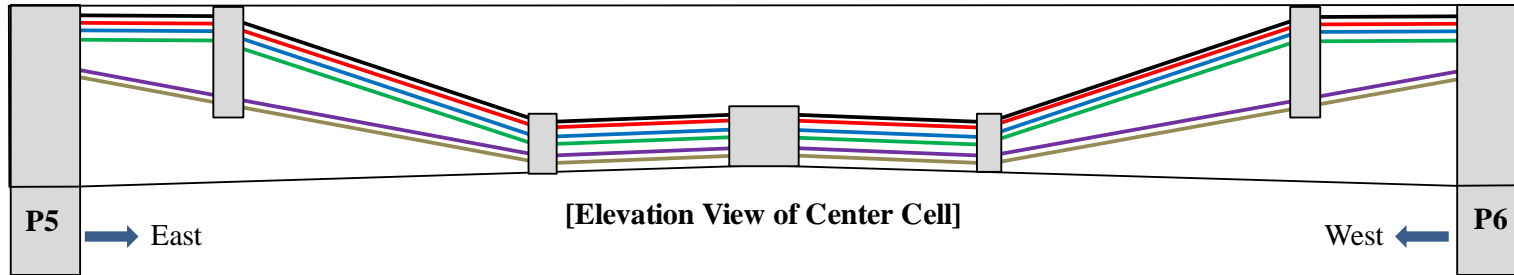
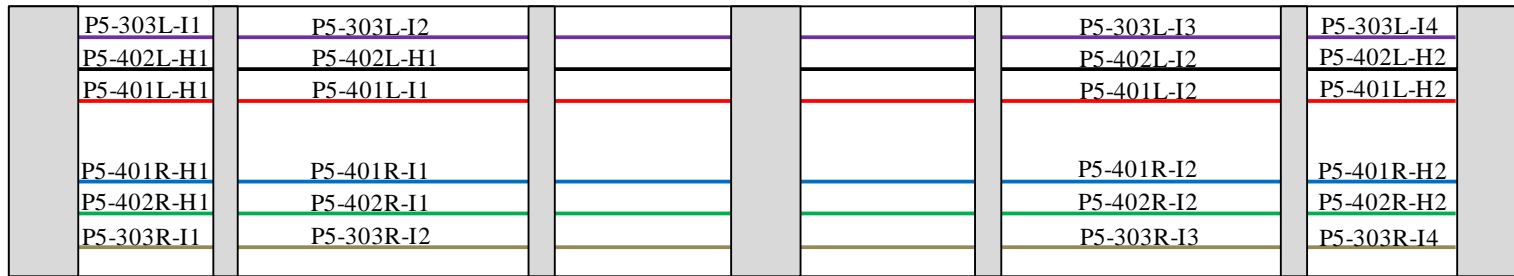
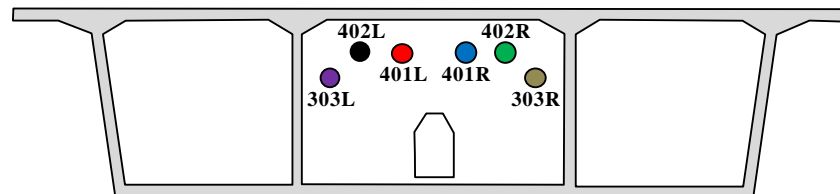
Figure . Scanned tendon sections in P5 – P6 (center cell).

[Diaphragm: East Face at Pier 5]

[Plan View of Center Cell]

[Diaphragm: West Face at Pier 6]

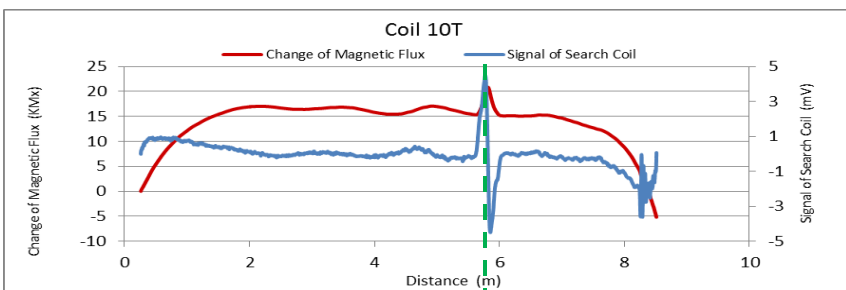
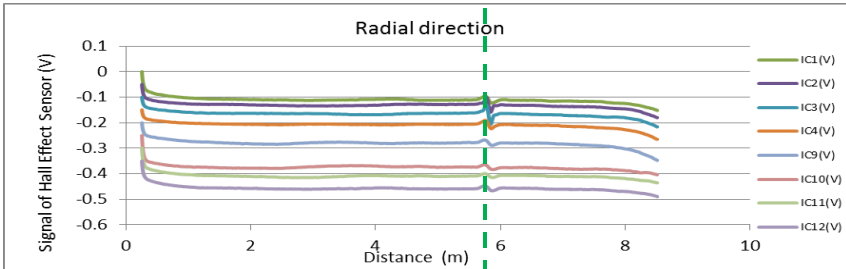
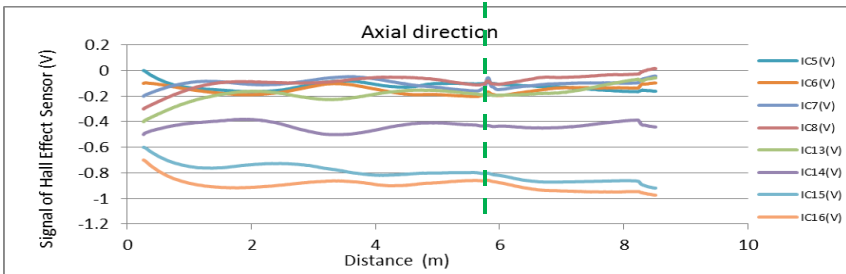
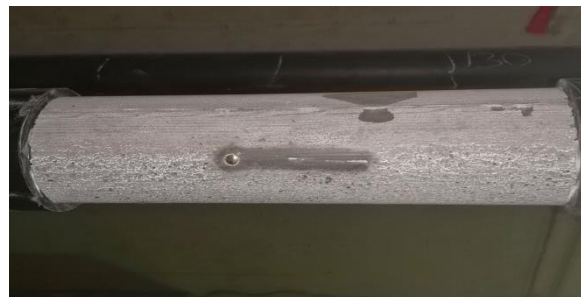
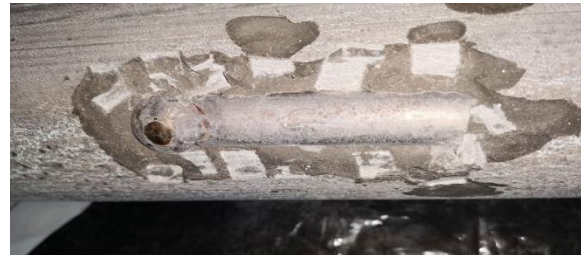
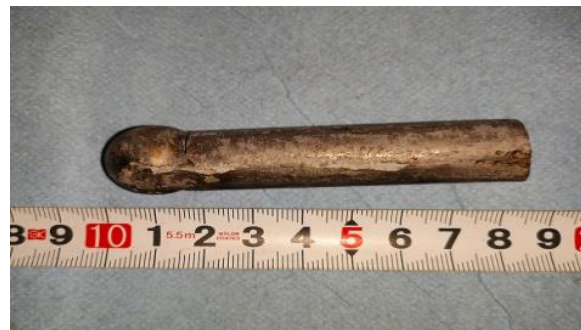
File Name 【Pier-Tendon-Section】	Section Total Length(m)	Scanned Length		Note			
		Starting Point(m)	Ending Point(m)				
P5-303L-I4	9.55	0.26	8.57	Identified damage 1 : Increase of change of magnetic flux Starting point of damage : 5.72m			
Identified damage 1				Identified damage 2			
Max Loss Point(m)	Section Loss (%)	Damage Length(m)	Damage Orientation	Max Loss Point(m)	Section Loss (%)	Damage Length(m)	Damage Orientation
5.8	-2.2	0.16	4~7 o'clock

Total Length(m)	Scanned Length		Identified damage 1			
	Starting point(m)	Ending point(m)	Center Point(m)	Loss (%)	Length(m)	Direction
9.55	0.26	8.57	5.81	-2.22	0.2	4~8 O'clock

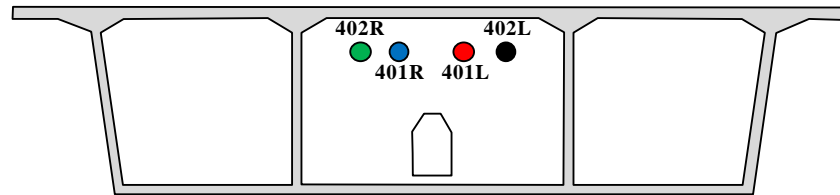
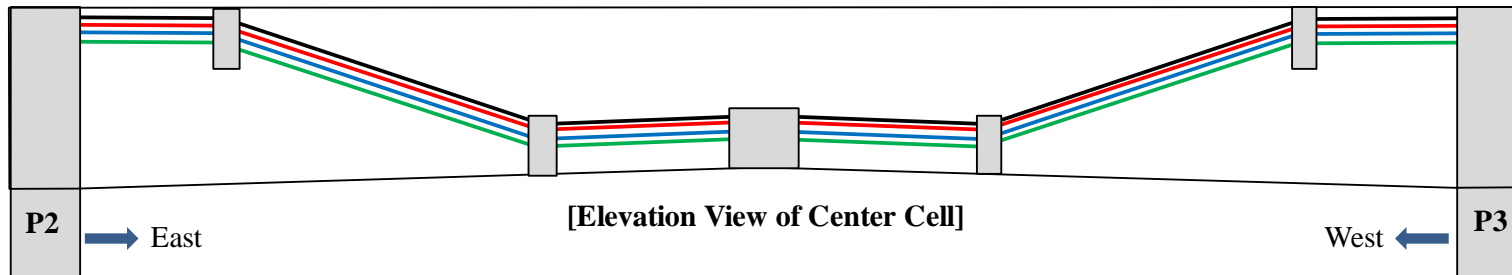
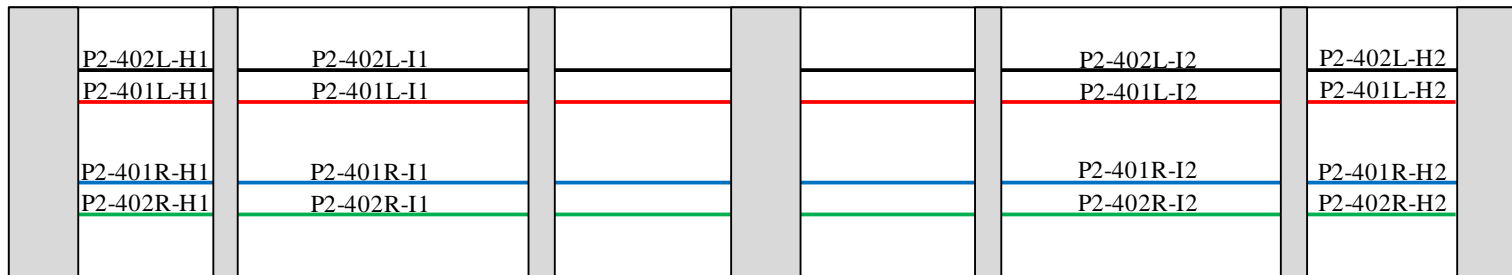
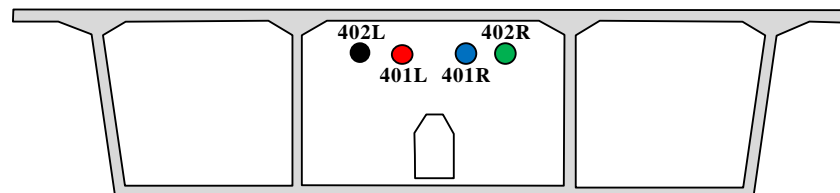
Figure . Scanned tendon sections in P2 – P3 (center cell).

[Diaphragm: East Face at Pier 2]

[Elevation View of Center Cell]

[Plan View of Center Cell]

[Diaphragm: West Face at Pier 3]

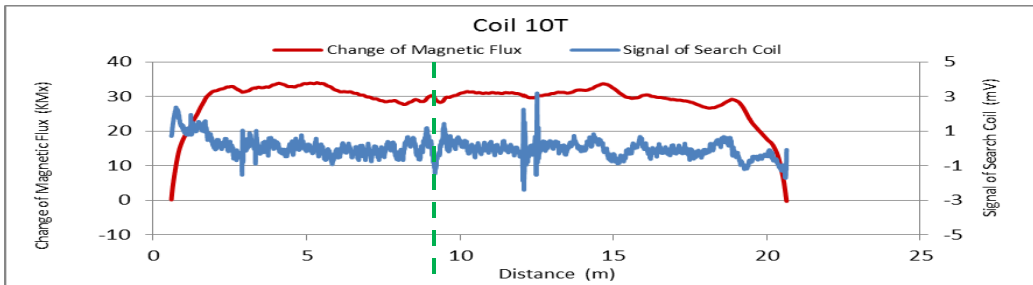
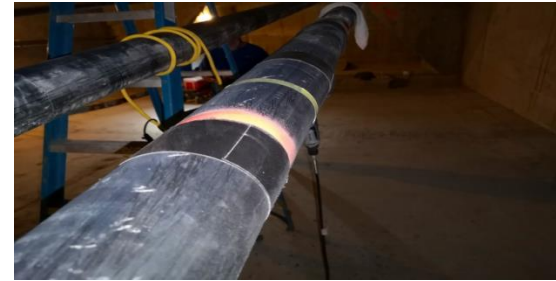
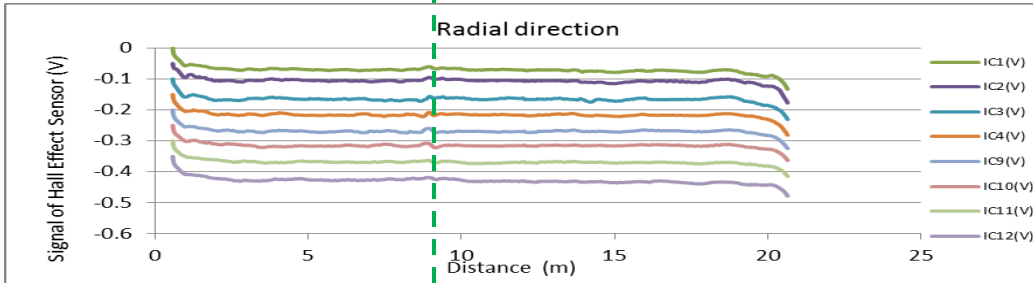
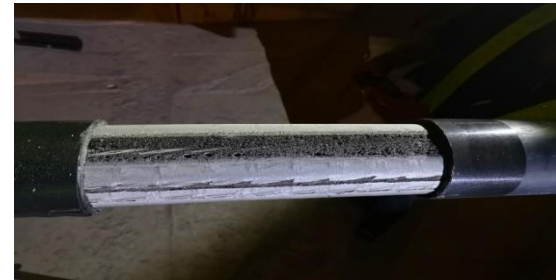
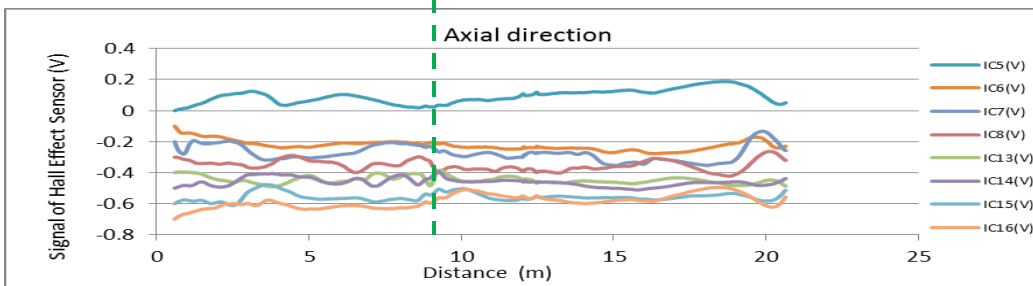
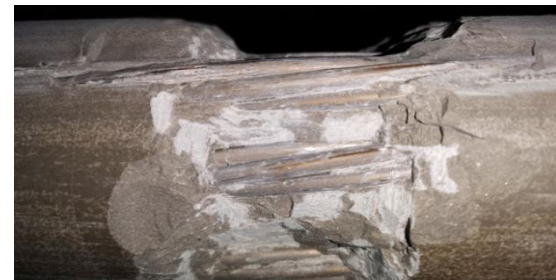
File Name 【Pier-Tendon-Section】	Section Total Length(m)	Scanned Length		Note			
		Starting Point(m)	Ending Point(m)				
P2-402L-II	21.37	0.59	20.68	Joint position : 12.3m Starting point of damage1 : 7.15m			
Identified damage 1				Identified damage 2			
Max Loss Point(m)	Section Loss (%)	Damage Length(m)	Damage Orientation	Max Loss Point(m)	Section Loss (%)	Damage Length(m)	Damage Orientation
8.2	2.4	1.78	6~8 o'clock

5‡ The location of verification had been changed to P2-402L-I1 (Defect:2.4%)

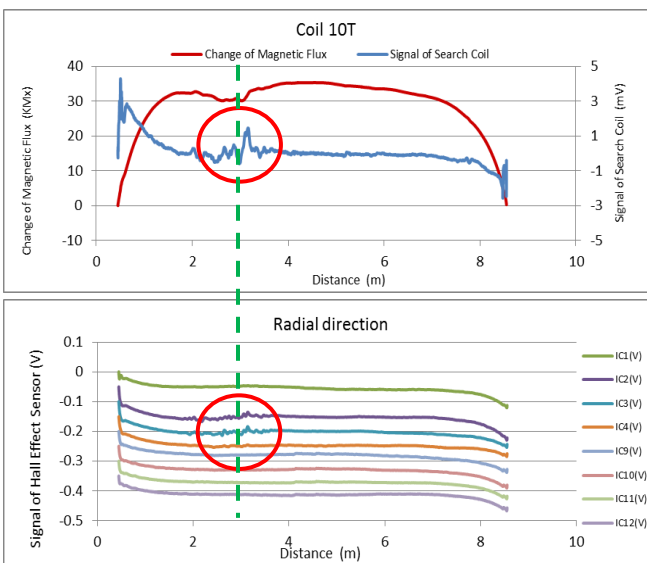
Site 1 P8-403R-H1 Signal

- Comparison of the signals (Green line shows where opened 1ft for verification)

- Comparing the 2 Signals of Site 1 and Site 2 (above), change of Magnet Flux (shown in red line) are similar, however short frequency wave on the signal of Search Coil (shown in blue line) is visible where the corrosion existed in Site 1, while there are no wave visible on the signal of Search Coil in Site 2.
- Also the Signals of Hall Effect Sensor showed wave in Site 1, while no wave were observed in the Signals of Hall Effect Sensor (V) on Site 2.
- From this observation, we can conclude that there is a possibility of corrosion loss when both Search Coil and the Hall Effect Sensor shows waves on the signals, however, Search Coil signals without the waves from the Hall Effect Sensor will likely be the other reason than corrosion.

- TR Test Result: Approx. 1.5% section loss signal
- Verification Result: Corrosion found

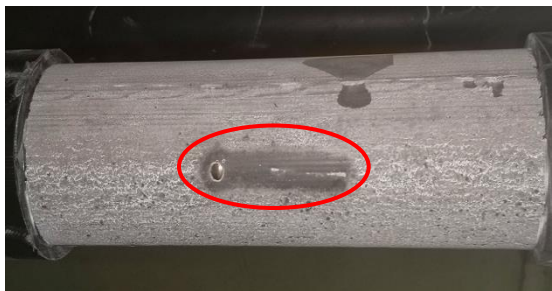
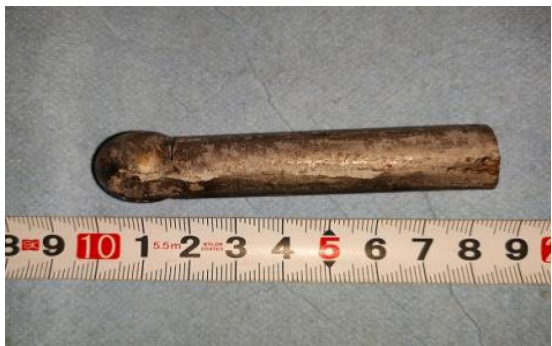
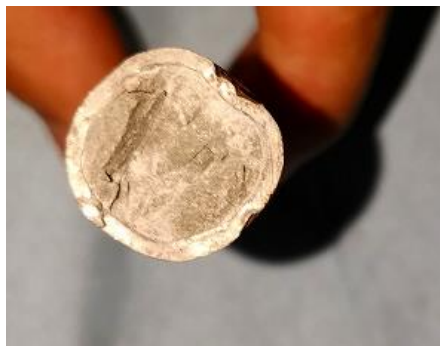
Metallic object found in grout

- TR Test Result: Approx. 2.2% section increase signal
- Verification Result: Metal object found in the grout (see photos below)

- Metal object was found and extracted from the grout as shown in the photos.
- The measurement of the object was equal to approx. 2.7% of the total area of PC Strands, which is close to the signal (2.2%) observed in the testing.
- We have observed 21 locations of similar section increase within 221 locations tested in February.

1. As a result of the verification opening, we had 2 positive result where actual sectional loss from corrosion and sectional increase by the foreign object has been found. (Site 1 and Site 4)
2. We could not find any visible defect in 2 Sites (Site 2 and Site 5). While we analyzed that the reason for not finding the defect in Site 2 could be because of the deviation of strands, we assume that there could be a possibility of

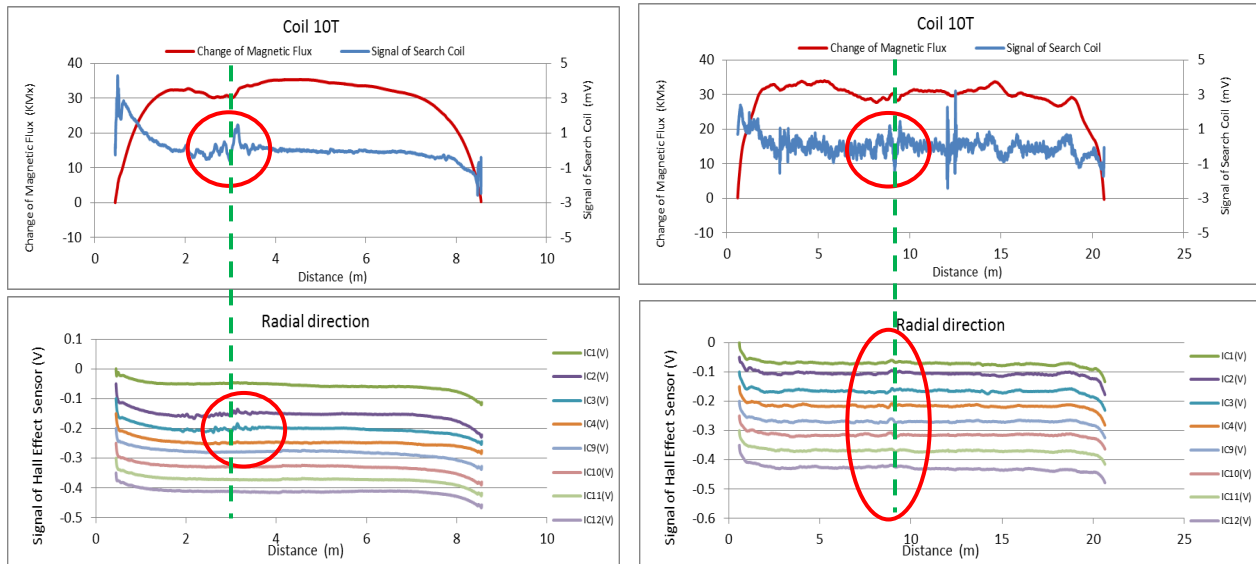
- TR Test Result: Approx. 2.4% section loss signal
 - Verification Result: No corrosion observed on the surface of the PC Strand
 - To analyze the result, we have compared with the signal of Site 1
- Comparison of the signals (Green line shows where opened 1ft for verification)

Site 1 P8-403R-H1 Signal

Site 5 P2-402L-I1 Signal

- Comparing the 2 Signals of Site 1 and Site 5 (above), we analyzed that the signal output of both Sites were similar but Site 5 seemed to have larger cross sectional loss than Site 1 where corrosion loss has been actually observed.
- After opening, PC Strands in Site 5 observed to be in oval shape but no corrosion was seen on the surface of the PC Strands.
- Unlike Site 1, all of the Hall Effect Sensors showed wave signals in Site 5 at the same output level.
- Observing the signals from the Hall Effect Sensors in Site 5, which shows waves in all of the Hall Effect Sensors at equal output level, we assume that there is a possibility of sectional loss in the center (core) area of the strands.

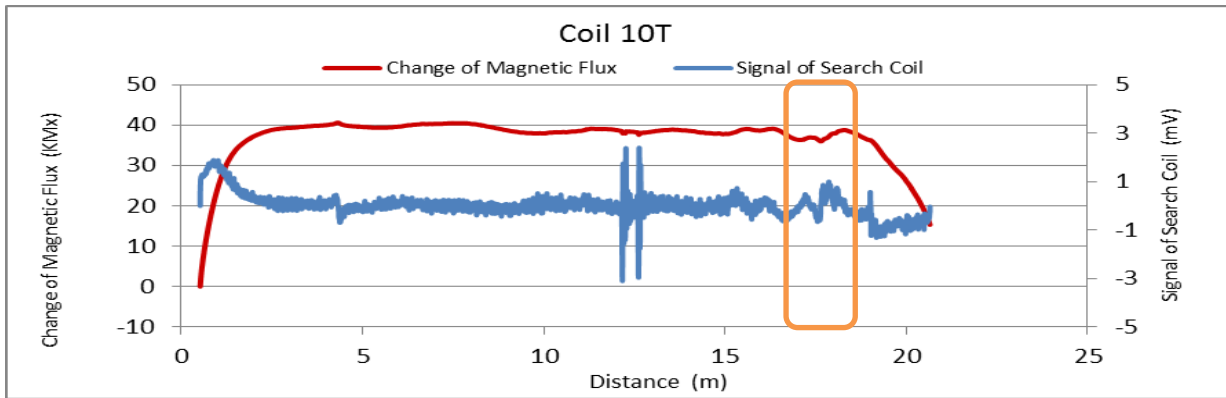
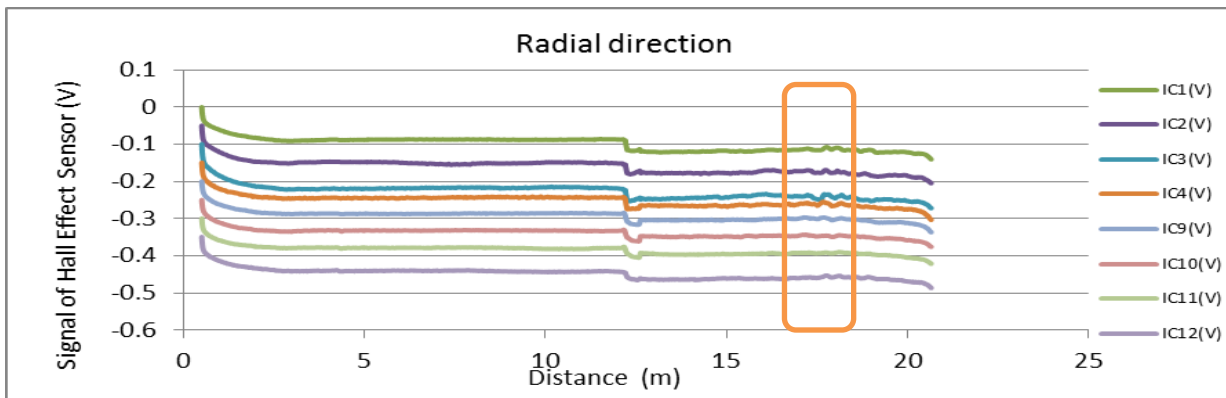
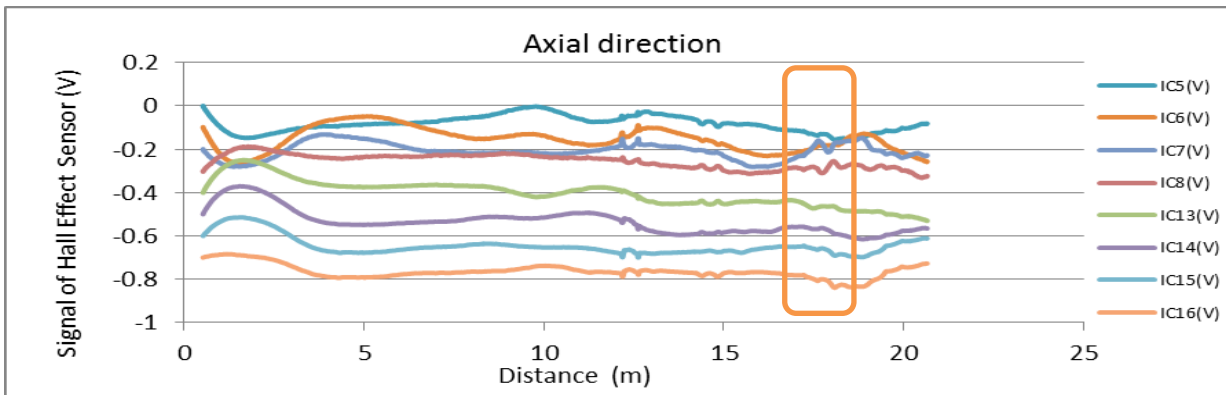
File Name 【Pier-Tendon-Section】	Section Total Length (m)	Scanned Length		Note Joint position : 12.37 m Starting point of damage 1 : 17.15 m			
		Starting Point (m)	Ending Point (m)				
P4-401R-I1	21.57	0.52	20.65				
Identified Damage 1				Identified Damage 2			
Max Loss Point (m)	Loss (%)	Length (m)	Damage Orientation	Max Loss Point (m)	Loss (%)	Length (m)	Damage Orientation
17.6	1.2	0.74	8~11 o'clock	—	—	—	—

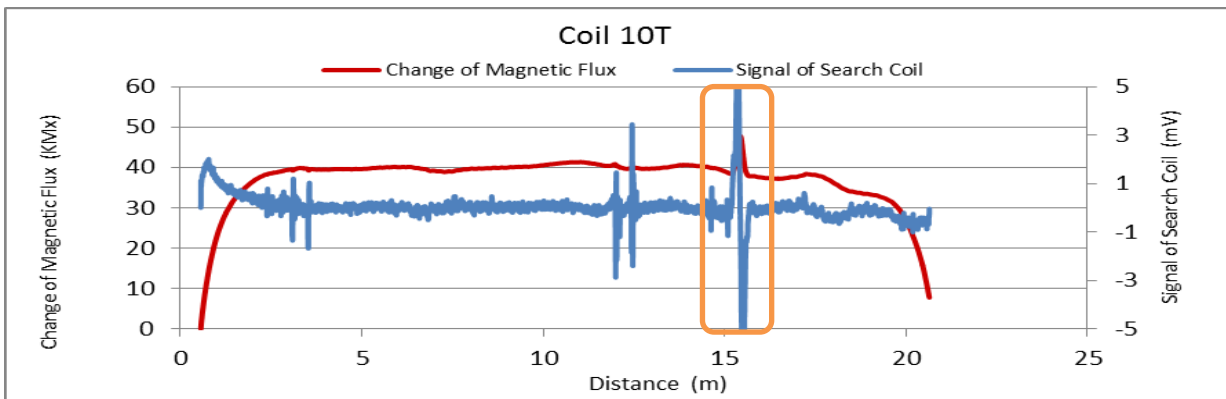
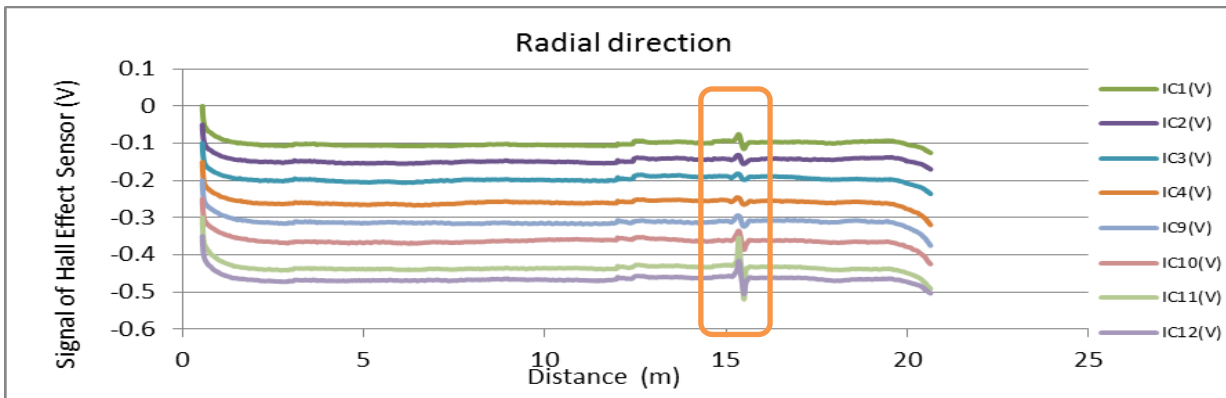
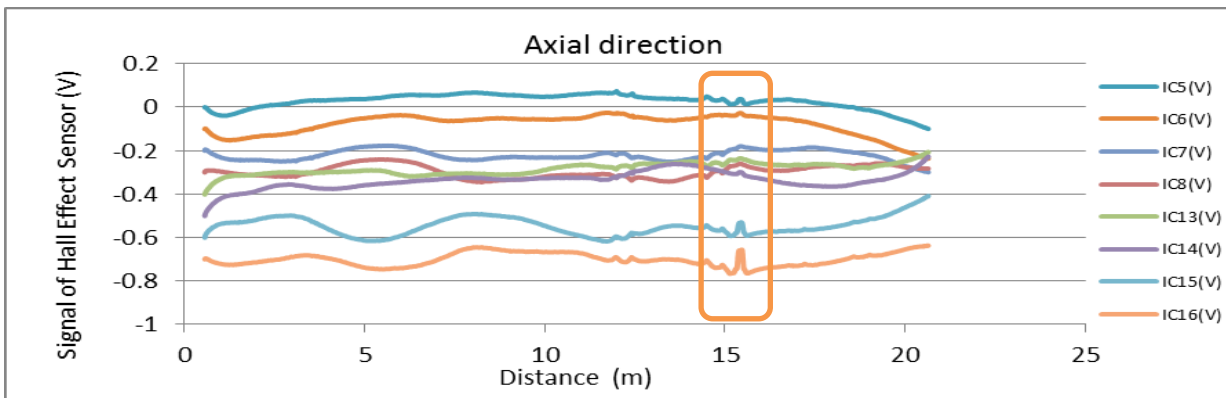
File Name 【Pier-Tendon-Section】	Section Total Length (m)	Scanned Length		Note			
		Starting Point (m)	Ending Point (m)				
P2-401R-II	21.43	0.56	20.64	Joint position : 12.2 m Identified damage 1 : Increase of magnetic flux Starting point of damage 1 : 15.33 m			
Identified Damage 1				Identified Damage 2			
Max Loss Point (m)	Loss (%)	Length (m)	Damage Orientation	Max Loss Point (m)	Loss (%)	Length (m)	Damage Orientation
15.4	-3.8	0.17	8~12 o'clock	—	—	—	—
