Final Report

FDOT BDV31-977-121

Use of Infrared Thermography for the Inspection of Welds in the Shop and Field- Phase II

Department of Materials Science and Engineering
University of Florida
549 Gale Lemerand Dr.
Gainesville, FL 32611

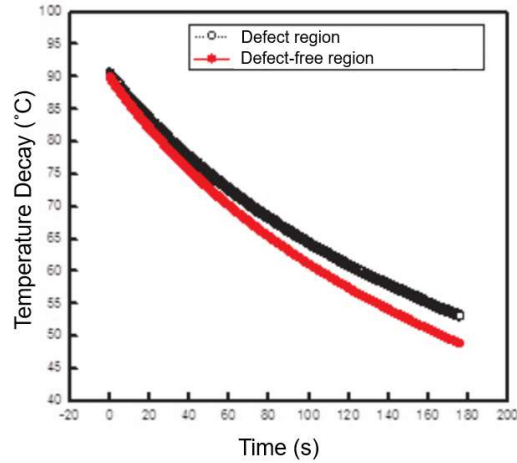
Figure 0-5 – Temperature decay plot of an Al joint welded using FSW, comparing defect and defect-free regions of the weld [19].

Figure 0-5 [19]. Only one Al joint was tested in this study, creating a need to verify the techniques' repeatability on other joint types. Another study that tested IR-TNDT on FSW Al joints analyzed weld process-related discontinuities, which can obscure the thermal signal from nearby defects [20].

Two studies have attempted to document the heat transfer behavior of a weld with a defect by analyzing the cool-down curves of carbon steel weld joints with defects and comparing them to weld regions without defects [7], [9]. An example is shown in Figure 0-7, where the time-dependent thermal profile differs in the defect-free and defective areas. The portion of the weld containing the defect cools faster than the defect-free region [9], opposingly to the data obtained for Al weld joints, as shown in Figure 0-5 [19].

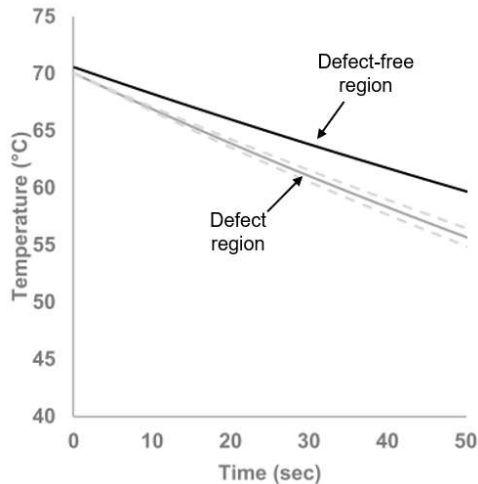
Figure 0-7 – Cool-down behavior of a carbon steel weld in a region with and without a crack defect [9].

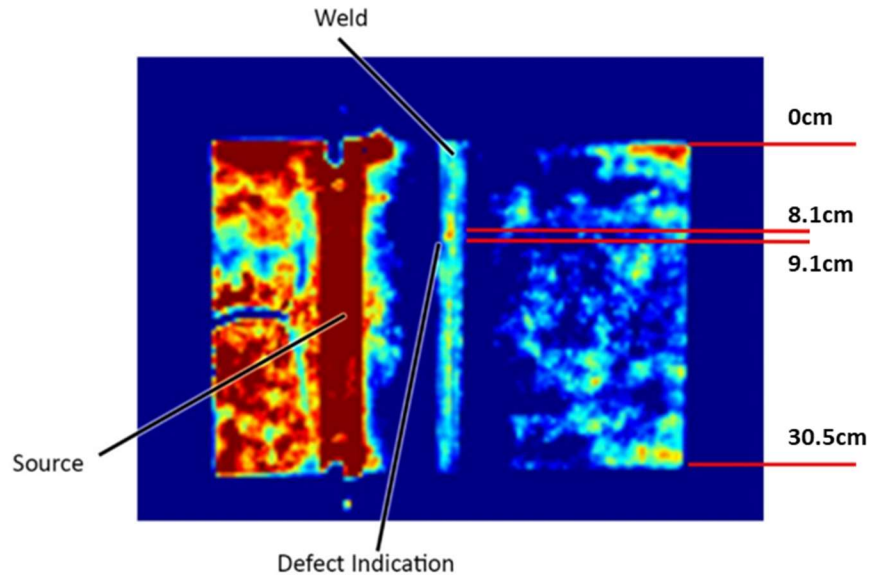
Figure 0-10 – IR-UTD processed image from weld cooling showing indication in the toe crack [8].

The author's FDOT BDV31 977-64 Phase I report [8] investigated an infrared ultra-time domain (IR-UTD) processing approach that utilizes time-lapse thermal images captured during the heating and cooling process to detect subsurface defects. As seen in Figure 0-10, it was demonstrated that in a conventional IR image produced without the time-lapse processing implemented in the IR-UTD, the crack identification did not appear clearly due to the noise created by other surface anomalies.

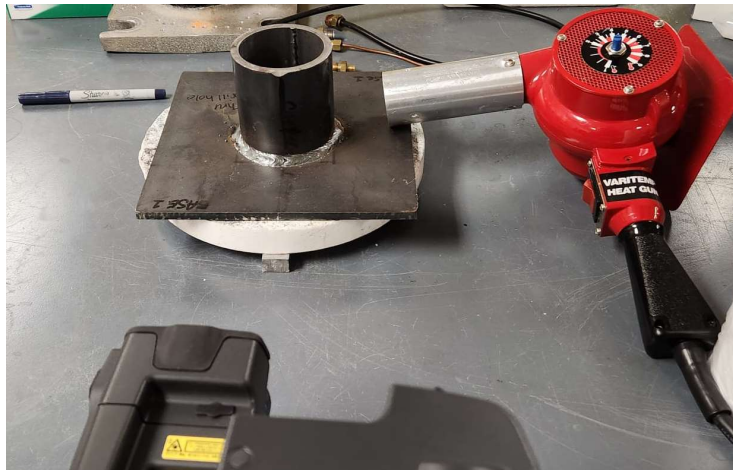
Figure 0-20 – Photography of the trial assembly, showing sample, camera, and heat gun positioning.

Infrared images were taken every 15 seconds for the Al samples and every 30 seconds for the steel samples until the sample cooled to 35°C. The temperature measurement during the cool-down was taken by positioning the measuring spot on top of the drilled hole. For the subsurface pseudocrack, the measuring spot was placed at the beginning of the machined region. The visual analysis examined any discontinuities in the weld thermal signal in regions with known defects. This technique simulates the investigation performed in the field, as represented in the trial assembly shown in Figure 0-20.

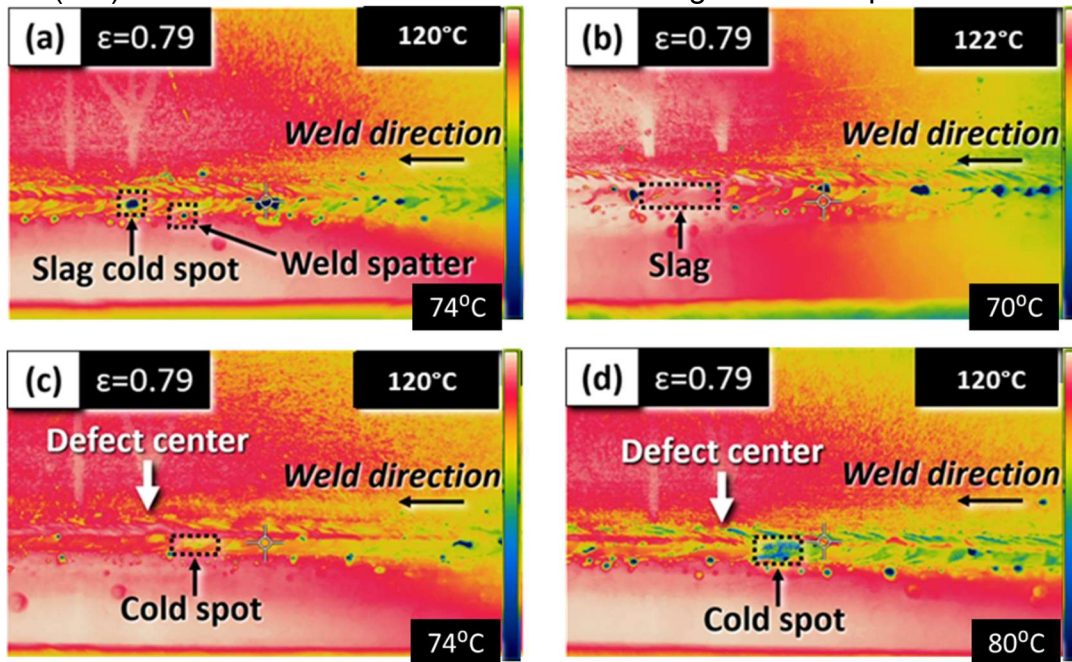
Figure 0-1 – (a-b) The defect-free IR images of the steel plate-to-plate joint using the FLIR T620 camera. (c-d) The FLIR T620 IR images of the steel plate-to-plate joints with manufactured subsurface cracks from a Cu contaminant (defect location labeled). The emissivity (ϵ) that the user sets in the camera is shown on the top left and on the right of the image is the corresponding temperature scale color scheme, which is automatically performed by the camera.

The IR images from two baseline defect-free control samples, and steel plate-to-plate weld joint samples that were taken using the FLIR T620 camera are given in Figure 0-1(a-b). The observed weld artifacts include slag and weld spatter.

Figure 0-1(b-c) shows representative IR images from two of the twelve defect steel plate-to-plate weld joints. The defects in the steel plate-to-plate joints have subsurface cracks formed by a Cu contaminant in the root of the joint. These images show a white arrow above the weld region where defects were placed (labeled defect center). The defects were not visually detectable in steel plate-to-plate joints using the FLIR T620 camera.

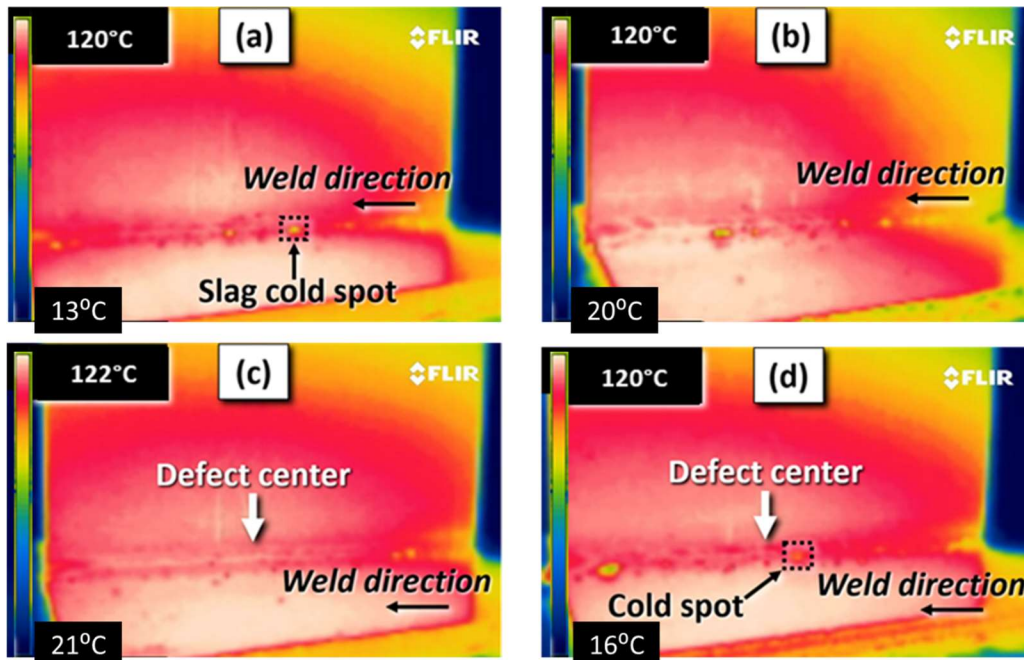
Figure 0-2 – (a-b) The defect-free IR images of the steel plate-to-plate joint using the FLIR C5 camera. (c-d) The FLIR C5 IR images of the steel plate-to-plate joints with manufactured subsurface cracks from a Cu contaminant (defect location labeled). The temperatures on the left of the images correspond to the temperature scale color scheme which is automatically performed by the camera.

The defect-free IR images from the FLIR C5 are shown in Figure 0-2(a-b). The weld artifacts include cold spots from regions where slag was present. Representative IR images of two of the twelve weld joints with defects for the FLIR C5 are shown in Figure 0-2(c-d). The defects were not visually detectable in the steel plate-to-plate joints using the FLIR C5 camera.

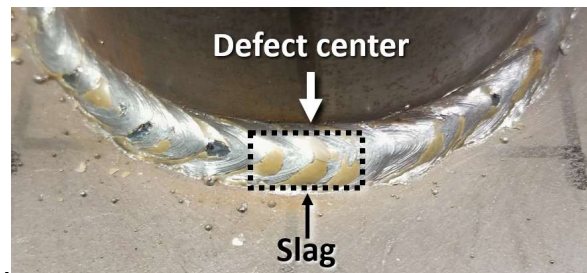
Figure 0-4 – Optical image of the steel pipe-to-plate weld joint with slag over the defect center corresponding to the IR image in Figure 35(c).

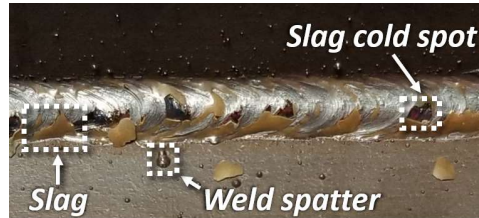
Figure 0-6 – Optical image of the baseline sample steel plate-to-plate weld joint with labels showing examples of slag, cold spots (regions where slag spontaneously removed from the weld during cool-down), and weld spatter.

In addition to the slag, there are regions where slag was present on the weld but spalled during cooling. These regions are referred to as cold spots. These spots result in weld metal with a different surface finish (emissivity) than the surrounding weld metal, as shown in Figure 0-6. For some weld samples, these cold spots can also be present in the regions of interest, e.g., defective location.

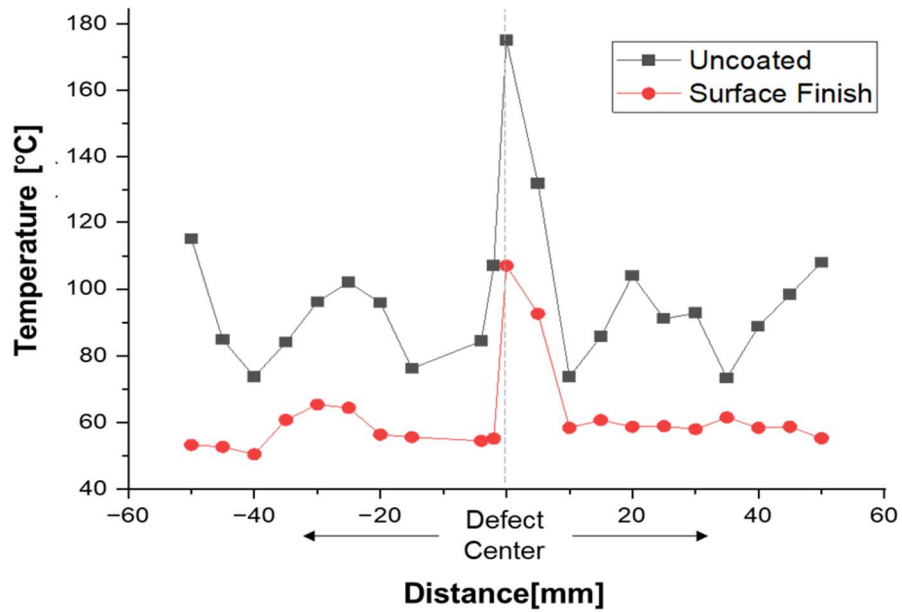
Figure 0-17 – Visual (top) and IR-TNDT (bottom) images at 100°C of the Al pipe-to-plate samples with the surface-breaking drill hole: (a) in the uncoated condition, (b) with the applied surface finish. The black arrows point to the location of the surface-breaking drill hole. (c) Analysis of the temperature profile along the weld line plotted from the IR images of the uncoated and with surface finish samples.

Analysis from the Al weld samples in the pipe-to-plate and plate-to-plate surface-breaking drill hole conditions are shown in Figure 0-17 and Figure 0-18, respectively. Visual and IR images of the weld joints are demonstrated for uncoated and surface-finished samples. In the IR images, the temperature color scale is positioned on the right side of each image. The temperature read by pointing to the measuring spot (Sp1) on the top of the drilled hole location is approximately 100°C, shown in the upper left corner of their IR image.

Analogously to the temperature versus position analysis presented by Teyssieux et al. [54] based on IR images, a linear temperature profile was plotted along the weld line and across the drilled defect, shown in Figure 0-17(c) and Figure 0-18(c). In those plots, the x-axis refers to the position relative to the defect center, and the y-axis refers to the temperature reading. The IR images with the reference temperature of 100°C were used to build the profiles. The uncoated and surface finish samples for Al pipe-to-plate and plate-to-plate geometries show a temperature peak at the defect center.

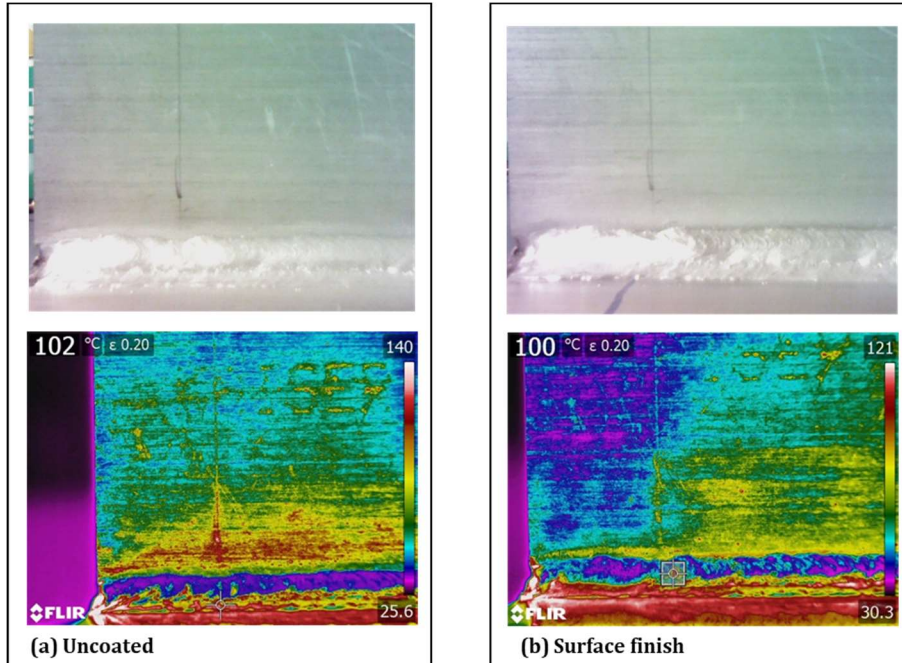
Figure 0-19 – Visual (top) and IR-TNDT (bottom) images at 100°C of the Al plate-to-plate samples with subsurface pseudocrack: (a) in the uncoated condition, (b) with the applied surface finish. No subsurface defect could be identified.

Figure 0-19 displays visual and IR images of Al plate-to-plate weld joints with a subsurface pseudocrack. The machined subsurface pseudocrack could not be identified in the uncoated (a) or applied surface finished condition (b). The temperature color

scale is positioned on the right side of each IR image. The temperature was read by pointing the camera on the measuring spot, Sp1, at the beginning of the machined pseudocrack and is shown in the upper left corner of the image. Since no defect could be detected, no temperature profile was produced.

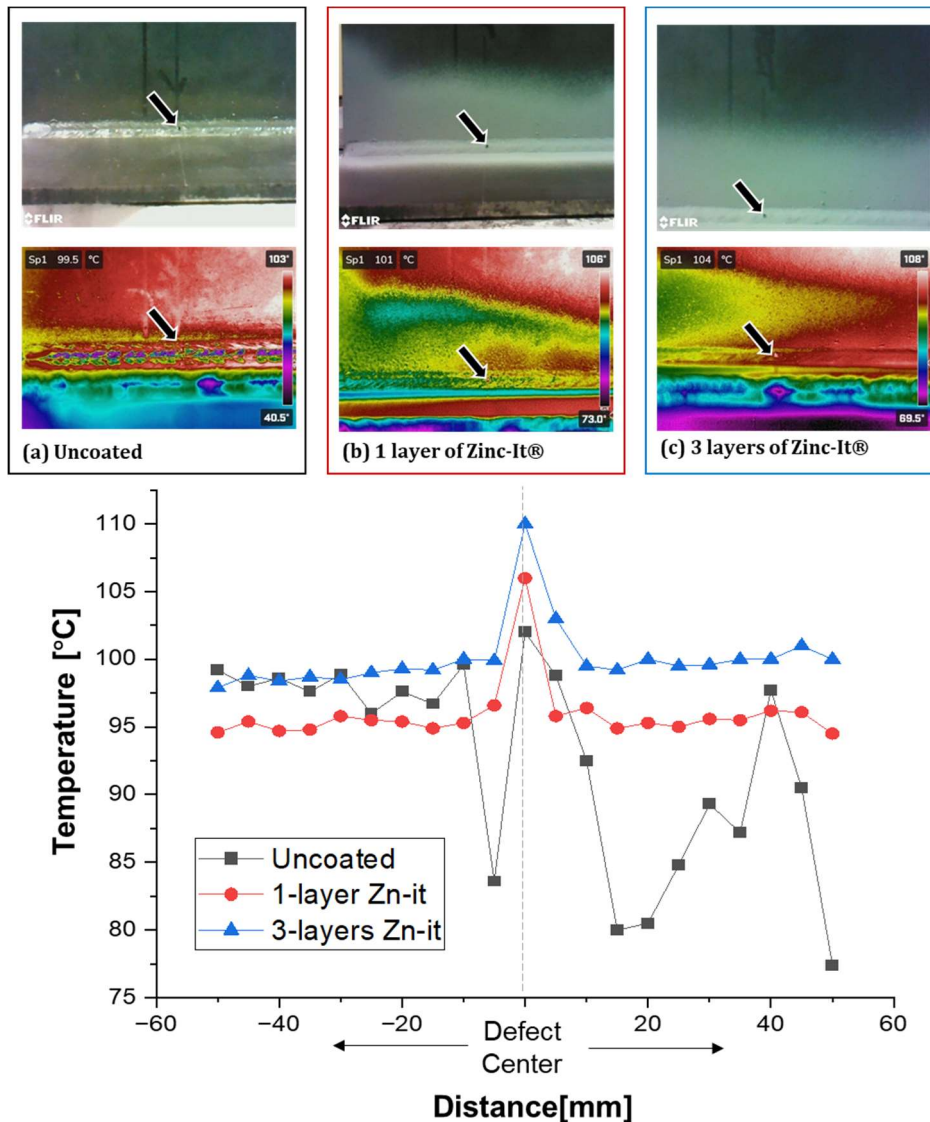
Figure 0-21 – Visual (top) and IR-TNDT (bottom) images at 100°C of the steel plate-to-plate samples with the surface-breaking drill hole: (a) in the uncoated condition, (b) coated with 1 layer of Zinc-It® spray, (c) with 3 layers of Zinc-It® spray. Black arrows point to the location of the surface-breaking drill hole. (d) A linear temperature profile along the weld line plotted from the IR images of the uncoated and coated samples.

For the steel pipe-to-plate and plate-to-plate analysis presented in Figure 0-20 and Figure 0-21, the three sections compare the uncoated condition and samples with one and three layers of the Zinc-it® coating. The defect is visible in the IR images in all the samples with the surface-breaking drill hole, as highlighted by a black arrow. The temperature color scale appears on the right side of each IR image. The temperature on the upper left corner of each IR image refers to the reference temperature read by Sp1.

Analogously to the temperature *versus* position analysis presented by Teysieux et al. [54] based on IR images, a linear temperature profile was plotted along the weld line and across the drilled defect, shown in Figure 0-20(d) and Figure 0-21(d). In those plots, the x-axis refers to the position at the defect center, and the y-axis refers to the temperature reading. The IR images with the reference temperature of 100°C were used to build the profiles.

1. In the uncoated condition, represented by the black line in Figure 0-20(d) and Figure 0-21(d), the temperature profile varies continuously across the sample, affecting the ability to identify the defect visually.
2. The defect center's temperature peak decreased considerably upon applying the third layer of Zinc-It® coating in the steel pipe-to-plate geometry, as shown in Figure 0-20(d).

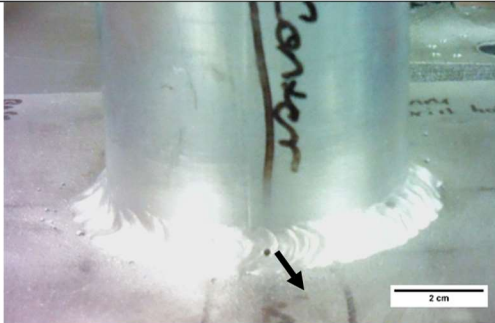
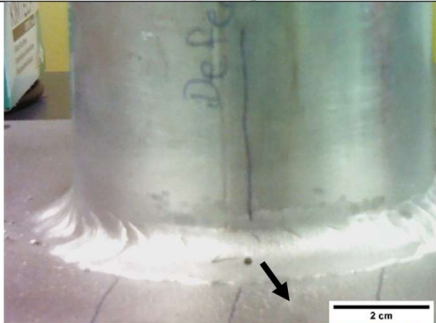
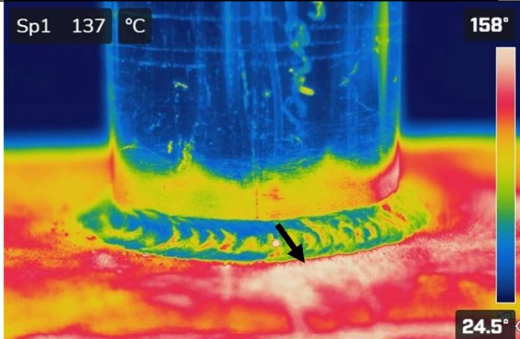
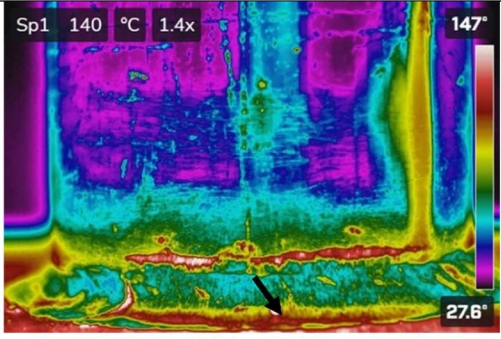
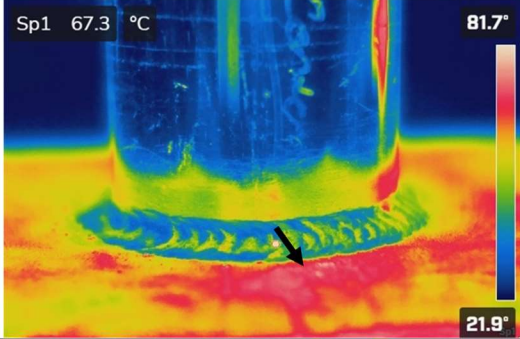
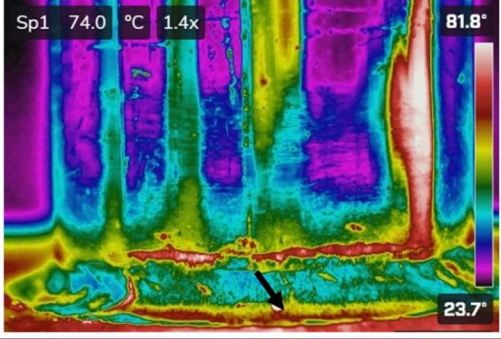
Al pipe-to-plate with surface-breaking drill hole

T	Uncoated	120-grit rub
Photo

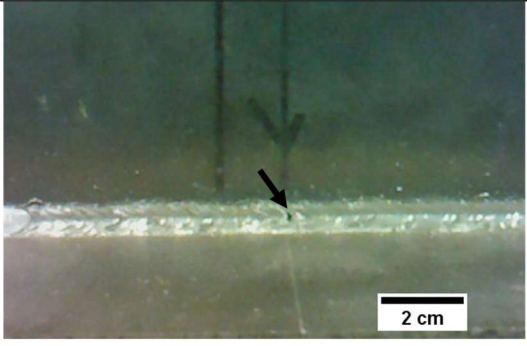
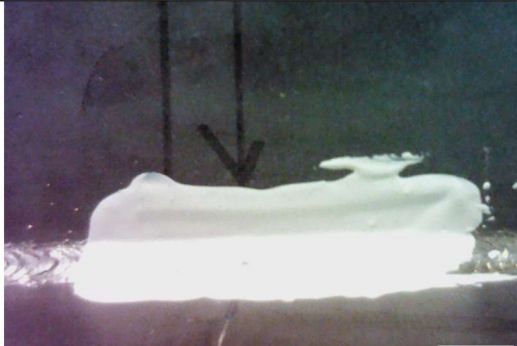
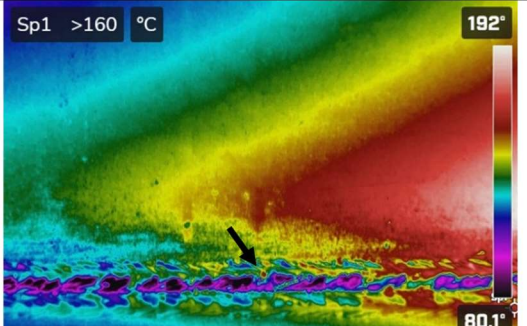
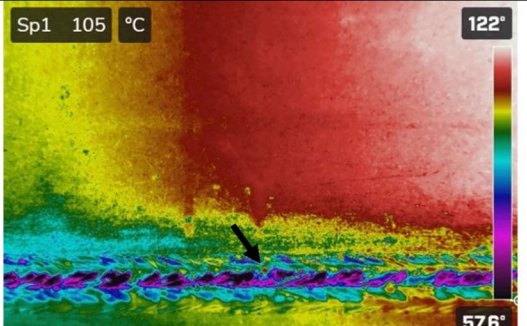
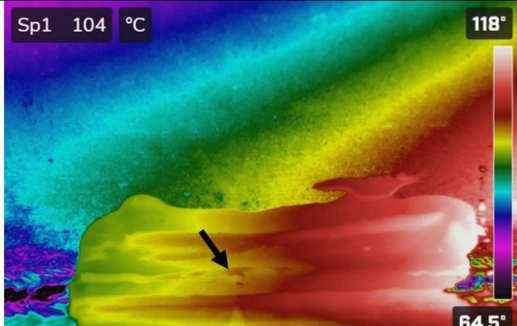
Steel plate-to-plate – Epoxy-based coating

T	Uncoated	Coated
Photo
