4100601 Precast Concrete Box Culvert.
COMMENTS FROM INTERNAL/INDUSTRY REVIEW

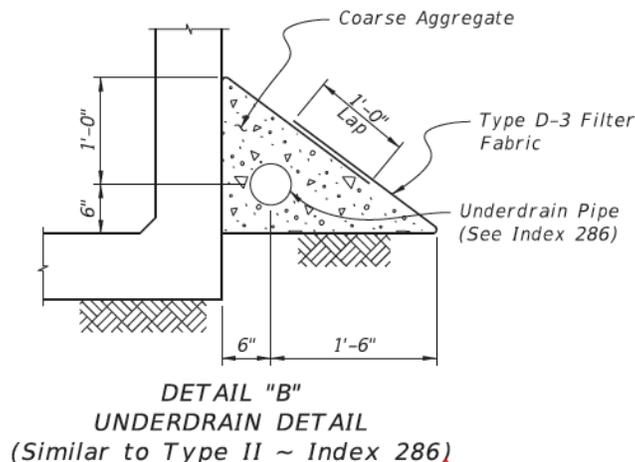
The comments regarding changes to the PPM and Design Standards were forwarded to the State Drainage Office for possible inclusion in the 2013 PPM and Design Standards. The new detail that will be shown on sheet 5 of Index 289 of the 2012 Design Standards is shown below.

12-2-11 From the State Specifications Office (HRP): Based on conversations with Andre, the proposed language describing weep holes in box culverts will not be implemented. There is no apparent need to provide weep holes in box culverts and the current requirements in Article 400-6 cause confusion in the field resulting in questions. If for some reason, a designer feels weep holes are needed then the details would be shown in the plans. A continuous underdrain will be required for box culverts to aid in drainage as shown above.
