How do I make my bridges more resilient to the damaging effects of natural disasters?

FRP materials could be the answer

David White, P.E.
W-4 Workshop

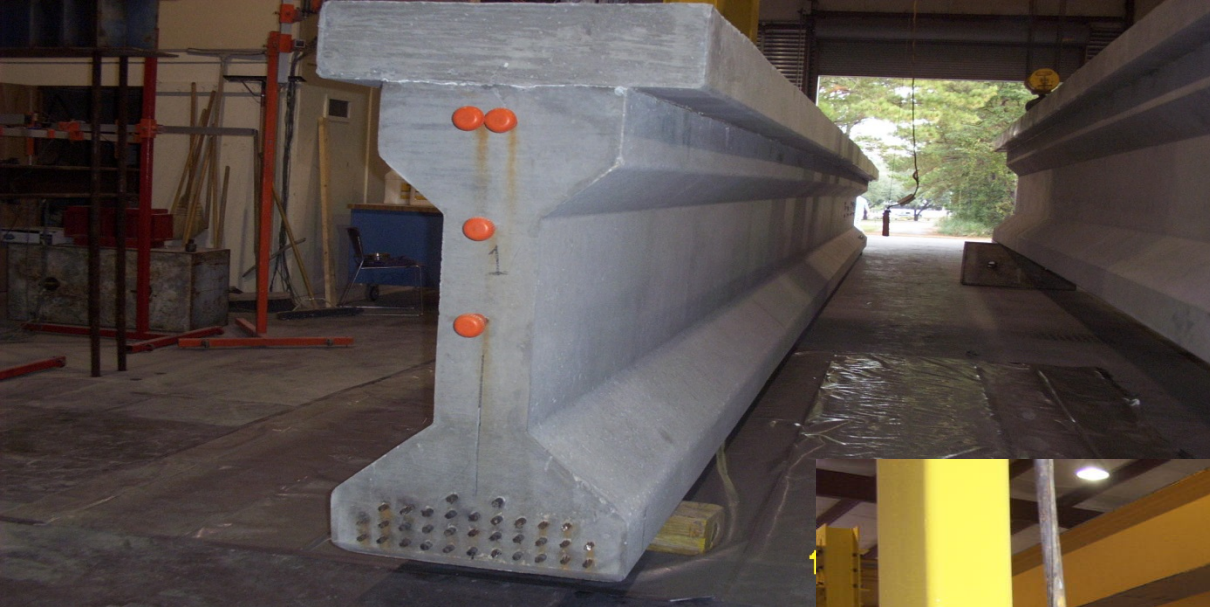
TRESTLE SPAN REPAIRS

- Shear deficiencies at ends of AASHTO Type IV girders
- Shear cracks injected with epoxy
- Girders wrapped with bi-directional, carbon fiber fabric
- Protective coating applied over strengthened area

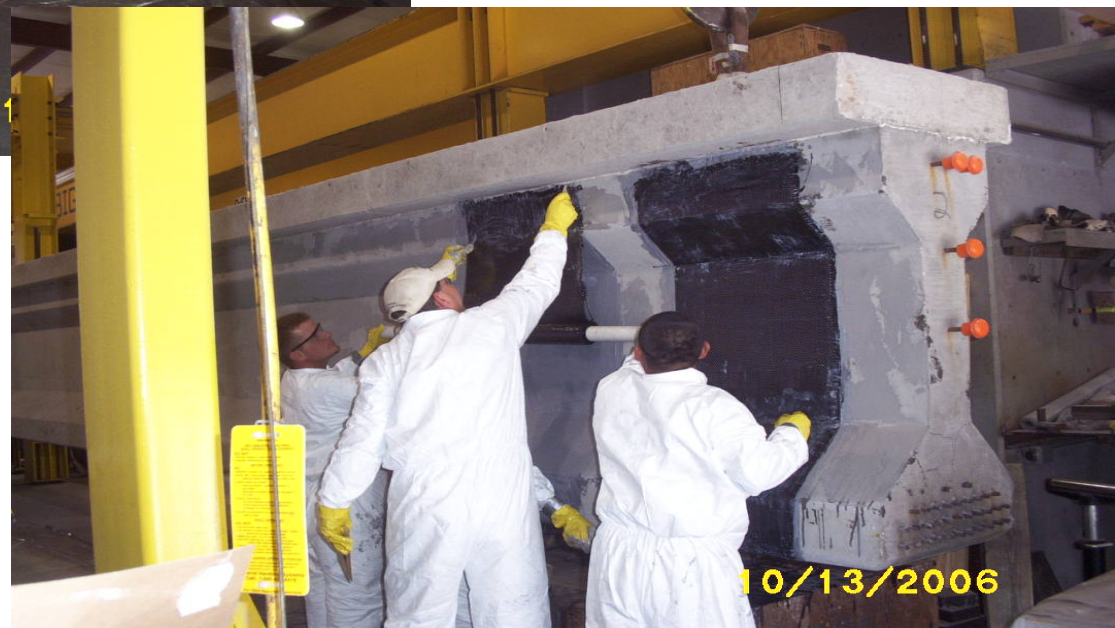
Mock-up on AASHTO Girders @ FDOT Lab for Skyway Project

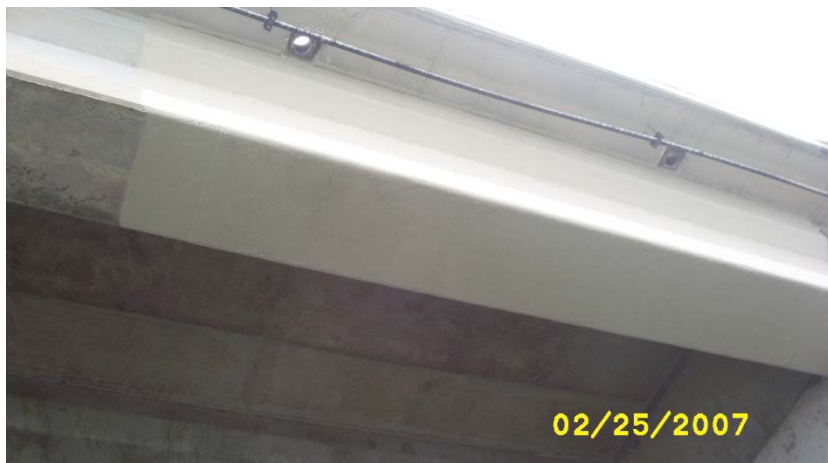
2007

SUNSHINE SKYWAY BRIDGE

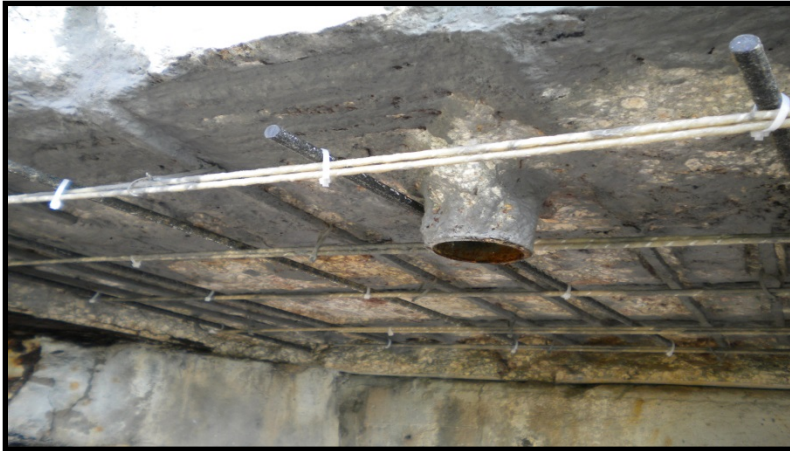
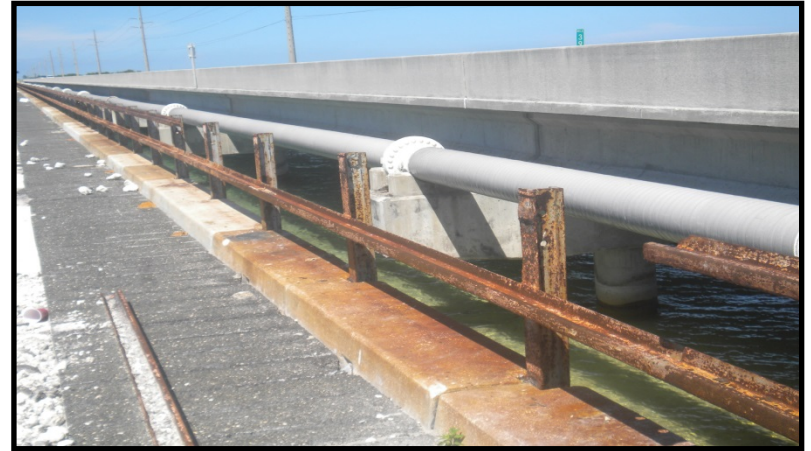
STRUCTURAL PROBLEMS

- Aggressive coastal environment
- Salt water ingress caused significant corrosion of steel H beams and rebar

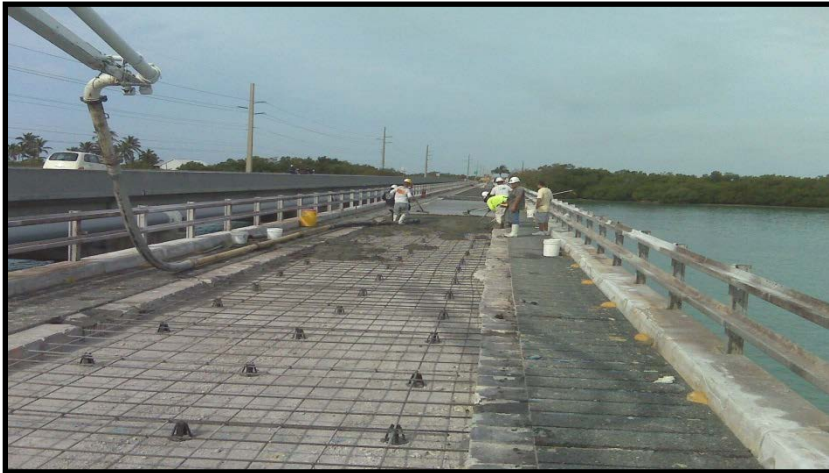
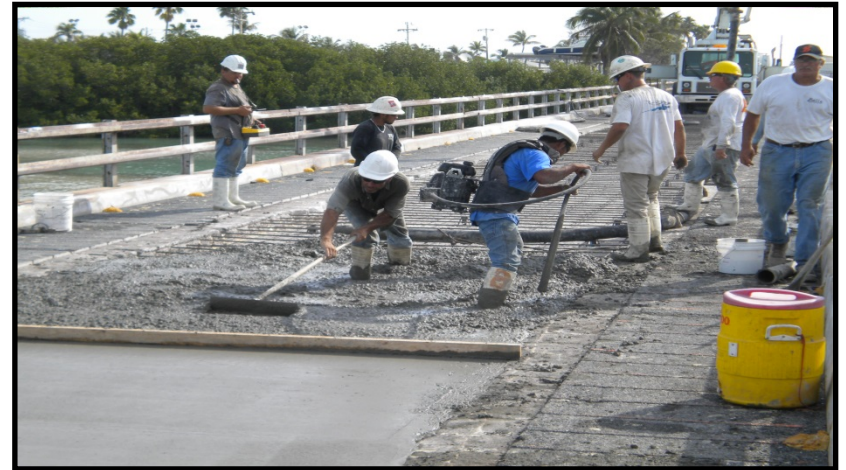
CONCRETE REPAIR

- Old asphaltic roadway removed down to lime rock fill atop superstructure
- New concrete slab poured on top of fill
- New FRP rebar dowelled into concrete with epoxy resin

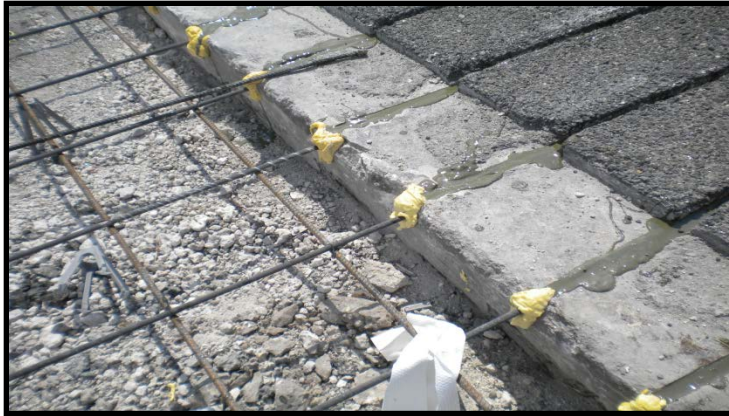
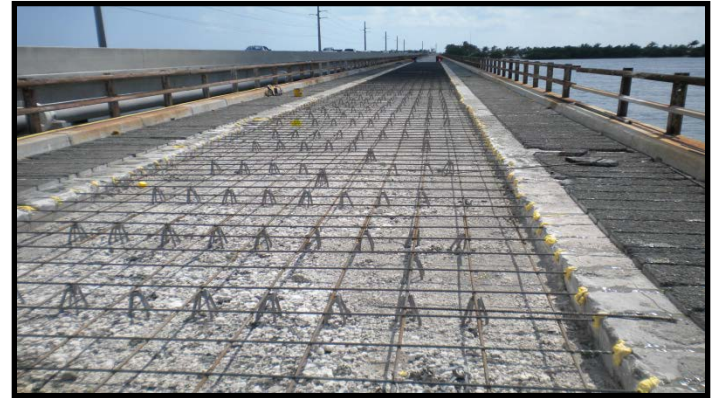
FRP REINFORCEMENT

- Non-corrosive rebar for long lasting repair
- FRP rebar provides alternative support to deteriorated H-beams
- Additional FRP bars used to replace small rebar from original construction

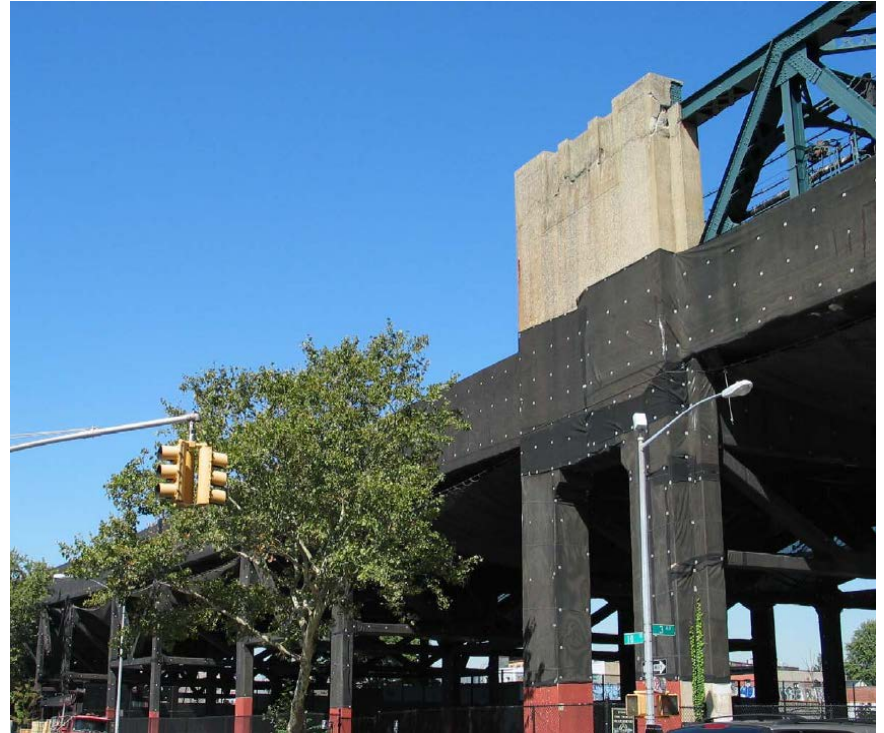
“TEMPORARY” SOLUTION

- Wrap concrete with black netting to prevent chunks of concrete from falling below
- Budget constraints meant dealing with “symptoms” and not “root cause”
- Short term solution turned in 15 year eyesore

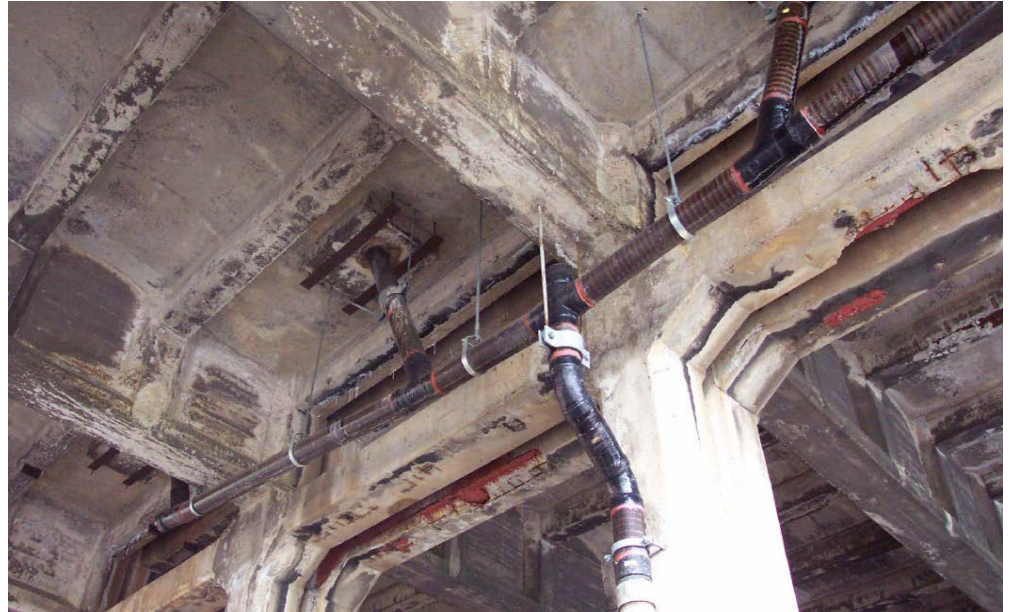
PROBLEMS

- Failed deck waterproofing
- Concrete spalling
- Exposed steel

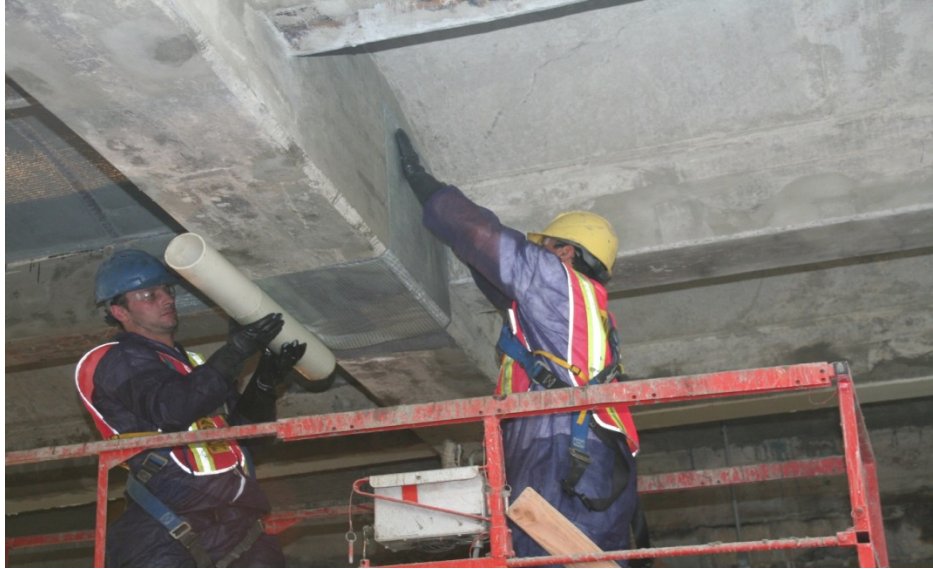
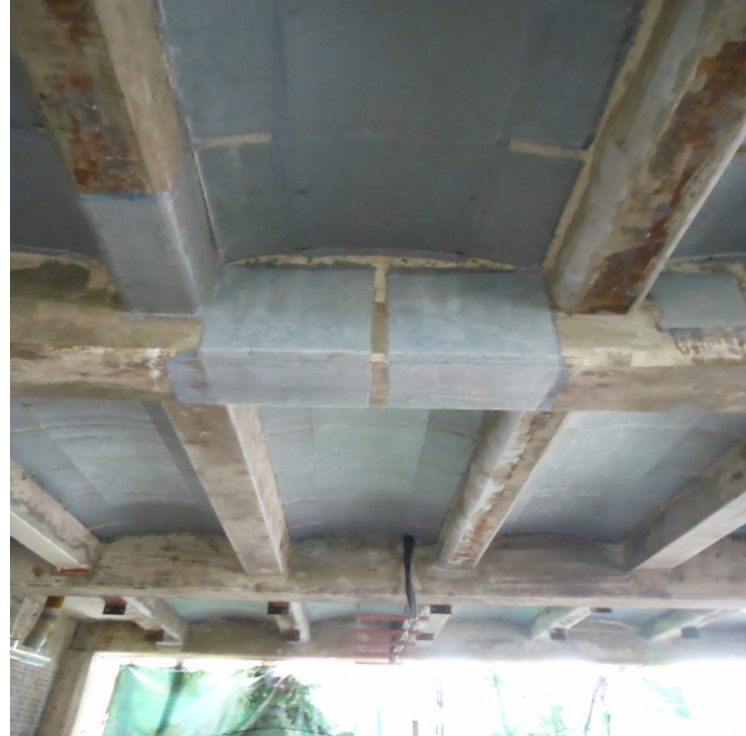
FRP REPAIRS - BEAMS

- Remove existing black netting
- Perform structural concrete repairs
- Waterproof concrete deck
- Replace black netting with FRP composite materials
- Structural enhancement
- Prevent concrete from falling in future
