FDOT Evaluation Guide – Temporary Concrete Barrier

This is a guide developed to aid in evaluating the condition of Temporary Concrete Barrier used in work zones and is based, in part, on information published by the American Traffic Safety Services Association (ATSSA). This guide illustrates examples of FDOT specific Temporary Concrete Barriers, which include Type K, proprietary concrete (i.e. JJ Hook), and Low-Profile categorized into acceptable and unacceptable conditions. It should not be considered comprehensive and should be used in conjunction with good engineering judgement.

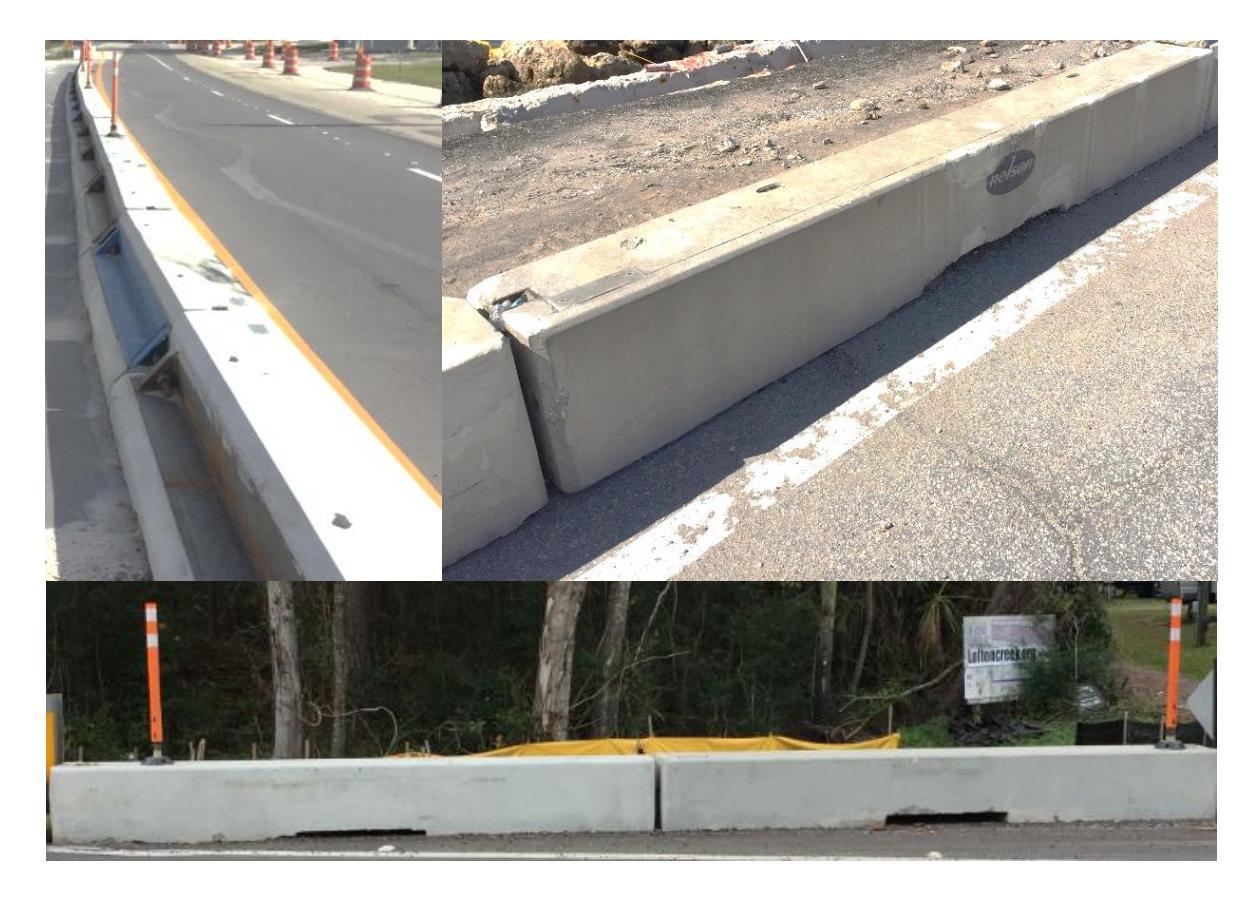
Figure 1: Examples of Acceptable Low-Profile Concrete Barrier

- 1. The barrier is completely intact and has only minor blemishes or imperfections, which may include superficial gouges or minor cracks. The barrier has no structural cracks or cracks that exist through the entire cross-section.
- 2. Minor spalls with a depth of 1.5 inches or less, and no exposed rebar (excluding anchor slots).
- 3. The unit-to-unit connection assemblies are functional with no damage, are all intact, and fixed in their positions.
- 4. Temporary Concrete Barrier previously repaired in accordance with Specification 102.
- 5. Examples of acceptable Low-Profile concrete barrier are shown in Figures 1 and 2.
- 6. Examples of acceptable Type K or Proprietary concrete barrier are shown in Figures 3, 4, and 5.

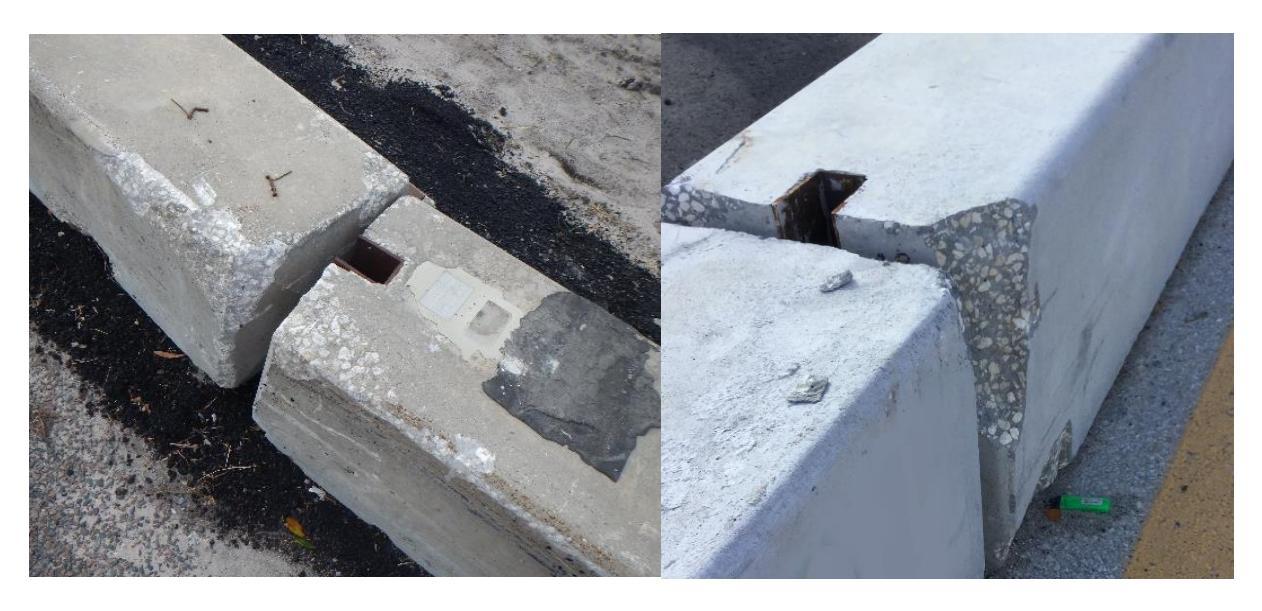
Figure 2: Acceptable Low-Profile Concrete Barrier with spalls of 1.5 inches or less

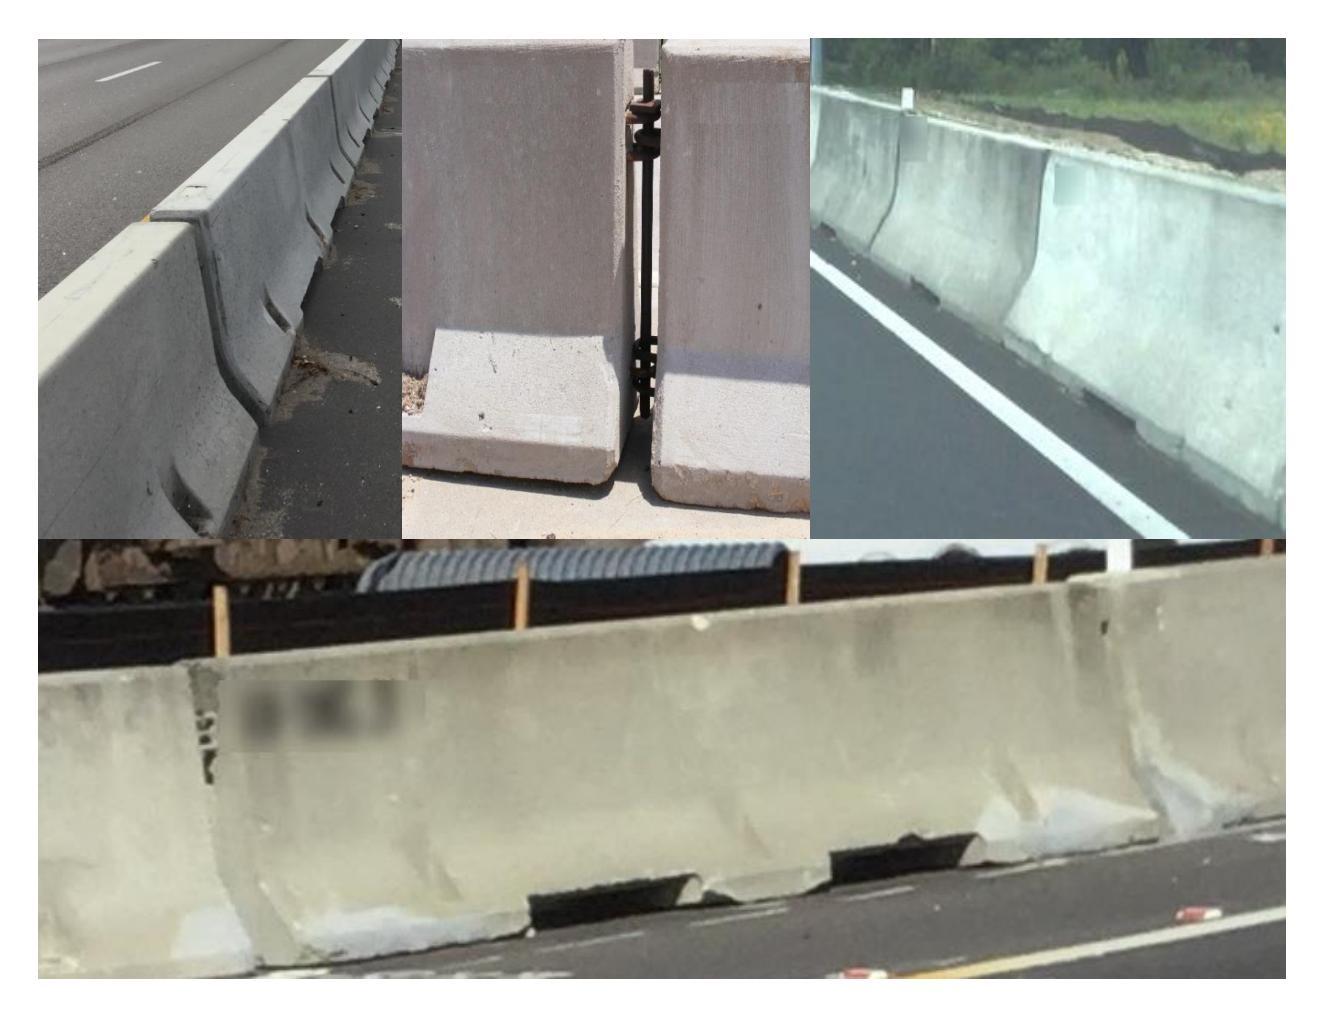
Figure 3: Examples of Acceptable Type K or Proprietary Concrete Barrier

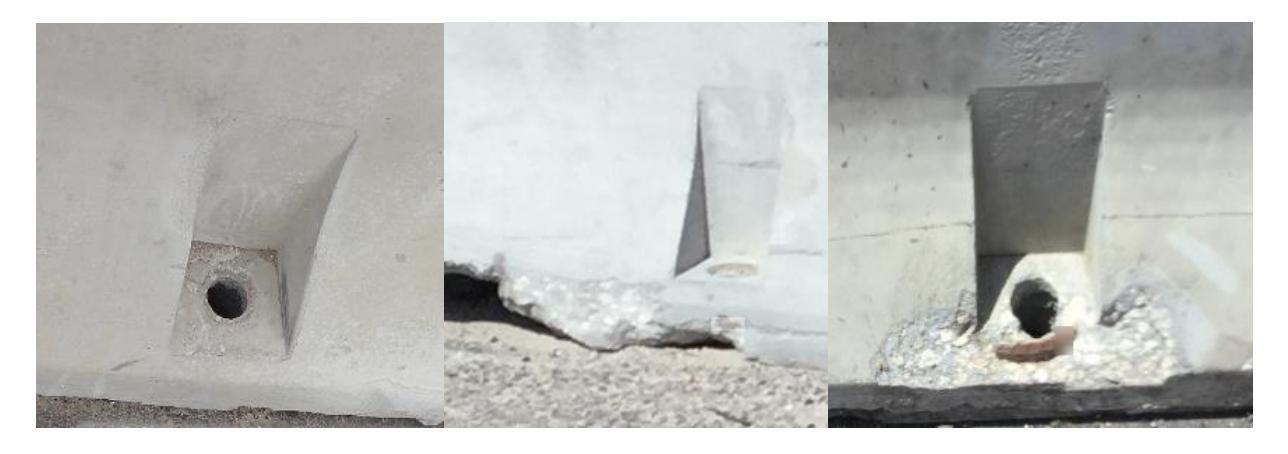
Figure 4: Acceptable Type K or Proprietary Concrete Barrier Anchor Slots – From left to right: Undamaged anchor slot; Anchor slot with spalled concrete less than 1.5 inches in depth; Anchor slot with spalled concrete less than 1.5 inches in depth and exposed rebar

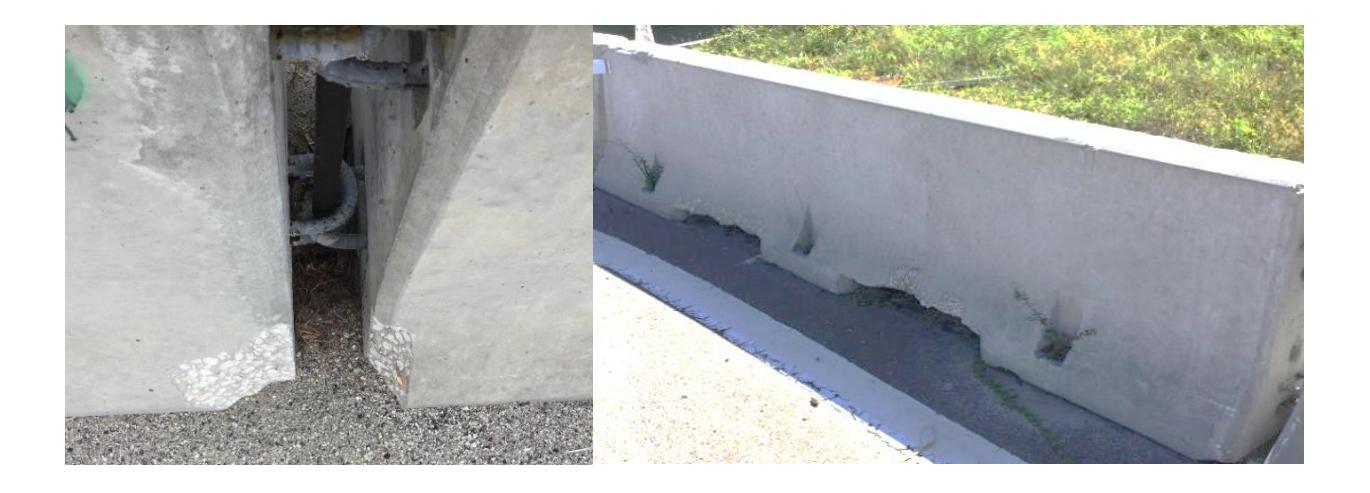
Figure 5: Examples of Acceptable Type K or Proprietary Concrete Barrier with spalls of 1.5 inches or less

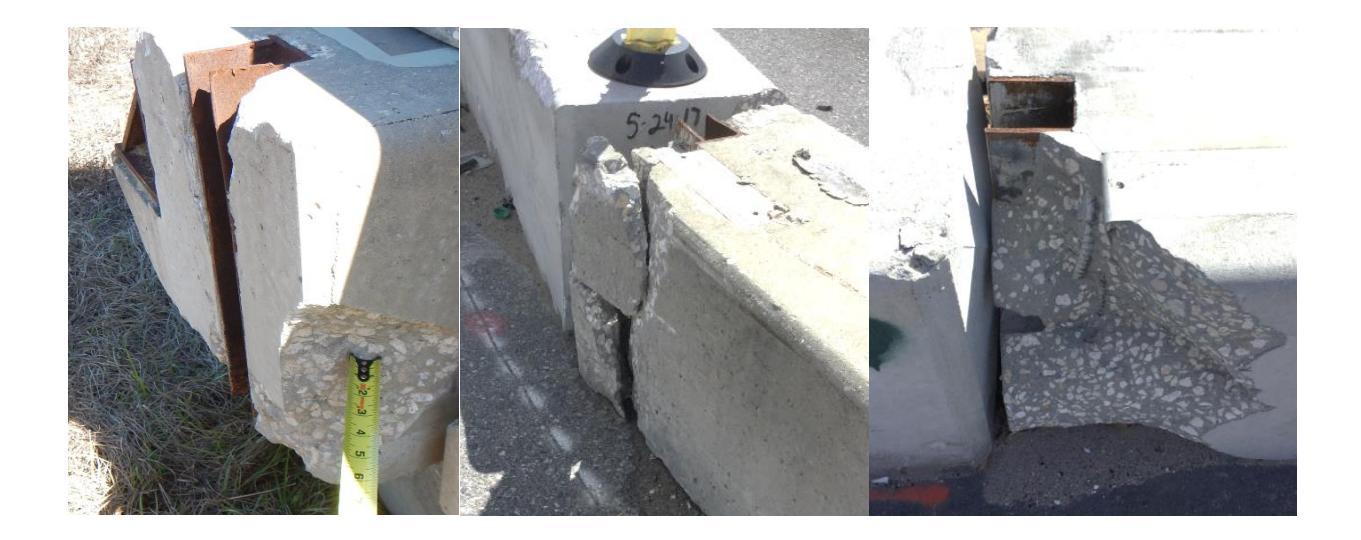
Figure 6: Examples of Unacceptable Low-Profile Concrete Barrier – From left to right: Barrier with spall greater than 1.5 inches; Barrier with cracked and broken concrete that could easily be dislodged resulting in conditions 1 or 2 above; Barrier with damage to a connection assembly and spalling greater than 1.5 inches in depth with exposed rebar.

- 1. The barrier has multiple cracks throughout, structural cracks or cracks through the entire cross-section.
- 2. Spalls with a depth greater than 1.5 inches; any location with exposed rebar or rebar protruding from the barrier (excluding anchor slots); or bolts protruding from the barrier face.
- 3. Cracked or broken concrete that could easily be dislodged if hit, resulting in either of the two conditions above.
- 4. Anchored barrier with broken concrete with shear cracks.
- 5. The unit-to-unit connection assemblies are deformed, bent, broken, or no longer in a fixed position.
- 6. Examples of unacceptable Low-Profile concrete barrier are shown in Figure 6.
- 7. Examples of unacceptable Type K or Proprietary concrete barrier are shown in Figures 7 through 10.

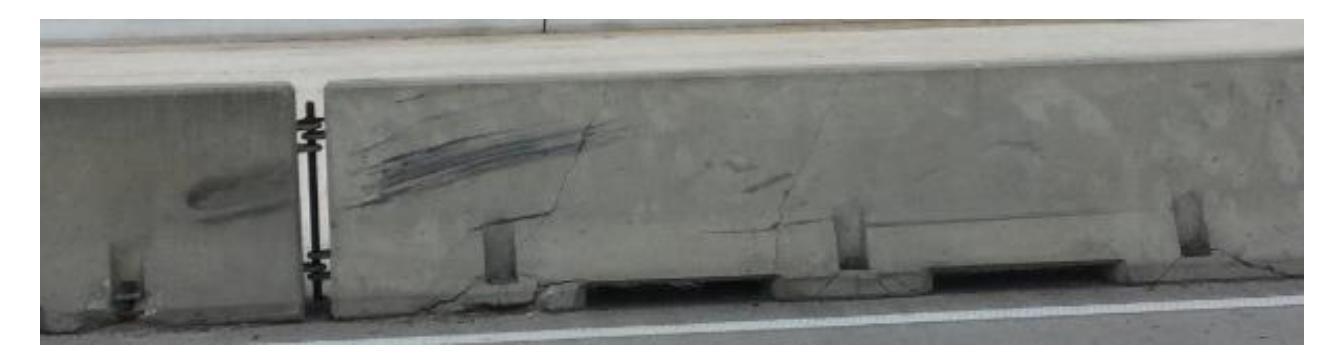
Figure 7: Example of Unacceptable Type K or Proprietary Concrete Barrier – Barrier has multiple cracks that extend through the entire cross-section and broken concrete with shear cracking around the anchor slots.

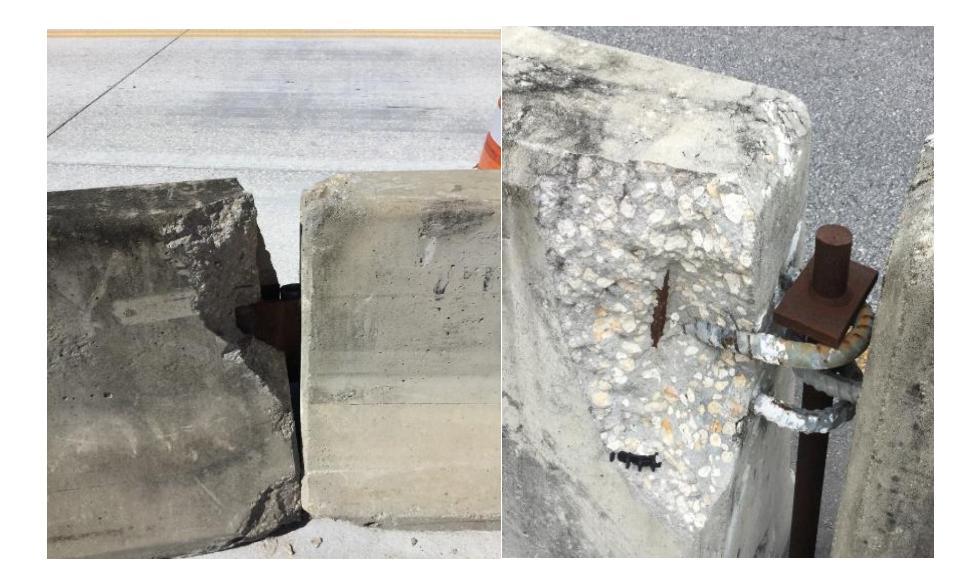
Figure 8: Examples of Unacceptable Type K or Proprietary Concrete Barrier with connection assembly damage – From left to right: Barrier has damage to unit-to-unit connection assembly and spalls greater than 1.5 inches in depth; Barrier has damage to unit-to-unit connection assembly, spalls greater than 1.5 inches in depth, and exposed rebar.

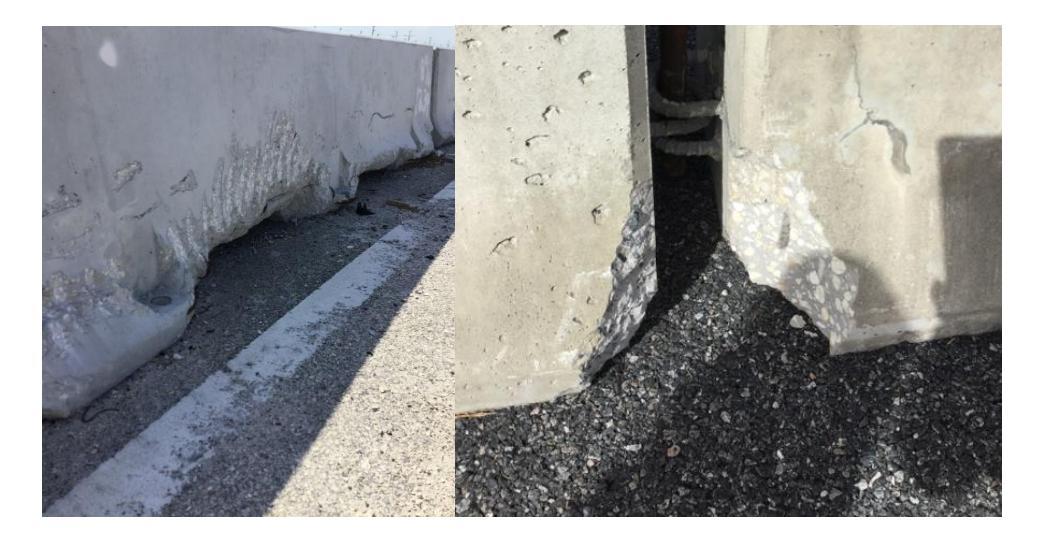
Figure 9: Examples of Unacceptable Type K or Proprietary Concrete Barrier with spalls greater than 1.5 inches– From left to right: Barrier has spalls greater than 1.5 inches in depth; Barriers have spalls greater than 1.5 inches in depth and the righthand unit has exposed rebar.

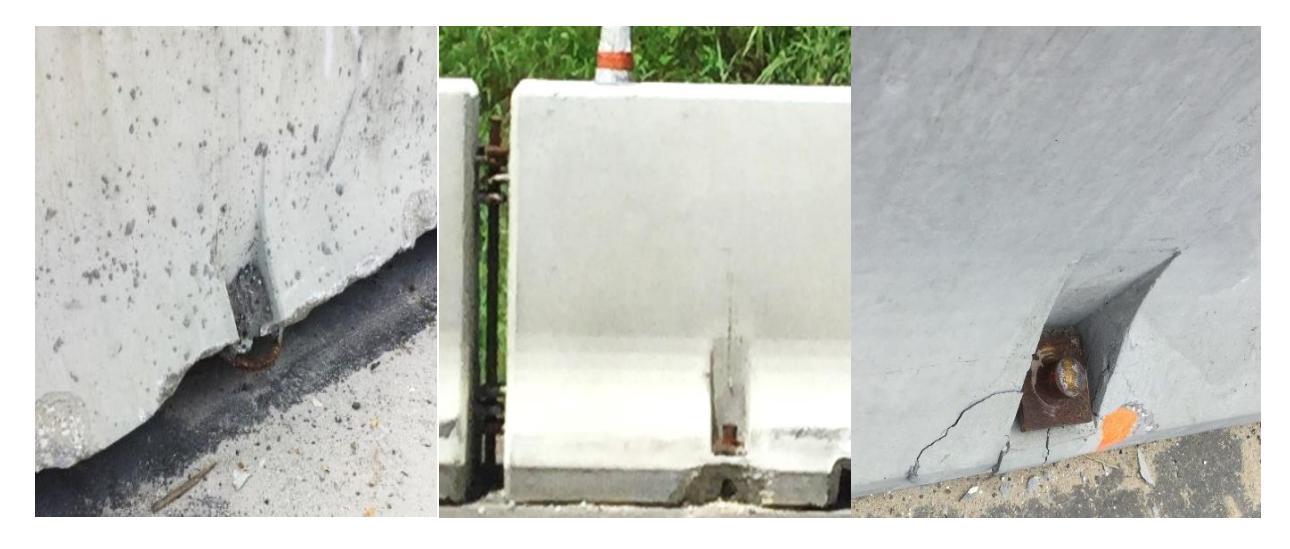
Figure 10: Examples of Unacceptable Type K or Proprietary Concrete Barrier with broken concrete or shear cracking at the anchor slot – From left to right: Concrete has completely broken away at the anchor slot due to shear cracking; Broken concrete at the anchor slot due to shear cracking; Broken concrete at the anchor slot due to shear cracking.
