## **2000 FLEXIBLE PAVEMENT CONDITION SURVEY FACTS AND FIGURES**

**FL/DOT/SMO/00-438**

**April 2000**

**STATE MATERIALS OFFICE**

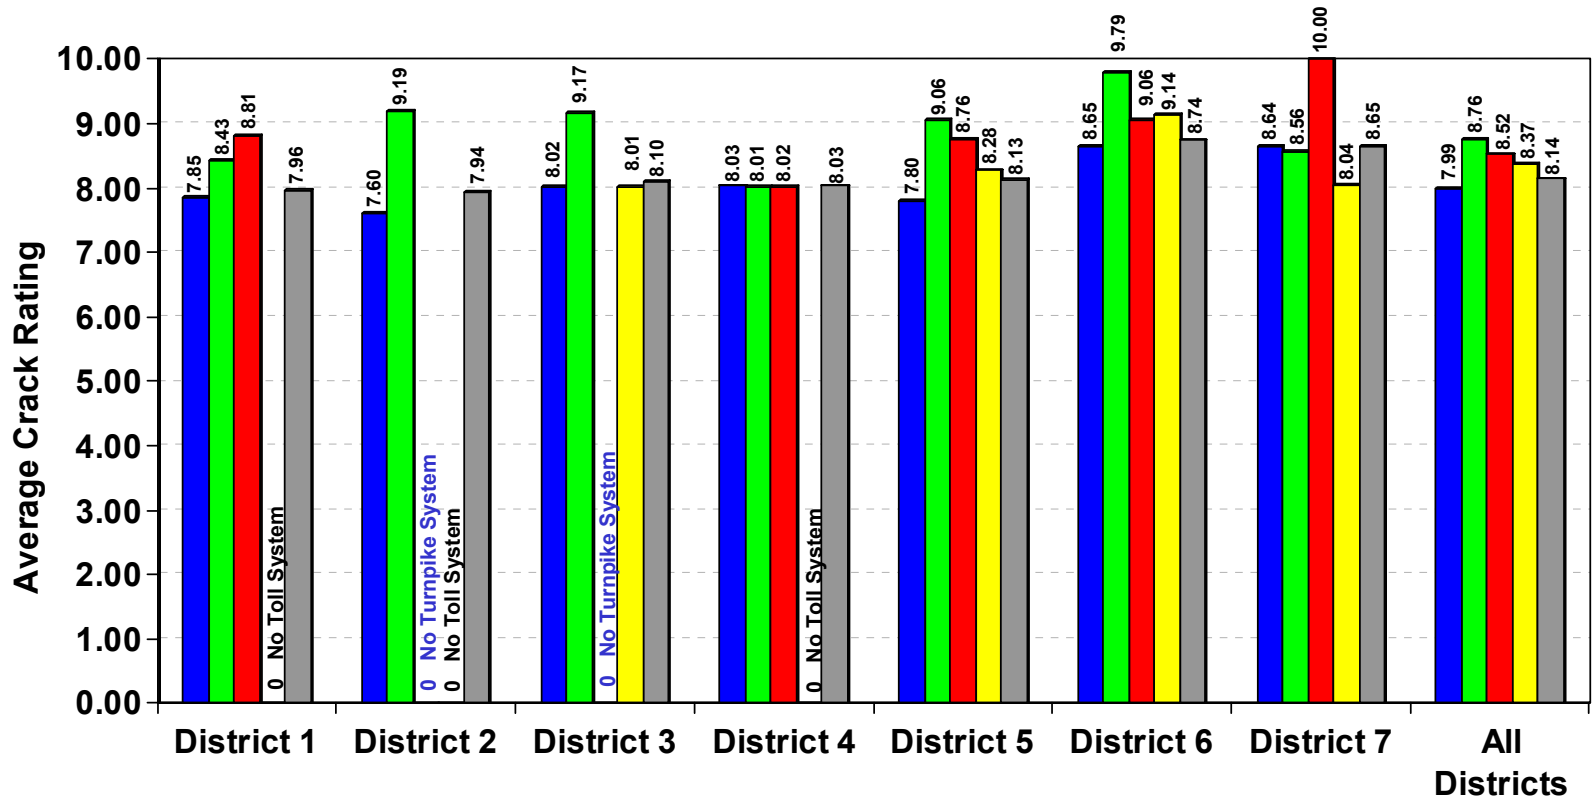
# Crack Ratings by System and District

## 2000 Flexible Pavement Condition Survey
