# Surface Pavement Solution for Poor Subgrade Conditions

Web Interim Report

County: Palm Beach  
Section/Subsection No. 93140  
State Road: 15  
FIN: 413804-1-52-01

The objective of this study is to evaluate the relative performance of four different materials to reinforce pavements built over organic soils and peat. The treatment materials include Petrogrid, Glasgrid, Pavetrac and Asphalt Rubber Membrane Interlayer (ARMI).

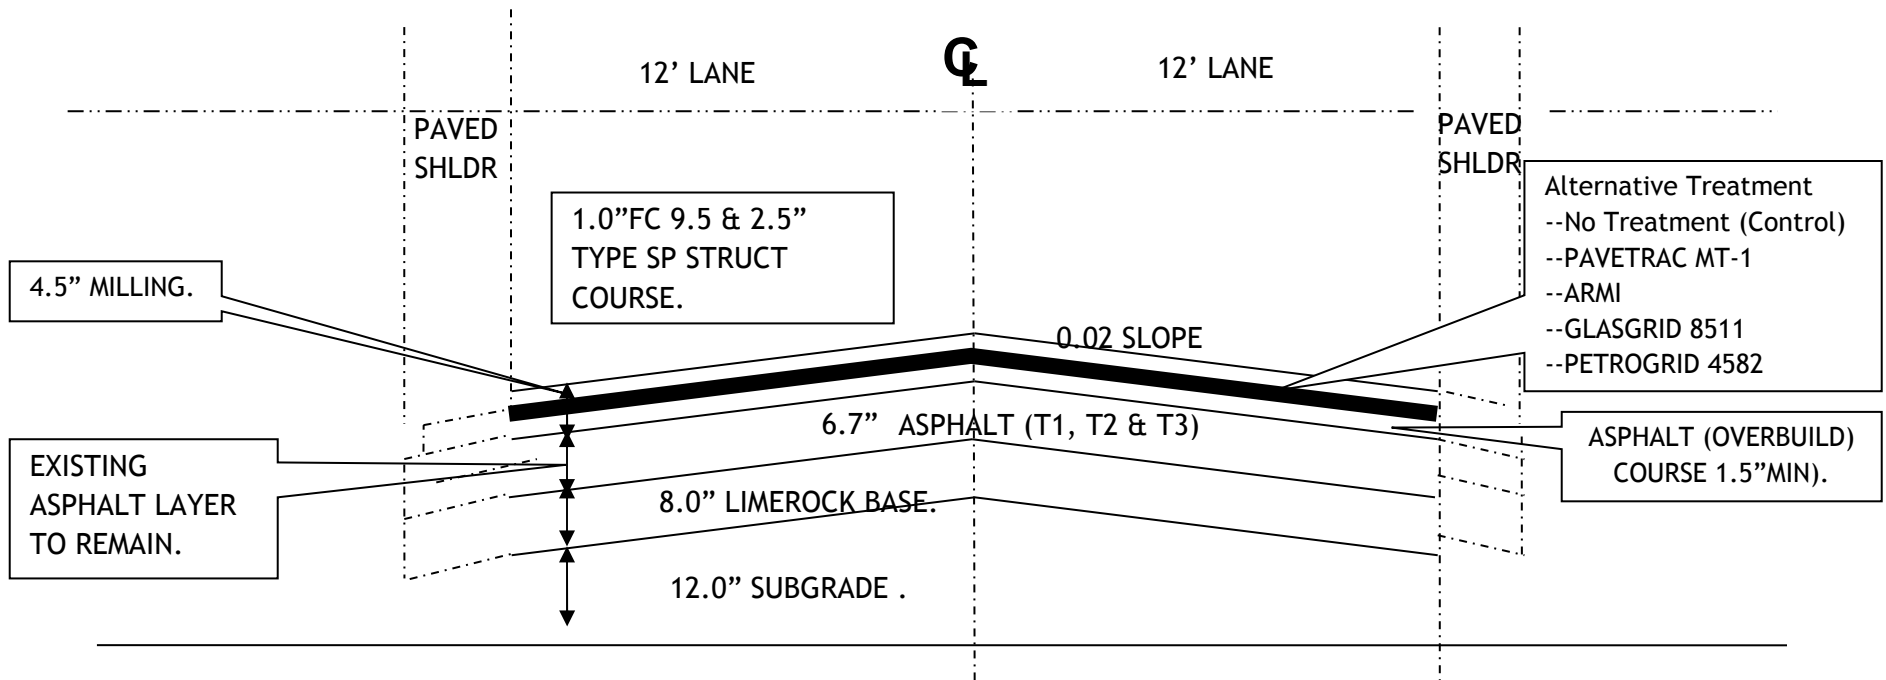
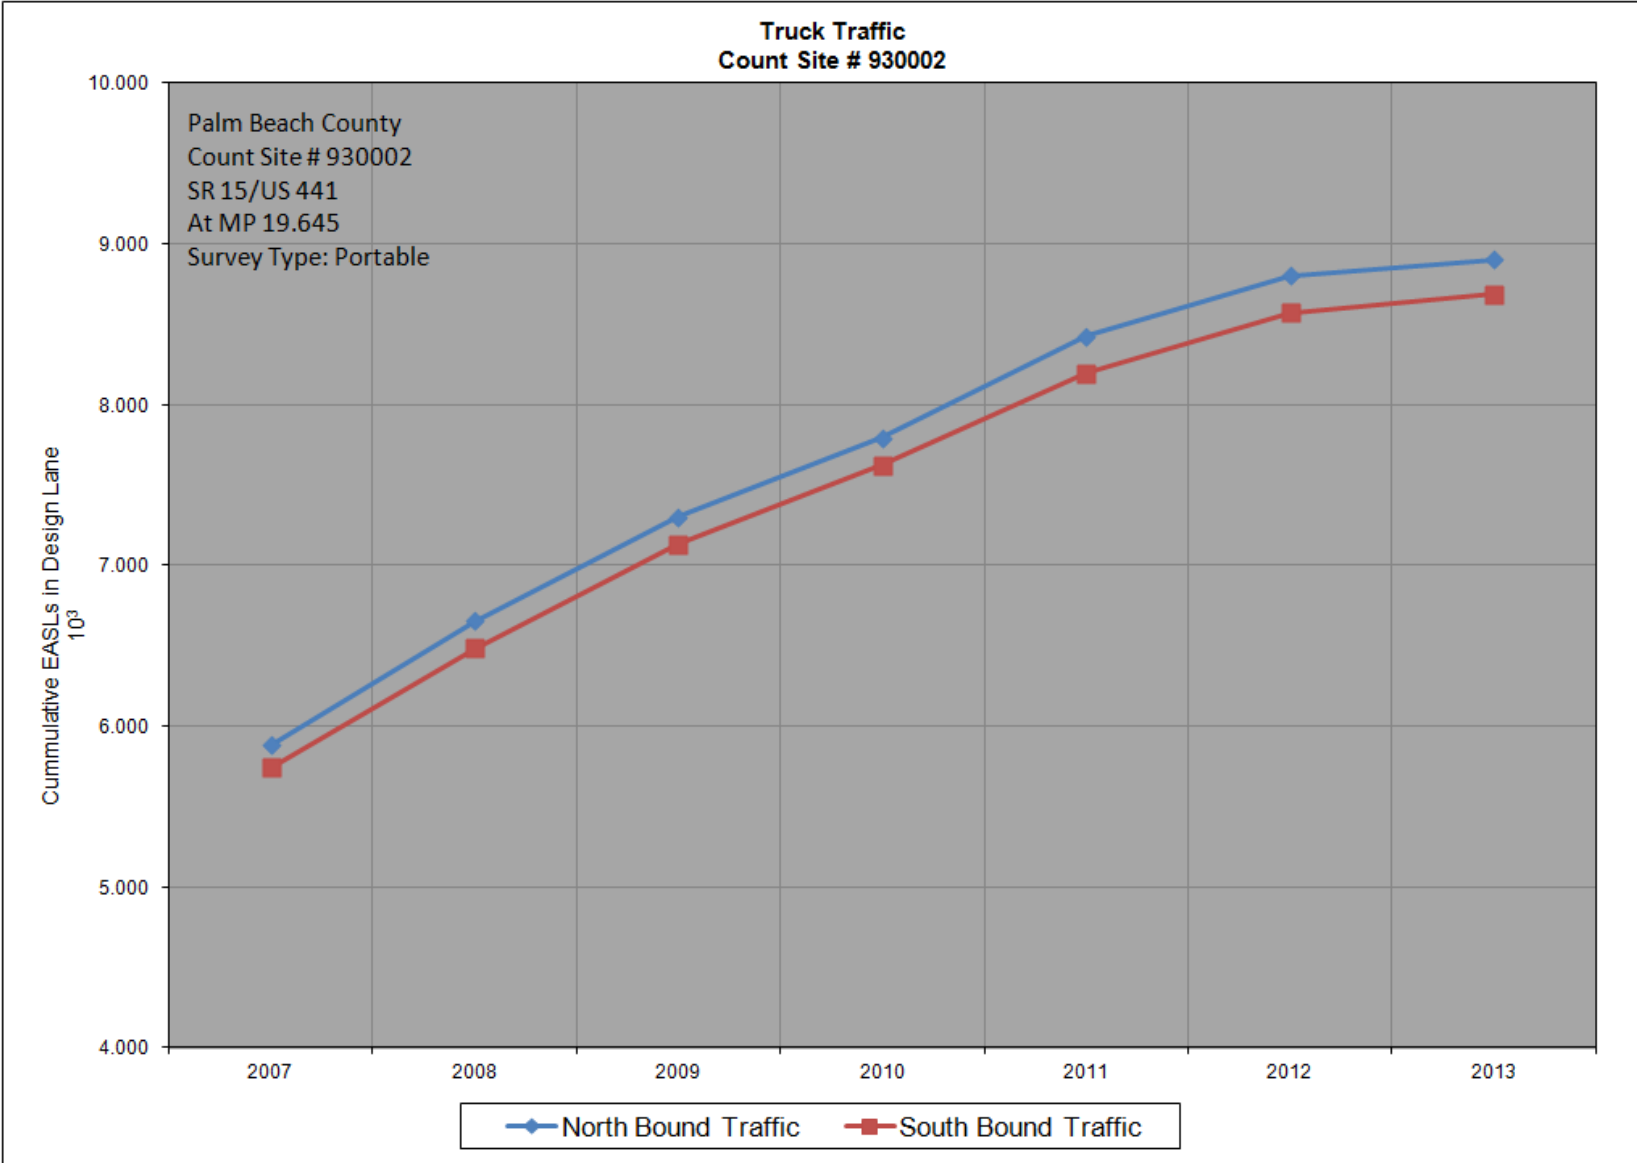
# TYPICAL SECTION

Each test site consists of six test sections, one for each reinforcement material and control sections, one at the beginning and end of each site.

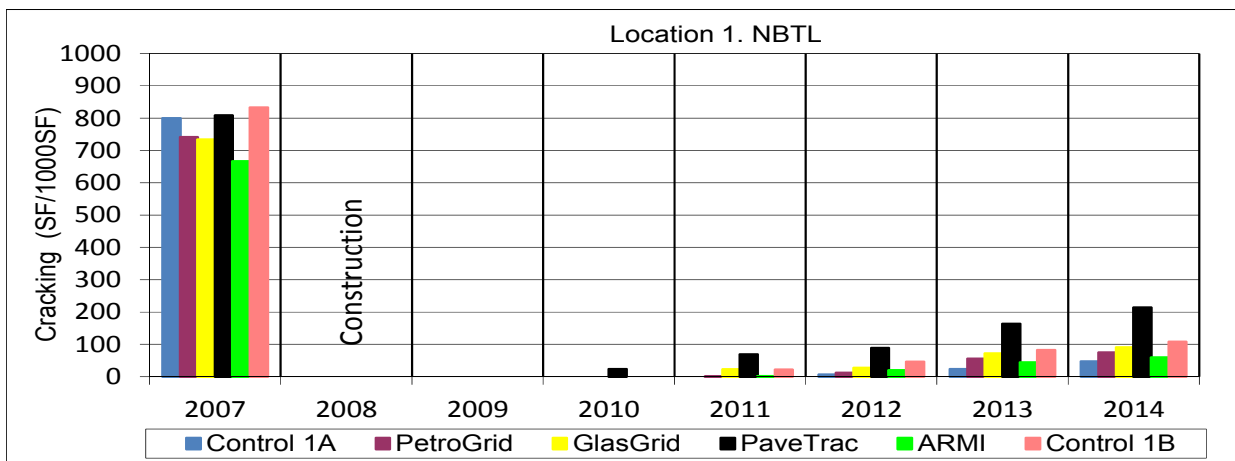
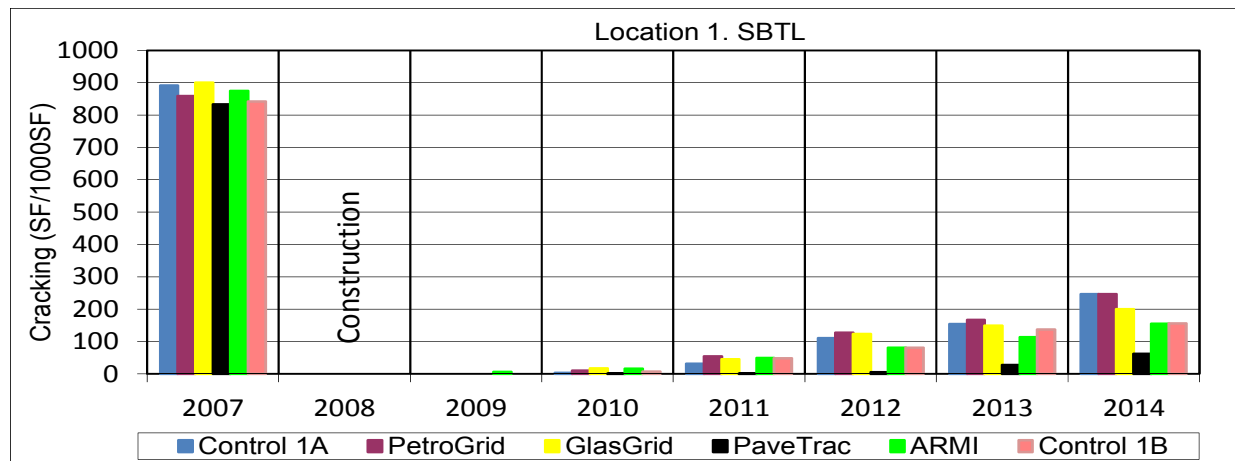
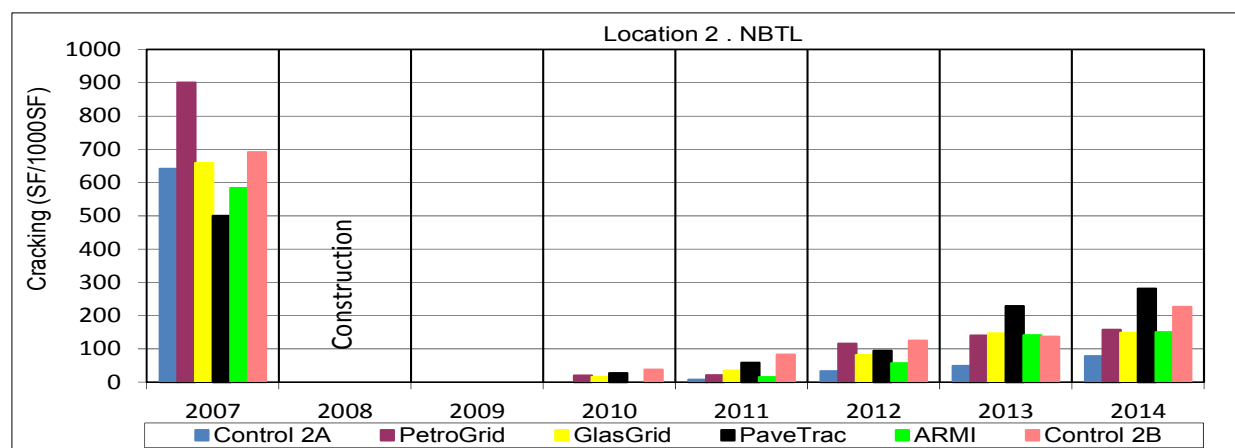
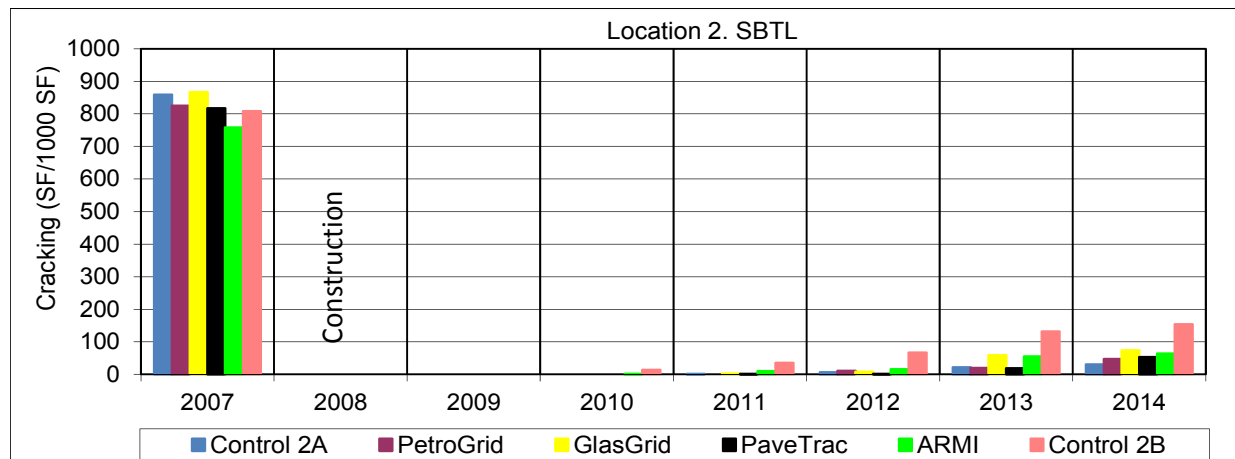
# Cracking

Performance is evaluated in term of deflection, ride, rutting and cracking.
