Florida Department of Transportation Research

Steel Shear Strength of Anchors with Stand-Off Base Plates

BDK75-977-49

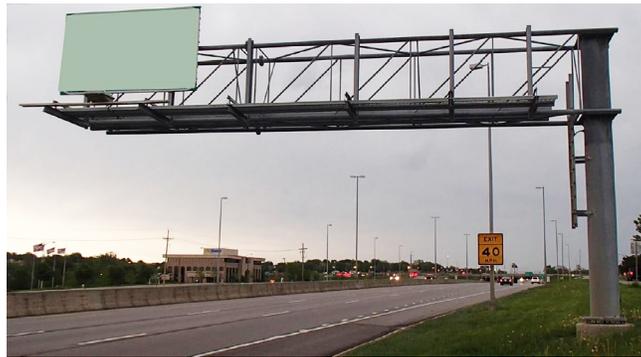
Wind loading on cantilevered highway signs creates large torsional forces on the base plate connections.
