BDV29-977-05

Florida Department of Transportation Research

Non-Destructive Testing (NDT) of a Segmental Concrete Bridge Scheduled for Demolition, with a Focus on Condition Assessment and Corrosion Detection of Internal Tendons

June 2017

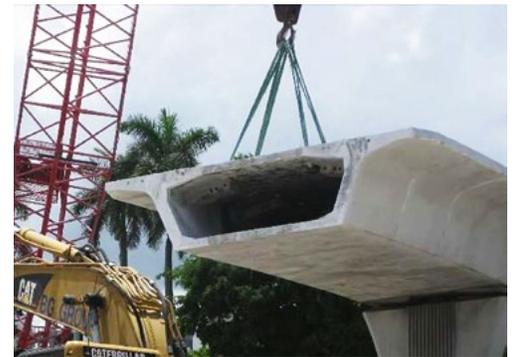
Segments from this decommissioned ramp were used to evaluate non-destructive testing methods.

Tendon damage was investigated by examination of segments removed from an interstate highway off-ramp, in laboratory tests of mockups, and in computer simulations. Six detection technologies were studied, some onsite and some in the laboratory: impulse response, infrared thermography, magnetic flux leakage, acoustic emission, interferometric phase radar, and inductance measurement.
