===== FIXED BEARING DETAILS =====

===== EXPANSION BEARING DETAILS =====

<b>FDOT DESIGN STANDARDS</b> FY 2012/2013	<b>TEMPORARY DETOUR BRIDGE DETAILS -</b> <b>TIMBER PILE FOUNDATIONS</b>	INDEX NO.	SHEET NO.
07/01/06					21610	1

BACKWALL BENT DETAILS

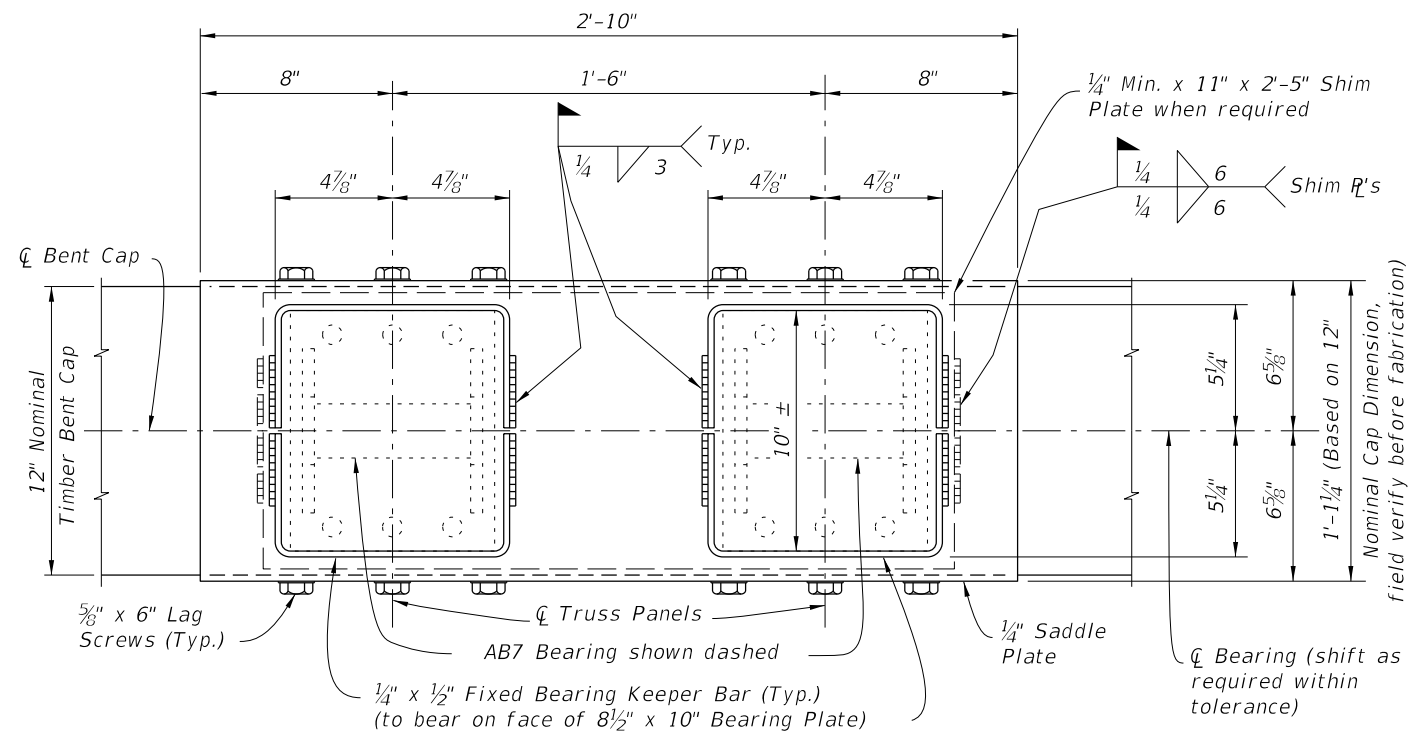
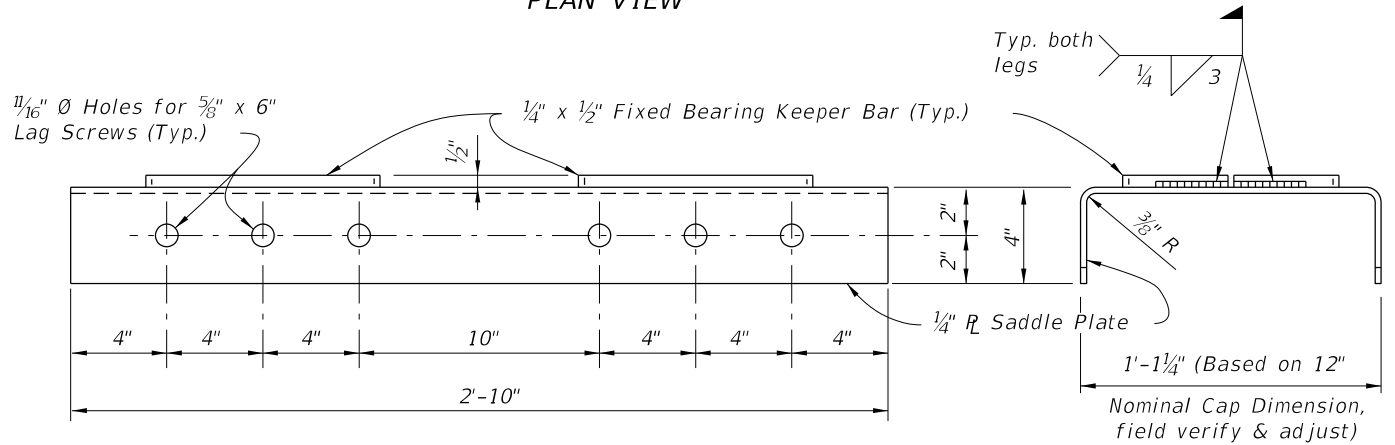
PLAN VIEW

ELEVATION VIEW OF SADDLE PLATE

END VIEW

FIXED BEARING KEEPER BAR DETAIL

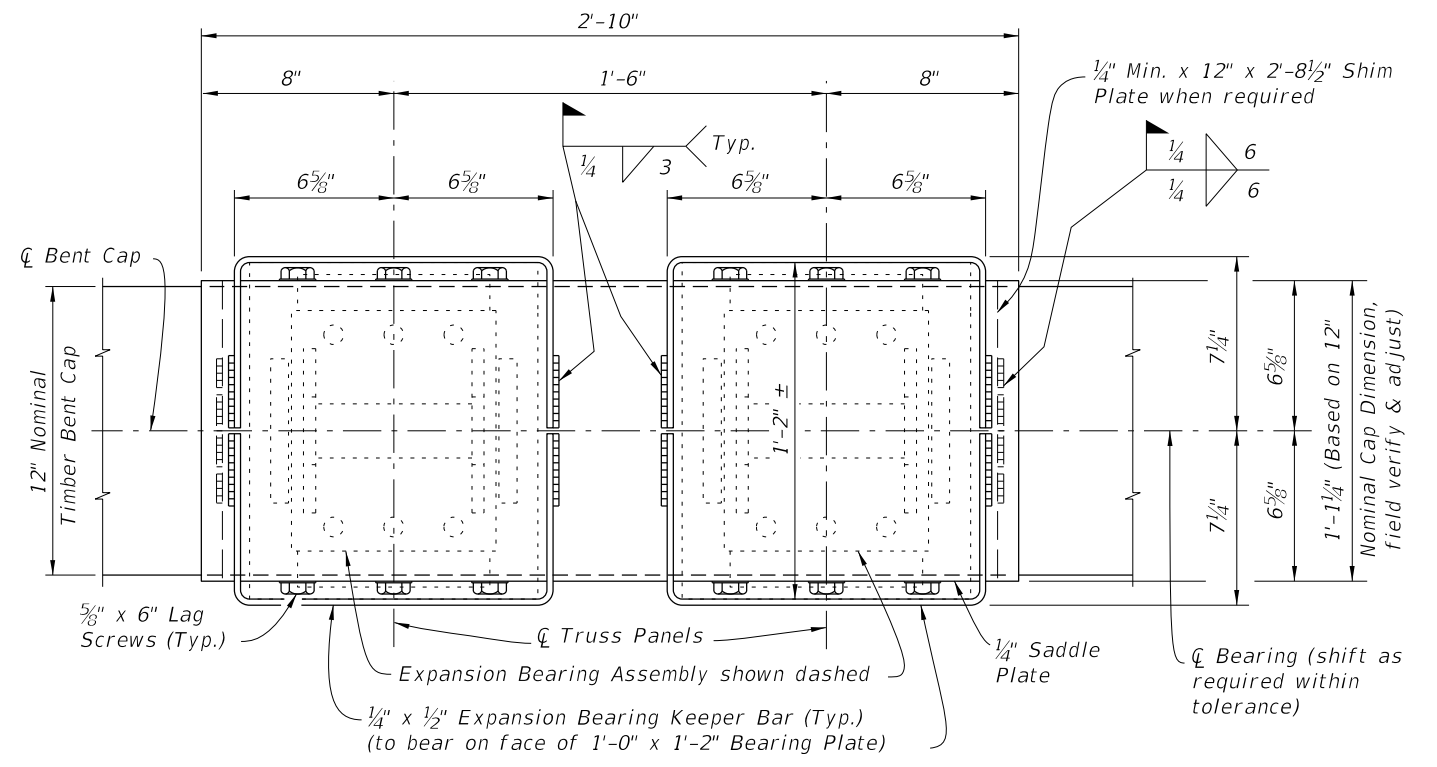
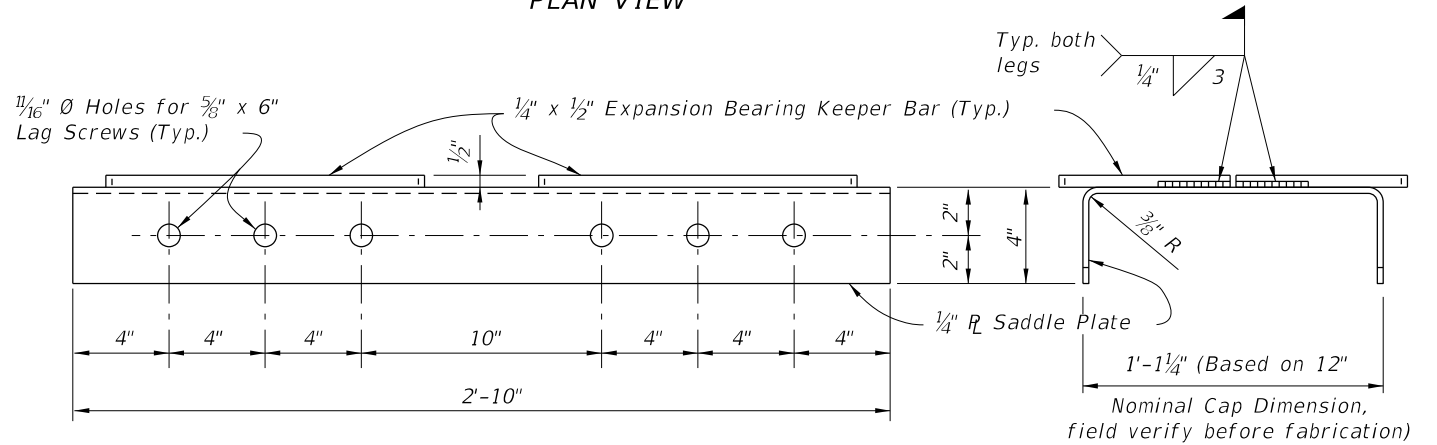
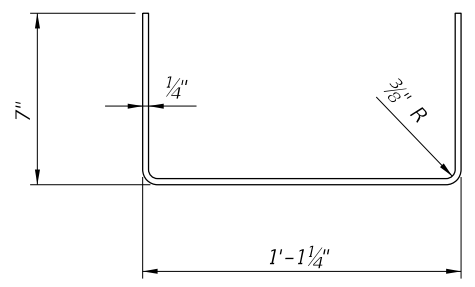
PLAN VIEW

ELEVATION VIEW OF SADDLE PLATE

END VIEW

EXPANSION BEARING KEEPER BAR DETAIL

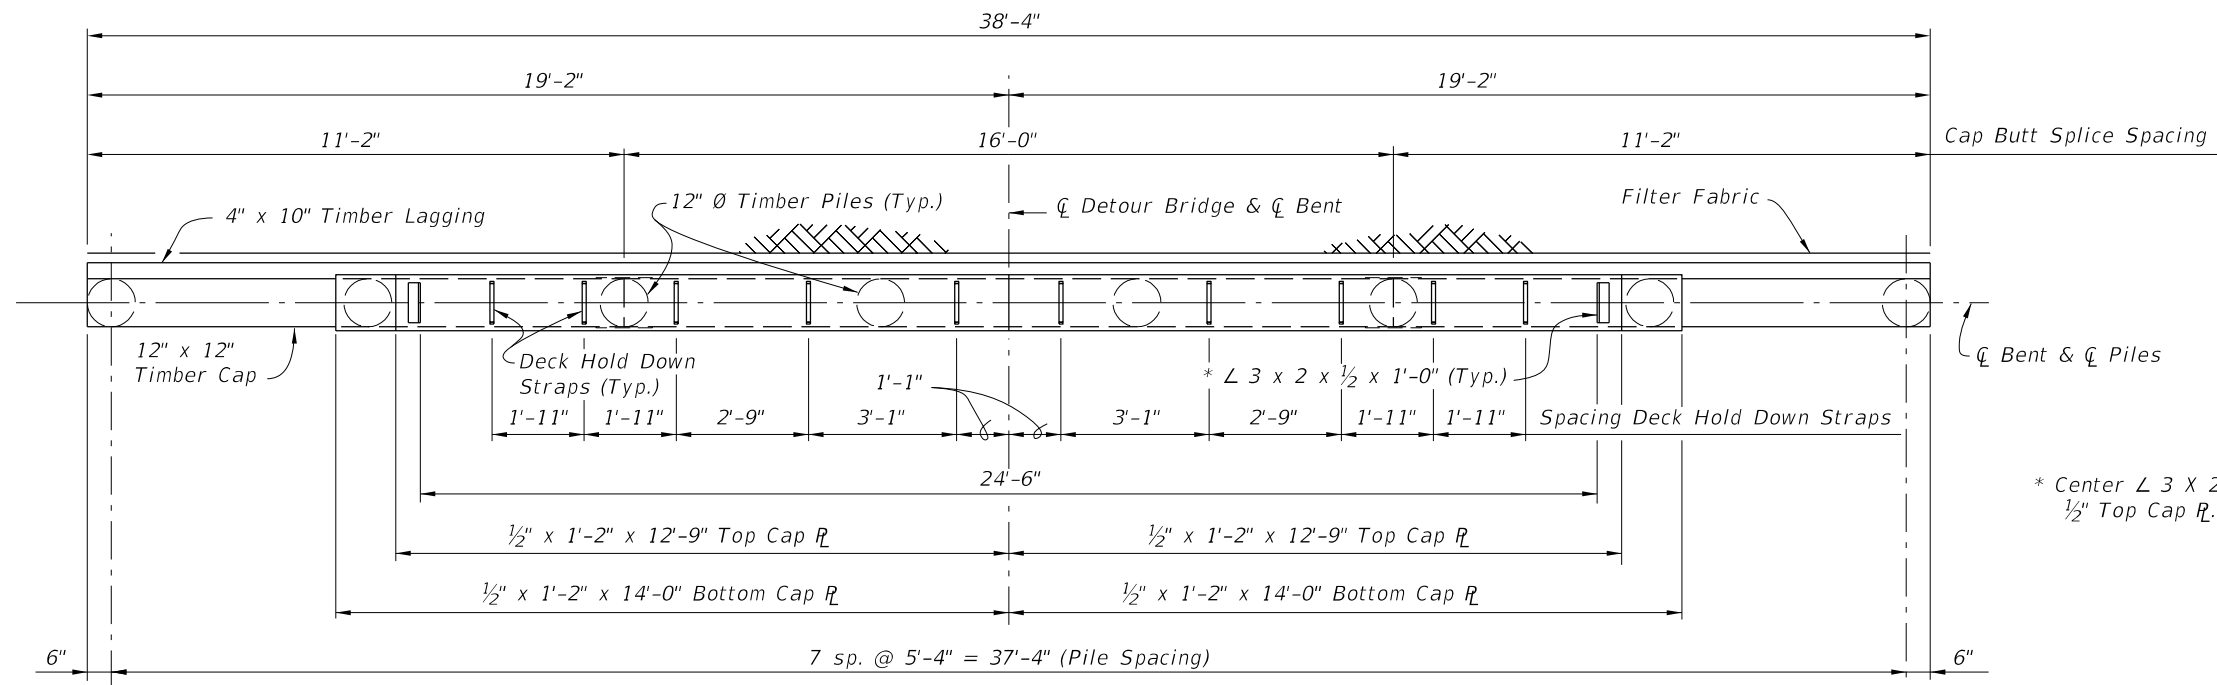
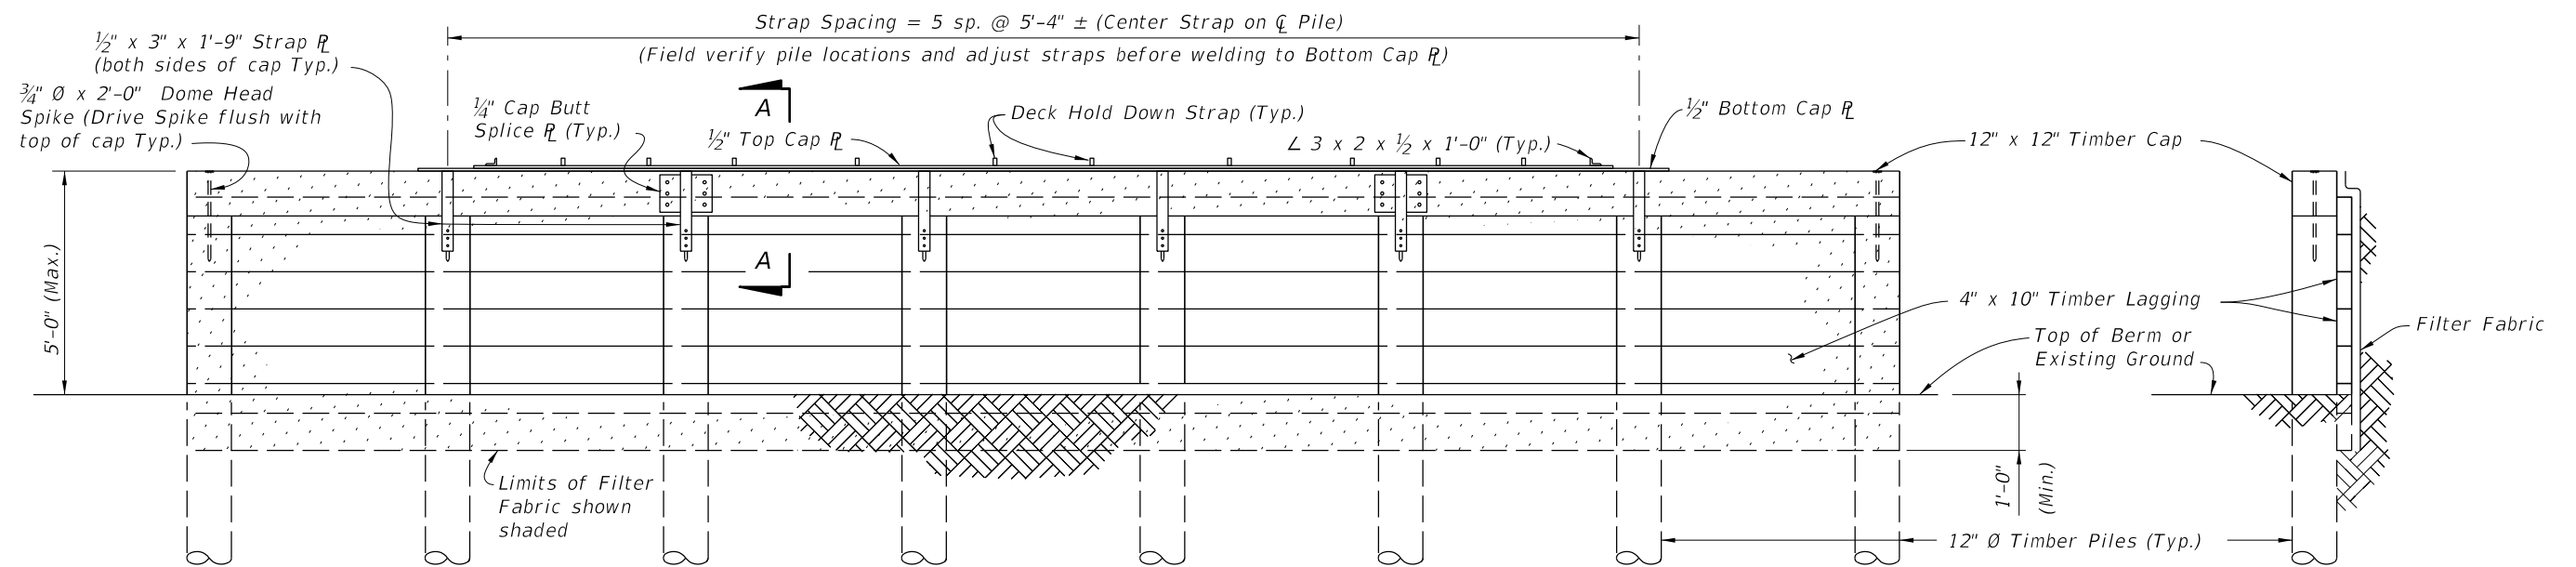
PLAN VIEW

ELEVATION VIEW

END VIEW

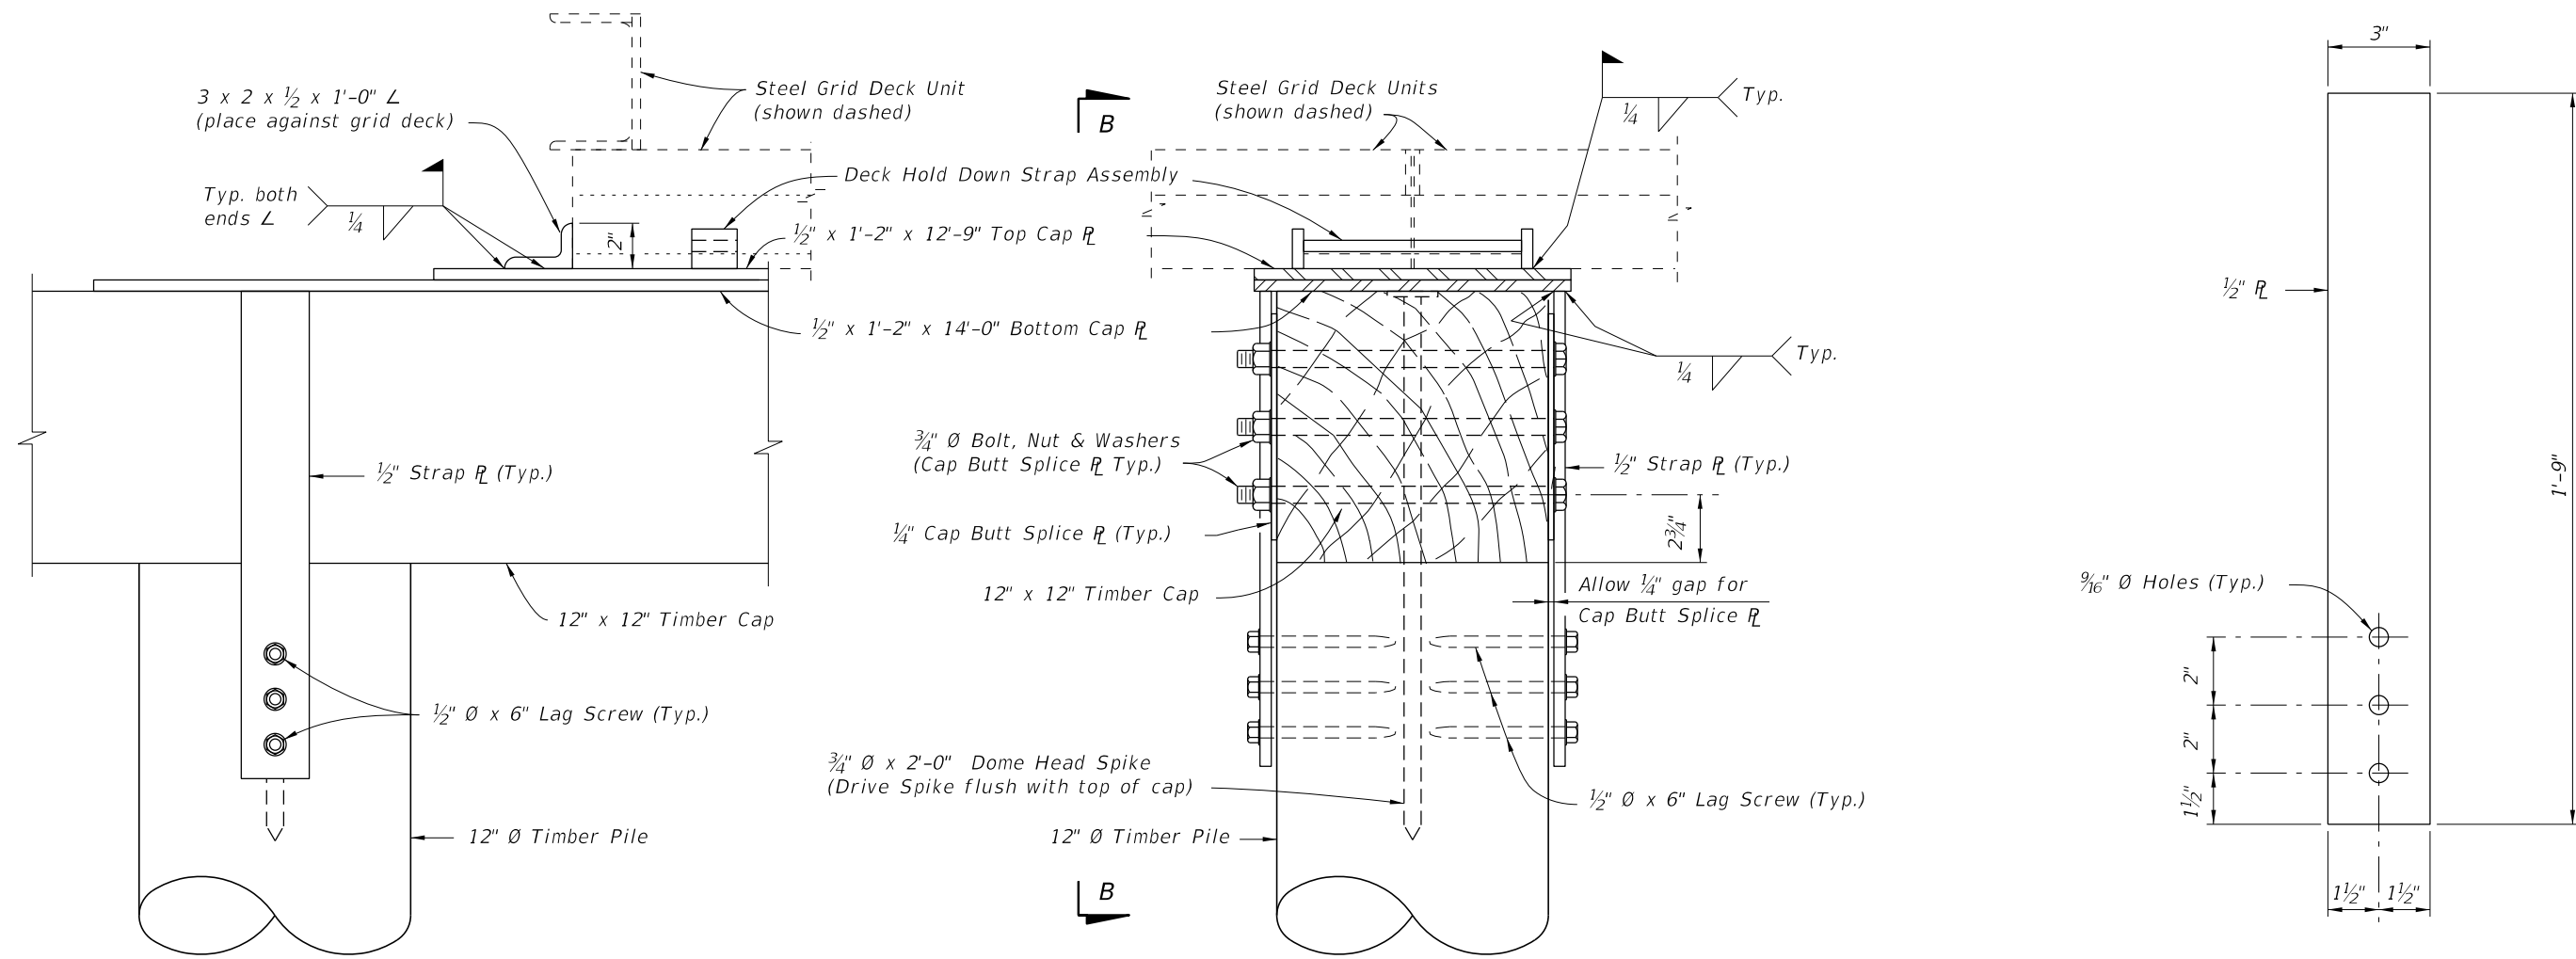
VIEW B-B  
(SHOWING END OF CAP PLATES)

SECTION A-A

STRAP PLATE DETAIL

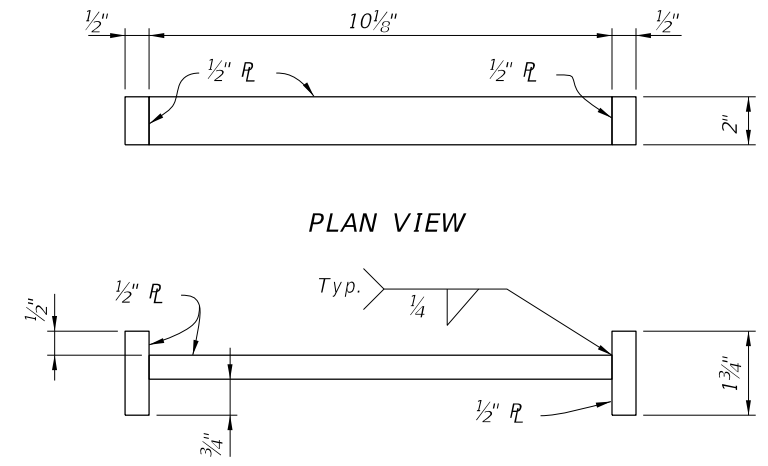
PLAN VIEW  
ELEVATION VIEW  
HOLD DOWN STRAP ASSEMBLY DETAIL

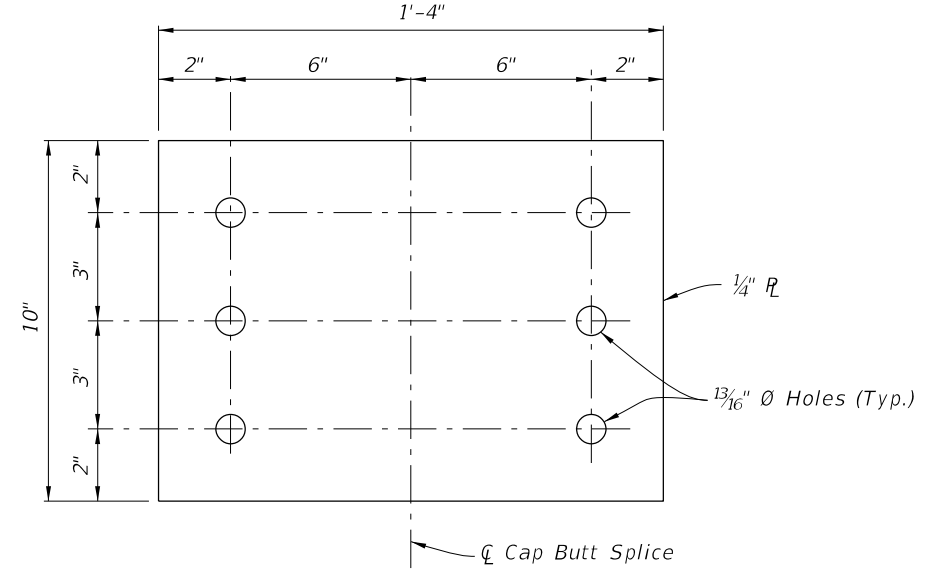
CAP BUTT SPLICE PLATE DETAIL
