**ANCHORAGE PROTECTION FOR STRAND TENDONS**

**ANCHORAGE PROTECTION FOR BAR TENDONS**

LAST REVISION 11/01/16	REVISION	DESCRIPTION:	 <b>FY 2018-19 STANDARD PLANS</b>	<b>POST-TENSIONING ANCHORAGE PROTECTION</b>	INDEX <b>462-002</b>	SHEET <b>1 of 1</b>
---------------------------	----------	--------------	--	---	-------------------------	------------------------

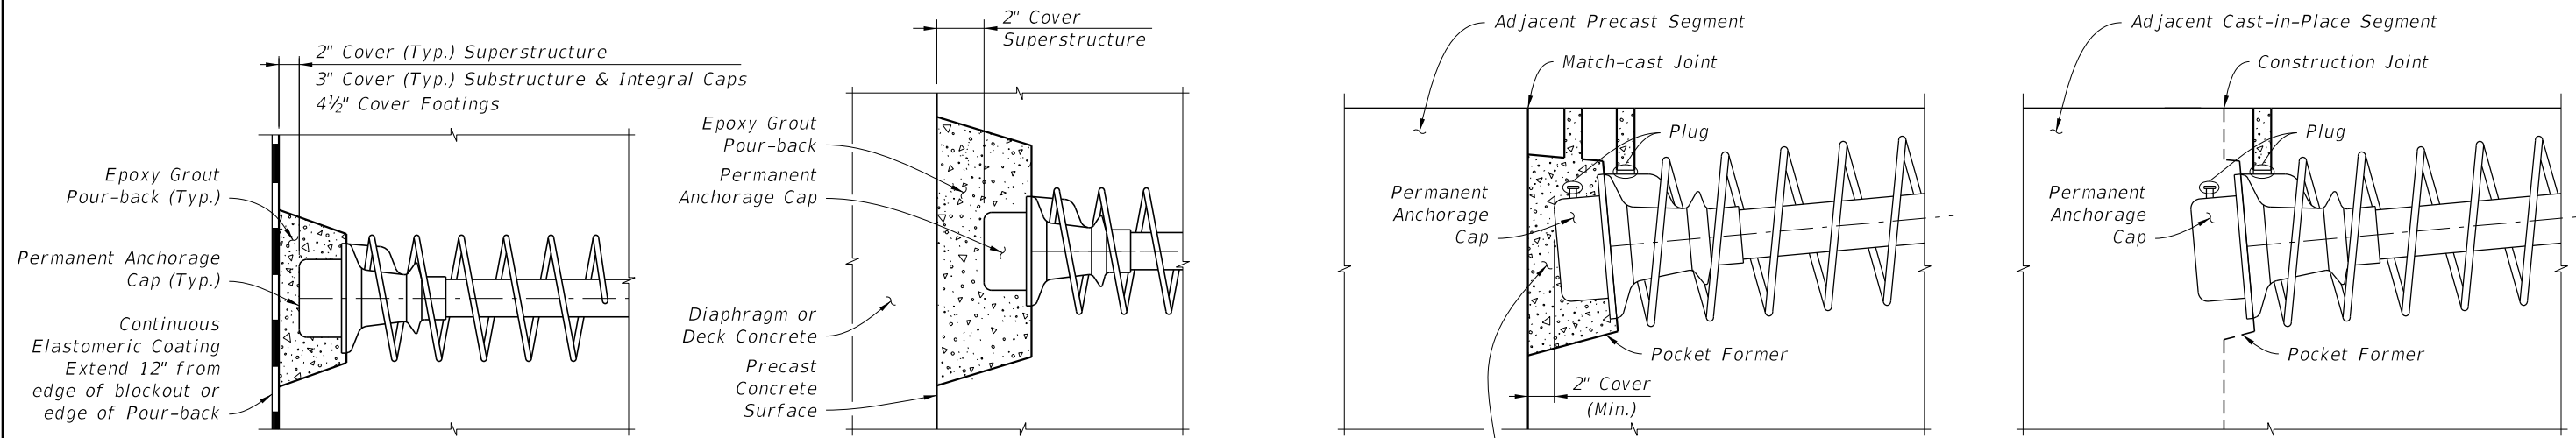
**TYPE 1**

**TYPE 2**

**TYPE 3A**

**TYPE 3B**

Epoxy Grout Pour-back placed after permanent tendons anchored in adjacent segment have been stressed

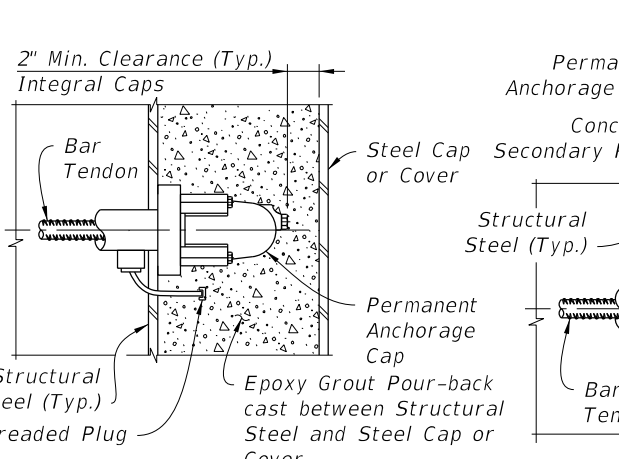
**TYPE 11**

(Shear Studs not Shown for Clarity)
