FDOT  
 FY 2020-21  
 STANDARD PLANS

TEMPORARY DETOUR BRIDGE  
 TIMBER PILE FOUNDATIONS

INDEX	SHEET
102-210	1 of 3

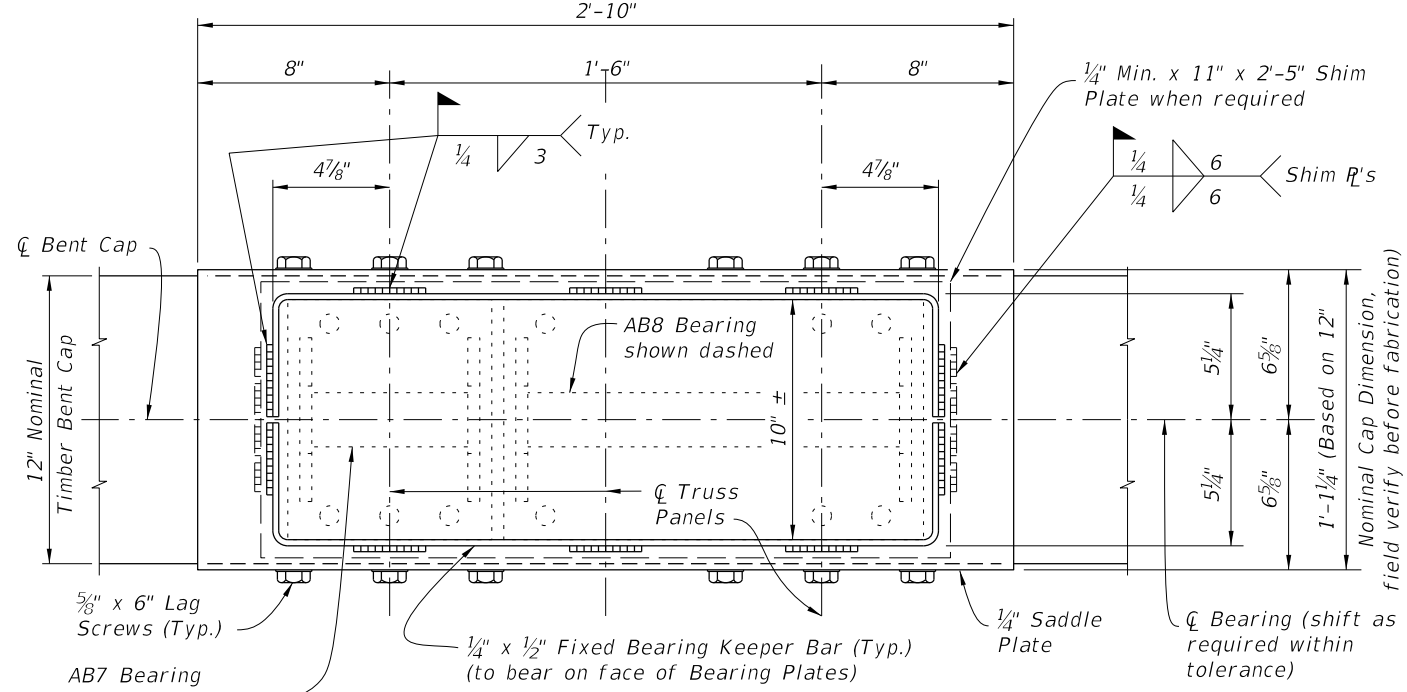
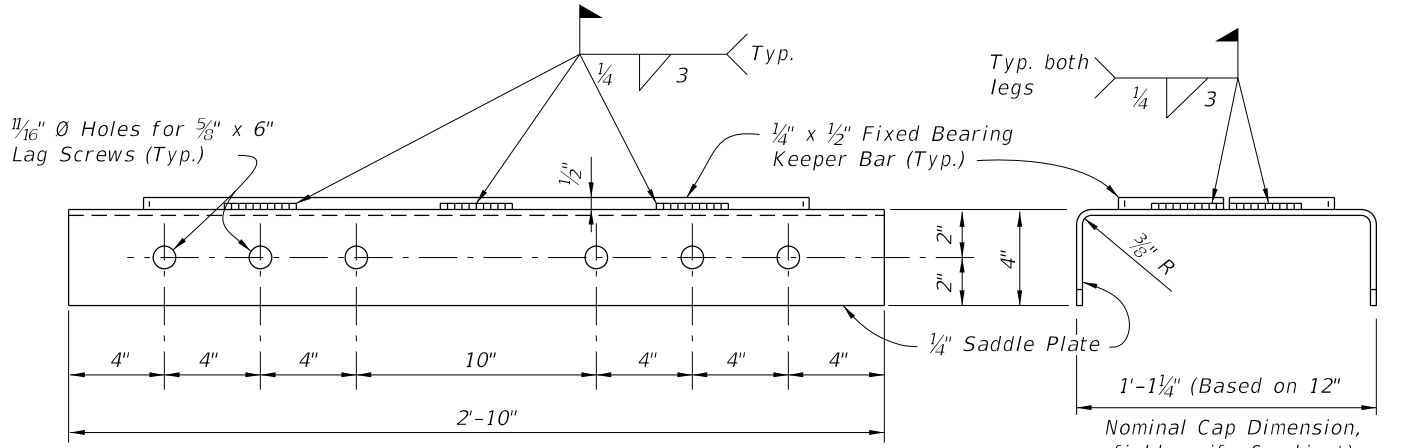
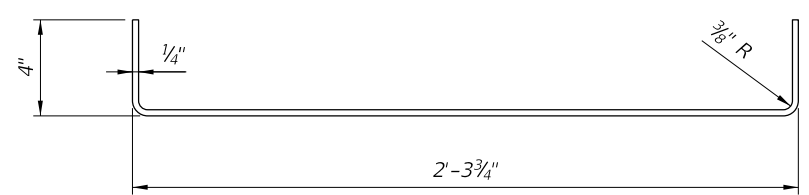
FIXED BEARING DETAILS

PLAN VIEW

ELEVATION VIEW OF SADDLE PLATE

END VIEW

FIXED BEARING KEEPER BAR DETAIL

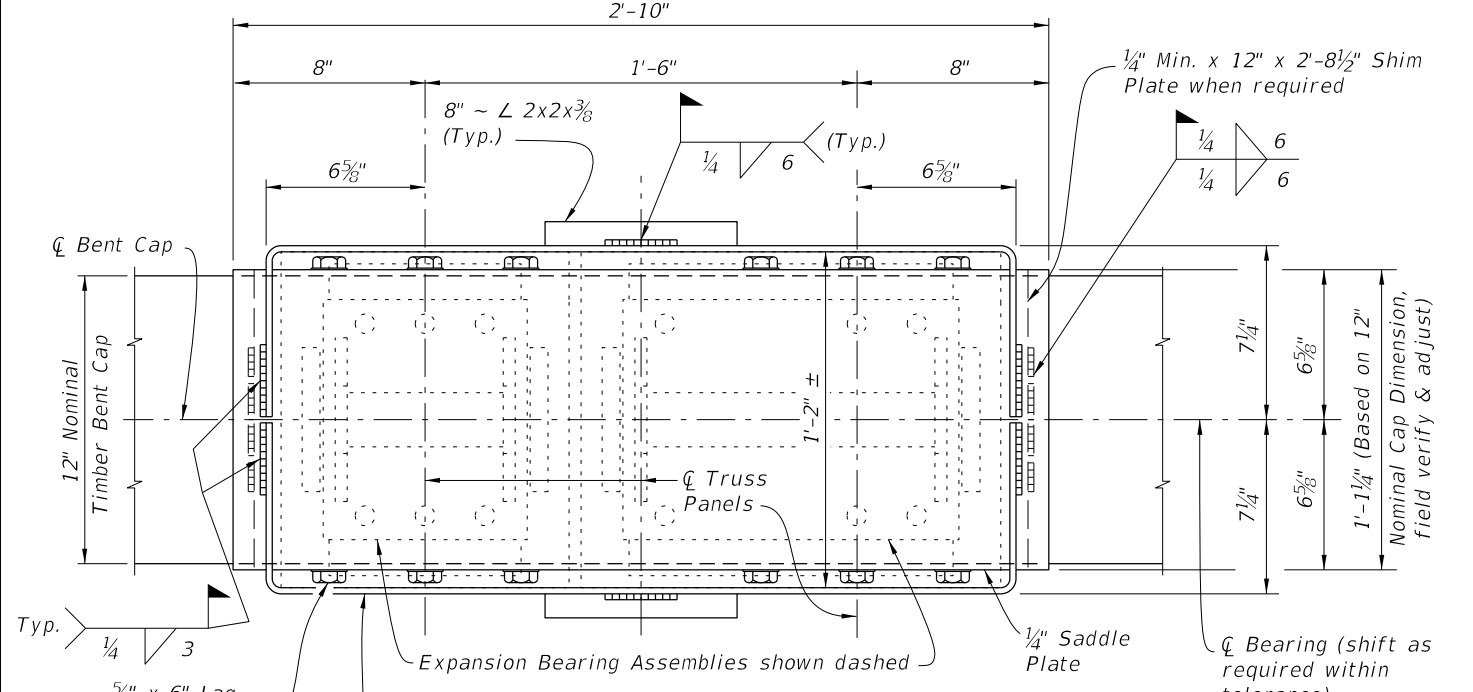
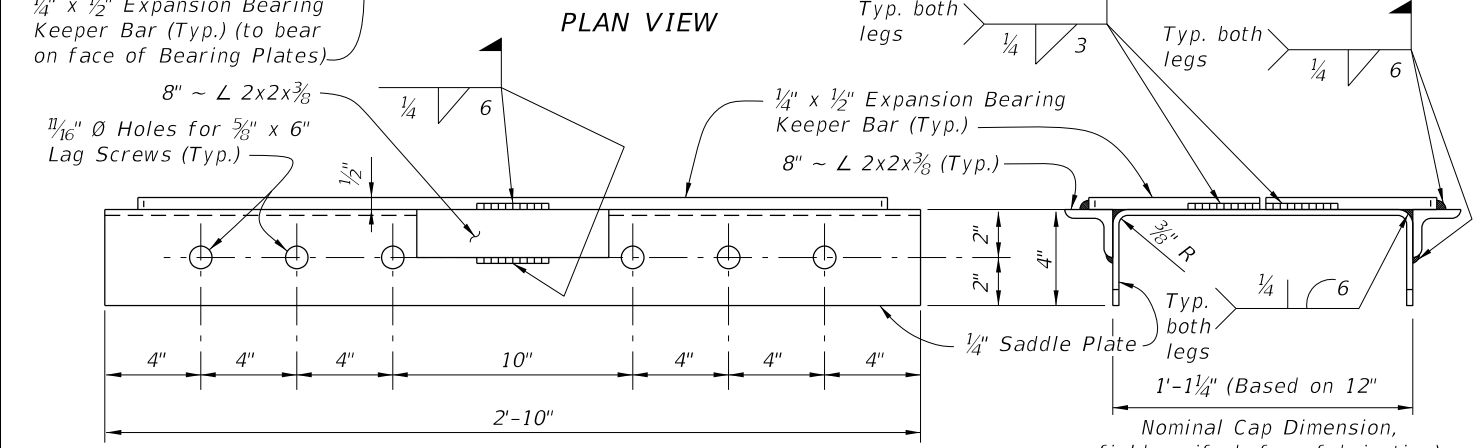
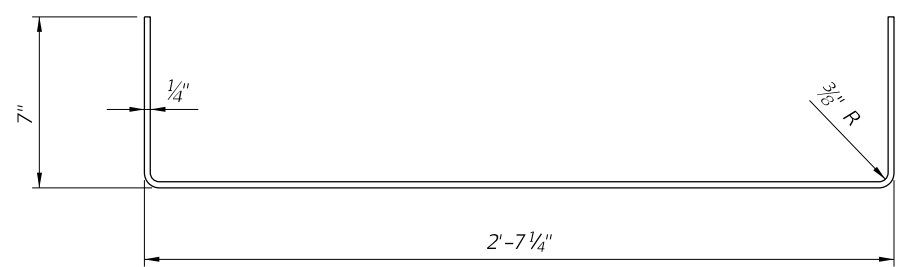
EXPANSION BEARING DETAILS

PLAN VIEW

ELEVATION VIEW OF SADDLE PLATE

END VIEW

EXPANSION BEARING KEEPER BAR DETAIL

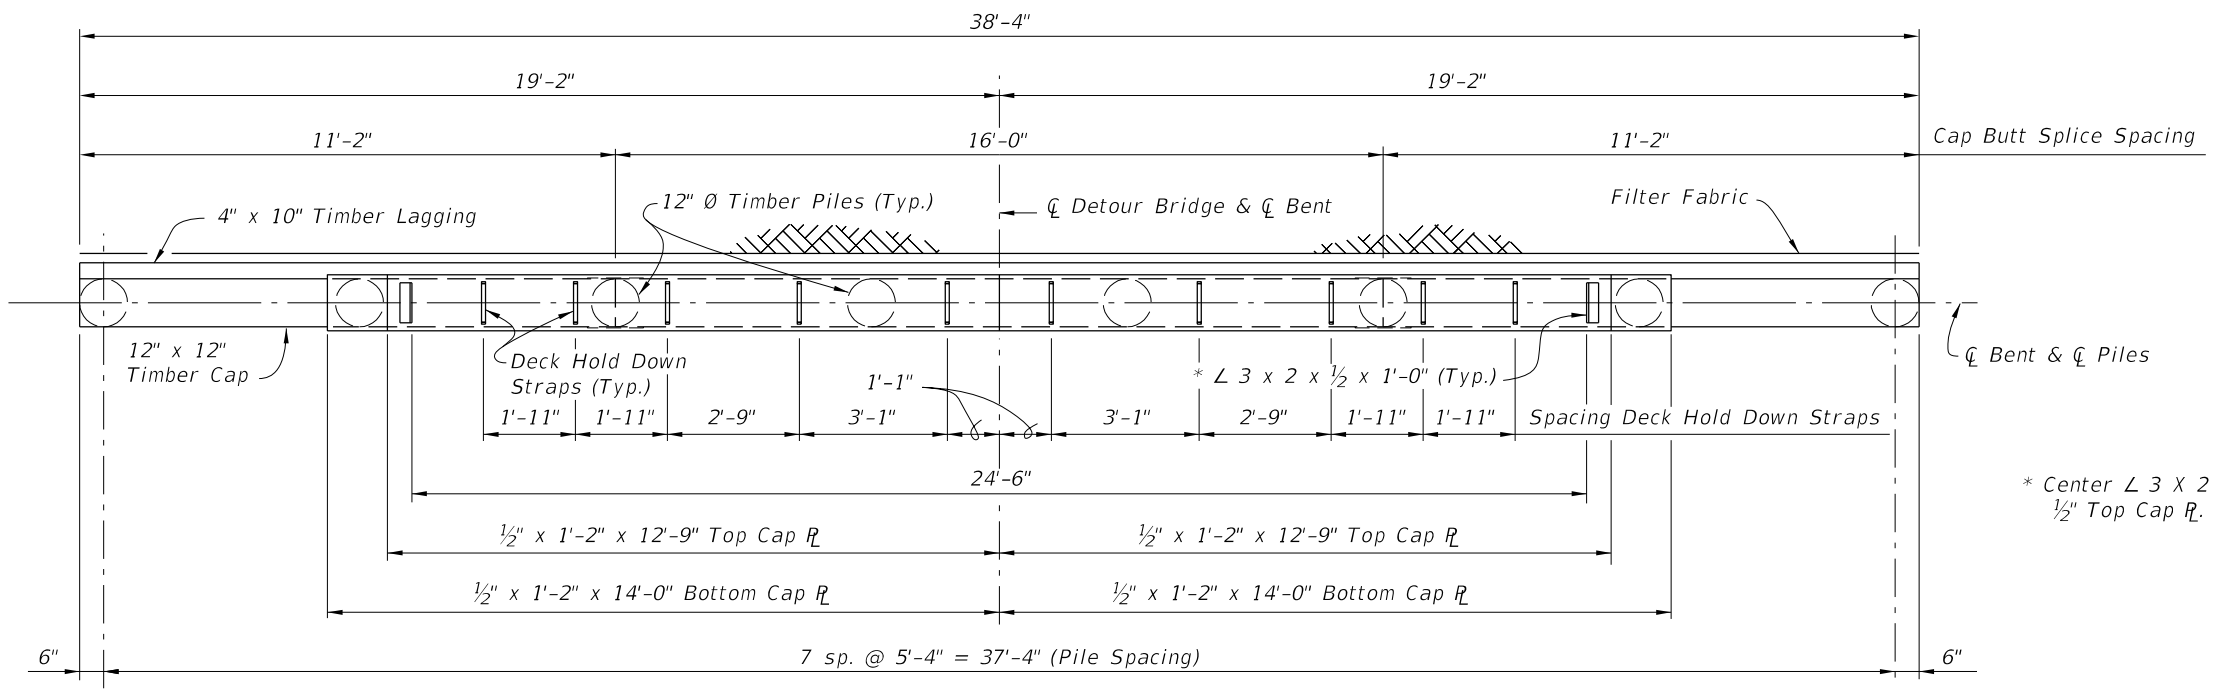
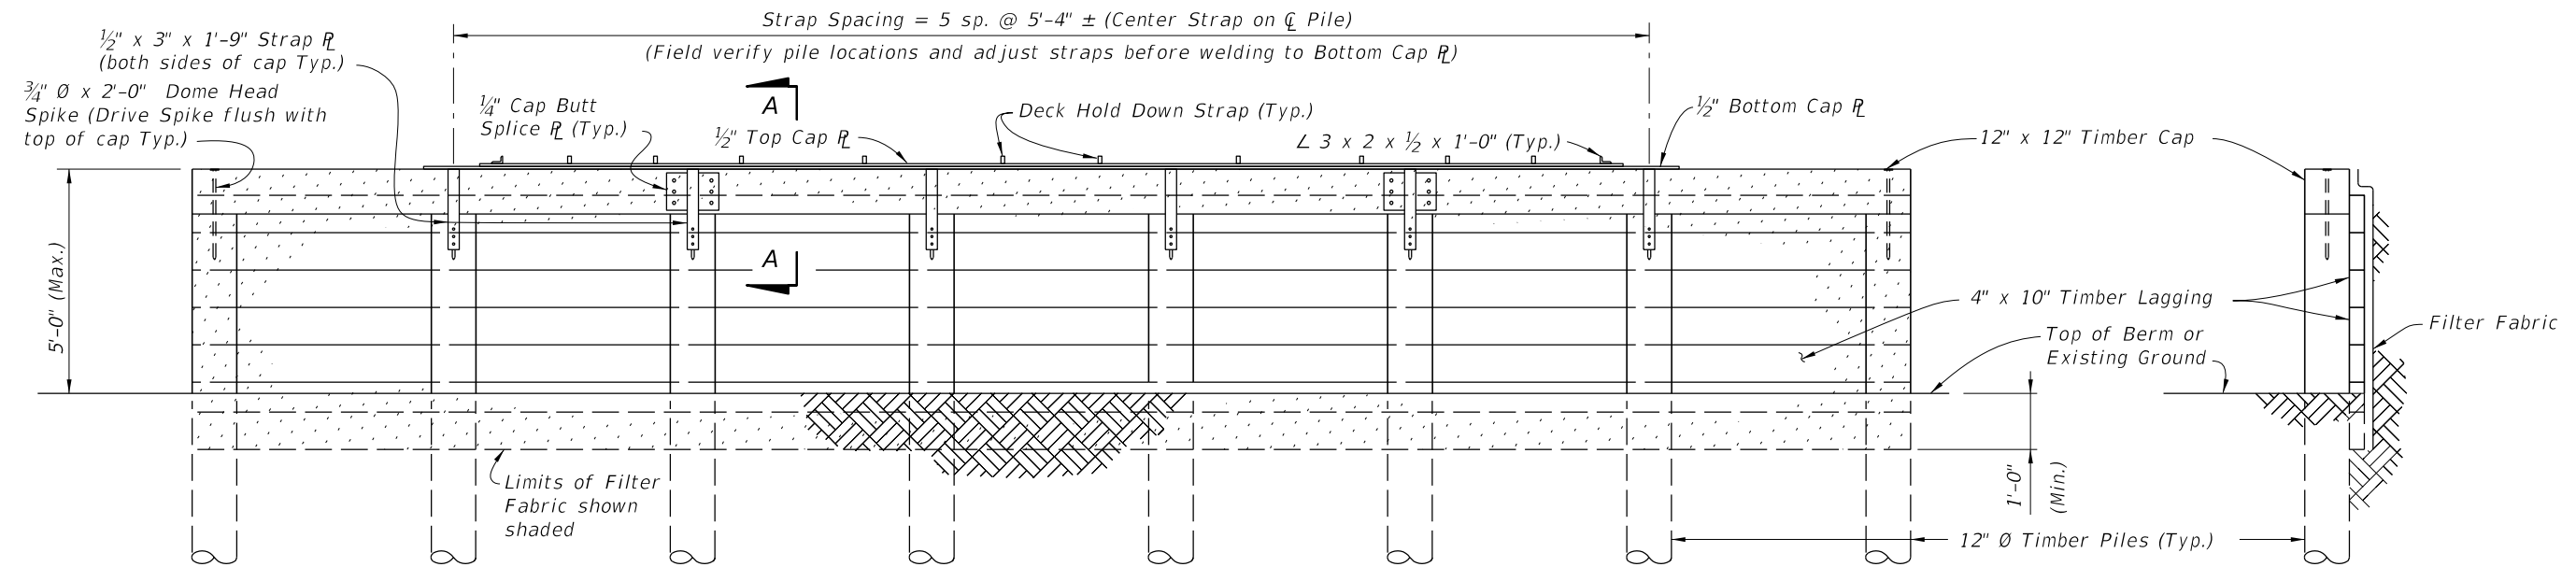
BACKWALL BENT DETAILS

PLAN VIEW

ELEVATION VIEW

END VIEW

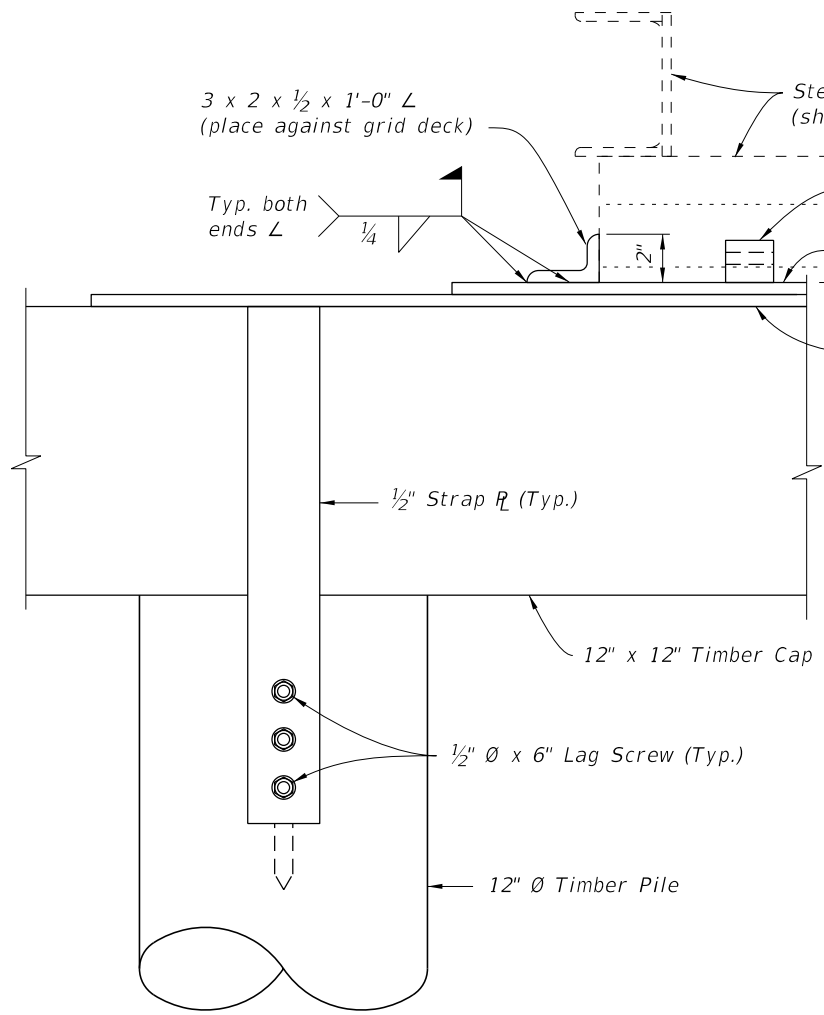
VIEW B-B  
 (SHOWING END OF CAP PLATES)

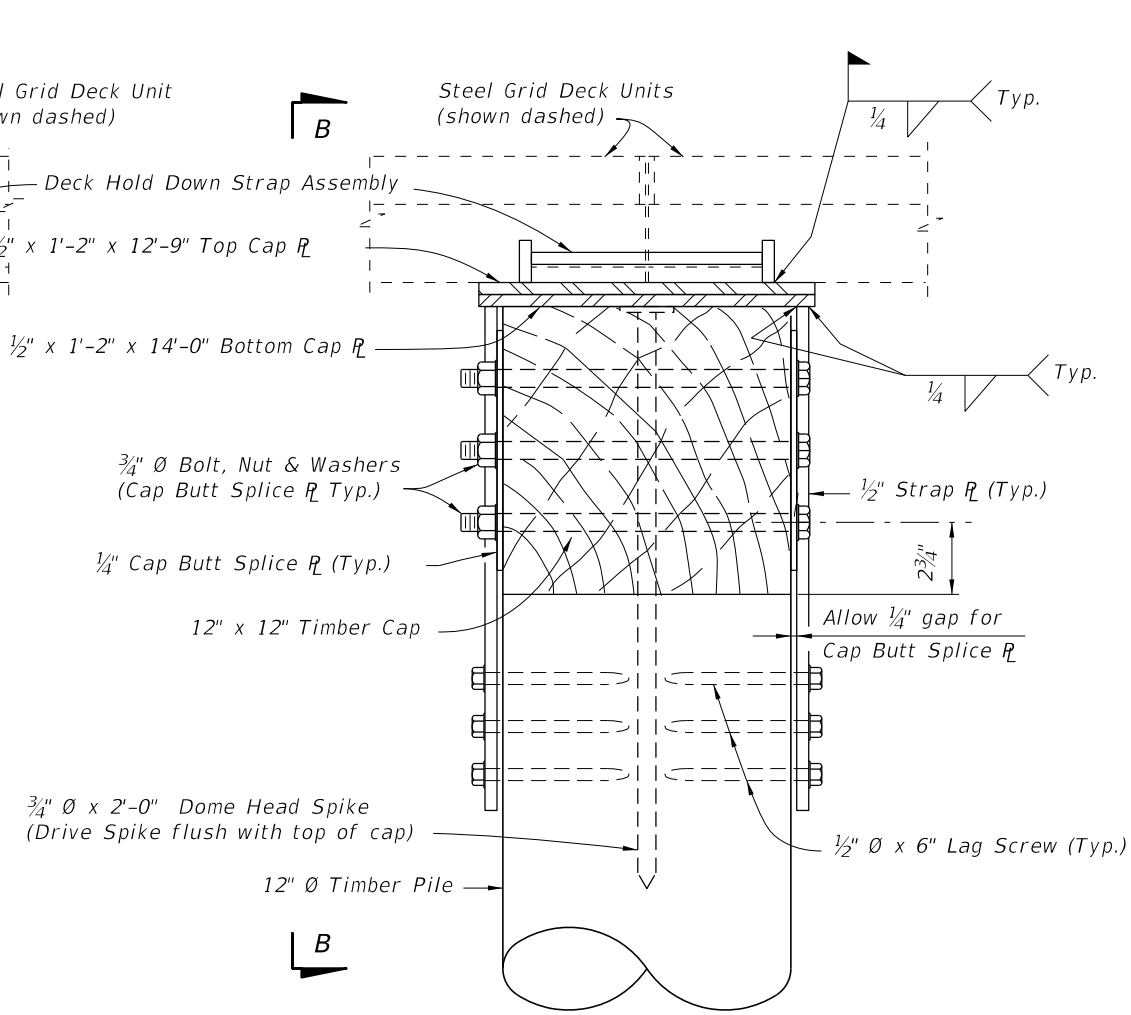
SECTION A-A

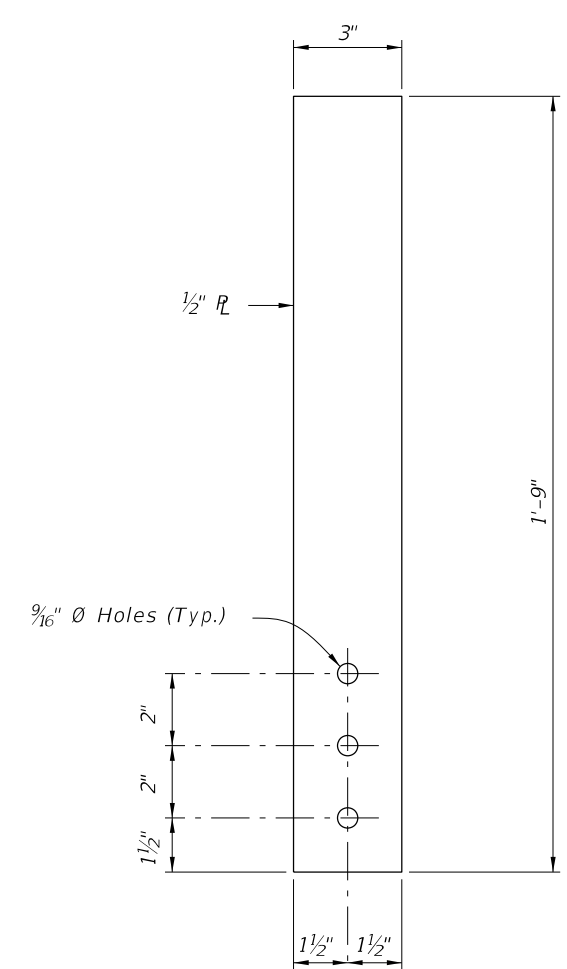
STRAP PLATE DETAIL

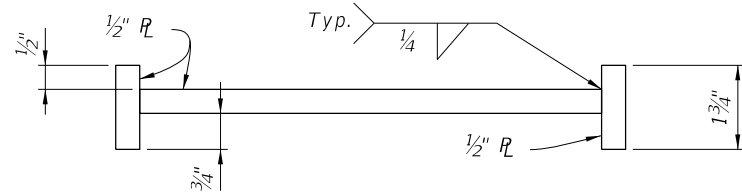
ELEVATION VIEW

HOLD DOWN STRAP ASSEMBLY DETAIL

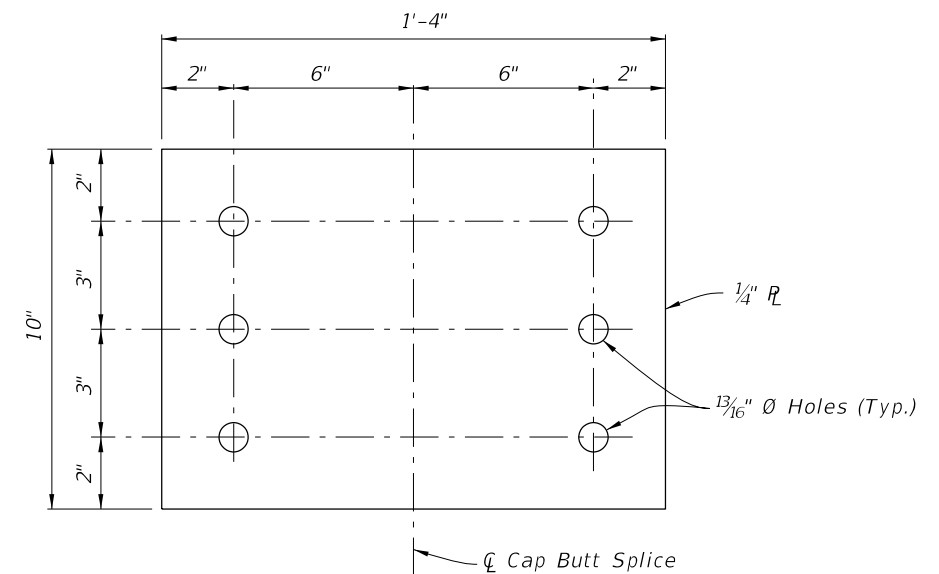
CAP BUTT SPLICE PLATE DETAIL
