FY 2024-25  
STANDARD PLANS

TEMPORARY DETOUR BRIDGE  
TIMBER PILE FOUNDATIONS

INDEX  
102-210

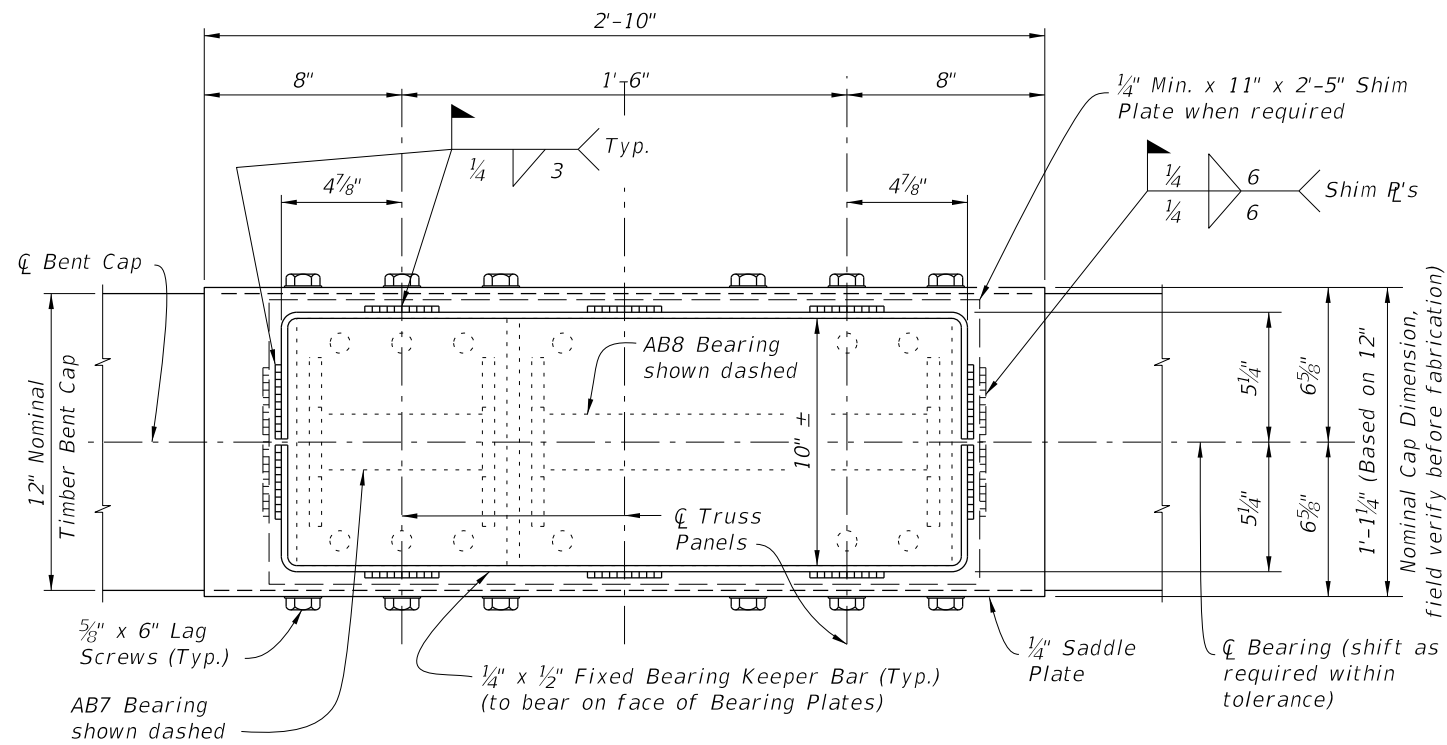
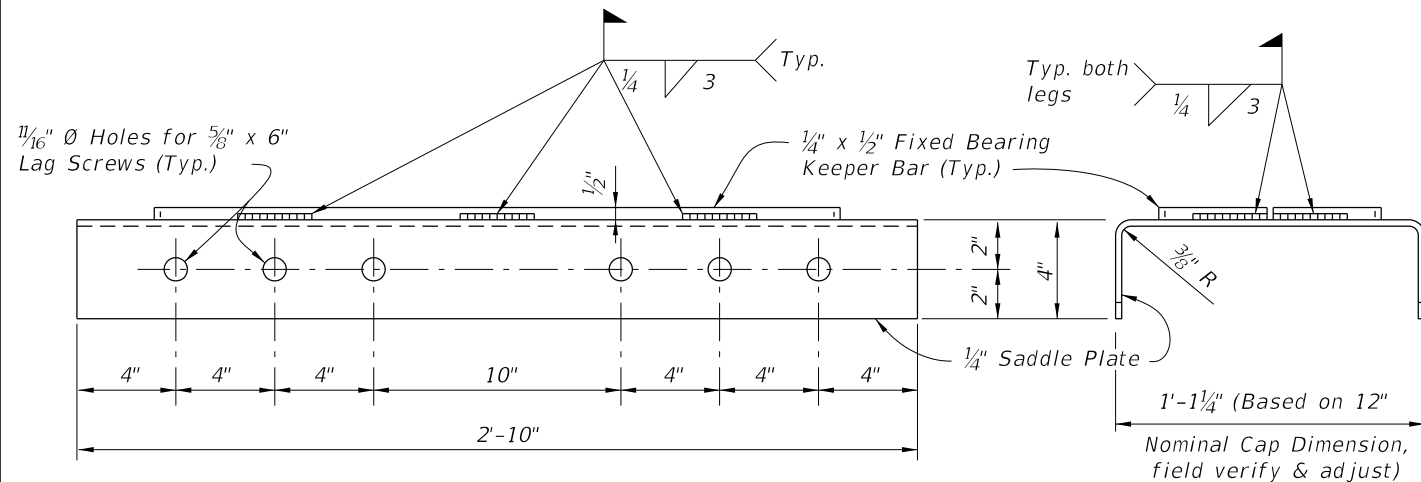
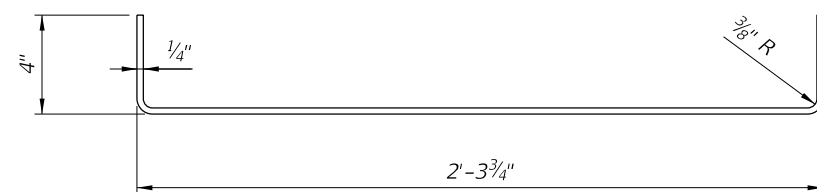
FIXED BEARING DETAILS

PLAN VIEW

ELEVATION VIEW OF SADDLE PLATE

END VIEW

FIXED BEARING KEEPER BAR DETAIL

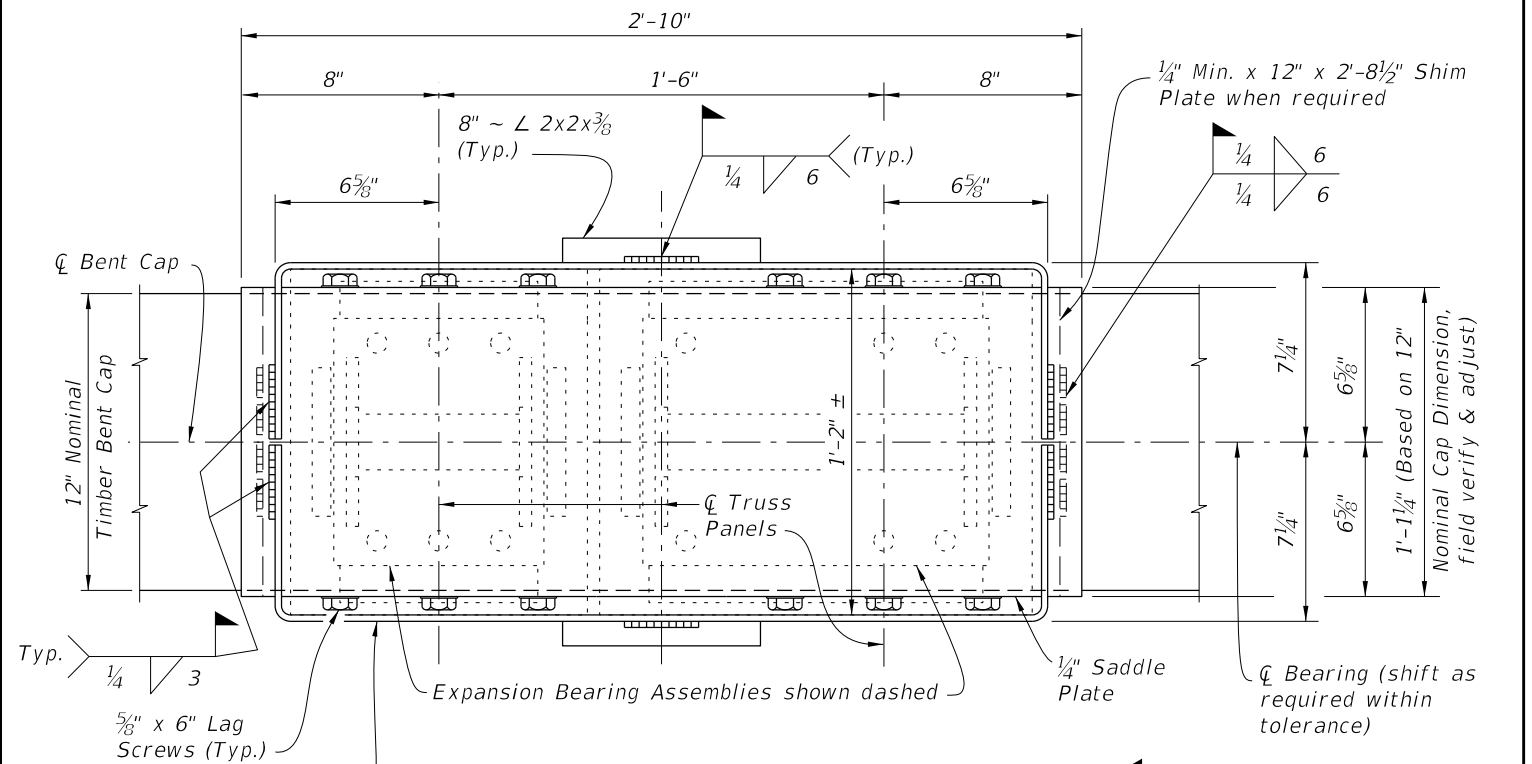
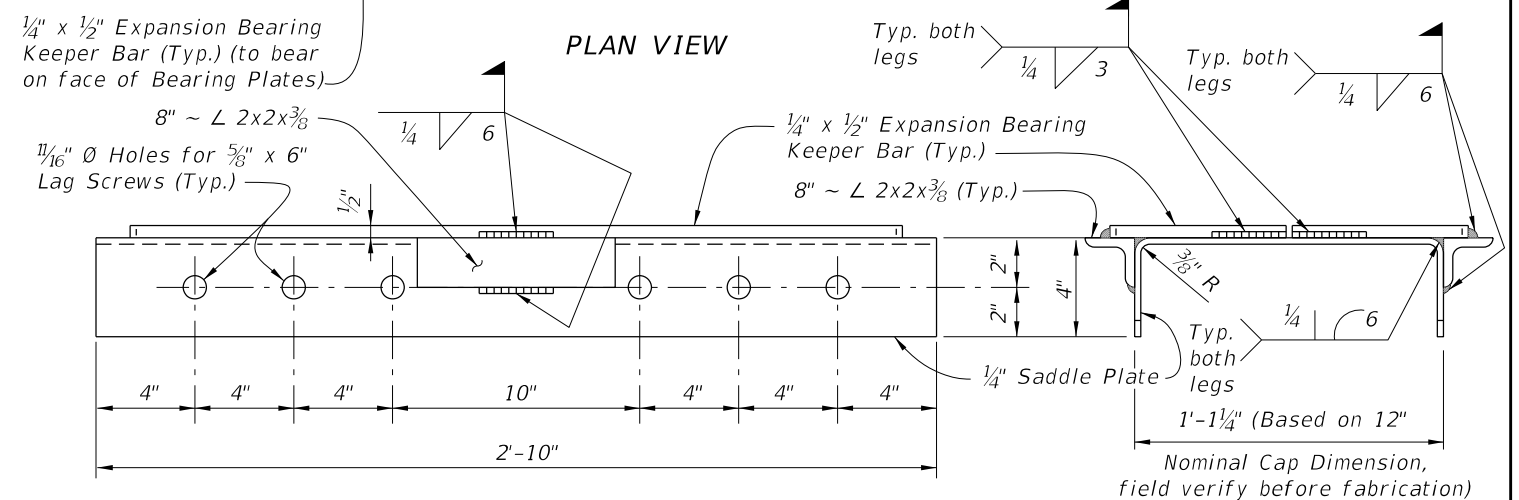
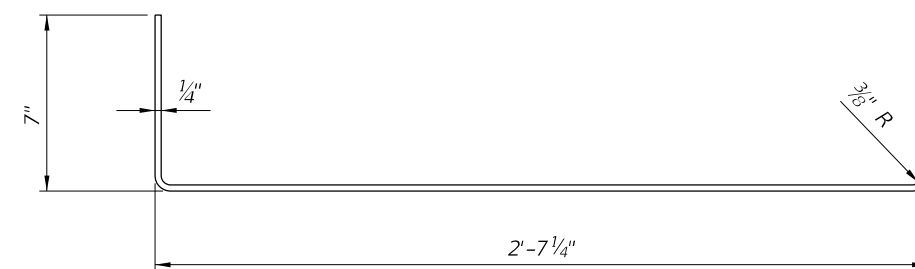
EXPANSION BEARING DETAILS

PLAN VIEW

ELEVATION VIEW OF SADDLE PLATE

END VIEW

EXPANSION BEARING KEEPER BAR DETAIL

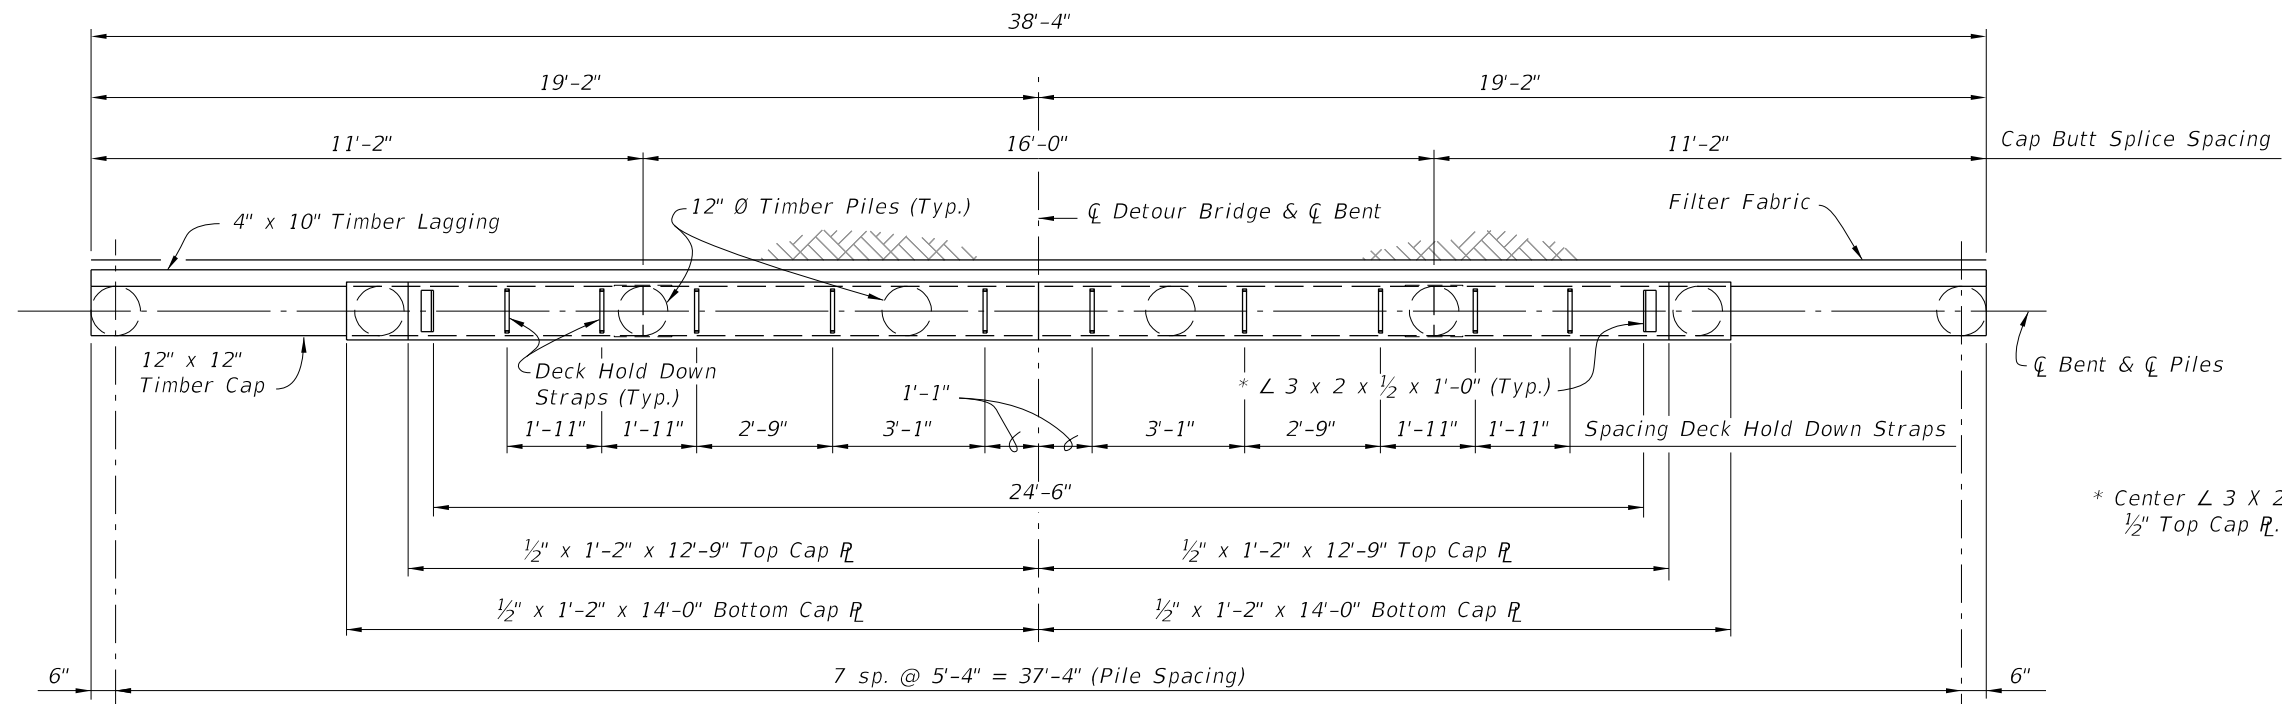
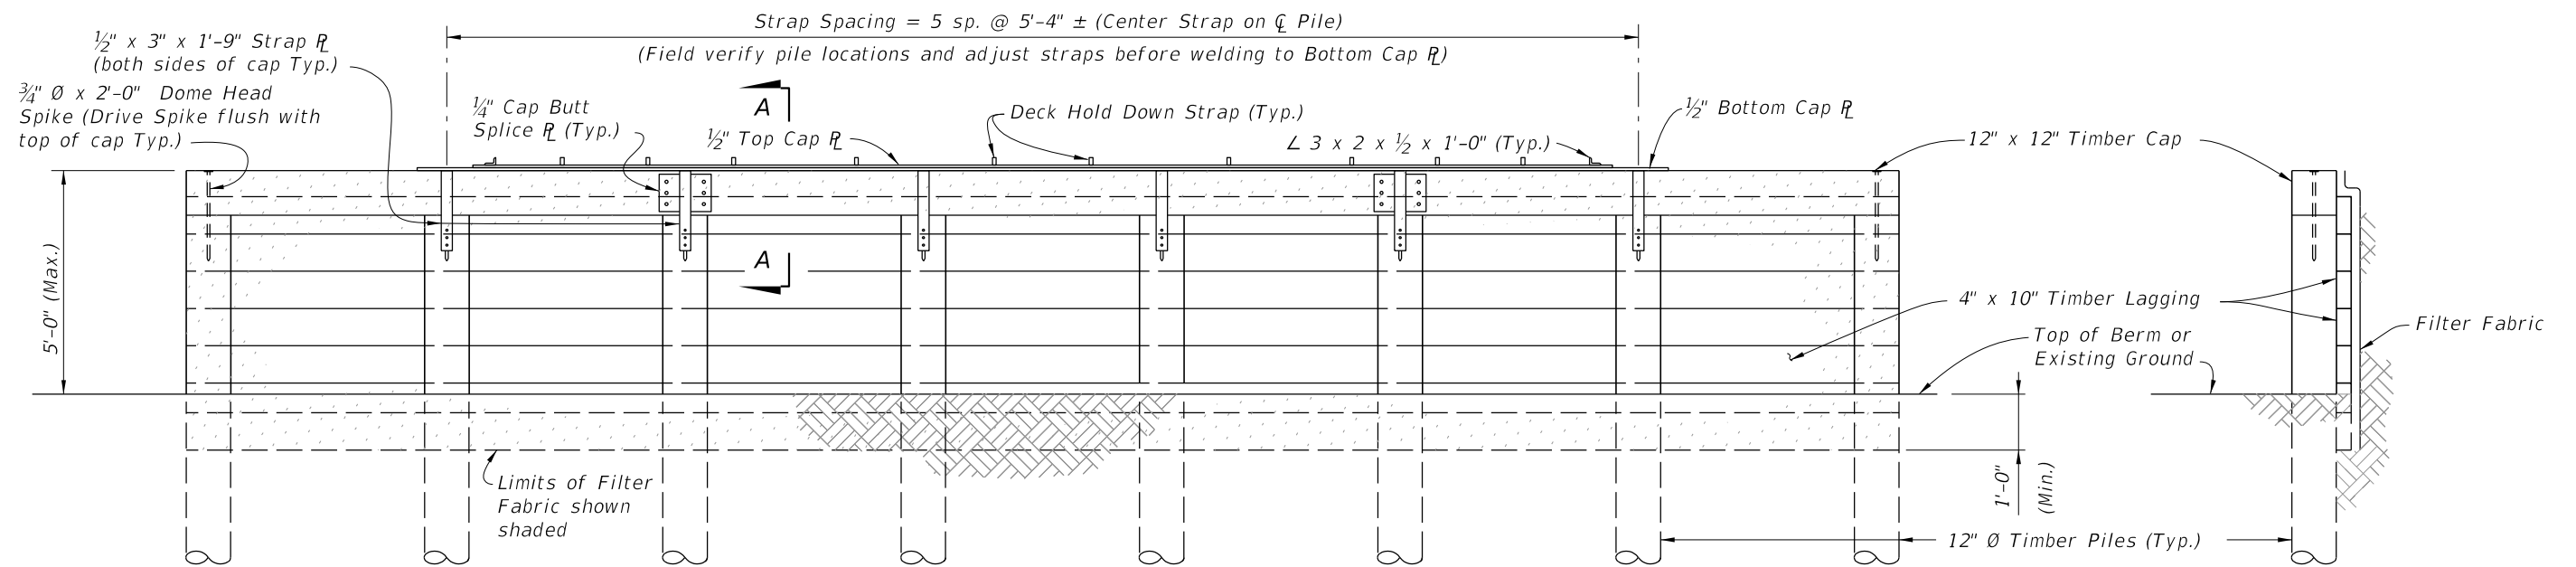
BACKWALL BENT DETAILS

PLAN VIEW

ELEVATION VIEW

END VIEW

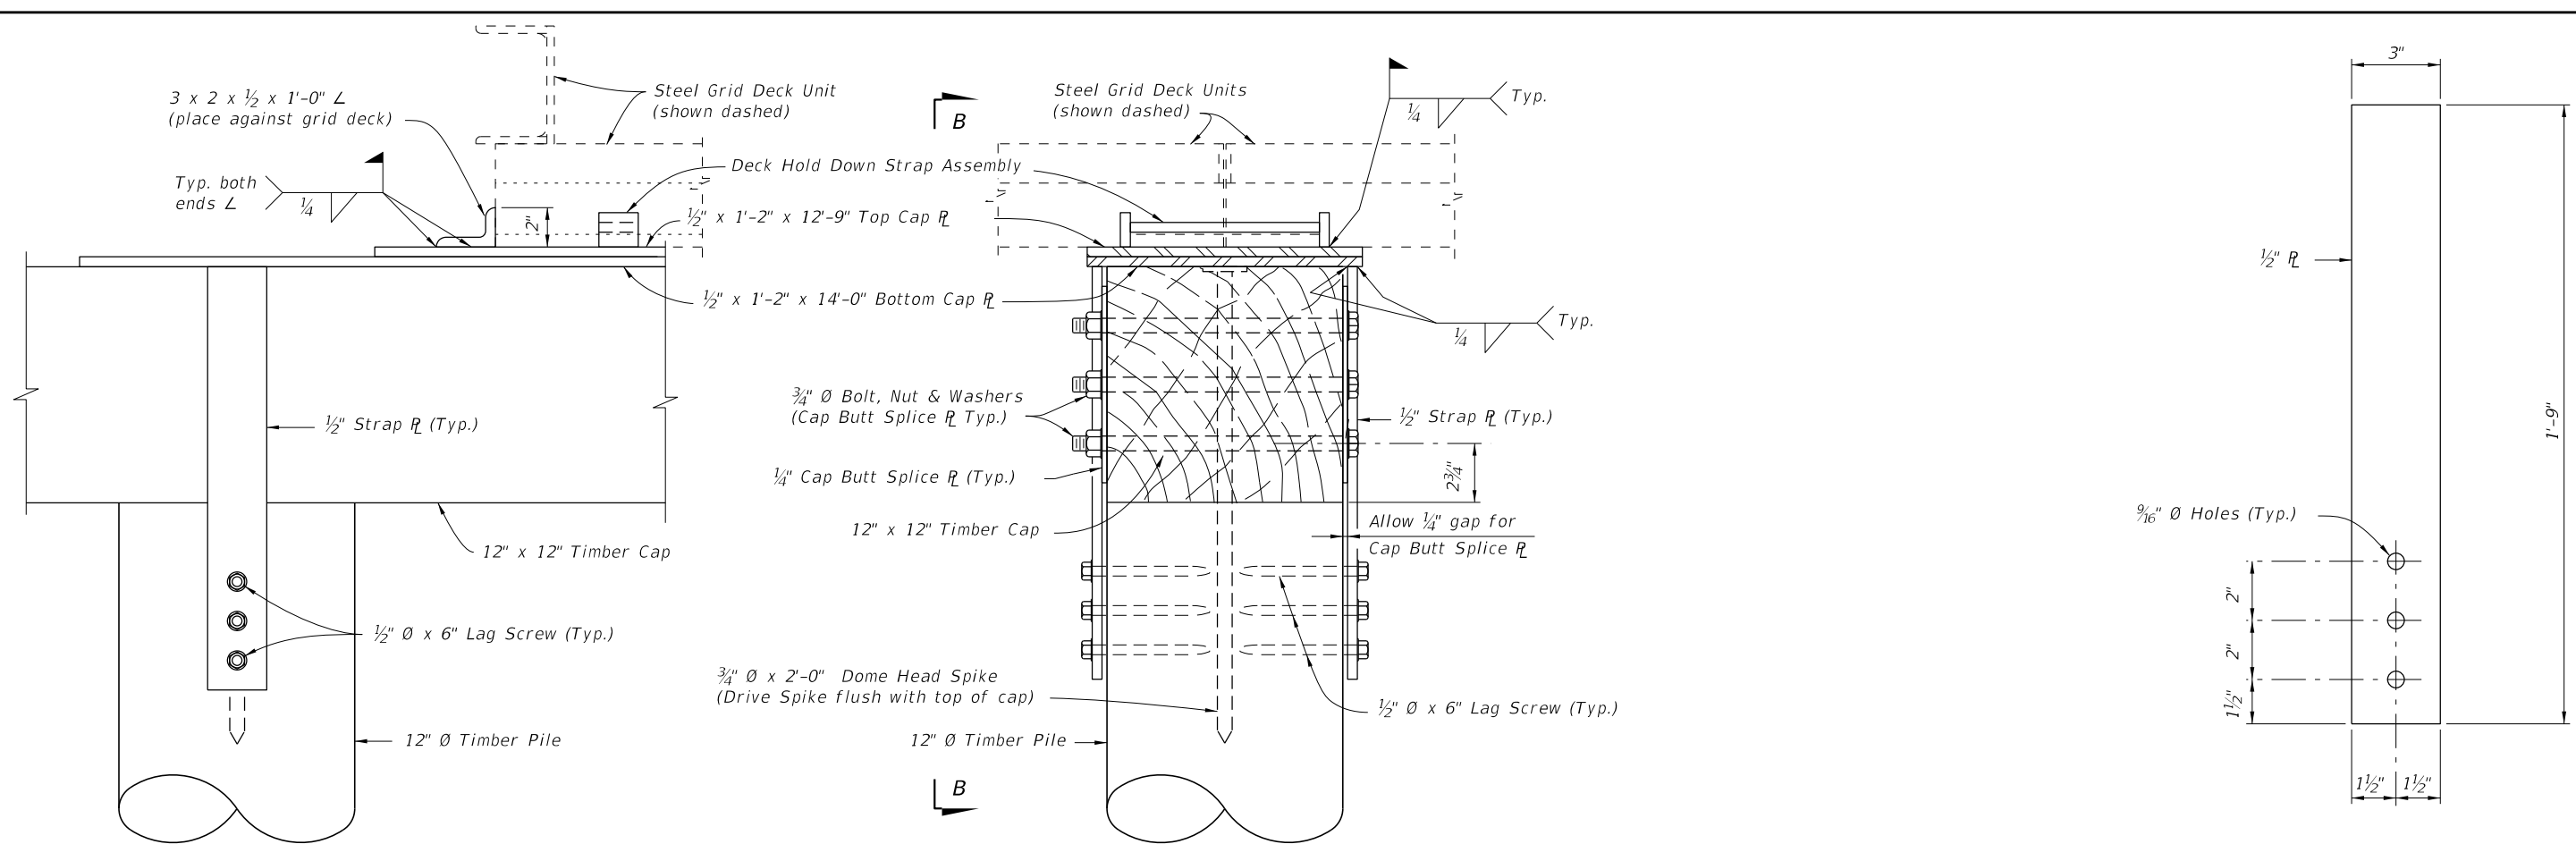
STRAP PLATE DETAIL

VIEW B-B  
(SHOWING END OF CAP PLATES)

SECTION A-A

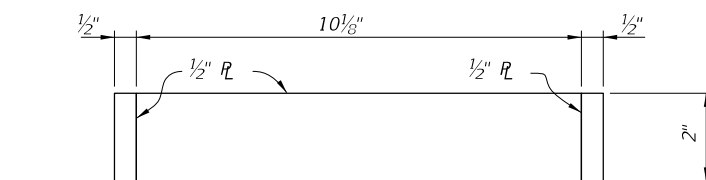
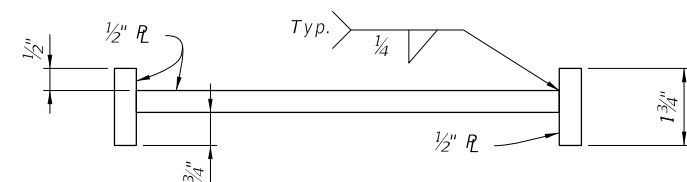
HOLD DOWN STRAP ASSEMBLY DETAIL

PLAN VIEW

ELEVATION VIEW
