# SECTION 4(f) RESOURCES

Project Development and Environment (PD&E) Study  
SR A1A Over Sebastian Inlet – Bridge 880005  
Bridge Replacement  
Indian River County and Brevard County, Florida

Financial Project ID: 445618-1-22-02  
Federal Aid Number: D420 075B  
ETDM Number: 14433

November 2022

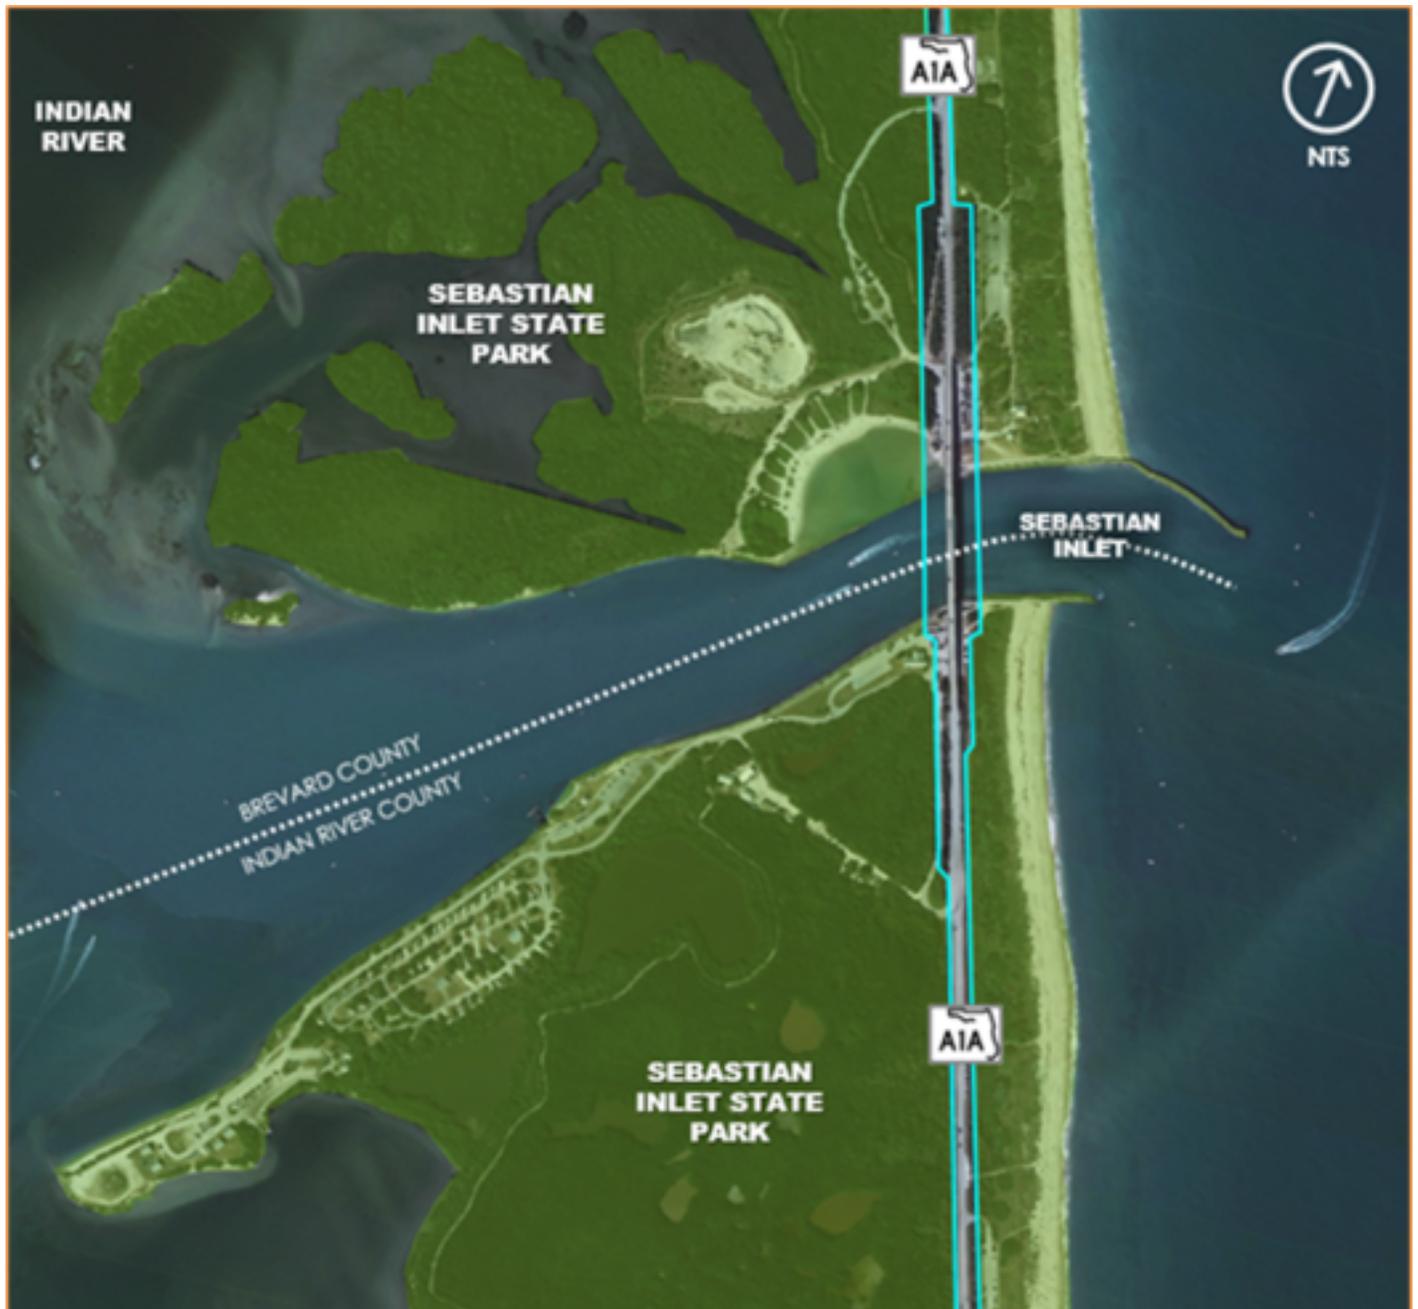
**FIGURE 2. PROJECT LOCATION**

1. The existing bridge has been constructed along SR A1A crossing the Sebastian Inlet at the most feasible and prudent location. The project location is surrounded by the Sebastian Inlet State Park with the Atlantic Ocean to the immediate east beyond the dunes and the Indian River to the west (**Figure 2**).

1. The existing bridge has been constructed along SR A1A crossing the Sebastian Inlet at the most feasible and prudent location. The project location is surrounded by the Sebastian Inlet State Park with the Atlantic Ocean to the immediate east beyond the dunes and the Indian River to the west (**Figure 2**).

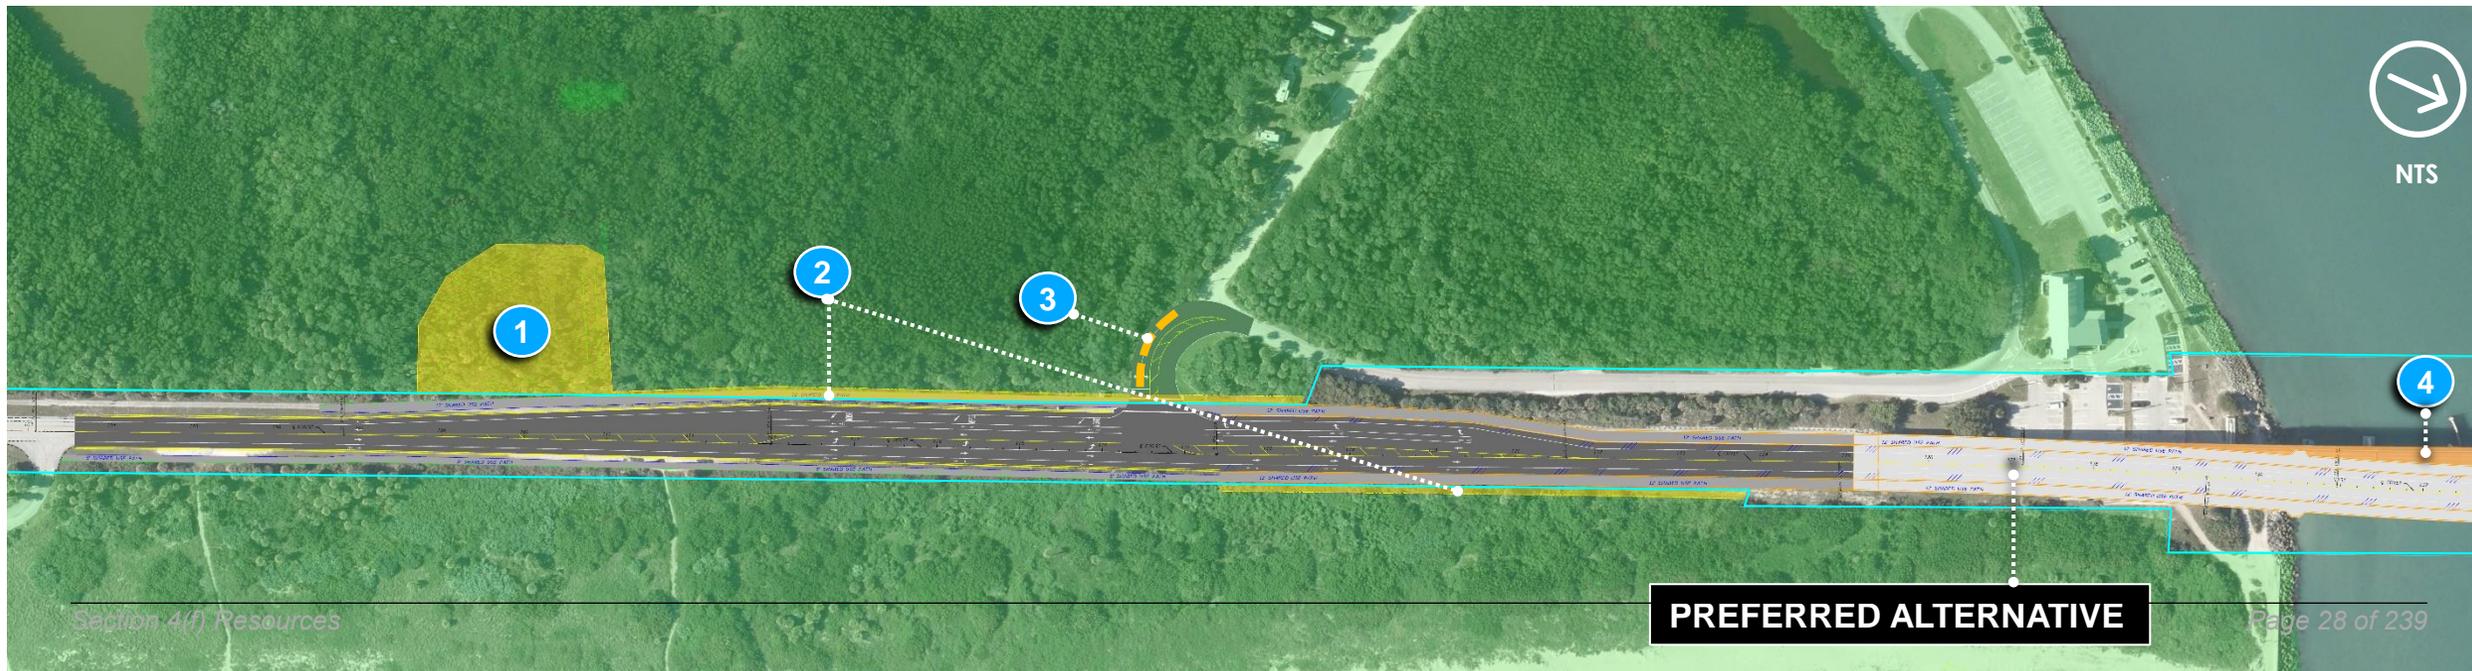
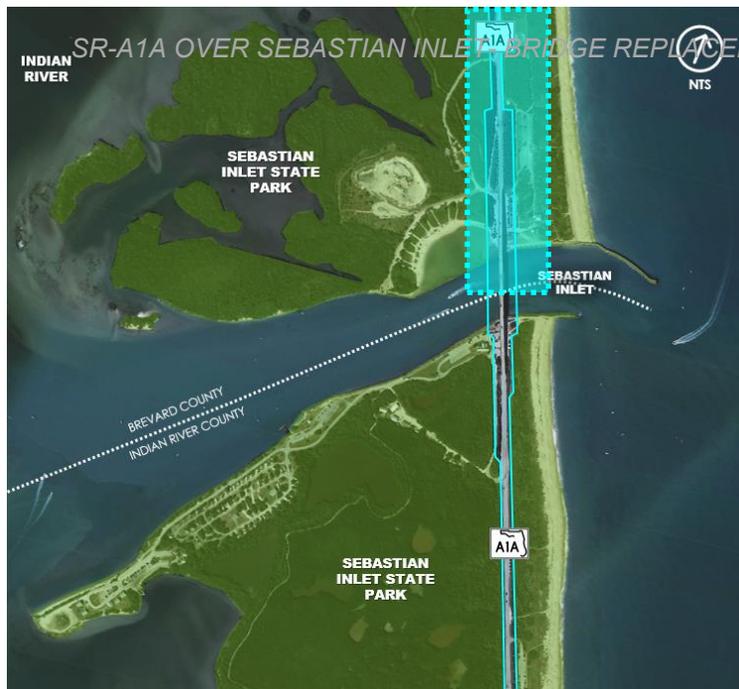
## HIGHLIGHTS OF SECTION 4(F)

- 1 South Stormwater Pond – 0.74 Acres
- 2 Clear Zone and Maintenance for Shared Use Path – 0.33 Acres
- 3 Right Turn Lane from Park Entrance – 0.08 Acres
- 4 Demolition of James H. Pruitt Memorial Bridge

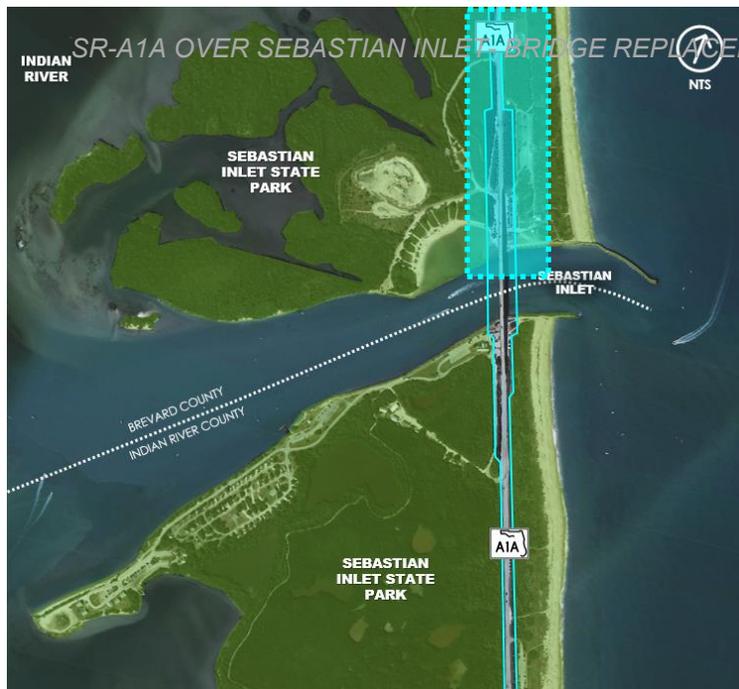
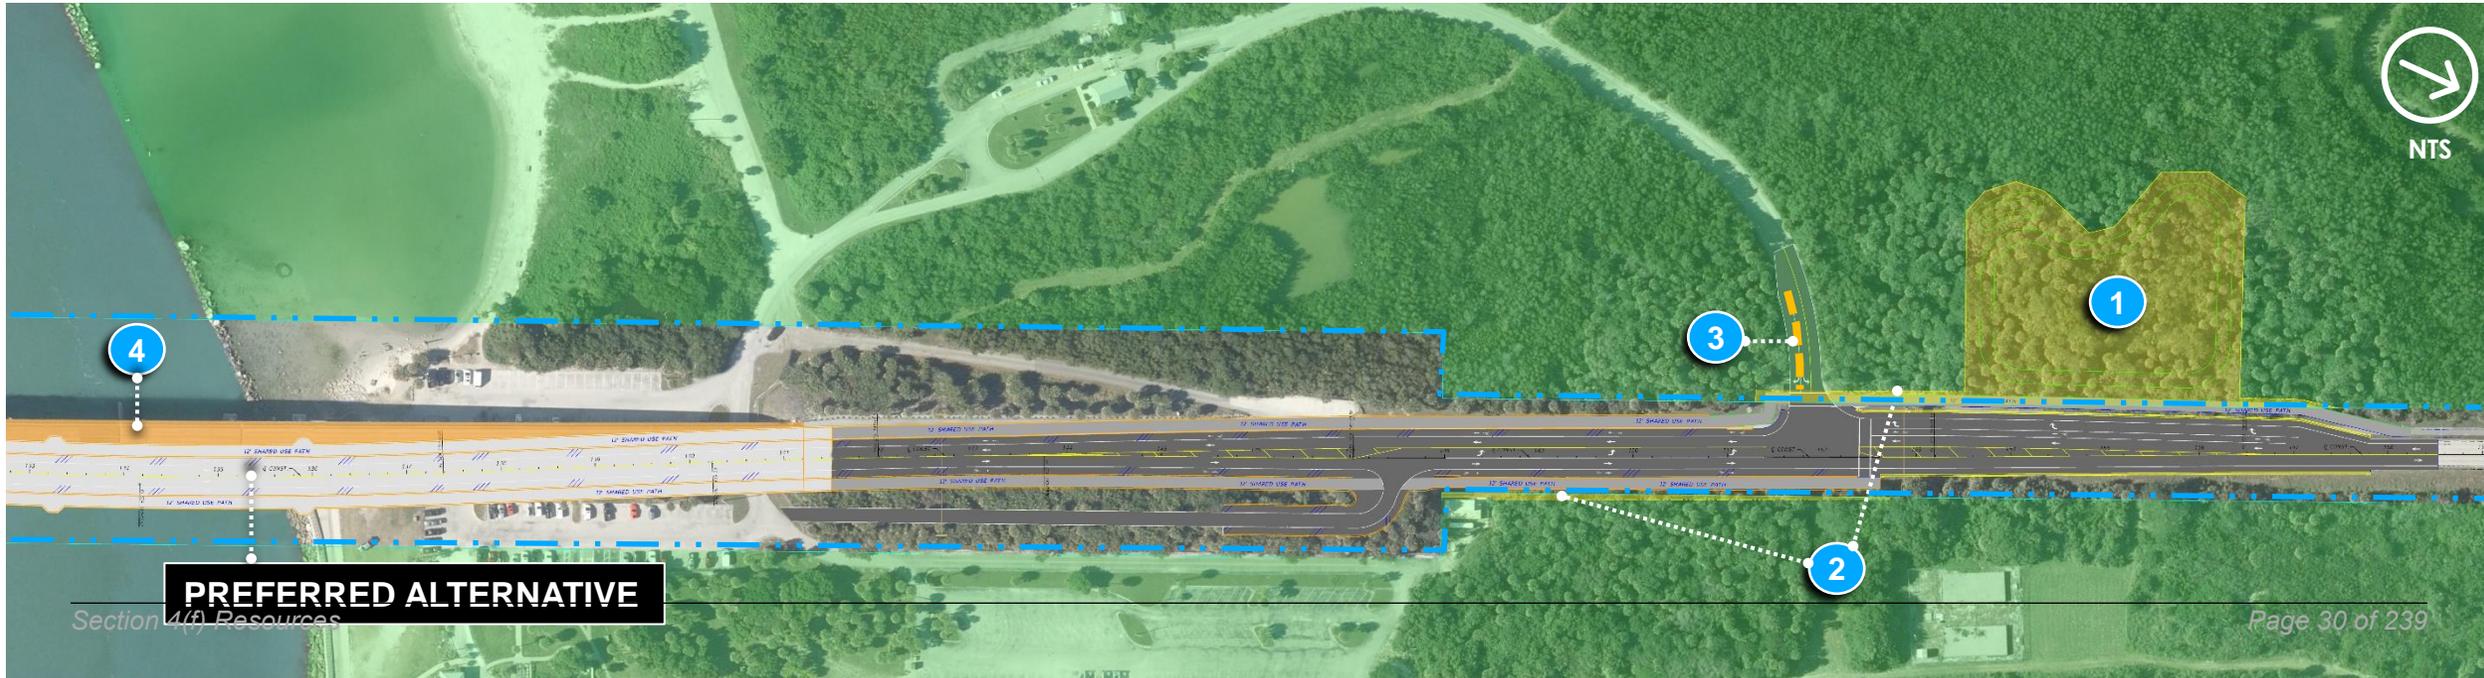
## HIGHLIGHTS OF SECTION 4(F) & SECTION 106 IMPACTS PREFERRED ALTERNATIVE North of Bridge (Brevard County)

- 1 North Stormwater Pond – 1.39 Acres
- 2 Clear Zone and Maintenance for Shared Use Path – 0.26 Acres
- 3 Right Turn Lane from Park Entrance – 0.04 Acres
- 4 Demolition of James H. Pruitt Memorial Bridge

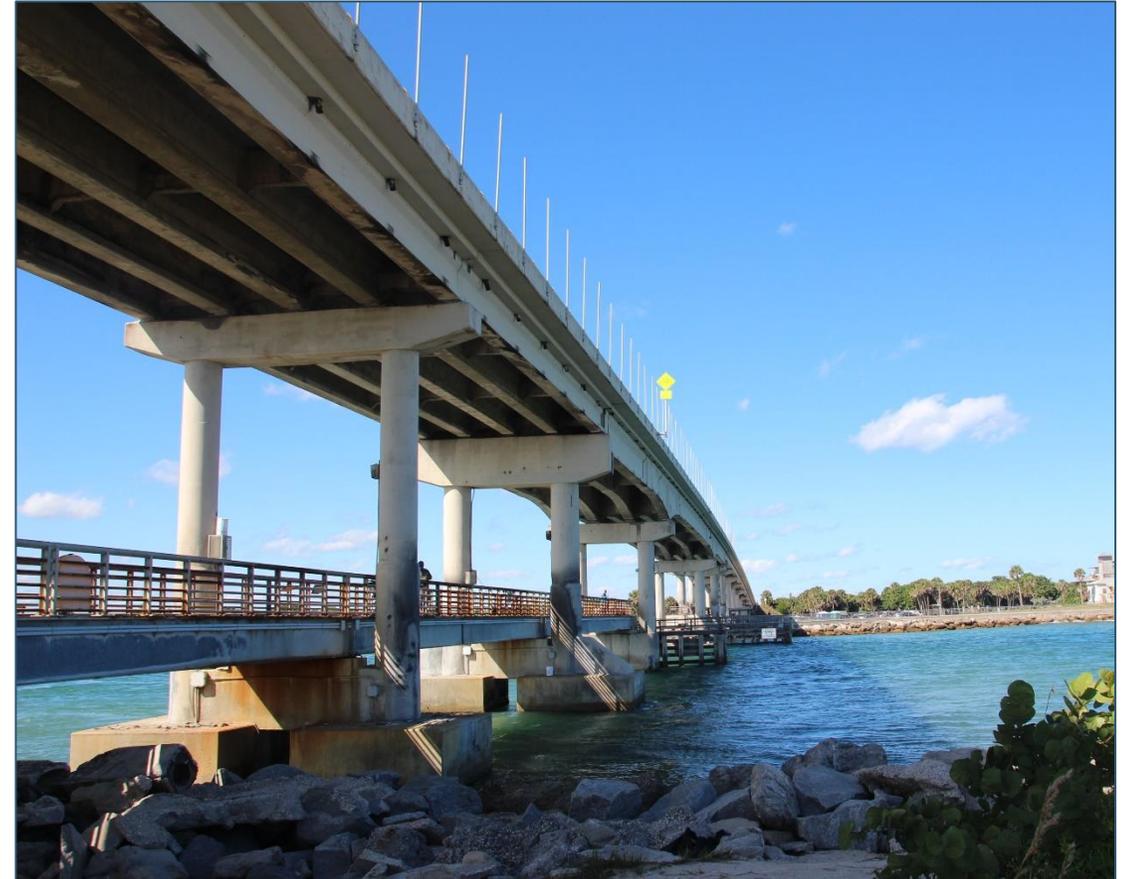
**James H. Pruitt Memorial Bridge**

- Constructed 1964
- Repaired or retrofitted – 1978 and 2003
  - Vertical clearance: 39-feet
  - Horizontal clearance: 150-feet
  - Bridge width: 34-feet 3-inches
- Observation/fishing piers under bridge deck on the north and south sides of the bridge
- November 2018 bridge inspection:
  - Bridge Health Index of 79.8
  - Per FHWA’s national bridge rating system – “structurally deficient” (This does not mean the bridge is unsafe – the rating indicates the need for repair or replacement)

Determined Eligible for Listing under **Criterion C** in the area of Engineering for its high-integrity embodiment of a prestressed concrete bridge in Florida

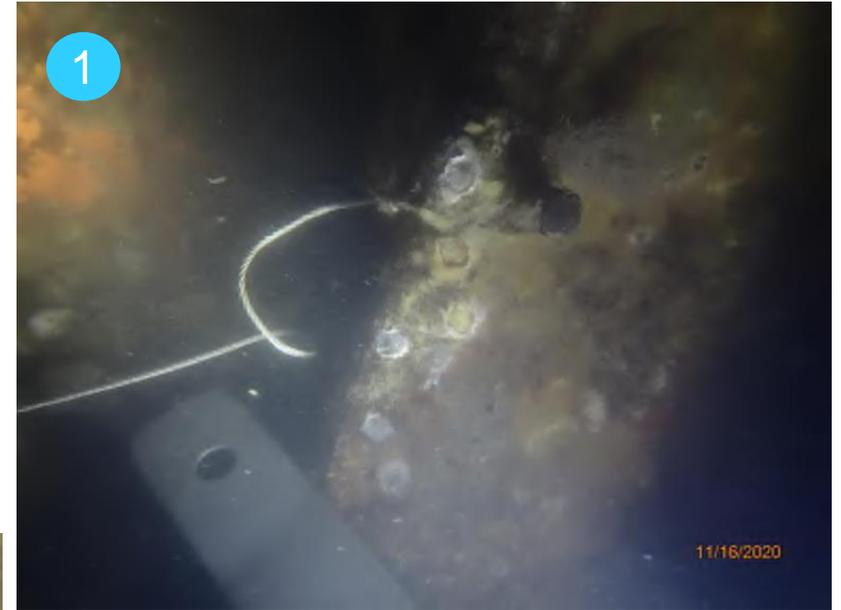
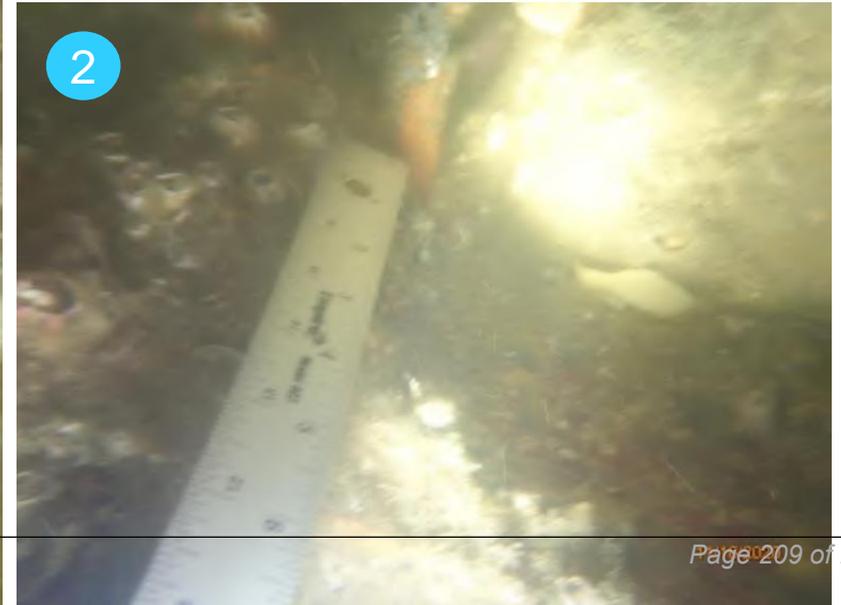
# Existing Bridge Deficiencies

1. Pile exposed with corrosion and pitting
2. Pile jacket voids
3. Pile jacket spalling

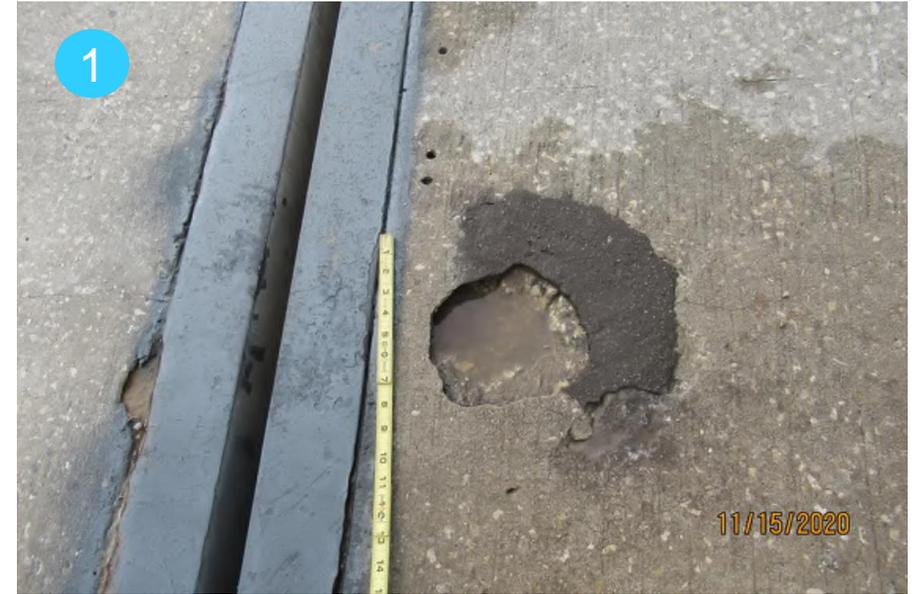
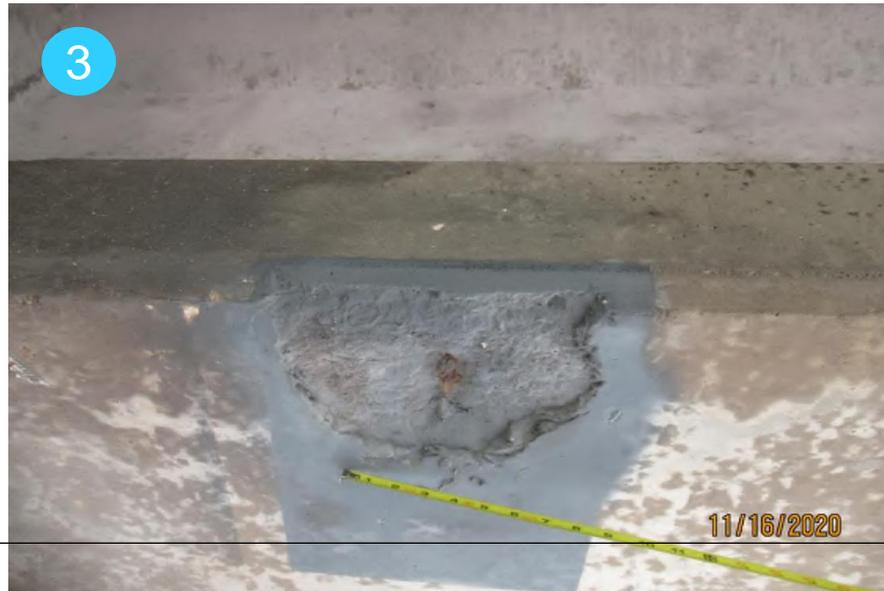
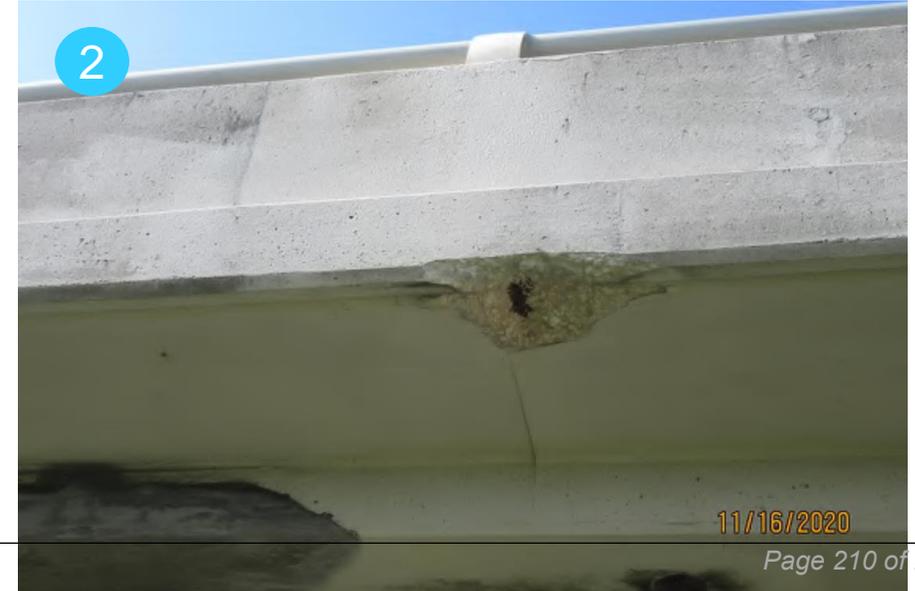
# Existing Bridge Deficiencies

1. Deck exposing steel tie back at Pier 9
2. Deck spall with exposed corroded rebar
3. Spall with exposed steel

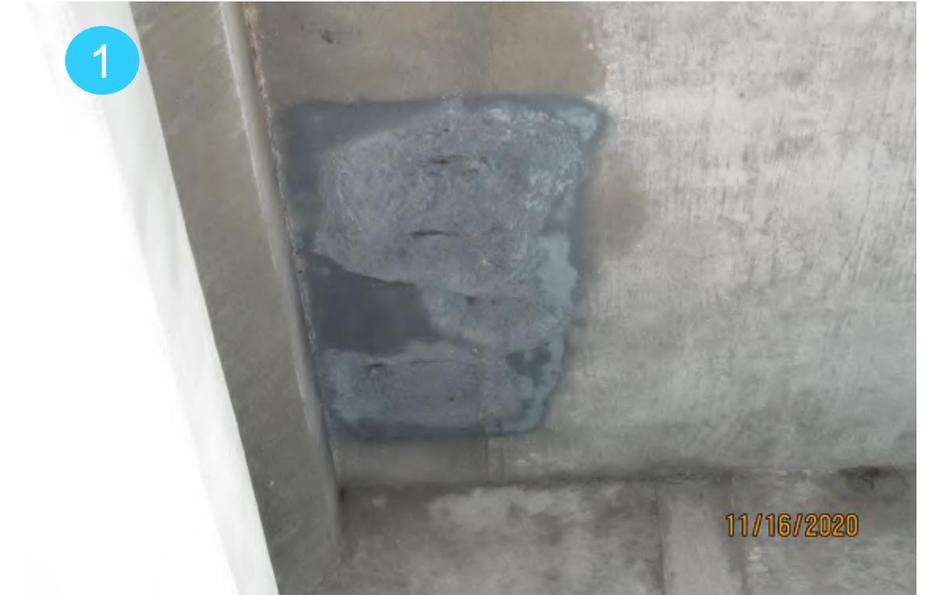
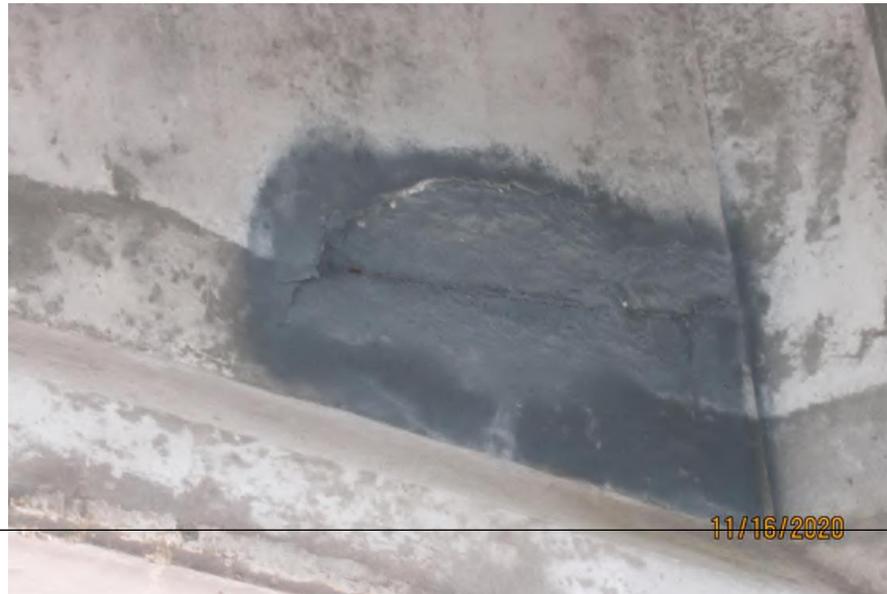
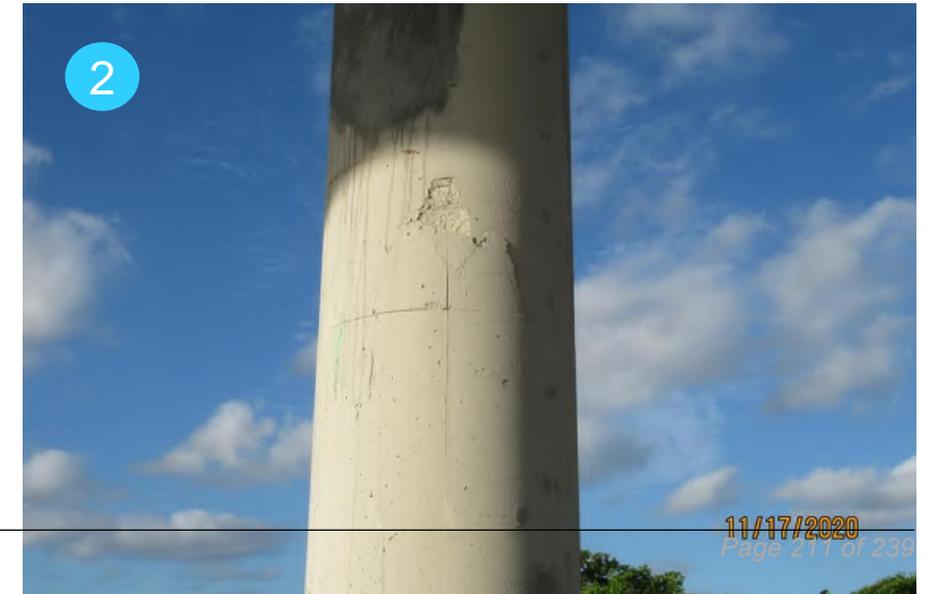
# Existing Bridge Deficiencies

1. Exposed steel, painted
2. Column spalling/delamination
3. Spall with exposed steel – concrete girder/beam

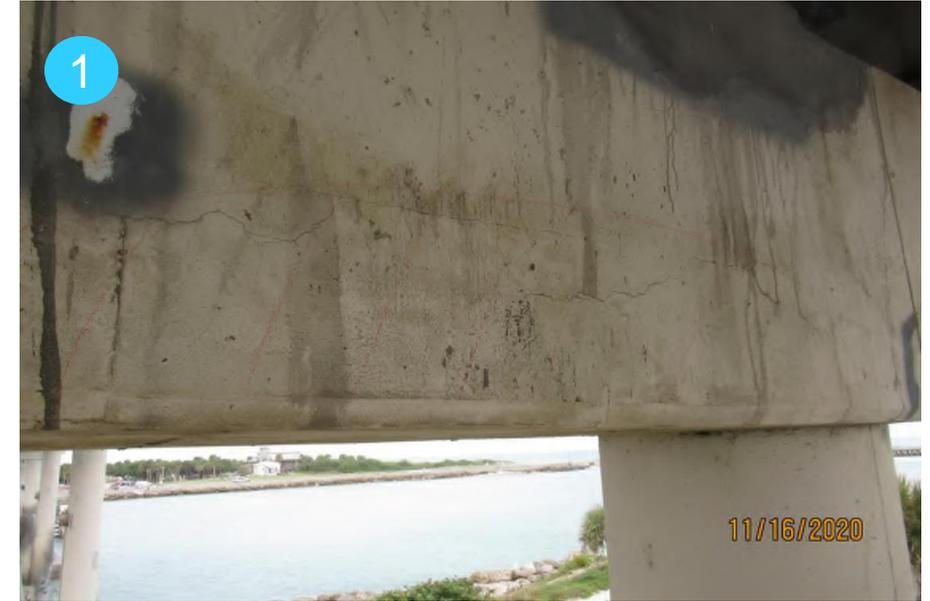
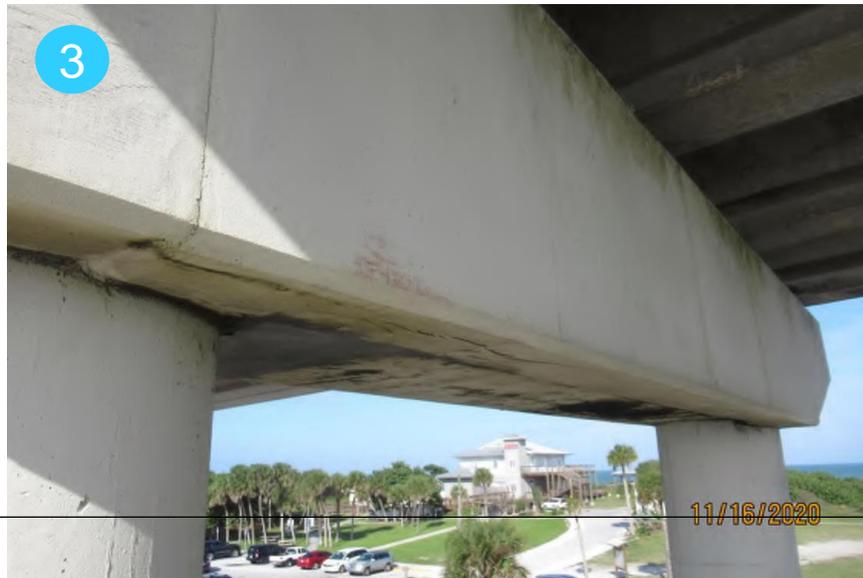
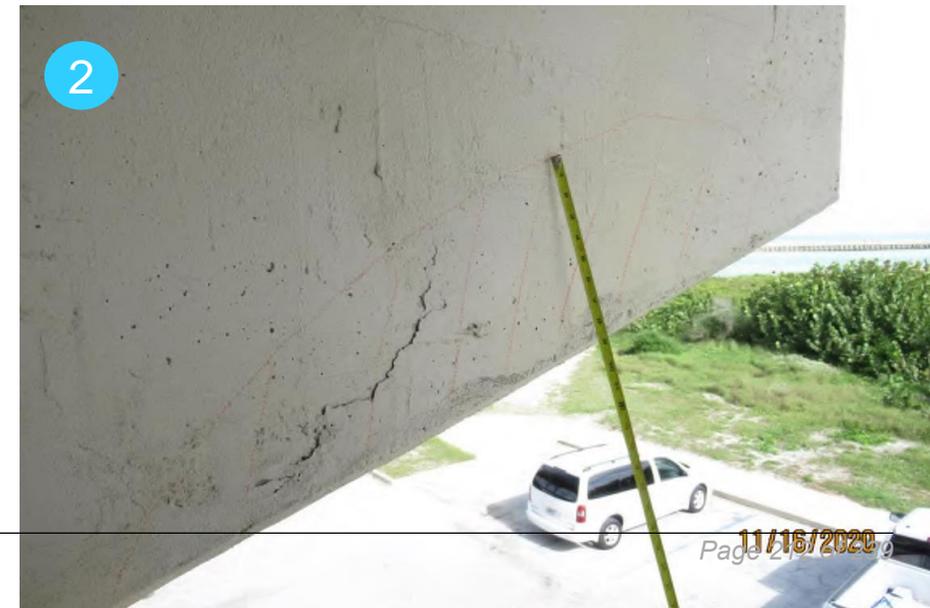
# Existing Bridge Deficiencies

1. Bridge cap delamination between columns
2. Bridge pier cap delamination
3. Bridge cap delamination bottom face

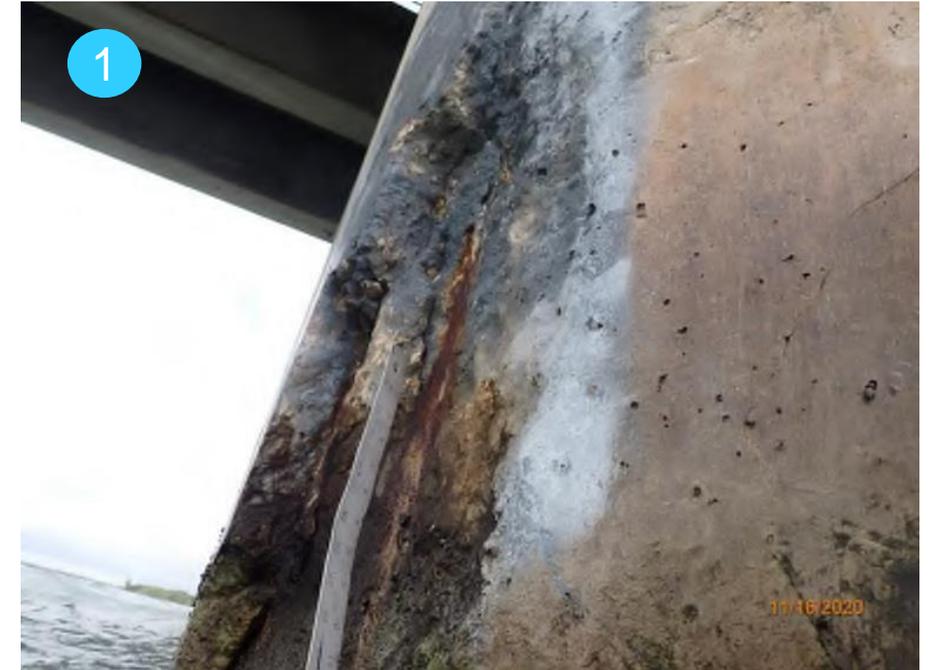
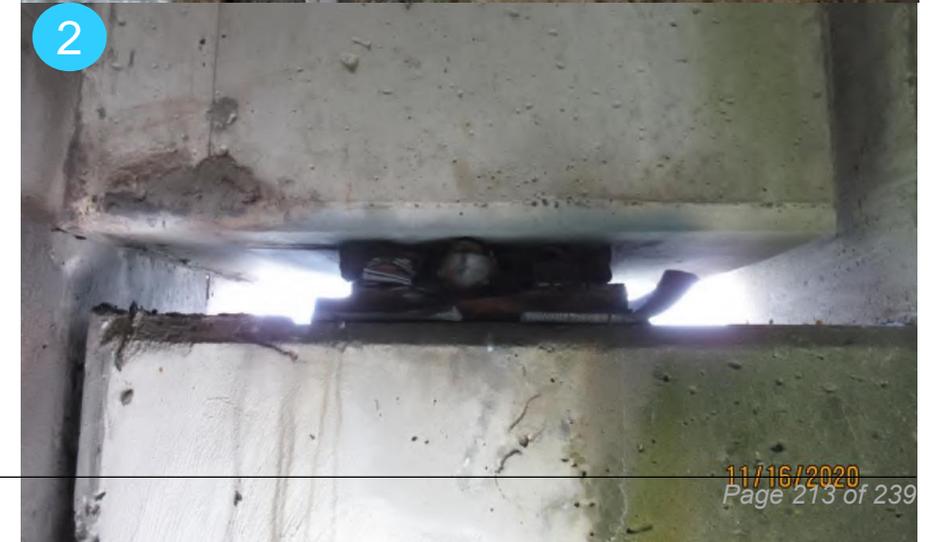
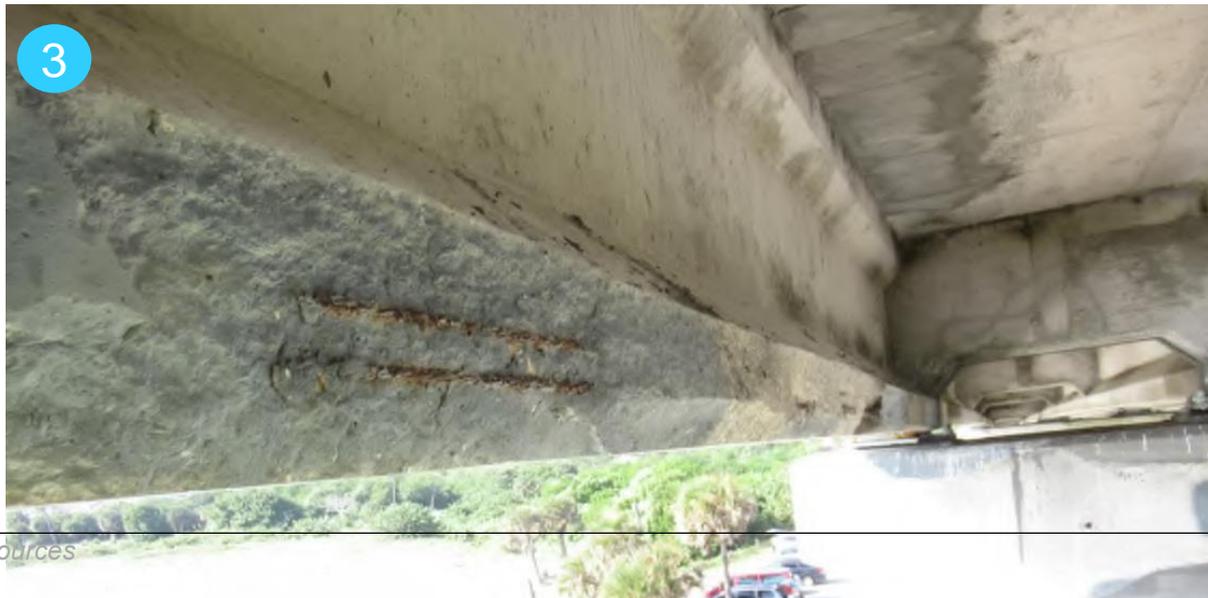
# Existing Bridge Deficiencies

1. Corrosion - Exposed Strands
2. Corrosion on bearing – cantilevered section
3. Spall/delamination of concrete girder/beam with exposed strands

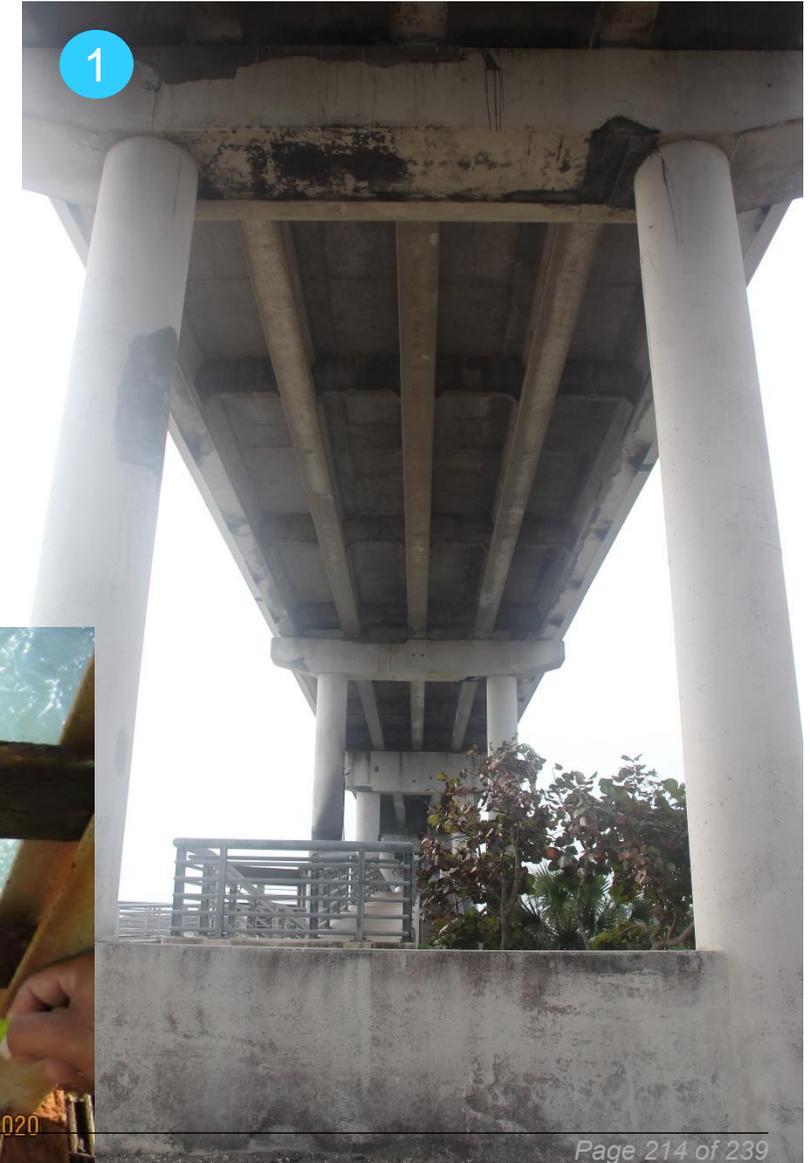
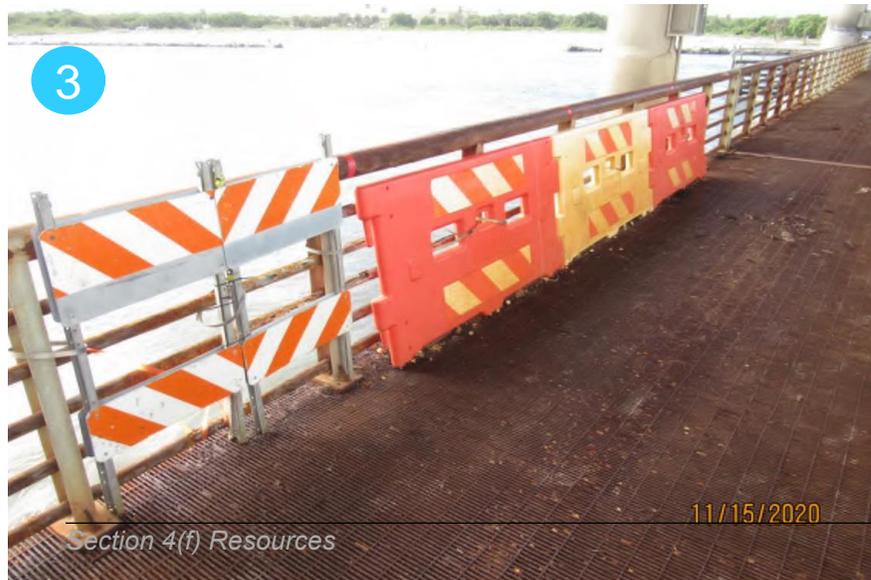
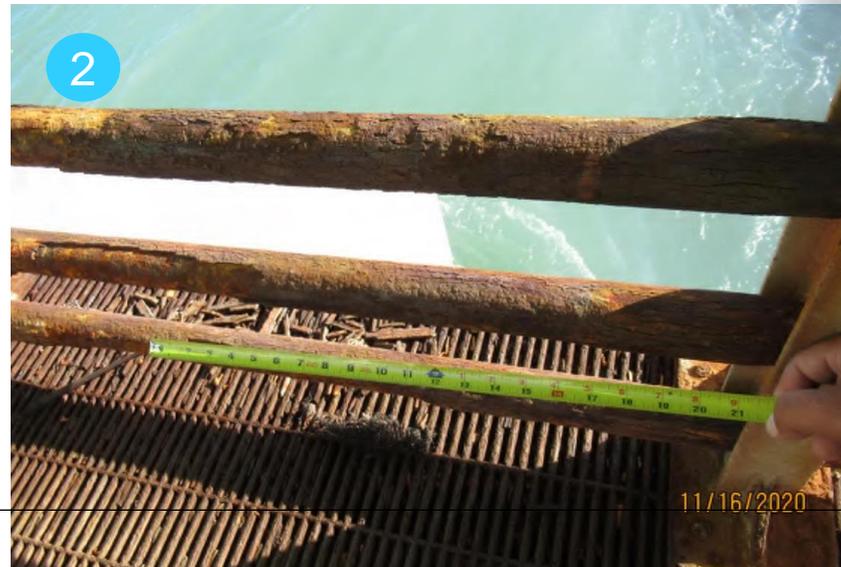
# Existing Bridge Deficiencies

1. Bridge delamination and spalling
2. Corrosion on under bridge fishing pier railing and deck
3. Corrosion on under bridge fishing pier

- Concrete spalling of bridge deck, columns, girders/beams
- Concrete delamination of bridge cap, pier cap
- Steel corrosion - exposed strands, rebar, bearing cantilevered section, girders/beams

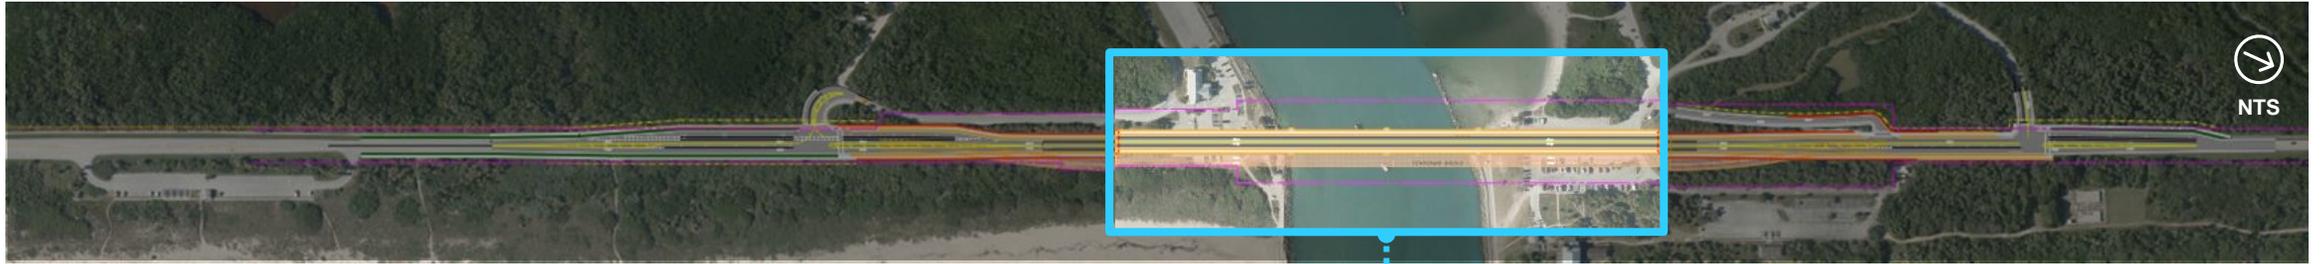
# Viabile Build Alternative 1: Existing Alignment with Temporary Bridge

- EXISTING R/W
- PROPOSED R/W
- ASPHALT PAVEMENT
- SHOULDER
- SHARED USE PATH
- TRAFFIC SEPARATOR
- MSE WALL
- GRASS
- TEMPORARY BRIDGE

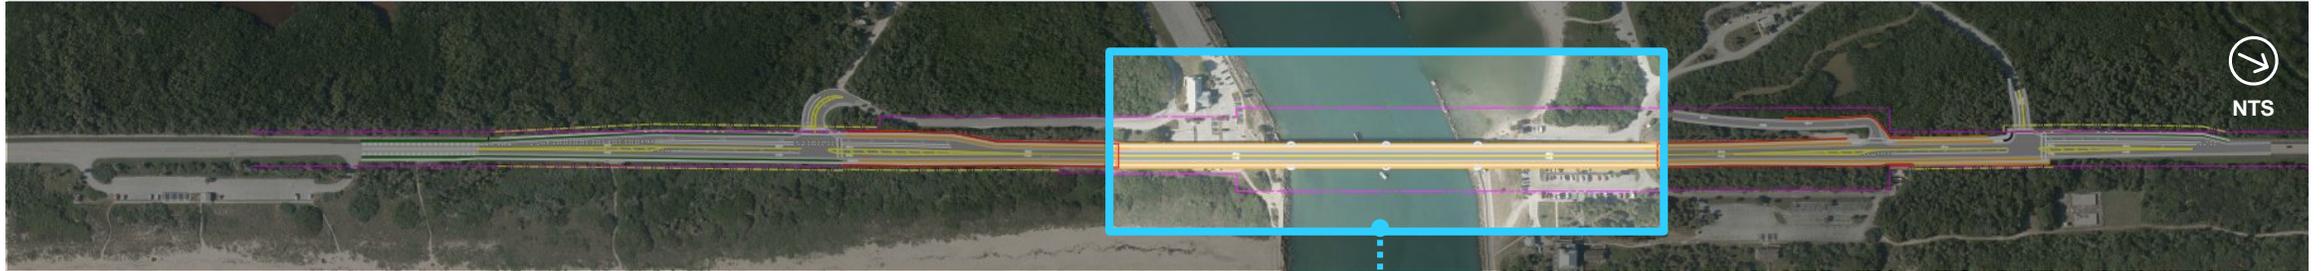
# Viabile Build Alternative 2: East Alignment

- EXISTING R/W
- PROPOSED R/W
- ASPHALT PAVEMENT
- SHOULDER
- SHARED USE PATH
- TRAFFIC SEPARATOR
- MSE WALL
- GRASS
