## Technical Memorandum

To: FDOT/District 7, Freight Coordinator (Brian Hunter)

Re: Public Rest Area Truck Parking

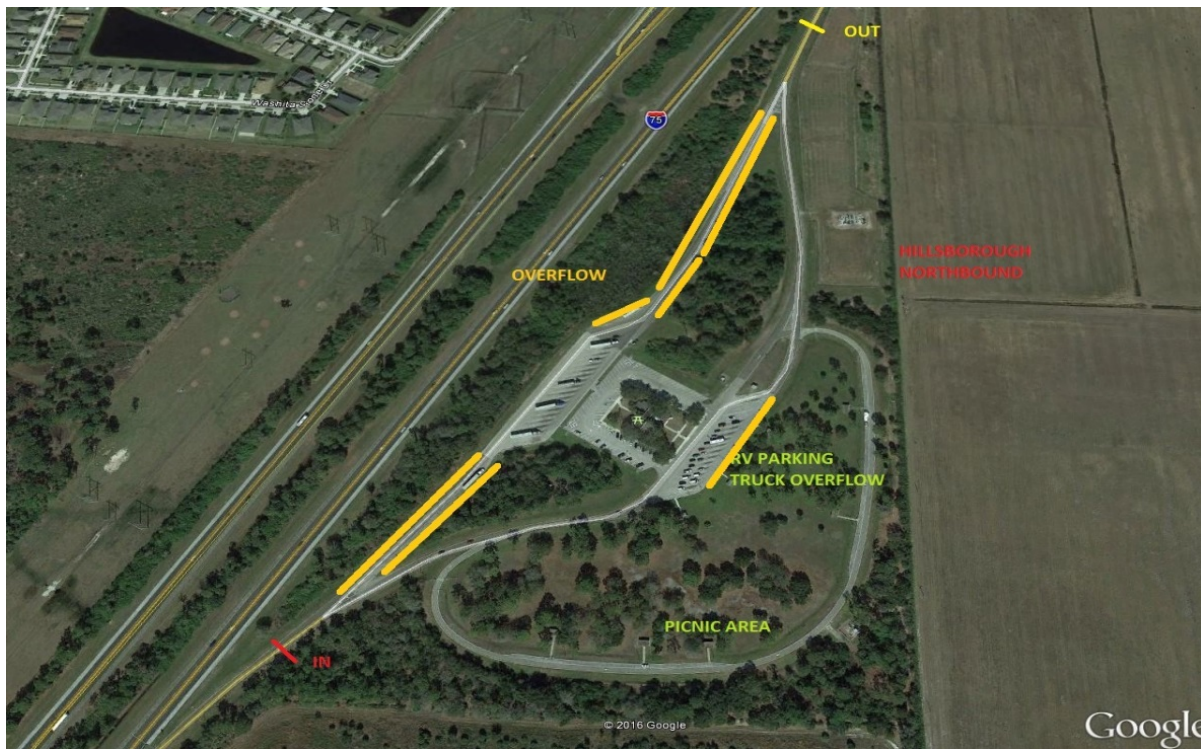
**FIGURE 1  
NORTHBOUND HILLSBOROUGH REST AREA OVERFLOW PARKING**

Both graphs show a clear pattern of limited to overcapacity parking between the hours of approximately 8:00 p.m. and 8:00 a.m. (shown in red). The blue lines show the number of available large vehicle parking slots during the various time periods. Note that the maximum number of available large vehicle spaces in this rest area is 36 even though the graphs might indicate more availability. The excesses are due to counting errors that affected the totals. Except for a lengthy period of time from mid Tuesday morning to later that evening, the truck parking was at or above capacity for the 19 available spaces. As a result, some trucks were probably parked in the RV area and others were parked on the inbound and outbound shoulders as shown on **Figure 1**.

On 12/1/2016 this rest area was visited at approximately 6:00 a.m. in order to validate parking overages and determine where the trucks were illegally parked. At that time 54 trucks were counted within the rest area and on the inbound and outbound shoulders within the truck parking area as shown in **Figure 1** above. The available truck spaces were exceeded by 35 vehicles and the total large vehicle parking was exceeded by 18 vehicles.

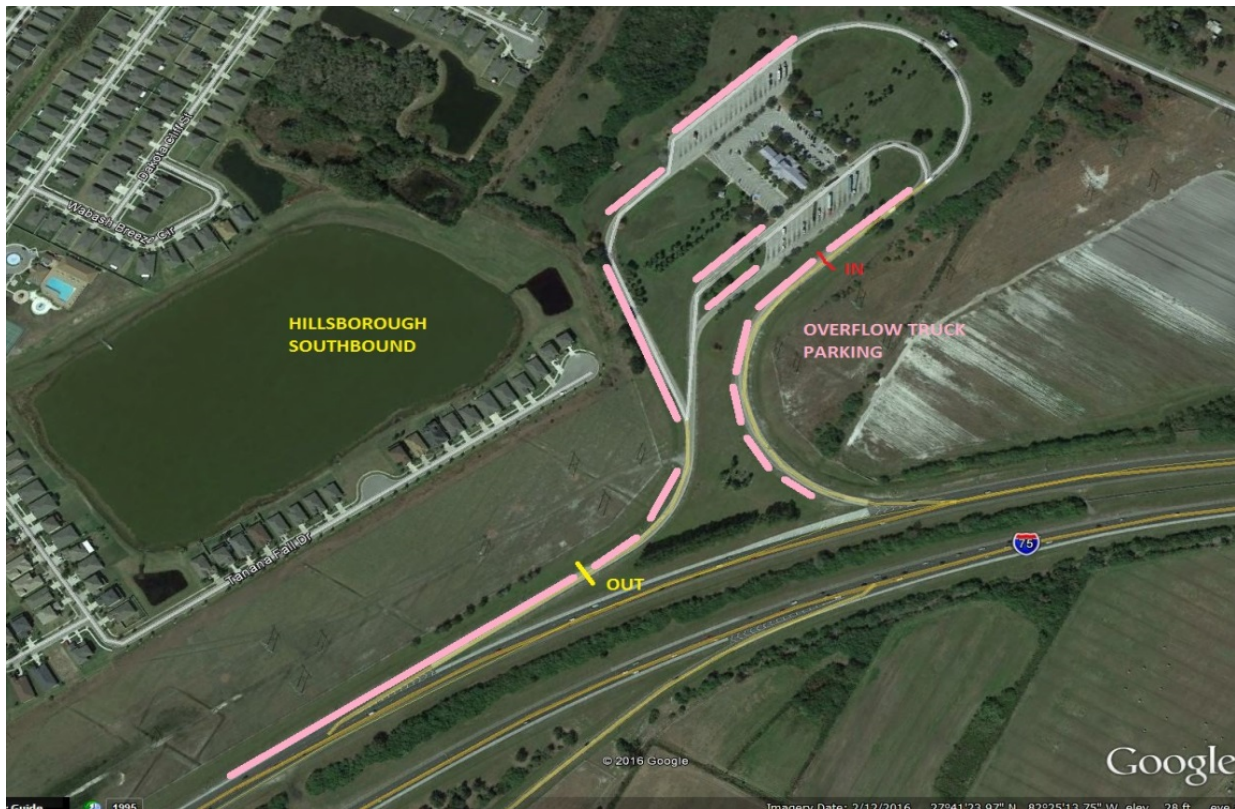
**FIGURE 2  
SOUTHBOUND HILLSBOROUGH REST AREA OVERFLOW PARKING**

The field team noted several trucks parked on the inbound shoulder within the rest area at the time of tube deployment (11/14/2016 between 10:50 a.m. - 11:10 a.m.), even though there appeared to be several open spaces in the truck parking area. The assumption is that these trucks arrived in the early morning hours when the lot was full and remained for their required rest period after the usual morning departures. The day the count tubes were retrieved, there were still trucks parked on the shoulder as far south as the merge lane to SB I-75 (11/17/2016 from 8:10 a.m. - 8:30 a.m.). Note that there is a lot more available shoulder parking in the Southbound rest area than in the Northbound area (**Figure 2**).

A visit on 12/1/2016 at 5:40 a.m. revealed 71 trucks parked in available spaces along the inbound and outbound ramps, along the back shoulder of the RV parking area, and on the exit ramps to SB I-75. The total trucks exceeded all the available large vehicle parking by 30 vehicles.

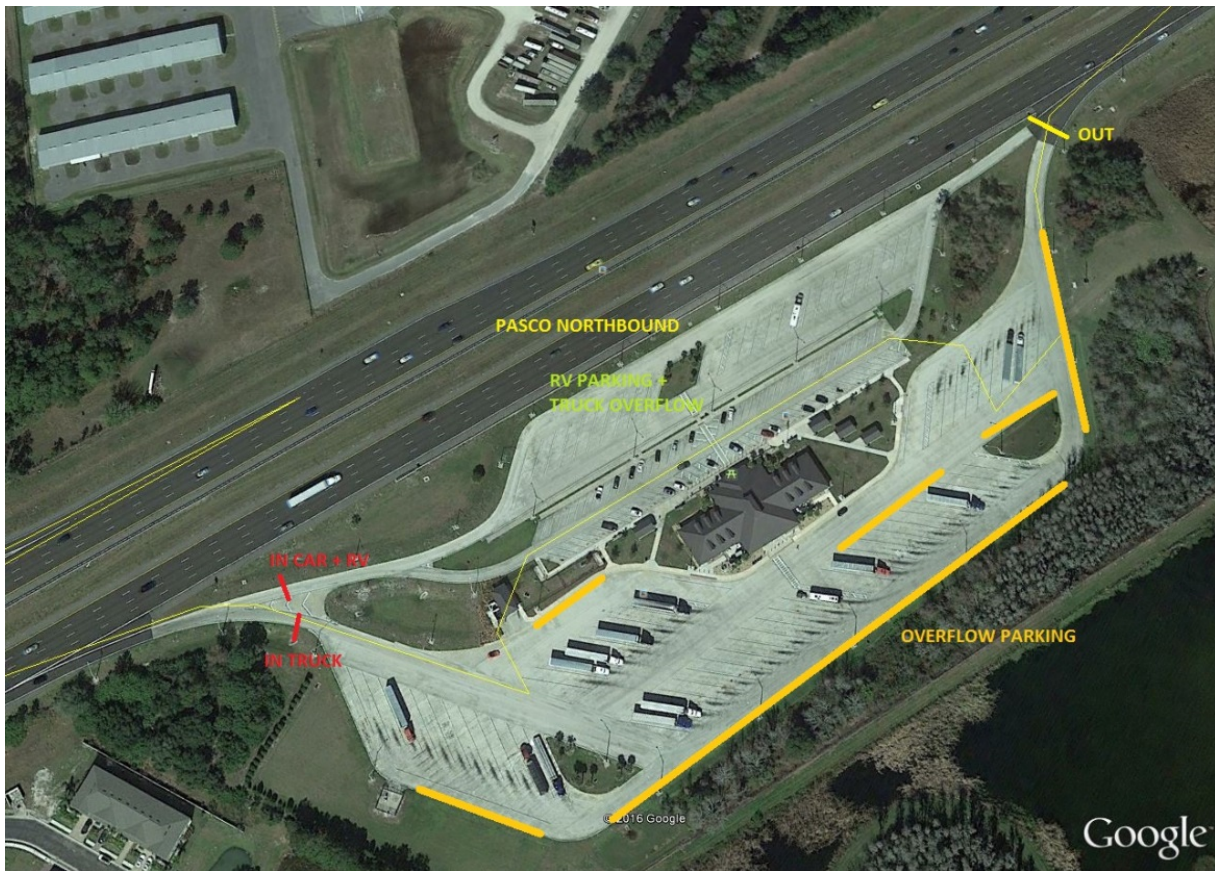
**FIGURE 3  
NORTHBOUND I-75 PASCO REST AREA OVERFLOW PARKING**

and an additional 26 spaces for RVs for a total large vehicle capacity of 83 spaces. **Attachment 5** shows that even with this number of parking spaces, capacity is routinely exceeded. However, unlike the Hillsborough rest areas, the overcapacity periods were from the late afternoon to early morning. During the count period, there appears to be a small anomaly from Tuesday evening to Wednesday morning where the lot was crowded but capacity was not exceeded. Static counts taken at the time of counter deployment and pick up both during the late morning were 20 and 37, respectively. **Figure 3** shows where the overflow parking occurs in addition to the RV spaces.

Additional visits were made on 12/6/2016 at 5:15 a.m. and on 12/28/2016 at 10:30 p.m. During the first visit, the truck lot was not full (38 vehicles). However, a maintenance worker interviewed in the rest area stated that the truck parking is completely full by 2 a.m. daily. The second visit resulted in a truck count of 69 vehicles. Within the truck-only area, four trucks were illegally parked in back of the trucks occupying legal spaces and one truck was parked in the deceleration lane about two-hundred feet from the entrance. The remaining seven trucks were parked in the RV area.

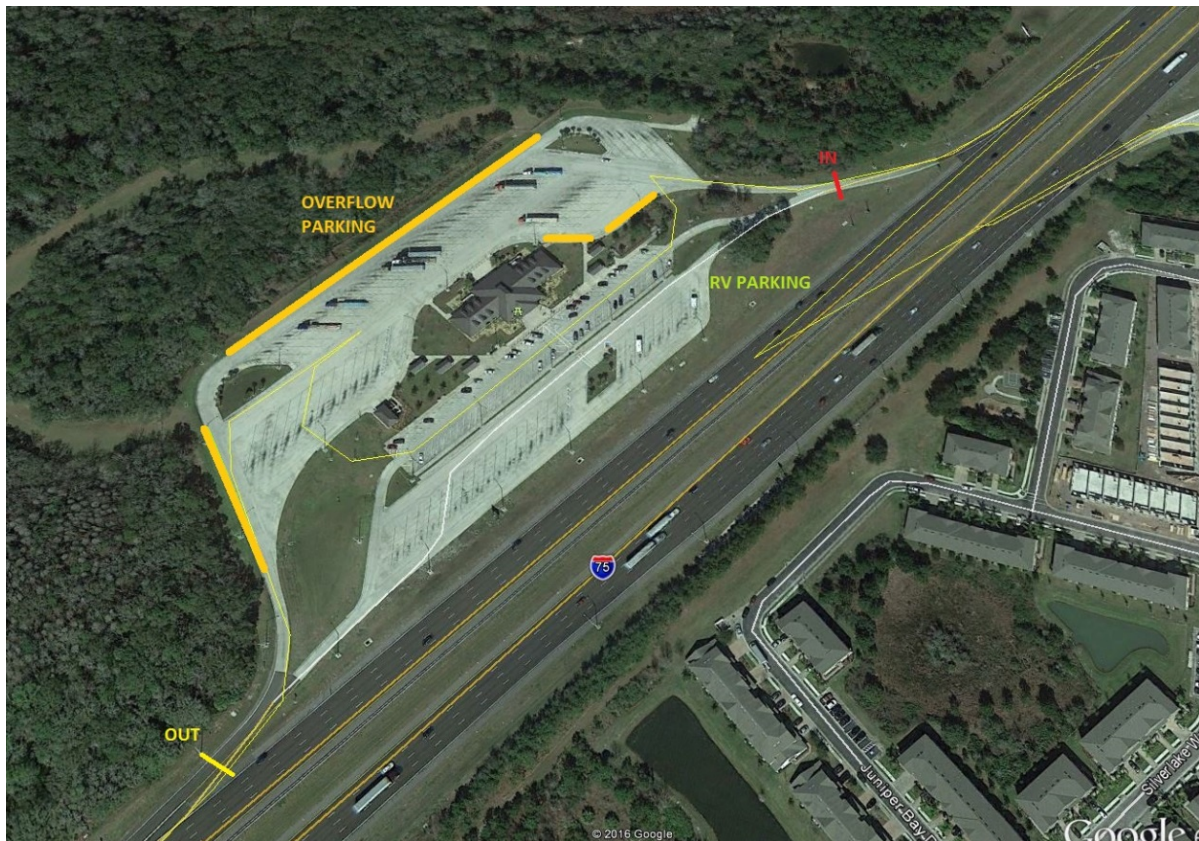
**FIGURE 4**  
**SOUTHBOUND I-75 PASCO REST AREA OVERFLOW PARKING**

pattern for illegally parked vehicles appears to follow a regular pattern from approximately 8:00 p.m. to 8:00 a.m.; however, there was a counting error introduced in the Southbound Pasco rest area where the inbound counts were higher than the outbound, which compounded as the time period progressed. For this reason, graphics of the Southbound truck parking are not presented. Also, the Southbound counts were conducted on a different set of days than the counts at the other Southbound rest areas. This was due to a hose failure during the original counts. The Southbound Pasco rest area shows a similar pattern to that of the Northbound rest area with overflows occurring between early evening and early morning the following day. From mid-morning to mid-afternoon there are plenty of truck spaces available. **Figure 4** shows where most of the overflow parking occurs in addition to the RV spaces.

The rest area was visited on 11/28/2016 at 11:15 p.m. and on 12/6/2016 at 5:35 a.m. to validate the excessive truck parking indicated during the count period. During the first visit, there were 58 trucks parked within the rest area including three parked parallel behind the legally parked trucks, three on the shoulder, and one on the shoulder south of the southbound merge lane to I-75. At the time of the second visit, 70 trucks were parked within the rest area including 12 parked in the RV area, five parked parallel behind the legally parked trucks, one on the shoulder, and one on the main line merge shoulder.

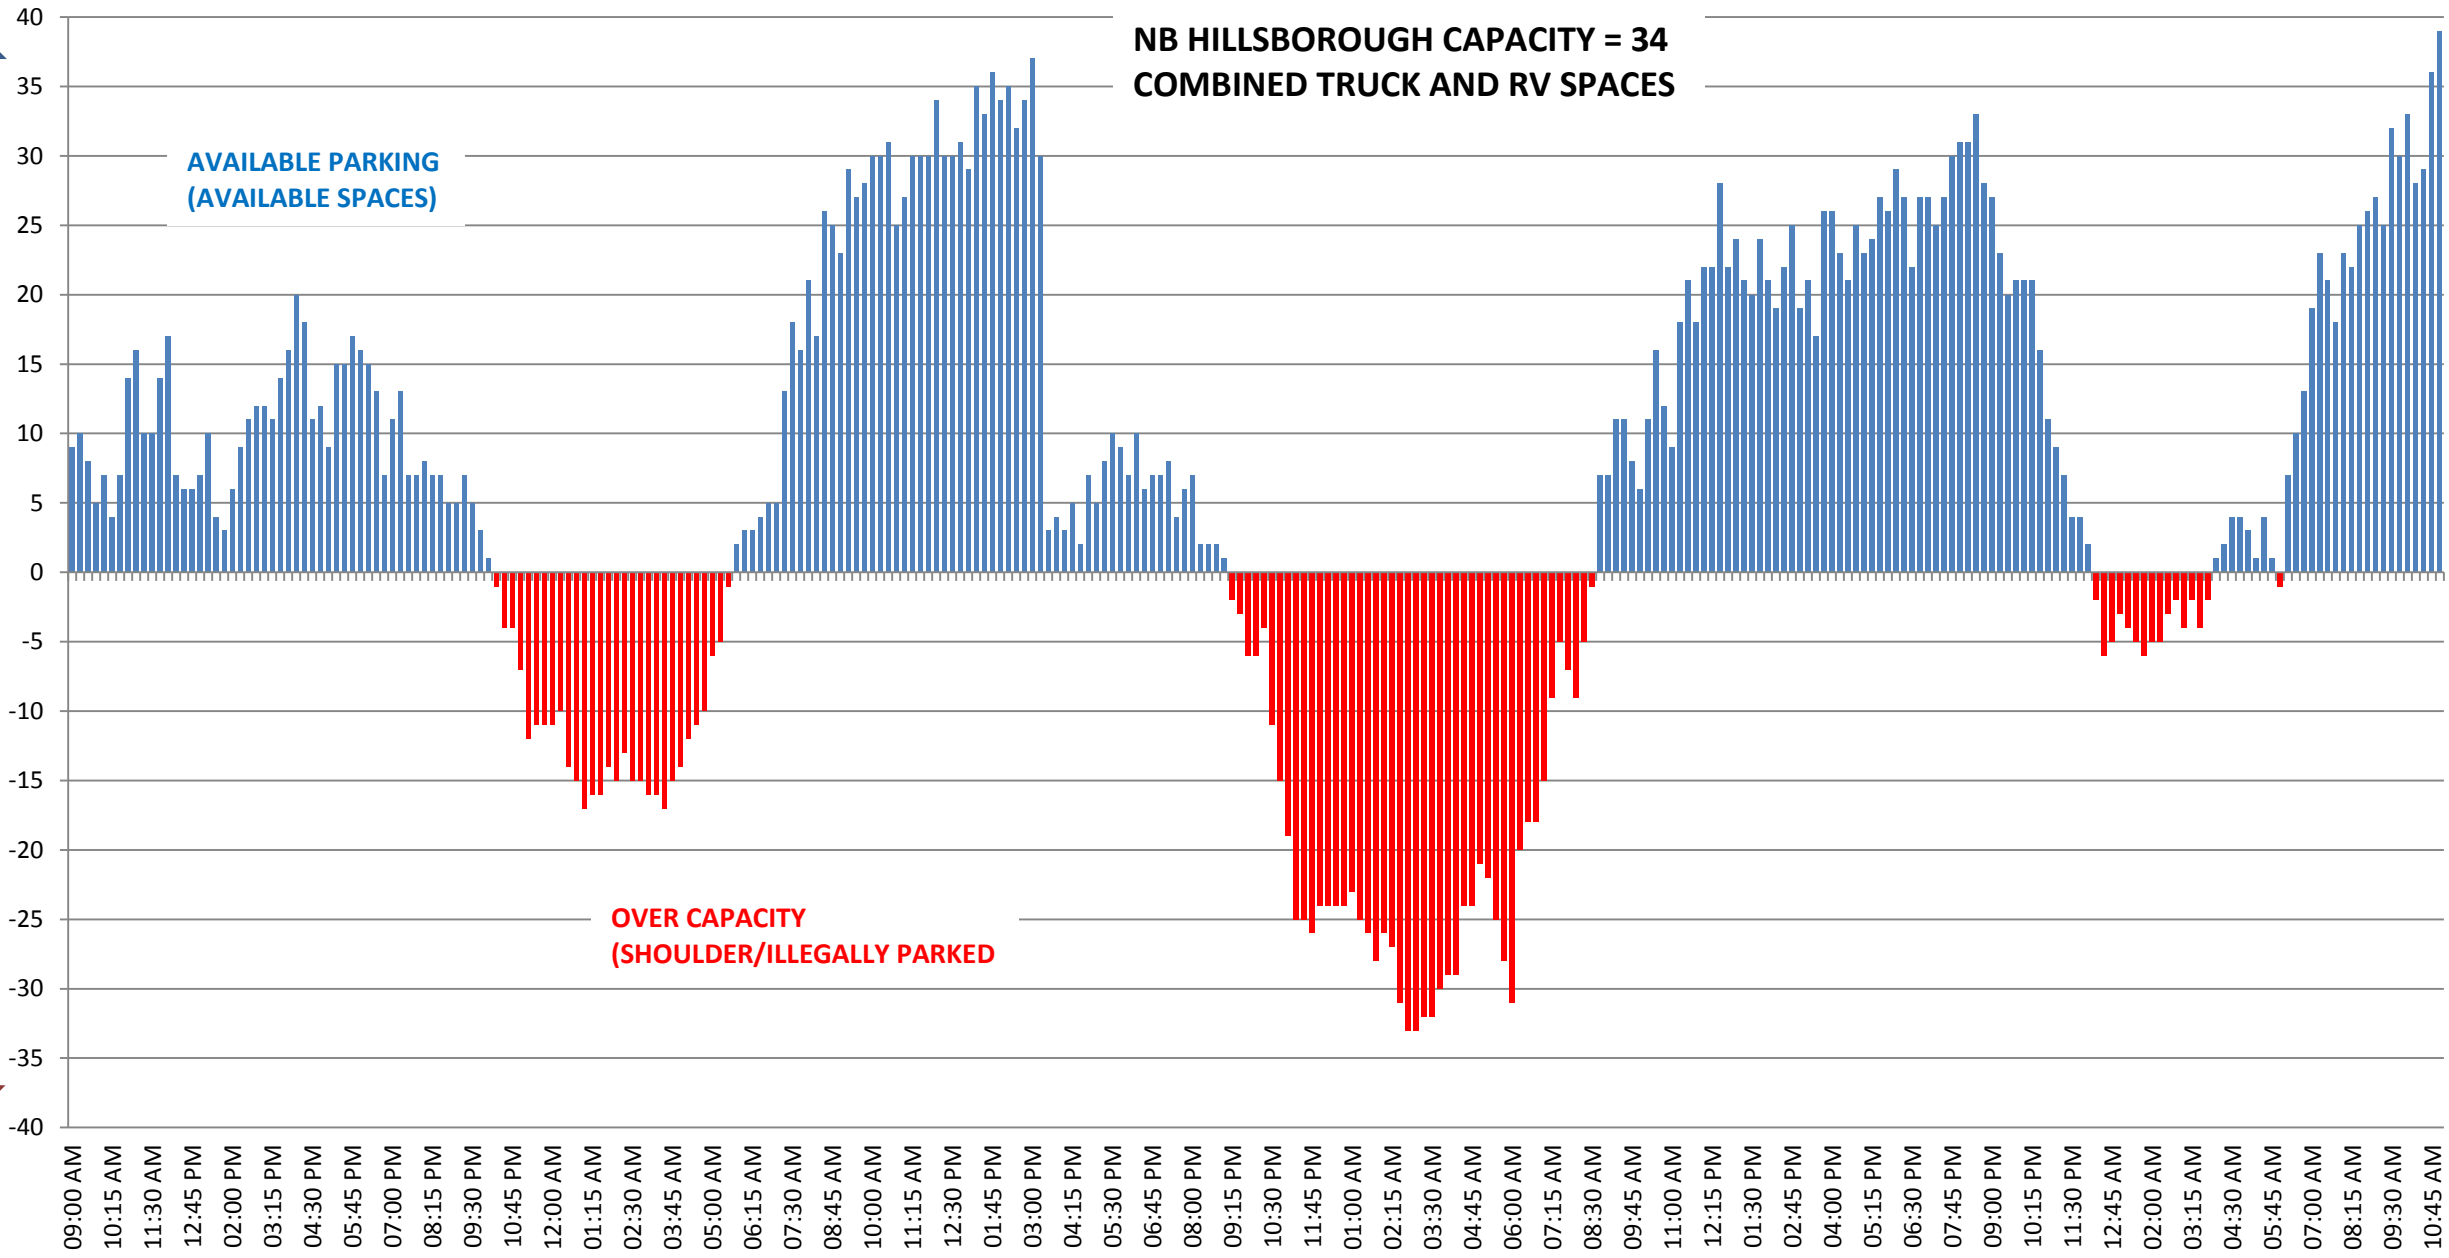
# NORTHBOUND HILLSBOROUGH REST STOP

The Hillsborough northbound rest area is located approximately 3 miles south of SR 674 (Sun City Center Blvd). There are two graphs located in **Attachment 3**. The first includes both the truck-only plus RV spaces, and the second shows the truck-only spaces.

NB HILLSBOROUGH CAPACITY = 34  
COMBINED TRUCK AND RV SPACES

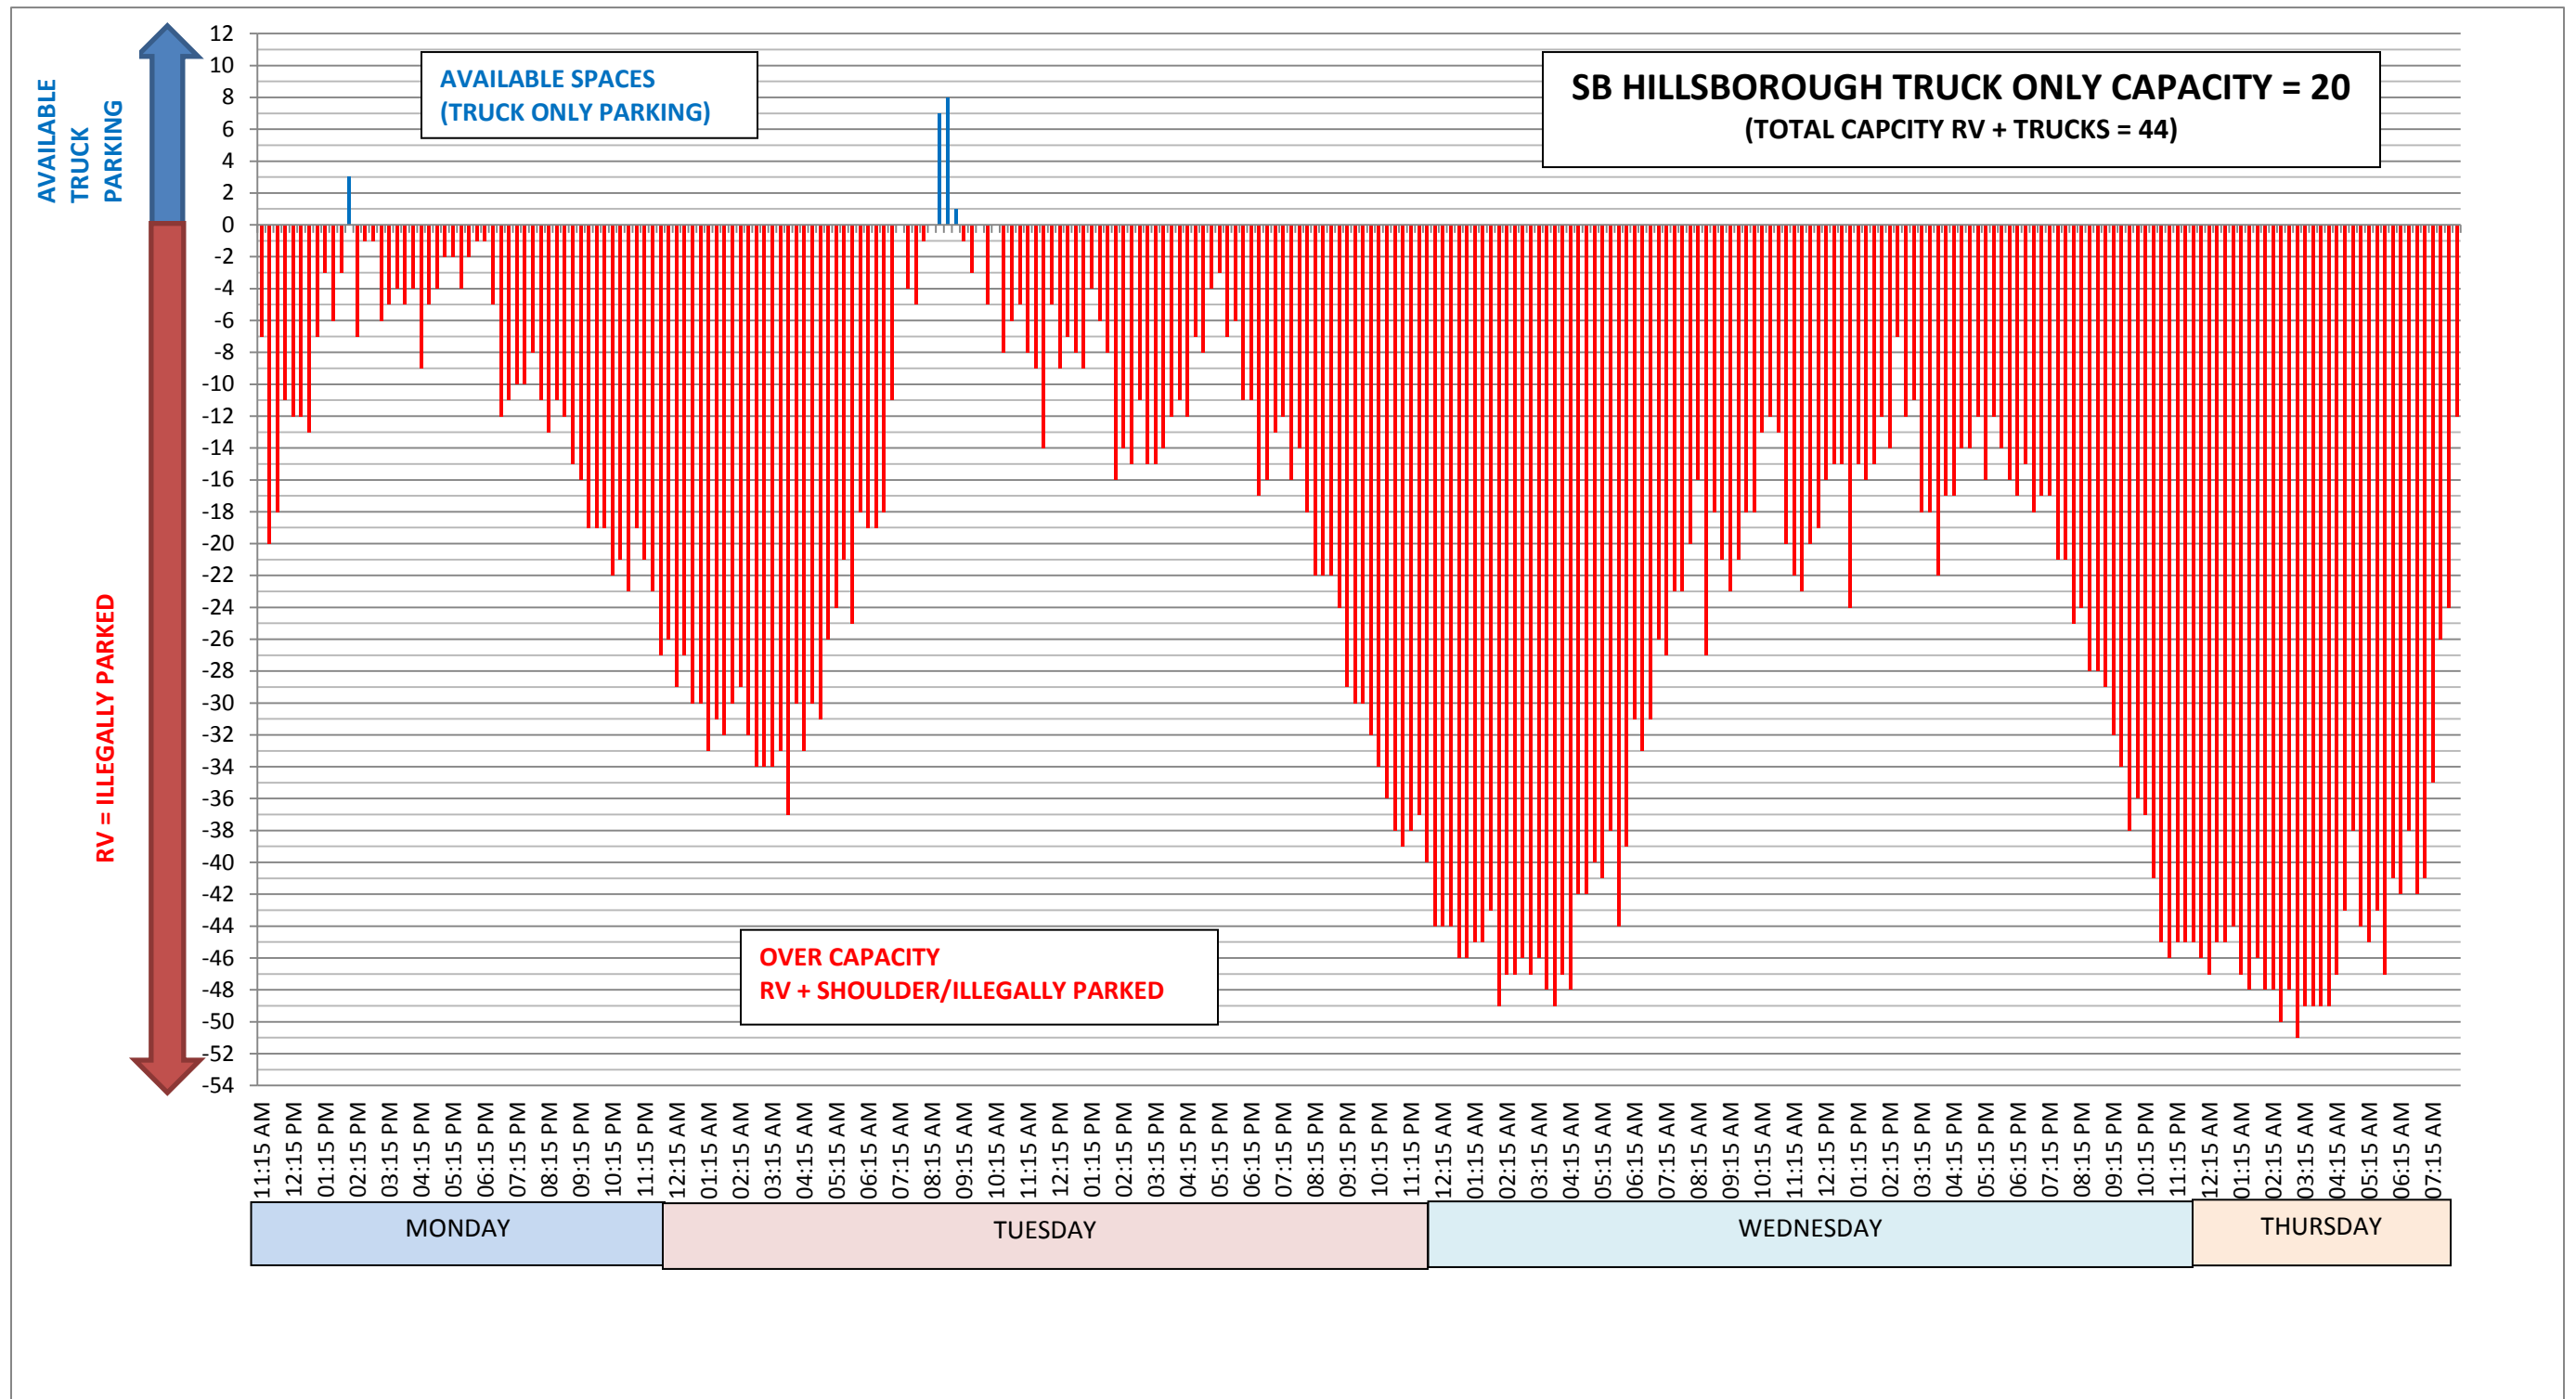
# SOUTHBOUND HILLSBOROUGH TRUCK ONLY PARKING

The Hillsborough Southbound rest area is located approximately 2.5 miles south of SR 674. The two graphs associated with this rest area are shown in **Attachment 4**. Both the large vehicle parking and the truck-only parking graphs show a similar pattern to the Hillsborough Northbound rest area with overcapacity parking during the late evening to early morning hours and a large amount of spaces available during the daytime hours. However, the truck-only graph shows a much different story than

the Northbound rest area, with trucks exceeding the available truck spaces throughout the entire day especially during the heavy use hours. The worst case conditions suggest that trucks exceeded all available parking by as many as 30 trucks.
