**EVALUATION OF PATCHING MATERIALS AND PLACEMENT  
TECHNIQUES FOR RIGID PAVEMENTS AND BRIDGE DECKS**

**FINAL REPORT**

**Florida Department of Transportation  
(BB452-WPI 0510861)**

**September 1999**

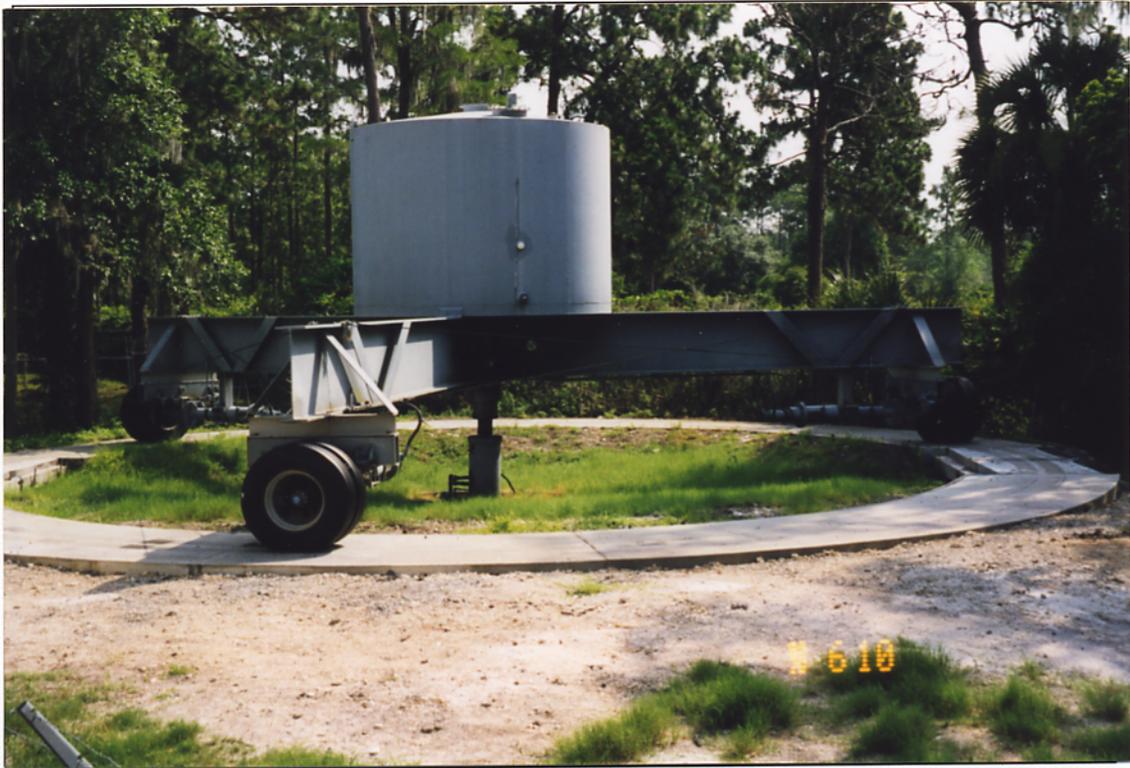
**PHOTOGRAPH 1. University of Central Florida Circular Accelerated Test Track**

The University of Central Florida (UCF) tackled the task of researching for quality patching materials to test the performance for the rehabilitation of potholes and spalls on concrete pavements as a project funded by the Florida Department of Transportation (FDOT). UCF was also responsible for new guidelines in laboratory testing and material placement techniques, so appropriate materials can effectively be used in field application. The performance of the patching materials was tested at UCF and its Circular Accelerated Test Track (CATT) facility (Photograph 1).

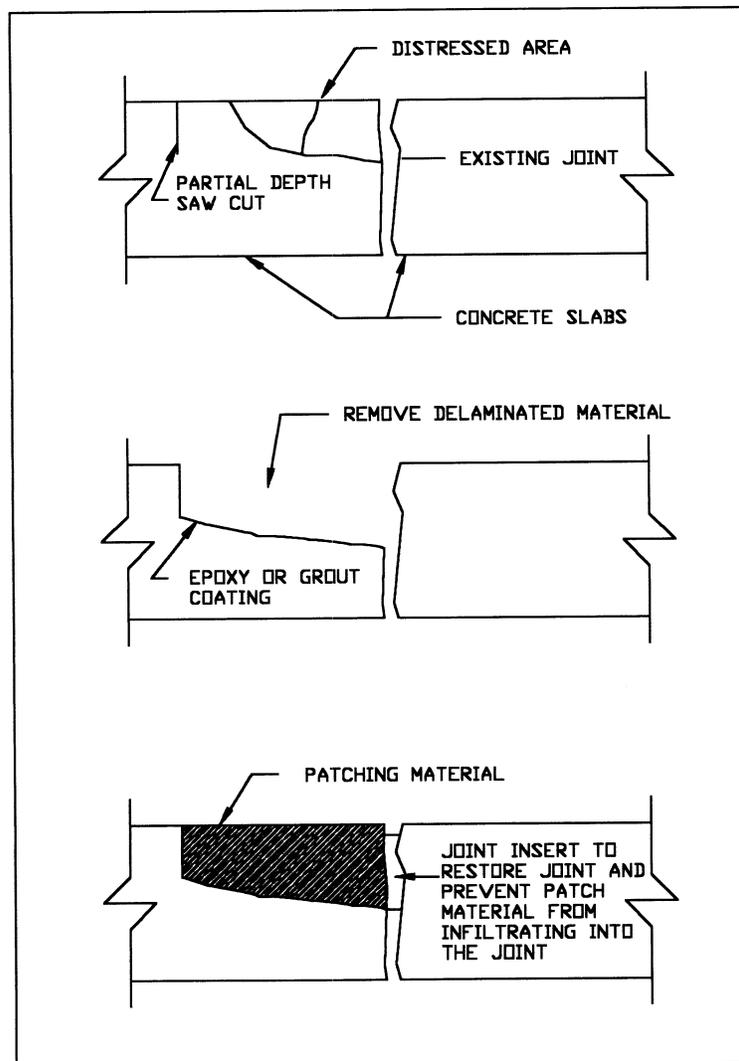
**FIGURE 1. Steps for Partial Depth Spall Patching (Darter, 1985)**

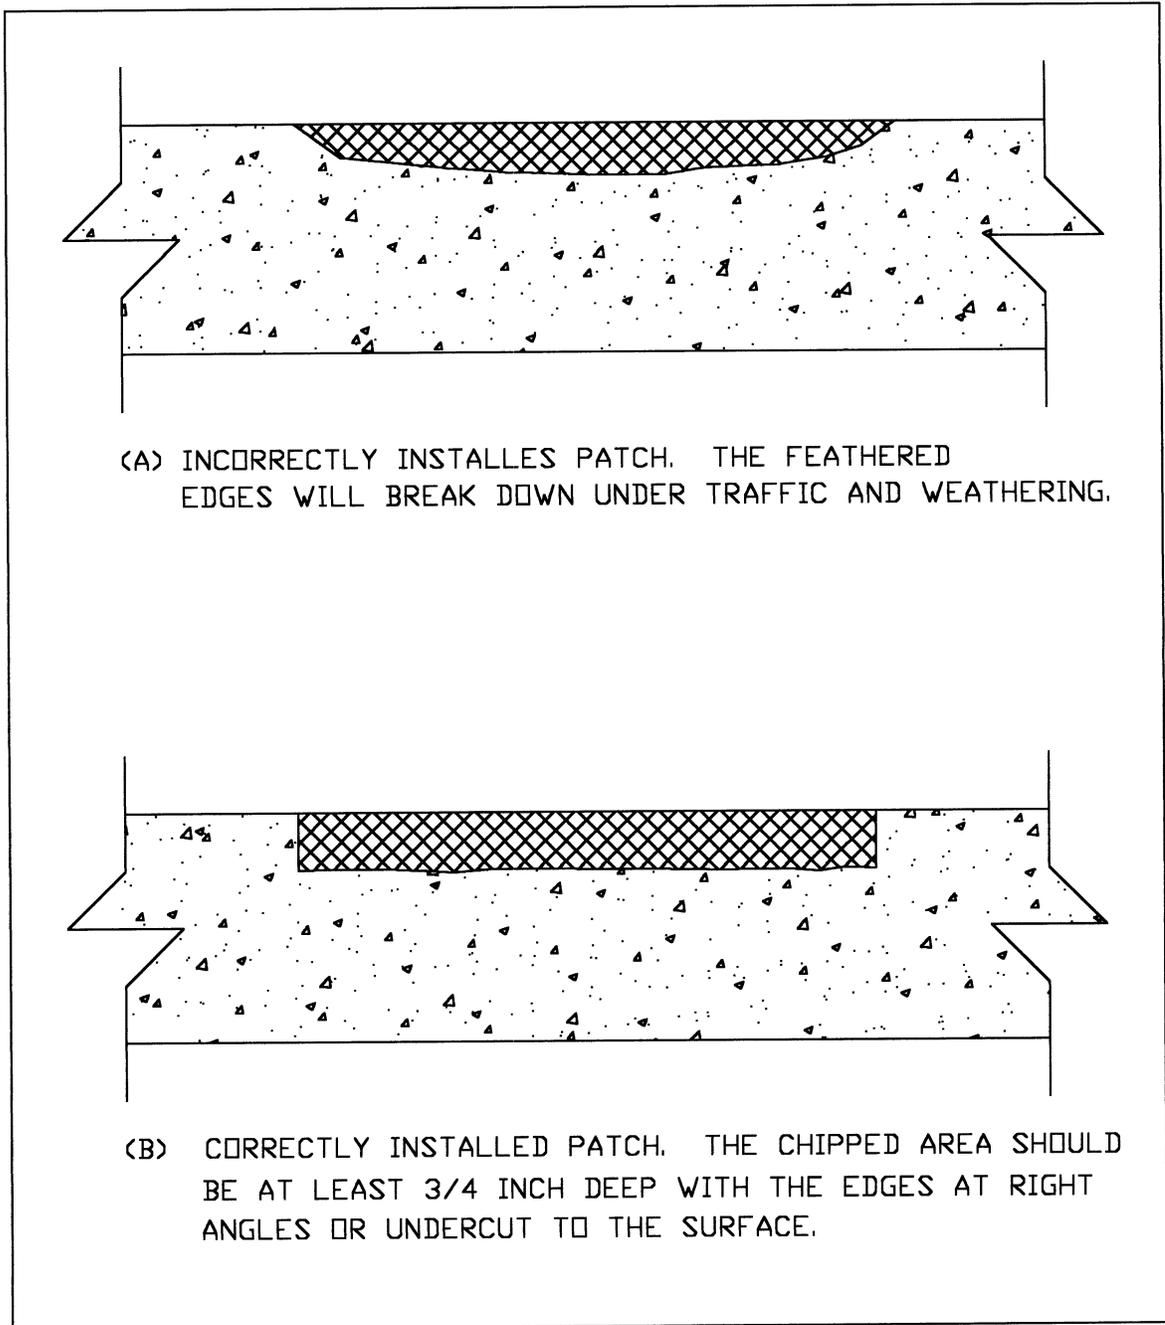
**FIGURE 2. Partial Depth Patching Installation by PCA (Kosmatka, 1985)**

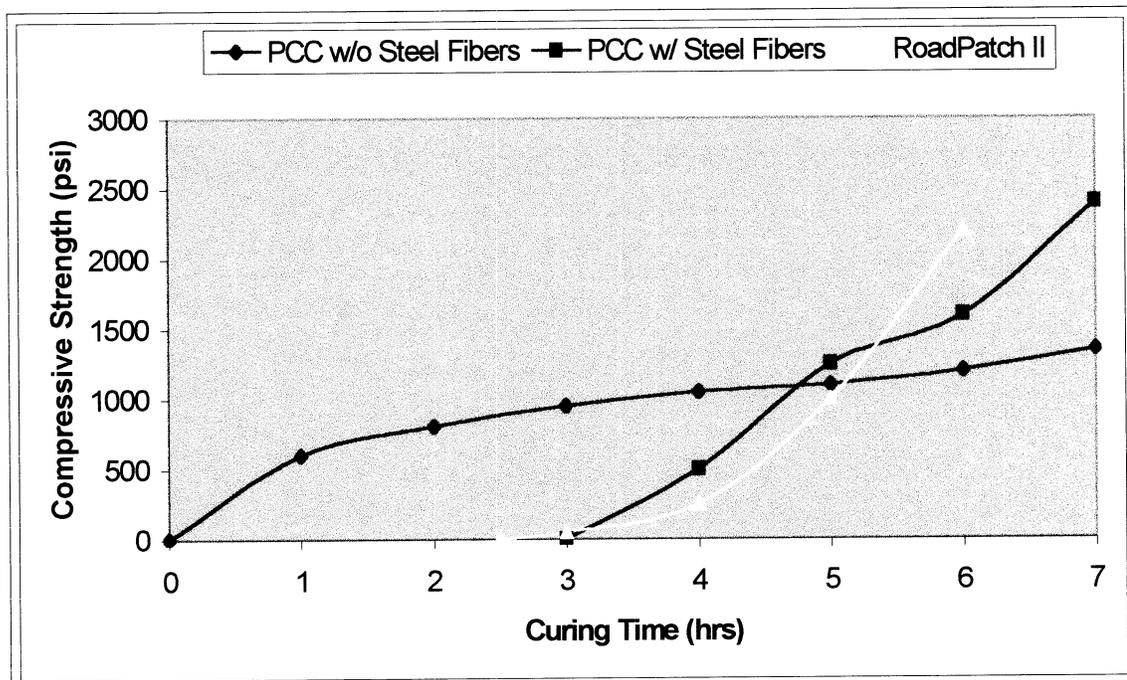
**Figure 3. Laboratory Early Strength-Development Curves (Parker et. al, 1991)**

Above laboratory tests showed that four-hour compressive strength tests of the PCC materials were higher than the proprietary material. However, after 6 hours, the strengths of PCC were lower. During field investigation, the effects of pavement location

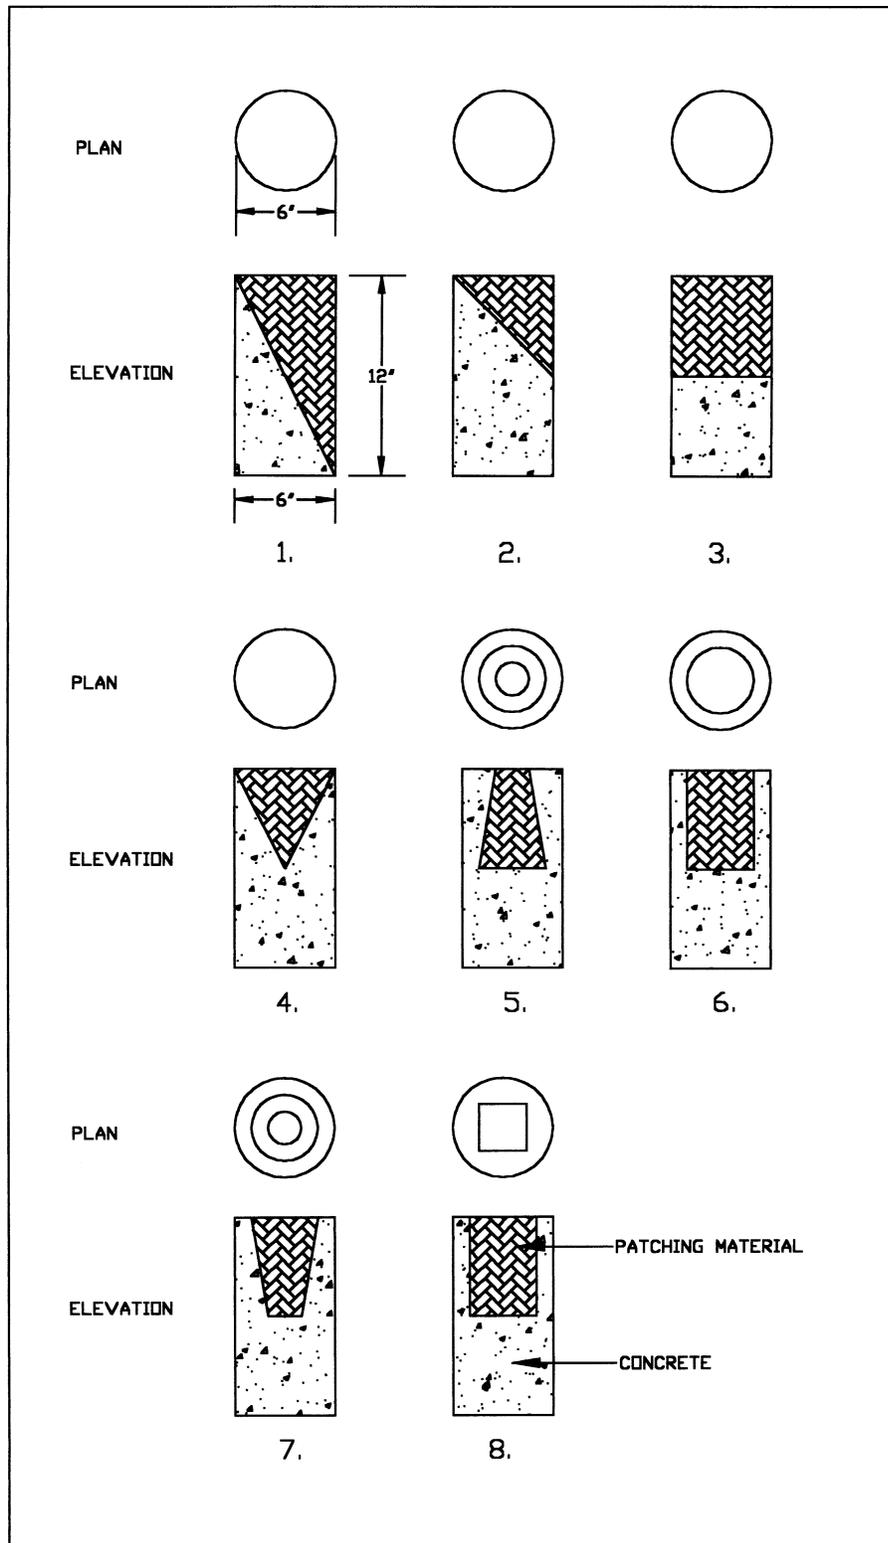
**FIGURE 4. Composite Specimen Patching Configurations**

<b>Compressive Strength Results</b>			
<b>Composite Specimen</b>	<b>Configuration No. (From Figure 4)</b>	<b>Load kN (lbs)</b>	<b>Strength MPa (psi)</b>
<b>Control Section (Type I Cement) 28-day cure</b>	-	874 (196,500)	47.9 (6,950)
	-	912 (205,000)	50.0 (7,250)
	-	867 (195,000)	47.6 (6,897)
<b>D</b>	1	133 (30,000)	7.32 (1,061)
	5	191 (43,000)	10.5 (1,521)
	8	189 (42,500)	10.4 (1,503)
<b>E</b>	4	534 (120,000)	29.3 (4,244)
	6	478(107,500)	26.2 (3,802)
	8	334 (75,000)	18.3 (2,653)
<b>F</b>	2	156 (35,000)	8.53 (1,238)
	6	698 (157,000)	38.3 (5,553)
<b>G</b>	1	89 (20,000)	4.88 (707)
	3	300 (67,500)	16.5 (2,387)
<b>H</b>	4	423 (95,000)	23.2 (3,360)
	6	778 (175,000)	42.7 (6,189)
	7	756 (170,000)	41.5 (6,013)
<b>Control Section (Type II Cement) 1-day cure</b>	-	945 (212,000)	51.7 (7,498)
	-	923 (207,500)	50.6 (7,339)

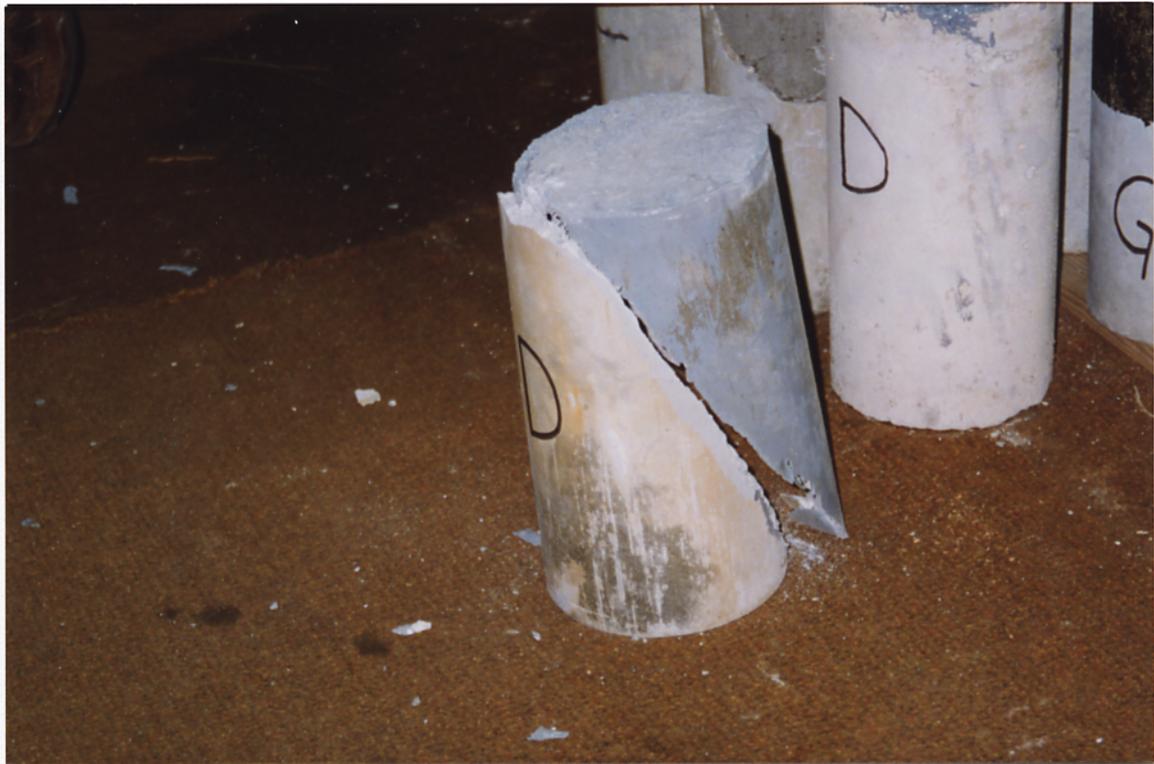
**PHOTOGRAPH 5. Bonding Failure at Interface for PAC 1 and Material D**

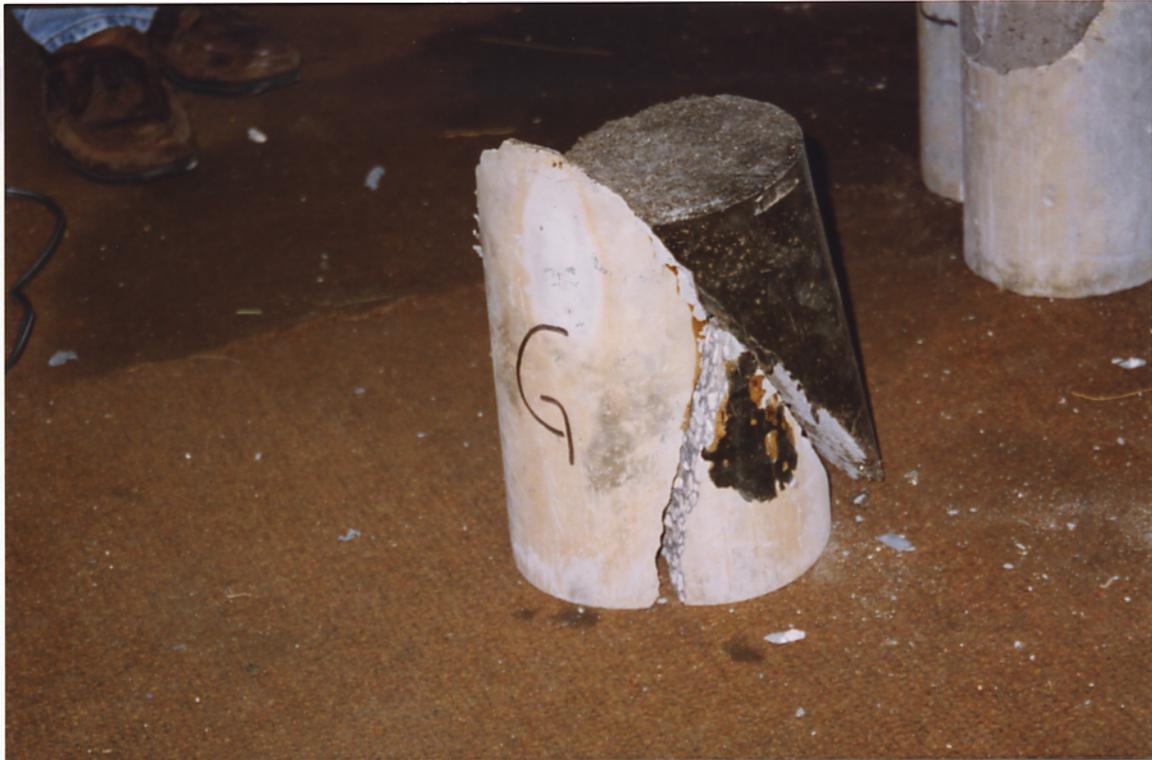
**PHOTOGRAPH 6. Bonding and Fracture Failure for PAC 1 and Material G**

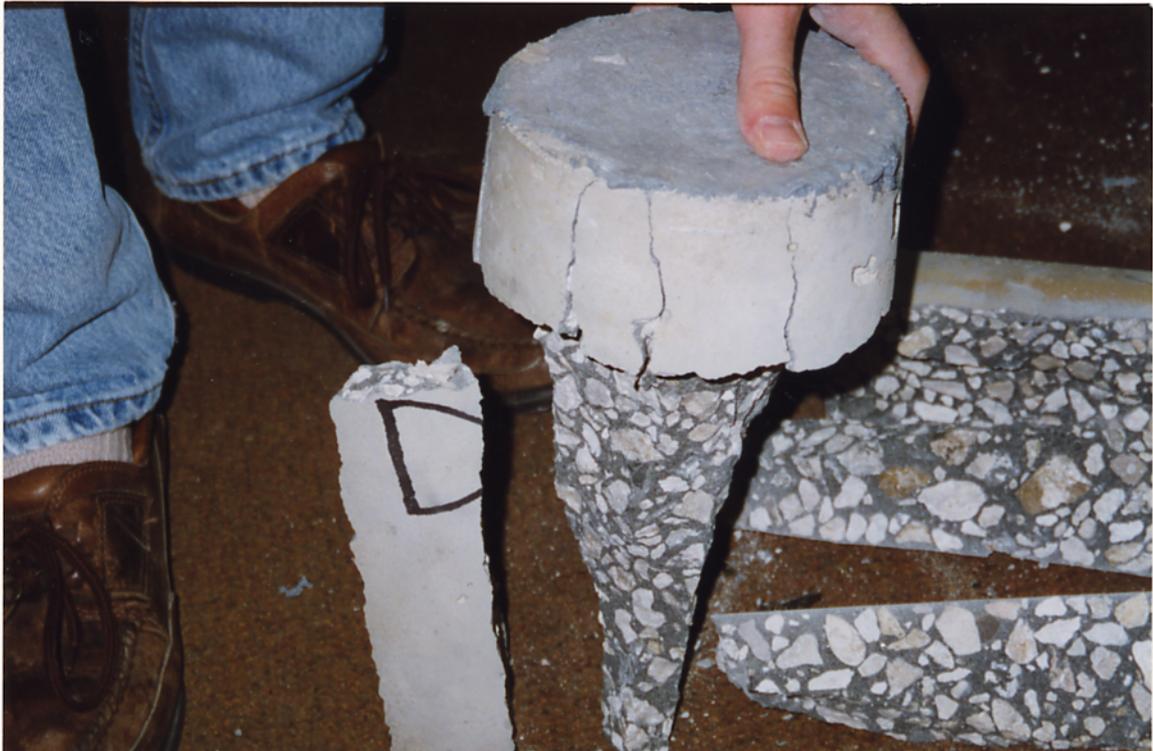
**PHOTOGRAPH 7. Complete Fracture of Concrete below Material D (PAC 5)**

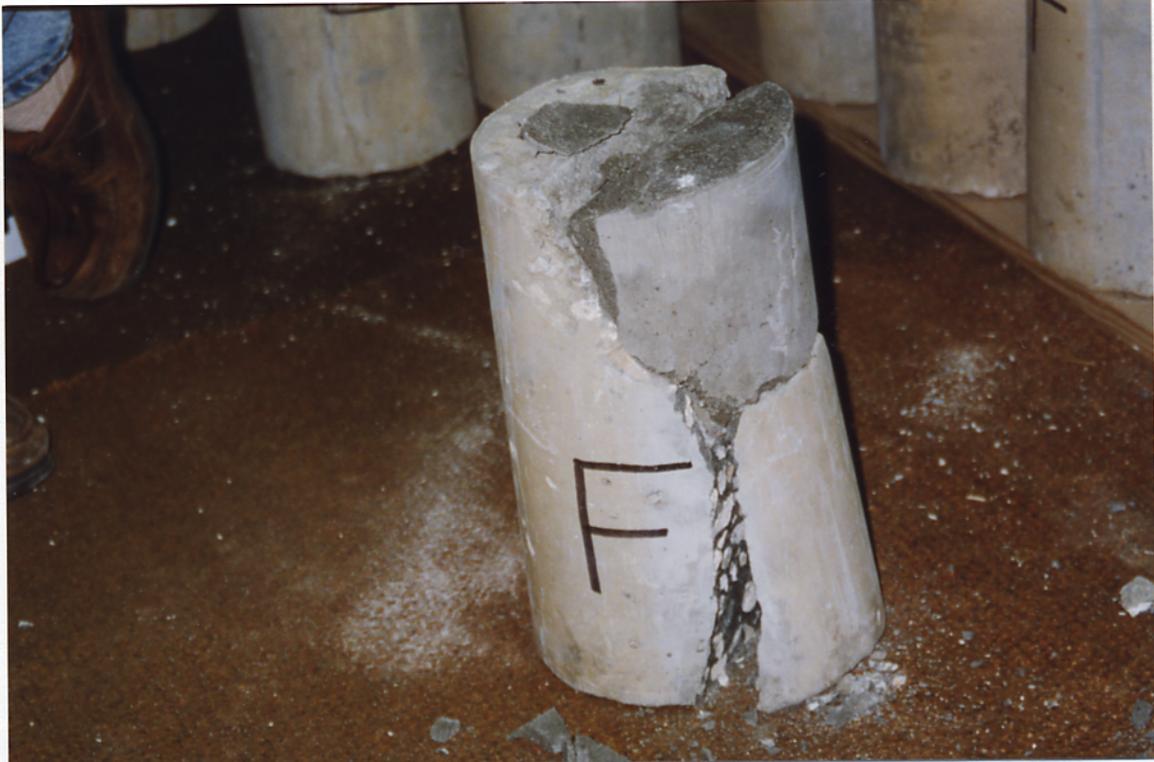
**PHOTOGRAPH 12. Complete Fracture of Material and Concrete (PAC 2)**

PAC 2 and 6 cylinders were cast with material F. The compressive strength was 8.53 MPa (1,238 psi) and 38.3 MPa (5,553 psi) respectively. PAC 2, as seen in Photograph 12 clearly failed in bonding, which resulted in a low compressive strength. Photograph 13 shows that the entire specimen fractured through patching material F and the PCC. This occurrence is evident because of the higher compressive strength of 38.3 MPa (5,553 psi). This material certainly would not be chosen for the accelerated performance test due to its poor bonding characteristics although it had a relatively high compressive strength. Material G was tested with PAC 1 and 3 cylinders. PAC 1 failed in bonding quickly at a very low compressive strength. For PAC 3, the aspect ratio was approximately 1 for the PCC. However, the compressive strength only reached 16.5 MPa (2,387 psi) when the concrete cracked. The strength is expected to be much higher when referring to the figure in Appendix B. Due to this result, it is recommended that more samples be cast and tested in the future. Photograph 14 clearly shows the fractures only occurred on the PCC underneath the patching material. Three composite specimens were cast with material H, in PAC's 4, 6, and 7 cylinders for compressive tests. The compressive strength reached approximately 41.4MPa (6,000 psi) for PAC's 6 and 7, closely achieving the compressive strength of the control sections. However, PAC 4 only sustained a compressive strength of 23.2 MPa (3,360 psi). The lower compressive strength may be attributed to the conical shaped composite specimen, which allowed the higher strength patching material due to the confining pressure to wedge into the lower strength PCC causing failure in the PCC. Photographs 15 and 16 show the interesting fracture patterns of the laboratory samples. The final compressive tests were conducted

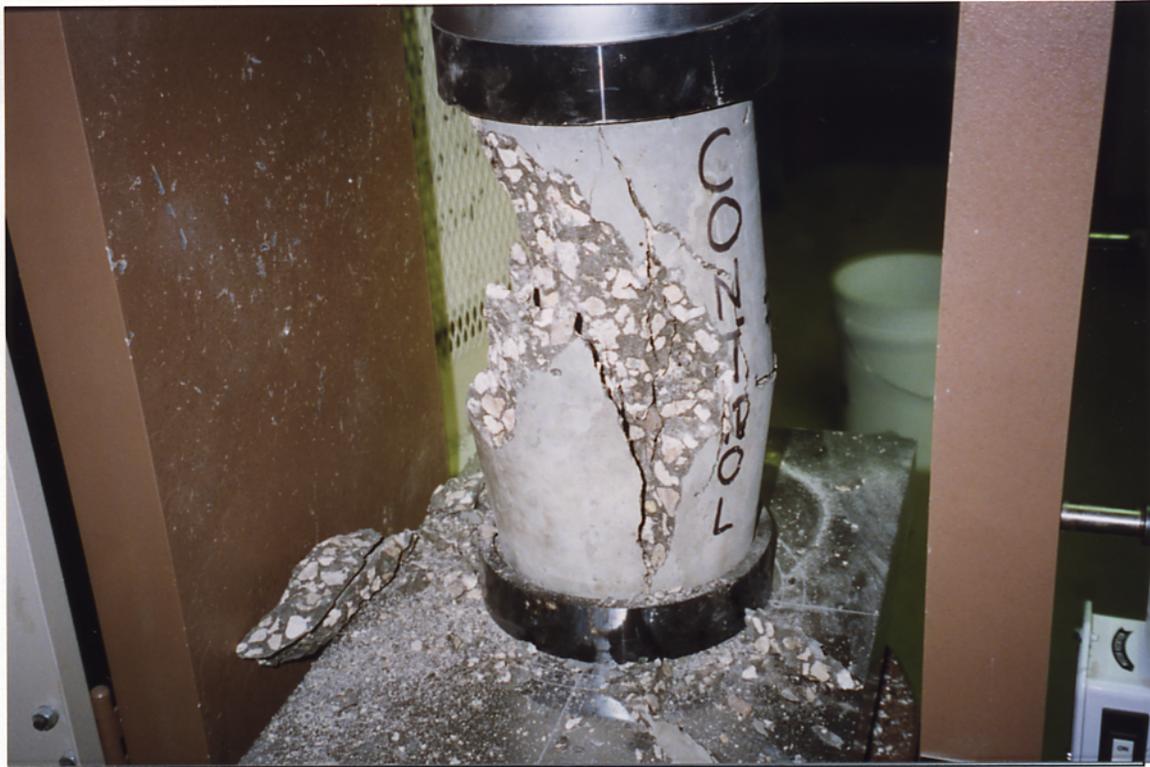
**PHOTOGRAPH 17. Failure of Type II Cement Control Section**

on the fast-set Type II cement mix (Table 5). As previously mentioned the Type II cement mix was used for the control section during the accelerated performance testing. The two cylindrical specimens were allowed to cure for only 24-hours. Yet, the average compressive strength for the Type II cement mix was 51.2 MPa (7,419 psi). As seen in Photograph 17, typical failure of the specimen is shown.

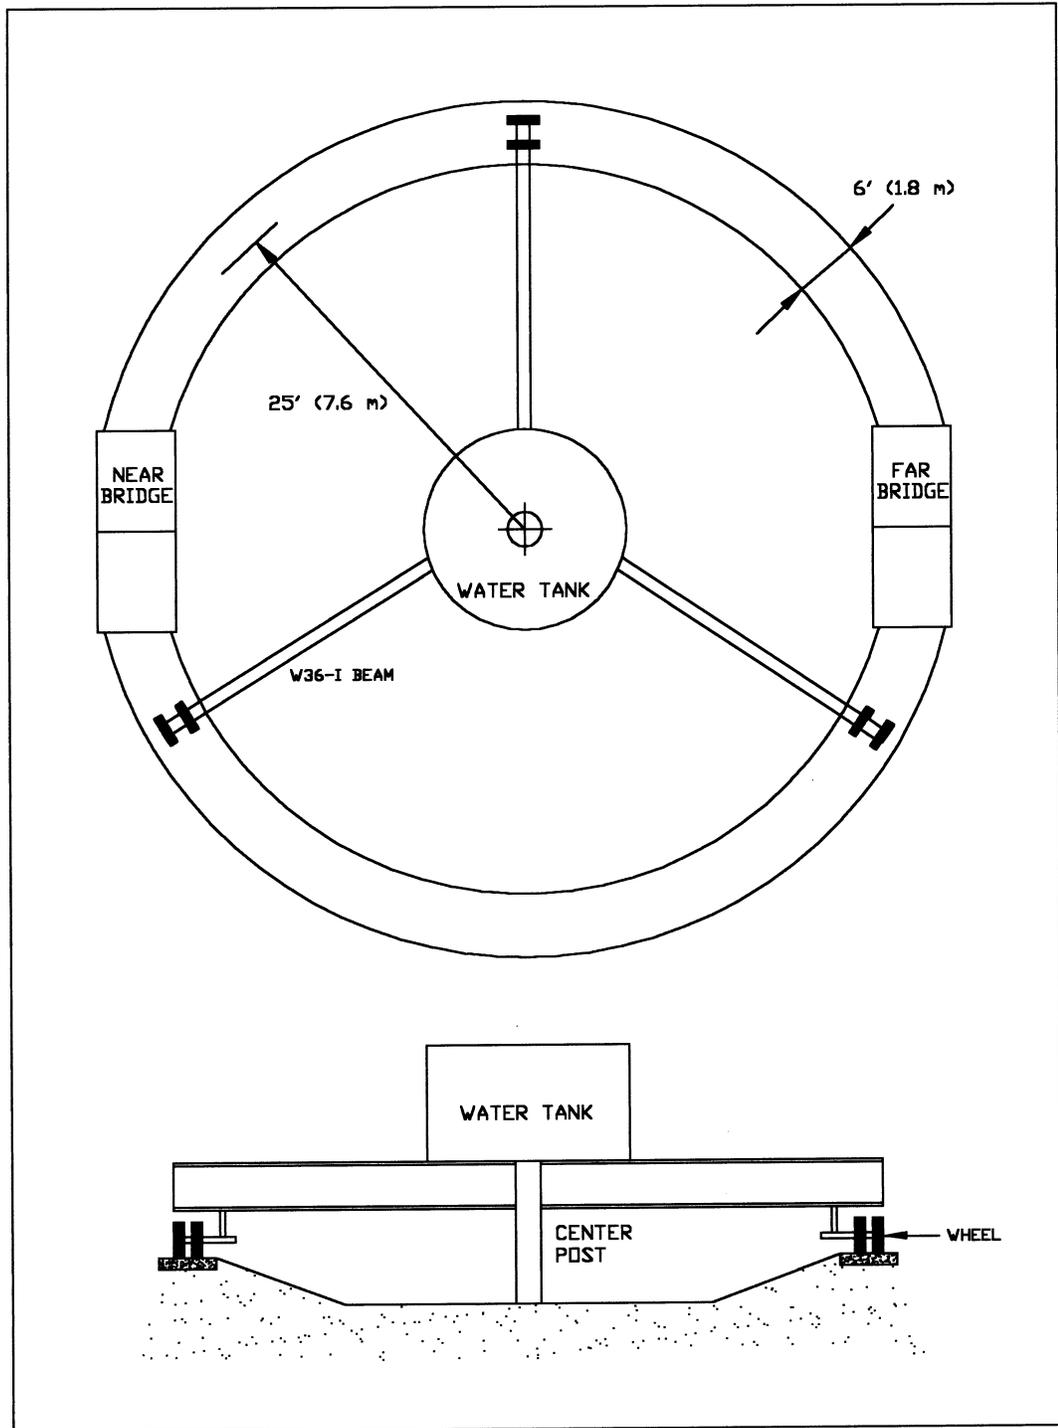
**FIGURE 5. UCF Circular Accelerated Test Track**

The loading on the dual-wheel assemblies is created by a 28.49 m<sup>3</sup> (7,500 gallon) water tank, 3.7 meters (12 ft) in diameter by 2.4 meters (8 ft) high plus the weight of the structural members. The tank is placed on top of the center support, supported by the I-beams. Depending on the water level in the tank, the total load of the structural weight and filled water tank can vary between 133.5 kN (30,000 lbs) and 356 kN (80,000 lbs). This load is evenly distributed to the three dual-wheel assemblies. This facility, which was illustrated in Photograph 1, has been used to test large-scale bridge expansion joints, experimental pavements, and patching materials since 1990.

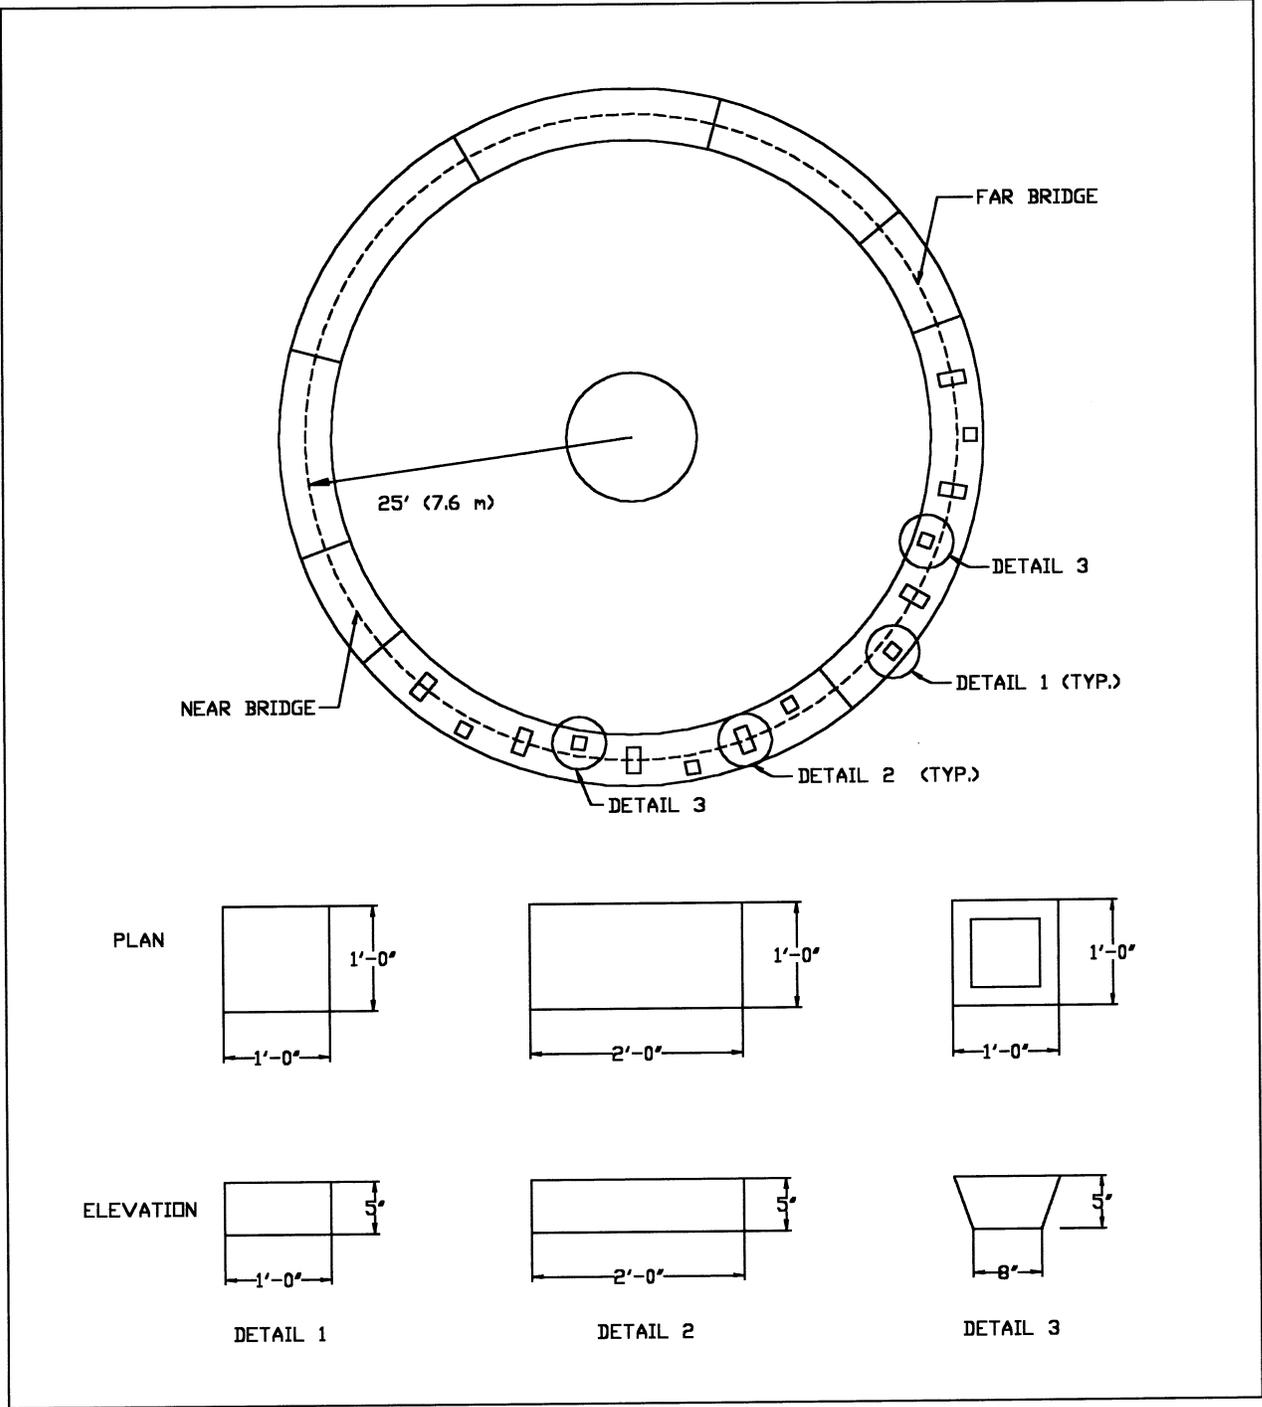
**FIGURE 6. Pothole Layout**

Figure 6 illustrates the locations of fourteen (14) potholes and two (2) spalls at the pavement joints. three different pothole sizes were created. Seven (7) at the size of 30.4 x 30.4 x 12.7cm (1 x 1 x 0.4 ft) (Detail 1), seven (7) at the size of 60.96 x 30.48 x 12.7cm (2 x 1 x 0.4ft) (Detail 2), and two (2) feathered edged at the size of 30.48 x 30.48 x 12.7cm (1 x 1 x 0.4ft) (Detail 3). Each patching material was placed in two of the pothole molds as seen in Detail 1 and Detail 2 in Figure 6. The purpose of placing the same material in two different potholes was that one pothole is placed under a single tire that may cause the edge of the patching to detach, while the other pothole is under the dual tires that may cause a higher displacement of patching. The placement of the patching materials onto the pre-formed potholes was not an easy task for this project. Leveling the materials with the track surface became somewhat difficult with the cementitious materials and the control section due to the large size of the aggregate involved. This was the reason that the patchings with cementious materials caused uneven levels with the concrete track surface. If the size of the aggregate can be reduced in these materials, then patching will be easier.

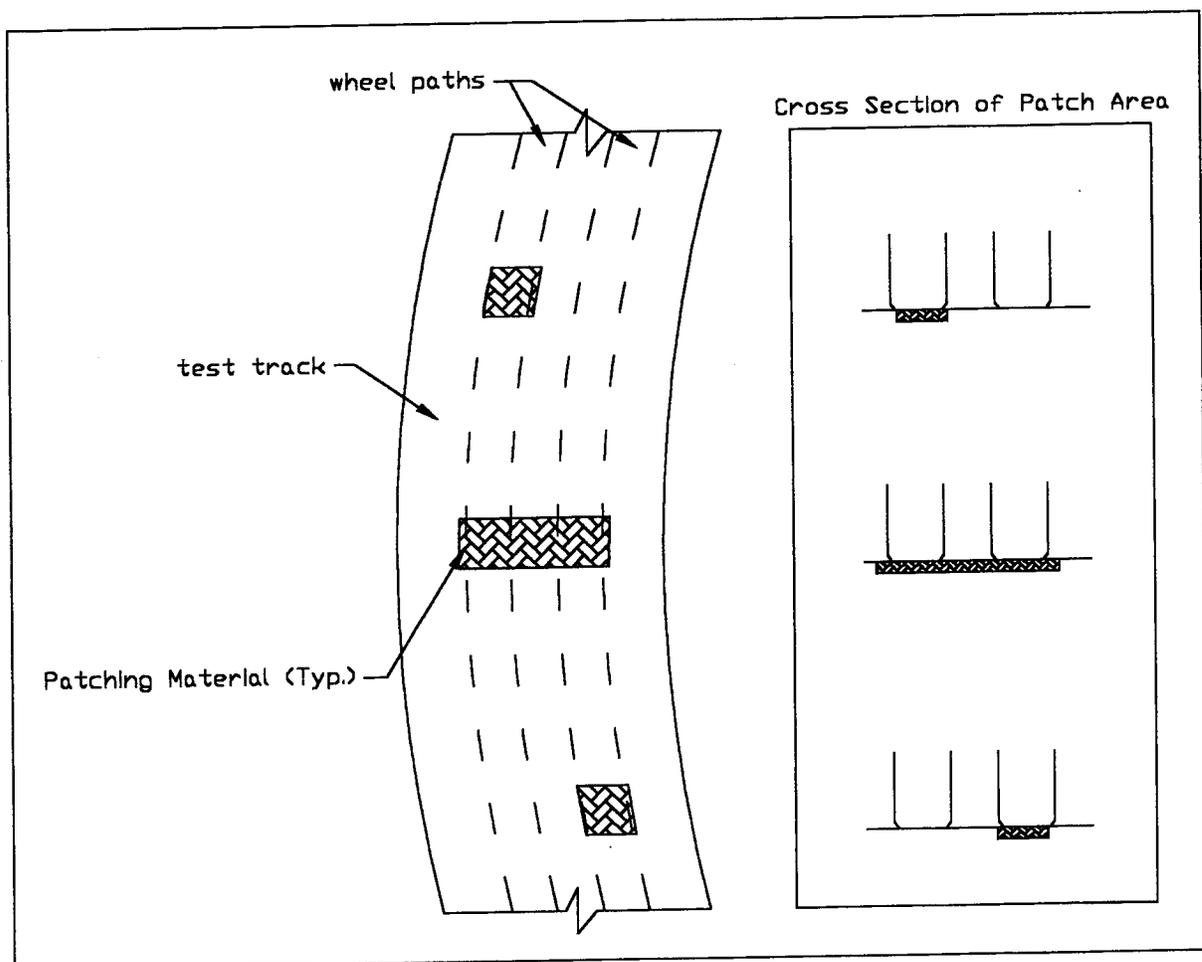
**FIGURE 7. Typical Location of Patching Materials on Test Track**

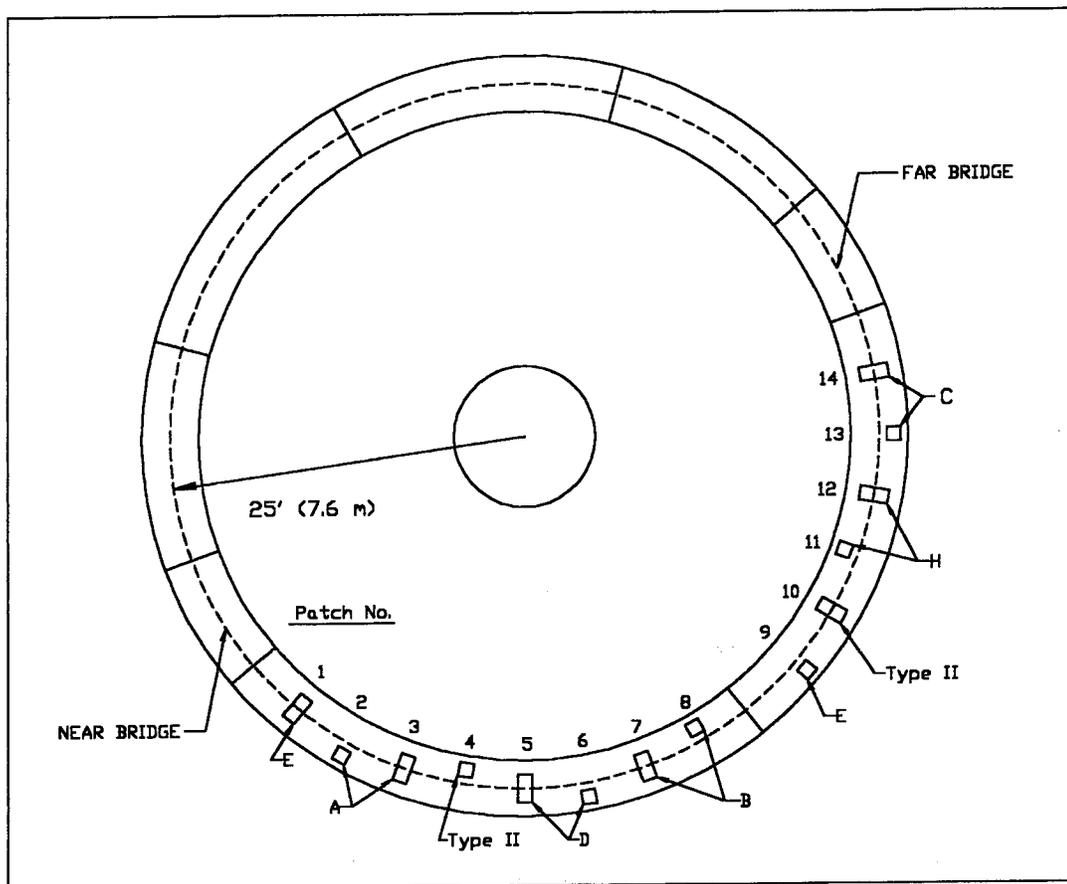
Material Type	Property	Mixing Procedure	Workability	Aggregate Additives	Curing Time
A	Polymer	moderate	moderate	pre-packaged	2-4 HRS
B	Cementitious	easy	moderate	3/8" clean	2 HR
C	Cementitious	easy	moderate	3/8" clean	4 HR
D	Elastomeric	easy	easy	pre-packaged	4 HR
E	Elastomeric	moderate	moderate	pre-packaged	4 HR
H	Cementitious	easy	moderate	3/8" clean	2 HR
Control Section	Type II (PCC)	hard	difficult	57 stone	24 HR

**FIGURE 8. Placement and Characteristics of Selected Patching Materials**

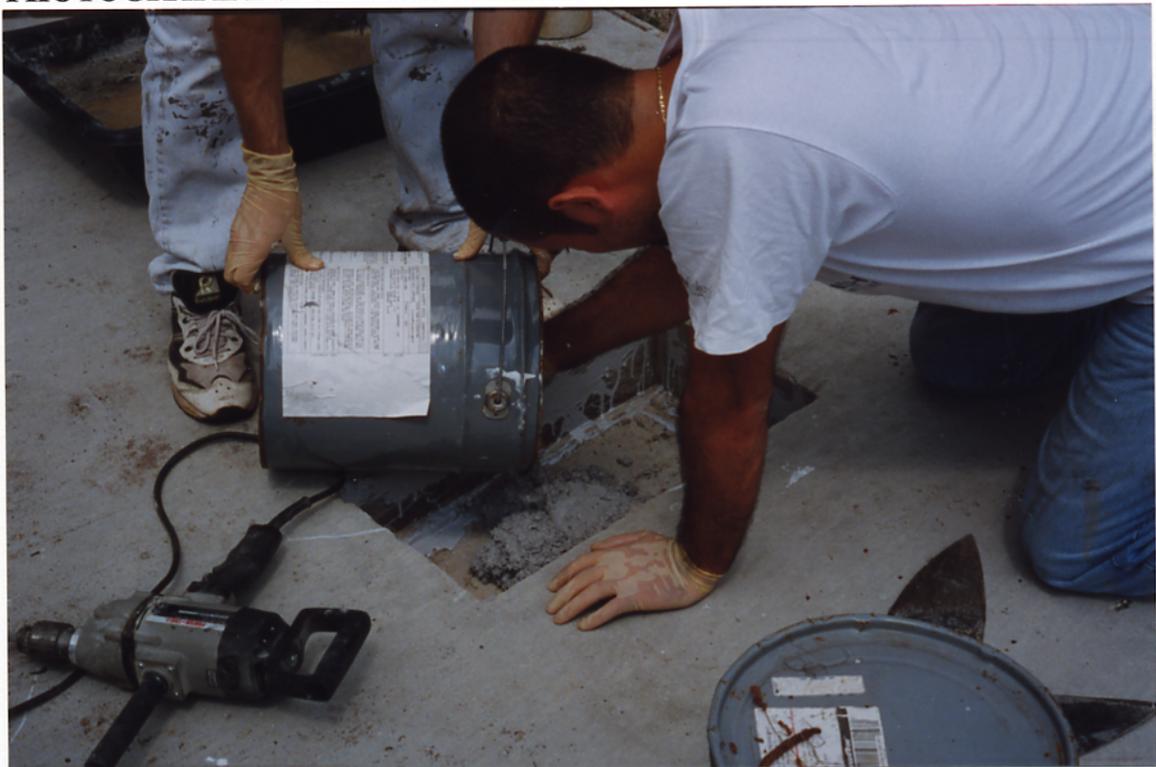
**PHOTOGRAPH 29. Placing Material E with Bonding Agent Adhered to Sides**

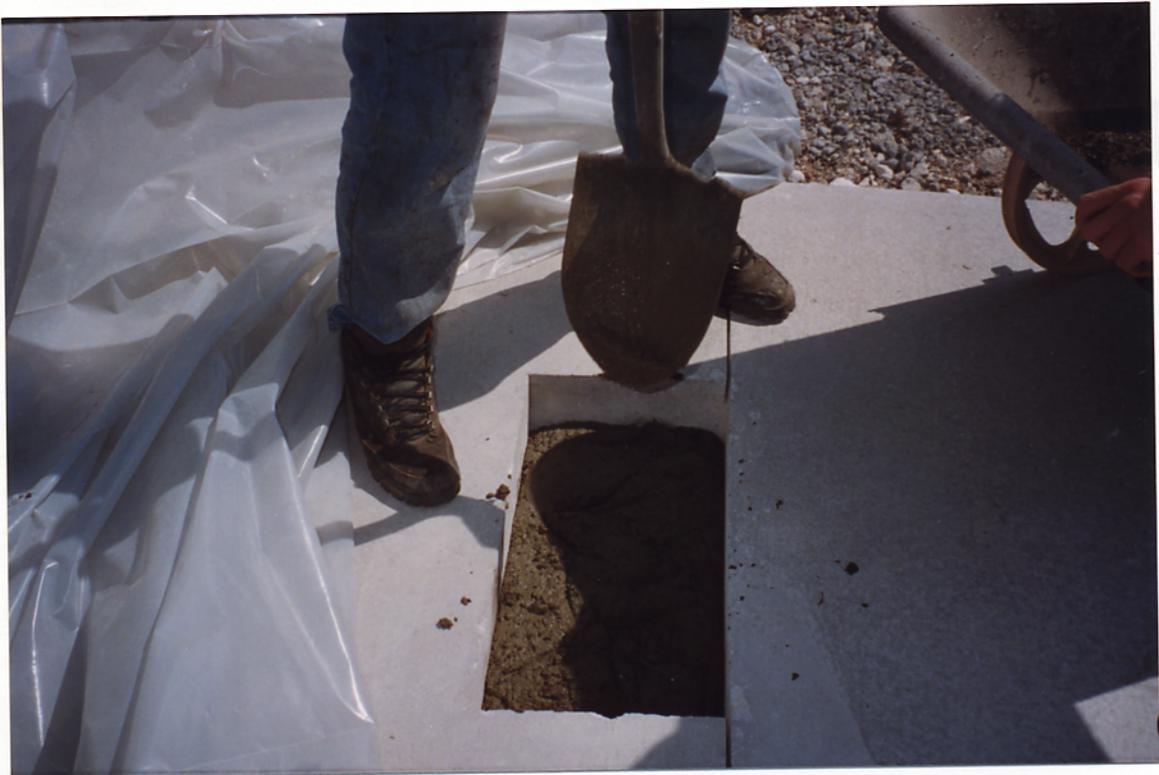
**PHOTOGRAPH 30. Placement of Material H in two lifts**

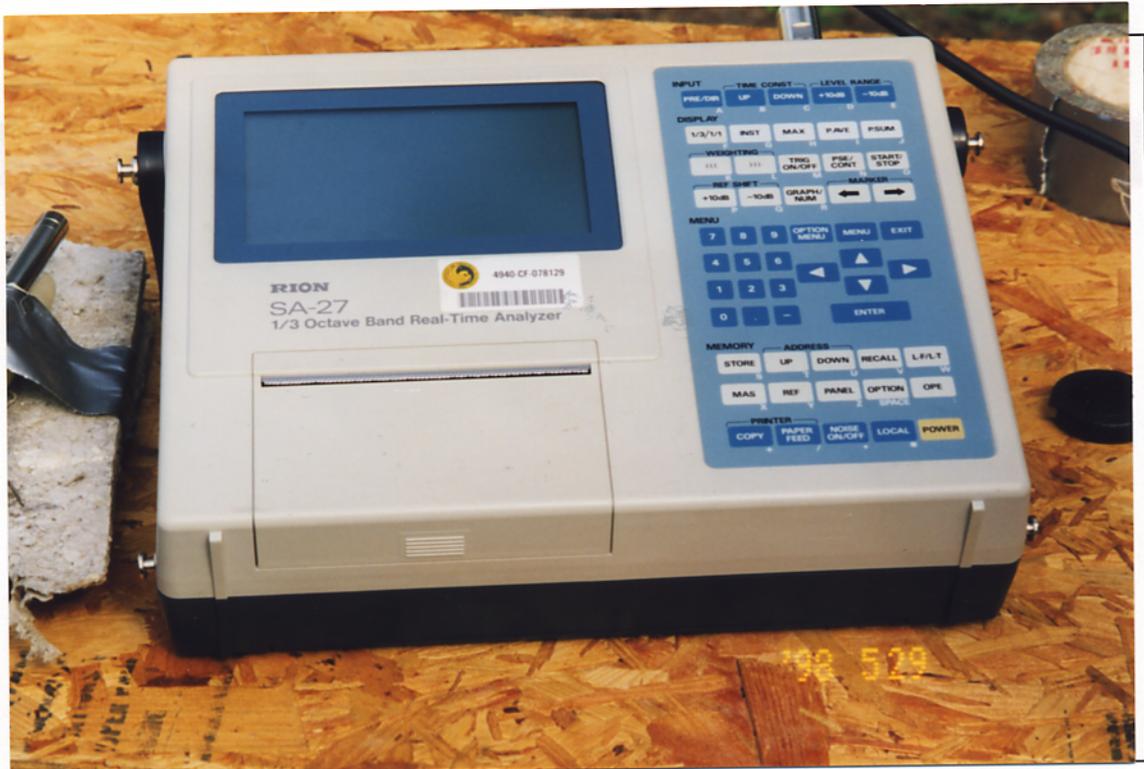
**PHOTOGRAPH 34. Rion SA-27 Octave Band Real Time Analyzer**

An Octave Band Real-Time Analyzer was used to measure the decibel levels while the wheels passed across the joint (Photographs 33 and 34). A microphone was placed on the test track to record the decibel levels. The collected data could be compared with and without material being placed in the joint (Photograph 35).

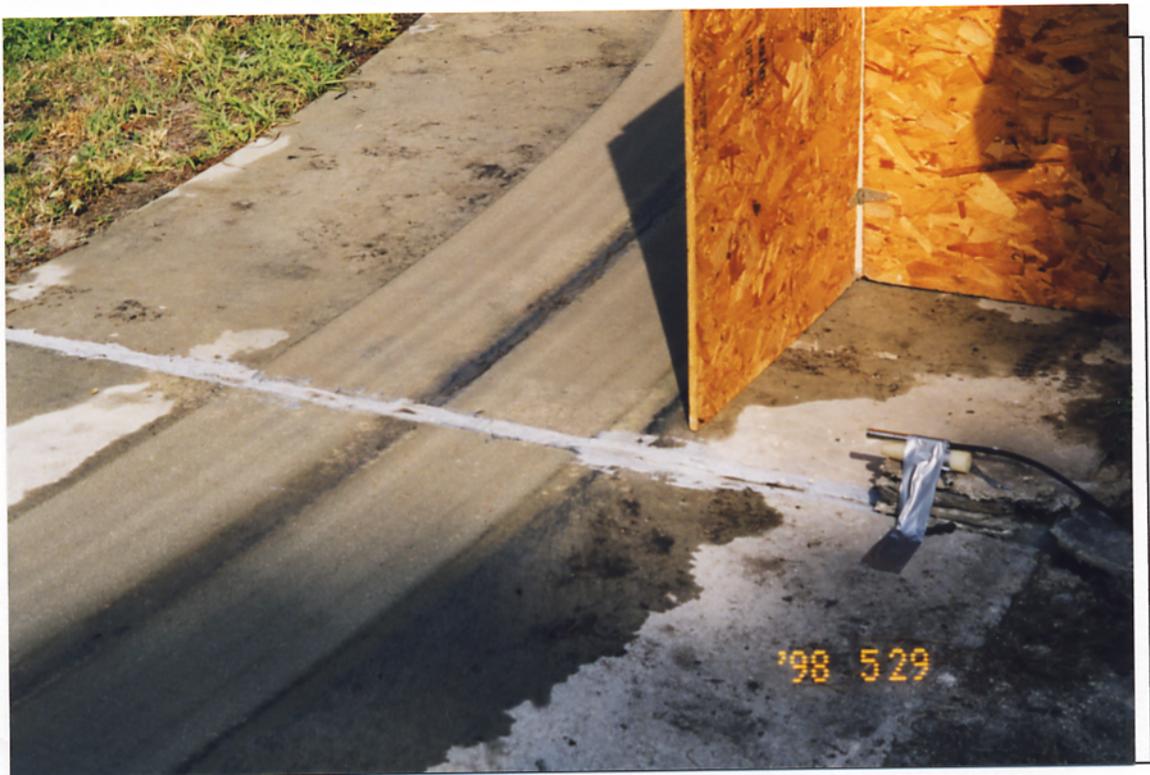
**PHOTOGRAPH 35. Microphone Placement for Decibel Level Readings**

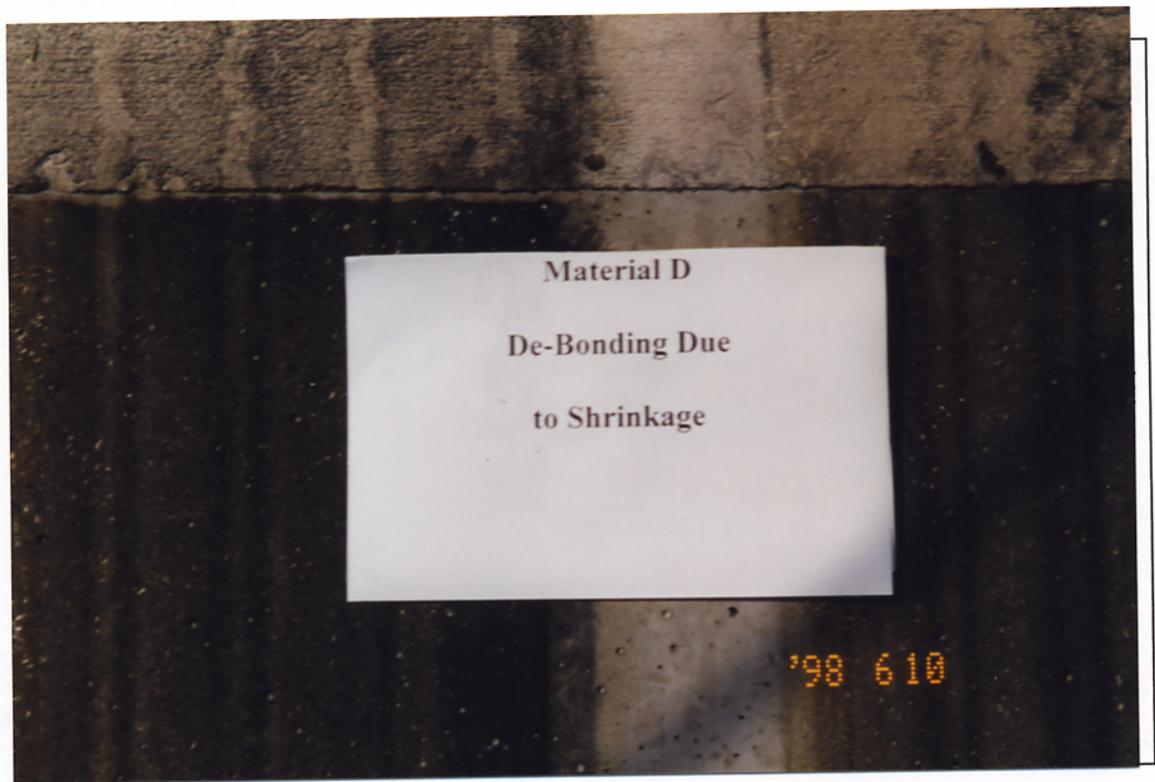
**PHOTOGRAPH 36. Cracks along Interface Due to Shrinkage (Patch No. 5)**

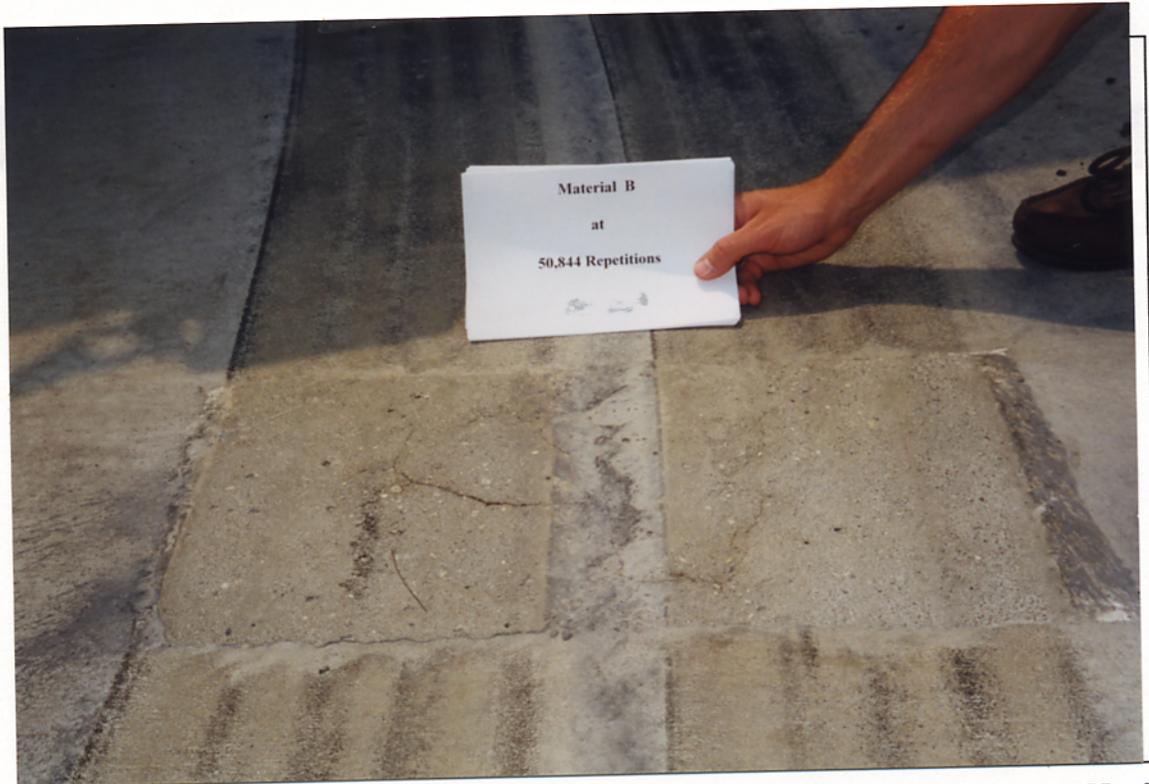
**PHOTOGRAPH 39. Shrinkage Crack Due to Excessive Water in Mix (Patch No. 7)**

shrinkage/expansion cracks along Material B's surface is present. This was due to excessive addition of water while mixing the cementitious material. This factor is evident, because the other pothole with Material B present has no cracks or other failures associated with bad mixing procedures (Photograph 40).
