**EVALUATION OF PATCHING MATERIALS AND PLACEMENT  
TECHNIQUES FOR RIGID PAVEMENTS AND BRIDGE DECKS**

**FINAL REPORT**

**Florida Department of Transportation  
(BB452-WPI 0510861)**

**September 1999**

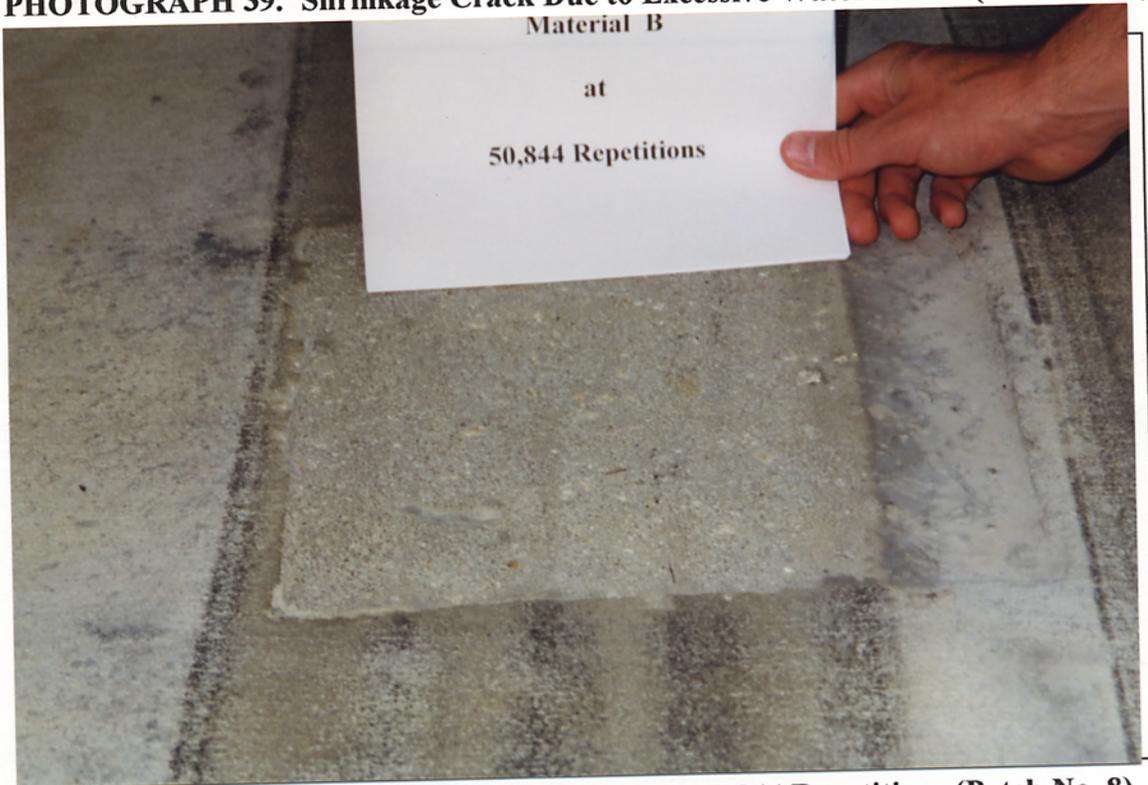
**PHOTOGRAPH 40. Material B at 71 Hours and 50,844 Repetitions (Patch No. 8)**

shrinkage/expansion cracks along Material B's surface is present. This was due to excessive addition of water while mixing the cementitious material. This factor is evident, because the other pothole with Material B present has no cracks or other failures associated with bad mixing procedures (Photograph 40).

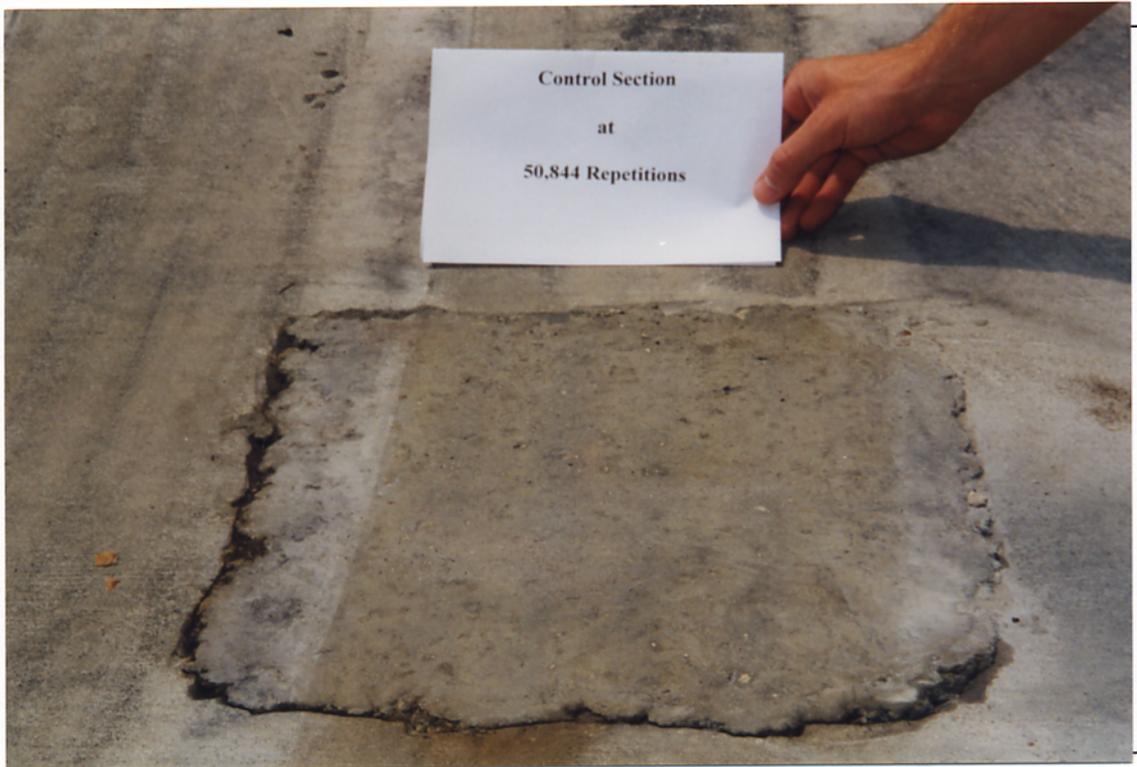
**PHOTOGRAPH 41. Unevenness of Type II Due to Large Aggregate (Patch No. 4)**

As discussed in Chapter IV, leveling of some of the patching materials was difficult. The control section was especially challenging due to the size of aggregate in the mix. Photograph 41 displays the unevenness of the material with the concrete pavement. Due to this problem, de-bonding of material may likely occur and propagate faster.

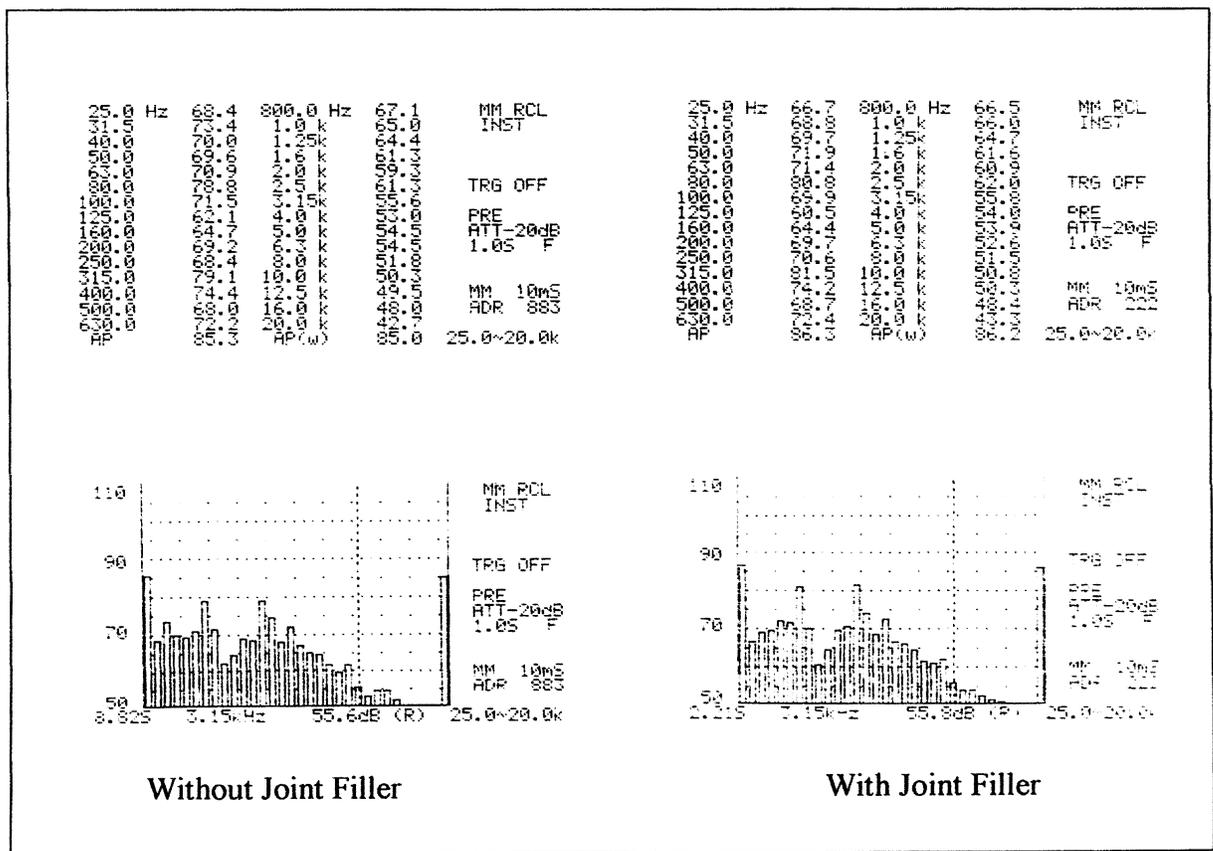
**FIGURE 9. Joint Noise Decibel Recordings**

been contributed by the noise of the test track powered engine and the relatively slow speed of the wheel passes. In order to obtain variable data, the engine noise must be isolated by an insulated structure as recommended by a transportation noise research professor. The design and construction of this insulated structure may require some funding and period of time. A small project of this research can be done in the near future.

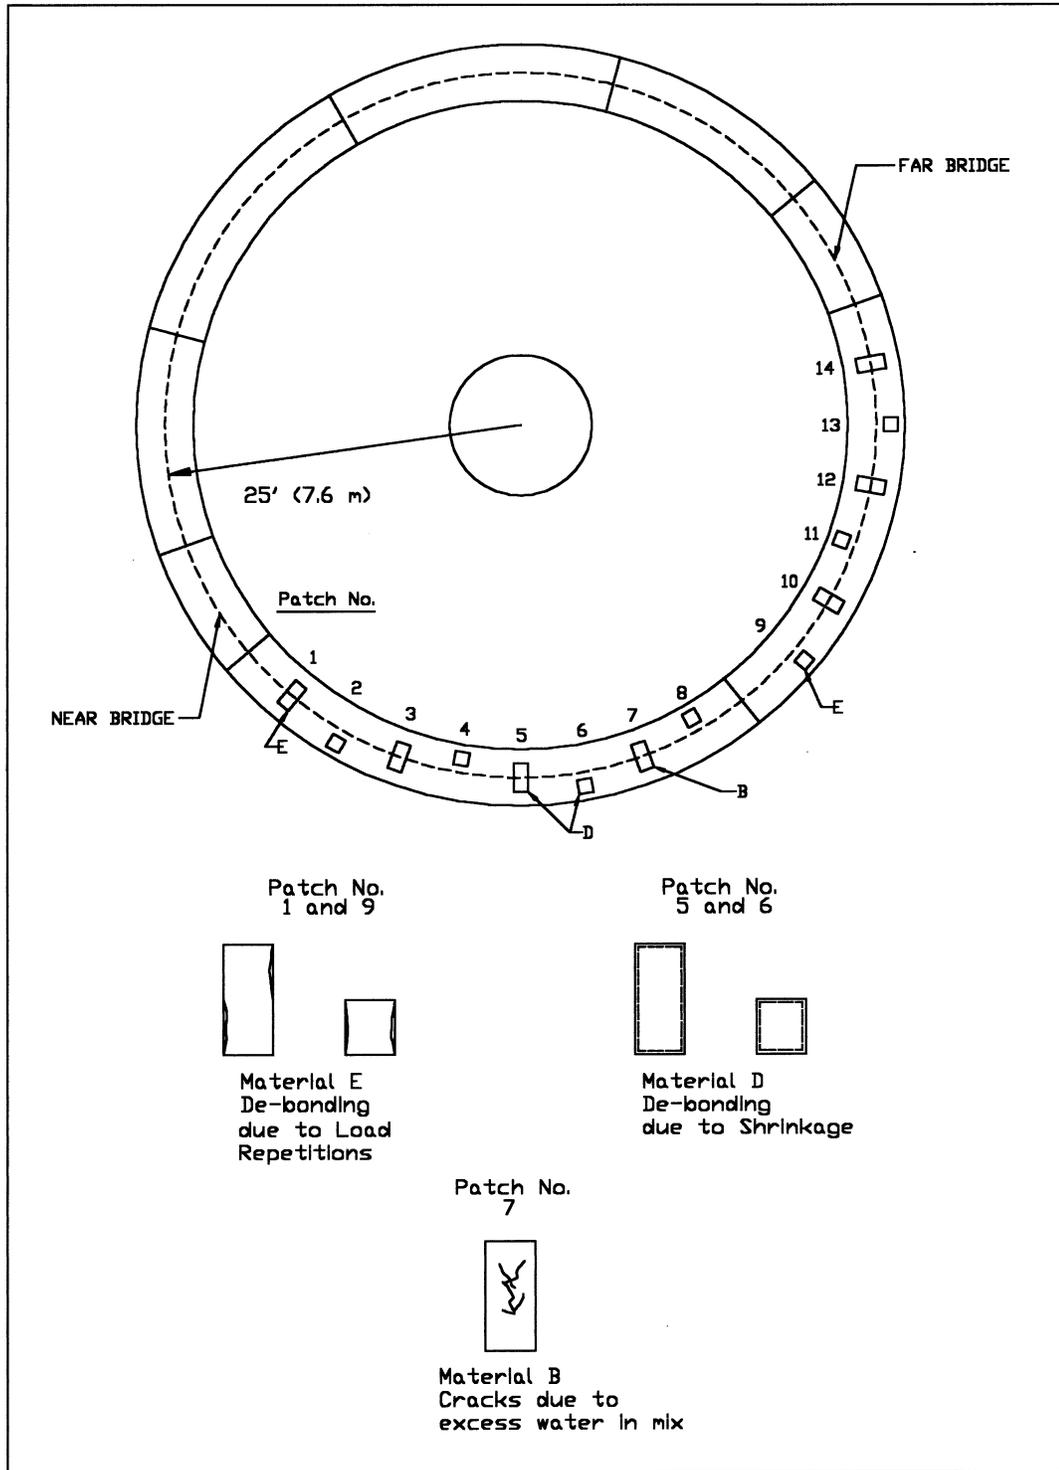
**FIGURE 10. Distress Location of Patching Materials**

<b>C</b>	Little wear Little debonding Little exposure of coarse aggregate at edges
<b>D</b>	Debonding Exposure of fiber reinforcement
<b>E</b>	Debonding Some exposure of voids and coarse aggregate
<b>H</b>	Little debonding Little exposure of voids and coarse aggregate
<b>Control Section</b>	Little wear Chipping at edges Some exposure of coarse aggregate at edges
<b>Spalls</b>	
<b>Spall #1</b>	<b>Distress Description After 420,000 Repetitions</b>
<b>Material G</b>	Little Wear Little chipping at edge
<b>Spall #2</b>	<b>Distress Description After 400,000 Repetitions</b>
<b>Material B</b>	Some exposure of fine aggregate
