Selecting the Most Effective ITS Application for Pedestrian Safety in Florida

This report summarizes a research project conducted for the Florida Department of Transportation by the Center for Urban Transportation Research at the University of South Florida. The purpose of the research project was to identify those Intelligent Transportation Systems (ITS) applications that are applicable to pedestrians and determine which of these would be expected to prove most beneficial to pedestrians in Florida.

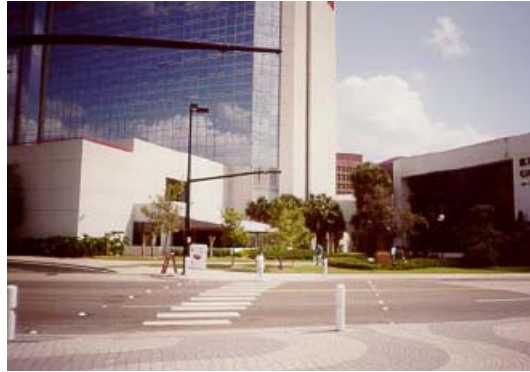
Figure 1 below shows the in-pavement light installation in Orlando, Florida adjacent to the TD Waterhouse Center. The view is from the TD Waterhouse Center side of the road looking across the roadway crossing. The circles on the pavement that are on each side of the crosswalk are the in-pavement lights. The bollards on each side of the crosswalk house the passive detection system. When a pedestrian walks between the bollards, the

system is activated and the lights begin to flash for a predetermined period of time. Figure 2 shows the same location at night from the street view.

Figure 1 – Daytime view of in-pavement light installation

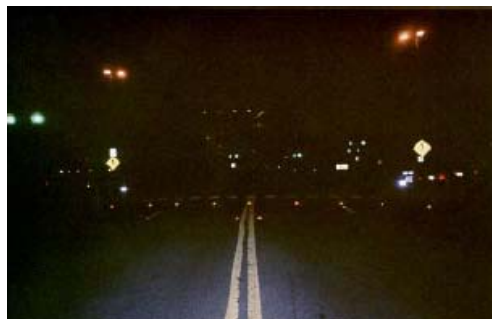
Figure 2 – View of in-pavement lighting at night

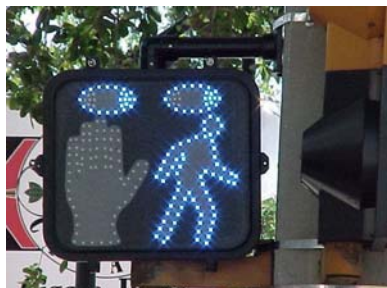
Animated Eyes: The animated eyes display is a signal indication that features eyes that oscillate between looking left and right in order to remind the pedestrian to look both ways before entering the crosswalk. Figure 3 shows an animated eyes display in use at an intersection in Clearwater⁴.

Figure 3 – Animated eyes display

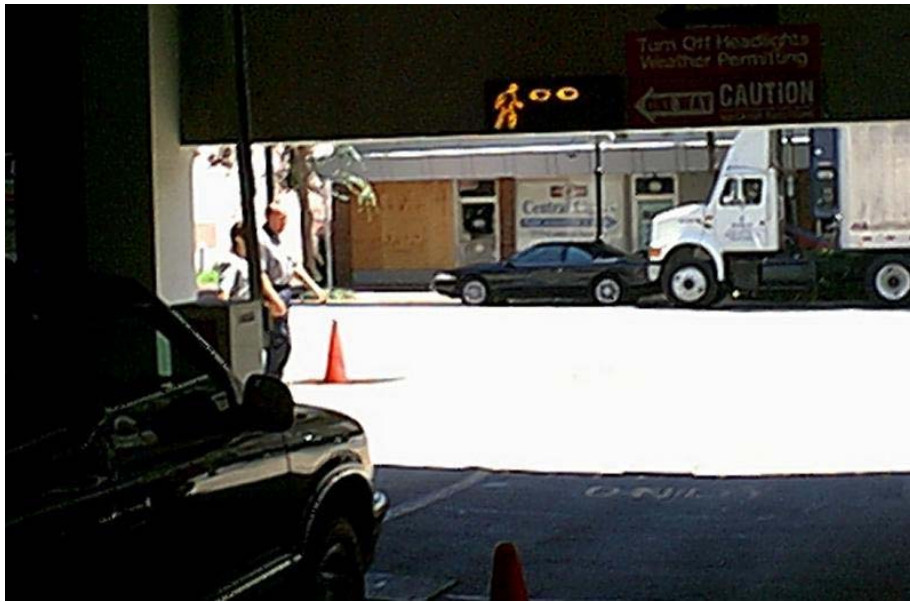
The animated eyes display may also be used to alert the motorist to the presence of pedestrians. In Figure 4 below, motorists exiting a parking garage are reminded to be aware of pedestrians that may be on the sidewalk just outside the garage. This was proven to be very effective in reminding motorists to yield to the pedestrians on the sidewalk⁵.

Figure 4 – Animated eyes at the exit to a parking garage

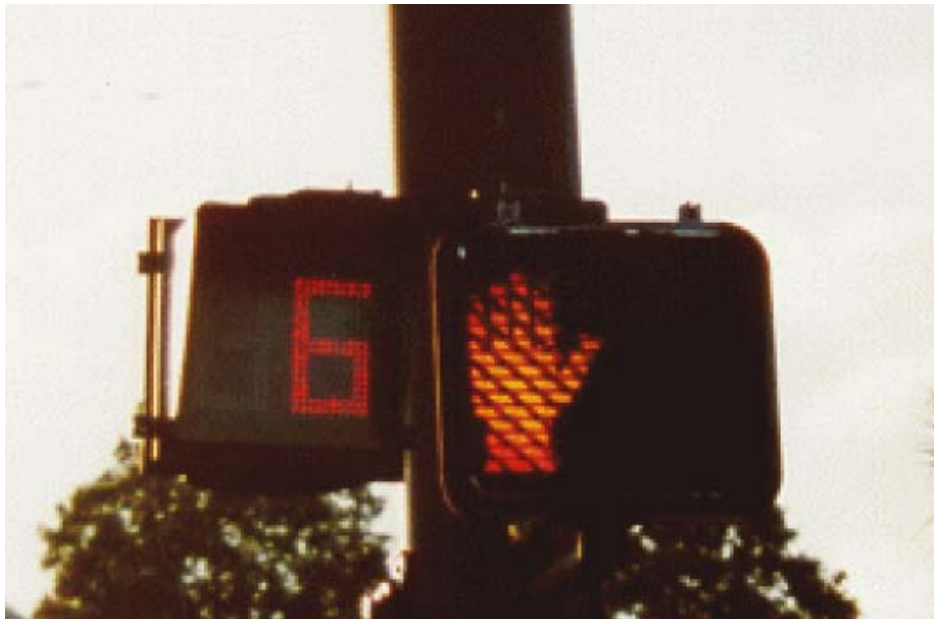
Countdown signal: Probably one of the most useful pedestrian ITS treatment is the pedestrian countdown signal. This device displays to the crossing pedestrian the remaining time that they have to cross the street. Past studies have indicated that a very small proportion of pedestrians understand the meaning of the flashing hand display. Figure 5 shows a countdown display added as a retrofit to an existing pedestrian signal.

Figure 5 – Countdown display shown beside conventional pedestrian display

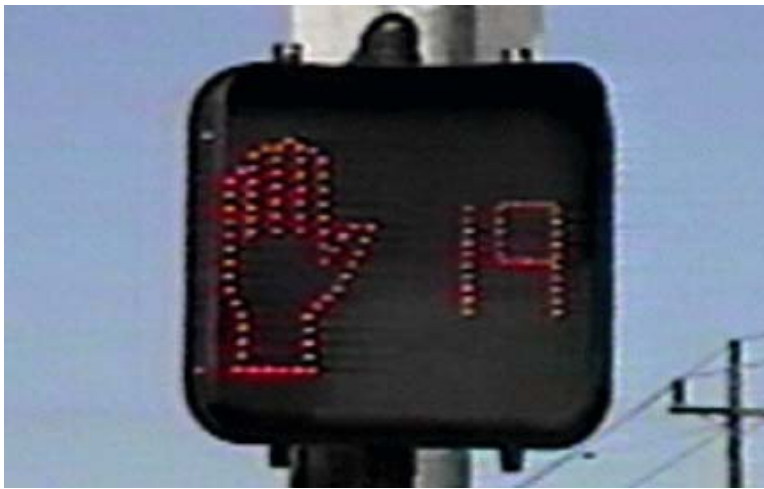
Figure 6 shows another countdown display that is integrated into the pedestrian indication. This type of display is becoming more common as countdown indications are increasing in popularity.

Figure 6 – Integrated pedestrian countdown signal
