**FINAL REPORT**

**U.F. Project No: 49104504972-12**

# **Evaluation of Early Strength Requirement of Concrete for Slab Replacement Using APT**

**Mang Tia  
Wasantha Kumara**

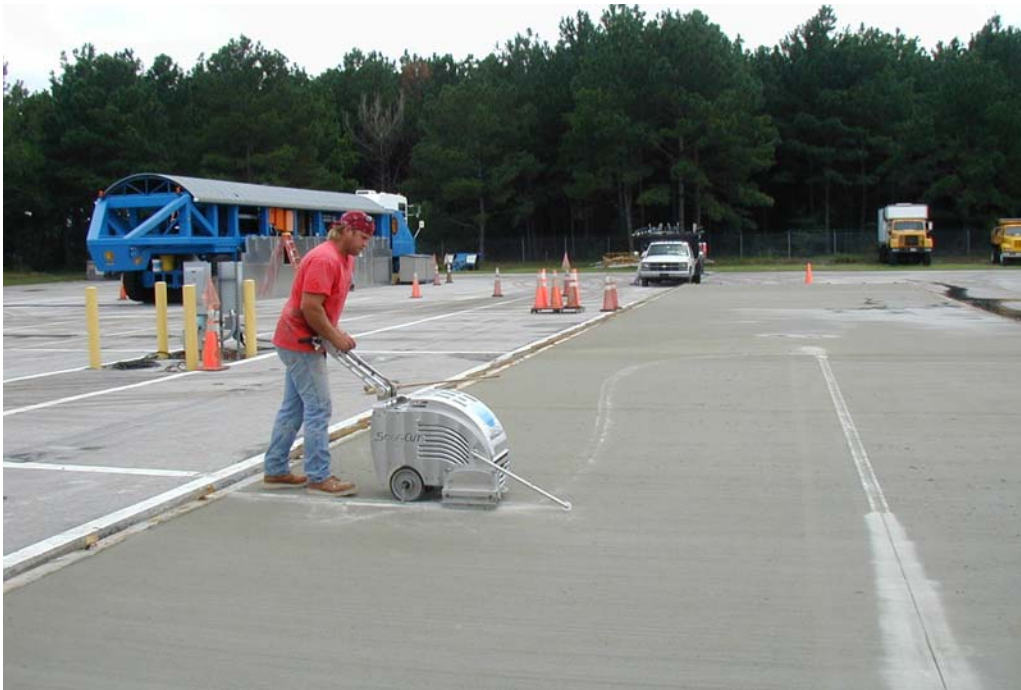
After placement and finishing of the concrete on the test track, 3-in. (7.6 cm) deep saw cuts were made to form the joints for the slabs. A diamond-bladed saw was used for these cuts to ensure a smooth, straight vertical surface. Figure 4 shows a photo of this sawing operation.

Figure 4. Making a 3-inch deep saw cut at the joint

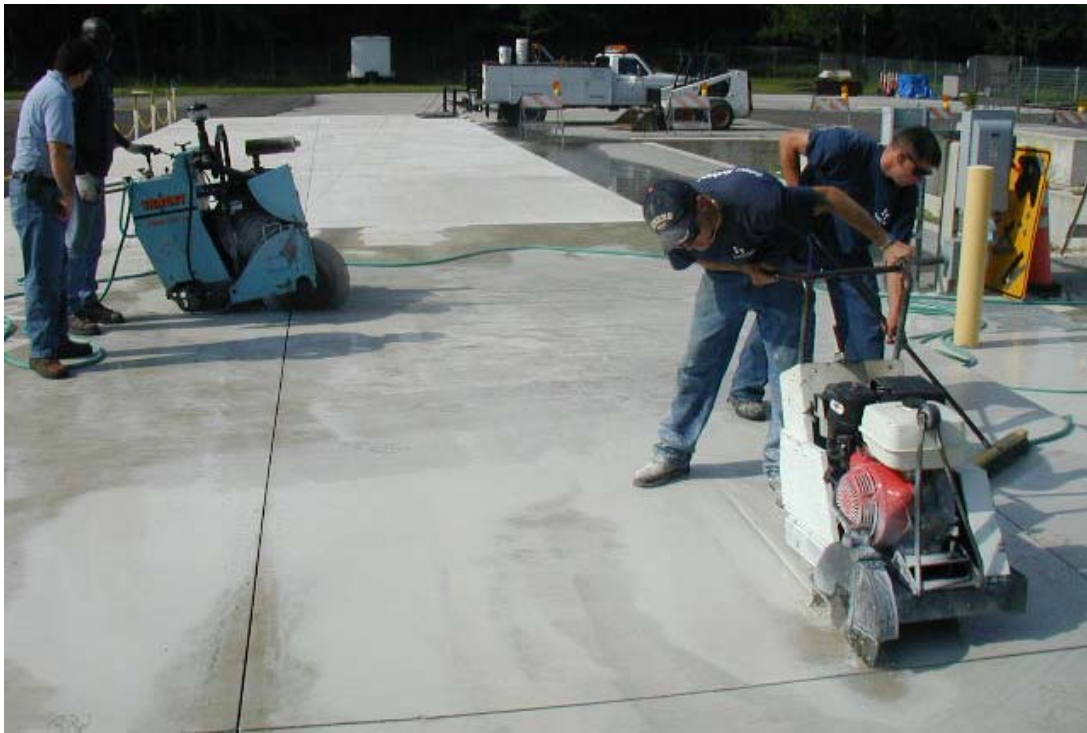
Slab removal for the first slab replacement test was conducted on July 17, 2003 under the supervision of FDOT personal. A 12 ft × 16 ft slab was separated into 3 ft × 4 ft pieces using a diamond bladed saw as shown in Figures 20 and 21. Each separated piece was removed using the weight lifter as shown in Figure 22. Special attention was given to protect the surrounding slabs. Steel plates were placed along the joint to protect the adjacent slab from damage as the broken pieces were removed, as shown in Figure 23. The damaged places of the asphalt base were patched using a cold asphalt mix and compacted using a vibrator as shown in Figure 24.

Figure 20. Cutting of a concrete slab (12 ft  $\times$  16 ft) into small pieces (3 ft  $\times$  4 ft)

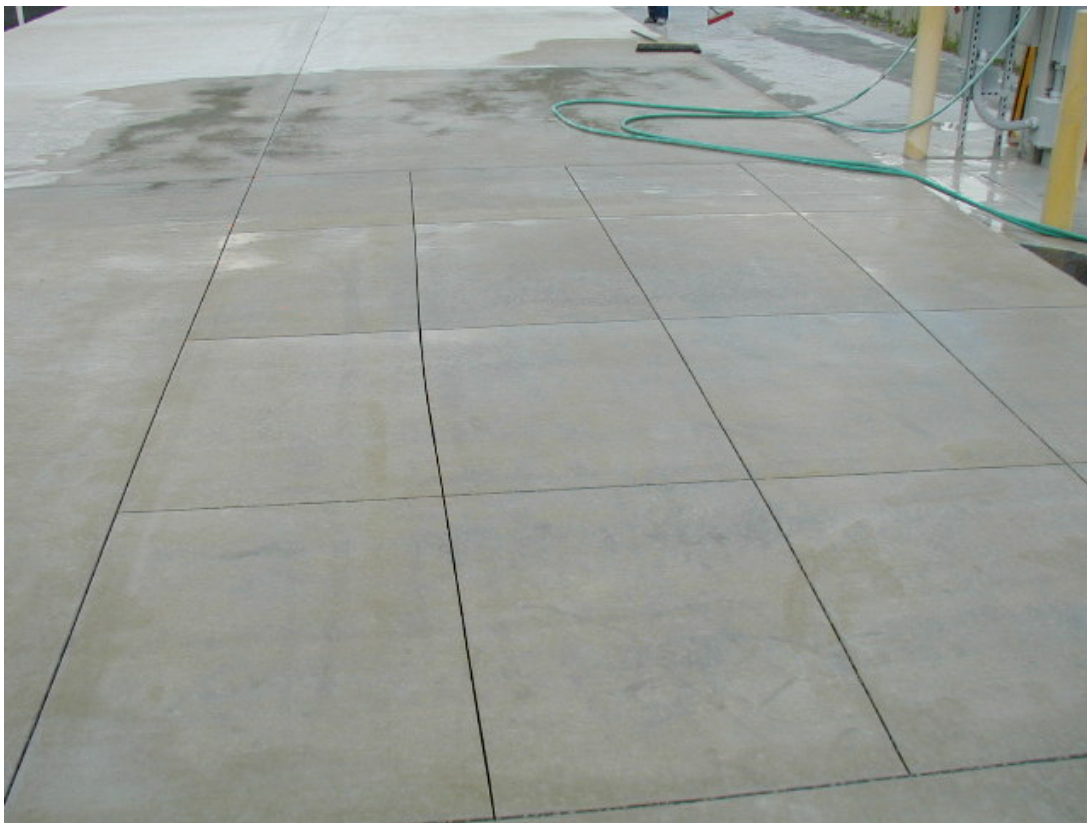
Figure 21. Separated concrete pieces after cutting with diamond bladed saw

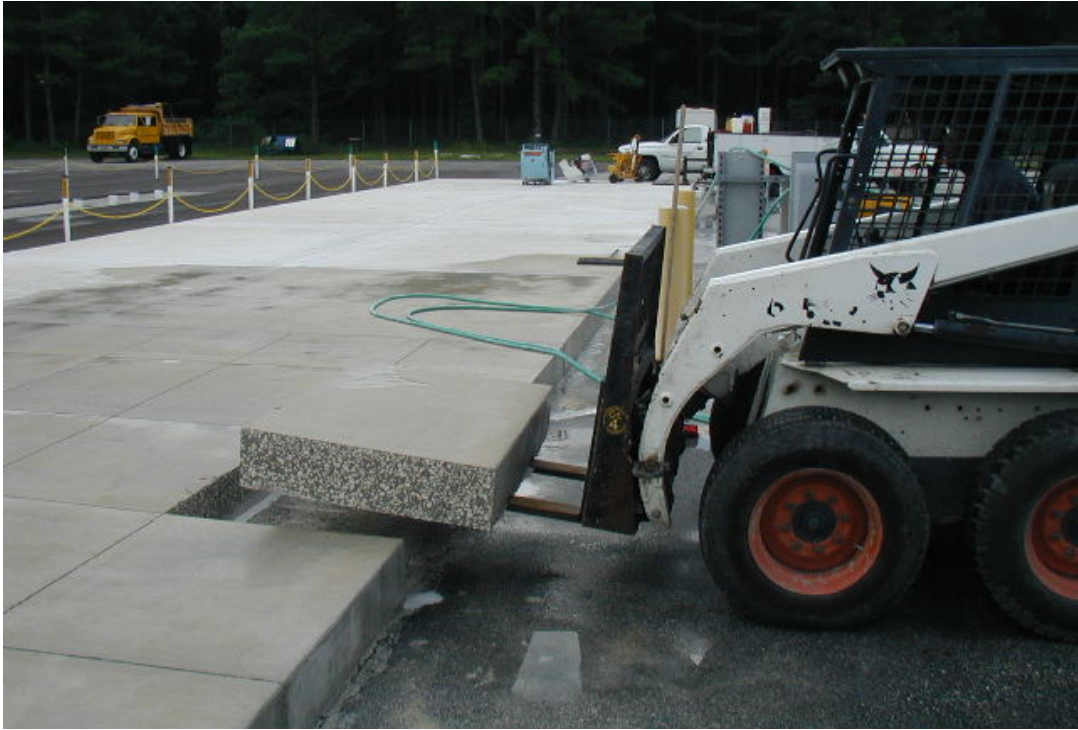
Figure 22. Removal of separated pieces using a lifter

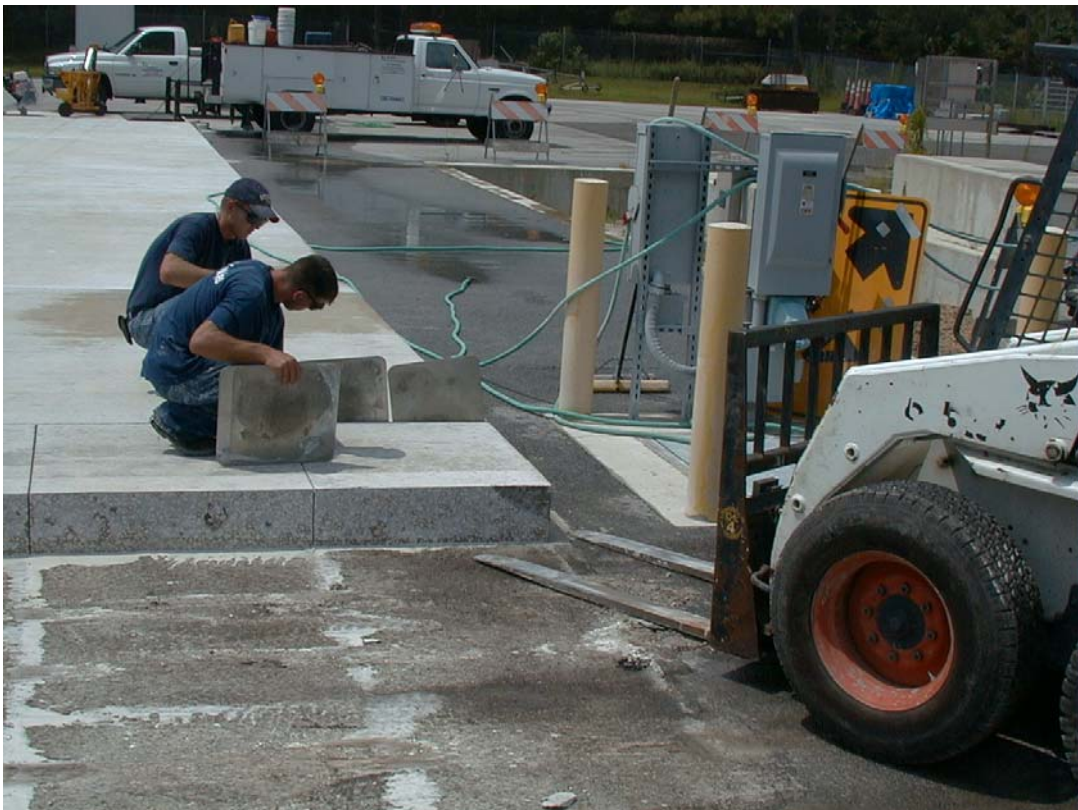
Figure 23. Removal of concrete pieces adjacent to the surrounding slabs

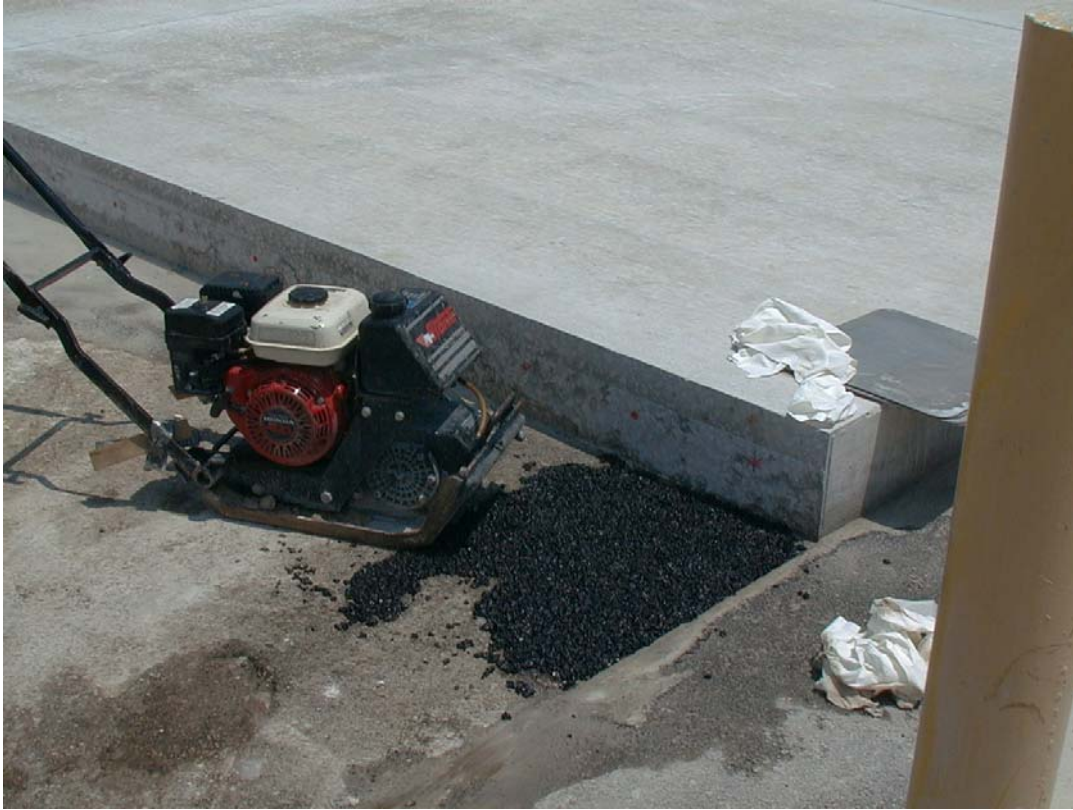
Figure 24. Correcting the damaged portion of the asphalt base

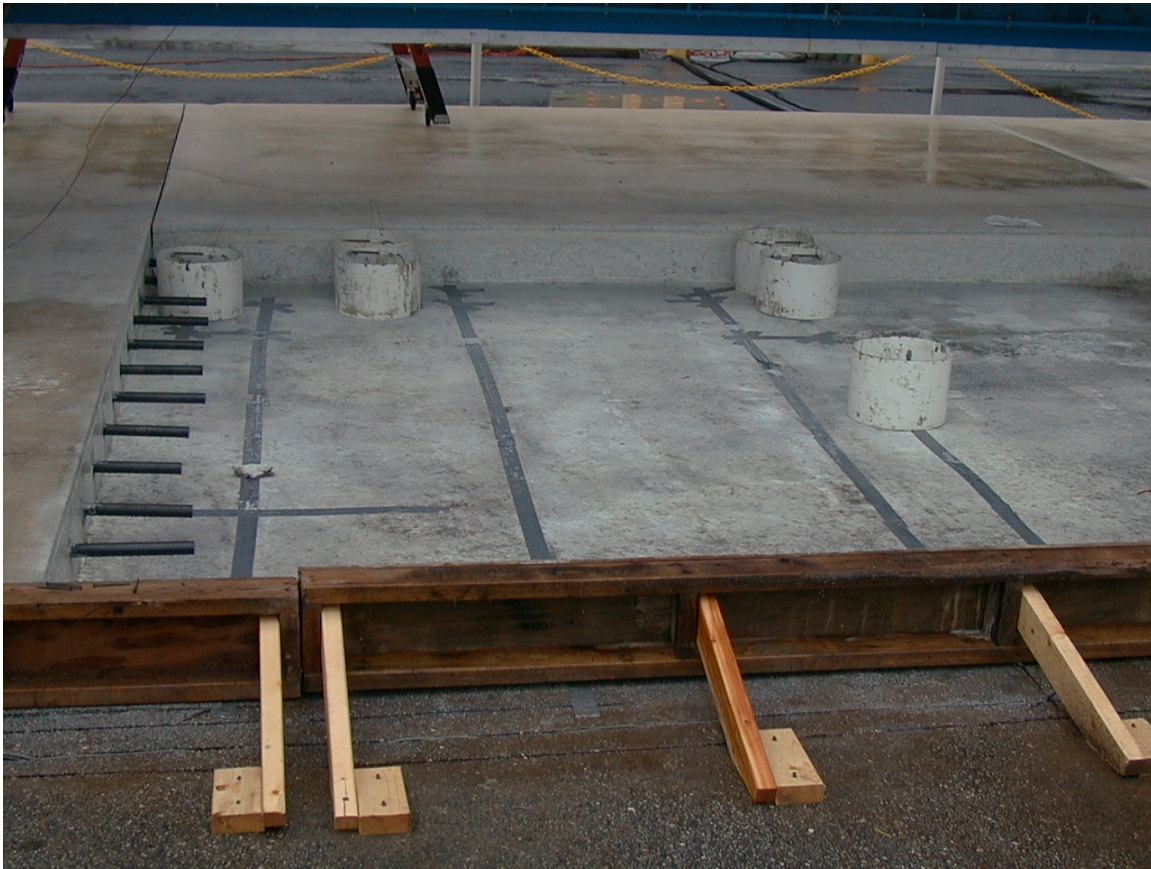
Figure 25. Dowel bars epoxied to an adjacent slab before placement of the test slab

Dowel bars were placed in drilled holes made on the adjacent slabs in one-foot intervals starting six inch from the edge. The dowel bars were fixed to the adjacent slabs using an epoxy and the open ends of the bars to be embedded in the concrete of the test slab were sprayed with a lubricant to allow movement in the longitudinal direction. Figure 25 shows the dowel bars epoxied to an adjacent slab before placement of the concrete test slab.

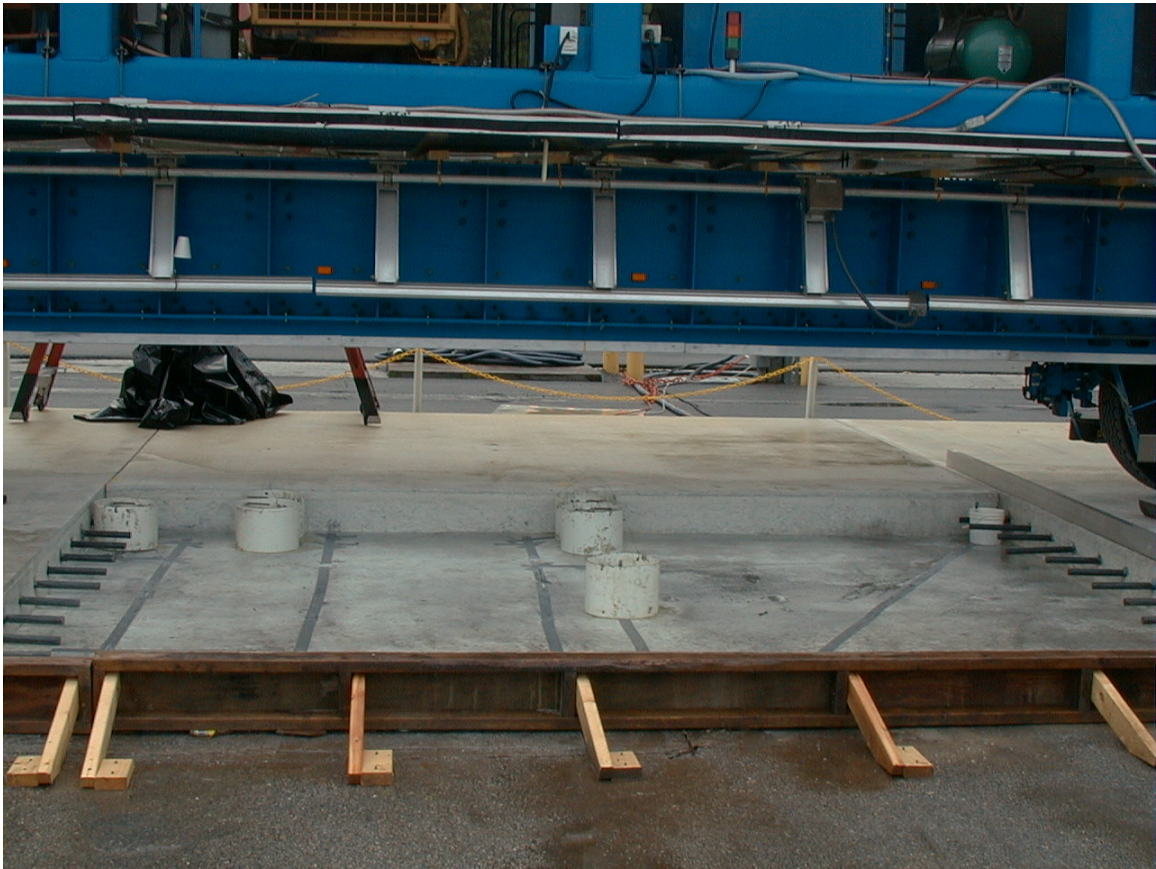
The first test slab (1C) to be replaced was confined by three adjacent slabs and had one free edge. Figure 27 shows the formwork for the free edge of Slab 1C. The other four test slabs (1G, 2C, 2E & 2G) to be placed were free at both longitudinal edges. So formwork was used for on both edges of these test slabs.

Figure 27. Formwork for the free edge of Test Slab 1C

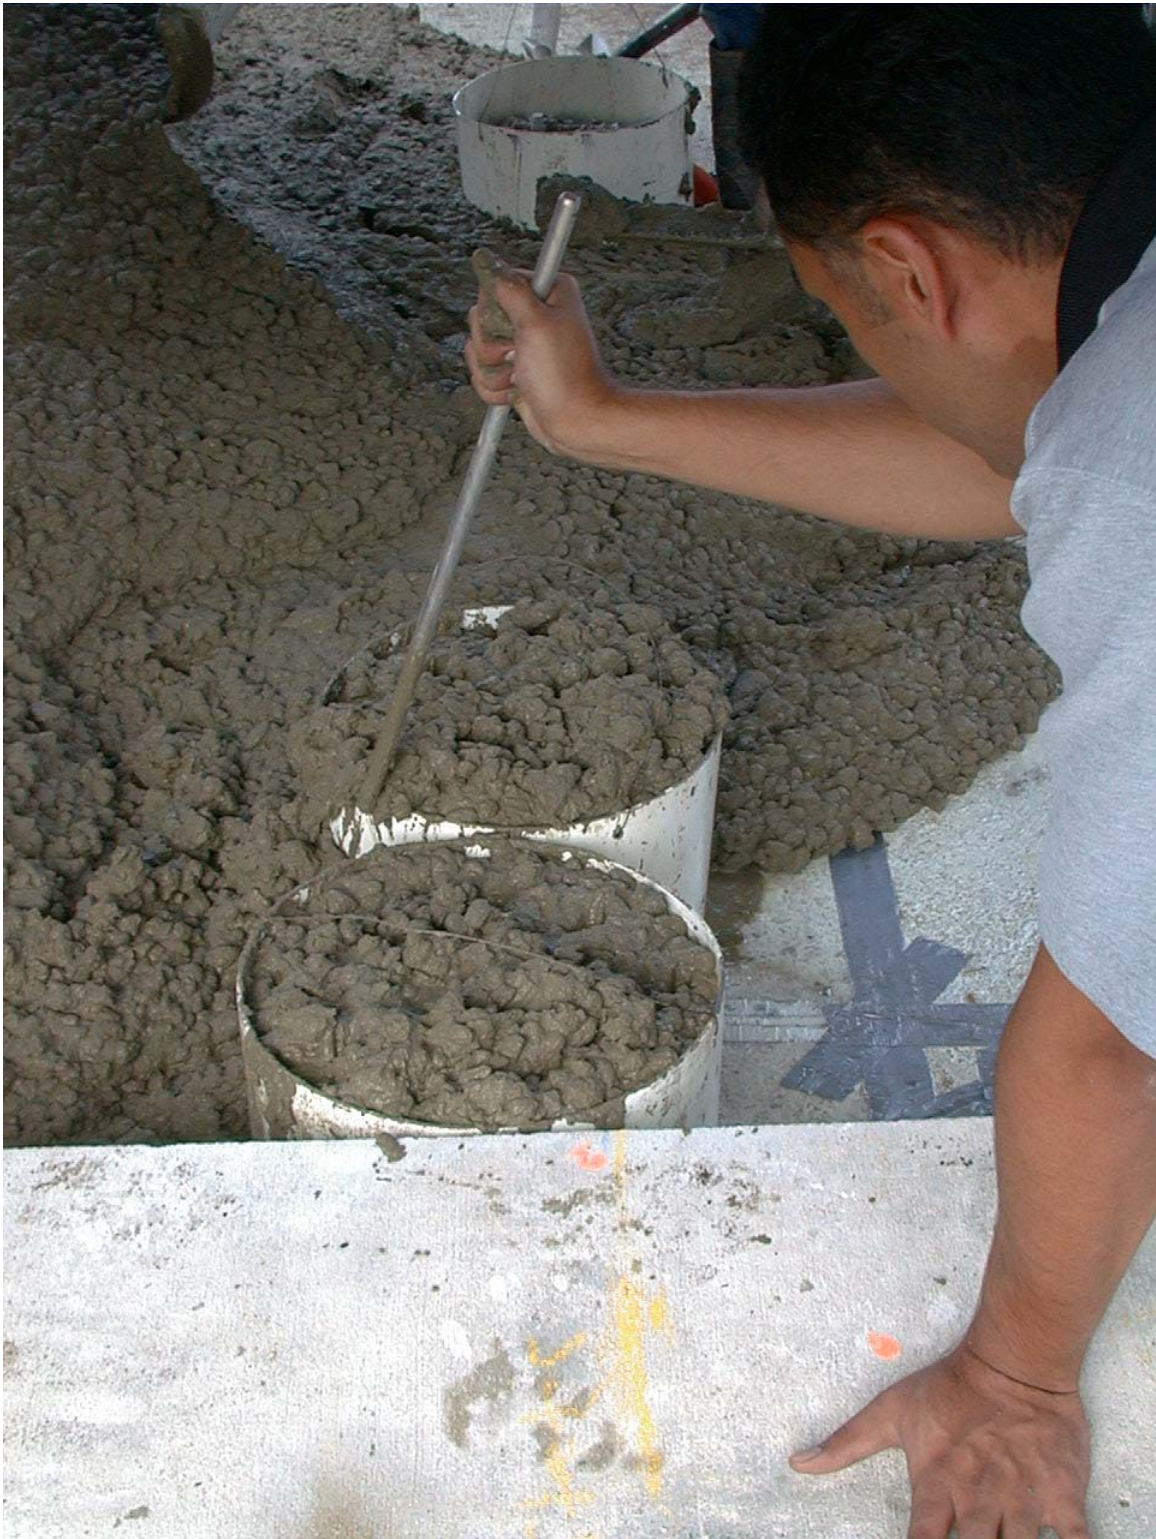
PVC pipes were placed around the strain gauges to protect them from concrete handling instruments during the placement of concrete. The concrete was placed manually around the strain gauges inside the PVC pipes. Figure 28 shows a picture of how the concrete was placed in two PVC cylinders where the strain gauges were held in position. After the concrete was placed to the same thickness on both the inside and outside of the PVC pipe, the PVC pipe was then pulled out manually. Figure 29 shows the placement of concrete for a test slab. The concrete was placed manually in the wooden blocks where the dummy strain gauges were located. Figure 30 shows the placement of concrete around the dummy gauges. Vibrators were used to consolidate the concrete in the test slab and the dummy gauge blocks.

Figure 28. Placing concrete around strain gauges

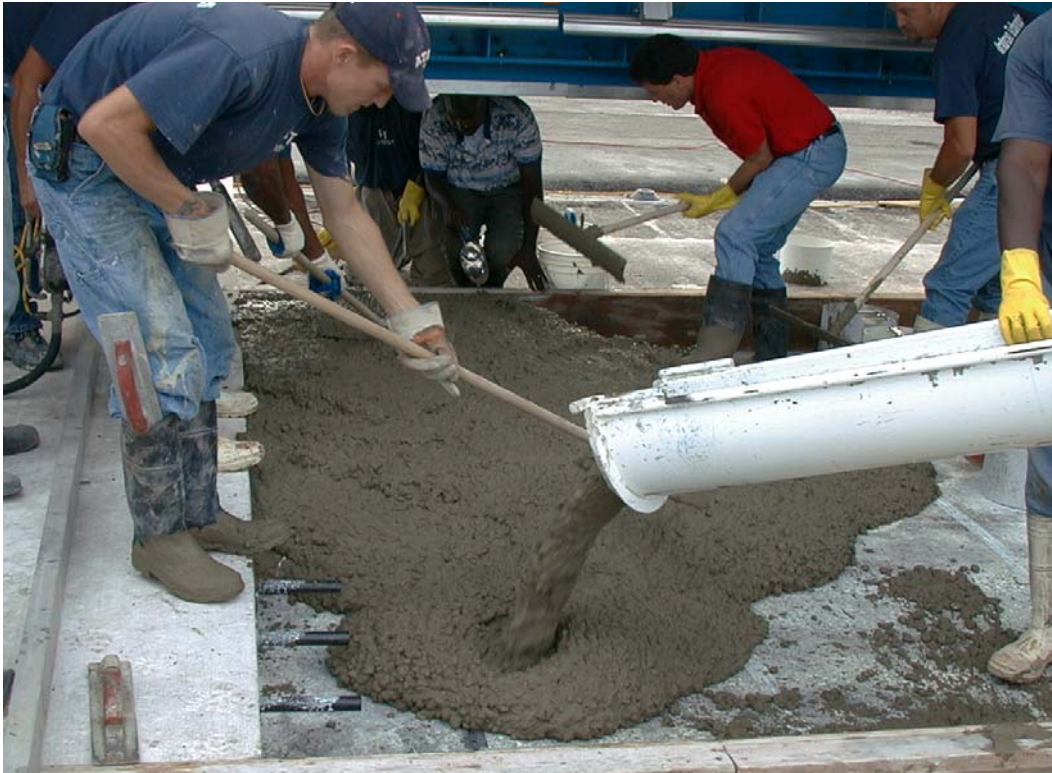
Figure 29. Placement of concrete for a test slab

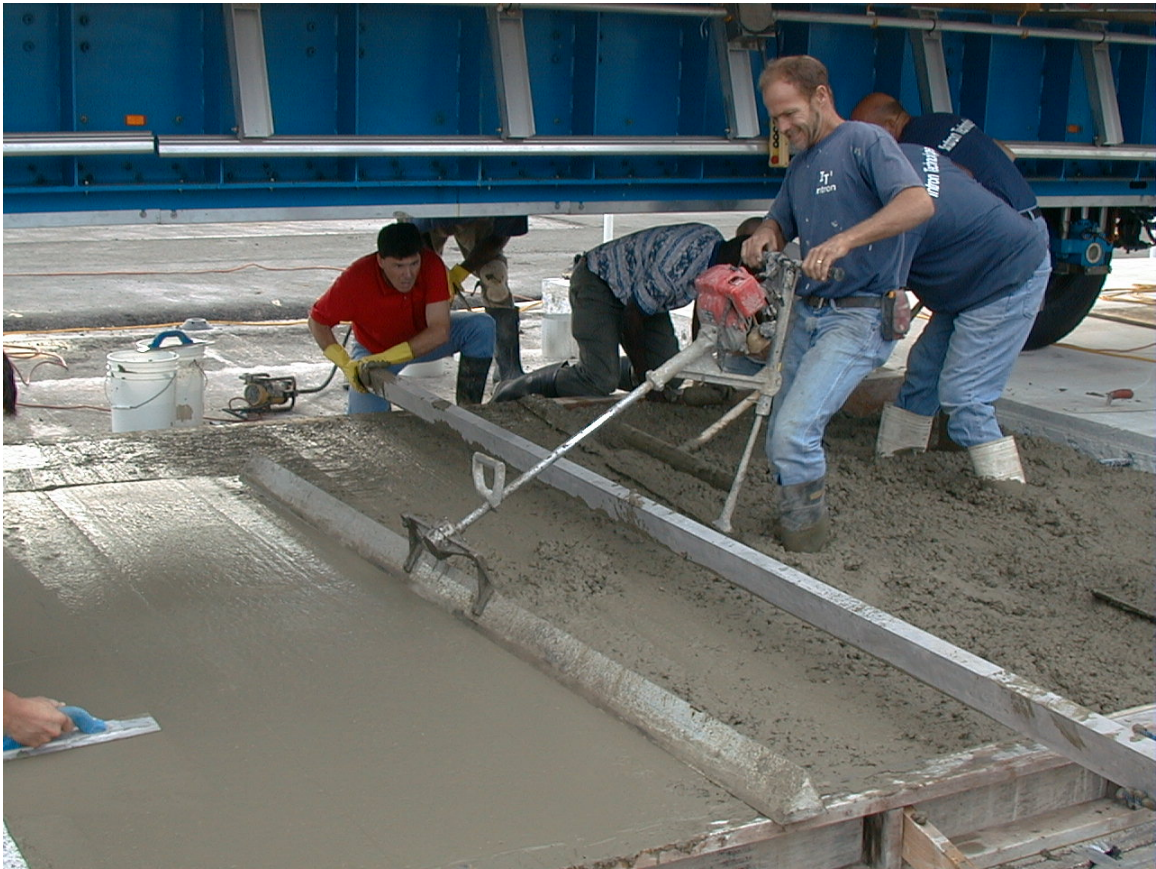
Figure 31. Leveling of concrete surface

A vibrating leveling bar was used to level off the concrete. Figure 31 shows the leveling of the concrete surface of the test slab. The concrete surface was finished with additional hand troweling. A broom was passed over the concrete surface to produce a rough surface texture before it hardened. After placement and finishing of the concrete, 3-in. (7.6 cm) deep saw cuts were made to form the joints for the slabs. Figure 32 shows a picture of this sawing operation.

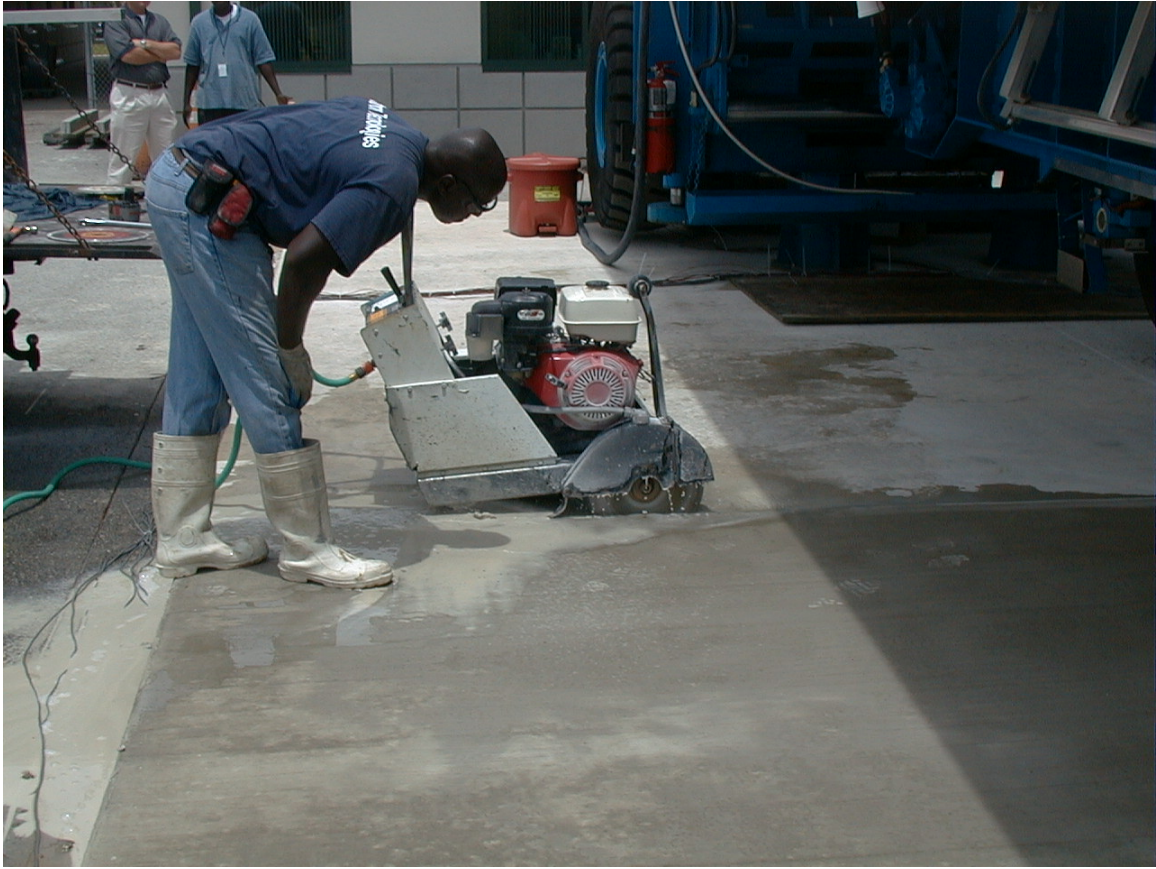
Figure 32. Making a 3-inch deep saw cut at the joint

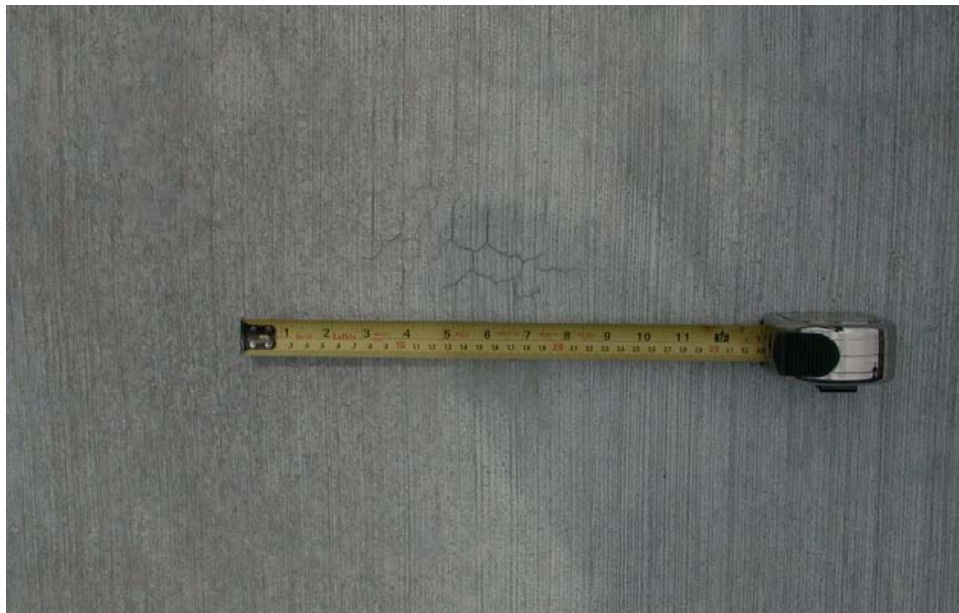
Figure 42. Shrinkage cracks on Test Slab 1C

Shrinkage cracks were observed at a few places on the finished surface of Slab 1C within a few hours after the placement of the concrete. Figure 42 shows the shrinkage cracks induced on the slab. The first load related crack was detected on the 15<sup>th</sup> day of loading, which was one day after the load had been increased to 18 kips. The first detected crack was a corner crack, which occurred on the wheel path at the north end of the slab. Figure 43 shows a picture of this corner crack. This corner crack extended from the joint at 25 inches from the edge to the edge at 35 inches from the joint. HVS loading was continued for another day, at which point another corner crack, which extended from the joint at 47 inches from the edge, was observed. Figure 44 shows a picture of the cracked Slab 1C at the end of HVS testing. Figure 45 shows the initial and final crack map for Slab 1C.

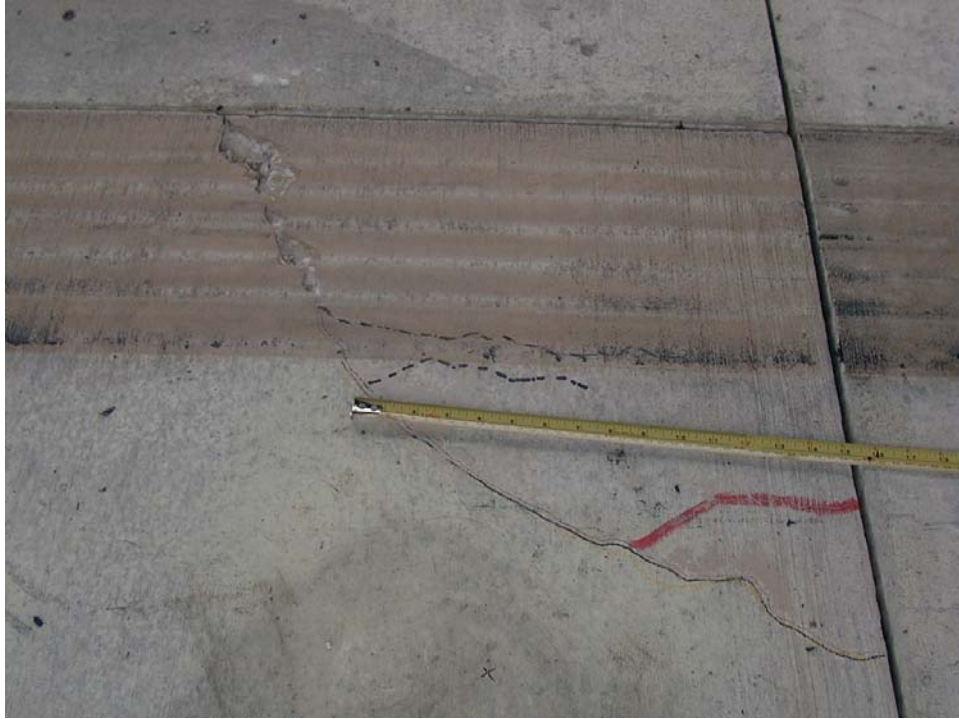
Figure 43. Corner crack on Slab 1C

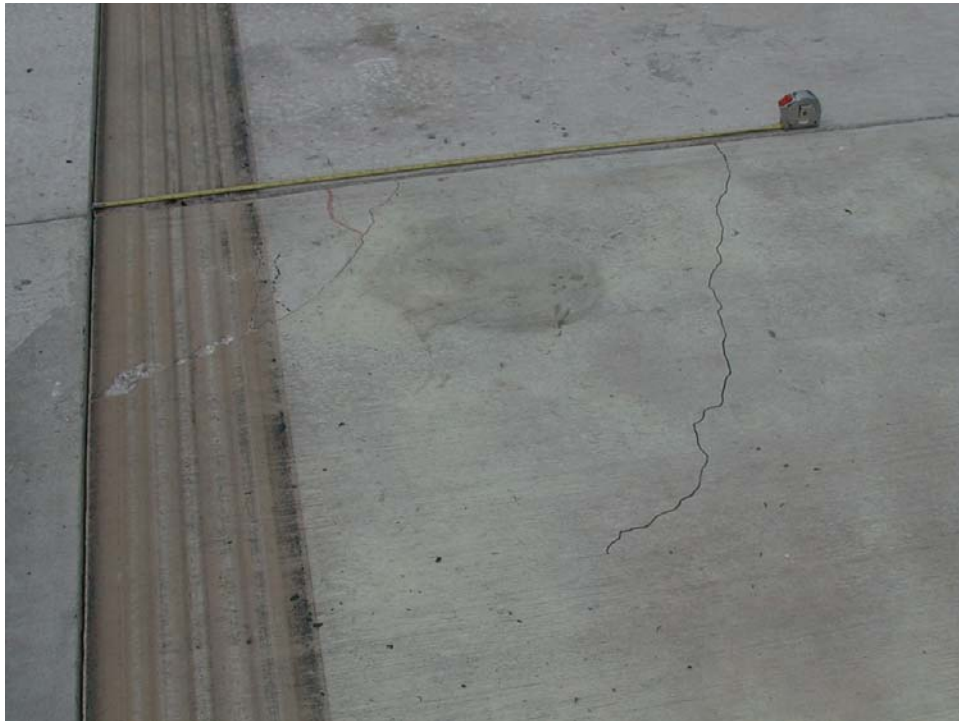
Figure 44. Cracked Slab 1C at the end of HVS testing

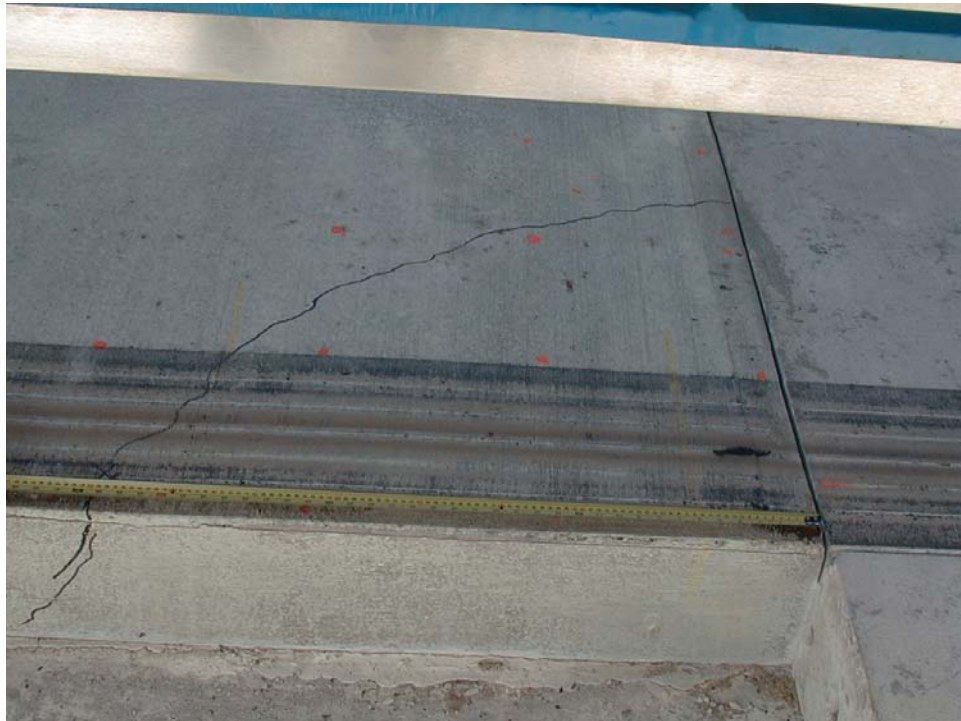
For Slab 1G, cracking was detected after 11 days of HVS loading and 2 days after the HVS load was raised to 15 kips, with a total of 107,152 load repetitions at 12 kips and 20,464 load repetitions at 15 kips. At the southern end of the slab, there was a corner crack, which extended from the joint at 30 inches from the edge to the edge at 33 inches from the joint. This crack happened to run over the location of strain gauge no. 3. Figure 46 shows a picture of this corner crack. There was also a similar crack on the northern end of the slab, which extended from the edge at 34 inches from the joint. However, this crack did not propagate all the way to the joint. In addition to the corner cracks, there were two transverse cracks at the mid-edge of the slab (89 and 100 inches from the southern joint of the slab). Figure 47 shows the transverse cracks at the mid-edge of the slab. These cracks propagated towards the center of the slab with additional HVS loading. Figure 48 shows the propagation of the mid-edge cracks with additional

Figure 46. Corner crack at the southern end of Slab 1G

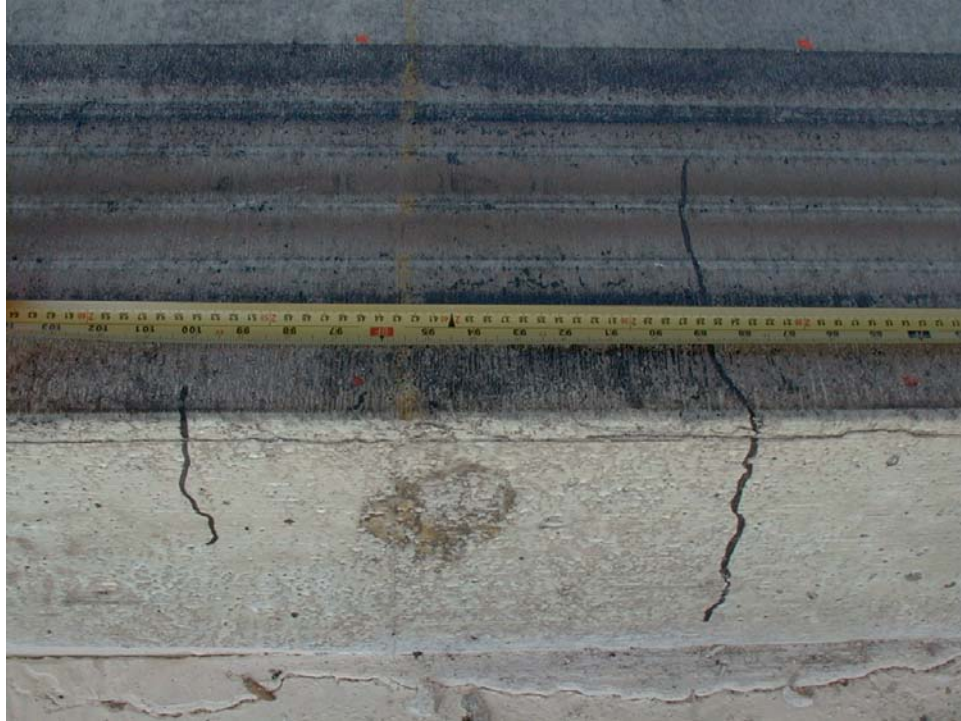
Figure 47. Transverse cracks at the mid-edge of Slab 1G

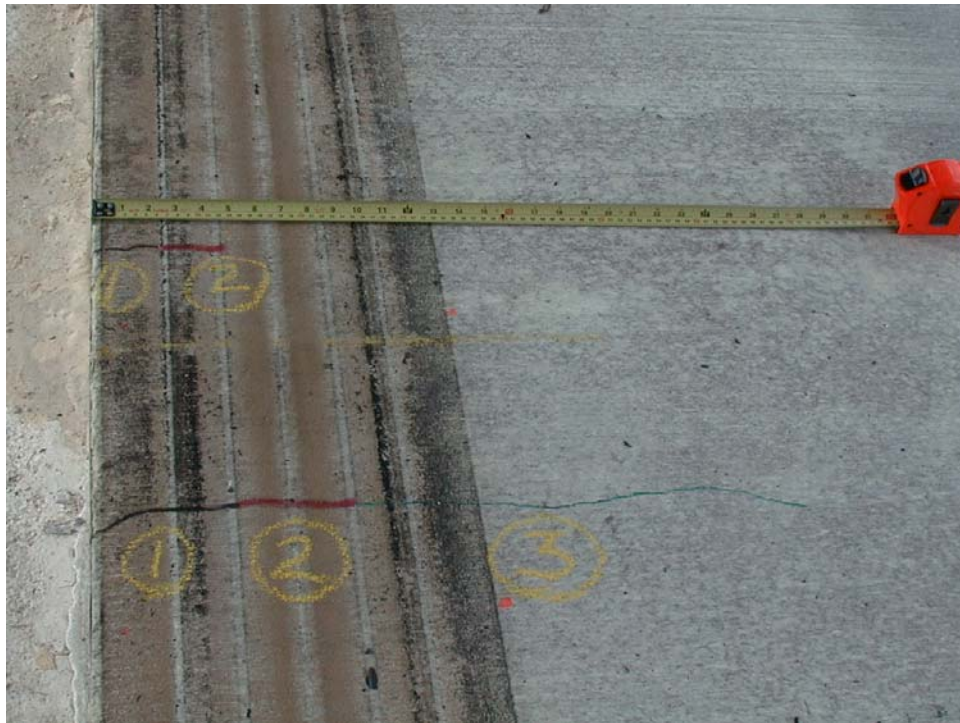
Figure 48. Crack propagation at the mid-edge of Slab 1G with additional loading

loading. The portions of the cracks that are marked as 1, 2 and 3, as shown in the picture, indicate the amount of crack propagation on the 1<sup>st</sup>, 2<sup>nd</sup> and 3<sup>rd</sup> day after crack initiation.

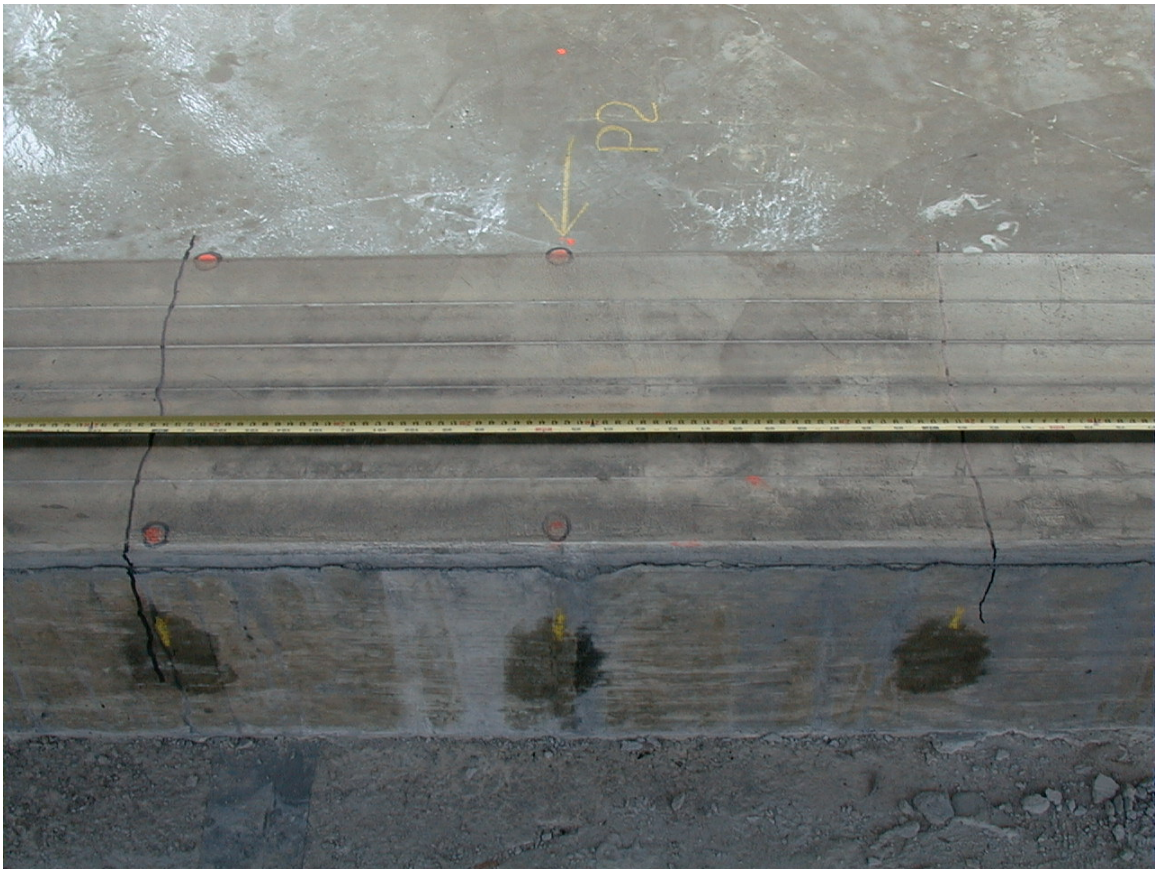
For Slab 2C, cracks were first detected after 3 days of HVS loading, with a total of 33,176 load repetitions at 12 kips. There were two transverse cracks at about 1 foot off from the center of the slab on the wheel path. Figure 50 shows a picture of these two transverse cracks. Additional hairline cracks were detected after 7 days of loading, with a total of 82,243 load repetitions at 12 kips. Figure 51 shows a picture of the cracks on Slab 1C after 7 days of HVS loading. Figure 52 shows the initial and final crack map of Slab 2C.

Figure 50. Transverse cracks at mid-edge of Slab 2C

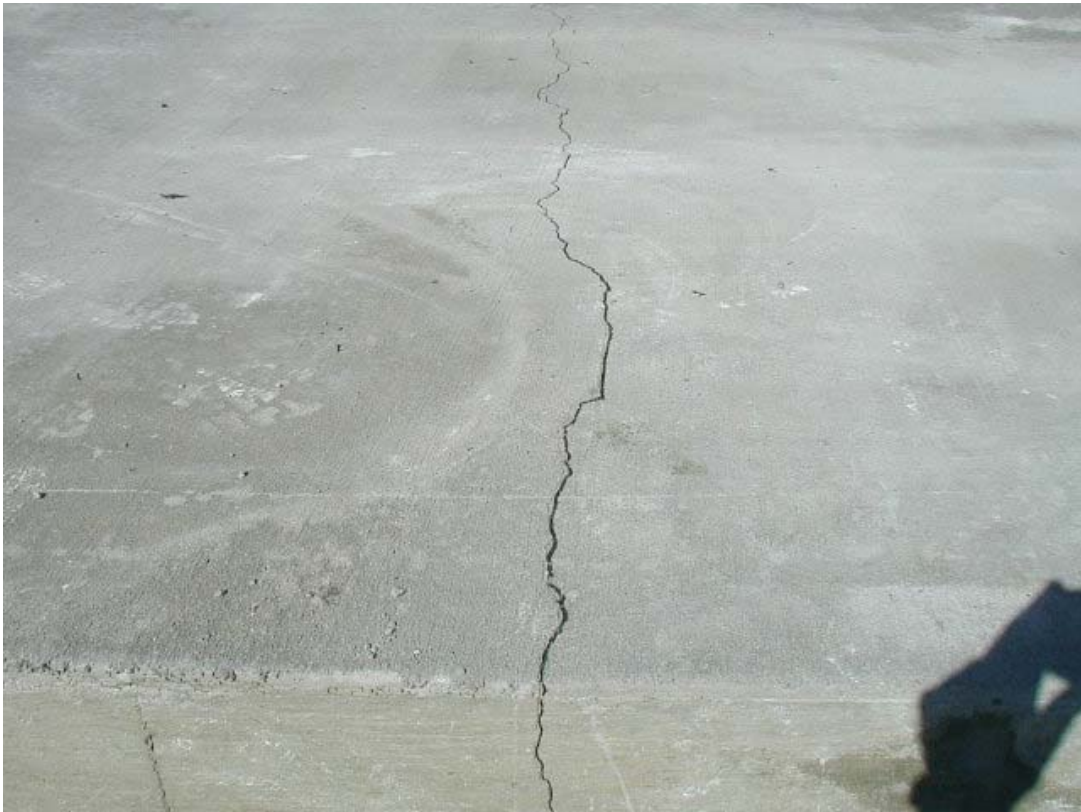
For Slab 2E, cracks were first detected at the 7<sup>th</sup> day after the start of HVS loading, with a total of 40,809 load repetitions at 12 kips. The HVS loading was halted for 3 days due to a mechanical problem with the HVS after 3 days of loading. A transverse crack was first detected one day after HVS loading at 12 kips was resumed (or at the 7<sup>th</sup> day of test). This crack extended from the loading edge to the opposing edge at the middle of the slab. Figure 53 shows the transverse crack that developed on Slab 2E. Figure 54 shows the crack map of Slab 2E.

Figure 53. Transverse crack on Slab 2E at the middle of the slab

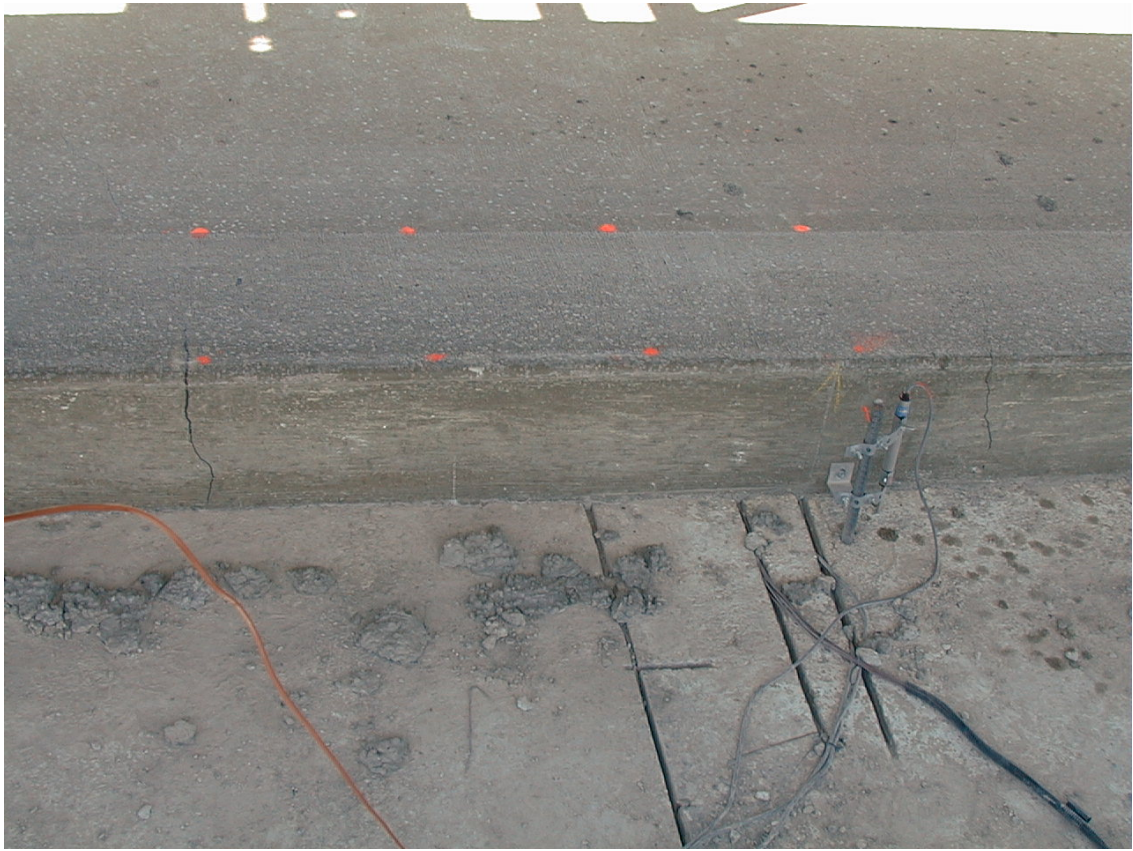
For Slab 2G, the first crack was detected at the 6<sup>th</sup> day of loading with 50,933 passes of HVS wheel load at 12 kips. Two transverse cracks were noted to start from the edge. One transverse crack started at 9 inches south of the mid-point, while the other started at 36 inches north of the mid-point. Figure 55 shows a picture of the transverse cracks that developed on Slab 2G. Figure 56 shows the initial and final crack map of Slab 2G.

Figure 55. Transverse cracks on Slab 2G at the middle of the slab
