## **FINAL REPORT**

| <p><b>SITE PREPARATION FOR A DEEP FOUNDATION<br/>TEST SITE AT THE UNIVERSITY OF CENTRAL FLORIDA</b></p> |

# FINAL REPORT

## Site Preparation for a Deep Foundation Test Site at the University of Central Florida

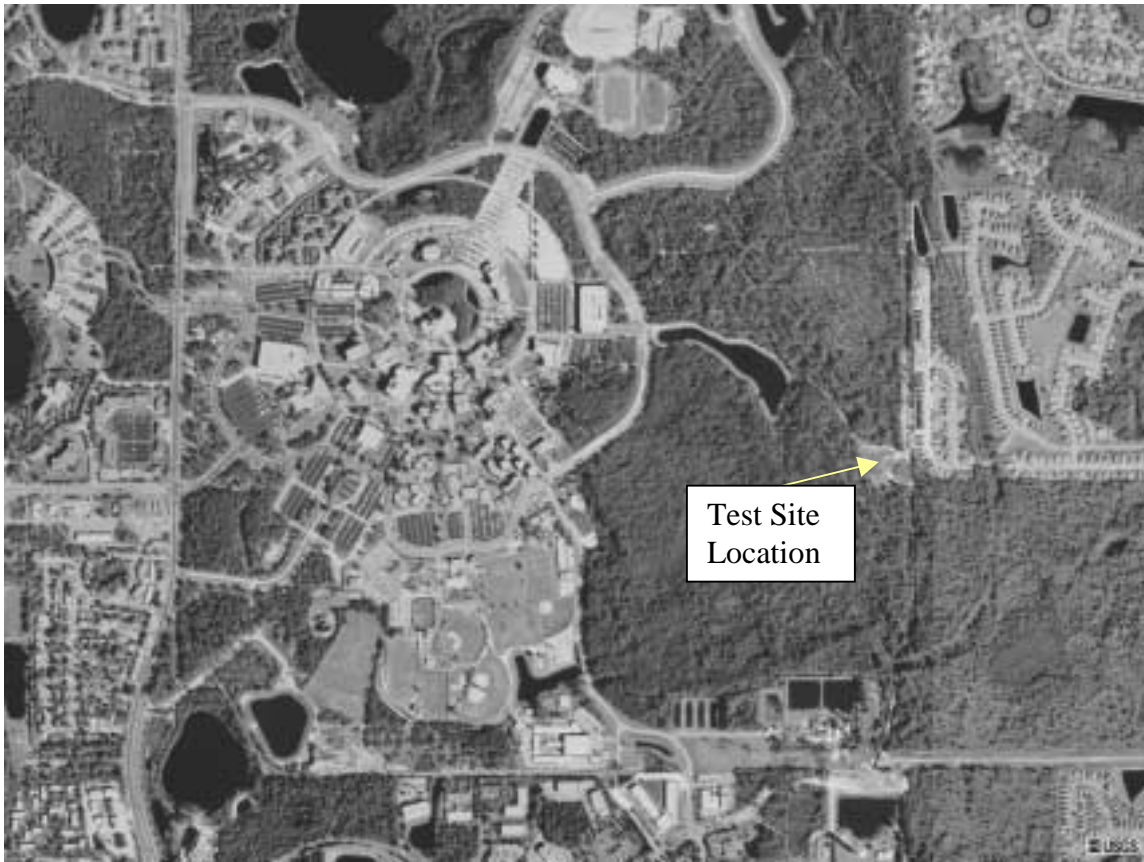
Figure 1 - UCF/FDOT Test Site at the University of Central Florida

A site was selected along the east boundary of the University of Central Florida as shown in Figure 1. The site was cleared and grubbed in October 2001. All debris was removed and the site was graded level. The cost for this part of the project was \$8650.

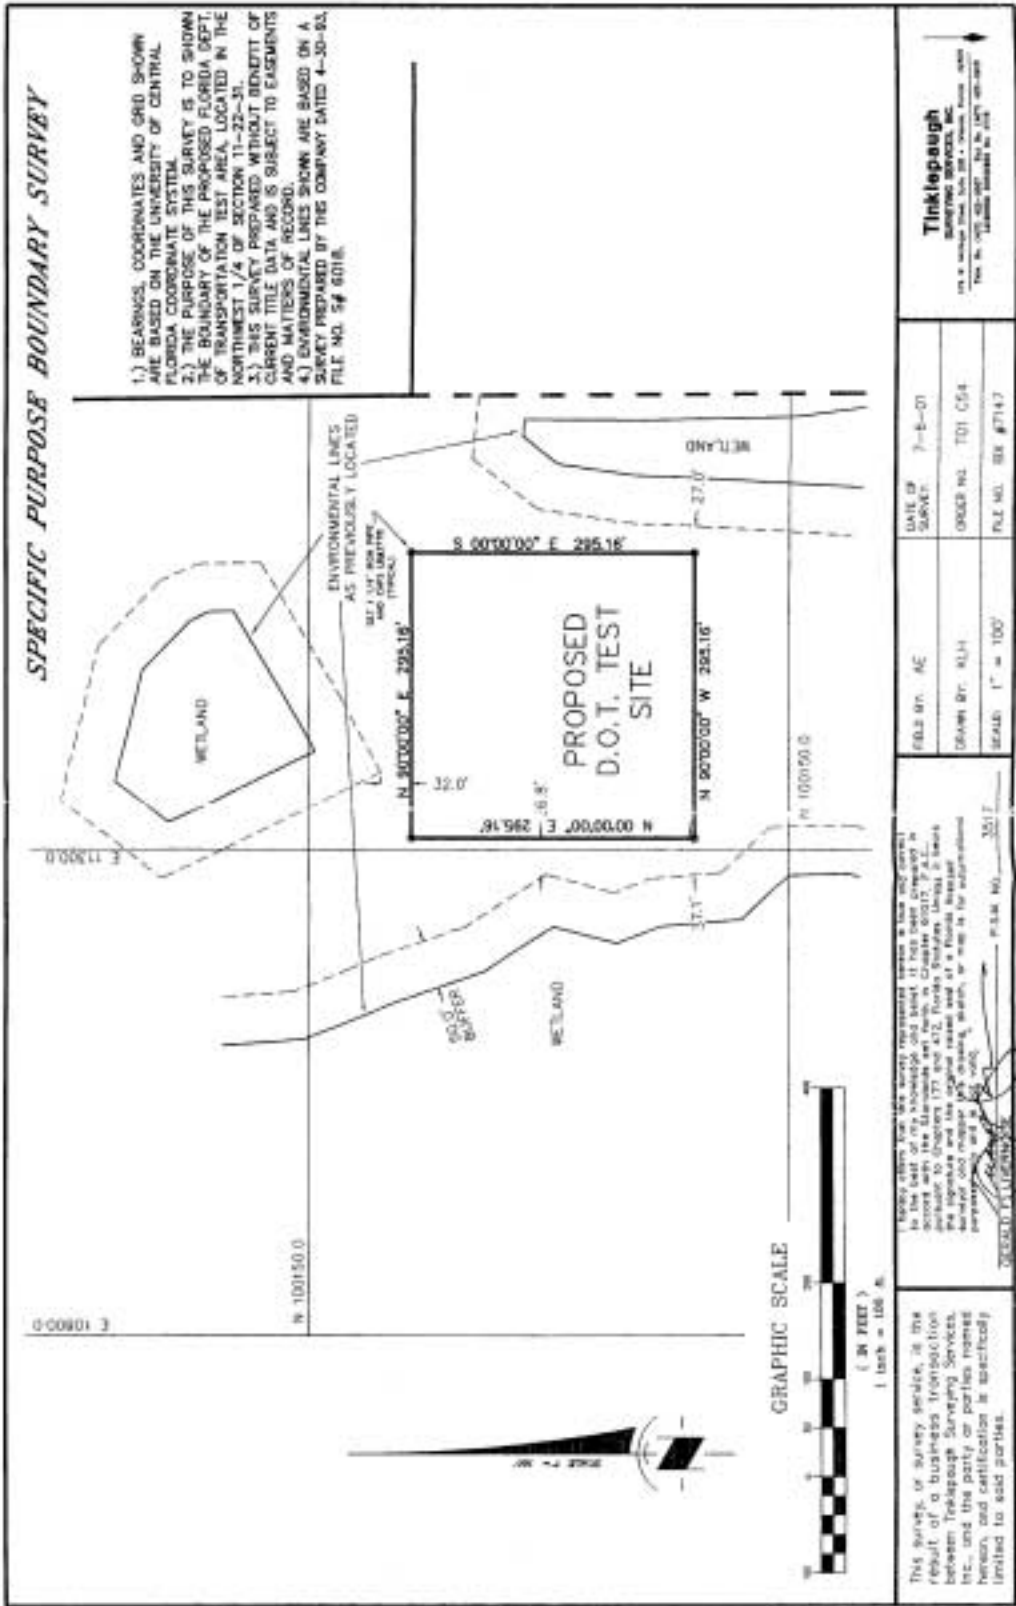
Figure 2 - Initial Site Survey to show Boundary of Test Site

An initial survey of the site was conducted in July 2001 to determine the location of the site. It showed the four corners and the boundary of the site. This survey is attached as Figure 2.

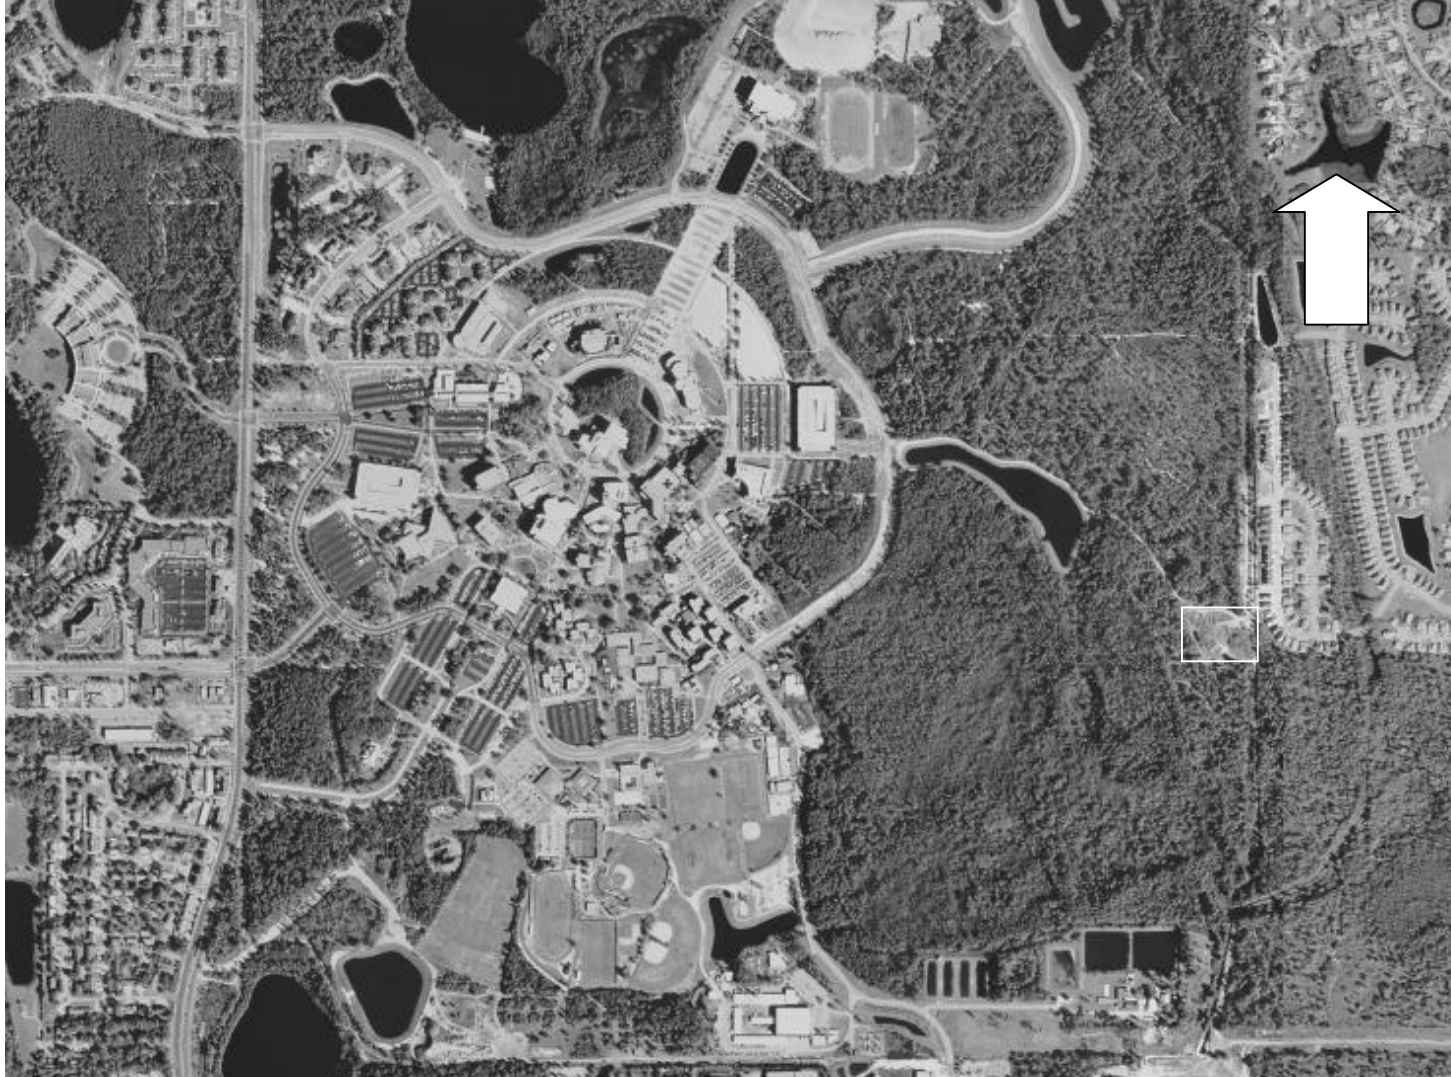
Figure 1. Aerial View of the UCF Research Site

Site characterization is the preliminary phase in foundation selection and design. An experimental test site located in the proximity of the University of Central Florida (UCF), Orlando has been selected for evaluating deep foundations. The test site is about 300 feet by 300 feet, has been cleared of trees and bushes, and is protected with a fence. Topographically, the lot is flat and there are no significant differences in elevation through the site. Figure 1 is an aerial view of the research site.

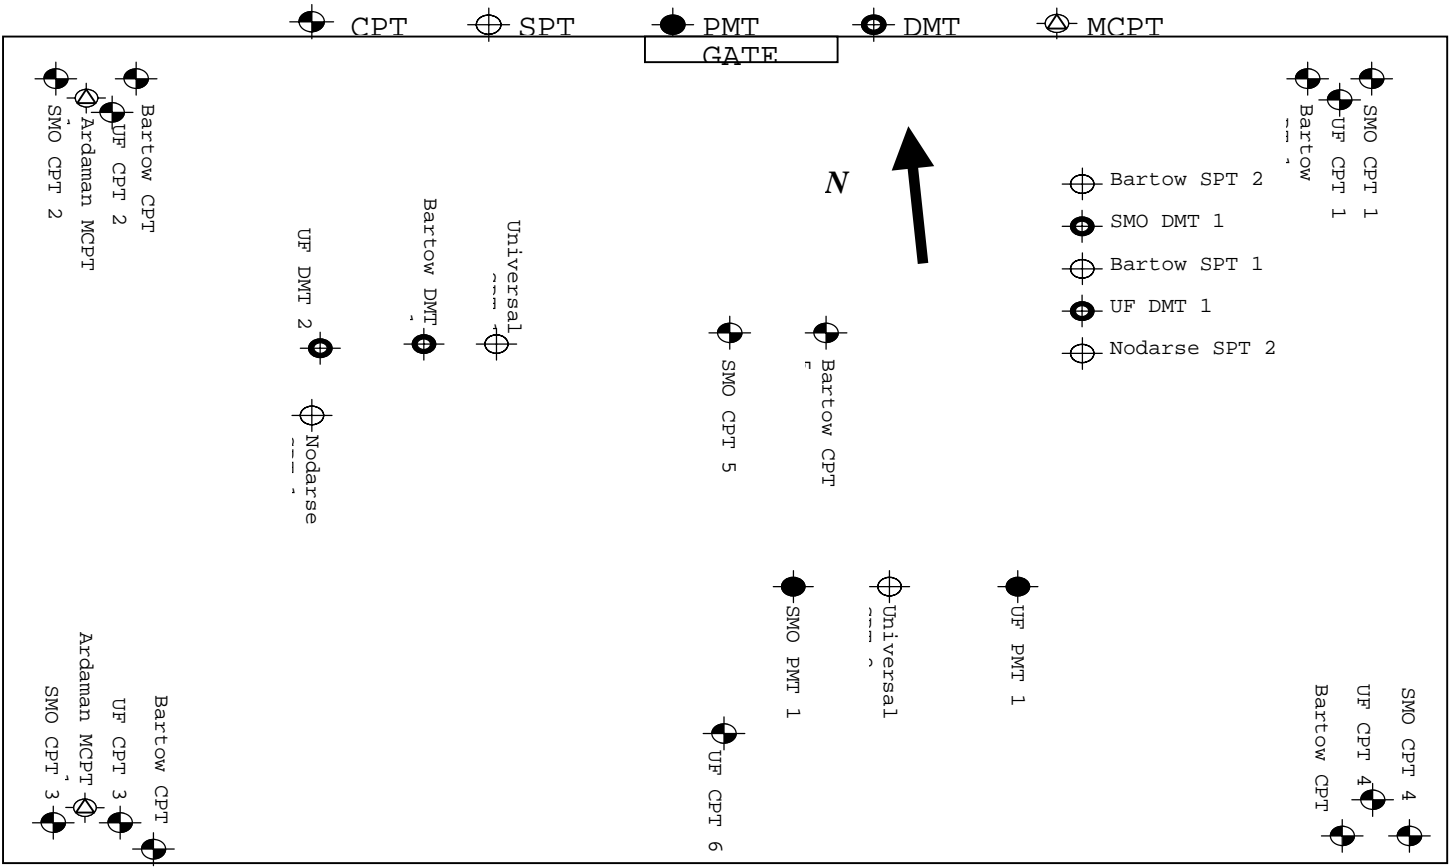
Figure 2. Boring and Sounding Plan

Bartow SPT # 1 and # 2 are located on same area of the site on a straight-line heading North (see Figure 2). At the location of this group of borings the goal was to try to compare the use of hollow stem auger versus the use of casing to maintain an open hole. The same automatic hammer was used to perform both tests. As shown in the Figure 4, little difference between the boring results was found. The SPT-N blow count at the same depth is very similar, but the simultaneous energy measurements indicate substantial differences between the two borings. Both bore holes were drilled using an automatic hammer. Note that there may be errors associated with the energy measurements for Bartow SPT 1 by SMO due to a bad cable. GRL-PDI assisted with simultaneous measurements and assisted SMO personnel with troubleshooting the system (see Table 7).

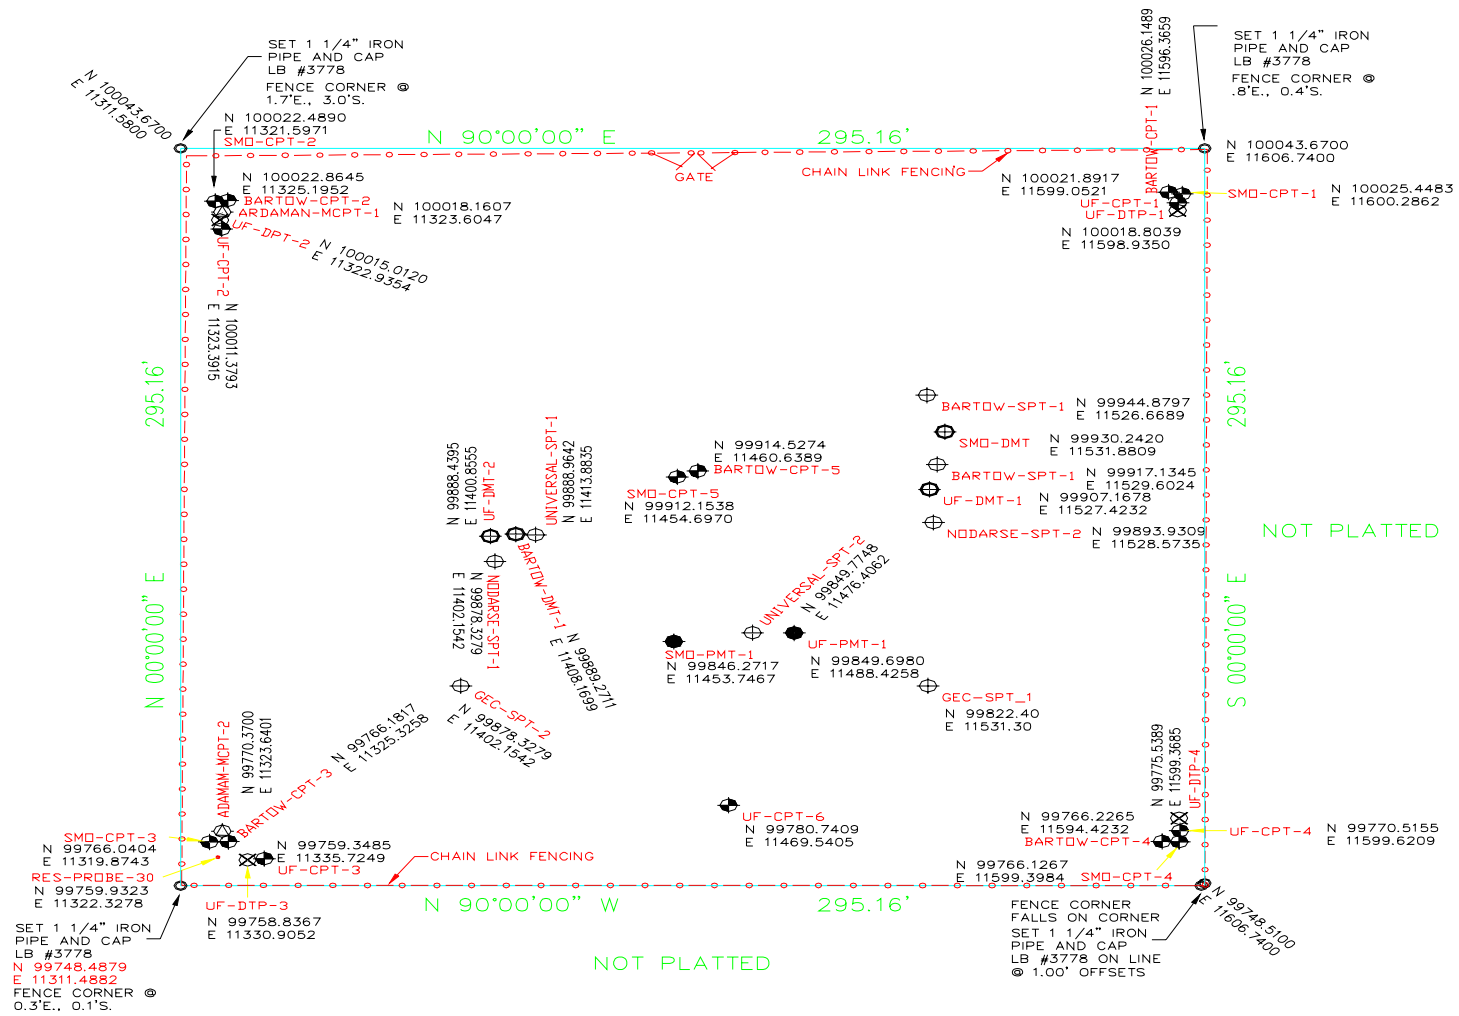
Figure 3. Plan View of the Site with the Exact Location of the Tests Performed

Upon completion of all the site investigation activities, it was determined that an accurate survey of the site was needed to document the locations of the various tests, namely, SPTs, CPTs, DMTs and others. This second survey was conducted in August 2002 and is attached as Figure 3.

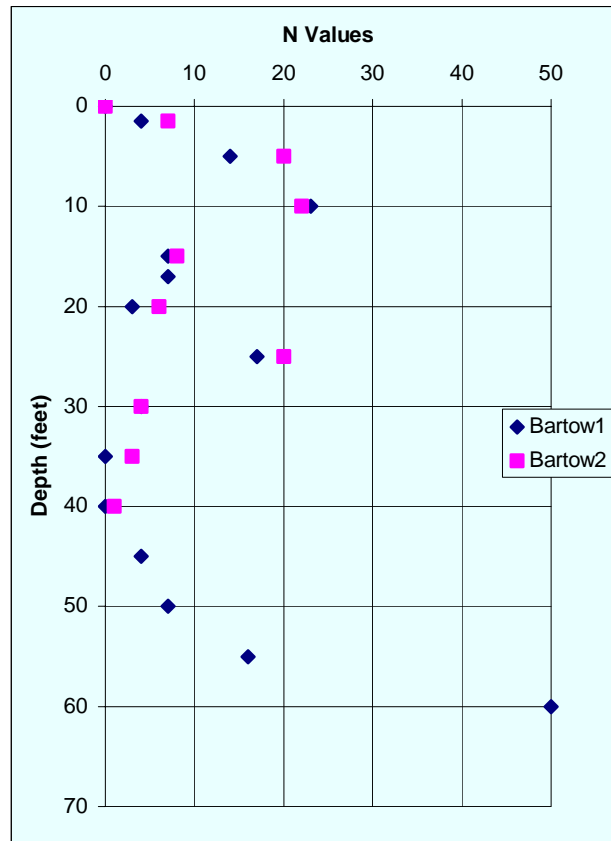
Figure 4. Energy Analysis SPT Group East

Bartow 1  
Using casing to  
Depth 50'

Bartow 2  
Using Hollow  
Stem Auger

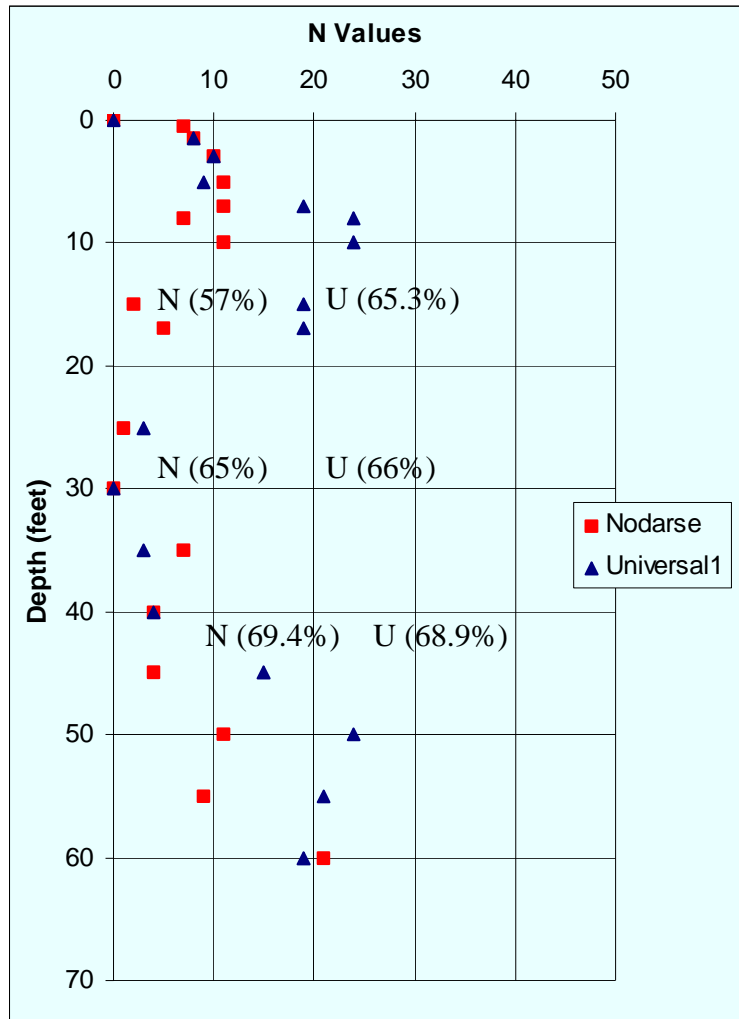
Figure 5. Energy Analysis SPT Group West

Note: An appreciable difference of N values exists between the SPT's from 8 to 17 feet. Probable cause is due to existence of hardpan layer located at this same depth. Both are mudded holes (Bentonite).

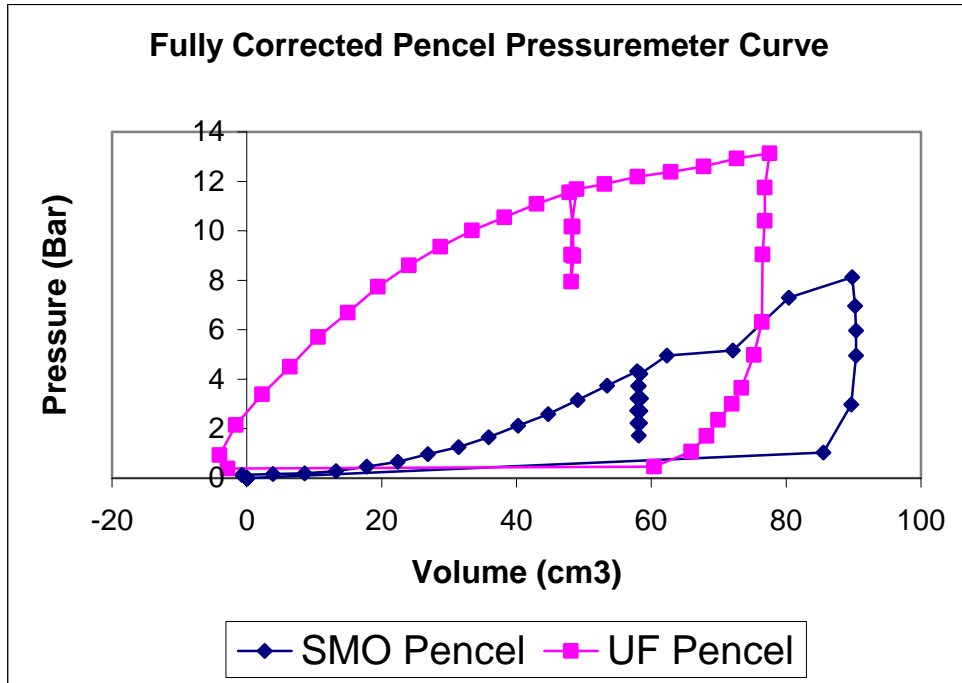
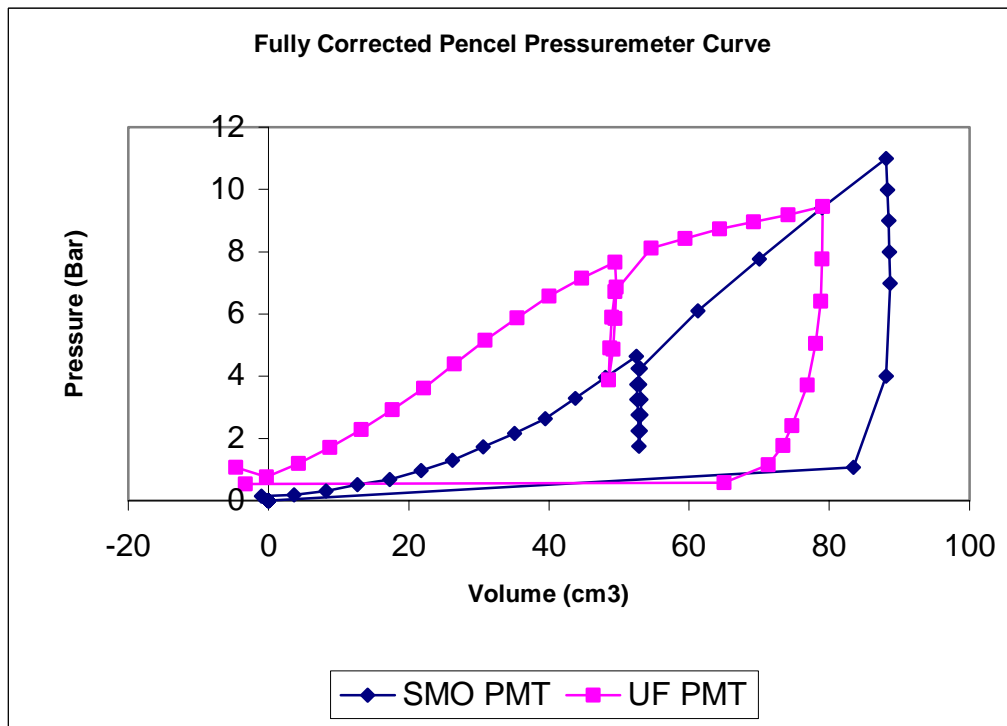
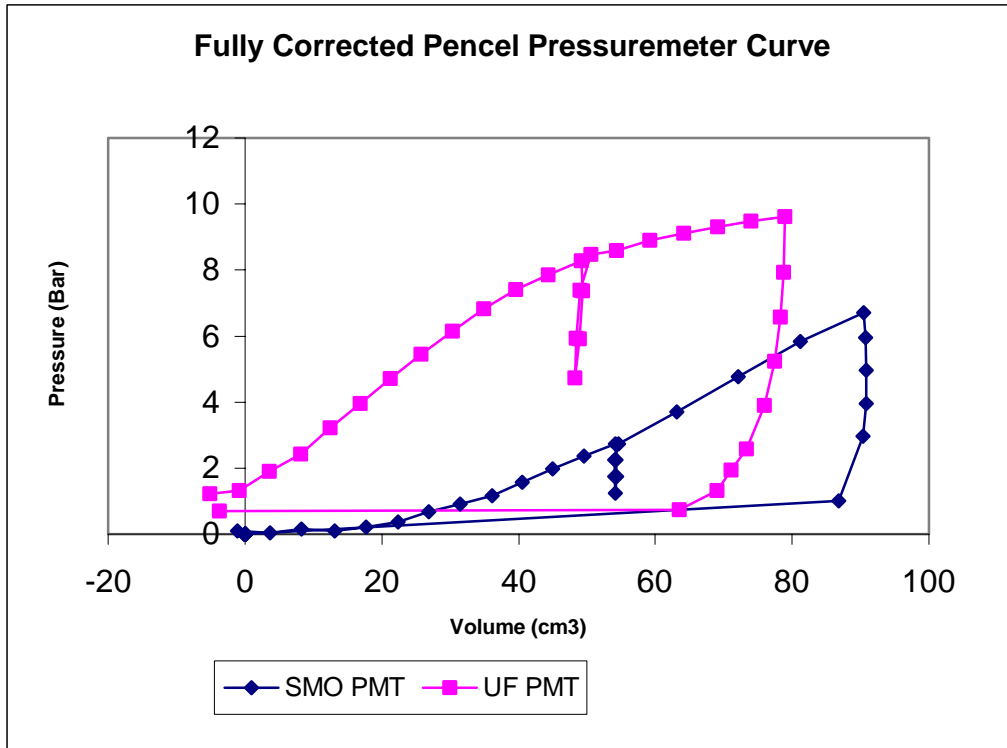
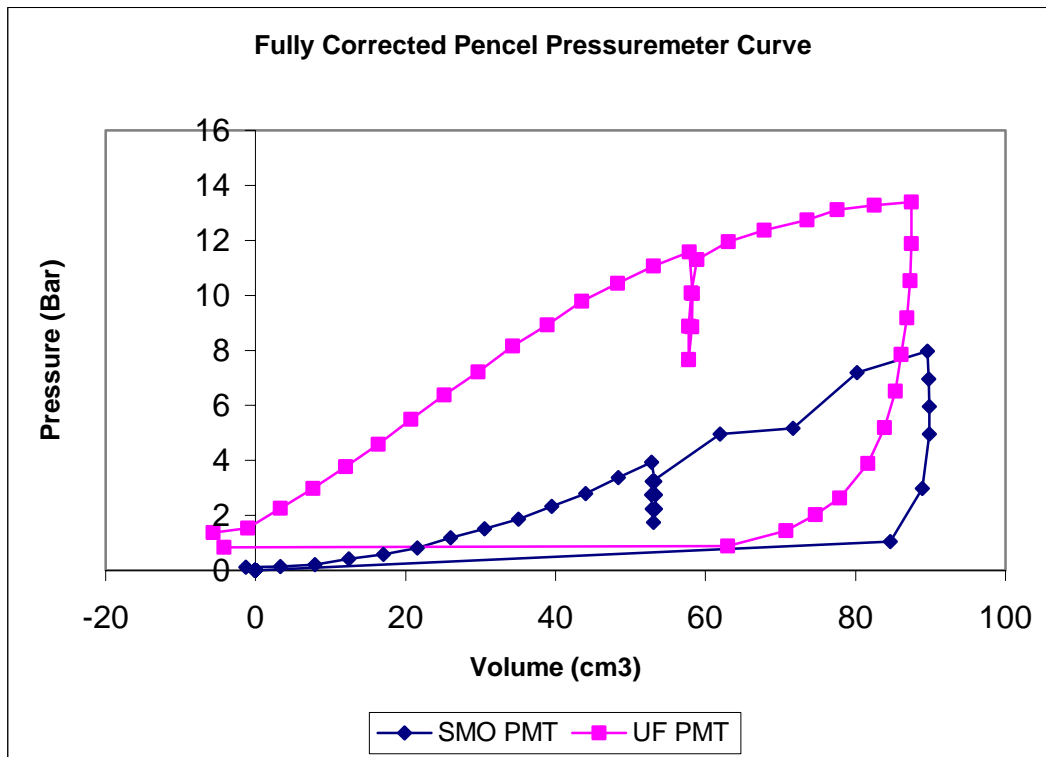
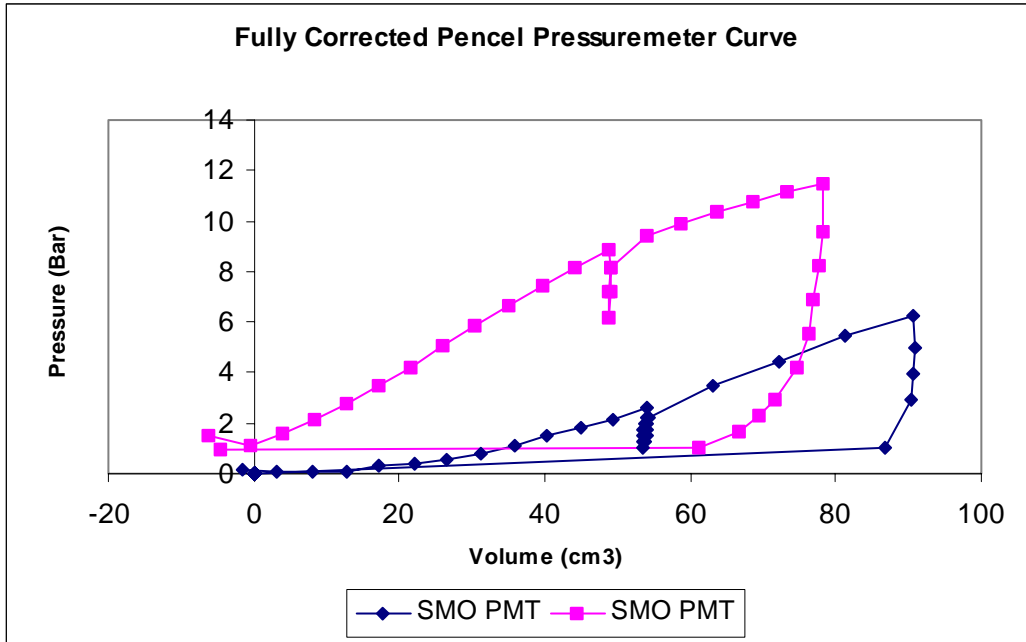
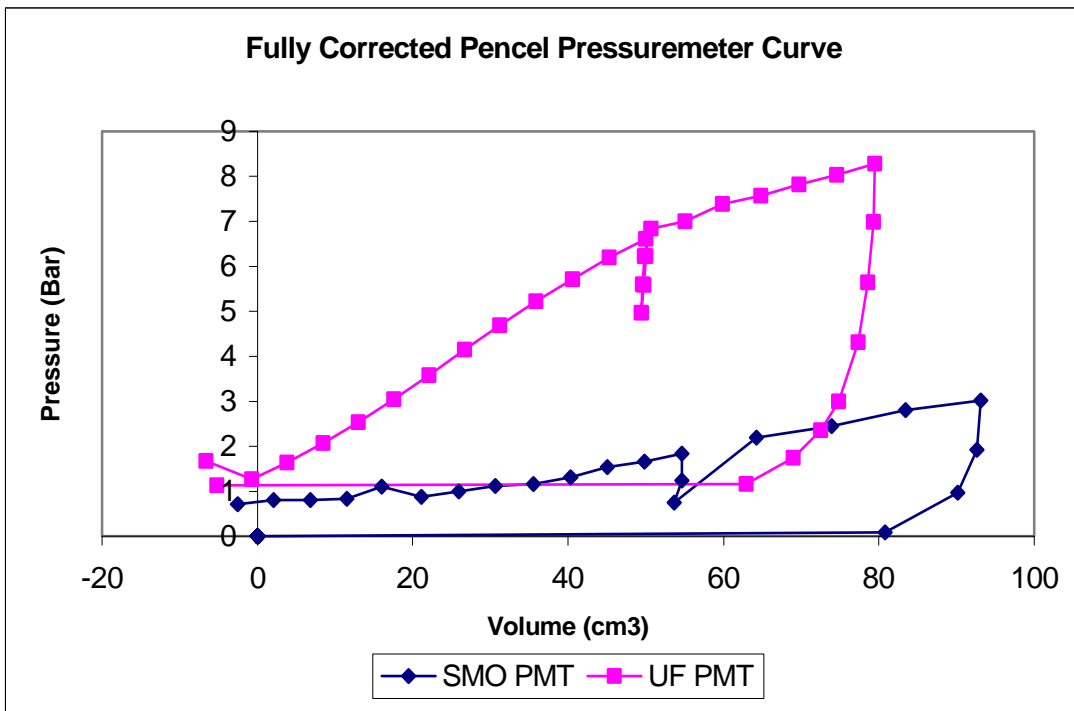
The comparison between the two PMT tests is shown in Figures 10 to 16. For all depths the UF results are much stiffer than the comparison SMO results.

6. PMT measurements between two different agencies revealed substantial differences. These differences are attributed primarily to an oversized friction reducer on the tip, which caused an oversized hole and subsequent near hole disturbance leading to a softer response.

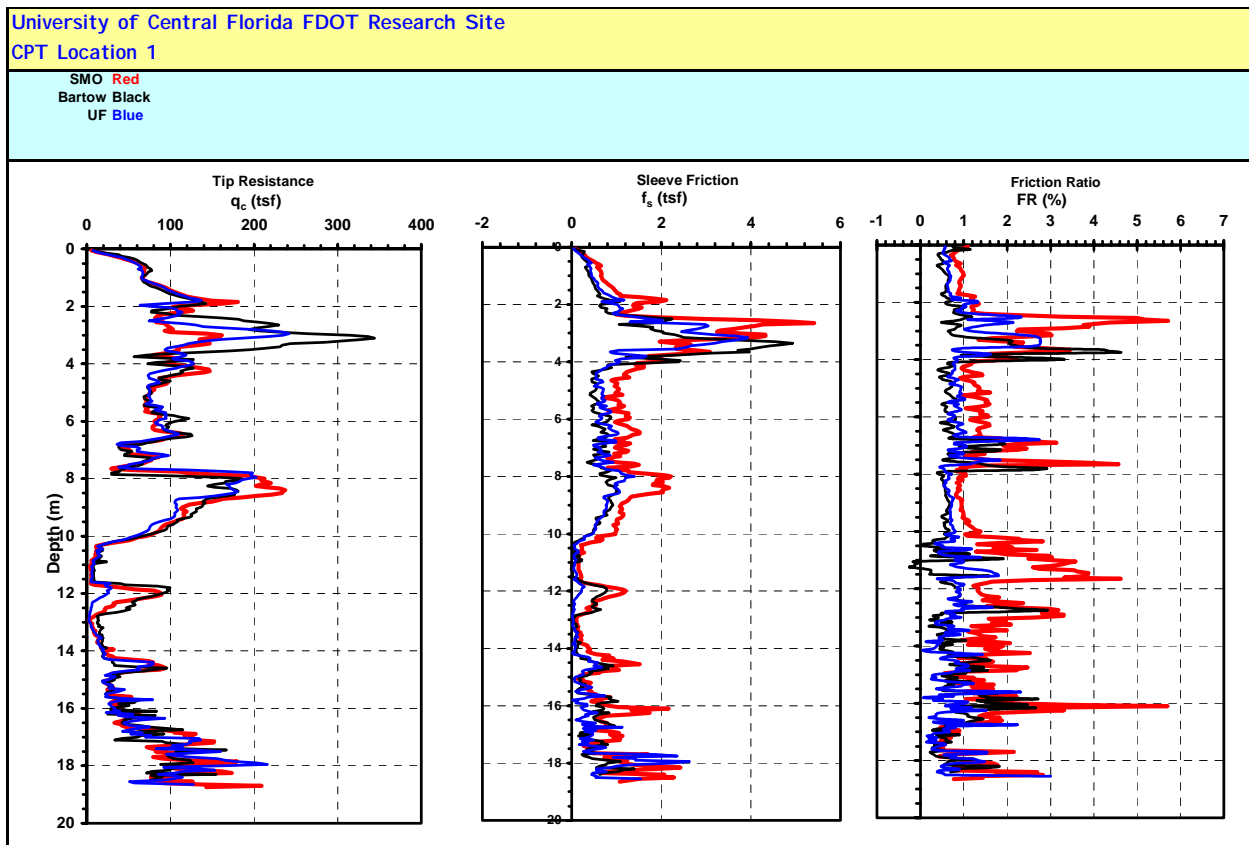
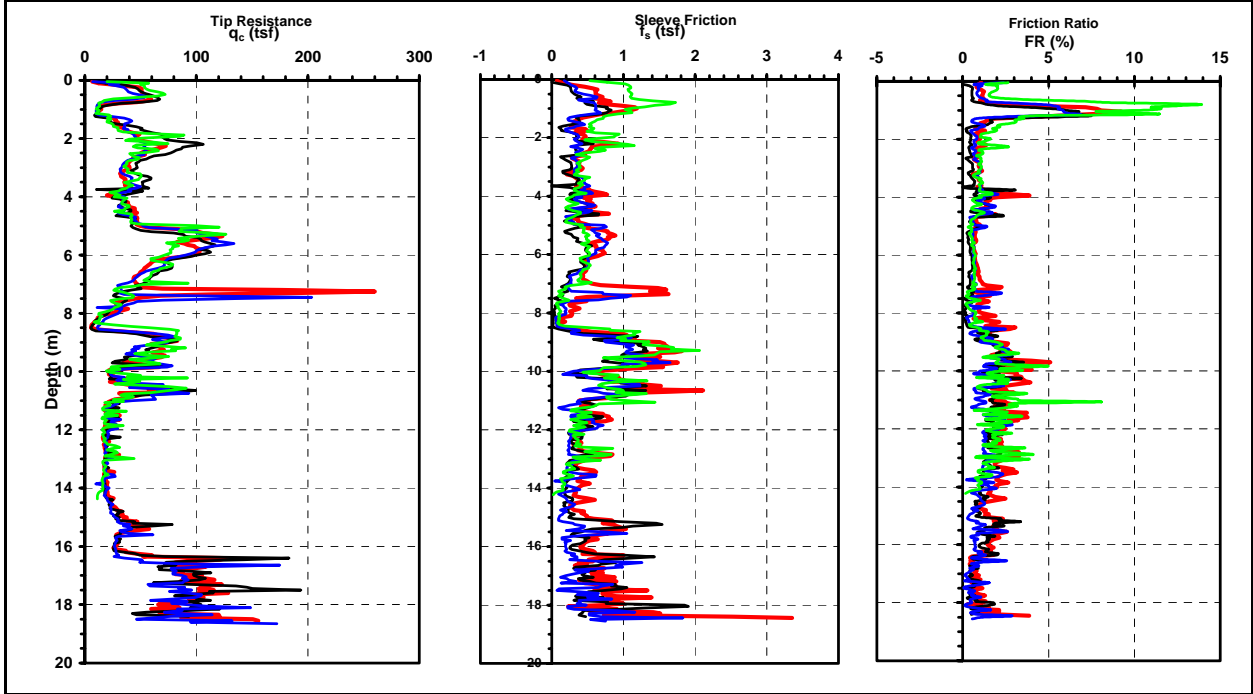
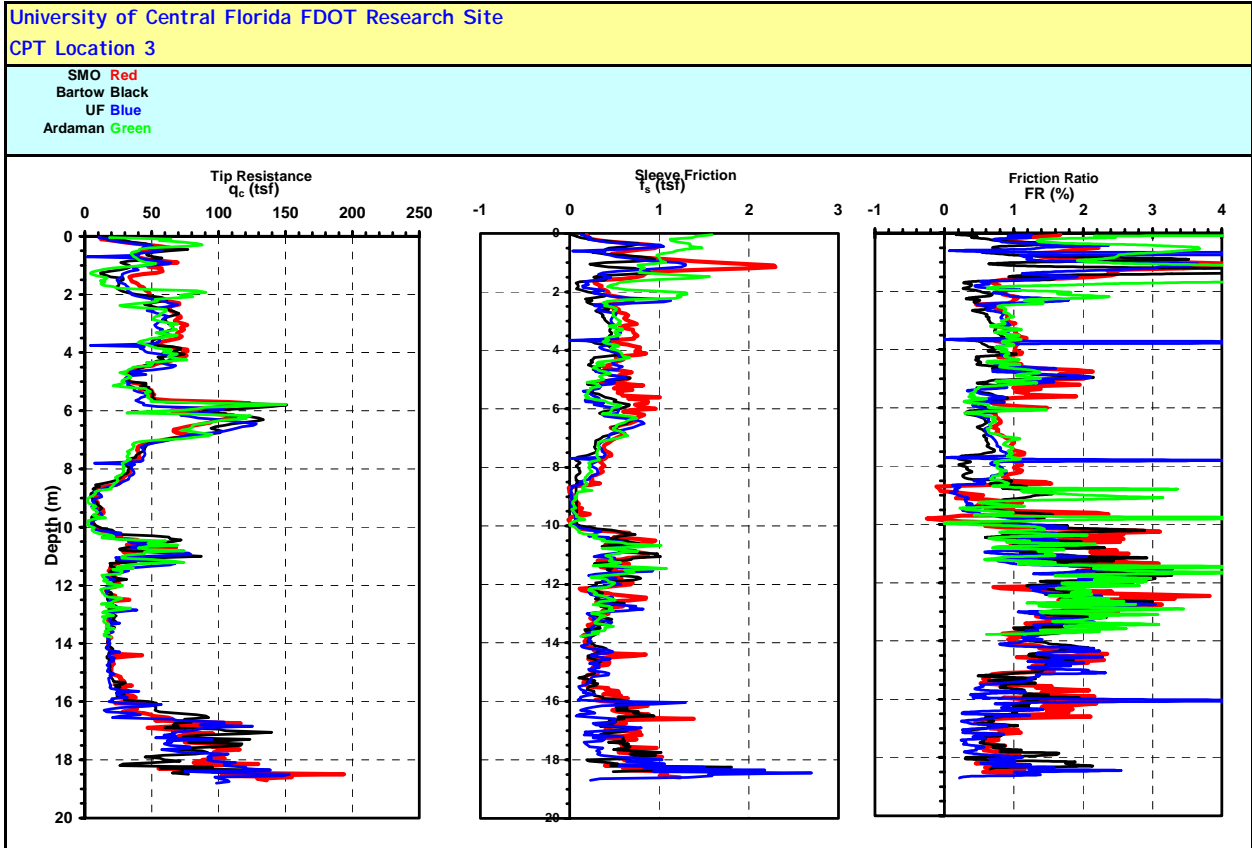
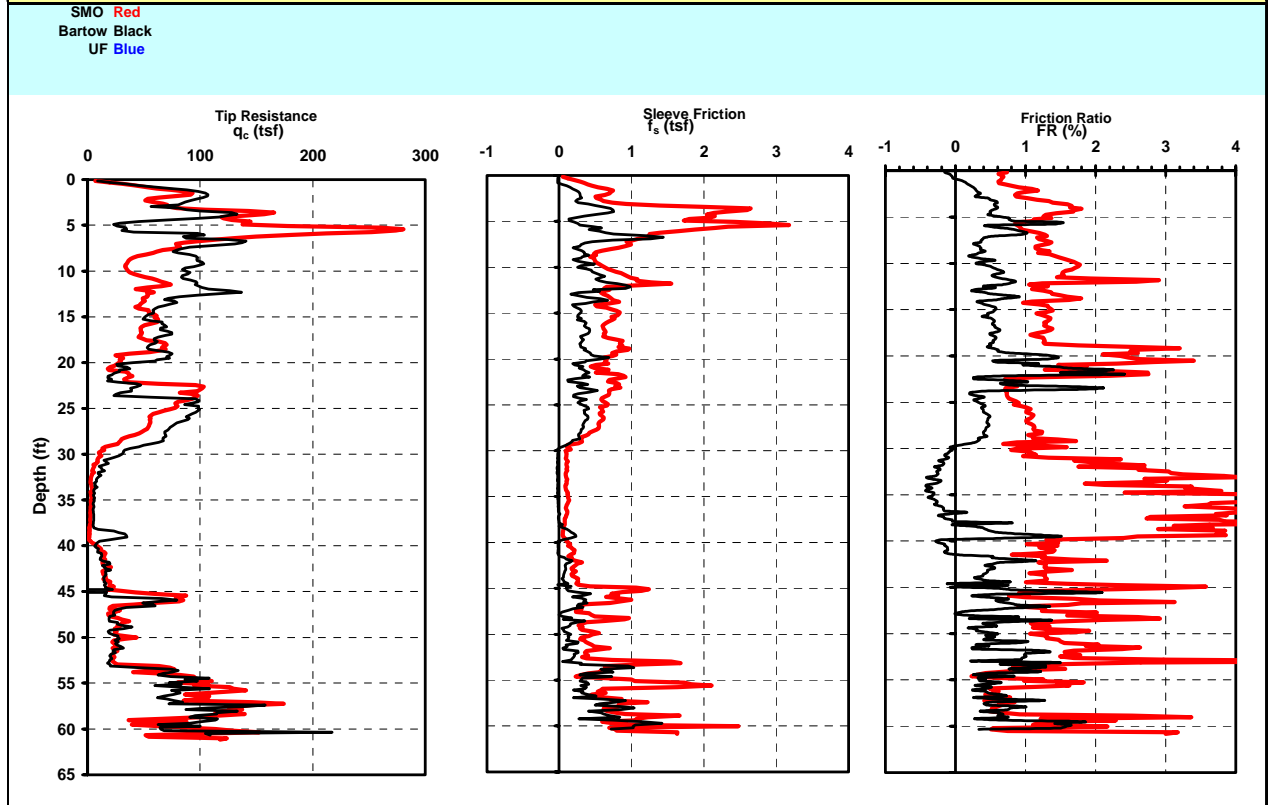
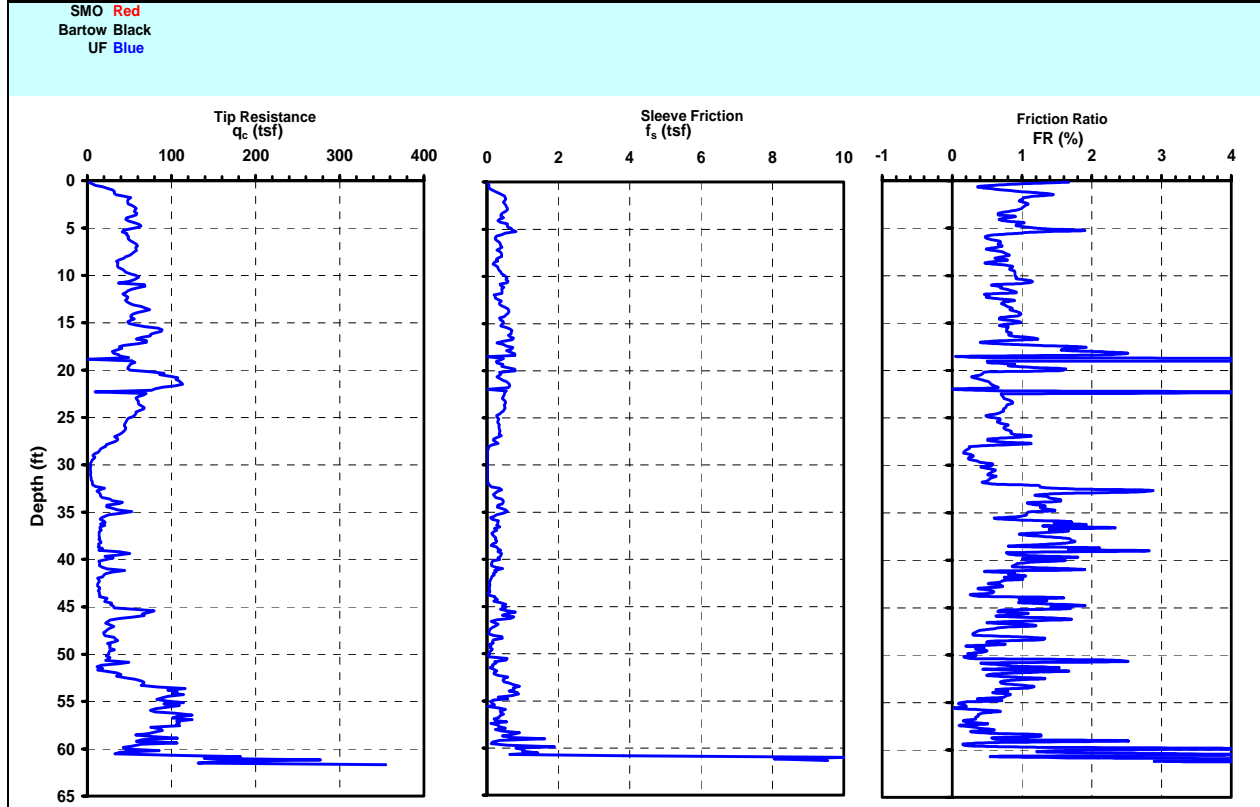
The comparison between the participating companies at different locations of the site is shown in Figures 17 to 25. Comparison charts indicate that little or no-change is observed between them. These results confirm the soil stratigraphy results of the area obtained with the rest of the equipment (DMT, PMT and SPT). This is:

- The data obtained with the cone confirm the existence of a hardpan layer located between 8 and 12 feet on the East region of the site.
- The little change of values for tip resistance, friction ratio, etc shown in the charts is an indication of a relative uniformity on the site.
- The transition from a “Soft Material” to a “Hard Material” in the upper layer of sand and silty sand is easily appreciated (see cross sections in Figures 21, 22 and 23).
- The existence of a well-defined layer of silty clay or clayey silt from depth 33 to 50 feet in the entire area was confirmed by the test.

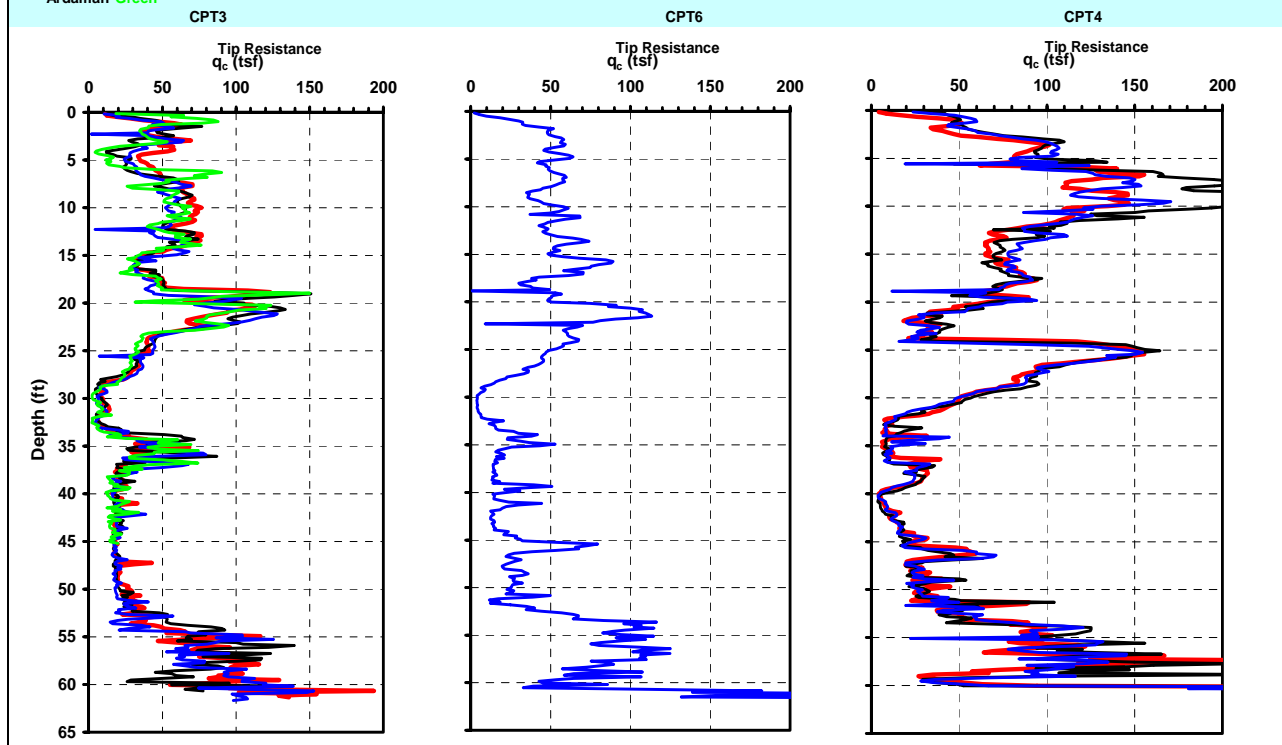
Figure 23. CPT Soundings Cross Section Show Increasing Tip Resistance Along SW to SE Portion of the Site

Cross section CPT 3-6-4

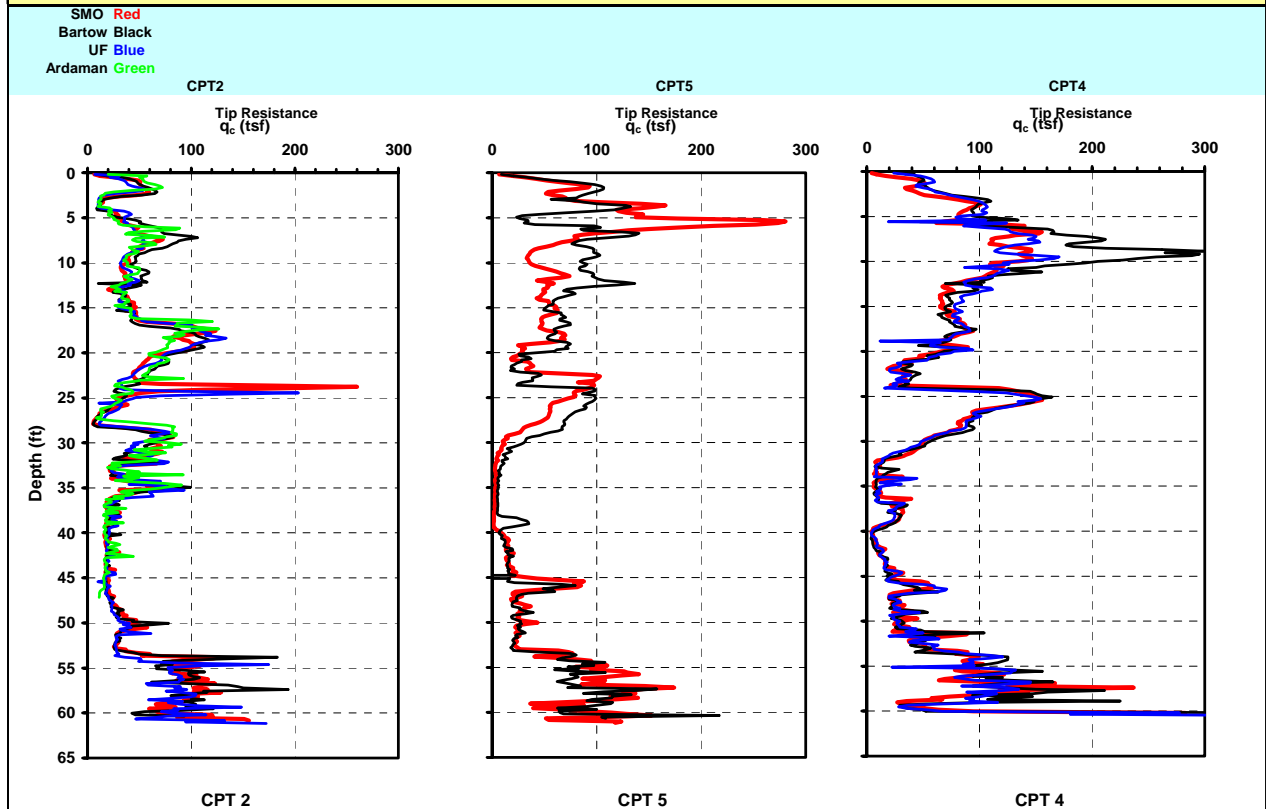
Figure 24. CPT Soundings Show Increasing Tip Resistance Along NW to SE Cross Section of the Site

Cross section CPT 2-5-4

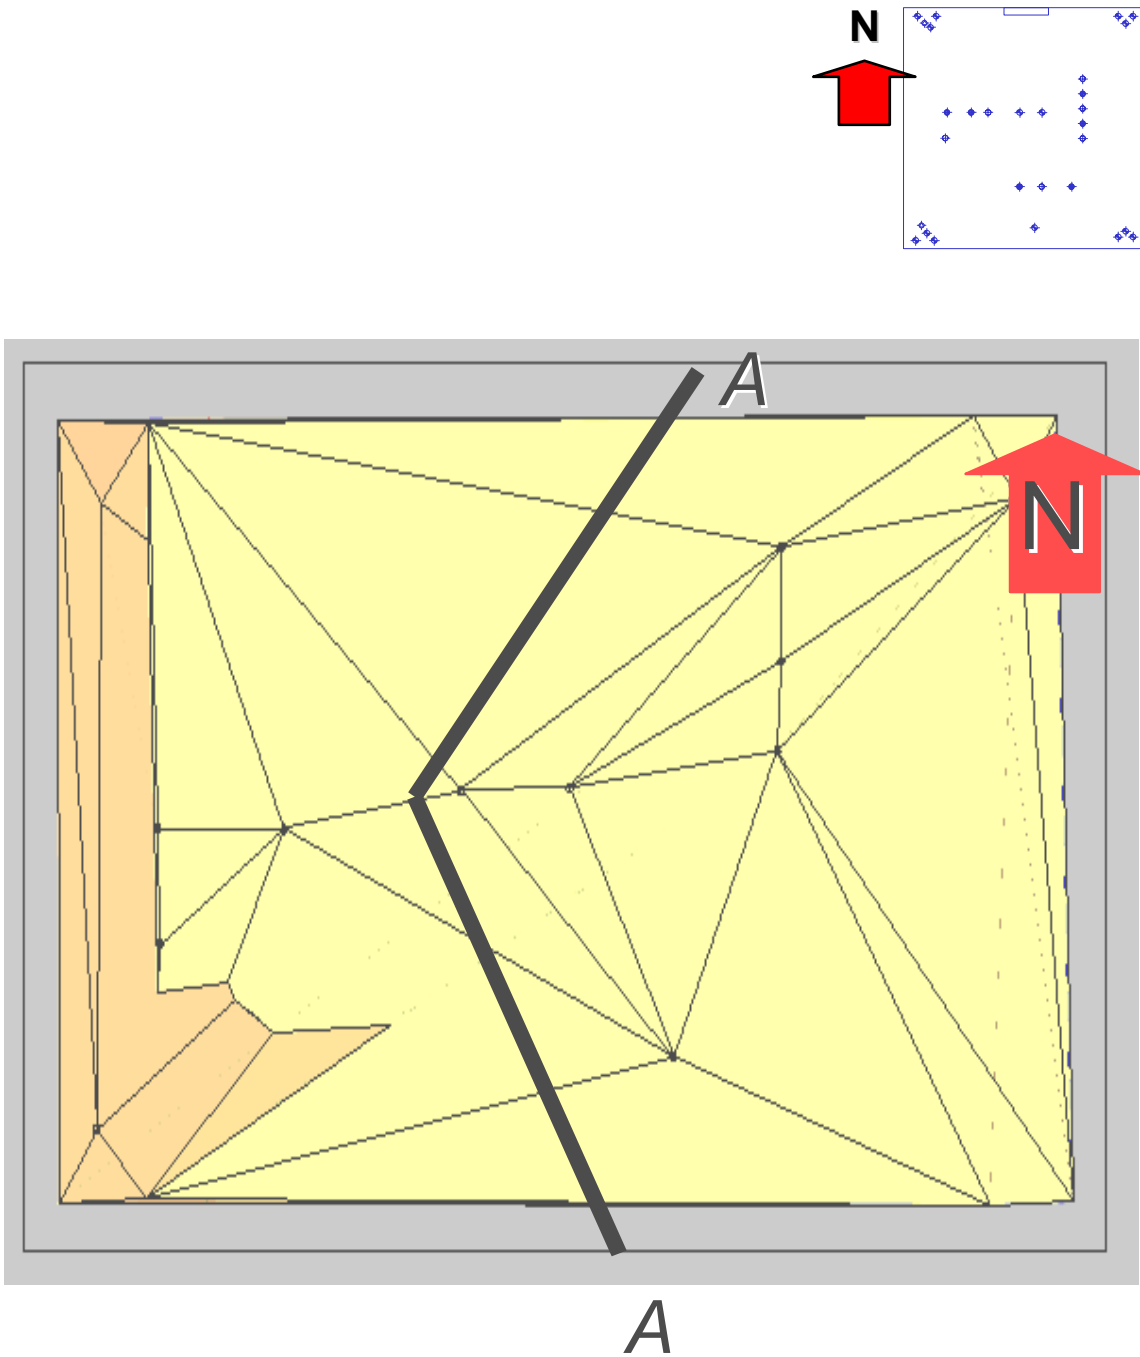
Figure 34 Overhead view at depth of 5 ft.

Cross section A-A delineates the border line between “soft” SW corner and “hard” NE corner. Figure shows horizontal planar view at elevation 5 ft. Hard pan is located at depths 5 to 10 feet.

Figures 34 through 39 illustrate successive overhead views of horizontal cross-sections at depths of 5, 15, 30, 45, and 50 ft. On Figures 34 and 35 line A-A delineates the separation between the "hard" NE corner and "soft" SW corner.
