Final Report FDOT Project BD521-02

Performance Assessment of Portland Cement Pervious Pavement

Report 2 of 4: Construction and Maintenance Assessment of Pervious Concrete Pavements

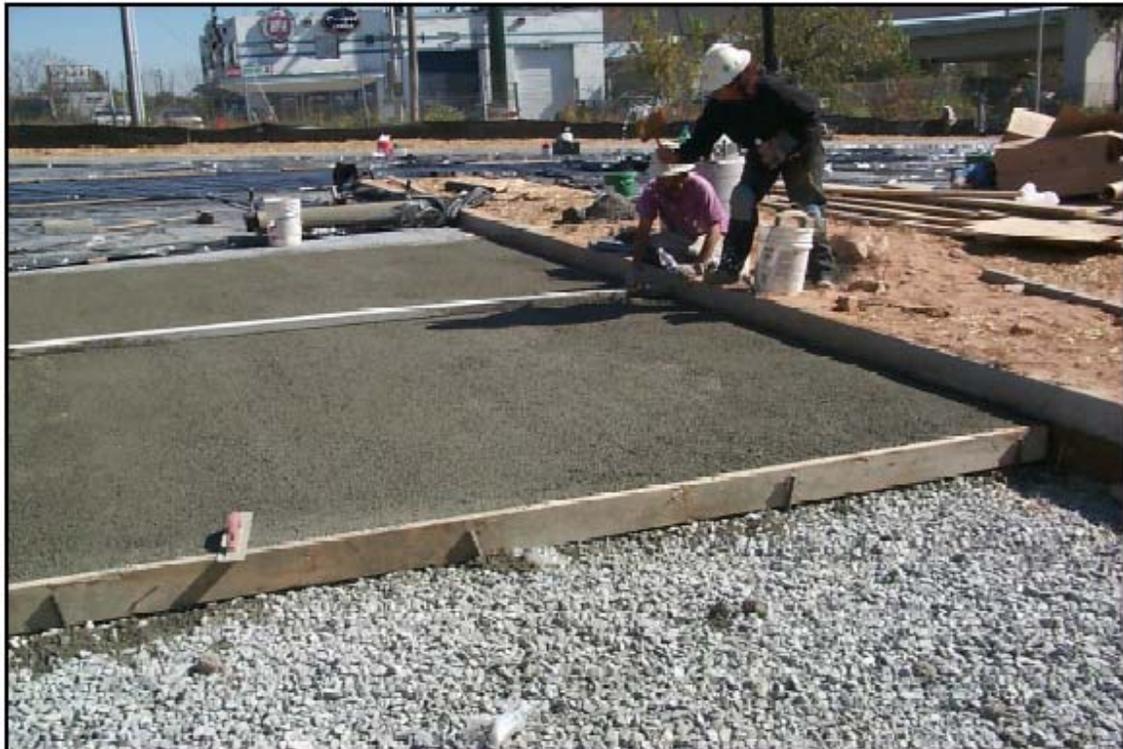
Figure 2: Typical Porous Concrete Installation

Porous concrete systems are typically used in low-traffic areas, such as, parking pads in parking lots, residential street parking lanes, recreational trails, golf cart and pedestrian paths and emergency vehicle and fire access lanes. Heavy vehicle traffic use must be limited to ensure raveling or structural failure does not occur in the porous pavement surface, which may fail under constant exposure to heavy vehicle traffic. The slopes of these installations should be flat or gentle to facilitate infiltration versus runoff and the EPA recommends a four-foot minimum clearance from the bottom of the system to the water table if infiltration is to be relied on to remove the stored water volume (EPA, 1999). Figure 2 shows a typical porous concrete installation.

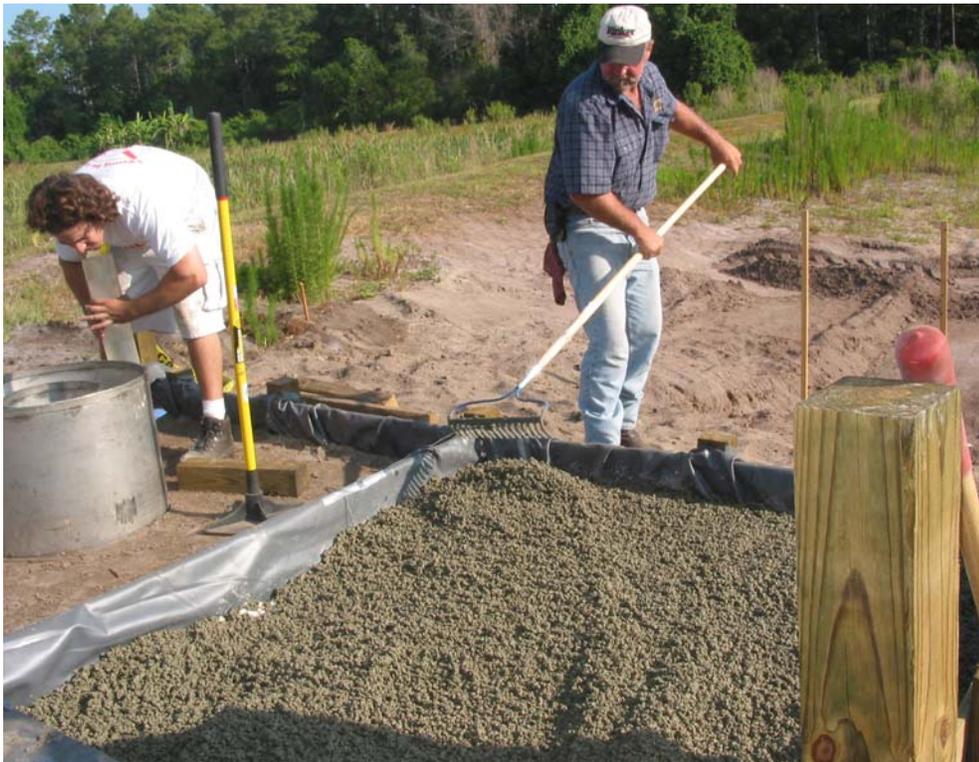
Figure 3: Stormwater Academy Porous Concrete Test Cell Installation

per hour as determined by application of a double-ring infiltrometers test (ASTM D 3385-94). One cell contains a five-inch deep reservoir of $\frac{3}{8}$ to $\frac{1}{2}$ inch coarse aggregate, and both cells have a five- inch thick pervious concrete slab. Depicted in Figure 3 is the installation of the pervious concrete in the test cells as well as a double-ring infiltrometer test being performed on the compacted subsoil.

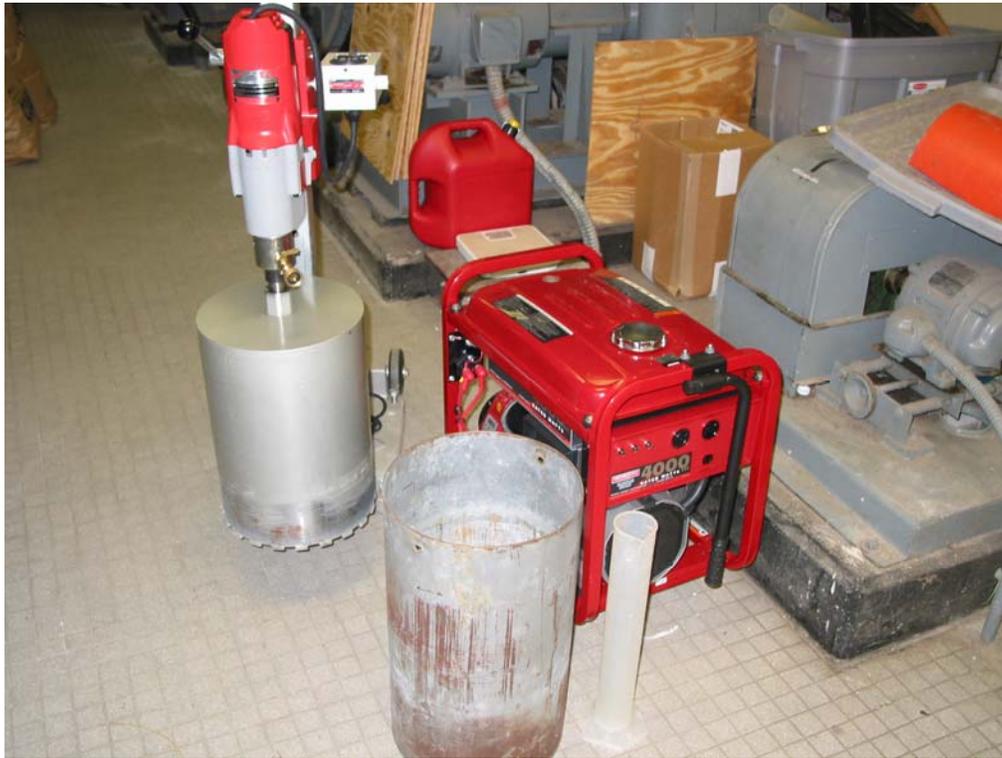
Figure 7: Coring Rig, Core Bit, Single-Ring Infiltrometer, and Generator

1. The pervious concrete surface is cored in three evenly spaced locations utilizing a 12 inch outside diameter, diamond tipped concrete core bit. The drilling process takes between 10 and 30 minutes per concrete core depending on the type of aggregate used in the concrete mix and depth of the concrete slab. The coring rig and the core bit are shown in Figure 7.

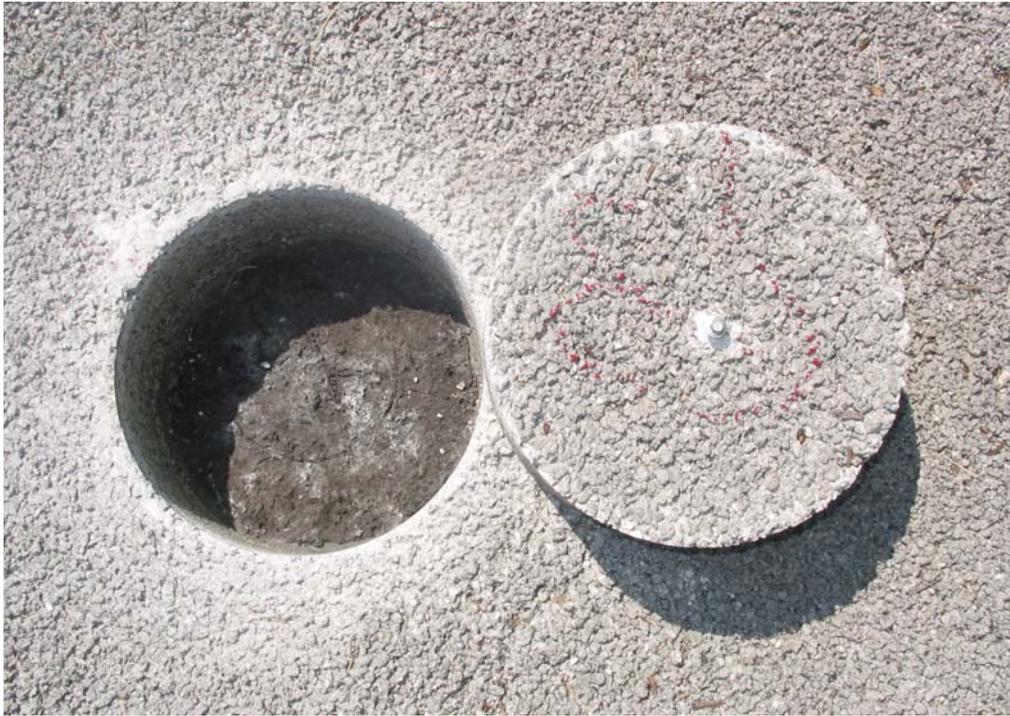
Figure 8: Pervious Concrete Pavement Core

The core samples are left in place after drilling for in-situ infiltration testing. When necessary, the cores were extracted and grinded along the sides to remove irregularities formed during the coring process to allow the single-ring infiltrometer to fit around the core. A four-inch angle grinder with a masonry disk was utilized for this task. Figure 8 shows the 12 inch core placed next to the location it was removed from in the pavement. It is clear that the pavement system at this site does not have a drainage layer of gravel. This configuration is typical for pavements on soils with high permeability values.

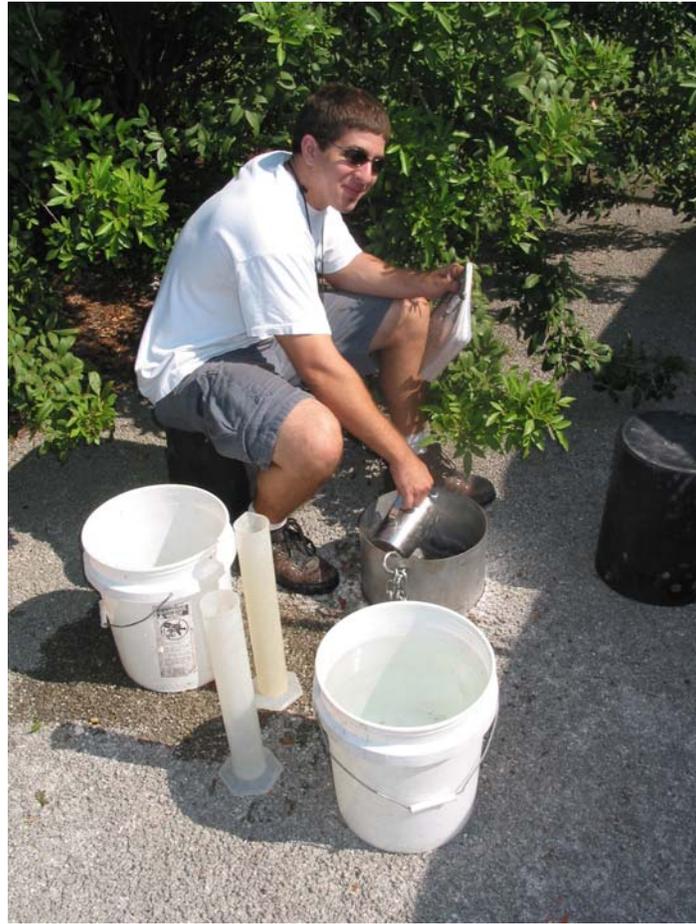
Figure 9: Pervious Concrete Pavement Core Test

2. Once the single-ring infiltrometer can pass into the cut made by the coring rig, the infiltrometer is embedded into the subsoil by applying a downward force. The infiltrometer is typically installed using a hand-tamper making sure to mark the infiltrometer before embedment to ensure the infiltrometer is installed to the proper depth.
3. After the single-ring infiltrometer is embedded to the proper depth, a bead of plumber's putty is placed around the inside circumference of the infiltrometer to prevent side-wall leakage.
4. Infiltration rates of the three cored locations are measured using the embedded Single-ring Infiltrometer Test as discussed in the previous section. Figure 9 shows a test in progress with the infiltrometer in the embedded state.

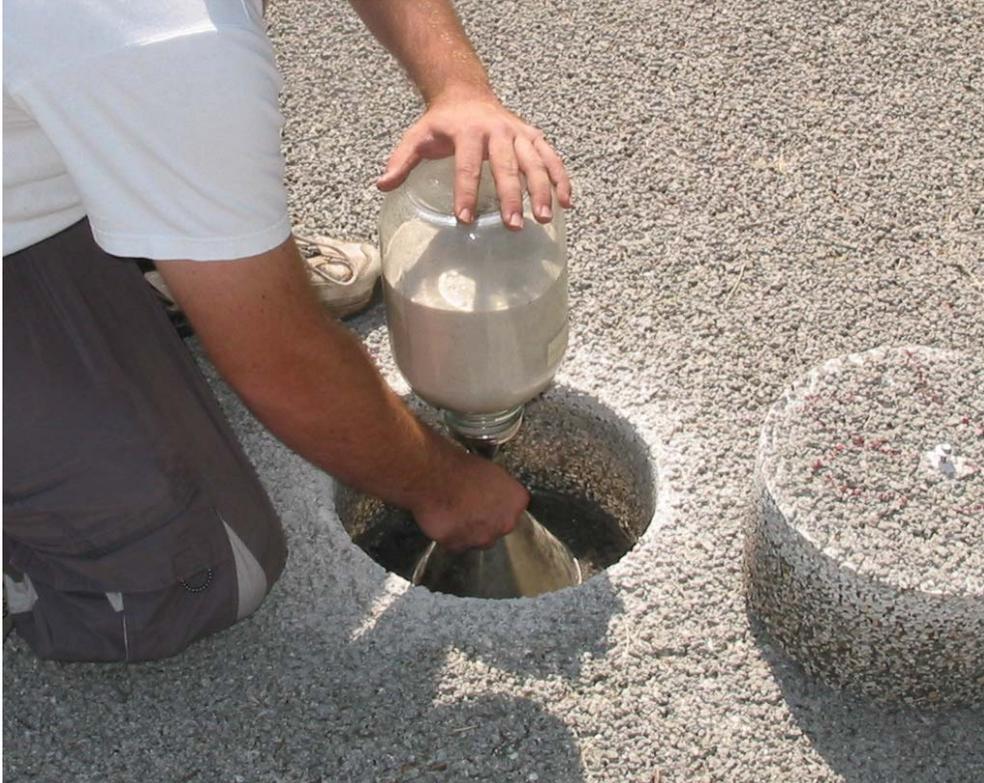
Figure 10: Performing Sand Cone Test

7. The field unit weight of the subsoil is then determined using the Sand Cone Method as outlined in ASTM D 1556 “Standard Test Method for Density and Unit Weight of Soil in Place by the Sand-Cone Method”. Figure 10 shows a sand cone test in progress.

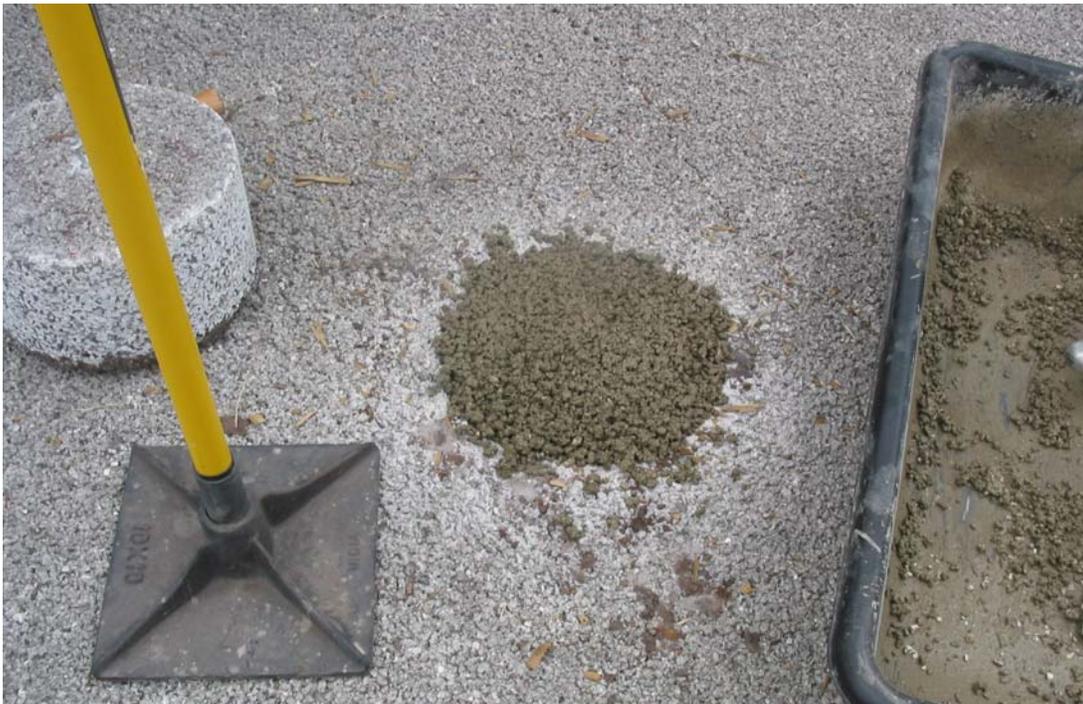
Figure 11: Repair of Concrete Core Area

9. Water table depths are recorded for use in modeling studies planned for the pervious concrete system.
10. The subsoil shall be replaced and the pervious concrete is repaired using the original specifications at the locations where it was cored. An example of this patching is depicted in Figure 11.

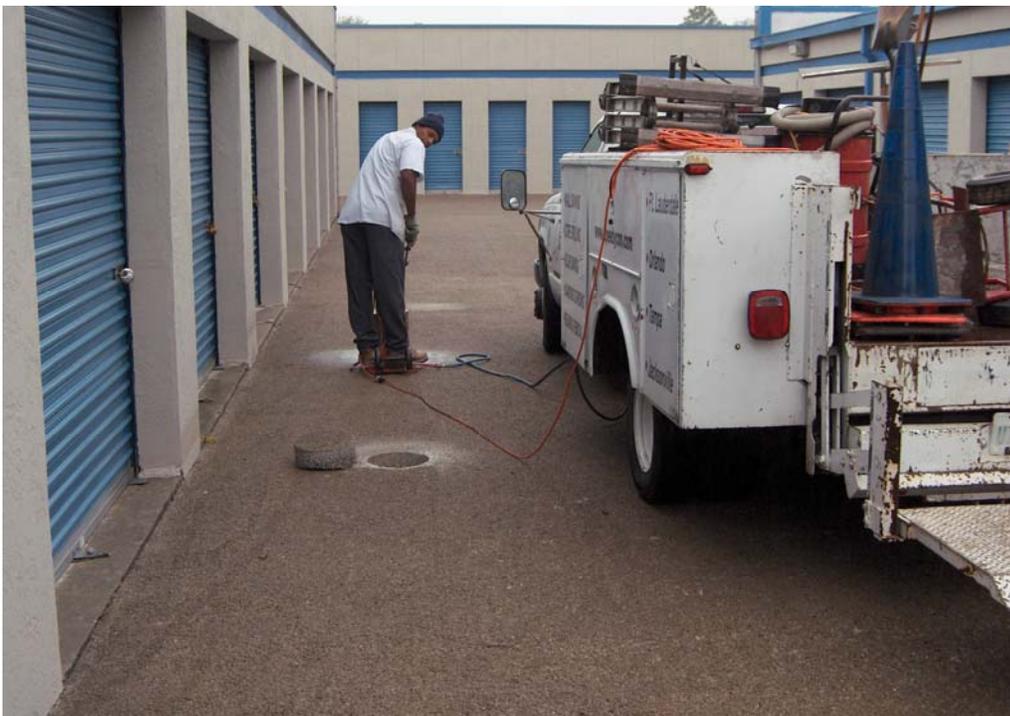
Figure 16: Sun Ray Store-Away Pervious Pavement at Core Locations 1, 2 & 3

infiltration rates measured in the laboratory that ranged from a high of 627 to a low of 3 in/hr. Instances where the system infiltration rates are higher than the individual core infiltration rates measured in the lab is due to infiltration along the sidewall of the cores that occurred in the field but was restricted in the lab producing false high infiltration rates in the field. The cores performed in the area of cores 1, 2 and 3 exhibited higher infiltration rates than other areas. This result was anticipated as the pervious concrete surface in that area was after visual determination in better condition; this area is shown in Figure 16.

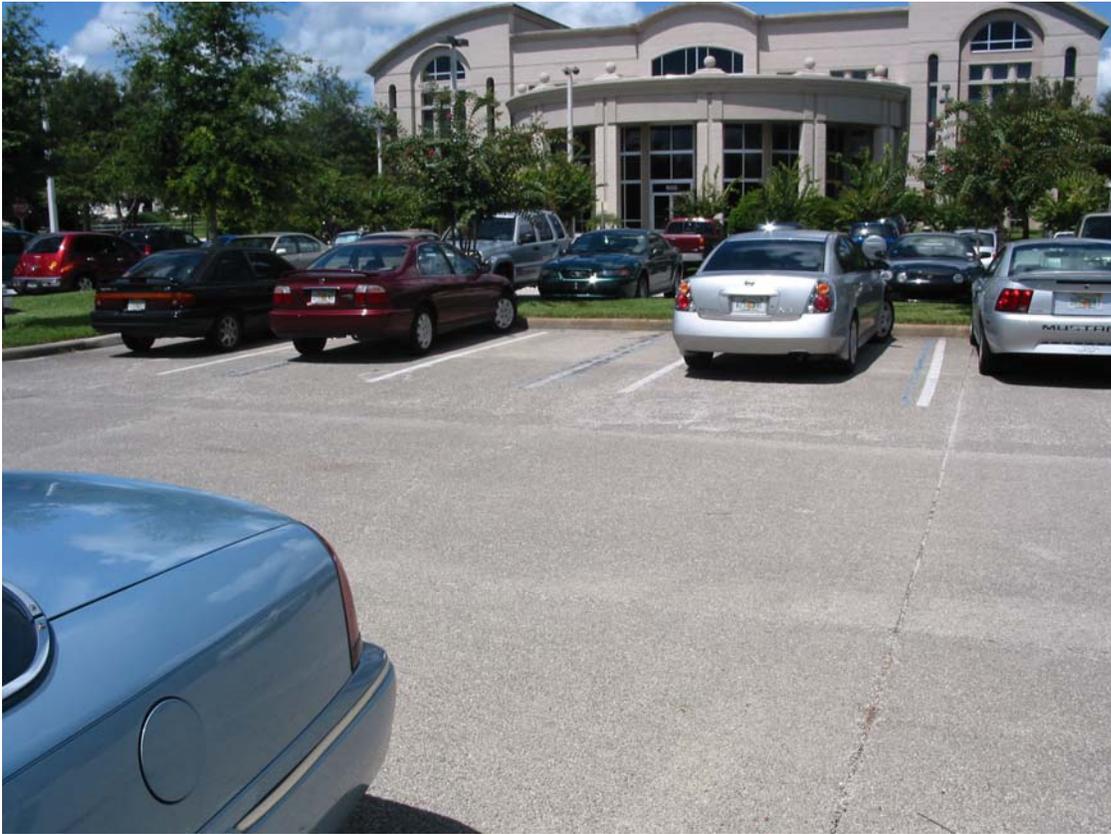
Figure 18: Strang Communication Office Parking Lot

This pervious parking lot exhibited minimal damage to the surface, although, significant raveling has taken place in one location on the site. Raveling is the deterioration of the concrete due to repeated loads over time on an area. The nine spaces located in the northwest area of the pervious concrete are raveling at the entrance to each stall. Also, a small amount of raveling at the entrance to the parking row on the west was also noted. Algae and leaf debris staining are also present over a majority of the pervious concrete parking lot. Figure 17 shows the location of the raveling and algae in this parking area. Depicted in Figure 18 is a picture of this site.

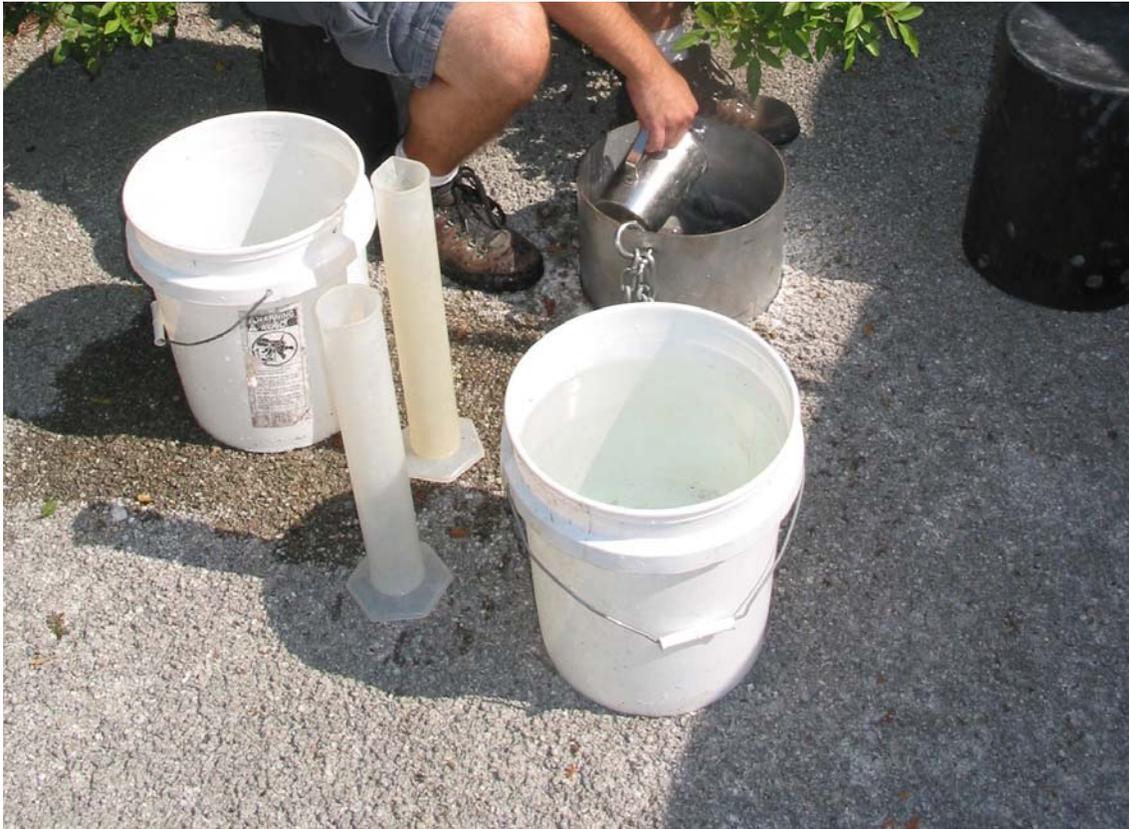
Figure 20: Murphy Veterinarian Clinic Core Test

The subsoil characteristic to the pervious concrete parking lot at the Murphy Veterinarian Clinic exhibited infiltration rates typical of type A hydrologic soils. Infiltration rates of the subsoil ranged from 15.78 to 27.21 in/hr. in the field and 3.41 to 7.91 in/hr. in the laboratory permeability tests. The difference in infiltration rate is believed to be due to the higher level of compaction of the laboratory soil samples. Field system infiltration rates were not measured due to the lack of access to a power source at the field site, which limited the ability to grind the sides of the pervious concrete cores to allow the single-ring infiltrometer to fit around the core. Core infiltration rates exhibited infiltration rates measured in the laboratory that ranged from 2.3 to 24 in/hr. This result indicates that the pervious concrete surface is acting as the limiting factor at this pervious concrete installation. Figure 20 depicts a subsoil infiltration test being performed at the field site.

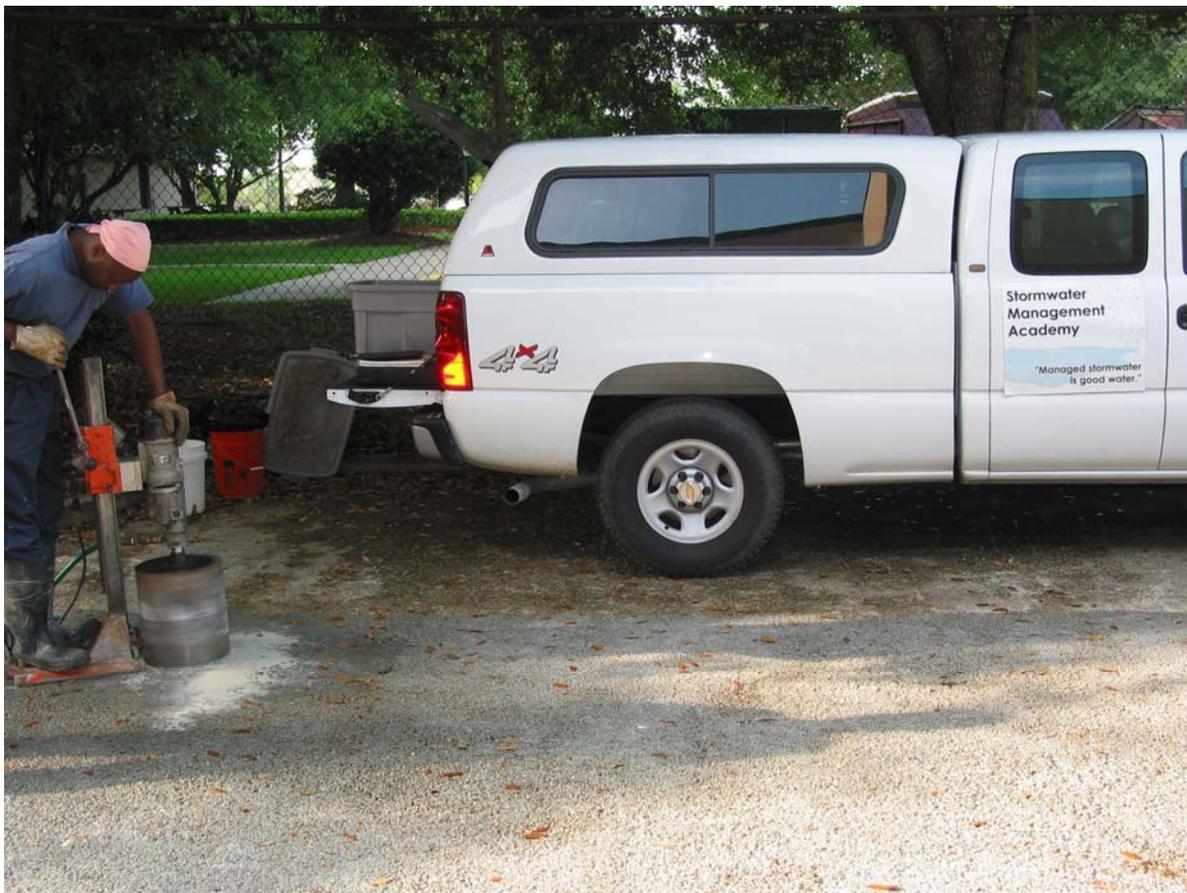
Figure 22: FDEP Parking Lot Core Test

ranged from 0 to 5.2 in/hr. The cores performed in the area of cores 4, 5 and 6 exhibited higher infiltration rates than other areas. This result was anticipated as the condition of the pervious concrete surface in the other areas was compromised due to poor construction practices. Higher than typical unit weights are also indicative of poor construction practices. Low infiltration rates of the subsoil in the areas of Cores 4 through 6 was due to a layer of poorly draining, orange clay encountered directly beneath the pervious concrete. Figure 22 depicts the coring operation performed at this site.

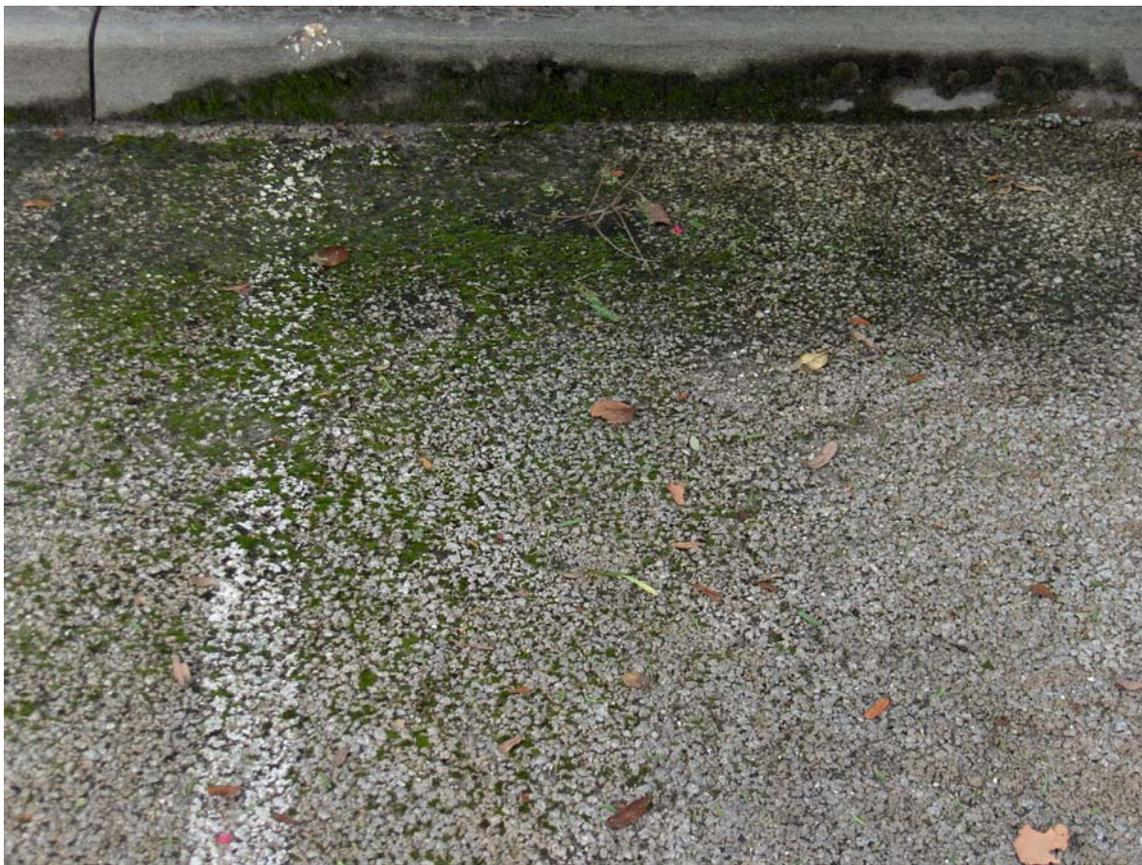
Figure 24: FCP&A Parking Lot

ranged from 8.54 to 9.07 in/hr. in the field and laboratory permeability tests confirmed these rates. Core infiltration rates measured in the laboratory ranged from 1.8 to 5.8 in/hr. Field system infiltration rates were not measured due to the lack of access to a power source on the site, which limited the ability to grind the sides of the pervious concrete cores to allow the single-ring infiltrometer to fit around the core. This result indicates that the pervious concrete surface is acting as the limiting factor at this pervious concrete installation. A photograph depicting the condition of the pervious concrete in this area is shown in Figure 24.

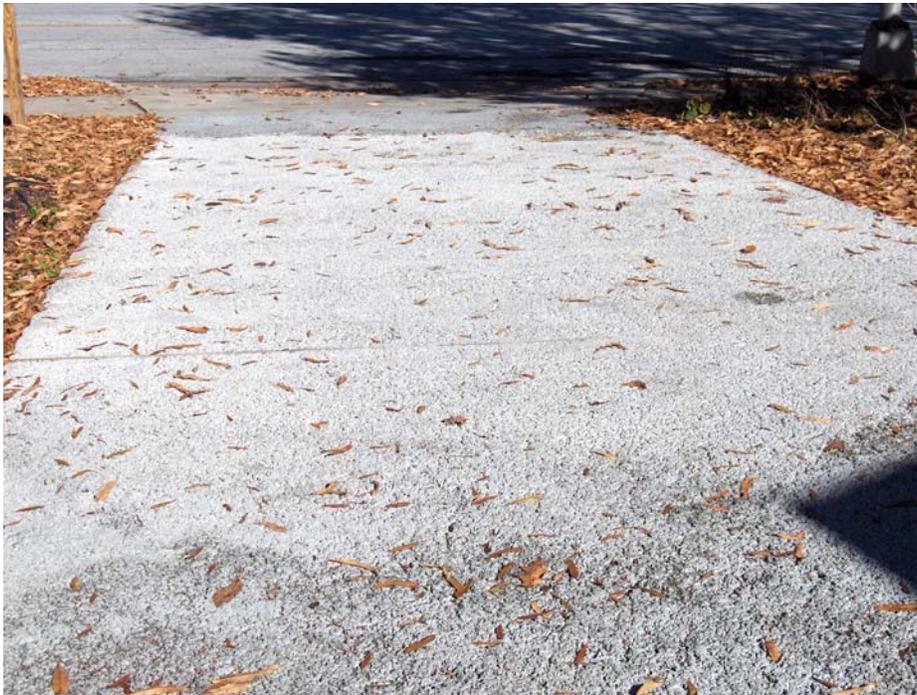
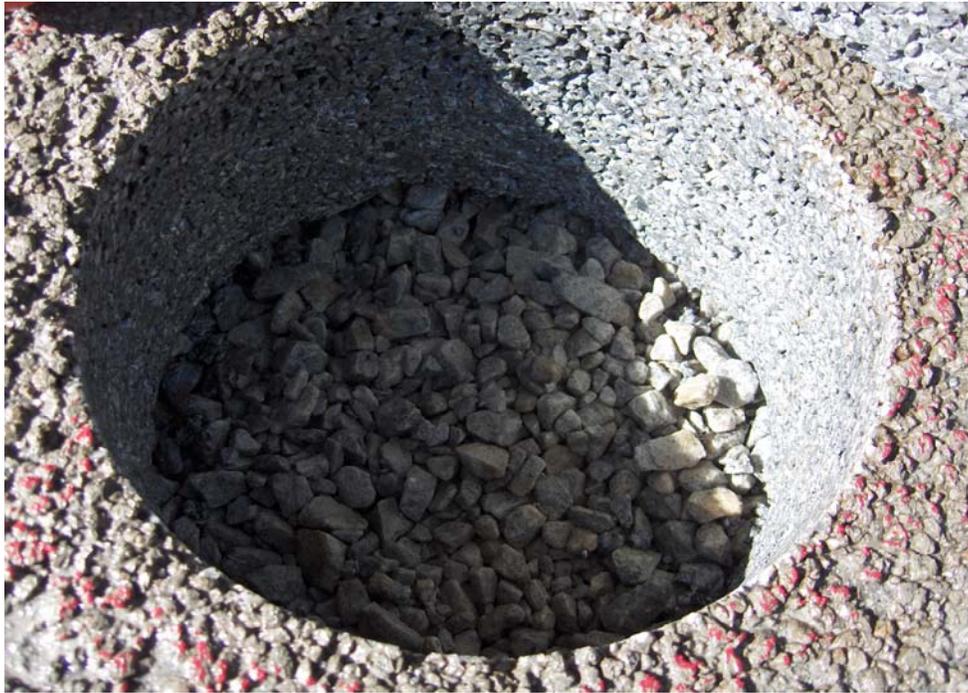
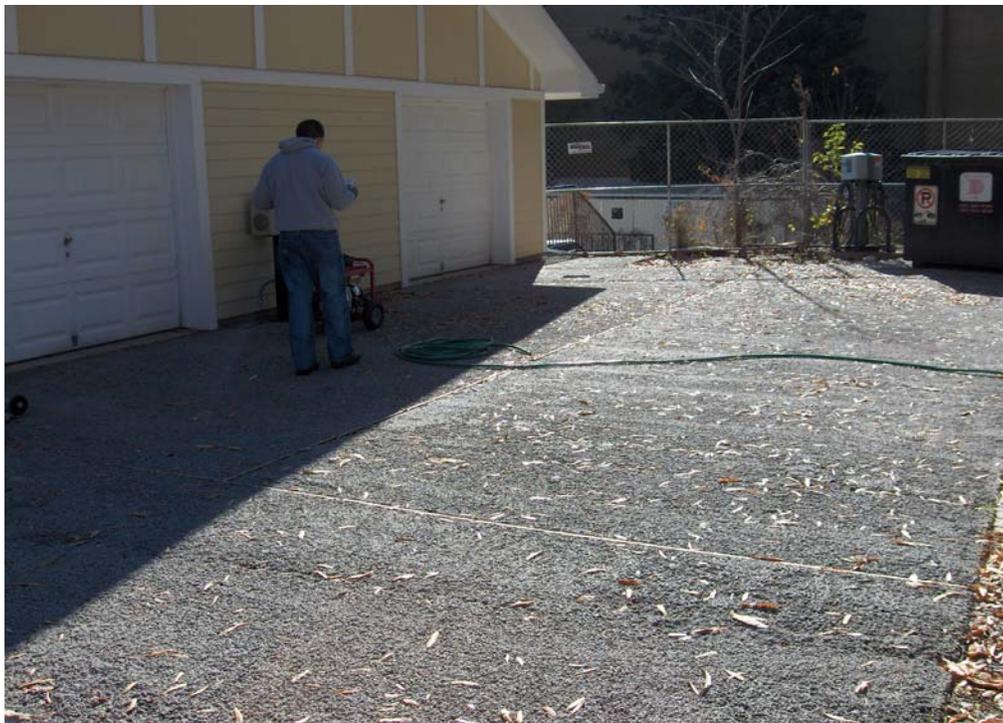
188 in/hr. This wide range of infiltration rates can be contributed to varying surficial pore sizes and unit weights in pervious concrete due to poor construction techniques. Field system infiltration rates were not measured due to the presence of a gravel reservoir, which the single-ring infiltrometer is unable to penetrate. These results indicate that the subsoil is acting as the limiting factor at this pervious concrete installation, however a gravel reservoir has added storage to the site to allow a longer recharge time. Laboratory tests indicate the gravel reservoir has a porosity of approximately 0.32 or a storage capacity of approximately 2 inches of water. Photographs depicting the condition of the pervious concrete in this area are shown in Figures 26, 27 and 28.

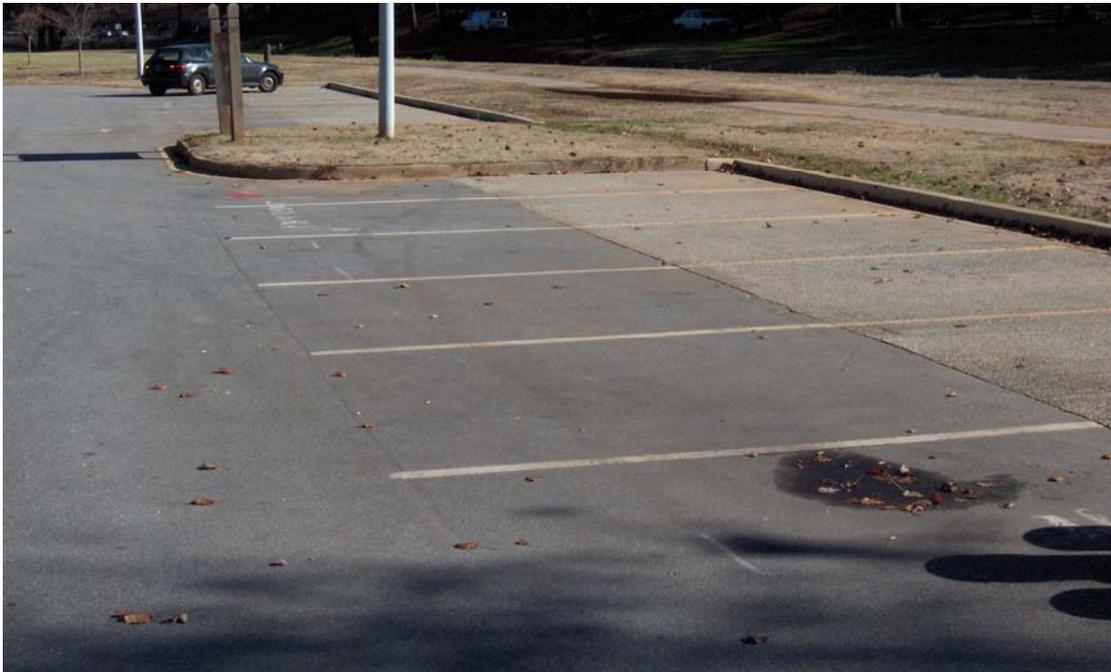
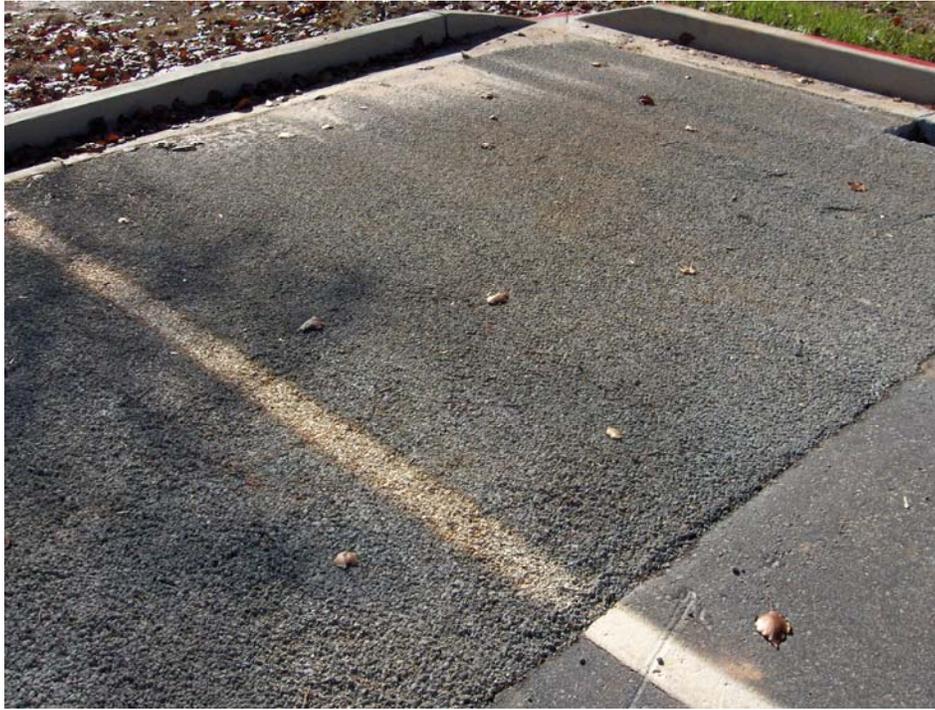
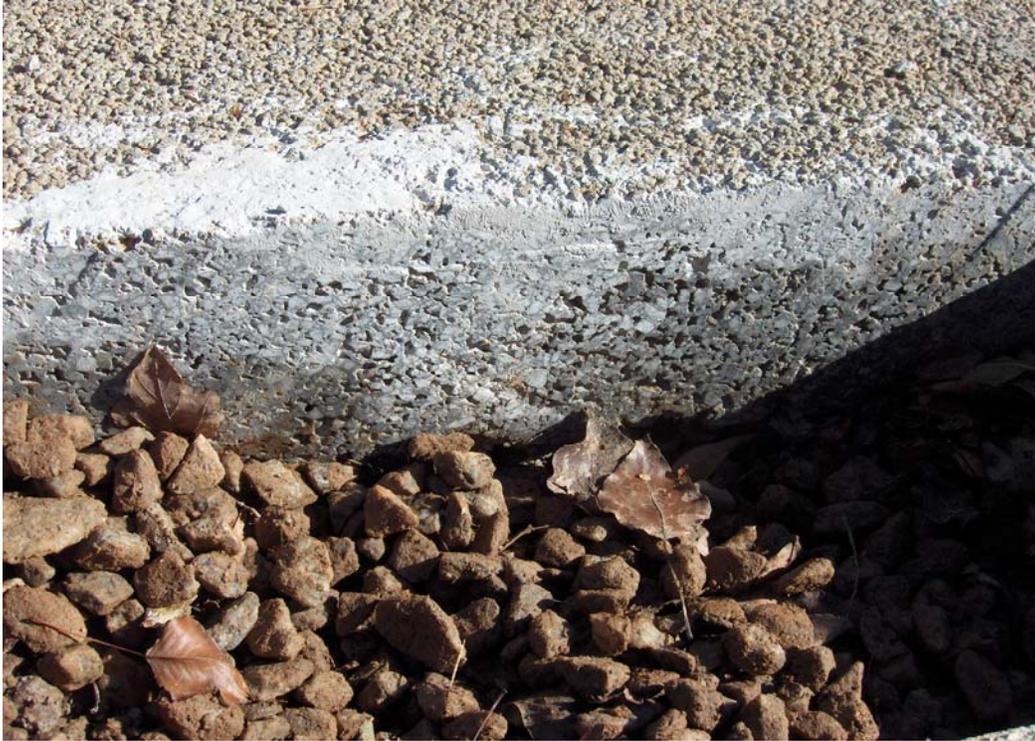
zero that was measured was due to a lack of voids present in the concrete due to poor construction techniques as verified by the comparatively high unit weight of the core. Field system infiltration rates were not measured due to the presence of a gravel reservoir, which the single-ring infiltrometer is unable to penetrate. These results indicate that the subsoil is acting as the limiting factor at this pervious concrete installation, however, a gravel reservoir has added storage to the site to allow a longer recharge time. Laboratory tests indicate the gravel reservoir has a porosity of approximately 0.32 or a storage capacity of approximately 2 inches of water. Photographs depicting the condition of the pervious concrete in this area are shown in Figures 30, 31 and 32.

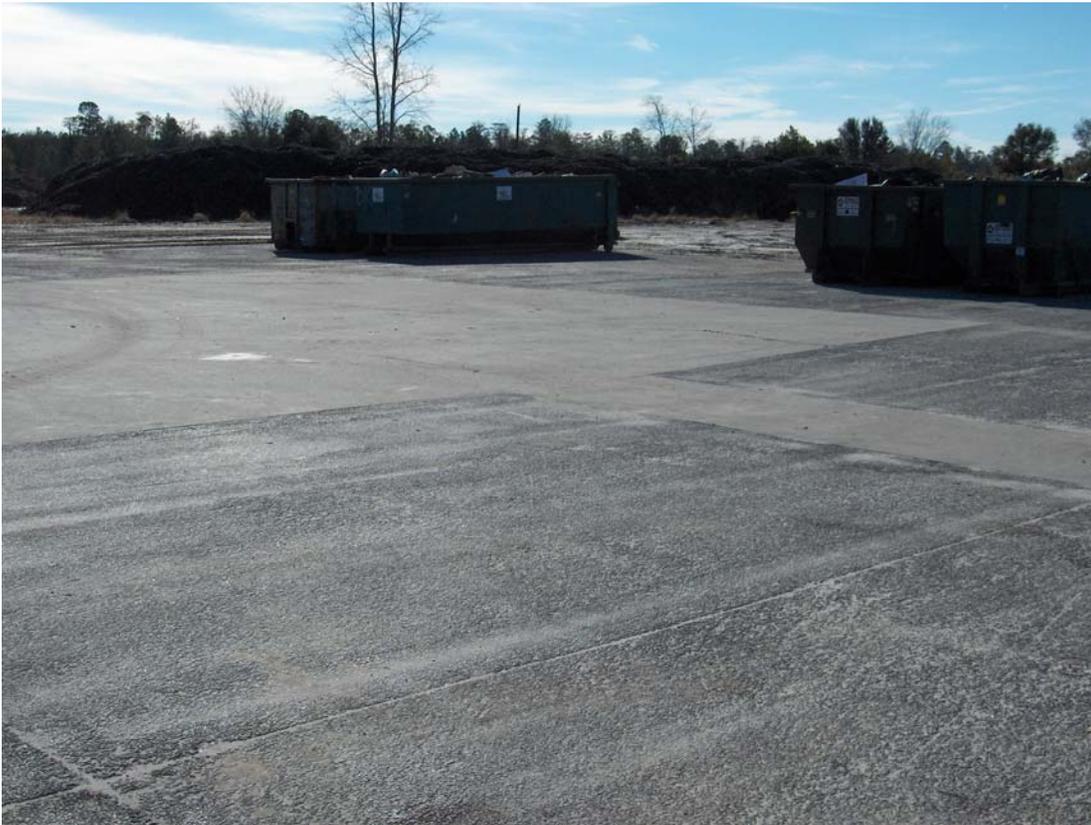
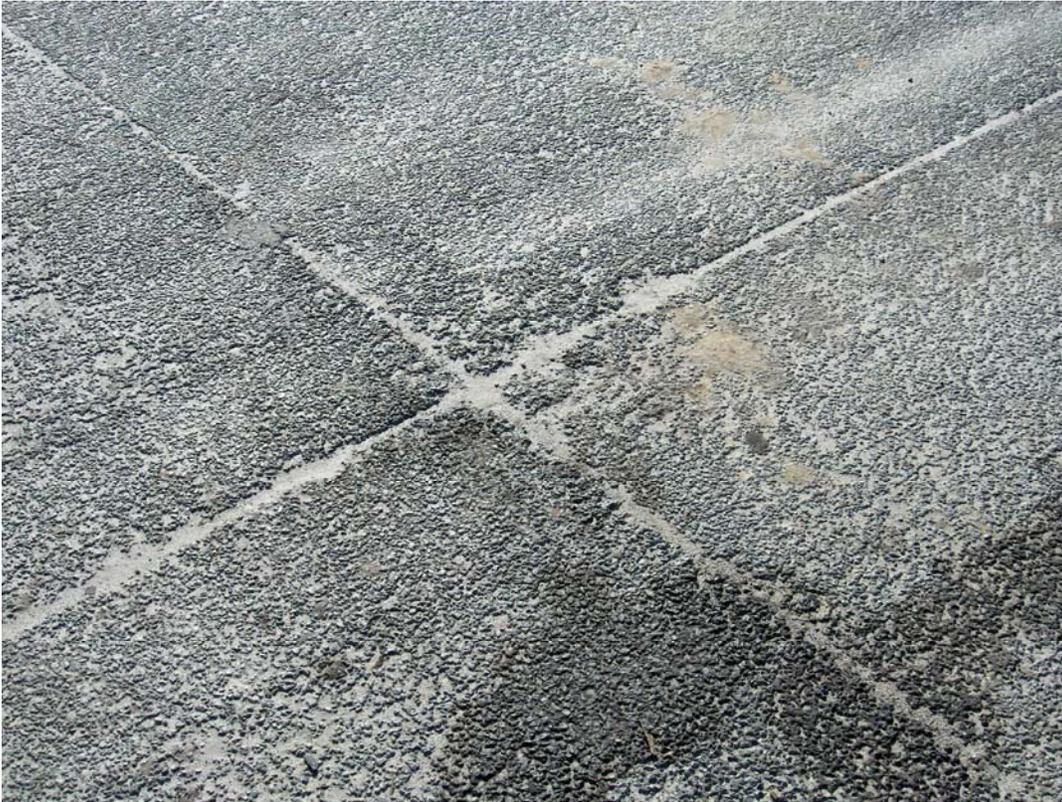
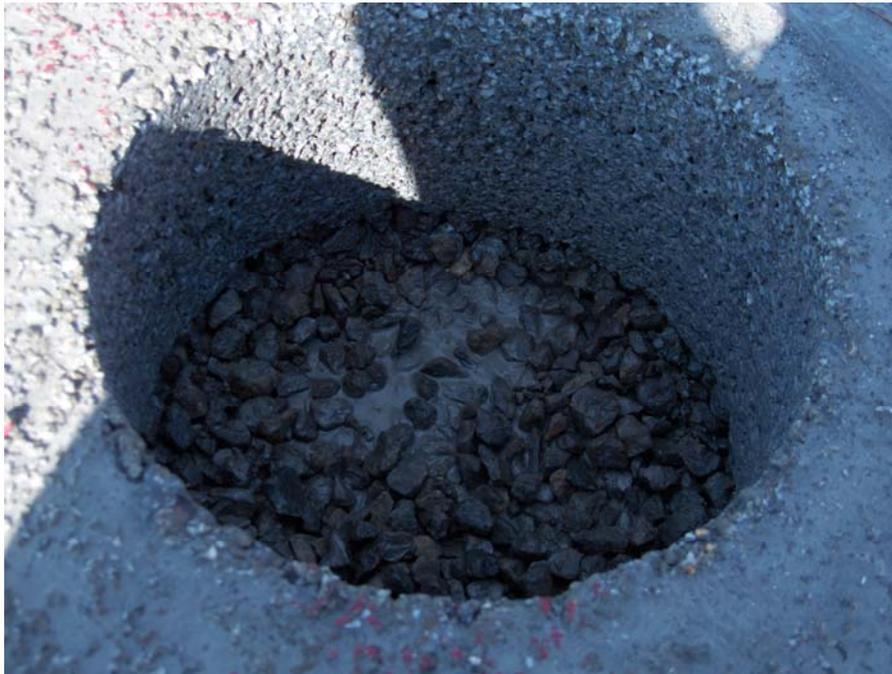
be attributed to varying surficial pore sizes in the pervious concrete due to poor construction techniques. Field system infiltration rates were not measured due to the presence of a gravel reservoir, which the single-ring infiltrometer is unable to penetrate. These results indicate that the subsoil is acting as the limiting factor at this pervious concrete installation, however, a gravel reservoir has added storage to the site to allow a longer recharge time. Laboratory tests indicate the gravel reservoir has a porosity of approximately 0.32 or a storage capacity of approximately 2 inches of water. Photographs depicting the condition of the pervious concrete in this area are shown in Figures 34, 35 and 36.

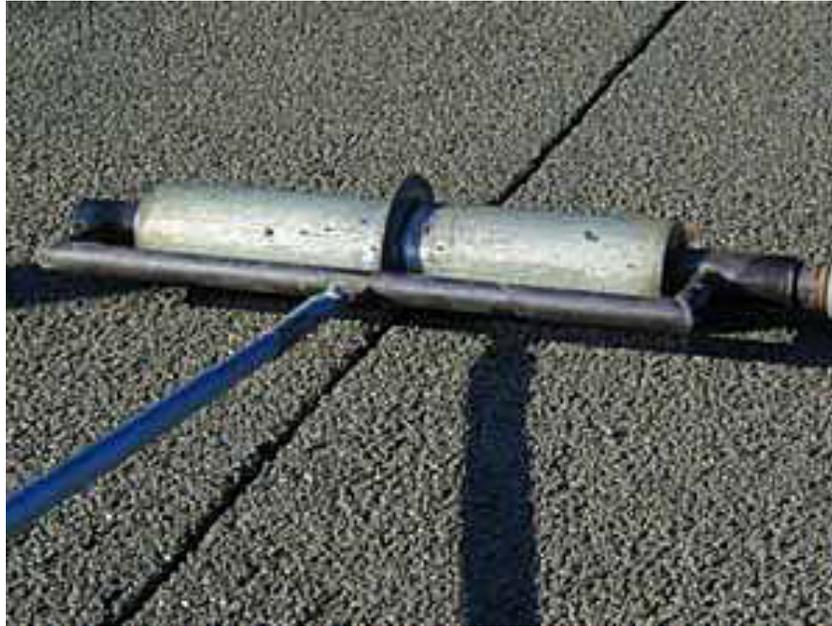
Figure 43: Roller Used to Create Joints in Pervious Concrete
