**FINAL REPORT**

**Improvements in Design Scour Depth Prediction**

**FDOT No.: BD545-34**

**D. Max Sheppard**

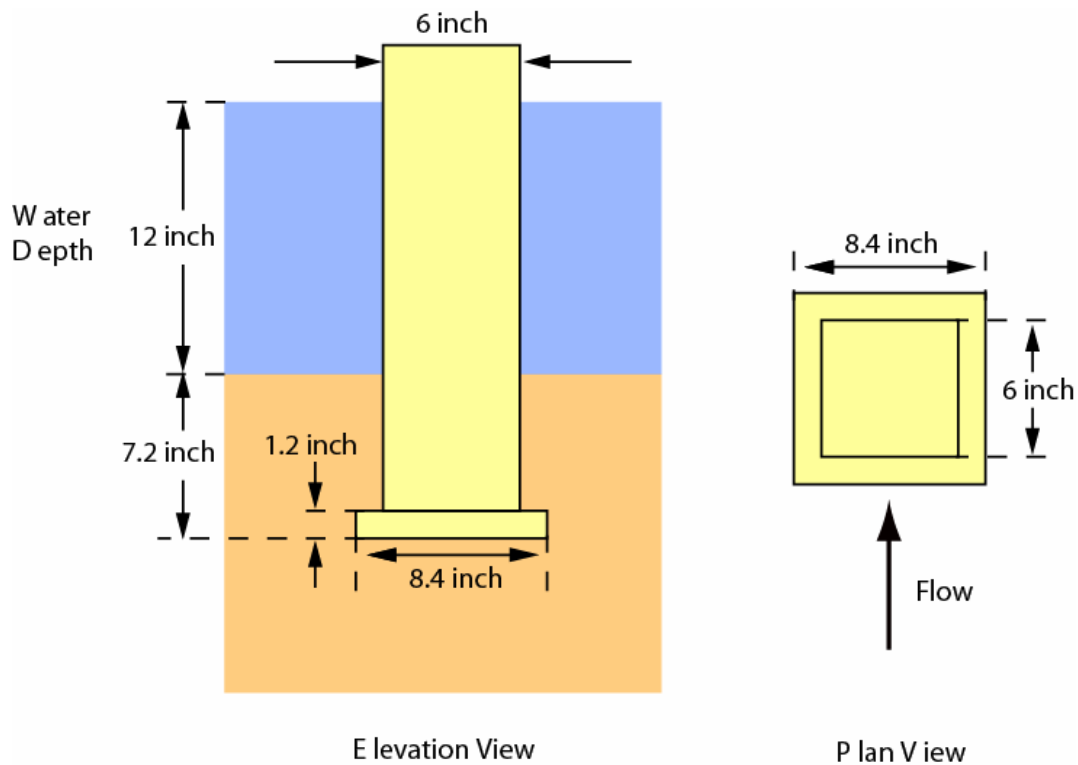
Figure 10 Plan and Elevation Views of Test 1 Set-Up (Pier 1).

The first experiment was performed in a 1-ft water depth with Pier 1. Table 1 lists the experimental conditions during the scour test and the velocity profile measured during the experiment is shown in Figure 17. The bottom of the pile cap was positioned 7.2 inches below the pre-scoured bed and supported from above as illustrated in Figure 10. Scour depths were measured with two acoustic transponders. One was located on the upstream face of the structure as shown in Figure 18 and the other was located inside the pile cap so that once the scour undermined the pile cap, it could measure scour depths below the pile cap.

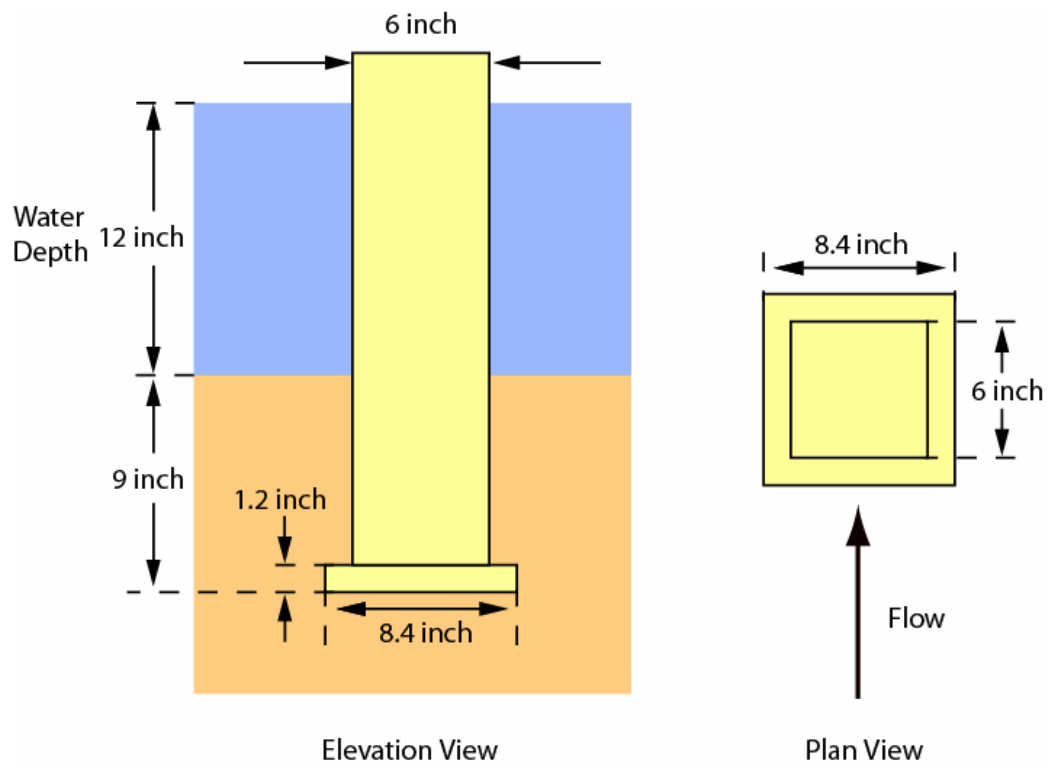
Figure 11 Plan and Elevation Views of Test 2 Set-Up (Pier 1).

The second experiment was performed with a 1-ft water depth and Pier 1. Table 2 lists the conditions present during the test. The bottom of the pile cap was positioned 9 inches below the pre-scoured bed for this test and again suspended from above as illustrated in Figure 11. Figures 26-28 are photographs taken prior to starting the experiment. Figures 29-32 show the pier and scour hole after the experiment was concluded. Scour depth as a function of time is shown in Figure 33. The duration of the experiment was 160 hours and the final measured scour depth was 0.86 ft.

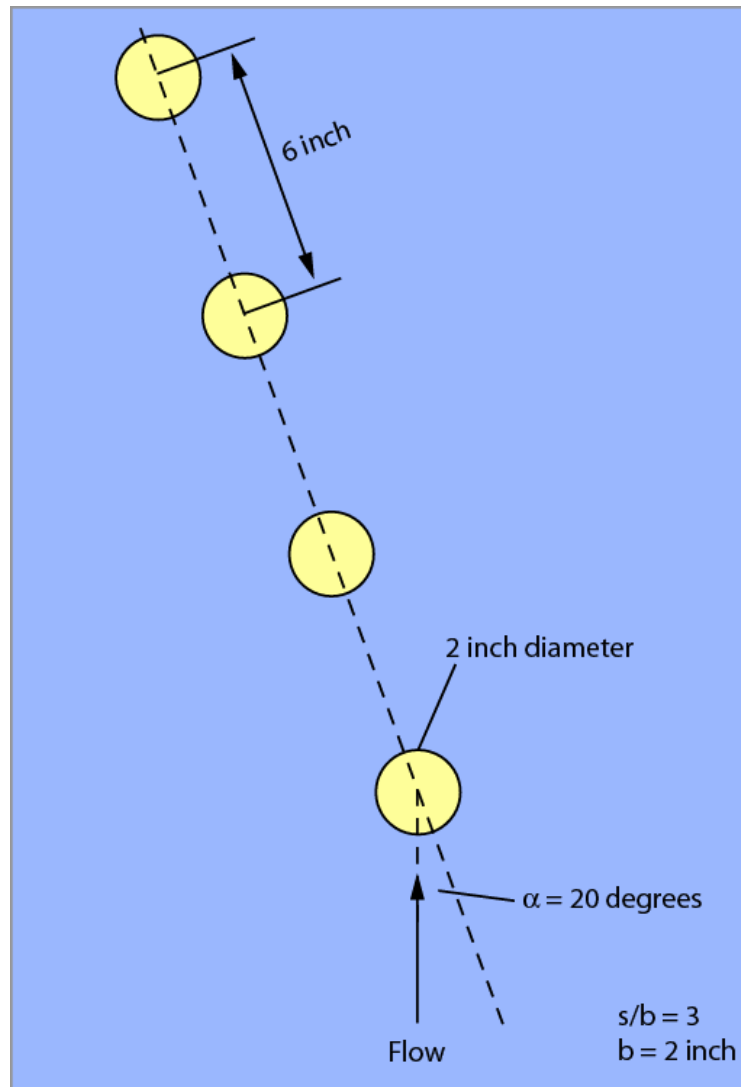
Figure 13 Plan View of Test 4 Set-Up (Pier 3).

The fourth experiment was performed with a 1.5-ft water depth and Pier 3. Table 4 lists the conditions present during the test. Test 4 was similar to Test 3 except the centerline spacing to pile diameter was 3 instead of 2 (see Figure 13). The pile group was equipped with two acoustic transponders as shown in Figure 40. Figures 41-44 show the pier and surrounding bed after the experiment was concluded. The scour depths as functions of time, measured by the inner and outer transponders are plotted in Figure 45. The experiment ran for a total of 167 hours and the final measured scour depth was 0.24 ft.

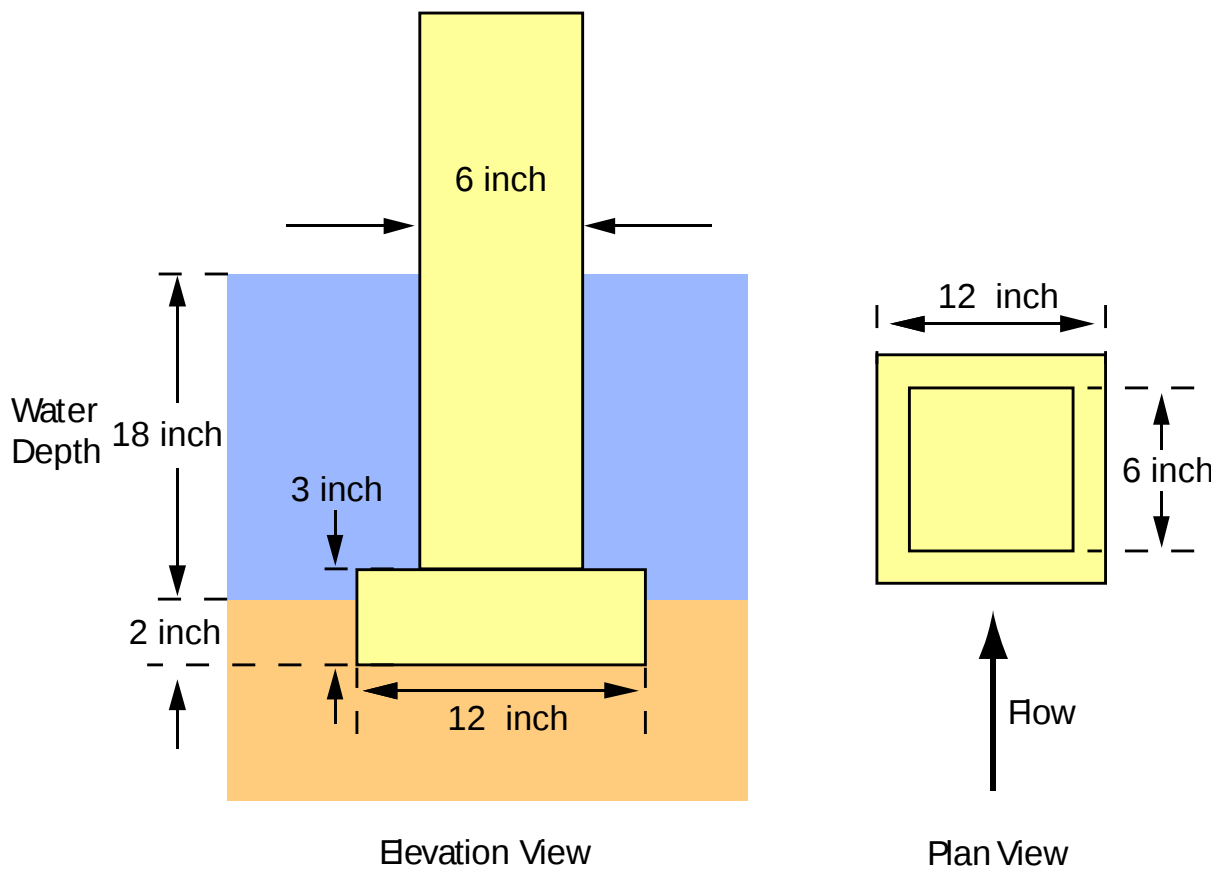
Figure 16 Plan and Elevation Views of Test 7 Set-Up (Pier 5).

Seven different scour experiments were performed for the five different piers discussed in the previous section. All of the scour experiments were performed in the clear-water scour regime. The first two scour tests were performed with Pier 1, as illustrated in Figures 10 and 11. The third scour experiment, Figure 12, employed Pier 2 with no skew angle. The pier was aligned so that it had 4 piles normal to the flow (four by one). The fourth scour experiment was performed with Pier 4 with no skew angle (Figure 13). The fifth scour experiment used Pier 3 at a 20 degree skew angle relative to the flow (Figure 14). The sixth scour test employed Pier 5 at a 20 degree skew angle similar to the fourth scour test (Figure 15). The final scour test, Test 7, employed Pier 5 in a partially buried configuration as illustrated in Figure 16.

The seventh experiment was performed in a 1-ft water depth with Pier 5. The bottom of the pile cap was positioned 2 inches below the surface as illustrated in Figure 16. Table 7 lists the conditions present during the test. The complex pier was equipped with two acoustic transponders, one in the front and another under the pile cap. Figures 58-61 show the pier and surrounding bed after the experiment was concluded. Scour depths as functions of time, measured by the inner and outer transponders are shown in Figure 62. The experiment ran for a total of 287 hours and the final measured scour depth for this test was 0.76 ft.

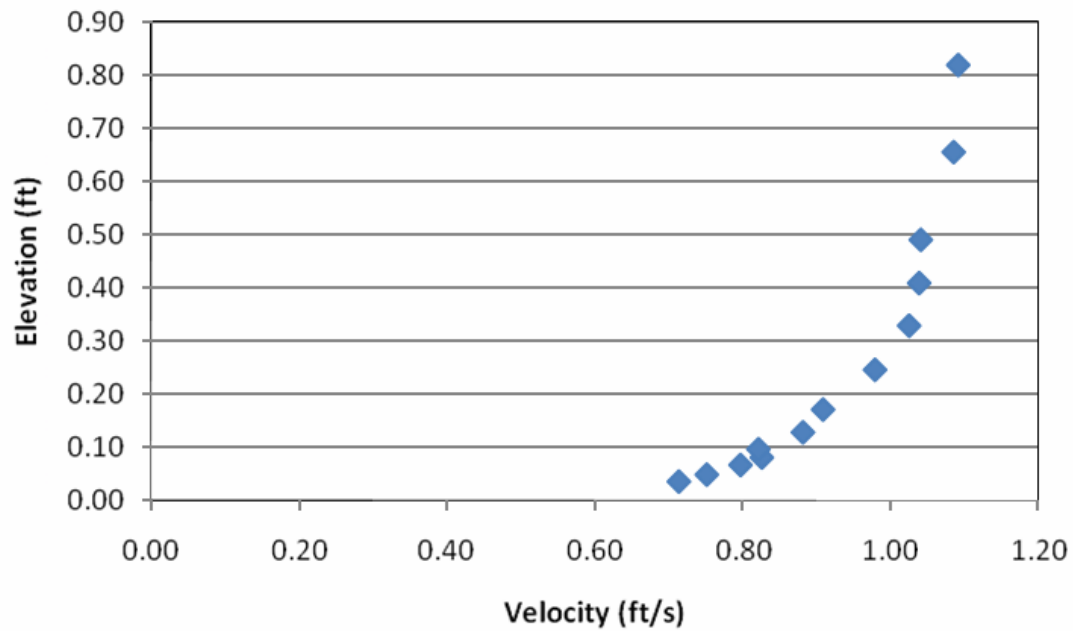
Figure 17 Typical Velocity Profile Upstream of Model Structure.

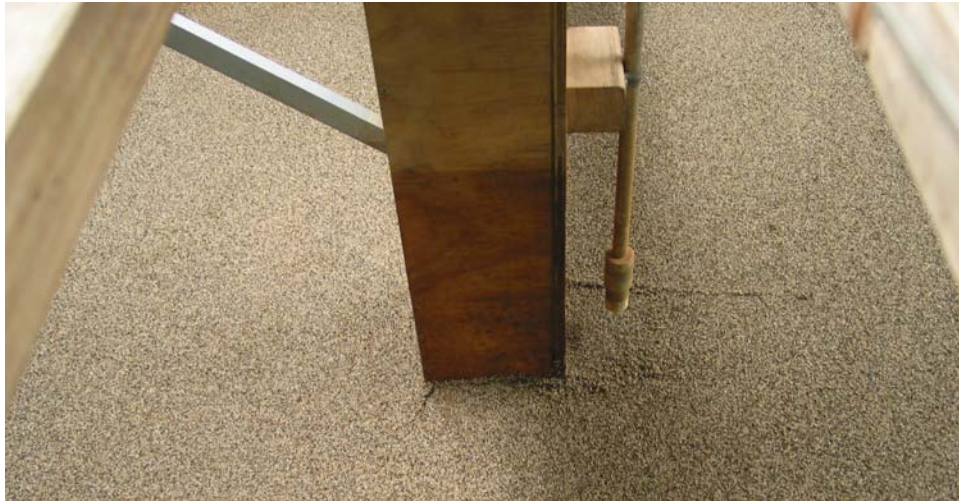
Figure 18 Side View of Pier Showing Front Face Transponder Location.

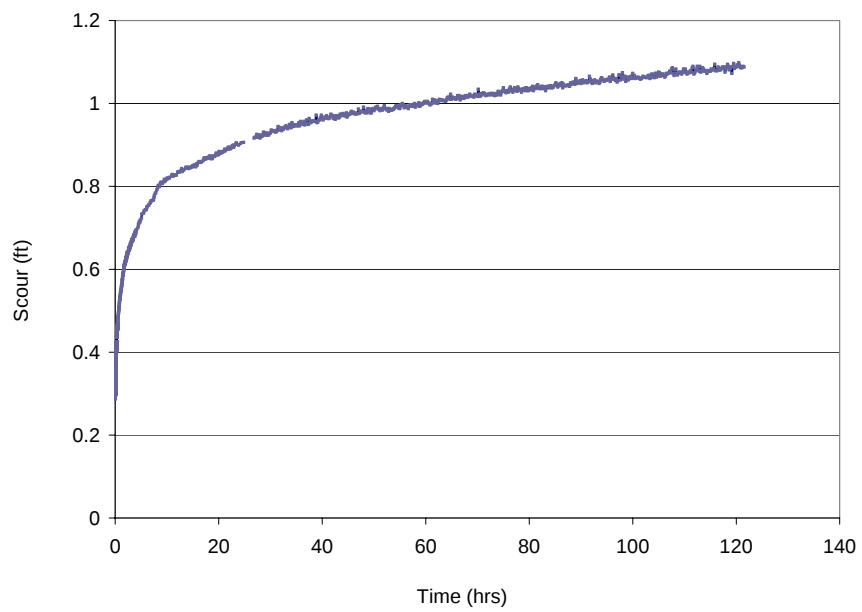
Figure 25 Time History of Scour Depth during Test 1 (Outer Transponder Data).

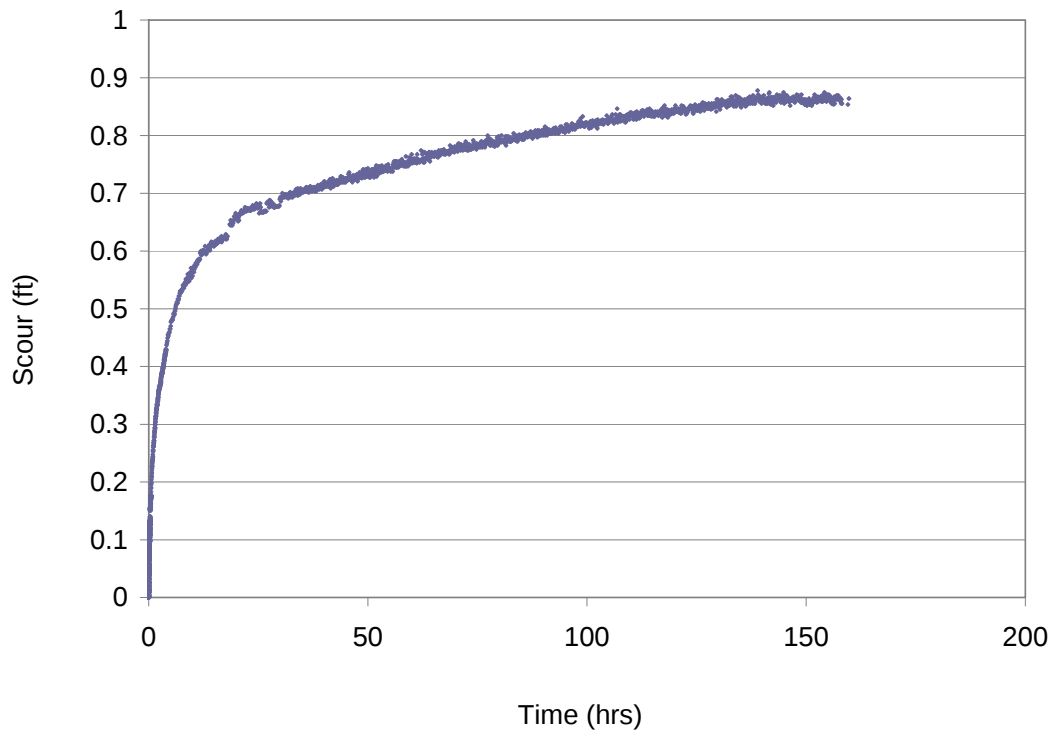
Figure 33 Time History of Scour Depth during Test 2 (Outer Transponder Data).

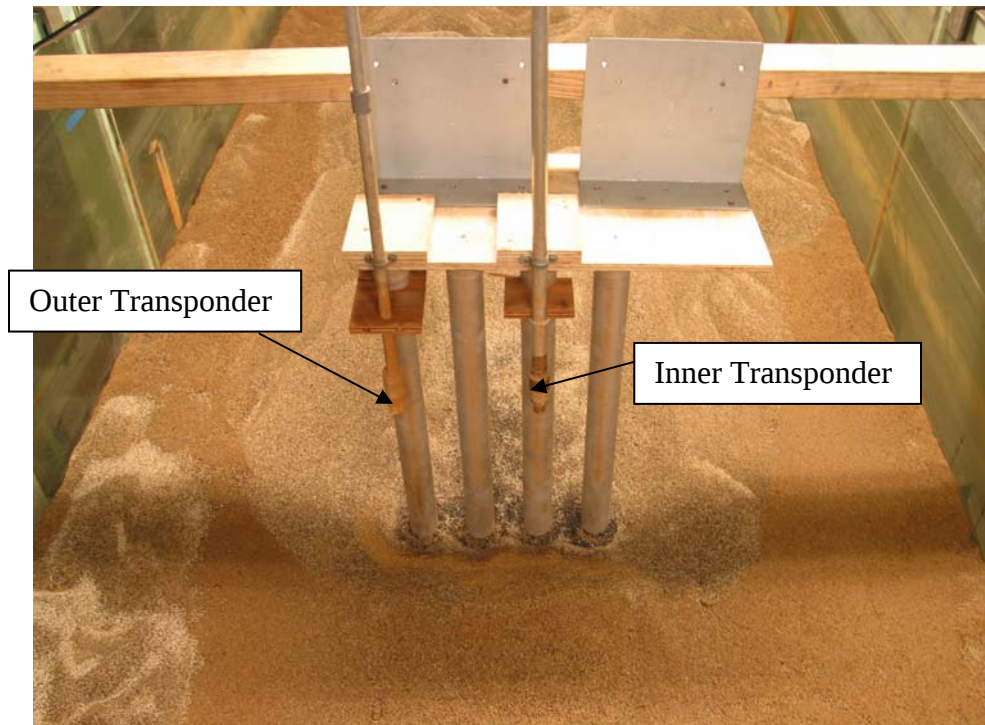
Figure 34 Post Scour Test 3 Photograph Showing Inner and Outer Transponder Locations.

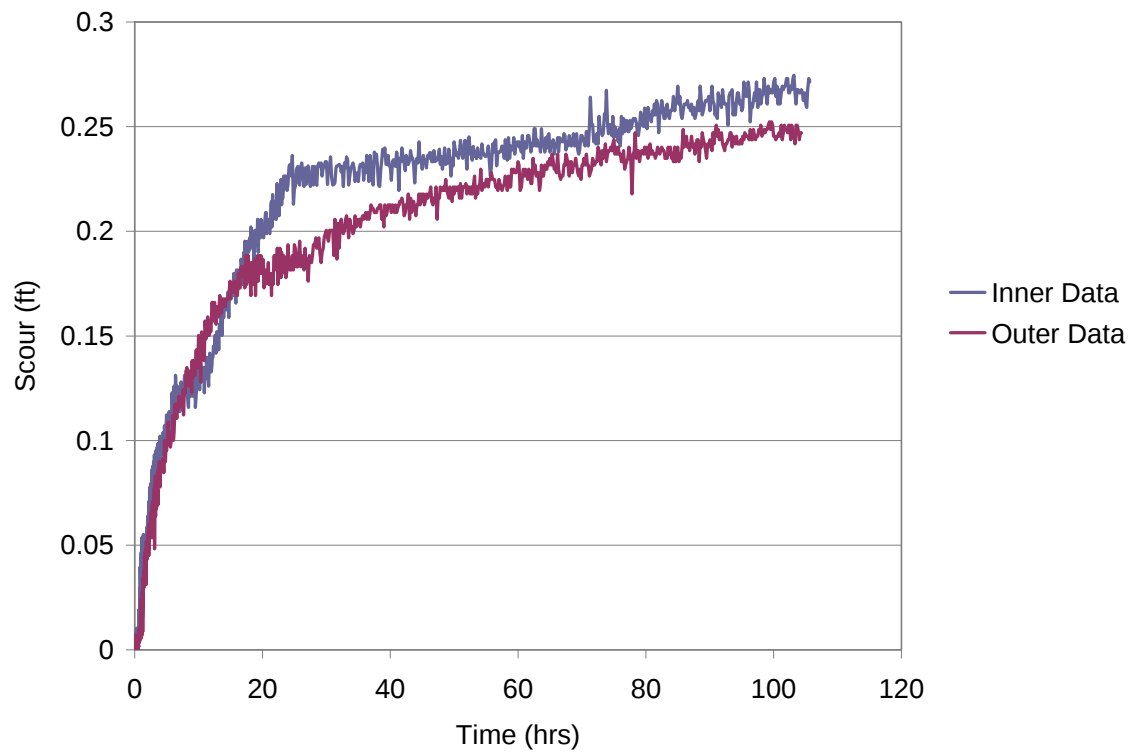
Figure 39 Time History of the Test 3 Scour Depth as Measured by the Inner and Outer Transponders.

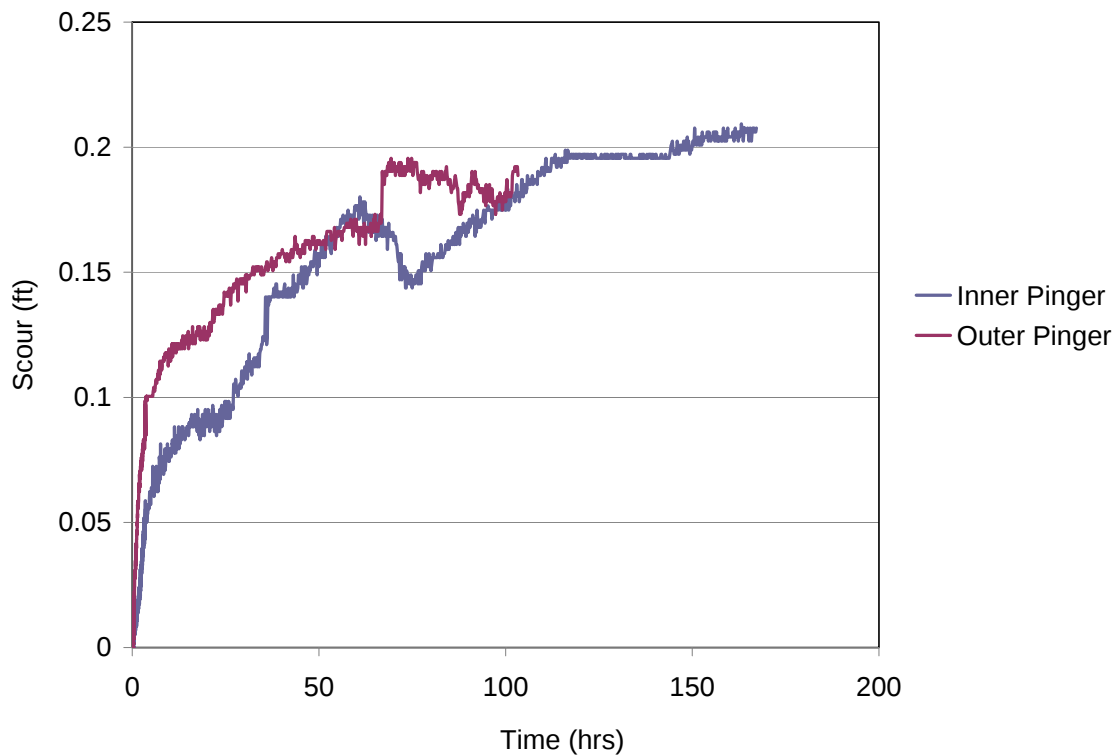
Figure 45 Time History of the Test 4 Scour Depth as Measured by the Inner and Outer Transponders. Note that sand waves of significant magnitude propagated through the test area during the test.

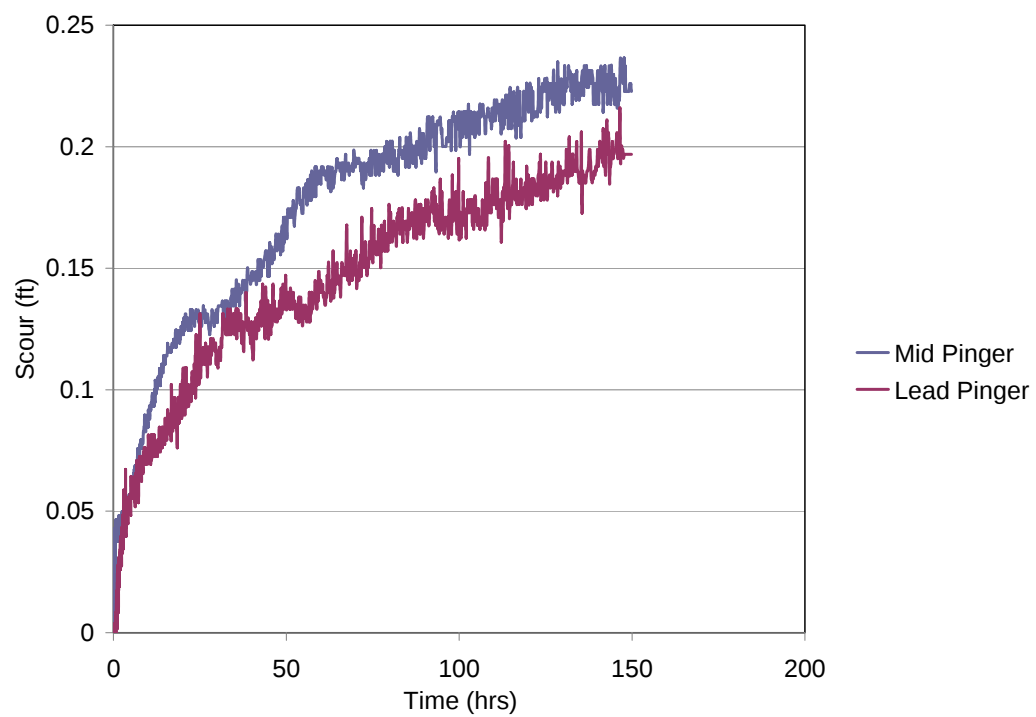
Figure 51 Time History of the Test 5 Scour Depth as Measured by the Leading and Mid Transponders.

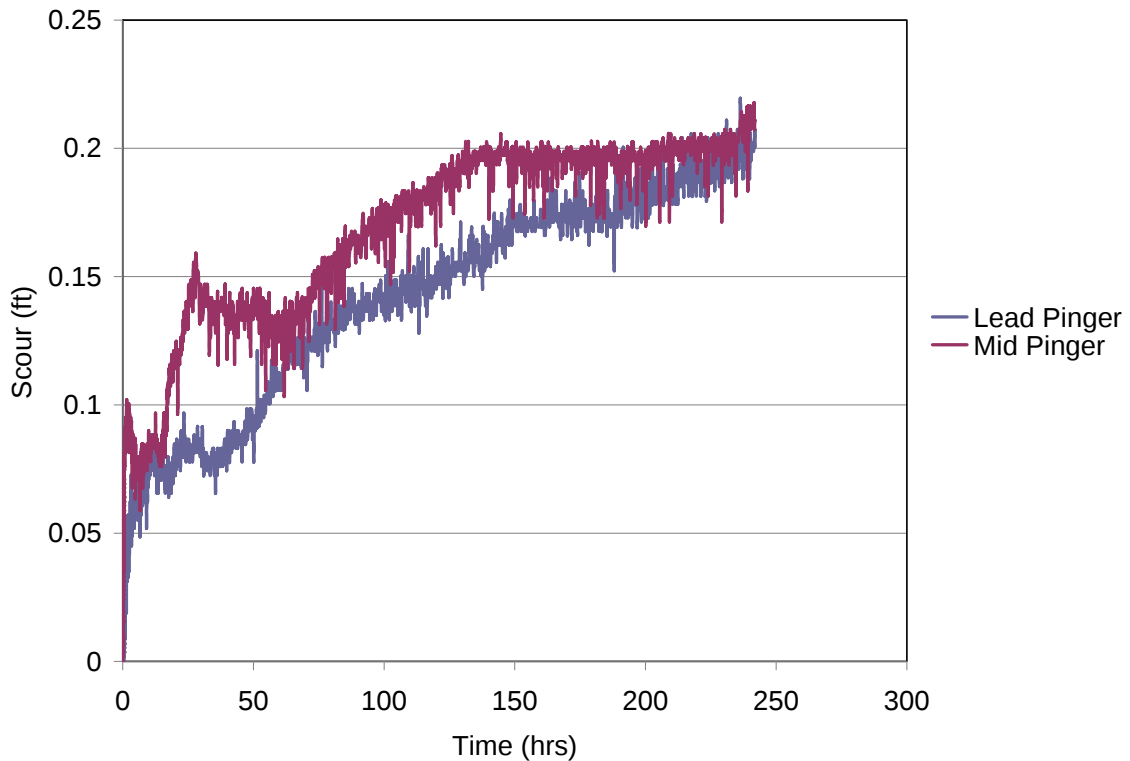
Figure 57 Time History of the Test 6 Scour Depth as Measured by the Leading and Mid Transponders.

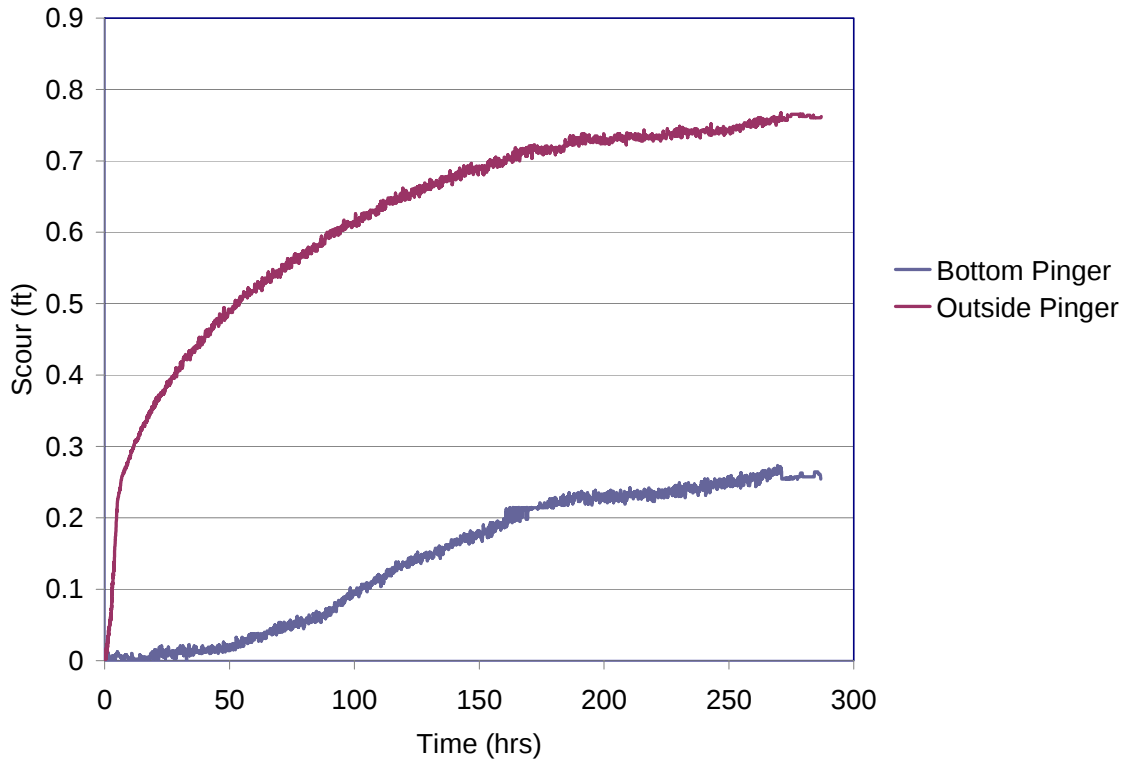
Figure 62 Time History of the Test 7 Scour Depth as Measured by the Outer and Bottom Transponders.

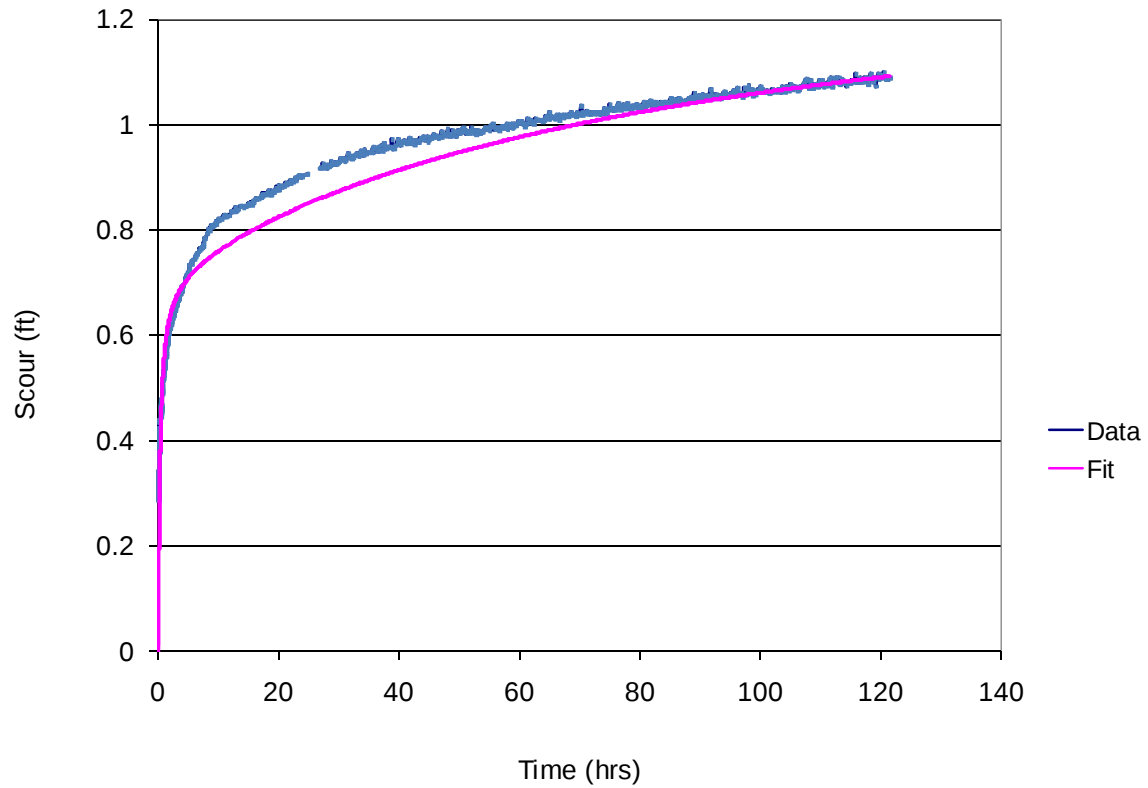
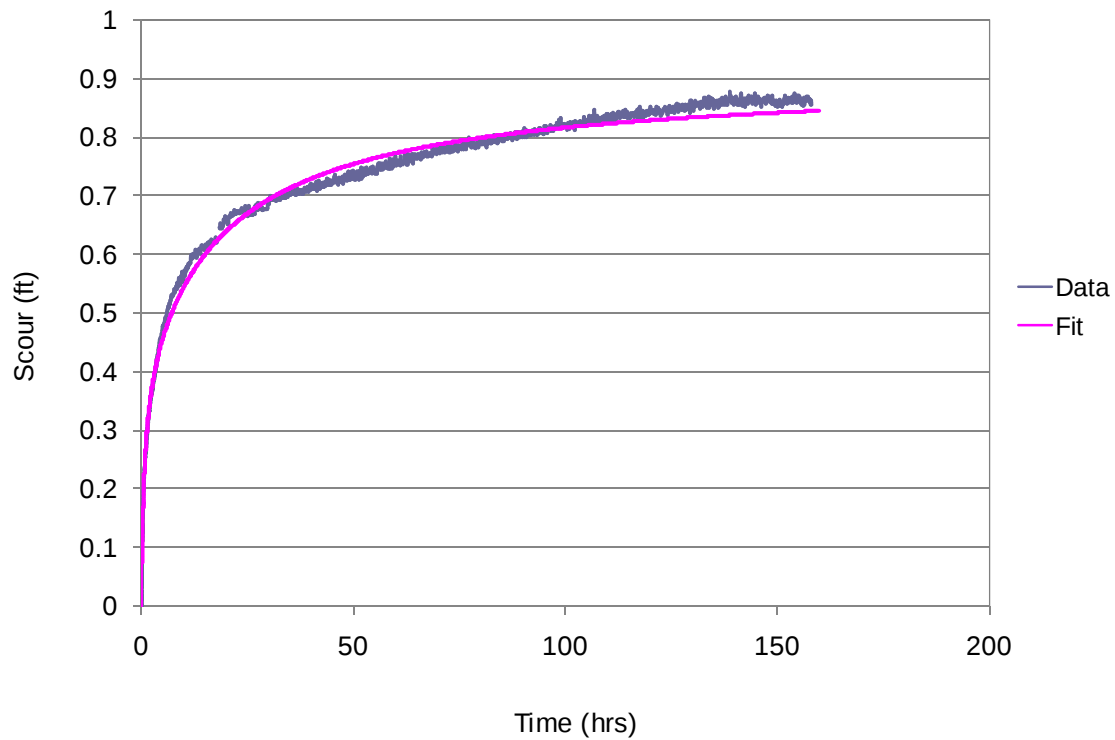
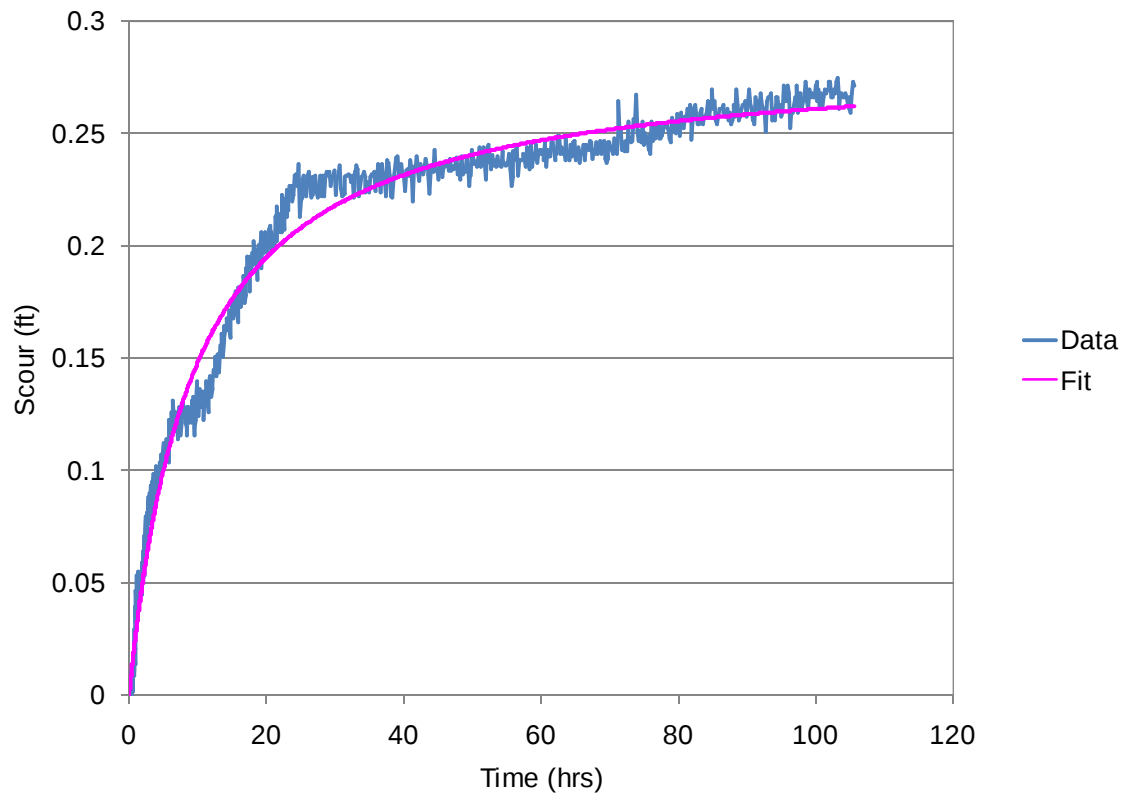
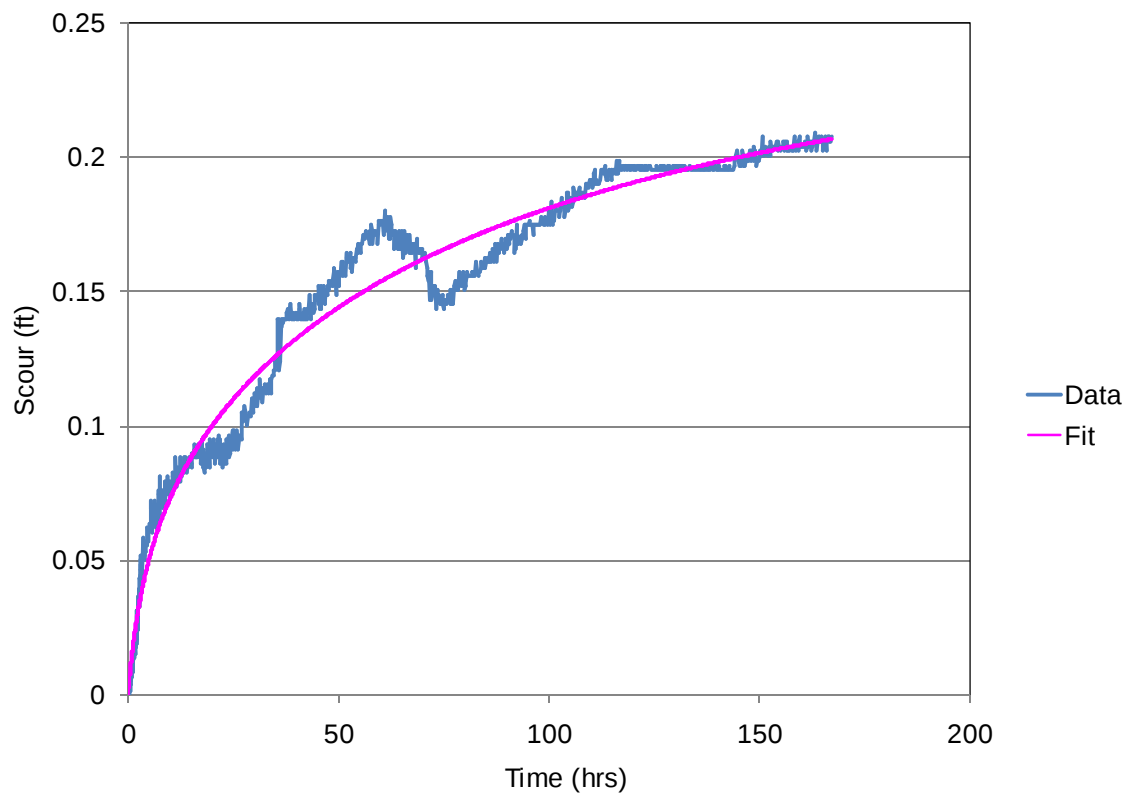
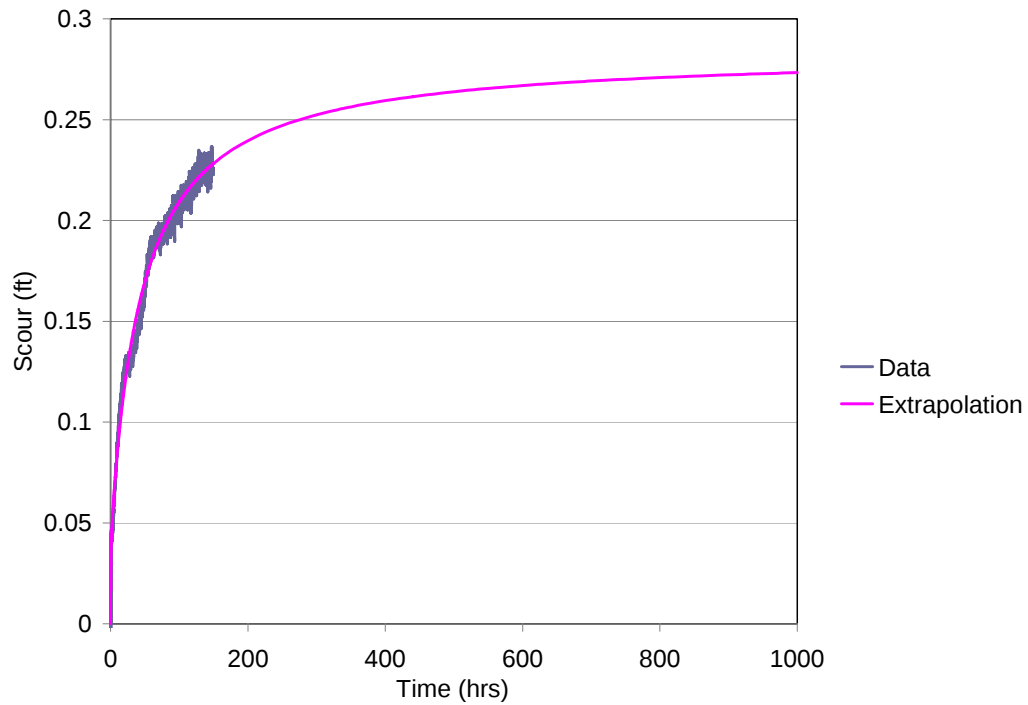
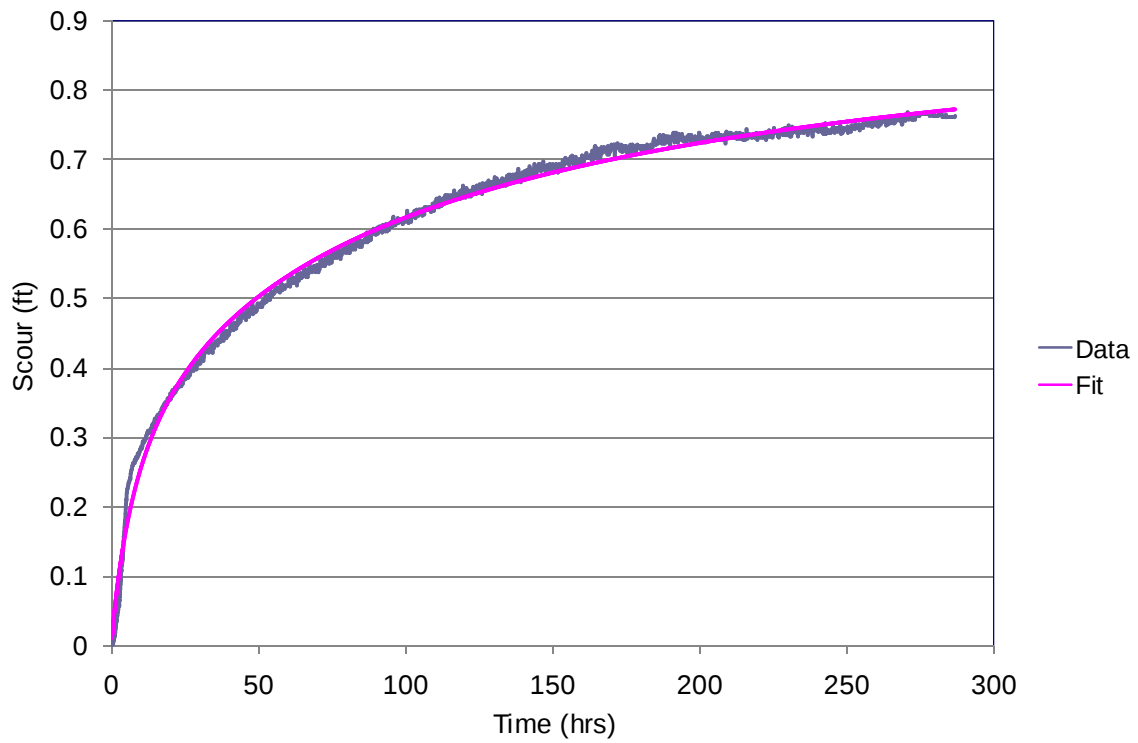
Figure 63 Test 1 Time History of Scour Depth and Curve Fit to Data.

Figure 64 Test 2 Time History of Scour Depth and Curve Fit to Data.

Figure 65 Test 3 Time History of Scour Depth and Curve Fit to Data.

Figure 66 Test 4 Time History of Scour Depth and Curve Fit to Data.

Figure 67 Test 5 Time History of Scour Depth and Curve Fit to Data.

Figure 69 Test 7 Time History of Scour Depth and Curve Fit to Data.

The results of fitting Equation 1 to the measured transponder data are presented in Figures 63-69. The coefficients employed for the individual fits are listed in Table 9. The plots indicate that the equations fit the measured data well. Note that due to the presence of sand waves early in Test 6 (Figure 64) the curve fit is not as good as for the other tests. A better fit at the earlier stages of this test would result in a less accurate fit as time progresses and an unrealistic extrapolated equilibrium value. Equilibrium scour depths were determined by extrapolating the curves out to time equal infinity. Figures 70-75 show extrapolations to 500 hours and Figure 76 an extrapolation to 1000 hours. The estimated equilibrium scour depths are given in Table 10 along maximum measured scour depths, and the percent difference between the two. The difference between the measured scour depths and the extrapolated scour depths range from 5% for experiment 2 and 3 up to 24% for experiment 6.

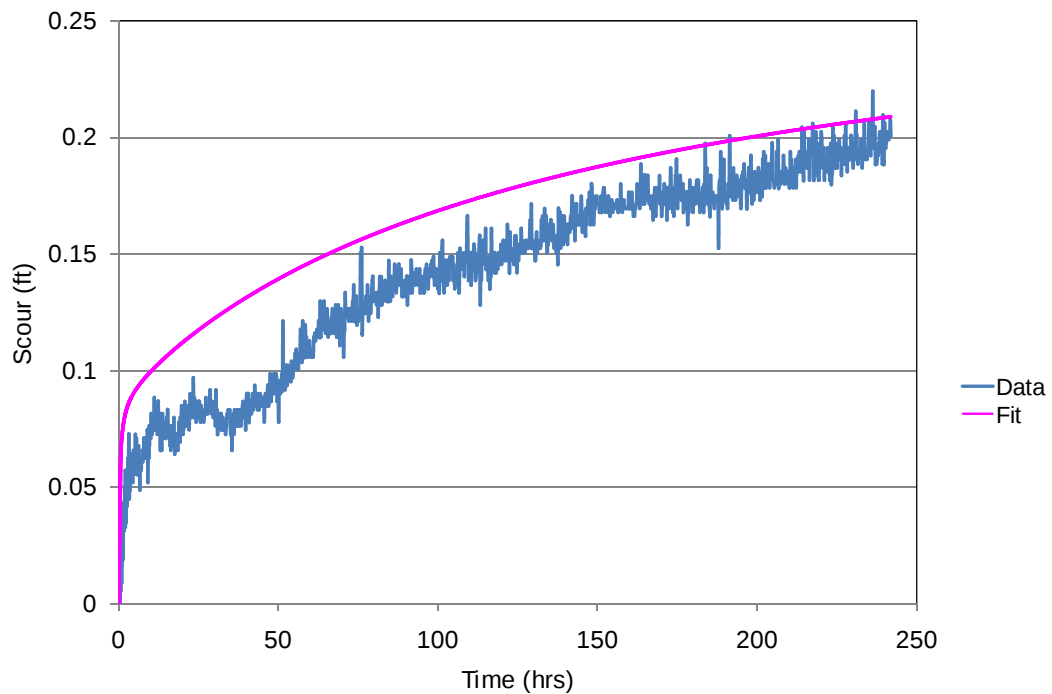
Figure 68 Test 6 Time History of Scour Depth and Curve Fit to Data. Note the presence of sand wave propagating through the test area. Due to the presence of sand waves the function used to fit the data is not as accurate during the earlier stages of the scour in this case.
