**FINAL REPORT**

**Improvements in Design Scour Depth Prediction**

**FDOT No.: BD545-34**

**D. Max Sheppard**

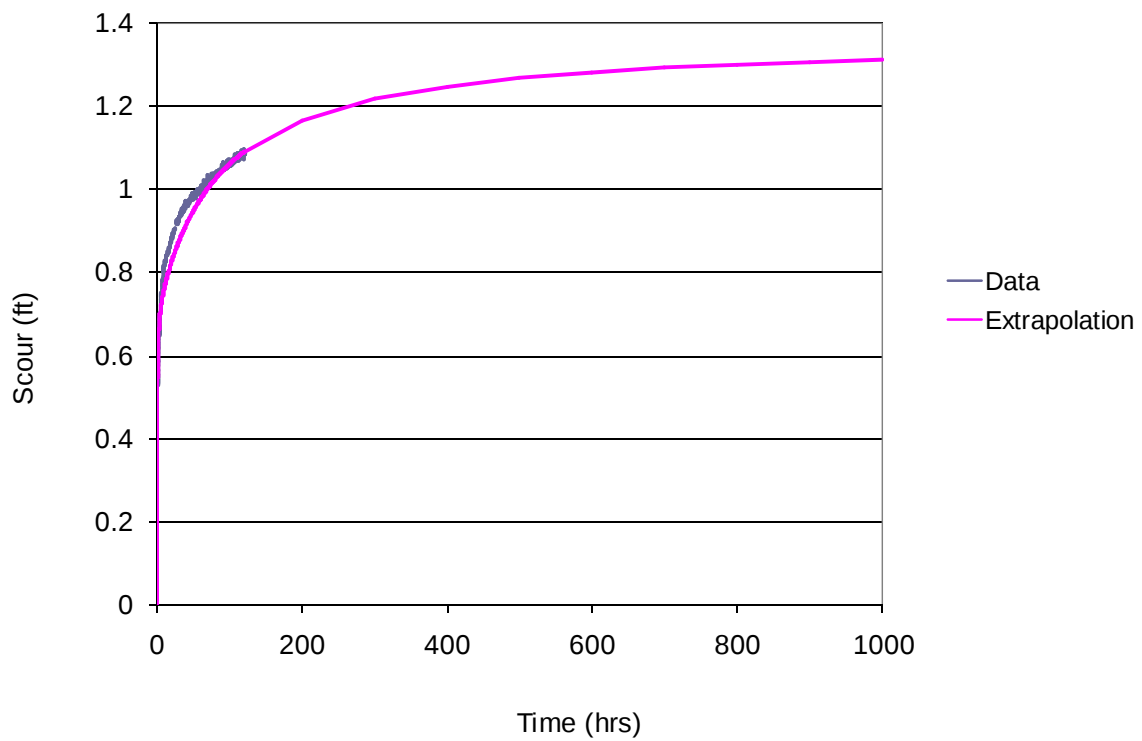
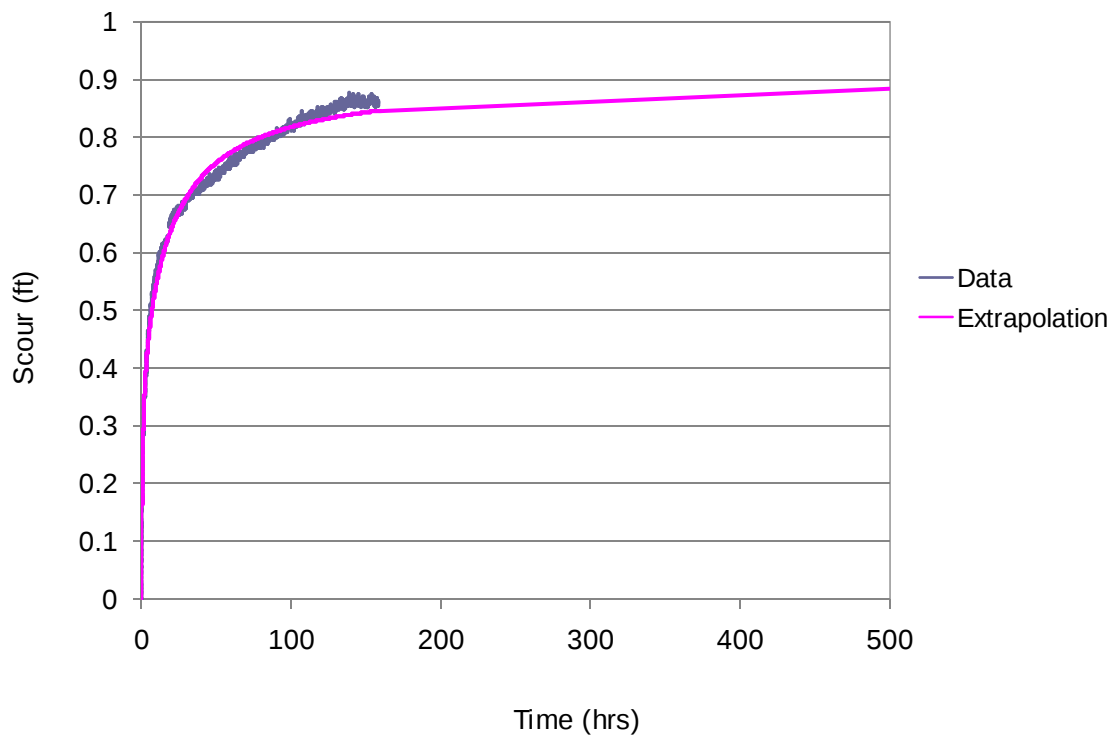
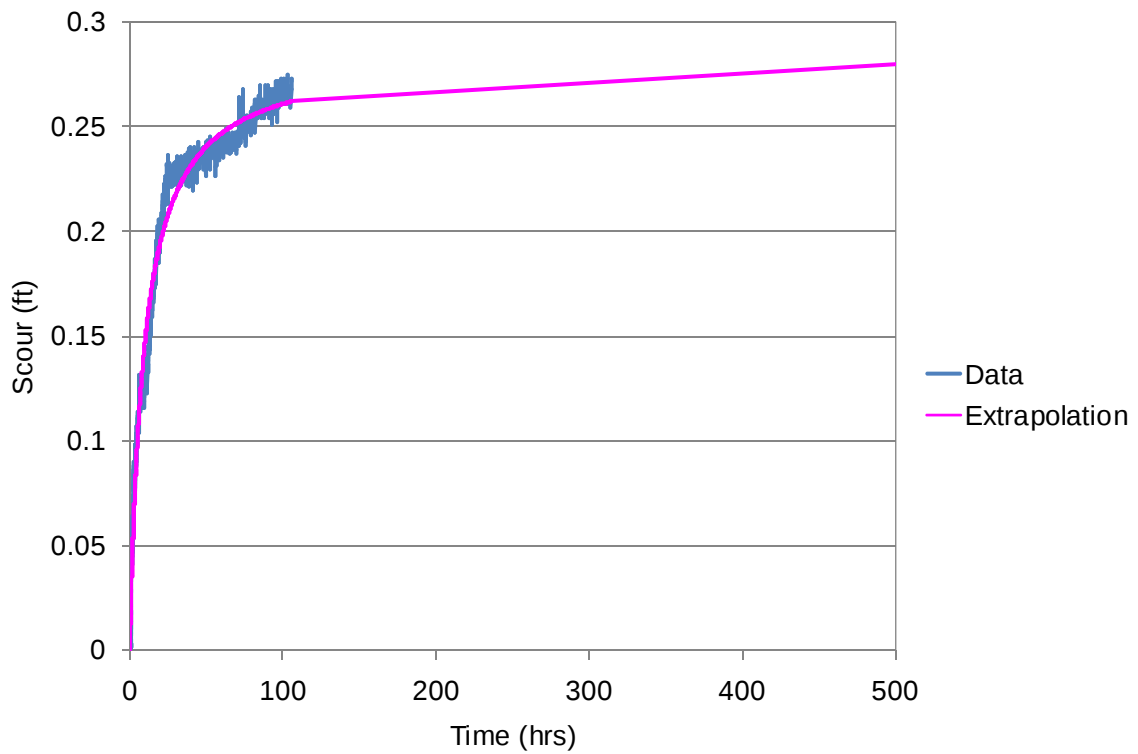
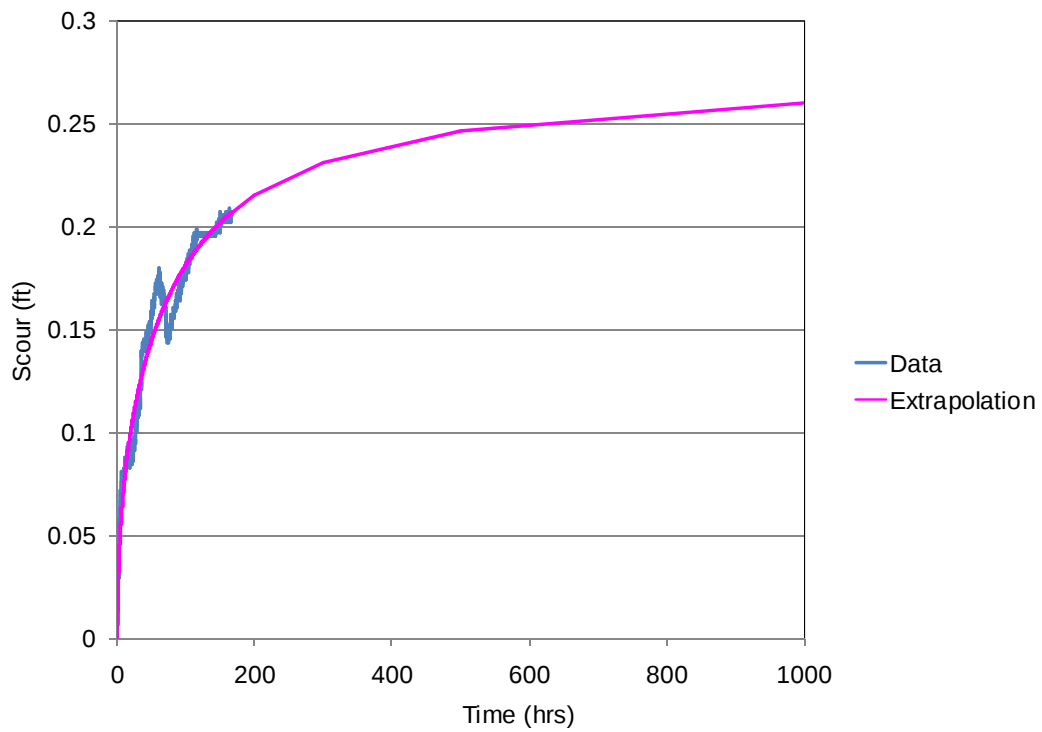
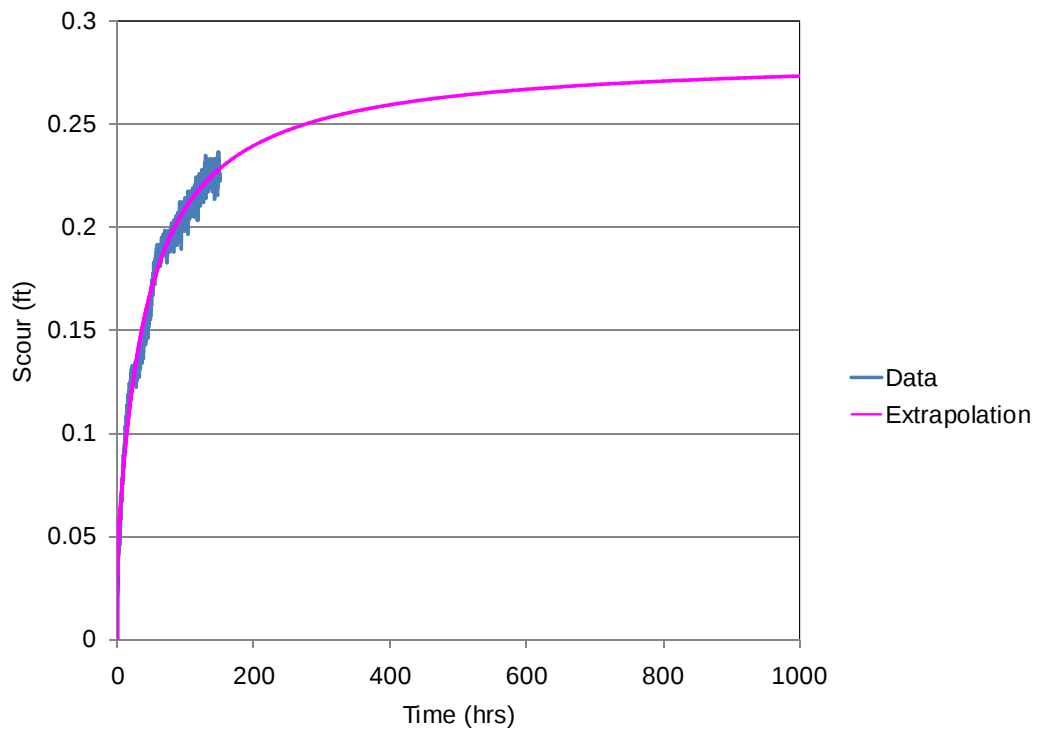
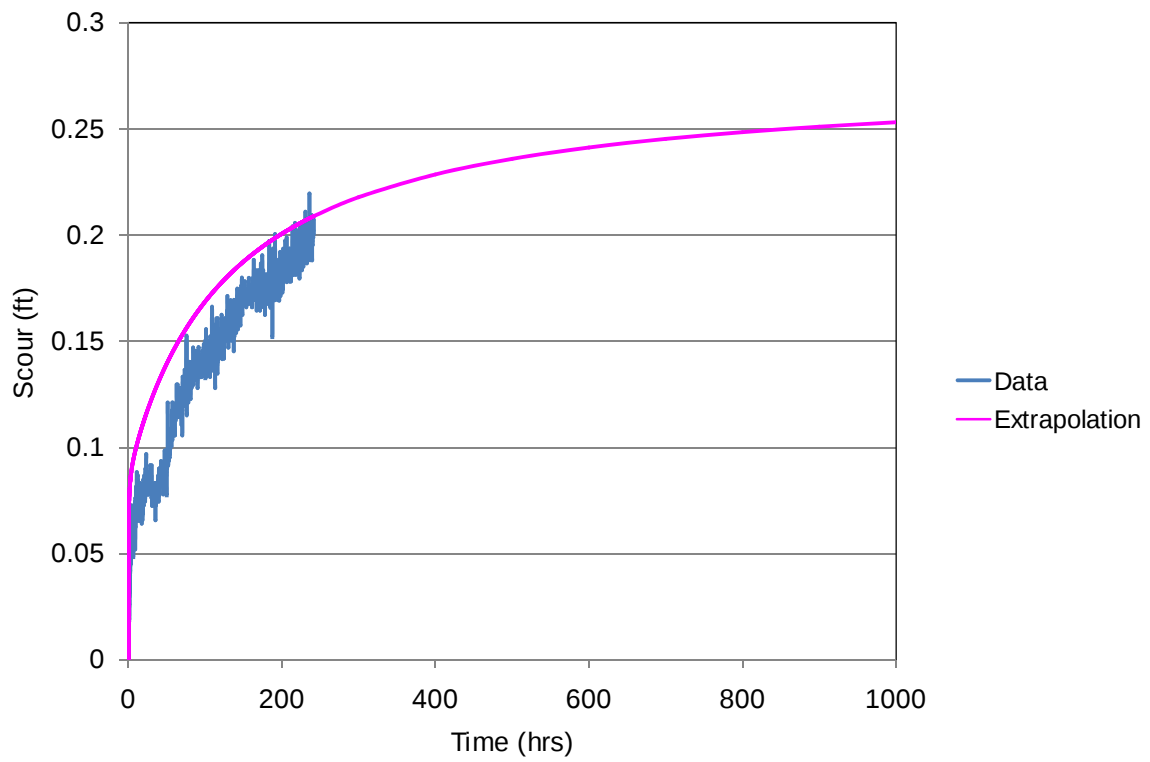
Figure 70 Test 1 Fit Curve Extrapolated to 500 hours.

Figure 71 Test 2 Fit Curve Extrapolated to 500 hours.

Figure 72 Test 3 Fit Curve Extrapolated to 500 hours.

Figure 73 Test 4 Fit Curve Extrapolated to 500 hours.

Figure 74 Test 5 Fit Curve Extrapolated to 500 hours.

Figure 75 Test 6 Fit Curve Extrapolated to 500 hours.

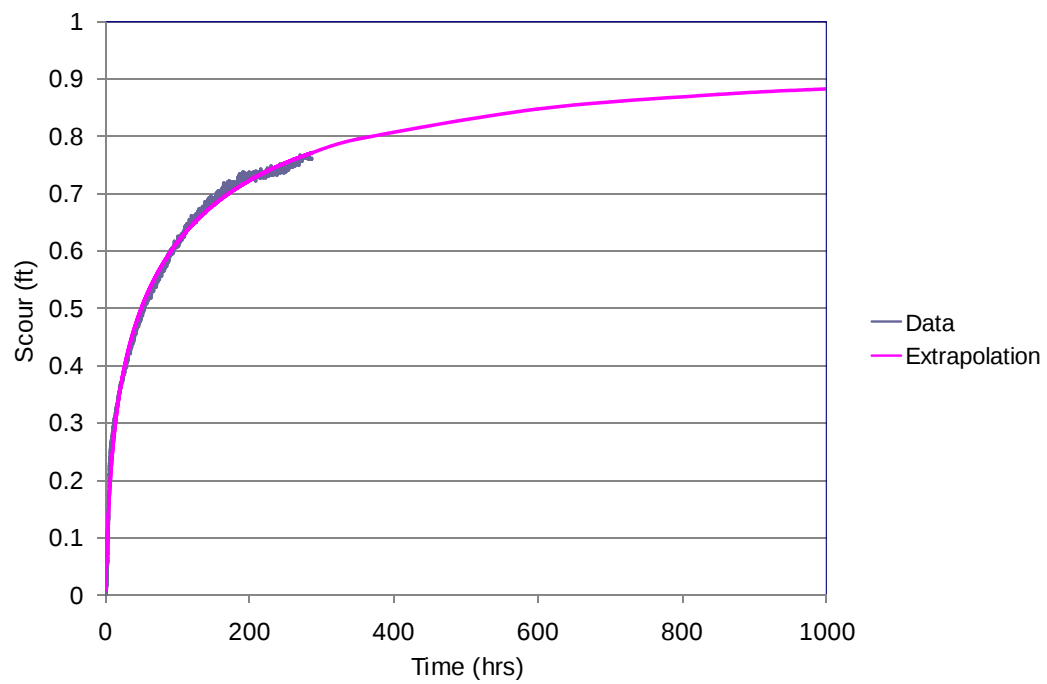
Figure 76 Exp 7 Extrapolated to 1000 hours

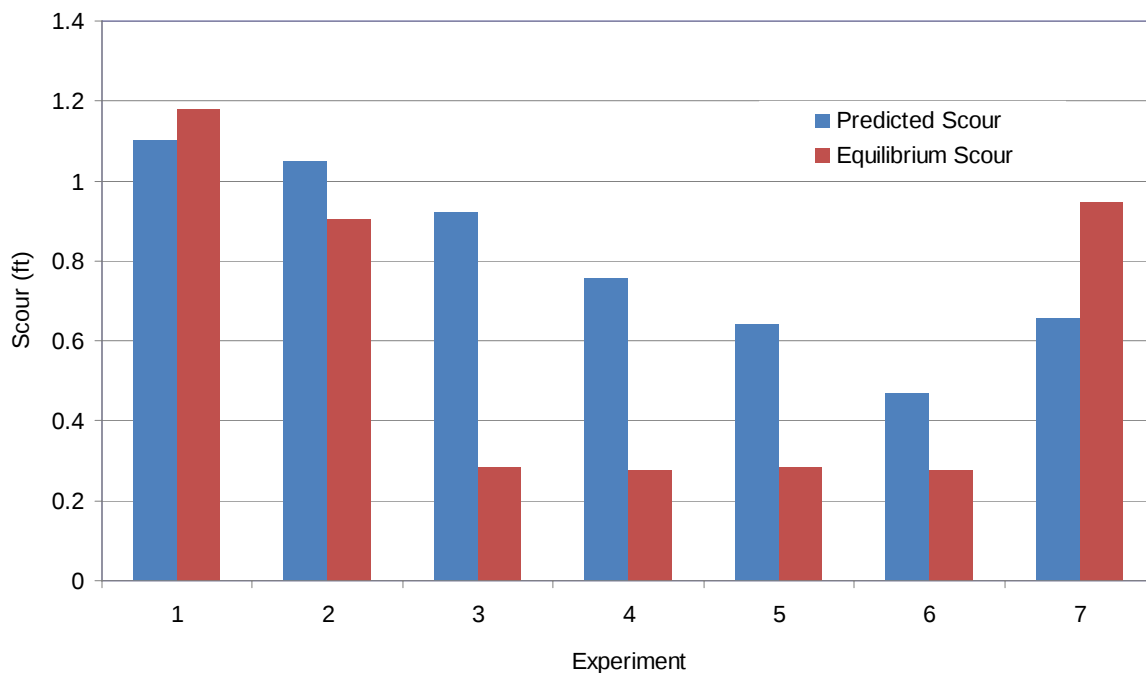
Figure 77 Predicted Versus Extrapolated Scour Depths

As discussed above the primary purpose for performing the scour experiments was to provide data missing in the literature for partially and fully buried pile caps and for pile groups with different centerline spacings and orientations to the flow. The equations were evaluated for the conditions of the tests and the results compared with the extrapolated equilibrium scour depths. Figure 77 shows the comparison between the predicted and extrapolated values. The comparison is also presented in Table 11.

The equations under predict the extrapolated scour depths in the New Zealand tests with partially and fully buried pile caps (Tests 1 and 7) and over predict the depths for the pile group tests (Tests 2-6). It should be pointed out that only limited data existed for scour at partially and fully buried pile caps when the complex pier scour equations were developed. The premise on which these equations were developed is that a complex pier consisting of up to three components (column, pile cap and pile group) can be replaced by a single circular

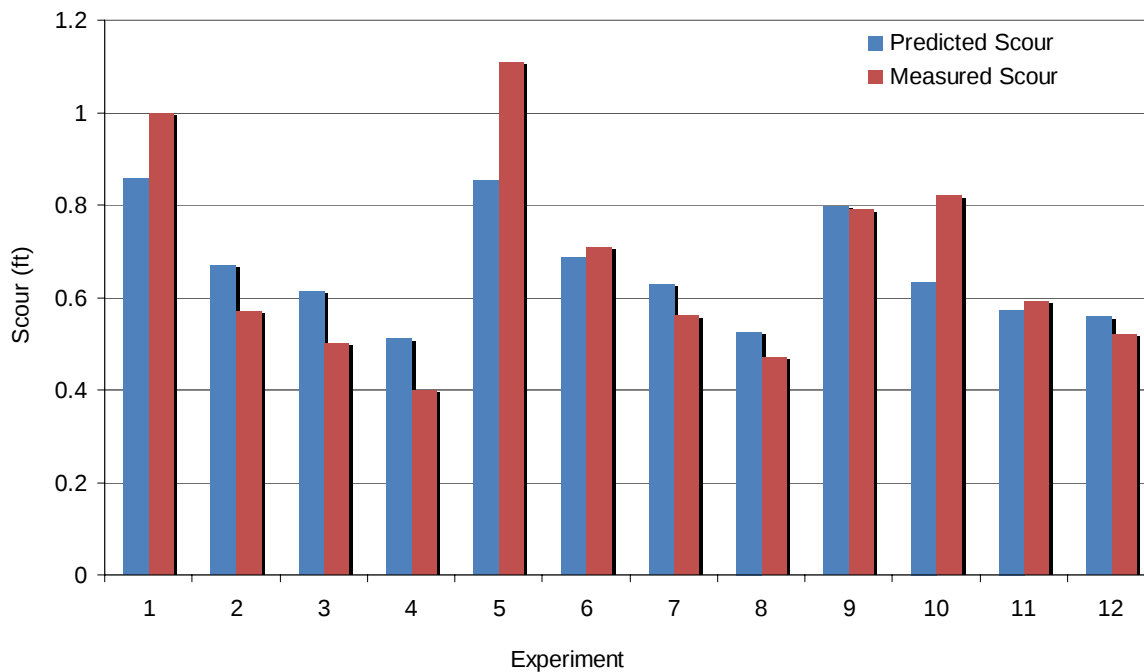
Figure 78 Experiments Performed by Sterling Jones at the FHWA Turner-Fairbanks Laboratory. All Experiments Performed with Column and Footer (no piles). Experiments 1, 5 and 10 were with buried footers. Experiment 9 is suspect.
