# **Moving the Bus Back into Traffic Safely - Signage and Lighting Configuration Phase I**

**FDOT BD 549-34  
Final Report  
November 2007**

Florida Department of Transportation  
BD 549-34

Prepared by  
Huaguo Zhou, Ph.D., P.E., Senior Research Associate  
Stephanie Bromfield, Graduate Research Assistant

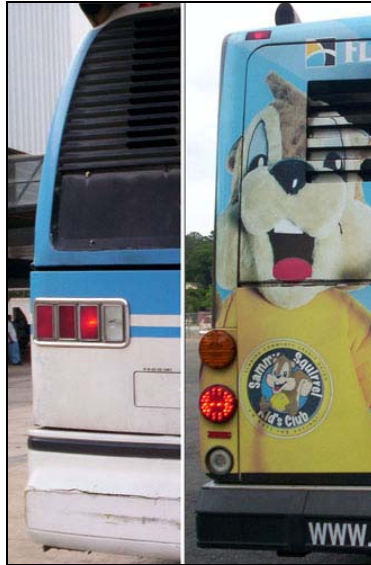
The exact placement of these lights and markers vary by bus make and model. The lights are sometimes placed low on the bus close to the bumper, other times they are placed higher up. Lights may be aligned vertically or horizontally as shown in Figure 1, as long as they are located at the corner of the bus.

**Figure 1 Vertical and Horizontal Light Configurations**

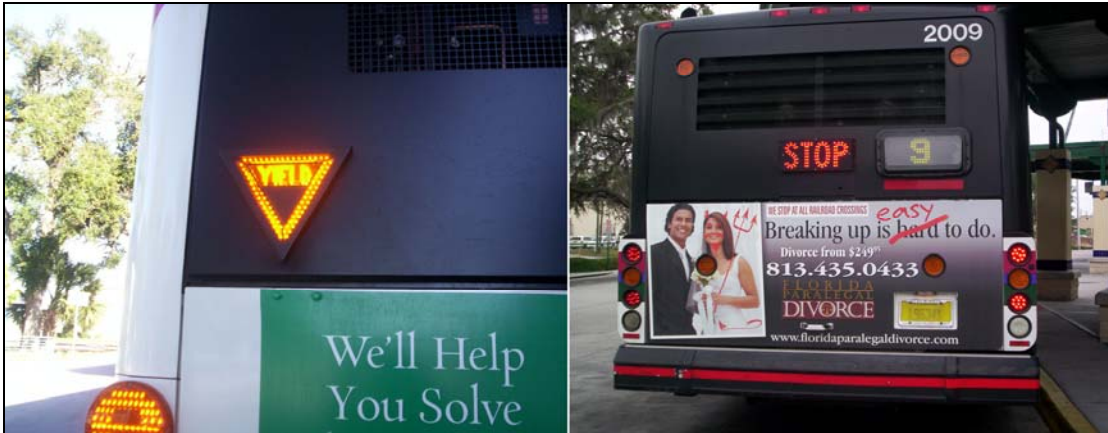
Additional light emitting diode (LED) lights and deceleration lights are sometimes added to improve bus safety. Options available in LED lights include lights that spell the word STOP and YIELD (Figure 2). Transit agencies may also change the positions of amber and red lights and increase the size of the lights. Reflective tape is also used to increase the conspicuity of buses. Other lighting used to improve the conspicuity of the bus includes daytime running lights, additional lights around the bus, and strobe lights. LED lights have additional benefits as they are said to have a useful life approximately 100 times greater than incandescent bulbs. Incandescent lights have been traditionally used for the external lighting on buses.

**Figure 2 YIELD and STOP LED Lights**

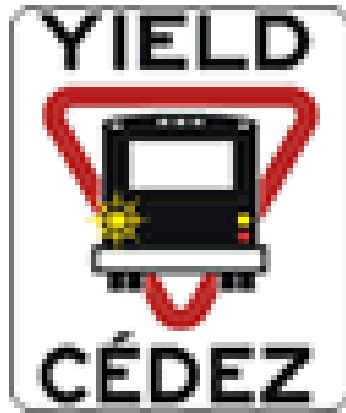
In 2004, Ontario, Canada passed a Yield-to-Bus law similar to the ones in the U.S. The new law applies to all buses that bear the YIELD / CÉDEZ decal (Figure 4) near the left turn signal on the rear of the bus. When a bus displaying the sign is signaling its intention to leave a bus bay by activating the left turn signal, drivers approaching from the rear in the adjacent lane are required to slow down or stop to allow the bus to re-enter the lane, unless it is unsafe to do so.

**Figure 4 Yield/Cédez Decal in Canada**

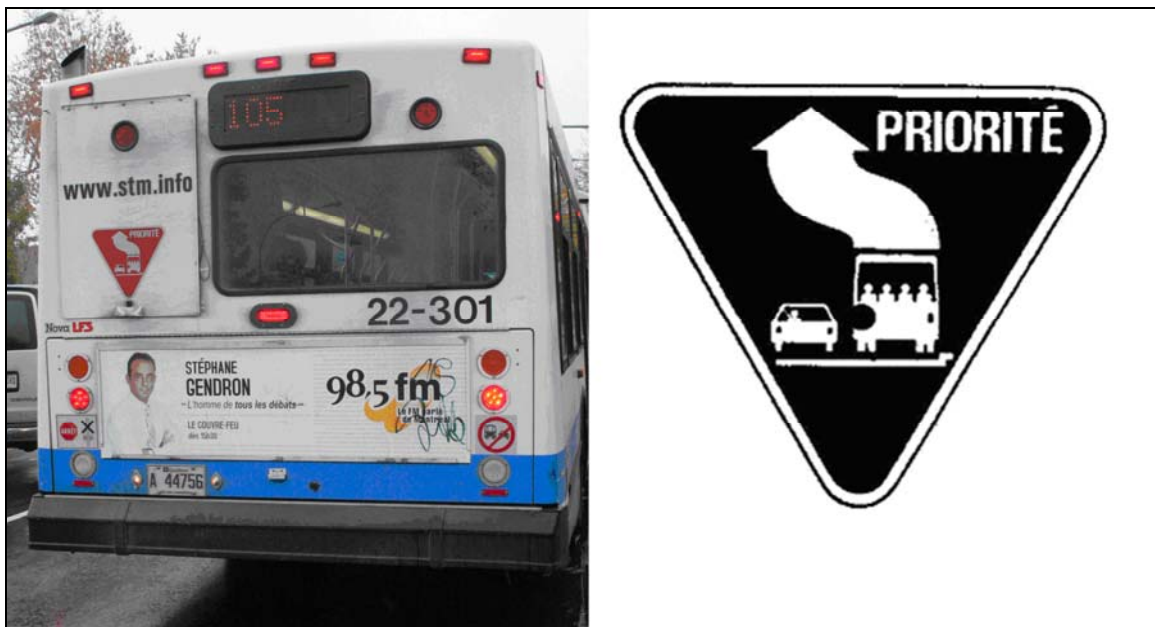
Yield-to-Bus legislation has been in effect in Quebec since 1982. The law was drafted similar to the European laws. A decal is placed on the lower-left corner of the rear window of the bus. The decal consists of an inverted equilateral triangle with sides 38 cm and a red message on a white back ground (Figure 5).

**Figure 5 Bus Priority Sign in Canada**

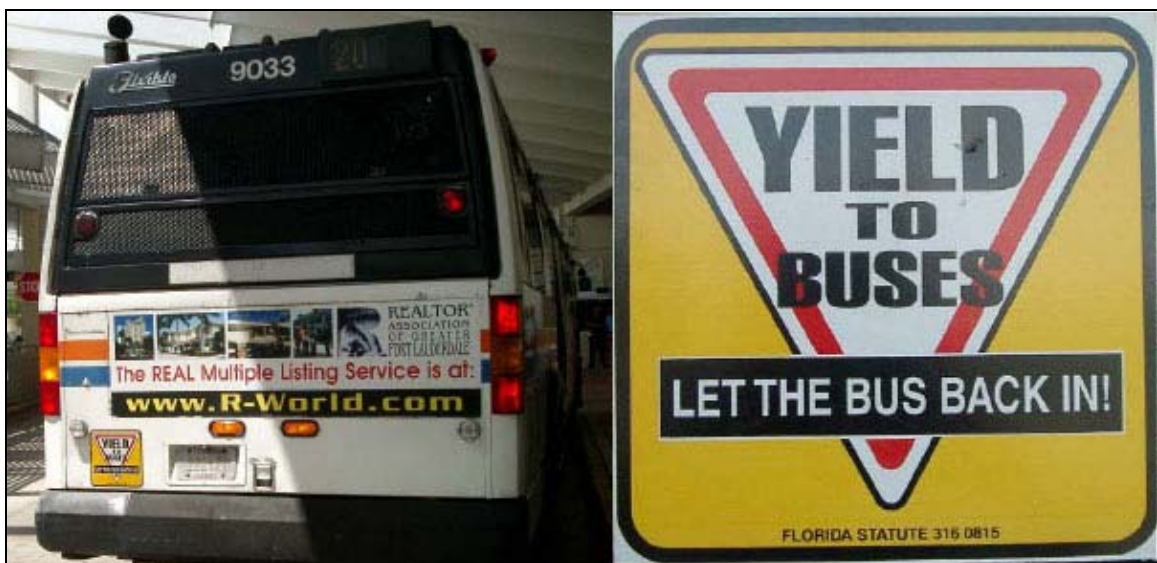
As shown in Figure 6, Broward County Transit (BCT) uses a reflective Yield-to-Bus (YTB) decal on the lower-left rear corner above the bumper of the bus. The decal is an equilateral triangle with sides approximately 18 inches in length. The triangle is red on a yellow background with white words on a black background. BCT also considered using an electronic flashing yield sign but they were concerned with electrical power load.

**Figure 6 YTB Decal 1 (Broward County Transit)**

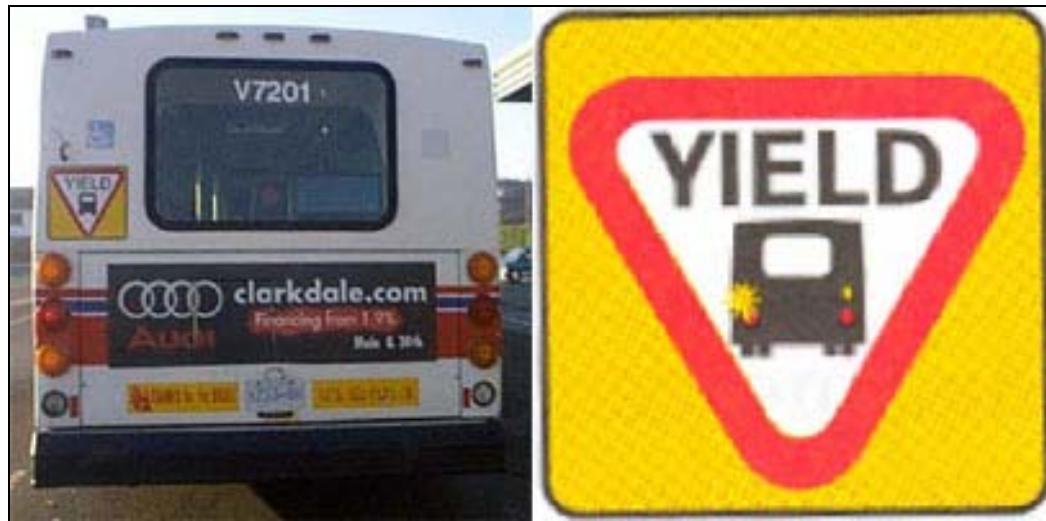
As shown in Figure 9, Coast Mountain Bus Company (CMBC) uses a reflective square decal with sides approximately 10 inches in length. Inside the square is a red equilateral triangle on a yellow background. Inside the triangle is white with “Yield” written in black letters and the silhouette of a bus below it. The decal is located to the left of the rear window on the back of the bus. A decal was chosen over the electronic yield sign because the decal was significantly less expensive. However, some CMBC buses that operate in West Vancouver use the LED yield sign in combination with the decal. On the rear bumper, CMBC also includes a YTB-related decal signs that say “Thanks for the Brake” and “Please Yield it’s the Law”, as shown in Figure 10.

**Figure 9 YTB decal 2 (Coast Mountain Bus Company)**  
(Source: TCRP Synthesis 49)

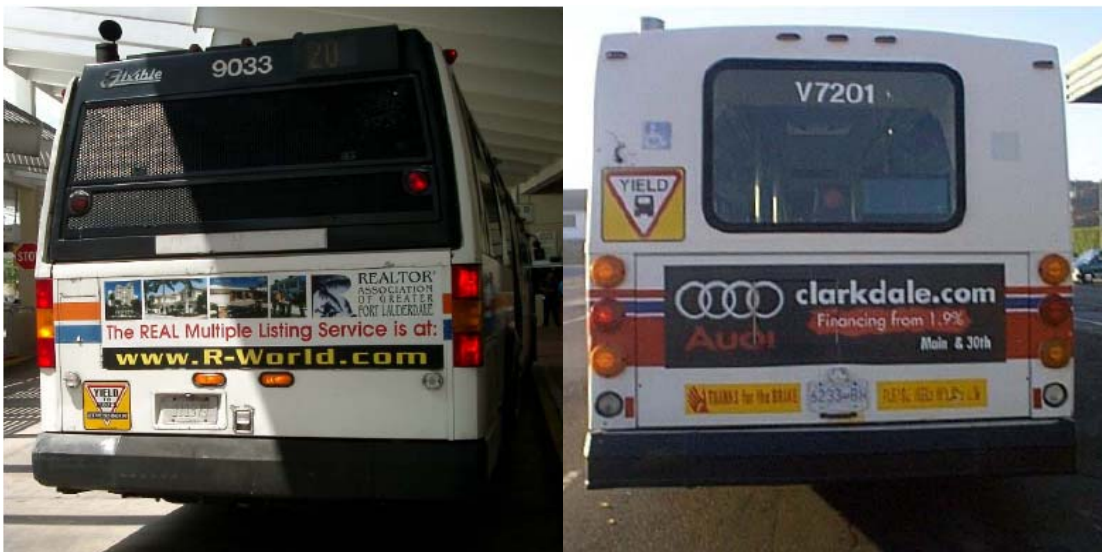
Decal 1 and Decal 2 are very similar, except for the location of each decal on the back of bus. Decal 1 is installed just above the bumper, and Decal 2 is installed at half way up and to the left side on the rear of the bus, as shown in Figure 15.

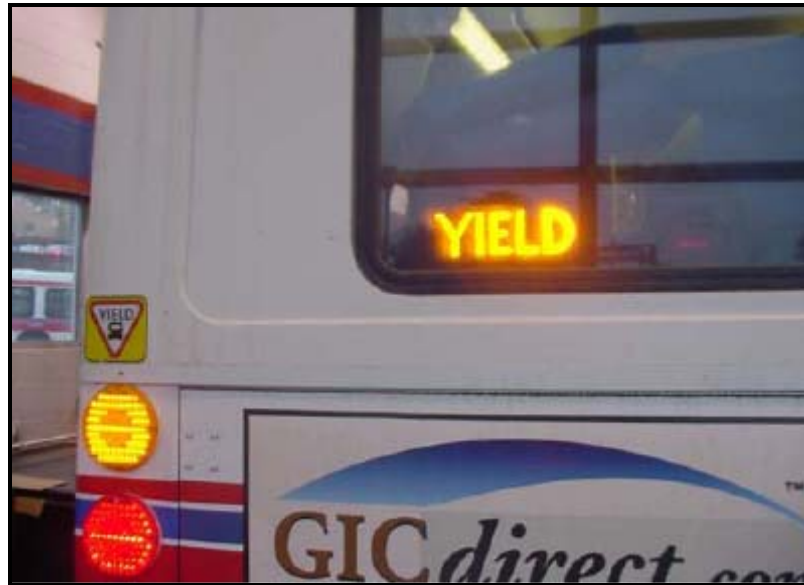
British Columbia (BC) Transit uses a six inch square reflective yield decal and a LED yield sign as shown in Figure 18. Inside the square is a red equilateral triangle on a yellow background. Inside the triangle is white with “Yield” written in black letters and the silhouette of a below it. This decal is used throughout British Columbia and is similar to the CMBC decal. The LED yield sign is located in the lower-left corner of the rear window.

**Figure 18 British Columbia Transit YTB decal and Yield LED Sign**  
(Source: TCRP Synthesis 49)

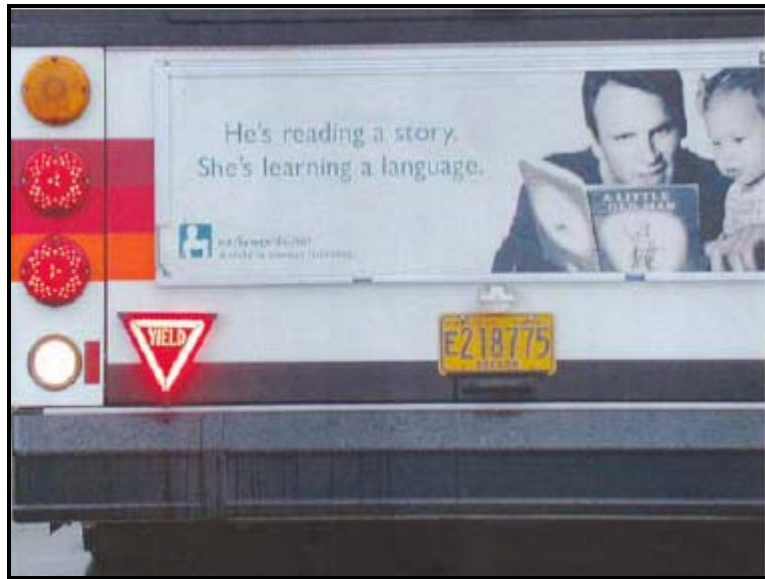
In Oregon, specifications have been developed by the Oregon Transportation Commission for a yield sign that includes a 6.75 inch tall triangle with the word “Yield” inside. Both the triangle and yield message must be red when flashing. Tri-County Metropolitan Transportation District (Tri-Met) uses a red LED flashing yield sign with a triangle that is approximately eight inches on each side as shown in Figure 19. The flashing yield sign is located on the lower-left corner above the bumper. A control switch is used by the bus operator to activate the yield sign. The operator first activates the amber turn signal then the yield sign. The yield sign is deactivated when the left turn signal switch is released.

**Figure 19 Tri-Met LED Yield sign**

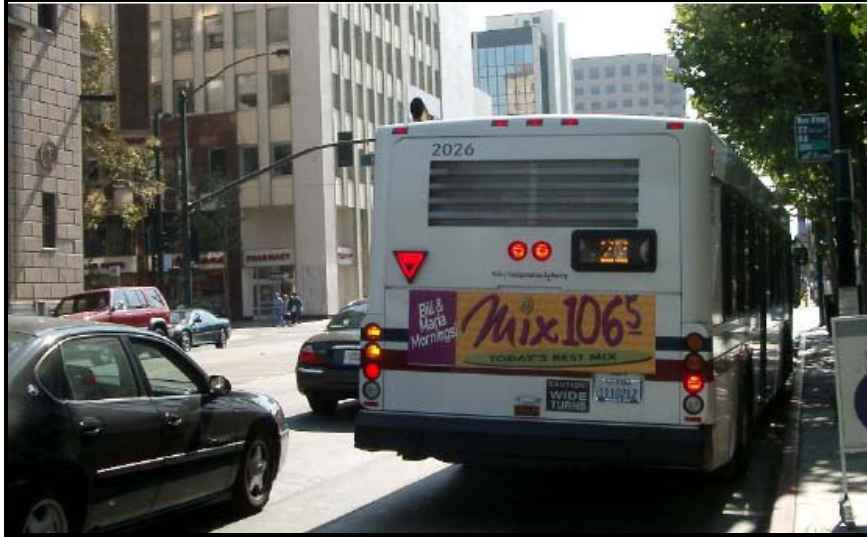
California law requires that buses be equipped with a yield right-of-way sign on the left rear of the bus. The sign must be illuminated by a flashing light when the bus is signaling to enter a traffic lane. The Santa Clara Valley Transportation Authority and the Santa Cruz Metropolitan Transit District use the same flashing yield sign as Oregon, mounted on the rear left of the bus above the engine access door as shown in Figures 22 and 23. The yield sign is activated first, followed by the left turn signal and both signals will stop when the left turn signal is turned off. Arming the yield signal first allows the bus operator to have both hands on the steering wheel when pulling out from a stop. After 10 to 15 seconds, the yield sign deactivates; therefore, if the operator cannot move before then, the left turn signal must be released and the yield control button pushed again.

**Figure 22 Santa Clara Valley Transportation Authority Bus with LED Yield Sign**  
(Source: TCRP Synthesis 49)

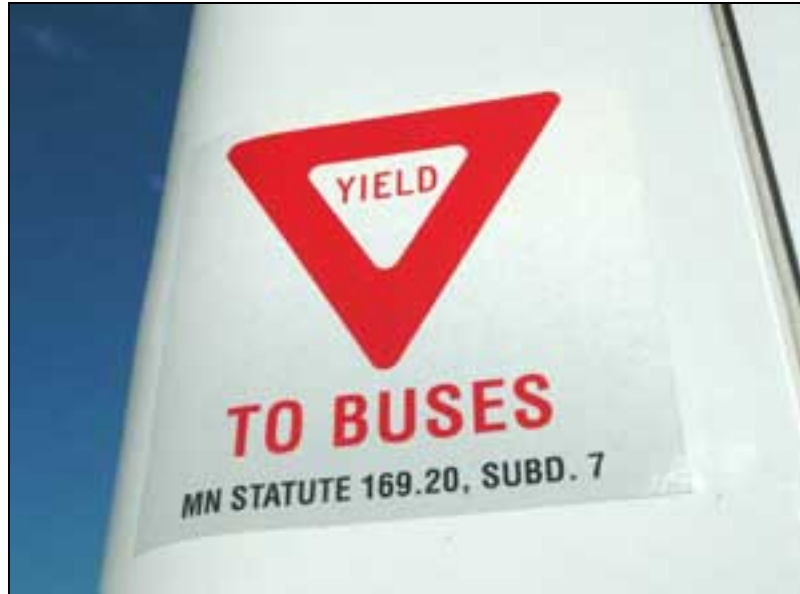
The Metro Transit decals feature a red yield sign along with a reference to the Minnesota statute that gives buses priority as shown in Figure 26. The decals are being positioned on the left side and above the brake lights for maximum visibility. These decals have only recently been developed even though the law requiring motorists to yield to the bus has been around for many years.

**Figure 26 Metro Transit Decal**

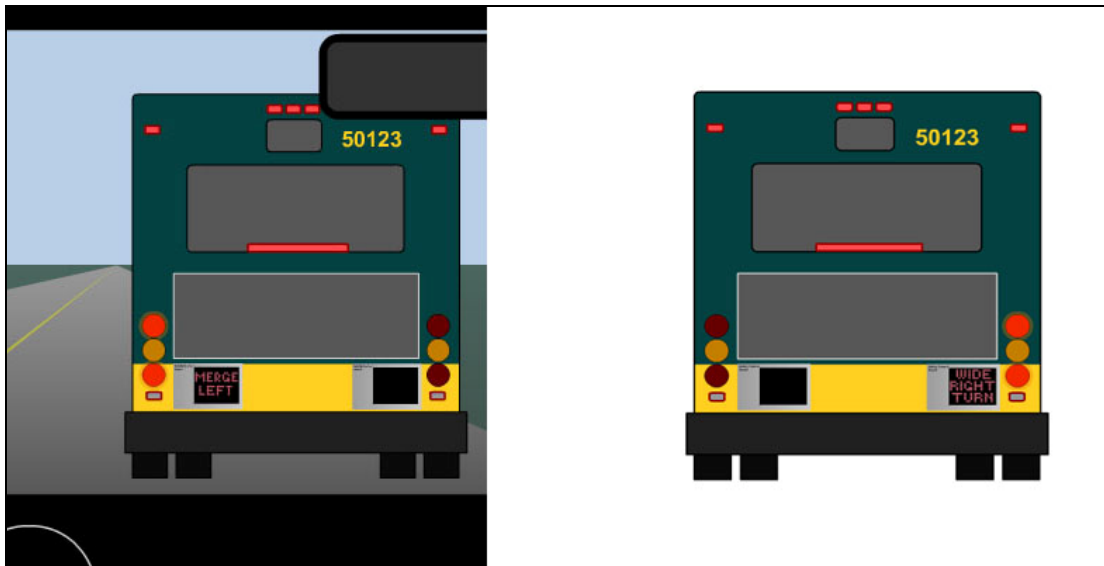
“Wide-Right Turn”, then stroiling arrows pointing right. A “Thank You” message appears when the turn signal is turned off.

**Figure 31 Advanced Safety Wheel and Hubs Alert System**

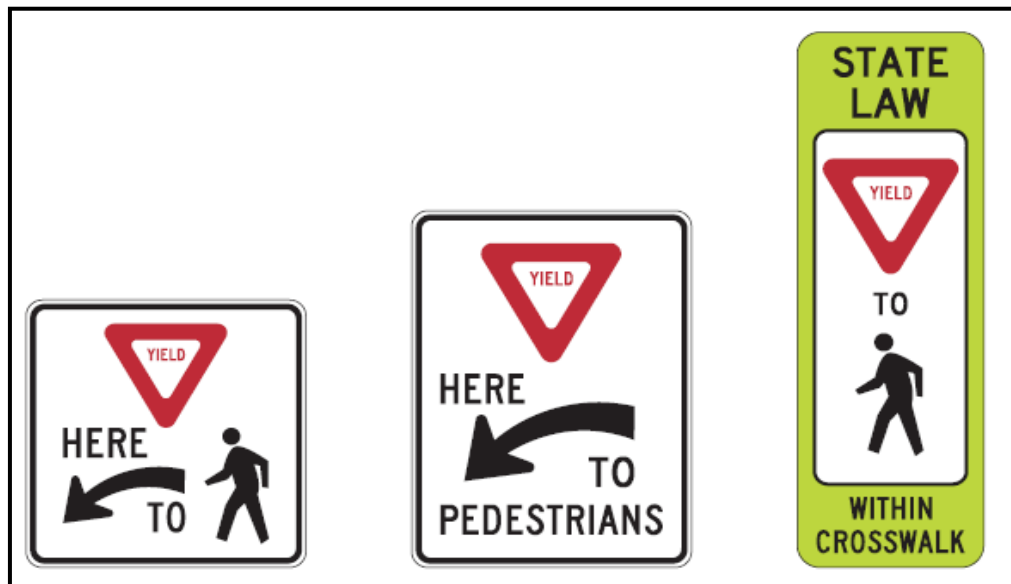
Vehicles controlled by a yield sign need to slow down or stop when necessary to avoid interfering with conflicting traffic. The MUTCD states that the yield sign assigns right-of-way to traffic on certain approaches to an intersection. It makes no mention of using yield-to-bus signs, but they do have special yield signs for yielding to pedestrians. If yield lines are used in advance of an unsignalized, marked midblock crosswalk, “Yield Here to Pedestrians” signs should be placed 6.1 to 15 m (20 to 50 ft) in advance of the nearest crosswalk line. The “In-Street Pedestrian Crossing” sign may be used to remind road users of laws regarding right of way at an unsignalized pedestrian crossing. The legend “State Law” may be shown at the top of the sign if applicable. The legends “Stop for” or “Yield to” may be used in conjunction with the appropriate symbol. Yield lines may be used to indicate the point behind which vehicles are required to yield in compliance with a “Yield” sign or a “Yield Here to Pedestrians” sign as shown in Figure 35.

**Figure 35 Yield to Pedestrians Signs** (Source: MUTCD, 2B.13)

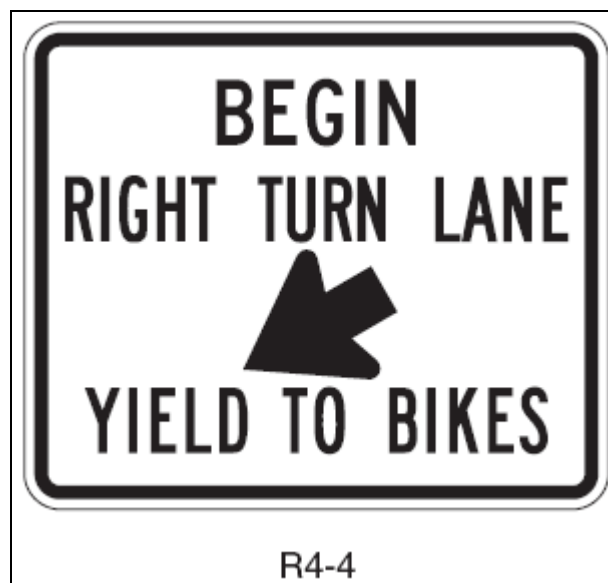
Other yield signs available are for yielding to bicyclists. The sign is 900 mm by 750 mm. The sign is used where motor vehicles entering an exclusive right-turn lane must weave across bicycle lanes; the “Begin Right Turn Lane Yield to Bikes” (R4-4) sign (Figure 40) may be used to inform both the motorist and the bicyclist of this weaving maneuver.

**Figure 40 Begin Right Turn Lane Yield to Bikes Sign**  
(Source: MUTCD)

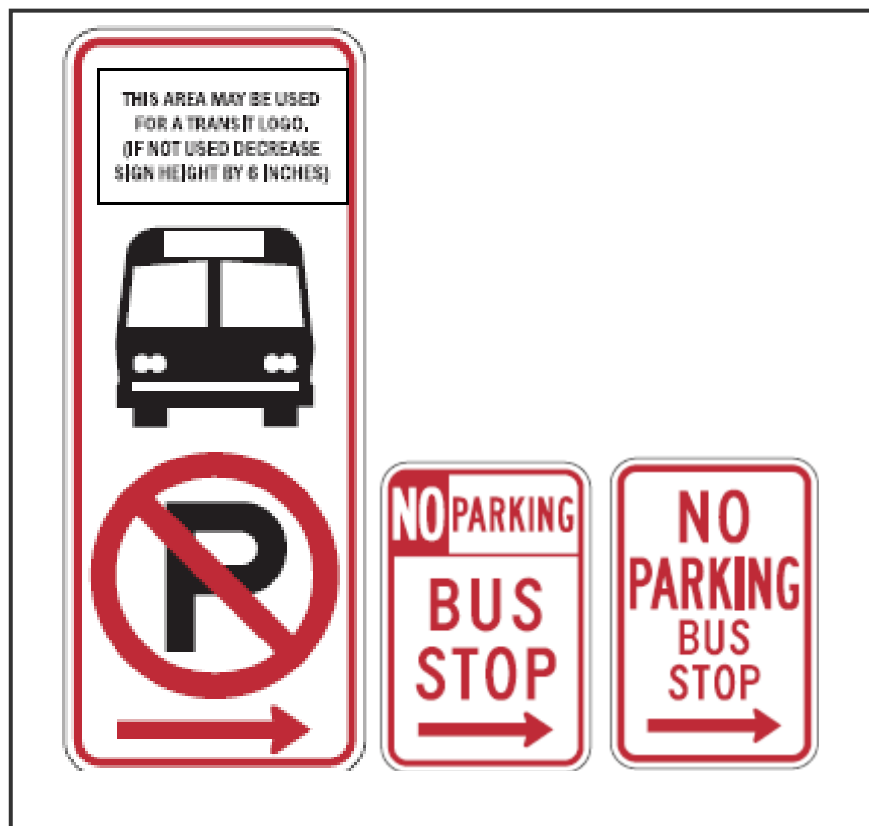
parking signs and parking regulations in Section 2B.40 of the MUTCD apply to parking and stopping. Prohibitive signs should have a red legend and border on a white background while permissive signs should have a green legend and border on a white background. Alternate designs may include, on a single panel, a transit logo, an approved bus symbol, the words “Bus Stop”, and an arrow. The preferred bus symbol color is black, but other dark colors may be used. Additionally, the transit logo may be shown on the bus face in the appropriate colors instead of placing the logo separately. The reverse side of the sign may contain bus routing information. Parking prohibition signs around bus stops are illustrated in this section of the MUTCD (Figure 41).

**Figure 41 No Parking Signs Related to Transit Stops**

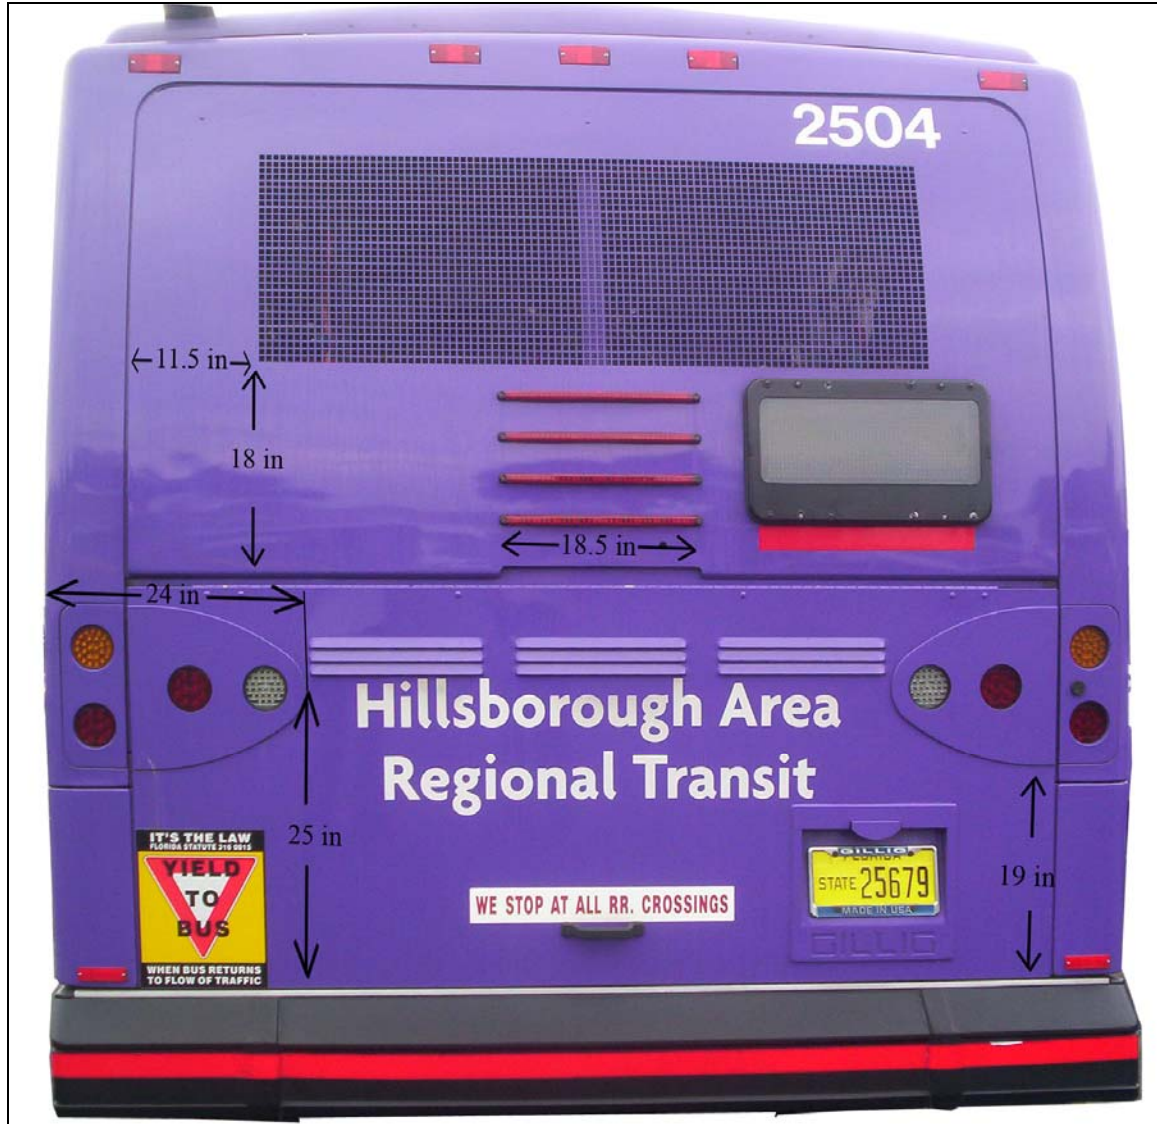
Figure 64 HART Bus with YTB Decal and Dimensions
