## Florida Department of Transportation Research

### Alternative Support Systems for Cantilever Signal/Sign Structures

BDK75 977-04

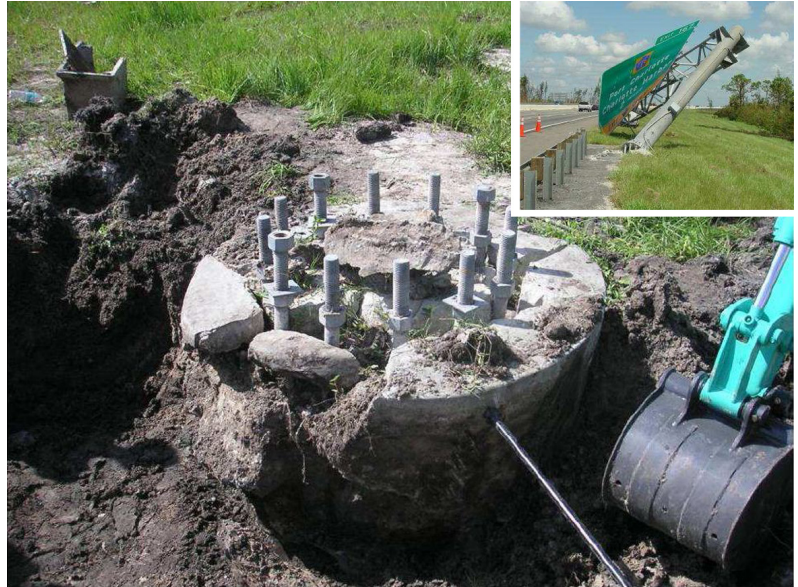
*Partially excavated foundation showing concrete breakout that leads to collapse of the sign structure (inset, upper right).*

During the 2004 hurricane season, the failure of several foundations of cantilever sign structures occurred along Florida highways, necessitating a review of the design and construction procedures for those foundations (FDOT Research Report BD545-54). In the design at that time, sign support columns were a one-piece design, attached to foundations by anchor bolts secured through an annular plate welded to the bottom of the column. The earlier project found that failures happened when torsion on the support column twisted the anchor bolts in their circular concrete foundations, resulting in shear parallel to the foundation edge which caused concrete breakout. The current project extended the earlier one with primary objectives to identify a viable alternative to transfer load from the superstructure to the foundation other than through anchor bolts and to provide design guidelines for the alternative selected.
