**Final Report**

**March 2013**

# **END REGION DETAILING OF PRETENSIONED CONCRETE BRIDGE GIRDERS**

Florida Department of Transportation (FDOT)  
Sam Fallaha, P.E. – Project Manager

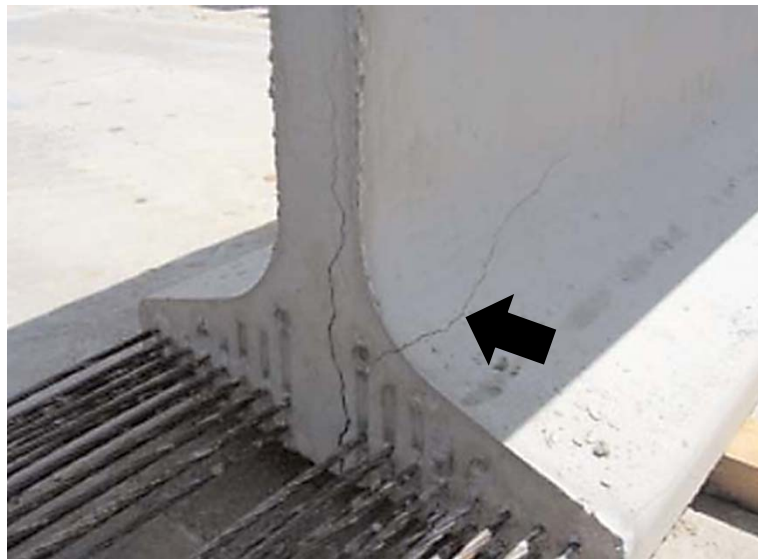
Figure 4—Flange splitting crack (Tadros et al. 2010)

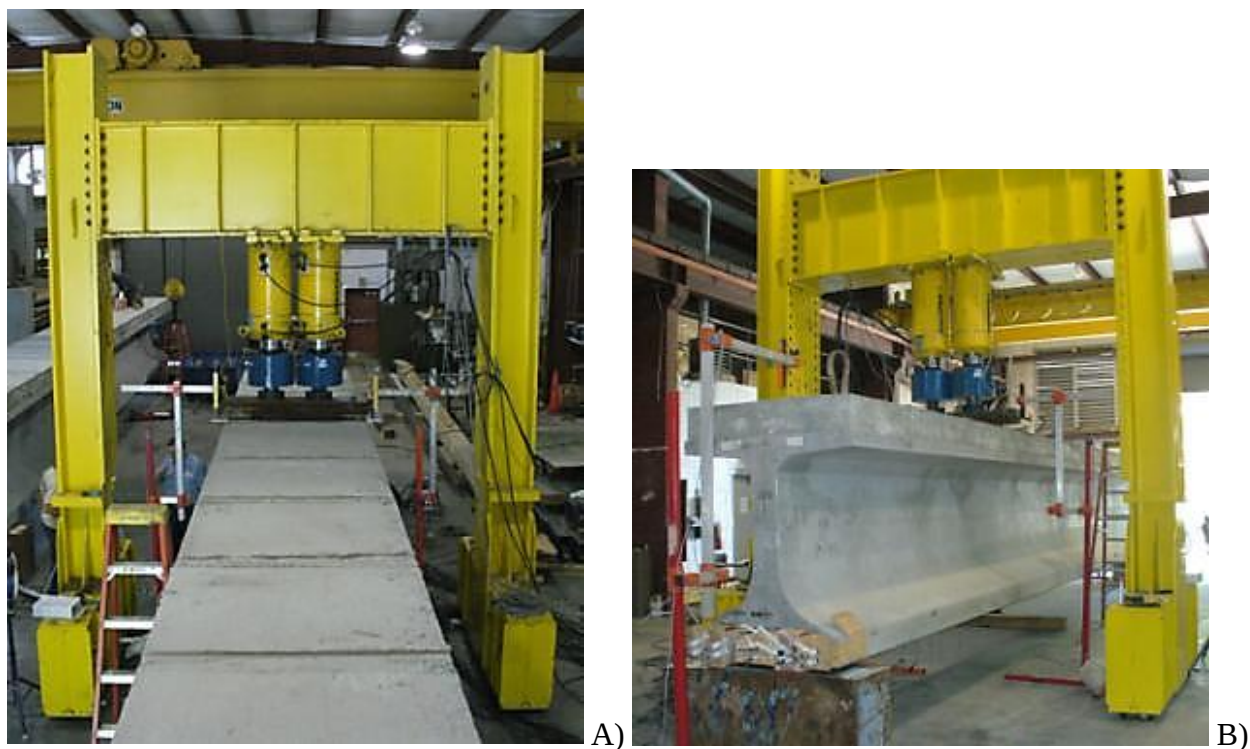
Figure 21–Test specimen and load frame view of A) top and B) side of girder

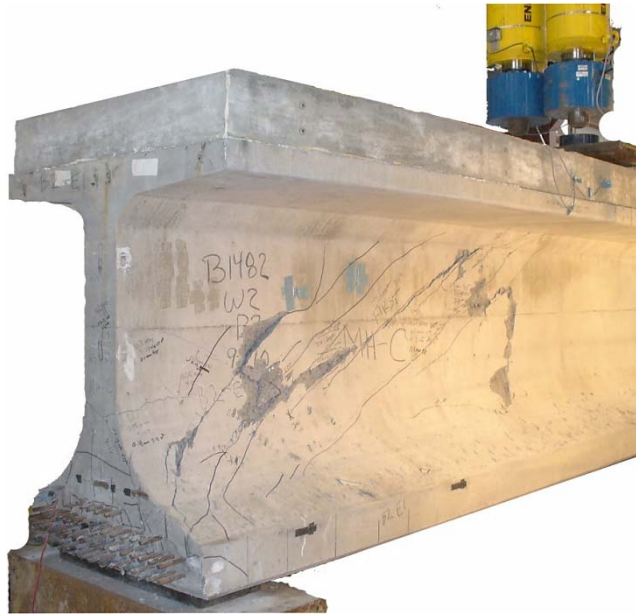
Figure 30–Web-crushing failure

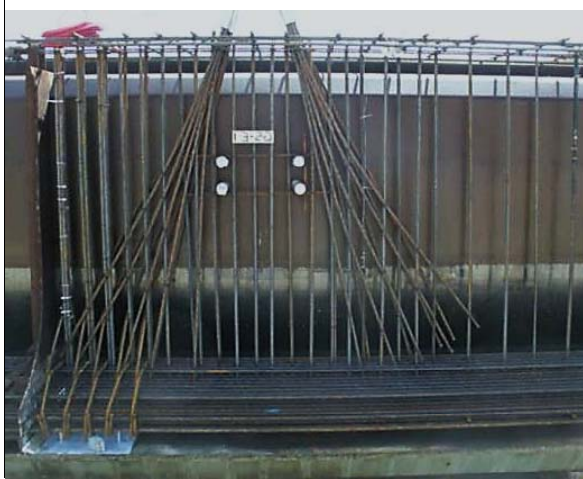
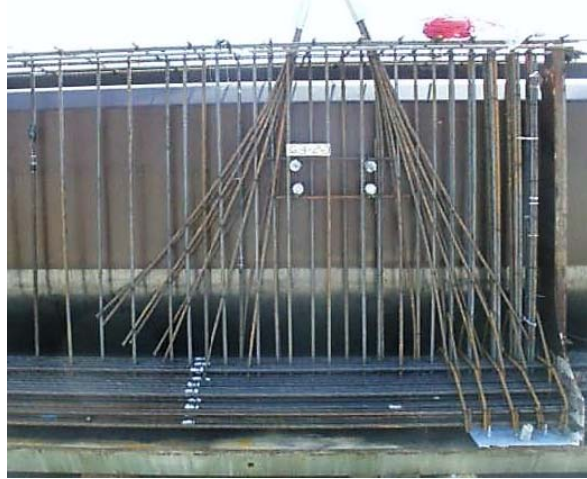
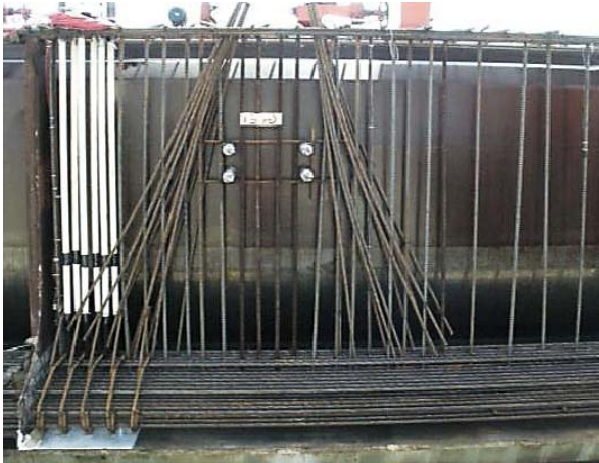
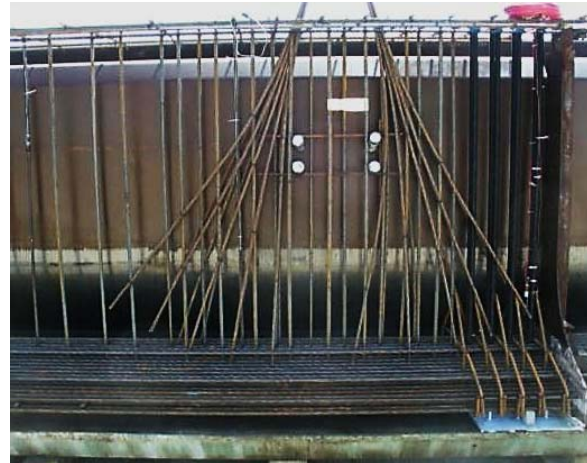
Figure 33—FIB-63 test specimens during construction

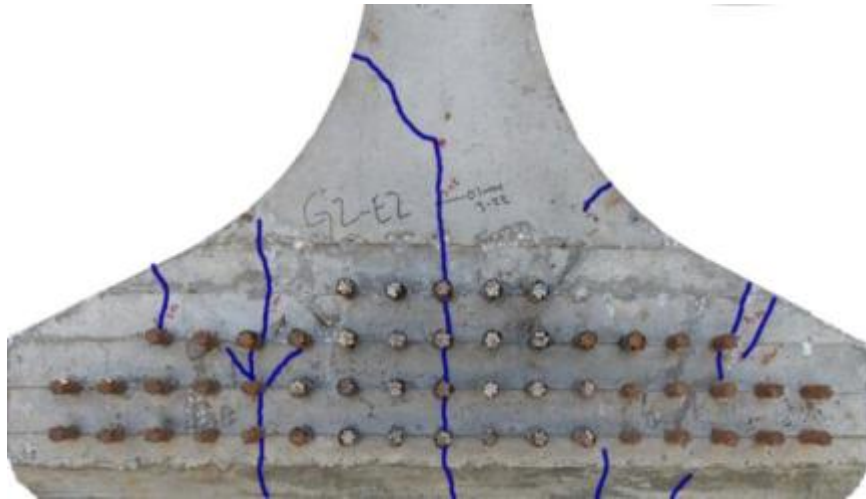
Figure 53–Flange splitting in experimental girder
