Report No. BDK75 977-32
FINAL REPORT

Contract Title: Base Connections for Signal/Sign Structures
UF Project No. 00087289
Contract No. BDK75 977-32

**BASE CONNECTIONS FOR
SIGNAL/SIGN STRUCTURES**

Department of Civil and Coastal Engineering
College of Engineering
University of Florida
Gainesville, FL 32611

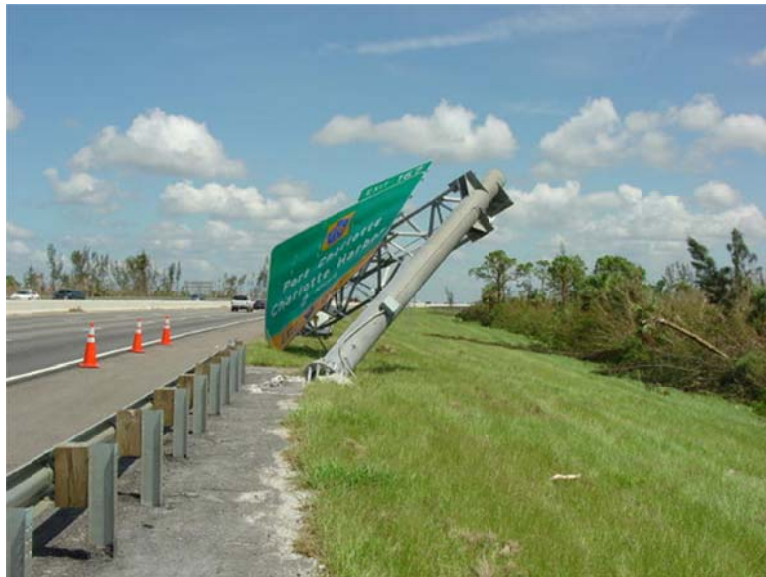
Figure 1-1. Failed cantilever sign structure. Photo courtesy of FDOT.

During the Atlantic hurricane season of 2004, four major hurricanes made landfall across the state of Florida within a six-week time period. During this time, a number of overhead cantilever sign structures along the interstate system failed during extreme wind load conditions (Figure 1-1). As a result, the Florida Department of Transportation (FDOT) began a series of research projects to investigate why these failures occurred and ways to improve the design of these structures. Two research projects on the subject have preceded this one and have prompted this third project.

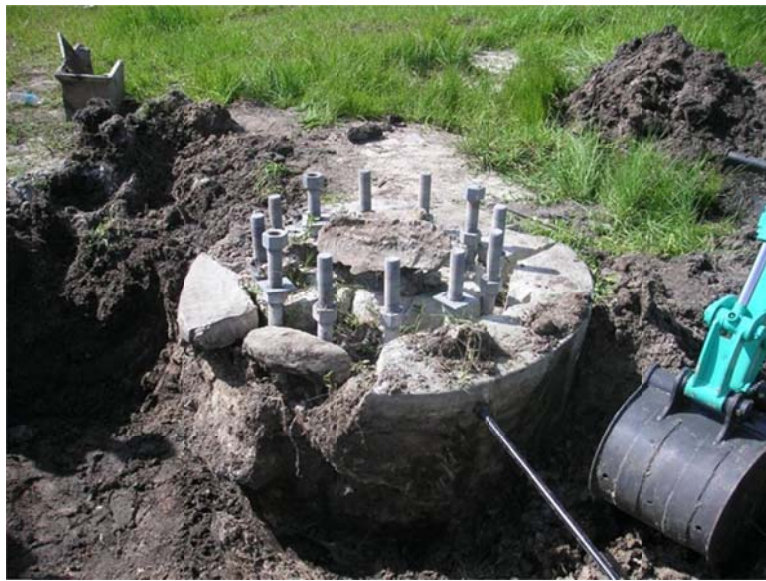
Figure 1-2. Failed concrete foundation of cantilever sign structure. Photo courtesy of FDOT.

the anchor bolt group in the concrete foundation and identifies it as the primary cause of the failures of a number of cantilever sign structures (Figure 1-2).

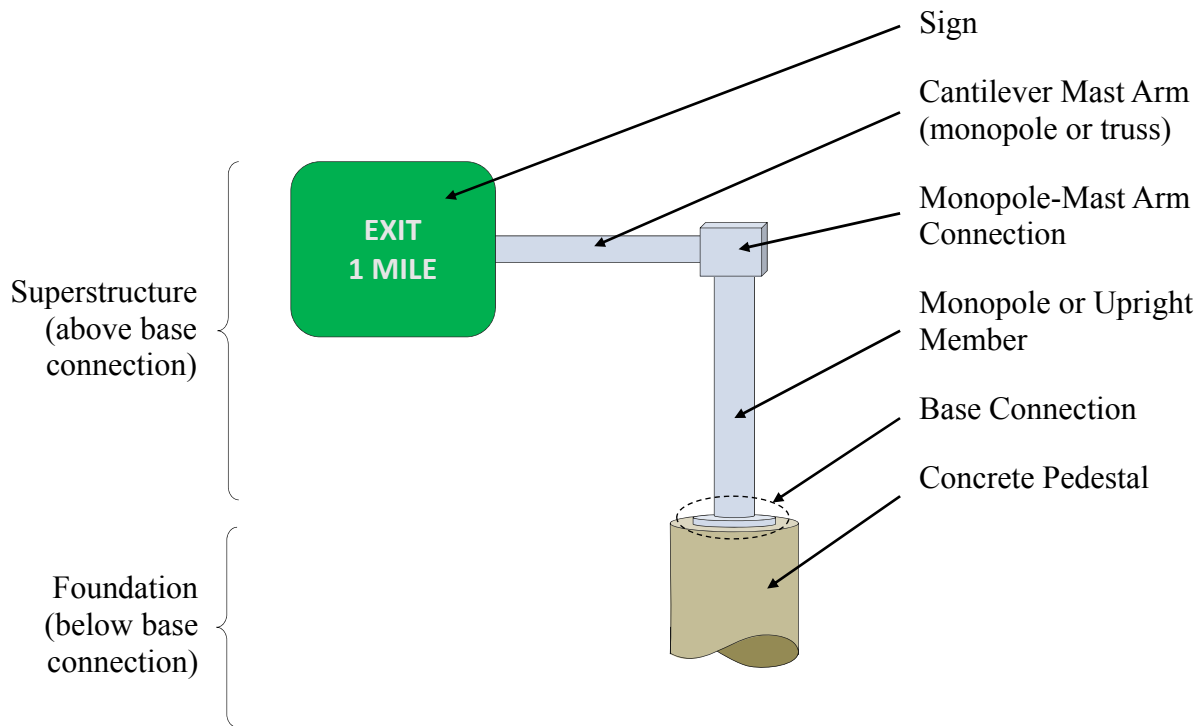
Figure 1-3. Typical cantilever sign structure

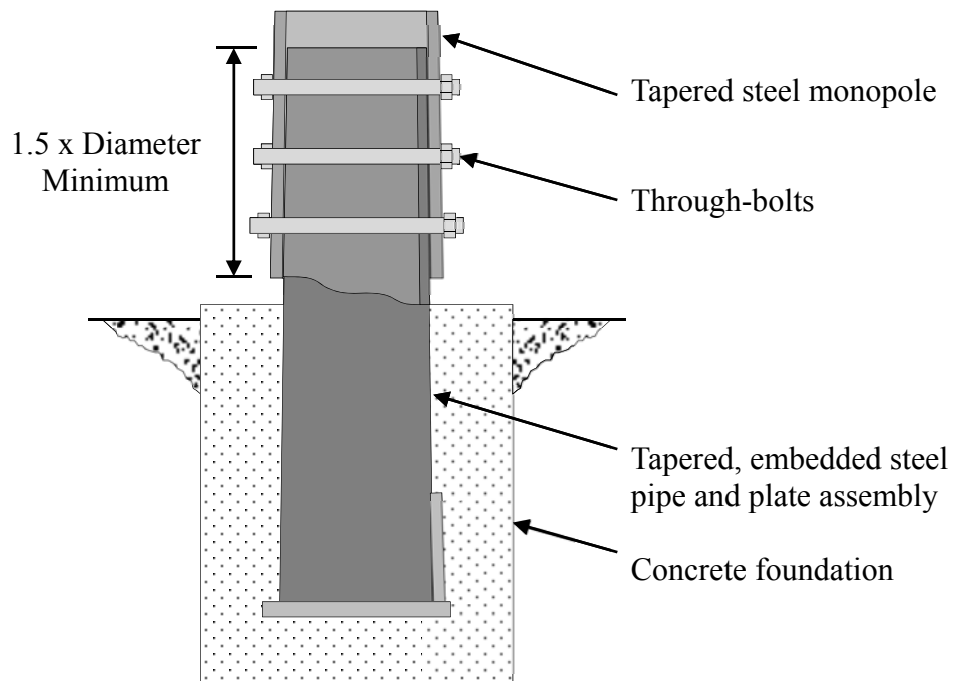
Figure 2-5. Tapered bolted slip base connection

In this option, the base connection is made between the steel pipe and plate assembly embedded in the foundation and the monopole. Both pieces share the same taper so as to fit snugly together and are secured by bolts extending through the diameter of the sleeved connection (Figure 2-5).

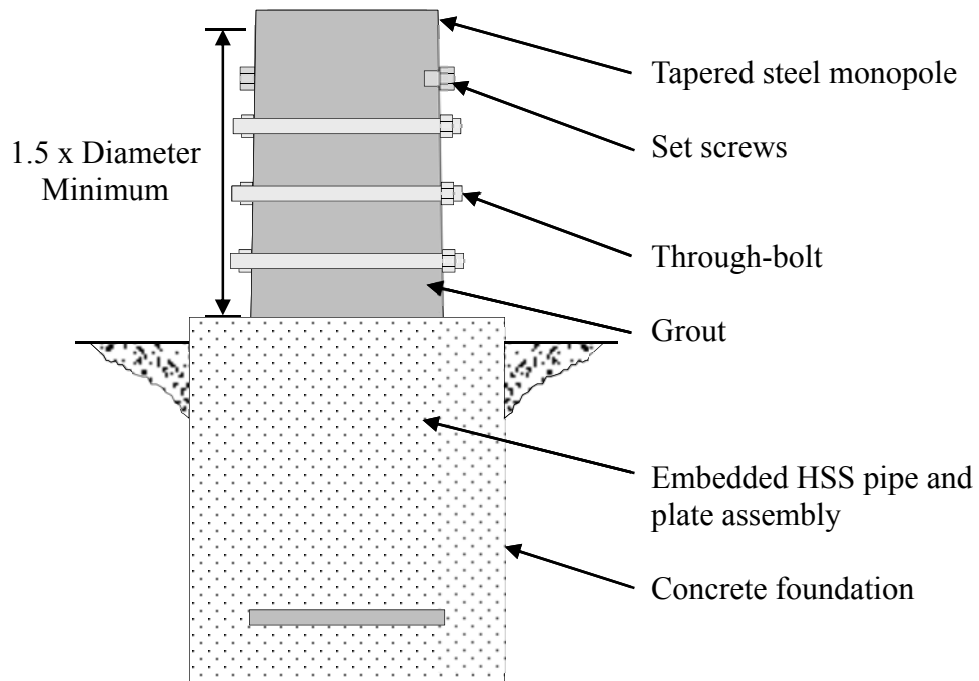
Figure 2-7. Grouted slip base connection

connection. The void space between the prismatic and tapered monopole sections is then filled with high-strength grout (Figure 2-7).

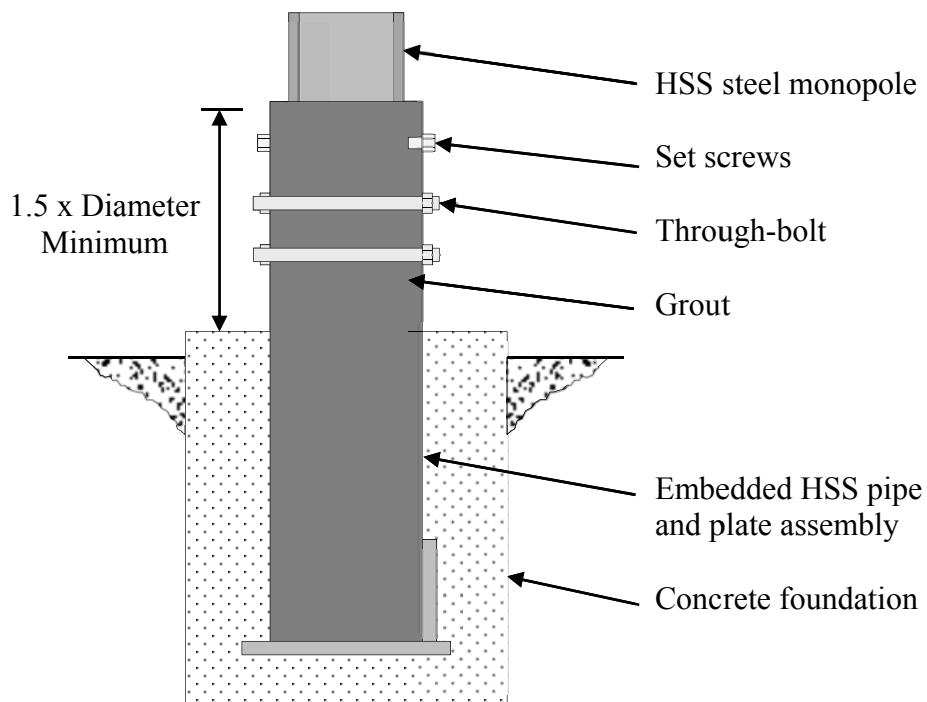
Figure 2-9. Inverted grouted slip base connection

assembly in a typical concrete foundation. However, instead of oversizing the steel pole for the superstructure to fit over the embedded pipe, the embedded pipe is oversized so that the steel superstructure pole will fit down inside of it. The concrete on the inside of the embedded pipe serves as the base on which the superstructure pole rests. Set screws hold the superstructure plumb while grout is poured into the annular space between the two steel members. Through-bolts may still be required to transfer the torsional load from the superstructure to the base considering the substantially larger torsional loads likely experienced by a cantilever signal or sign structure as compared to a transmission pole (Figure 2-9).

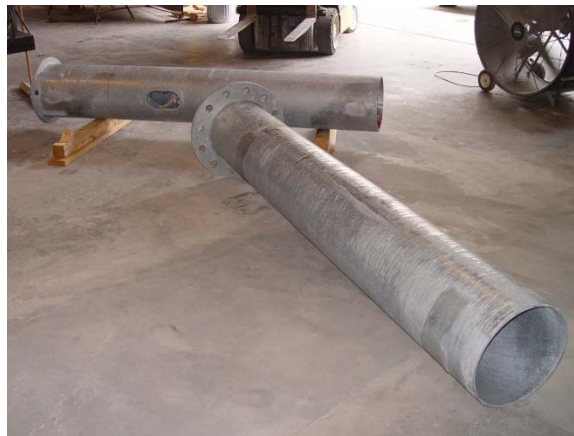
Figure 3-10. Tapered steel poles manufactured by Valmont Structures. Photo courtesy of FDOT.

results in a longer theoretical slip joint. This is beneficial, because any imperfections in the shape of the poles as well any added wall thickness from galvanization hinders slip and decreases the slip joint length. The longer theoretical slip joint length could also allow extra room for the placement of the necessary number of through-bolts. As a result, the final design length of each pole section is 8'-4" and the diameter is 16" at the large end (Figure 3-10). The actual length of the slip joint was determined during assembly and adjustments to the location and placement of through-bolts made as necessary.

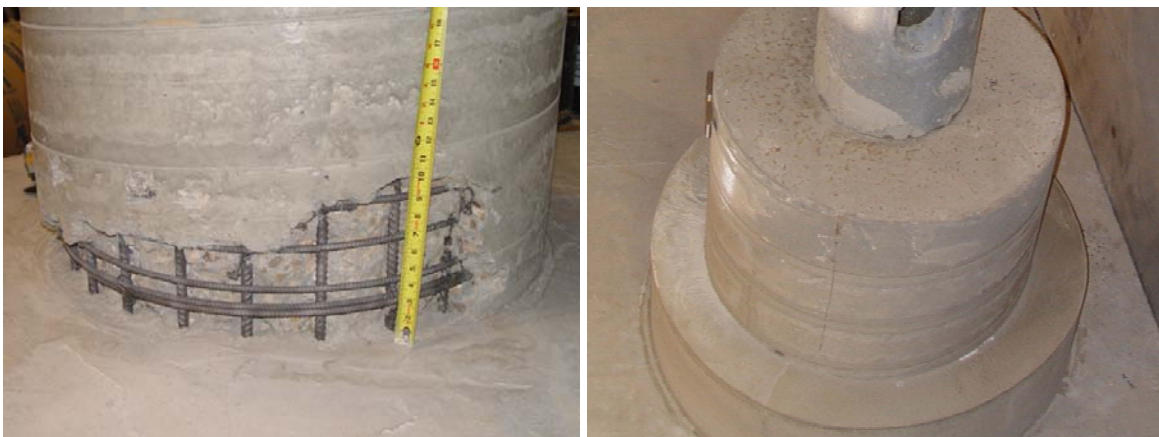
Figure 4-1. Honeycomb around pedestal and repair of pedestal. Photo courtesy of FDOT.

The reinforced concrete pedestal that encases that lower portion of the steel pole was made from a third batch of concrete. This pour was not made until June 17, 2011, since it required placement of the lower steel pole before casting the concrete. After removal of the formwork, an area surrounding the base of the pedestal was discovered in which honeycombing existed around the reinforcement cage. As a precaution to prevent an unwanted failure of the pedestal during testing, a ring of high-strength grout was placed along the bottom portion of the pedestal to fully encase the exposed area (Figure 4-1). Any additional strength from the high strength grout used to repair the pedestal was ignored for the purpose of strength calculations. The average concrete strength determined from the cylinder tests was 6,992 psi for the concrete pedestal.

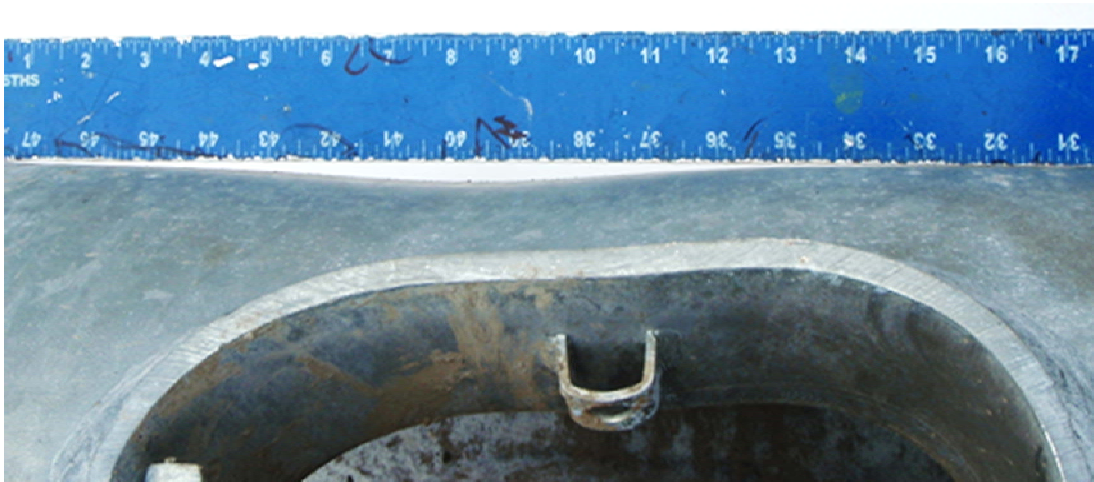
Figure 5-1. Pipe buckling near the access panel on the embedded pole. Photo courtesy of S. Dalton.

The intent of the test program was to conduct two separate tests that would evaluate the capability of the through-bolts to transfer torsion and the slip joint to transfer flexure. The design of the first test was intended to allow for failure of the through-bolts in the slip joint while precluding all other failure modes. However, the actual ultimate tensile strength of the threaded rods was much greater than the upper bound values that had been anticipated and the test apparatus experienced pipe buckling along the region of the embedded pole near the access panel before the through-bolts completely sheared (Figure 5-1). Although the pole buckled prior the expected through-bolt failure, the pole did not buckle prematurely. The applied load reached and exceeded the predicted load for the pole capacity based on the interaction of flexure and torsion.

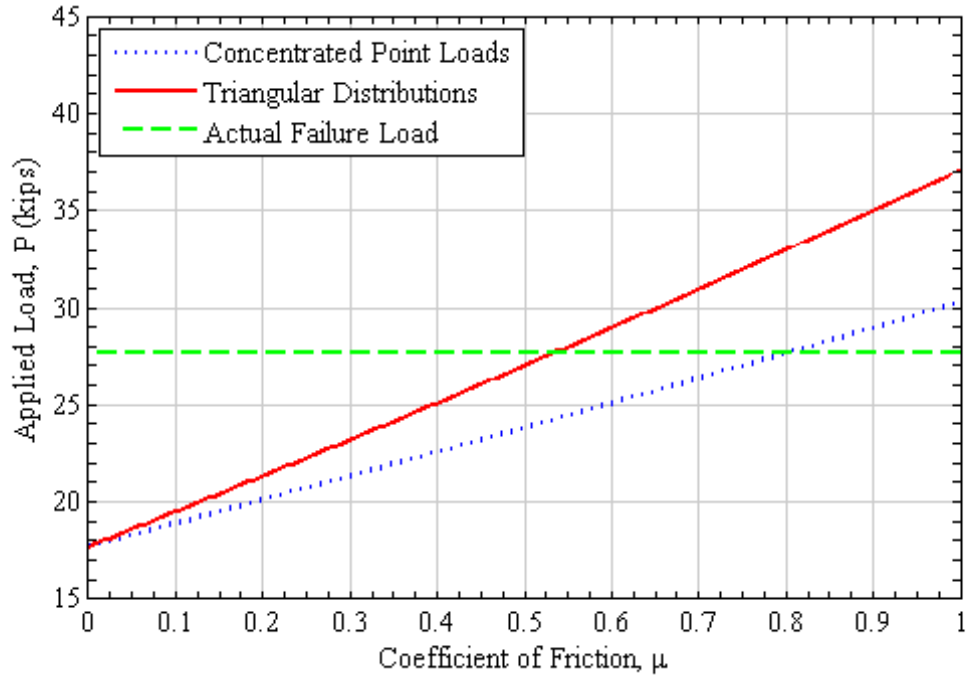
Figure 5-7. Plot of the impact of friction on predicted applied load

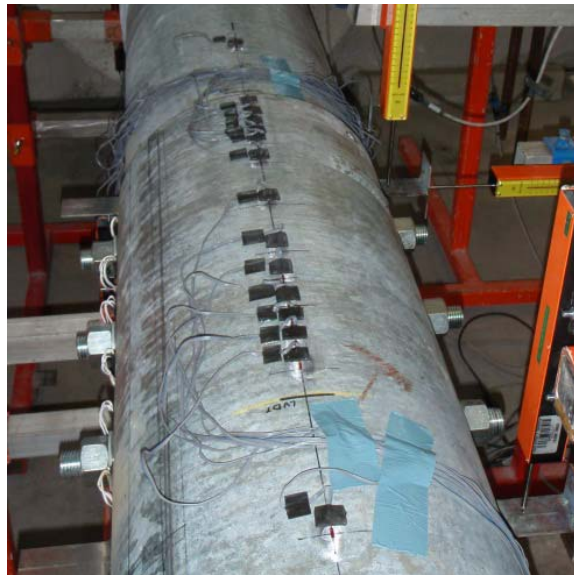
Figure 5-9. Flexural strain gauges on compression face of outer pole along the slip joint. Photo courtesy of S. Dalton.

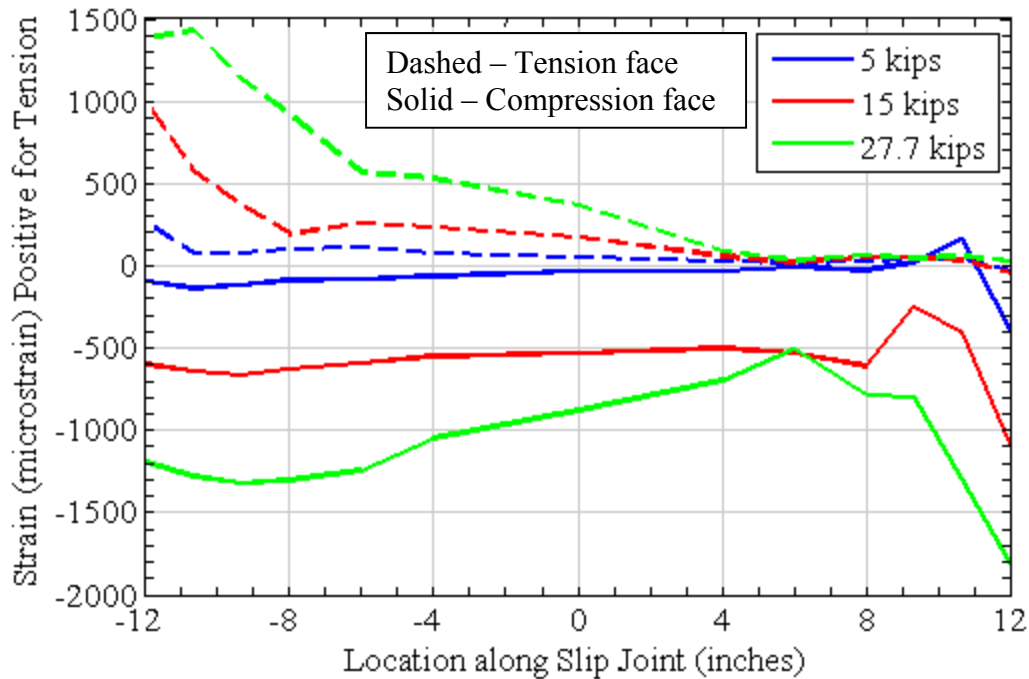
Figure 5-10. Flexural strain measured along the length of the slip joint

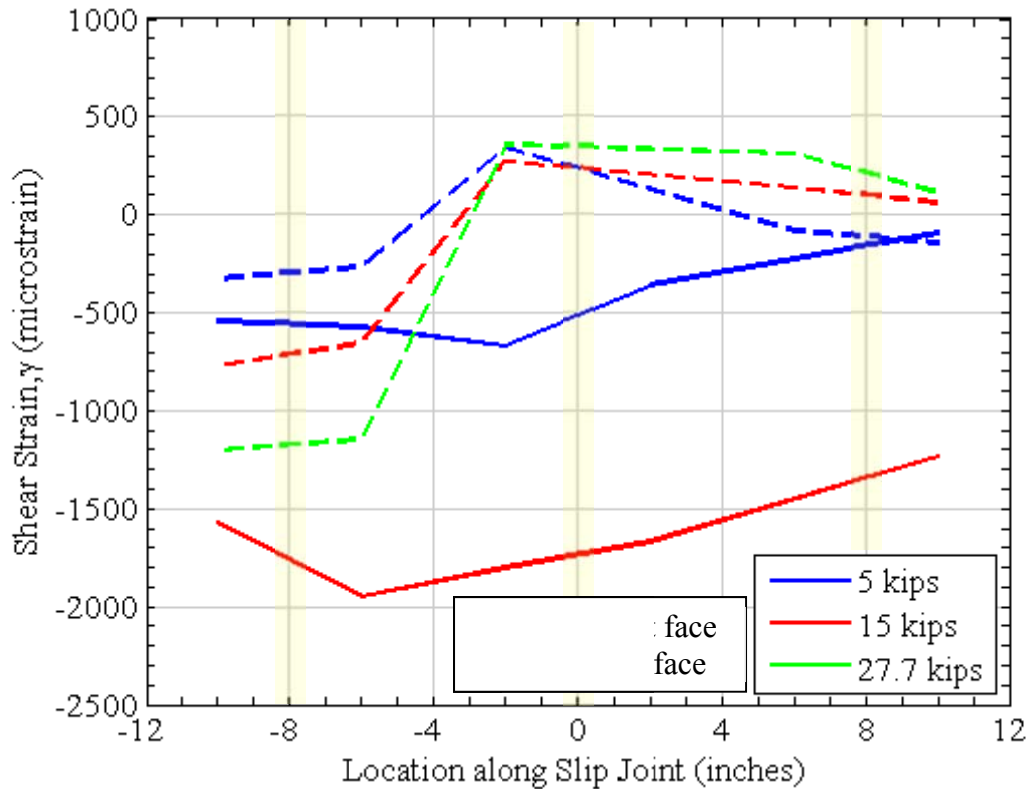
Figure 5-16. Plot of shear strain measured along slip joint for select load cases (limited view)

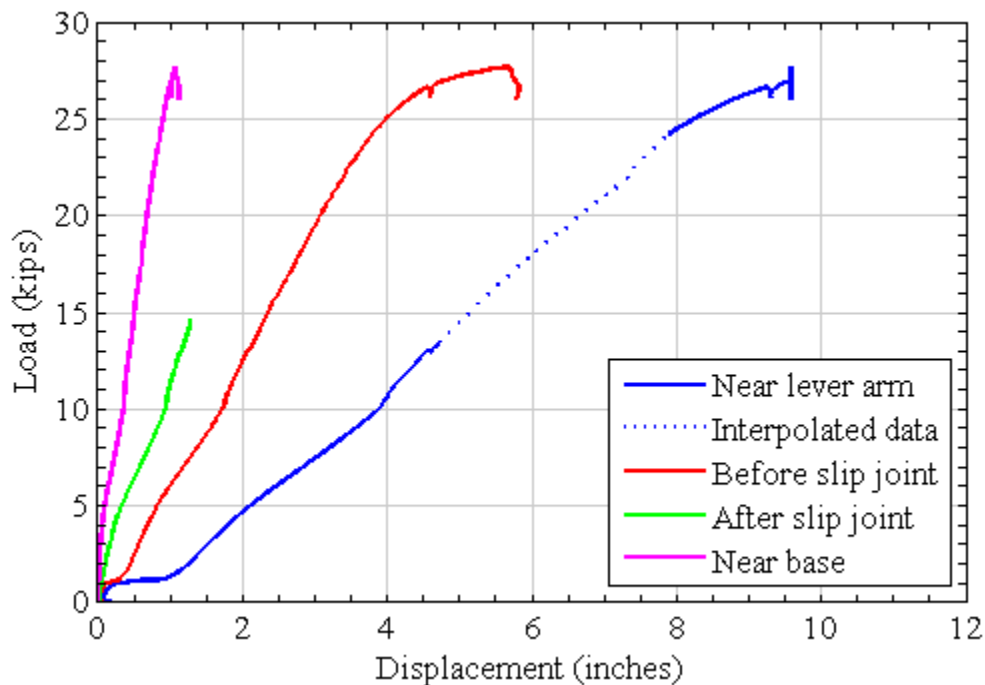
Figure 5-21. Vertical displacements along the left edge of the test poles

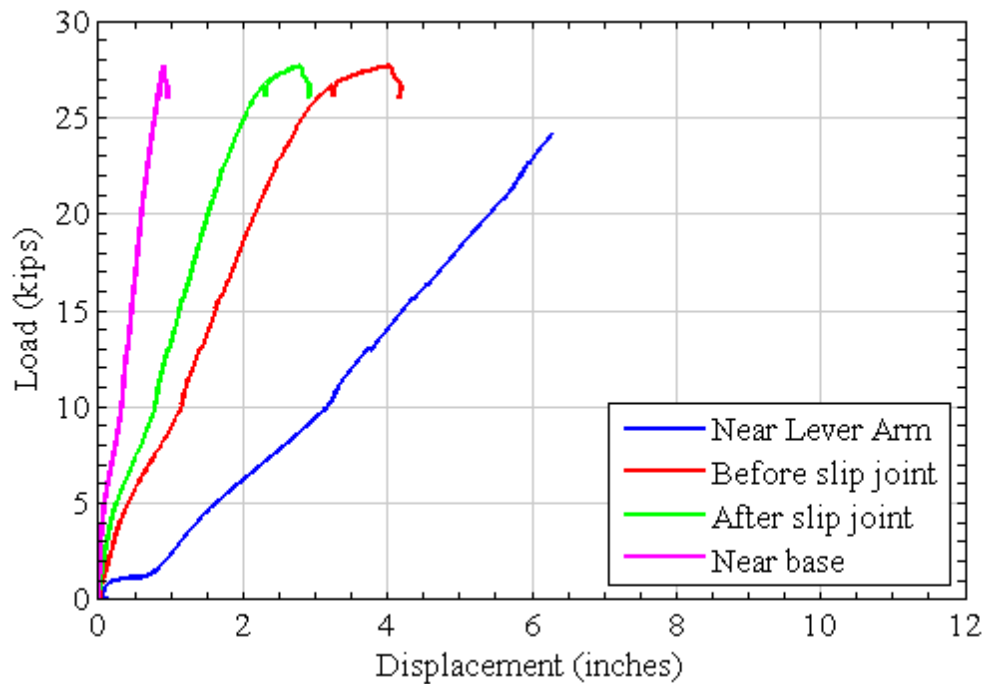
Figure 5-22. Vertical displacements along the right edge of the test poles

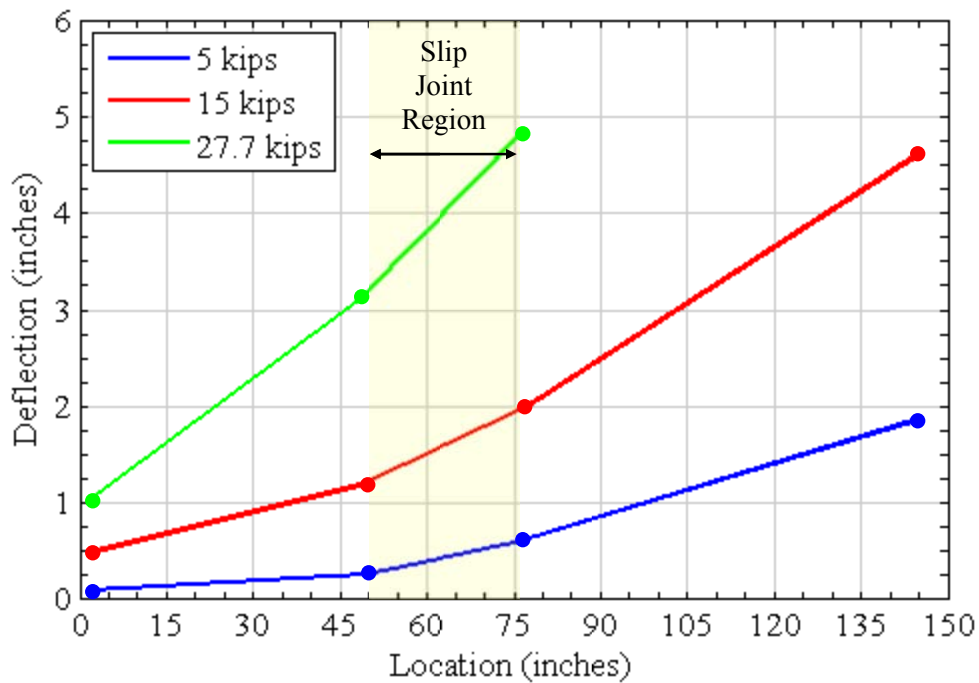
Figure 5-24. Unaltered deflection data along the length of the test poles

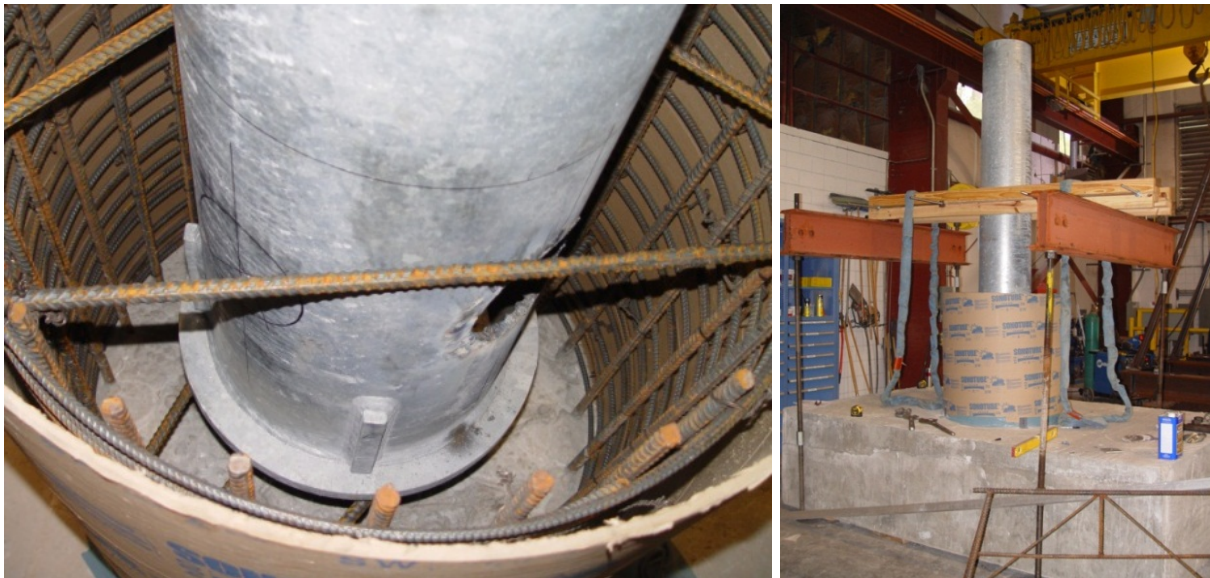
Figure 6-1. Alignment rebar within pedestal and external bracing of embedded pole. Photos courtesy of FDOT.

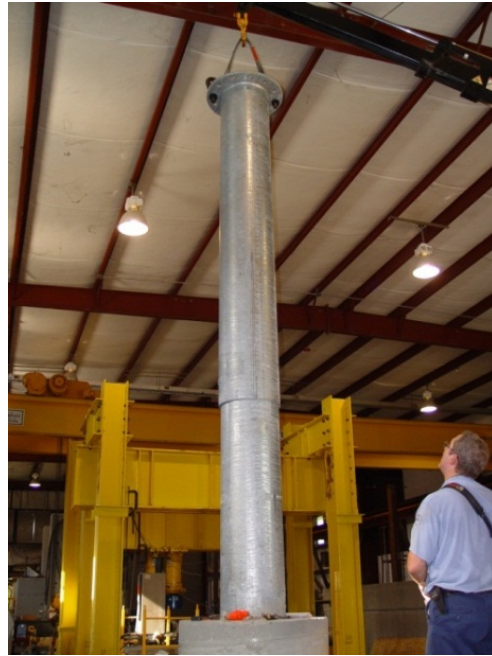
Figure 6-3. Placement of the upper pole for the test apparatus using an overhead lift. Photo courtesy of FDOT.

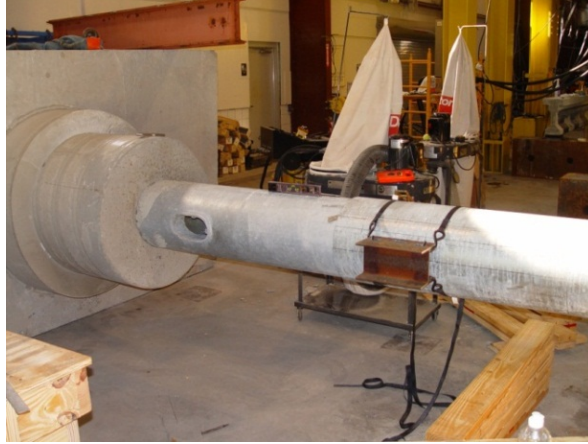
Figure 6-4. A short I-beam for supporting the drilling equipment for placement of bolt holes. Photo courtesy of FDOT.

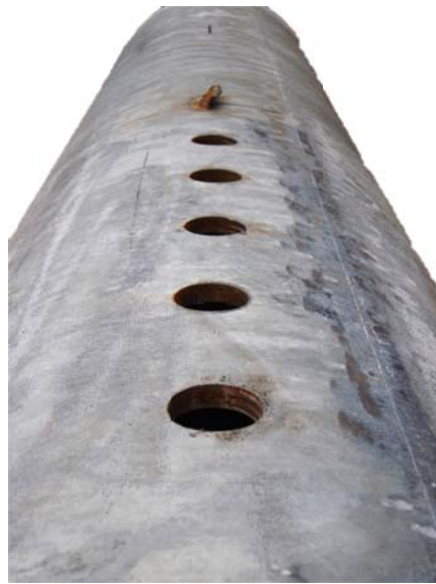
Figure 6-5. Longitudinal seam weld placed to the right of through-bolt holes. Photo courtesy of S. Dalton.

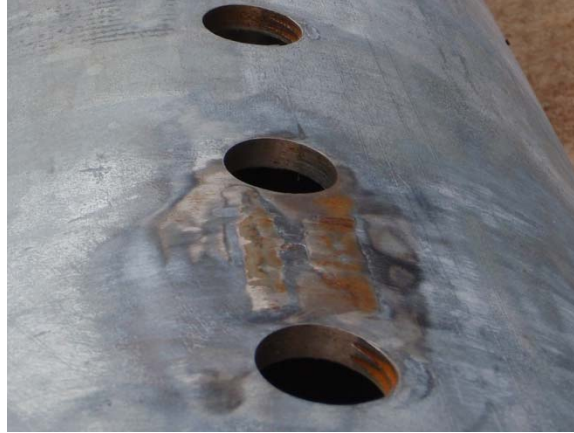
Figure 6-6. Rust on the surface of a pole and within the bolt holes. Photo courtesy of S. Dalton.

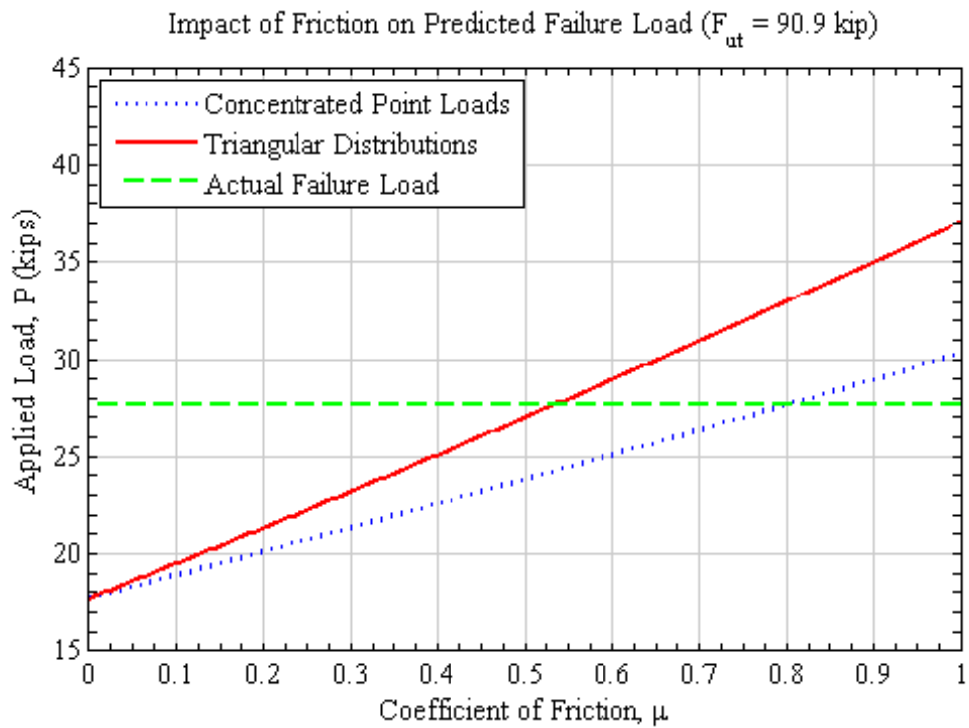
Figure D-6. Plot of the impact of friction on predicted applied load
