Simulation of Prepackaged Grout Bleed under Field Conditions

Revised Draft Final Report

April 2014

Florida Department of Transportation (FDOT)
Michael Bergin, P.E. – Project Manager

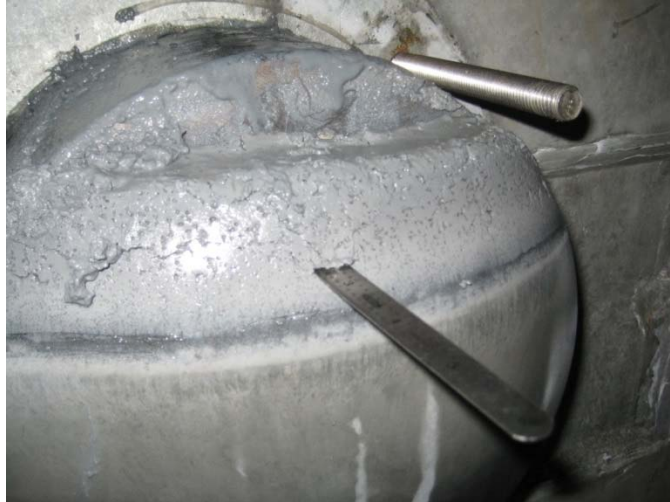
Figure 2—Soft grout sample identified in field by FDOT

Problems have been discovered with the grout in several bridges around the state of Florida. In these bridges, the grout was found to be soft (unhydrated) and contain high levels of moisture and potentially damaging chemicals several years after construction was complete. Figure 2 shows an example of unhydrated material that accumulated under the cap on PT anchor. The texture of the grout is similar to wet clay. Soft grout samples can be collected by gently scraping the material and moisture contents are typically 50-80%.

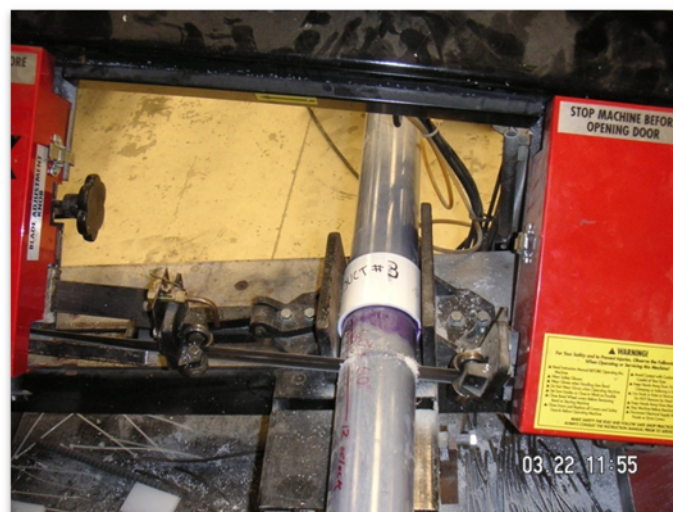
After the grout had been allowed to set for at least 24 h, samples were collected along the length of the tube. Early in the testing program, each tube was generally sampled in 4 to 5 locations along its length. When possible, the grout in the fitting at the very top of the tube was sampled as well. First, the tubes were cut into three 5 ft long sections for handling and storage on a band saw (Figure 12). The cuts passed through the tube, grout and strand and required a special bi-metal blade that required frequent replacement. The cut tube sections were labeled with flow direction, 12 o'clock position, and dimensions.

Figure 12—Saw-cut tubes for sampling

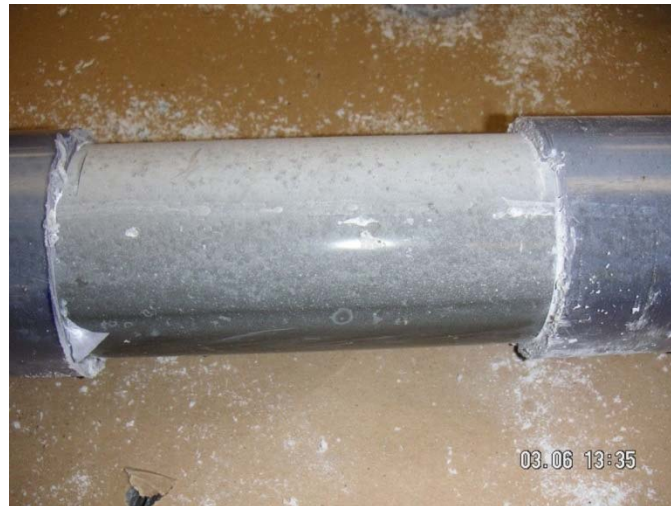
disturb the surface of the grout. Typically, a 6 in. window of PVC casing was removed (Figure 13).

Figure 13—Tube wall removed for sampling

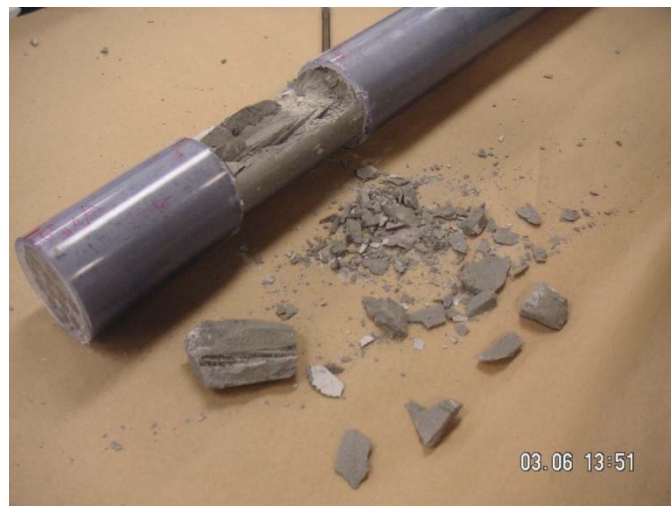
After exposing the surface of the grout, a chisel was used to collect at least 50 grams of grout sample (Figure 14). Samples were stored in sealed plastic bags to prevent loss of moisture. During sampling, observations were made on grout color, hardness, surface condition, and consistency.

Figure 14—Grout sample removed with chisel

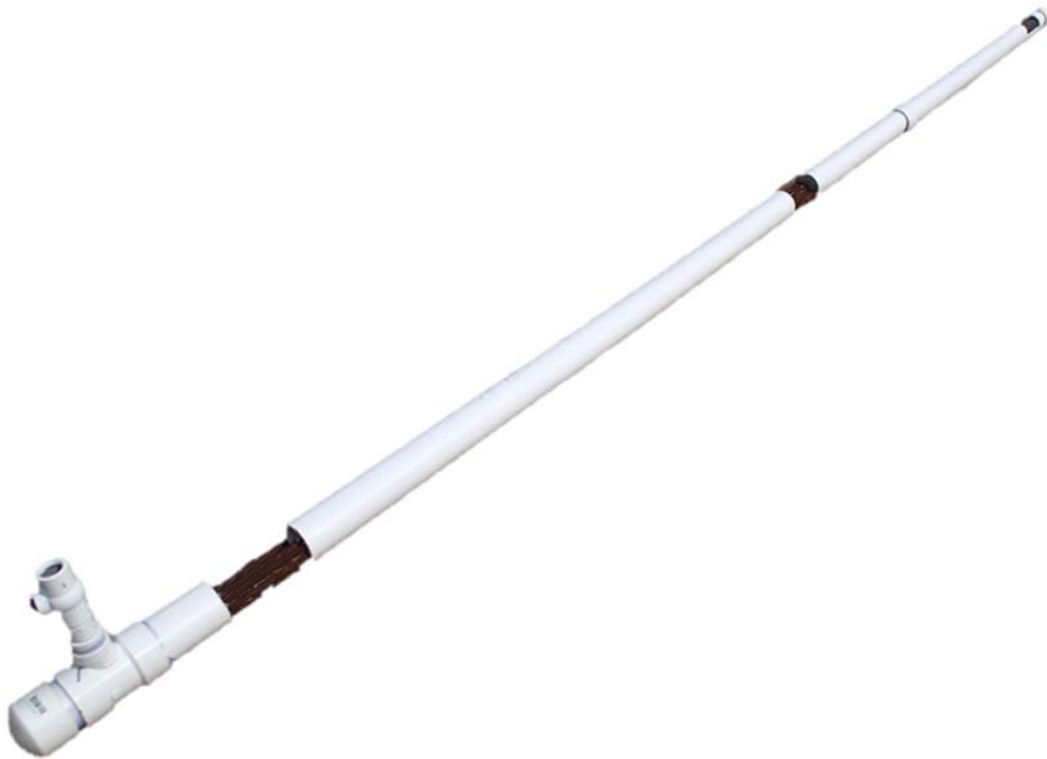
moisture content of the grout and to recover soft grout that might be present. Figure 15 shows an example inclined test tube after sampling. Strand surface is corroded due to outdoor exposure that occurred after sampling and was not due to exposure to the PT grout. The base and mid-height of the inclined tube were sampled by cutting and removing the PVC tube over a length of approximately 6-in (Figure 16). Grout samples were then taken from around the strand bundle without the need to cut the strand. At the top of the incline, grout is more easily sampled due to lack of strand near the top. Samples are taken in two locations: one under the end cap and over a 6-in. length near the end of the strand bundle. Because the primary focus of the inclined testing was on measurement of soft grout and moisture content, opaque tubes were used to reduce testing costs. Figure 19 shows the specimen construction along with the sampling locations.

Figure 15—Sample locations for MITT

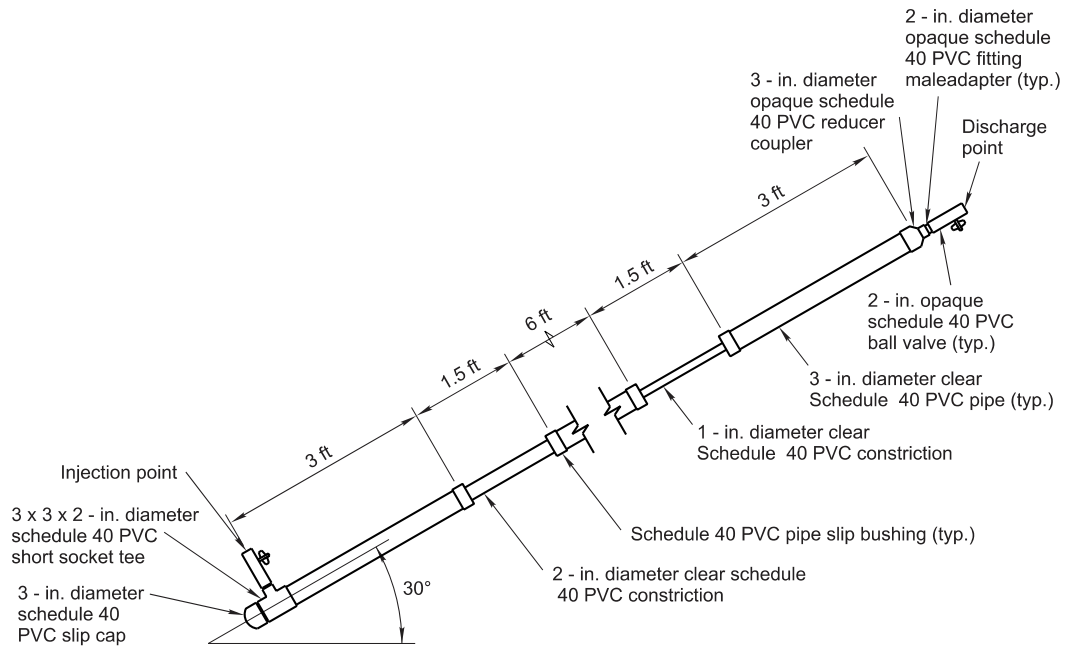
Post-tensioning ducts may have constrictions due to anchorages or couplings, which may force grout through a tortuous path and perhaps result in a mechanical filtering of large particles, causing different behavior in the fluid or hardened grout. To simulate the effect of these constrictions the inclined tube specimen was redesigned with a series of smaller diameter sections (Figure 19). To further enhance the constriction, the reduced-diameter sections were packed full with 7-wire strand. Some of the 7-wire strand was separated into individual wire and packed into the constrictions in order to create the tightest fit possible. No strand was placed in the remainder of the specimen.

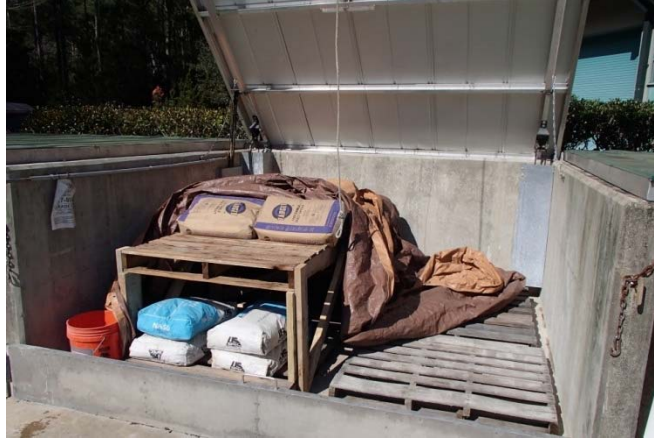
A bulk aggregate storage bin on the FDOT State Materials Office Site was used for the *Field* storage condition (Figure 21). The bins are fitted with permanent retractable covers that protected the PT grout from rainfall and direct sun, but leave the grout exposed to ambient temperature and humidity. This form of storage might be considered “dry” and thus in accordance with some manufacturer’s recommendations. These conditions were chosen to reflect uncontrolled field storage conditions on a construction site during summer in Florida. PT grout was stacked on pallets inside the chamber and left undisturbed until they were removed from the chamber for mixing and testing. The bags were left intact and in the same position on the pallets as they arrived when received from shipping. It was noted during testing that the bags closer to the bottom of the pallet had pre-hydrated considerably more than those near the top of the pallet. In a heavy downpour, rainwater collected under the pallets. Although the grout did not have direct contact with the rainwater, high heat and evaporation were likely to increase the humidity in the storage area. During the exposure period from June 2013 to November 2013, the average monthly conditions are shown in Table 7.

Figure 21—*Field* storage condition

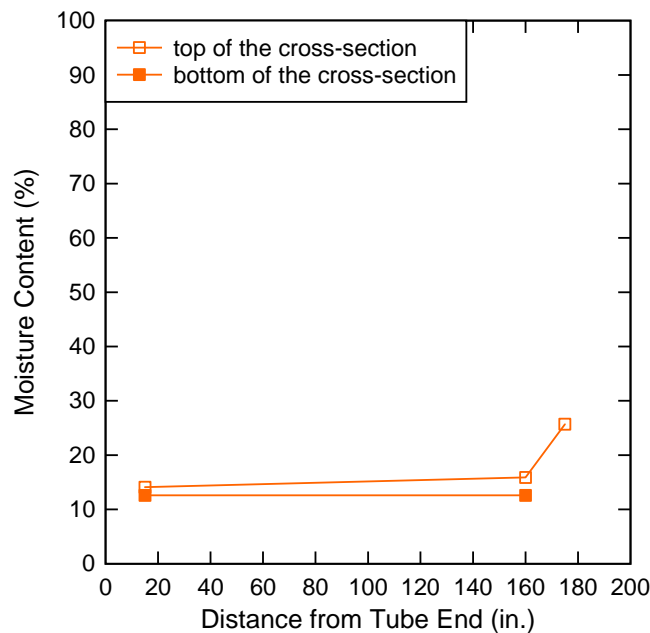
PT1-2, PT2-2, and PT3-1 were tested once at MWD. PT4-1 was tested twice under this condition. Figure 36 shows the variation in moisture content value with respect to location along the tube for PT4-1 mixed at MWD.

Figure 36—Variation of moisture content with respect to position along tube for material PT4-1 mixed at MWD

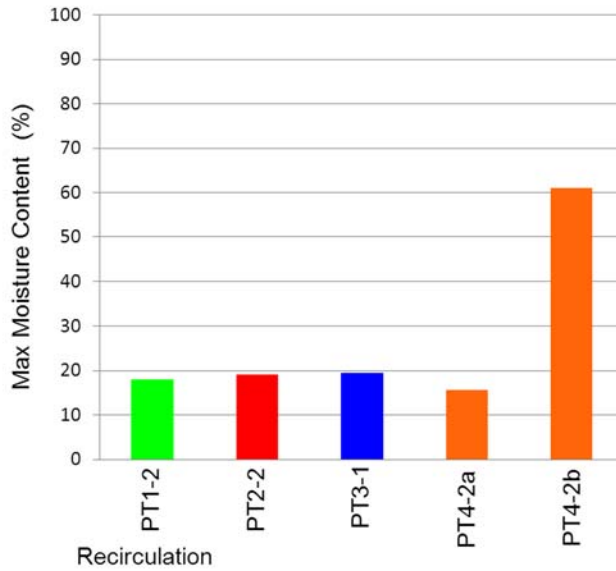
Moisture content samples for the constricted tube were collected on both ends of both constrictions and at the top of the incline. Figure 38 shows the maximum moisture content measured at any of these locations for each test. Results indicate that the PT4-2 had high moisture content relative to the other results, indicating soft grout. Figure 39 shows the variation in moisture content with respect to position along the tube for material PT4-2 in the non-recirculation case.

Figure 38—Maximum moisture content measured for all grouts with constricted tubes

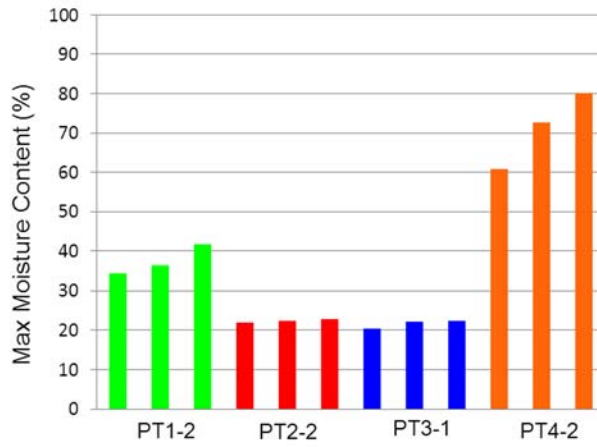
Figure 41—Maximum moisture content measured in tube for all grouts at 1.15-MWD

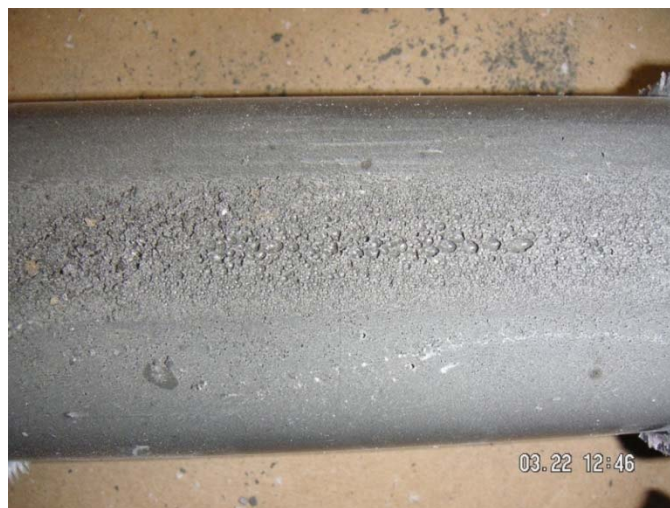
When mixed at MWD, PT1-2 exhibited a smooth surface in the bottom half of the tube, and a porous surface in the top half of the tube (Figure 50). The bubbles on the top half of the tube did not extend into the grout beyond what was visible on the surface.

Figure 50—Porous surface observed in top half of tube containing PT1-2 at MWD

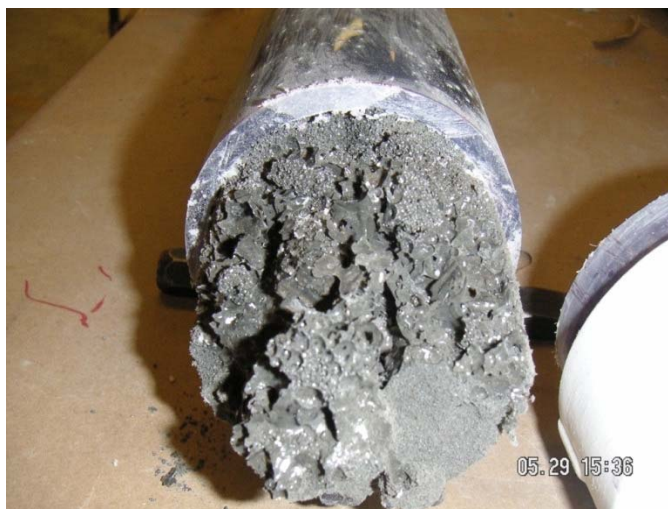
At 1.15·MWD, PT1-2 exhibited a much more porous surface than it had at MWD. This was specifically noted in the samples collected at the top of the tubes (Figure 51).

Figure 51—Porous grout observed in PT1-2 at 1.15·MWD

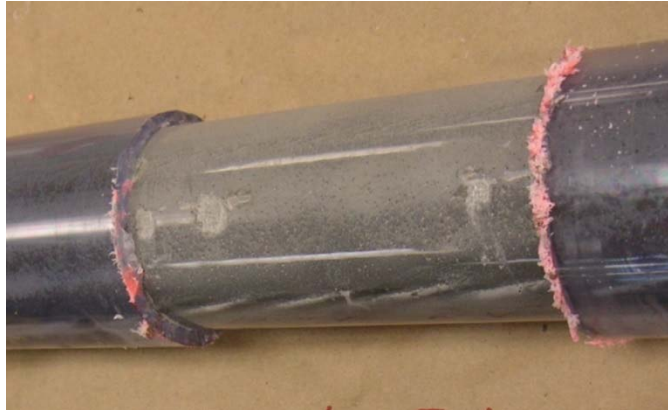
When the MITT was conducted on PT2-2 at MWD, the grout surface was found to be fairly smooth around the circumference. Figure 52 contains a photo showing the surface of the grout under this condition.

Figure 52—Smooth grout surface observed in PT2-2 mixed at MWD

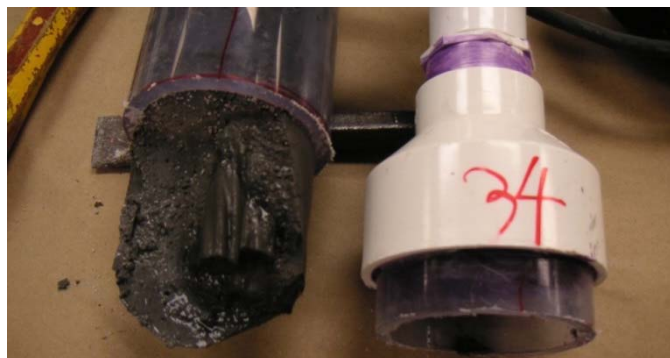
A set of three MITT were conducted on PT2-2 at 1.15-MWD. In each case, during sampling, the surface of the grout everywhere but the top of the tube was smooth as it was under when mixed with MWD. Bleed water was observed in each case when the tube was cut open at the top, but no soft grout was found even though it appears soft in Figure 53.

Figure 53—Grout at top of tube when PT2-2 at 1.15-MWD

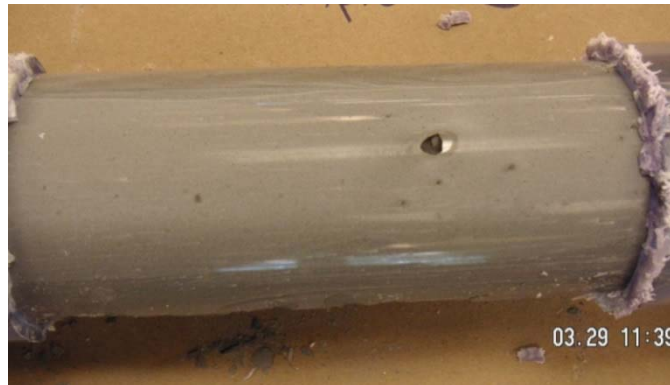
When MITT was conducted on PT3-1 mixed at MWD, the grout surface was found to be smooth around the circumference with some smaller and one larger air bubble (Figure 54).

Figure 54—Smooth grout surface with air bubble observed in PT3-1 mixed at MWD

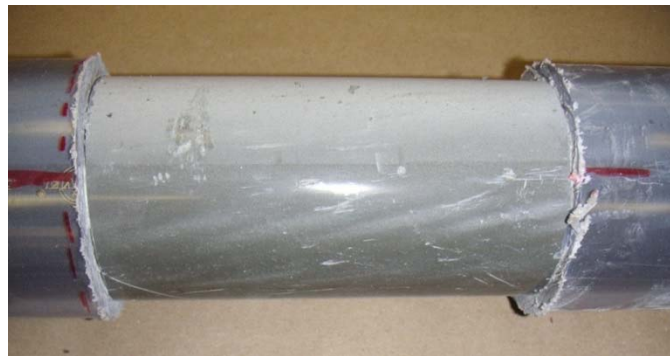
Figure 55—Surface of PT4-1 at MWD. Top half is lighter than bottom half

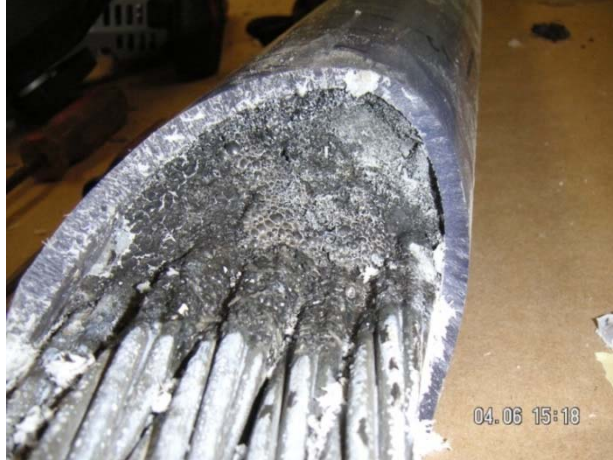
Figure 56—Grout containing air bubbles found at top of tubes containing PT4-1 mixed at MWD

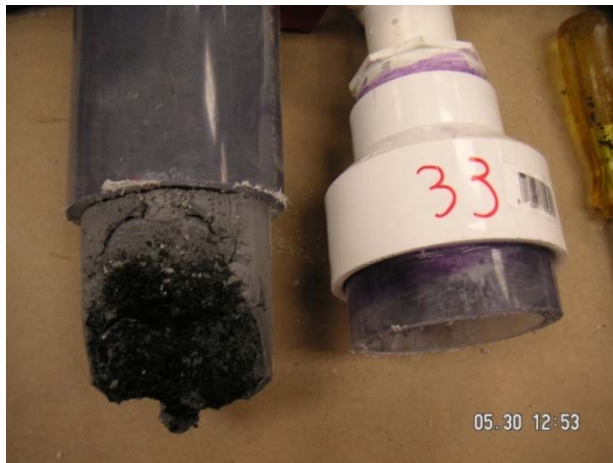
Figure 57—Black material and soft grout found in tubes injected with PT4-2 mixed at 1.15·MWD

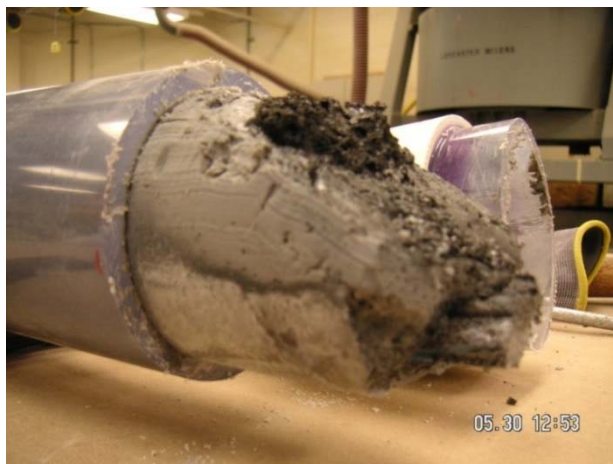
The soft grout could be sampled by moderate scraping. In each case, there was layer of black material found on top of the soft grout. Figure 58 contains another photograph of the soft grout with the black material on the surface.

Figure 58—Soft grout and black material found in tubes injected with PT4-2 mixed at 1.15·MWD

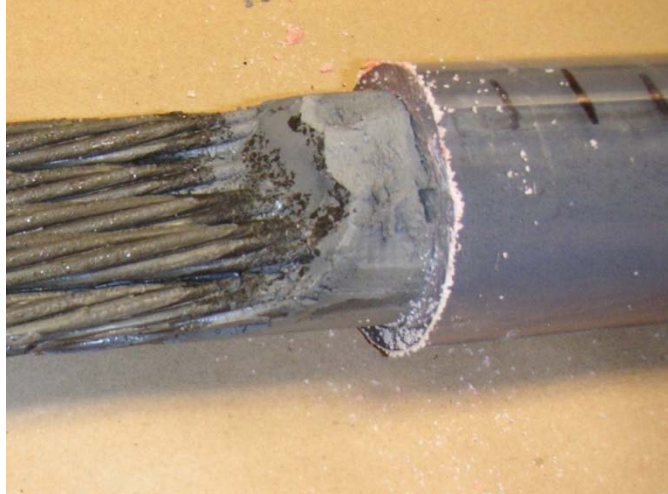
Similar results were found for the tubes injected with PT4-1 and PT4-2 when the tubes were filled with 2 gallons of water prior to injection. In each case, the grout along the length of the tube was hard. The grout at the top of the tube, however, was soft. Very similar results were found in the case when PT4-1 was injected with 2 gallons of water in the grout hose. Figure 60 contains a photograph showing the soft grout discovered at the top of the tube in which the grout hose was filled with 2 gallons of water prior to injection.

Figure 60—Soft grout found at top of tube containing PT4-1 in which the grout hose was filled with 2 gallons of water prior to injection

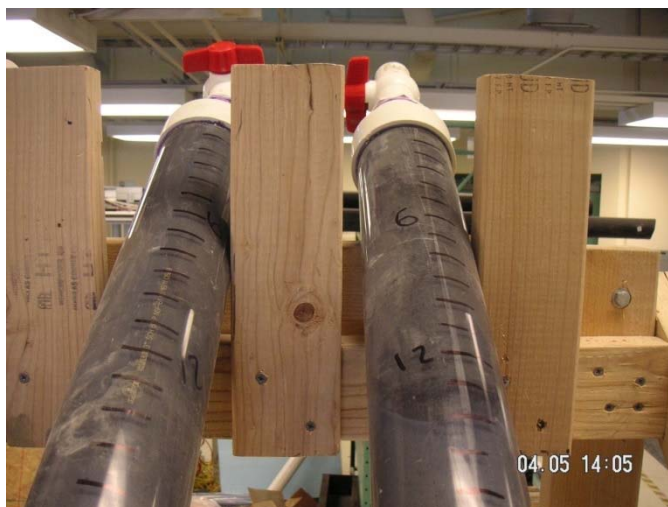
Figure 64—Opaque PVC fittings used on end of inclined tubes

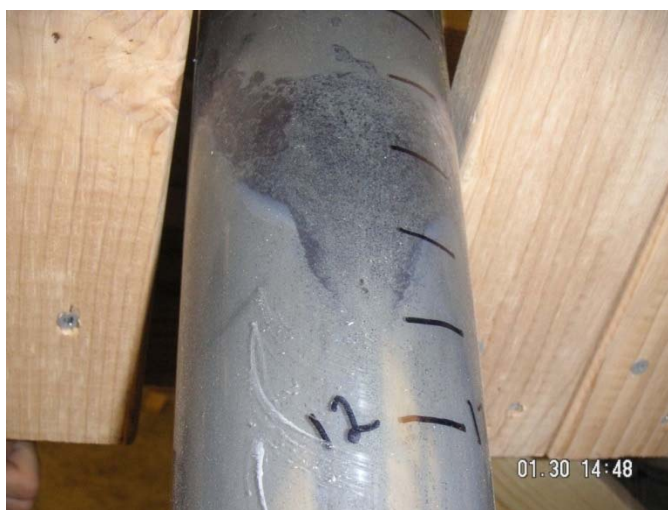
Figure 65—Grout coating interior wall of clear PVC tube

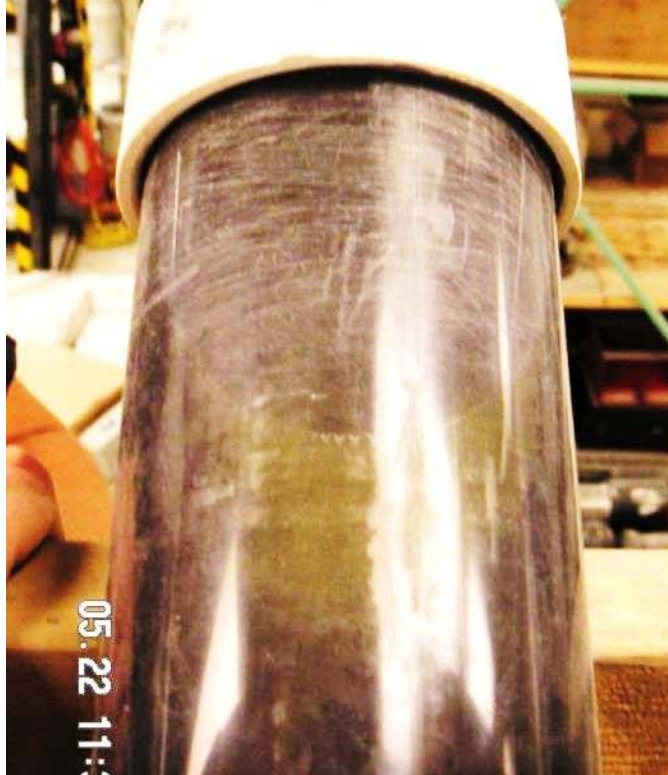
Figure 66—Bleed water visible in PT2-2 24 h after injection

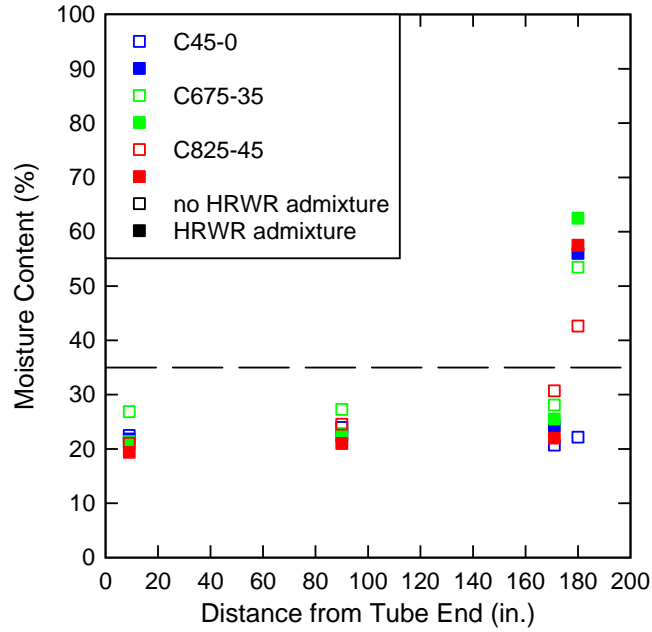
Figure 77—Moisture content for C45-0, C675-35, and C825-45

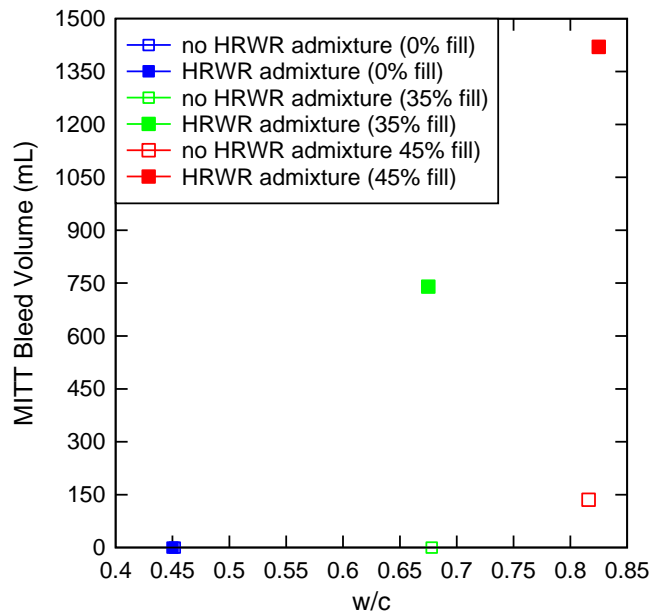
Figure 78—Bleed water for mixes with and without HRWR

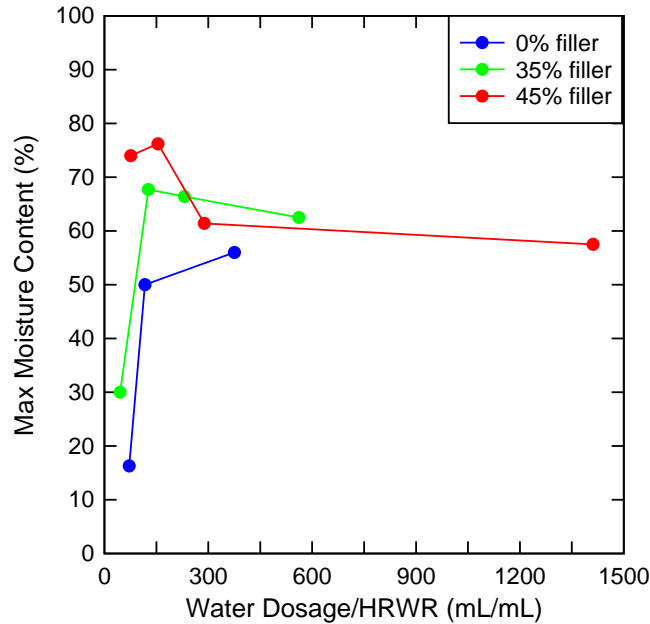
Figure 81—Maximum moisture content versus water/HRWR ratio

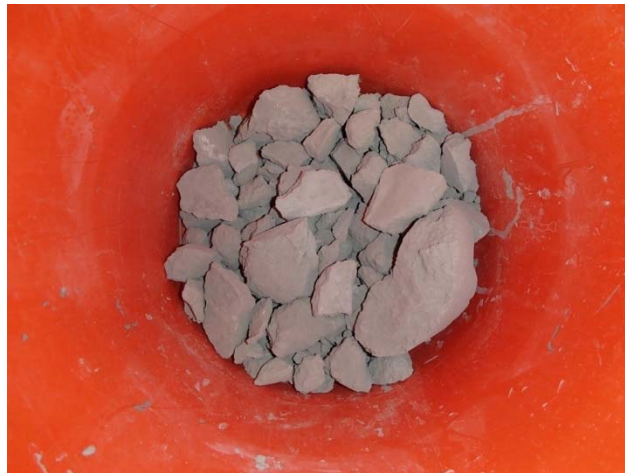
Figure 93—Pre-hydrated grout chunks removed before mixing

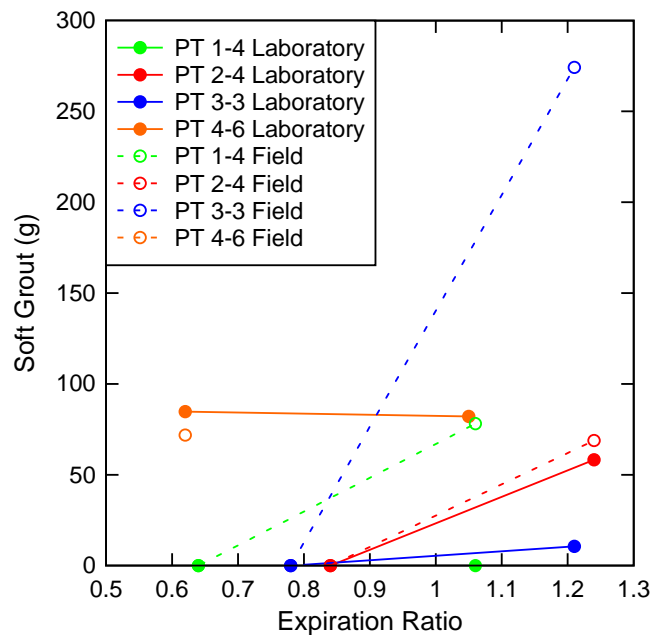
Figure 94—Mass of soft grout collected during MITT for expired and unexpired grout in *Laboratory* and *Field* conditions

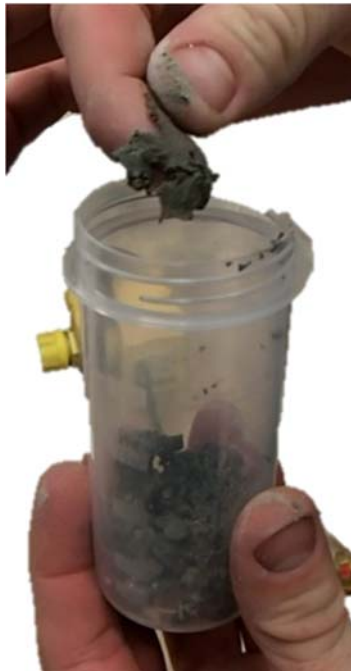
Figure 107—Moist clay like soft grout with darker coloration

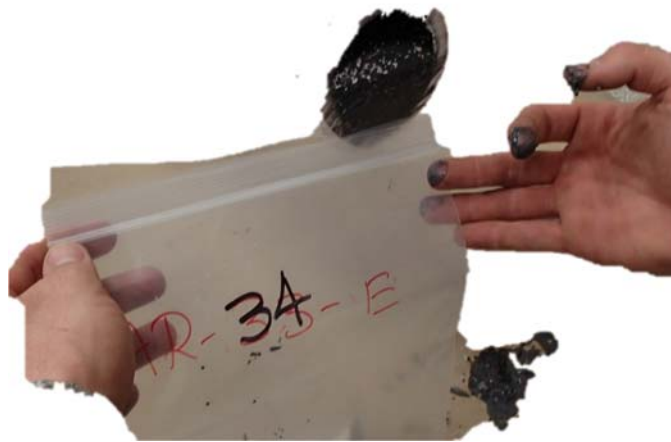
Figure 108—PT4-6 Soft Grout

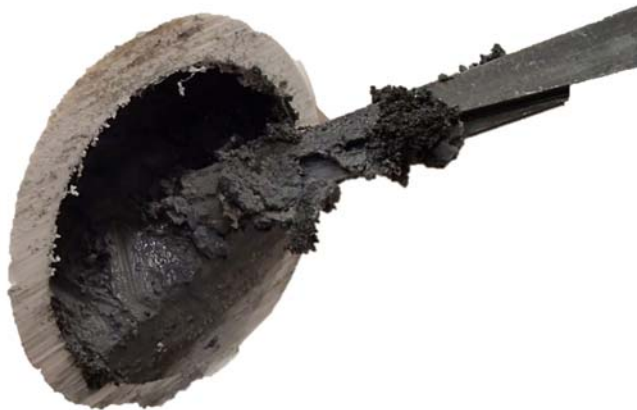
Figure 109—PT4-6 soft grout

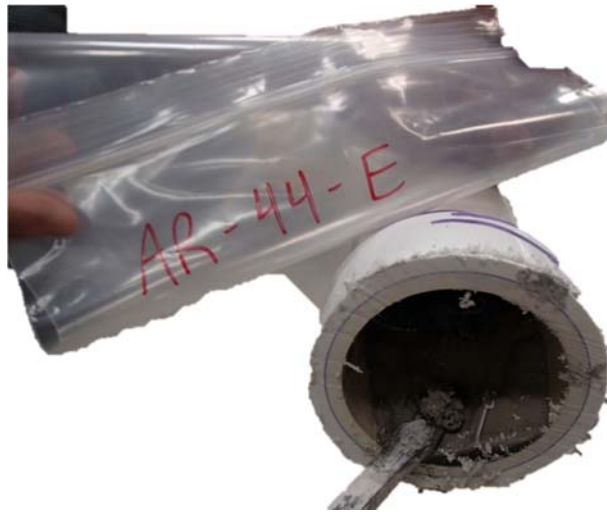
Figure 110—C675-45 soft grout

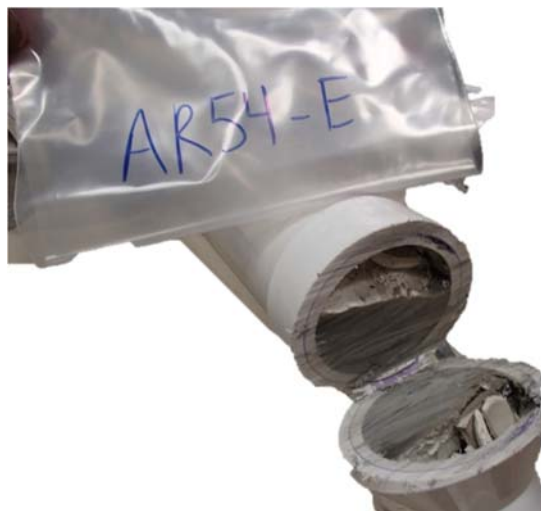
Figure 111—C35-0 soft grout

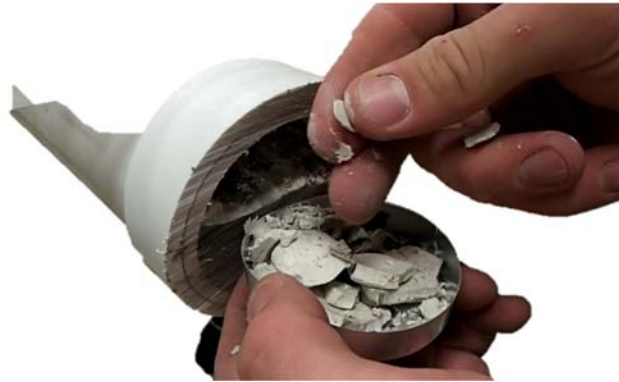
Figure 112—C35-0 soft grout

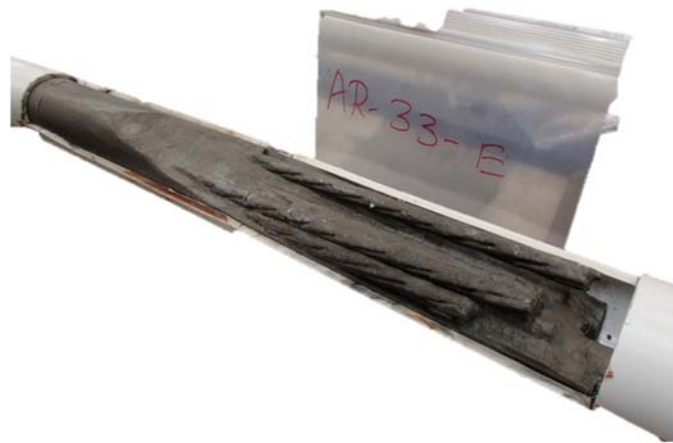
Figure 114—C675-35 large void due to bleed water
