# Simulation of Prepackaged Grout Bleed under Field Conditions

**Revised Draft Final Report**

**April 2014**

Department of Civil and Coastal Engineering  
University of Florida  
P.O. Box 116580  
Gainesville, Florida 32611

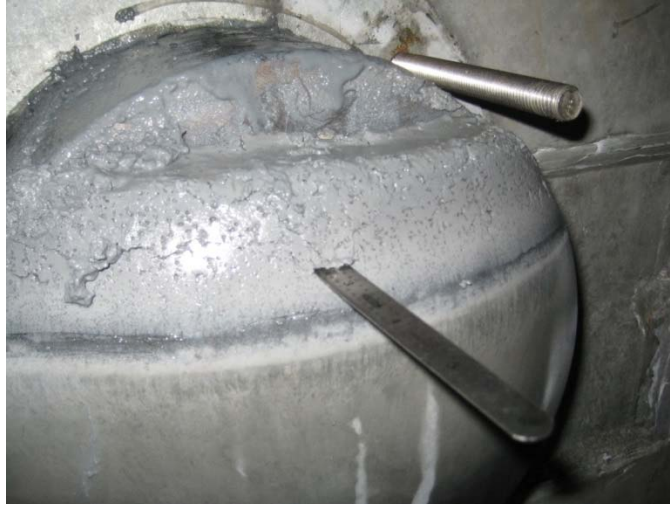
Problems have been discovered with the grout in several bridges around the state of Florida. In these bridges, the grout was found to be soft (unhydrated) and contain high levels of moisture and potentially damaging chemicals several years after construction was complete. Figure 2 shows an example of unhydrated material that accumulated under the cap on PT anchor. The texture of the grout is similar to wet clay. Soft grout samples can be collected by gently scraping the material and moisture contents are typically 50-80%.

Figure 2—Soft grout sample identified in field by FDOT

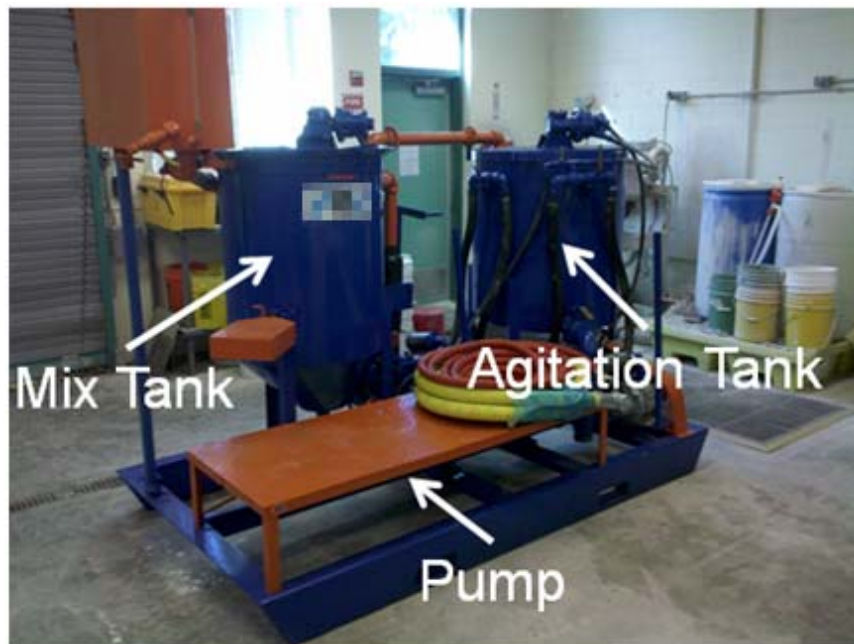
Figure 6 shows the grout plant used to prepare grout mixtures for testing. The plant was equipped with a centrifugal diffuser-type pump rotating at speeds up to 2,000 RPM (209 rad/s) to encourage dispersal and complete wetting of fine cementitious particles. The agitator tank was equipped with a variable speed paddle mixer that prevents the grout from building structure before it is pumped. The grout pump, connected directly to the agitator tank, was a three stage progressing cavity, positive displacement, rotor-stator pump. Two grout plant models were used in this research. While mixing, agitation and injection components were similar, one plant was powered by compressed air and the other was electric/hydraulic.

Figure 6—Colloidal grout plant with various parts labeled

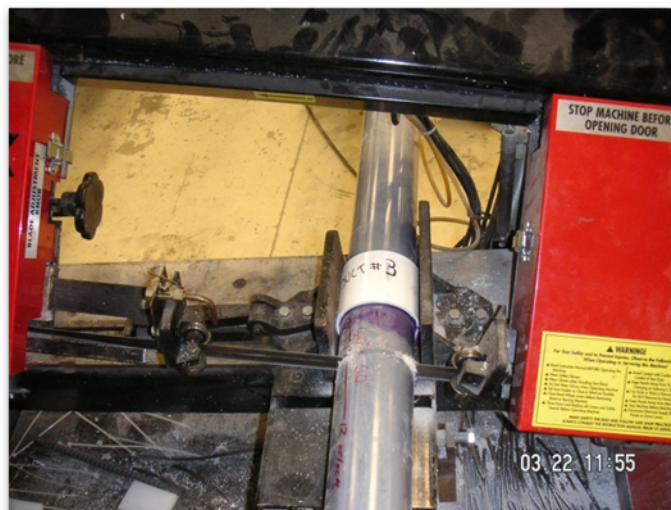
After the grout had been allowed to set for at least 24 h, samples were collected along the length of the tube. Early in the testing program, each tube was generally sampled in 4 to 5 locations along its length. When possible, the grout in the fitting at the very top of the tube was sampled as well. First, the tubes were cut into three 5 ft long sections for handling and storage on a band saw (Figure 12). The cuts passed through the tube, grout and strand and required a special bi-metal blade that required frequent replacement. The cut tube sections were labeled with flow direction, 12 o'clock position, and dimensions.

Figure 12—Saw-cut tubes for sampling

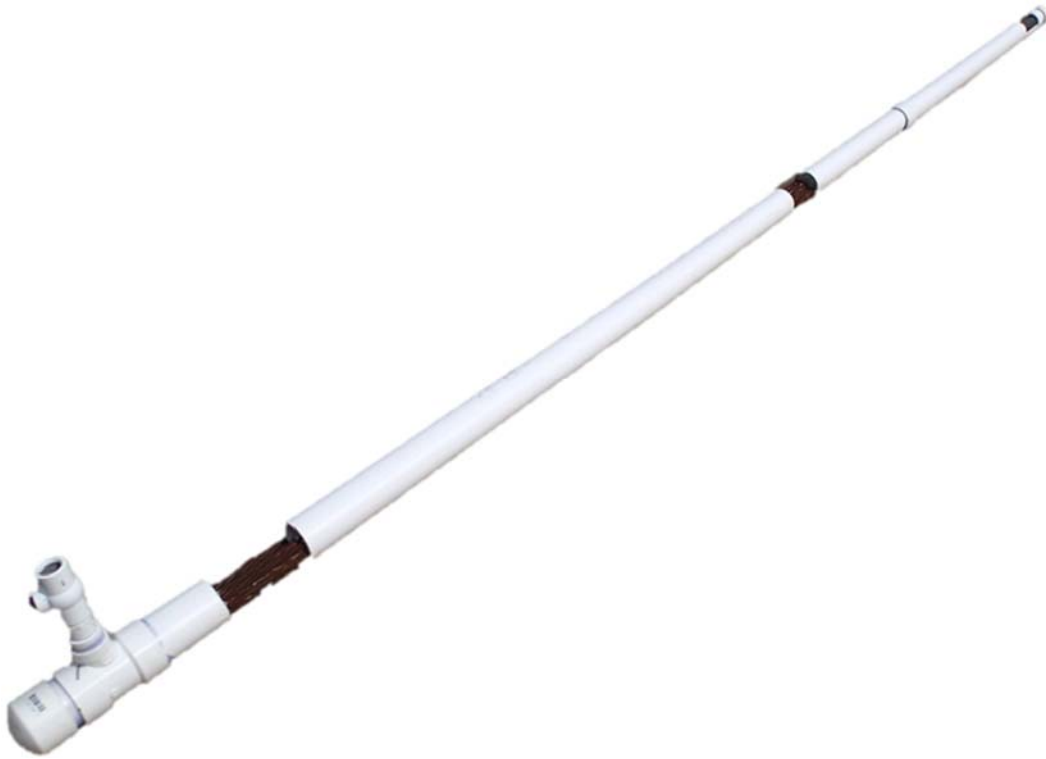
moisture content of the grout and to recover soft grout that might be present. Figure 15 shows an example inclined test tube after sampling. Strand surface is corroded due to outdoor exposure that occurred after sampling and was not due to exposure to the PT grout. The base and mid-height of the inclined tube were sampled by cutting and removing the PVC tube over a length of approximately 6-in (Figure 16). Grout samples were then taken from around the strand bundle without the need to cut the strand. At the top of the incline, grout is more easily sampled due to lack of strand near the top. Samples are taken in two locations: one under the end cap and over a 6-in. length near the end of the strand bundle. Because the primary focus of the inclined testing was on measurement of soft grout and moisture content, opaque tubes were used to reduce testing costs. Figure 19 shows the specimen construction along with the sampling locations.

Figure 15—Sample locations for MITT

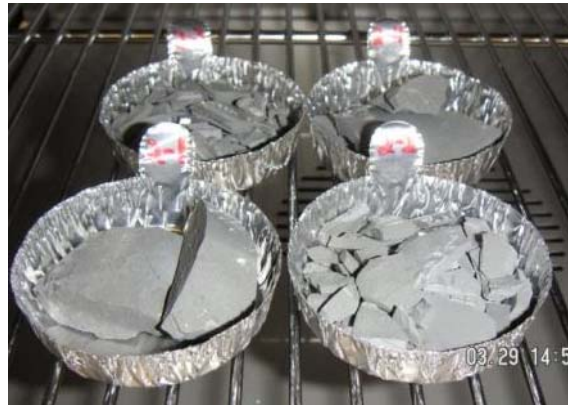
4. Moisture content is defined as the difference between initial weight and dry weight divided by initial weight.

Figure 18—Grout samples drying in oven for moisture content test

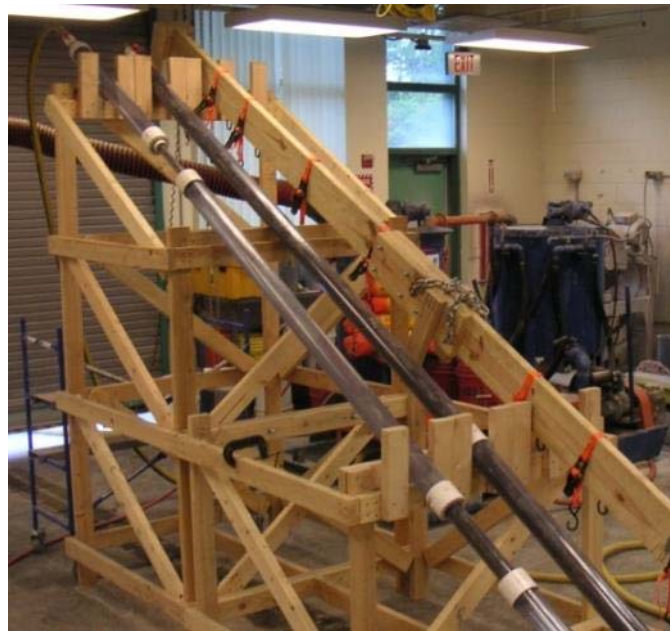
Post-tensioning ducts may have constrictions due to anchorages or couplings, which may force grout through a tortuous path and perhaps result in a mechanical filtering of large particles, causing different behavior in the fluid or hardened grout. To simulate the effect of these constrictions the inclined tube specimen was redesigned with a series of smaller diameter sections (Figure 19). To further enhance the constriction, the reduced-diameter sections were packed full with 7-wire strand. Some of the 7-wire strand was separated into individual wire and packed into the constrictions in order to create the tightest fit possible. No strand was placed in the remainder of the specimen.

Figure 19—Inclined tube specimen modified with constrictions  
(a) schematic (b) compared to typical specimen.

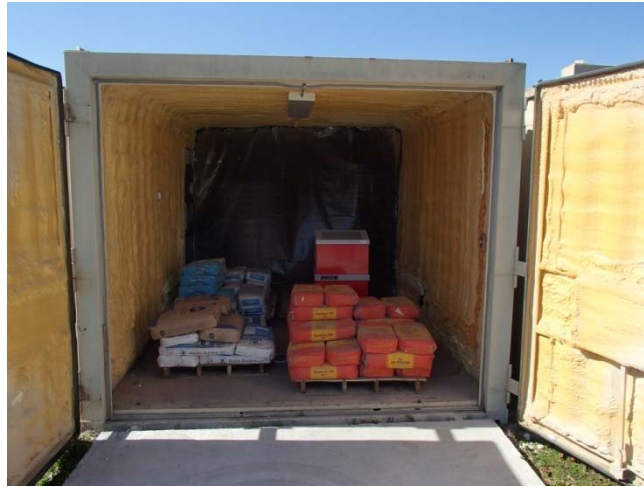
conditions are typically kept at 75°F with approximately 50% RH. PT grout bags were stacked on pallets and left undisturbed until they were removed from storage for mixing and testing. The bags were left intact and in the same position on the pallets as delivered. This environment was expected to be the most suitable of the three and ultimately produce the most consistent PT grout mixtures under modified inclined tube testing.

Figure 20—*Laboratory storage condition*

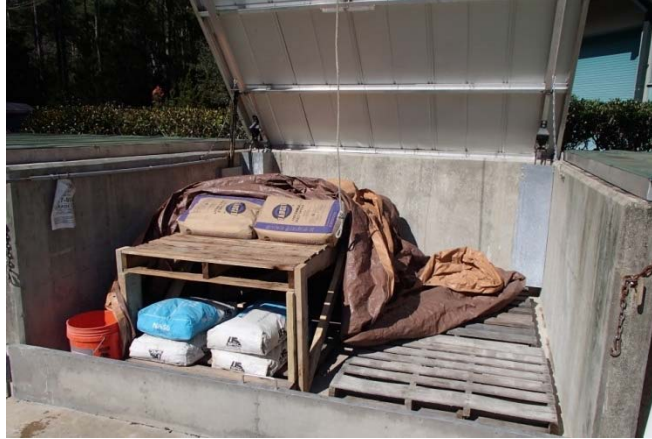
A bulk aggregate storage bin on the FDOT State Materials Office Site was used for the *Field* storage condition (Figure 21). The bins are fitted with permanent retractable covers that protected the PT grout from rainfall and direct sun, but leave the grout exposed to ambient temperature and humidity. This form of storage might be considered “dry” and thus in accordance with some manufacturer’s recommendations. These conditions were chosen to reflect uncontrolled field storage conditions on a construction site during summer in Florida. PT grout was stacked on pallets inside the chamber and left undisturbed until they were removed from the chamber for mixing and testing. The bags were left intact and in the same position on the pallets as they arrived when received from shipping. It was noted during testing that the bags closer to the bottom of the pallet had pre-hydrated considerably more than those near the top of the pallet. In a heavy downpour, rainwater collected under the pallets. Although the grout did not have direct contact with the rainwater, high heat and evaporation were likely to increase the humidity in the storage area. During the exposure period from June 2013 to November 2013, the average monthly conditions are shown in Table 7.

Figure 21—*Field* storage condition

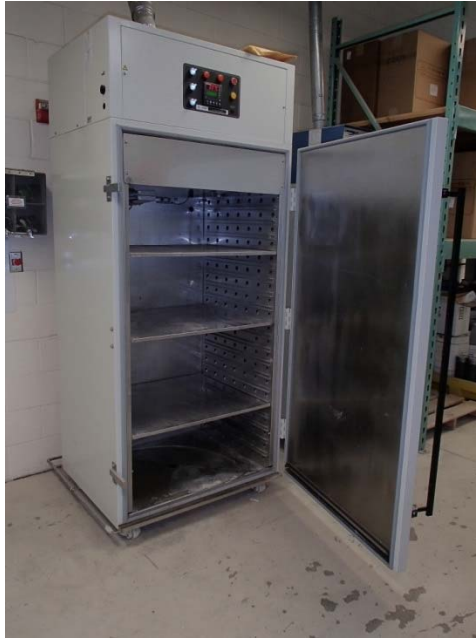
Figure 22—*Extreme storage condition*

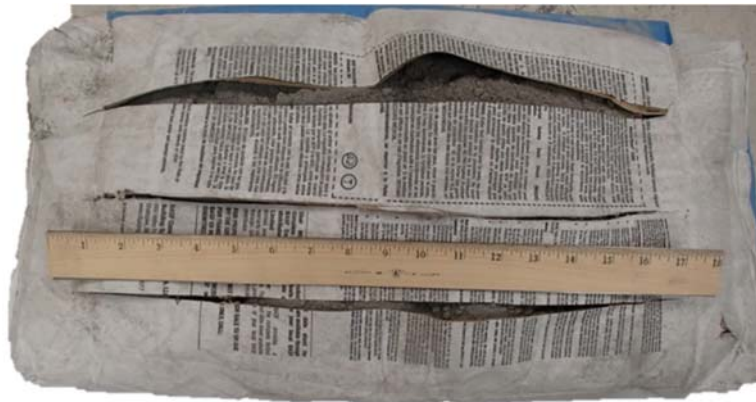
Figure 23—Cut bag before placement into incubator

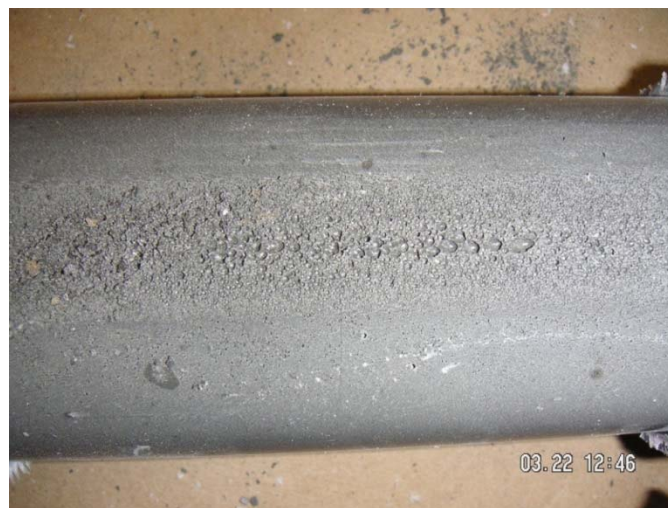
When mixed at MWD, PT1-2 exhibited a smooth surface in the bottom half of the tube, and a porous surface in the top half of the tube (Figure 50). The bubbles on the top half of the tube did not extend into the grout beyond what was visible on the surface.

Figure 50—Porous surface observed in top half of tube containing PT1-2 at MWD

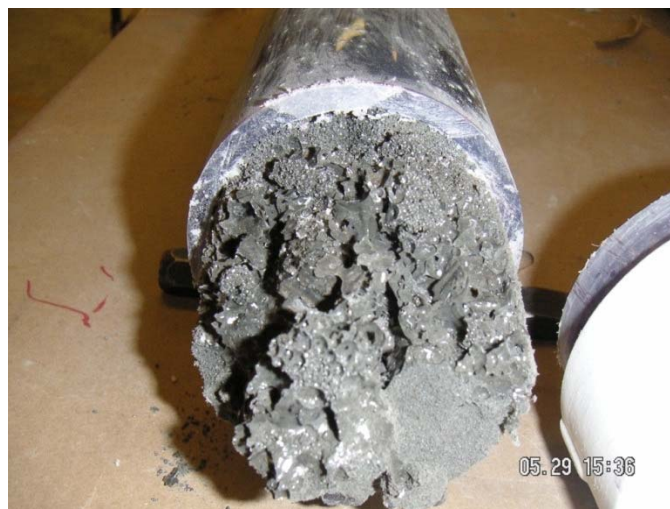
At 1.15·MWD, PT1-2 exhibited a much more porous surface than it had at MWD. This was specifically noted in the samples collected at the top of the tubes (Figure 51).

Figure 51—Porous grout observed in PT1-2 at 1.15·MWD

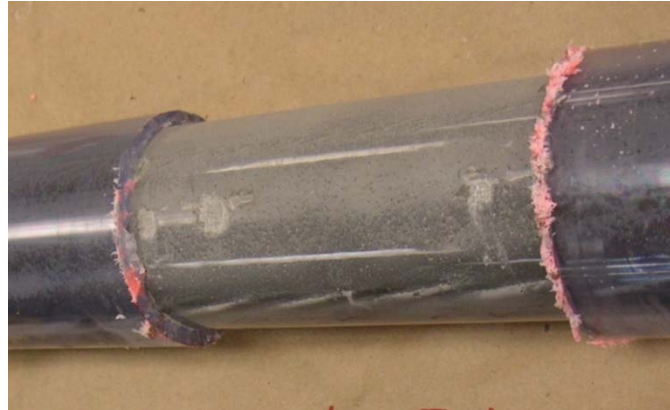
When the MITT was conducted on PT2-2 at MWD, the grout surface was found to be fairly smooth around the circumference. Figure 52 contains a photo showing the surface of the grout under this condition.

Figure 52—Smooth grout surface observed in PT2-2 mixed at MWD

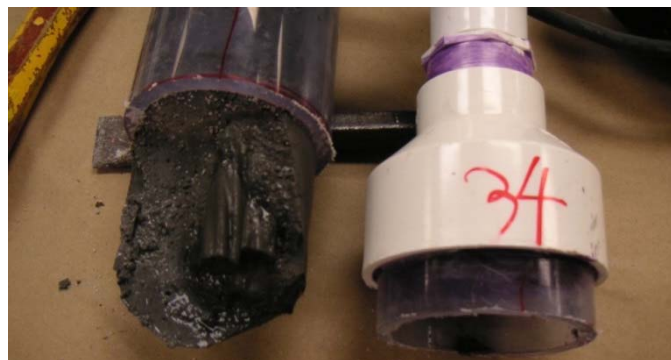
A set of three MITT were conducted on PT2-2 at 1.15·MWD. In each case, during sampling, the surface of the grout everywhere but the top of the tube was smooth as it was under when mixed with MWD. Bleed water was observed in each case when the tube was cut open at the top, but no soft grout was found even though it appears soft in Figure 53.

Figure 53—Grout at top of tube when PT2-2 at 1.15·MWD

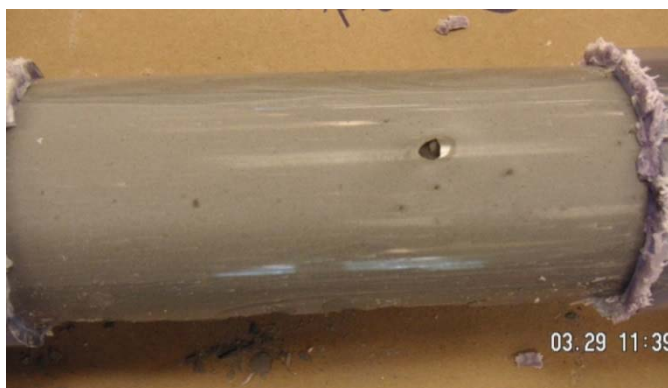
When MITT was conducted on PT3-1 mixed at MWD, the grout surface was found to be smooth around the circumference with some smaller and one larger air bubble (Figure 54).

Figure 54—Smooth grout surface with air bubble observed in PT3-1 mixed at MWD

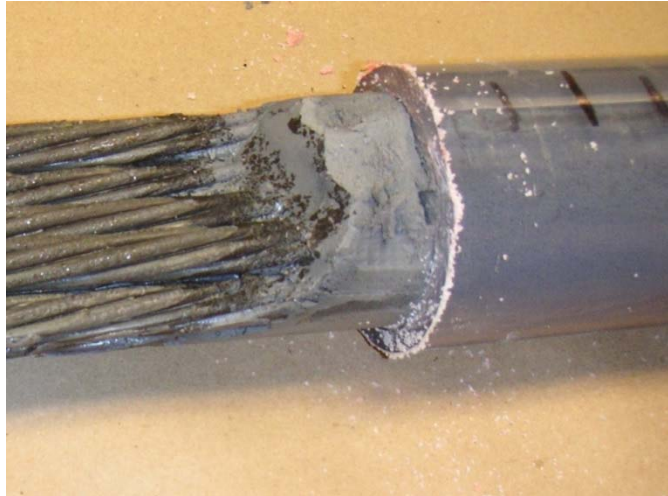
Similar results were found for the tubes injected with PT4-1 and PT4-2 when the tubes were filled with 2 gallons of water prior to injection. In each case, the grout along the length of the tube was hard. The grout at the top of the tube, however, was soft. Very similar results were found in the case when PT4-1 was injected with 2 gallons of water in the grout hose. Figure 60 contains a photograph showing the soft grout discovered at the top of the tube in which the grout hose was filled with 2 gallons of water prior to injection.

Figure 60—Soft grout found at top of tube containing PT4-1 in which the grout hose was filled with 2 gallons of water prior to injection

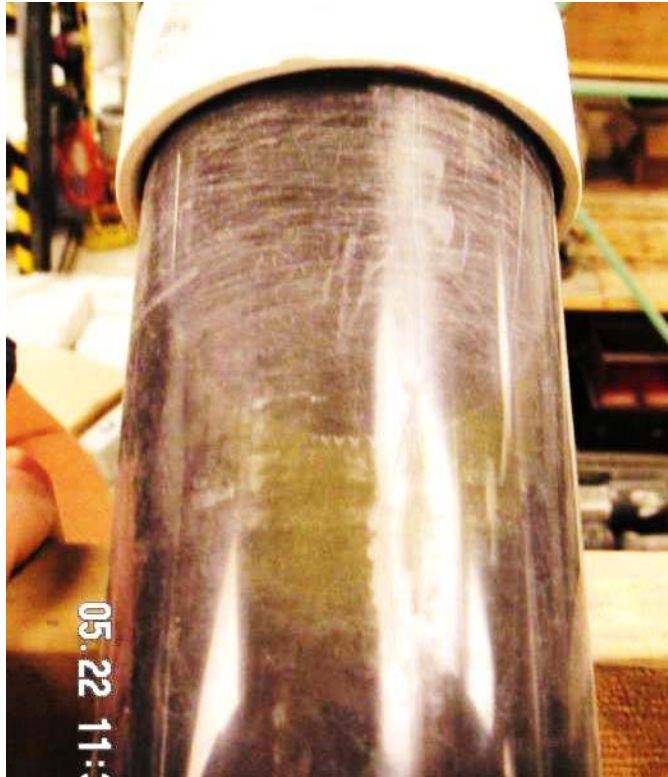
Figure 66—Bleed water visible in PT2-2 24 h after injection

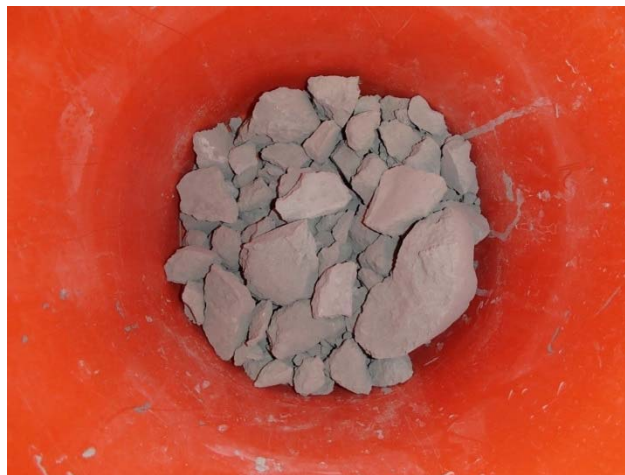
Figure 93—Pre-hydrated grout chunks removed before mixing

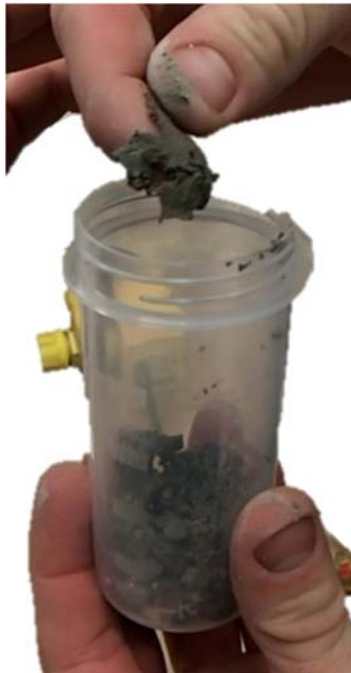
Figure 107—Moist clay like soft grout with darker coloration

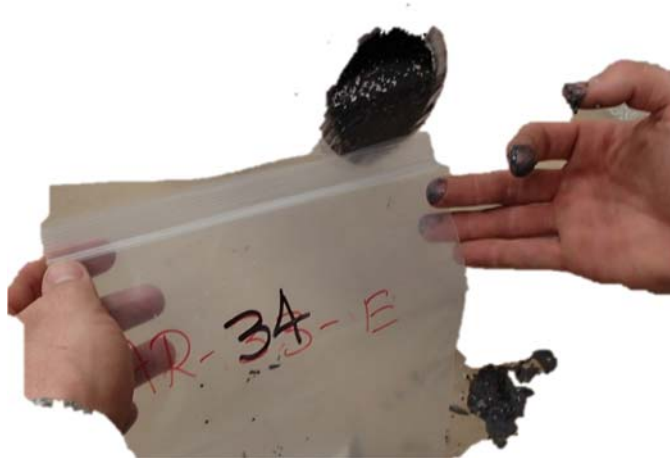
Figure 108—PT4-6 Soft Grout

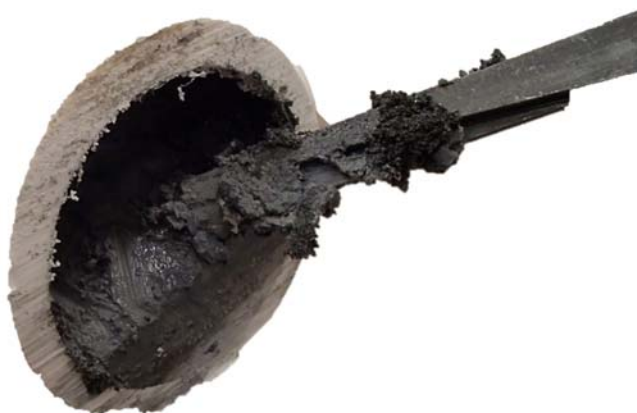
Figure 109—PT4-6 soft grout

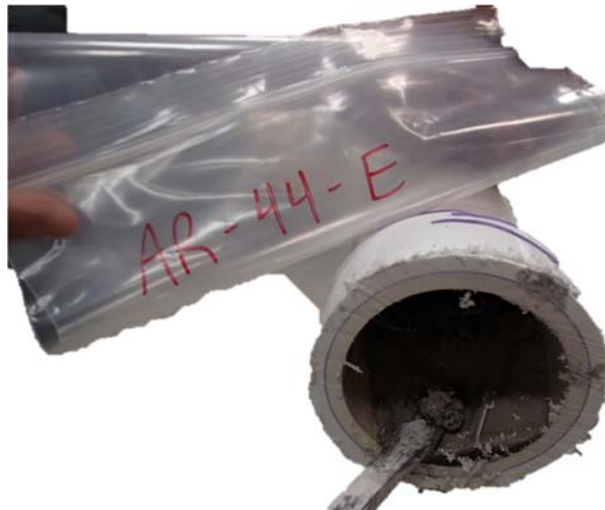
Figure 110—C675-45 soft grout

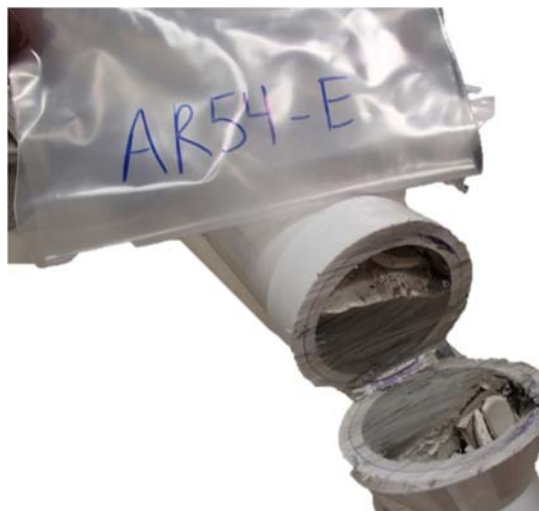
Figure 111—C35-0 soft grout

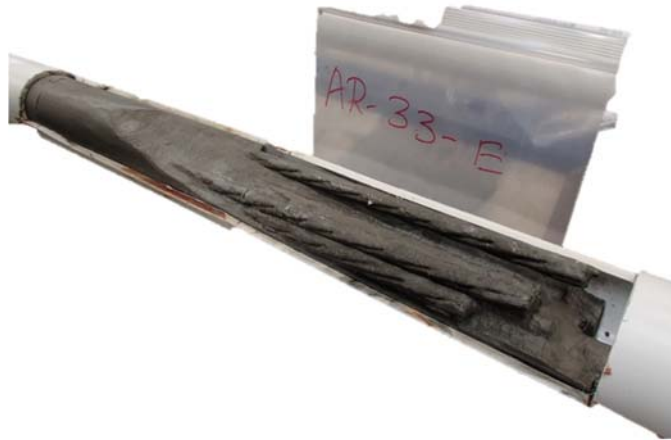
Figure 114—C675-35 large void due to bleed water
